REPAIR OF IMPACT-DAMAGED PRESTRESSED BRIDGE GIRDERS WITH STRAND  
SPLICES AND FABRIC REINFORCED CEMENTITIOUS MATRIX SYSTEMS

Master of Science  
In  
Civil Engineering

June 5, 2015  
Blacksburg, Virginia

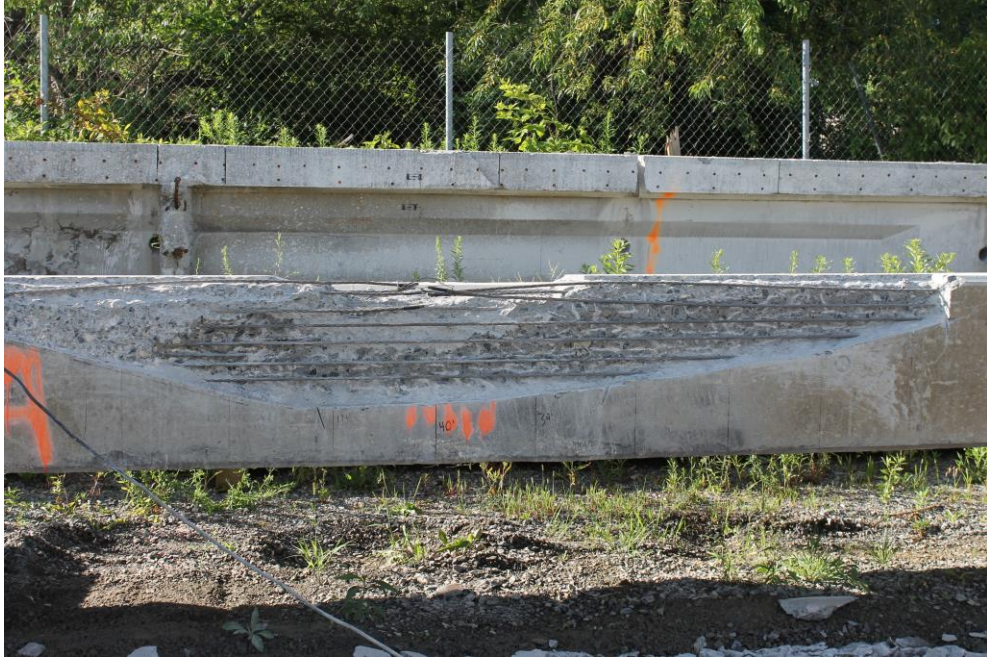
**Figure 49- Damage Location for Test 4 Before Repair**

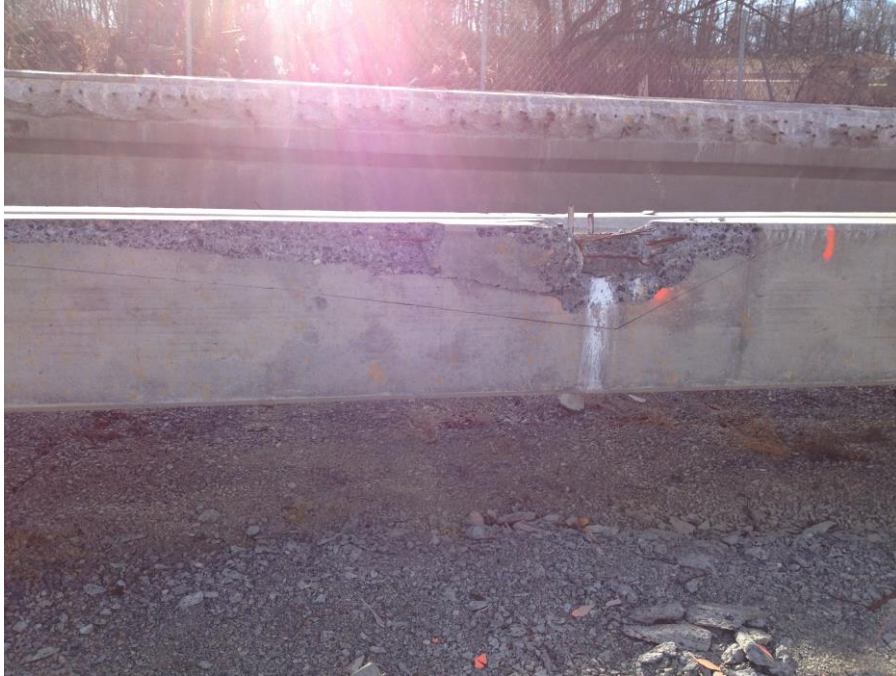
**Figure 65- Girder D after Damage from Hydraulic Hammer**

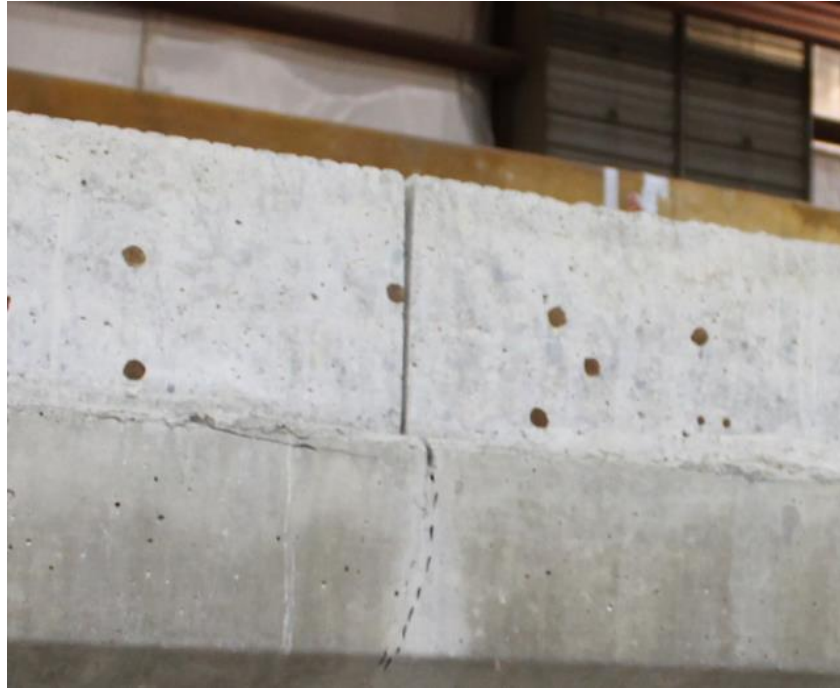
**Figure 79- Saw Cut Gaps in the Deck Concrete of Girder D**

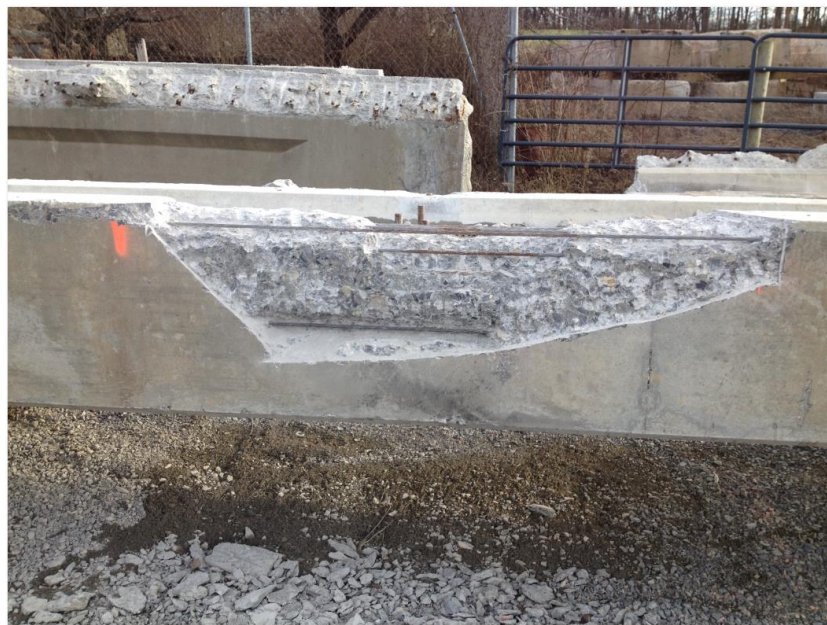
**Figure 82- Test 6 Repair area after Damage**

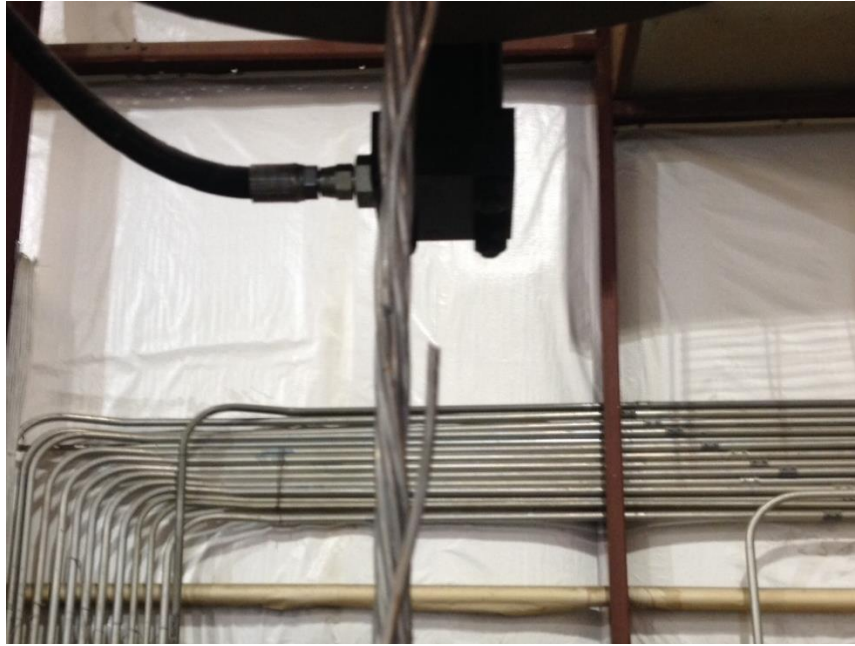
**Figure 98- Prestressing Strand Rupture at Ultimate Tensile Strength**

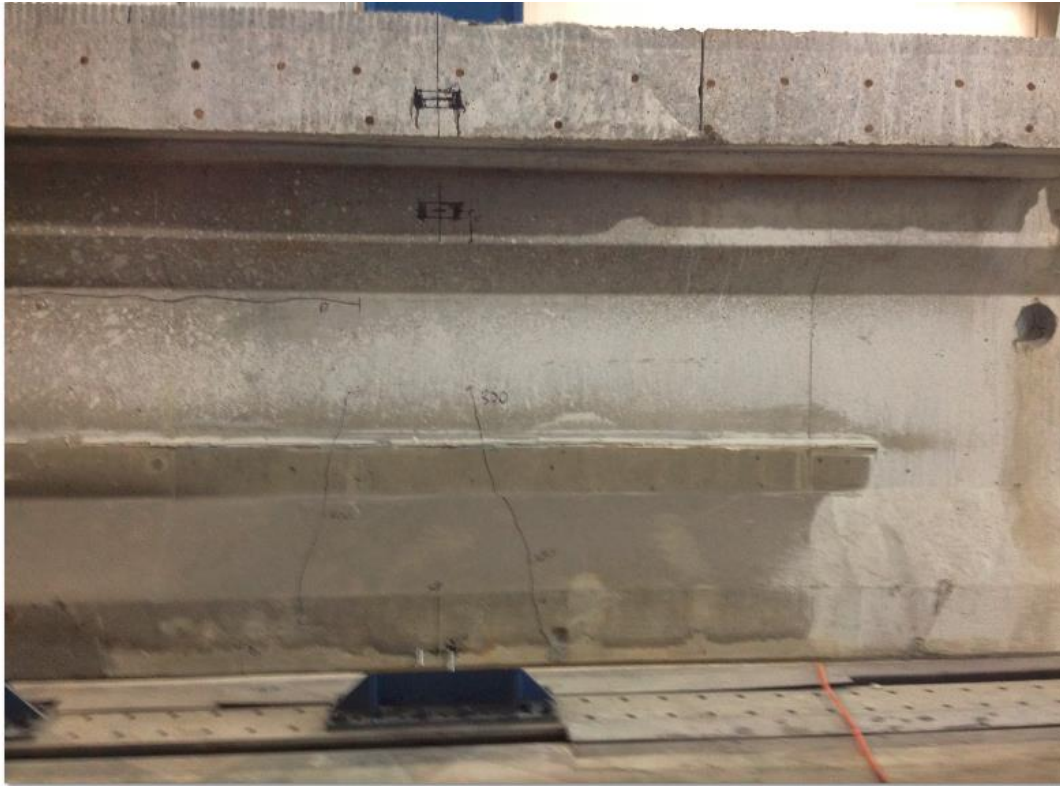
with a shear failure, though not necessarily an impending one. Flexural cracks are shown in Figure 102. The failure load predicted from non-linear finite element analysis was 403 kips with concrete crushing as the failure mode, and a deflection of 1.81 in (Gangi, 2015). Figure 103 shows the measured moment versus deflection curve and compares it to the predicted moment capacities found using AASHTO and moment-curvature. Since the girder had already cracked during the first trial, the second test trial has less stiffness as it nears the original cracking moment. Table 22 compares the cracking moment and the nominal moment obtained from the test with predictions using AASHTO, moment-curvature, and finite element modeling. This table also includes a ratio of the predicted moments divided by the experimental moments. The predictions based on each analysis method are conservative in estimating both the ultimate moment capacity and the cracking moment. The moment capacity calculated from this test was used for comparison between an undamaged girder and that damaged girders that were repaired in ensuing tests.

**Figure 102- Flexural Cracking in the Bottom Flange and into the Web**

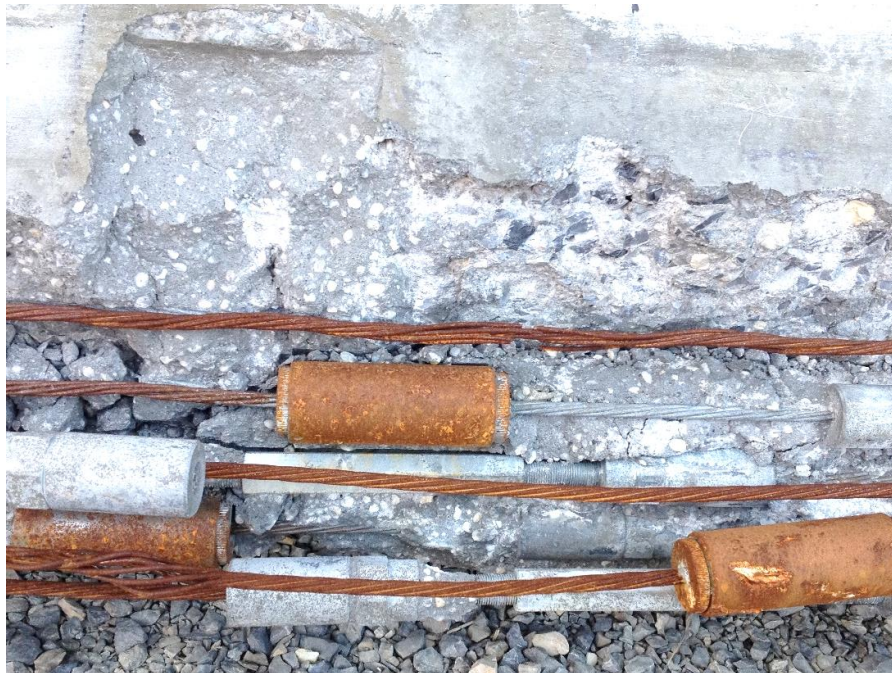
**Figure 105- Test 2 Failed Splice and Ruptured Strand**

repair concrete not being precompressed during installation. Adding a positive moment during installation of the repair material and then releasing it adds a precompressive force to the repair material and prevents premature cracking.

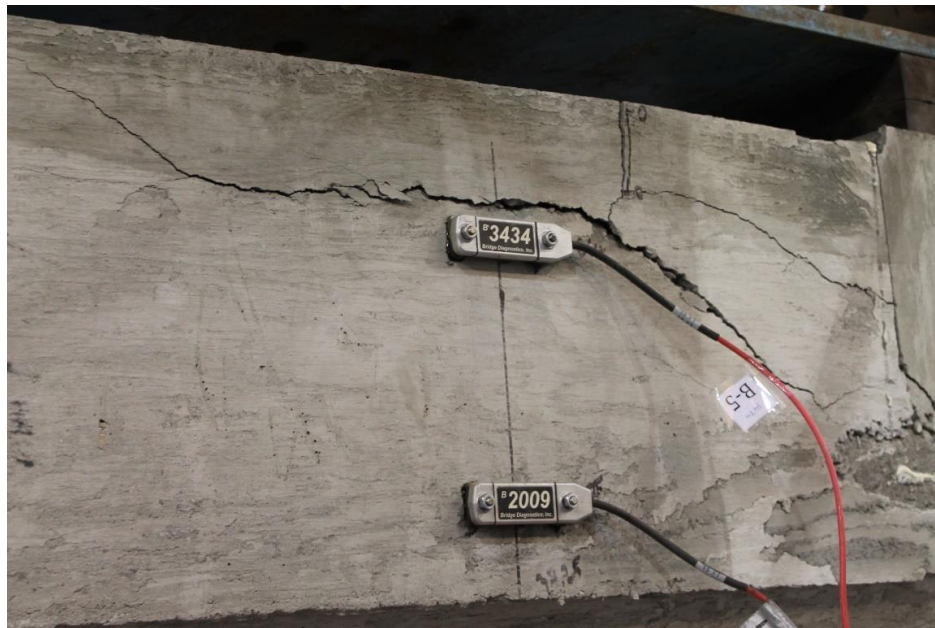
The failure mode of Test 4 was a flexural compression failure in which the concrete in the deck between the load points crushed. This failure is shown in Figure 107. Flexural cracking was observed along the bottom flange, with widening cracks as the load increased near the ultimate capacity, as shown in Figure 108 and Figure 109. After completion of the test, the repair concrete was chipped out to investigate the performance of the strand splices. The splices showed no observable slipping, rutpuring, or excessive yielding.

**Figure 107- Test 4 Flexural Compression Failure in the Deck**

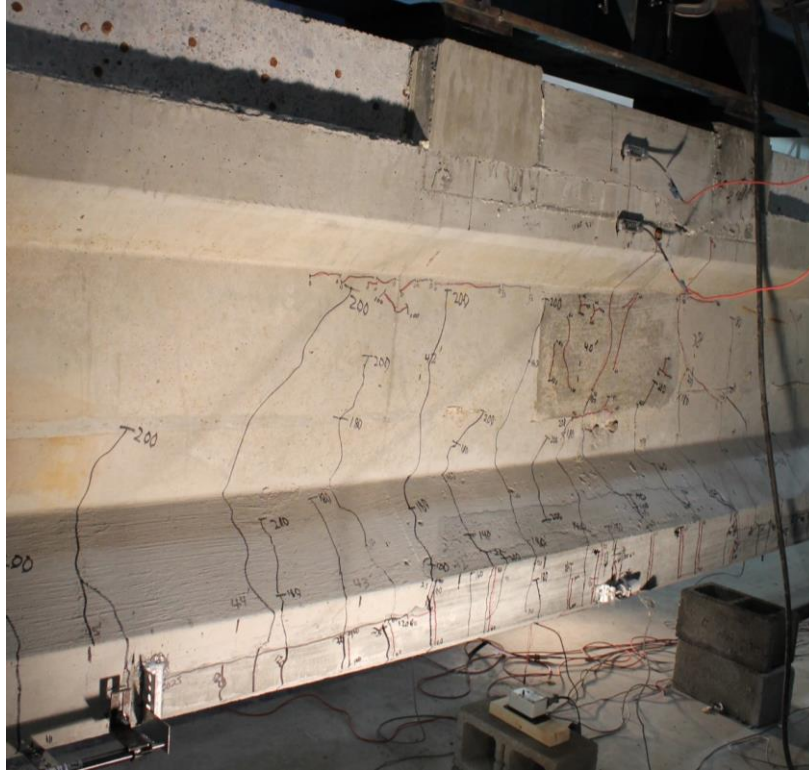
**Figure 108- Test 4 Cracking Pattern at the Load Points during Iteration 1**

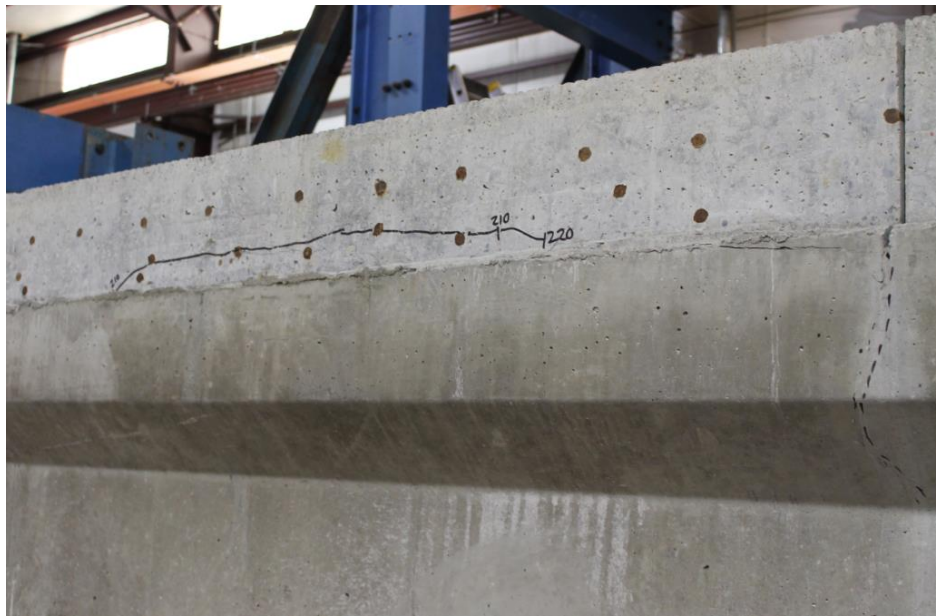
The girder failed in horizontal shear transfer due to saw cut gaps along the length of the girder from demolition of the bridge. These saw cuts split the composite deck into different lengths and restricted the deck's ability to act compositely with the girder. Cracking occurred in the deck but cracks retreated below the saw cuts into the girder, creating a stress concentration. The failure occurred suddenly with concrete crushing in the interface of the deck and the girder, shown in Figure 112.

**Figure 112- Test 5 Horizontal Shear Transfer Failure**

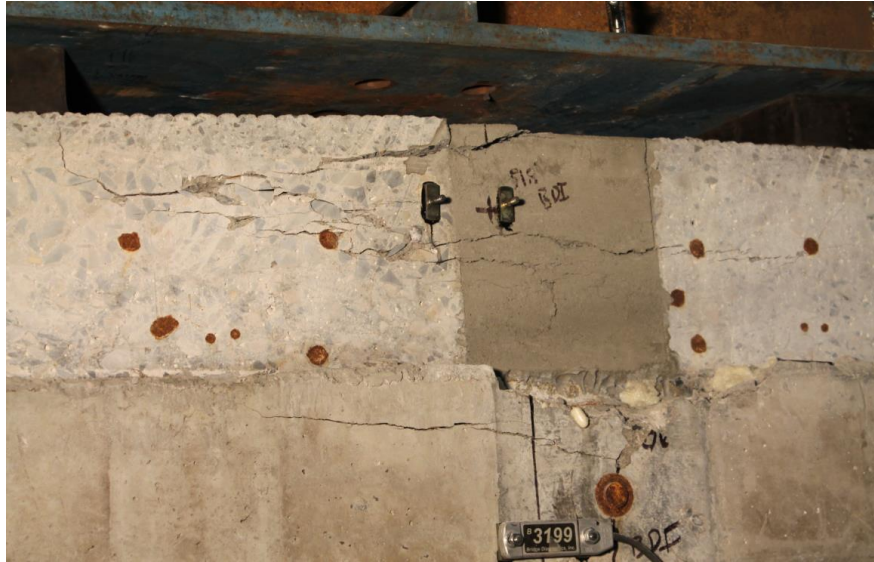
**Figure 116- Compression Failure in the Composite Deck**

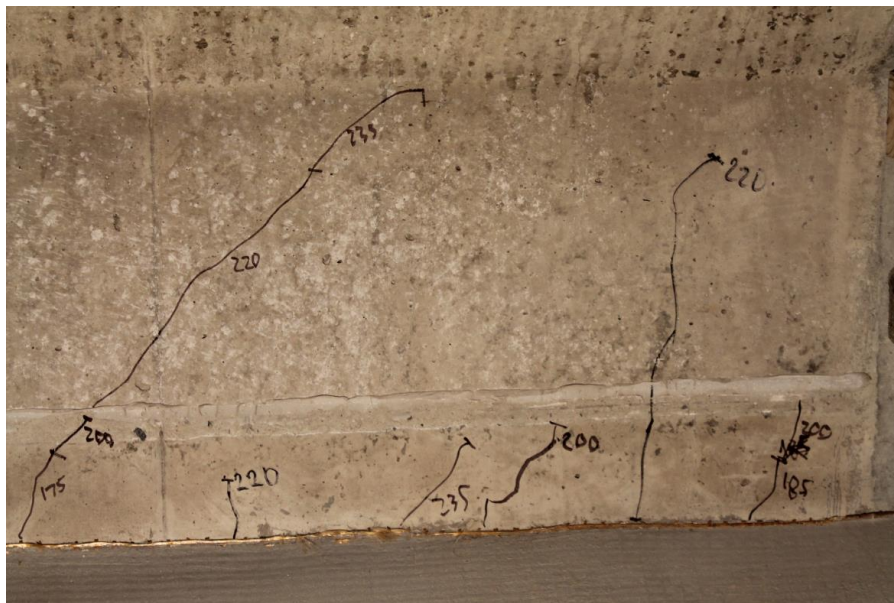
**Figure 117- Flexural Cracks Progressing up the Web**
