# Hurricane Michael in the Area of Mexico Beach, Florida

**Abstract:** Category 5 Hurricane Michael made landfall near Mexico Beach, Florida on October 9, 2018, with measured high water marks (HWMs) reaching 7.2 m NAVD88. The town itself received great damage, with many areas destroyed down to the foundations. In this study, we document the storm and its effects on the greater Mexico Beach area: hazard, structural damage, and their relationships. Wave and surge damage was nearly total for low-lying properties, but damage decreased greatly with increasing elevation. Major wave and surge damage was noted in Federal Emergency Management Agency (FEMA) X zones, which are out of the 100-year floodplain, and it is suggested that the 100-year storm is a deficient measure for categorizing flood risk. **DOI: 10.1061/(ASCE)WW.1943-5460.0000590.** This work is made available under the terms of the Creative Commons Attribution 4.0 International license, <https://creativecommons.org/licenses/by/4.0/>.

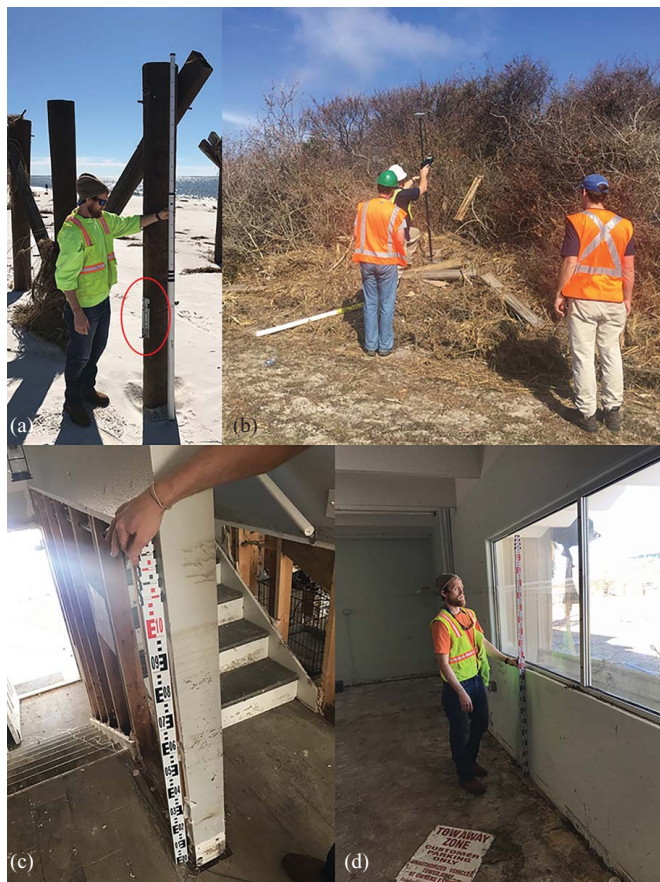
rapid gauge FLBAY03283, which was mounted on one of the pilings on the Mexico Beach Pier (Byrne 2019). The deck and almost all of the pilings seaward of the gauge were destroyed, but the gauge itself survived and provided good measurements. Fig. 2 shows a time series of the instantaneous water levels (computed using the hydrostatic assumption, and with atmospheric pressure, corrections using a nearby noninundated pressure gauge) measured every 30 s on October 10, and a 15 min average of these water levels which will be taken as the surge elevation. Fig. 3 shows the overall gauge location in Mexico Beach, and Fig. 4(a) shows a photograph of the gauge location poststorm.

**Fig. 4.** (Color) Examples of water level measurements: (a) location of USGS water level gauge at the Mexico Beach Pier, with bracket location circled; (b) highest wave runup location; and (c and d) examples of interior watermarks. (Images by authors.)

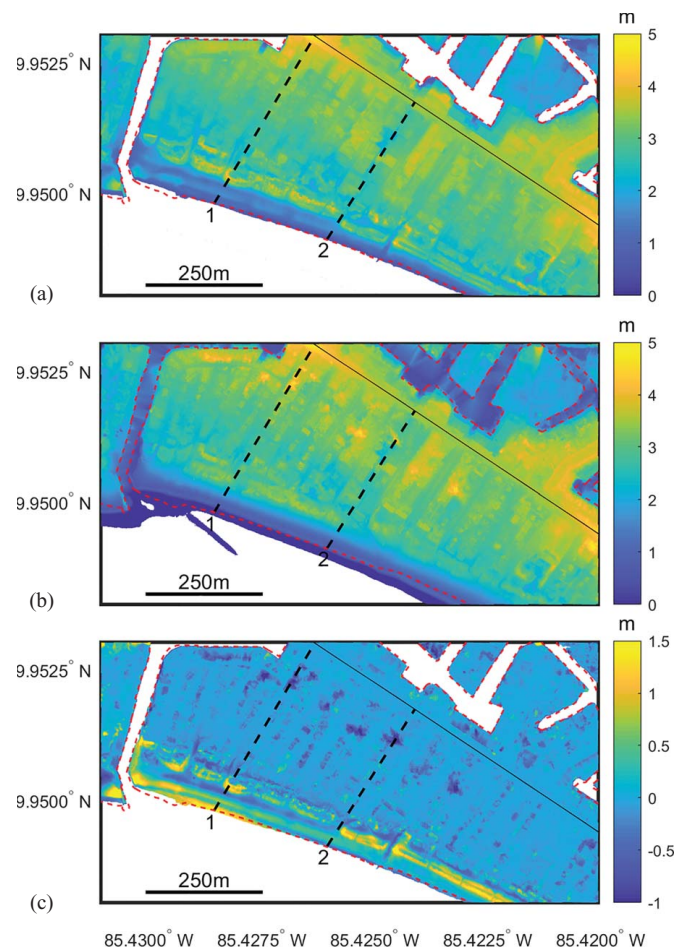
Fig. 5 shows a small but typical section of the beach and the erosion that occurred during Michael. Poststorm (October–November 2018, US Army Corps of Engineers) and prestorm lidar (April–May 2017, Northwest Florida Water Management District) are used to create a difference map, with positive numbers showing the locations of erosion. Both datasets have standard errors listed as 10 cm, which are much lower than the differences seen pre to poststorm. Apart from Michael, there were no major storms in the region in between survey periods.

The major difference in prestorm and poststorm onshore data arises from the complete erosion of the coastal dune system, with up to several meters of elevation loss. Areas of deposition are seen landward in some locations and represent debris piles generated from more seaward houses and other moveable objects. Fig. 6 shows the two transects identified in Fig. 5 before and

**Fig. 5.** (Color) Erosion example showing elevations in NAVD88 datum: (a) before; (b) after; and (c) difference. Erosion is shown as positive and deposition as negative. Elevations for transects 1 and 2 are shown in Fig. 6.

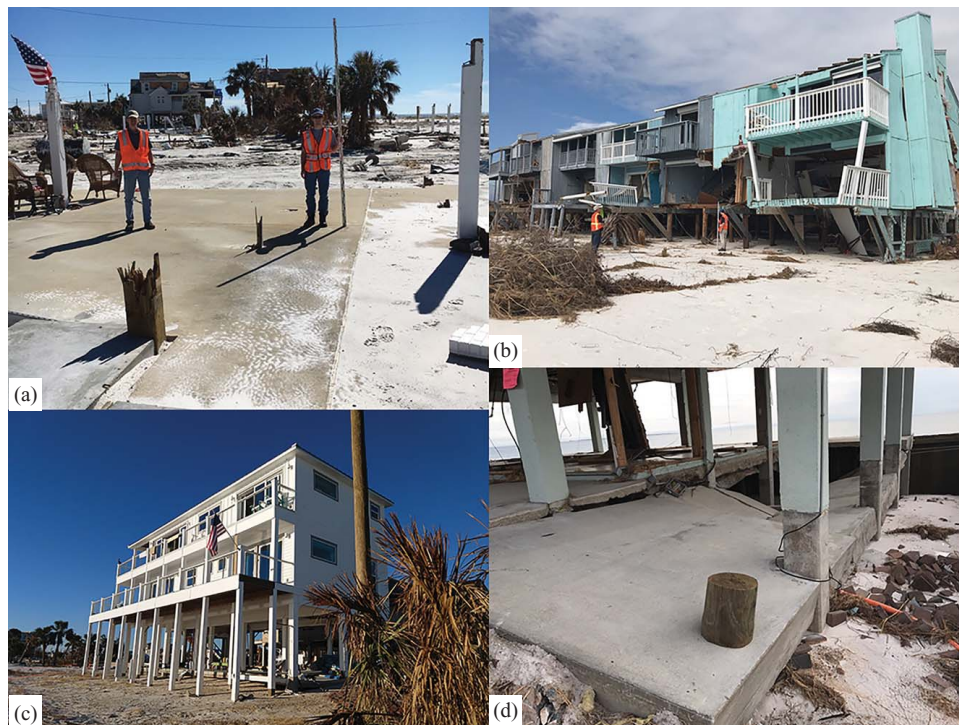
Near to the shoreline, the only structures that did not experience major damage were well built elevated structures, and even these generally lost utility connections and often staircases [e.g., Fig. 8(c)], and were prone to interior water damage from loss of soffits and damaged fenestration. Figs. 7 and 8 show examples of damage observed in the Mexico Beach area. Failure modes

**Fig. 8.** (Color) Examples of structural damage: (a) complete failure of pile elevated house (DS6); (b) severe damage to beachfront pile elevated row houses (DS5); (c) minor damage to Sand Palace (DS3); and (d) scour and partial failure of concrete floor pad underneath pile elevated house (DS5). (Images by authors.)

There were examples of good design and practice, the most impressive structural survival was the famous Sand Palace house built in 2018 and shown in Fig. 8(c). Although it is in the first row of houses near the region of worst surge and damage, the Sand Palace only had damage to: (1) utilities and local HVAC destroyed; (2) exterior staircase and lower story breakaway walls and interior destroyed; (3) a cracked window on the top floor; (4) one electrical outlet on the top floor ceiling popped out of its socket due to the pressure difference between the house interior and attic; (5) damage to parking slab and pavers; (6) minor water intrusion; and (7) one porch ceiling damaged. No roof damage was recorded. By the time of the team’s visit, the owners had installed solar panels and batteries to provide electricity and except for town utilities were fully functional. The Sand Palace was in DFIRM Zone AE, elevation 12 ft (3.66 m) NAVD88, while the measured elevation of the LHM was 6.3 m (20.7 ft) NAVD88. This elevation almost exactly matched the largest measured wave elevation of 6.28 m NAVD88 measured at the nearby pier. Because the pier was slightly seaward of the Sand Palace, wave crest elevations at the house would likely have been slightly lower. Therefore, the largest wave crests during the storm came close to or barely touched, the LHM, and wave loads were certainly much lower than those experienced by houses at a lower elevation. As reported, the Sand Palace costs approximately 15%–20% additional per square foot when compared with standard construction practices (Dal Pino 2019). After Michael, and compared with its neighbors, this additional cost appears very well spent. This study also demonstrates that community

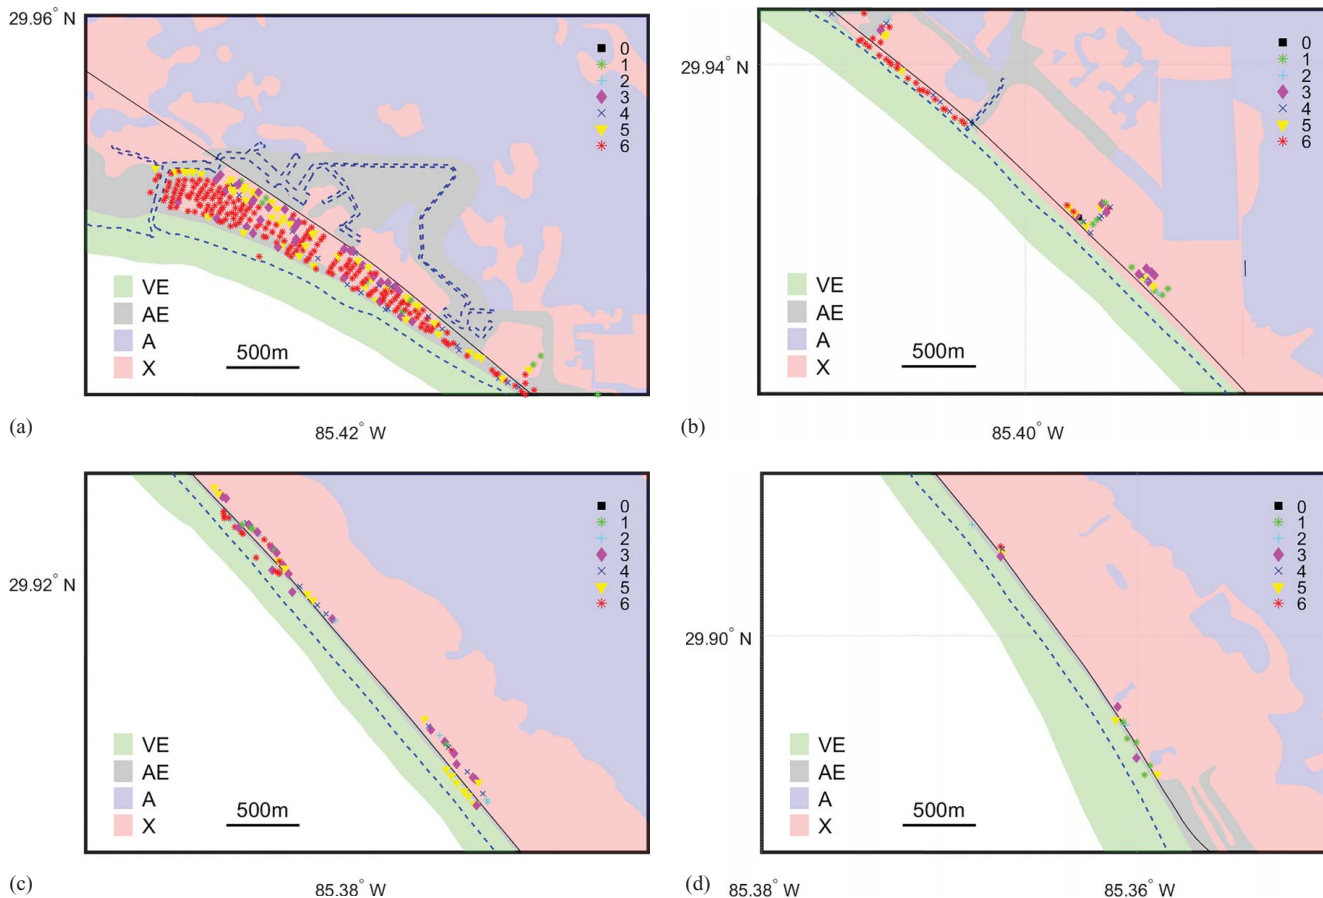
Fig. 10 shows the overall surge and wave induced damage ratings for all structures surveyed by the team in the Mexico Beach area, divided into the four subregions shown in Fig. 9. It is clear that in area (a) (furthest NW), large areas near the shoreline suffered complete damage, while the furthest SE section (d) showed areas near the shoreline with damage, but not anywhere near the extent of (a), with (b–c) demonstrating intermediate levels of damage.

**Fig. 10.** (Color) Surge and wave induced structural damage states as in Tomiczek et al. (2017). Black square = DS0; green diamond = DS1; cyan + = DS2; magenta diamond = DS3; blue x = DS4; yellow triangle = DS5; red \* = DS6: (a) subregion a; (b) subregion b; (c) subregion c; and (d) subregion d. FEMA DFIRM flood zones are as labeled.

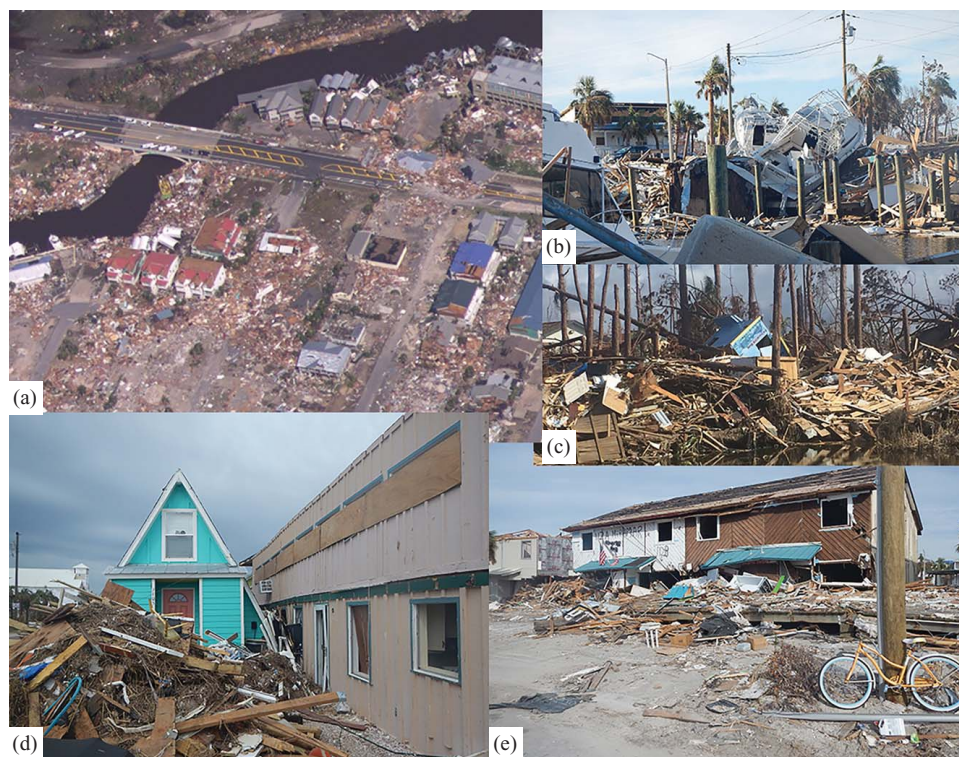
The destruction of structures and infrastructure generated large amounts of debris, much of which was transported inland. Fig. 14 shows typical examples of debris and debris piles. These could be quite large at times for both plan area and height above ground, as shown in the transects in Fig. 6. On a large scale, this debris was composed of entire structures detached from their

In some cases, shown in Figs. 6(a) and 14(a) which depict elevations and imagery from the same region, debris clusters had very high heights above ground and may have been grounded during the storm, that is, the cluster was higher than water levels and reached the ground, acting as a dam, collecting additional debris, and preventing further transport. Although, to the best of our knowledge, no systematic study has been carried out, very large clusters not backed by a surviving structure often had large debris objects (LDOs) such as transported houses, roofs, or other large objects as nuclei. Fig. 16 shows LDOs, defined here as transported intact or semi-intact structural assemblies or whole structures, travel trailers, and recreational vehicles (RVs). Although structures are clear when out of place, trailers and RVs are fundamentally mobile

**Fig. 14.** (Color) Examples of debris transport and deposition: (a) Western Mexico Beach (image courtesy of NOAA), showing large debris piles; (b) boats and terrestrial debris; (c) waverunner rental shack and other debris in forested area; (d) large pile of woody debris and transported A-frame house grounded next to larger building; and (e) 34 m-long section of Mexico Beach Pier deck grounded against houses. (Images (b–e) by authors.)
