Walls 04NAc

Wall 04NAc2

Wall 04NAc2r

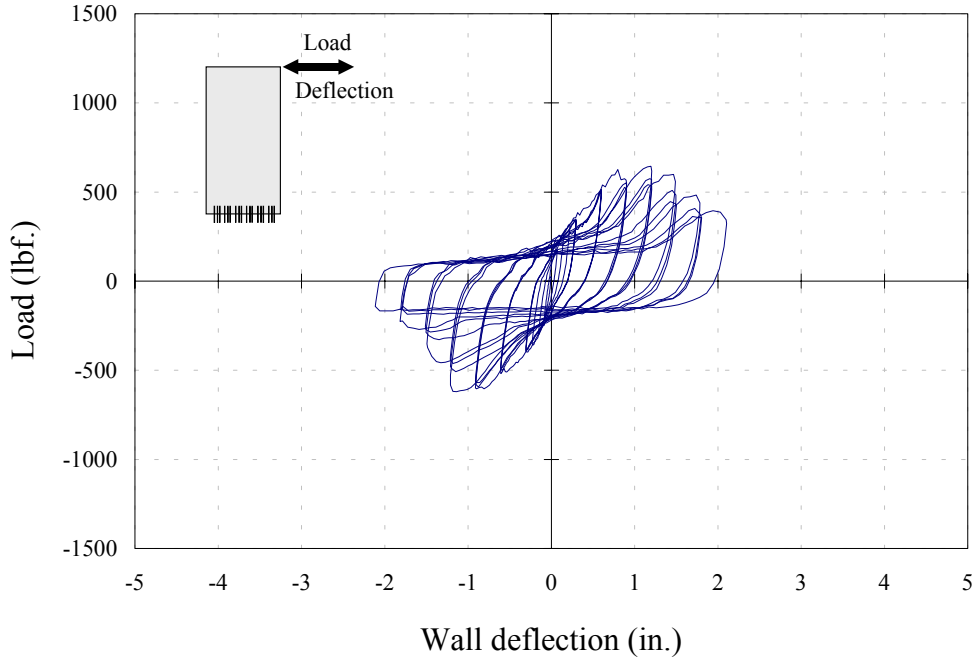
Figure 04NAc2- a. Observed load-deflection curve¹.

Observations: This wall was attached to the base with thirty-six 16d nails (three rows at 3 in. o. c.). The shear modulus was 50% higher than in corresponding 04IAc tests. The average peak load 632 lbf. 9(0.16 Kips./ft.) was reached at 1.2 in. deflection. Figure 04NAc2-a shows that the resistance on the positive stroke was undercut. A likely reason for that was the inadequate edge distance on the left side of the specimen (Photo815). Having reached the peak load, the wall rapidly degraded during the next phase (1.5 in.). Figures 04NAc2-c and 04NAc2-d show that the wall rocked as a rigid body around the center.
