### **5.1 Test results of braided composite frame B**

## 5.2 Test results of braided composite frame C

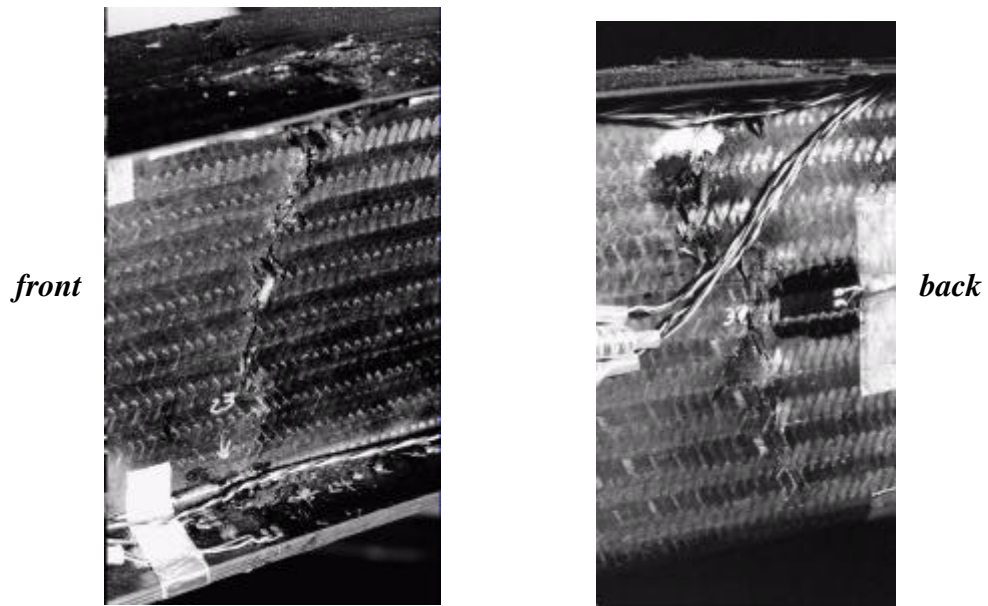
**Fig. 5.2 Braided composite frame B after first failure event. The crack in the web is located at the apex of the frame.**

(3319.2 lb, 0.9366 in.). The crack in the web at the apex of the frame propagates from the junction of the web and outer flange through one side of the outer flange. There is a drop

in the load at this third failure event, followed by a reloading to the fourth failure event at point B<sub>4</sub> (3124 lb, 1.125 in.), where a fourth drop in the load occurs. The crack at the apex propagates to the other side of the outer flange, completely fracturing the outer flange. After the force drop at point B<sub>4</sub>, another reloading occurs. Only the inner flange remains intact at the apex of the frame. The test is stopped before the crack could propagate through the inner flange. The surface fractures tend to follow the  $\pm 64^\circ$  braider yarns in a zigzag pattern similar to what is observed in the tensile and flexure test coupons. After the test, some damage is also observed in the inner flange, at both ends of the frame.

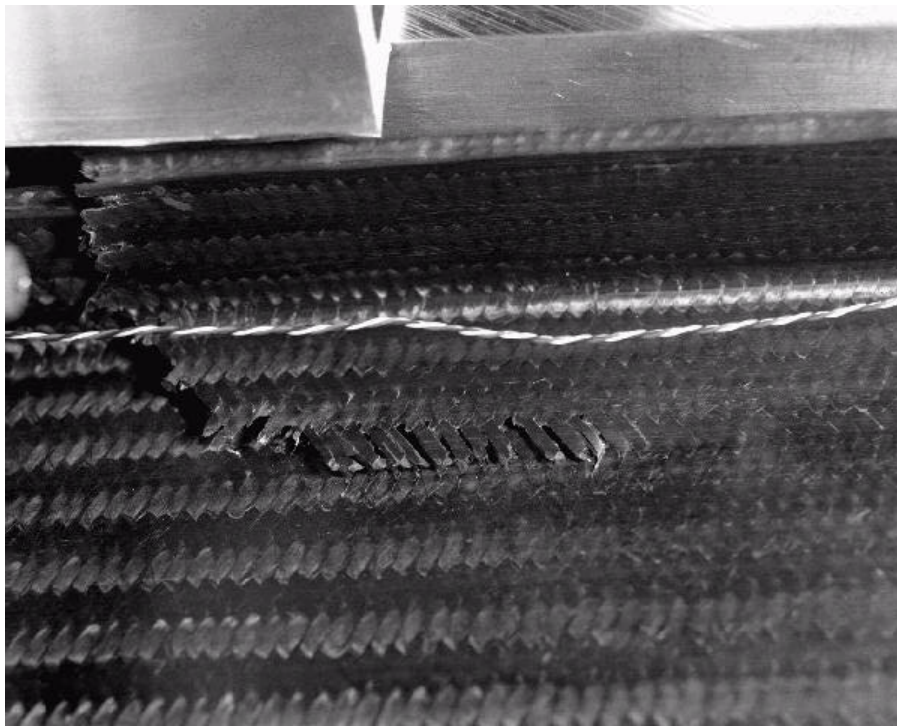
back side of the J-section refers to side opposite to the inner flange, or for the side of the web in the cross section where the  $y$ -coordinate is negative. Refer to Fig. 4.9 on page 88.) The first major failure event occurs at the point labeled  $C_1$  (6331.9 lb, 0.5187 in.). This failure manifests as a crack in the back side of the outer flange at  $q = 0^\circ$ , beginning at the junction of the web and outer flange. Also, damage appears to begin at  $q = \pm 5^\circ$  in the front part of the outer flange. As the test continues, the material in the web and along the junction of the web and outer flange deforms in such a manner to suggest that the crack is extending internally from the center ( $q = 0^\circ$ ) to  $q = \pm 5^\circ$ . After the first failure, a drop in the force is observed, from 6331.9 lb to 4494.5 lb. After this first drop in the force, the force remains almost constant as the displacement increases. The second failure event begins at point  $C_2$  (4517.9 lb, 0.601 in.), after which there is small drop in force. Then the force drops slightly again to 4416.4 lb at a displacement of 0.6293 in. This second failure event initiates at the junction of the web and outer flange at  $q = -5^\circ$  and propagates toward the front of the outer flange at this circumferential location. After this, the force drops to 4000.0 lb, and continues dropping slightly until reaching 3752.7 lb, corresponding to a displacement of 0.714 in. As the test continues, a very slight and irregular reloading is observed, until the third failure event at point  $C_3$  (4153.5 lb, 0.8969 in.) occurs. Then the

load drops slightly to 4065.0 lb, corresponding to a displacement of 0.9196 in. In this third failure event the crack that began at  $q = -5^\circ$  in the front side of the outer flange propagates to the back of the flange. The force drops to 3815.2 lb, and reloading initiates again to the fourth failure  $C_4$  (4450.2 lb, 1.0847 in.). At  $q = -5^\circ$ , the crack in the front part of the outer flange grows to completely fracture the flange and simultaneously another crack begins to propagate from the interface between the web and outer flange into the web. Also at this time, at  $q = -7^\circ$  the back of the outer flange fractured. The force then drops to 2641.5 lb. The fifth failure event  $C_5$  begins at 2589.4 lb and 1.1491 in. At  $q = -5^\circ$  the inner flange is cracked. The crack in the outer flange propagates radially into the web to a length of about 2 in. and then turns in the circumferential direction increasing its length to about 3 inches. So, this fracture, located in the front side of the web is L-shaped as shown in Fig. 5.13. At

**Fig. 5.13 L-shaped crack in the web of braided composite frame C at  $q = -5^\circ$ .**

$q = -7^\circ$ , the fracture that began in the back side of the outer flange, extends to the front.

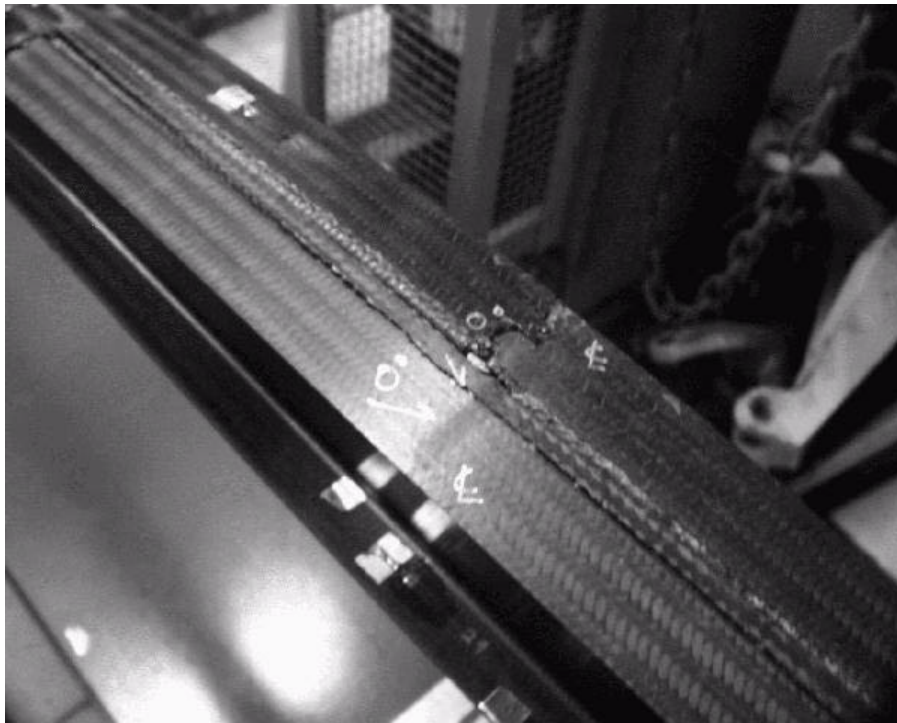
When compared to the response of braided frame B, the failure events on frame C occur at similar displacement magnitudes as in frame B, but at different locations in both frames. Cracks develop in frame B in the outer flange and radially along the web at the apex ( $q = 0^\circ$ ), and in the inner flange at the ends ( $q = \pm 21.4^\circ$ ). The cracks in frame C develop at several locations: in the outer flange at  $q = 0^\circ, \pm 5^\circ$ , and  $-7^\circ$ , and in the inner flange and web at  $q = -5^\circ$ . The reason for these different failure locations could be related to defects in the composition of the braided material. There are maybe voids, resin rich zones and resin starved zones, that could influence crack initiation sites and crack paths. Further inspection of frame C after the test reveals a crack at the junction of the web and outer flange extending circumferentially from  $-9^\circ$  to  $9^\circ$ . Over this same circumferential arc length, two parallel, circumferential fractures isolate a ligament of material at the center of the outer flange, with some of this material slightly protruding from the flange. See Fig. 5.14. This ligament of material appears to be a filler inserted into the surface of the outer flange just above the junction with the web.

**Fig. 5.14 Parallel, circumferential cracks in the outer flange over the junction with the web in frame C.**
