1. Introduction

2. Objectives

1. To devise a methodology for residential wood deck and balcony inspection for conventional dimension lumber (2x_ material) construction that is accessible to a building inspector or consultant.
2. To complete a draft manual for possible publication that will contain methods for wood deck and balcony inspection.
3. To collect information that can be subsequently used to prepare articles for appropriate magazines and trade journals to increase awareness about the potential problem of wood deck and balcony failure.

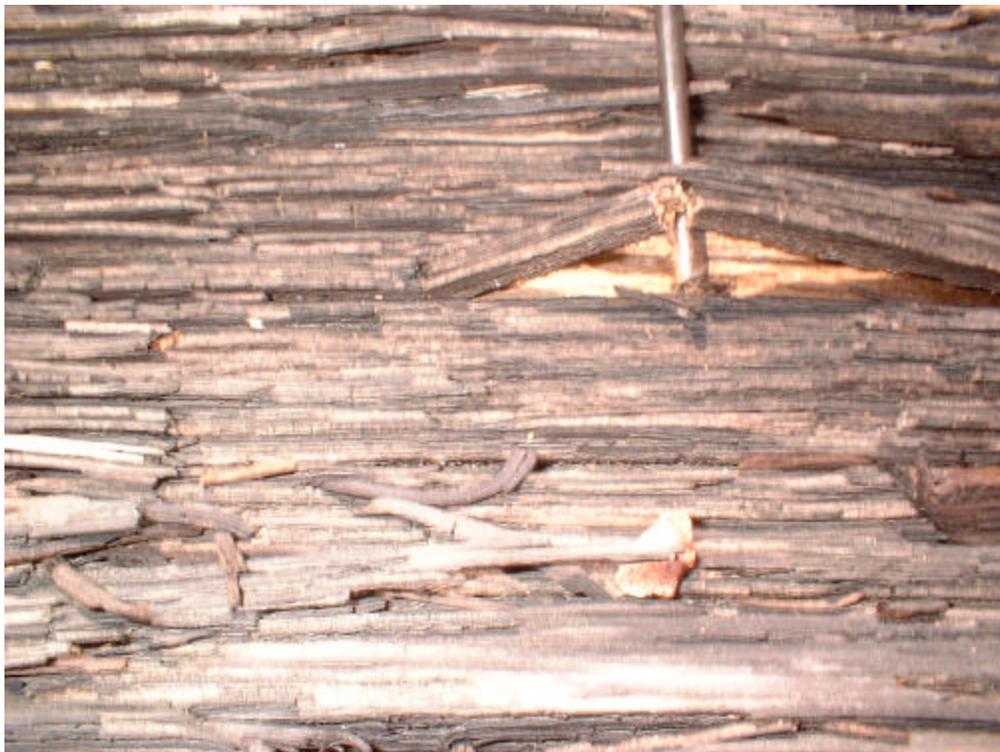
Figure 4.10. The decayed wood broke easily; the break is across the grain with no splinters.

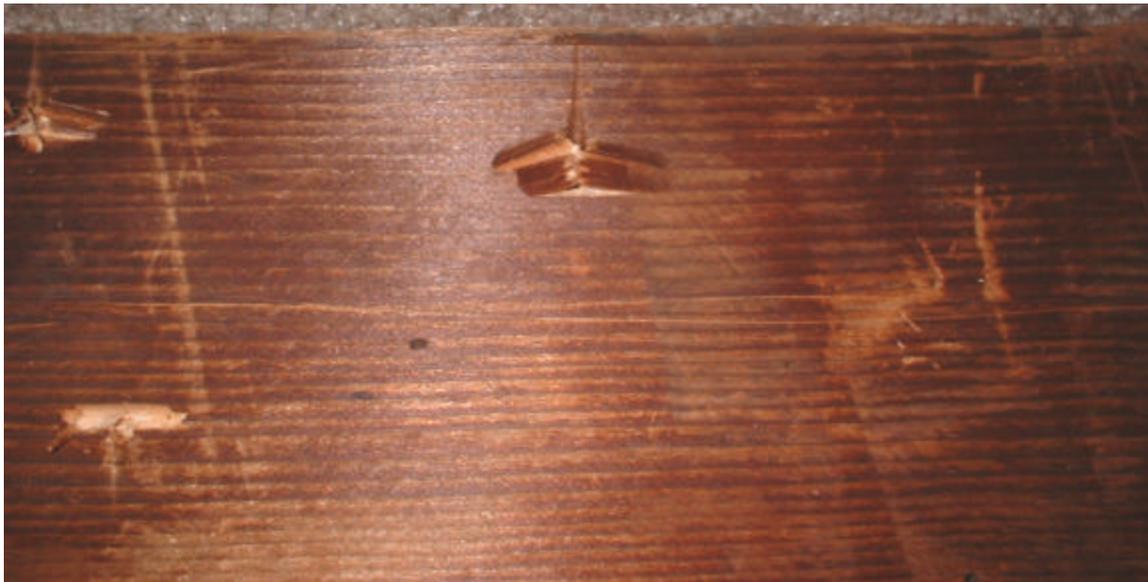
Figure 4.12. On the surface, this 50-year-old Douglas Fir purlin looked sound, however with the pick test, decay is indicated by a brittle cross grain break directly over the tool. The entire break is less than one inch long.

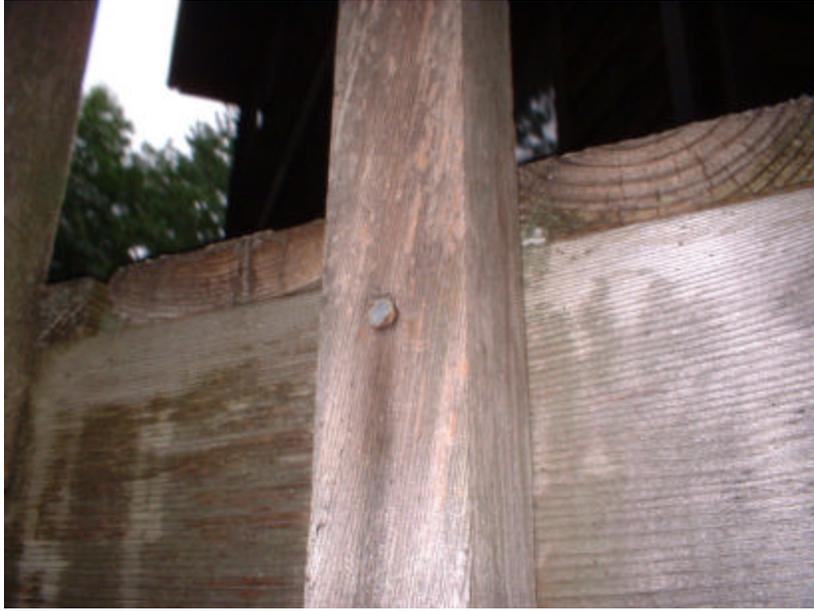
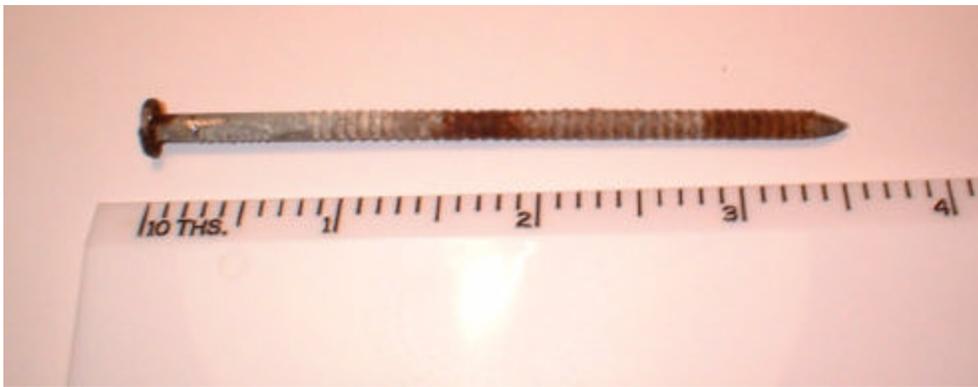
Figure 5.2. The nail removed from a rail post (a) before it was removed and (b) when it was measured.

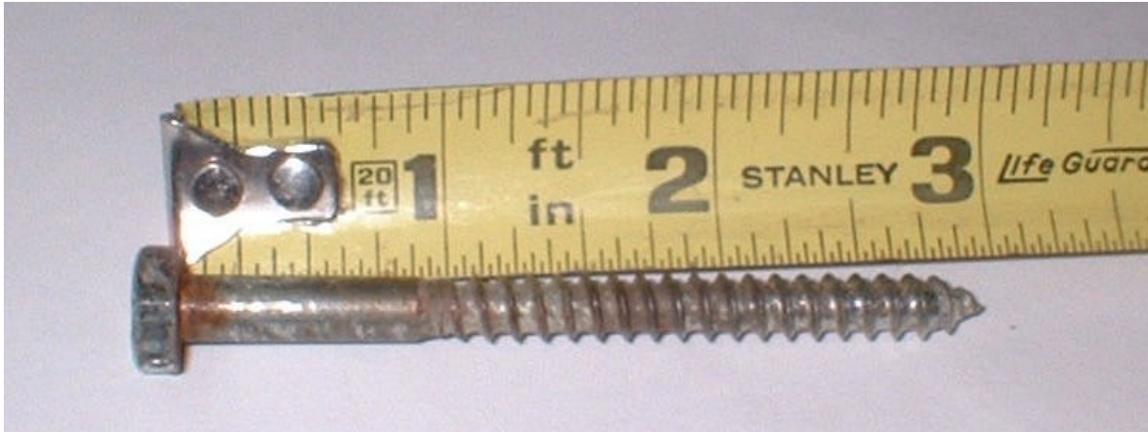
One lag screw was removed and it had a 0.234 in. shank diameter and 0.175 in. root diameter. The effective length of the lag screw was 2.75 in. Discoloration was seen in the shear plane. The nail was 16d annular threaded with a shank diameter of 0.150 in. The root diameter was 0.140 in. at the unaffected areas and 0.139 in. at the discolored area. Photographs of the nail and lag screw are shown in Figures 5.2 and 5.3.

Figure 5.3. The lag screw that was removed from the rail post. There is noticeable discoloration at the screw head and the interface between the post and the perimeter joist.

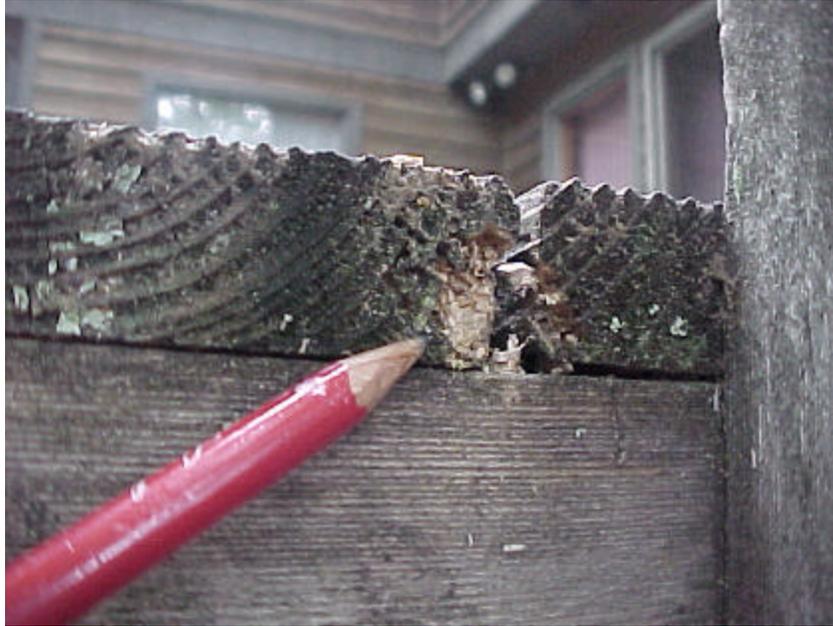
The decking was 5/4x6 Western Cedar attached to the joists using two 2.5 in. annular threaded nails. A small amount of iron stain was noticed around the nail heads. Some nails were missing on a few deck boards. In one area, nails were missing, but the deck boards were well secured to the joists by other nails. A level was used to show that there was no detectable deflection or sagging of the structure. Decay was found in a few deck boards, as shown in Figure 5.6, where the end grain was exposed to weather. It was limited to a small section of sapwood. Mildew was present on the deck and a few knotholes were found. On the underside of the deck boards, a white substance was seen, probably mold.

Figure 5.6. Sapwood decay was present at the end-grain of deck boards.

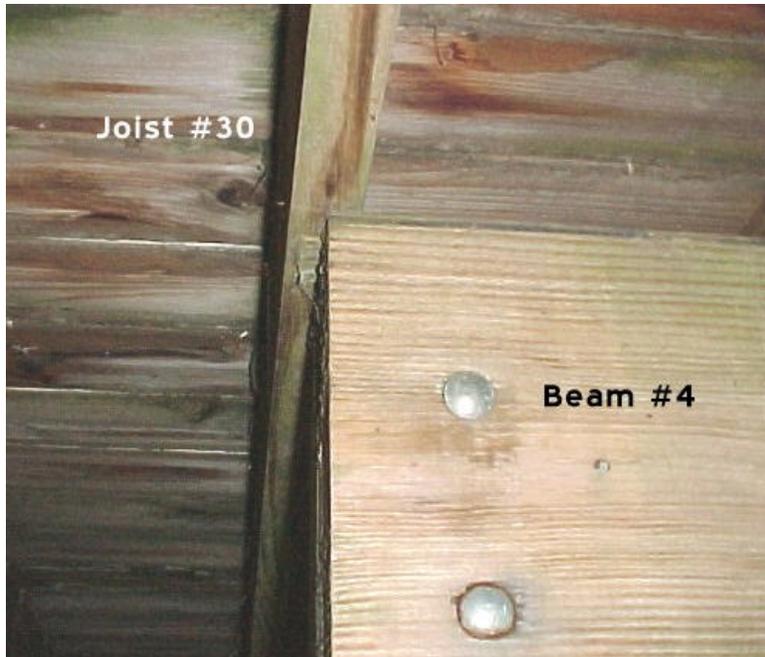
Each joist was checked over and noted in Table 5.3. One-half of joist No. 30 was supported by beam No. 4 as shown in Figure 5.7.

Figure 5.7. One half of joist No.30 was supported by the beam, which was probably a construction error and not intended.

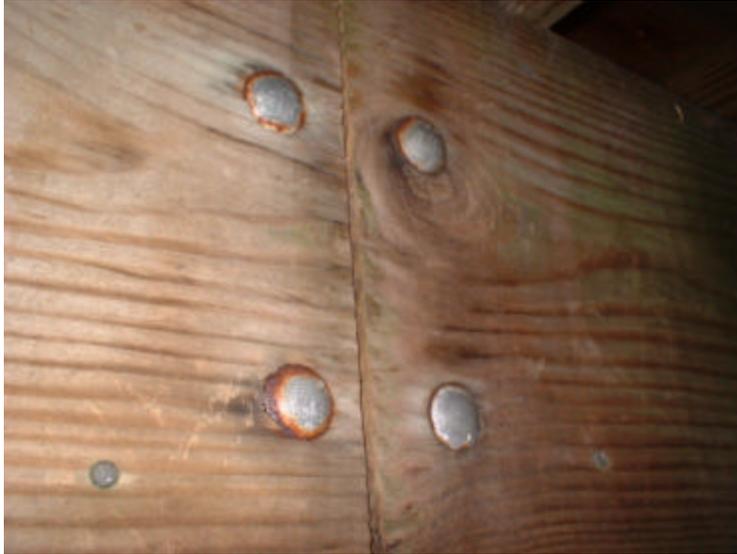
Built-up beams (beam spans 1 through 4) were 2-2x12 No. 2 Southern Pine nailed together with two nails roughly spaced at 2 ft on-center with a single nail located near the middle of the space. The posts were notched for the beams and attached with two 1/2 in. machine bolts. The beams were notched at the posts (no more than 1/4 in.) to make up for the top of the posts not being at the correct elevation during installation. Other beams were 2x12 No. 1 Western Cedar and 2x8 No. 2 Southern Pine. Figure 5.8 shows how the carriage bolts were rusted around the edges and crushed the wood around them.

Figure 5.8. Carriage bolts, which are not recognized by the NDS rusted around the edges and crushed the wood around them.

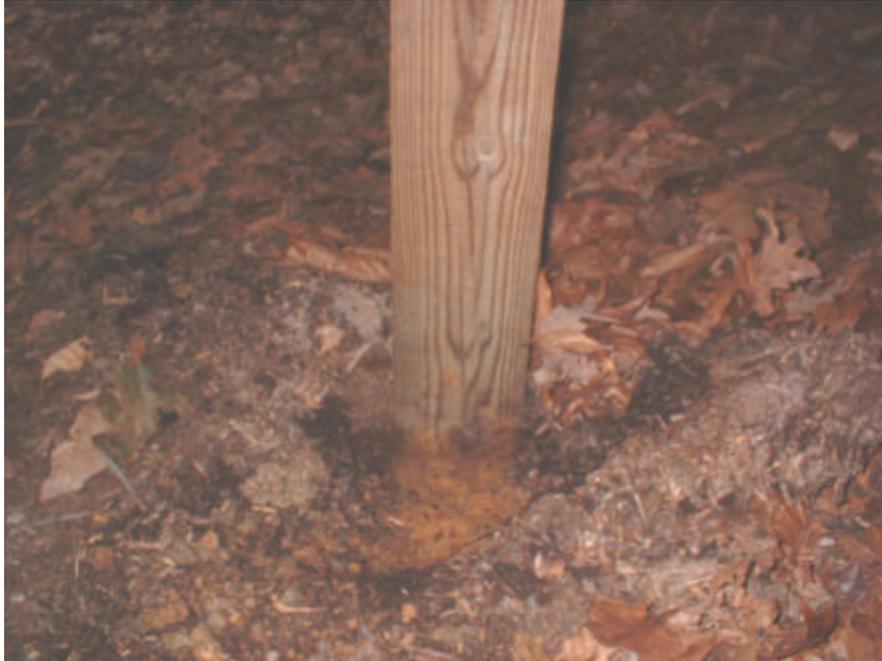
The ground below the deck sloped sufficiently away from the house and was dry at the time of inspection. All posts were No. 2 Southern Pine, CCA pressure-preservative-treated. The amount of treatment could not be determined, but was deemed to be effective after a pick test. The pick test was performed 6 in. below the ground surface at post No. 5 and revealed no evidence of decay as shown in Figure 5.9.

Figure 5.9. Digging 6 in. below the ground surface and using the pick test showed no evidence of decay on Post No. 5.

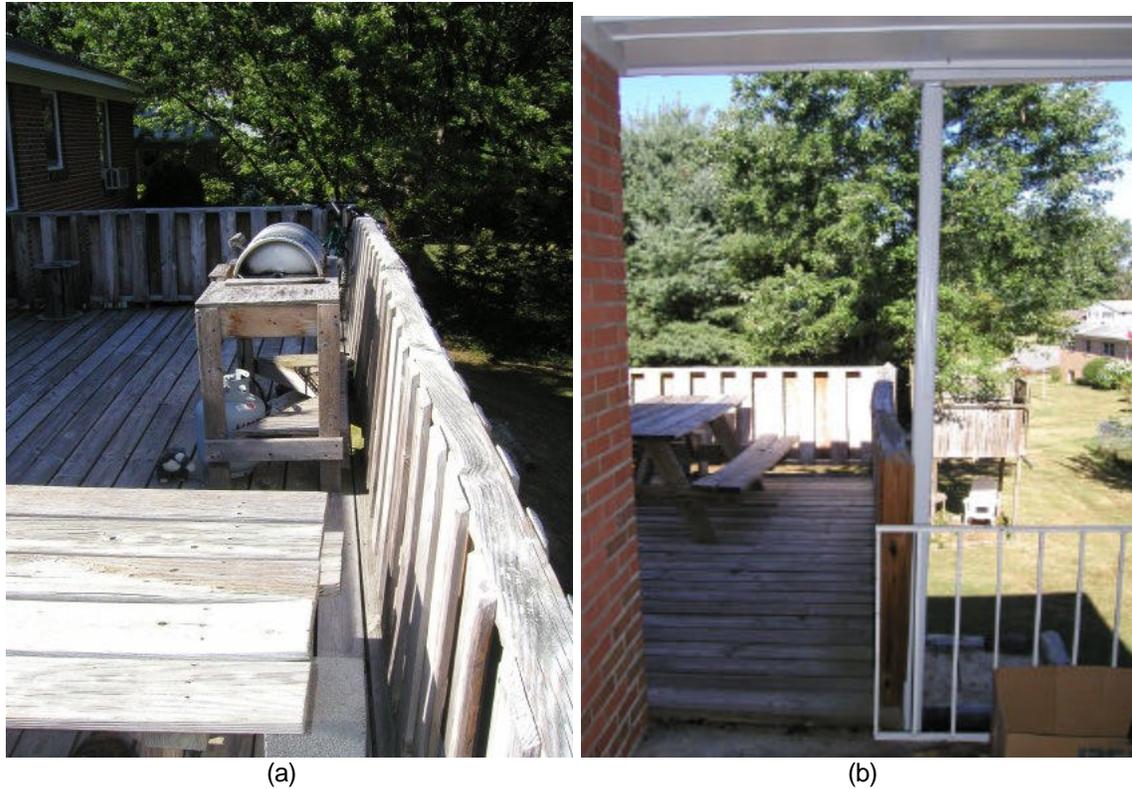
Figure 6.3. (a) The longest section of deck railing leans outward 4 inches. (b). The side section of railing curves inward.

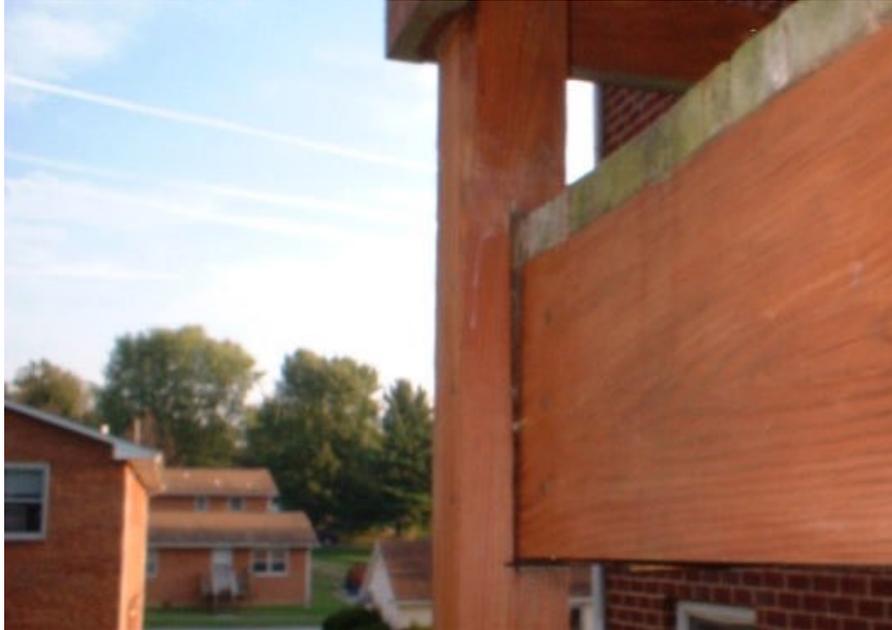
Figure 6.15. The notch for the 2-2x10 beams on posts P1, P2 and P3 in Deck E. The length, depth, and location of this notch are not allowed by the NDS-01.

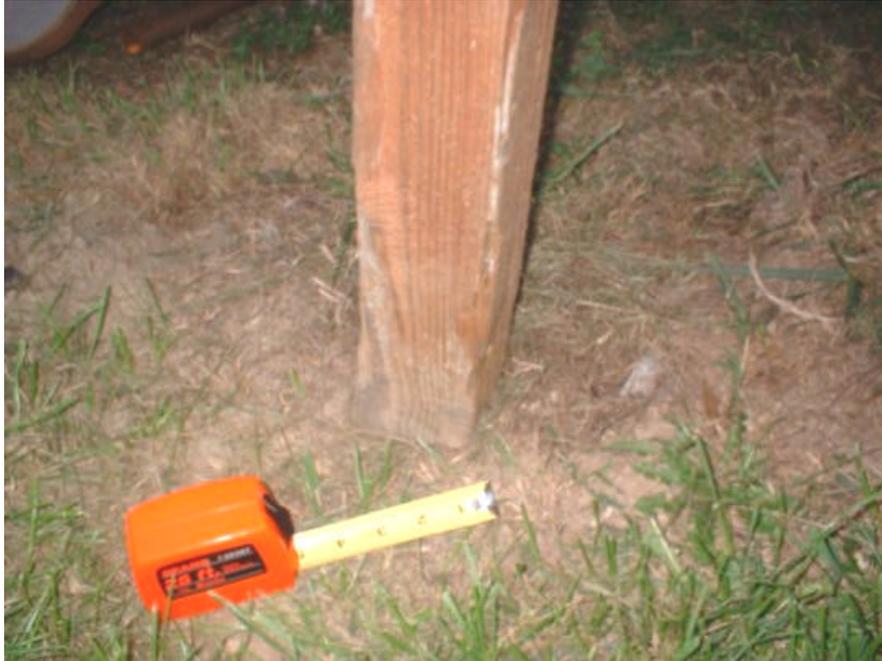
Figure 6.16. The erosion of a post in Deck E, possibly caused by surface water runoff.

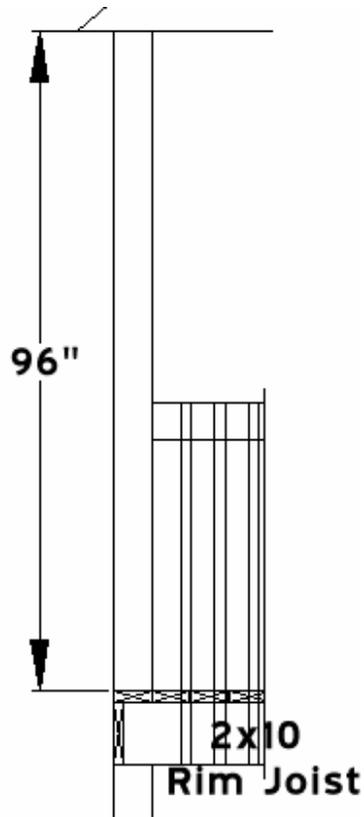
Figure 6.19. The post was not continuous through Deck F. It was toenailed to the deck boards. Another deck was under Deck F. Three separate posts created a column from the ground to the roof of the building.

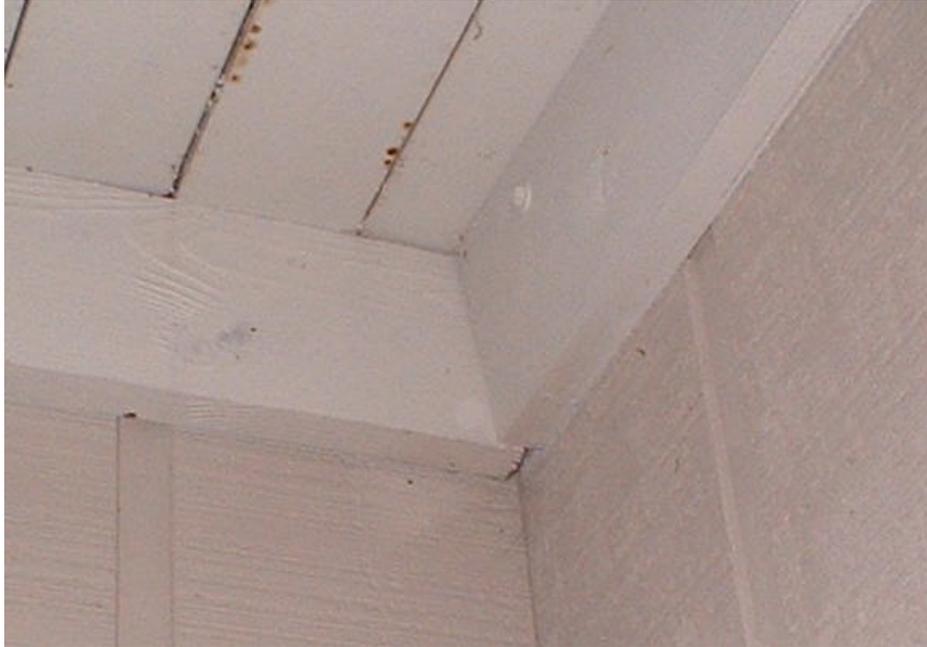
Figure 6.24. The ledger board bowed out $\frac{3}{4}$ " away from the building in one corner.
