## **Recovering from the 2010 Nashville Flood: Pavement Management as a Tool in Long Term Disaster Recovery**

Donald Reid

Jacob Walter, P.E.  
Corresponding Author

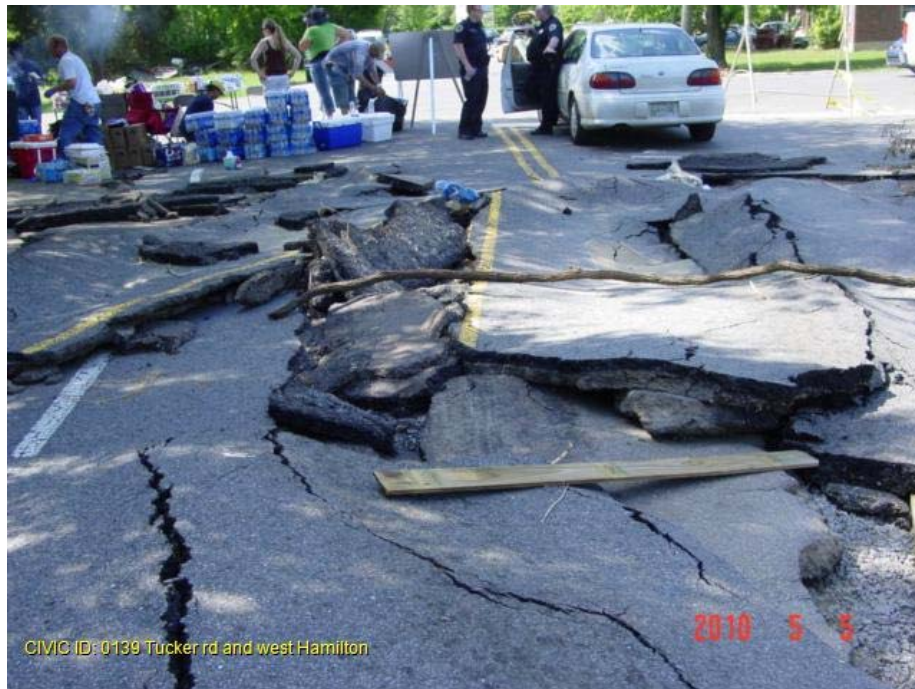
All transportation agencies need to manage the result of natural disasters as a part of their operations. Many times, these events are localized (tornadoes, landslides, and similar events), have limited effects after the initial event, and can be managed as either a single repair project or a limited collection of repair projects. However, some disasters cause major, widespread damage and must be dealt with at the network level as most of the transportation network experiences some level of damage. On May 1<sup>st</sup>, 2010, record-breaking storms across the State of Tennessee began in the region which would lead to a 1,000 year flood in cities along the Cumberland River (1). At the conclusion of the storm, 13.57 inches (345 mm) were measured in Nashville alone; communities upstream of Nashville also saw rain totals between 10 and 16 inches (254 mm to 406 mm) over the two day period (2,3). This rain lead to massive damage of the pavement network with instances such as those shown in Figure 1 and Figure 2 occurring throughout the Nashville Metropolitan area.

**FIGURE 1 Example of Pavement Damage Due to Severe Flooding.**

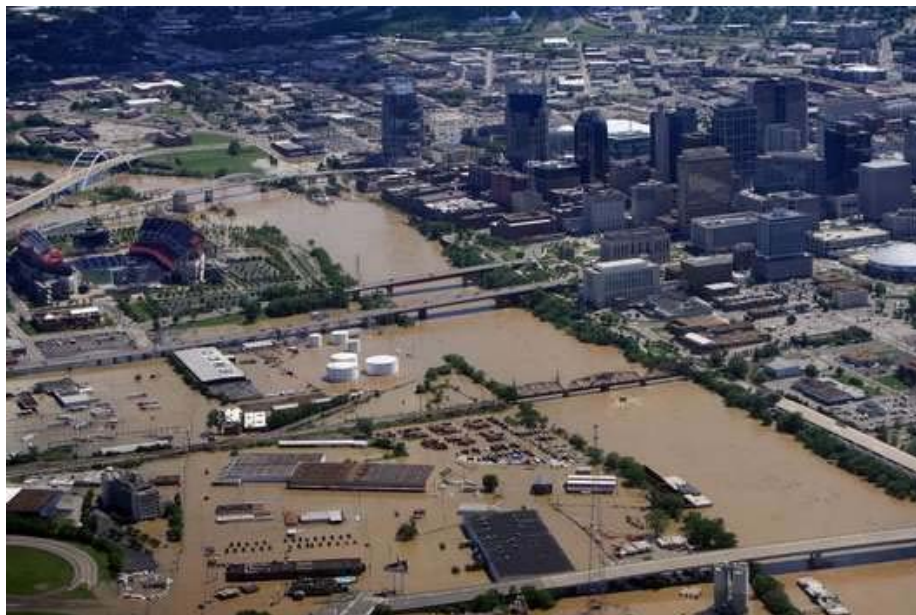
**FIGURE 2 Overview of Flooding Along the Cumberland River in Downtown Nashville.**

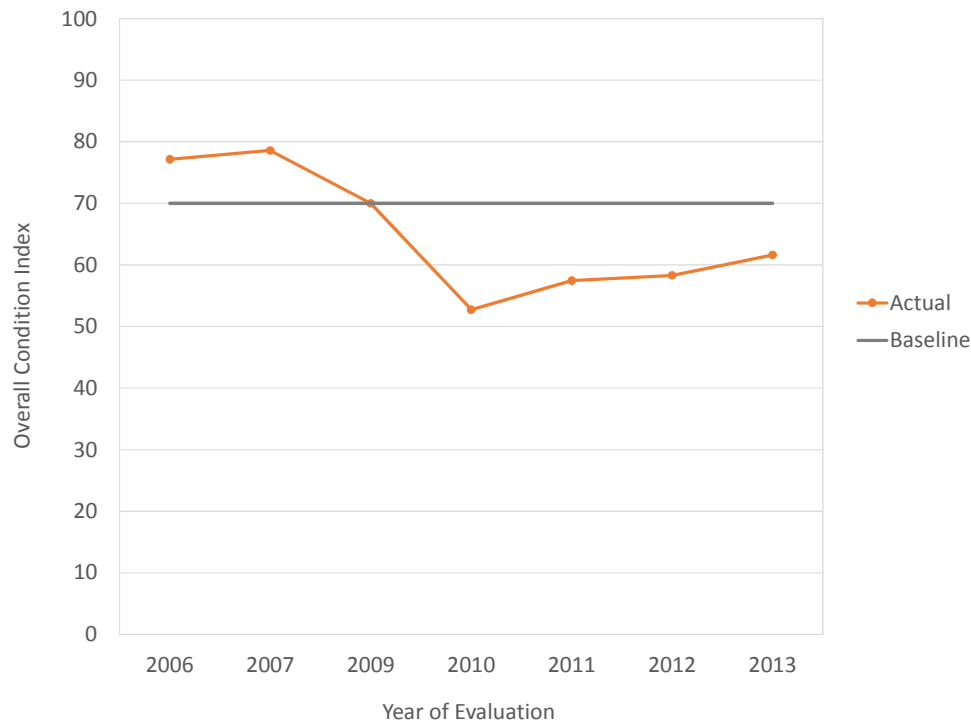
area) should have an OCI greater than 70. The pavement management system tracks compliance against this baseline. Obviously, as shown in Figure 4, this was a significant issue after the flood.

**FIGURE 4 Overall Condition Index Over Last 7 Years.**

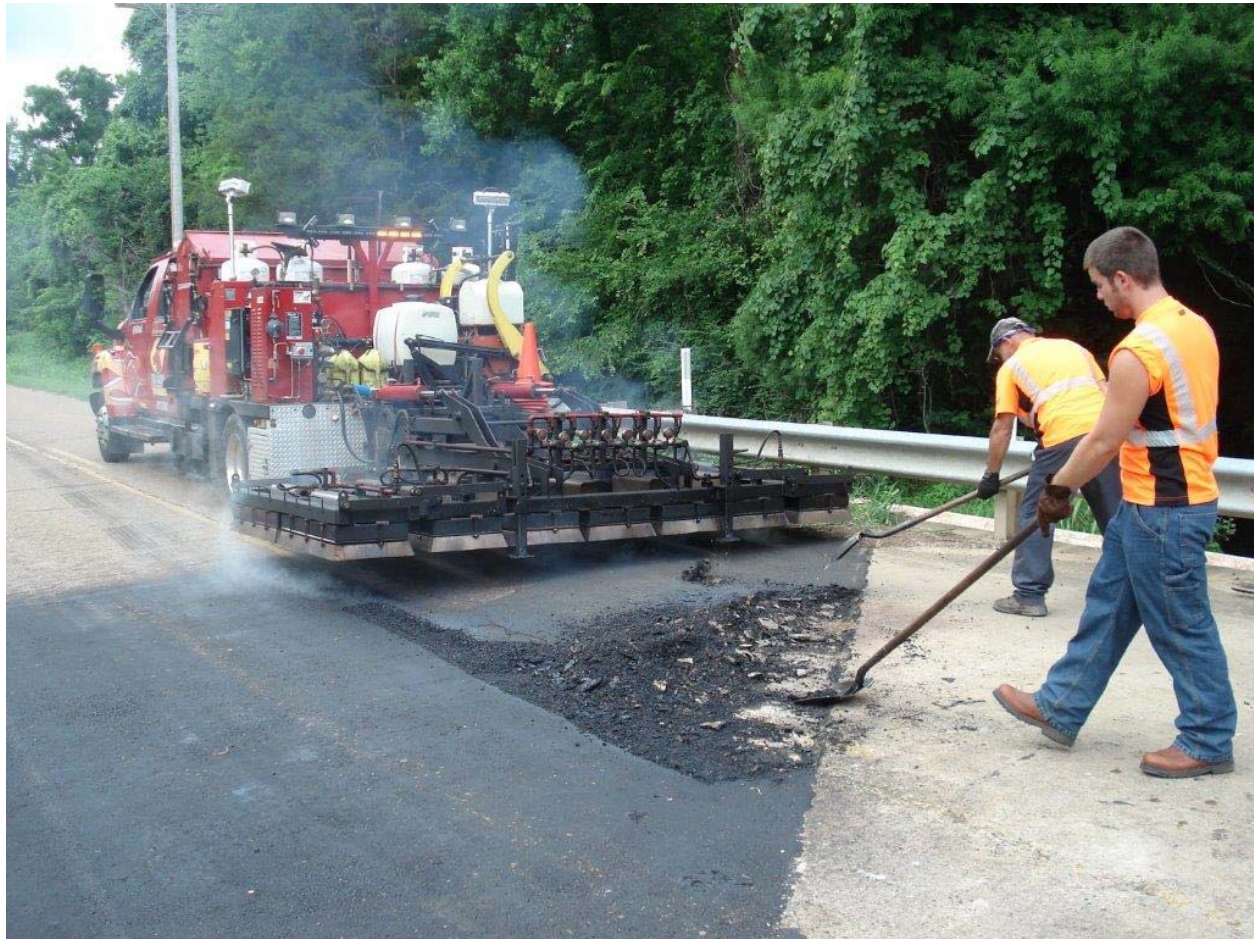
**FIGURE 5 Infrared Patching Equipment Example**

Metro Public Works had successfully used infrared patching technology to repair roads with 30% or less of the surface area affected by potholes and surface delamination as an alternative to the traditional overlay. The use of this treatment was already improving the life cycle cost of the Metro roadways. The technique involves using infrared heating equipment (such as the equipment shown in Figure 5) to soften the existing asphalt at the edges of each pothole. Once at the proper temperature, the heater is removed and a steel rake is used to scarify the pavement. Finally, new material is added and compacted to bring the pavement level with the existing roadway. The end product lacks the obvious sealed saw cuts that a traditional partial depth repair has which, in many cases, either eliminates the patch (the patch is indistinguishable from the original pavement) or maintains the patch at a low severity level as there are no edges to deteriorate.

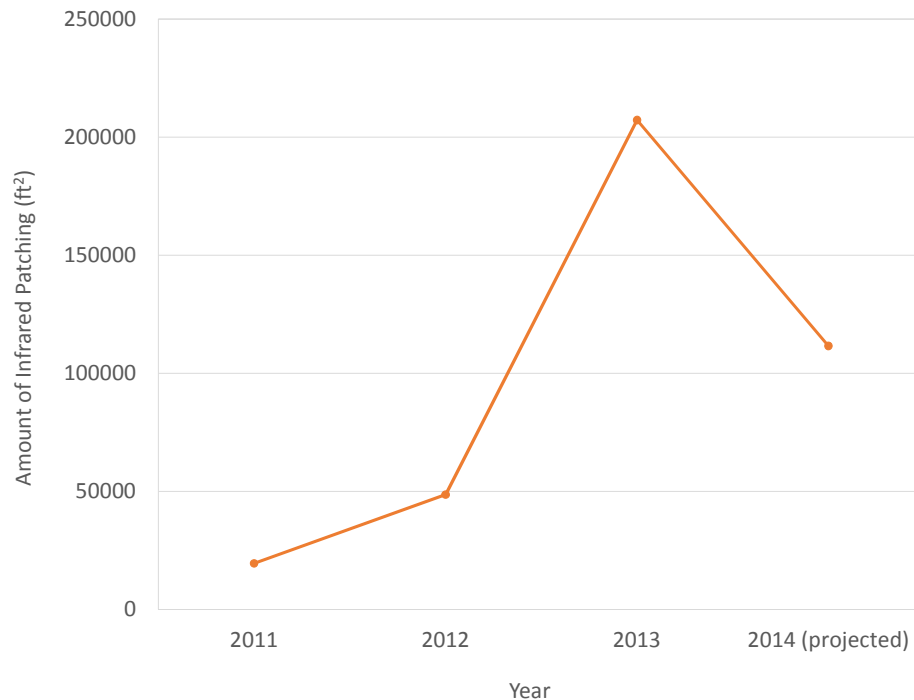
To track the initial results of infrared patching, Metro conducted an additional inspection at each site where infrared patching was used immediately after the maintenance was performed. Follow-up surveys were also performed as a part of Metro's normal pavement condition inspection routine. The overall results (Figure 4), show an increase in the average OCI for the overall network. Based on initial results, Metro has increased its spending on infrared repairs to approximately \$1 Million (US) per year. In 2013, that led to 1,660 individual repairs for a total of over 207,000 ft<sup>2</sup> (19,230 m<sup>2</sup>). Figure 6 shows the increase in repairs since the start of the infrared program. Please note that the large increase in repairs shown in 2013 was due to additional funds that were made available to Metro Paving. As the repair needs were already identified in the pavement management system, Metro was able to quickly deploy their repair contractors to the appropriate areas and complete many additional repairs in 2013 with this additional funding.

**FIGURE 6 Amount of Infrared Patching Used since 2010 Flood.**
