Evaluating the Long-Term Morphological Response of a Headwater Stream to Three Restoration Techniques

Thesis submitted to the faculty of the Virginia Polytechnic Institute and State University in partial fulfillment of the requirements for the degree of

Master of Science
In
Biological Systems Engineering

July 18, 2022
Blacksburg, VA

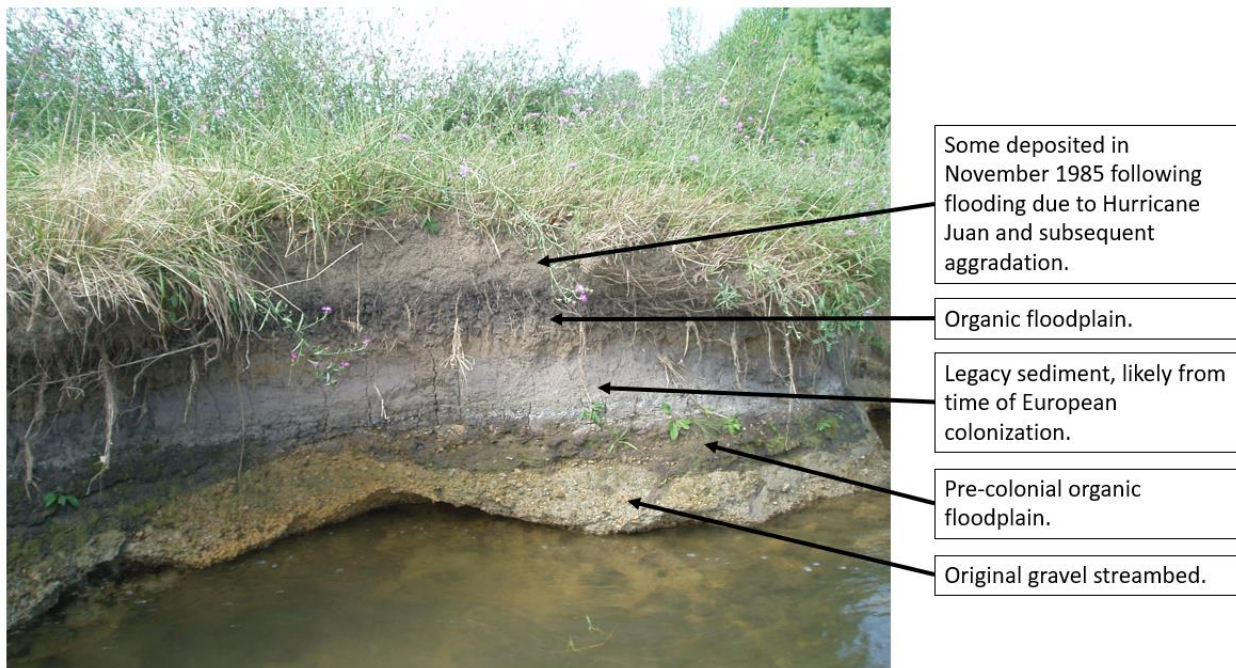
Figure 5: Stroubles Creek streambank (image was taken in Treatment 1).

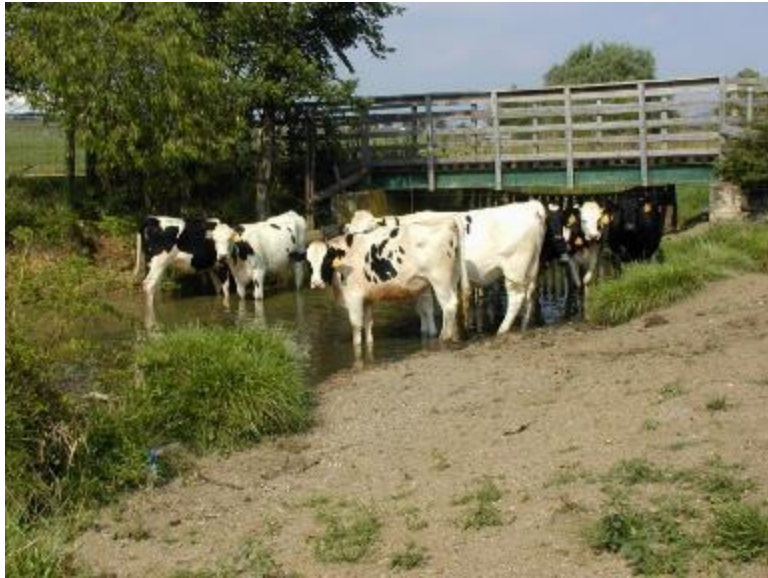
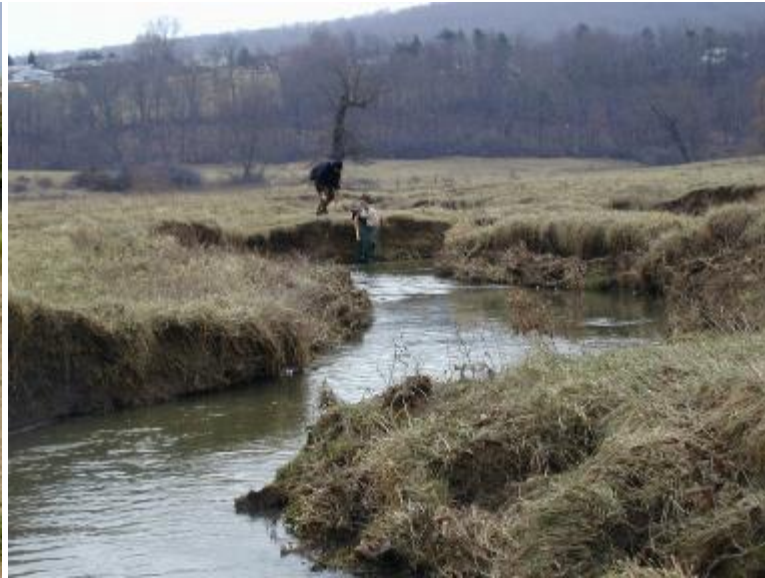
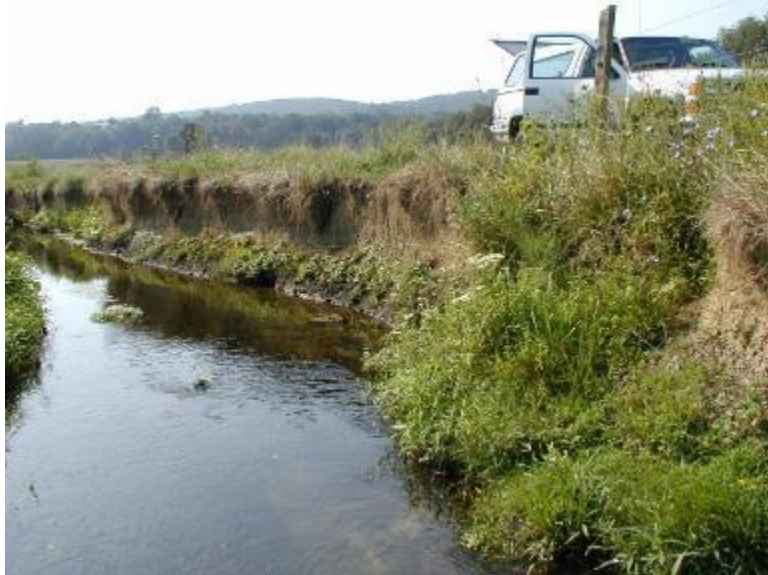
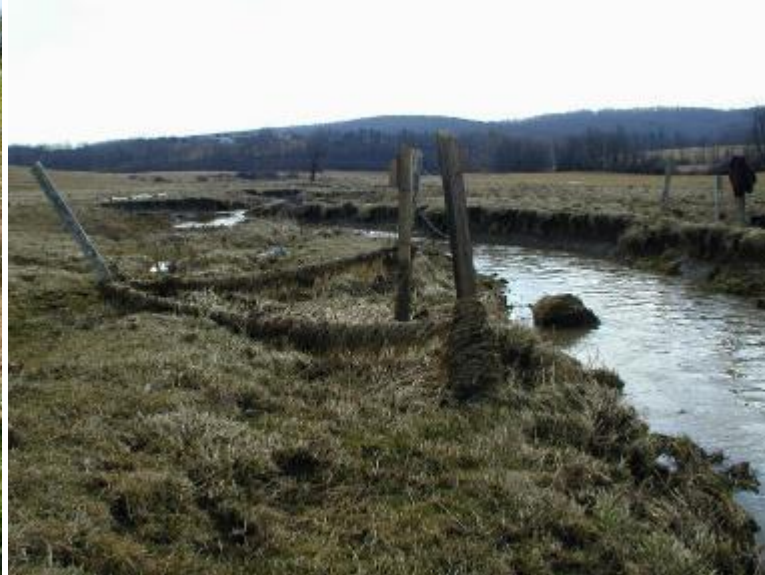
dairy farm, the StREAM Lab property was purchased by the Virginia Tech Foundation in 2001 and a 1.3-km long restoration was designed and implemented during 2009-2010 as part of the TMDL implementation plan for Stroubles Creek (Wynn et al., 2010). Pre-restoration data from 2006 and 2007 indicated ongoing erosion. In 2007, the banks were high due to legacy sediment deposition on the floodplain and channel incision. In 2007 bank heights averaged 0.93 m, and channel width averaged 6.93 m. Cantilever bank failures were common, contributing fine sediment to the channel (Figure 9).

Figure 9: Images of StREAM Lab property prior to restoration

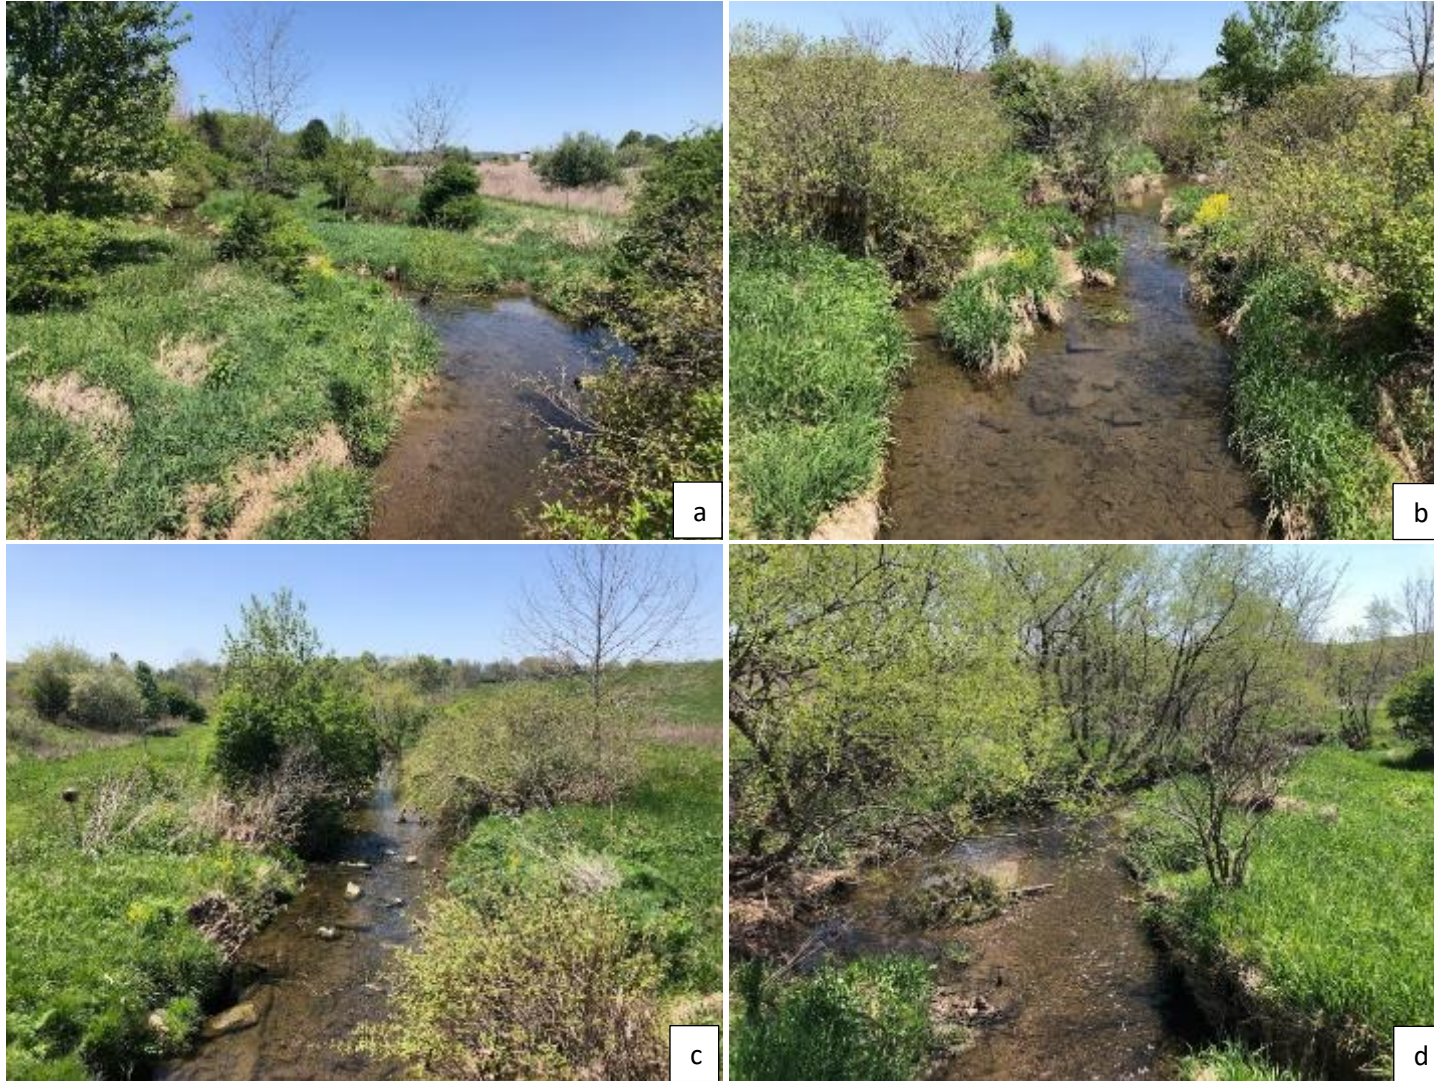
Figure 13: Images of StREAM Lab property 12 years after restoration in 2022. A) Treatment 1; B and C) Treatment 2; D) Treatment 3

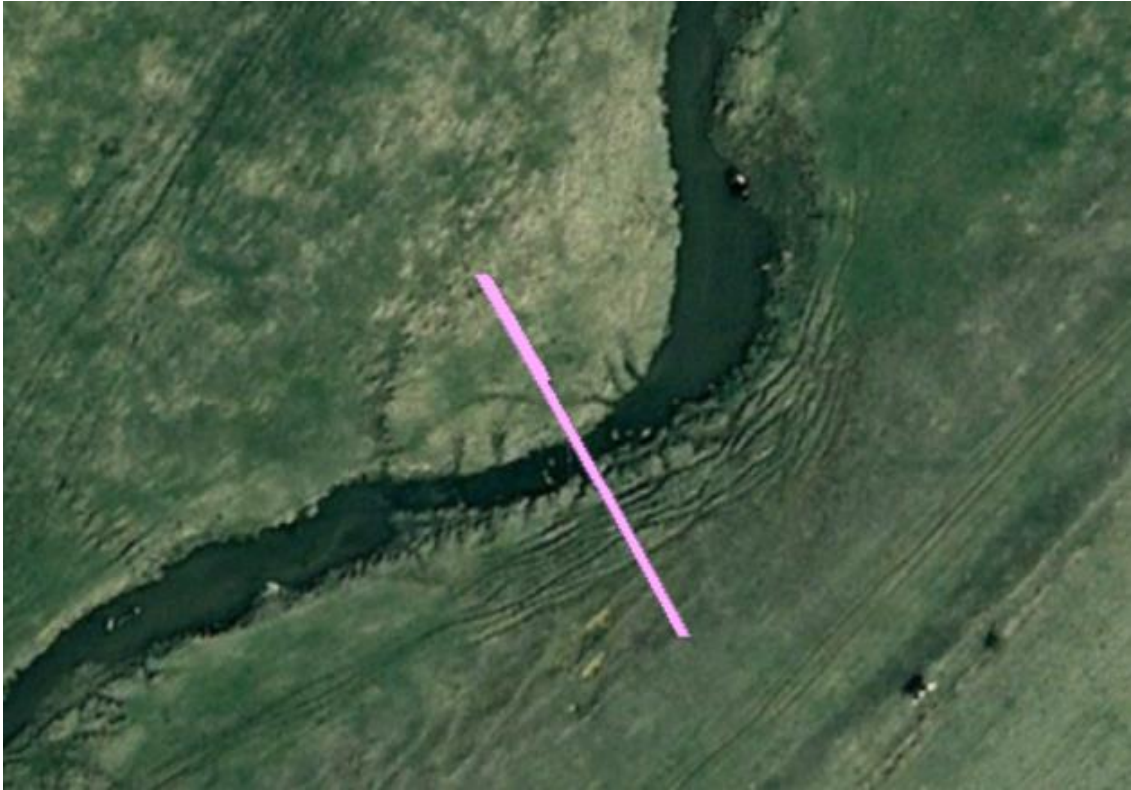
around this area can be seen in aerial photographs (Figures 22, 23). It is evident that the pool upstream of the cross section has filled in substantially since the restoration. In the 2009 aerial photograph, there are lines in the vegetation which show where the cattle frequently walked near and through the stream. Additionally, the pool just upstream of Cross Section 5 was a cattle wallow. It should also be noted that between Cross Section 4 and 5 there is a stormwater inlet from a neighboring apartment complex which supplies additional flow and sediment downstream of Cross Section 4.

Figure 22: Area around Cross Section 5 in 2009. Pink line is the location of Cross Section 5.

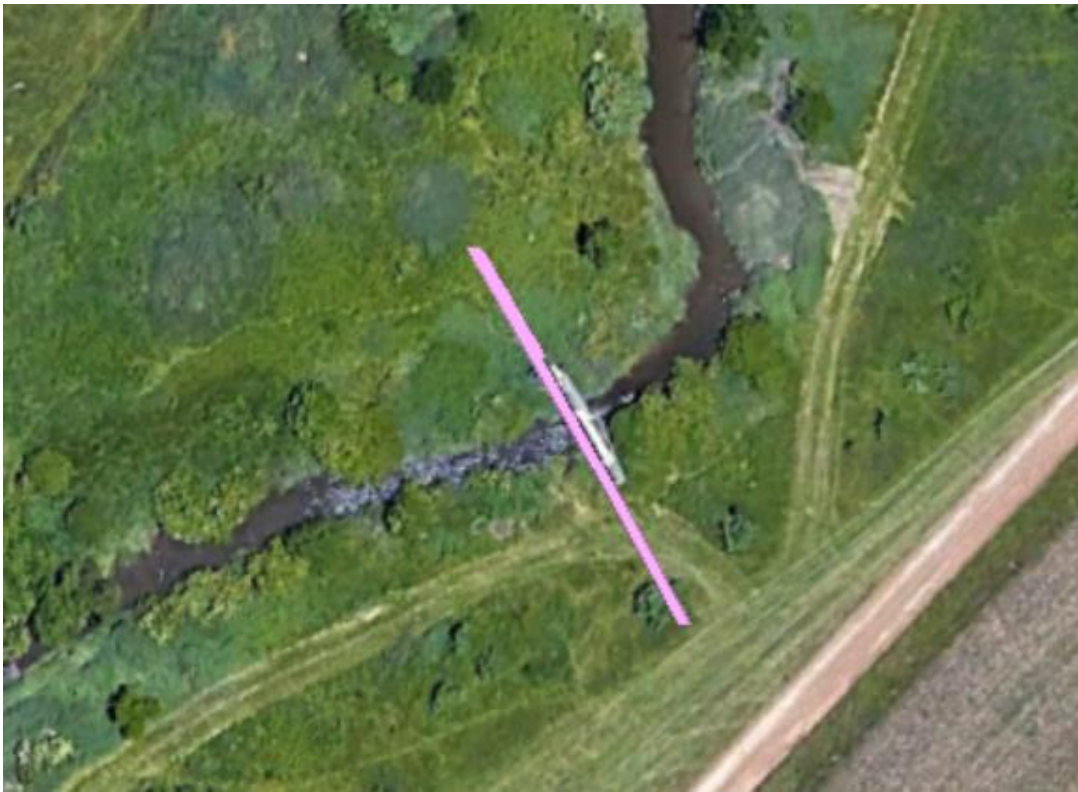
Figure 23: Area around Cross Section 5 in 2019. Pink line is the location of Cross Section 5.

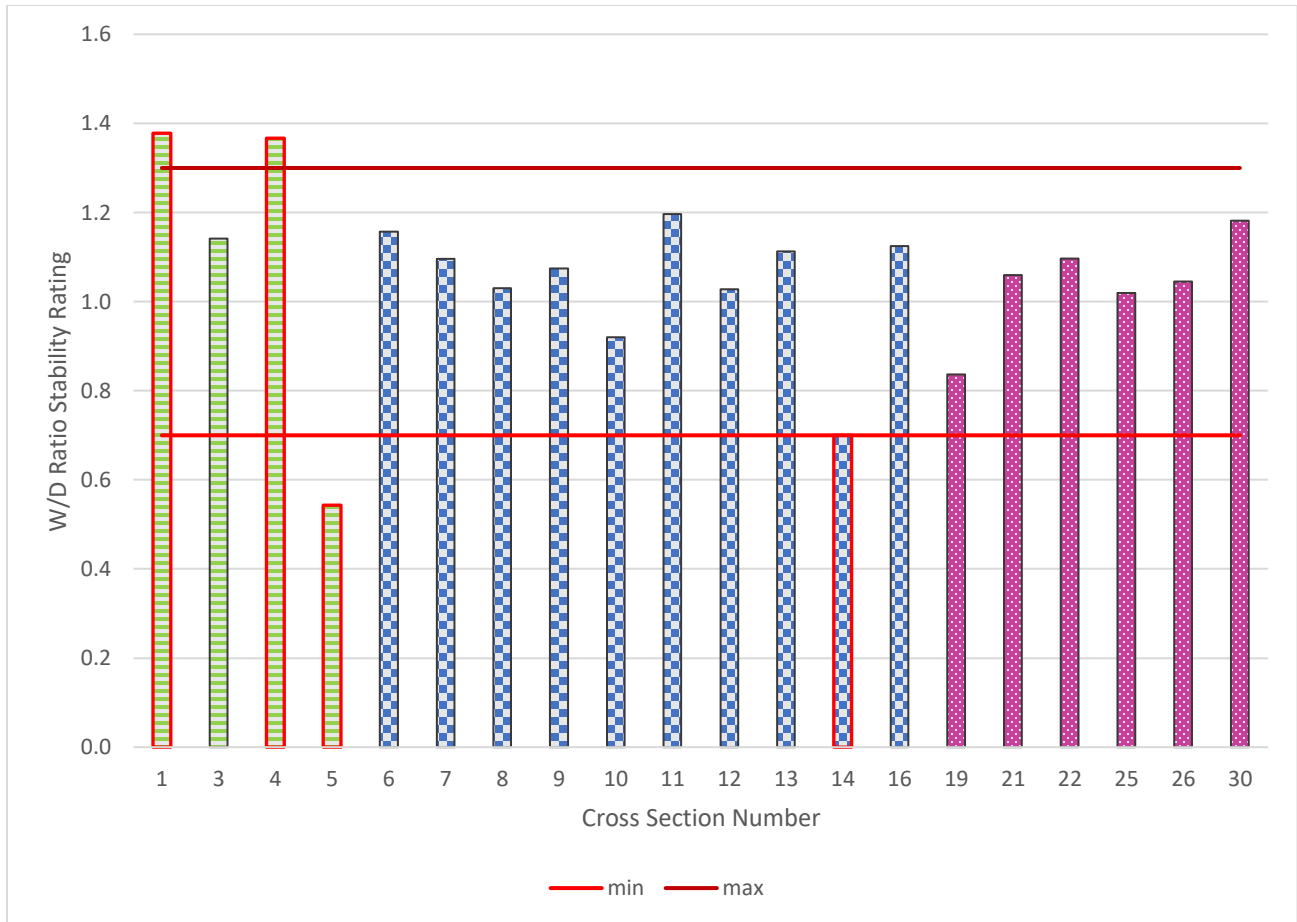
Cross section 5 (Appendix B-4) had a significantly lower W:D stability rating of 0.5 and is the only cross section to be below the lower limit. It should be noted that cross section 5 is directly under a sampling bridge, but there are no bridge piers or parts of the bridge in the active channel. All supports for the bridge are in the floodplain. The bridge is used to separate Treatment 1, where the banks are largely vertical, from Treatment 2, where the banks are gradually sloped. As more vegetation can grow on the gradually sloped banks and vegetation was actively re-established as part of Treatment 2, the roughness along the banks of Treatment 2 is higher than that of Treatment 1. This means that the flow velocity likely decreases at the transition between Treatment 1 and Treatment 2, causing sediment deposition at the bridge. Another potential

Figure 31: W/D Ratio Stability Rating for Stroubles Creek, Blacksburg, VA.

The two cross sections that exceed the higher limit are cross sections 1 and 4 which are both just over the limit at a stability rating of 1.4. These two cross sections have the highest positive percent change in W:D (37.8% and 26.7% respectively) and the highest positive percent changes in width (18.9% and 11.0% respectively) of all cross sections in the study. The changes in hydraulic depth for both cross sections are slightly above the 75th percentile for all cross sections in the study. These results reflect the ongoing channel degradation that is occurring in Treatment
