Chapter 6: Design Recommendations

The results from the usability evaluation were compared to findings from the expert information interview and PAU performance evaluations. These combined outcomes were reviewed for trends indicating aspects of the PAU design which may be decreasing performance effectiveness or user satisfaction. These findings have been interpreted and combined with design team input to produce a suggested list of design features which need to be addressed and possibly changed with the next PAU prototype iteration. In some cases recommendations for design alterations are offered. Design features requiring consideration are presented here in order of priority. Some changes in priority are expected to occur during the design process when feasibility of design options and their cost effectiveness are better understood.

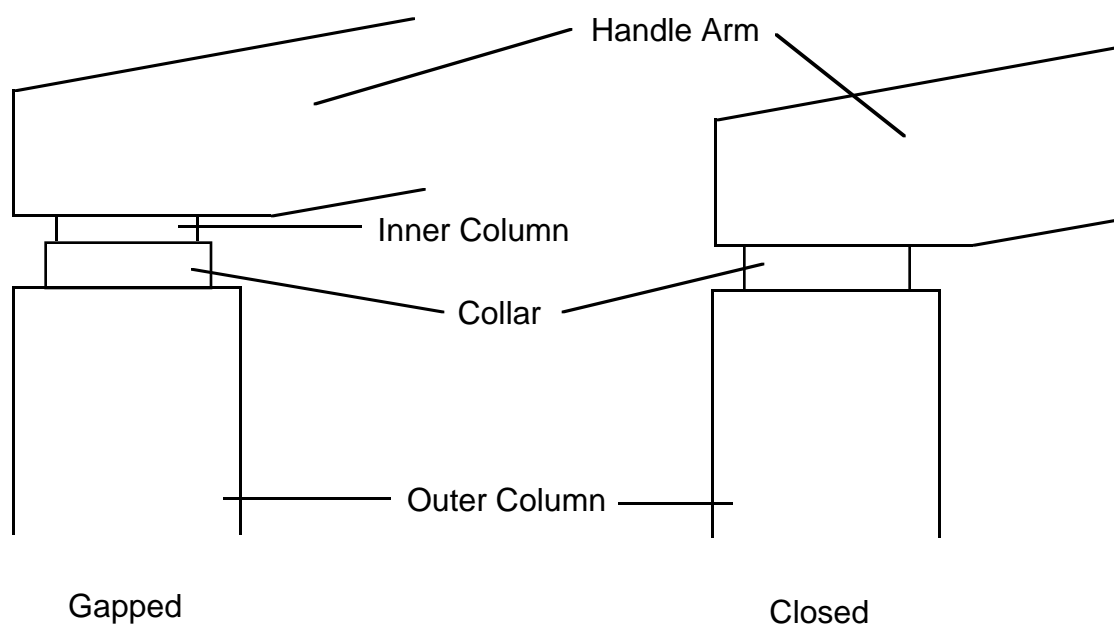
Figure 18. Collar solution for pinch point problem.

Column Pinch Point

Problem Definition. It was discovered that a pinch point exists in the juncture at the top of the outer column and the extended handle arm (component which reaches back toward the operator). The space between the two components gaps open when the unit is placed into power operating mode. This gap then closes again when the user switches the column out of power mode by rotating the drive wheels off of the ground. If the user handles the column at the gapped area while switching column positions, the hand can be pinched between the two metal pieces.

Option Recommendations. It may be possible to insert a collar around the inner column which would maintain a gap at all times. This would shift the area which gaps open and closes to a position next to the inner column; out of reach from the hands of the operator. Figure 18 illustrates the concept of a collar placed at the gapping juncture.

If this solution does not alleviate the problem, it may also be possible to guard the area (care must be taken not to create a new pinch point with the guarding).

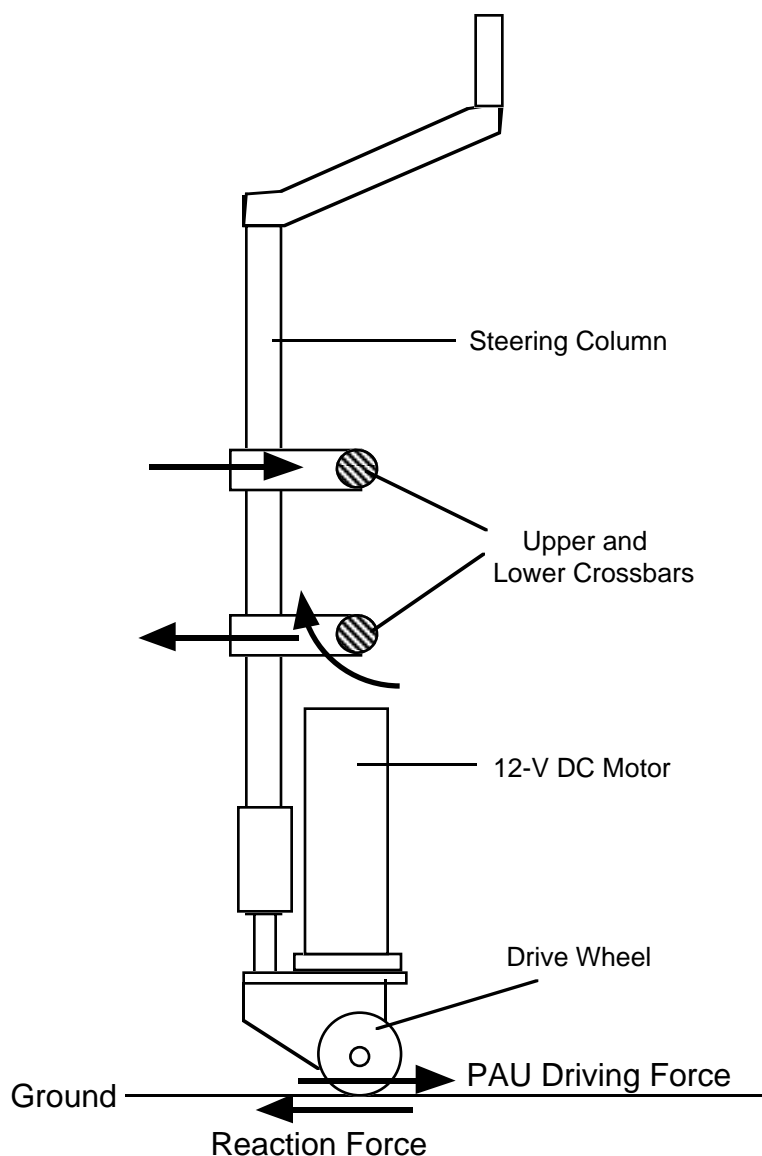
Figure 19. Column motions resulting from the ground reaction force.

Problem Definition. There is a reaction force created at the drive wheel/ground interface when driving in power mode (as the drive wheel pushes against the ground, the ground pushes back). This reaction force causes some motions in the column unit due to insufficient crossbar strength. Arrows in Figure 19 indicate the motions resulting from the ground reaction force in the PAU.

A moment is created about the lower securing crossbar which pushes the top crossbar back toward the wheelchair. There is also a linear component which pulls the lower crossbar forward. The motions of the crossbars are large enough to be detected by an observer and are seen as slight bending in the center of the bars. These motions are also sufficiently large to be easily detected at the handle by the operator.

No immediate problem exists with this type of design deficiency; it does not impact the effectiveness of the PAU. However, large bending motions of metal components may cause fatigue of the parts. Eventually these components will exhibit signs of wear and become nonfunctional, possibly breaking in an unsafe manner.

Option Recommendations. The securing crossbars should be stiffened to offer a more stable attachment to the wheelchair. Currently, 0.75-inch diameter aluminum tubes (0.125 inches thick) are used for crossbars. A tube with a larger diameter will provide a stronger support for the PAU column section. One-inch diameter tubes may be adequate, though testing will need to be done to confirm this hypothesis. If a change in diameter is not sufficient, then other material options should be considered as well.

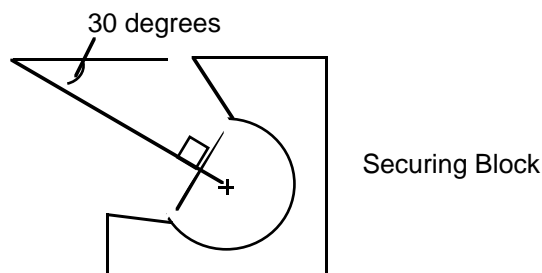
Figure 20. Column unit angle of approach for attachment.

Problem Description. Related to the bilateral handling requirement for the column, is the precision necessary for attachment and detachment. The column unit must be held at a correct angle and placed into position evenly on both sides at the securing blocks. When lifting the column out of the securing blocks, force must be applied at both sides uniformly and in the correct direction. These requirements imply the use of two dexterous hands for most users (one subject was capable of single-handed attachment and detachment). Even utilizing two hands, many subjects encountered difficulties such as overshooting the securing blocks during attachment and catching of the crossbar in the blocks while lifting it out.

This design deficiency did not prevent any of the subjects from performing the column attachment and detachment tasks. It was prioritized as problem number four in the critical incident analysis with a frequency of three and an average criticality rating of 4.3. The critical observation analysis also listed the problem as number four with a frequency of four and an average criticality of 3.9. Subject matter experts in the interview evaluation expressed a concern for the dexterity required for attachment and detachment of the column. One suggested that an assistant may be necessary to accomplish these tasks.

Currently, the openings in the securing blocks are angled so that the crossbar must approach the blocks horizontally but dropping slightly down. Figure 20 shows the required handling vector to place the unit into the blocks. The user must therefore move the column unit through a predominantly horizontal motion for attachment and detachment. This requirement is more difficult than simply lifting or dropping the unit vertically. It is recommended that the approach angle of the securing blocks be altered to permit a more vertical handling vector.

Option Recommendations. The most obvious option for minimizing the precision requirement is to improve the self-guiding characteristics of the securing blocks and crossbar. Flanges on the securing blocks which help to align the ends of the crossbar can be extended to provide a longer approach with a wider angle. This would present a larger target for the user to place the crossbar ends into; permitting a greater alignment error.

As an example, the block in Figure 20 could be rotated clockwise approximately 60 degrees from its current orientation.
