APPENDIX A. PERFORMANCE OF REINFORCED SOIL STRUCTURES DURING EARTHQUAKES

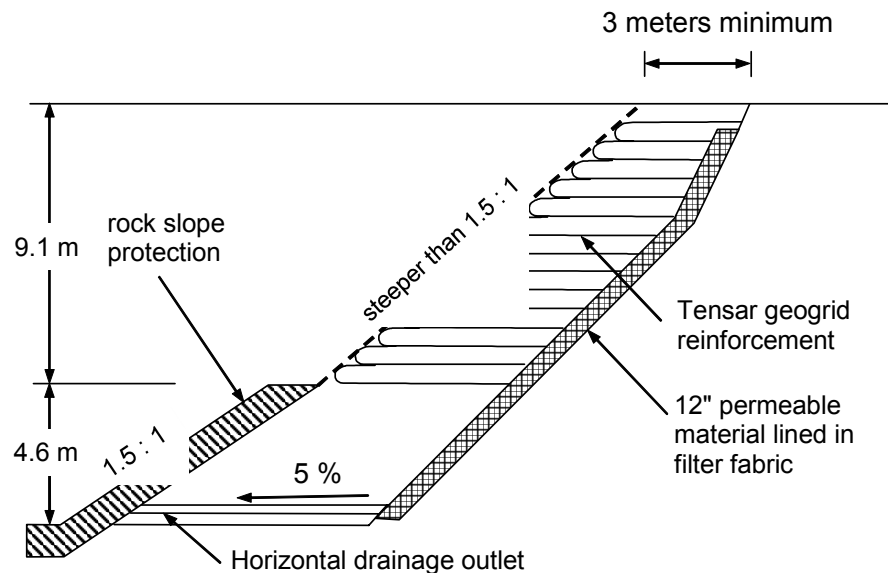
Several geosynthetic reinforced structures were identified and investigated. Of those structures reported the highest wall and slope were 5.5 meters and 24.5 meters respectively. These structures were built with geogrid reinforcements. Reinforcements were wrapped-around as wall facing in most of the structures. In some of the structures segmental masonry blocks were used as facing elements. No direct measurements were available at any of these sites except one. No signs of damage or cracking were observed. One of the reinforced slopes (La Honda Slope) had an inclinometer and it was possible to estimate the earthquake induced lateral displacements. Cross section of this slope is shown in Figure A-1. Inclinometer measurements were made before the earthquake to monitor the slope as shown in Figure A-2. Comparison of pre- and post-earthquake inclinometer measurements indicate that top of the slope deformed about 2 cm laterally, corresponding to 0.2% of the slope height.

Figure A-1. Cross section of La Honda reinforced slope (Collin et al. 1992)

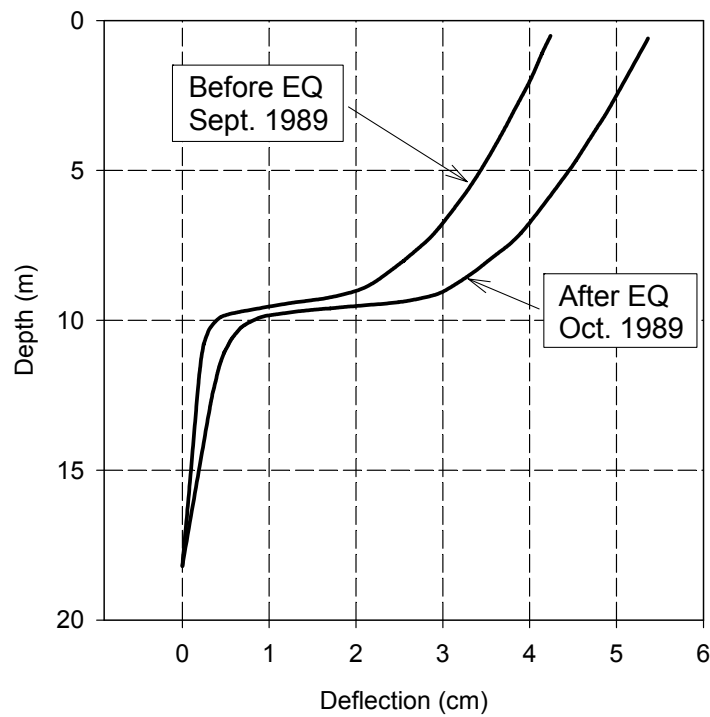
Figure A-2. Inclinometer data showing before and after earthquake measurements (Collin et al. 1992)

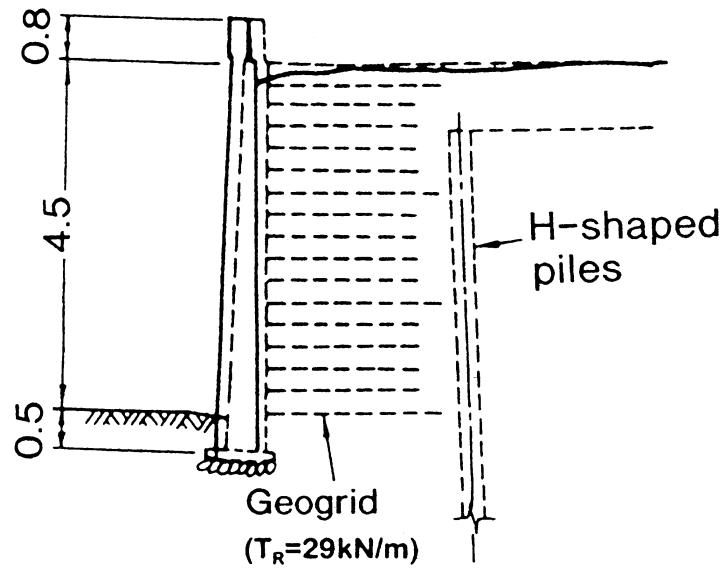
Performances of four geogrid reinforced walls with heights between 3 to 8 meters are reported. These walls support the railway embankment and also serve as bridge abutment at several locations. These structures were composed of a monolithic cast-in-place facing and relatively short reinforcements. (Tatsuoka et al. 1995, 1996a; Tatsuoka et al. 1996b; Tatsuoka et al. 1998). These walls were designed with the pseudo-static method using a seismic horizontal coefficient of 0.2. Peak ground accelerations at these sites reached up to 0.8g. Several nearby conventional retaining walls and houses suffered heavy damage. Three of the walls performed very well and exhibited no visual damage. The cross section of one of the walls along Japan Railway Tokaido Line is shown in Figure A-3. There is an electric supply frame located behind the wall and the 2.2 meter wide circular foundation of this frame embedded deep behind the retaining structure. A detailed description of this geogrid-reinforced retaining structure including construction details, monitoring data during and after construction is given in Kanazawa et al. (1992). Additionally, full-scale experimental studies performed to investigate the effect of the embedded foundation are reported in Tamura et al. (1992). A plan view and cross section of other geogrid-reinforced retaining walls along the same railroad line are given in Figure A-4. These are utilized as bridge abutments. Geogrid-reinforced soil structures at this site at Amagasaki, Japan and at two other sites performed very well. However, the fourth wall (Tanata wall) experienced some damage. The wall

moved about 30 cm horizontally as seen in Figure A-5. The wall also suffered facing panels spalling and cracking. This wall was built with relatively short reinforcements.

Figure A-5. Cross section of geogrid-reinforced wall that suffered some damage (Tatsuoka et al. 1996a)

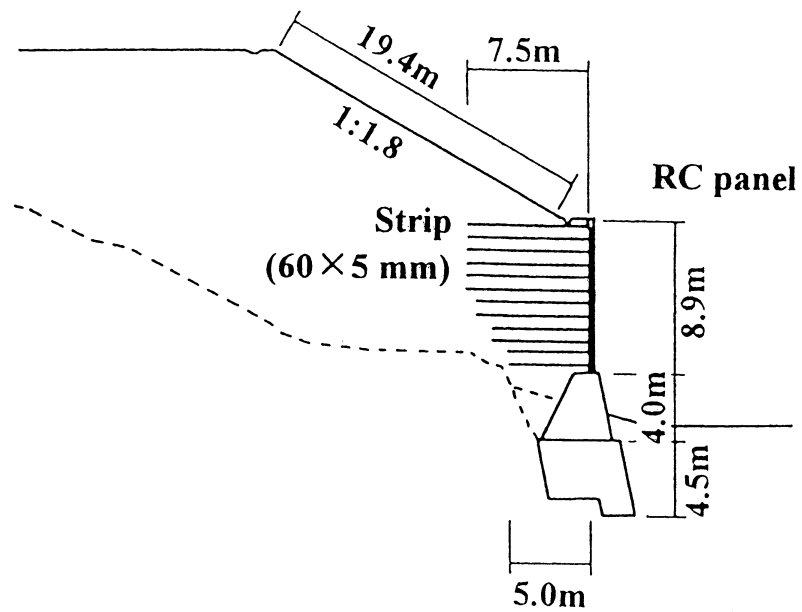
Mechanically stabilized earth walls built with steel strips (i.e. Reinforced Earth) also performed well. Kobayashi et al. (1996) reports 124 Reinforced Earth structures within 40 km of the earthquake source. Twenty-one of these were within the area of severe shaking. Most of these structures performed very well. However, some signs of damage were observed at three of these walls. One of walls that was built as part of the approach embankment is shown in Figure A-6.

The wall was 9 meters high at its maximum and was designed with a seismic coefficient of 0.15. Earthquake caused the top of the wall move outward about 15 cm. Similar damage patterns were observed at 2 other Reinforced Earth walls. Tatsuoka et al. (1996a) indicates 66 of these structures were identified within 70 km of the earthquake source. Obviously Reinforced Earth wall inventory from both reports overlap (Kobayashi et al. 1996; Tatsuoka et al. 1996a) and it is not possible to identify cases that are not reported in detail. Tatsuoka et al. (1996a) describes the same three walls that suffered damage and asserts the similar damage assessments.

Figure A-6. Cross section of the Reinforced Earth wall that suffered some damage (Tatsuoka et al. 1996a)

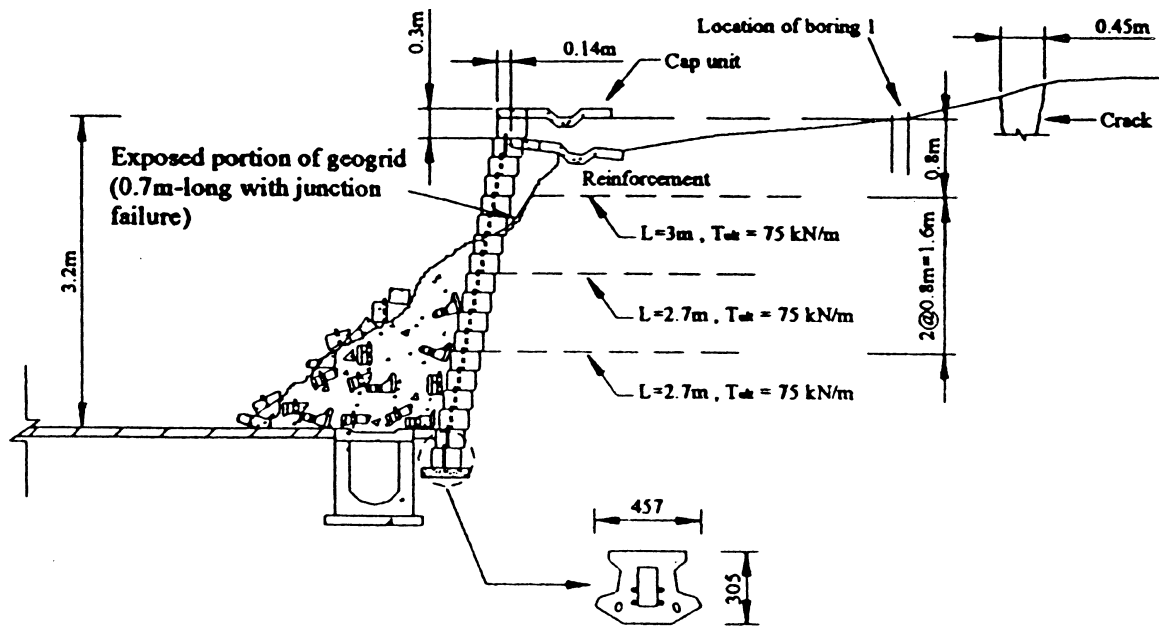
At another site along Ta Kung Roadway 129 a section of a geosynthetic-reinforced wall with modular block facing collapsed and other sections suffered heavy damage. This wall was built with geogrid reinforcements and silty sand backfill. The wall was 3.4 meters at the collapsed section. A cross section of the collapse is shown in Figure A-7. In addition to the section that collapsed, other sections of the wall also suffered significant damage where blocks moved out-of-alignment and separated causing backfill material to spill out. The largest bulging displacement was observed at about 1.6 meters from the bottom of the wall (about 1/2 to 1/3 of the wall height). Geogrid reinforcements were observed to be torn at location of connection pins. The cross section of the wall at this part of the wall and a sketch of the observed deformations are shown in Figure A-8. A 7.5-meter high conventional

reinforced concrete retaining wall supports the other side of the highway embankment and suffered only minor damage. This RC retaining wall was designed by the same organization that built the reinforced soil structure. Both structures were built around the same period of time (Huang 2000). Peak ground accelerations during the earthquake were in excess of 0.4g in the area whereas seismic provisions require a seismic coefficient $k_h=0.115$ for this area.

Figure A-7. Cross section of the collapsed geosynthetic reinforced modular block wall (Huang 2000)

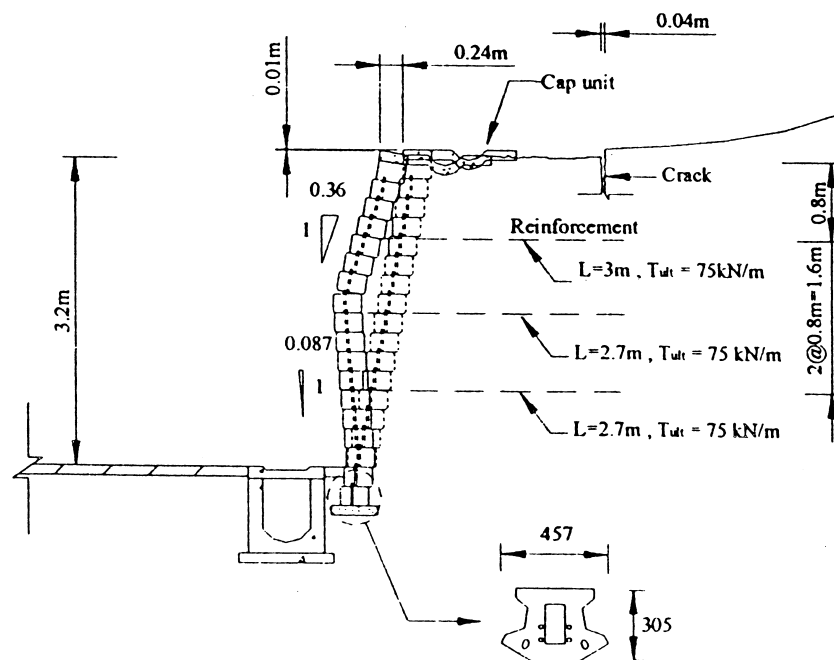
Figure A-8. Large deformations at the geosynthetic reinforced modular block wall (Huang 2000)

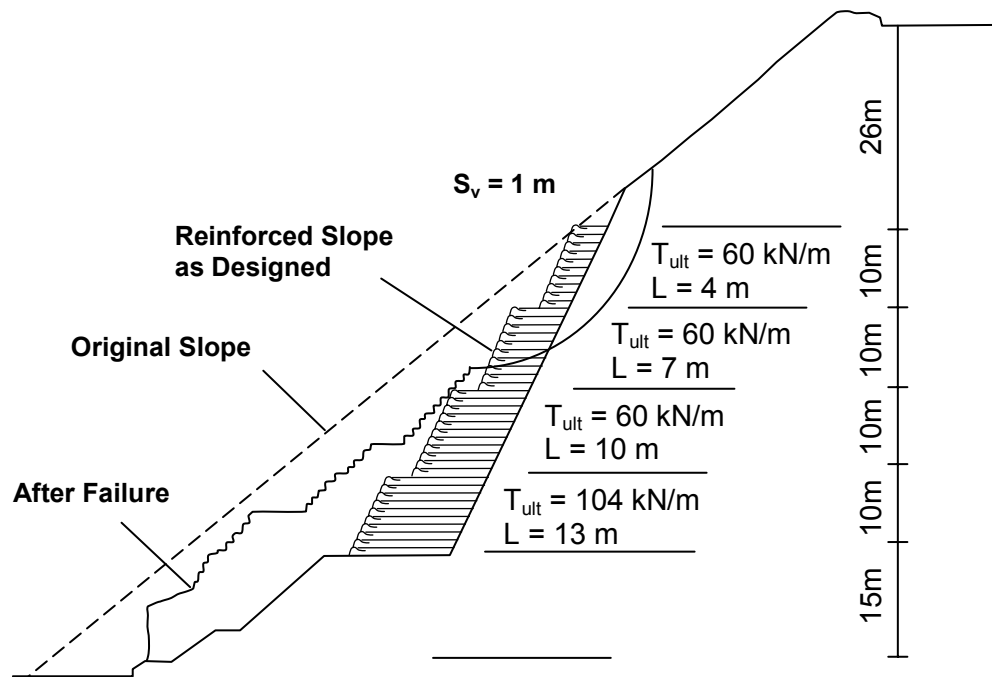
A 40-meter high reinforced slope collapsed during the earthquake. Geogrids were used as reinforcements and wrapped around as facing. On-site silty clay was used as backfill material (Huang 2000; Ling et al. 2001). The total height of the slope is 80 meters, 40 meters of that composed of 4 reinforced sections each 10 meters high as shown in Figure A-9. This slope failed in 1994 immediately following completion and large deformations were observed in 1996 following repair. In addition to this collapse-repair sequence, parts of the unreinforced slope beneath the reinforced slope were strengthened with reinforced concrete frame and tie-back anchors. All these complexities make it a difficult case to assess the mechanism that lead to collapse during the earthquake.

This slope was designed using a pseudo-static seismic coefficient $k_h=0.15$ and a pore pressure coefficient $r_u=0$. Slope stability analyses using these values in the design phase yielded a Factor of Safety, $FS=1.1$. Stability analyses performed after the earthquake, using the same parameters resulted in $FS=1.0$ (Huang 2000). In any case this slope exhibited stability problems immediately following construction and conventional stability analyses

yield a marginal factor of safety. Studies have been performed on this case study (Chen et al. 2000; Holtz et al. 2001). However, limitations on the pre-earthquake conditions prevent these studies to be conclusive about the collapse.

Figure A-9. Cross section of the failed reinforced slope (adapted from Huang 2000)
