LOAD TESTING DETERIORATED SPANS OF THE HAMPTON ROADS BRIDGE-TUNNEL FOR LOAD RATING RECOMMENDATIONS

Masters of Science
In
Civil Engineering

November 29, 2016
Blacksburg, Virginia

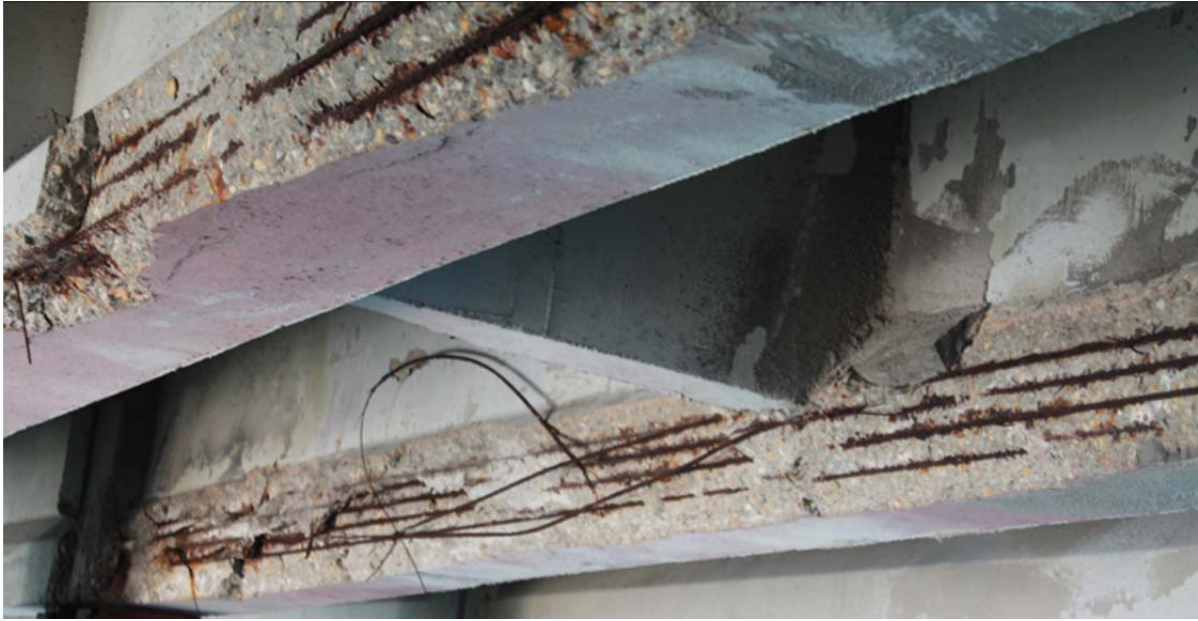
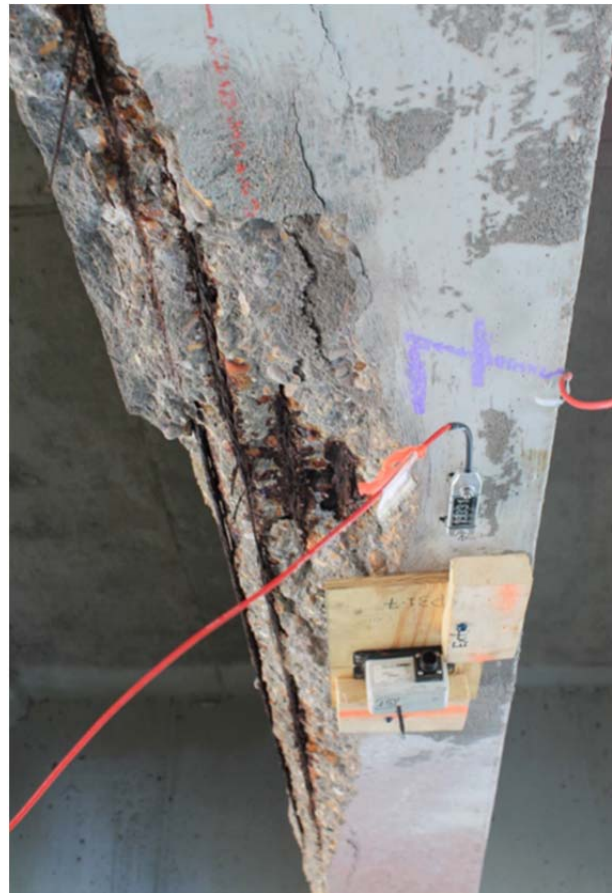
Figure 23: Current Deterioration of Westbound Span 31

Span 31 was designated as the “bad span” for the westbound tests. Girders 7 and 8 exhibited the most damage in their flexural region as shown in Figure 23. Girder 8 had four layers of prestressing strands exposed along the side of the bottom flange for approximately 70% of the span length. The strands showed heavy corrosion while some strands were completely severed. In Figure 23b, the orange reel is at midspan of girder 8 and the purple “8” chalk mark is 8 ft – 4 in. from the pier cap face ($\sim L/5$). Girder 7 had only three layers of strands exposed on the side of the bottom flange, but also had strands exposed on the soffit of the bottom flange (Figure 23c). The deterioration mapping diagrams from the Clark Nexsen inspection report dated June 2015 were accurate for all spans. Figures from this report of the damage mapping are presented in Appendix A.

a) Girder 7 on left, Girder 8 on right

b) Girder 8 Bottom Flange Soffit

c) Girder 7 Midspan Soffit

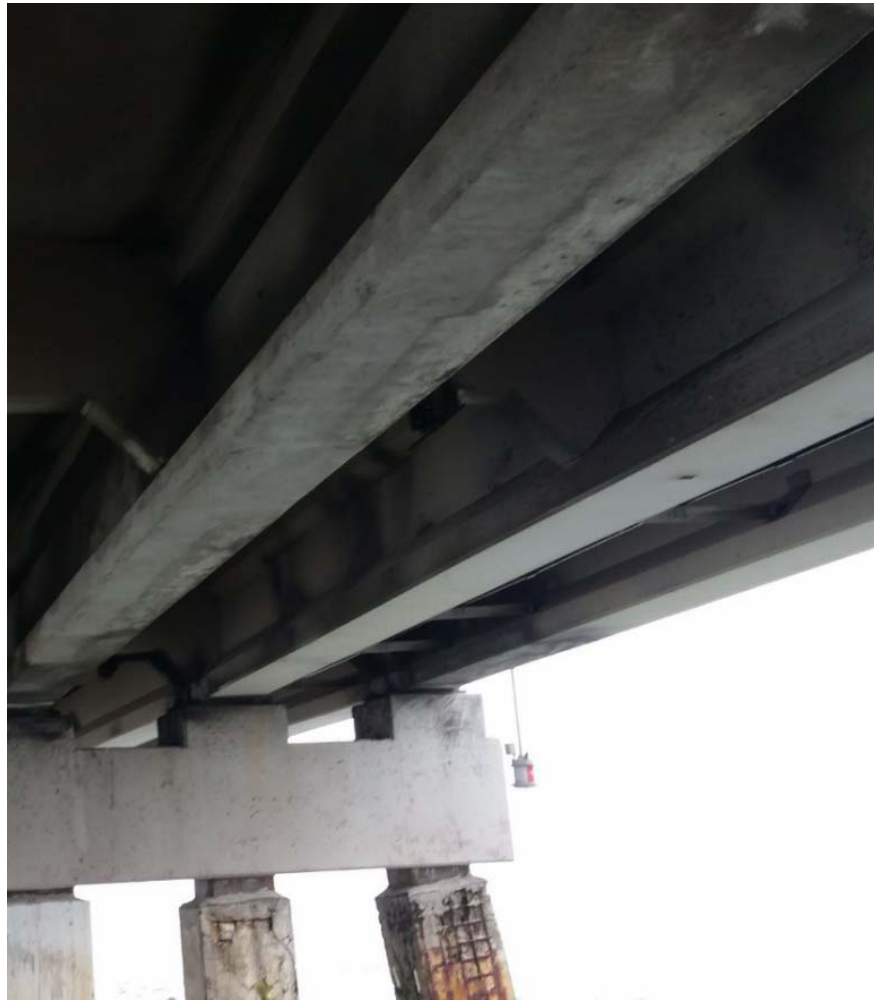
Figure 25: Shotcrete on Girder 5 Bottom Flange

The eastbound structure recently underwent rehabilitation as part of a VDOT construction contract; however, at the time of testing, no deterioration mapping was available to the project team. For span 56, mapping was performed by Virginia Tech on the day of the load test which highlighted obvious visual deterioration zones. Prior to mapping, it was known that girder 5 had severe corrosion to most of its lower layer of strands based on information provided by VDOT. Inspection mapping of this span is located in Appendix A which highlights areas of patchwork within the span. These locations were rehabilitated using shotcrete to cover spalled areas of concrete. The repairs were cosmetic only, meaning no structural repair was completed to increase member capacity. The condition of the previously exposed prestressing strands is unknown. Figure 25 shows the bottom flange of girder 5 which has been patched with shotcrete.

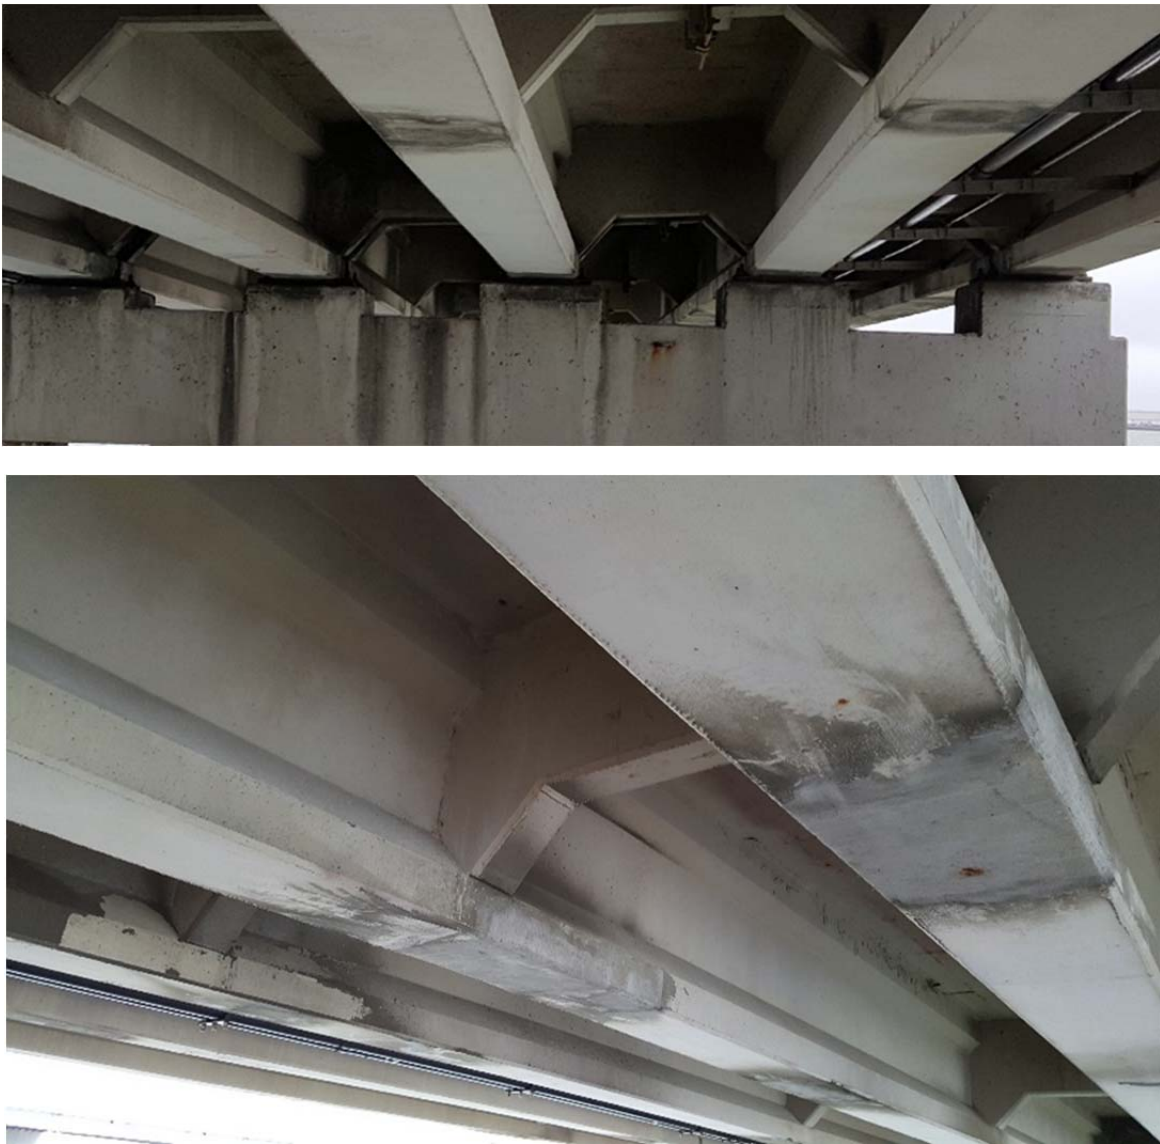
Figure 26: Patching on Girder Bottom Flanges

On the first day of instrumentation, the span 57 was selected to serve as a benchmark for comparison with span 56. The criteria for selection included minimal damage and close proximity to span 56 to allow for optimization of instrumentation equipment. Span 57 was designated as the “good span” for the eastbound structure. No apparent damage on span 57 was observed beyond intermittent patching on some of the girder bottom flanges. While these patches were not documented during testing, and inspection details were not available from VDOT, examples of the conditions of the girders are shown in Figure 26.

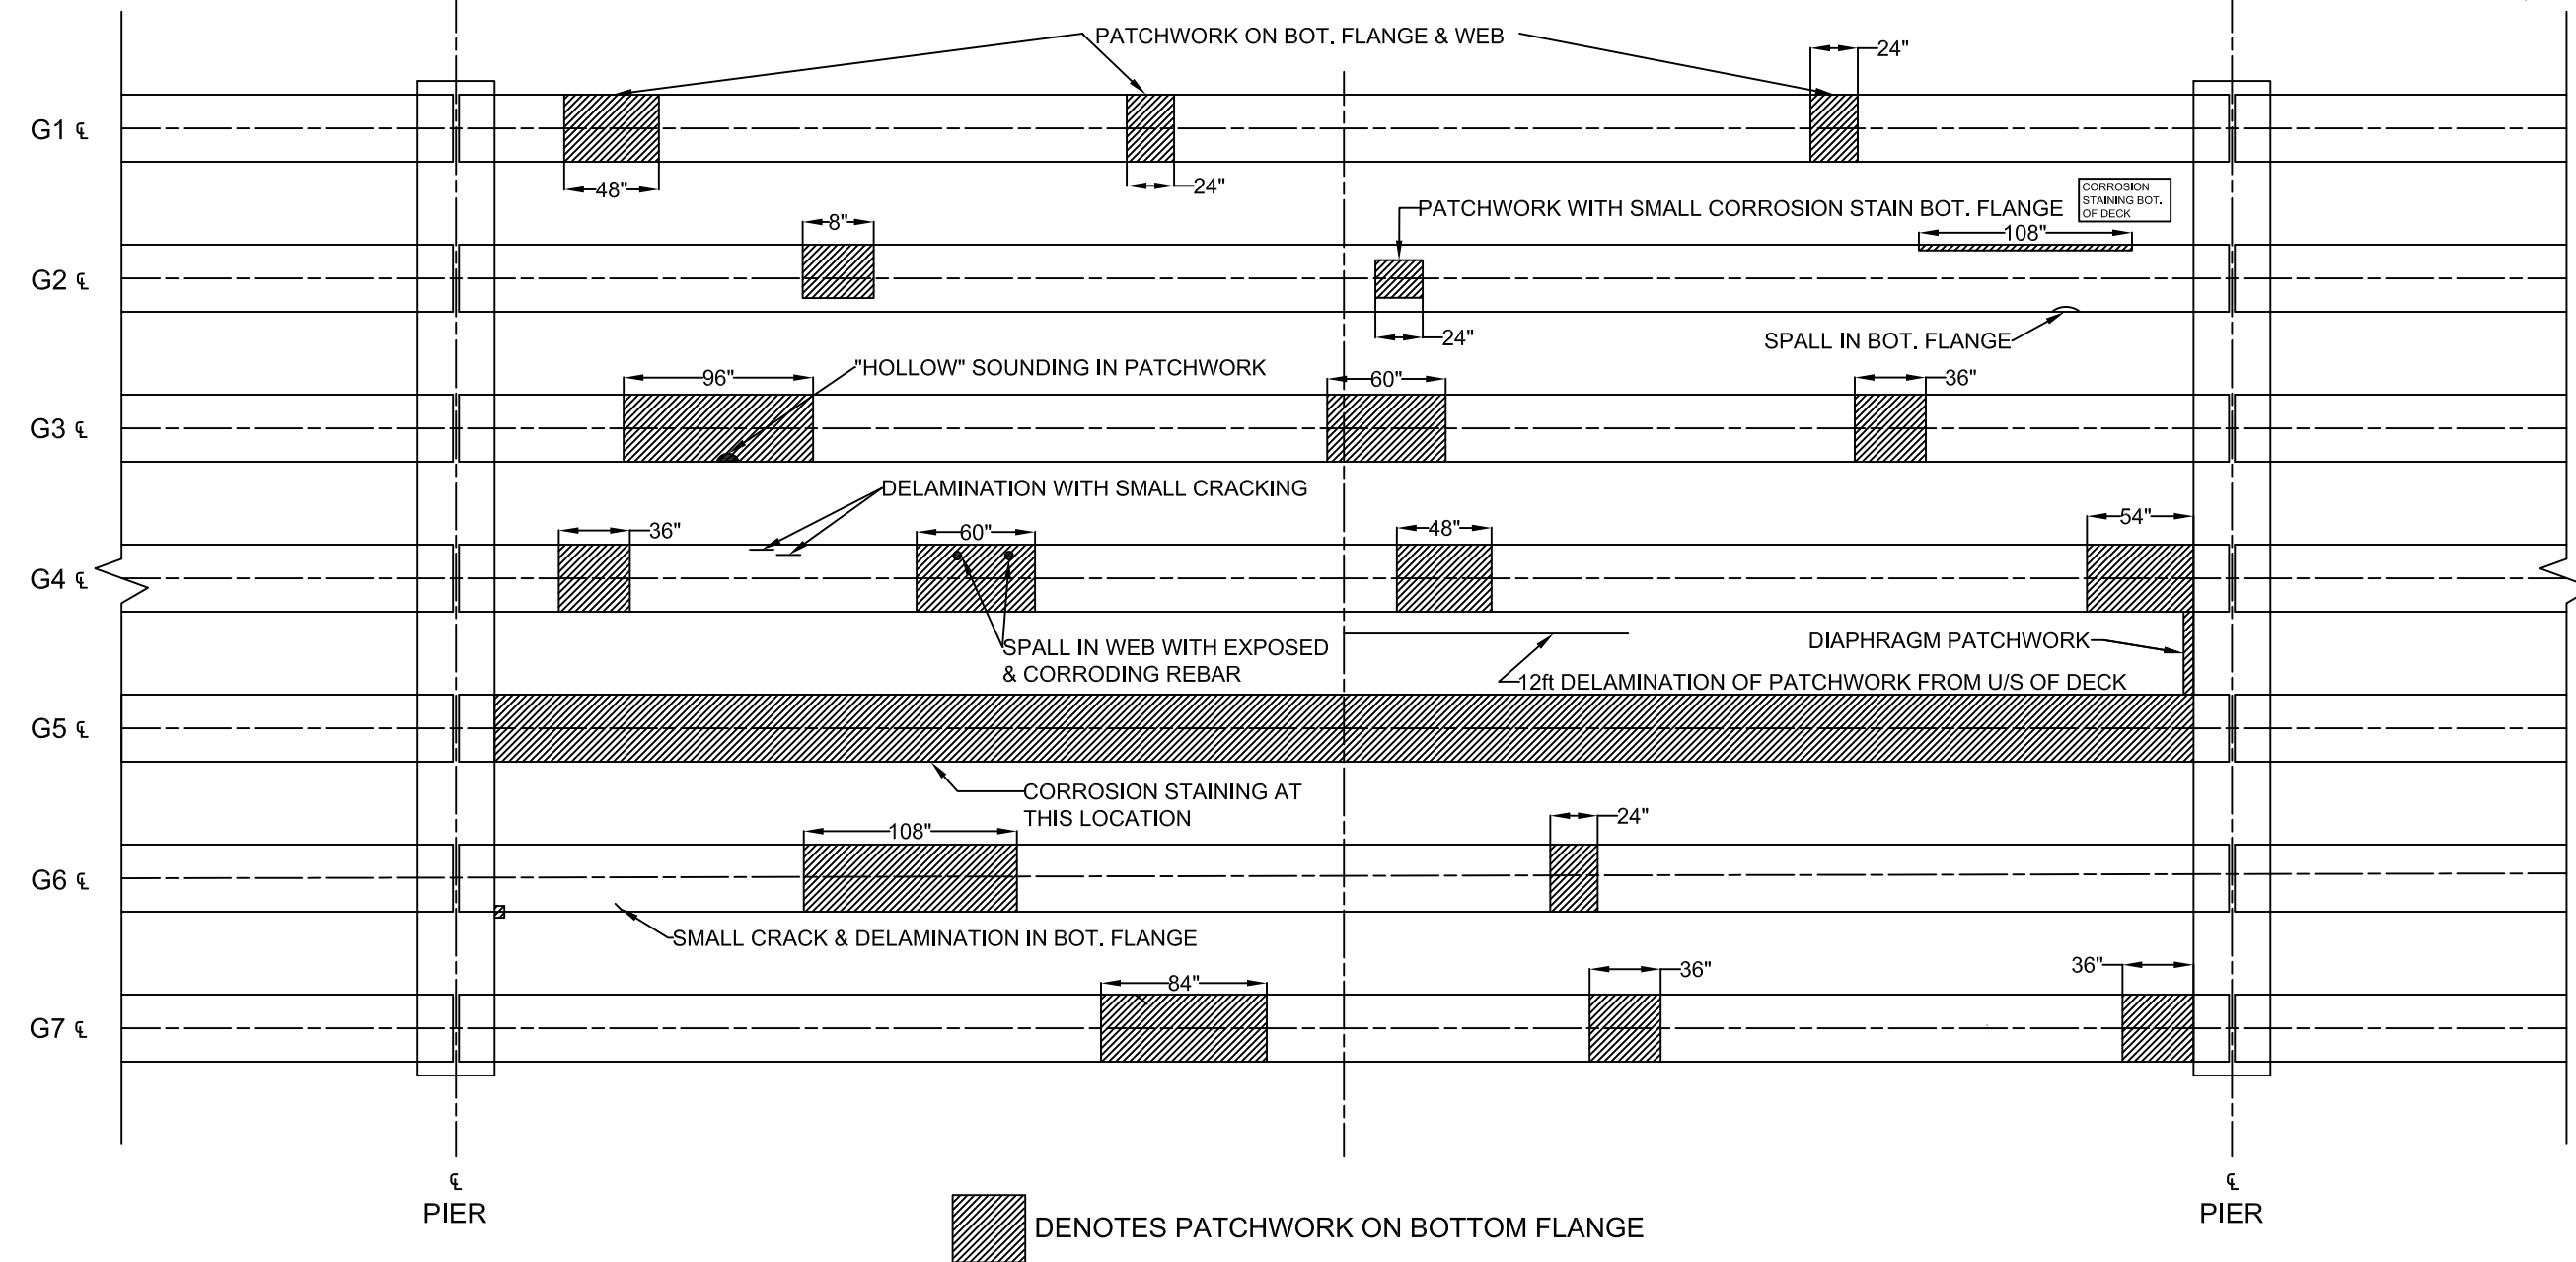
A PLAN - EB DEFECT MAPPING

ALL BEARINGS CORRODING
