**DETERMINATION OF REMAINING FATIGUE LIFE OF WELDED STUD DETAILS
ON OVERHEAD ALUMINUM SIGN PANELS IN VIRGINIA**

Contract Research Sponsored by
Virginia Transportation Research Council

March 2005
VTRC 05-CR10

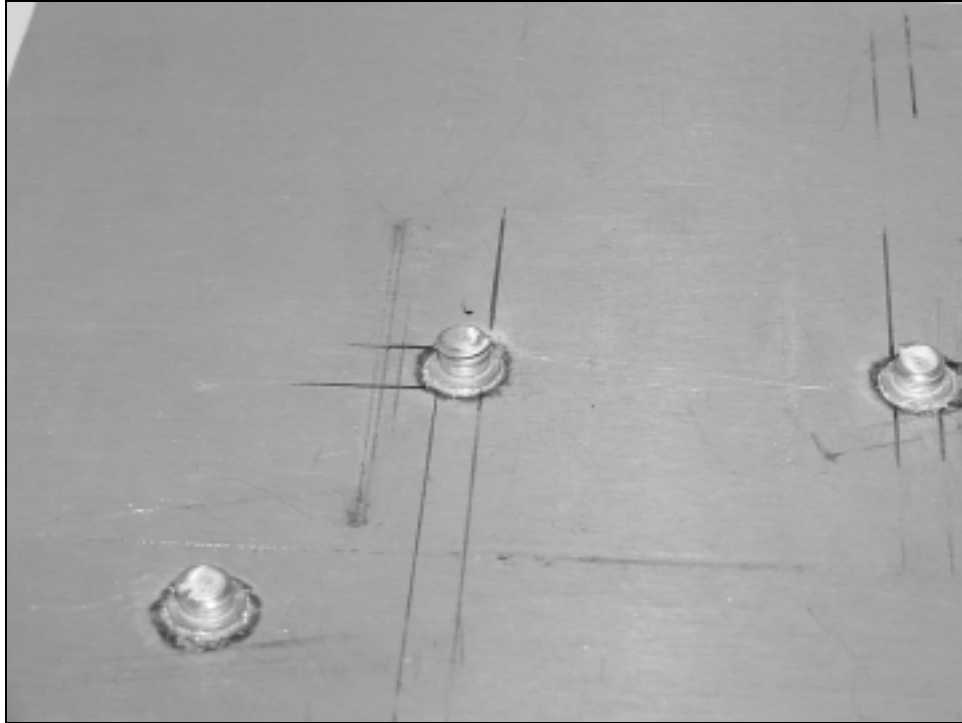
VDOT halted its production of the signs with this clip-angle connection detail many years ago, however, some contractors continued to use this detail until early in 2004. One of the reasons some VDOT Districts stopped using the clip and z-bar connection was because the studs can shear if the nuts were more than “hand-tightened” during installation. Figure 10 shows studs that failed during tightening in the laboratory. Other districts, however, did not stop allowing contractors to install this connection detail until early in 2004, after a few known sign failures in the field.

Figure 10. Stud Failure Due to Over Tightening.

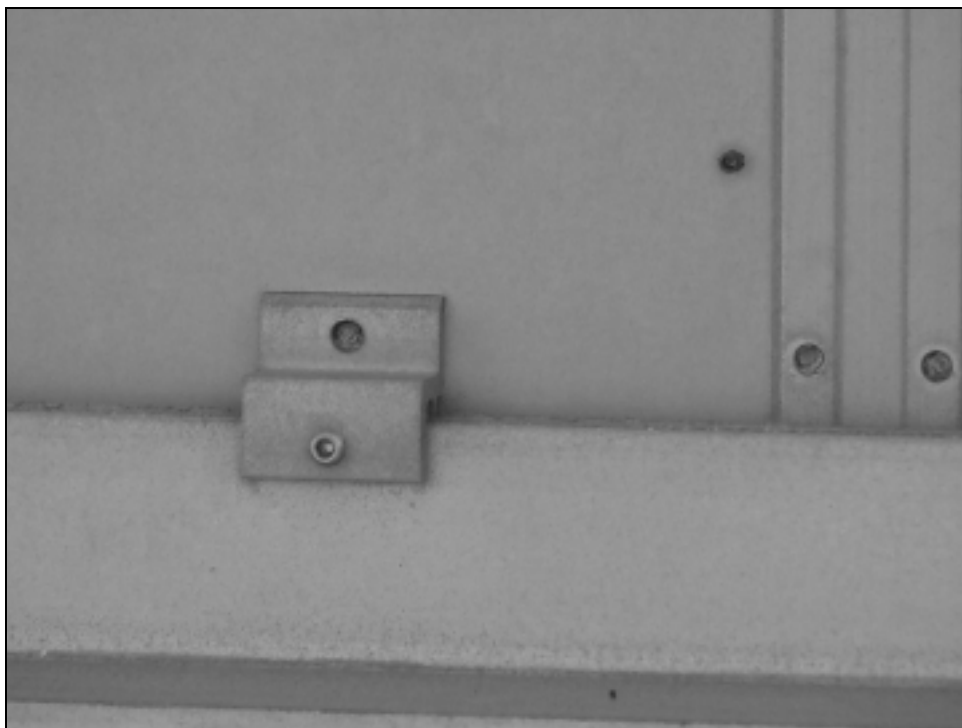
In April 2003, a sign failed and fell in the Hampton Roads District causing a traffic accident. Another sign failed in the Fredericksburg District in March 2004, luckily not causing injury. It was observed that these failures occurred due to the threaded studs “popping off” the sign panels. The failure mechanism was observed to be fatigue of the weld connecting the panel to the stud, caused by natural and/or truck-induced wind gusts. From inspection of other signs that had failed connections, but had not fallen, it was concluded that the bottom edge and corner connections are more susceptible to failing. After the edge connections fail, the interior connections start to fail. This can be described as an unzipping of the sign connections. A failed sign and stud can be seen in Figures 11 and 12.

Figure 11. Failed Stud on Sign.

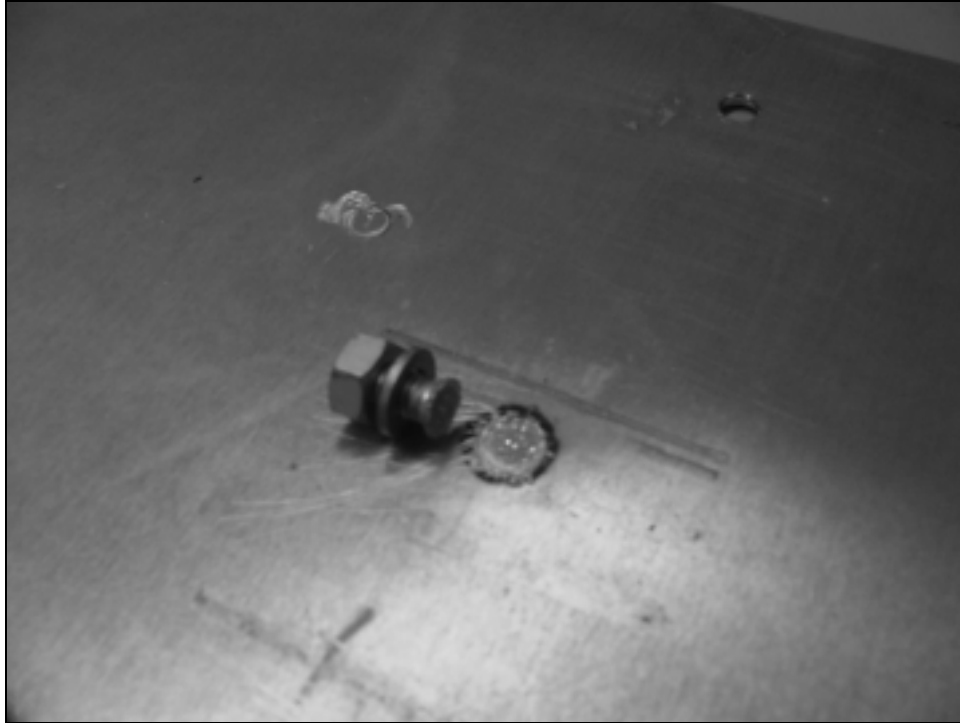
Figure 12. Failed Stud Due to Fatigue.

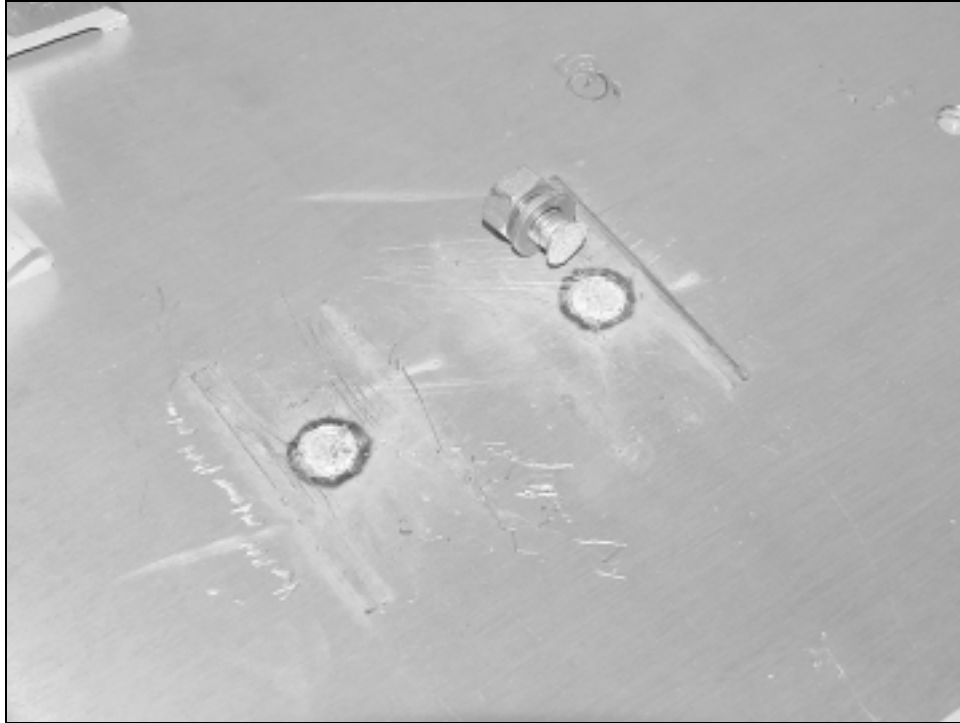
The results of the seven pseudo-static tests to failure are shown in Table 3. The average pseudo-static strength of the connection is 967 lb. The weld failed for all specimens, as seen in Figure 23. This failure mechanism was representative of most failures found in the field.

Figure 23. Failure of Weld.

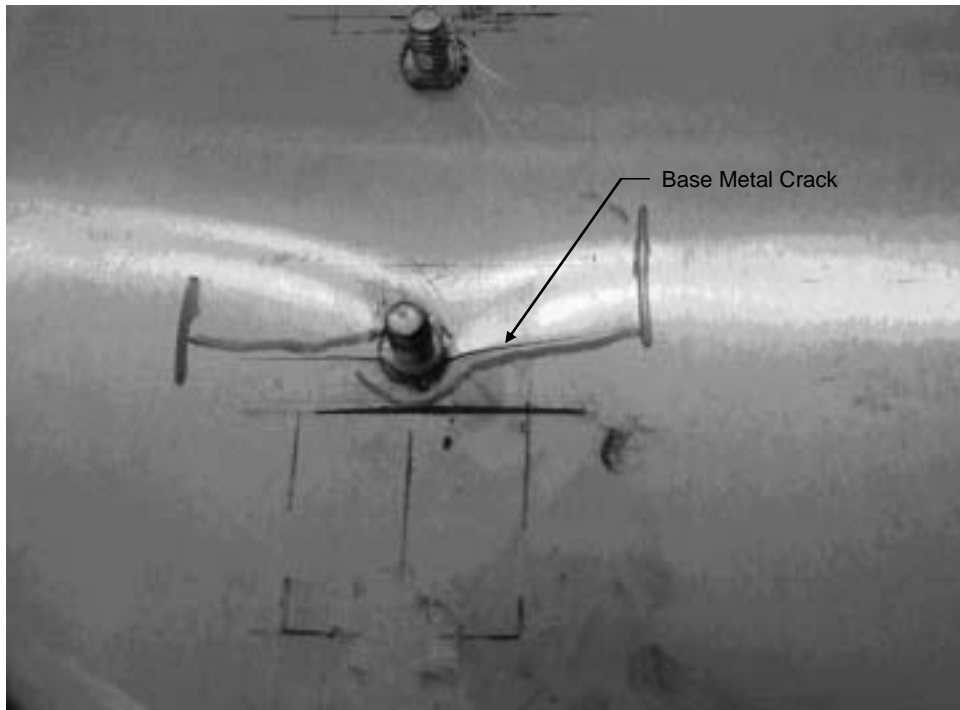
The connections tested for fatigue at stress range of 50-500 lb failed in the same manner as the pseudo-static tests. The connections tested cyclically at lower stress ranges developed cracks in the aluminum panel prior to the stud pulling out, as seen in Figure 24. In these cases, the welds did not fail. Crack initiation for these tests was estimated by changes in stiffness plots. Because these failures were not representative to any found in the field, the testing of interior connections was stopped. It was assumed that this was not the correct boundary condition and loading configuration that was in the field. The fatigue results can be seen in Table 4. There was no S-N curve developed for this loading condition because of the small number of samples tested.

Figure 24. Cracked Panel Leading to Stud Pullout.

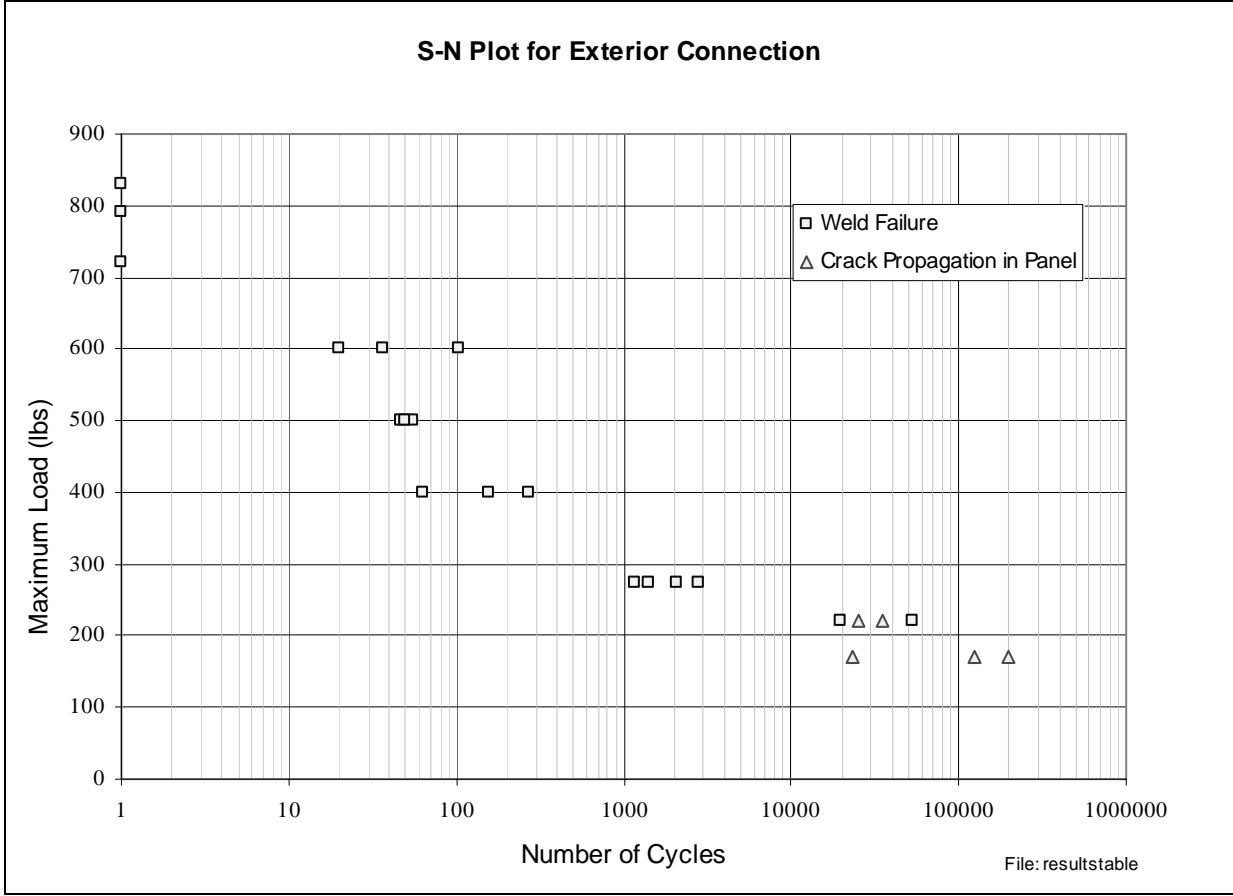
The connections tested at higher stress range exhibited failures of the weld between the stud and panel. Lower stress ranges exhibited cracking of the panel. Table 5 shows the results of the tests run, as well as the failure mechanisms. An S-N curve was developed from the exterior connection tests as seen in Figure 25.

Figure 25. S-N Plot of Exterior Connection.

The exterior connection was tested with the same objective as the interior fatigue connection, to start at a high stress range and progress to lower stress ranges until the infinite life stress range was determined. The exterior connections were observed to have lower pseudo-static strengths than the interior connections. This was expected due to the larger deformation and bending stresses induced on the stud connection. The weld fracture was the controlling failure mechanism at approximately 1.5 times that of hurricane design forces. The test panels exhibited base metal failure and cracking instead of a weld fracture at load ranges lower than 220 lb. The test panel tested at a load range of 100 lb exhibited an extended fatigue life. This load range is still above hurricane gusts of 90 mph and just below gusts of 120 mph for the sample sign. Under this loading type, the signs should not fail under common wind gusts. Because the tests did not model the failures found in the field, it is presumed that the loading conditions used for these tests did not properly simulate those found on full size signs in service.

1. *Inspections and retrofitting scheduling should be increased because of the statistical uncertainty.* Because there are so many uncertainties observed about how the signs are manufactured and erected it is suggested that the inspection process be accelerated.
2. *Full size highway signs that are still in use should be gauged and monitored to determine what type of loading to which they are subjected.* There are some issues concerning which signs should be tested because wind loads can be site specific. It is suggested that signs in the same area or setting as known failures be gauged.
3. *Full scale testing with wind loads may be the proper way to test the highway signs.* This requires multiple signs, which can be a problem because they are not readily produced anymore.
