**EVALUATION OF METAL CONNECTOR PLATES FOR
REPAIR AND REINFORCEMENT OF WOOD PALLETS**

Thesis submitted to the Faculty of the
Virginia Polytechnic Institute and State University
in partial fulfillment of the requirements for the degree of
MASTER OF SCIENCE
in
Wood Science and Forest Products

July, 1992
Blacksburg, Virginia

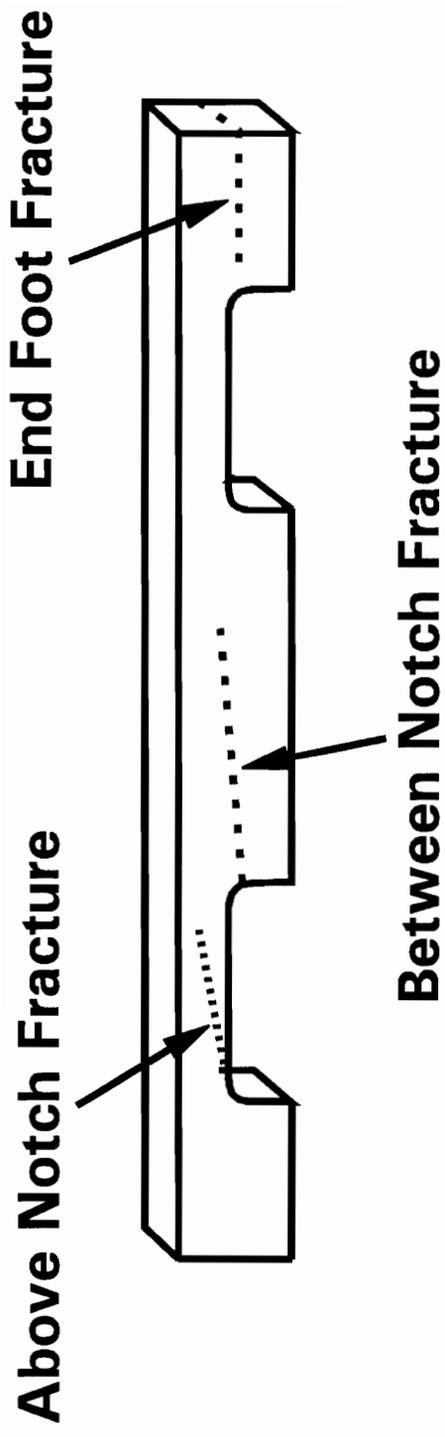
Wood pallet stringers commonly fail between the notches (BN), above the notches (AN), and in the end foot (see Figure 1.1). The first two result from bending loads on a notched beam, while the third is usually the result of an impact from a forklift tine. Metal connector plates (MCPs or plates) applied to repair fractures in these areas could return a damaged pallet to its original strength or stiffness. Alternatively, MCPs applied to reinforce these areas before use could increase economic life and load carrying capacity, as well as allowing for the potential use of underutilized species.

Figure 1.1 Schematic diagram of a notched stringer showing the three damages to be repaired and evaluated.

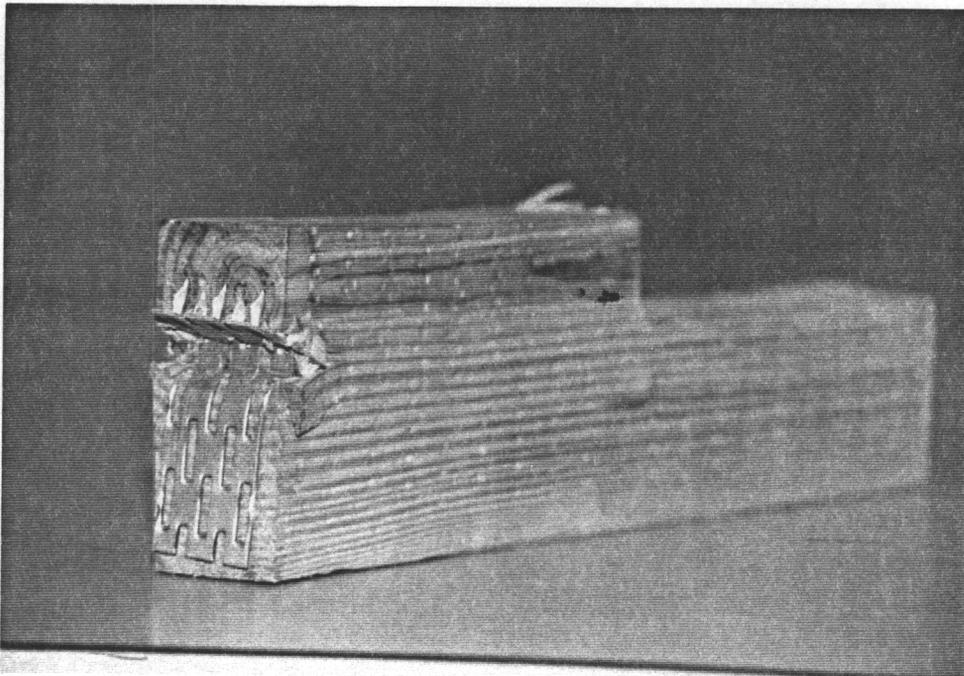
Figure 3.19 Curl Failures on End Grain MCPs

end grain plates to curl from the wood surface (see Figure 3.19), rendering the end of the foot unsafe for commercial use, possibly more unsafe than a broken end foot. The ram speed was slowed to 0.05 inch/minute, and it was determined that the MCP curl occurred before wood failure. Therefore, an end foot reinforced with an end grain plate would fail (by MCP curl) before an unreinforced end foot (by wood failure).

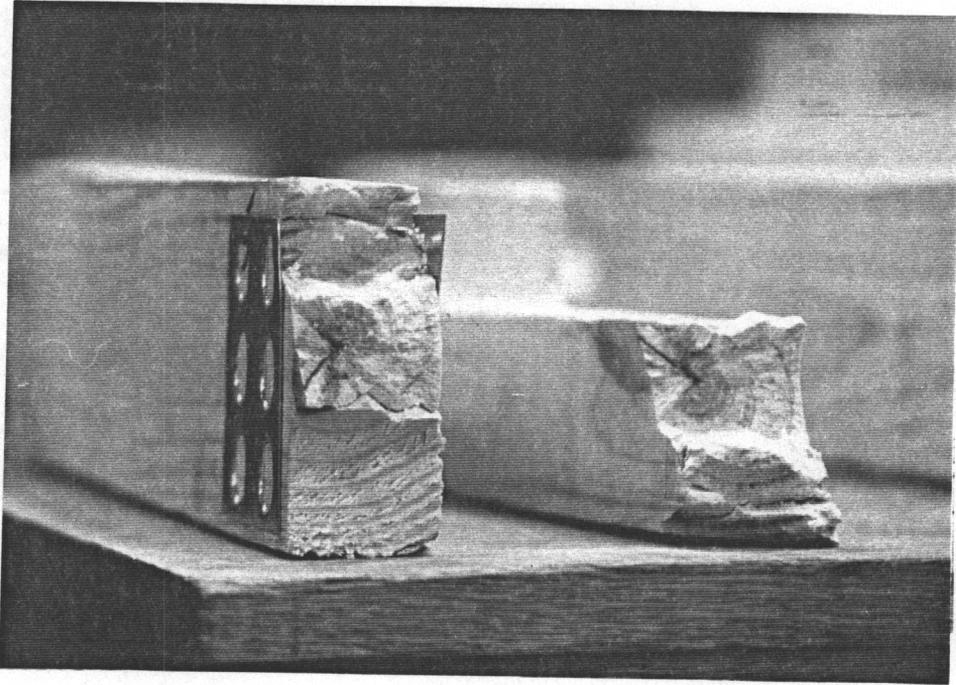
Figure 4.1 Above Notch (AN) Failure Mode in Stringer

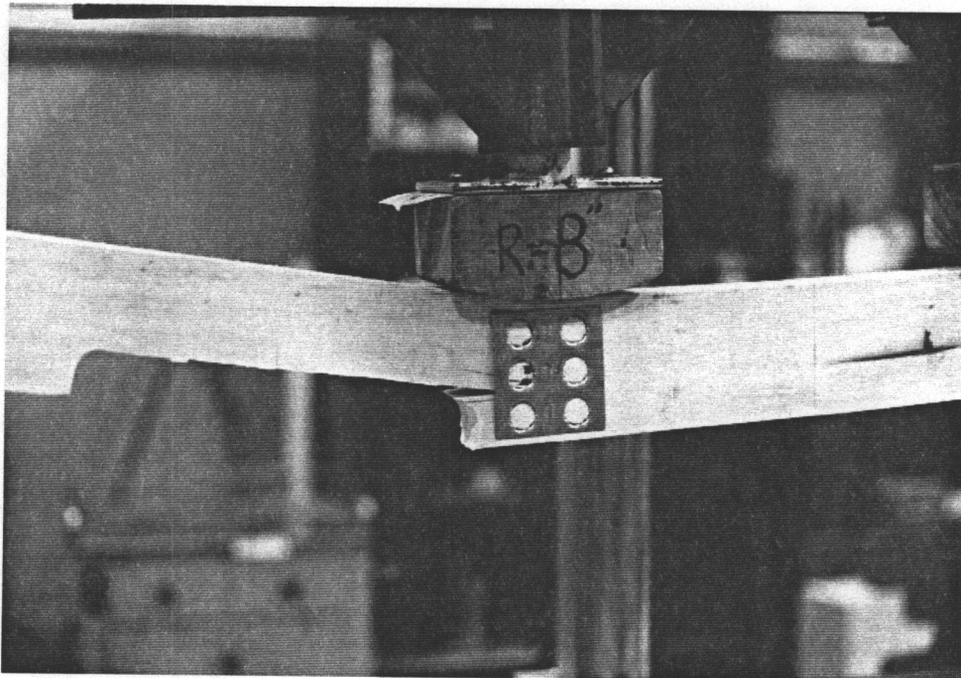
Figure 4.2 Plated Notch (PN) Failure Mode in Stringers

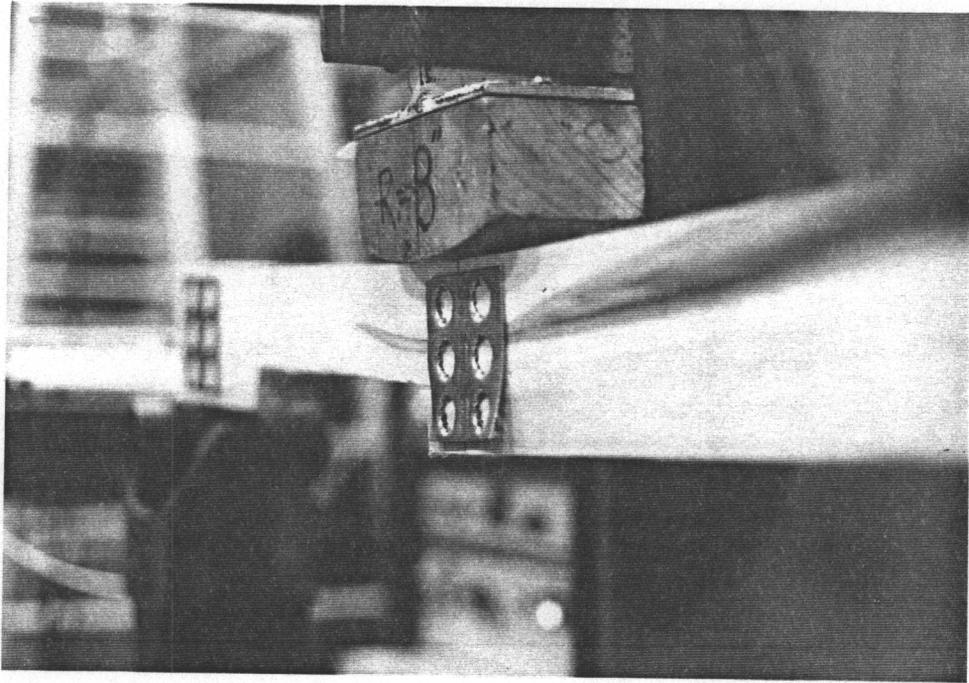
Figure 4.3 Tooth Withdrawal (TW) Failure Mode in Stringer

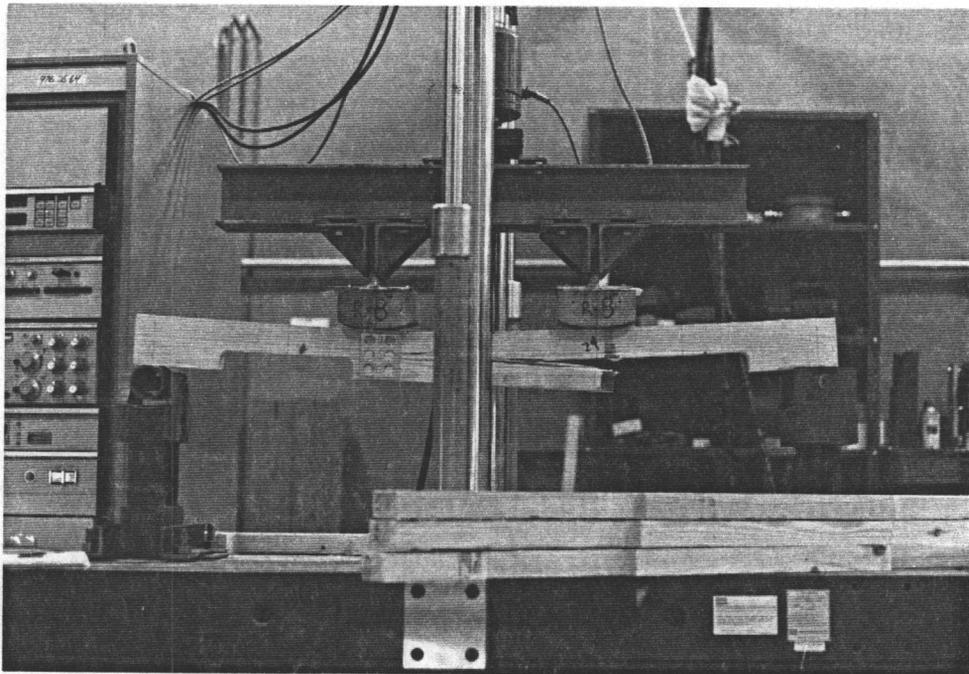
Figure 4.4 Unplated Notch (UN) Failure Mode in Stringer

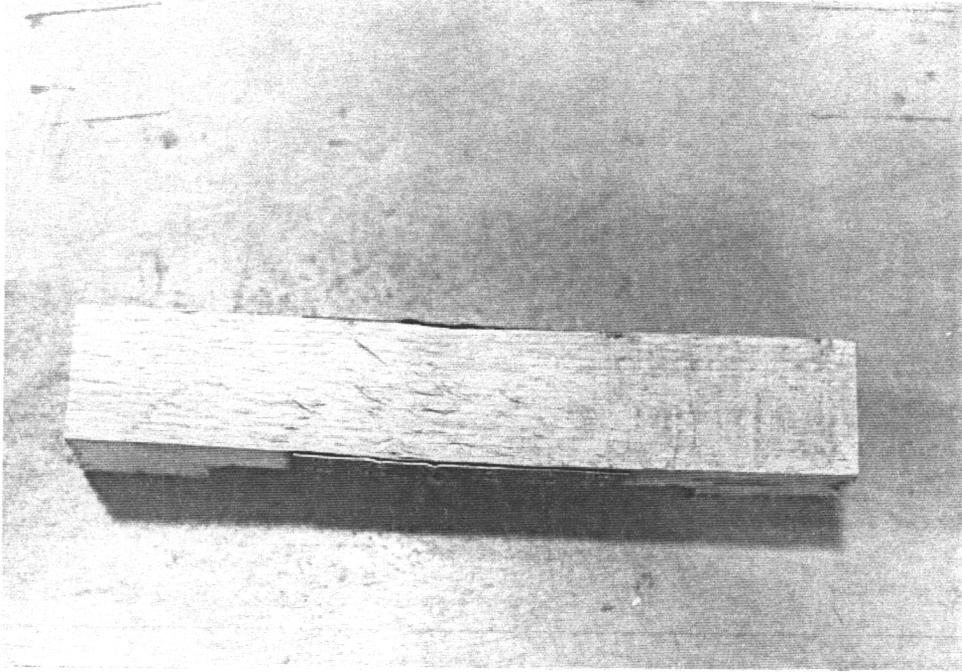
Figure 4.5 Plate Buckling (PBUC) Failure Mode in Notched Segment

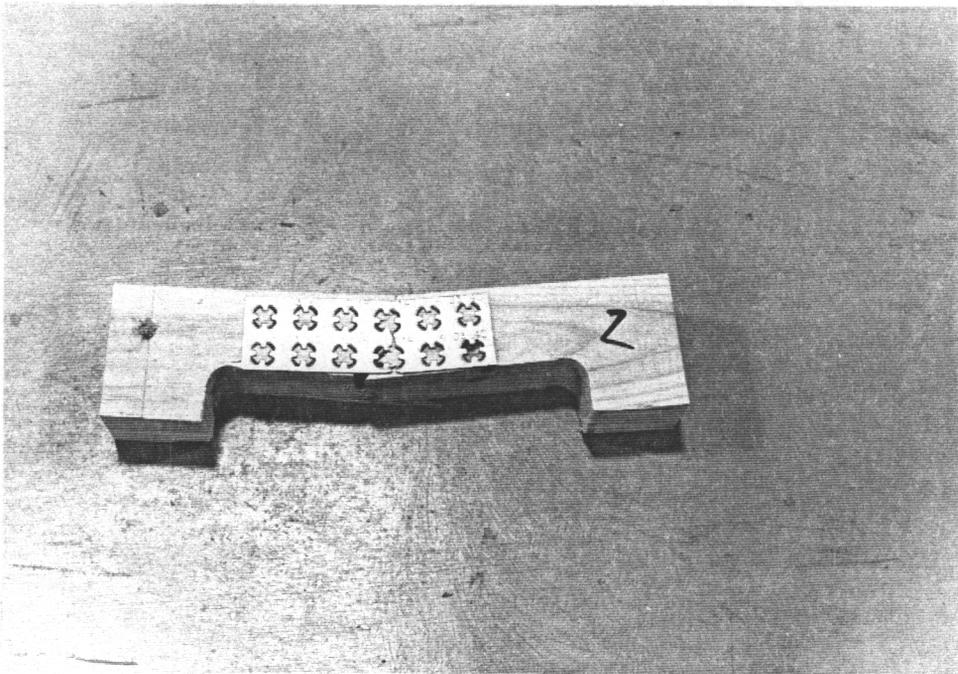
Figure 4.6 Plate Breaking (PBREAK) Failure Mode in Notched Segment

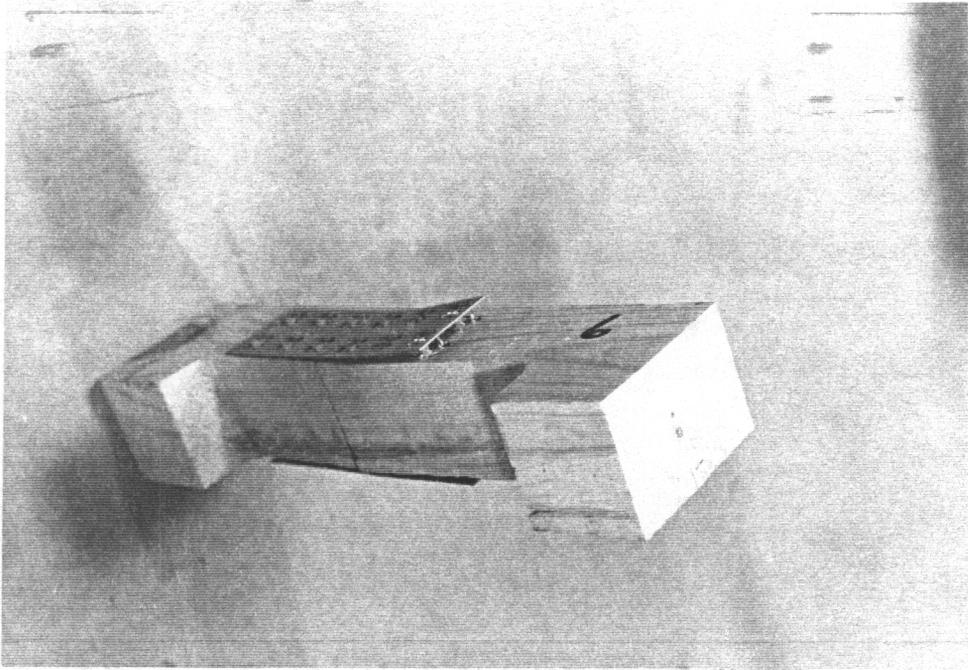
Figure 4.7 Tooth Withdrawal (TW) Failure Mode in Notched Segment

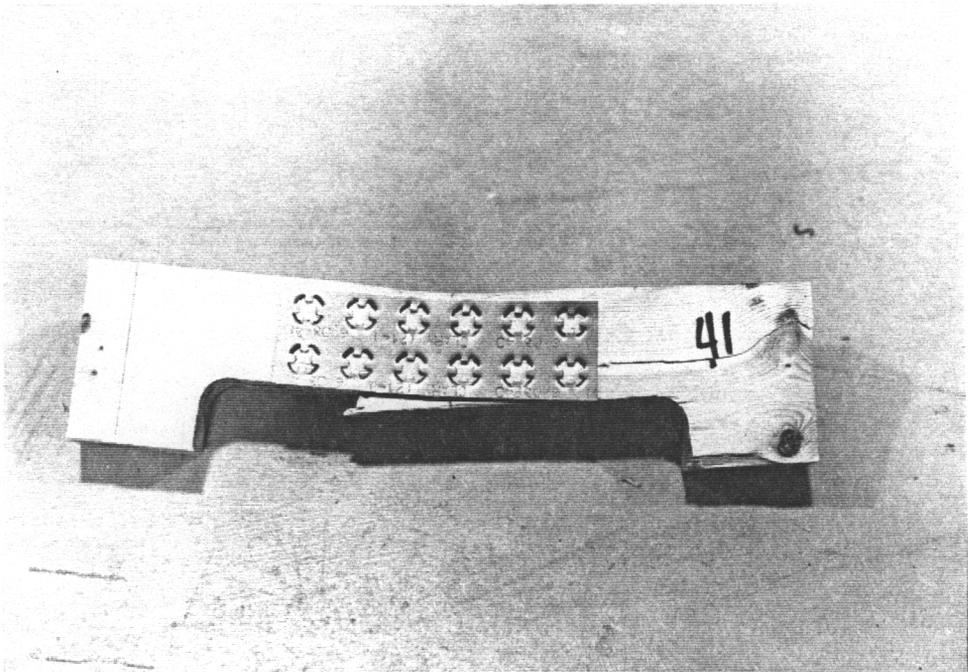
Figure 4.8 Wood Splitting (WOOD) Failure Mode in Notched Segment

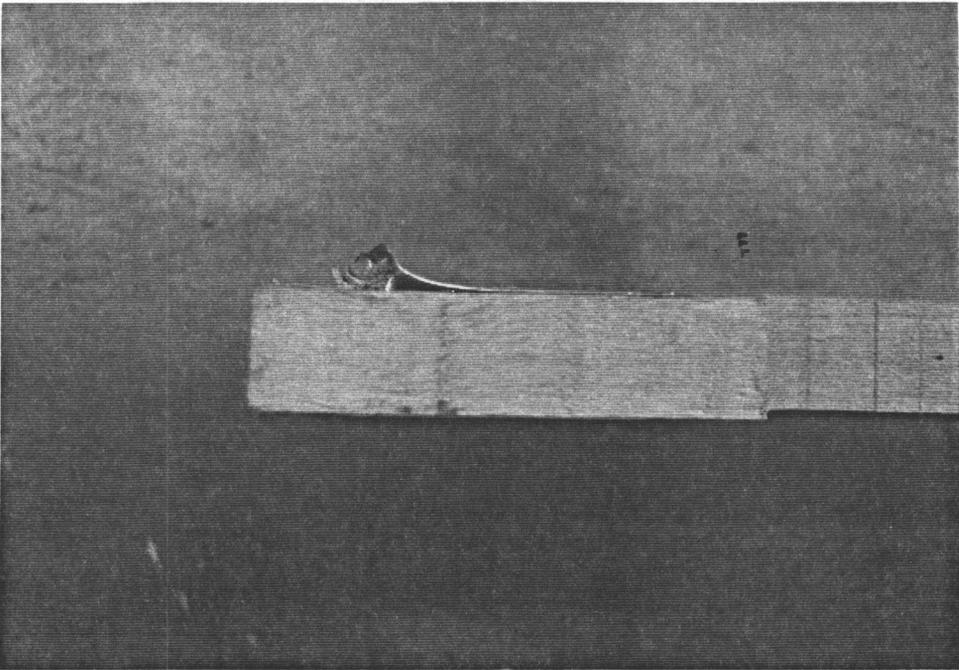
Failure Modes: Failure modes show that the true difference in impact resistance between end feet repaired with plates BN4 and BN5 was greater than indicated by the statistical analysis. Due to time constraints, testing of a sample was halted after 20 impacts. Nine BN5 samples did not fail after 20 impacts. If these samples had been tested to failure, the average impact resistance for plate BN5 would have increased, while the average impact resistance for plate BN4 would have remained the same. Plate BN4 was more

Figure 4.9 Plate Curling (CURL) Failure Mode in End Feet

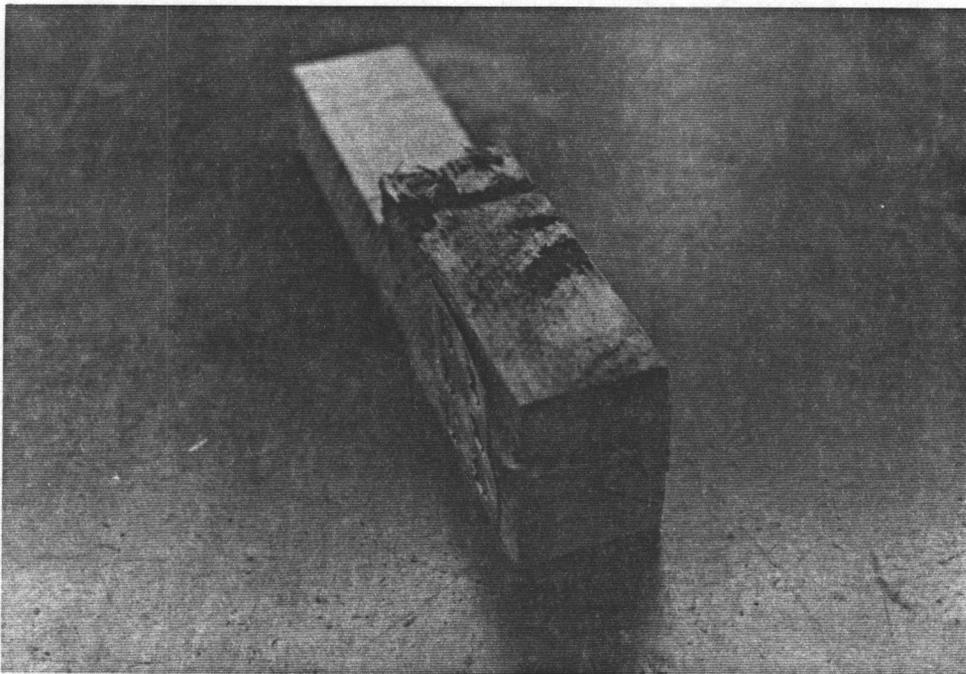
Figure 4.10 Tooth Withdrawal (TW) Failure Mode in End Feet

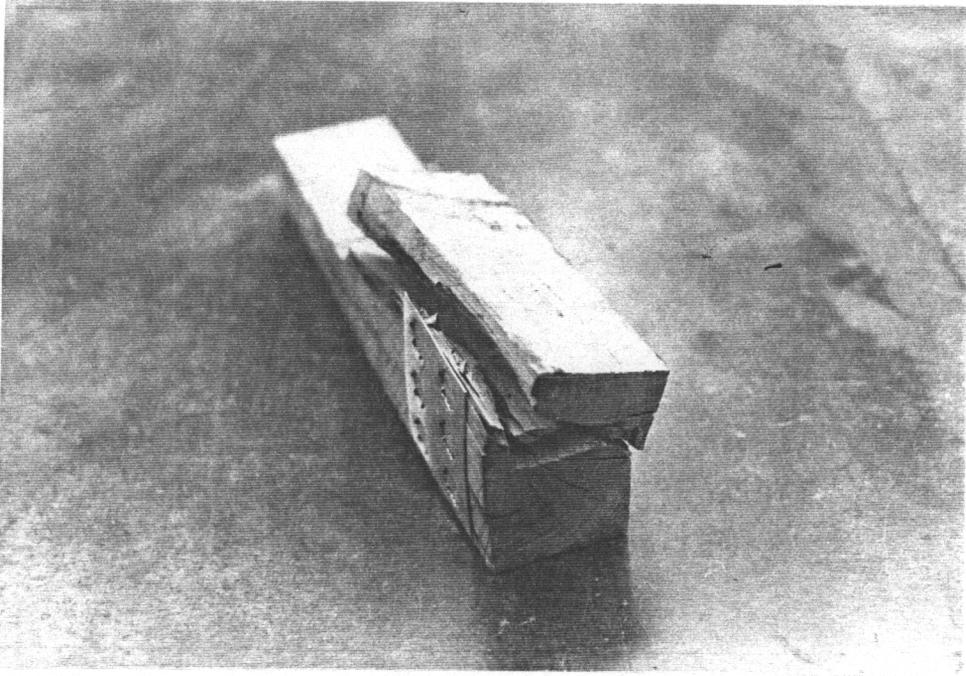
Figure 4.11 Wood Splitting (WOOD) Failure Mode in End Feet
