Bulletin 83-4

# Structural Development and Evaluation of a Modular House

Homer T. Hurst, P.E. and Research Professor Department of Agricultural Engineering

June 1983

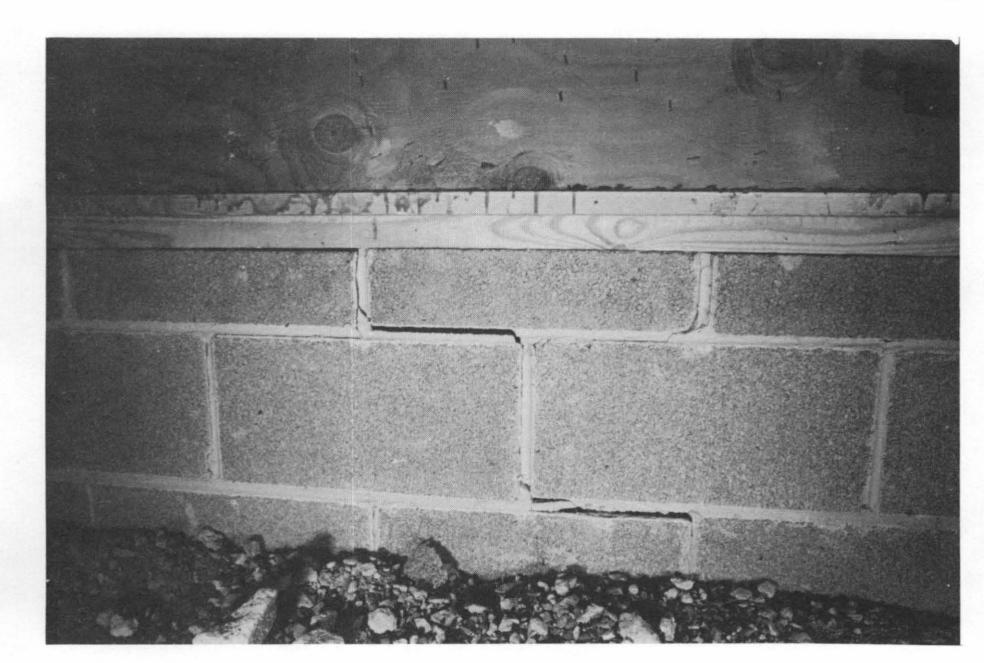
## Fig. 10. FOUNDATION FAILURE

The front wall was finally loaded to 26.0 psf with roof uplift of 20.2 psf. The foundation (Figure IO) failed and permitted an additional movement of 1.06 inches or a total movement of 1.43 inches at one end. The front overhang turned up when subjected to the above loads. Racking movements at the ends were 0.63 inch and 0.34 inch, which recovered to 0.13 inch and 0.09 inch, respectively, when the load was removed.

This failure resulted from appying (a) 26.0 psf to front wall and lower surface of overhang and (b) 20.2 psf uplift perpendicular to roof surface.

- The foundation used in this study, consisting of concrete block supports, was the weakest part tested. It is recommended that (a) the foundation be reinforced or strengthened, (b) special attention be given to anchorage of module to plate as well as plate to foundation, and (c) the hinged overhang be shortened to decrease the upper and lower surfaces, both of which are exposed to severe wind loading.

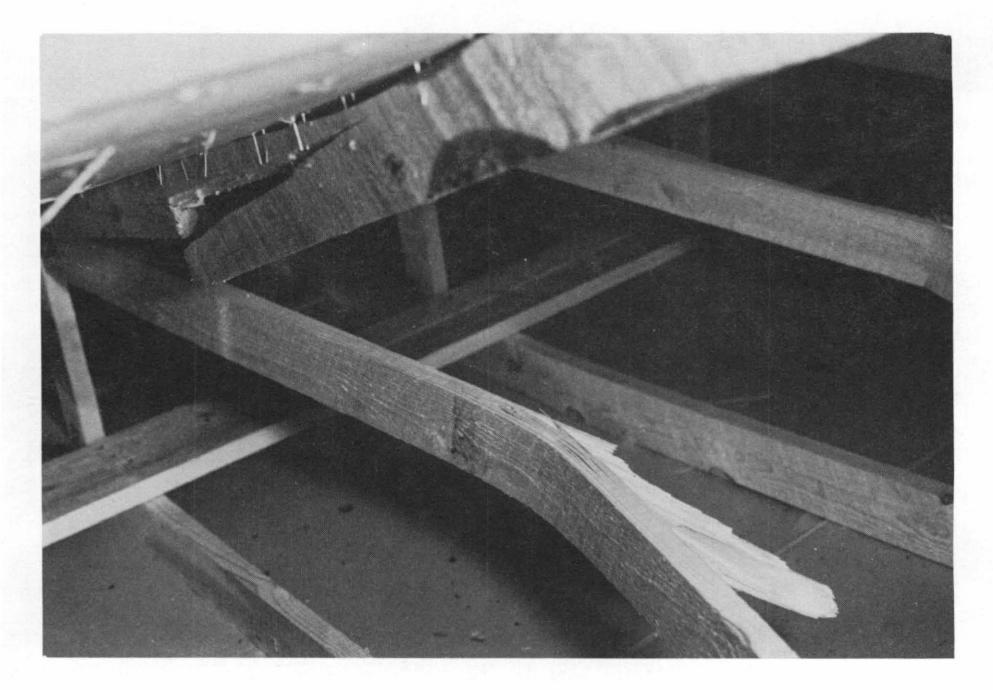
## Fig. 17. ROOF TRUSS FAILURE

The initial truss failure in every case resulted from buckling of the  $1 \times 4$  diagonal web member. Failure of the web members caused the upper rafters to fail from bending stresses, as shown in Figures 17 and 18. The whole roof structure could be strengthened substantially by laterally supporting the diagonal web members at the center with a 1 x 4 stringer running the full length of the house.

This typical failure resulted from the application of 93.6 psf applied perpendicular to the roof. The original failure was buckling of the diagonal web (lower right) which caused the rafter to fail in bending (upper left).

- On the basis of these tests, the roof trusses should be analyzed and the web members relocated if necessary to get more load-carrying capacity without increasing their cost. The diagonal web should definitely be laterally braced to prevent buckling.

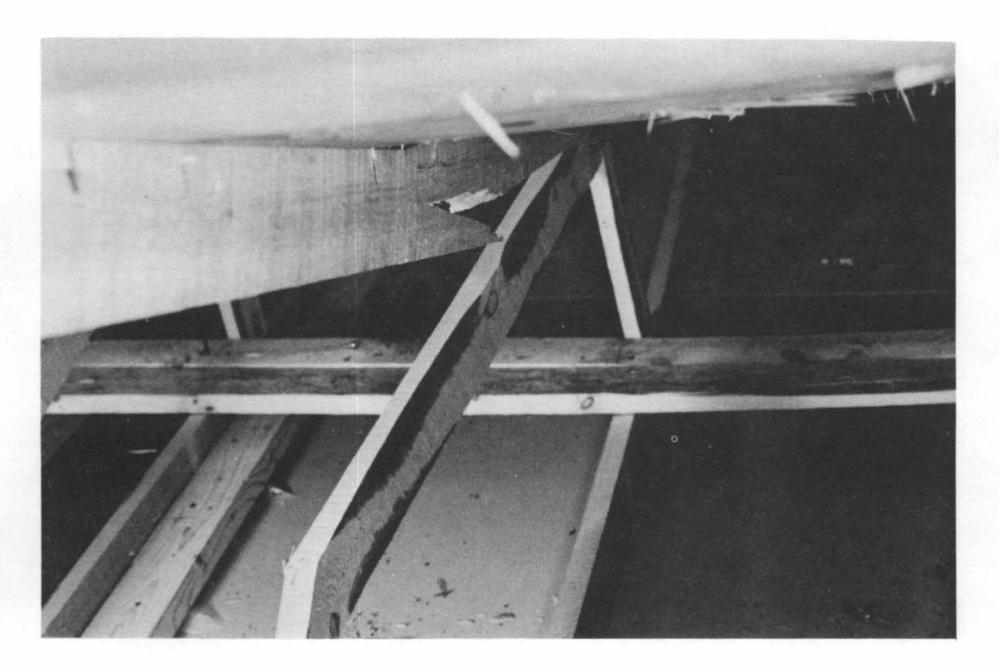
## Fig. 18. A TYPICAL ROOF TRUSS FAILURE

This truss failure and six others occurred under the same loading conditions as the one in Figure 17.

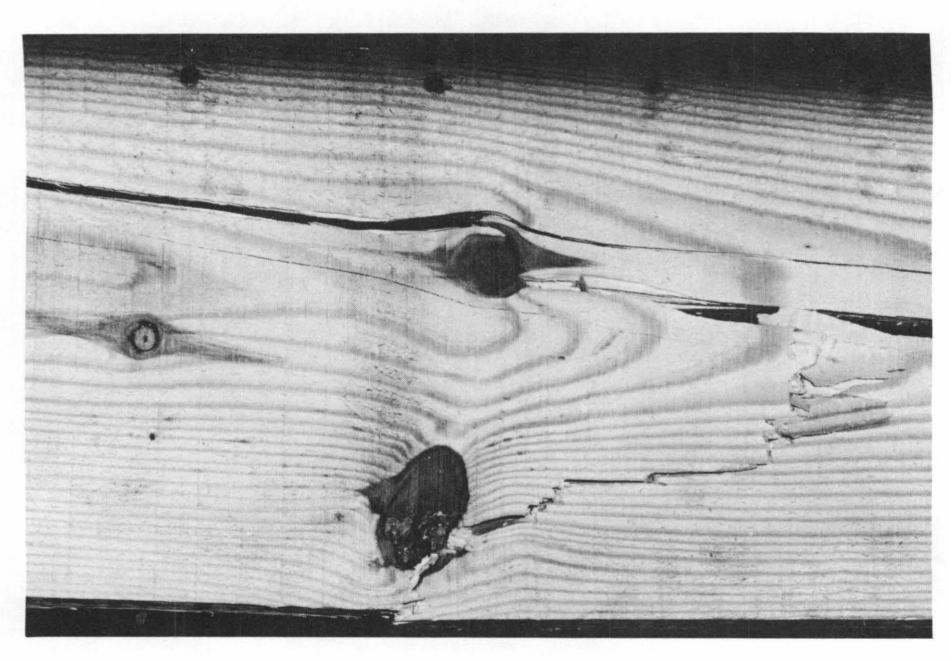
Fig. 19. JOIST 3 OF SPAN 3, EAST SIDE

Structural failure occurred within one minute after 202.8 psf were applied.

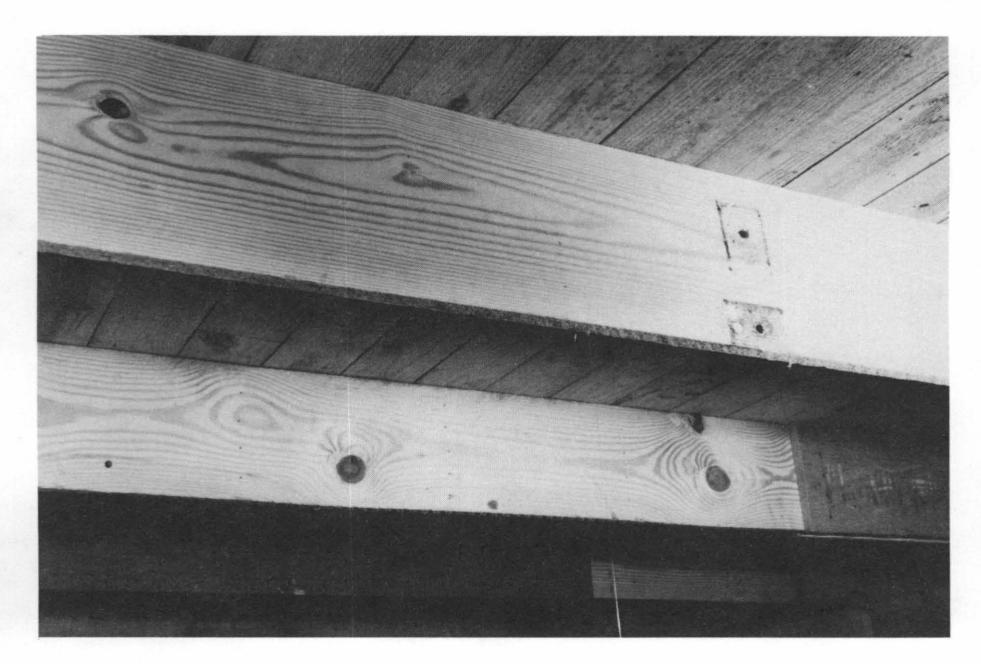
#### Fig. 20. (FRONT TO BACK) JOISTS 2 AND 3 OF SPAN 1

The bolt holes in joist 2 were necessary for attaching the transporting carriage. Joist 3 was changed before the final floor load-test because it was substandard. Before changing joists a load of 135 psf was applied which did not completely fail the substandard joist shown.
