Evaluating the Fracture Potential of Steel Moment Connections with Defects and Repairs

Thesis submitted to the Faculty of the
Virginia Polytechnic Institute and State University
in partial fulfillment of the requirements for the degree of

Master of Science
in
Civil Engineering

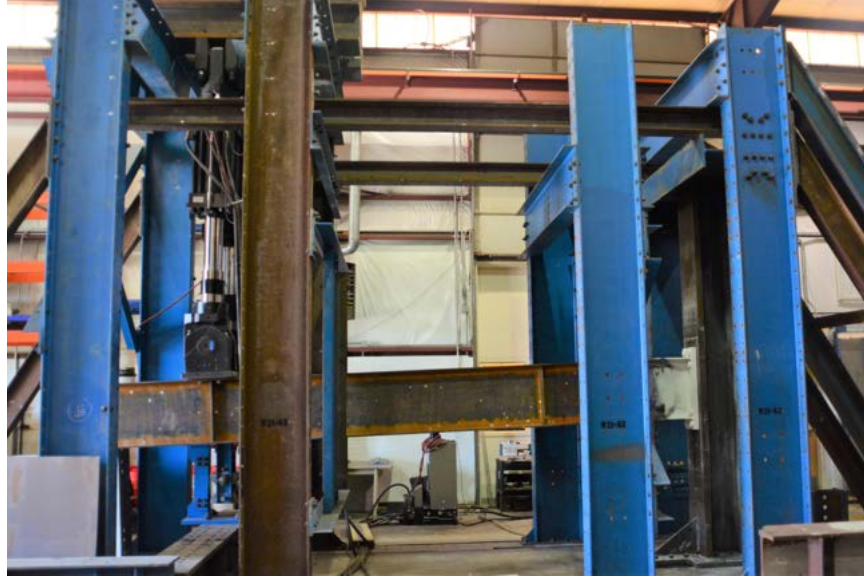
Figure 3.2. Test setup for full-scale moment connections.

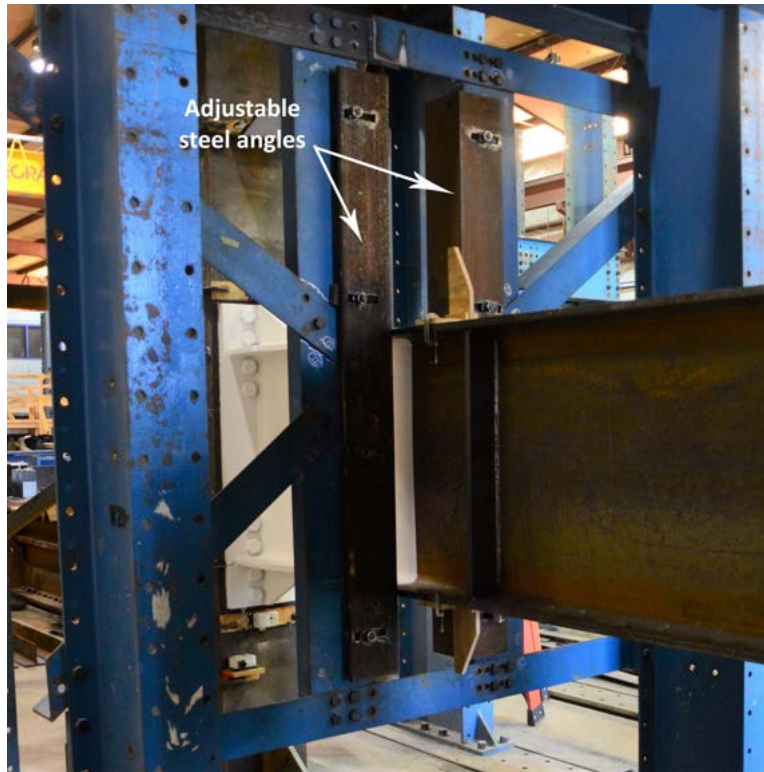
Lateral bracing of the specimen was provided at the loading point and the end of the plastic hinge, shown in Figure 3.3. This bracing consisted of adjustable steel angles that were moved such that the face of the angle was approximately 0.063 in. away from the flange tips. Lithium grease was applied to the face of the angles to reduce friction during the test. To position the bracing at the end of the plastic hinge, the bracing frame was moved such that the distance between the centerline of the bracing frame and the centerline of the reaction column was 4.5 ft. for specimens with W24×62 beams and 5.5 ft. for specimens with W36×150 beams.

Figure 3.3. Beam lateral bracing with adjustable steel angles.

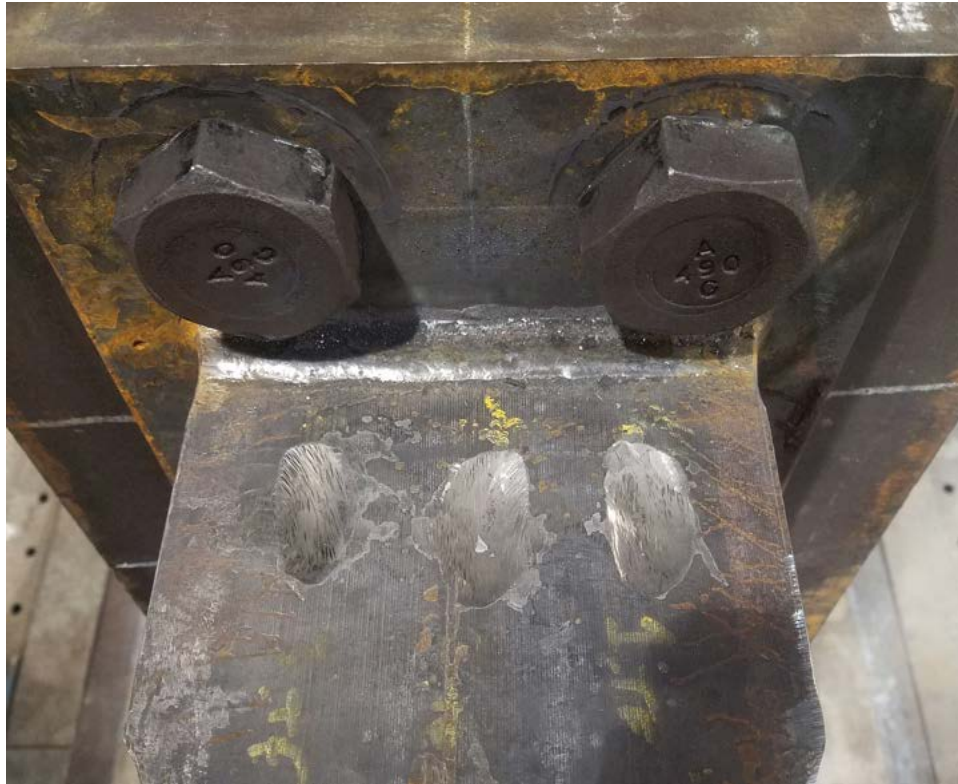
Figure 3.6. Finished 0.125 in. notches repair by grinding.

The 0.125 in. notches repaired by grinding were first ground to a 1:5 taper in the longitudinal direction and a 1:2.5 taper in the transverse direction (AWS 2016). Grinding was done using a die grinder and carbide burr or an angle grinder and abrasive grinding wheel. While grinding, the depth was periodically checked using a digital caliper to ensure the final depth was within ± 0.01 in. of the intended depth. After grinding, the notch was at least 1.25 in. long and 0.63 in. wide, measured on the surface of the flange. Examples of finished artifacts are shown in Figure 3.6.

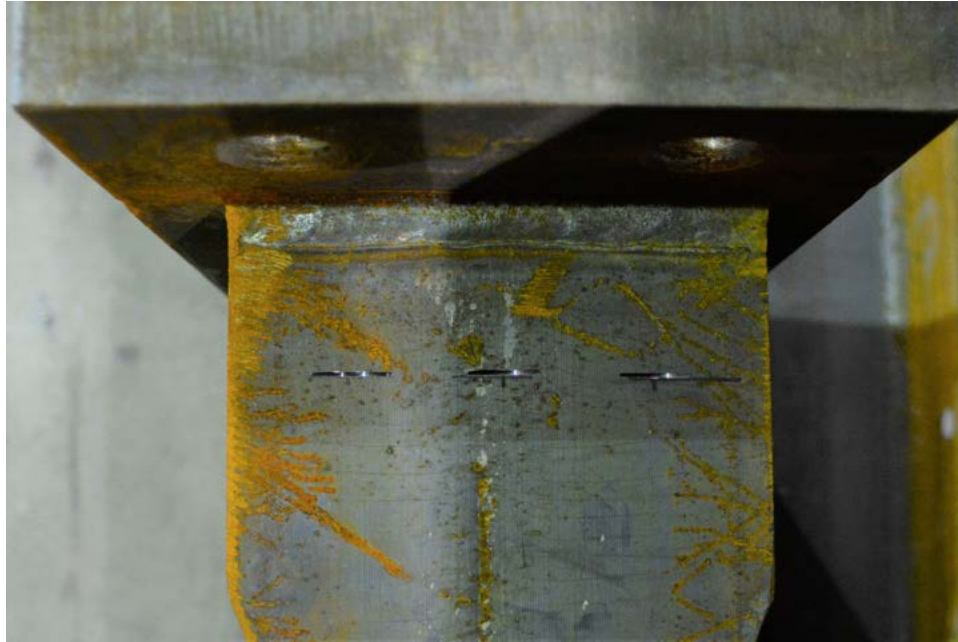
The sharp 0.25 in. and 0.375 in. notches were ground using a Dremel rotary tool and 426B abrasive cutting wheel, with a 1.25 in. diameter and a 0.045 in. kerf. As with the other artifacts, the depth was periodically checked during grinding to ensure the final depth was within ± 0.01 in. of the intended depth. Examples of finished, sharp 0.375 in. notches are shown in Figure 3.8.

Figure 3.8. Sharp 0.375 in. notches.

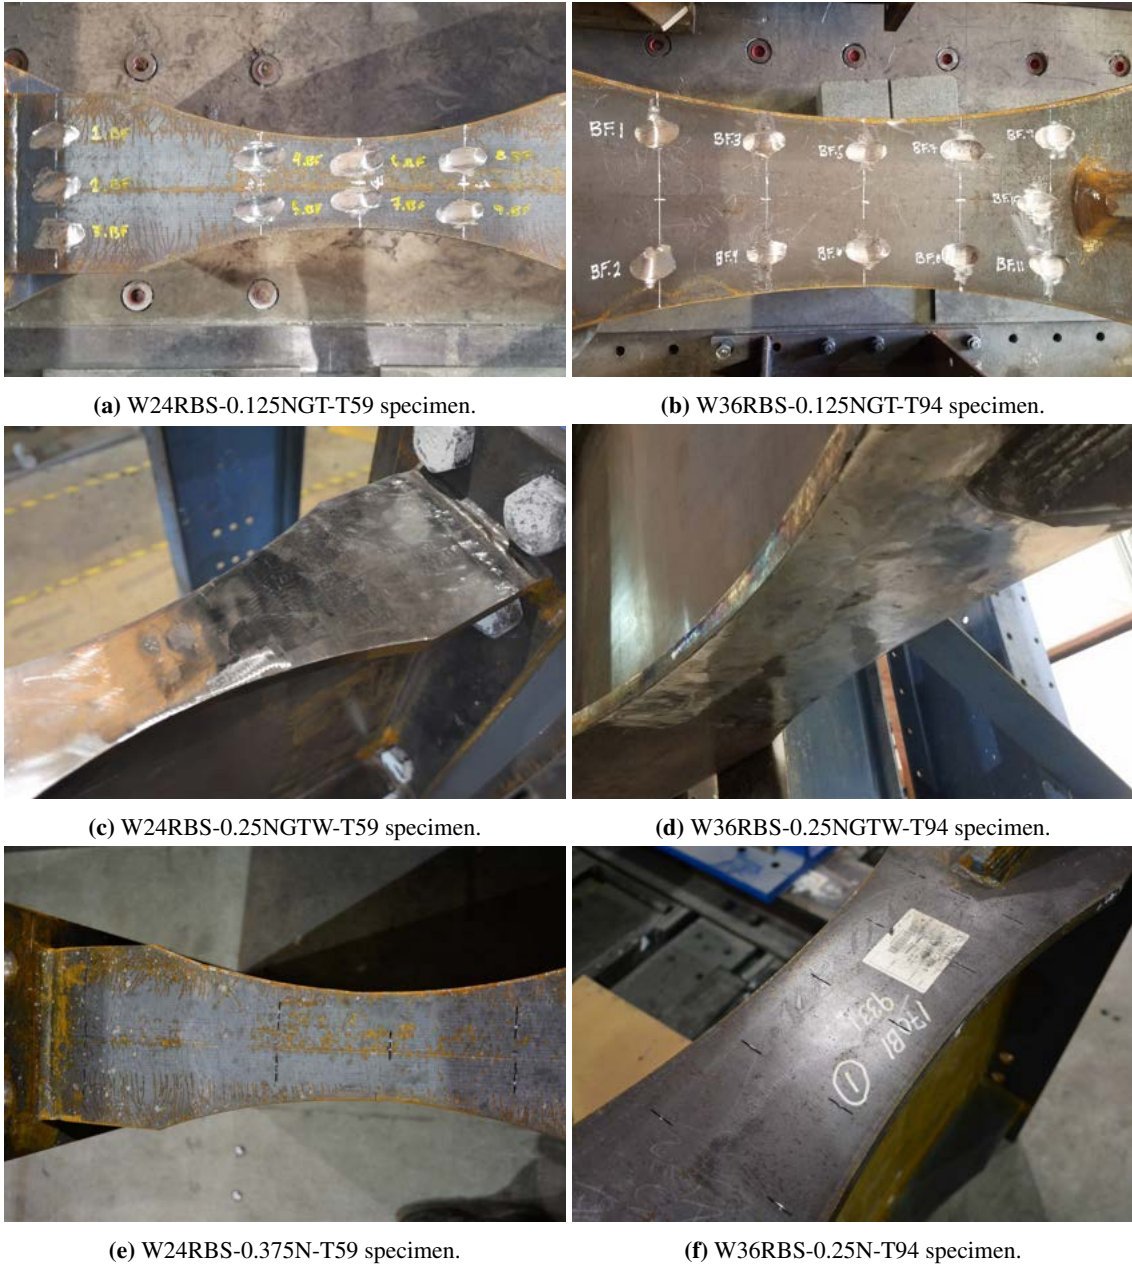
The dimensioned layouts for sharp 0.375 in. and 0.25 in. notches on the W24 \times 62 and W36 \times 150 beam specimens are shown in Figure 3.9a and Figure 3.9b, respectively. Layouts for the other artifacts were the same, and are provided in Appendix D. No artifacts were applied on the web of a specimen because the previous research investigating power actuated fasteners (PAF) and puddle welds showed that fractures were unlikely to start in the web (Eatherton et al. 2013). For specimens with a W24 \times 62 beam, a row of artifacts was placed adjacent to the end-plate because the moment is highest in this area. For specimens with a W36 \times 150 beam, an artifact was placed as close to the toe of the stiffener as possible, because this is a likely spot for fractures to initiate. Examples of the finished artifact arrays for all full-scale specimens are shown in Figures 3.10a to 3.10f.

Figure 3.10. Complete artifact arrays for full-scale specimens.

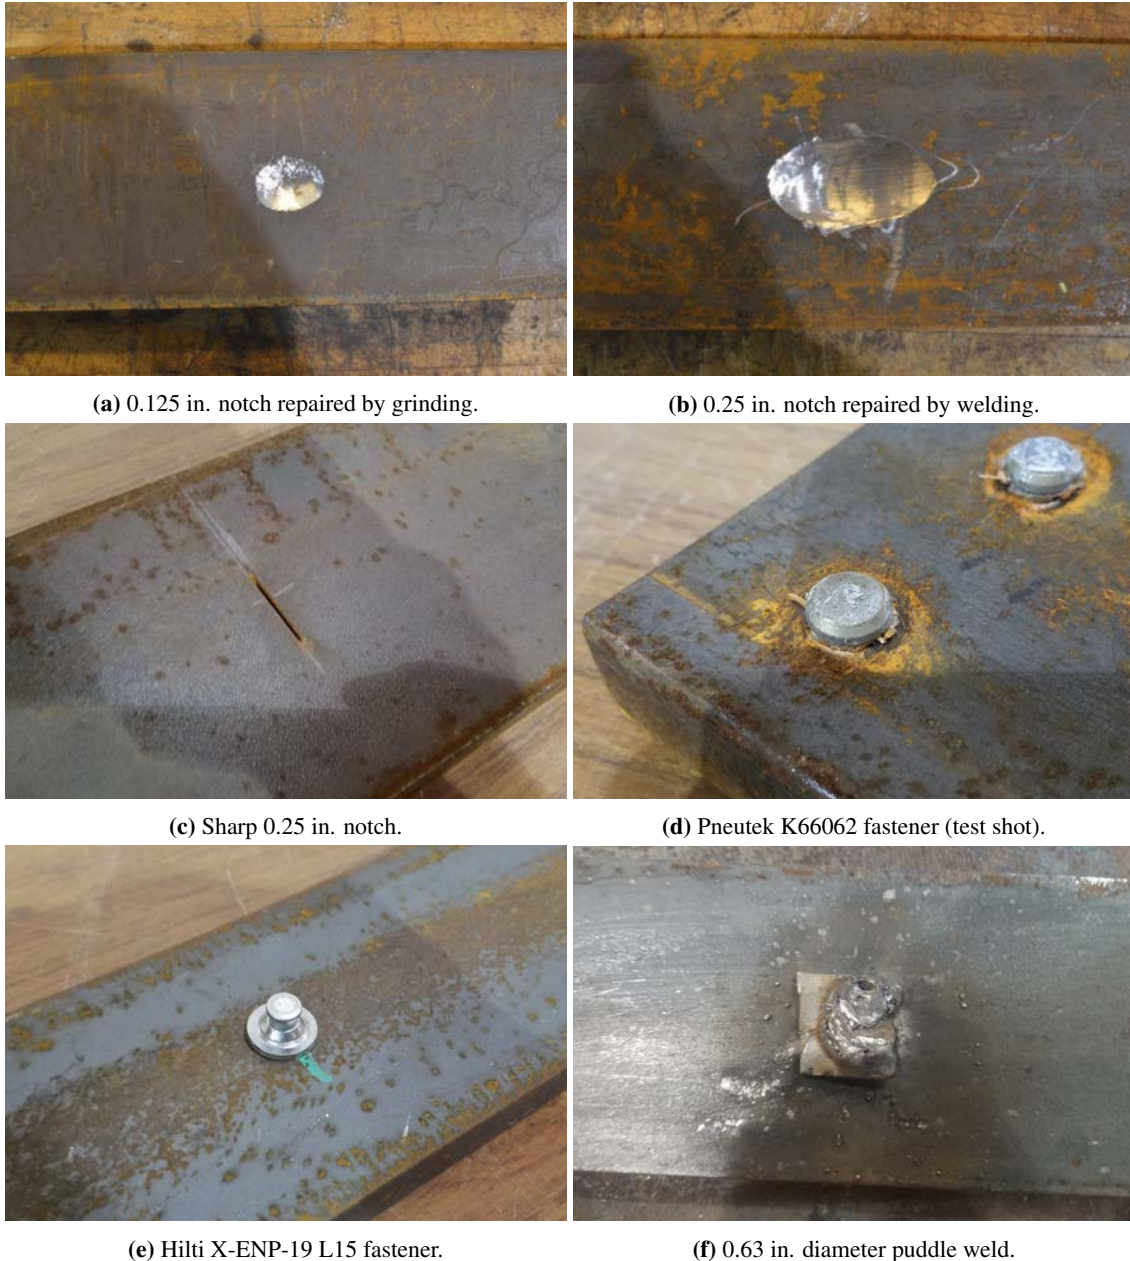
axis of the coupon. When the welds had cooled to ambient temperature, the runoff tabs were removed, the welds were ground flush with the bar, and the welded area was inspected with a magnetic particle tester. Examples of completed 0.125 in. notches repaired by grinding and 0.25 in. notches repaired by welding are shown in Figure 3.16a and Figure 3.16b, respectively.

The sharp 0.25 in. and 0.375 in. deep notches were ground using an abrasive cutting wheel with a 1.25 in. diameter and 0.045 in. kerf until the depth was within ± 0.01 in. of the intended depth. For these artifacts, the notches were cut perpendicular to the longitudinal axis of the coupon. An example a completed sharp 0.25 in. notch on a flat bar coupon is shown in Figure 3.16c.

The pneumatic actuated fasteners, Pneutek K66062 and K66075, were installed using a PT-2000Z tool operating at 180 psi. Proper installation of the Pneutek fasteners meant there was tight contact between the collation material, fastener, and steel. The Hilti X-ENP-19 L15 sheet metal nails were installed with a DX 76 PTR powder actuated tool and 0.27 caliber, 6.8/11 M10 powder cartridge. Proper installation of the Hilti fasteners was determined by three criteria: firm contact between the two washers on the fastener, a C-shaped mark on the top washer from the piston ring, and using a penetration adjustment guide. Examples of a properly installed Pneutek and Hilti fasteners are shown in Figure 3.16d and Figure 3.16e, respectively.

To fabricate the puddle weld specimens, a 1 in. by 1 in. square of 20 gauge galvanized deck was welded to the flat bar coupons using a 6010 SMAW electrode. An example of a finished, 0.63 in. diameter puddle weld is shown in Figure 3.16f.

Figure 3.16. Bend coupons with various artifacts.

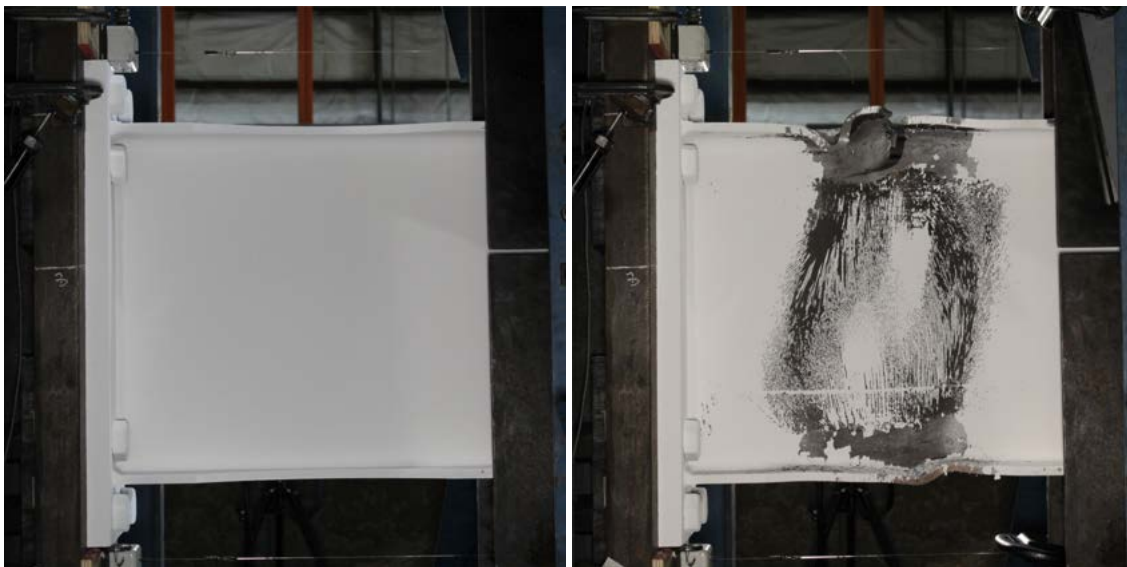
(a) Undeformed condition.

(b) Deformed condition.

The conditions of the specimen before testing and after a ductile tear of the top flange are shown in Figure 6.2. Top flange local buckling started in the first 4% story drift cycle and increased in the following cycles. Fractures were first observed at the flange tip at a local buckle in the second cycle of 4% story drift. In the subsequent cycle, this fracture turned into a ductile tear approximately 1.5 in. long, shown in Figure 6.3a. This fracture was 1 in. from the center of the RBS but did not pass through an artifact. During the fourth cycle of 4.5% story drift, this tear spread across the entire flange and about 3 in. into the web, shown in Figure 6.3.

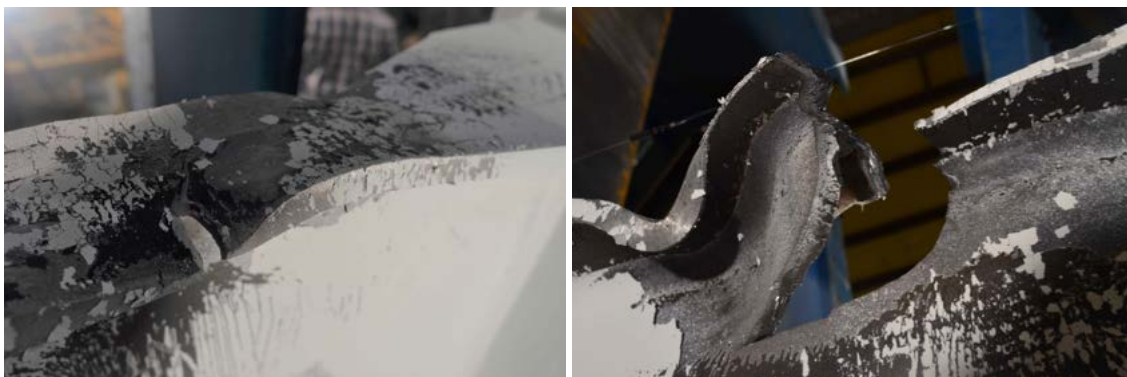
(a) Fracture initiation.

(b) Final fracture.

Figure 6.3. Fracture propagation of W24RBS-0.125NGT-T59.

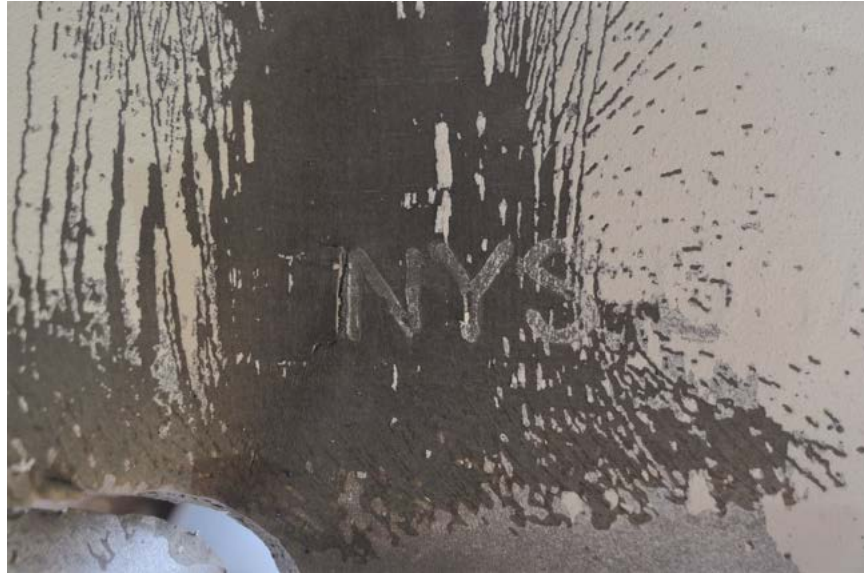
After testing was complete, a ductile tear approximately 1 in. long was found in the web at the vertical edge of the “N” in the “NYS-USA” rolling mill stamp, shown in Figure 6.4. The stamp was located in the protected zone, approximately 1 in. from the center of the reduced beam section (RBS) and 4.5 in. below the bottom of the top flange in an area of out-of-plane web buckling. It is unknown when the fracture initiated.

Figure 6.4. Web fracture at a rolling mill stamp on W24RBS-0.125NGT-T59.

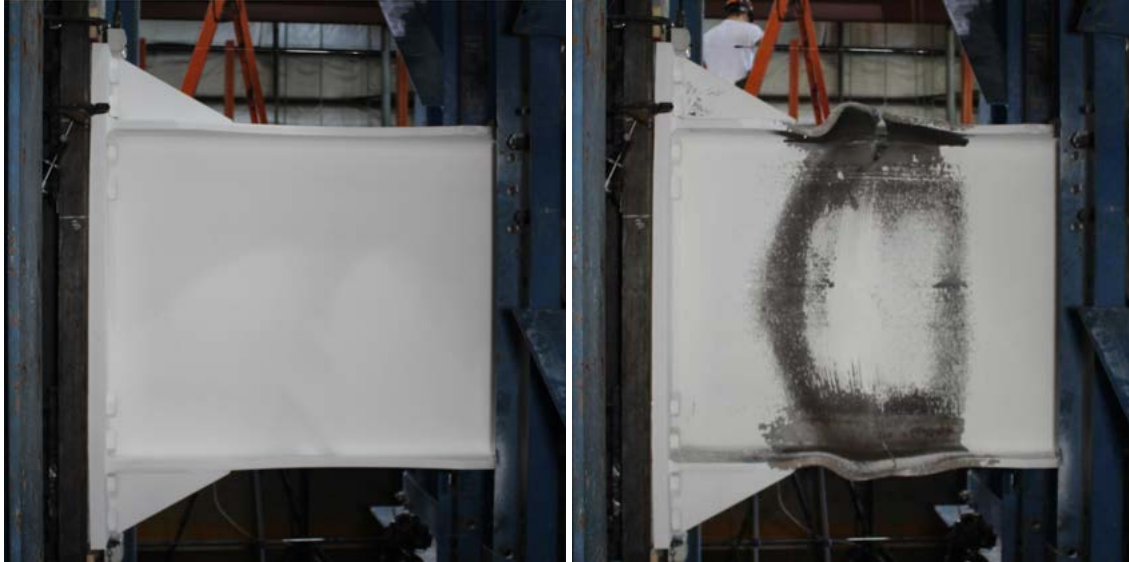
(a) Undeformed condition.

The conditions of the specimen before and after testing are shown in Figure 6.6. Local buckling of both flanges began in the first cycle of 3% story drift and increased in the following cycles. Fractures initiated in artifacts at the center of the RBS on both flanges in the second cycle of 4% story drift, shown in Figure 6.7, and grew in the first cycle of 5% story drift. There was also local buckling in this area. In the second cycle of 5% story drift, a ductile fracture opened up on the bottom flange at the center of the RBS, at the same location as fracture initiation. A complete ductile fracture of the top flange and partial fracture of the web occurred in the third cycle of 5% story drift, while a ductile fracture of the bottom flange and partial fracture of the web occurred in the fourth cycle of 5% story drift. The complete fracture of both flanges is shown in Figure 6.8. The top flange fracture propagated 6.5 in. into the web while the bottom flange fracture only propagated 3 in. into the web.

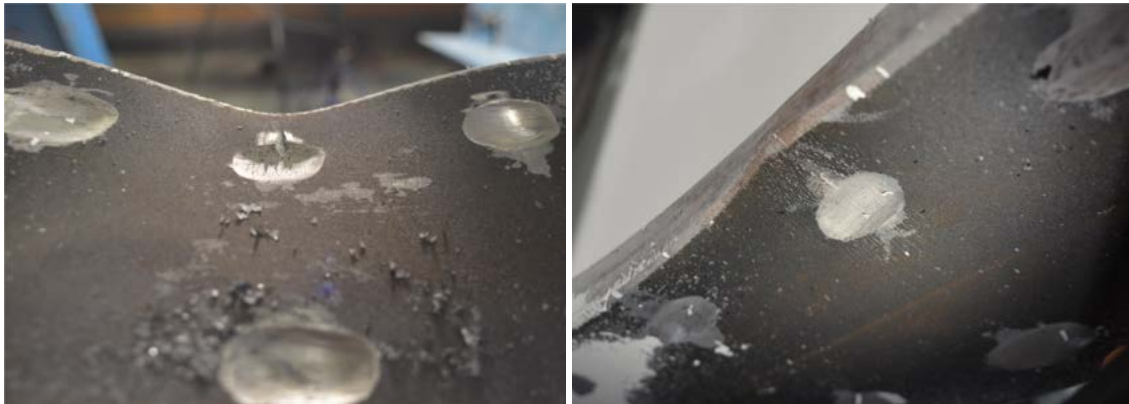
(a) Top flange.

(b) Bottom flange.

Figure 6.7. Fracture initiation of W36RBS-0.125NGT-T94.

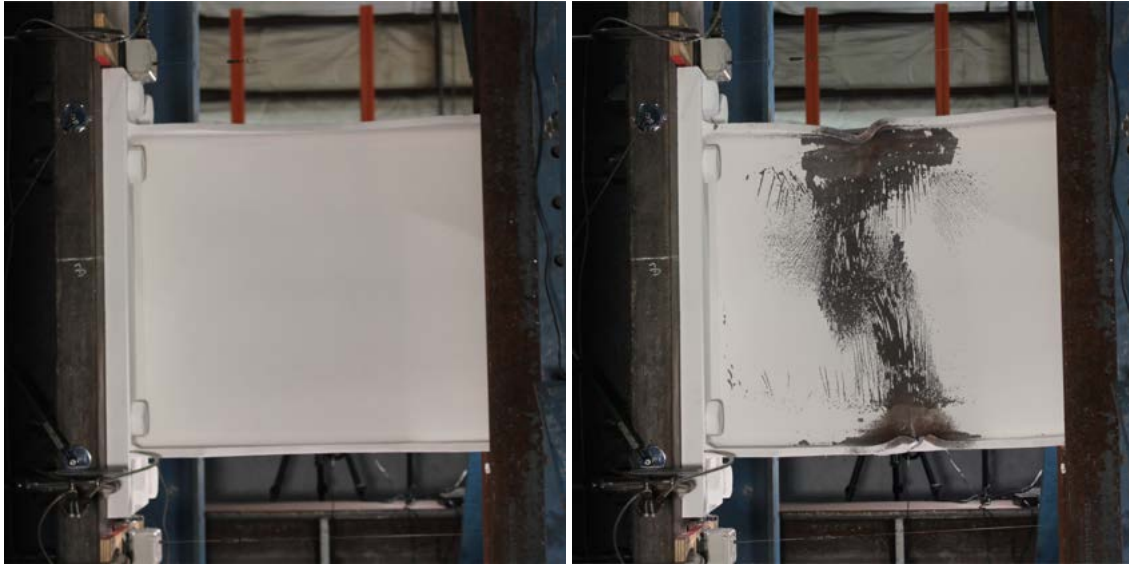
(a) Undeformed condition.

The conditions of the specimen before testing and after a ductile fracture of the bottom flange are shown in Figure 6.11. Local buckling of both flanges started in the first 3% story drift cycle. In the second cycle of 3% story drift, fractures initiated on the top flange. Fractures initiated on the bottom flange in the following cycle, in the weld metal of the artifacts on the bottom flange near the end of the RBS cut. These fractures were 0.25 to 0.5 in. long and are shown in Figure 6.12a. They were also similar to the folded steel defects that were observed in the previous small-scale tests. Fractures also formed on the bottom flange between the artifact and the flange tip at the center of the RBS, shown in Figure 6.12b. The bottom flange fractures at the center of the RBS grew slowly in the 4% story drift cycles until a ductile tear spread almost entirely across the flange and 2.5 in. into the web. This is shown in Figure 6.13.

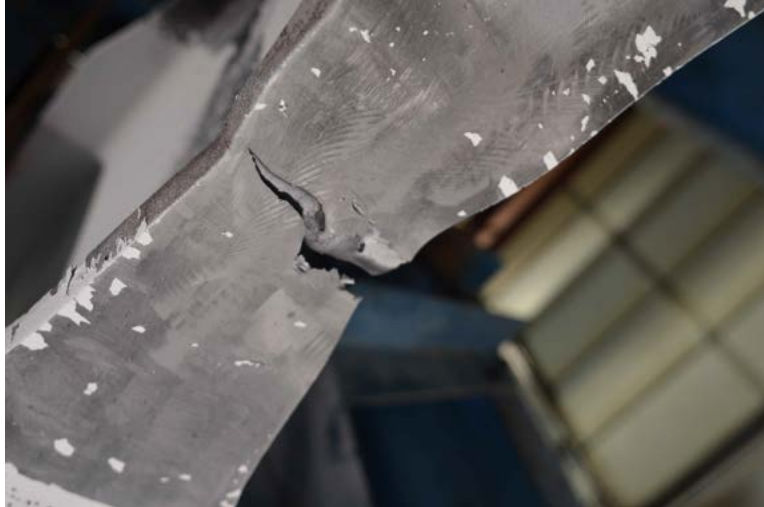
Figure 6.13. Bottom flange fracture of W24RBS-0.25NGTW-T59.

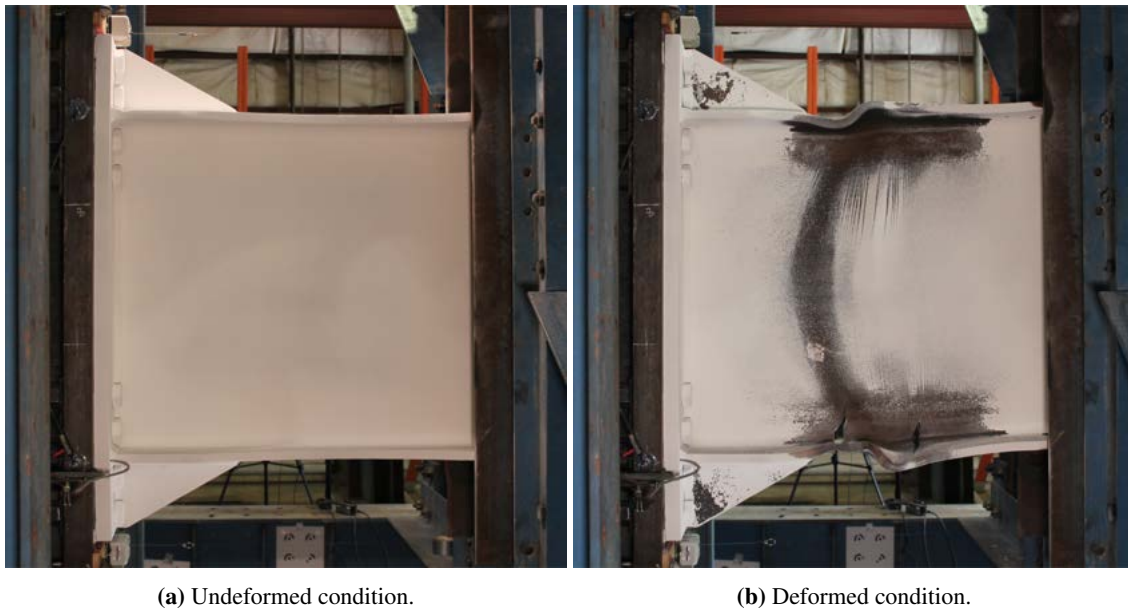
Figure 6.15. Undeformed and deformed conditions of W36RBS-0.25NGTW-T94.

The conditions of the specimen before testing and after a brittle fracture of the bottom flange are shown in Figure 6.15. Flange local buckling began in the 3% story drift cycles, while the first fractures were observed in artifacts on the bottom flange at the end of the first 4% story drift cycle. The fractures were seen in the artifacts at the center of the RBS and in the artifacts at the end of the RBS cut closest to the stiffener, shown in Figure 6.16. These artifacts were also near local buckles. An additional fracture was found at the toe of the top flange stiffener, but no fractures were seen in the artifacts on the top flange. The bottom flange fractures grew in the following cycles until there was a sudden brittle fracture of the bottom flange after the first 5% story drift cycle. The flange fractured at two places simultaneously, shown in Figure 6.17, which was at the same artifacts and local buckles where fractures were first observed. These fractures propagated 7.5 in. across the flange and 3 in. into the web. They grew slightly in the second cycle of 5% story drift but did not propagate across the entire flange.

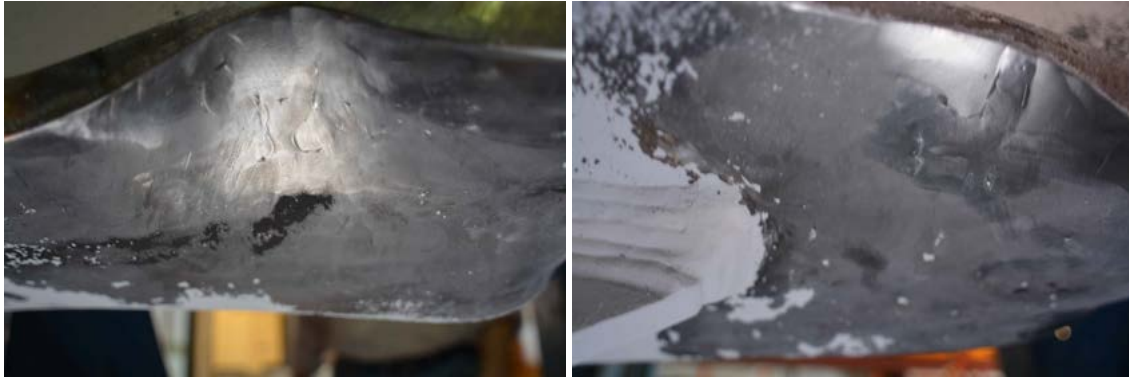
(a) Center of the RBS.

(b) End of the RBS, near the stiffener.

Figure 6.16. Bottom flange fractures at the end of the 3% story drift cycles on W36RBS-0.25NGTW-T94.

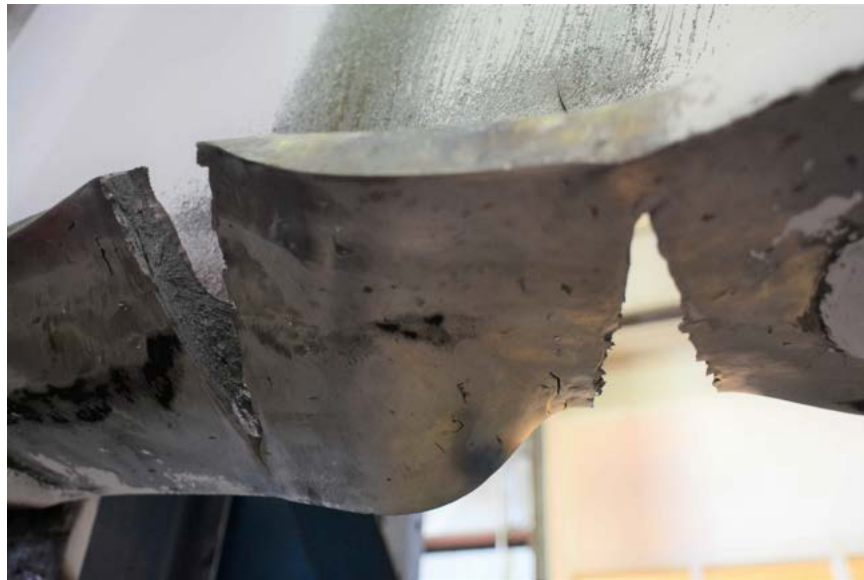
Figure 6.17. Bottom flange fractures on W36RBS-0.25NGTW-T94.

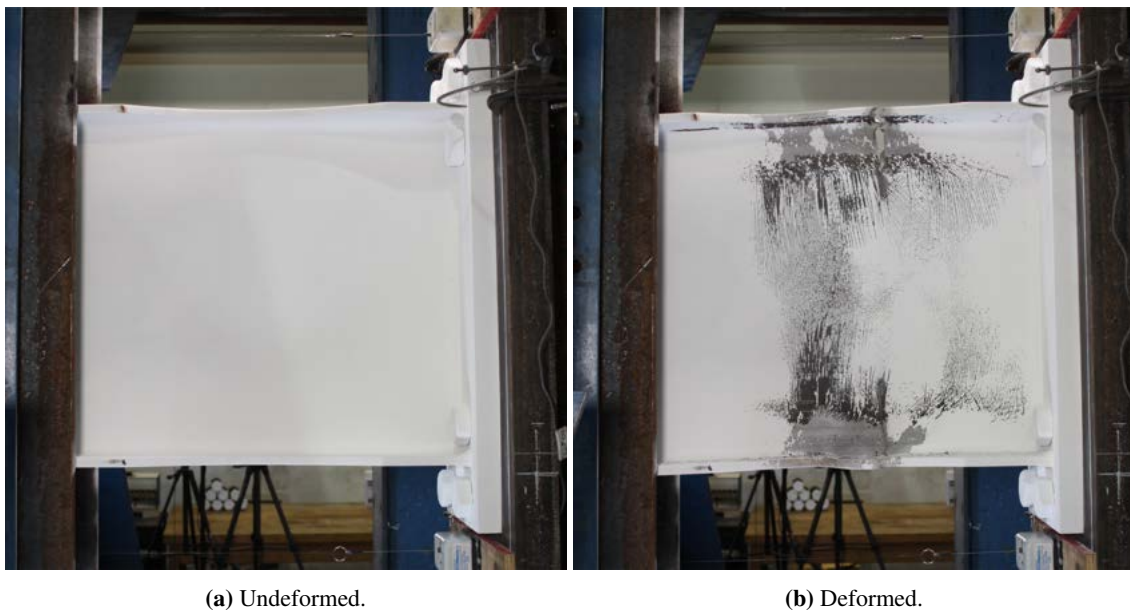
Figure 6.20. Undeformed and deformed conditions of W24RBS-0.375N-T59.

The conditions of the specimen before testing and after ductile fractures of the top and bottom flanges are shown in Figure 6.20. Flange buckling began in the first 3% story drift cycle, at which point the notches on the bottom flange closed up. Fractures also initiated in the bottom of notches on the top flange at the end of 1.5% story drift cycles, shown in Figure 6.21. In the second cycle of 3% story drift, a ductile fracture propagated through two notches on the bottom flange, while an additional ductile fracture propagated through two notches on the top flange. In the first 4% story drift cycle, the bottom flange fracture propagated across the remainder of the flange. Both flange fractures grew into the web: 2.75 in. at the top flange fracture and 5 in. at the bottom flange fracture. The final fractures of both flanges are shown in Figure 6.22.

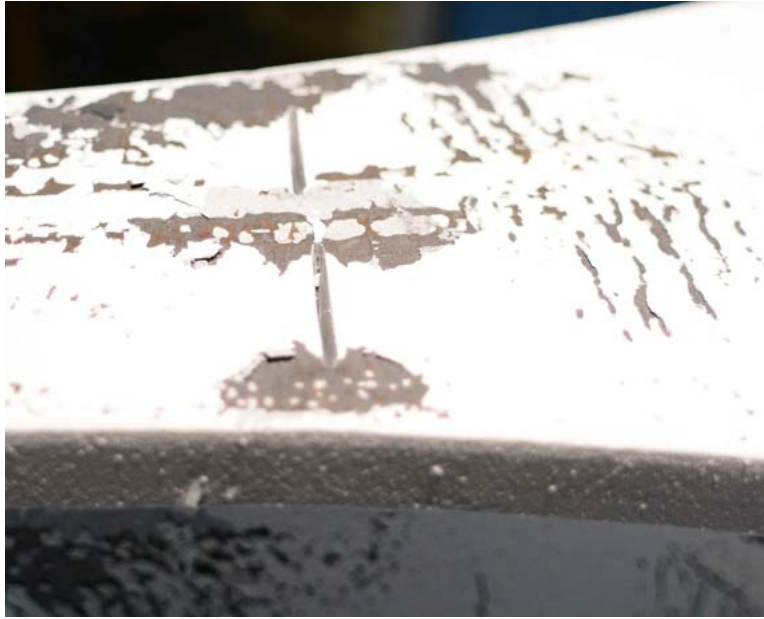
Figure 6.21. Fracture initiation in the bottom of a notch.

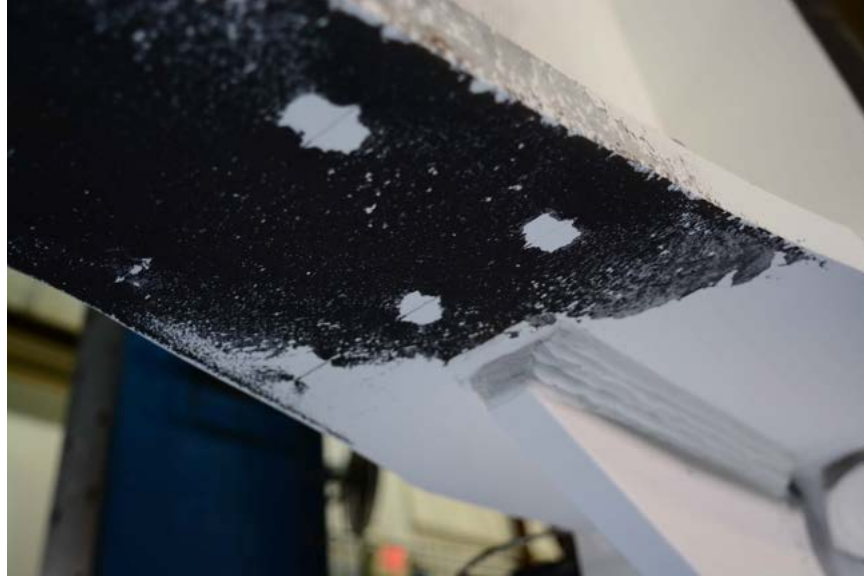
Figure 6.26. Notches closed up due to local buckling..

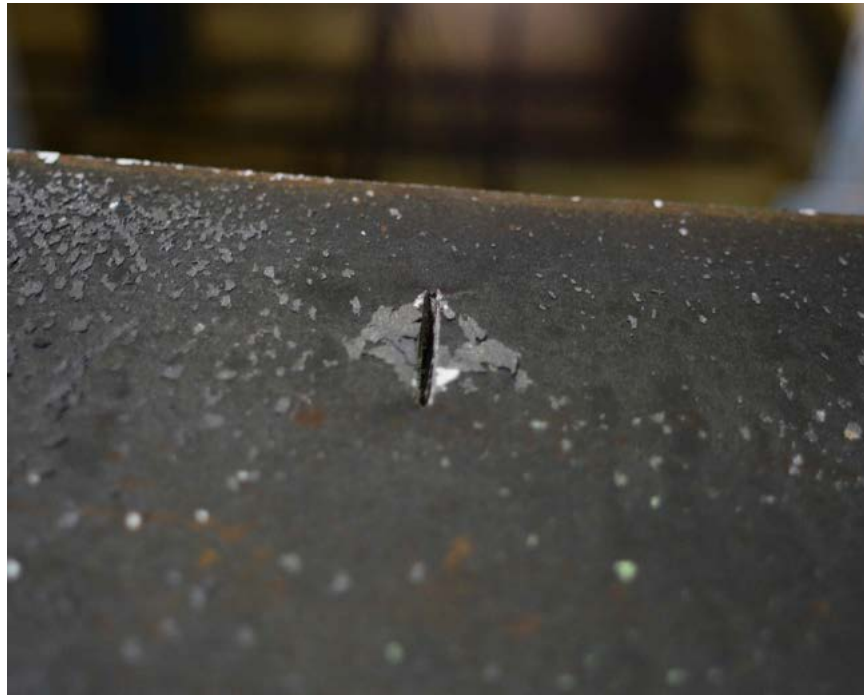
Figure 6.27. Fracture initiation in the bottom of notches on W36RBS-0.25N-T94.

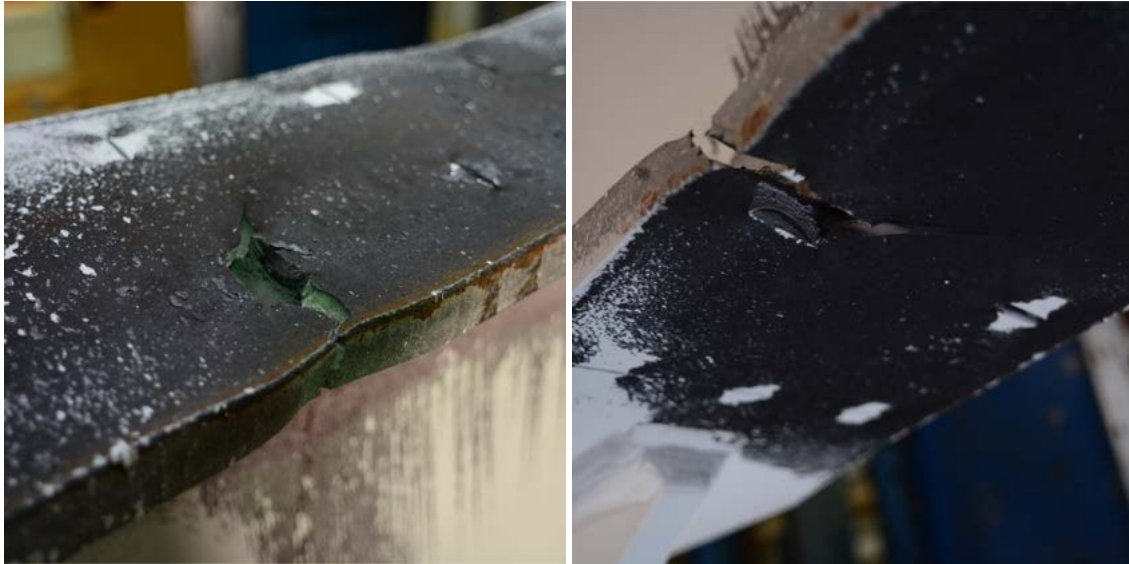
(a) Top flange fracture.

Figure 6.28. Fractures initiating at notches on W36RBS-0.25N-T94.

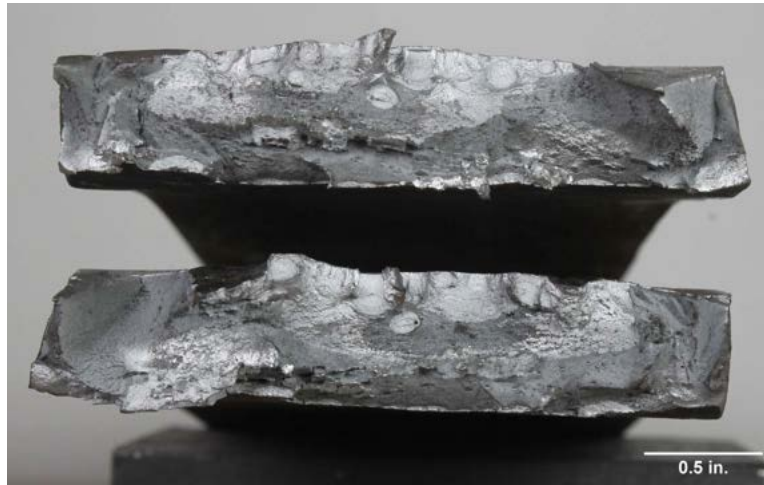
The fracture surface of one of these specimens is shown in Figure 6.35. In the weld metal, there were numerous small, circular fracture patterns, similar to the fracture pattern shown in Figure 6.14. As mentioned in Section 6.1.2, these fractures are considered to be subsurface-origin fatigue fractures that formed and grew in the weld metal before appearing as folded steel defects on the surface. From the recorded fracture propagation of the welded specimens, it was apparent that the folded steel defects formed at the same places as the circular fracture patterns. Hydrogen

Figure 6.35. Fracture surface of W24-0.25NGTW-T59-R11.01.

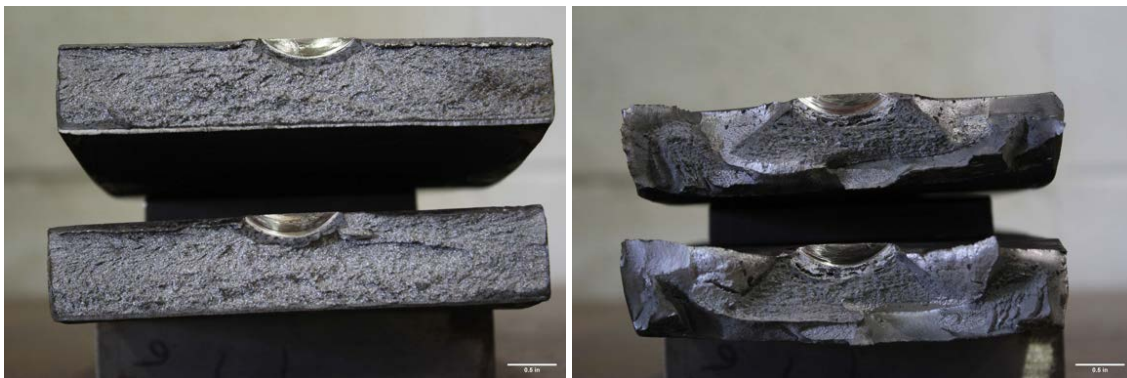
Due to the nature of this defect, fracture initiation was assumed to occur in the first cycle in the bottom of the notch where it was not visible. Final fracture of coupons with 0.25 in. notches always occurred when the top side was in tension. In most tests, there was visible fracture initiation and propagation on the bottom side that preceded the full fracture of the coupon. The only exceptions were the two specimens cut from 1 in. bar stock (W36-0.25N-T100-R11.01 and R11.02), which fractured suddenly in the second cycle. The fracture surface of one of these specimens, shown in Figure 6.36a, is compared with a more ductile fracture surface of a W36-0.25N-T94-R11.01 coupon.

(a) Fracture surface of W36-0.25N-T100-R11.01.

(b) Ductile fracture of W36-0.25N-T94-R11.01.

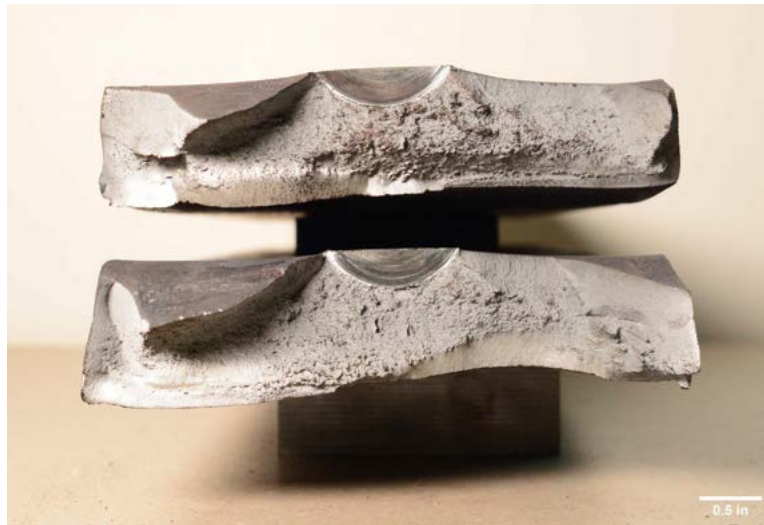
Similar to the coupons with sharp 0.25 in. notches, fracture initiation was assumed to occur in the first cycle but in the bottom of the notch where it was not visible. However, there was visible fracture initiation on the bottom side that preceded complete fracture. Unlike the specimens with 0.25 in. notches, specimens with 0.375 in. notches cut from 1 in. bar stock had a more ductile failure mode, shown in Figure 6.37.

Figure 6.37. Fracture surface of W36-0.375N-T94-R11.01.

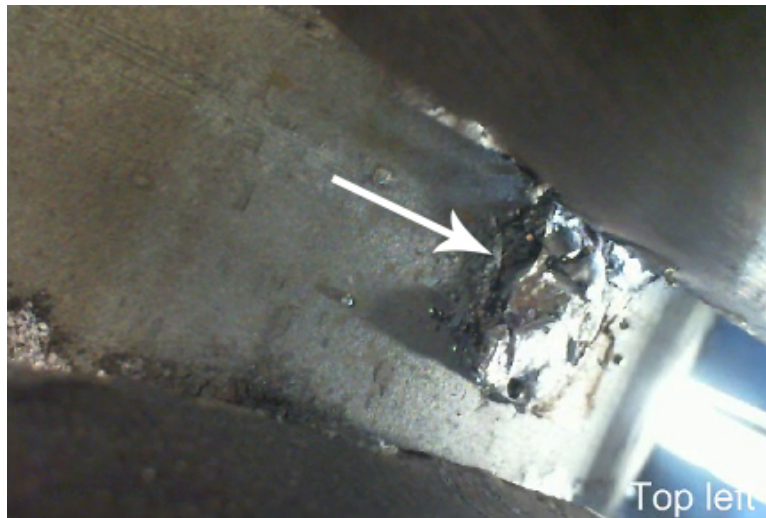
Fractures on puddle weld specimens always initiated at the edge of the weld on the top side, even on the 0.5 in. bar stock coupons, shown in Figure 6.40. These findings conflict with the findings of the previous research in that fractures on 0.59 in. coupons initiated on the bottom side, opposite the puddle weld (Abbas 2015). The fracture on 1.0 in. bar stock coupons was similar between the past and current research.

Figure 6.40. Fracture initiation under a puddle weld.

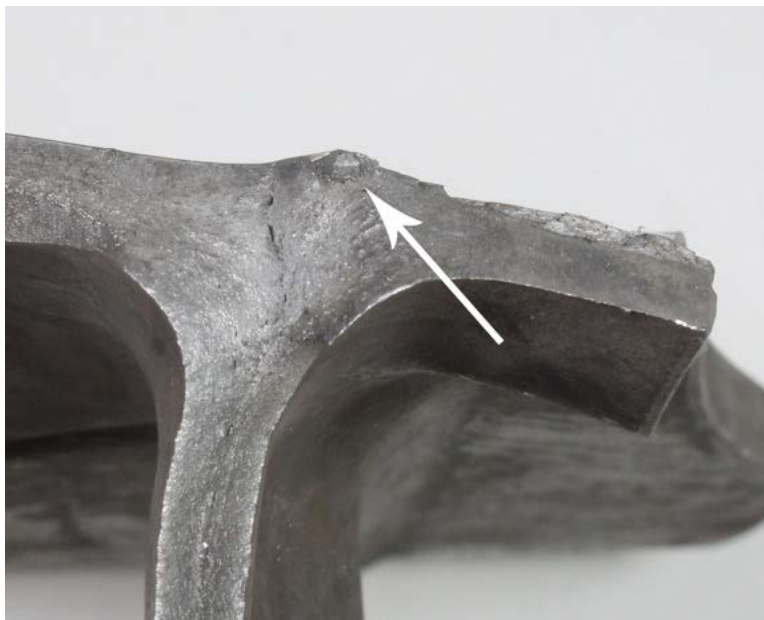
Figure 6.44. Subsurface-origin fatigue fracture on a full-scale specimen with welded artifacts.

Hydrogen embrittlement is also known to appear as small, relatively circular indications on the fracture surface, but they are not the same as the fractures shown in Figure 6.43 and Figure 6.44. This kind of fracture surface is characterized by a fisheye, shown in Figure 6.46. The fisheye has a blowhole at the center, with a silvery appearance, and a surrounding embrittled region with a shiny texture (Zapffe and Sims 1940, 1941). There are also fissures leading away from the blowhole. On the welded bend coupons, the circular fractures did not have a distinct blowhole or fissures, and the surface was smooth and dull, unlike the shiny, textured surface of a brittle fracture. Furthermore, the welding wire used had a low diffusible hydrogen content, H4, and was stored in a dry environment. The coupons were also cleaned and dried before welding commenced, all of which suggests the coupons should not have had hydrogen embrittlement.

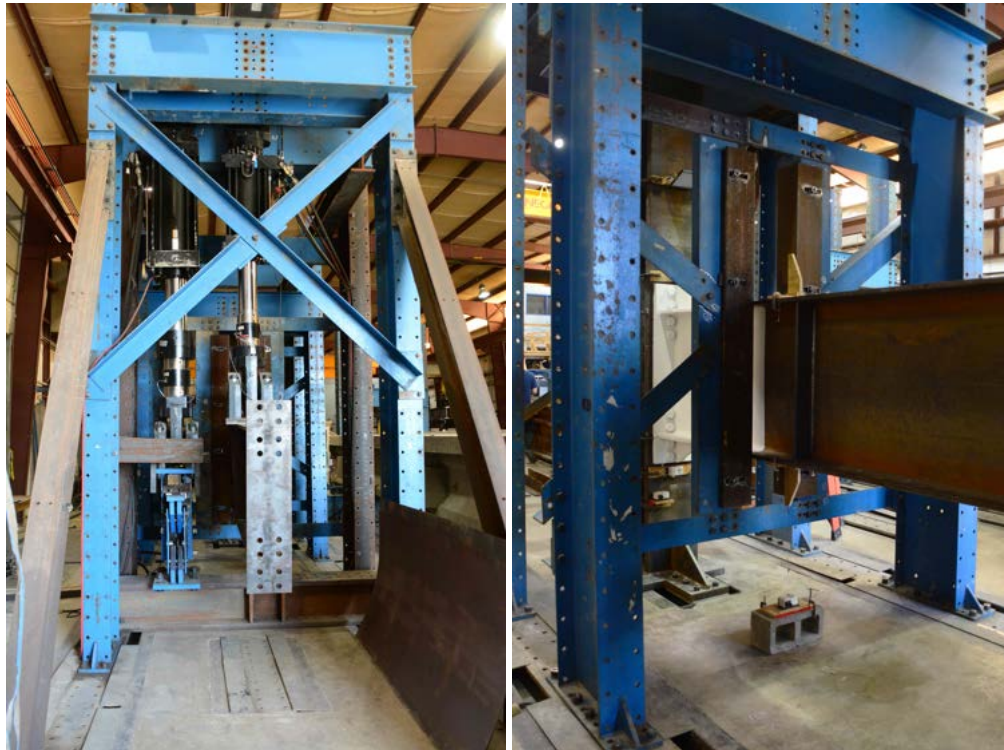
This appendix includes all drawings for the full-scale moment connection test setup, including the actuator frame, the lateral-torsional buckling frame, and the reaction frame. The actuator frame held the servohydraulic actuator used to apply force, the bracing frame limited lateral-torsional buckling outside of the plastic hinge region, and the reaction frame supported the beam-column subassembly. The actuator and bracing frames are shown in Figure A.1a and Figure A.1b, respectively.

(a) Actuator frame viewed from the south end. (b) Bracing frame viewed from the south end.

Figure A.1. Test setup components.

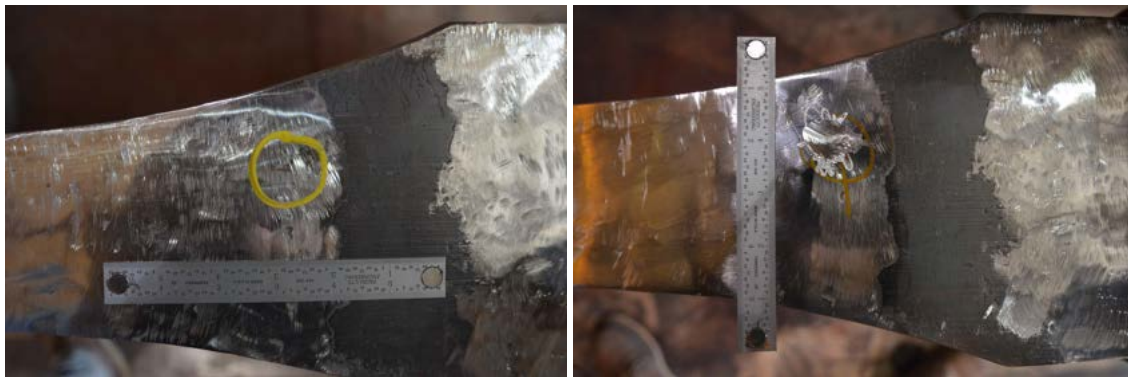
Two surface cracks were found on this specimen when the ground welds were inspected with the magnetic particle test. These cracks were ground out and then rewelded following the weld procedure specification. The first bottom flange surface crack is shown in Figure S.1 and the first top flange surface crack is shown in Figure S.2. Before welding, the new bottom flange notch was ground to 0.125 in. deep and the new top flange notch was ground to 0.063 in. deep.

(a) Surface crack.

(b) After surface crack was removed.

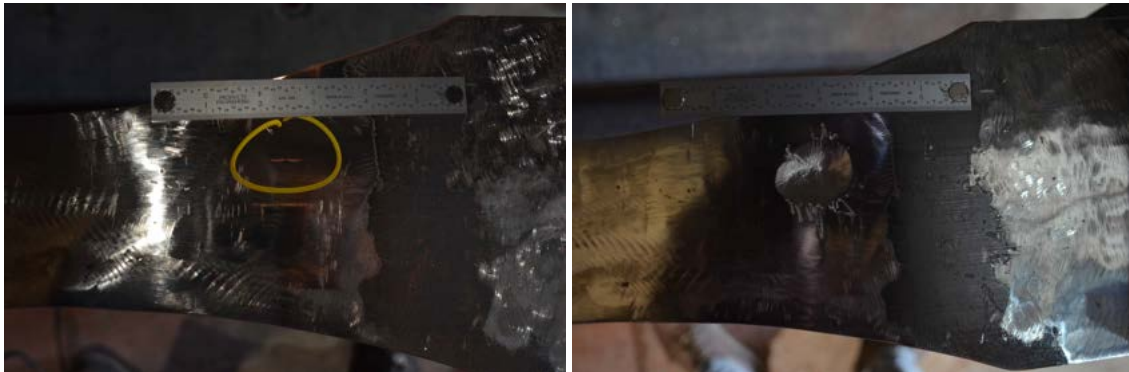
After the welds were ground flush and reinspected, two additional surface cracks were found in the same locations. The second bottom flange surface crack is shown in Figure S.3 and the second top flange surface crack is shown in Figure S.4. The crack on the bottom flange was ground out to a depth of 0.125 in. and the crack on the top flange was ground out to less than 0.06 in. deep. Only the new bottom flange notch was rewelded, as the new top flange notch was within the thickness tolerance given in AWS D1.8.

(a) Surface crack.

(b) After surface crack was removed.

**Figure S.3.** Second bottom flange surface crack and repair.

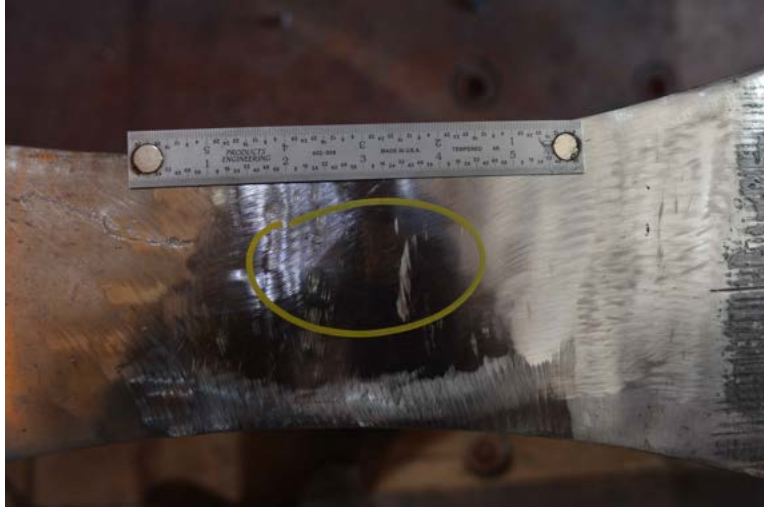
**Figure S.4.** Second top flange surface crack.
