Evaluating the Fracture Potential of Steel Moment Connections with Defects and Repairs

Thesis submitted to the Faculty of the
Virginia Polytechnic Institute and State University
in partial fulfillment of the requirements for the degree of

Master of Science
in
Civil Engineering

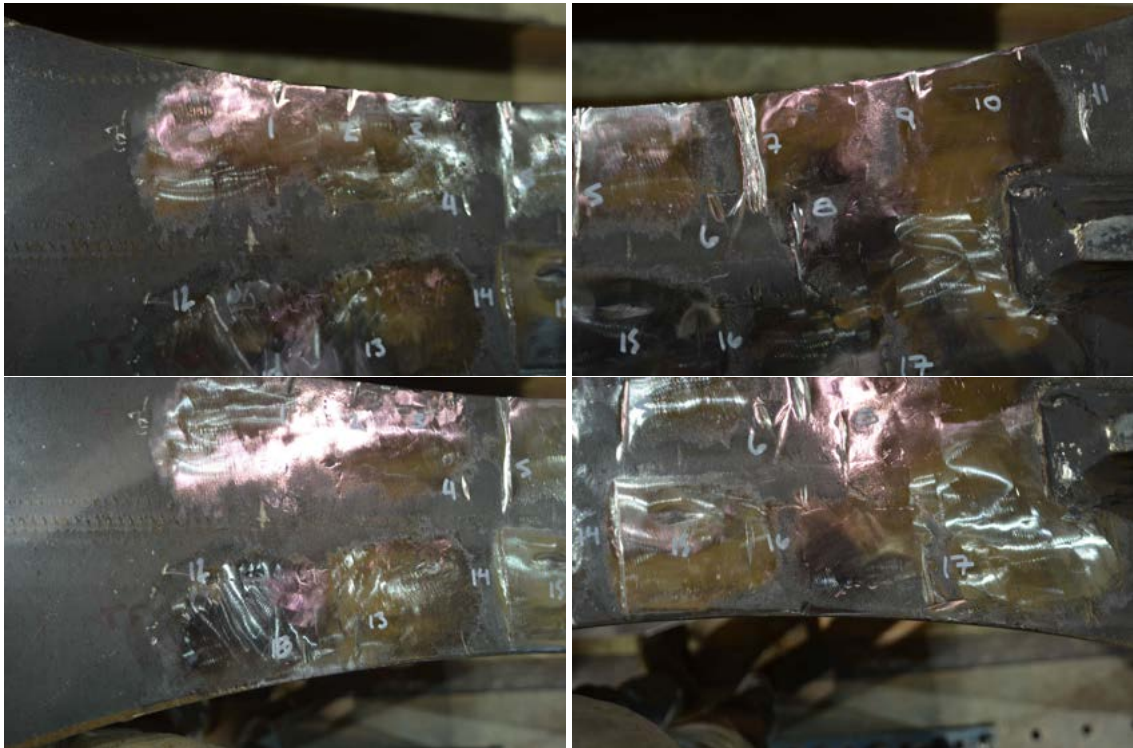
**Figure S.6.** Top flange defects.

Numerous surface defects were found when the weld runoff tabs were removed. These included errant gouges from the angle grinder and areas where the base metal was removed when the tabs were pried off. These defects are shown in Figure S.5 and Figure S.6. After documenting the location, size, and depth, the defects were ground to a smooth taper in every direction and rewelded. The rewelding followed the same weld procedure specification except runoff tabs were not used. The included drawings show the approximate location of each defect. The depth of the defects before and after grinding are given in Table S.1. The depth of the defects on the top flange before grinding are given in Table S.2, but the depth after grinding was inadvertently not recorded.

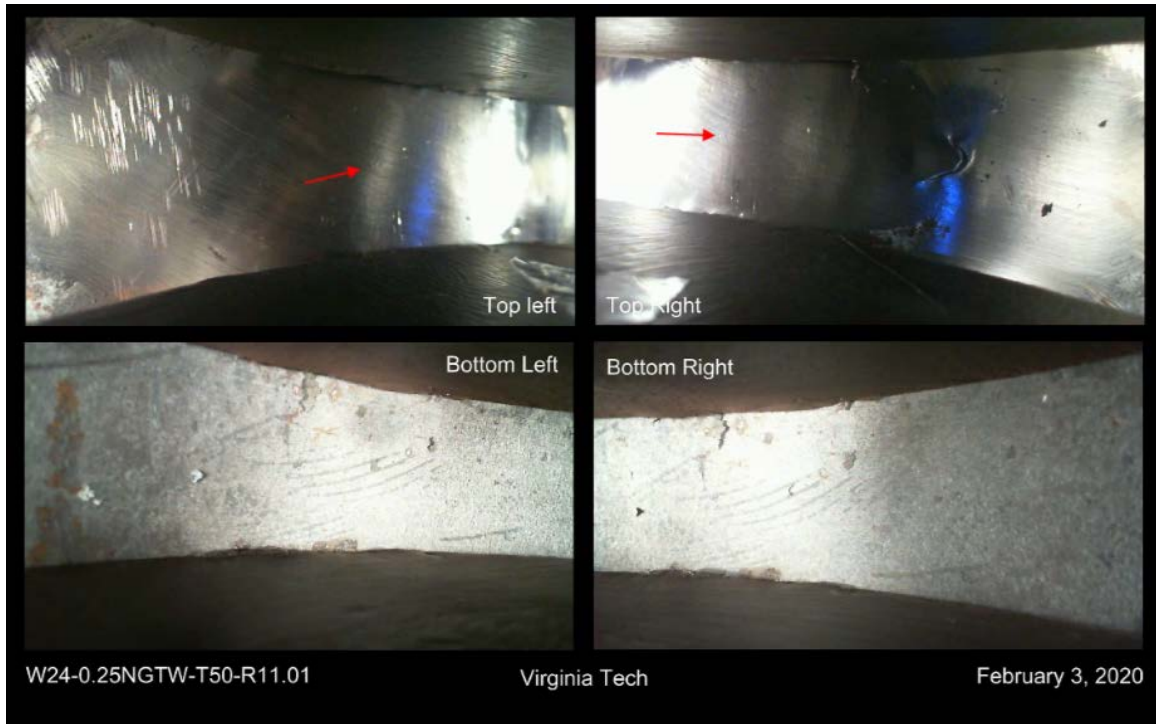
The first visible defect appeared in the second cycle, and the first folded steel defect appeared in the eighth cycle. Complete fracture occurred in the thirty-fifth cycle while the top was in tension. The first folded steel defect is shown in Figure [V.17](#) and the fracture surfaces of both halves are shown in Figure [V.18](#).

**Figure V.17.** Fracture initiation of W24-0.25NGTW-T50-R11.01.

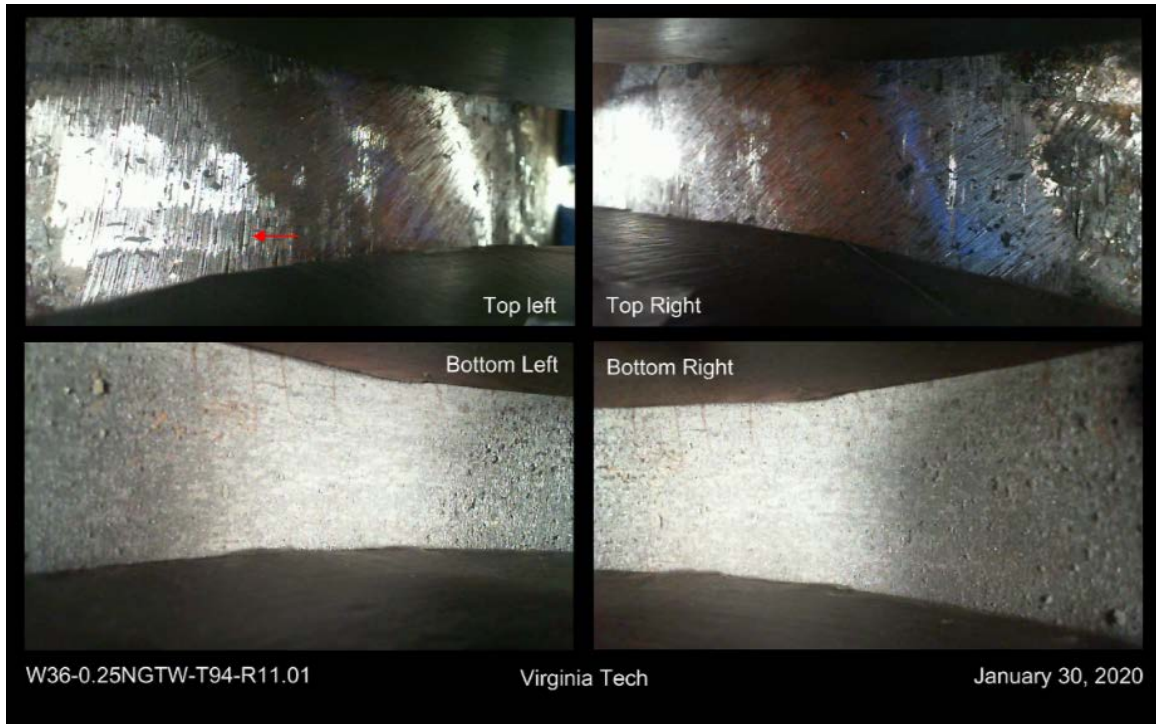
The first visible defect appeared in the second cycle, and there were no visible folded steel defects. Complete fracture occurred in the fifth cycle when the bottom was in tension. The first visible fractures are shown in Figure V.25 and the fracture surfaces of both halves are shown in Figure V.26.

**Figure V.25.** Fracture initiation of W36-0.25NGTW-T94-R11.01.

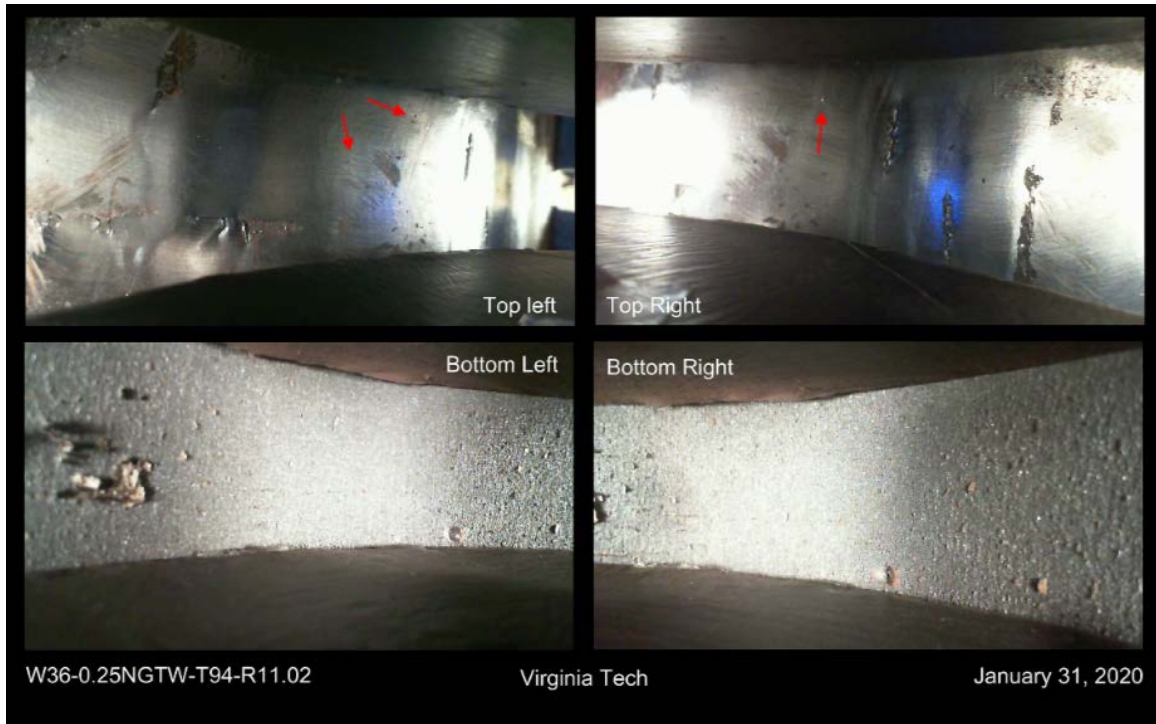
**Figure V.27.** Fracture initiation of W36-0.25NGTW-T94-R11.02.

The first visible defect appeared in the first cycle and the first folded steel defect appeared in the third cycle. Complete fracture occurred in the sixth cycle when the top was in tension. The first folded steel defect is shown in Figure V.27 and the fracture surfaces of both halves are shown in Figure V.28.

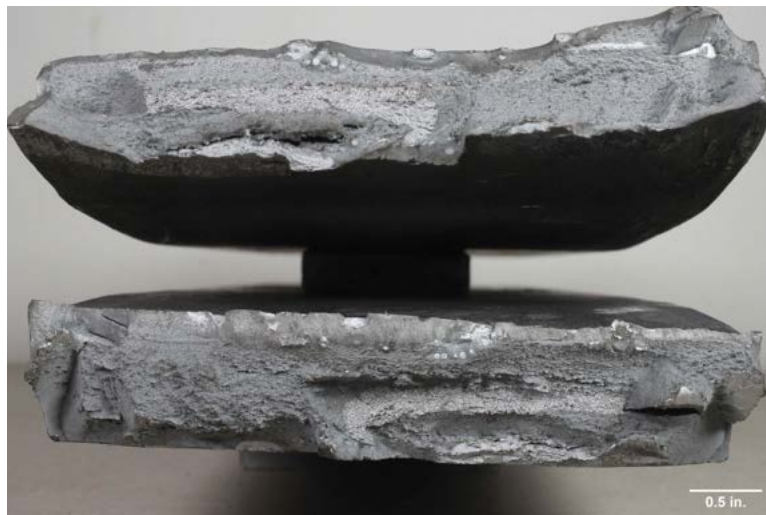
**Figure V.32.** Fracture surfaces of W36-0.25NGTW-T100-R11.02.

The first folded steel defect appeared in the third cycle, and there were no visible defects prior to this point. Complete fracture occurred in the fifth cycle when the bottom was in tension. The first folded steel defects are shown in Figure V.31 and the fracture surfaces of both halves are shown in Figure V.32.

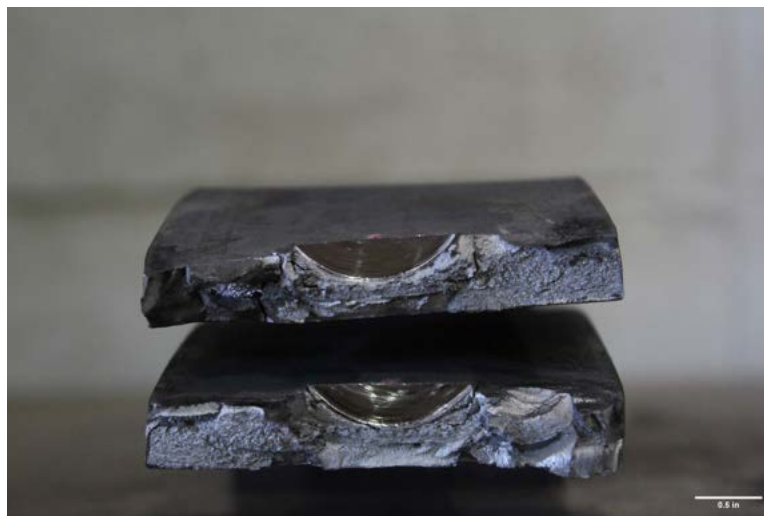
**Figure V.34.** Fracture surfaces of W24-0.25N-T50-R11.02.

Fracture initiation on the bottom side occurred in the fifth cycle, shown in Figure V.33, and final fracture occurred in the ninth cycle. The fracture surfaces of both halves are shown in Figure V.34.

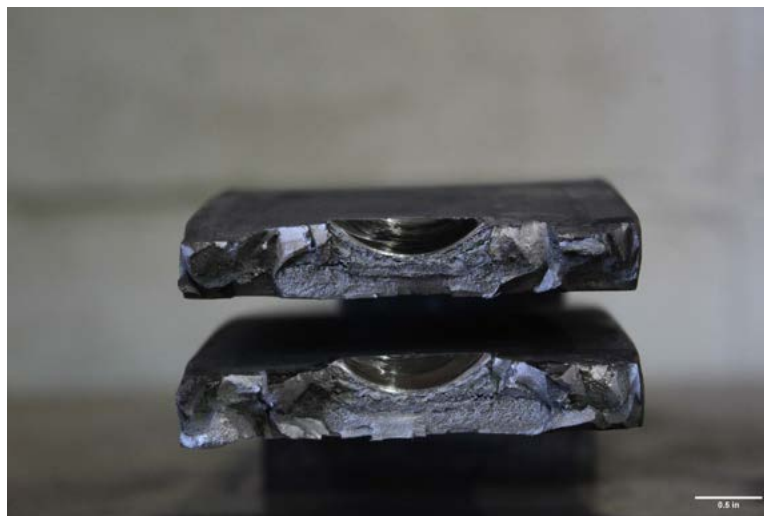
**Figure V.36.** Fracture surfaces of W24-0.25N-T50-R11.03.

Fracture initiation occurred on the bottom side in the fifth cycle, shown in Figure V.35, and complete fracture occurred in the eighth cycle. The fracture surfaces of both halves are shown in Figure V.36.

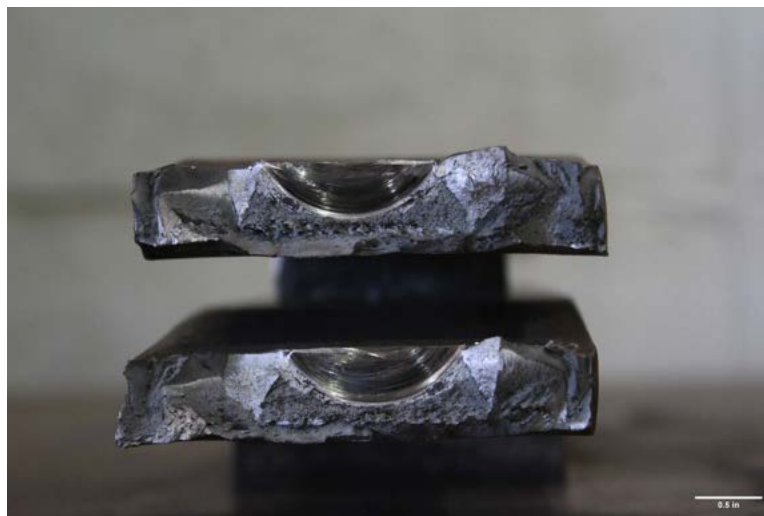
**Figure V.38.** Fracture surfaces of W24-0.25N-T59-R11.02.

Fracture initiation on the bottom side occurred in the third cycle, shown in Figure V.37, and complete fracture occurred in the fourth cycle. The fracture surfaces of both halves are shown in Figure V.38.

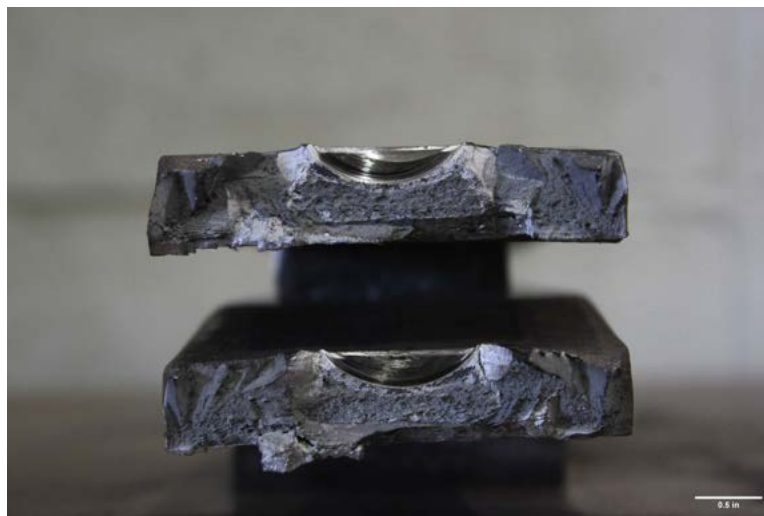
**Figure V.40.** Fracture surfaces of W24-0.25N-T59-R11.03.

Fracture initiation on the bottom side occurred in the third cycle, shown in Figure V.39, and complete fracture occurred in the fourth cycle. The fracture surfaces of both halves are shown in Figure V.40.

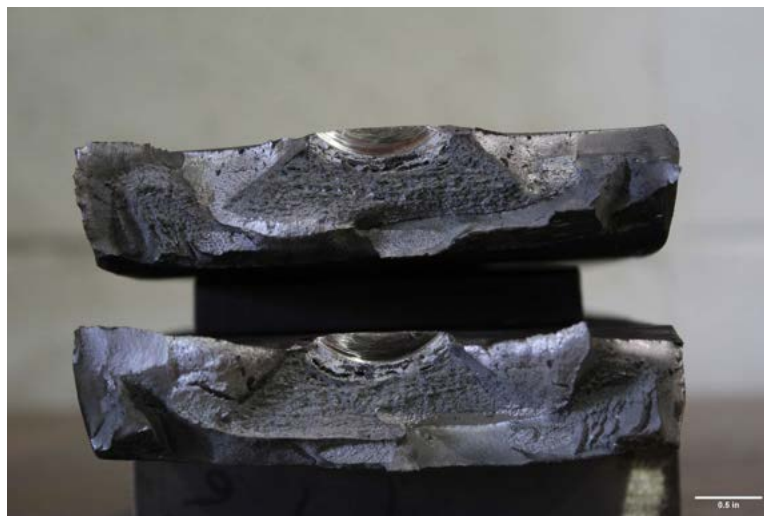
**Figure V.42.** Fracture surfaces of W36-0.25N-T94-R11.01.

Fracture initiation on the bottom side and complete fracture both occurred in the third cycle, shown in Figure V.41. The fracture surfaces of both halves are shown in Figure V.42.

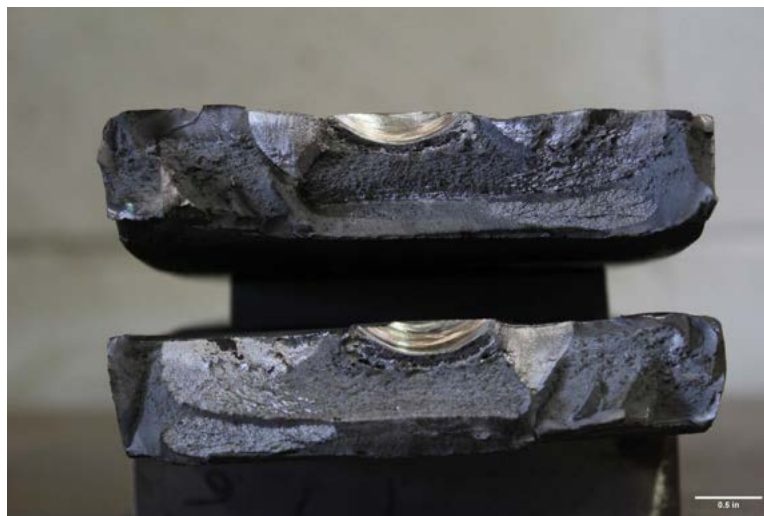
**Figure V.44.** Fracture surfaces of W36-0.25N-T94-R11.02.

Fracture initiation on the bottom side occurred in the third cycle, shown in Figure V.43, and complete fracture occurred in the fourth cycle. The fracture surfaces of both halves are shown in Figure V.44.

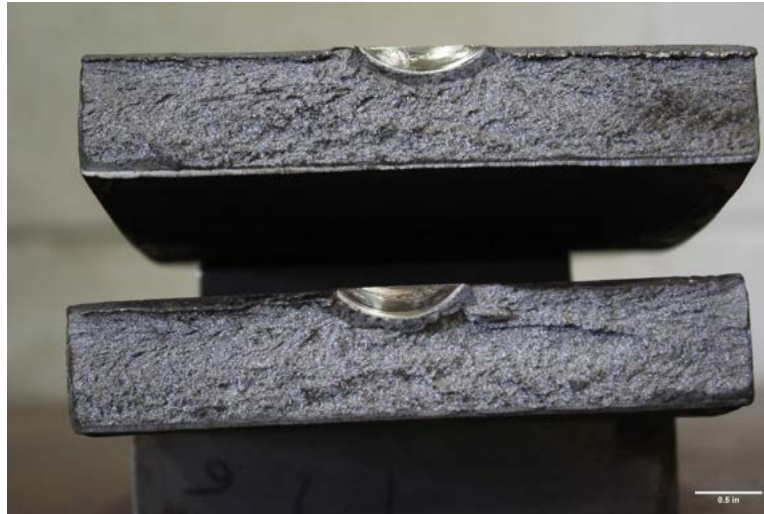
**Figure V.45.** Fracture surfaces of W36-0.25N-T100-R11.01.

There was no fracture initiation on the bottom side before the brittle fracture in the second cycle. The fracture surfaces of both halves are shown in Figure V.45.

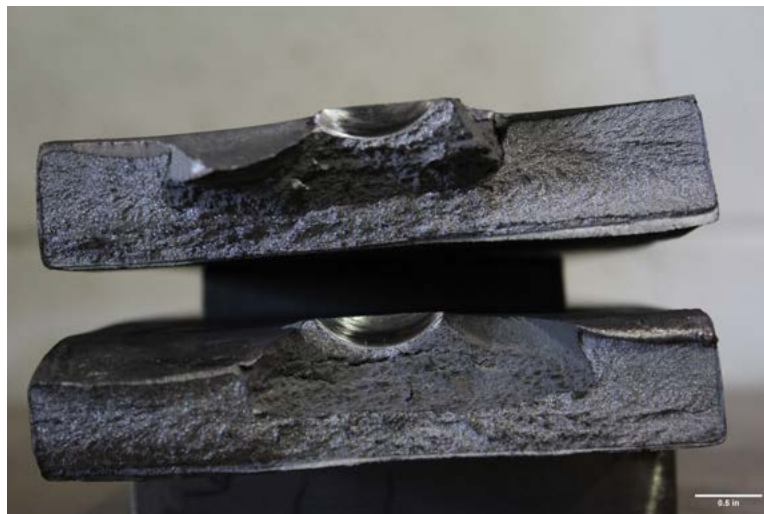
**Figure V.46.** Fracture surfaces of W36-0.25N-T100-R11.02.

There was no fracture initiation on the bottom side before the brittle fracture in the second cycle. The fracture surfaces of both halves are shown in Figure V.46.

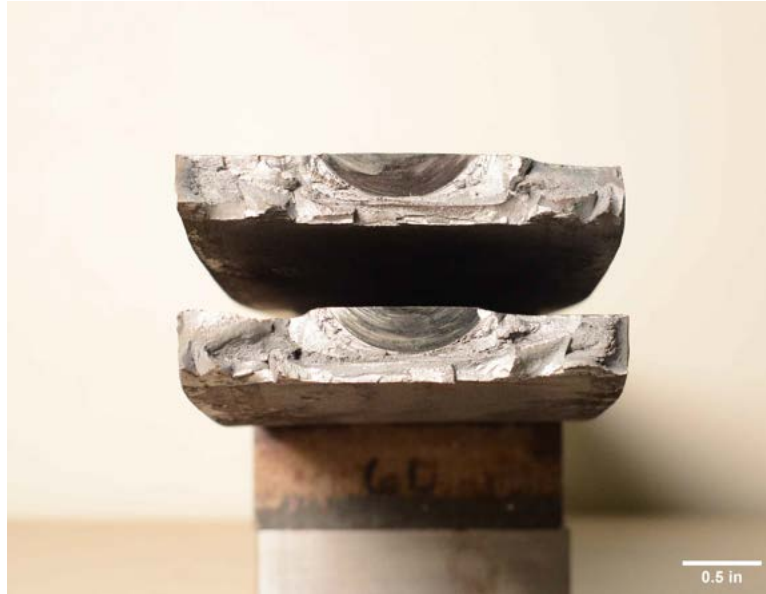
**Figure V.48.** Fracture surfaces of W24-0.375N-T50-R11.01.

Fracture initiation on the bottom side occurred in the fourth cycle, shown in Figure V.47, and complete fracture occurred in the eighth cycle while the bottom was in tension. The fracture surfaces of both halves are shown in Figure V.48.

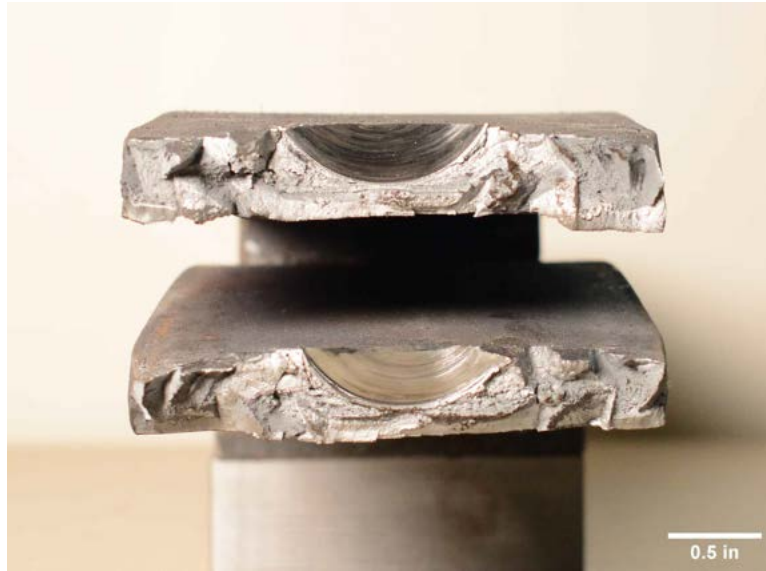
**Figure V.50.** Fracture surfaces of W24-0.375N-T50-R11.02.

Fracture initiation on the bottom side occurred in the third cycle, shown in Figure V.49, and complete fracture occurred in the sixth cycle while the top was in tension. The fracture surfaces of both halves are shown in Figure V.50.

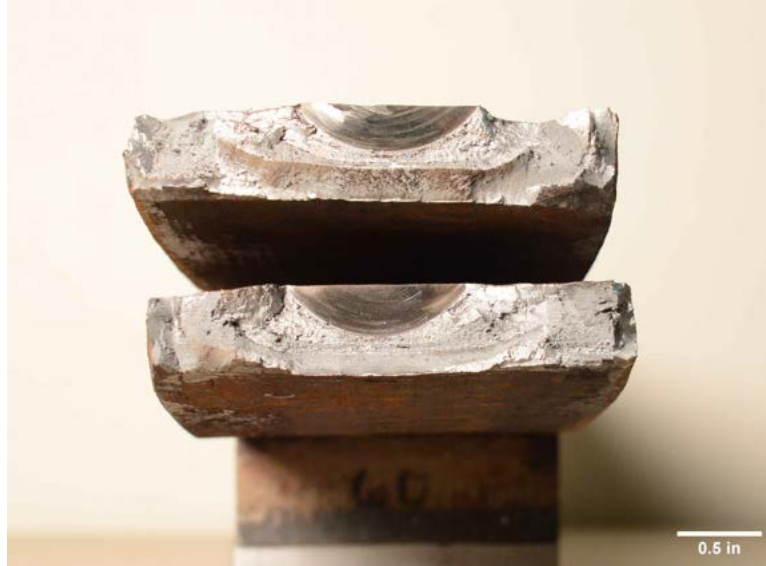
**Figure V.52.** Fracture surfaces of W24-0.375N-T59-R11.01.

Fracture initiation on the bottom side occurred in the third cycle, shown in Figure V.51, and final fracture occurred in the fifth cycle while the bottom was in tension. The fracture surfaces of both halves are shown in Figure V.52.

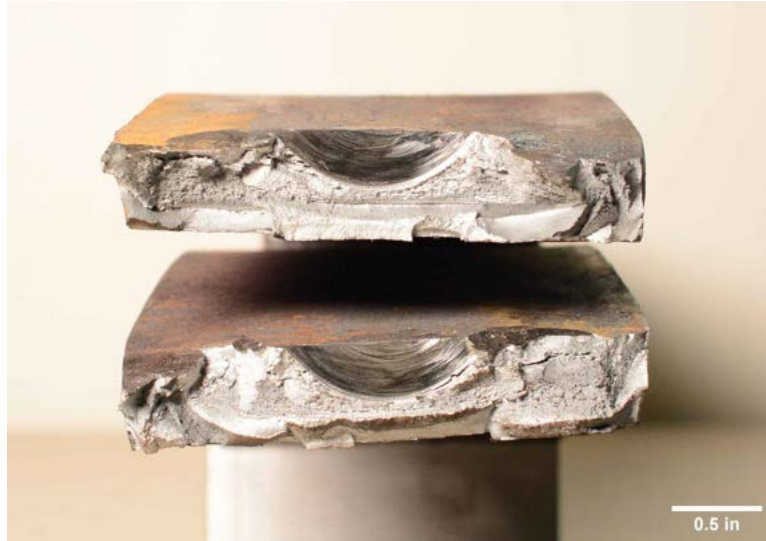
**Figure V.54.** Fracture surfaces of W24-0.375N-T59-R11.02.

Fracture initiation on the bottom side occurred in the third cycle, shown in Figure V.53, and final fracture occurred in the sixth cycle while the top was in tension. The fracture surfaces of both halves are shown in Figure V.54.

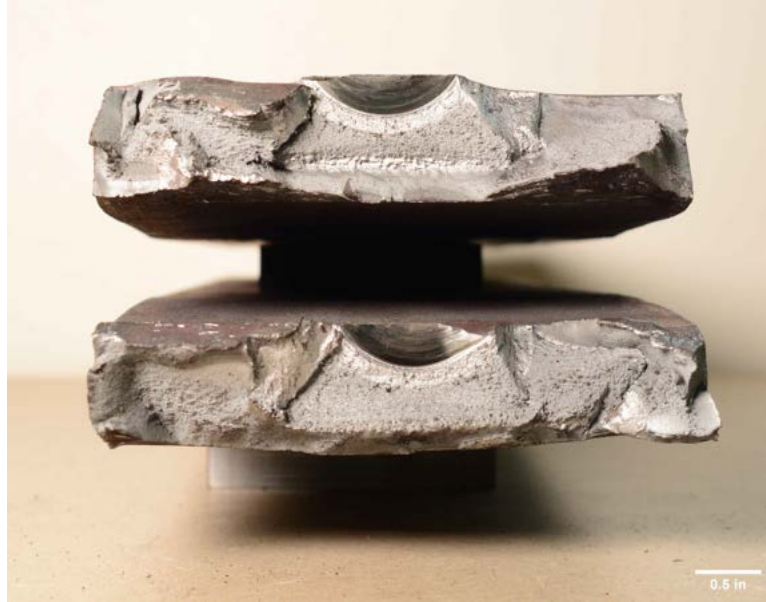
**Figure V.56.** Fracture surfaces of W36-0.375N-T94-R11.01.

Fracture initiation on the bottom side occurred in the second cycle, shown in Figure V.55, and final fracture occurred in the fourth cycle while the top was in tension. The fracture surfaces of both halves are shown in Figure V.56.

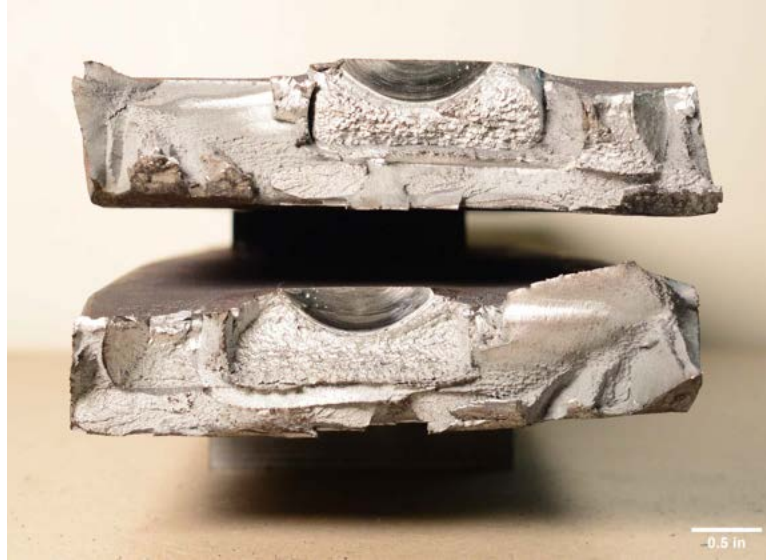
**Figure V.58.** Fracture surfaces of W36-0.375N-T94-R11.02.

Fracture initiation on the bottom side occurred in the second cycle, shown in Figure V.57, and final fracture occurred in the third cycle while the bottom was in tension. The fracture surfaces of both halves are shown in Figure V.58.

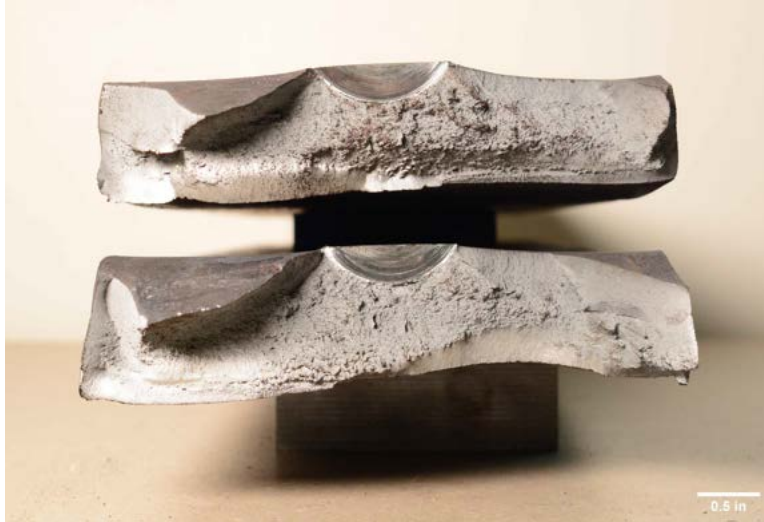
**Figure V.60.** Fracture surfaces of W36-0.375N-T100-R11.01.

Fractures formed on the bottom side in the second cycle, shown in Figure V.59, when the top flange fracture propagated through the thickness of the coupon. Complete fracture occurred in the second cycle while the top was in tension. The fracture surfaces of both halves are shown in Figure V.60.

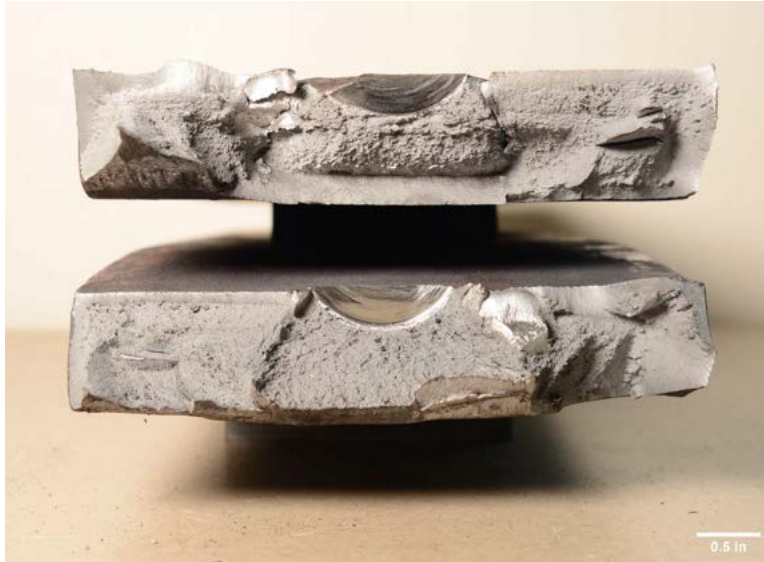
**Figure V.61.** Fracture surfaces of W36-0.375N-T100-R11.02.

Fracture initiation on the bottom side is not known due to issues with the video recording. The fracture surfaces of both halves are shown in Figure V.61. Complete fracture occurred in the second cycle.

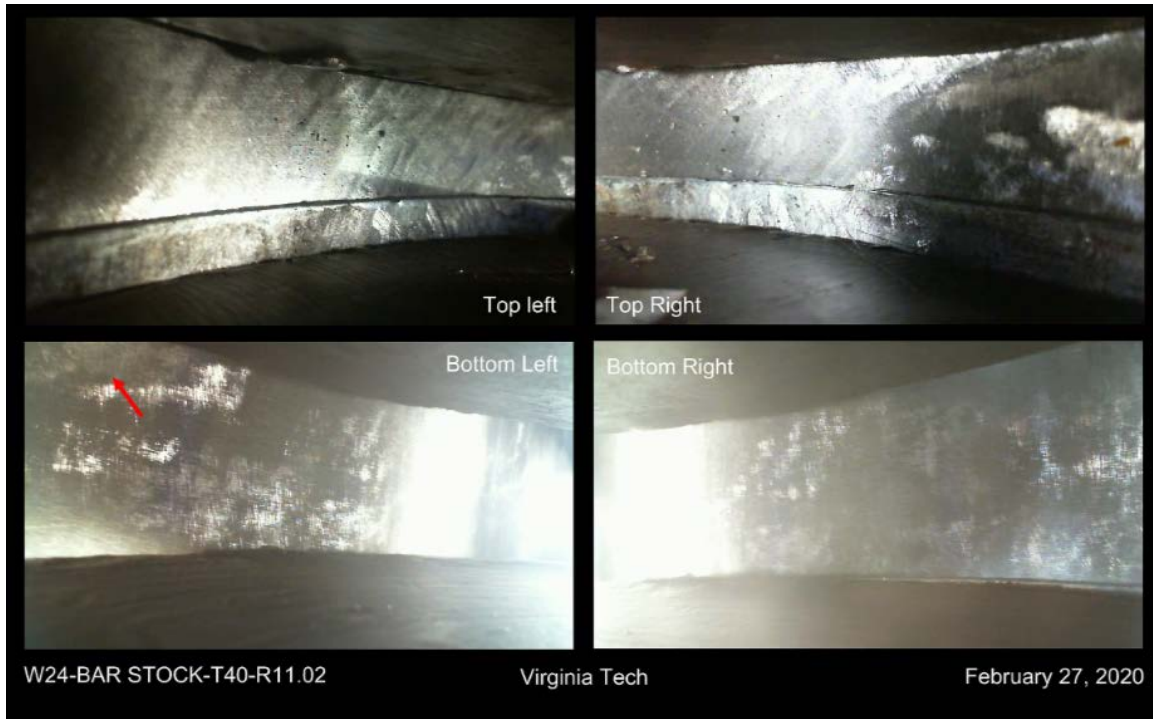
**Figure V.62.** Fracture initiation of W24-BAR STOCK-T40-R11.02.

Fracture initiation occurred in the twenty-eighth cycle while the bottom was in tension and final fracture occurred in the sixty-seventh cycle, also while the bottom was in tension. Fracture initiation is shown in Figure V.62 and the fracture surfaces of both halves are shown in Figure V.63.

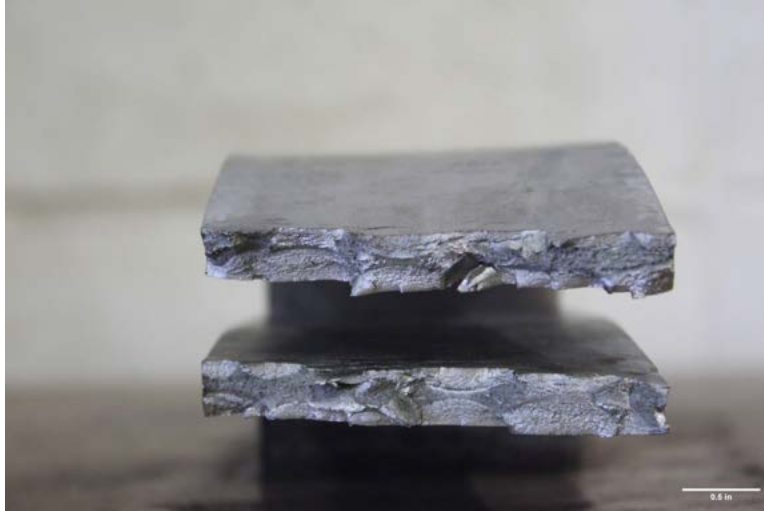
**Figure V.65.** Fracture surfaces of W24-FLANGE MATERIAL-T40-R11.01.

Fracture initiation occurred in the thirteenth cycle, shown in Figure V.64, and final fracture occurred in the sixty-ninth cycle when the bottom was in tension. The fracture surfaces of both halves are shown in Figure V.65.

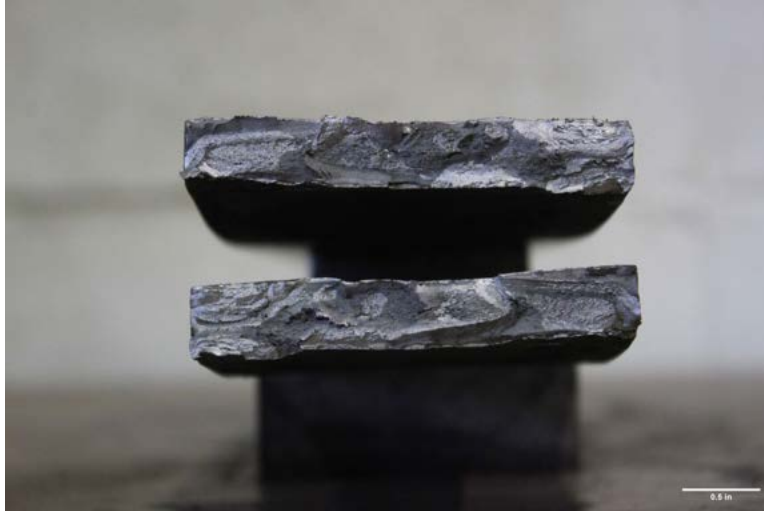
**Figure V.67.** Fracture surfaces of W24-STEEL-T50-R11.02.

Fracture initiation occurred in the thirty-first cycle, shown in Figure V.66, and complete fracture occurred in the thirty-third cycle while the top was in tension. The fracture surfaces of both halves are shown in Figure V.67.

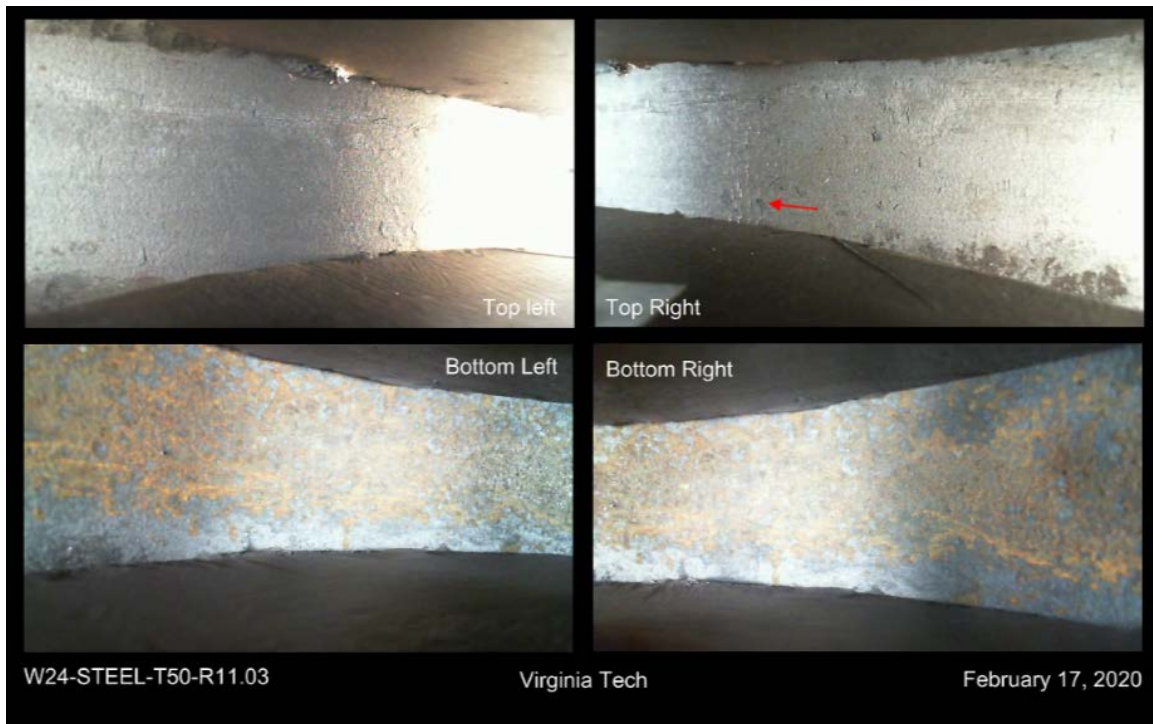
**Figure V.68.** Fracture initiation of W24-STEEL-T50-R11.03.

Fracture initiation occurred in the thirty-fifth cycle, shown in Figure V.68, and complete fracture occurred in the thirty-seventh cycle while the bottom was in tension. The fracture surfaces of both halves are shown in Figure V.69.

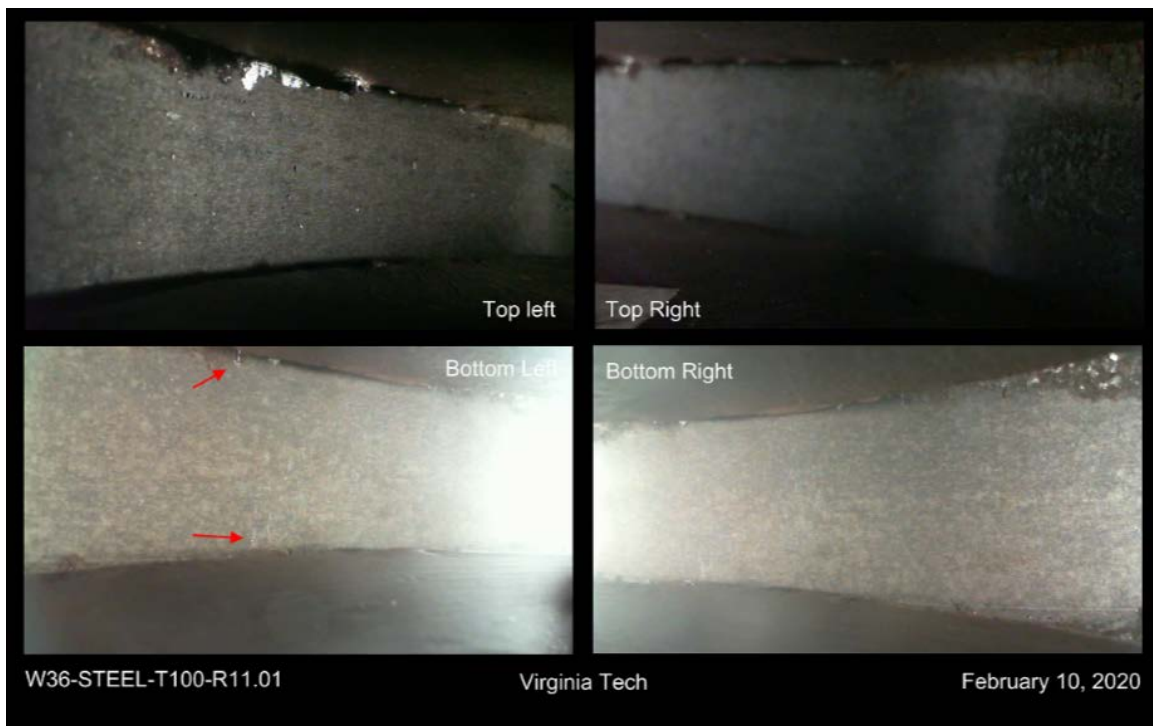
**Figure V.70.** Fracture initiation of W36-STEEL-T100-R11.01.

Fracture initiation occurred in the fifth cycle, shown in Figure V.70, and complete fracture occurred in the sixth cycle while the top was in tension. The fracture surfaces of both halves are shown in Figure V.71.

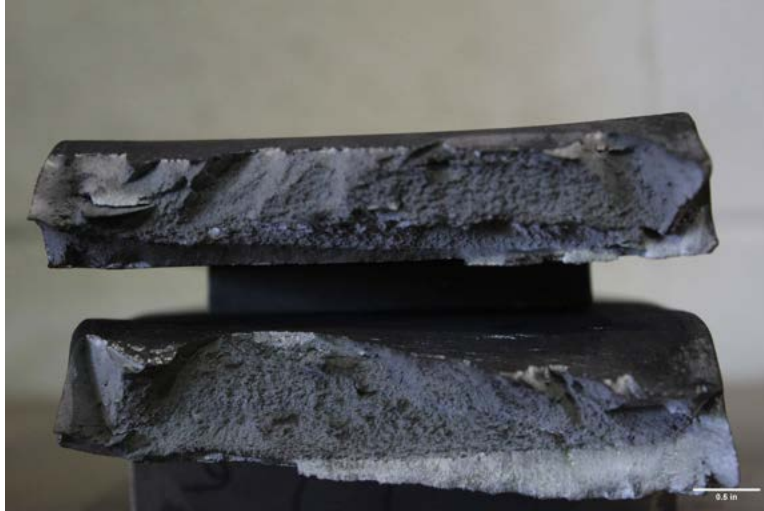
**Figure V.73.** Fracture surfaces of W36-STEEL-T100-R11.02.

Fracture initiation occurred in the fourth cycle, shown in Figure V.72, and complete fracture occurred in the fifth cycle while the bottom was in tension. The fracture surfaces of both halves are shown in Figure V.73.

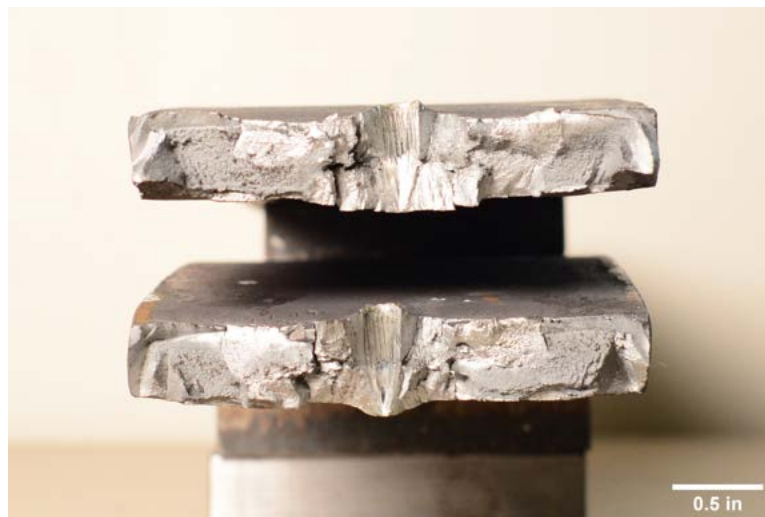
**Figure V.77.** Fracture surfaces of W24-0.625PnAF-T50-R11.02.

Fracture initiation occurred on the bottom side around the point formed by the fastener in the second cycle, shown in Figure V.76. Complete fracture occurred in the twelfth cycle while the bottom was in tension. The fracture surfaces of both halves are shown in Figure V.77.

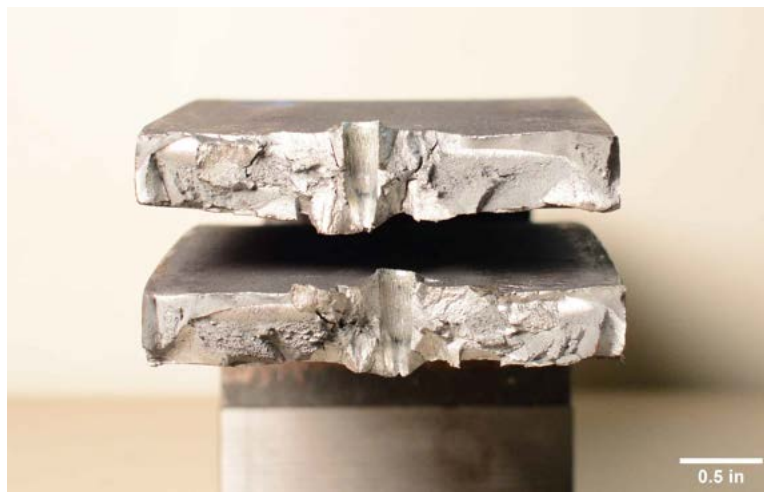
**Figure V.79.** Fracture surfaces of W24-0.75PnAF-T50-R11.01.

Fracture initiation occurred on bottom side in the first cycle around the hole formed by the fastener, shown in Figure V.78. Complete fracture occurred in the eighteenth cycle while the top was in tension. The fracture surfaces of both halves are shown in Figure V.79.

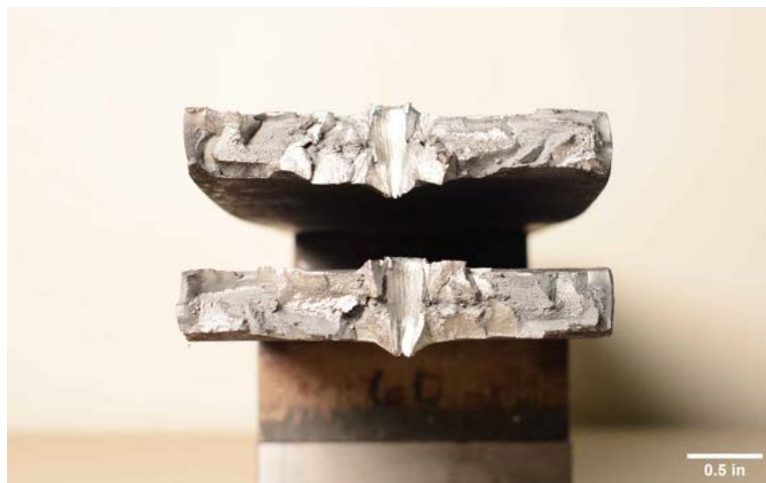
**Figure V.81.** Fracture surfaces of W24-0.75PnAF-T50-R11.02.

Fracture initiation occurred on the bottom side in the first cycle around the hole formed by the fastener, shown in Figure V.80. Complete fracture occurred in the eleventh cycle while the bottom was in tension. The fracture surfaces of both halves are shown in Figure V.81.

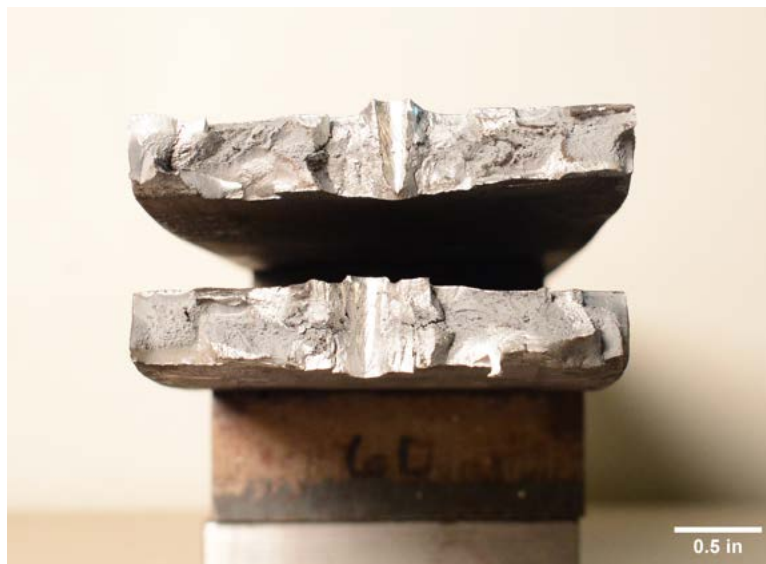
**Figure V.83.** Fracture surfaces of W24-PAF-T50-R11.01.

Fracture initiation occurred on the bottom side around the end of the fastener in the seventh cycle, shown in Figure V.82. Complete fracture occurred in the seventeenth cycle while the bottom was in tension. The fracture surfaces of both halves are shown in Figure V.83.

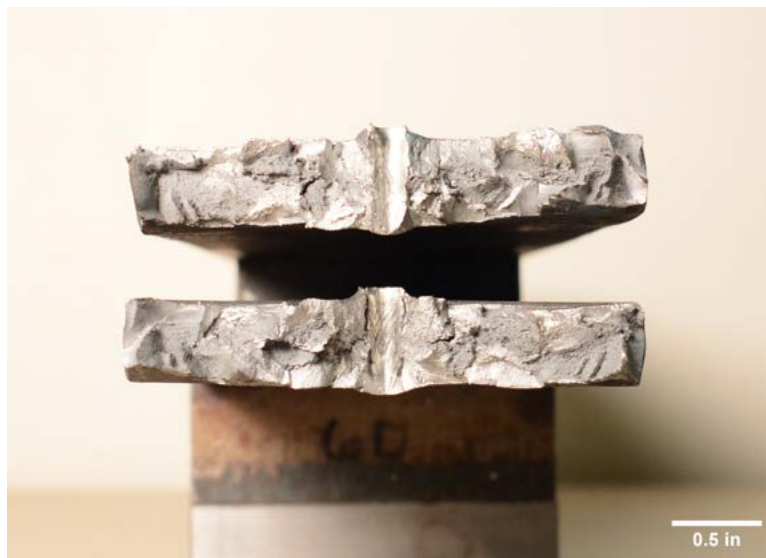
**Figure V.85.** Fracture surfaces of W24-PAF-T50-R11.02.

Fracture initiation occurred on the bottom side in the fifth cycle, shown in Figure V.84. Complete fracture occurred in the seventeenth cycle while the bottom was in tension. The fracture surfaces of both halves are shown in Figure V.85.

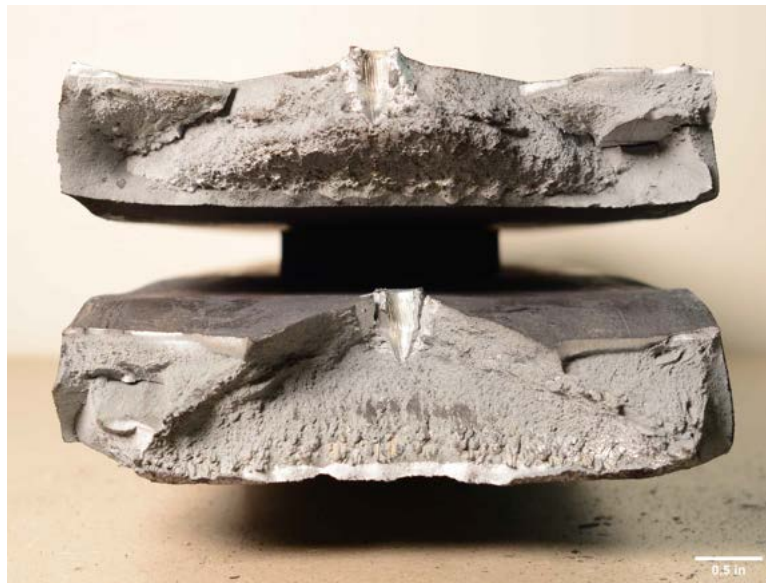
**Figure V.87.** Fracture surfaces of W36-0.625PnAF-T100-R11.01.

Fracture initiation occurred on the top side around the fastener hole in the second cycle, shown in Figure V.86. Complete fracture occurred in the third cycle when the bottom was in tension. The fracture surfaces of both halves are

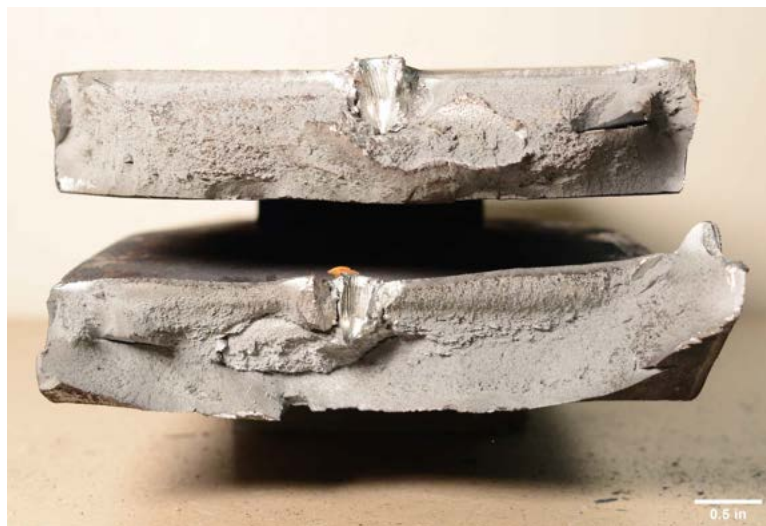
**Figure V.89.** Fracture surfaces of W36-0.625PnAF-T100-R11.02.

Fracture initiation occurred on the top side around the fastener hole in the third cycle, shown in Figure V.88. Complete fracture occurred in the fourth cycle when the top was in tension. The fracture surfaces of both halves are shown in Figure V.89.

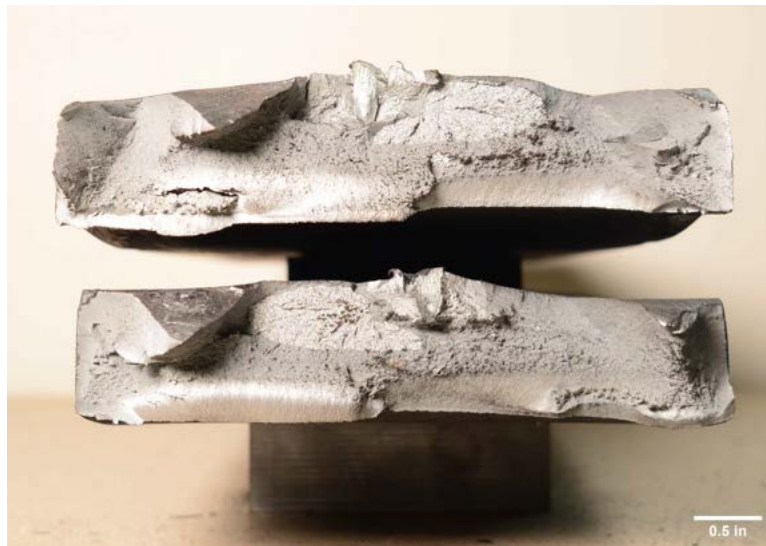
**Figure V.91.** Fracture surfaces of W36-0.75PnAF-T100-R11.01.

Fracture initiation occurred on the top side in the second cycle, shown in Figure V.90. Complete fracture occurred in the third cycle when the top was in tension. The fracture surfaces of both halves are shown in Figure V.91.

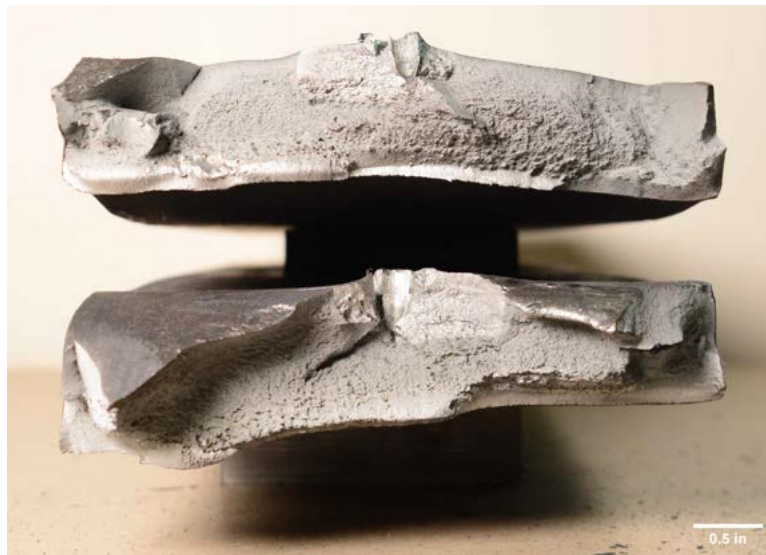
**Figure V.93.** Fracture surfaces of W36-0.75PnAF-T100-R11.02.

Fracture initiation occurred on the top side in the second cycle, shown in Figure V.92. Complete fracture occurred in the third cycle when the top was in tension. The fracture surfaces of both halves are shown in Figure V.93.

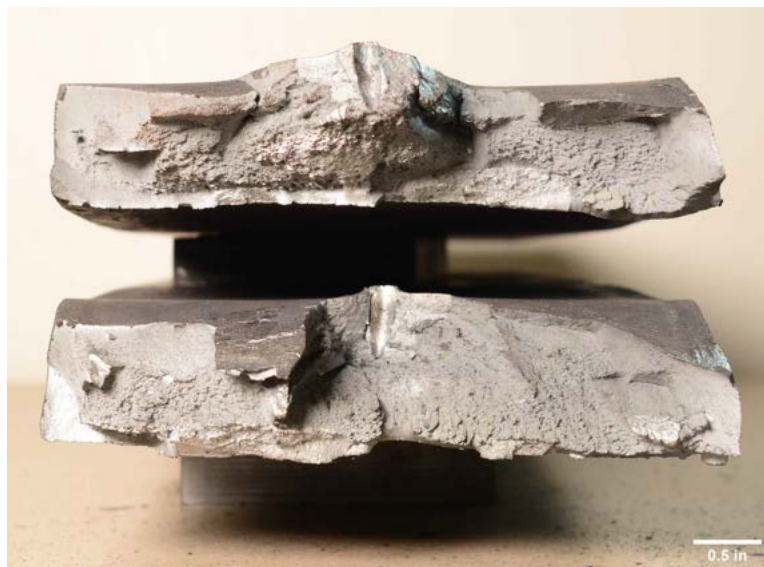
**Figure V.95.** Fracture surfaces of W36-PAF-T100-R11.01.

Fracture initiation occurred on the top side in the third cycle, shown in Figure V.94. Complete fracture occurred in the fourth cycle when the top was in tension. The fracture surfaces of both halves are shown in Figure V.95.

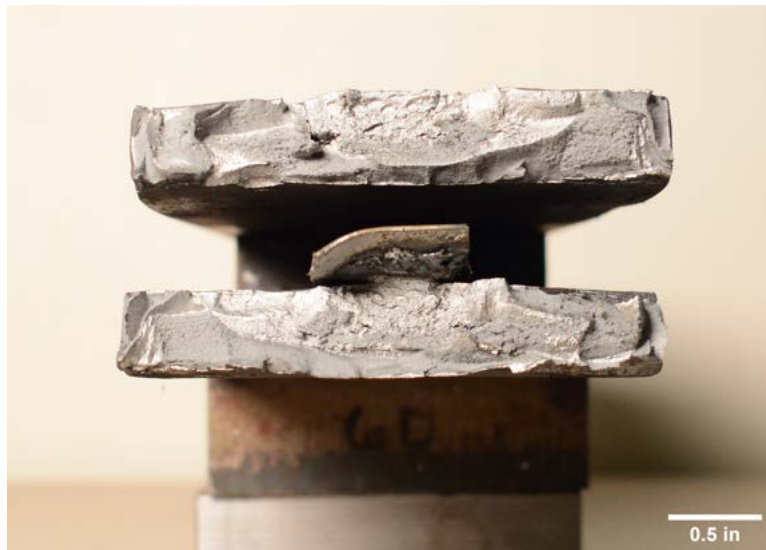
**Figure V.101.** Fracture surfaces of W24-PW-T50-R11.02.

Fracture initiation occurred in the fourth cycle at the edge of the puddle weld, shown in Figure [V.100](#), while the top was in tension. Complete fracture occurred in the twenty-second cycle while the bottom was in tension. The fracture surfaces of both halves are shown in Figure [V.101](#).

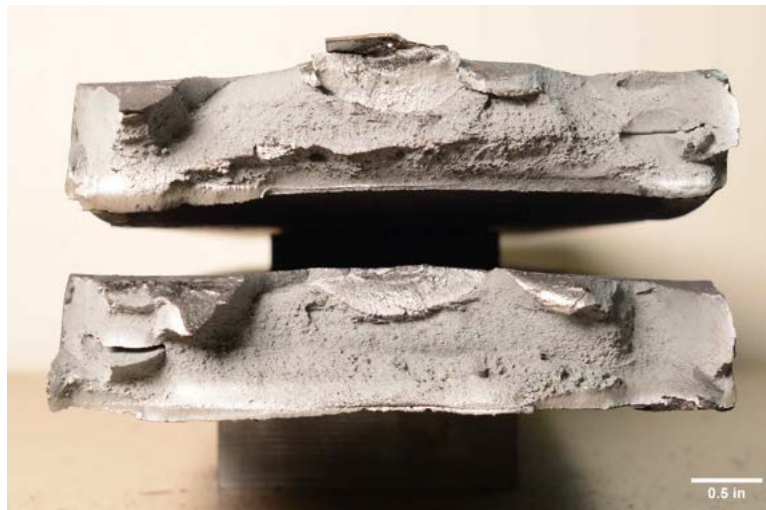
**Figure V.103.** Fracture surfaces of W36-PW-T100-R11.01.

Fracture initiation occurred in the second cycle at the edge of the puddle weld, shown in Figure V.102, while the top was in tension. Complete fracture occurred in the fourth cycle while the top was in tension. The fracture surfaces of
