# **HIGH TEMPERATURE CORROSION OF SINGLE CRYSTAL SAPPHIRE AND ZIRCONIA IN COAL GASIFICATION AND COMMERCIAL GLASS ENVIRONMENTS**

Thesis submitted to the Faculty of the Virginia Polytechnic  
Institute and State University in partial fulfillment of the  
Requirements for the degree of

Master of Science  
In  
Materials Science and Engineering

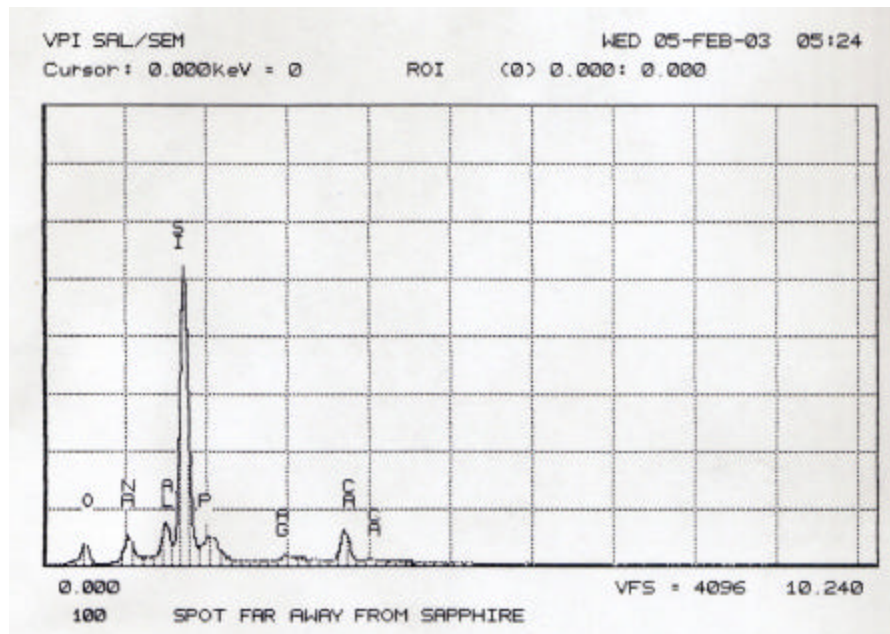
Figure 3-2- composition of soda lime glass

Soda lime glass was obtained by crushing a commercially available glass bowl. The spot scan obtained reveals the relative abundances of the elements present, Figure 3-2. Soda lime glass that we used for the experiments is rich in silicon, and contains smaller amounts of sodium, calcium and aluminum.

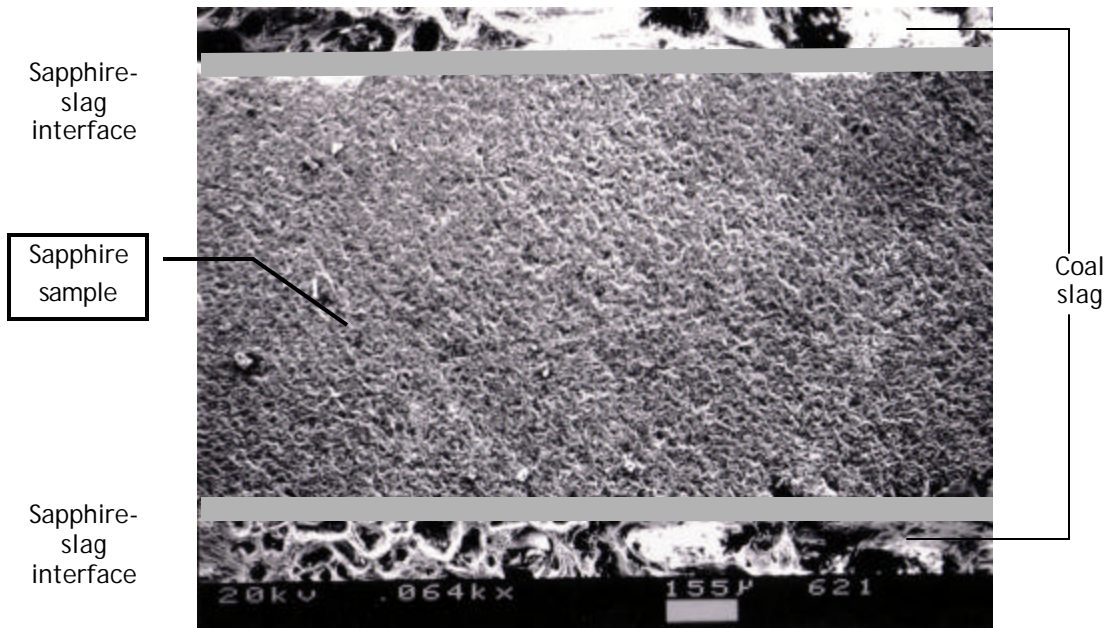
**Figure 4-6- SEM micrograph of sapphire corrode in coal slag at 1200°C for 4 days**

Under the conditions of 1200°C over 4 day period, the sapphire again showed no dramatic changes in the interface, Figure 4-6. Yellow highlights identify the interfaces between the sapphire and the coal slag. Both interfaces are strait with no major defects.
