Improving the Success of Stream Restoration Practices – Revised and Expanded

Final Project Report

28 June 2021

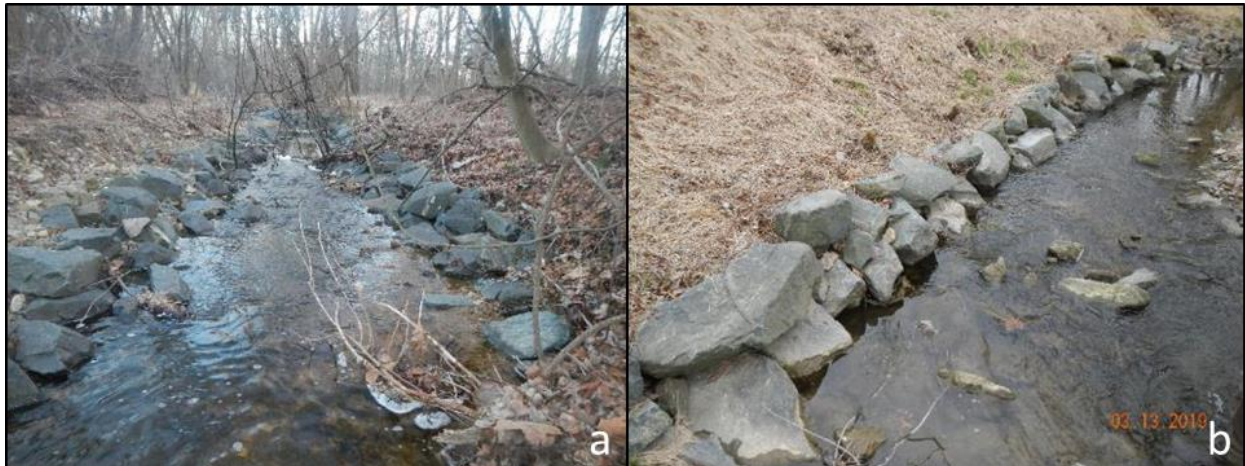
Figure 3.4 Examples of stone toe from restoration project 22 (a) and 33 (b).

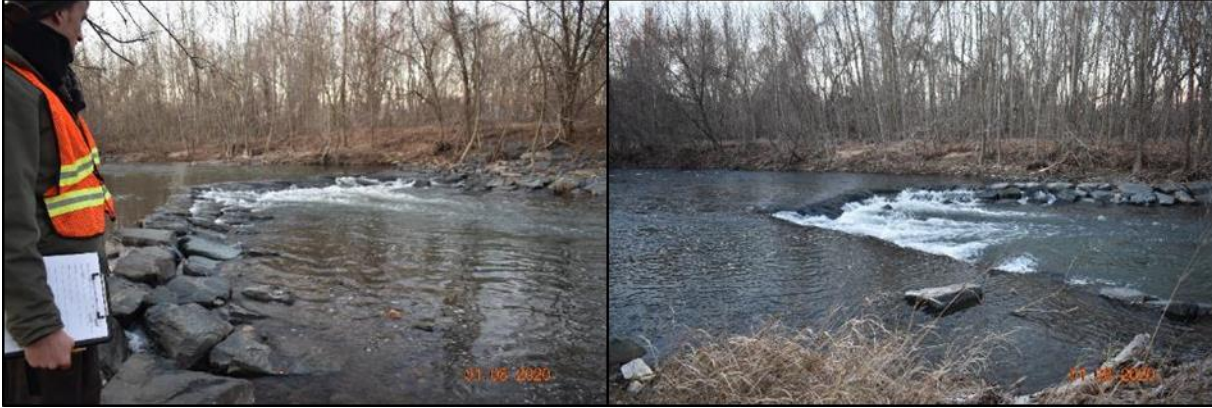
Figure 3.7 A cross vane constructed using dumped stone from restoration project 35.

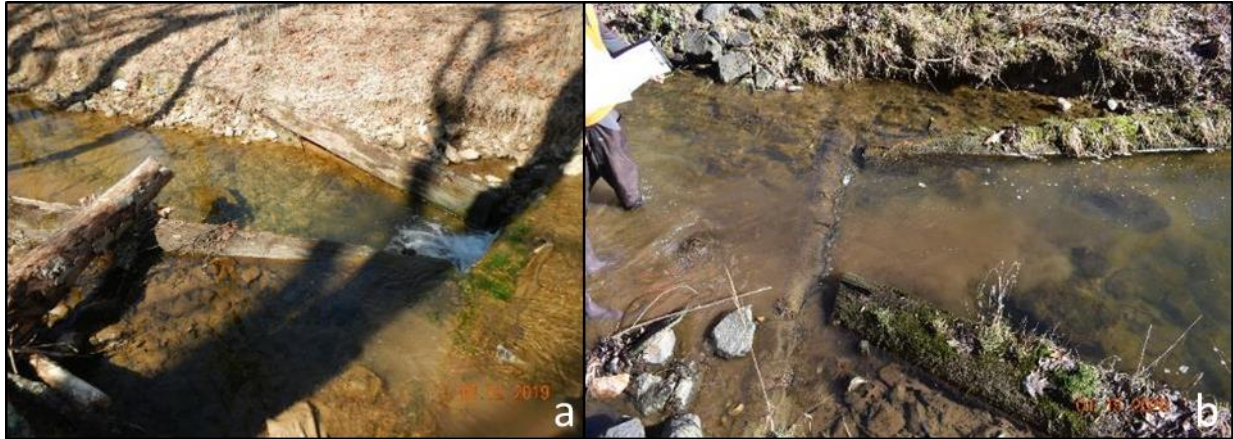
Figure 3.8 Two examples of log full span vanes from restoration projects 28 (a) and 36 (b).

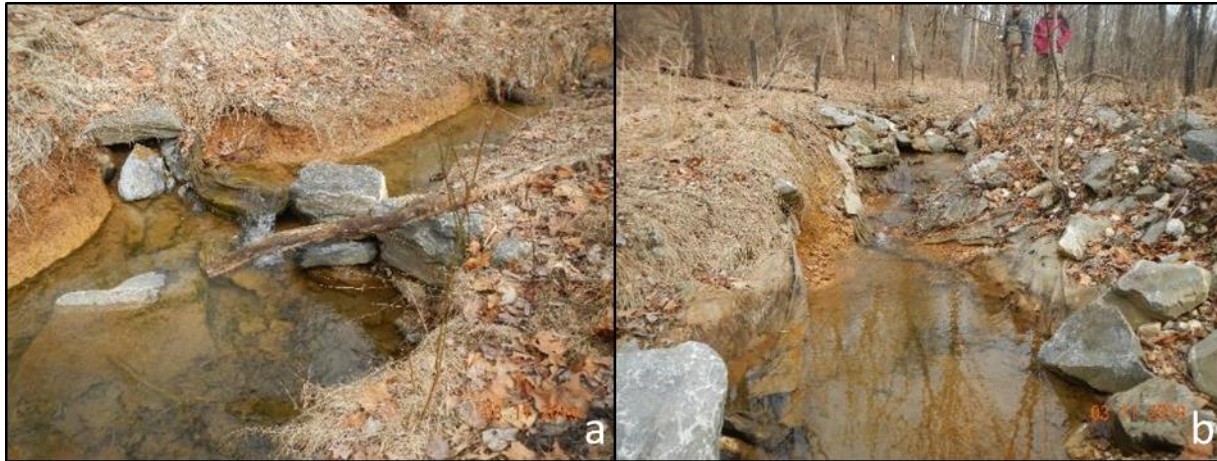
Figure 3.10 Examples of a knick-point and resulting structure failure from restoration project 8. A full span vane that failed due to the migration of a knick-point, such that the structure is now above the current baseflow water surface elevation and structure materials were displaced into the downstream pool (a) and the downstream reach that was affected by this knick-point (b).

A common failure mode for FSVs is undermining, which is caused by scouring below footers on the downstream side of the vane, which results in structure failure (Figure 3.10; Puckett, 2007). As a result,

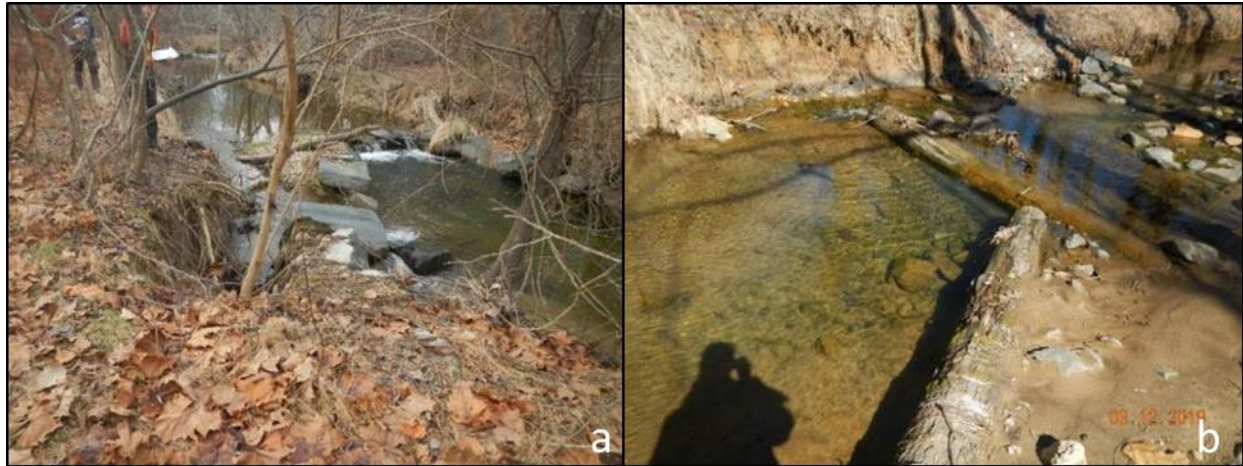
Figure 3.11 Two full span vanes that failed due to flanking. a) shows a rock cross vane from restoration project 31; b) shows a log cross vane from restoration project 28, which is missing the entire right arm.

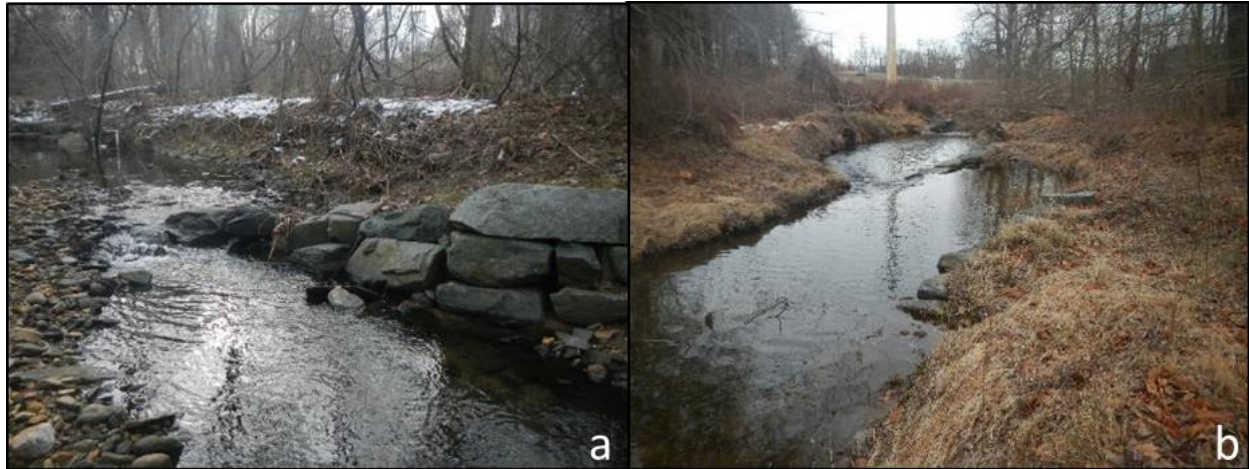
Figure 3.14 Two examples of rock partial span vanes. A single arm vane from restoration project 7 (a) and two single arm vanes from restoration project 31 (b).

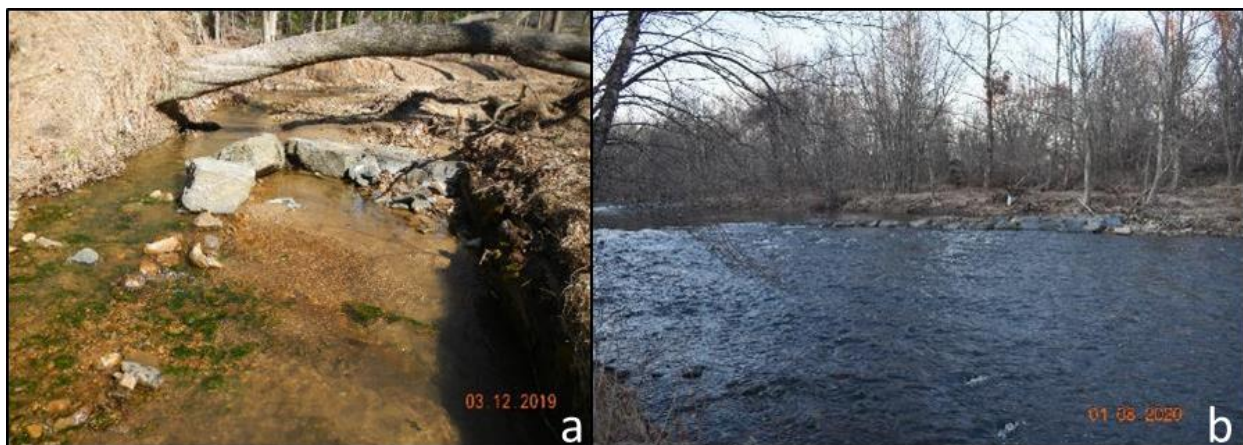
Figure 3.17 Two examples of rock j-hooks, including the sill portion of a j-hook from restoration project 28 (a) and a large j-hook from restoration project 35 where the sill is submerged (b).

J-hook vanes are similar to single arm vanes, but include a sill that is usually slightly curved (Figure 3.17; Rosgen, 2001). Previous design recommendations recommended spacing the top row of stones by half the diameter of the rocks, to induce additional scour (MDE, 2000; Rosgen, 2001); however, this recommendation is no longer used in practice. Contemporary j-hooks have largely been replaced by modified j-hooks, a FSV, discussed in section 2.2.3. It is recommended that the upper-most sill rocks extend at most 10% of the bankfull depth above the channel bottom and that the underlying footers be at least three times this protrusion height deep below the streambed (MDE, 2000; Rosgen, 2001). Furthermore, an entire j-hook vane should occupy no more than 60% of the bankfull width (MDE, 2000). See Table 3.2 for a summary of design recommendations for PSVs, with respect to the variables considered in this study.

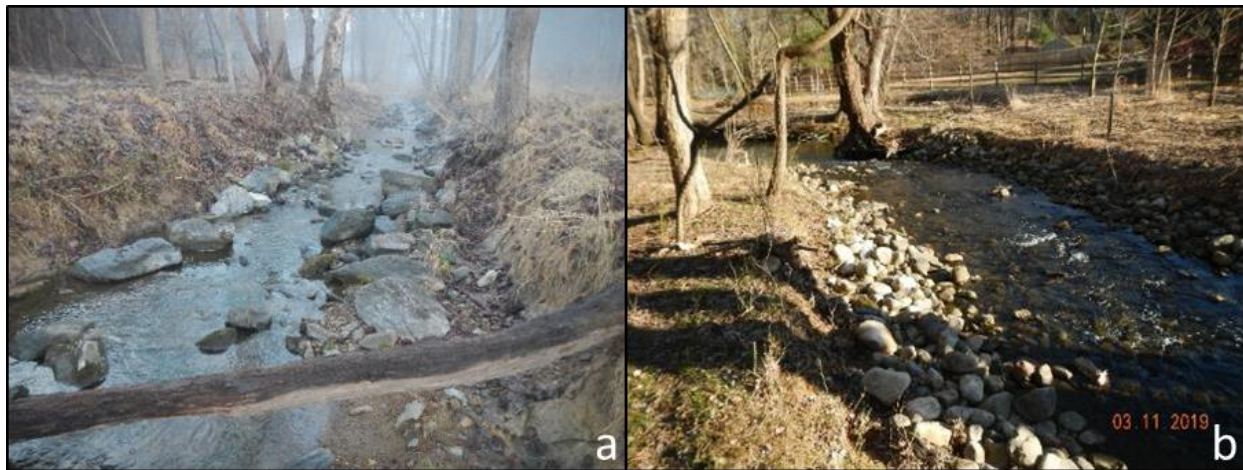
Figure 3.21 Two examples of constructed riffles that included armor on the adjacent banks. Constructed riffle from restoration project 10 that is experiencing bank erosion on the adjacent banks, despite large rocks that were placed to provide armoring (a). Constructed riffle from restoration project 18 that utilized the same substrate to construct the riffle and the bank armor (b).

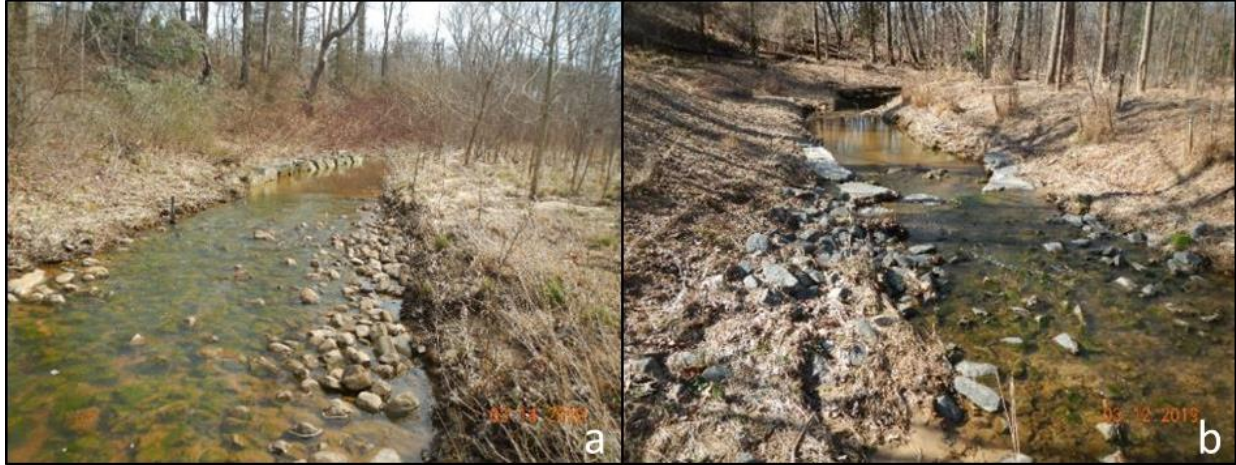
Figure 3.22 Two examples of RFs that did not utilize armor on the adjacent banks. Constructed riffle from restoration project 9 (a). Constructed riffle from restoration project 28 that is constructed directly upstream of a cross vane that is providing stabilization (b).

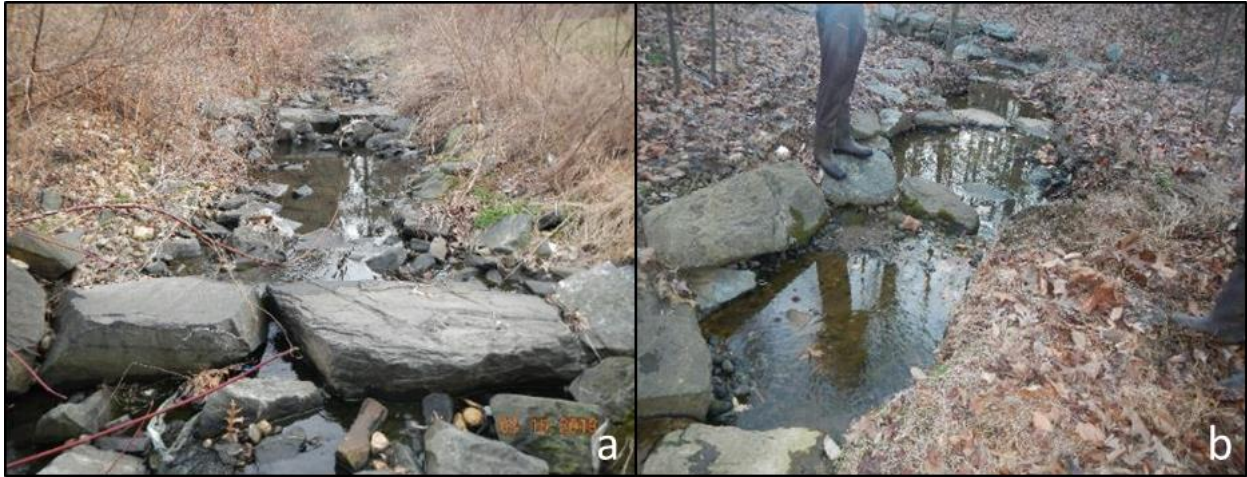
Figure 2-28 Two examples of step pools from restoration project 4 (a) and 28 (b).

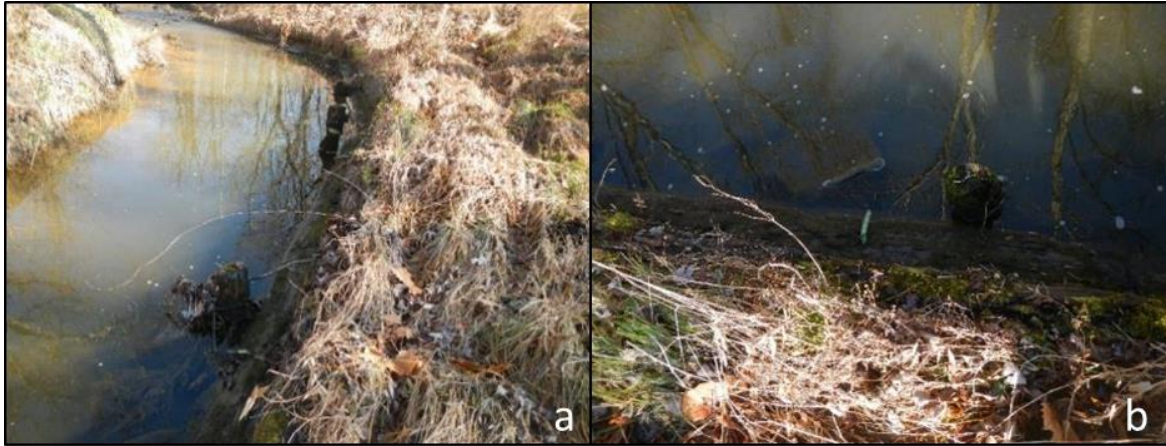
Figures 3.33 Log toe structure on the right streambank (a) and log toe with exposed rebar and visible wood piles (b). Both images are from restoration project 36.

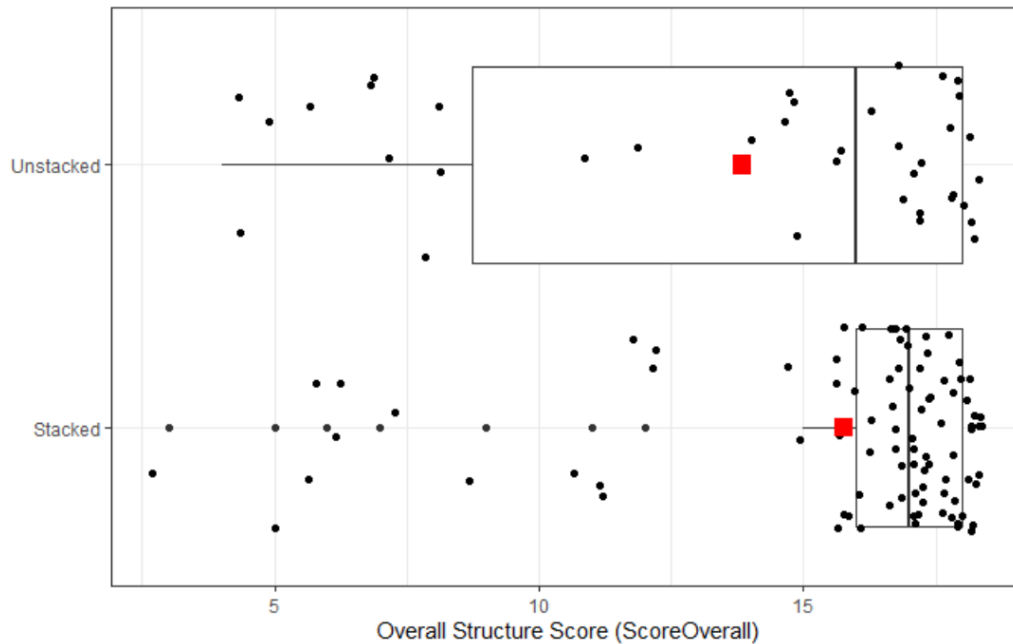
Figure 3.43 Differences between overall structure score for stacked versus unstacked bank protection.

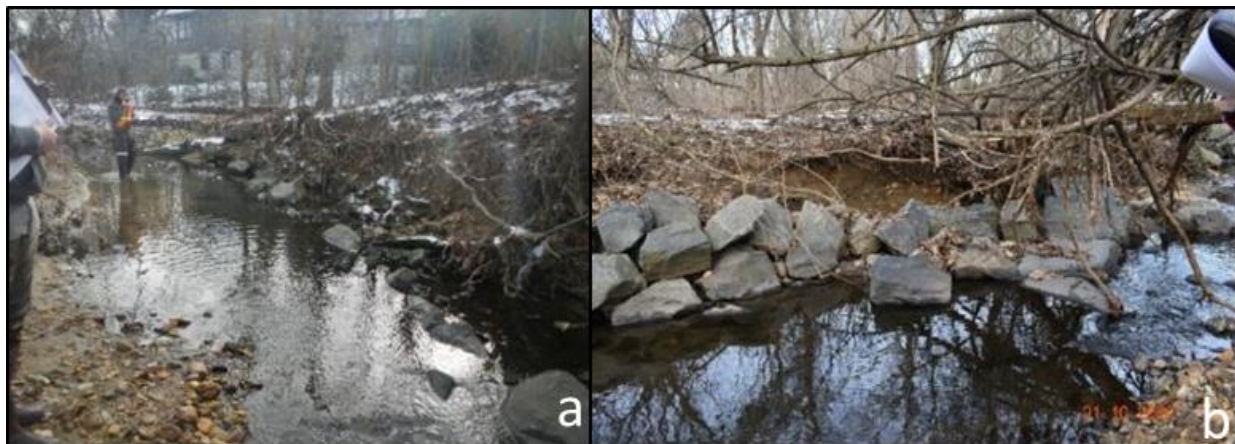
Figure 3.55 Two bank protection structures from restoration project 7 that illustrate how overtopping contributed to structure degradation. In both cases, the bank above the structure is eroded and the structure is destabilized.

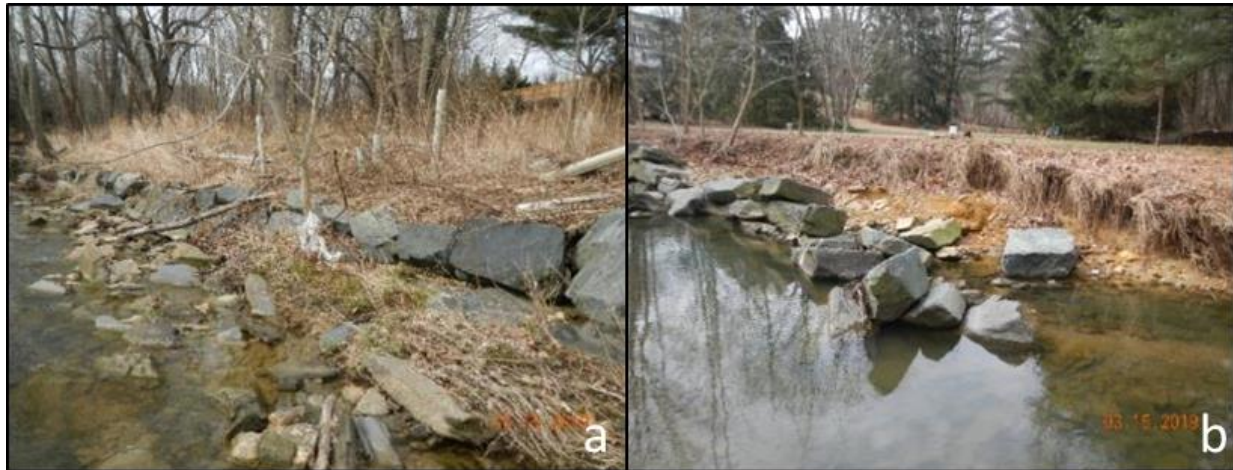
Figure 3.56 Two examples of BP structures from restoration project 24, one that is functioning (a) and one that is failing (b). The failing rock wall is the downstream end of a longer structure, and failure seems to have stemmed from overtopping leading to structure destabilization.

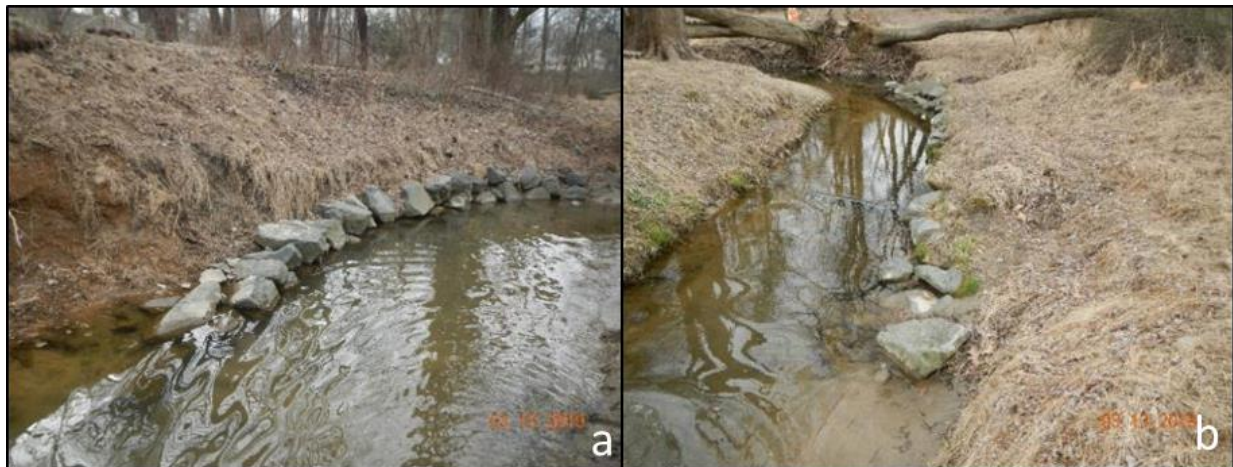
Figure 3.57 Two stone toe structures from restoration project 33. Both structures illustrate that the ends of these bank protection structures are compromising structure function. The structure in picture (b) is experiencing bank erosion on both ends.

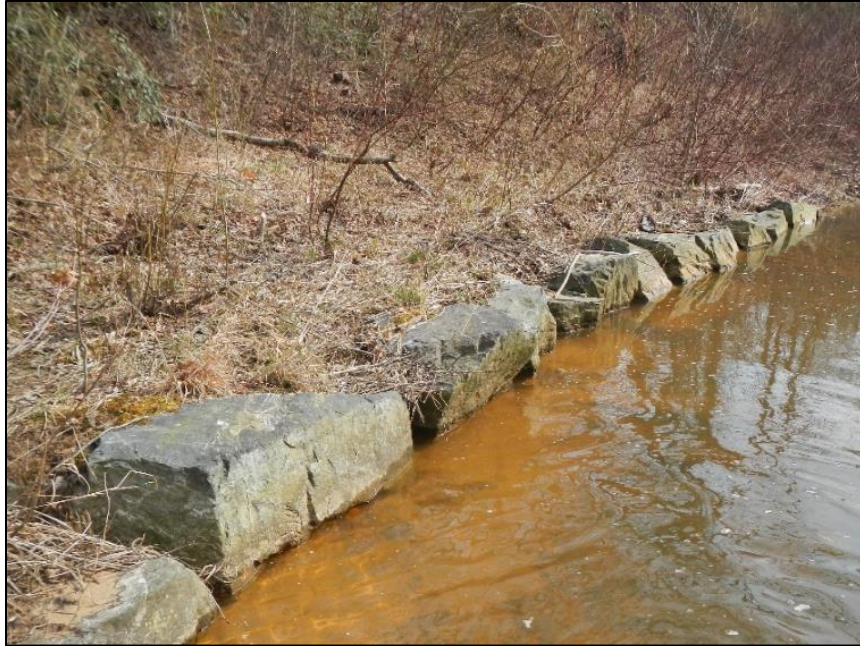
Figure 3.60 Example of stacked rock toe from restoration project 9. Although not visible in this photograph, there is a layer of footers below the stones.

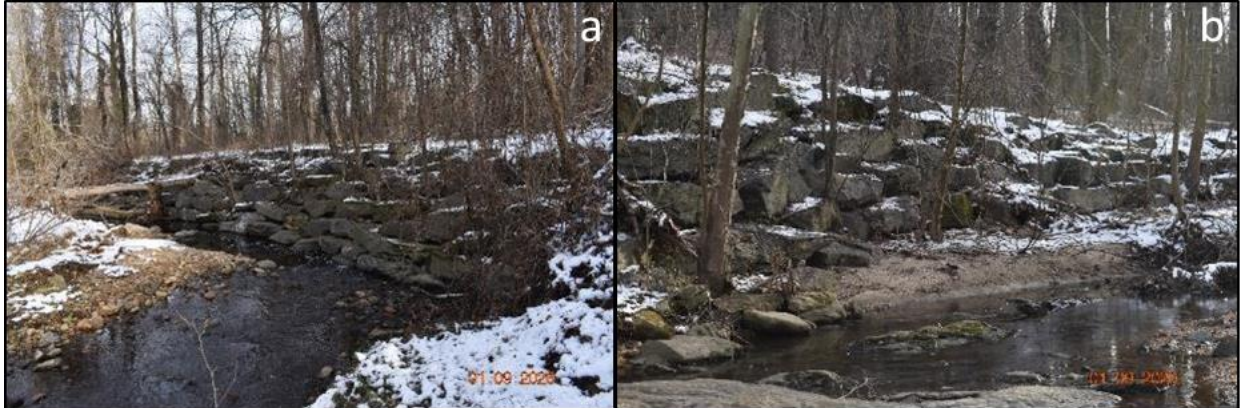
Figure 3.61 Examples of stacked bank protection from restoration project 16.

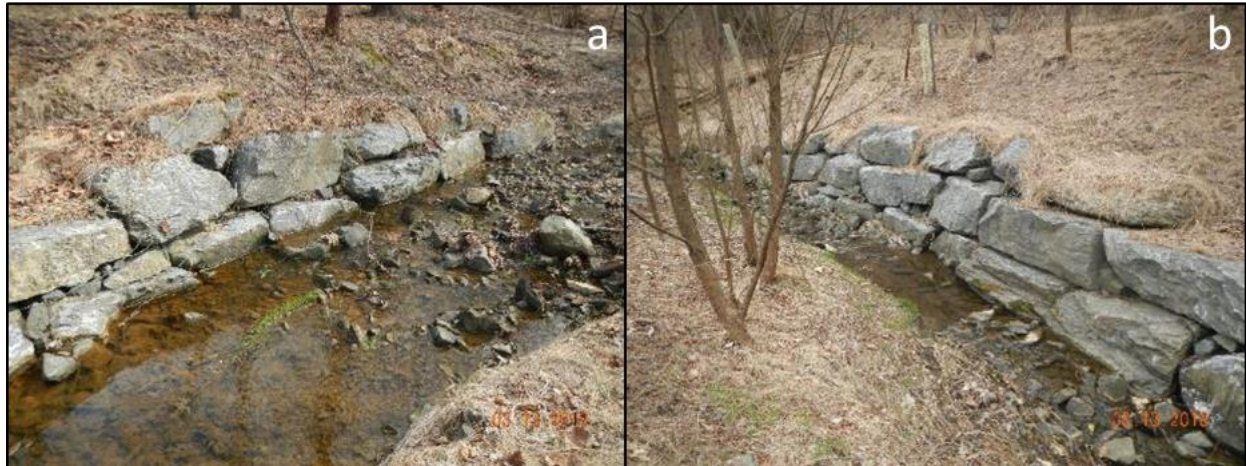
Figure 3.62 Stacked BP from restoration project 3.

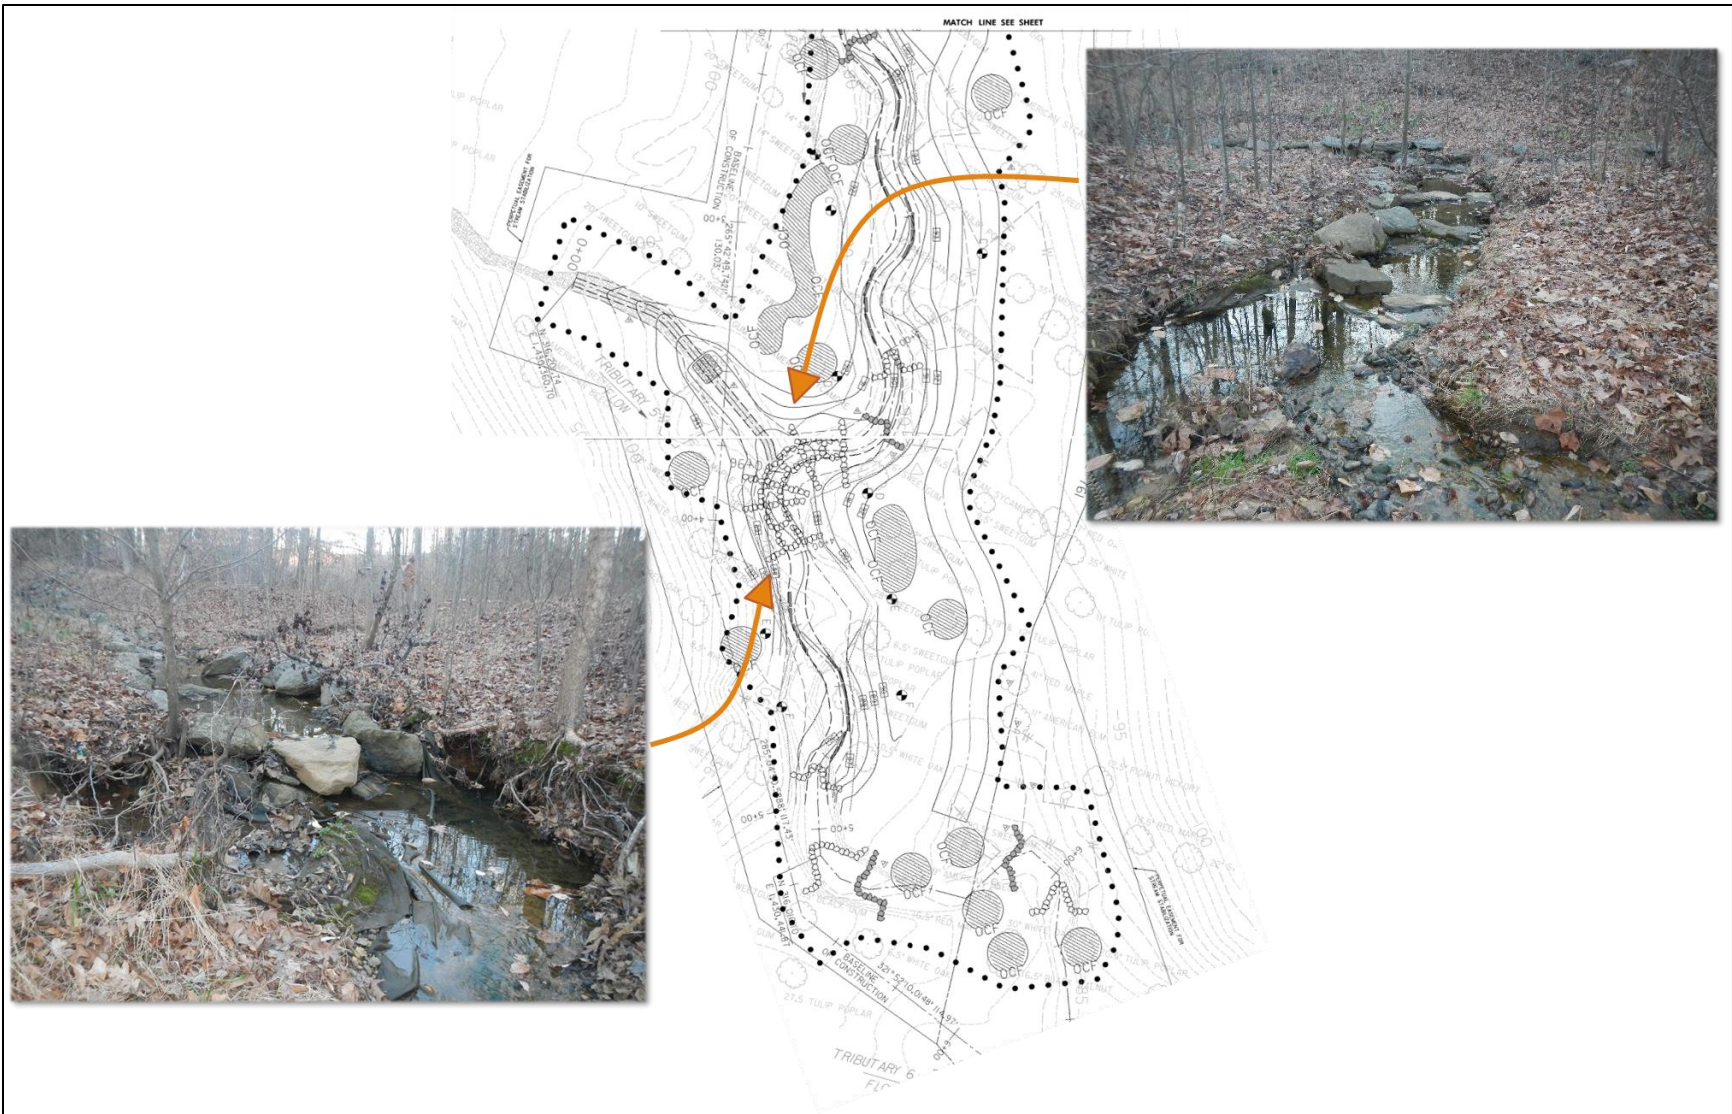
Figure 4.3 Design plan drawings and field pictures of a step pool structure in Project 25. The orange arrows indicate the direction the photographer was facing.

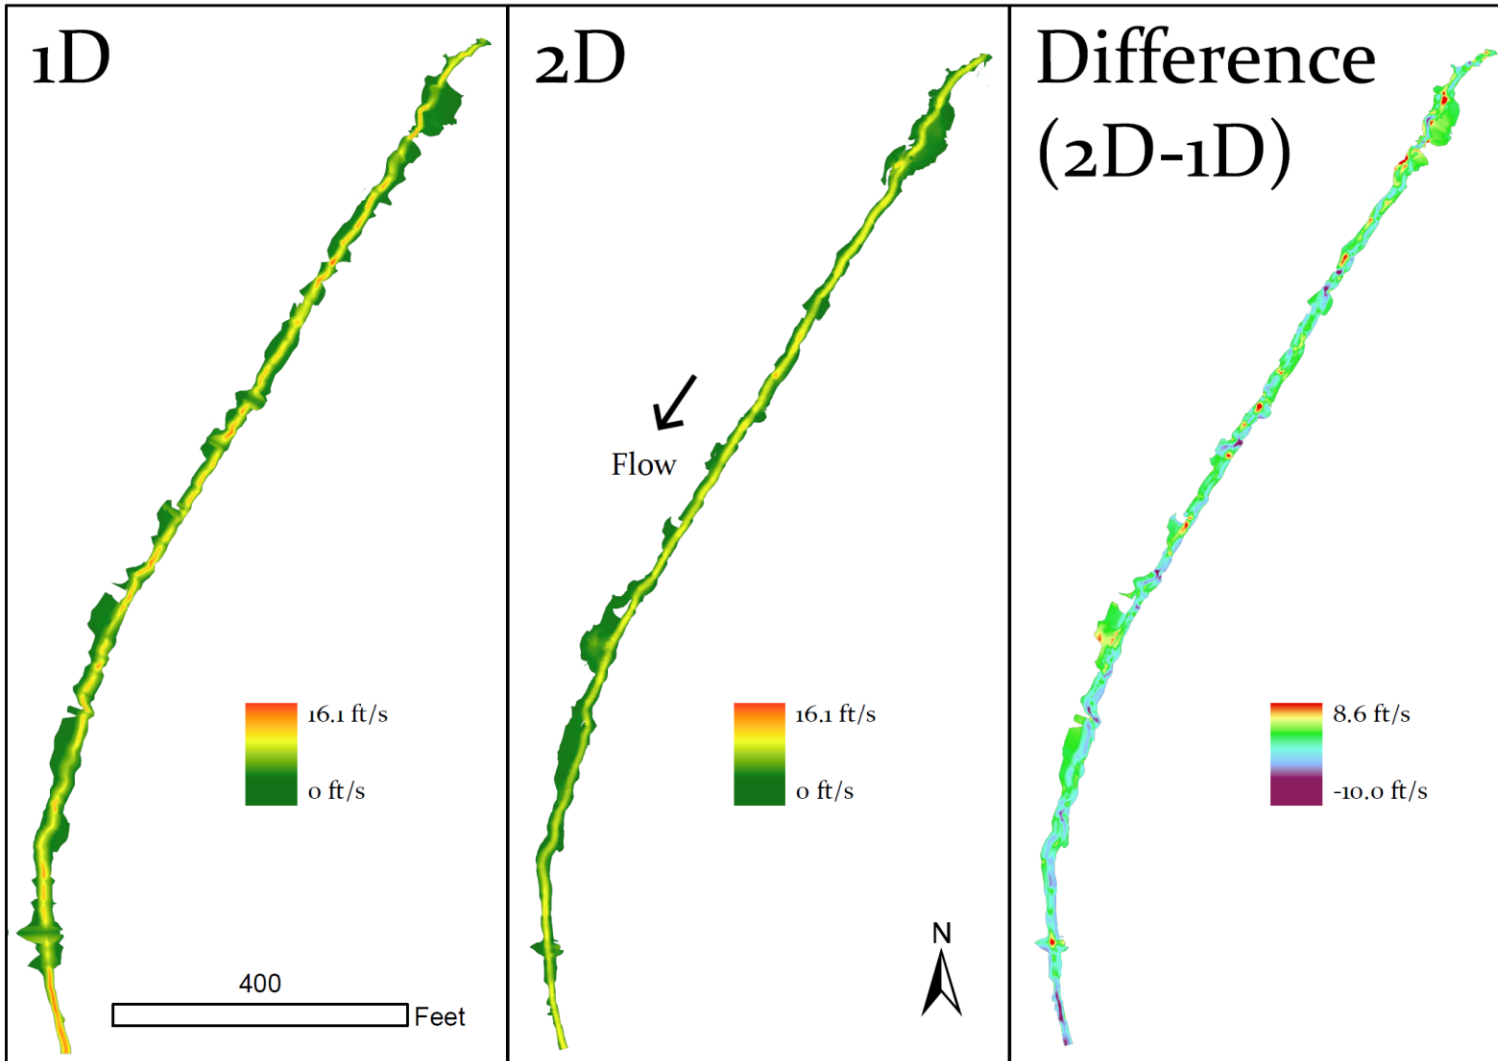
Figure C.19 Velocity for 1D and 2D models for Project 47.
