Experimental Investigations of Residual Strength and Repaired Strength of Corrosion Damaged Prestressed Bridge Beams

Dissertation submitted to the faculty of the Virginia Polytechnic Institute and State University in partial fulfillment of the requirements for the degree of

Keywords: Corrosion Damage, Flexural strength, Prestressed concrete girders, Bridges, Forensic engineering, Residual flexural strength

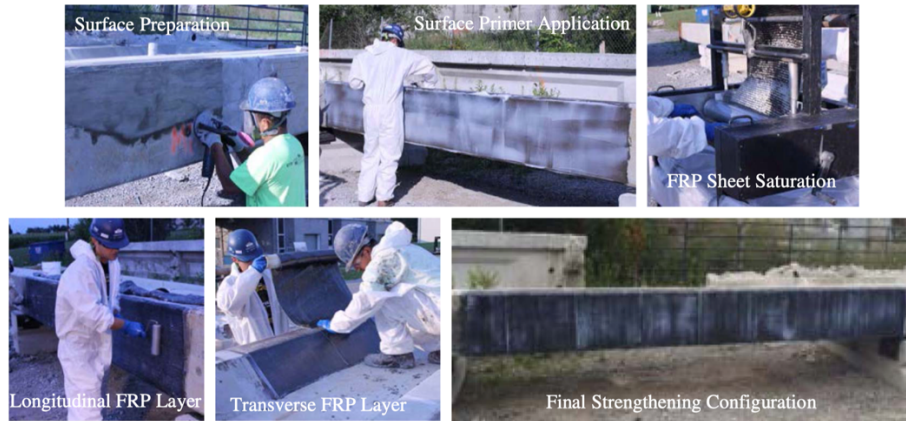
Figure 2.16. Procedure of installing CFRP sheets (Pino et al., 2017)

CFRP sheets and plates were precisely cut to the appropriate dimensions and attached to the beam specimens. After filling the holes approximately halfway with epoxy resin and applying an initial layer of epoxy resin to the surface of the RC beams, the CFRP anchors were inserted into the holes and rolled in the longitudinal direction of the fibers using an air removal roller and by hand to remove any trapped air bubbles and to firmly impregnate the fibers. The CFRP sheet was then applied after a high solids saturant was applied. After allowing the saturant to soak the carbon fiber sheet and embedded CFRP anchors for a period of time, a second application of epoxy resin layer was applied to the top of the CFRP sheet and the splayed CFRP anchor fibers to guarantee that the two components are linked together during curing. Hand rolling was then used to eliminate any trapped air bubbles from the interior. Before testing, the adhesive was cured at room temperature for at least 7 days in the laboratory.

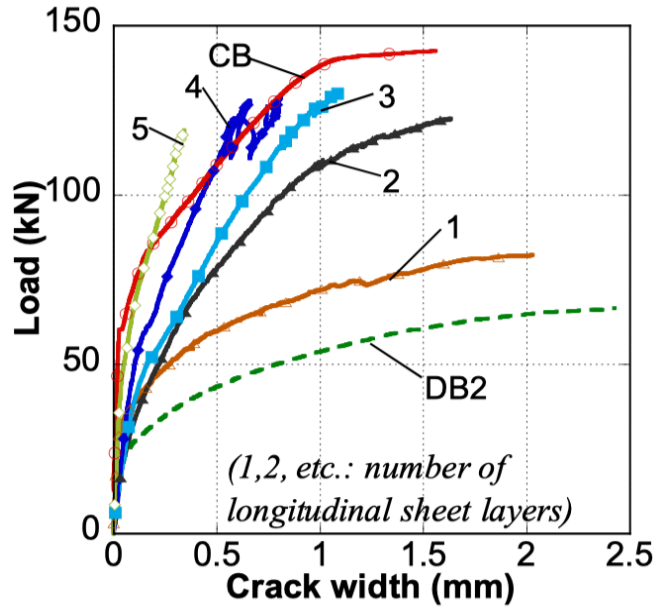
Figure 2.21. Effect of number of layers on flexural crack widths

(Nguyen et al., 2013) tested a total of 12 pretensioned concrete beams. The specimens were divided into three groups. In first group, there were three beams, one with no strands damaged and the other two with 25% and 50% strands damage. In second group, four specimens with 25% loss in the strands were reinforced with one layer of CFRP but with different length along the soffit of the beam (0.3, 0.5 and full beam length). While the third group, consisted of five beams with 50% loss in the stands, which were repaired with different numbers of CFRP layers (1 to 5 layers). Results showed that the length of the sheets increased the stiffness by 10%, but the ultimate loads were not affected by increasing the sheet lengths. However, the cracking load was significantly increased with the increase in number of CFRP layers. Hence, the initial stiffness was enhanced. However, the beam with three CFRP layers recovered strength to 91.5% of the controlling beam's strength. The trend of increasing strength did not continue with the beams that have four and five layers. The ultimate load for the beams strengthened with more than three layers shows a reduction compared to the one repaired with three layers. The debonding of CFRP sheets occurred earlier with these specimens. The cracks at midspan were well restrained and became smaller with the larger number of CFRP sheet layers (see Figure 2.21).

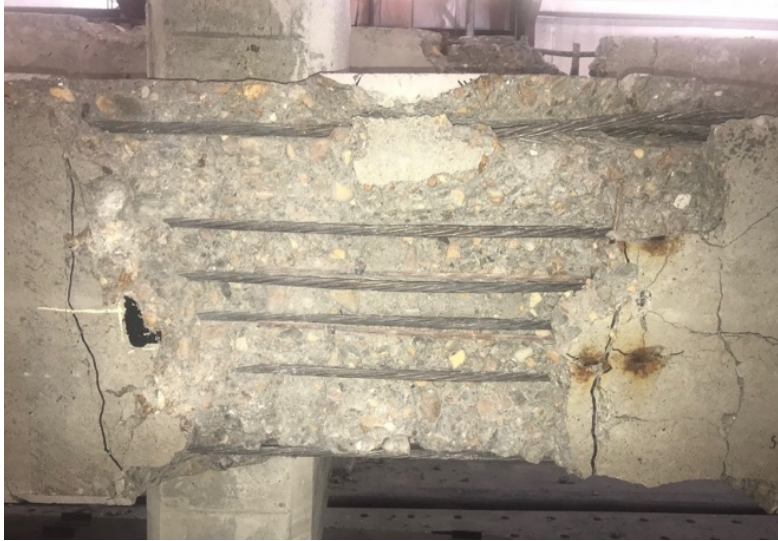
Figure 3.6. Bottom of I-Beam 7 after Testing

After testing, the concrete cover over the bottom strands was chipped to expose the strands. As can be seen in Figure 3.6, all strands were bright and shiny, showing no signs of corrosion.

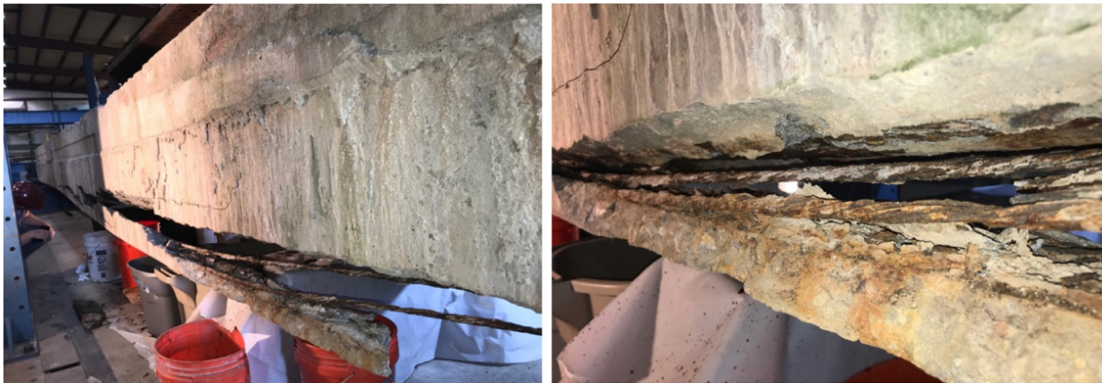
Figure 3.11. Box Beam 3 West Side After Testing

Upon examination after the test, strands along east side did not show significant corrosion, but the strands had yielded. The strands on the west side were heavily corroded (see Figure 3.11). The edge strands in the lowest level had severe corrosion, possibly exacerbated by the water that had been trapped in the beam. After the bottom concrete cover had spalled off, it was apparent that the three outermost bottom layer strands were severely corroded.

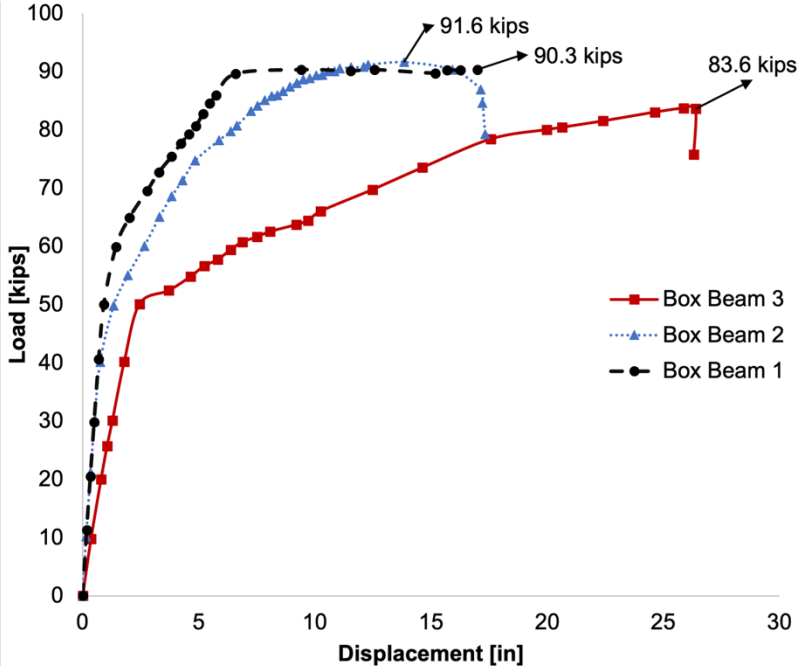
Figure 3.12. Load versus Displacement Plot for All Box Beams

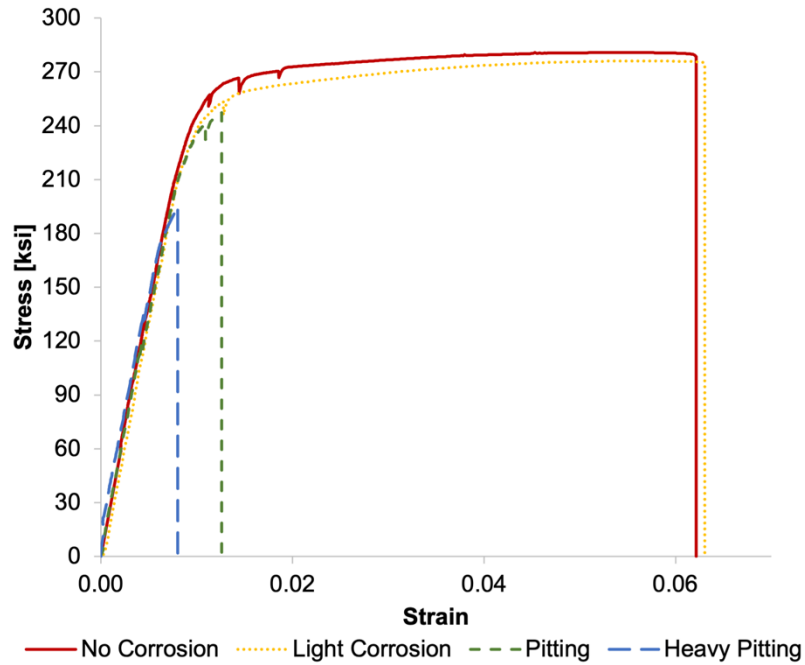
Figure 3.17. Stress-Strain Curves of Prestressing Strand with Various Levels of Damage

This section provides a guidance to estimate the flexural strength by limiting the strain at the bottom most layer. When the layer of strands reaches this limiting strain, it is assumed that the most damaged strand will rupture. Based on a study conducted by Alfaiakawi et al., (2022) the condition of the most damaged strands and its corresponding strain can be obtained from the visual inspection (see Figure 3.17). Therefore, neutral axis location, strain at the top and moment capacity can be calculated. After that, the most damaged strands will be eliminated, and a new sectional analysis is performed to estimate the flexural strength based on crushing failure. If the flexural strength determined by strand rupture is greater than the flexural strength determined by concrete crushing, then the flexural strength determined by strand rupture will be the maximum flexural strength; otherwise, the flexural strength determined by concrete crushing will be the maximum flexural strength.

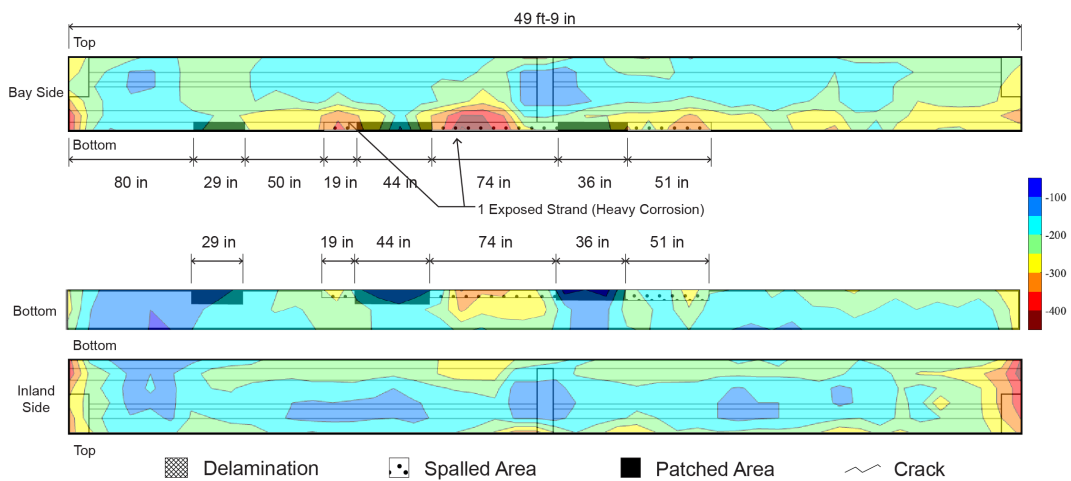
Figure 4.3. Heat Map for Half-Cell - I-Beam 5 (in millivolts)

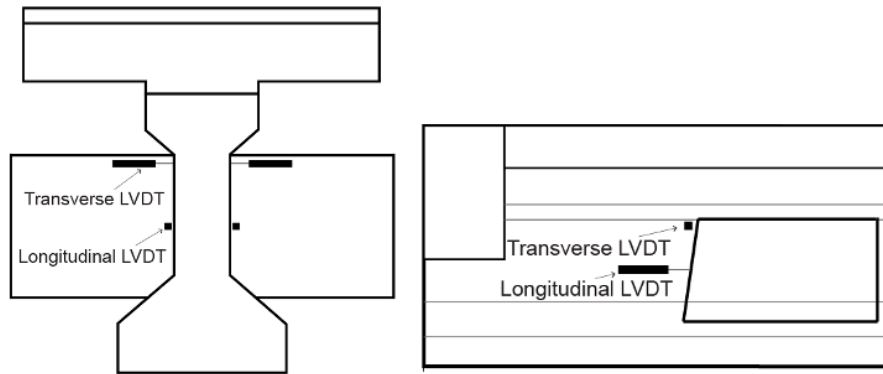
Figure 4.9. Locations of the LVDTs Behind the Anchor Blocks

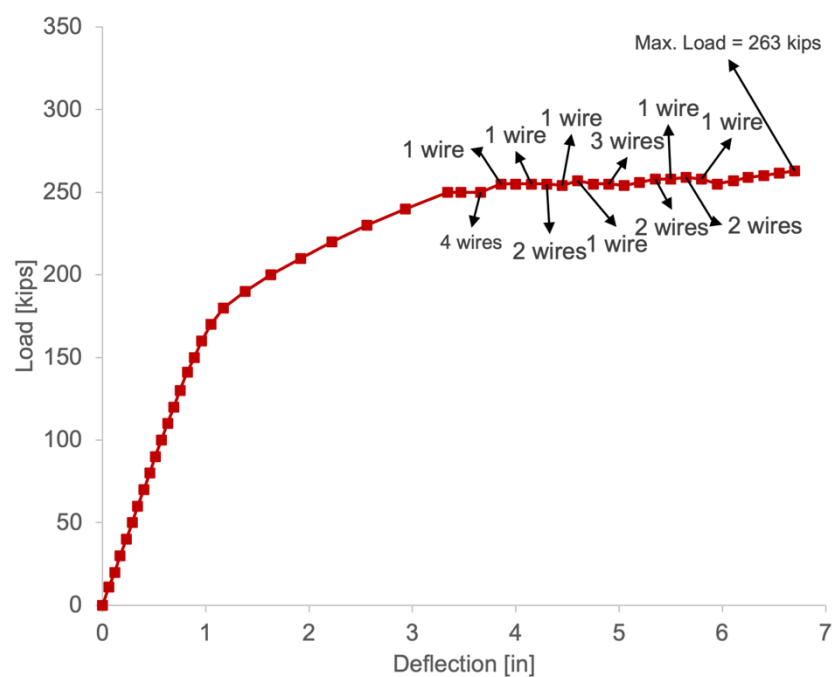
Figure 4.11. Load vs Deflection - I-Beam 1 - Repaired with Eternal PT – Wax

For this test, the beam was loaded in increments of 10 kips until the load reached 250 kips, at which point a displacement control was employed. During the loading process, the concrete ahead of the anchor block on the inland side at the live end began to crack, with shear cracks directed toward the load at 150 kips. At 160 kips, the first flexural crack formed, as indicated by the change in slope of the load-deflection plot (see Figure 4.11).

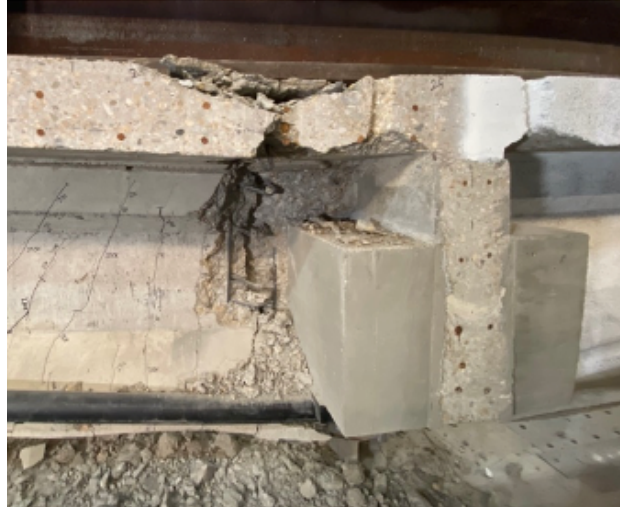
Figure 4.13. Concrete Crushing at the Top of the Beam – I-Beam 1 - Repaired with External PT – Wax

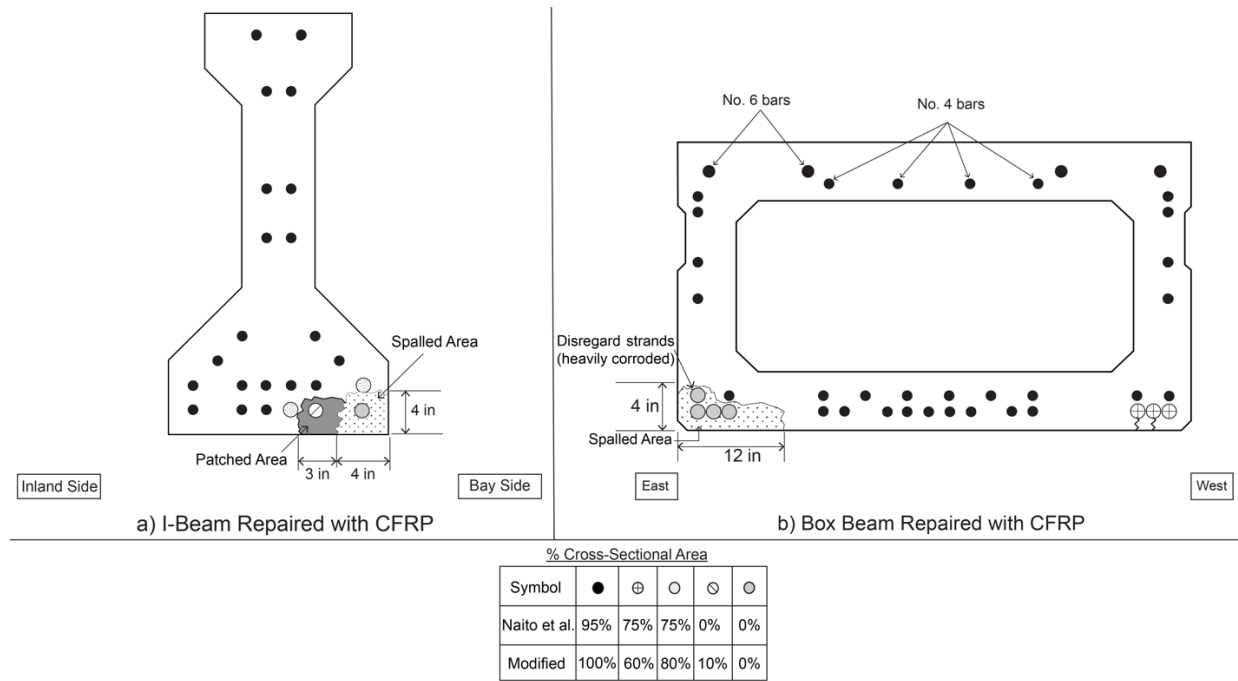
Figure 5.8. Beams Repaired with CFRP

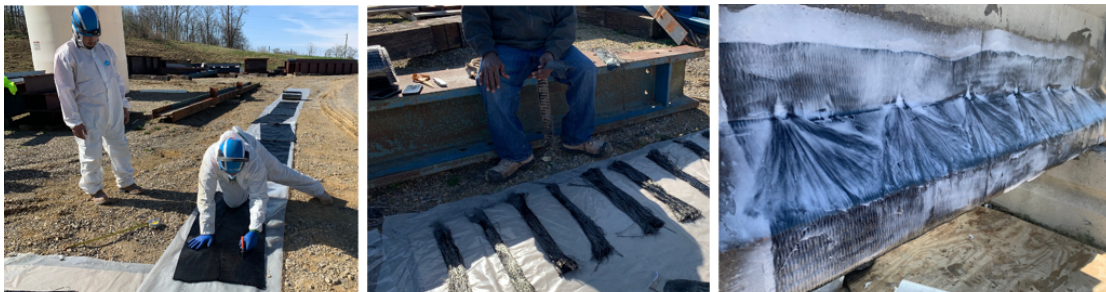
Figure 5.11. CFRP Installation on I- Beams

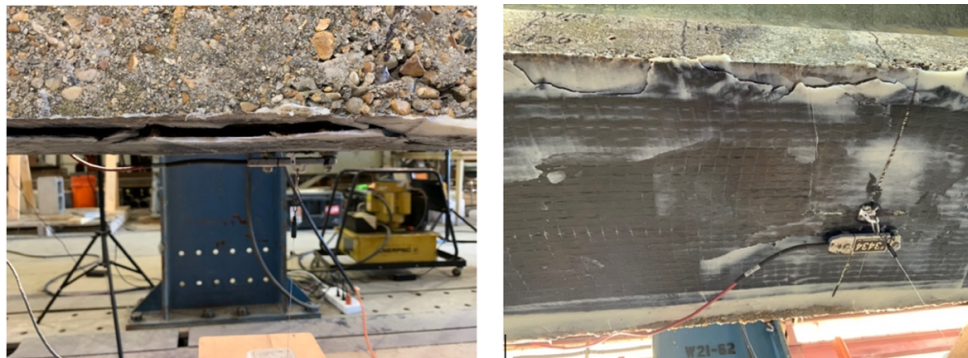
Figure 5.14. CFRP Debonded from the Soffit of the HRBT Beam

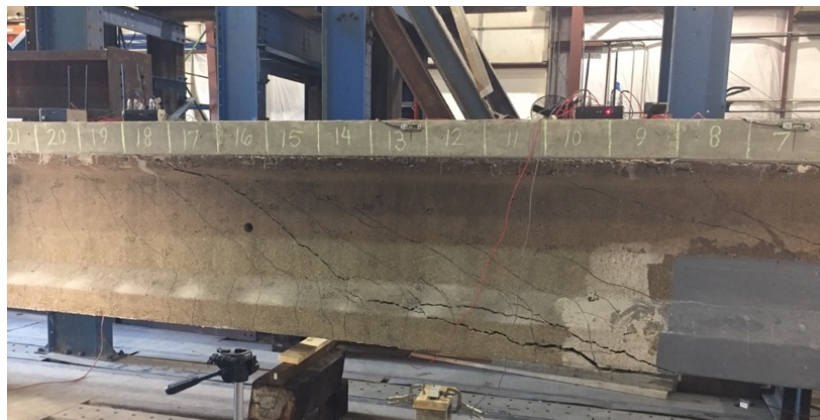
Figure 5.15. Flexural Shear Failure of the HRBT Beam Repaired with CFRP

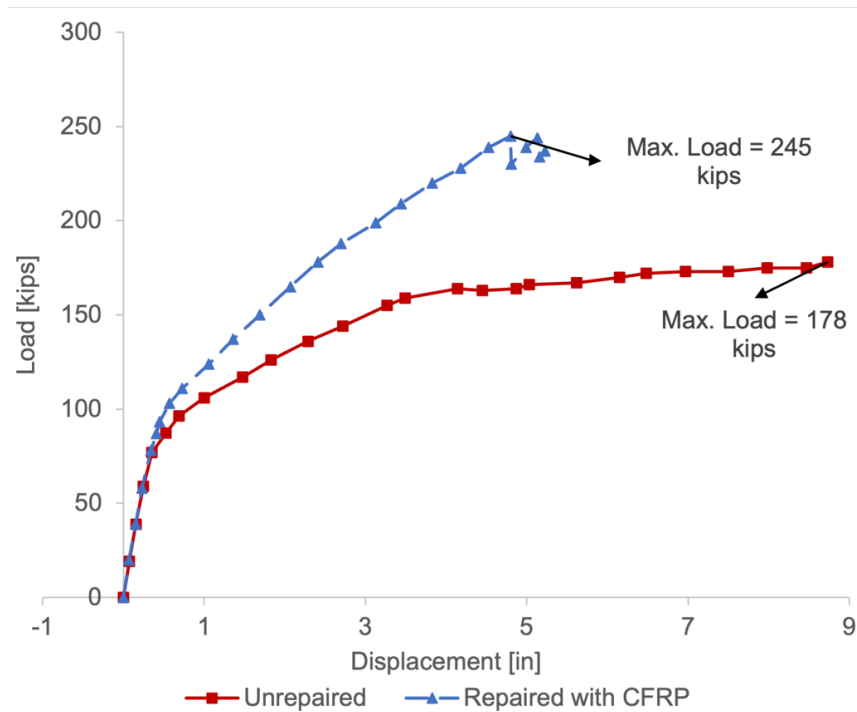
Figure 5.16. Load vs Deflection - HRBT Beams

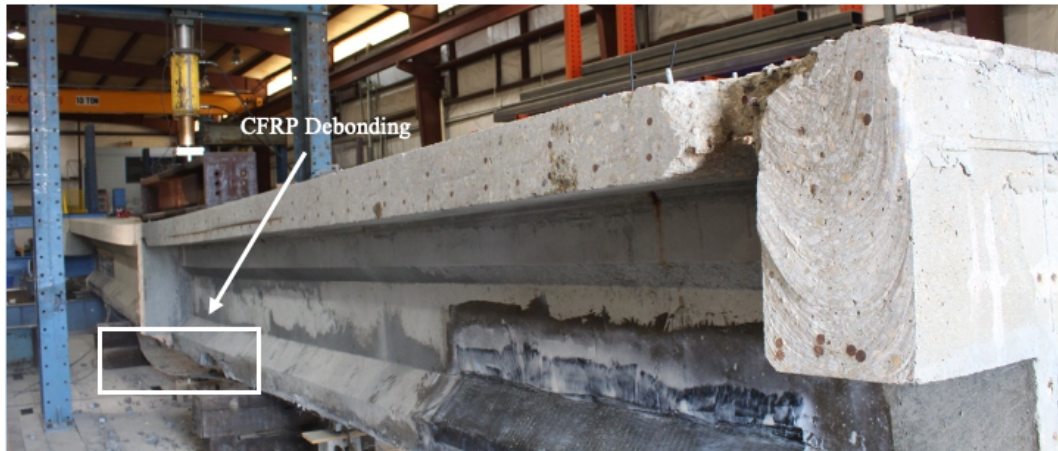
Figure 5.18. CFRP Debonded

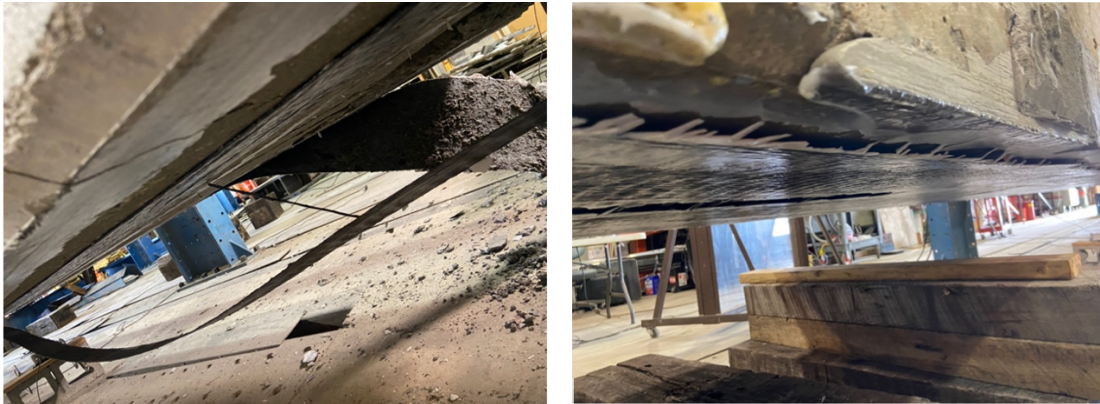
Figure 5.22. CFRP Debonded and Ruptured on Bottom of Box Beam
