# **SHEAR STRENGTH ASSESSMENT OF CORROSION-DAMAGED PRESTRESSED CONCRETE GIRDERS**

Thesis submitted to the faculty of the Virginia Polytechnic Institute and State University  
in partial fulfillment of the requirements for the degree of

Civil Engineering

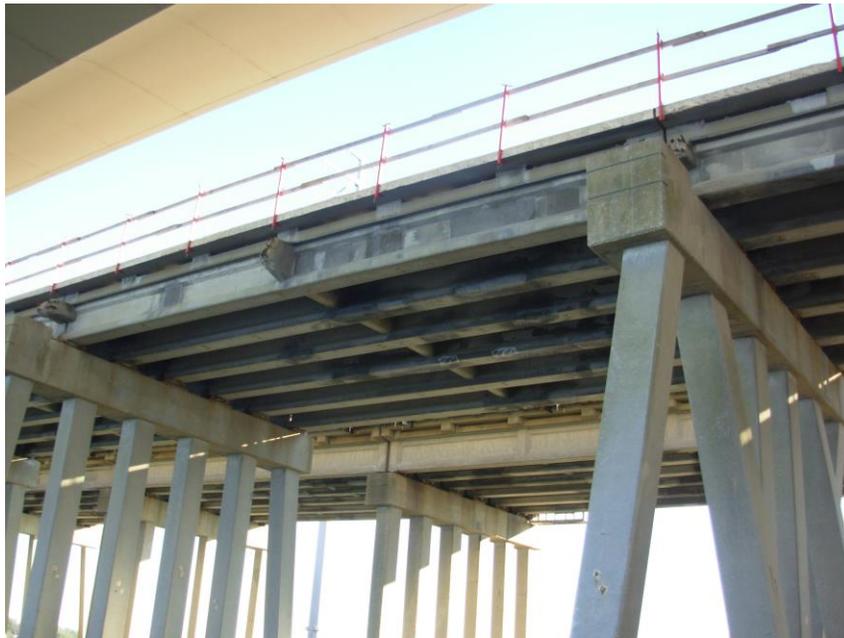
**Figure 1 Deterioration in the Lesner Bridge (Alfailakawi et al., 2020)**

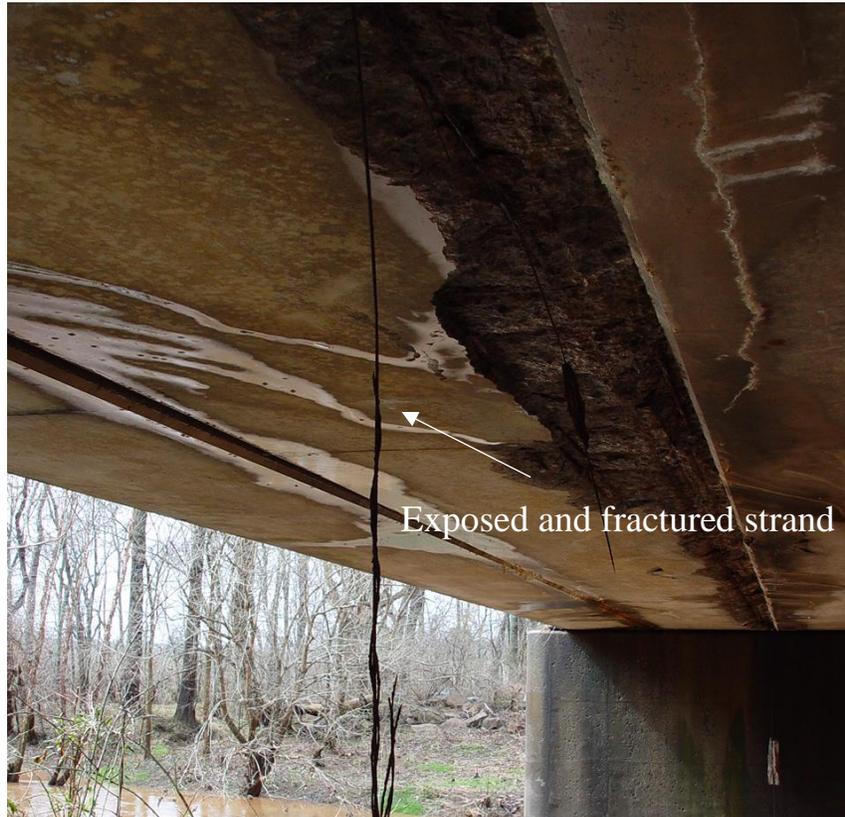
**Figure 2 Deterioration in the Aden Bridge (Alfailakawi et al., 2020)**

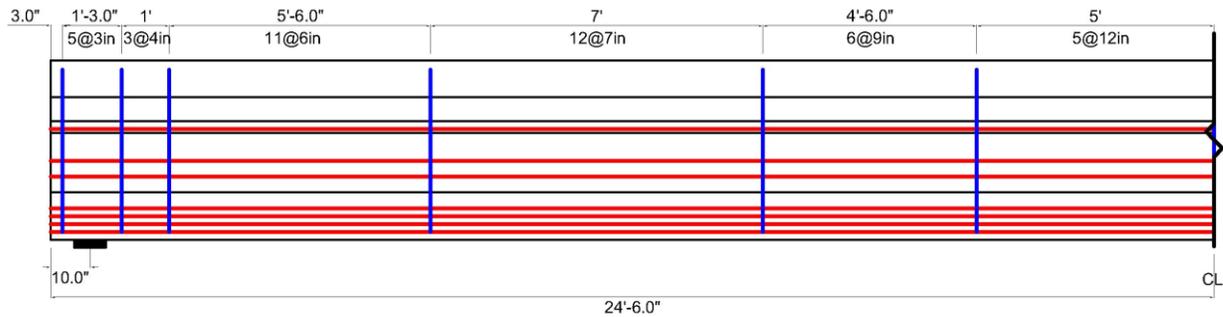
The shear reinforcement of the Lesner girders consists of two No. 4 bars spaced as shown in Figure 3. The yield stress of stirrups was missing in the bridge plans. However, 40 ksi was assumed for preliminary calculations as it was the commonly used grade for reinforcing bars at that time. Figure 4 shows the cross section of a Lesner Bridge girder.

**Figure 3 Longitudinal section of the Lesner girder**

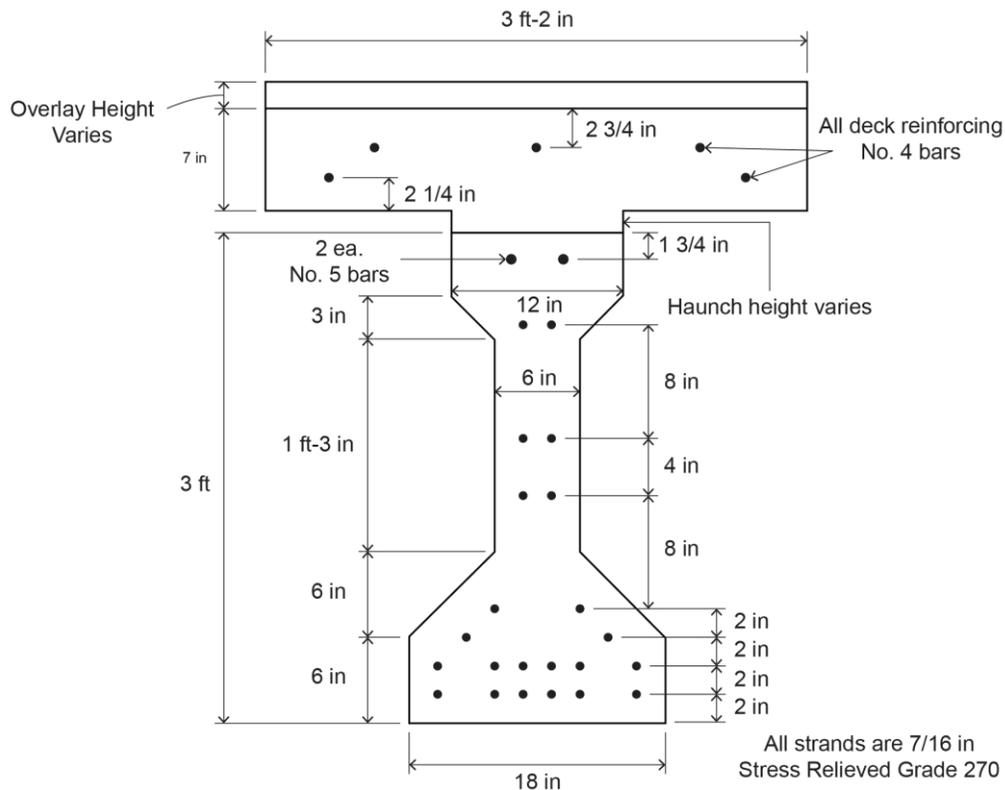
**Figure 4 Cross-section of the Lesner girder (Alfailakawi, 2020)**

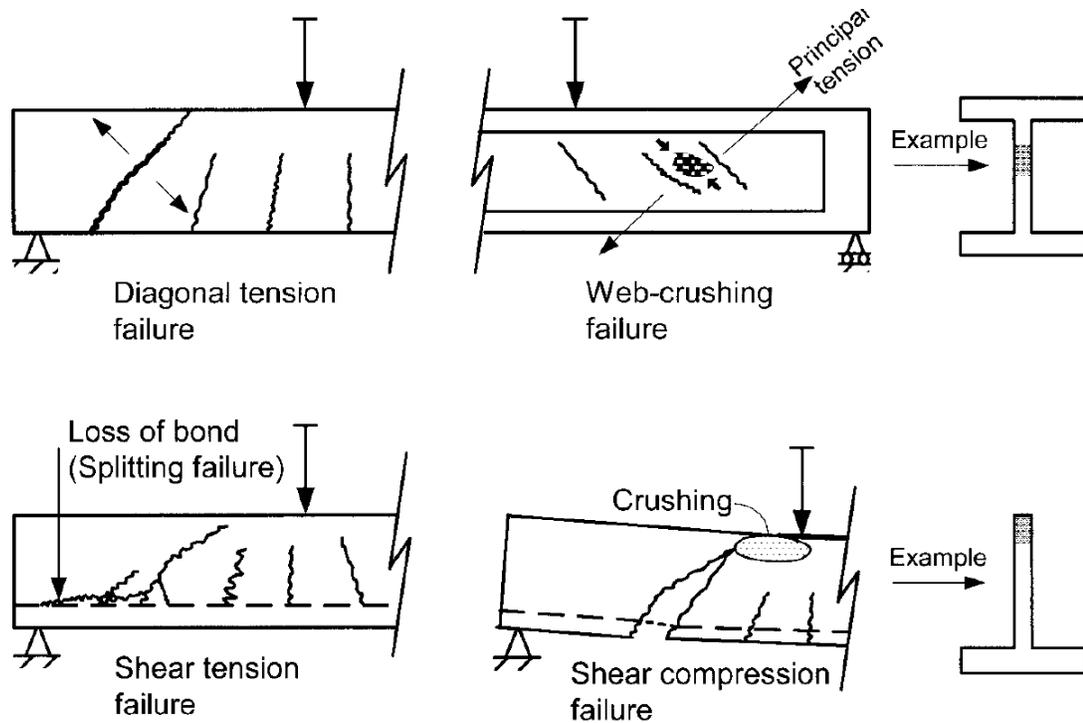
**Figure 7 Major shear failure modes (Naaman, 2012)**

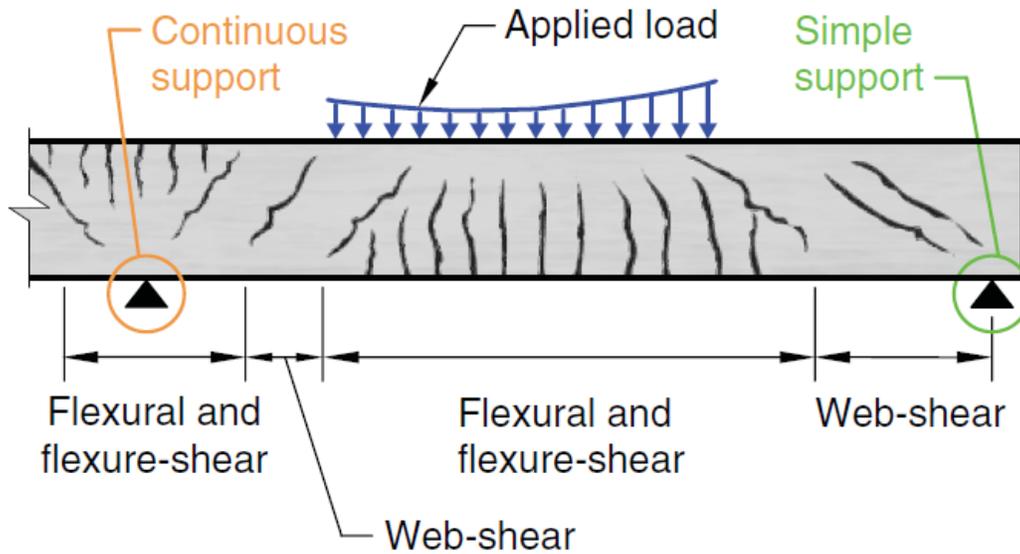
Two types of shear cracks form in beams subjected to vertical loadings. The first type is the web-shear crack. This crack initiates in the web and is formed when the diagonal tension caused by shear exceeds the cracking strength. Therefore, this type of cracks usually observed near the ends and inflection points of beams, where the shear force is high and the moment is low, with thin webs and high level of prestressing force. The second type of shear-related cracks is the flexural-shear crack. This crack occurs due to both flexure and shear. It initiates as a flexural crack in the tension side; then it transforms into an inclined crack propagating towards the applied load. When the flexural crack occurs, the shear stresses, and diagonal tension, increase at the tip of the crack due to redistribution of stresses, which transforms the crack into a flexural-shear crack. It is also important to mention that the shear cracks in prestressed concrete beams are generally shallower when compared to those of non-prestressed concrete beams. Figure 8 illustrates the shear-related cracks in concrete beams.

Figure 8 cracks in beams (from ACI318-19)

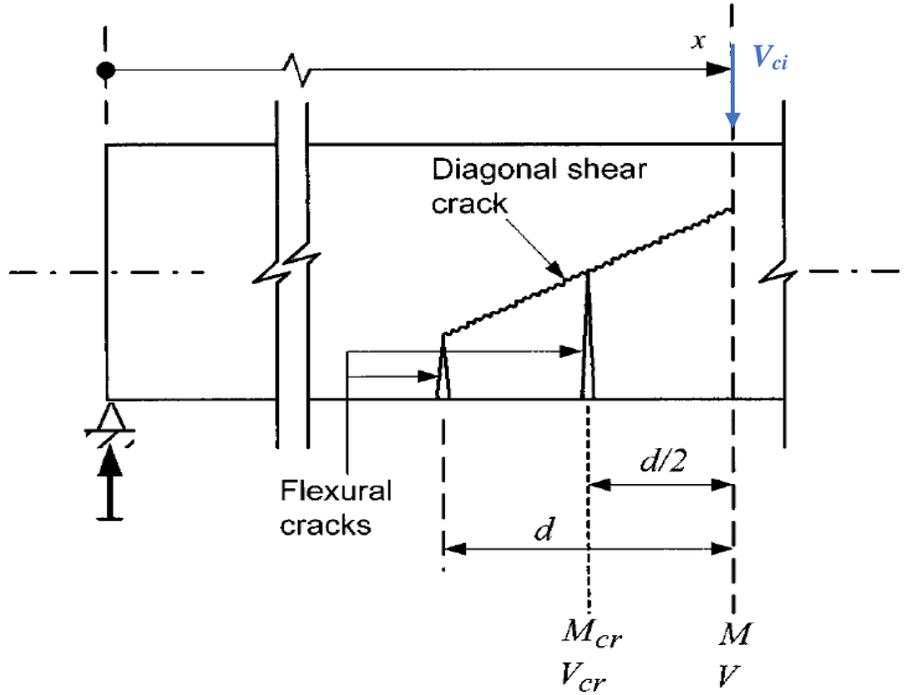
Tests have shown that the shear failure is triggered by a critical flexural-shear crack that has a horizontal projection of at least  $d$  from the critical section X. After the first flexural crack is formed at  $d$  from the section X, failure will be impending when another flexural crack forms at  $d/2$  from the section X. Finally, an additional increment of shear is required to transform the flexural crack into a flexural-shear one. Therefore,  $V_{ci}$  can be calculated as the sum of the pre-existing dead-load shear, the external-load shear at the instance of the second flexural crack located at  $d/2$  from the section under consideration, X, and an additional increment of shear required to develop a diagonal shear crack. Figure 10 illustrates the idealized critical flexural-shear crack, where  $V_{cr}$  and  $M_{cr}$  are the shear and moment at  $d/2$  from the section X when the second flexural crack develops;  $V$  and  $M$  are the shear and moment at the section X when the second flexural crack develops.

**Figure 10 Idealization of the critical flexural-shear crack (Naaman, 2012)**

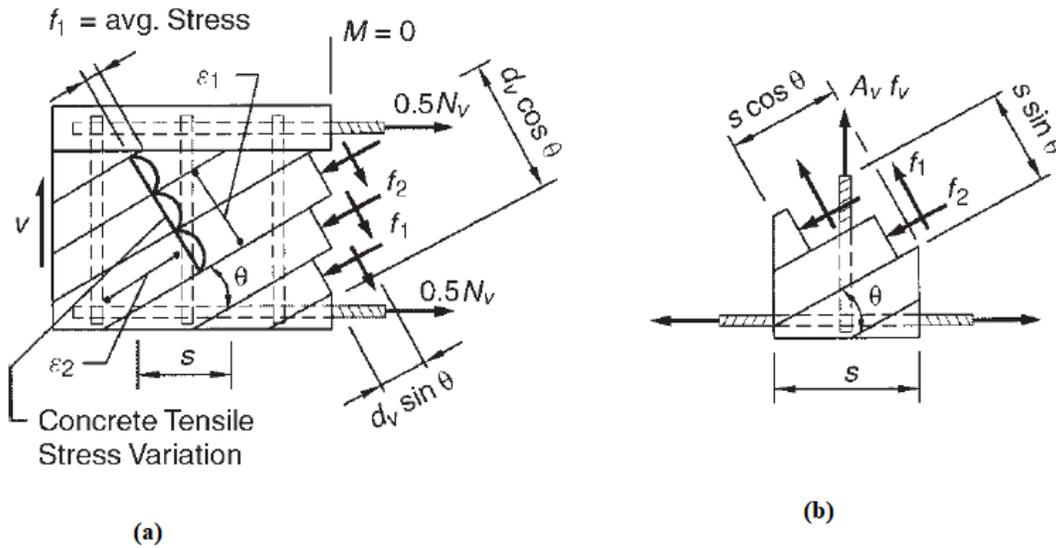
**Figure 11 (a) stresses in diagonally cracked reinforced concrete. (b) stresses in web reinforcement (Barker & Puckett, 2013)**

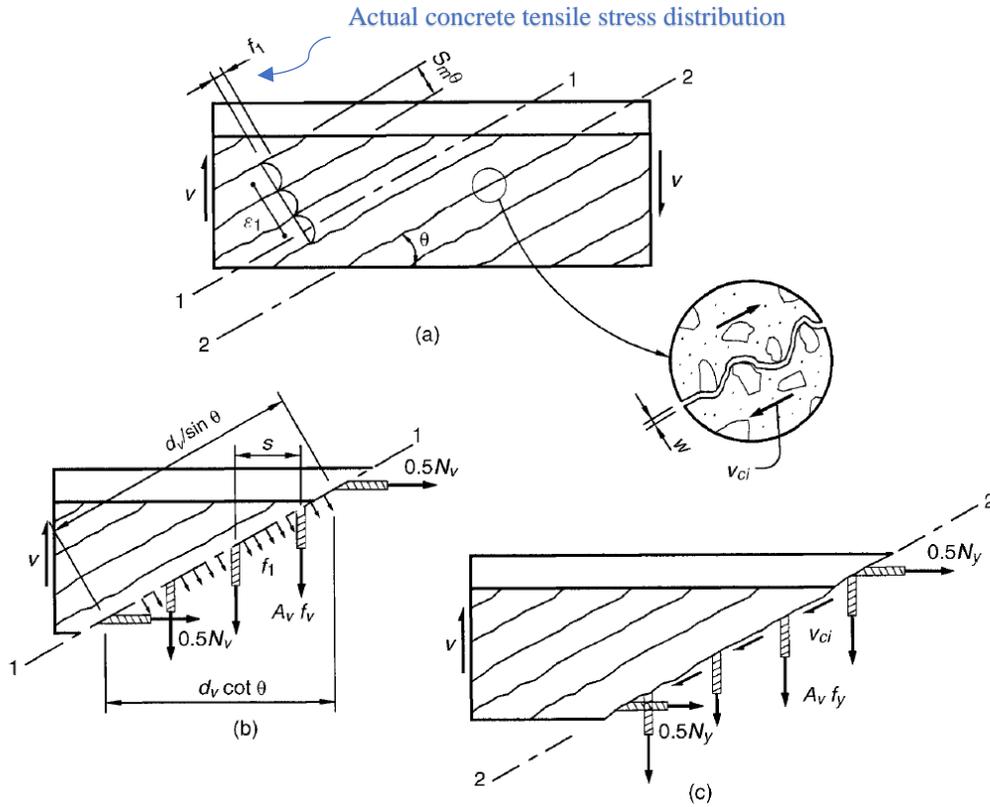
As the crack becomes wider and wider, at a crack location, the tensile stresses in the reinforcement becomes higher, until reaching the yield stress, while the tensile stresses in the concrete drop to zero. However, the concrete tensile stresses build up again due to bond as we move towards a plane that is parallel but away from crack surfaces, Figure 12 (a). At a crack location, the concrete carries only shear stresses provided by aggregate interlock and a small amount of local compressive stresses that can be neglected (Vecchio & Collins, 1986). Figure 12 demonstrates the stresses between and at diagonal cracks.

**Figure 12 Stresses in a cracked reinforced concrete web. (a) cracked web. (b) stresses between cracks. (c) stresses at a crack. (Barker & Puckett, 2013)**

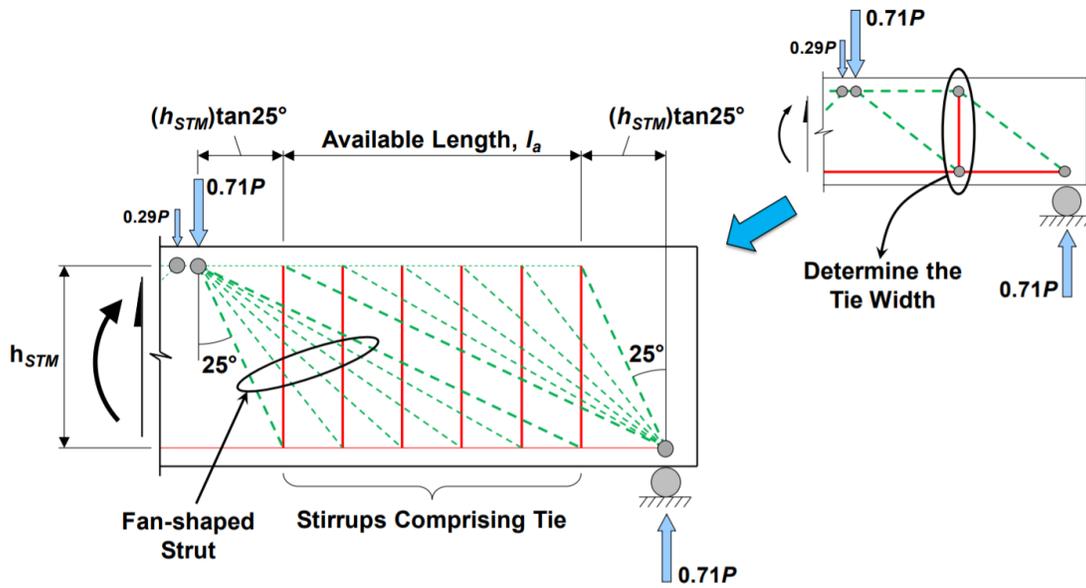
Proportioning of a horizontal tie is clear. However, vertical tie proportioning needs further explanation. Vertical tie forces are resisted by the transverse reinforcement, usually in the form of stirrups; sometimes they are made of a transverse prestressing tendon. Generally, vertical ties connect two smeared nodes. Therefore, it is not so clear how to select the width of a vertical tie. Wight and Parra-Montesinos (2003) suggested a technique to estimate the width of a vertical tie. It is based on the assumption that struts spread in a fan-like shape with an angle of no less than 25 degrees of the vertical axis. Therefore, stirrups engaged in carrying the load are those that are spread over a band bounded by the two 25-degree-inclined lines. Transverse reinforcement is to be lumped at the centroid of the vertical tie as shown in Figure 20 (Williams et al., 2011).

Figure 20 Proportioning of a vertical tie joining two smeared nodes based on Wight and Parra-Montesinos (2003). (Williams et al., 2011)

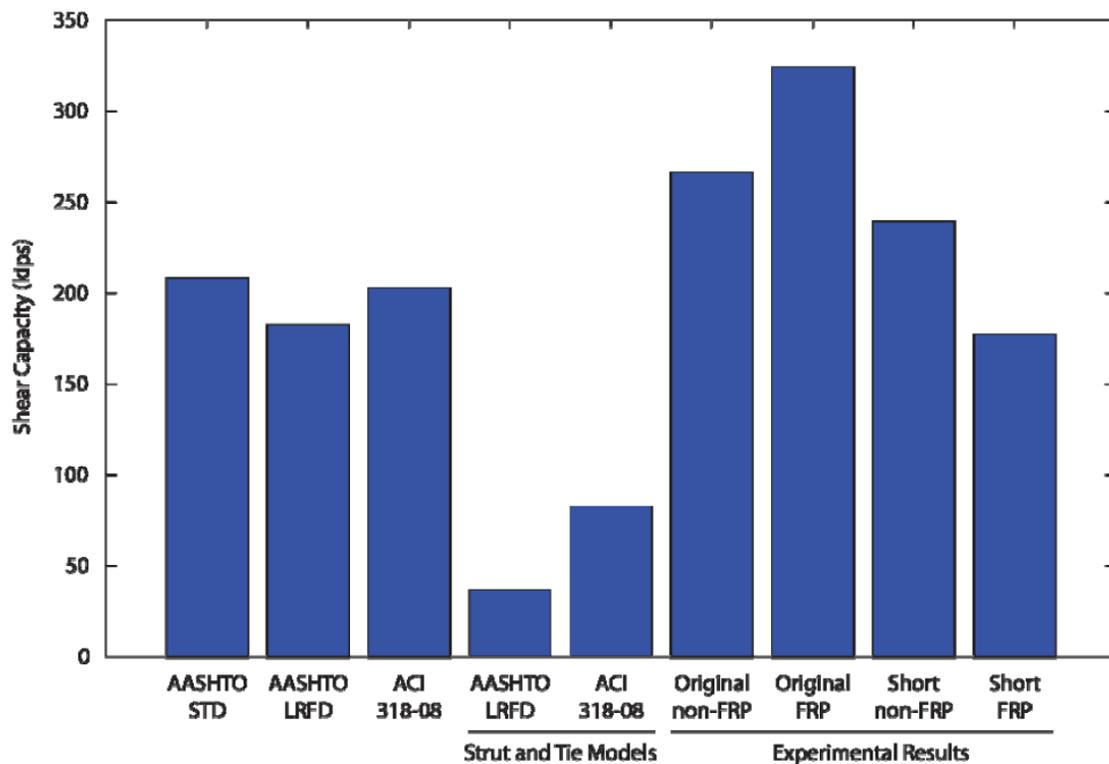
According to this study, the sectional design methods for shear showed consistent predicted strengths, except the STM which was very conservative. This was due to the limited anchorage for strands. However, tests showed higher experimental shear strengths than what was predicted by the various code provisions including the STM with a wide safety margin. Pei et al. (2008) concluded that these bridges were adequate in terms of shear capacity according to the AASHTO and the ACI codes. The reported results for the I-244 Bridge girder is shown in Figure 22 (Pei et al., 2008). It should be recalled that the ‘Short FRP’ in the figure is the one failed in flexure.

Figure 22 Results from Pei et al. (2008)

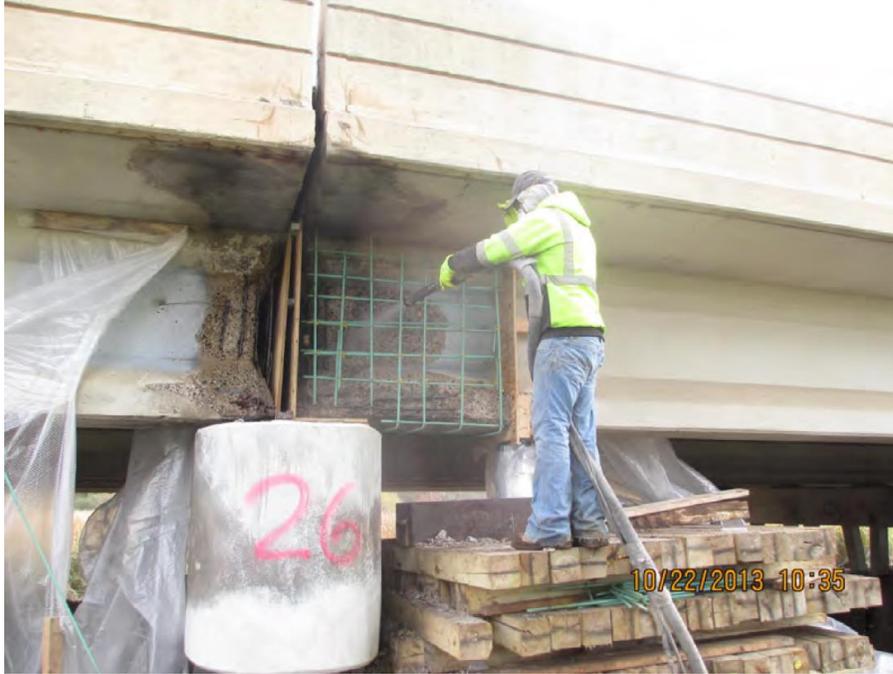
**Figure 23 Rehabilitation technique used in Shield et al. (2018) (Shield et al., 2018)**

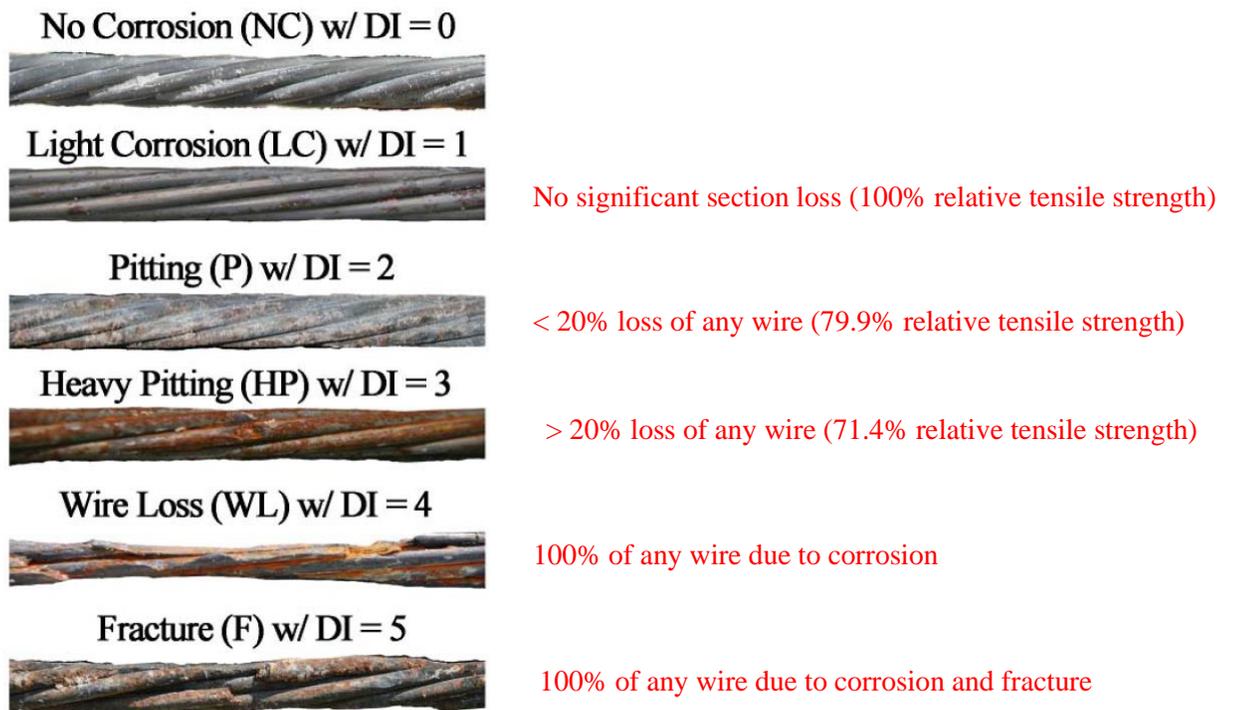
The investigation included inspecting all types of deterioration such as spalling, delamination, longitudinal cracks and exposed strands, half-cell potential and material tests were performed. In addition, strands were exposed and each level of corrosion in strands was given an index based on the sectional loss as illustrated in Figure 24.

Figure 24 Strand damage condition (Naito et al., 2011)

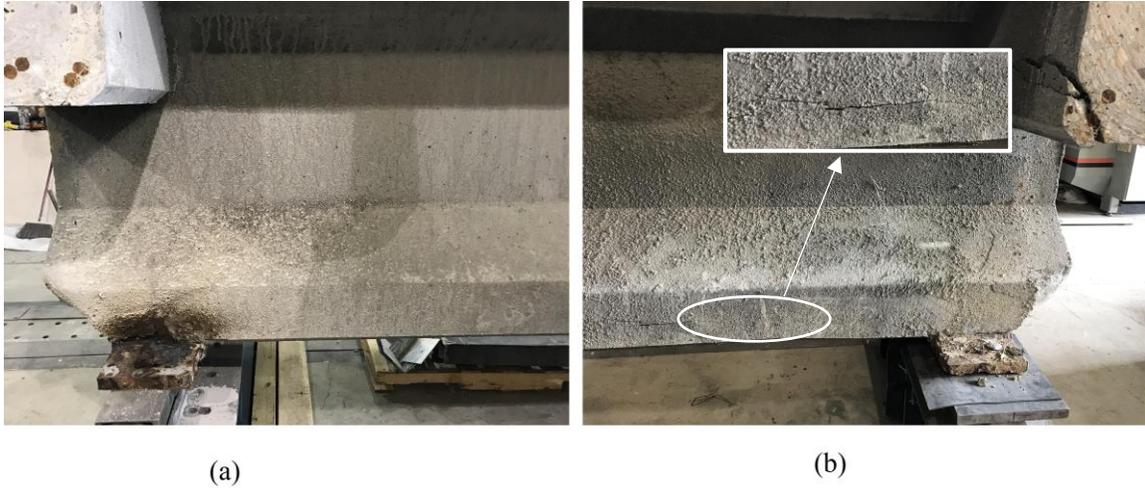
evidence of any pre-existing damage. In Figure 25 (b), a longitudinal crack with concrete delamination present in the bottom flange as highlighted. This crack indicates that the outer strands in the bottom flange have some level of corrosion damage.

**Figure 25 Lesner girder end regions. (a) Undamaged end. (b) Damaged end with longitudinal crack and delamination**

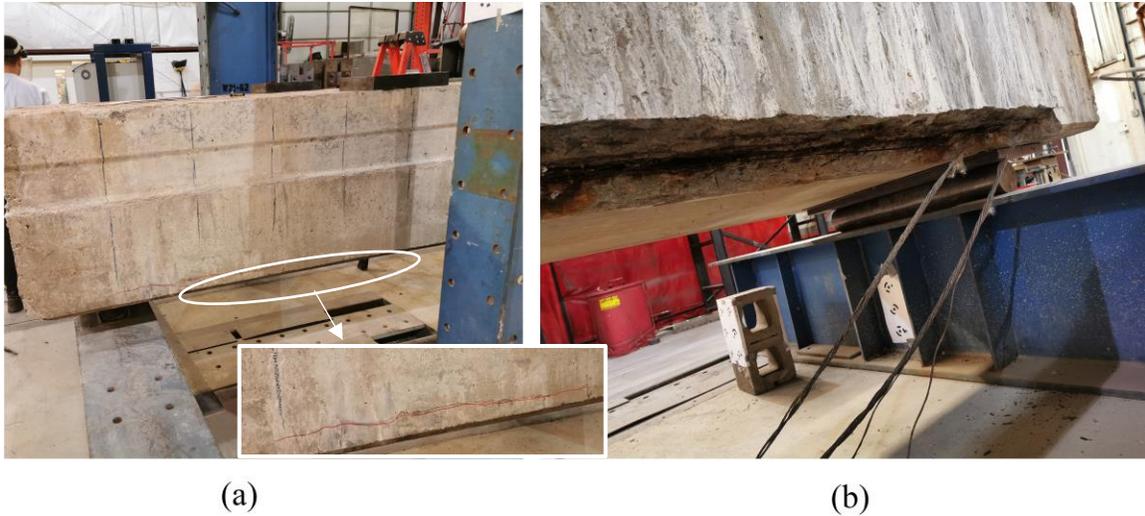
Obviously, the Aden girder had a heavier level of corrosion damage. Figure 26 (a) shows the first tested end of the Aden girder with less pre-existing damage manifested by a longitudinal crack as highlighted. In addition, three outer cracks were present beneath the girder at this end. Figure 26 (b), shows a significant section loss with four completely exposed strands in severe condition. In addition, an outer crack and another section loss with five exposed strands were present beneath the girder at a distance of 73 in. from the more damaged end.

**Figure 26 Aden girder end regions. (a) Less damaged end. (b) More damaged end with section loss and exposed strands**

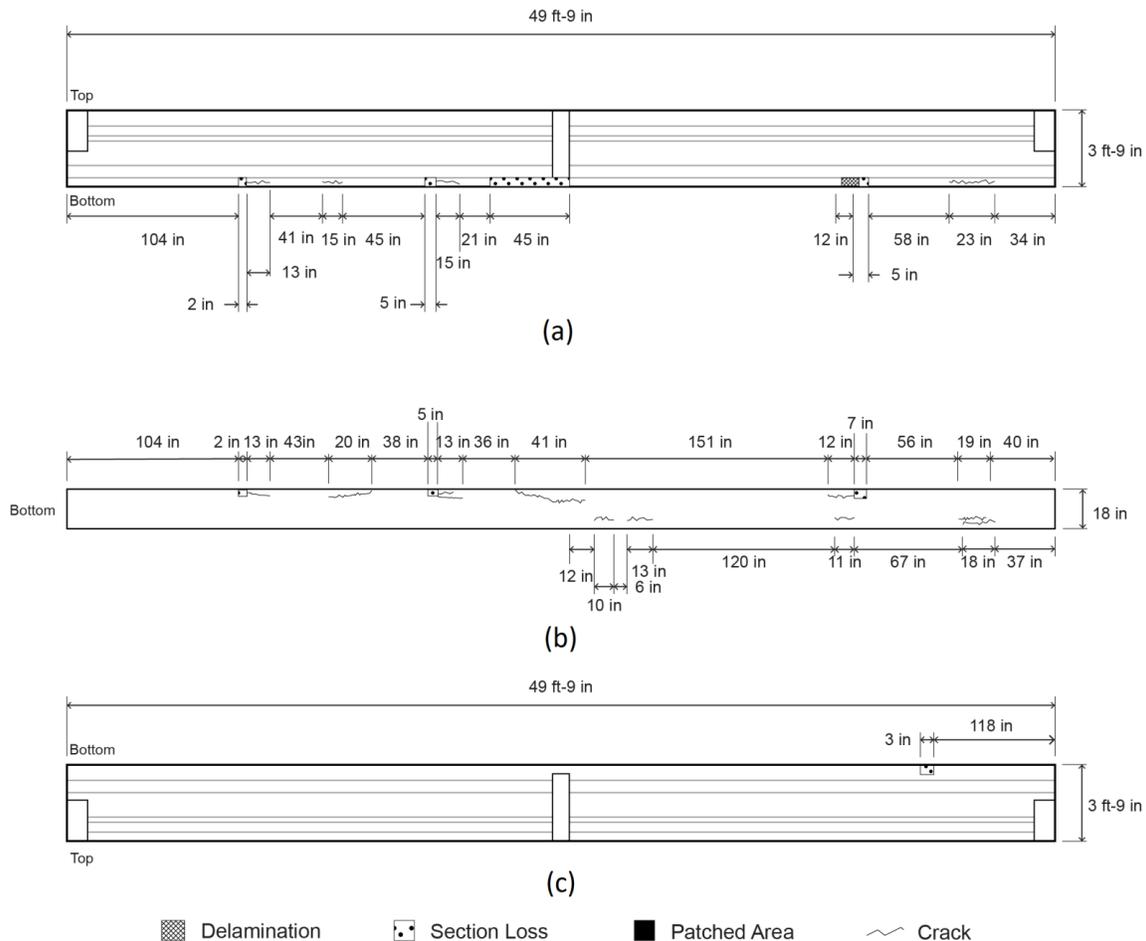
losses, one major section loss is present near the middle of the girder. All these defects were formed in the bottom flange of the girder. The bottom of the girder contained three outer section losses that were extensions from the bay side section losses, and ten longitudinal cracks with lengths varying from 10 in. to 41 in. Figure 27 shows a detailed damage map of the Lesner girder from the bottom and both sides.

**Figure 27 Damage map for Lesner girder. (a) Bay side. (b) Bottom. (c) Inland side.**

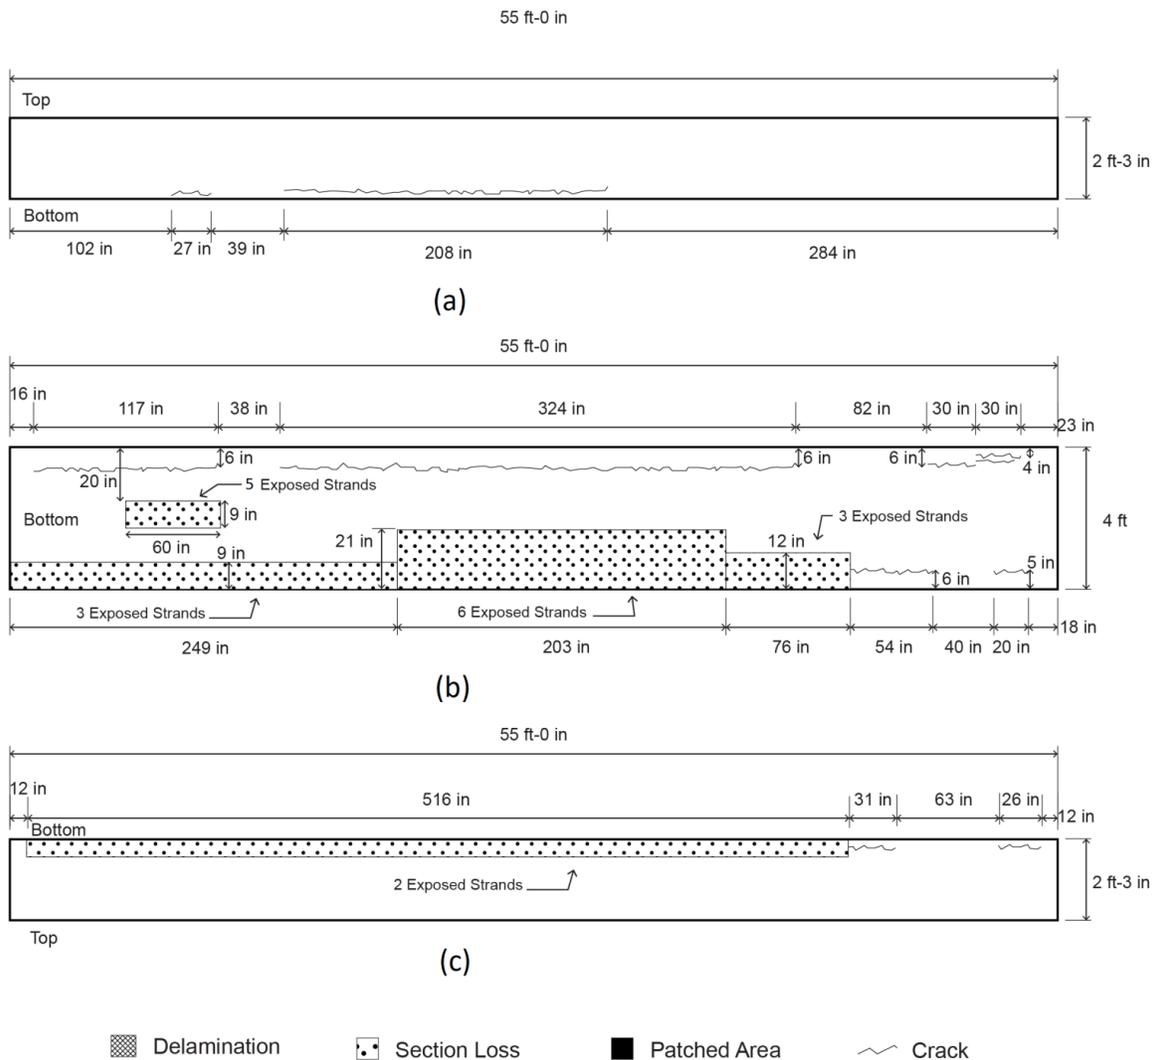
terminates as a continuous uniform section loss that runs through the rest of the length with two exposed fractured strands from the bottommost two layers. This can also be seen in Figure 26 (b). The height of this section loss is 9 in. (not shown in the damage map for clarity). The bottom of the girder contained several outer longitudinal cracks besides two major section losses with exposed strands. The first one is an outer section loss that runs through about one fifth of the girder's length with varying widths and three exposed strands. The other is at the middle of the girder's width with five exposed strands. **Figure 28** shows a detailed damage map of the Aden girder from the bottom and both sides.

**Figure 28** Damage map for Aden girder. (a) East side. (b) Bottom. (c) West side.

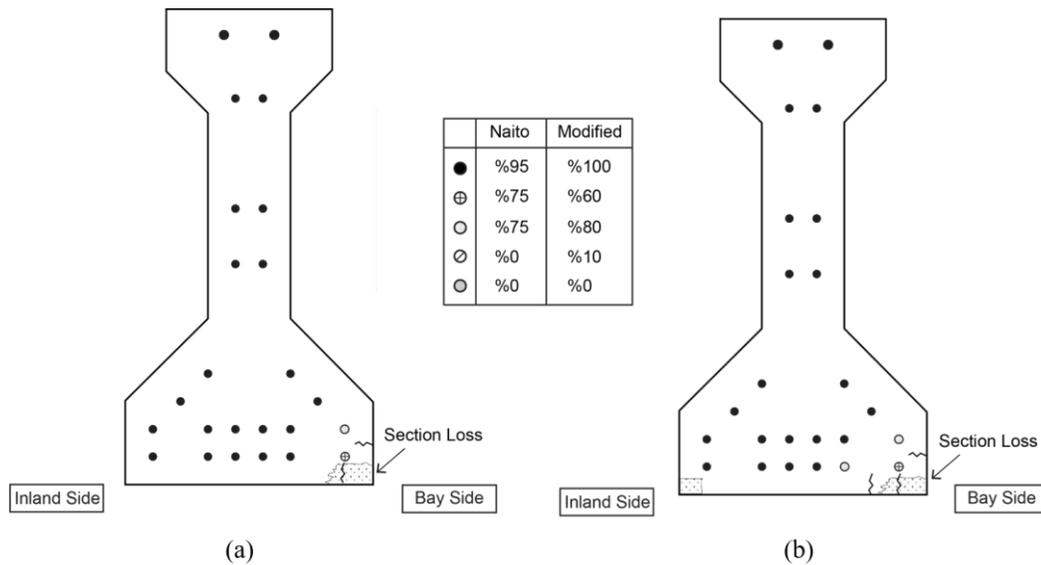
To perform shear and flexural analyses, a procedure proposed by Naito et al. (2011) is followed. Any damage within a window of two development lengths centered at the section to be analyzed is included. The development length for a bonded seven-wire strand is given in the AASHTO LRFD [5.9.4.3.2]. For the Lesner girder, the amount of the strands' area reduction follows the recommendations proposed by Alfaiakawi (2020). For the Aden girder, the amount of the strands' area reduction follows the recommendations proposed by Naito et al. (2011). This is due to the fact that the Naito proposal was developed for box beams only and confirmed to be accurate enough (Alfaiakawi, 2020). For I-beams, slight modifications to the original recommendations were made by Alfaiakawi (2020). Figure 29 and Figure 30 show the damaged cross sections for the first and the second tested ends of each girder. It should be noted that 'Modified' in the legends indicates the recommendations proposed by Alfaiakawi (2020).

**Figure 29 Damaged cross section for the Lesner girder. (a) First end (less damaged). (b) Second end (more damaged).**

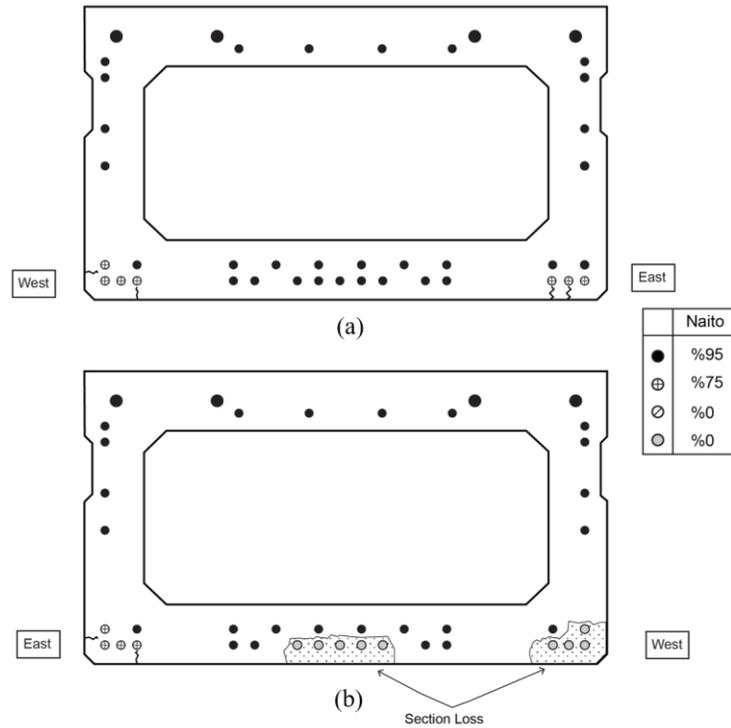
**Figure 30 Damaged cross section for the Aden girder. (a) First end (less damaged).  
 (b) Second end (more damaged).**

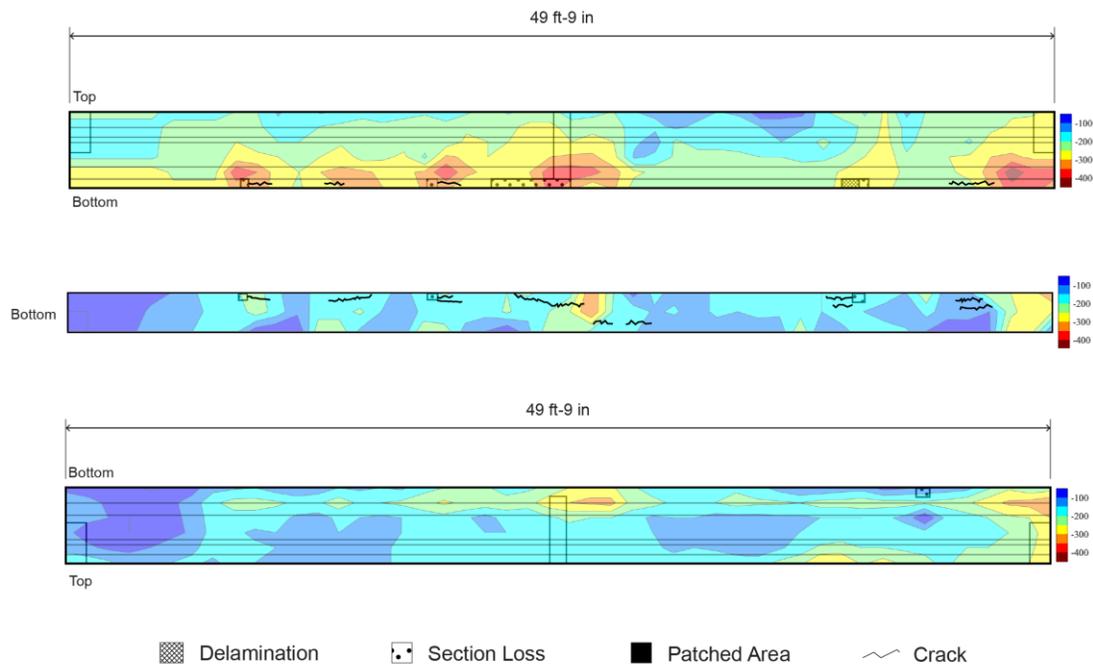
In the Lesner girder, at every 2 ft along the length of the girder, six measurements were taken over the depth from both sides while three measurements were taken from the bottom. In the Aden girder, three and five measurements were taken from the sides and the bottom, respectively, due its shallower depth and larger width. The data was then collected to produce contour maps shown in Figure 31 and Figure 32. The procedure followed was similar to that by Alfailkawi et al. (2020). In these figures, red areas indicate higher probability of corrosion compared to the blue areas.

**Figure 31 The half-cell potential map for the Lesner girder overlaid on the damage map**

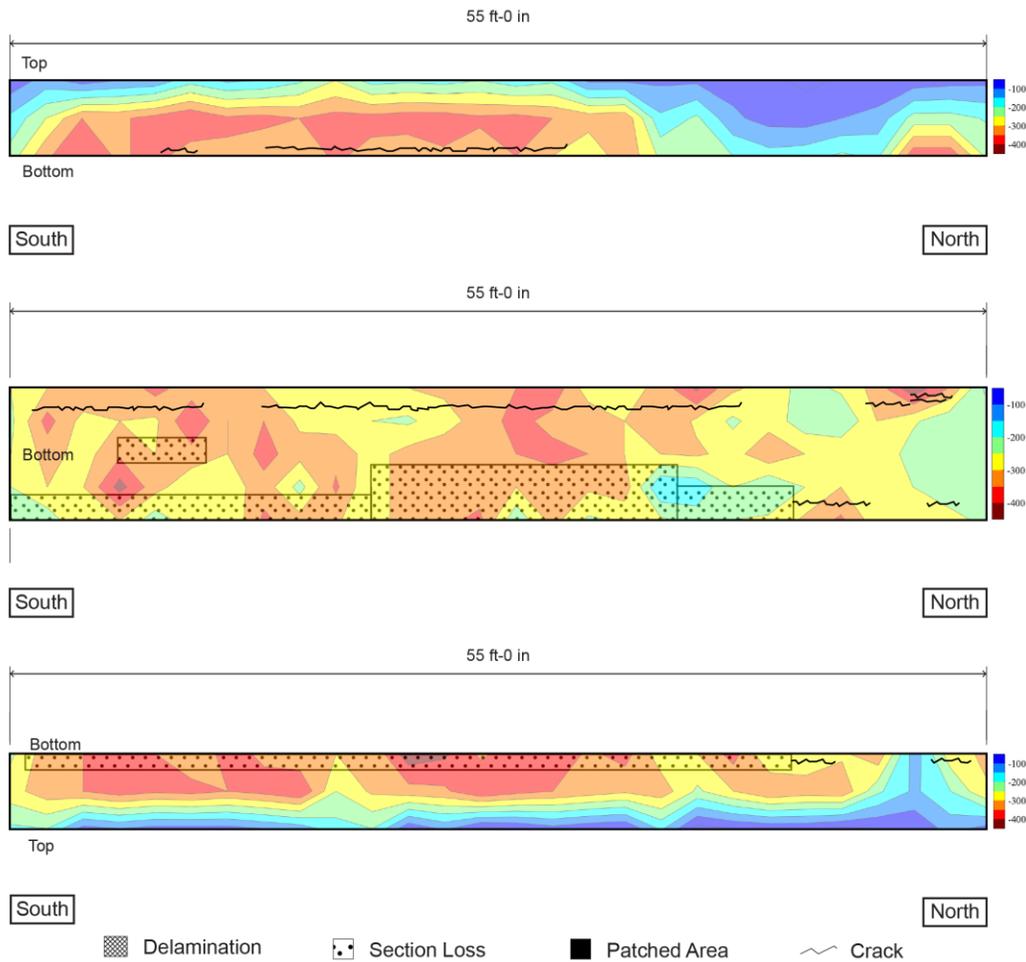
**Figure 32 The half-cell potential map for the Aden girder overlaid on the damage map**

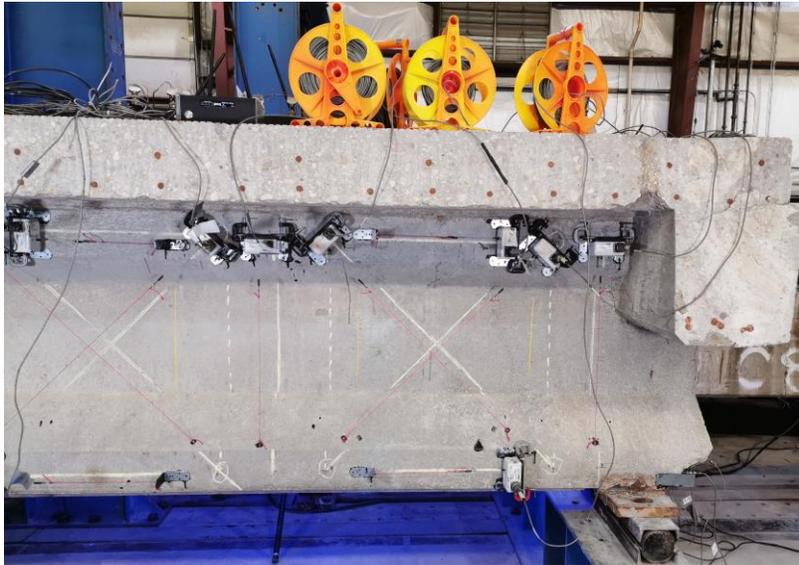
In the first Lesner test only, two panels of wire potentiometer rosettes were used along the shear span to measure the principle strains and the angle of inclination. A potentiometer rosette consists of two diagonal potentiometers at angles of  $-45$  and  $45$ , two horizontally placed potentiometers, and two vertically placed potentiometers as shown in Figure 33. However, data obtained from the potentiometer rosettes had a lot of noise and fluctuation. Therefore, the research team decided to replace it with LVDT rosettes in the next tests as will be discussed later.

**Figure 33 Wire potentiometer rosette (used for the first Lesner test only)**

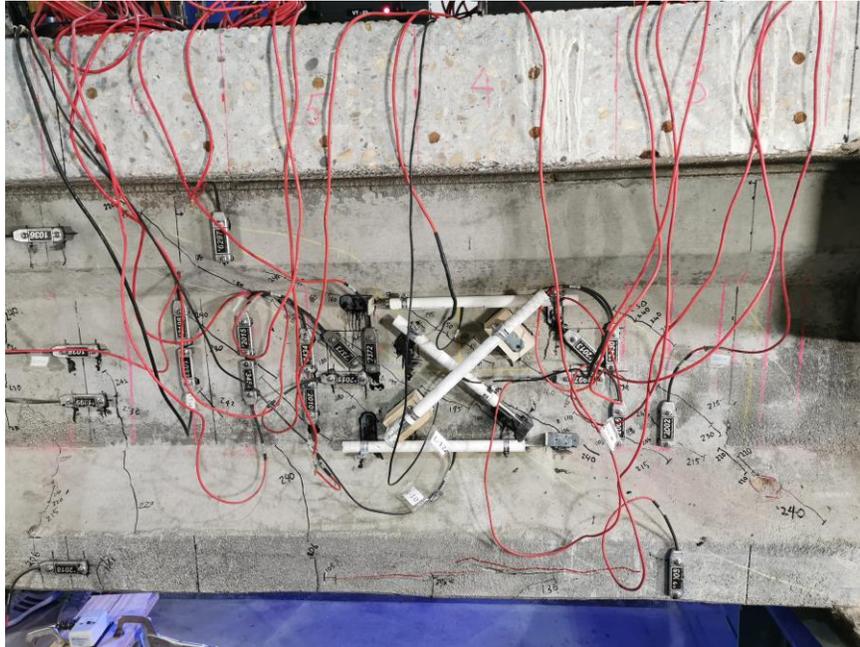
strain is compatible with the adjacent exterior concrete. The main goal of these strain gauges is to know whether the web reinforcement has yielded when the failure occurred. In addition, the DIC was used for performing this task as well. Strain gauges and LVDT rosette are shown in Figure 35.

**Figure 35 LVDT rosette and strain gauges installed on the Lenser girder**

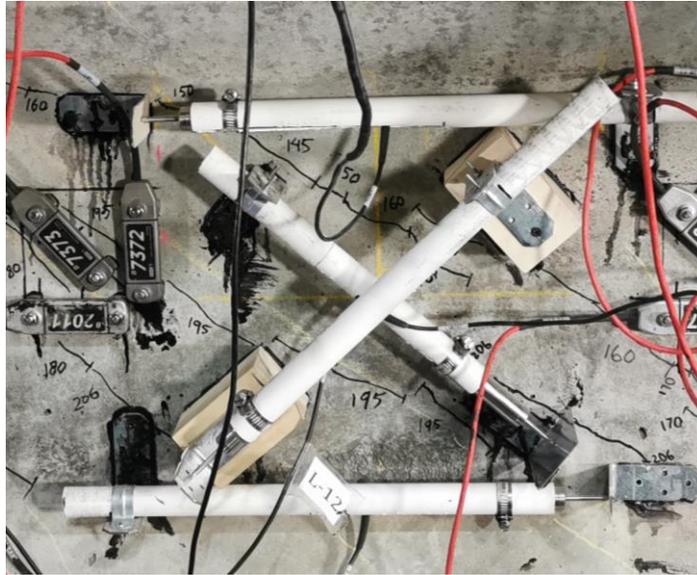
Except for the first Lesner test, an LVDT rosette was used for two purposes. These LVDTs have a gauge length of 2in. approximately. To obtain average strains, displacements are to be measured over long enough distance that includes at least one crack. This is the basis for the average strains and stresses discussed in the MCFT. Thus, LVDTs' gauges' lengths were extended to 16 in. using plastic tubes as shown in Figure 36. Each tube was attached to a piece of wooden block that was installed to the girder surface using adhesive material.

**Figure 36 LVDT rosette installed on Lesner girder**

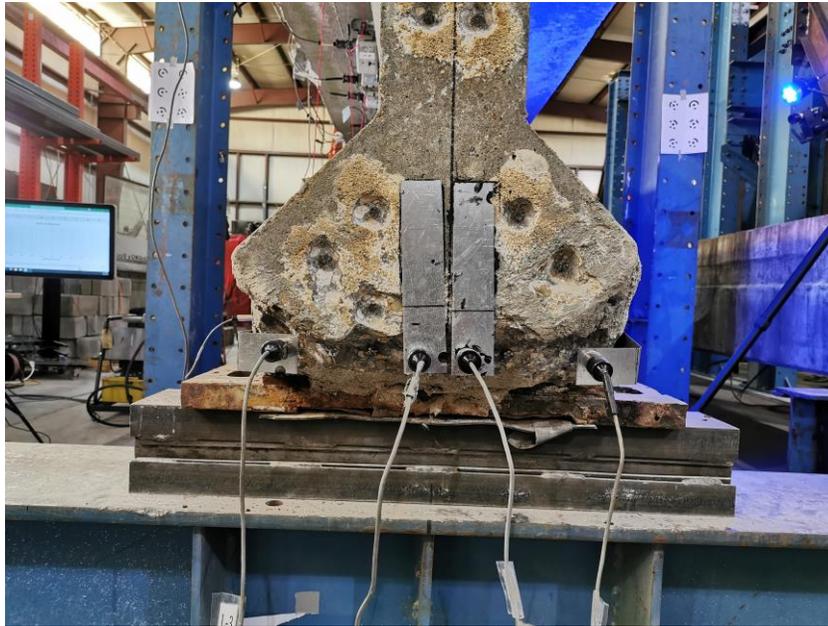
Because corrosion-damage is expected to significantly affect the outermost strands, four-short-stroke LVDTs were attached to the bottommost layer of strands. Two LVDTs were monitoring the outer strands slip, while other two were monitoring the inner strands slip. LVDTs were attached directly to the cross-sectional surface of the strands and held snug in their position using aluminum brackets glued to the concrete surface. Figure 37 shows the strands slip LVDTs.

**Figure 37 Strands slip LVDTs in Lesner girder.**

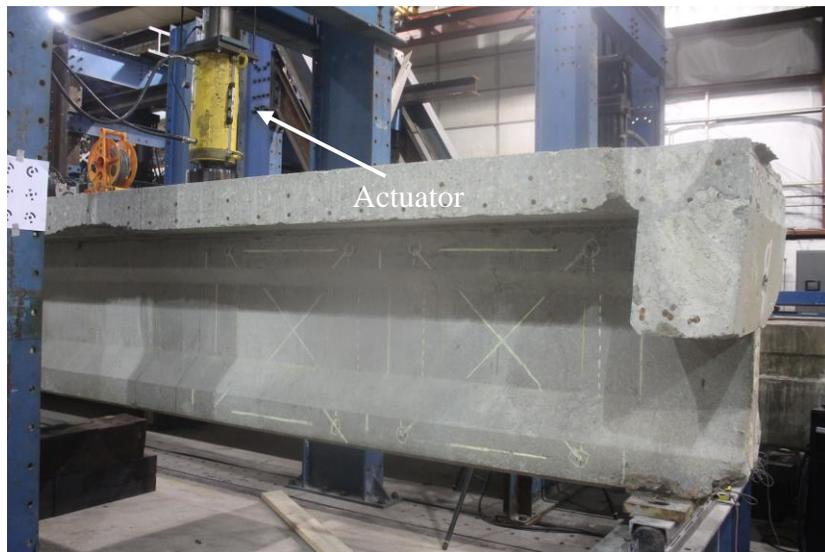
*Approach.* In addition, the shear capacity was estimated using the methods discussed in Section 2.2. All strength reduction factors, and load factors were taken as unity. In most tests, the load was applied in 10-kip increments. The loading increment was reduced to 5 kip as we approached the predicted cracking load. Then, the loading increment was returned to 10 kip. At each loading stage, the load value was entered into the GOM Correlate Software (see instrumentation subsection). In addition, the research team monitored and marked the new forming cracks and extension of the old cracks. This process ceased when getting close to the girder became a safety concern for people in the lab. Figure 40 shows the test set-up for the Lesner girder.

**Figure 40 Test set-up for Lesner**

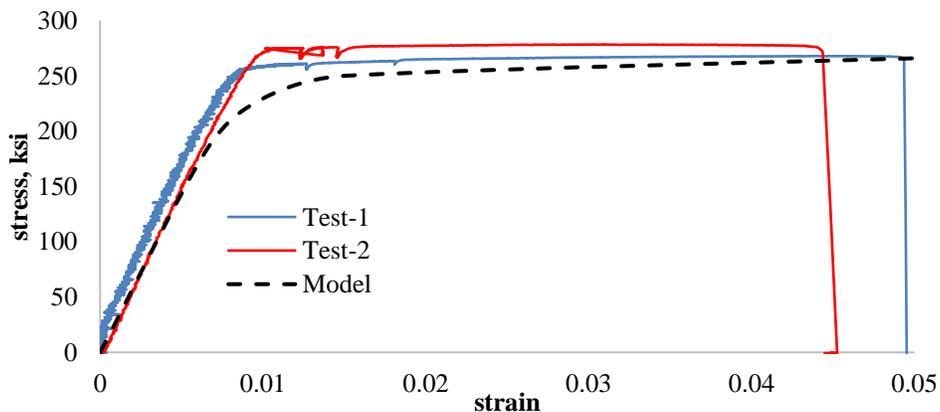
In addition, samples of the prestressing strands were retrieved as well for tension tests. The strand samples were about 4-ft long and were tested using a Universal Test Machine in the Virginia Tech lab as per the ASTM A370 standards. Unlike the mild reinforcement, strands consist of smooth seven wires helically wrapped. Therefore, a premature failure might occur at the highly stressed regions near the ends if strands were gripped directly by the testing machine jaws. To avoid this undesired failure, two pieces of an aluminum pipe were cut and attached to the strand ends using an adhesive mix of aluminum oxide and epoxy. More details about the tension test of the strands can be found in research by Loflin (2008). The strain was measured initially using a 9-in. gauge length extensometer until about 1% strain at which the extensometer was removed to prevent it from the potential damage due to the specimen rupture. After the extensometer removal, the strain was taken directly from the testing machine crosshead measurements. The stress-strain curves for the tested strands are shown in Figure 44 and Figure 45.

**Figure 44 Stress-strain curves for the strands retrieved from the Lesner girder**

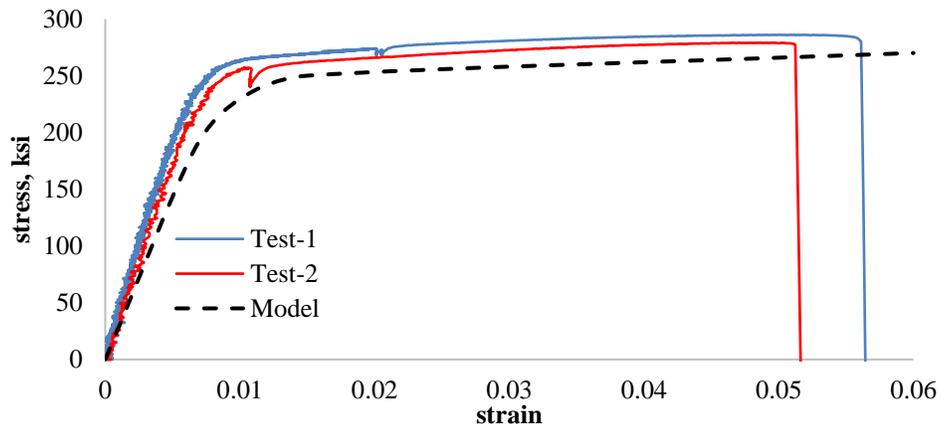
**Figure 45 Stress-strain curves for the strands retrieved from the Aden girder**

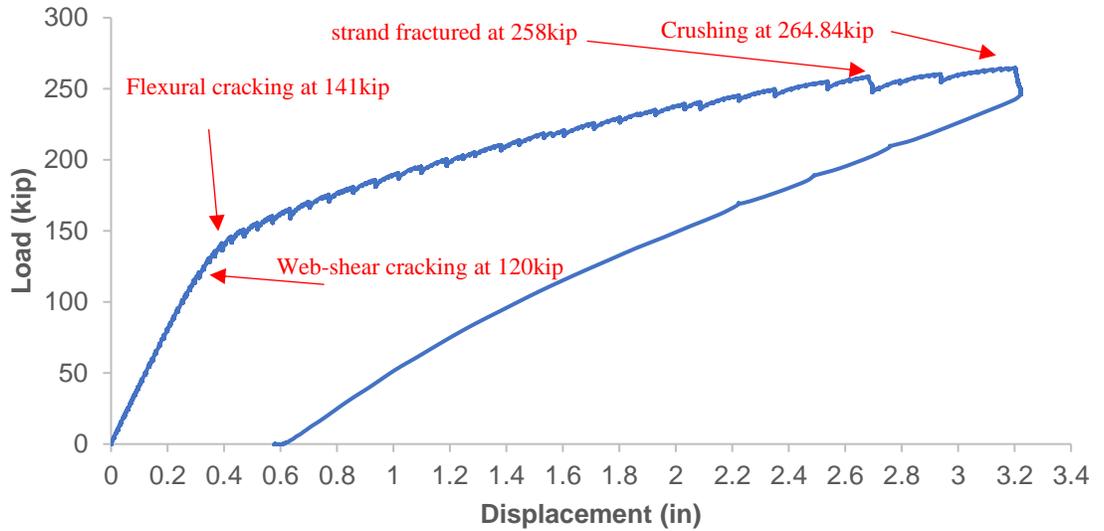
**Figure 46 Load-Displacement for the first Lesner test**
