# **SHEAR STRENGTH ASSESSMENT OF CORROSION-DAMAGED PRESTRESSED CONCRETE GIRDERS**

Thesis submitted to the faculty of the Virginia Polytechnic Institute and State University  
in partial fulfillment of the requirements for the degree of

Civil Engineering

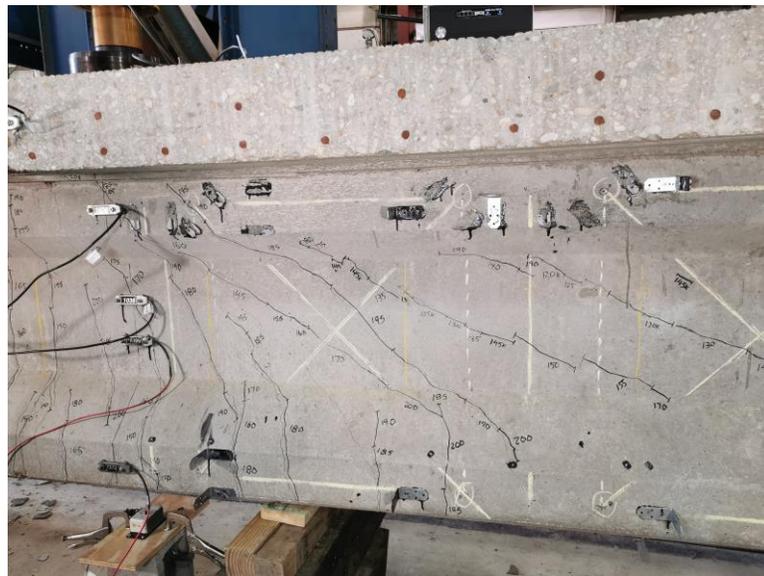
**Figure 47 Cracking pattern for the first Lesner test (inland side)**

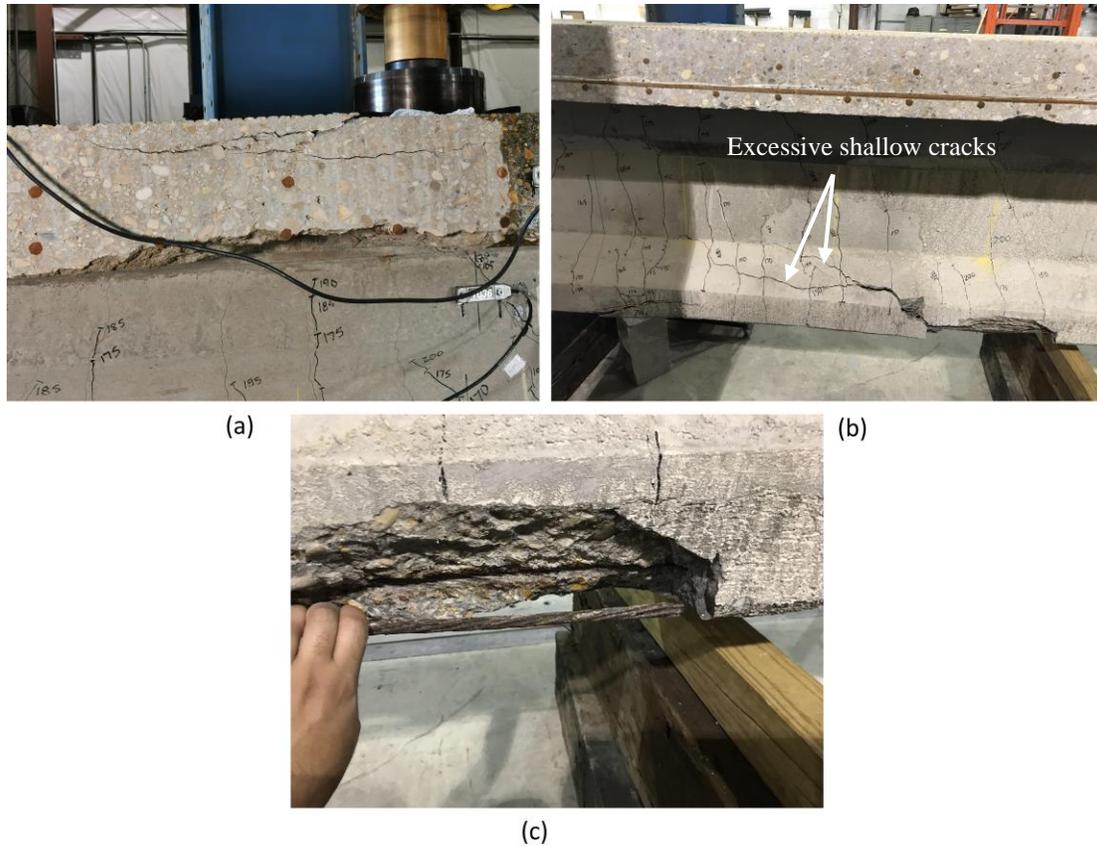
critical section for shear. The girder attained a maximum deflection of 3.22 in. when the girder failed. Figure 48 shows the failure mechanism of this girder end.

**Figure 48 Failure mechanism for the first Lesner test. (a) Top crushing. (b) Excessive cracking in the bay side where the strand ruptured. (c) Strand ruptured in the bay side.**

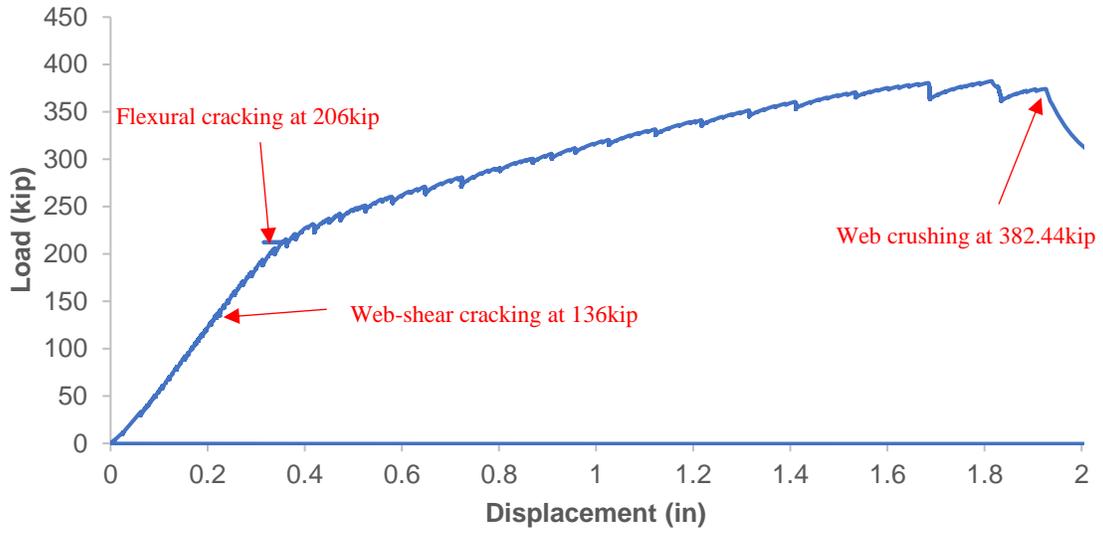
**Figure 49 Load-Displacement for the second Lesner test**

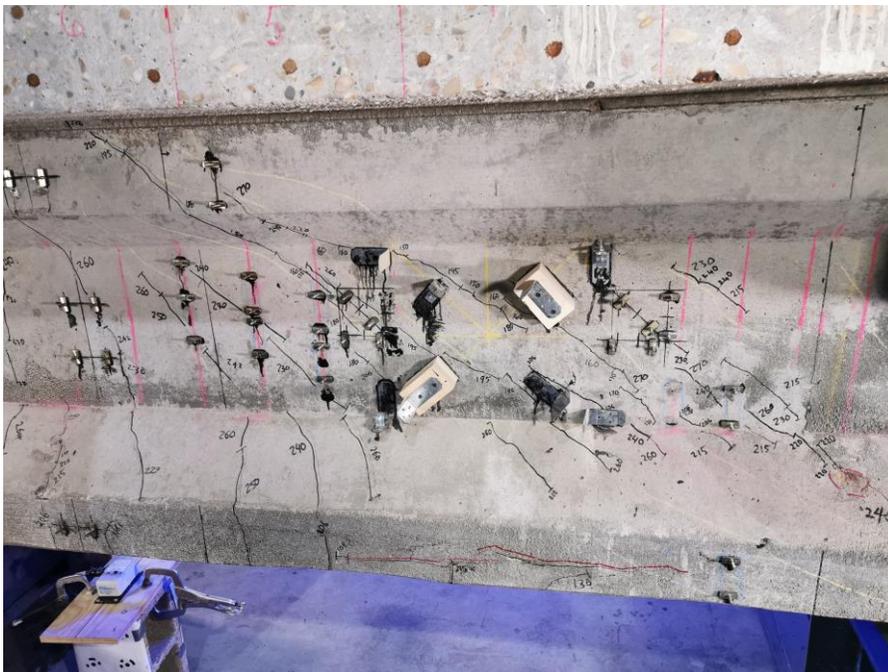
After that, several web-shear cracks and flexural cracks opened in both sides. These cracks were almost parallel. Some of these cracks propagated upwards reaching to the top flange of the girder. Figure 50 shows the cracking pattern for this test. The BDI instruments, except the wire potentiometer, were removed at a load of 271 kip for safety purposes. After reaching 340 kip of applied load, many “popping” sounds were heard repeatedly. Because there was no a major load drop in the Load-Displacement plot at 340kip (Figure 49), these sounds were attributed to opening of new cracks. In addition, post-testing investigation showed that no strands appeared to be fractured during the test. The load was increased consistently until 382.4 kip at which the diagonal strut crushed in a very explosive and brittle manner. The crushing occurred in the web and was located at the middle of the shear span along the length of the girder. This load corresponds to a total moment of 1910 kip-ft at the loading location, and a total shear of 318.2 kip at the critical section for shear. The girder attained a maximum deflection of 1.92 in. when it failed. Figure 51 shows the failure mode of this girder end. Before the web crushed, cracks were inclined with about 35-degree angle. However, at failure, the web crushed at a steep-angle crack which took a short path from the point load to a close concrete spall instead of extending towards the support as expected.

**Figure 50 Cracking pattern for the second Lesner test**

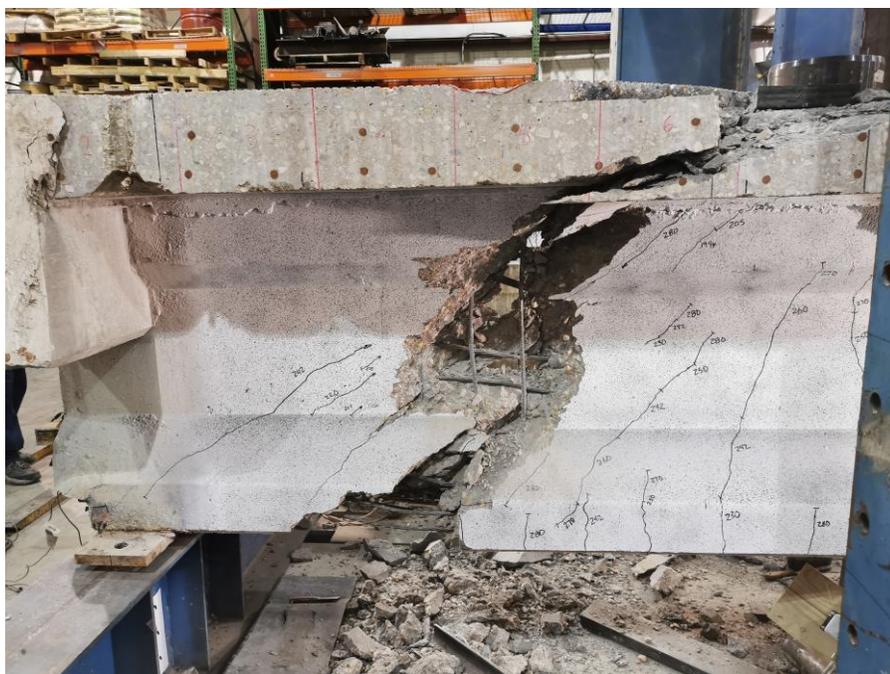
**Figure 51 Failure mode for the second Lesner test (Web crushing)**

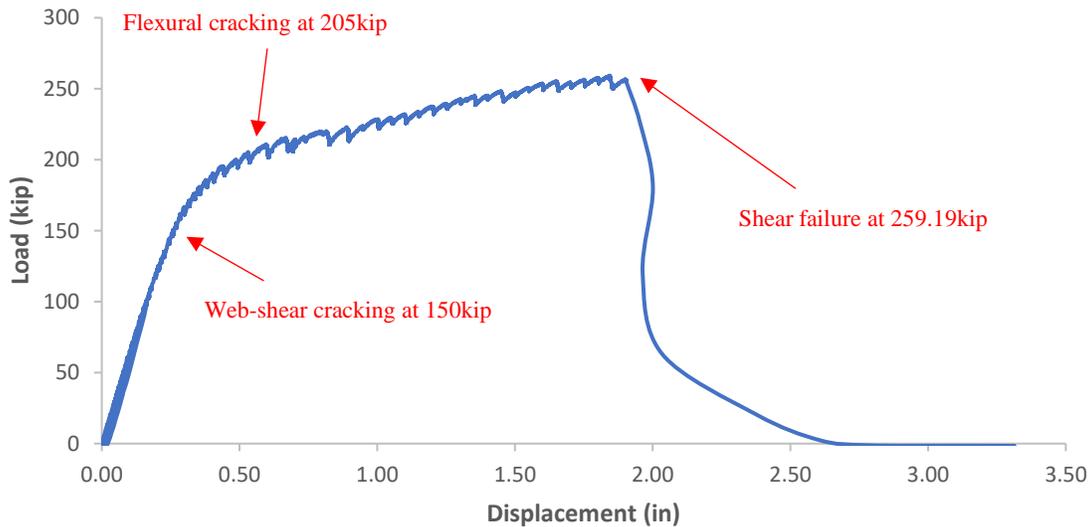
**Figure 52 Load-Displacement for the first Aden test**

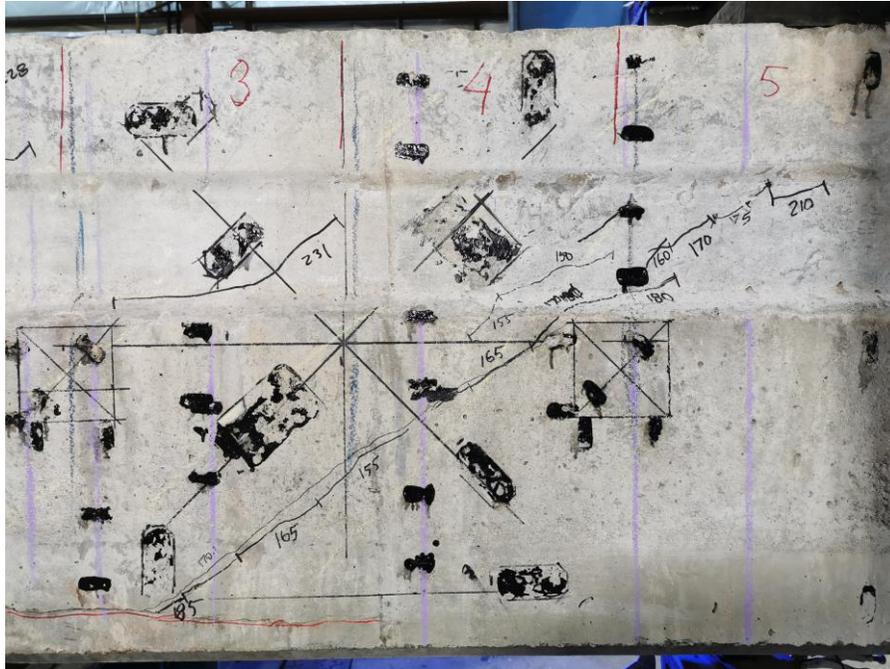
**Figure 53 Cracking pattern for the first Aden test**

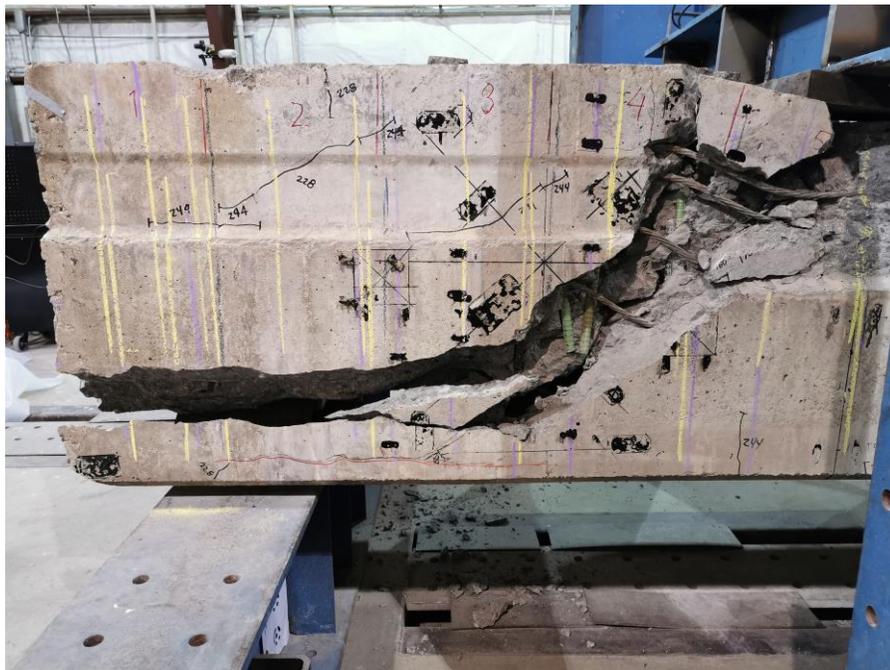
**Figure 54 Failure mode for the first Aden test (Diagonal tension)**

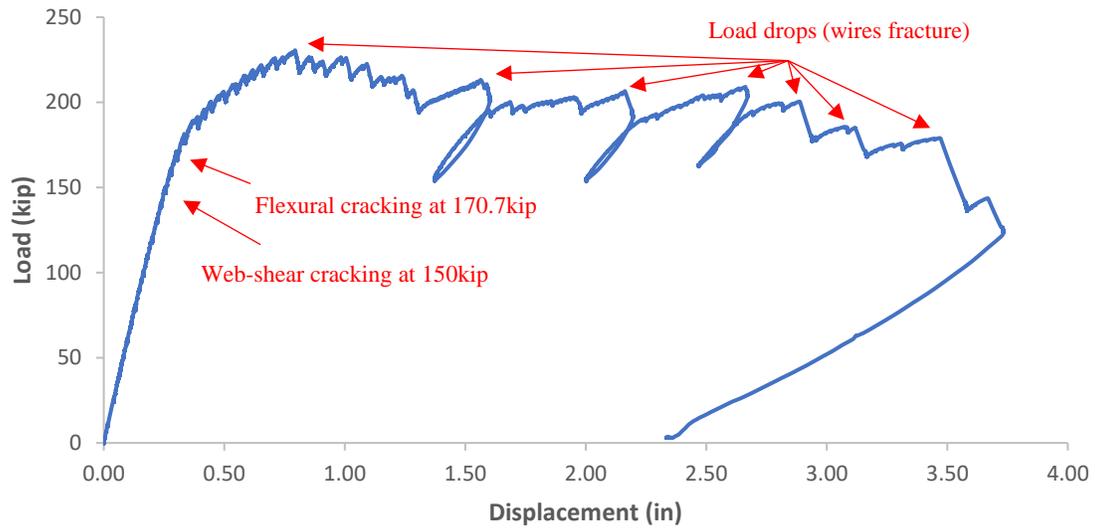
**Figure 55 Load-Displacement for the second Aden test**

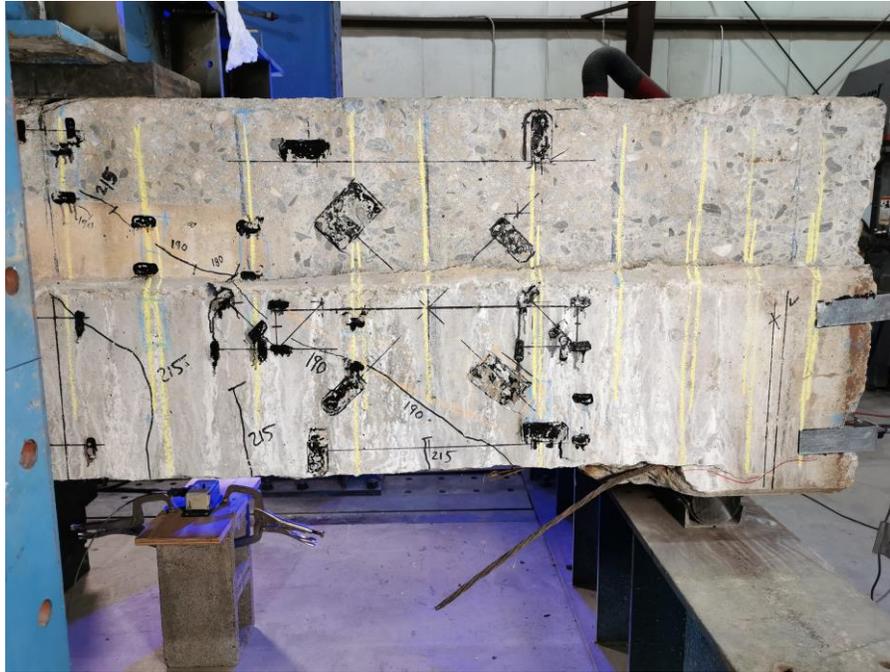
**Figure 56 Cracking pattern for the second Aden test**

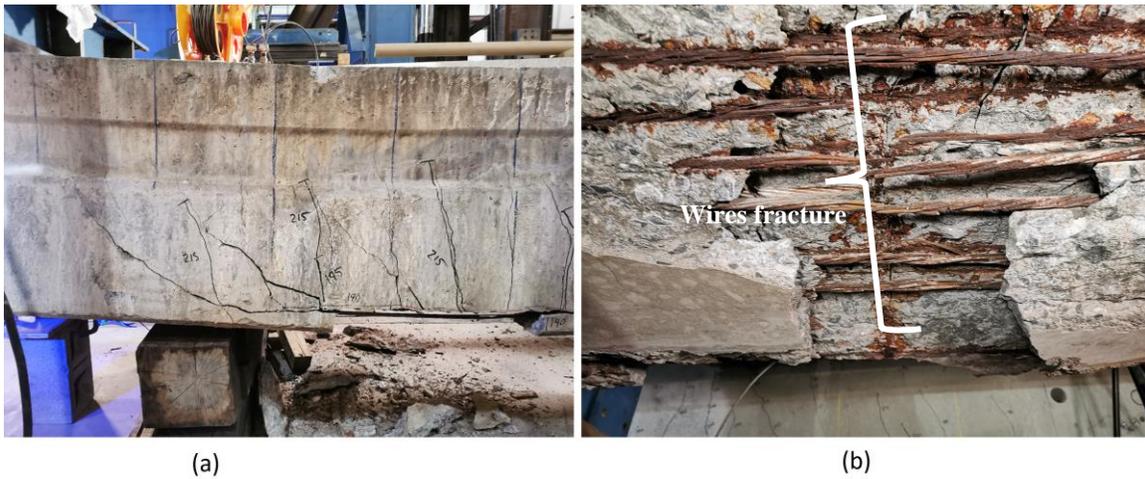
**Figure 57 Failure mode for the second Aden test (strands rupturing)**

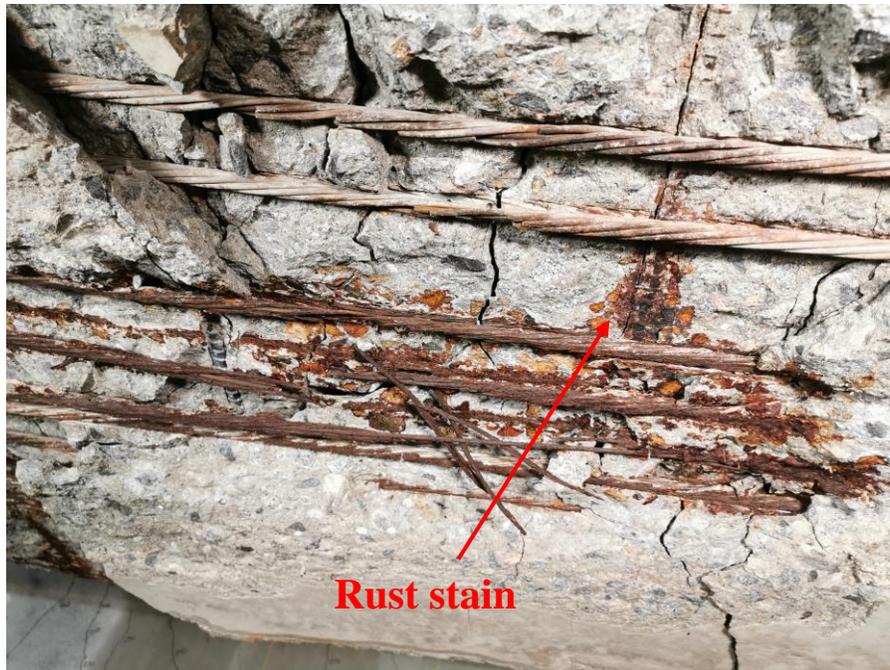
**Figure 58 Rust in the horizontal leg of a stirrup in the second Aden end**

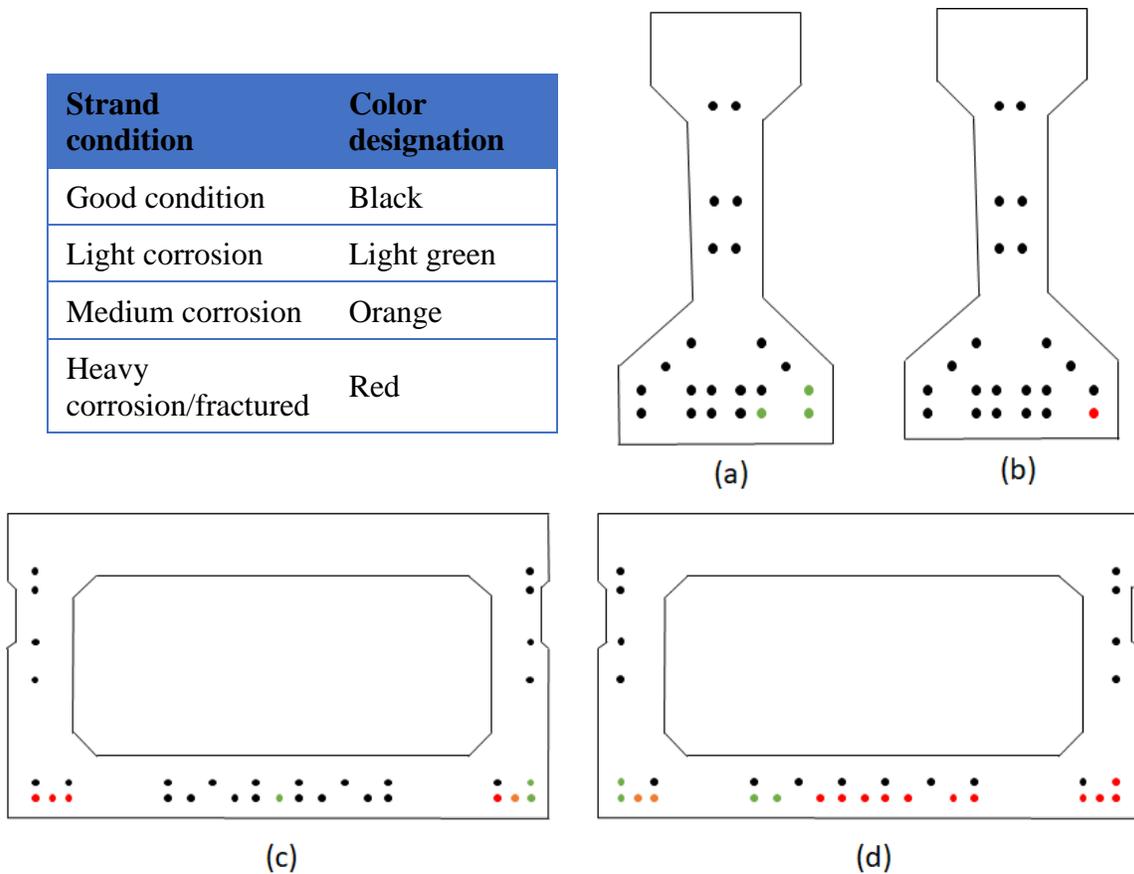
**Figure 59 Strands condition after investigation. (a) First Lesner. (b) Second Lesner. (c) First Aden. (d) Second Aden.**

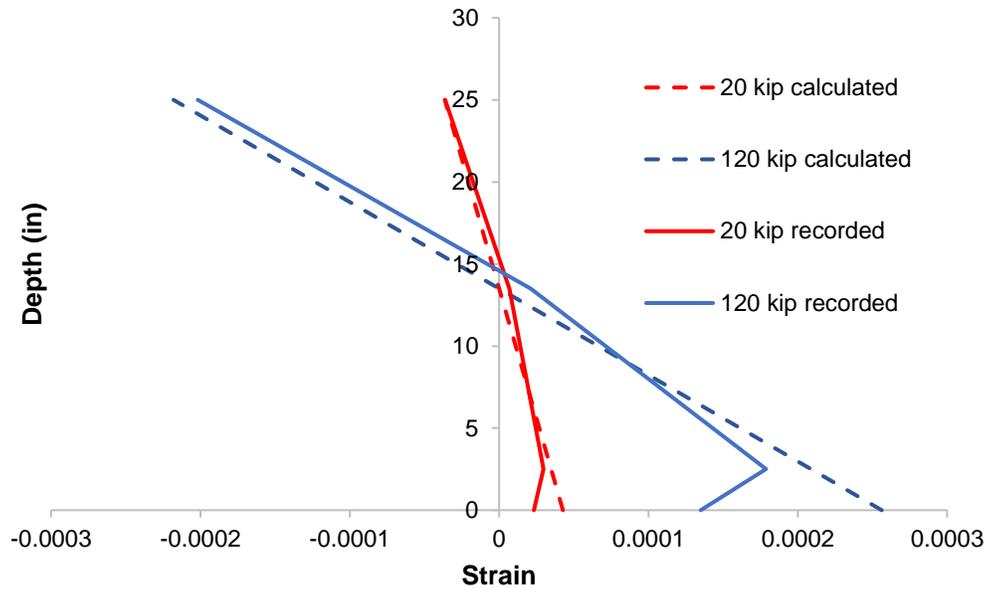
**Figure 61 Strain distribution for the Aden girder (first test)**

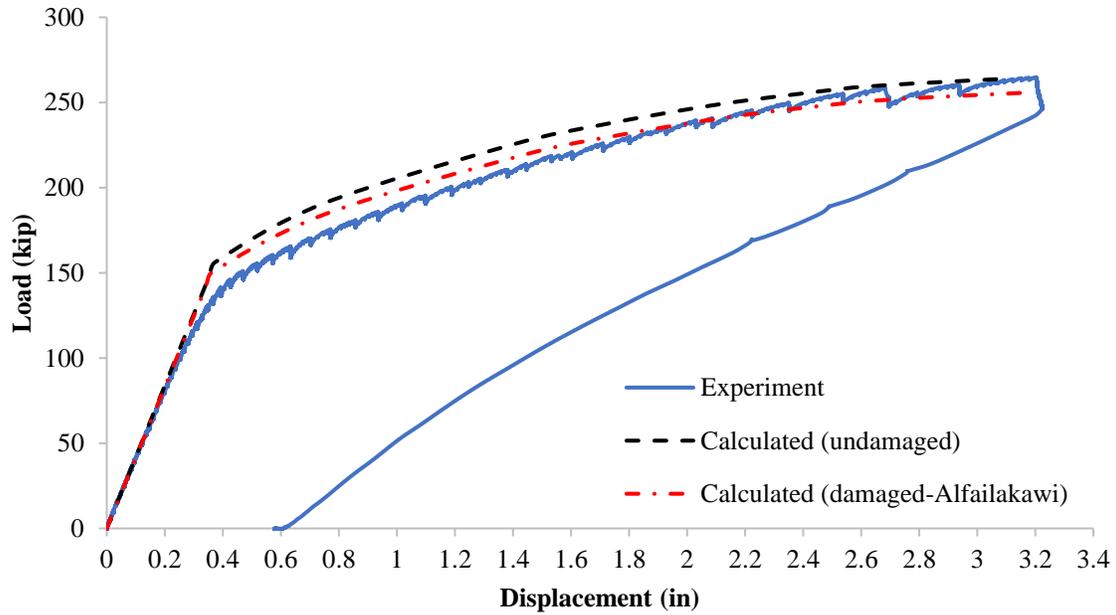
**Figure 62 Load-Displacement for the first Lesner test**

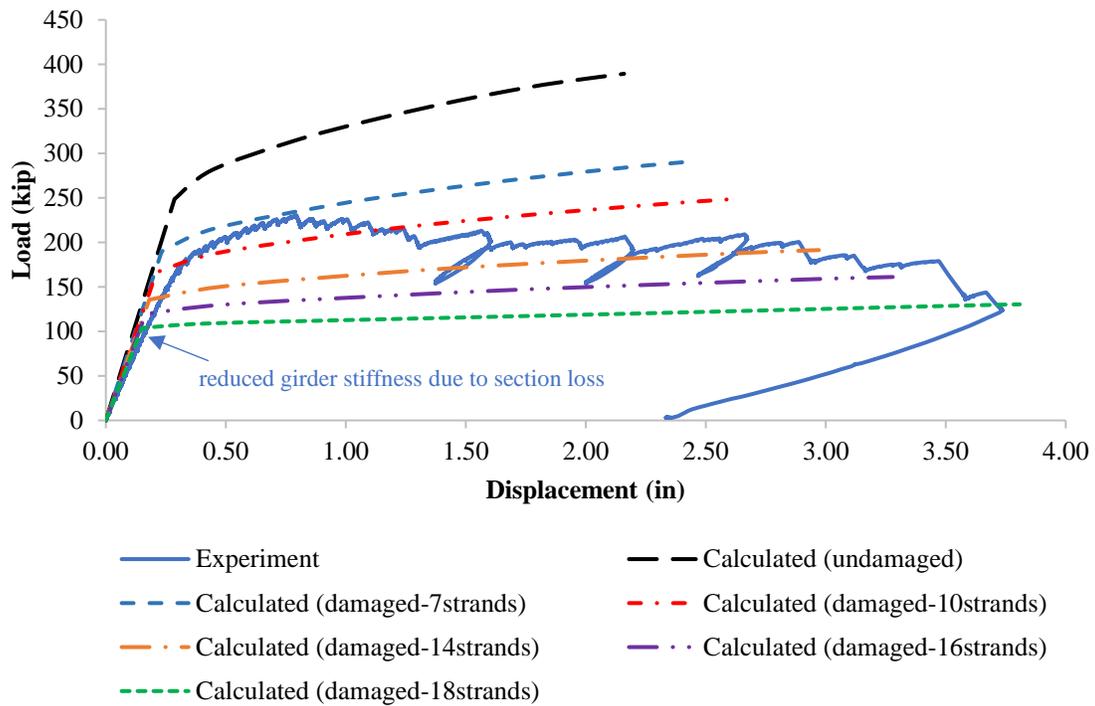
**Figure 63 Load-Displacement for the second Aden test**

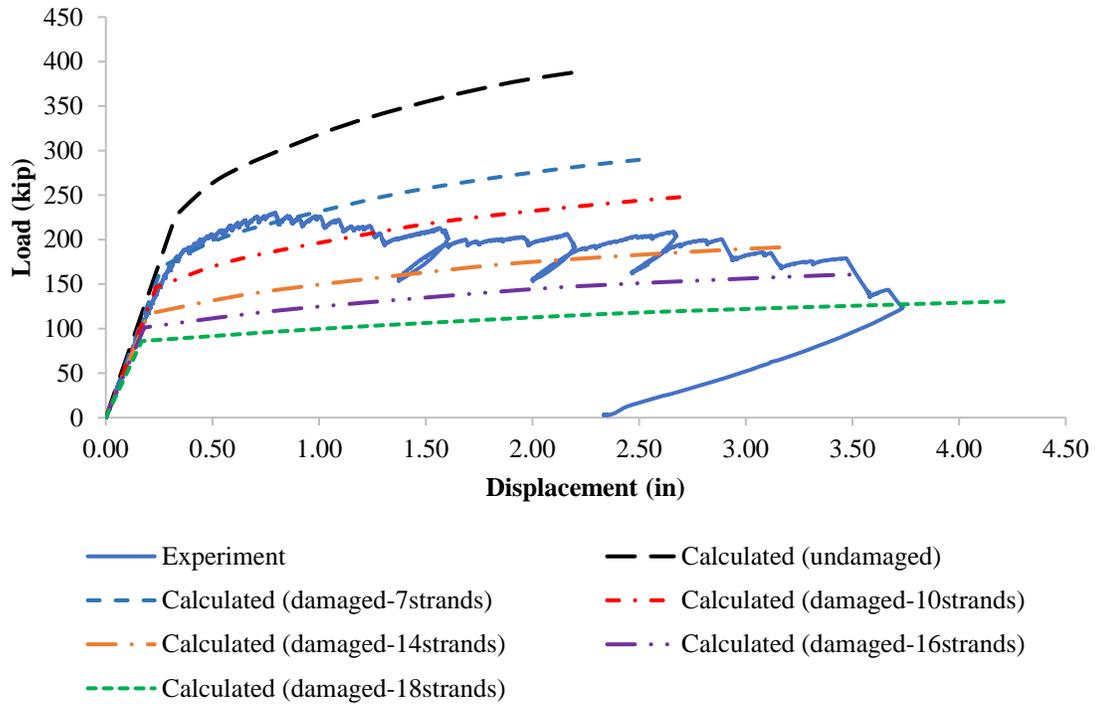
**Figure 64 Load-Displacement for the second Aden test (bottom concrete cover is removed)**

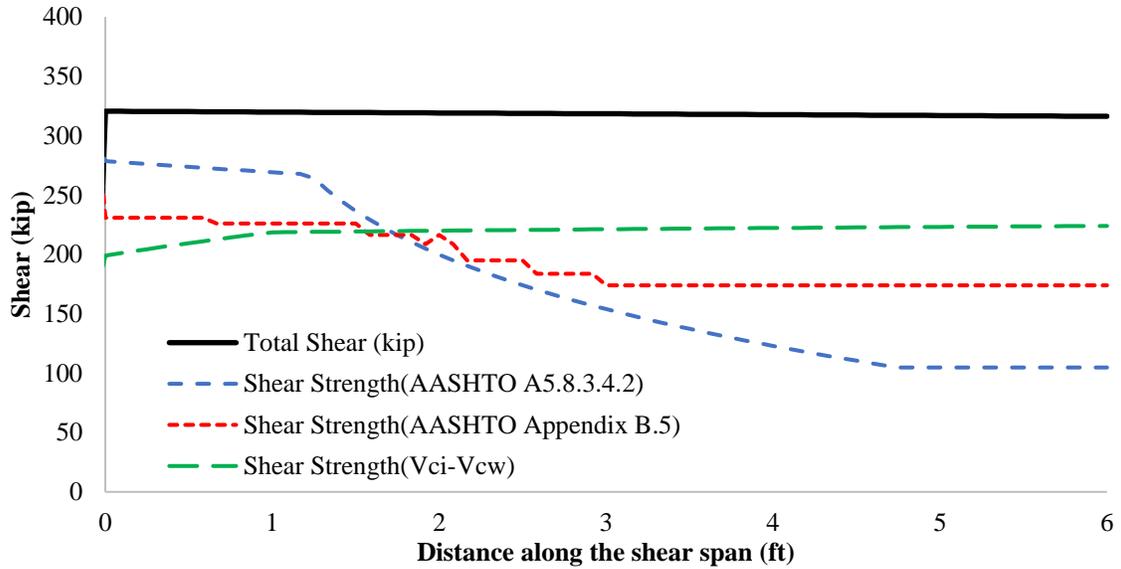
**Figure 65 Shear strength and demand for the second Lesner test under the observed failure load**

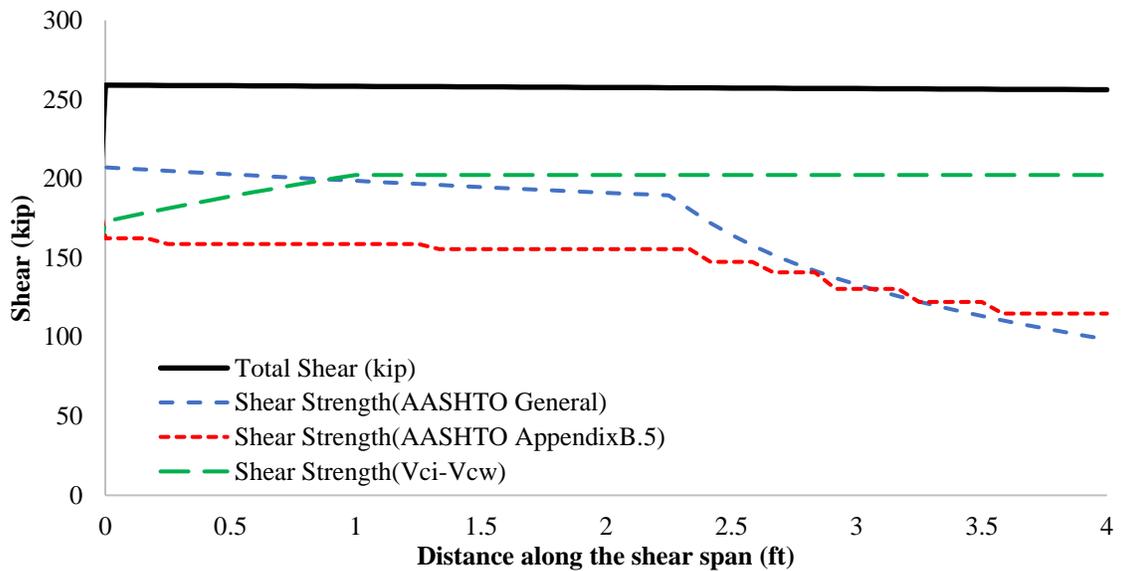
**Figure 66 Shear strength and demand for the first Aden test under the observed failure load**

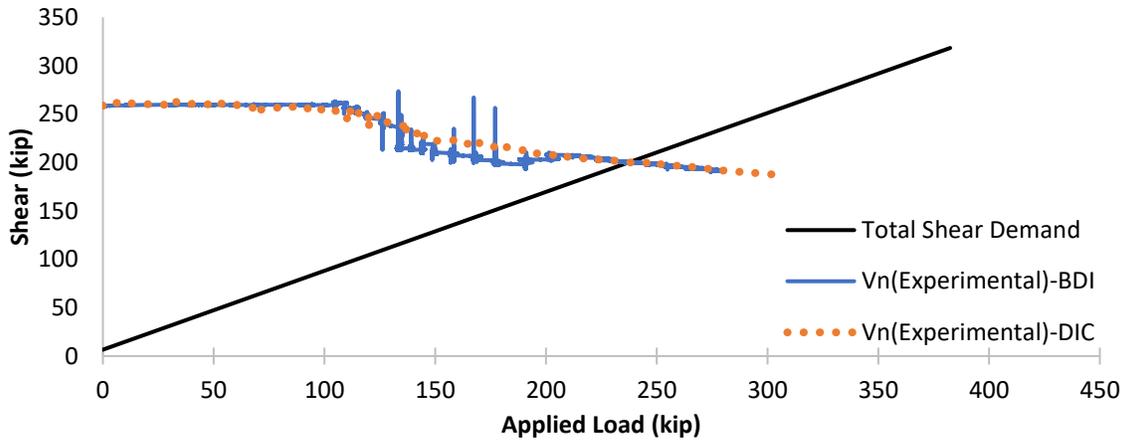
**Figure 69 Shear strength of the second Lesner end at the middle of the shear span using an experimental approach**

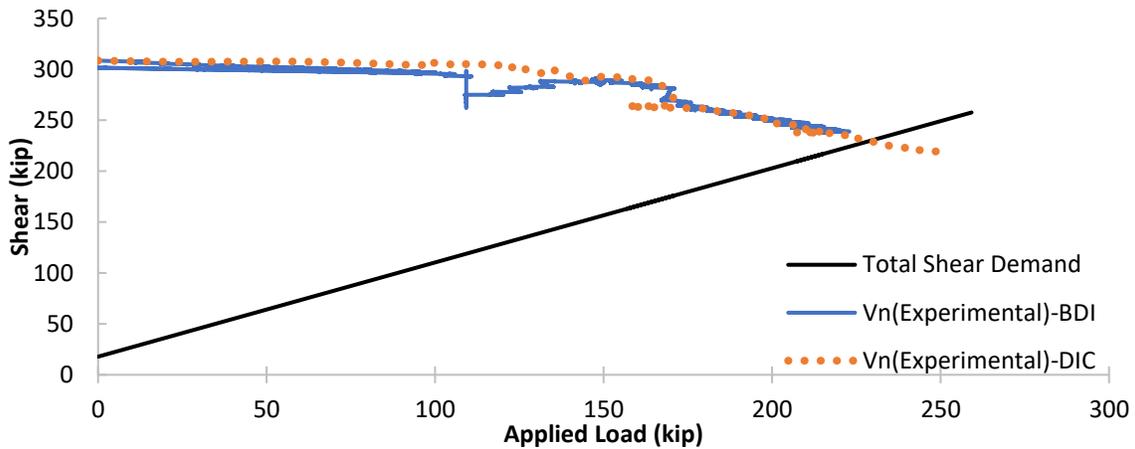
**Figure 70 Shear strength of the first Aden end at the middle of the shear span using an experimental approach**

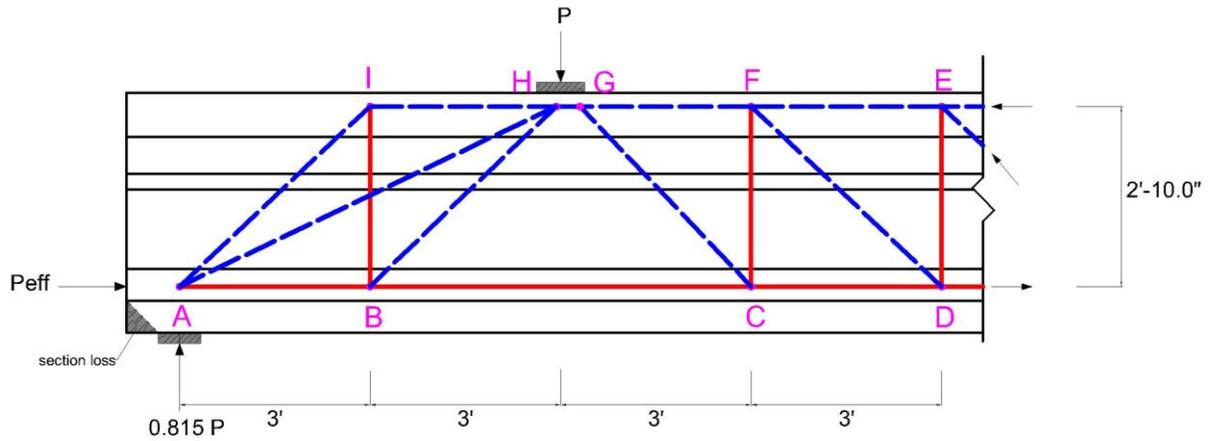
Figure 71 STM for the second Lesner test

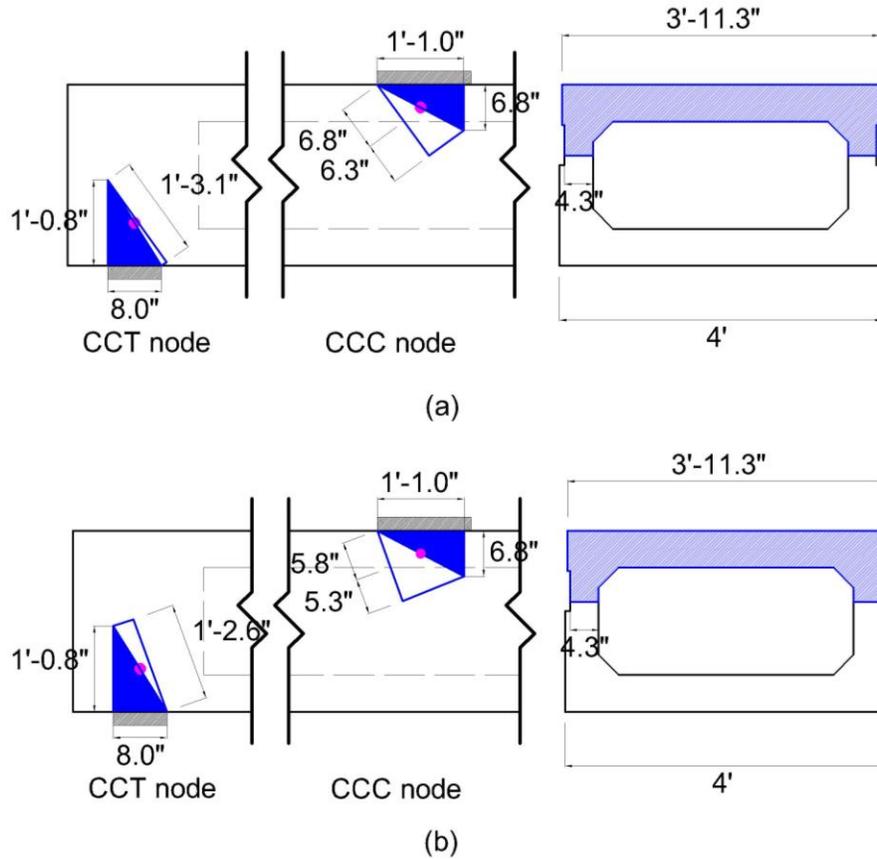
**Figure 75 Discrete node geometries for the second Lesner test. (a) Truss-1. (b) Truss-2.**

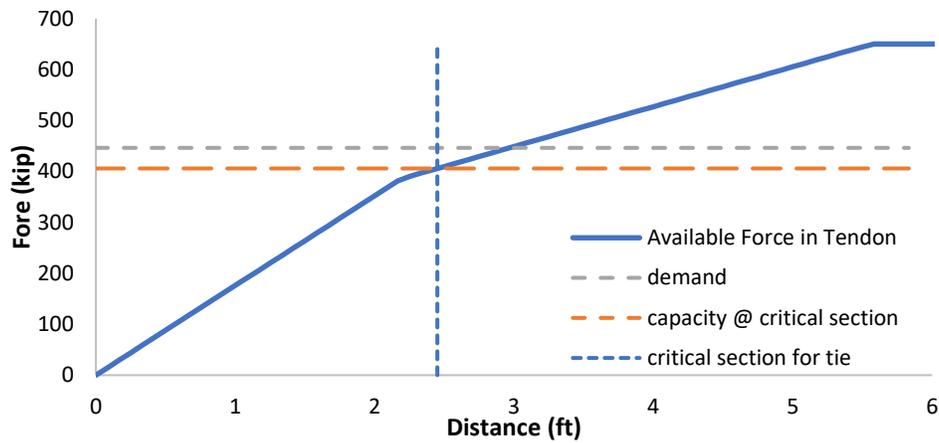
**Figure 78 Capacity and demand on the horizontal tie for the strut crushing load (second Lesner test)**

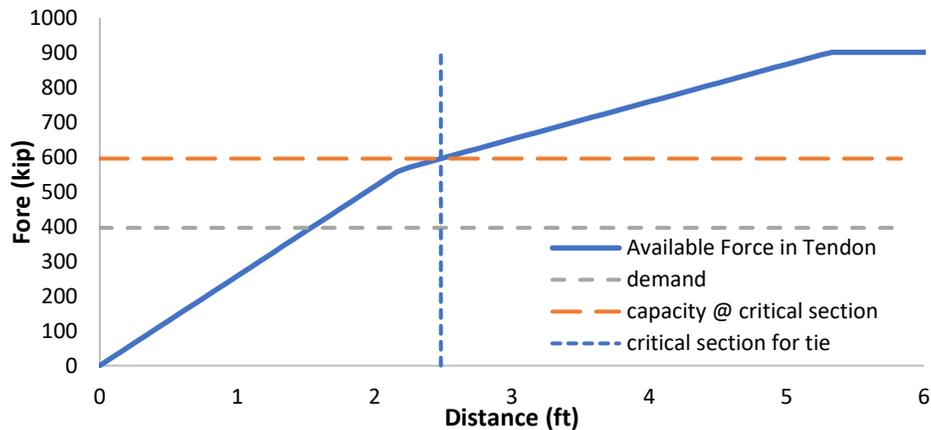
**Figure 79 Capacity and demand on the horizontal tie for the strut crushing load (first Aden test)**

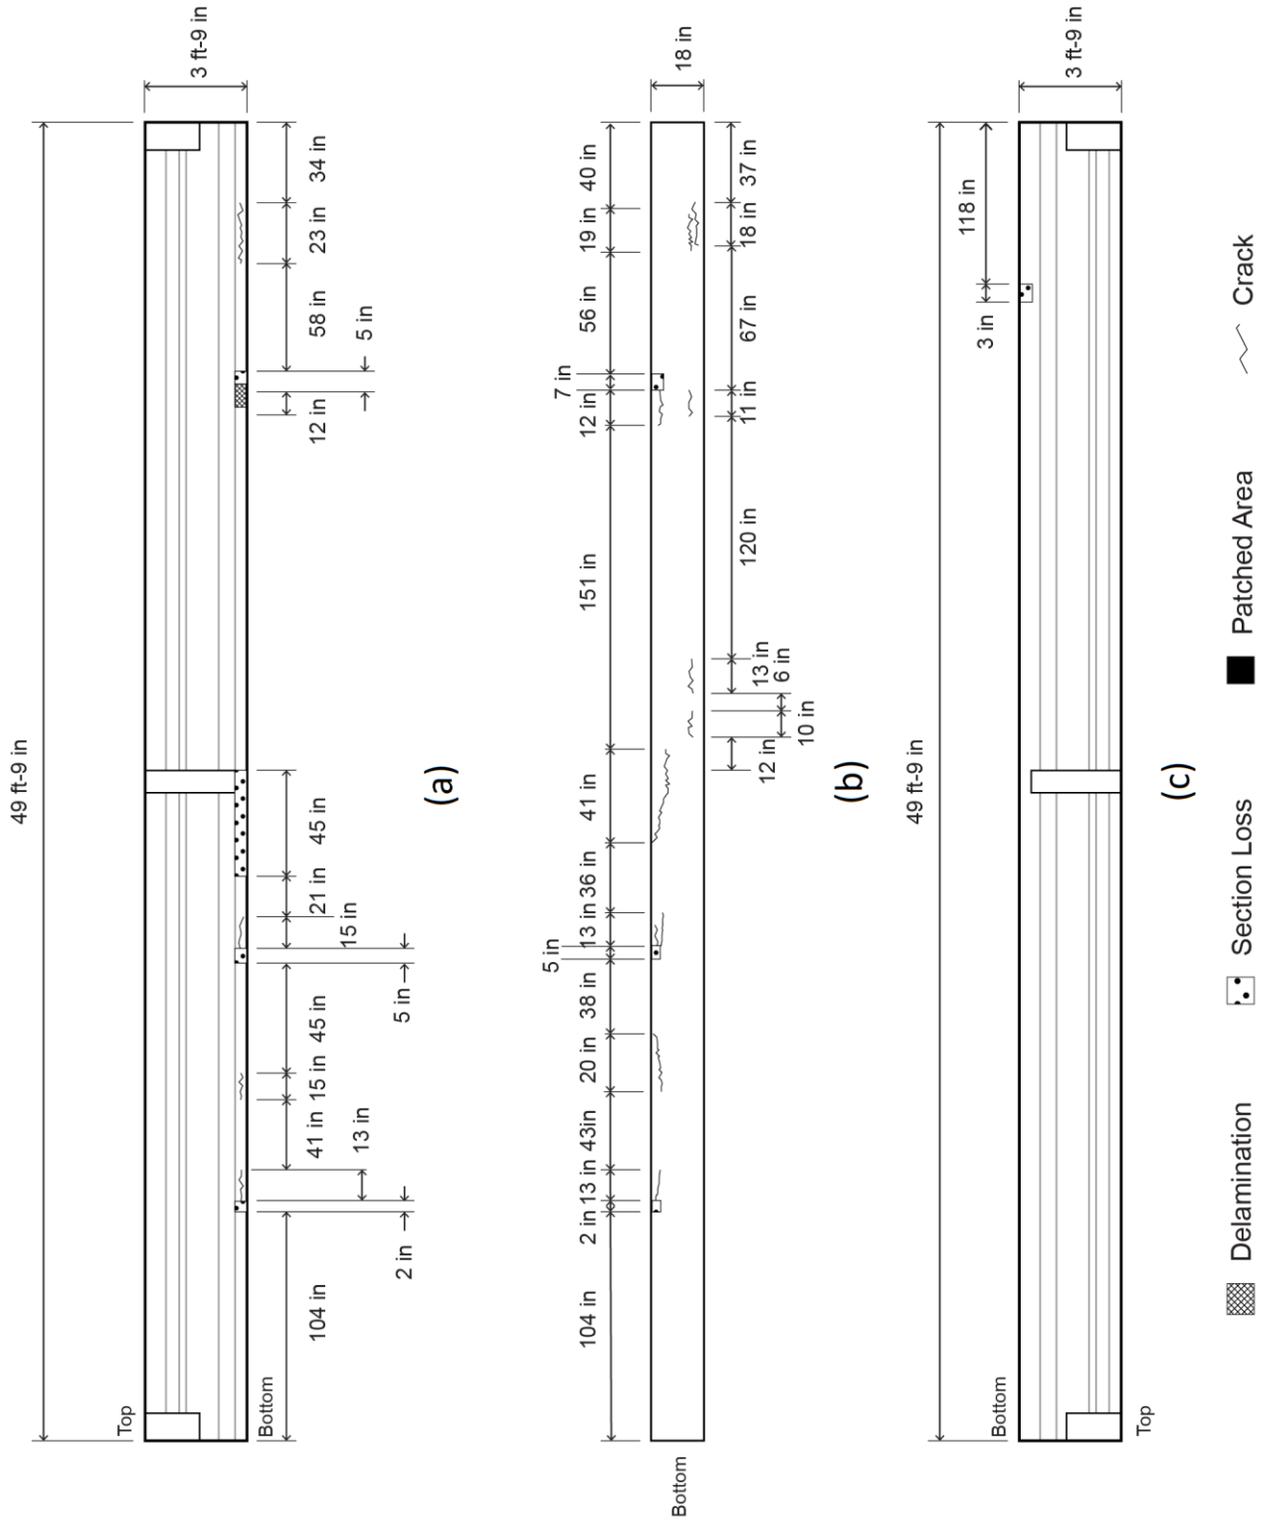
Figure 82 Damage map for the Lesner girder.
