Carbon Fiber Reinforced Polymer Retrofits to Increase the Flexural Capacity of Deteriorated Steel Members

Samuel Sherry

Dissertation submitted to the faculty of the Virginia Polytechnic Institute and State University in partial fulfillment of the requirements for the degree of

Civil Engineering

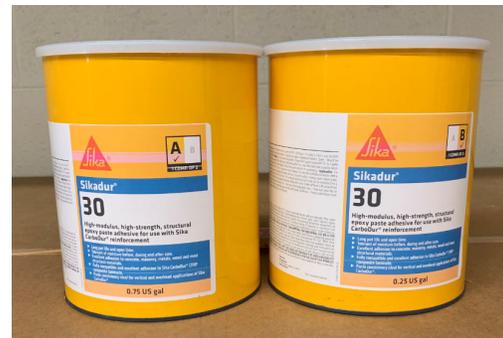
Figure 1. I. Different Types of CFRPs (A. = Prepreg Plate Material, B = Prepreg Strand Sheet, C = Unimpregnated Fiber Sheet), II. Adhesive Material (2 part epoxy)

When discussing a FRP retrofit, there is the item being strengthened/retrofitted and the FRP retrofit materials itself. In the case of this research, steel is the material that is being retrofitted and the FRP retrofit material is a CFRP strengthening system, which is comprised of two parts; the CFRP and the adhesive material used to "attach" the CFRP to the steel being retrofitted. An example of some CFRPs and adhesive material are shown in Figure 1 I. and II. respectively.

Figure 1 I. A. is a plate type material, which has been impregnated with resin, meaning the fibers and the resin have been combined to create the CFRP matrix. This type of manufacturing process is referred to as pre-impregnated or "prepreg" (Hyer 2009). Figure 1 I. B. is a strand sheet type of material, which is made up of prepreg strands that have been bound together by a plastic string. This material looks and feels very much like a bamboo mat, which is commonly used to roll sushi. Figure 1 I. C. is a fiber sheet, which is made up of unimpregnated fibers that have been stitched together by a string. This material will be impregnated with a resin before the material can be applied to a surface.

There are different advantages to the three different unidirectional CFRP types (A.-C.) shown in Figure 1 I. Generally speaking, prepreg material uses less resin and has better quality control compared to a material that is impregnated in the field. However, a plate material like the one shown in Figure 1 I A can generally only be used on a flat surface, unlike the fiber sheet shown in Figure 1 I. C. The fiber sheet shown in Figure 1 I. C. can be used to wrap around any contours. The other benefit of a fiber sheet is it generally comes on a wider roll than that of a flat plate type material; this means it can be cut to specific dimensions. This is generally not the case for flat plate type material which comes in stock dimensional sizes; while they can be cut to size it is much more difficult. Lastly, the strand sheet shown in Figure 1 I B. tries to combine the best of both of these CFRP types. Where there is a high degree of tailorability in conjunction with that of the high-quality control of the prepreg manufacturing process.

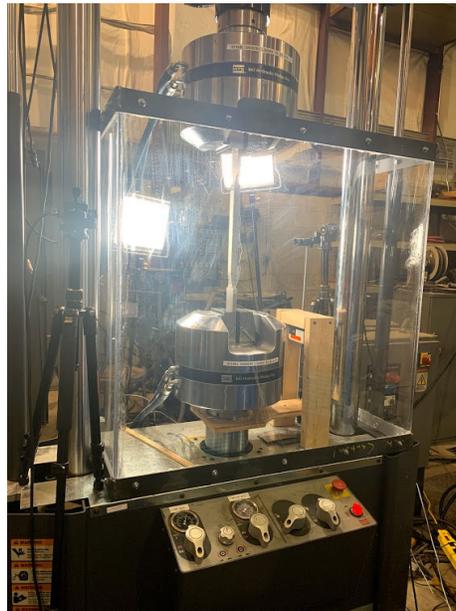
Figure 16. MTS Landmark 370.50 Testing a Double Strap Joint

All small-scale testing was completed on an MTS Landmark 370.50 universal testing machine with a 110 kip capacity and hydraulic wedge grips (shown in Figure 16). Load and crosshead displacement data was collected at a rate of 10 Hz. These tests were displacement-controlled, conducted at a rate of 0.005 in/min in tension. Termination of testing was controlled by the total debonding or rupture of the CFRP, indicated by a near-zero load.

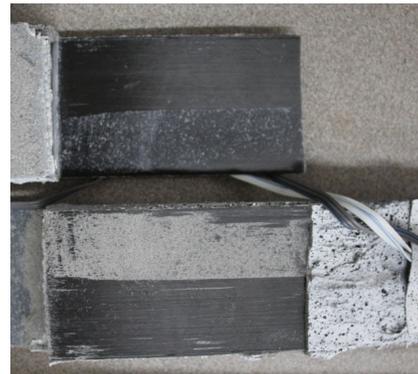
Figure 18 shows the different types of failure modes that were observed during this testing.

I. (a.) Adhesion failure between steel and priming adhesive

II. (b.) Cohesion failure between priming adhesive and FRP adhesive

III. (c.) Adhesion failure between FRP and FRP adhesive

IV. (d.) FRP delamination

V. (e.) FRP rupture

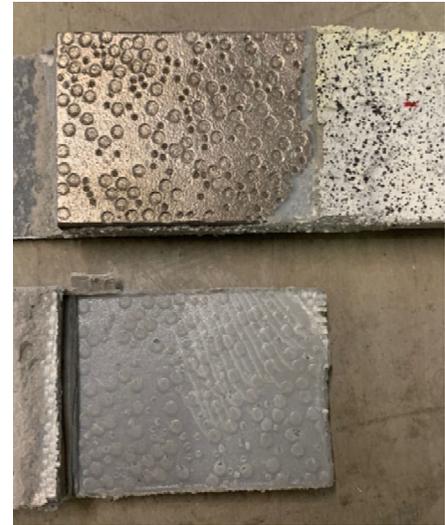
When looking at the failure modes of specimens with and without corrosion, there were no predominant failure modes for the Sika specimens. It was believed that the corrosion on the surfaces of the steel would serve as a bond enhancer using mechanical interlock. However, after examining the Sika and Nippon DSJ specimens that exhibited adhesion failures between the steel and priming adhesive, there was no residual adhesive in the pitting corrosion on the Sika specimens. Yet, there were signs that some mechanical interlock occurred in the Nippon DSJs. These Nippon DSJs, which showed interlock signs, had a 12.5% increase in failure displacement over the control specimens. Photos of Nippon and Sika adhesion failure surfaces are seen in Figure 23.

I. Nippon DSJ with Residual Adhesive in the Simulated Corrosion Pits

II. Sika DSJ with a "clean" Failure Surface

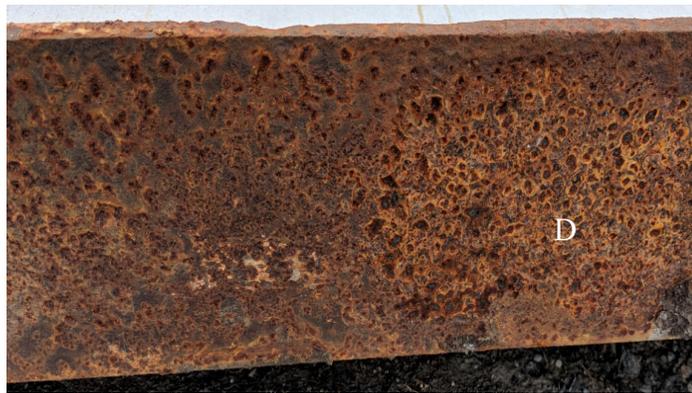
I. & II. The majority of the observed rusting on the surfaces to be retrofitted comprised of grades 'C' and 'D'. However, in some cases paint was still intact, indicating a rust grade 'A'.

I. Light to Severe Grades of Rust

II. Severe Grade of Rust

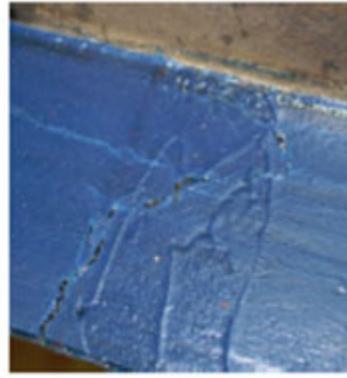
Figure 36. Examples of Nippon CFRP Rupture (I. & II.)

While this localized failure was quantified through strain gauge data, it was also observed visually and audibly during the testing. 11 audible CFRP rupture failures were heard during testing the Nippon 1-BBF specimen. After each of these failures, the researchers examined the location of failure. A typical localized Nippon CFRP rupture can be seen in Figure 36 I. & II. These observations demonstrate that many localized failures can occur before the complete failure of the Nippon CFRP retrofit.

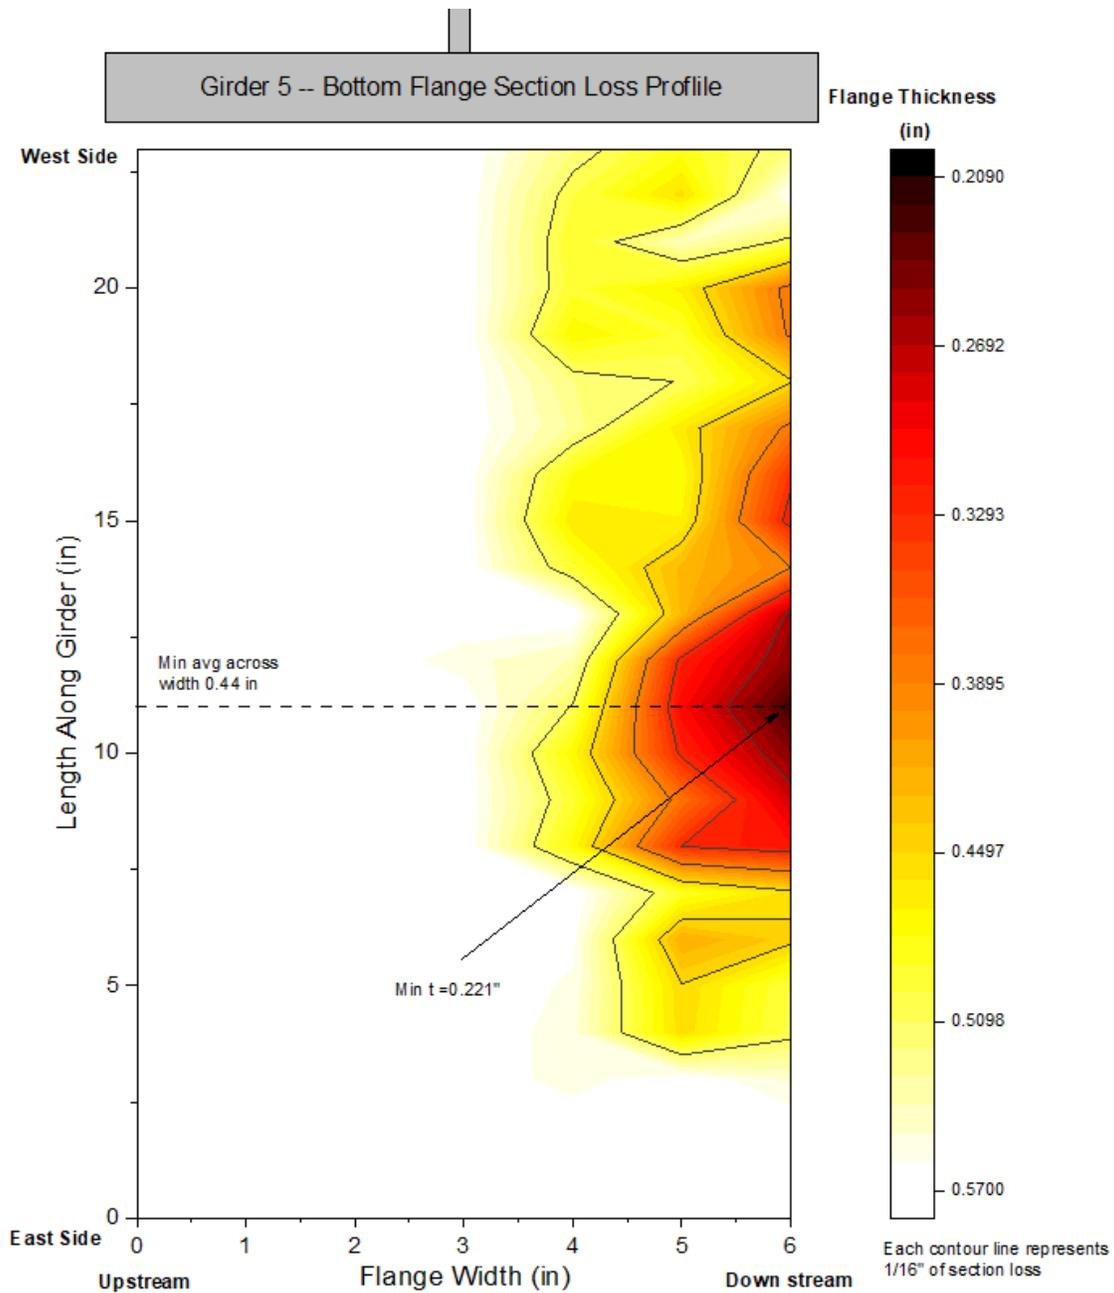
Figure 42. Heat Map of Beam 5's Bottom Flange Section Loss

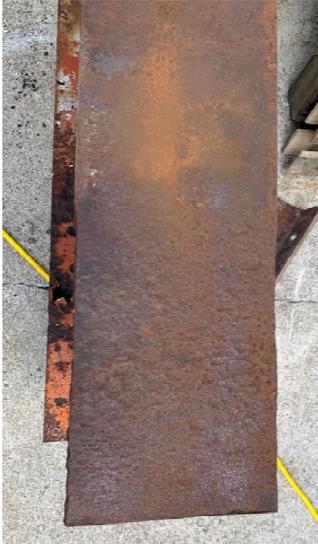
I. Representative Corrosion on the Pre-retrofitted Beam Specimen (BBF Near the End)

Before applying the CFRP retrofit on the retrofitted beam specimen, an extensive investigation of corrosion damage and surface roughness was completed. This data documented the severity and types of corrosion present on the bottom side of the bottom flange (BBF) to which a CFRP retrofit would be attached. Figure 43 I. and III. shows the corrosion damage on the pre-retrofitted beam after some spot cleaning with a needle gun, which was used to remove non-corrosion products (tar & sealer). The BBF was visually inspected using ISO 8501-1 (2007) to grade the

surface and rust condition before preparing the surfaces. These rust grades range from ‘A’ (little to no rust) to ‘D’ (millscale has rusted away and has general pitting). The majority of the observed rusting on the surfaces to be retrofitted comprised of grades ‘C’ and ‘D’.

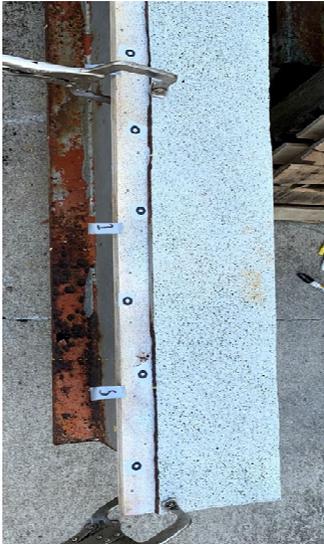
II. Stochastic Pattern on the Pre-retrofitted Beam Specimen (BBF Near the End)

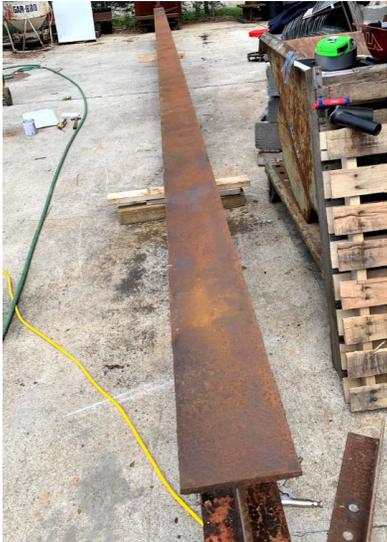
III. Total Corrosion Overview on the Pre-retrofitted Beam Specimen

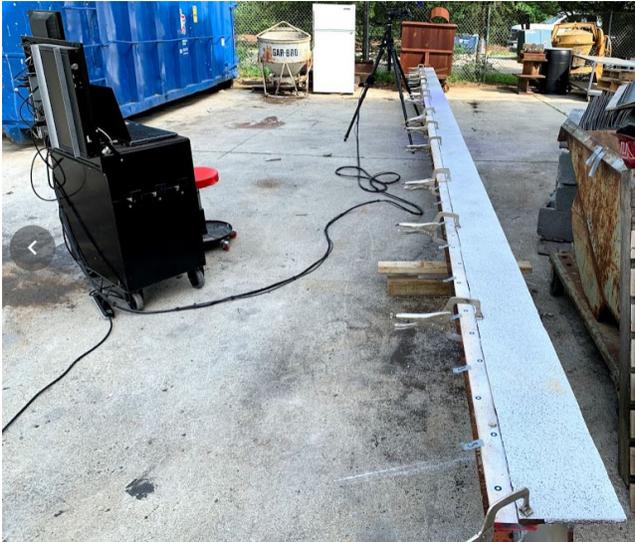
IV. DIC Being Used on the Stochastic Patterned Pre-retrofitted Beam Specimen

Figure 43. I-IV. Different Stages of Inspection on the Pre-retrofitted Beam Specimen

After the visual inspection, the entire 2,970 in² of the BBF's surface was inspected with a digital image correlation (DIC) system, shown in Figure 43 IV. The DIC system used in this testing consisted of a pair of 12 Megapixel CMOS sensors on an 800mm adjustable base, manufactured by GOM. The use of stereo vision and a stochastic pattern allowed for creating a 3D surface in space. This 3D surface was then analyzed to look at surface roughness parameters and section loss. This 3D surface consisted of over 9,697 inspection points. This roughly corresponded to a data point being taken on a 0.5-in by 0.5-in grid over the entire flange's bottom surface area. All points were examined for their deviation from a reference plane. These measurements provide the difference for each point inspected compared to the reference plane in the direction of the flange's thickness (Z-direction). The reference plane was created by evaluating all the points' Z locations. With the Z-location data, the mean reference plane was created from a Gaussian distribution (ignoring values outside three standard deviations). Figure 44 I. shows an example surface deviation heat map and a datum along the length of the plot. Figure 44 II. shows how the reference plane was defined, where the green plane in Figure 44 II. is the datum from which surface points (gray surface plane) are measured.

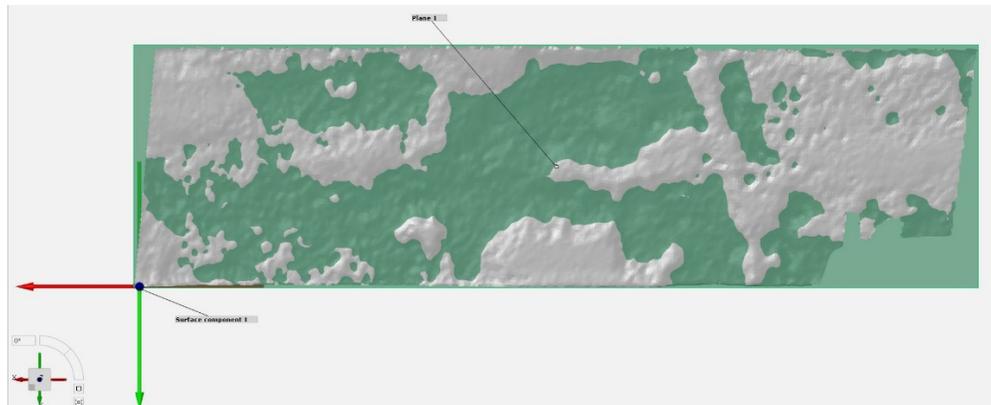
II. How the Reference Plane was Defined (Gray=3D Surface, Green= Reference Plane)

Figure 44. Example Surface Deviation Profile from the Retrofitted Beams Bottom of the Bottom Flange

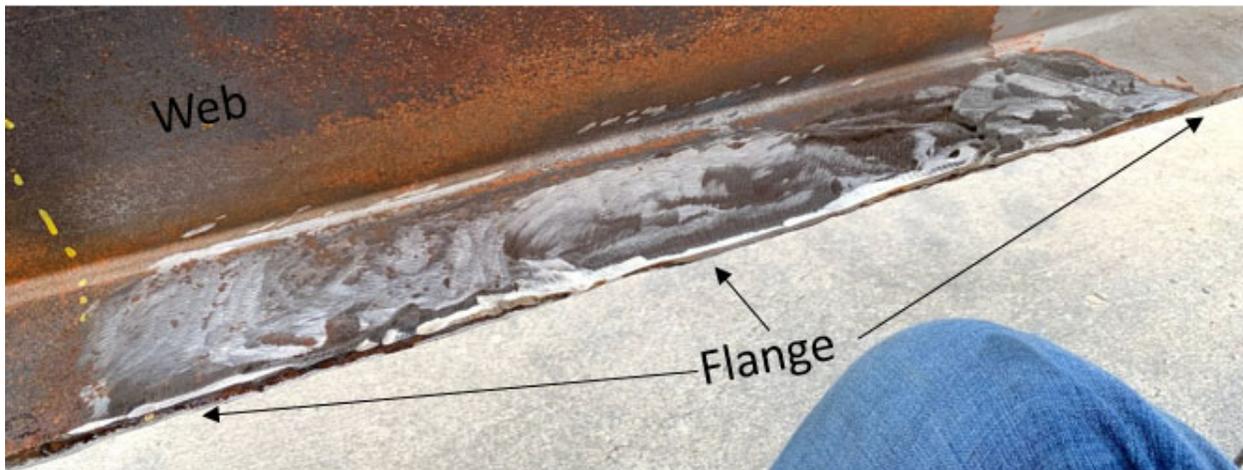
Figure 46. Recreated Beam 5 Corrosion on Laboratory Tested Beams

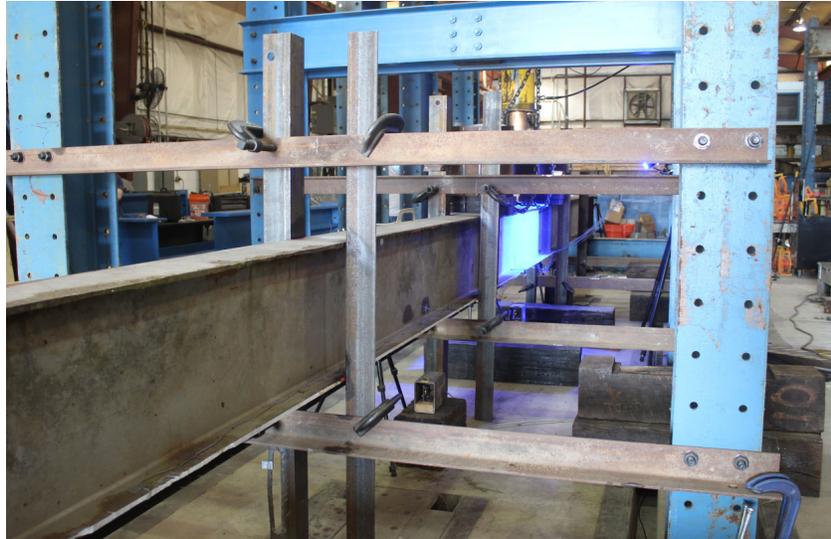
Figure 49. View of the Control Beam Before Testing

The loading of all the tested beams was carried out in a step-wise fashion in 5 kip increments before reaching the yield moment. After the yield moment of the beams was reached, the beams were loaded in 0.1 in increments until the termination of testing. An isometric view of the control beam being loaded is shown in Figure 49.
