An Investigation of Nut Loosening and Review of Tightening Procedures for Anchor Rods in Highway Ancillary Structures

Dissertation submitted to the faculty of the Virginia Polytechnic Institute and State University in partial fulfillment of the requirements for the degree of

Civil Engineering

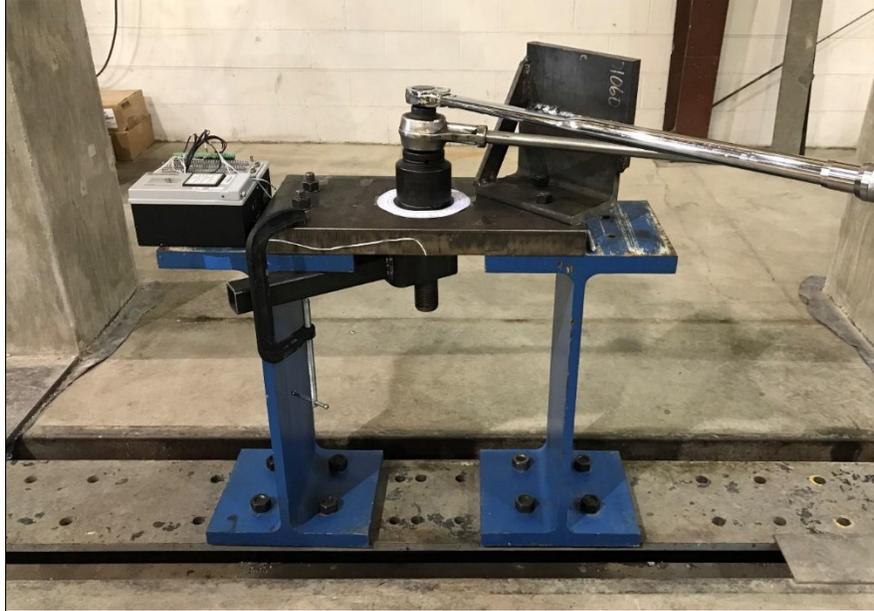
Figure 7. Test-setup for a 2 inch thick base plate

gauge with 360° markings around the anchor rod hole. The complete test setup for a 2 inch thick base plate is shown in Figure 7.

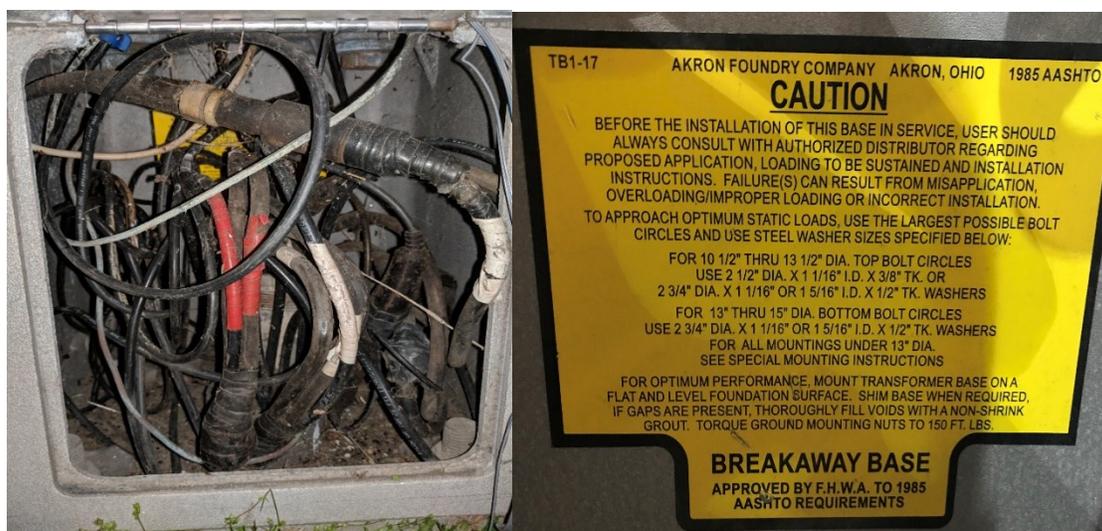
Figure 15. Electrical wiring (left) and manufacturer's instructions for installation (right) inside T-base

are not followed for tightening anchor nuts inside a T-base. Instead, breakaway T-bases generally come with manufacturer's instructions for installation. Most of the breakaway T-bases require the anchor rods to be torqued to 150-200 ft-lbs instead of using the turn-of-the-nut procedure (see Figure 15). As seen in Figure 15, it can be challenging to tighten anchor nuts using a hydraulic wrench or torque wrench inside the transformer base due to limited access and a high amount of electrical wiring. The structural bolts connecting the pole/shoe base to the T-base may be required to be tightened using the turn-of-the-nut method as per the shop drawings.

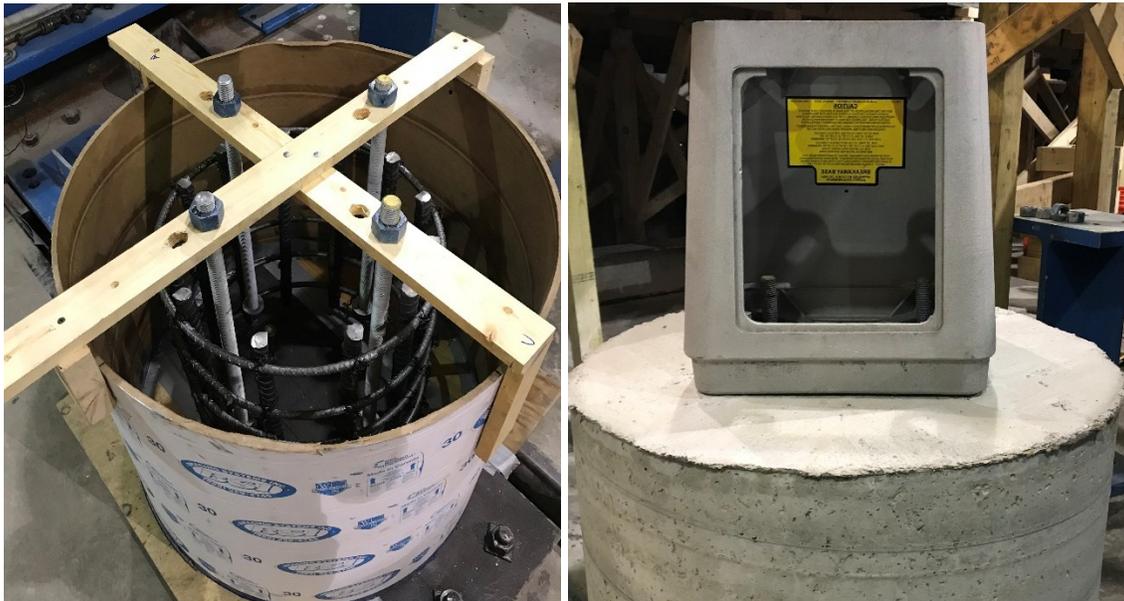
Figure 16. Formwork for the concrete foundation (left) and T-base with the casted foundation (right)

Four 1-inch, grade 55 anchor rods were cast inside a 30-inch diameter concrete foundation. The typical detailing given in the VDOT 2016 Road and Bridge Standards was followed (VDOT 2016b). The foundation was 24 inches deep. The anchor rods were surrounded by a rebar cage consisting of 12-#8 vertical rebar and 5-#4 rebar ties at 4.5 inches on center. The concrete foundation was connected to a 1-inch thick A36 grade steel plate using (4) 0.75-inch diameter steel stud anchors. The plate was further fastened to the strong floor of the laboratory. The formwork before placing of concrete and the final test-setup is shown in Figure 16.

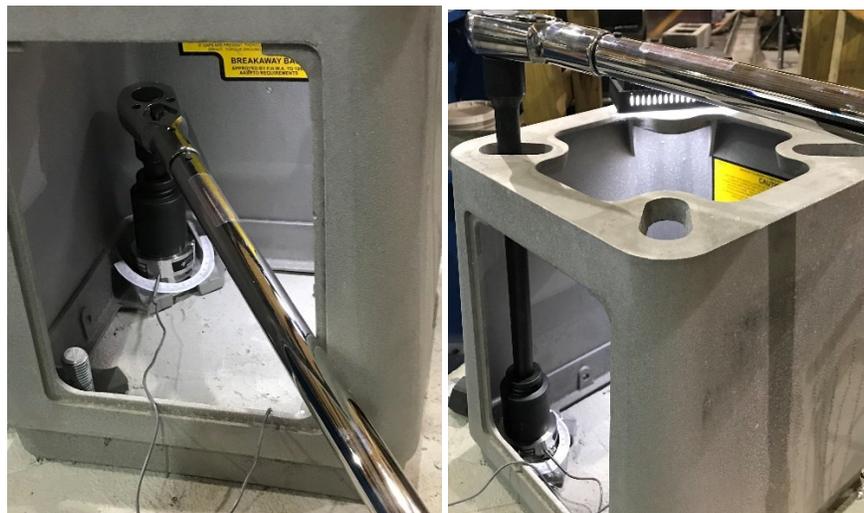
Figure 17. Tightening through the access hole (left) and tightening using the extension from the top (right)

Each of the four anchor rods was tightened five times in total using two tightening techniques. The first technique involved tightening the anchor rod using a 3-inch deep socket from the access hole of the T-base (see Figure 17). The second technique involved tightening the anchor rod using the 3-inch deep socket along with a 16-inch long extension. For ease of tightening, the extension was passed through the upper holes for structural bolts (see Figure 17).

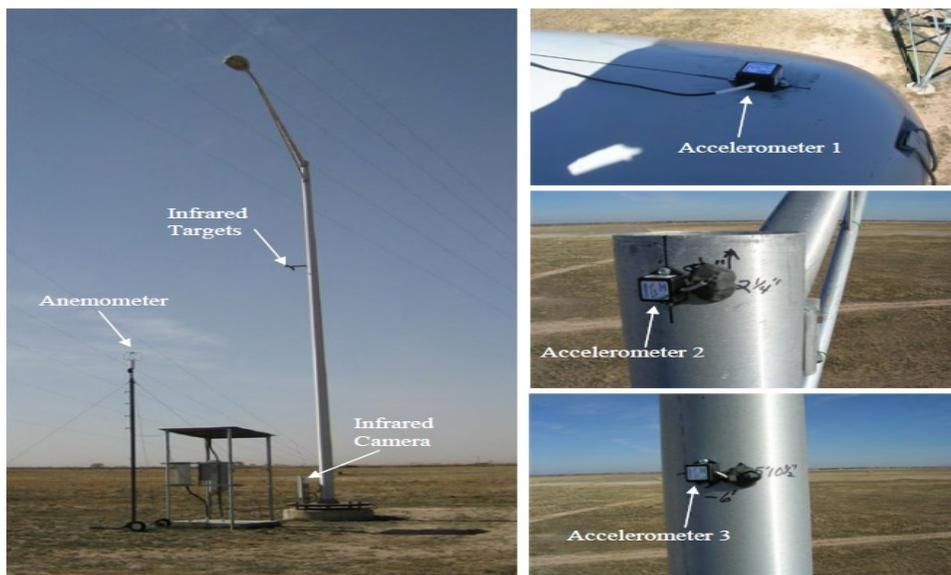
Figure 23. The instrumentation on the forty feet aluminum pole (Zuo and Letchford 2008). Reproduced with permission from the author.

In some field monitoring studies, multiple accelerometers have been used along the height of the structure to capture multiple modes of vibrations seen in the field (see Figure 23). The latest technologies, such as infrared cameras, were also used for measuring and validating deflections

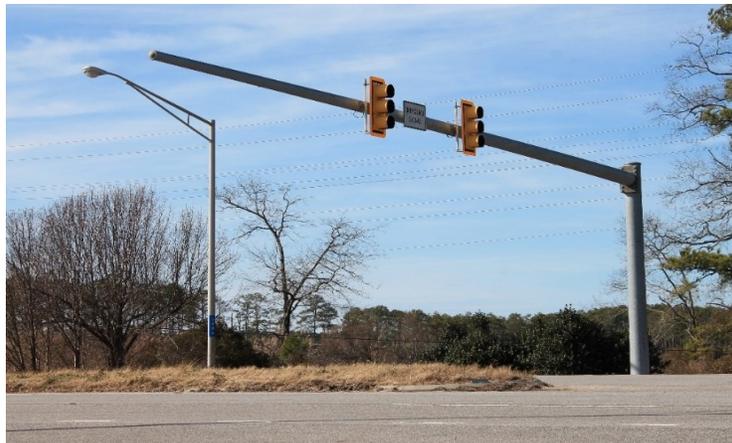
Figure 25. Instrumented luminaire and traffic signal near the east coast of Virginia

Two ancillary structures were instrumented and monitored for four months in a high wind speed region near the east coast of Virginia. Two different structure types—one aluminum luminaire and one overhead galvanized steel traffic signal located near the James River Bridge in Carrollton, Virginia, were field monitored from April 2018 to July 2018 (see Figure 25). The structures were instrumented with accelerometers, a wind monitor, and strain gages. The sensor data history was collected using a data acquisition system over the four months and used to analyze and determine observed vibration loads and stress ranges on these structures relative to specific wind speeds and wind direction. Similar loading conditions were simulated in the large-scale experimental testing program. The other purpose of the field monitoring was to determine the dominant modal frequencies and the structural behavior under vibrations.

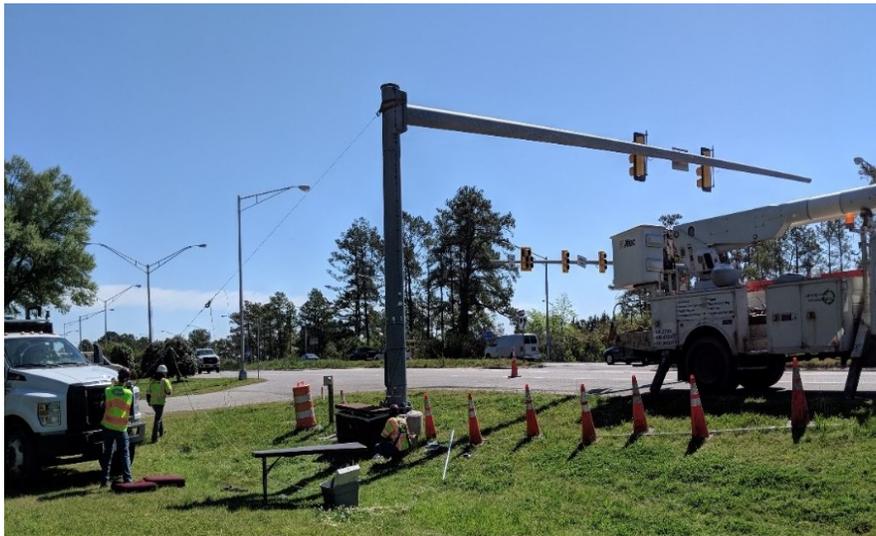
Figure 26. Pluck test performed on the overhead traffic signal

Pluck tests were performed on the individual poles to quantify their dynamic characteristics (see Figure 26). Pluck tests were conducted by pulling the top of the poles laterally using an instrumented cable. One end of the cable was tied to the top of the pole using a sling, and the other end was tensioned using a come-along attached to the trailer hitch. The cable was released using a quick-release shackle. Pluck tests were done to induce free vibrations in the poles. The resulting vibration data was further used to calculate the natural frequencies and damping ratios of each of the modes of the two poles.

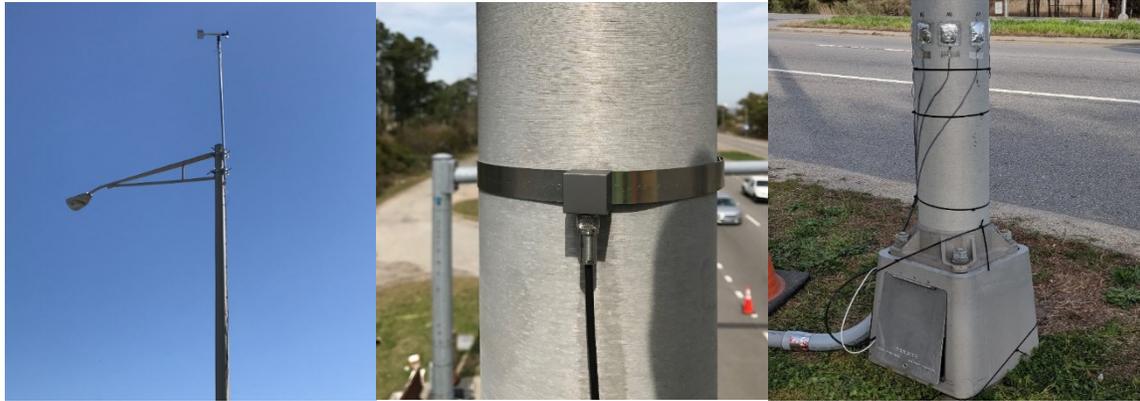
Figure 27. Wind monitor (left), Accelerometer (center), and Strain Gages (right)

or base plate. A K-type thermocouple (Omega Engineering) with a separate data logger was also installed near the job-box to measure the change in temperature of the ambient conditions every 5 minutes throughout the duration of the field monitoring. The instrumented sensors are shown in Figure 27.

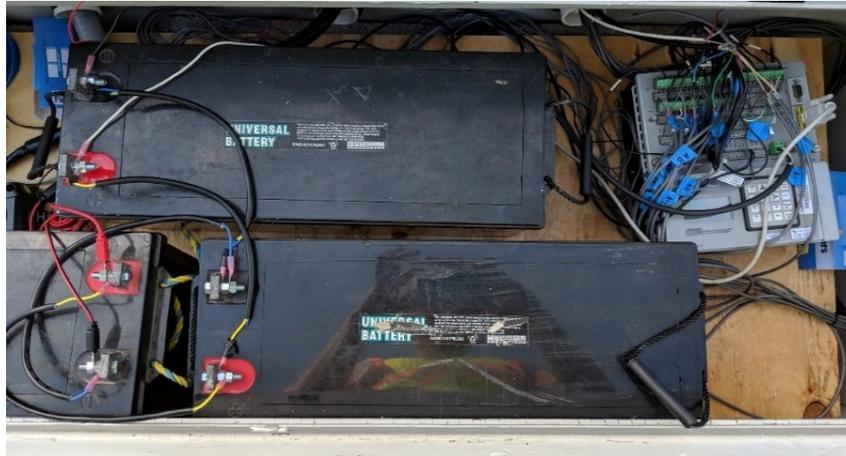
Figure 28. Parallel battery connection for charging CR5000

A CR5000 data logger from Campbell Scientific, Inc. was used for recording data and remote monitoring. The data-logger was a 16-bit data acquisition system with 20 differential and 40 single-ended analog channels. Sixteen strain gages, two accelerometers, and a wind-monitor were connected to the CR5000 data acquisition system. The CR5000 data logger was further connected to a cellular modem (Sierra Wireless Raven X) for wireless communications through a satellite internet connection. The data logger was constantly powered through three universal 12-volt, 200Ah batteries connected in parallel (as seen in Figure 28). The batteries were charged by a 7.5A–12V smart battery charger for approximately 8 hours each night where external power was supplied to the luminaire circuit. The sensors, batteries, data acquisition system, and modem were enclosed in a weather-proof job-box at the site.

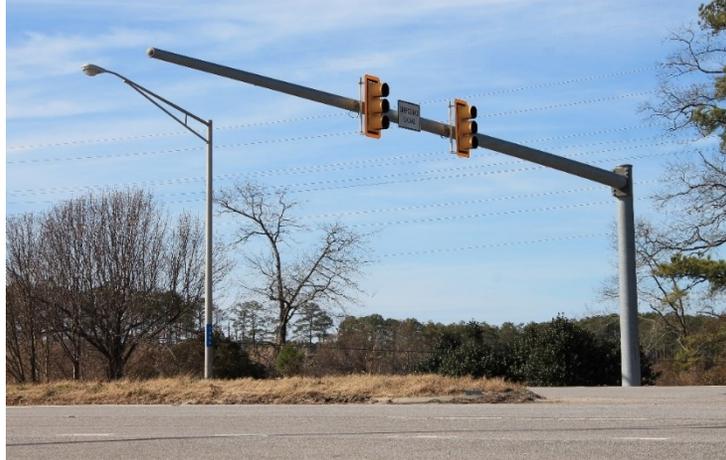
Figure 41. Instrumented traffic signal and luminaire in Carrollton, VA

Two previously installed ancillary structures (one aluminum luminaire and one galvanized steel traffic signal) close to each other were instrumented and monitored near the James River Bridge in Carrollton, Virginia for a four-month period from April 2018 to July 2018 (see Figure 41). The location was chosen on the basis of historical high wind speeds in the region due to the proximity to a large water body and minimal surrounding forest cover. The traffic signal consisted of eight, 2 inch diameter anchor rod fastened to a 21 feet high straight pole. The outside diameter of the straight pole of the traffic signal was 17 inch at the top and 19.5 inch at the bottom. The luminaire was a four 1 inch diameter anchor rod configuration structure with an overall height of 26 feet. The outside diameter of the straight pole of the luminaire was 6 inch at the top and 8 inch at the bottom. Multiple sensors, including accelerometers, wind anemometer, strain gages, and thermocouple, were instrumented on each structure. Pluck tests were conducted on the first day of the field monitoring program to identify and calculate the dynamic characteristics like modal frequencies and damping ratios of the individual structures. After the pluck tests, the ancillary structures were remotely monitored for wind-induced vibration data including accelerations, wind speeds, wind direction, vibration stress, and temperature change for a four-month period. However, only data pertaining to observed pole vibration stresses and anchor rod vibration stresses for the traffic signal is relevant to the discussion in this paper and hence, has been discussed in detail here.

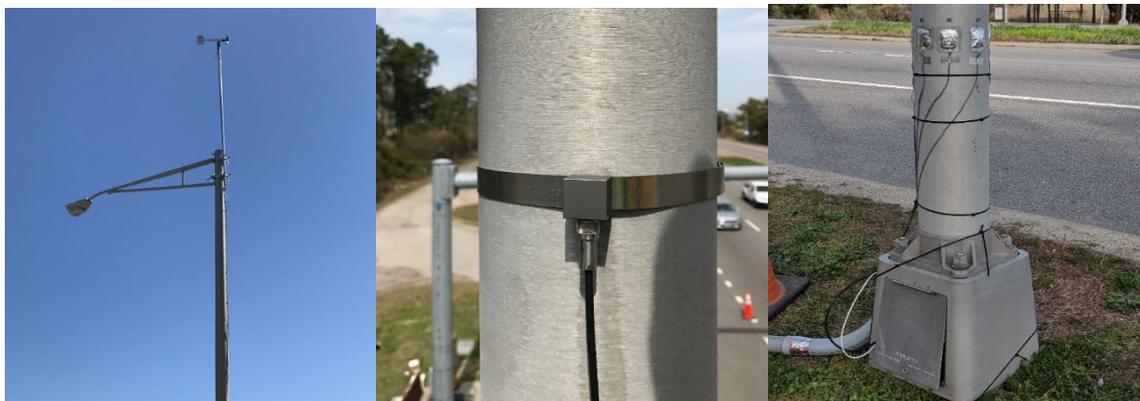
Figure 42. Wind monitor (left), Accelerometer (center), and Strain Gages (right)

A propeller-type anemometer (Model 05103: RM Young Company) was installed on top of the luminaire for recording wind speeds and wind direction. One tri-axial accelerometer (Model 3713E1125G: PCB Piezotronics, Inc.) was installed on top of each of the two structures for measuring the amplitude and frequency of accelerations due to wind loads. Eight temperature compensated strain gages (Model CEFLA: Tokyo Measuring Instruments Laboratory Co., Ltd.) were installed radially, 45° apart from one another on each pole above the hand-hole to record the bending stresses corresponding to the wind-induced vibrations, as shown in Figure 42. A Campbell Scientific CR5000 data logger was used for recording and monitoring data.

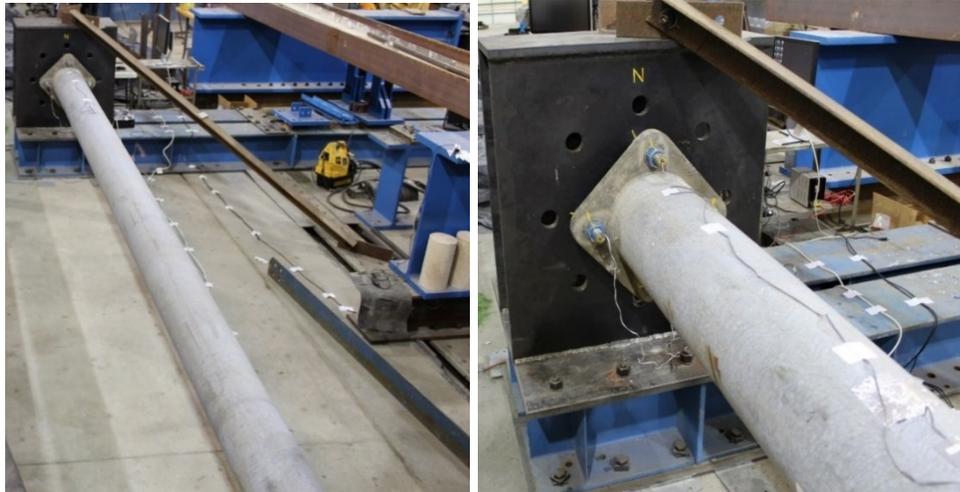
The reaction box fixture was fastened to two W14x99 sections, which were connected at three locations to the floor of the laboratory, eight feet apart (see Figure 46). The two W sections were also connected using plates at the top and bottom to provide resistance to torsional movements during vibrations.

Figure 46. Complete view of the test-setup for large-scale testing

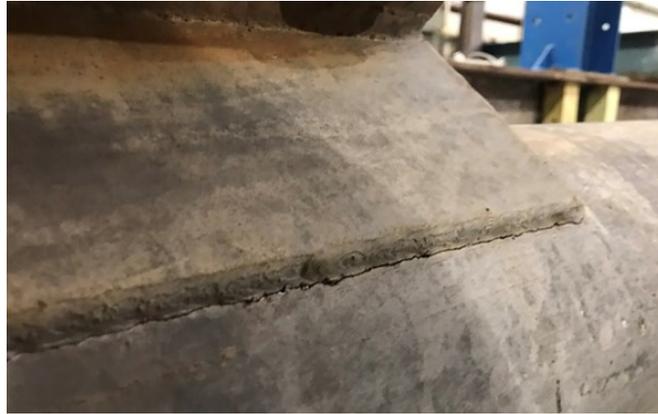
Figure 48. Weld crack at the connection between straight pole and mast arm

Fifteen tests were conducted in total during the large-scale vibration testing. The first test involved vibration of the traffic signal with a 15-foot mast arm. The vibrations were induced in the 2nd mode (fundamental out-of-the plane mode of the mast arm) of the traffic signal. After vibrating the pole for 600,000 cycles (including trial tests), a weld crack was observed on the connection between the mast arm and straight pole (see Figure 48). Due to weld cracking, the remainder of the fifteen tests were conducted on the straight pole in the first natural mode.

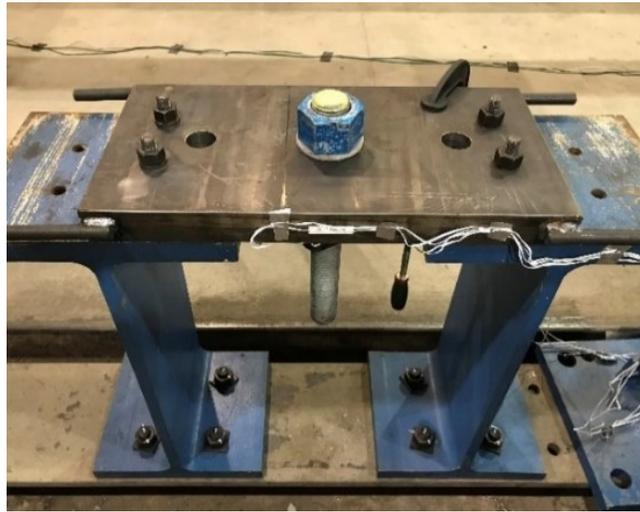
(W27x217) using 7/8 inch diameter A490 bolts. The beam stubs were further connected to the strong floor of the laboratory. Each anchor rod was passed through a predrilled hole in the center of the base plate. The top nut was snug-tightened using an adjustable length ratchet. The bottom nut was prevented from rotating while tightening by using an adjustable wrench clamped to the bottom of the base plate. The test-setup for snug-tightening of a 2 inch anchor rod is shown in Figure 62.

Figure 62. Test-setup for snug-tightening
