Investigation of Chloride-induced Stress Corrosion Cracking for Long-Term Storage of Spent Nuclear Fuel in Dry Storage Systems

Thesis submitted to the faculty of the
Virginia Polytechnic Institute and State University
in partial fulfillment of the requirements for the degree of

Nuclear Engineering

Keywords: chloride-induced stress corrosion cracking, stress corrosion
cracking, spent nuclear fuel dry storage, CISCC, SCC, ISFSI

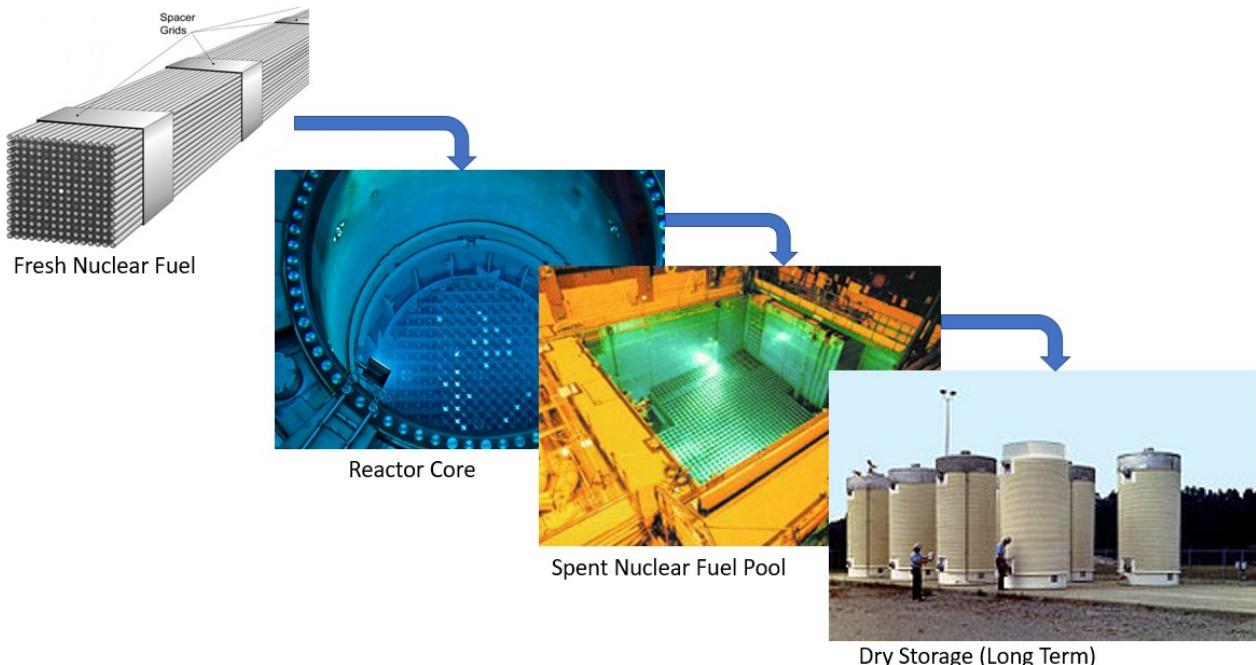
Figure 2. Nuclear Fuel Cycle in the United States

fission process during the reactor's operation. Therefore, SNF must be stored in a pool next to the reactor's core for a minimum of five years until they reach a lower activity level suitable for DSCs that are shown on the far right of Figure 2.

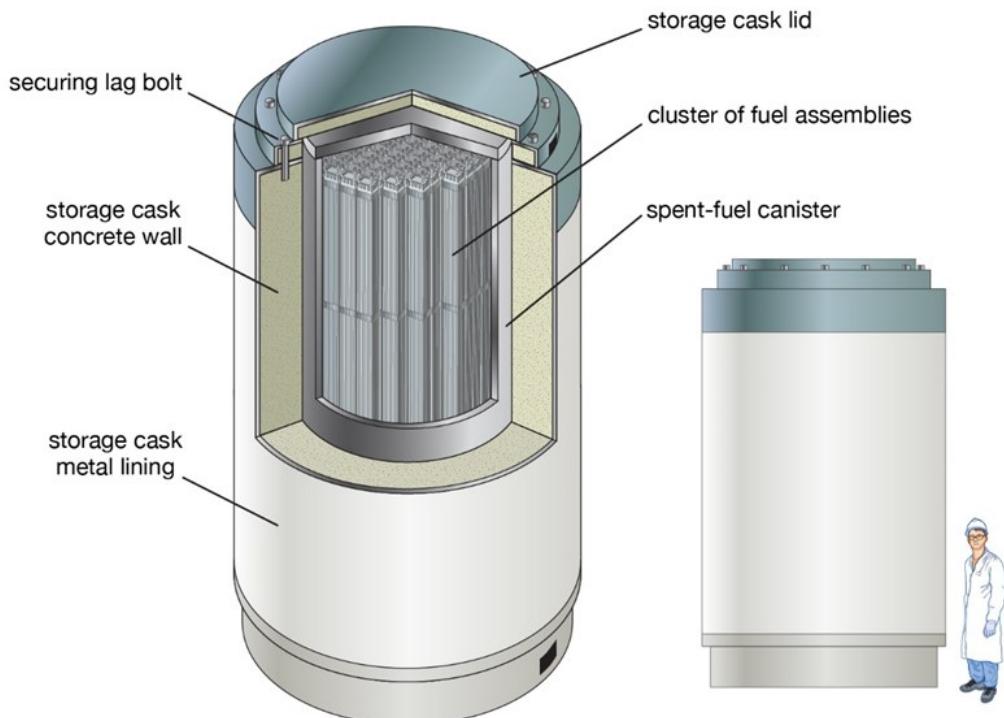
Figure 3. Vertical SNF Dry Storage System (HI-STORM) [12]

There are two dry storage cask designs that are currently licensed by the NRC, vertical and horizontal systems shown in Figure 3 and Figure 4, respectively. The two designs are similar in their capability of decay heat removal from the SNF by natural convection, but the onsite footprint, construction method, construction material, and their efficiency of heat removal are different.

A typical dry storage cask unit consists of a concrete vault surrounded by an outer metal lining. Inside the concrete vault (shell) is the stainless steel canister that houses the SNF assemblies. The primary construction material of the internal canister is 300-series stainless steel and most

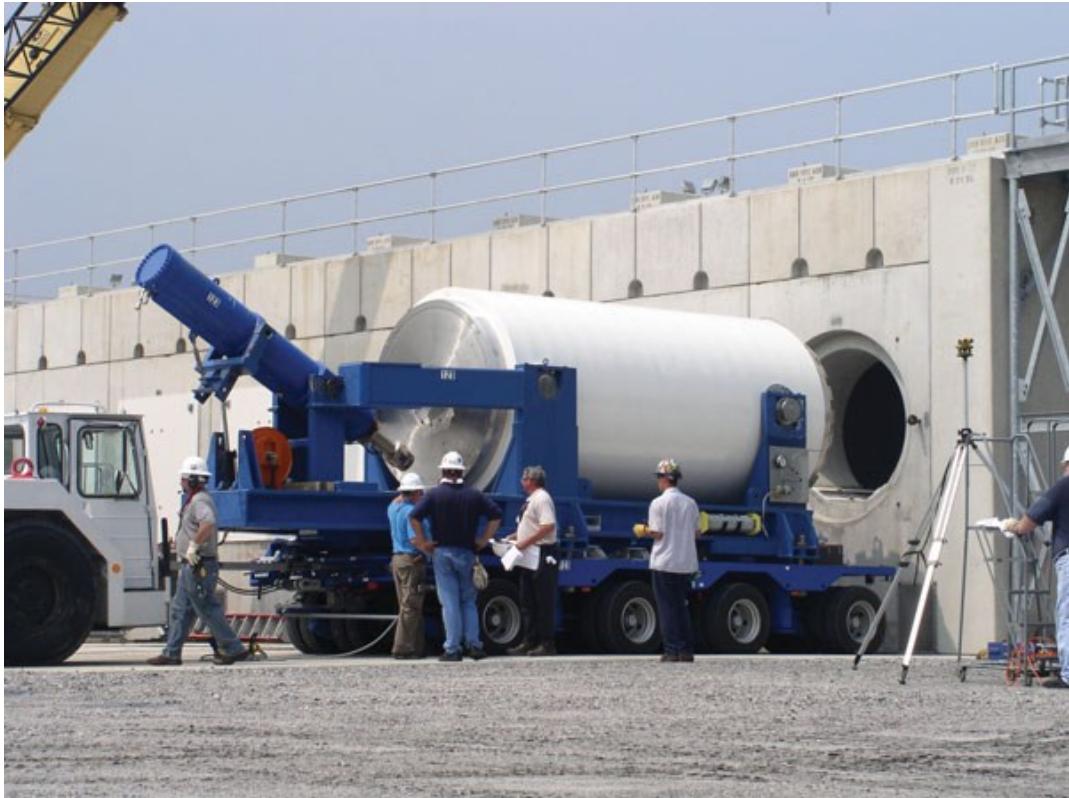
Figure 4. Horizontal SNF Dry Storage System (NUHOMS) [13]

commonly austenitic stainless steel 304, 304L, 316, and 316L grades with bolted or welded canister's lid [2]. DSC systems are stored independently outdoors within the nuclear plant's vicinity on a designated concrete pad to allow for natural convection. Vertical DSCs can be stored as independent units, such as the Hi-STORM dry cask shown in Figure 3 which is made by Holtec International [12]. Horizontal DSCs are stored in groups as shown in Figure 4 with a natural convection cycle through the concrete structure to remove decay heat, such as the NUHOMS dry cask made by Orano [13].

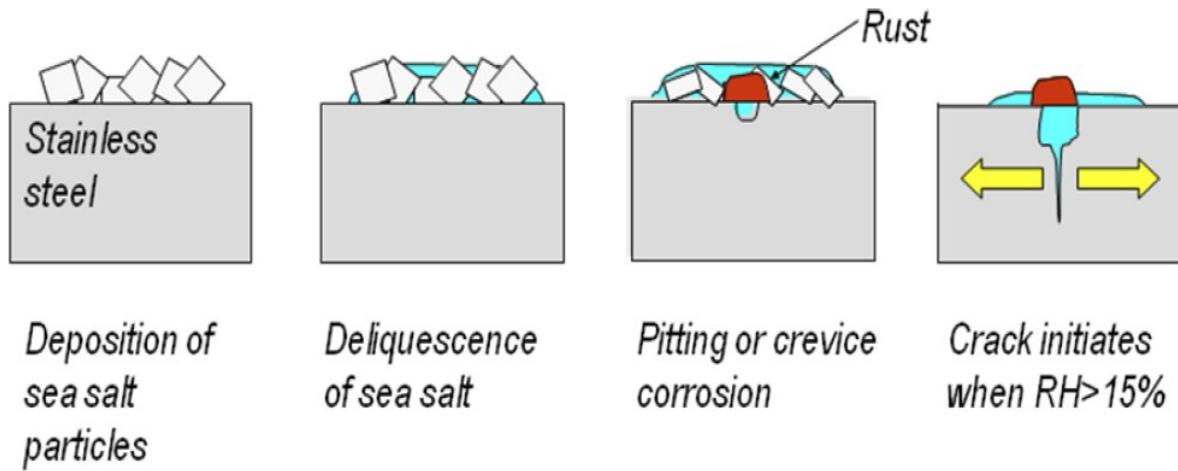
Figure 5. Stages of Stress Corrosion Cracking [19]

threshold for tensile stress to initiate SCC but increased tensile stress accelerates time to failure. Applied stresses makes the stainless steel's protective oxide layer susceptible to damage which encourages pitting corrosion [17] [18]. Pitting corrosion advances into SCC when the appropriate conditions are present as depicted in Figure 5 [19].

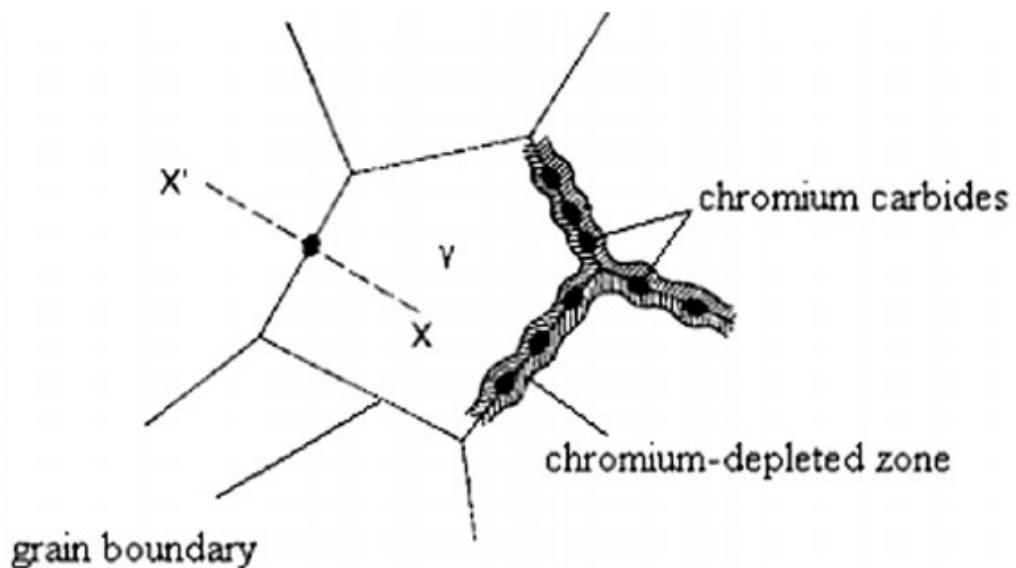
Figure 6. Chromium Carbide Precipitation from Welding [21]

Additionally, heat sensitization due to welding or heat treatment reduces the material's resistance to corrosion. Welding stainless steel requires heating to 400-800°C resulting in a HAZ where carbon atoms diffuse to the edges of the grain boundaries and react with the available chromium forming chromium carbides (Cr_{23}C_6) as shown in Figure 6 [21]. Chromium in stainless steel is the primary protective element as it reacts with oxygen when exposed to the atmosphere to form a protective oxide layer on the material's surface. On the other hand, chromium depletion can be detrimental to the stainless steel's ability to fight corrosive attacks by weakening the grain boundaries leading to intergranular stress corrosion cracking [22]. Low carbon materials such as, 304L or 316L (L indicates a low carbon content) are recommended for welded structures to mitigate the effect of heat sensitization [22] [23]. DSCs are made from rolled stainless steel shells which are likely to have residual stresses from manufacturing and some are welded which further increases its susceptibility to CISCC.

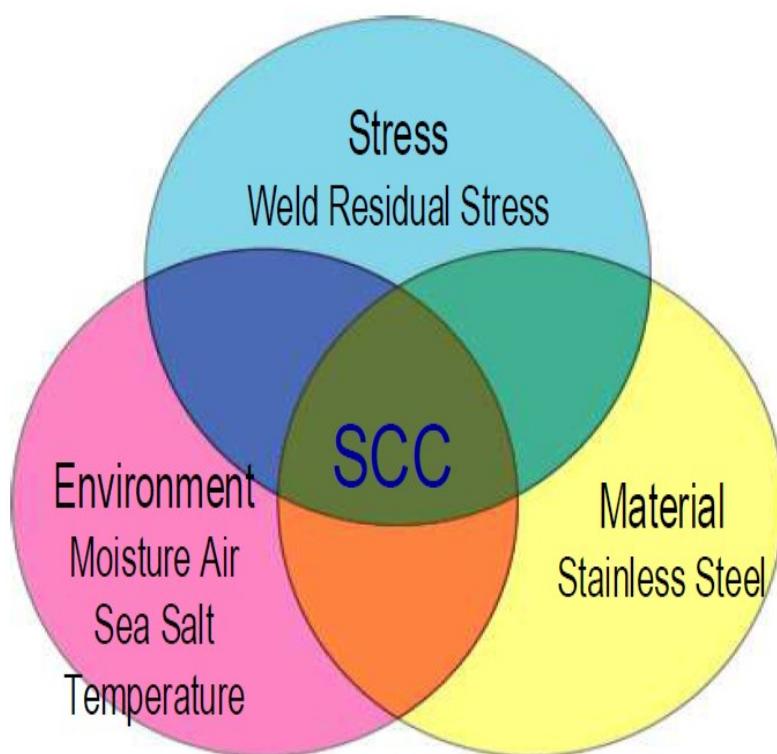
Figure 7. Stress Corrosion Cracking Conditions Map [24]

The presence of a susceptible alloy, heat sensitization, and tensile stresses without a corrosive environment is not enough to trigger concerns over CISCC. Crack initiation and propagation is also dependent on the environmental conditions surrounding the material. Figure 7 shows the conditions that must be present simultaneously for the initiation of SCC [24]. If one condition is eliminated or avoided, the likelihood of developing SCC will be reduced dramatically. Likewise, exposure duration is an essential variable to the development of SCC although not depicted in Figure 7. SCC is a long-term phenomenon as stated previously, its development takes place over extended exposure given all pre-conditions are met.

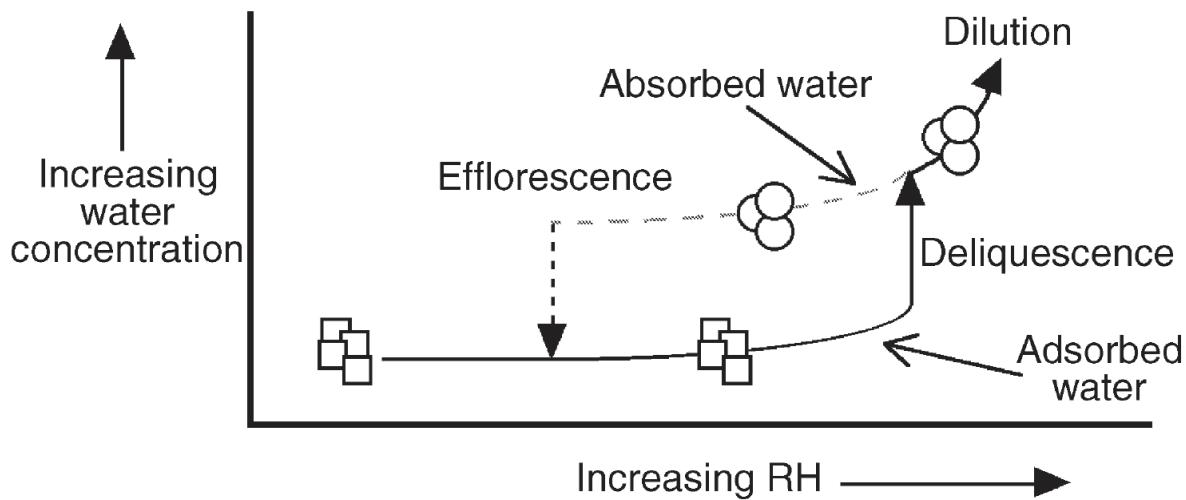
Figure 8. Salt Deliquescence, Efflorescence, and RH Relationship [25]

A typical corrosive environment is best characterized with high concentrations of salts, high atmospheric temperature, and high RH. High RH coupled with high concentration of salts in the atmosphere enables a process known as deliquescence. Deliquescence is the process where solid salt deposits on material surfaces absorb humidity from the surrounding air to form a chloride rich liquid film that eventually dissolves the stainless steel's chromium passive layer leading to the oxidization of the base metal (Fe_2O_3). On the other hand, high temperatures enable efflorescence which is the process of drying the material's surface leaving behind solid salt deposits as shown in Figure 8 [25]. Both deliquescence and efflorescence, which are competing processes, contribute to the material's degradation and lead to corrosion, pitting, and cracking after extended exposure.

Research suggests that there is a threshold RH at which the risk of SCC increases which is known as “deliquescence relative humidity”. The deliquescence RH threshold is a function of the salt type and is independent of the quantity of deposited salt [26].

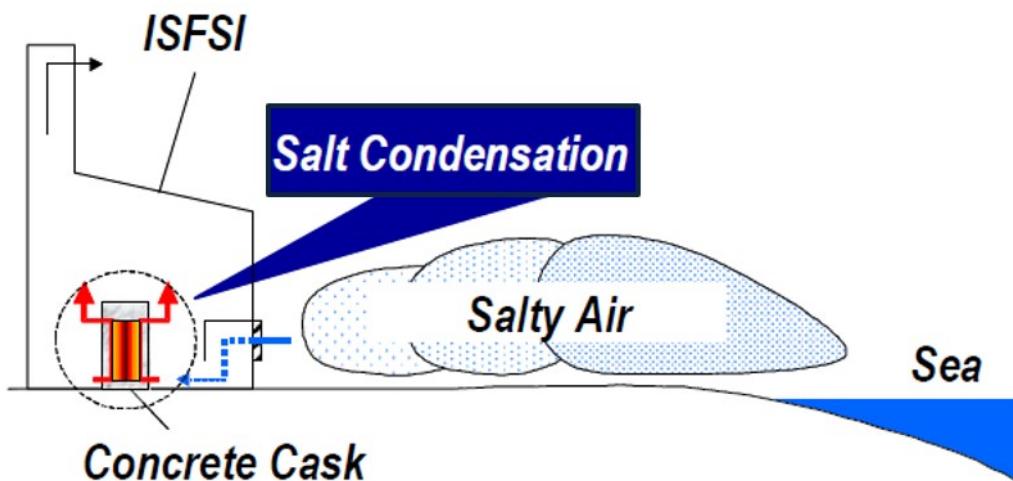
Figure 9. Schematic of ISFSI in a Corrosive Environment [24]

The schematic in Figure 9 shows a DSC (*aka.*, ISFSI) unit located near sea water which is the motivation behind this research to examine its service life. NPPs located near marine environments and considering DSCs for long-term storage must be mindful of the CISCC risk within their aging management strategy. Experimental data on pitting and cracking can be useful to the NRC in licensing commercial DSCs for long-term storage beyond the initial 20-year term.

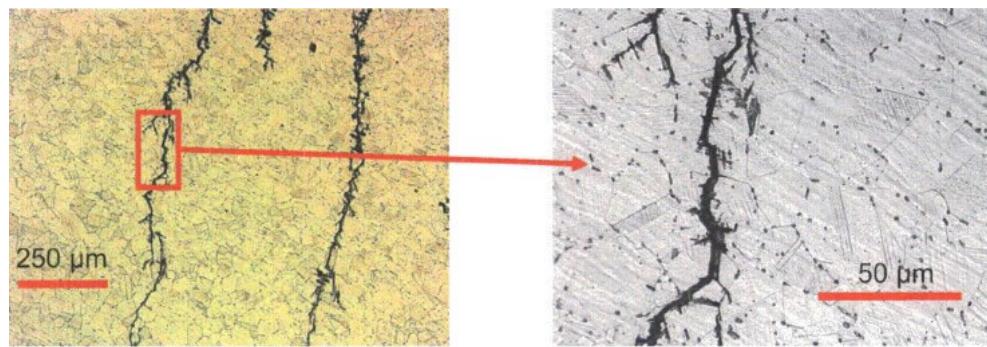
Figure 10. CISCC Observed on 304 Sample Exposed to 43°C for 16 Weeks [16]

The NRC in collaboration with the SWRI performed an accelerated CISCC experiment [16] following a modified version of GM 9540P accelerated test procedure. The NRC used a standard fogging chamber to evaluate U-bend and welded U-bend samples made of 304, 304L, and 316L austenitic stainless steel at temperatures ranging from 25°C - 176°C and varying RH. The corrosion chamber used by the NRC (Auto Technology model number CCT-NC-40) has a cyclic capability to maintain a salt layer on the samples. The cyclic feature works by fogging salt for a predetermined duration and then dispersion stops for drying leaving behind salt deposits on the sample's surface. RH was a function of the exposure zone temperature, wet and dry cycles alternated RH from high to low and vice versa but it did not exceed 75% in any of the experiments. The NRC used an optical microscope to examine corroded samples; cracks were observed under 50X magnification with widths ranging from 3 to 5 µm as shown in Figure 10 for the 304 sample exposed to 43°C for 16 weeks.

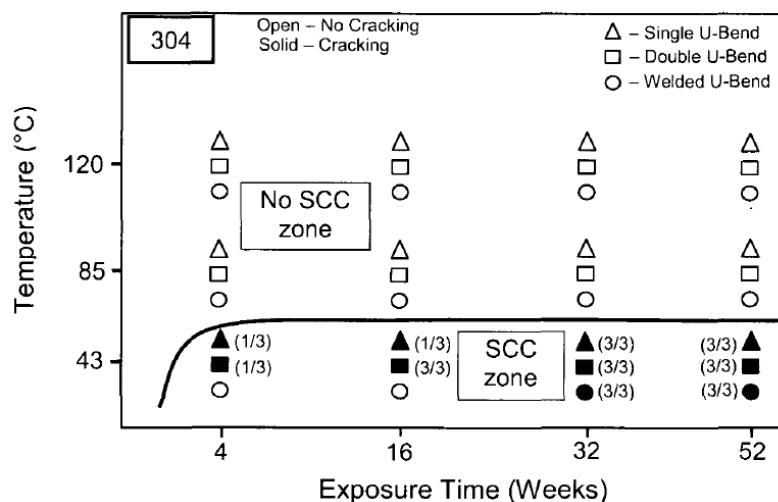
Figure 11. Exposure Time vs. Temperature for 304 Samples [16]

The NRC conclusions did not agree with previous published literature [27] relative to the effect of temperature on SCC. The NRC observed cracks at exposure temperature below 43°C for all sample types and exposure durations (4 - 32 weeks). The NRC findings indicate that CISCC does not accelerate at higher temperatures as evident by the plot shown in Figure 11 for 304 samples. Moreover, welded U-bends did not crack between 4 and 16 weeks of exposure at 43°C while at least one unwelded U-bend cracked during this time undermining the effect of sensitization due to welding.

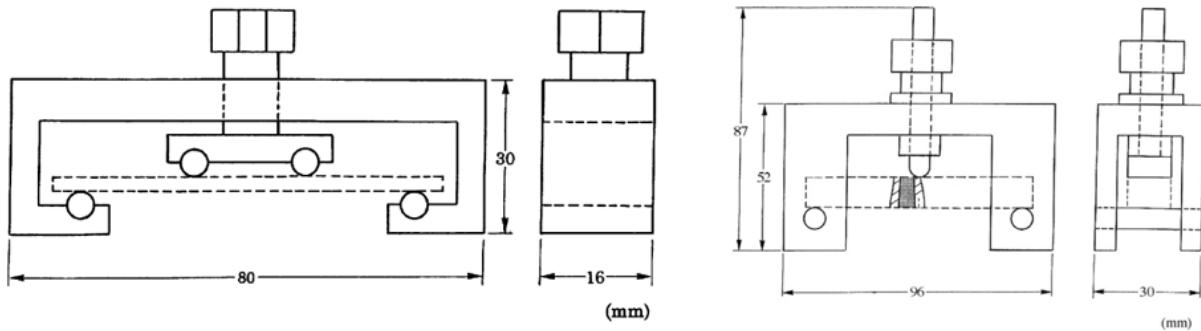
Figure 12. Kosaki Samples, 4-point Bend (Left) and 3-point Bend (Right) [4]

Kosaki [4] performed two experiments to estimate SCC initiation time and crack growth rate under both natural and accelerated exposure conditions. The SCC initiation experiment was performed using the 4-bend point samples without cracks, the crack growth experiment utilized 3-bend point samples with a pre-existing crack. The Kosaki experiment utilized base metal and welded samples made from 304, 304L, 316LNG (NG is a nuclear grade designation), refer to Figure 12 for the sample's configurations.

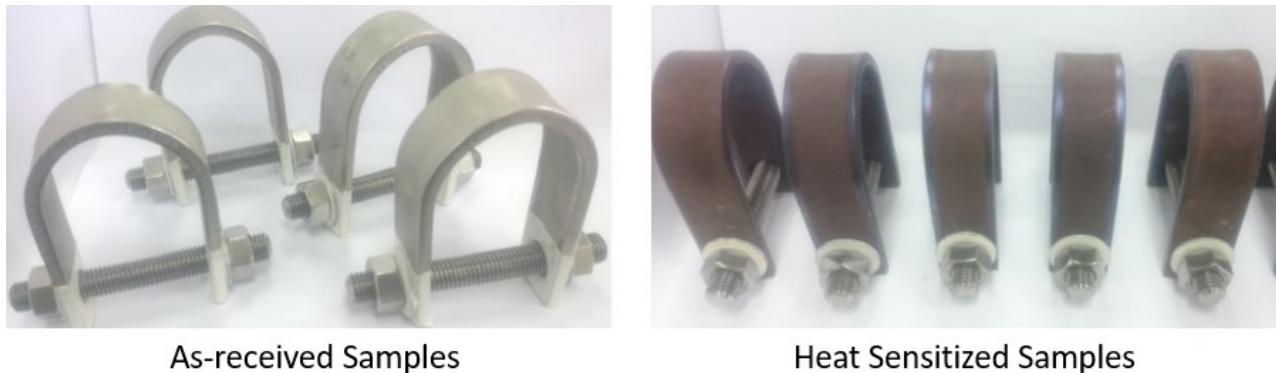
Figure 13. U-bend Samples from Zakaria's Immersion Experiment [27]

Zakaria et al. [27] performed an accelerated experiment using 304L U-bend samples prepared in accordance with the ASTM G30 standard [28]. The experiment method was long-term immersion of as-received and heat sensitized samples (600°C for 2 hours). This experiment utilized NaCl salt solutions with 0.1 wt.%, 1 wt.%, and 3.5 wt.% concentrations and 28°C , 70°C , and 90°C exposure temperatures. The samples were immersed for 42 days to examine the effect of heat sensitization, temperature, and salt concentration on the acceleration of CISCC.

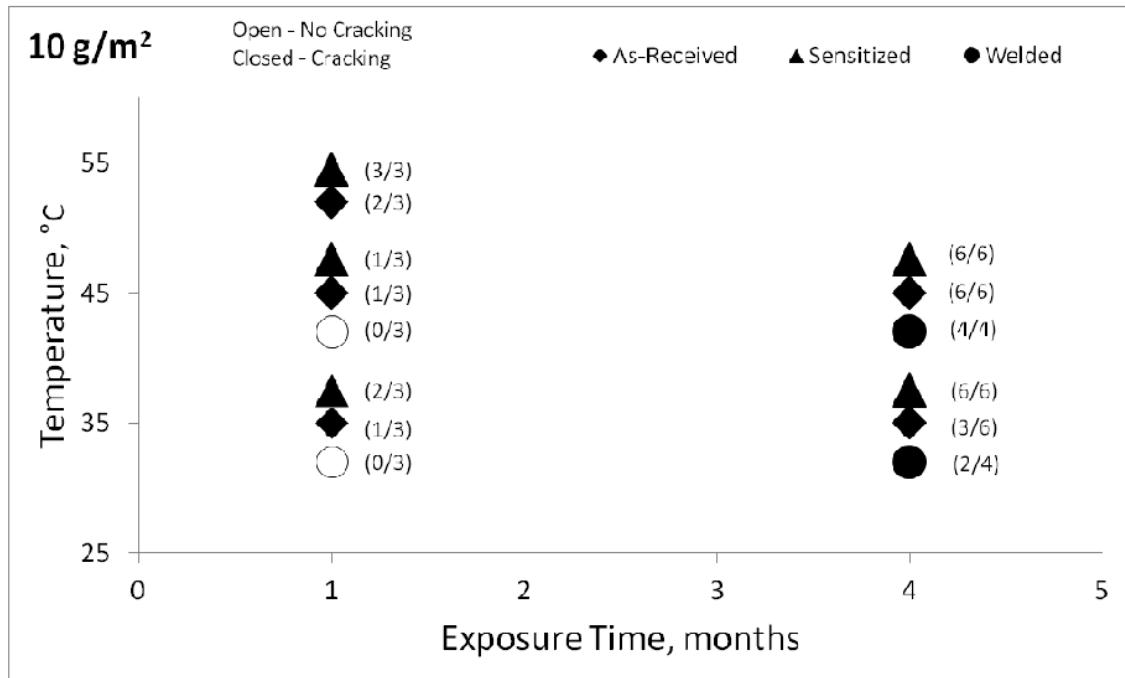
Figure 14. SCC Map for 10 g/m² Simulated Sea Salt [30]

The results from the first cyclic experiment showed high dependence between salt concentration and SCC. The samples exposed to 10 g/m² deposition density were more susceptible than those exposed to 0.1 and 1 g/m² deposition densities and cracked as early as one month of exposure. Refer to Figure 14 and Figure 15 for susceptibility maps for 10 g/m² and 0.1 g/m² simulated sea salts, respectively. Mintz observed cracks on the samples exposed to 35, 45, and 52°C but not at 60°C. Sensitized specimens showed more cracking than as-received samples and more interestingly welded samples were less susceptible to cracking than heat sensitized and as-received samples similar to the conclusion drawn from the NRC study [16]. Cracks were observed in the cyclic experiment after one month and it was more severe after four months as evident in the susceptibility maps in Figure 14 and Figure 15. On another observation from this experiment, samples exposed to lower simulated sea salts showed increased susceptibility at lower temperatures. This experiment shows that CISCC depends on salt deposition density and temperature (coupled dependence), increasing temperature only did not necessarily correlate with increased susceptibility to SCC in agreement with the NRC conclusions [16].

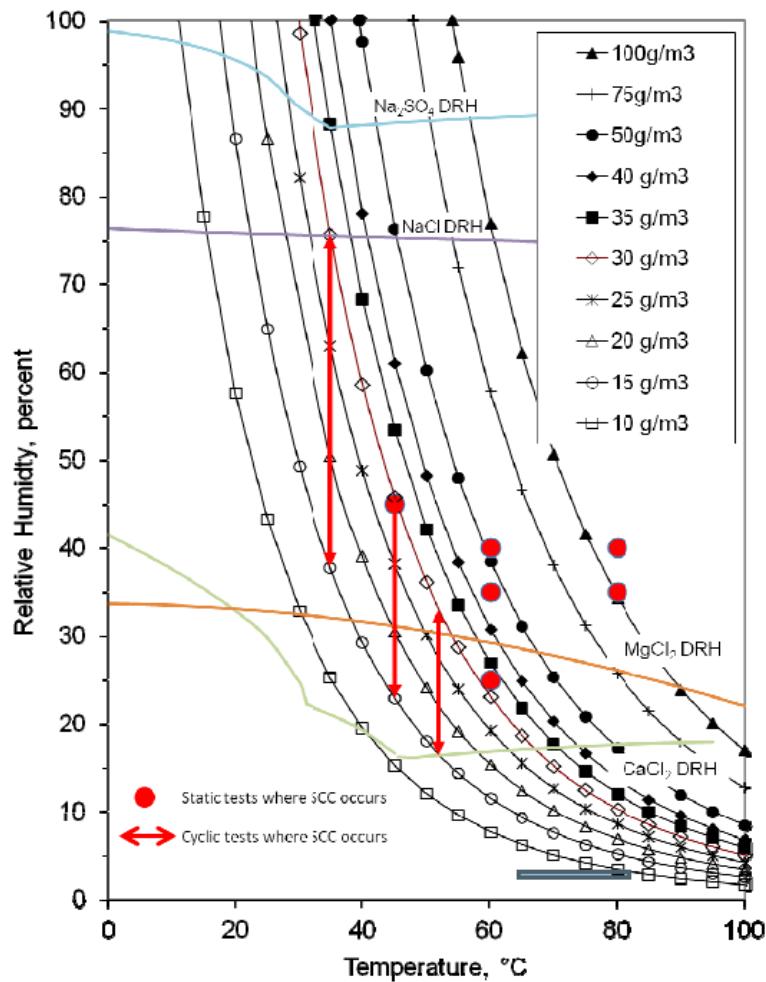
Figure 16. SCC Map for RH vs. Temperature for Cyclic and Static Tests [30]

The results from the second experiment at constant humidity or static environmental conditions were consistent with the results from the cyclic tests. At 60°C of the constant humidity test, crack initiation was observed at above 25% RH and no cracking or pitting were observed below this threshold. For the samples held at 80°C, the RH threshold was determined 35% or higher as illustrated in Figure 16 for both the cyclic and static tests. The experimental work performed by Mintz indicates that crack initiation is a function of RH, temperature, and salt deposition density as shown in Figure 16.

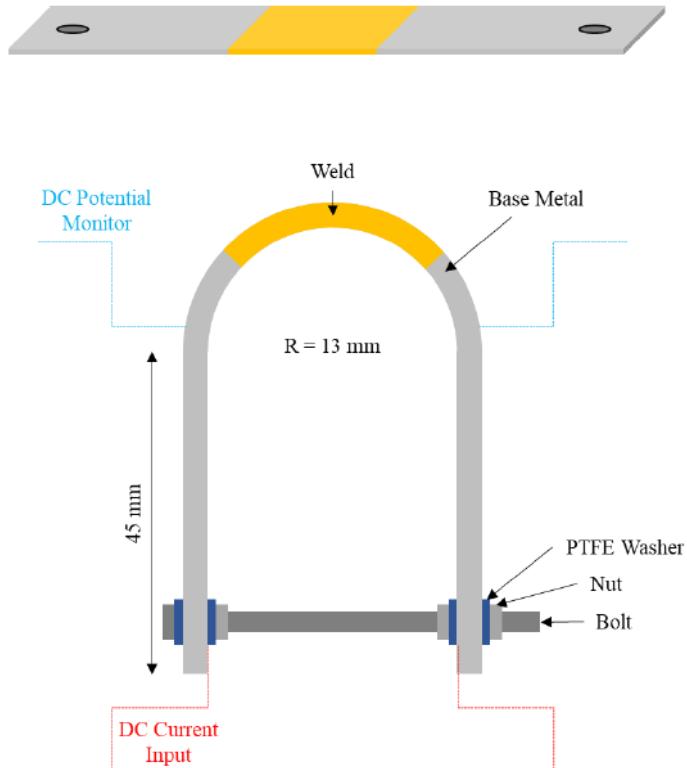
Figure 17. Sample Configuration for CISCC Signal Monitoring [32]

Kim et al. [32] performed an accelerated experiment to evaluate welded U-bend samples made from 304L and 316L austenitic stainless steel at different temperatures and RHs. The objective of this experiment was to examine the effect of temperature and RH on welds. The samples were welded using automated gas tungsten arc weld (A-GTAW) method, welding temperature was maintained below 175°C . The samples were instrumented with a direct current potential drop (DCPD) to monitor the initiation of CISCC signal as shown in Figure 17.

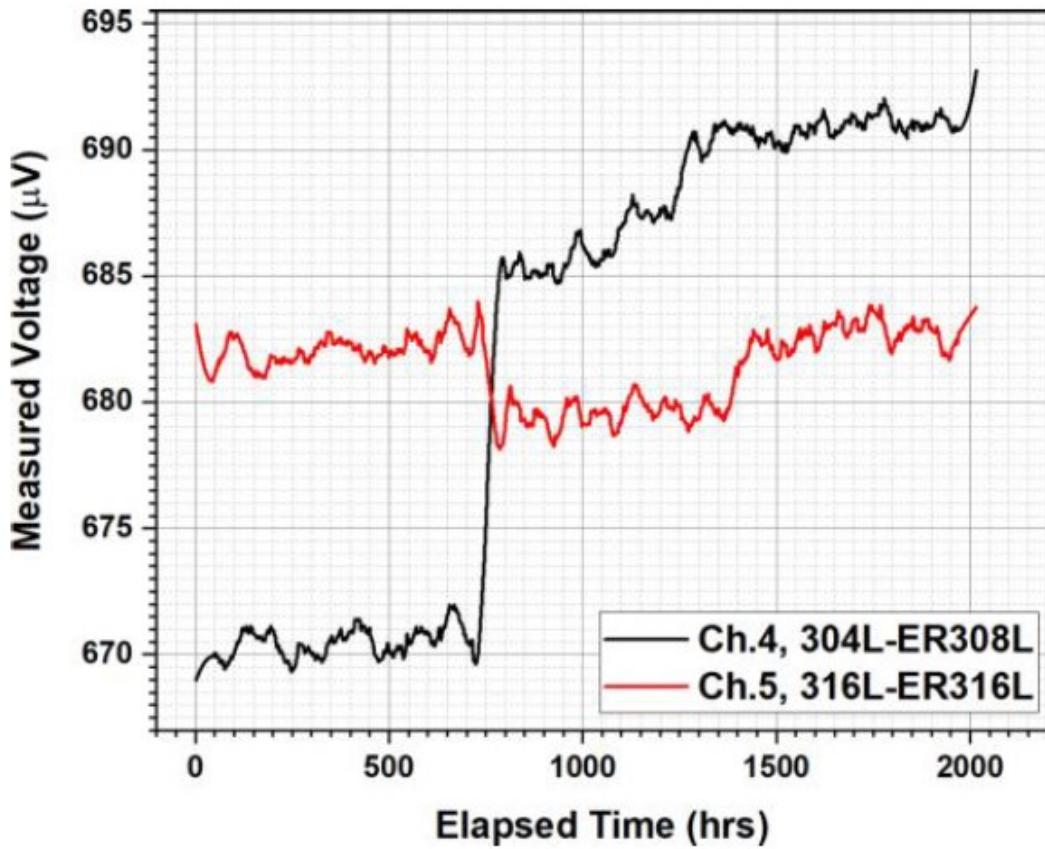
Figure 18. DCPD Results for 304 and 316 at 60°C, RH 30% [32]

Figure 18 shows the DCPD signal for 304L and 316L samples at 60°C and RH 30%. The graph shows a sharp increase in the signal for 304L after 800 hours of immersion indicating a crack initiation. This voltage increase was not observed on the 316L sample which emphasizes the increased resistance of 316L grades to CISCC over 304L grades.

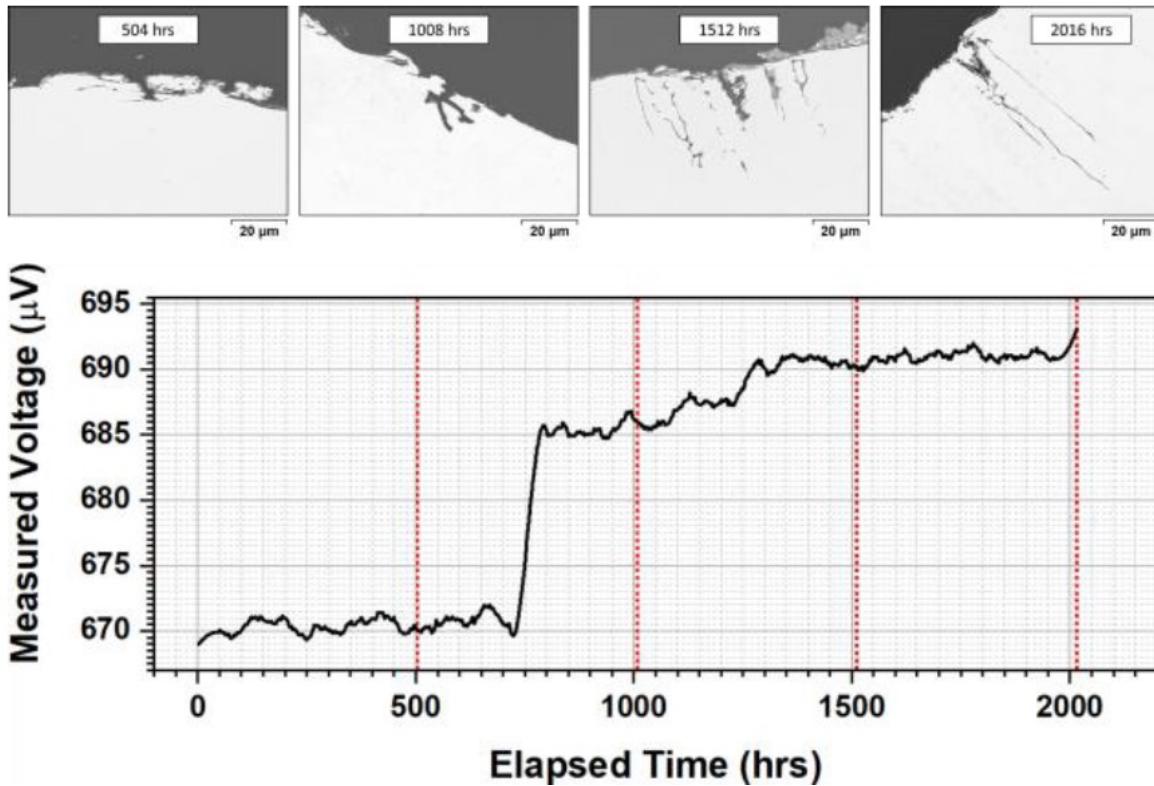
Figure 19. Pits Development and Cracks in 304L Welded Sample [32]

the approach to detect cracking in U-bend samples. This experiment illustrates the mechanism for pitting development and crack propagation through stainless steel and emphasizes the effect of material composition to CISCC susceptibility. This paper didn't report the results of the 50°C at 30% RH or the 60°C at 20% RH experiments to evaluate the effects of RH and temperature.

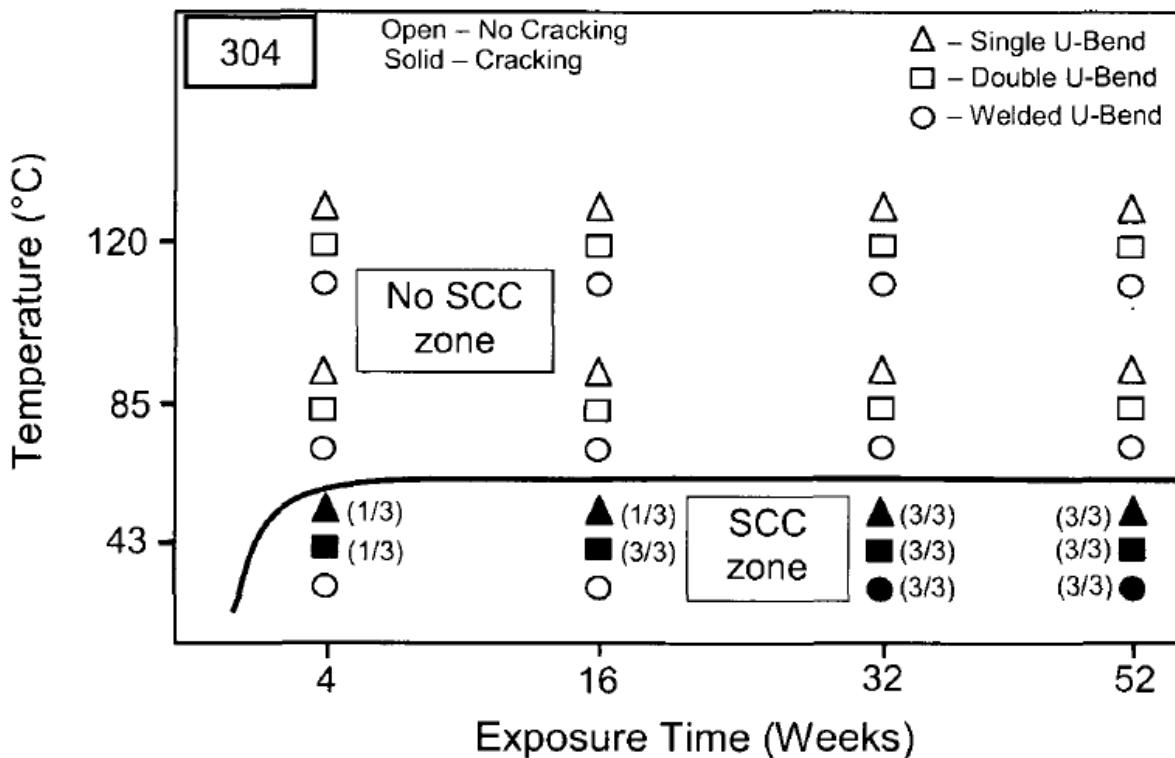
Figure 20. NRC CISCC Susceptibility Map for 304 Stainless Steel [16]

and Figure 21 (number of cracked samples/total samples are in parenthesis). At least one 304 single U-bend sample cracked after 4 and 16 weeks of exposure as shown in Figure 20, while no cracking was observed under the same experimental conditions and temperatures on the 316L U-bend samples as shown in Figure 21. After 32 weeks of exposure, three welded U-bend samples cracked while only two 316L cracked under the same conditions. The number of cracked samples was the same for the two material grades at 52 weeks of exposure indicating increased susceptibility with increased exposure duration.

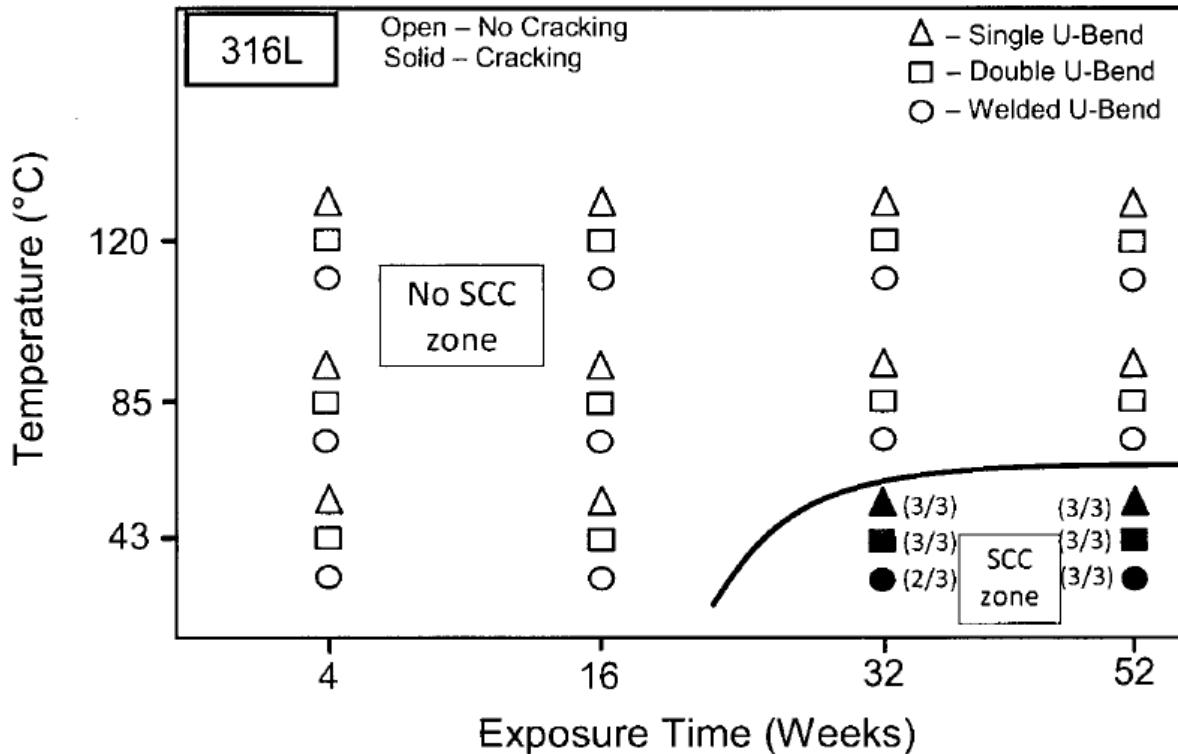
Figure 21. NRC CISCC Susceptibility Map for 316L Stainless Steel [16]

Figure 21 shows the susceptibility of welded and unwelded 316L U-bend samples. Ignore the double U-bend depicted in rectangles as these are not discussed from this paper.

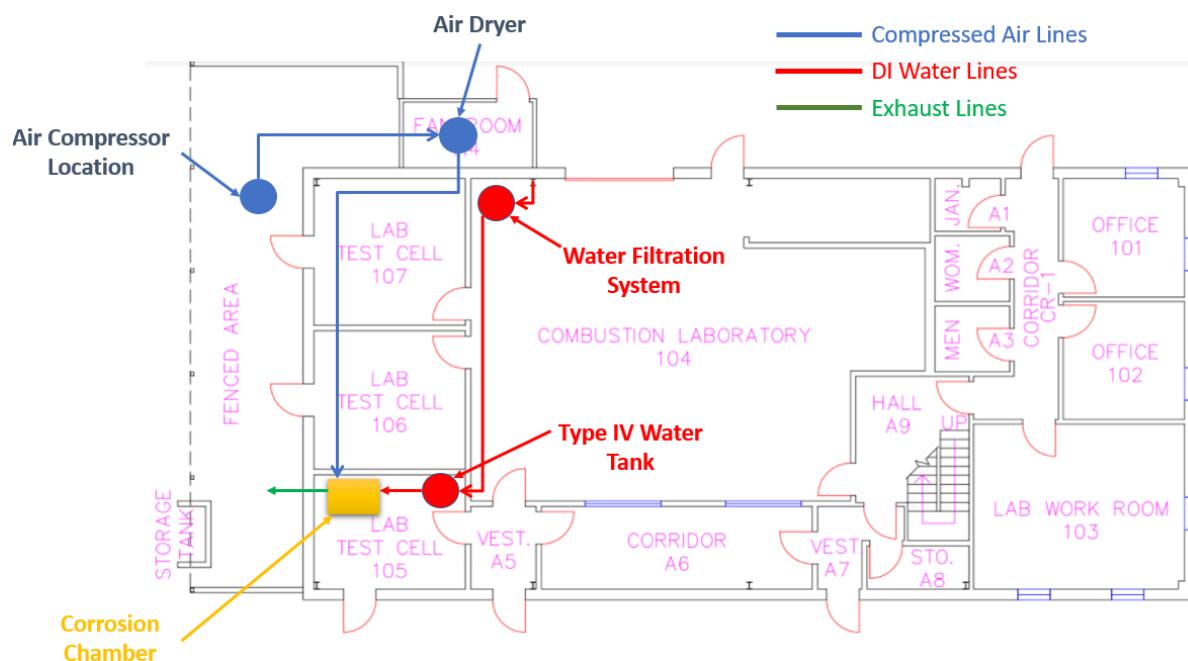
Figure 22. Experimental Setup and Equipment Locations

A high-level schematic of the accelerated CISCC experimental setup is shown in Figure 22. The main components are the corrosion chamber, compressed air supply, air dryer, Type IV water filtration system, and the exhaust outlet. The experimental setup relies primarily on the corrosion chamber that is depicted by the yellow box. Compressed air passes through an industrial air dryer and is directly connected to the corrosion chamber as depicted in the blue lines. A dedicated water filtration system was installed at the lab to produce Type IV water (red lines). The green exhaust line is a direct connection from the corrosion chamber to the atmosphere to exhaust fogging and to vent the chamber for data collection.

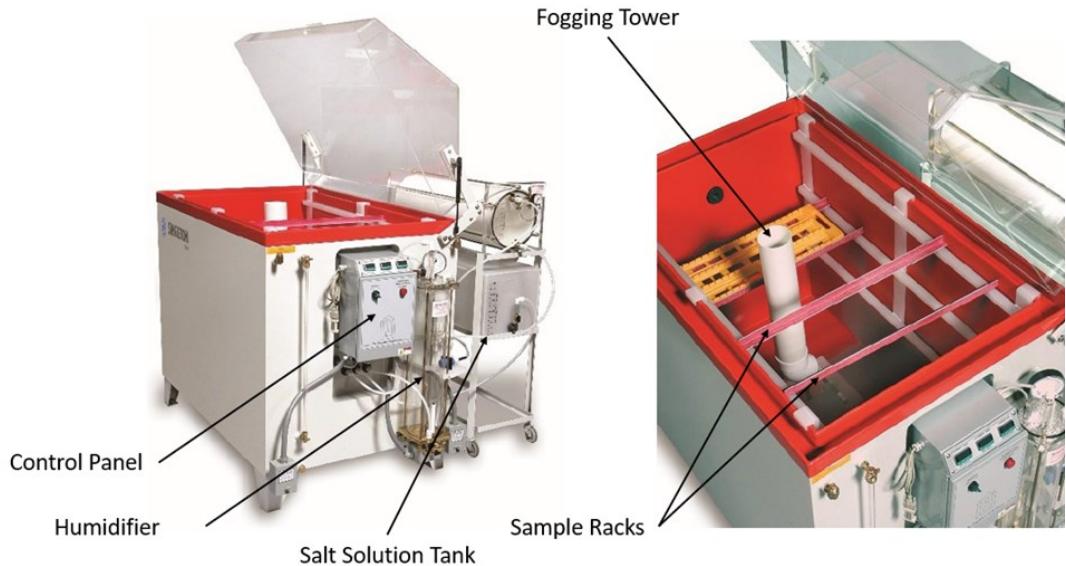
Figure 23. Singleton SCCH22 Corrosion Chamber [34]

The chamber features a water jacket design with Polypropylene covers, the water jacket ensures a tight seal around the covers during operation and to prevent fogging leakage. Additionally, the chamber has a data logging capability through PLC communication and control software for monitoring the experiment conditions remotely.

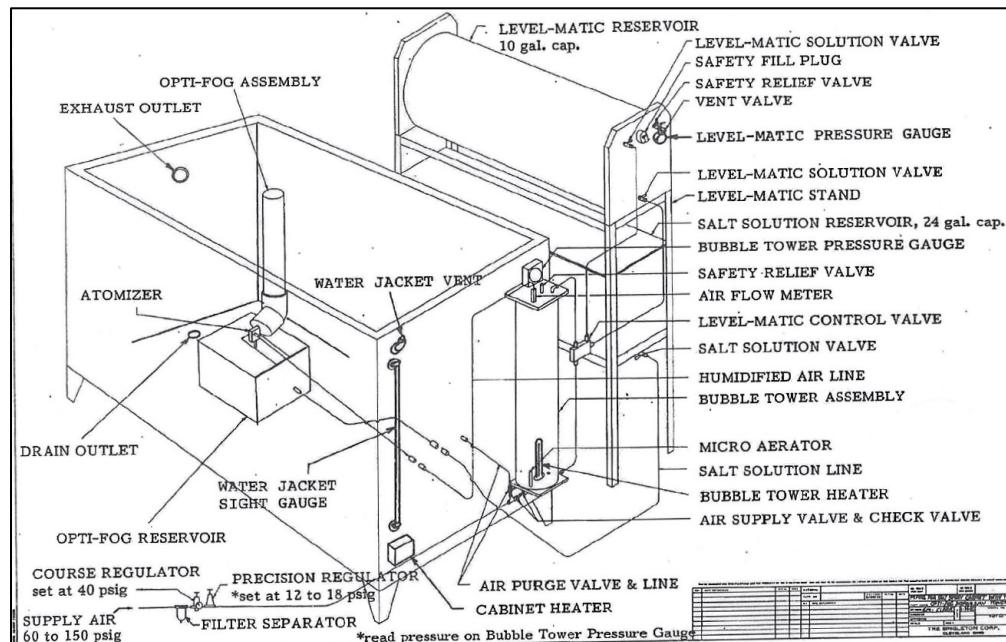
Figure 24. Drawing of Singleton SCCH22 Corrosion Chamber (Manual)

Refer to Figure 24 and Figure 25 for a detailed view of chamber's components [34] that could be referenced in this Chapter.

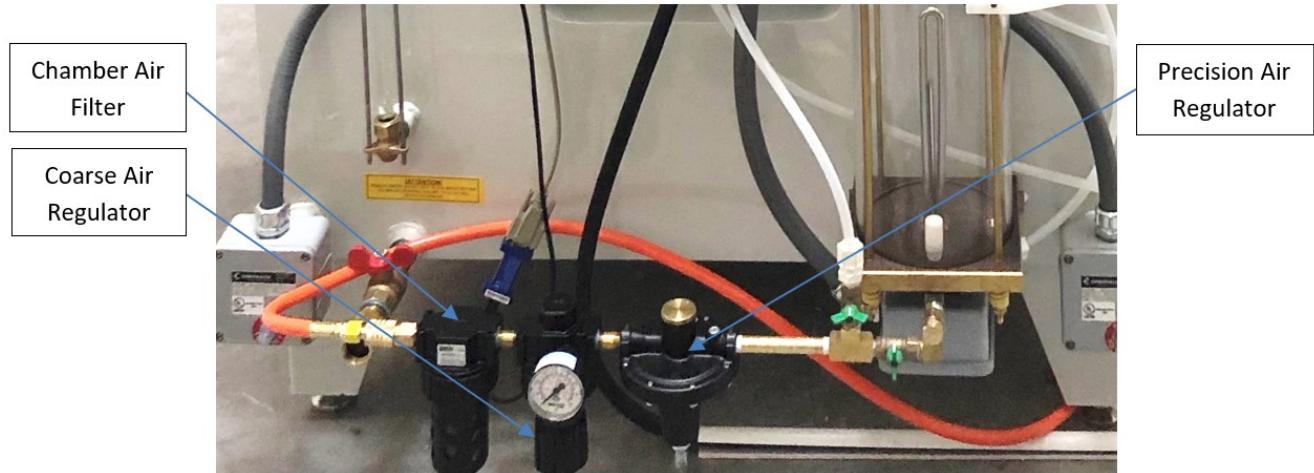
Figure 26. Filter-Regulator Assembly for Compressed Air Supply

A 5 HP piston type air compressor was used to provide a constant air supply at 3CFM and 60 PSI which is necessary to operate the corrosion chamber [35]. Compressed air passes through an oil and water separator first and then air dryer to remove humidity before reaching the corrosion chamber. At the corrosion chamber, compressed air passes through another air filter and the regulator assembly shown in Figure 26. The coarse air regulator reduces the pressure of incoming air from 60 to 40 PSI, and the precision regulator further reduces the air pressure from 40 to 15 PSI before reaching the humidifying tower tank. This process ensures only clean and dry air at the appropriate pressure gets to the atomizer, and prevents oil and dirt collections which may cause clogging of the atomizer's fine orifices and affect fogging rate.

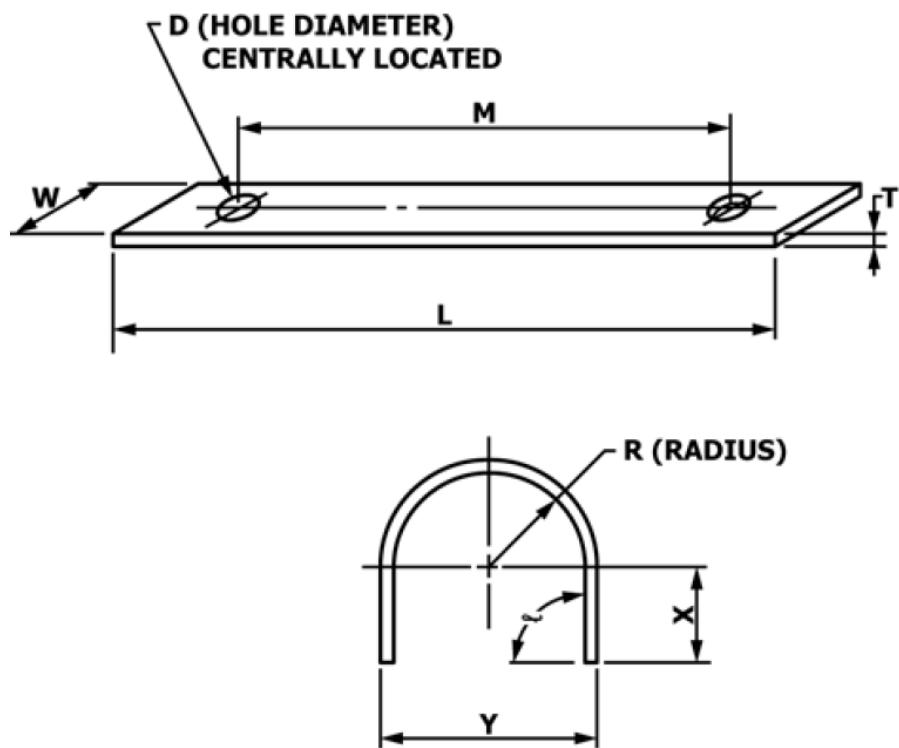
Figure 27. U-bend Sample Configuration [28]

The samples used in this experimental work were U-bends and welded U-bends made from 304 and 304L austenitic stainless steel. U-bend samples were fabricated in accordance with the ASTM G30 standard requirements and made from a flat stainless steel strip and then shaped and fixed with a bolt/nut as shown on Figure 27 [28]. Welded U-bend samples were fabricated in accordance with the ASTM G58 standard requirements and made from a welded flat stainless steel strip and then shaped as shown in Figure 28 [29]. Note that welds at the tip of the welded U-bend samples were polished and may not be visible to the naked eye.

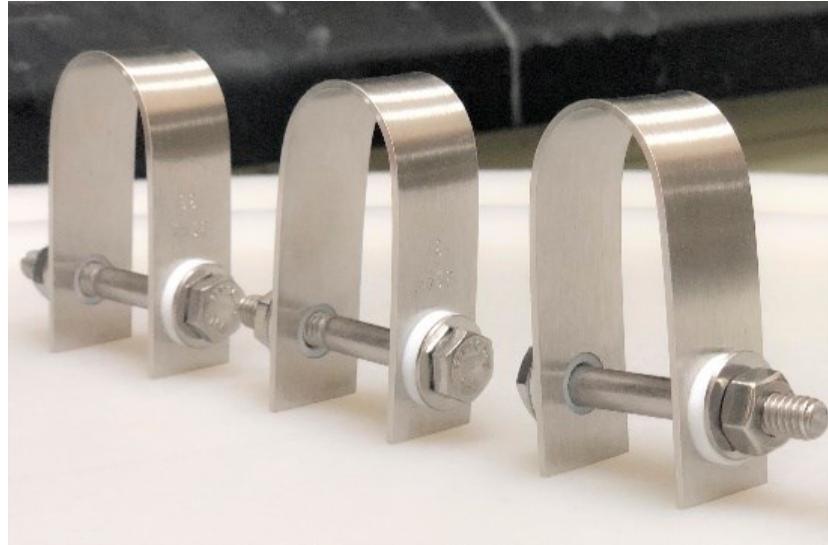
Figure 30. U-bend Sample Picture

Figure 30 shows a picture of the actual samples. Each sample is stamped with the material grade (304 or 304L), sample identification number, and the designation “W” for welded samples (304W or 304LW).

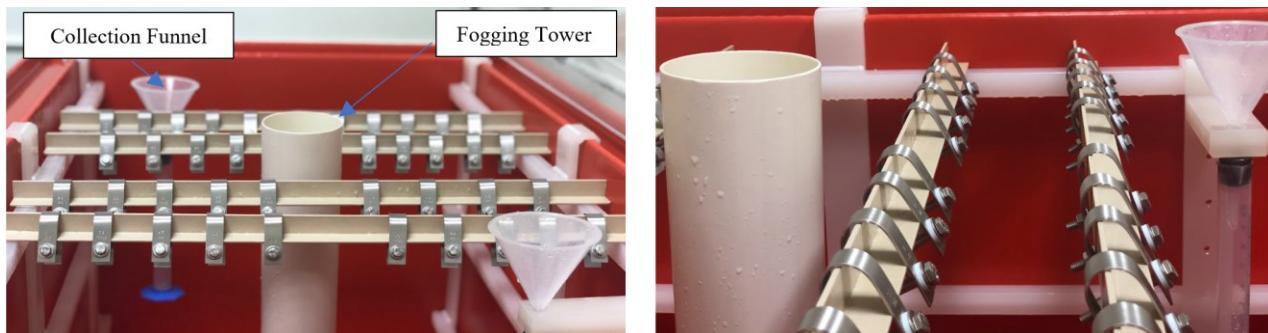
Figure 35. Experimental Setup and Sample's Placement in Corrosion Chamber

Note the sample racks are made from plastic material that does not corrode or impact the sample's corrosion rate. Figure 35 shows a fully loaded chamber with 39 samples ready for experimentation.

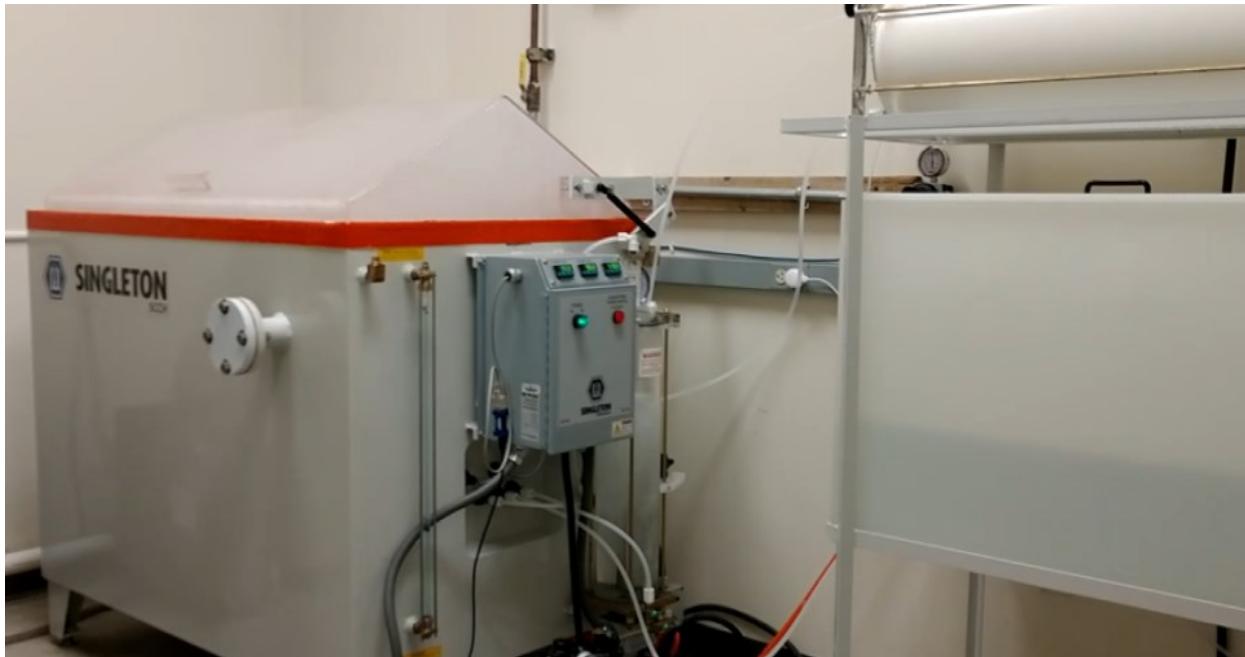
Figure 36. SCCH22 Corrosion Chamber in Operation

The level-matic tank supplies Type IV water to the humidifying tower during operation, the humidifying tower heats incoming water then bubbles are generated through a micro aerator located at the bottom of the tower (compressed air is required for this operation). The fine aerosols (fogging) pass through the salt solution in the Opti-fog reservoir to the atomizer which is located directly above the Opti-fog reservoir; and then the salty fogging is channeled into the chamber through the fogging tower. Collected salt solution at the bottom of the chamber drains directly to the main drainage lines in the lab through a drain outlet. The chamber runs continuously at the preset exposure temperature (35°C or 50°C) until it is manually shut down by the experiment's operator to either collect data or remove a set of samples for characterization (after 4, 8, 12, or 14 weeks). Refer Figure 36 shows the corrosion chamber in operation, notice the clouded chamber through the top cover.
