Investigation of Chloride-induced Stress Corrosion Cracking for Long-Term Storage of Spent Nuclear Fuel in Dry Storage Systems

Thesis submitted to the faculty of the
Virginia Polytechnic Institute and State University
in partial fulfillment of the requirements for the degree of

Nuclear Engineering

Keywords: chloride-induced stress corrosion cracking, stress corrosion
cracking, spent nuclear fuel dry storage, CISCC, SCC, ISFSI

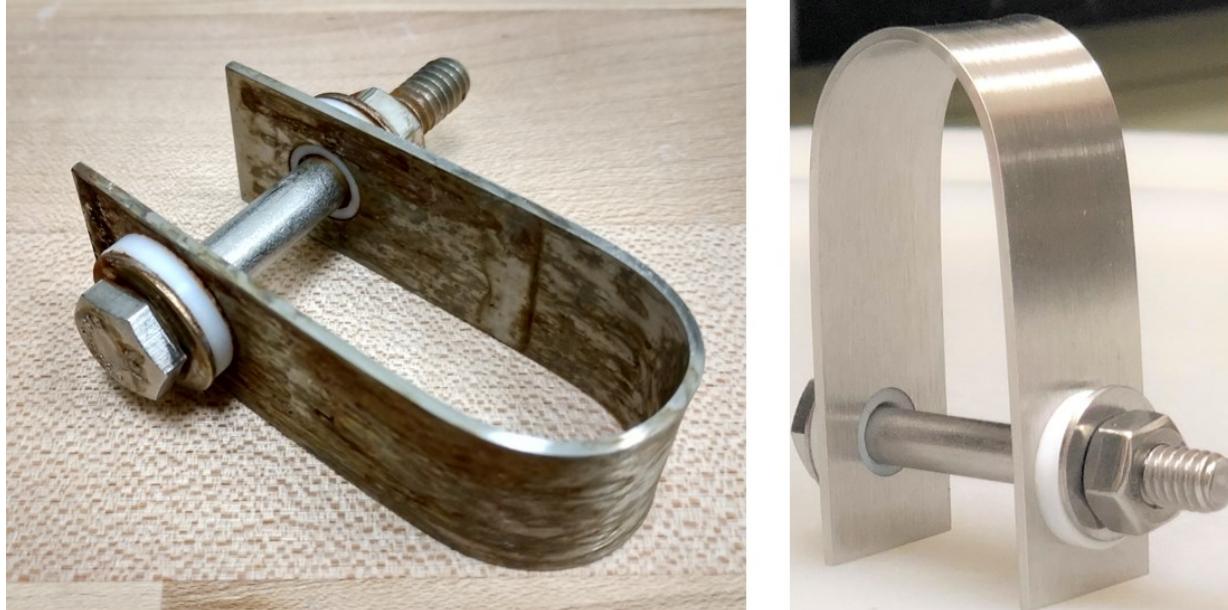
Figure 38. U-bend Sample Before and After Exposure to 50°C for 14 Weeks

and after exposure are included in Appendix D. Figure 38 shows a sample photograph before and after exposure at 50°C for 14 weeks. Notice the heavy signs of corrosion on the sample post exposure in the corrosion chamber in comparison with the clean sample.

At the end of each exposure duration, the 13 removed samples were then washed in Type IV water, dried with compressed air, photographed, weighed, inspected visually for any signs of cracking, and stored in air-tight containers pending microscopic analysis and characterization. Samples were weighed before and after exposure to quantify weight loss which could be an indication of corrosion rate or cracking potentially. Weights of all samples listed in Table 9 and Table 10 before

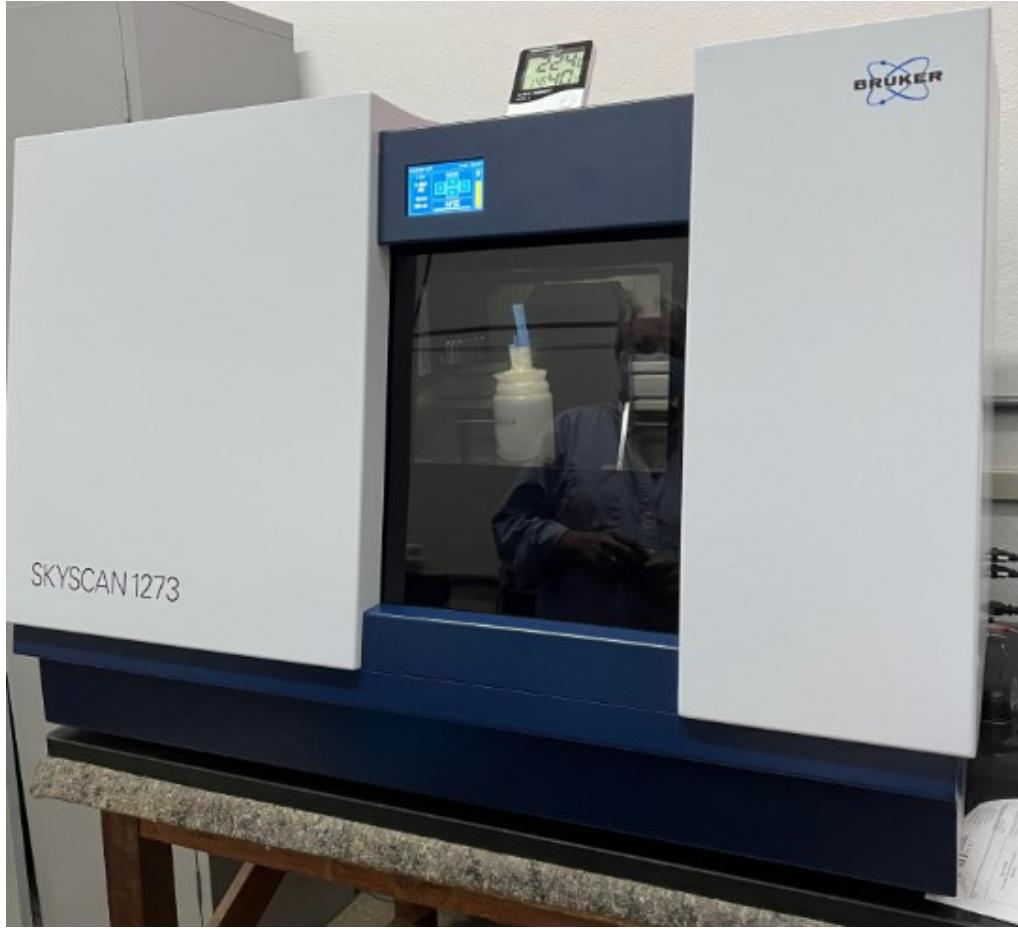
Figure 39. SKYSCAN 1273 at LIN (Nuclear Instrumentation Laboratory)

Selected U-bend samples with heavy signs of corrosion were scanned with a Micro Computed Tomography (CT) scanner at the Federal University of Rio De Janeiro in Brazil for crack detection. The scanner model used is SKYSCAN 1273, this scanner features a combination of high energy X-ray source running at higher power with a large format flat-panel detector which provides excellent image quality in seconds. The SKYSCAN 1273 is capable of testing samples up to 500 mm length, 300 mm diameter, and a maximum weight of 20 kg. Refer to Table 11 for the SKYSCAN 1273 specifications and Figure 39 for a picture of the machine used.

Feature	Specification
X-ray source	40-130 kV 39 W
X-ray detector	Active pixel CMOS flat-panel, 6 MP (3072 x 1944)
Object size	250 mm diameter 250 mm height
Power supply	100-240 VAC, 50-60 Hz, 3 A max

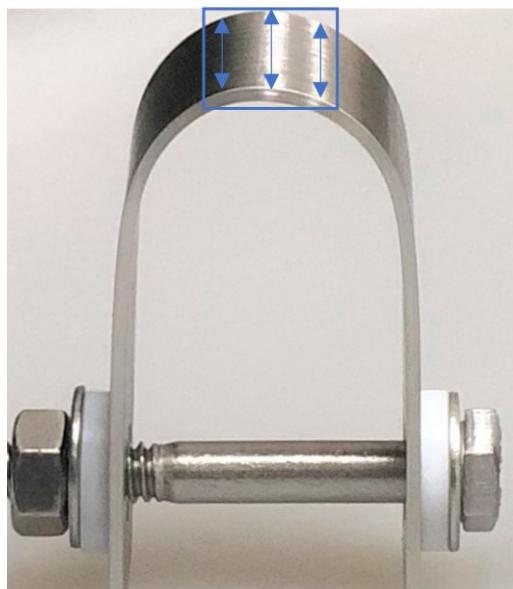
**Figure 43. Characterization Region with 3D Surface Profiler**

Surface profiles were generated only at the arch region of the U-bend samples as depicted in Figure 43. The applied tensile stress at the arch region is the highest and it is the most likely location to show signs of pitting and cracking. Approximately, the same region was scanned on all sixteen (16) U-bend samples to establish surface profiles for a qualitative microscopic characterization and quantitative statistical analysis for comparisons among the samples.

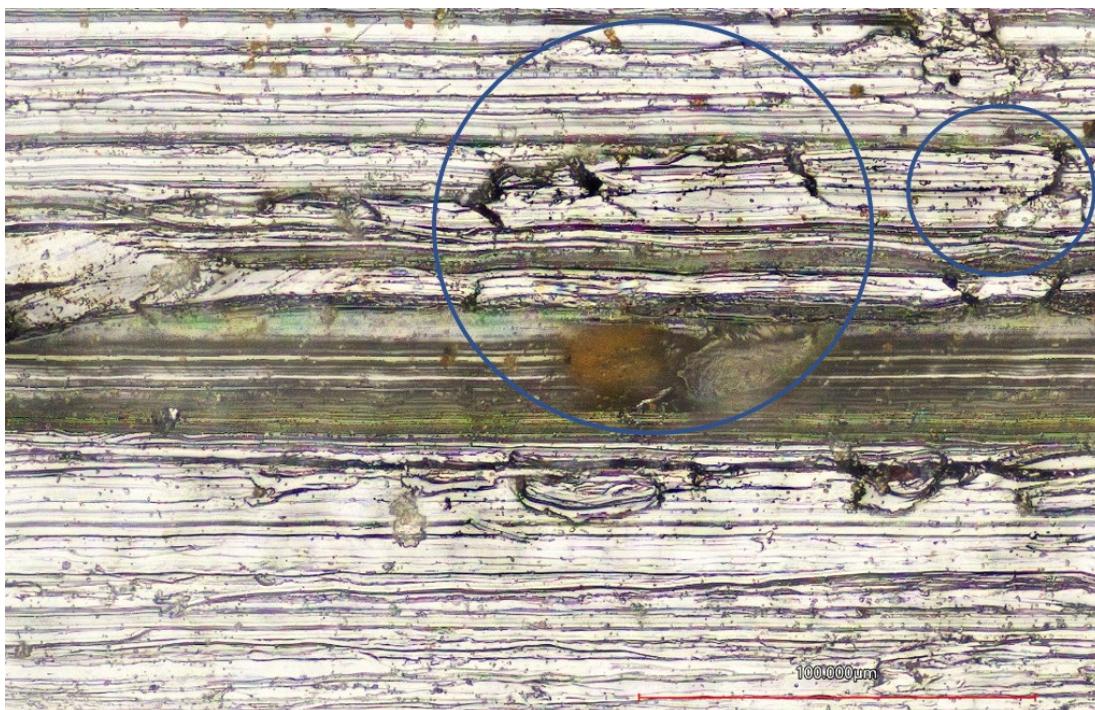
Figure 50. Cracking at the Arch Region on 304 Exposed to 35°C for 8 Weeks

Figure 50 shows a micrograph of the 304 sample exposed to 35°C for 8 weeks at 50x magnification. A few small cracks circled in blue appear to be developing in the expected direction perpendicular to the applied stress; such lines were not observed on the reference samples. Additionally, the color profile for these lines is different from the surrounding material indicating a deeper surface. Moreover, the observed lines in Figure 50 show signs of branching as opposed to the straight polishing lines on the reference samples. Cracks were also observed on the 304L and 304LW samples exposed to 35°C for 8 weeks as shown in Figure 51 and Figure 53, respectively. Micrographs of the 304W sample exposed to 35°C for 8 weeks did not show cracking lines consistent with the established criteria except for one “likely cracking” observation that is shown in Figure 52.

Test Duration	Experimental Campaign 1 (35°C)			
8 weeks	304 (#11)	304L (#06)	304W (#26)	304LW (#06)
	Cracking Light Pitting	Cracking Light Pitting	Likely Cracking Heavy Pitting	Cracking Heavy Pitting
12 weeks	304 (#16)	304L (#07)	304W (#27)	304LW (#08)
	Cracking Moderate Pitting	Cracking Moderate Pitting	Cracking Heavy Pitting	Likely Cracking Heavy Pitting
Test Duration	Experimental Campaign 2 (50°C)			
8 weeks	304 (#26)	304L (#14)	304W (#35)	304LW (#13)
	Cracking Light Pitting	Likely Cracking Light Pitting	Cracking Heavy Pitting	Likely Cracking light Pitting
14 weeks	304 (#28)	304L (#17)	304W (#38)	304LW (#16)
	Cracking Heavy Pitting	Cracking Heavy Pitting	Cracking Heavy Pitting	Cracking Heavy Pitting

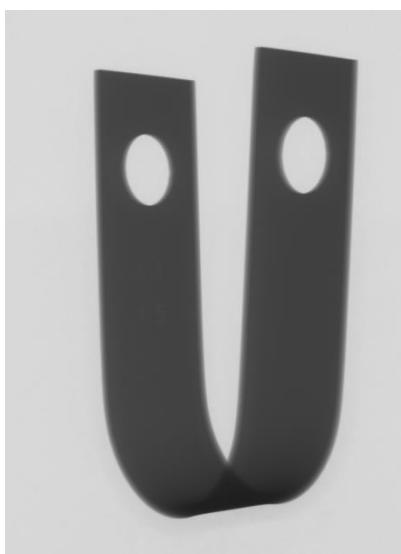
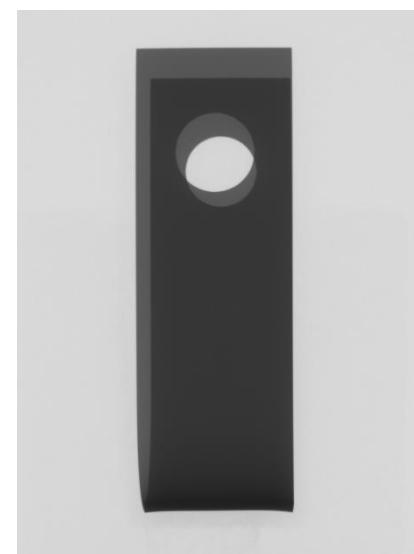
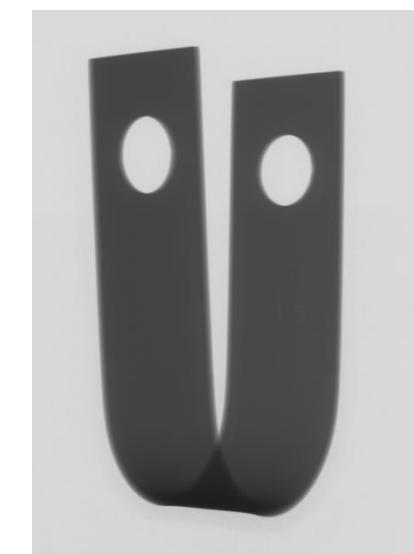
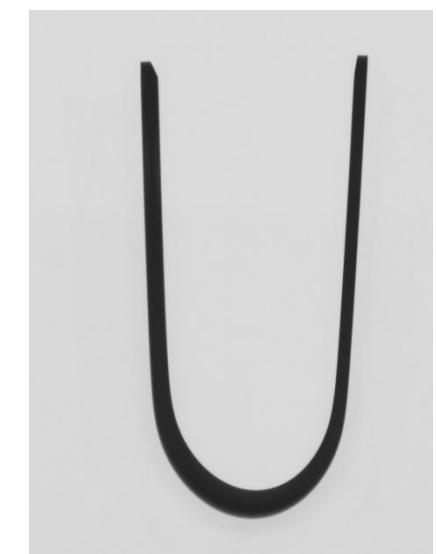
MicroCT (SKYSCAN 1273) Rotational Scans for U-bend Sample 304_15_50C_14 weeks

The MicroCT characterization provided scans at small angular increments generating 360° scans of the entire U-bend sample. Additionally, the samples were characterized at small increments along the cross-section starting from the tip of the arch region through the entire length of the sample. Refer to Figure 40 for a schematic of the scanning procedure used. SKYSCAN 1273 is capable of detecting cracks larger than 7 μ m, but it did not reveal any cracking or pitting on the twelve (12) scanned U-bend samples from both experimental campaigns 1 and 2. If cracking is present, it could potentially be smaller than 7 μ m. Refer to Figure 41 for a sample MicroCT rotational and cross-sectional scans, additional sample MicroCT scans are included Appendix F.

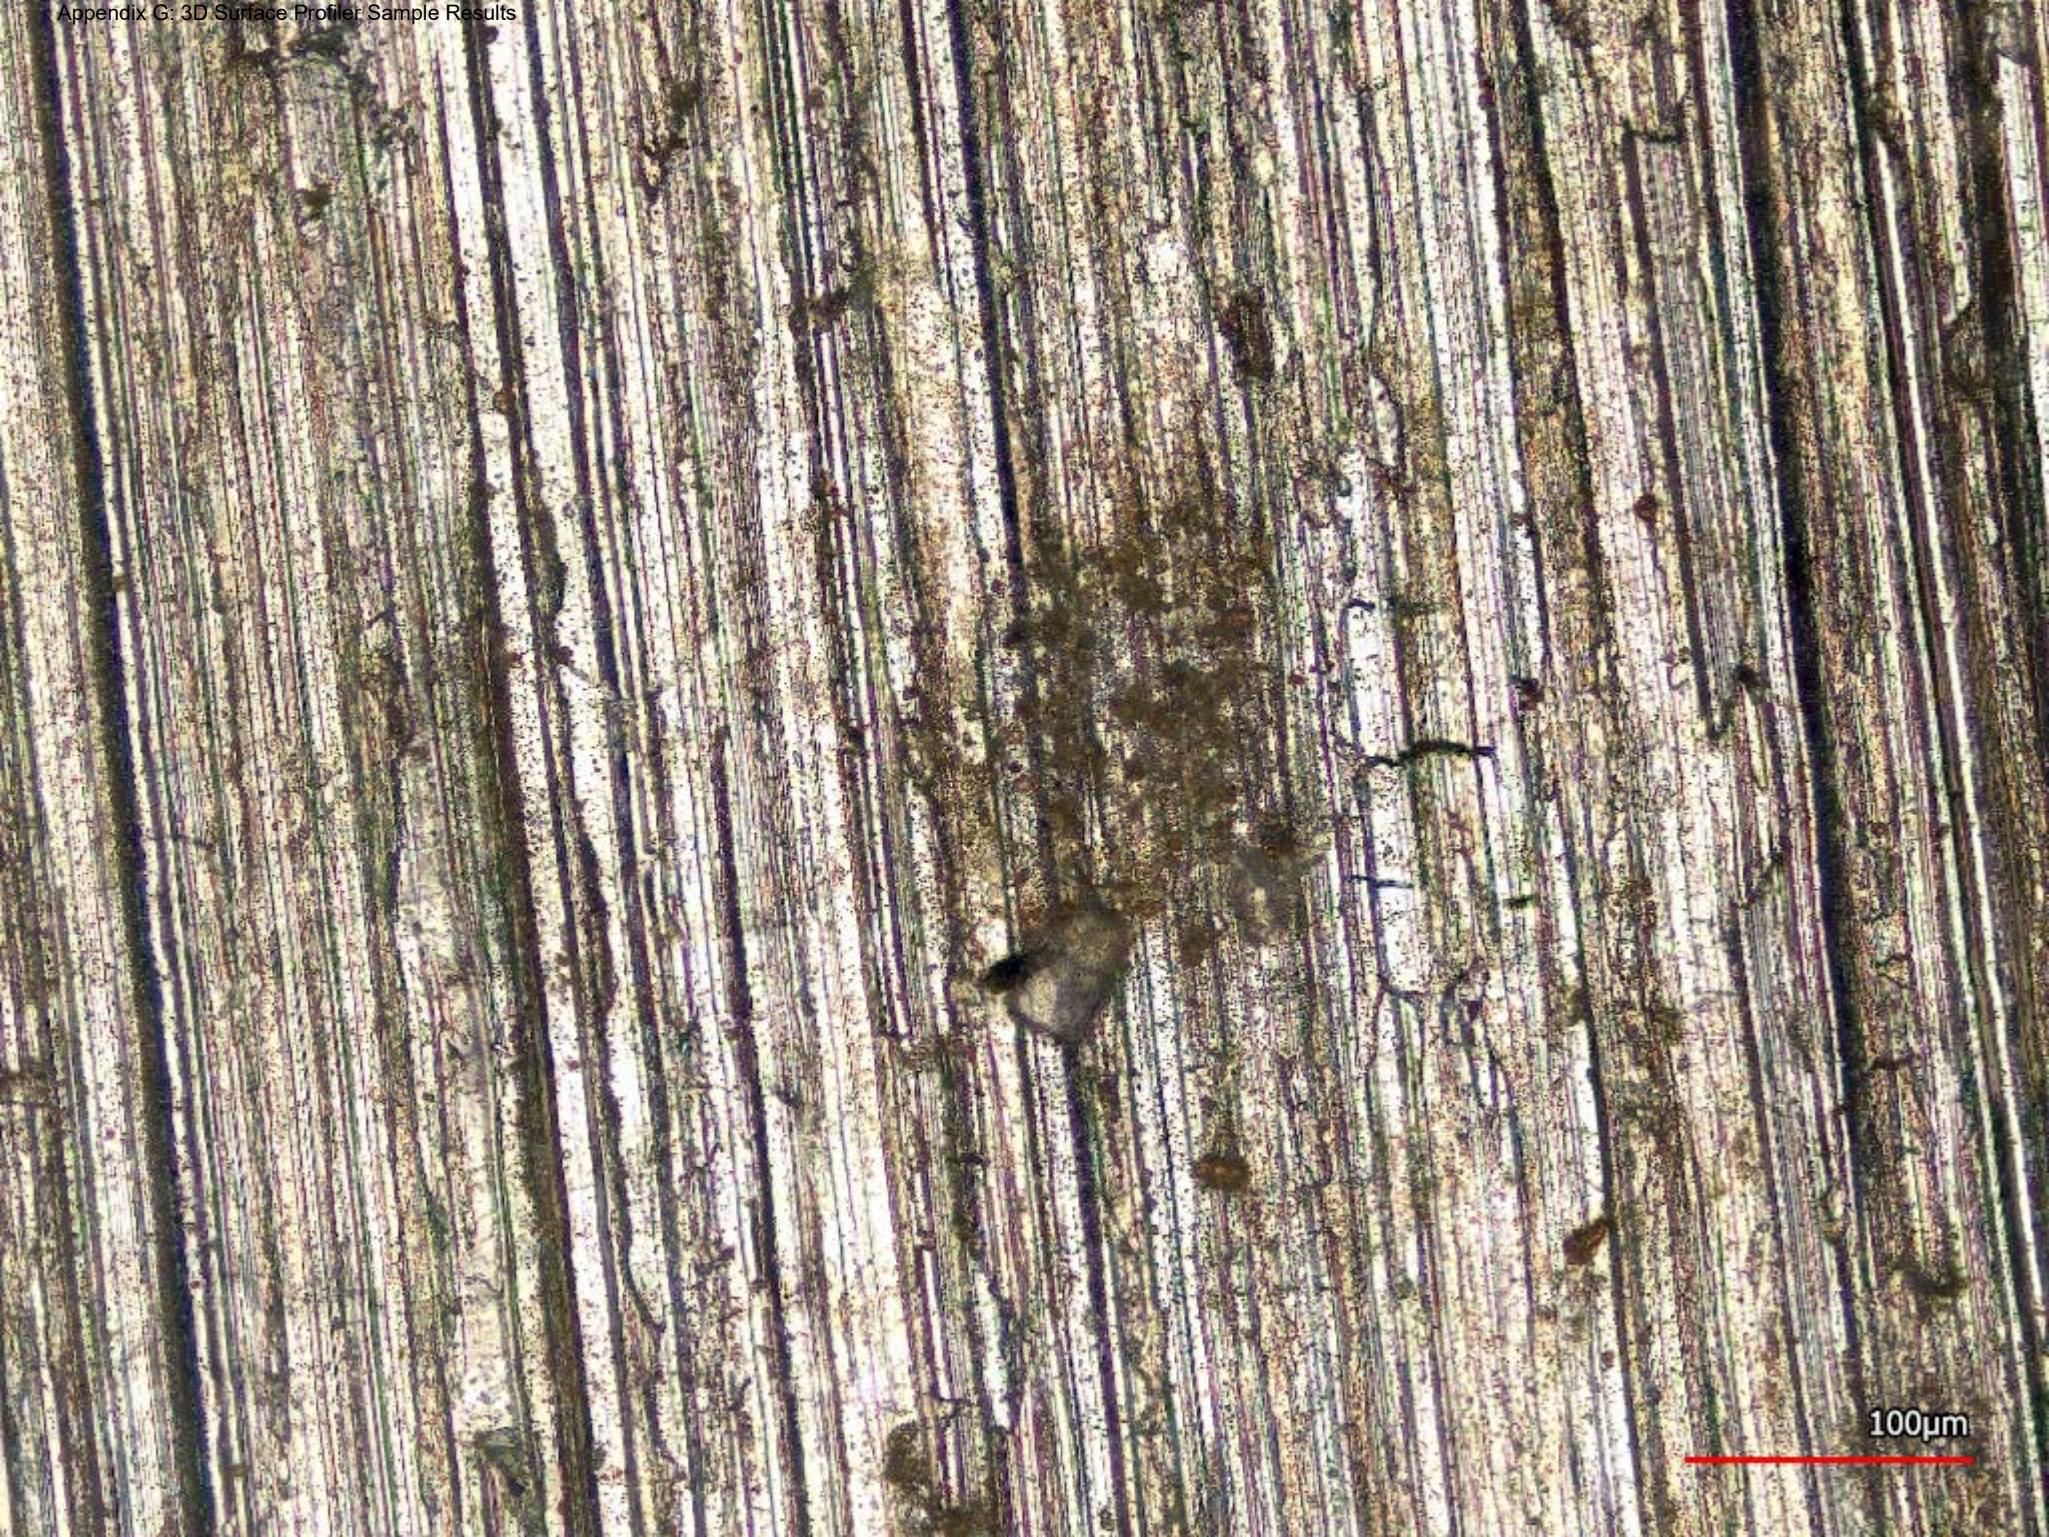
Profile measurement - SS304LW_No. 13_50°C_8 Weeks

Figure 46 shows an example surface profile characterization report. The report shows the optical micrograph on the left and the surface height profile on the right. The height profile shows the peaks and valleys (depth) to a reference plane relative to the sample itself, plane correction was done automatically in the 3D Surface Profiler. Beside the profile report, additional micrographs at various magnification levels ranging from 10x to 50x were saved for each U-bend to qualitatively characterize pitting and cracking. The height color bar on the far right of the report shows the height color gradient of the scanned surface and lists the maximum peak's height (+) and the maximum valley depth (-). The maximum valley data of all scanned surfaces were used to quantitatively characterize pitting and cracking. Additional optical micrographs and surface profile reports are included in Appendix G.
