**OUT-OF-PLANE WEB DEFORMATION AND RELATIVE ARCH
MOVEMENT OF HYBRID-COMPOSITE BEAMS BASED ON
PHOTOGRAMMETRY**

Report No. CE/VPI-ST-12/08

Report submitted to the Faculty of the Virginia Polytechnic Institute and State University in
partial fulfillment of the requirements for the degree of

Civil Engineering

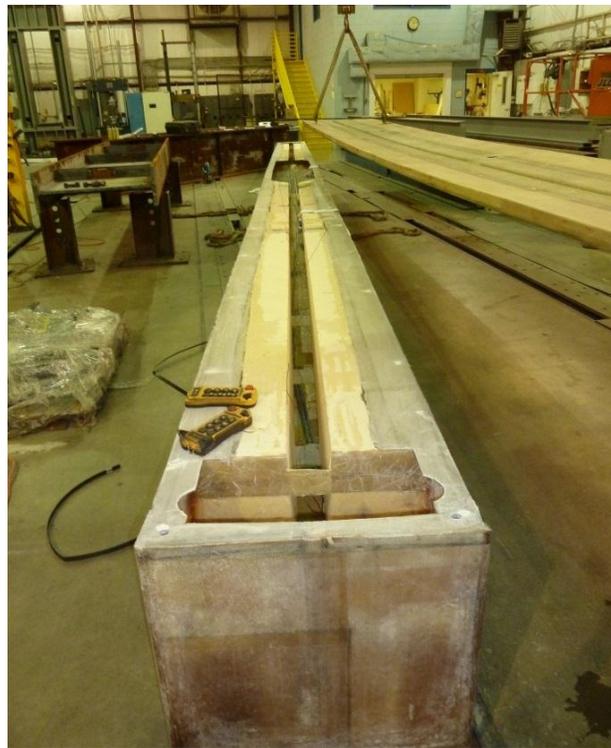
Figure 1-3: A hybrid-composite beam without the lid or concrete arch

When the three HCBs arrived at the lab, the FRP lids were unattached and the concrete arches had not yet been placed (Figure 1-3). Wire pots were attached to the bottom of the FRP at the midspan and both quarter points to monitor deflection. Two dial gauges were set up at the face of one of the supports to detect lateral movement of the top and bottom of beam. Linear Variable Differential Transformers (LVDTs) were used to detect relative vertical arch movement at the midspan and one quarter point. Among other purposes, it was hoped that these additional sources of instrumentation would provide data to cross-check and confirm the validity of the results found using photogrammetry.

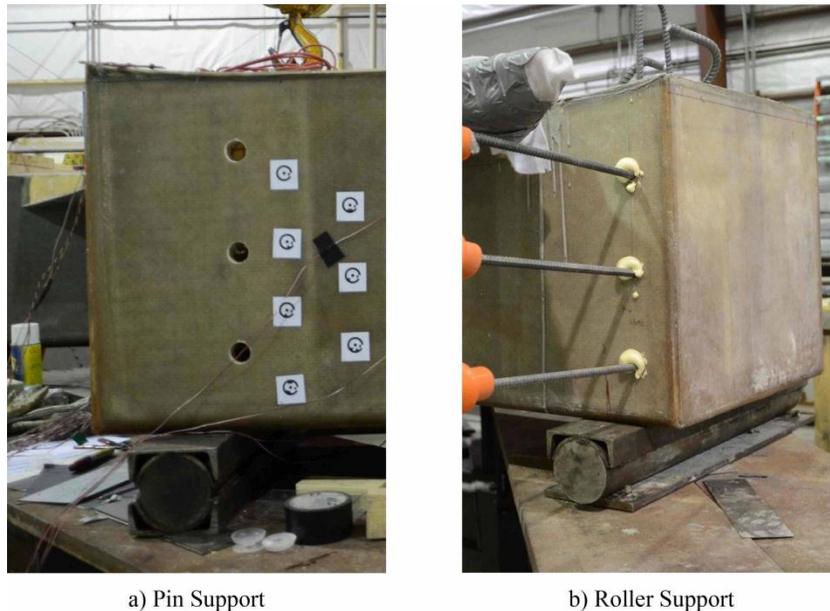
Figure 1-4: Support Conditions

The support conditions of the beams were simplified by using a pin connection on one end and a roller connection on the other (Figure 1-4). This created a determinate system for the individual HCB tests and allowed the support reactions to be calculated using simple statics principles. The pin and roller supports for each beam were placed perpendicular to the length of the beam.

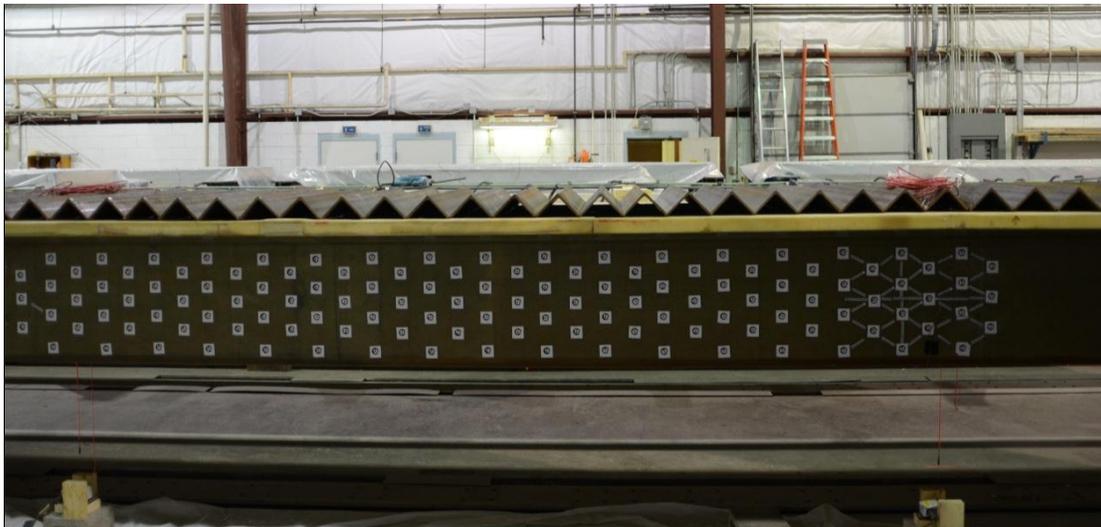
Figure 1-5: Phase I distributed load test in progress

lbs, were used to create a distributed load of approximately 50 plf. As shown in Figure 1-5, the angles were placed adjacent to one another along the length of the beam. The second test configuration consisted of a single 250 lb. point load at the midspan of the beam. To achieve this load, ten of the angles used in the previous test were stacked on top of one another at the midspan.

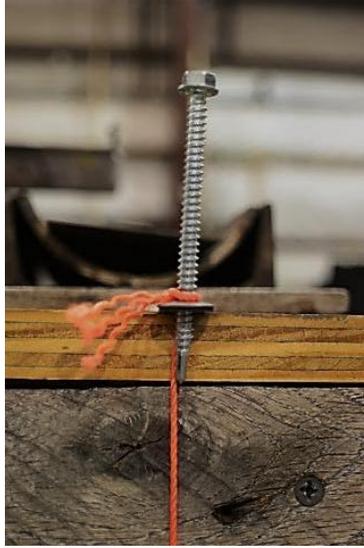
Figure 1-6: Screw, washer and string prior to being embedded inside the beam

Upon completion of Phase I, the shear reinforcement for the deck was placed and tied. In addition, a ¼ in. diameter hole was drilled from the bottom of the arch downward through the bottom of the FRP shell at the midspan and at one of the quarter points. At each location, a string was tied to a 3 in. long screw and fed through the hole. The screw had a washer on one end that plugged the hole in the foam to prevent concrete from entering the hole. Figure 1-6 shows the screw, washer, and string before being placed inside the beam.

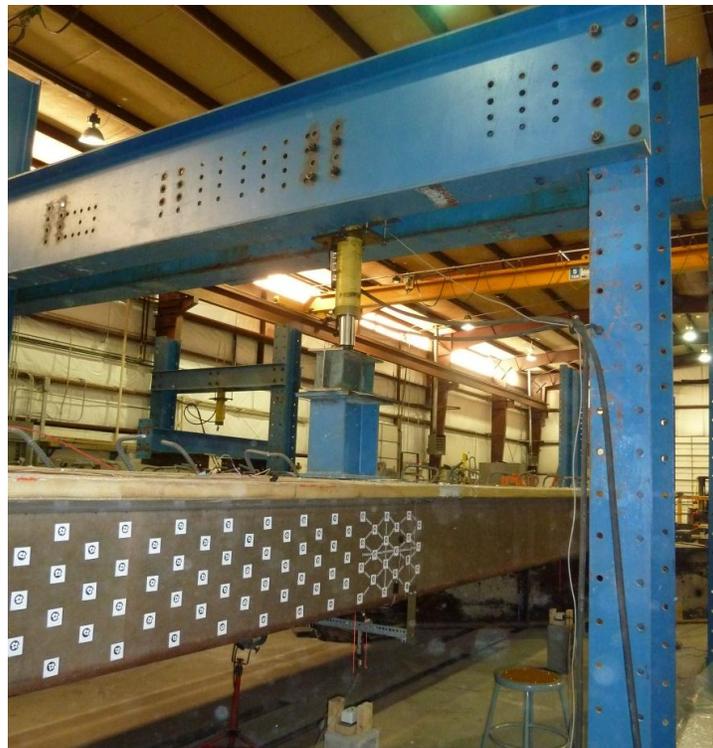
Figure 1-8: Phase II midspan point load test setup

For all tests done in Phase II, a hydraulic static actuator was used to apply the load in 5 kip increments. The same pin and roller connections that were used in Phase I were used at the supports for Phase II. For the first load scenario, the static actuator was centered at the midspan and the beam was loaded to a maximum load of 15 kips. The test setup is shown in Figure 1-8. As in Phase I, each test was repeated to ensure consistency and quality of the results.

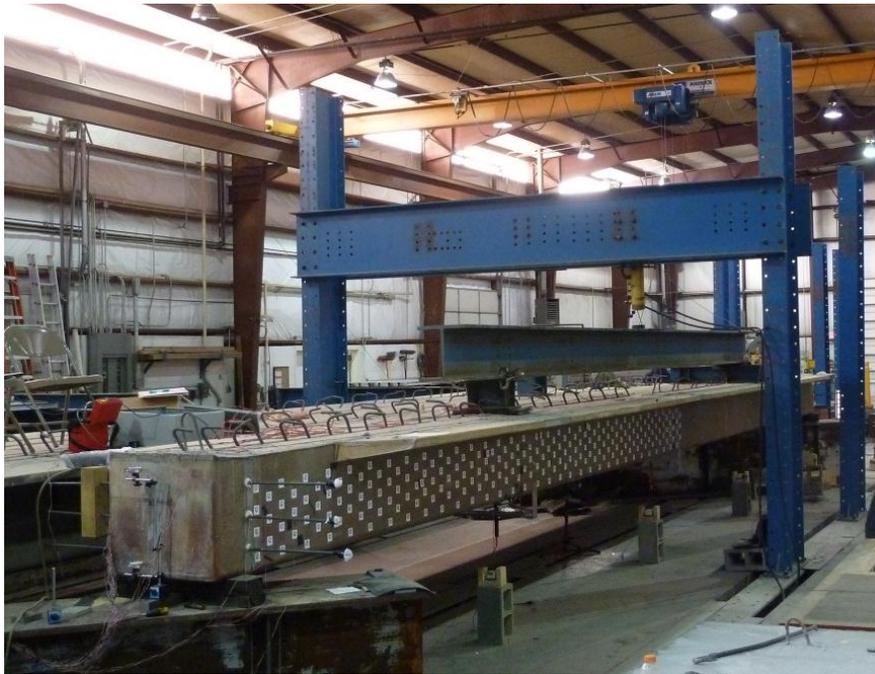
Figure 1-9: Phase II quarter point load test setup

The second load scenario in Phase II was composed of two equivalent loads at the quarter points. To achieve this, the same setup was used from the first scenario; however an additional steel beam reaching to the two quarter points was placed underneath the load actuator to spread the load into two equal loads applied at the quarter points. Figure 1-9 displays the setup for the second load scenario. The beam was loaded to a total of 25 kips at maximum load, resulting in each quarter point experiencing a 12.5 kip load simultaneously. This test was also performed twice for each beam.

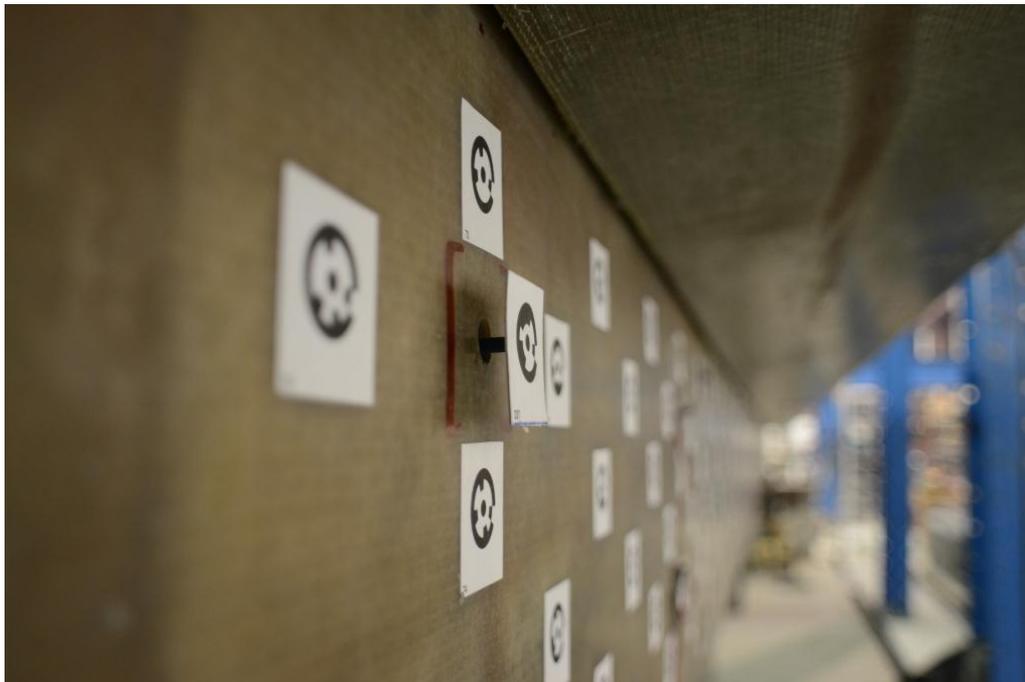
Figure 2-3: One of the RAD targets embedded in the concrete arch

A total of 231 RAD targets were printed on adhesive paper and attached to the side of the FRP shell in the aforementioned grid before the first test of Phase I. After the concrete arch was placed and cured, ¼ in. holes were drilled through the FRP web at five locations spaced approximately 3 ft apart along the arch profile. Five additional targets were printed and attached to screws that were embedded into the concrete arch through the holes as seen in Figure 2-3. The purpose of embedding these five targets in the arch was to detect if the arch would move vertically relative to the FRP shell during the various test scenarios.
