# **STUDY OF THE I-35W HIGHWAY BRIDGE COLLAPSE MECHANISM**

Thesis submitted to the Faculty of the  
Virginia Polytechnic Institute and State University  
In partial fulfillment of the requirements for the degree of

Keywords: I-35W Bridge Collapse, Collapse Mechanism, Gusset Plate Buckling,  
Plastic Hinges, Plastic deformations

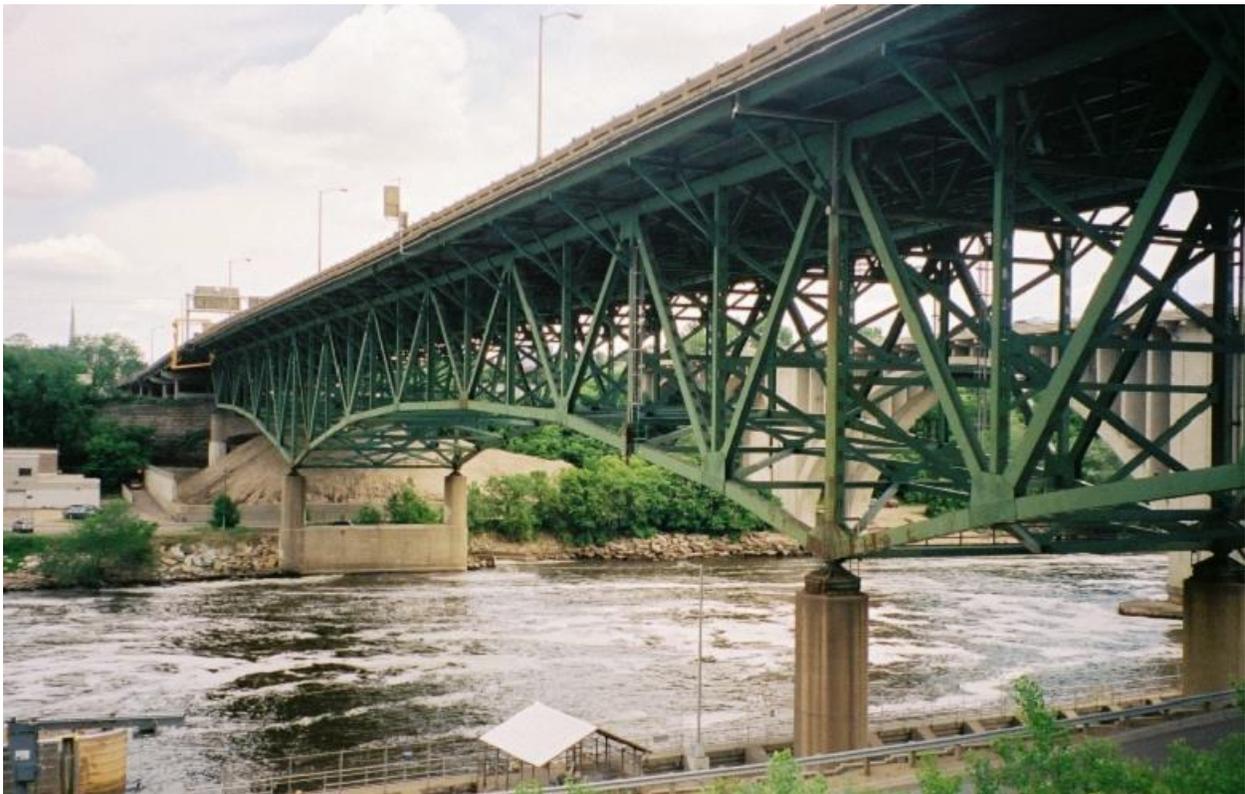
*Figure 1.1-1: View of the deck truss portion of the bridge, looking northeast  
(Source: NTSB)*

The Warren-type Deck truss portion of the I-35W Highway Bridge in Minneapolis, Minnesota, shown in Figure 1.1-1, collapsed on August 1, 2007 while roadwork was underway on the bridge. The entire truss was recovered from the river to study the causes of failure. The National Transportation Safety Board (NTSB) attributes the collapse to inadequate load carrying capacity of the steel gusset plates connecting the main truss members at four specific nodes. Permanent deformations of the members in the proximity of these nodes were documented and a surveillance video camera recorded the collapse of a major part of the structure.

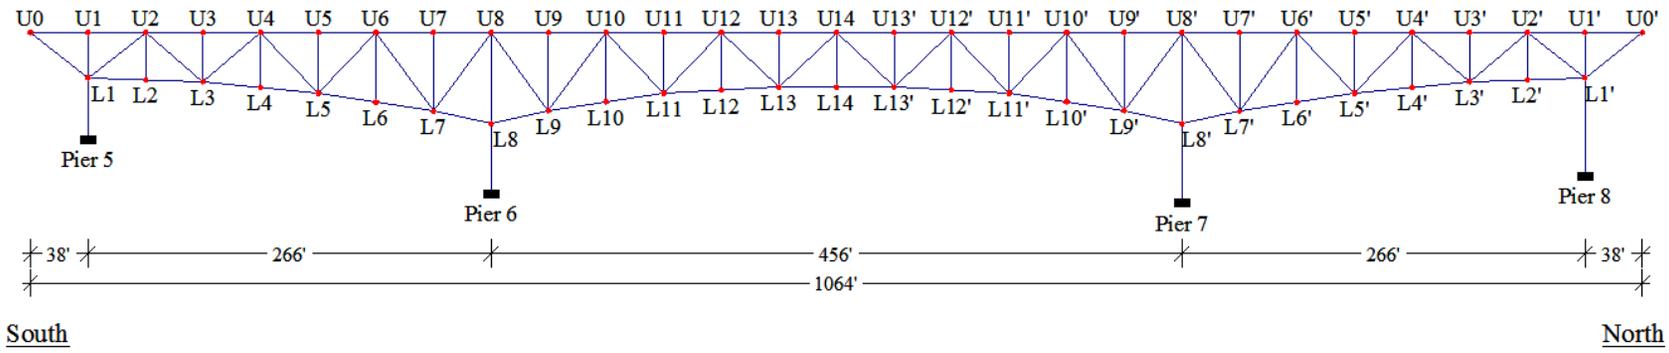
Figure 2.1-1: Typical main deck truss elevation, looking west

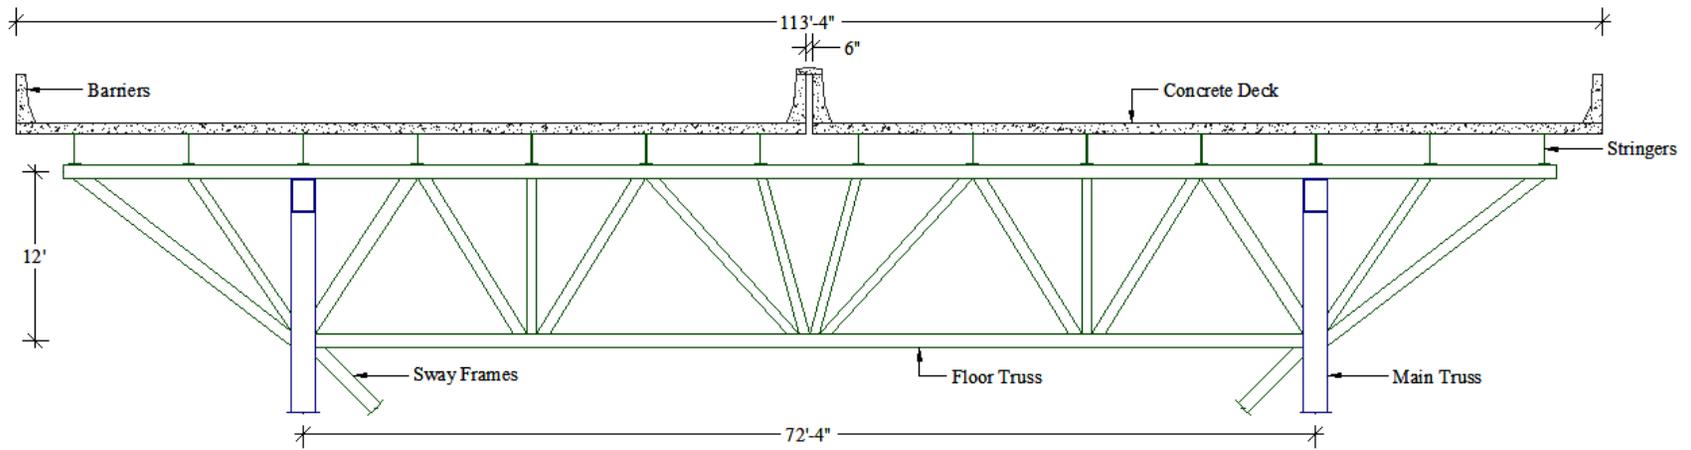
Figure 2.1-2: Typical cross-section of the deck truss portion

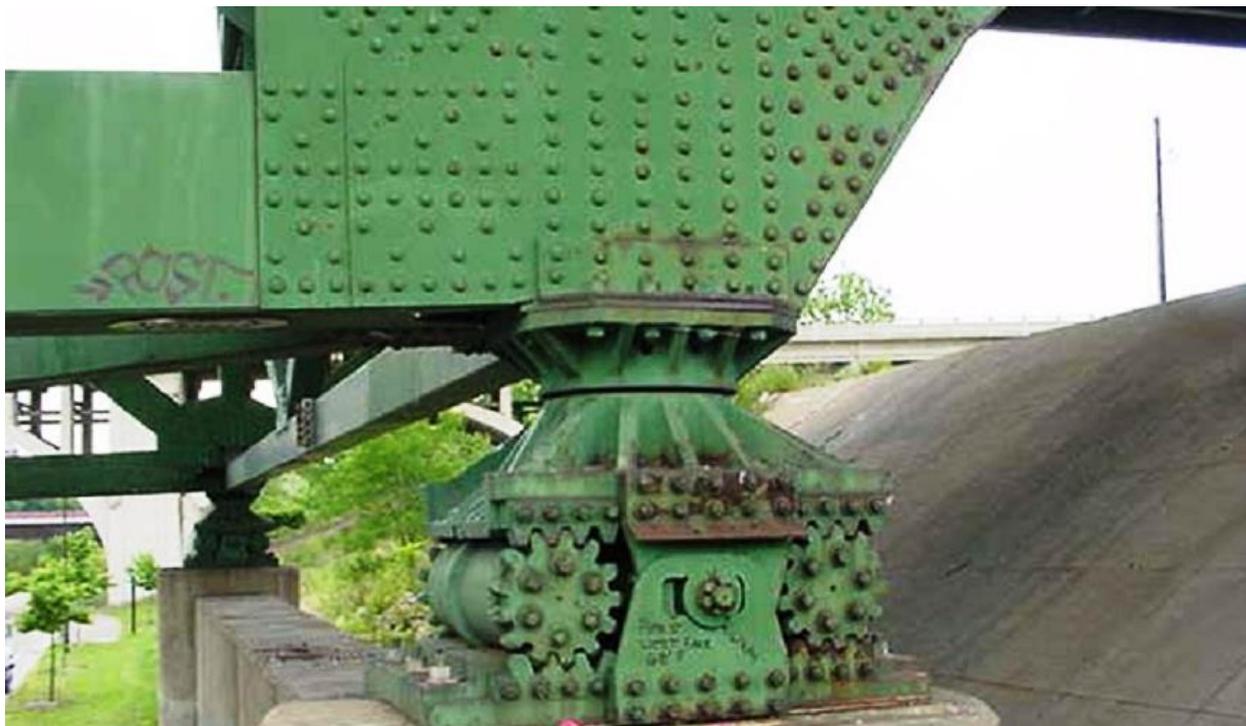
*Figure 2.1-3: Expansion roller bearings at pier 5, looking east  
(Source: NTSB)*

The overall bridge had 14 spans supported by 13 piers and 2 abutments. Eleven of these spans were approach spans to the deck truss portion, five to the south side and six to the north side. The main trusses were supported at piers 5, 6, 7, and 8 and were labeled spans 6, 7 and 8 of the overall bridge. Short cantilevers supported a portion of approach spans 5 and 9. To accommodate longitudinal thermal expansion, fixed bearings were located at pier 7, and roller bearing at piers 5, 6, and 8 (see figure 2.1-3).

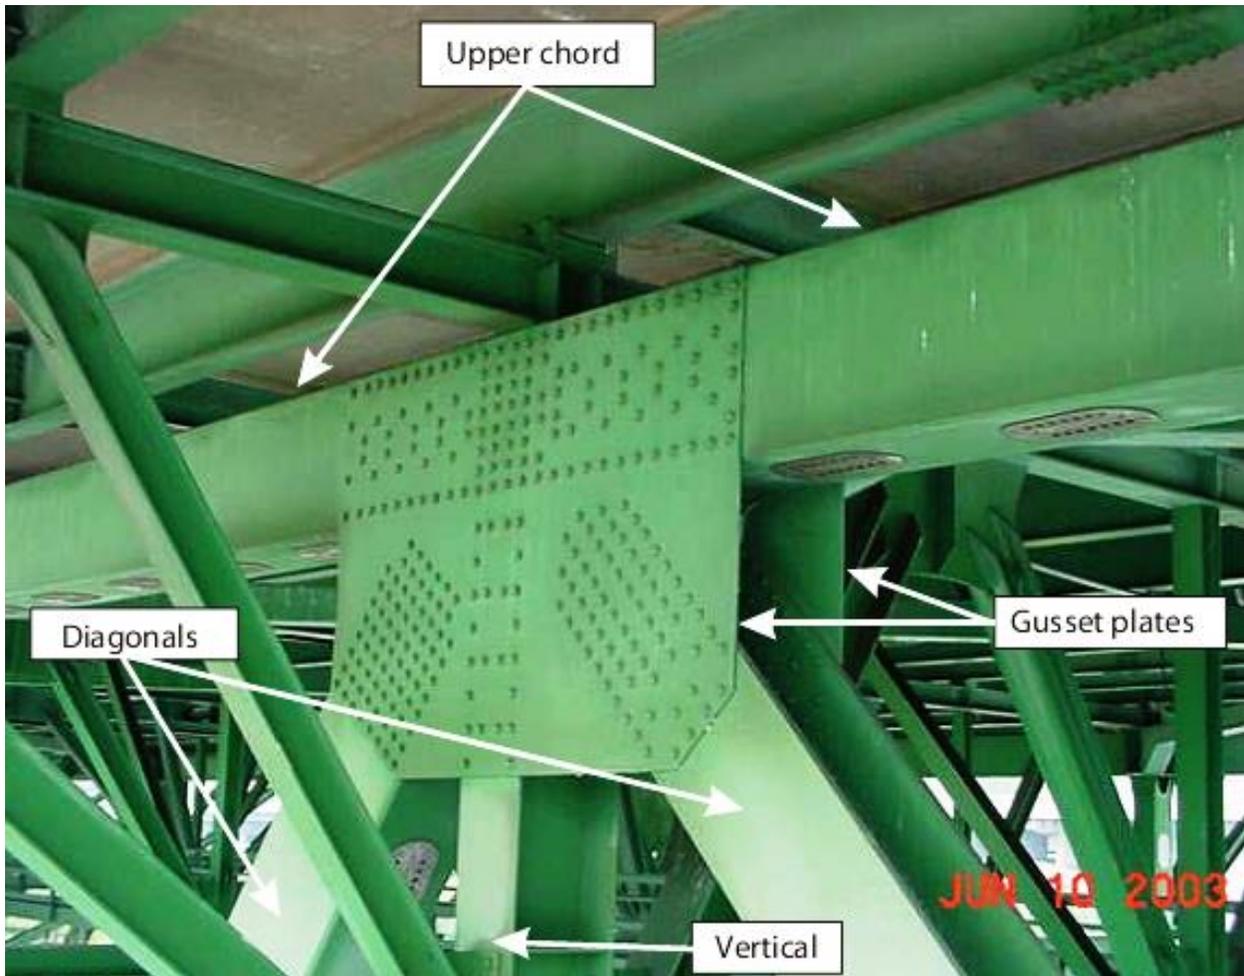
*Figure 2.1-4: Typical five-member connection of the main trusses  
(Source: NTSB)*

The vertical and diagonal members designed primarily for tension forces were built-up H-shaped members with flanges on the east and west sides welded to a web plate. All main truss members were 21 inches wide measured in the east-west direction. The main truss members were connected at the nodes by riveted steel gusset plates similar to the one shown in Figure 2.1-4.

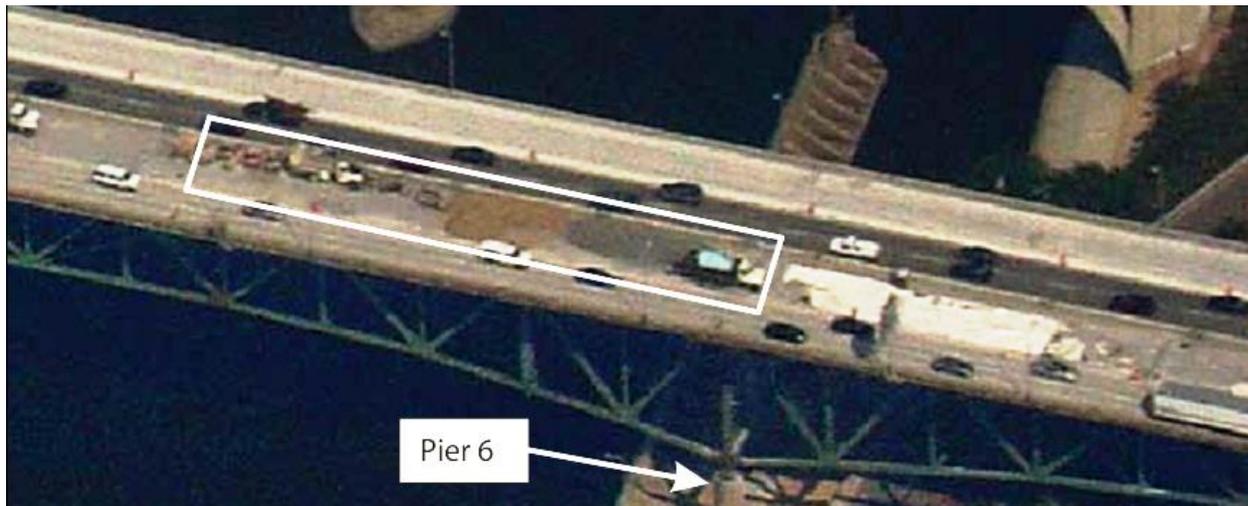
*Figure 2.2-1: Construction equipment and aggregates about 2:15 hours before the collapse. (Enlargement of photograph taken by a passenger in a commercial airliner. Source: NTSB)*

The main truss portion of the I-35W highway bridge collapsed on August 1, 2007 about 6:05 p.m. central daylight time (NTSB, 2008). Photographic evidence from the day of the collapse event and post-collapse observations of the wreckage show that the bridge collapsed under the combined effect of self-weight, vehicle traffic, and construction loads. Deck resurfacing work was underway the day of the collapse. Construction equipment and piles of aggregate were positioned on the deck directly over nodes U10 that was found to be the initiation point for the collapse (see Figure 2.2-1).

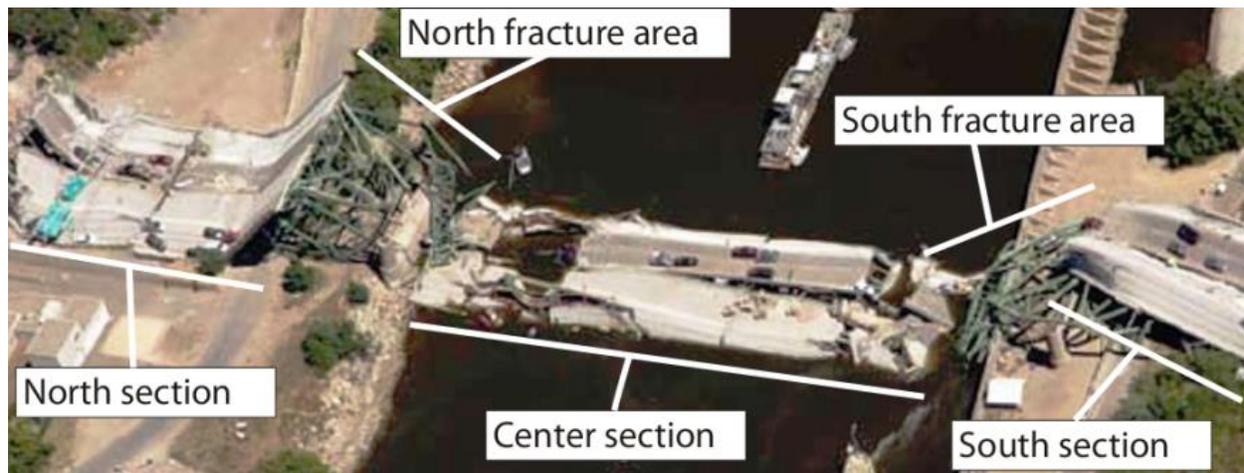
*Figure 2.2-2: Collapsed deck truss north, center, and south sections of the bridge  
(Source: NTSB)*

Most of the inelastic behavior occurred between nodes 8 and 11 at both ends of the center span, specifically in the upper chord between nodes U8 and U10, and in the lower chord between nodes L9 and L11; these are henceforth called the fracture areas.

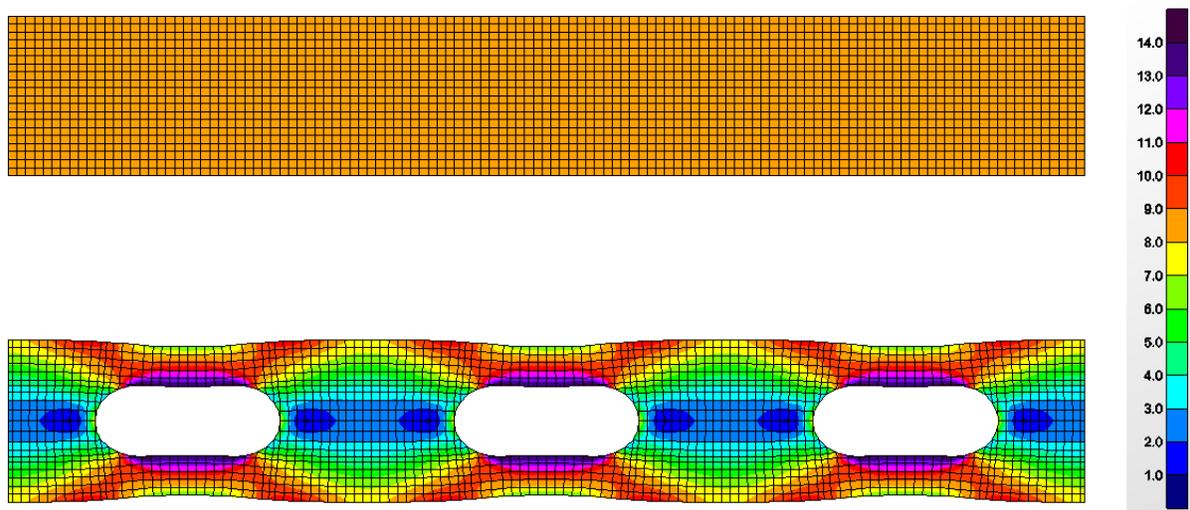
*Figure 3.1-3: Von Mises stresses (ksi) plotted on the deformed shape of the cover plates solid plate (top) and plate with access holes (bottom)*

The effective thickness of the cover plates was determined by performing FEA on two plates of the same width, length, and boundary conditions. One of the plates had access holes and the other was a solid plate. The same axial force was applied to both plates and the thickness of the solid plate was changed until its axial displacement matched that of the plate with the access holes (see Figure 3.1-3). The results show that a factor of 0.5984 can be applied to the cover plates with access holes to obtain a solid plate with equivalent longitudinal stiffness.

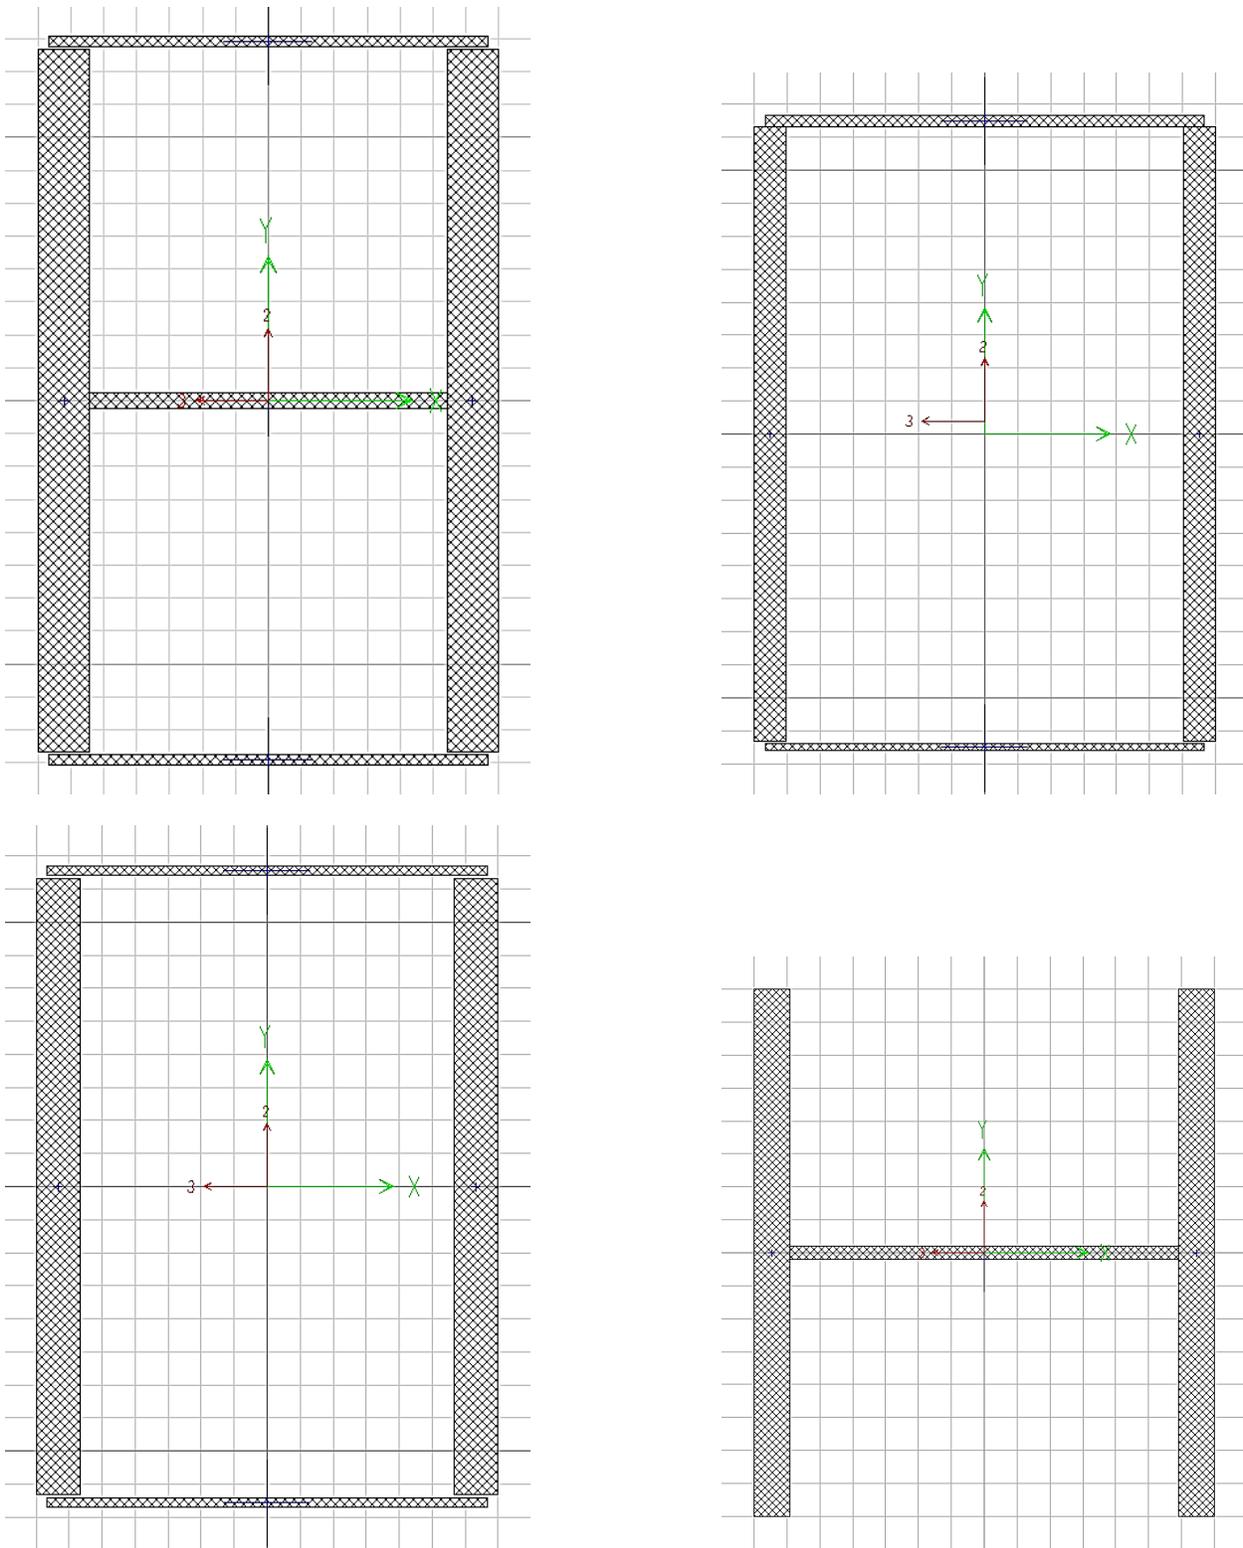
*Figure 3.1-4: Typical cross sections of the main trusses members  
 U8-L8 (top left), U8-U10 (top right), L9-U10 (bottom left) and U10-L11 (bottom right)  
 (Grids 1.5 by 1.5 inches)*

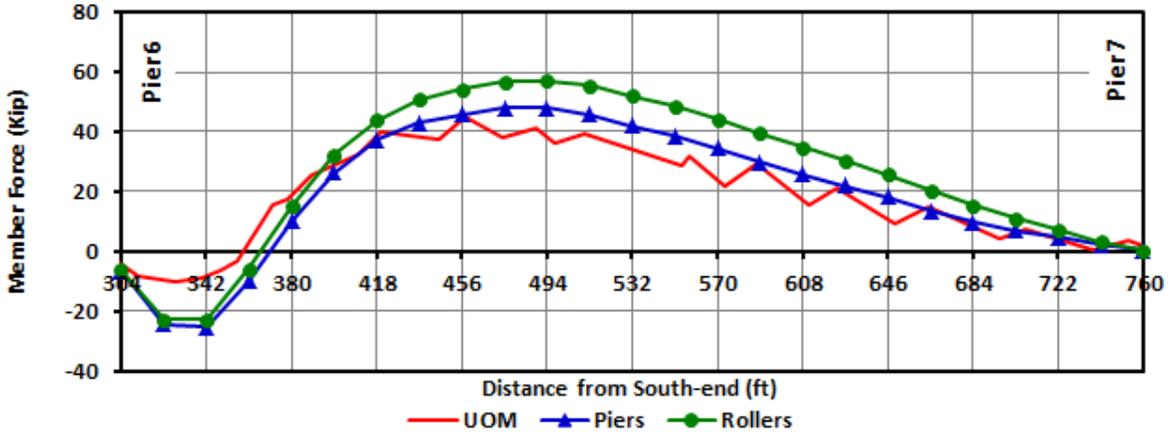
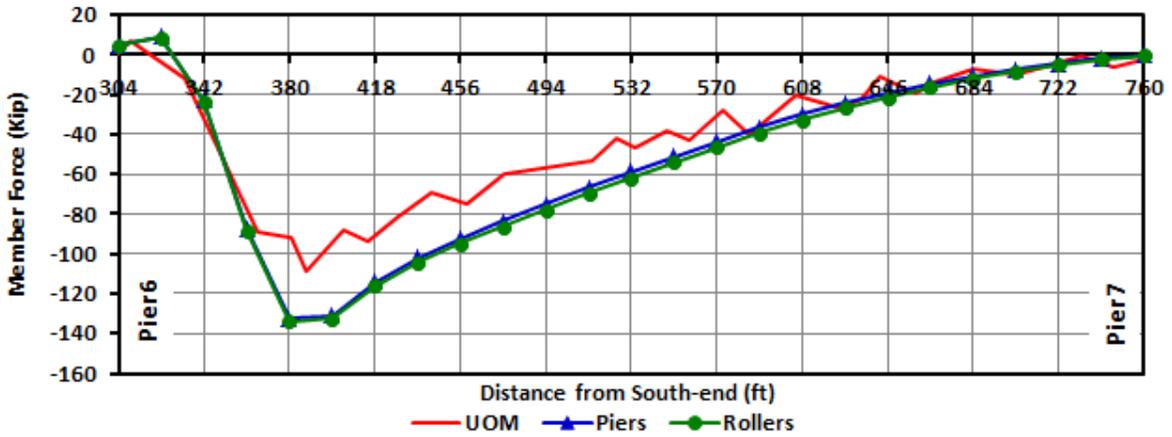
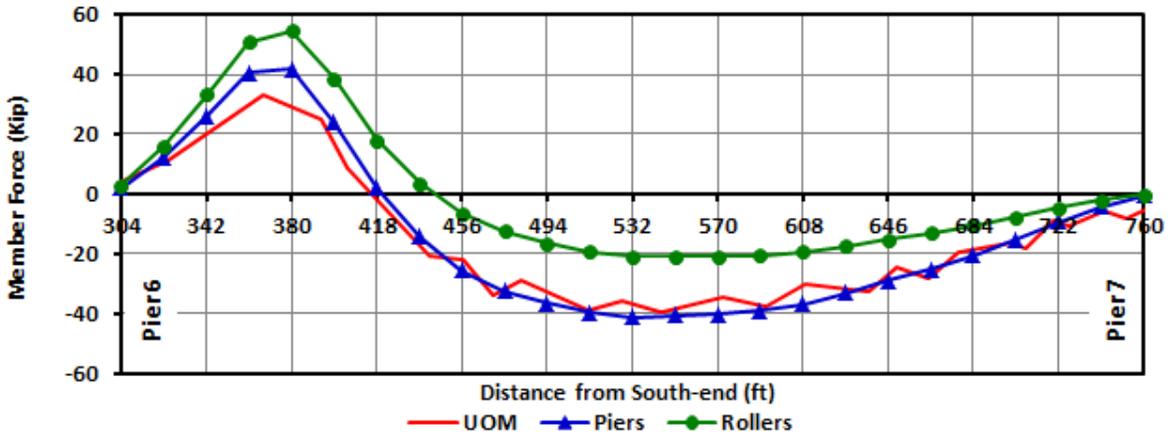
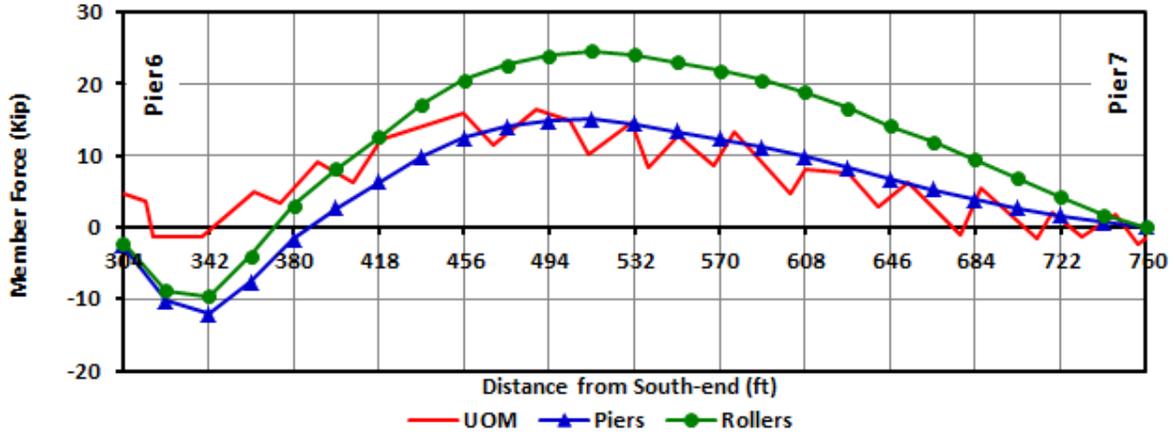
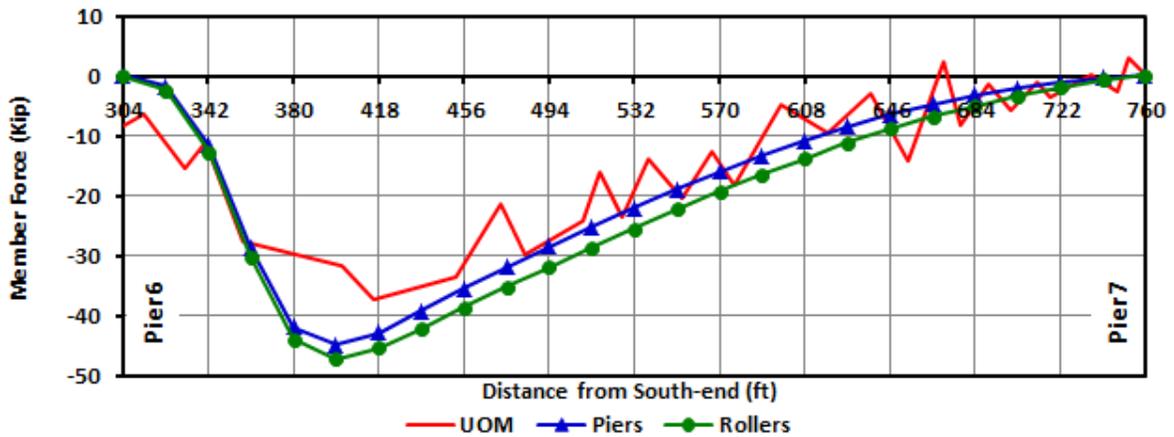
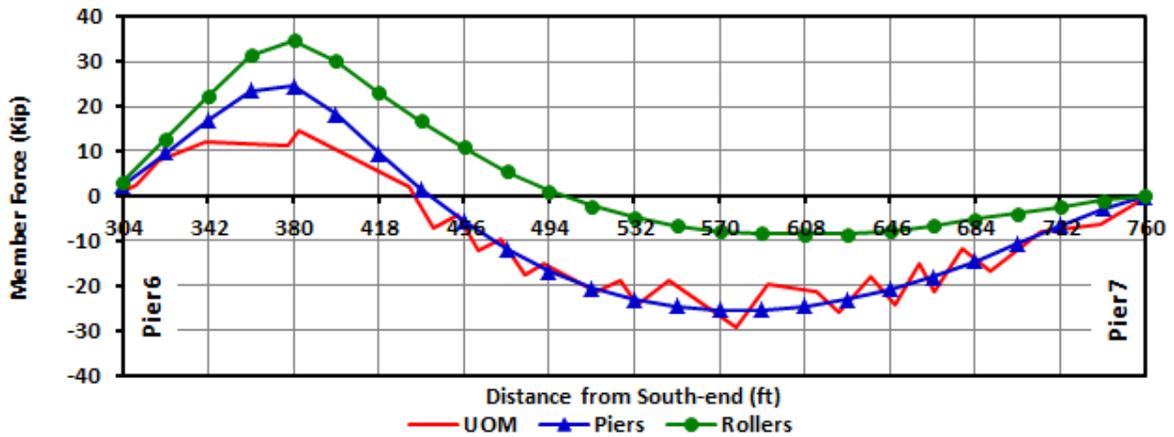
Figure 3.1-5: Influence lines for calibration of upper chord member U8-U10 West

Figure 3.1-6: Influence lines for calibration of diagonal member L9-U10 West

Figure 3.1-7: Influence lines for calibration of lower chord member L9-L11 West

Figure 3.1-8: Influence lines for calibration of upper chord member U8-U10 East

Figure 3.1-9: Influence lines for calibration of diagonal member L9-U10 East

Figure 3.1-10: Influence lines for calibration of lower chord member L9-L11 East

To calibrate the model, the stress histories were converted to axial forces to create influence lines for the members. Two different boundary conditions were considered: (1) the ideal pin and rollers (called “rollers”); and the “piers” boundary condition that assumed the rollers were locked and the longitudinal bridge movement caused bending of the piers. The stiffness of the concrete piers was modified to account for cracking that was observed in the field. The influence lines for the center span (between piers 6 and 7), shown in Figures 3.1-5 to 10, indicate that the locked “piers” boundary condition provides the closest agreement to the UOM data.

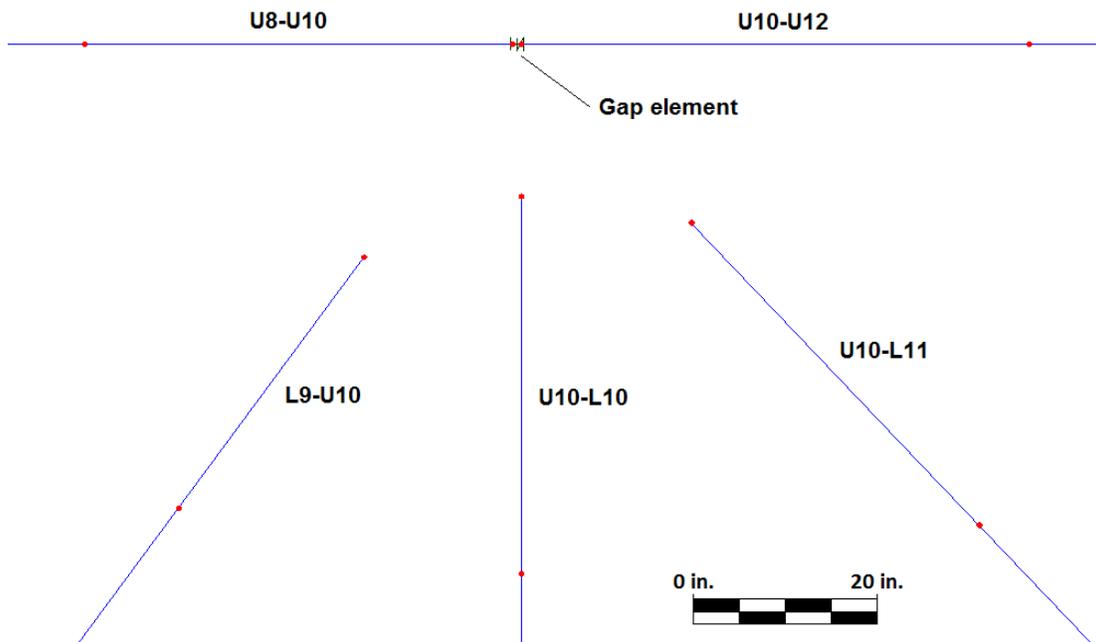
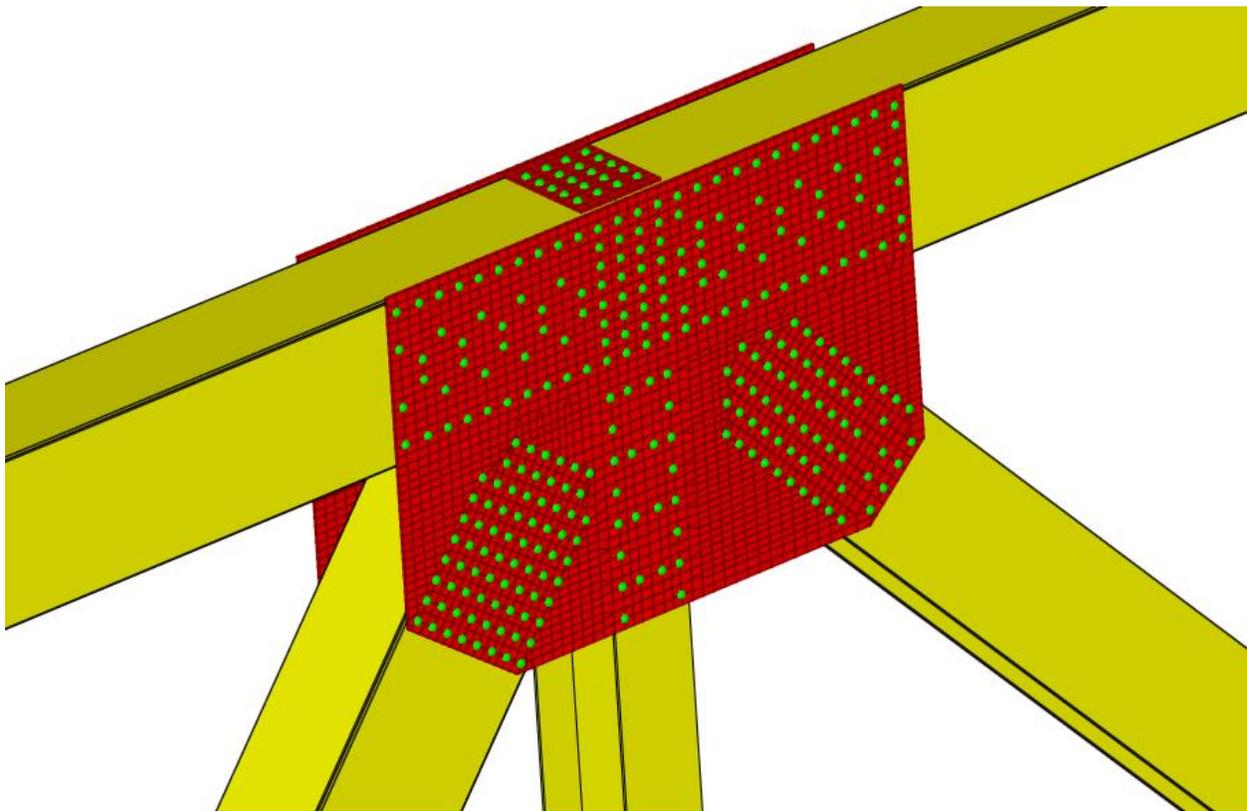
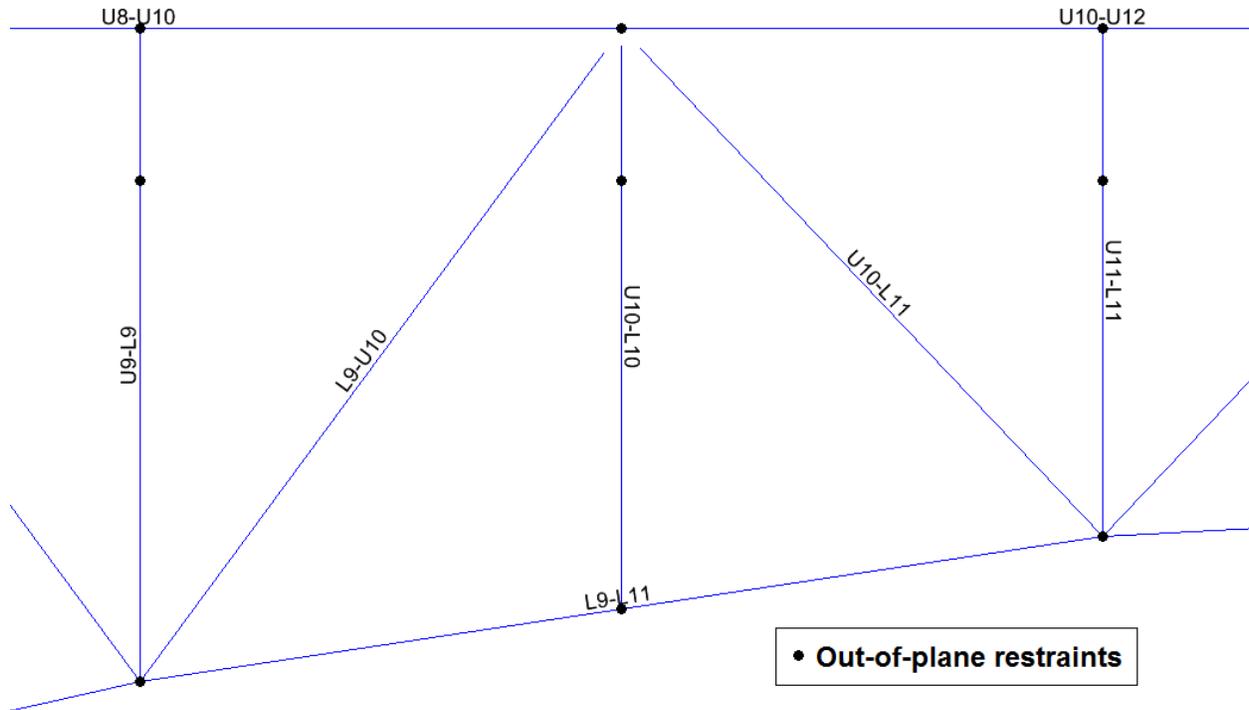
Figure 3.3-1: Main truss members at node U10 in the “Detailed U10 Connection” model

Figure 3.3-2: Extruded view of detailed U10 connection, looking down to northwest

Figure 3.3-3: Typical out-of-plane restraints in the “Detailed U10 Connection” model

Starting from the base two-dimensional model, the main truss members at node U10 were disconnected from the node and the end-point was defined at the actual location according the shop drawings (Allied Structural Steel Company, 1966). The top chord members of the main truss at node U10 were connected with Gap elements that only transfer compression forces (see Figure 3.3-1). The gusset plates connecting the side plates and flanges together and the smaller plates connecting the cover plates of the top chord members were discretely modeled using Nonlinear Layered Shell elements in SAP2000 (CSI, 2009). The individual Frame elements were connected to the corresponding joints of the shell element mesh using Body Constraints at the rivet locations (see Figure 3.3-2). This ignores any possible slip between the connected plates. The rivet holes were not discretely modeled because they have little effect on the buckling capacity of the gusset plates. All six degrees of freedom were activated to allow the full shell behavior of the gusset plates. Out-of-plane restraints were added to the main truss nodes where the sway frames, the top and bottom chords of the floor trusses connected to the main trusses (see Figure 3.3-3).

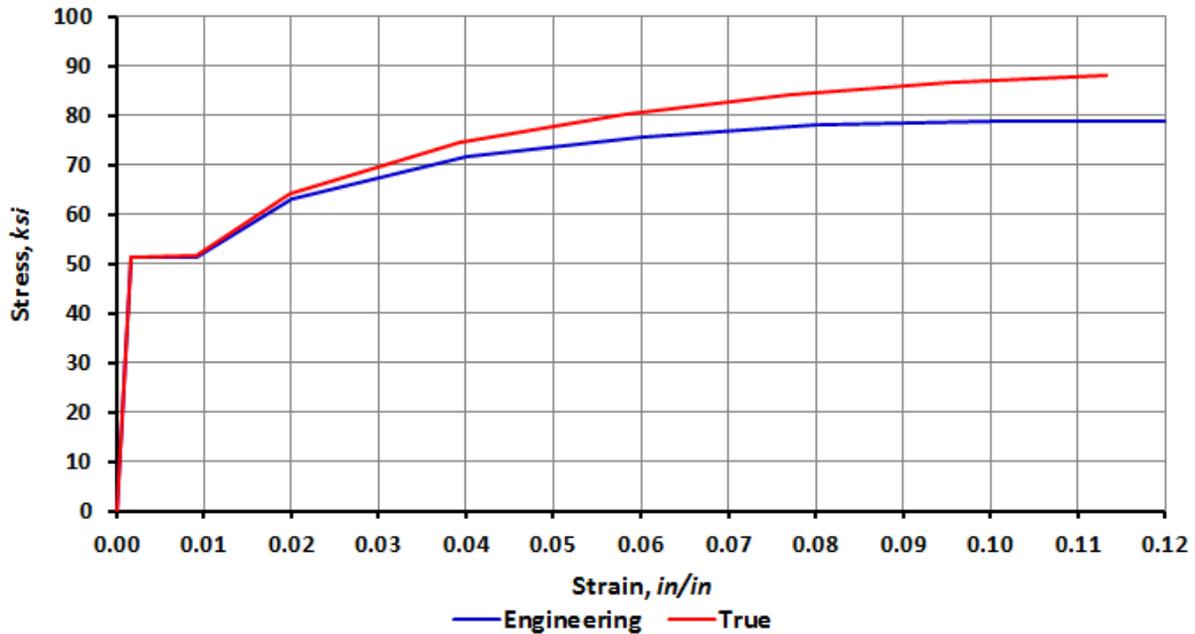
Figure 3.3-4: Stress – Strain relations for the U10 gusset plates material

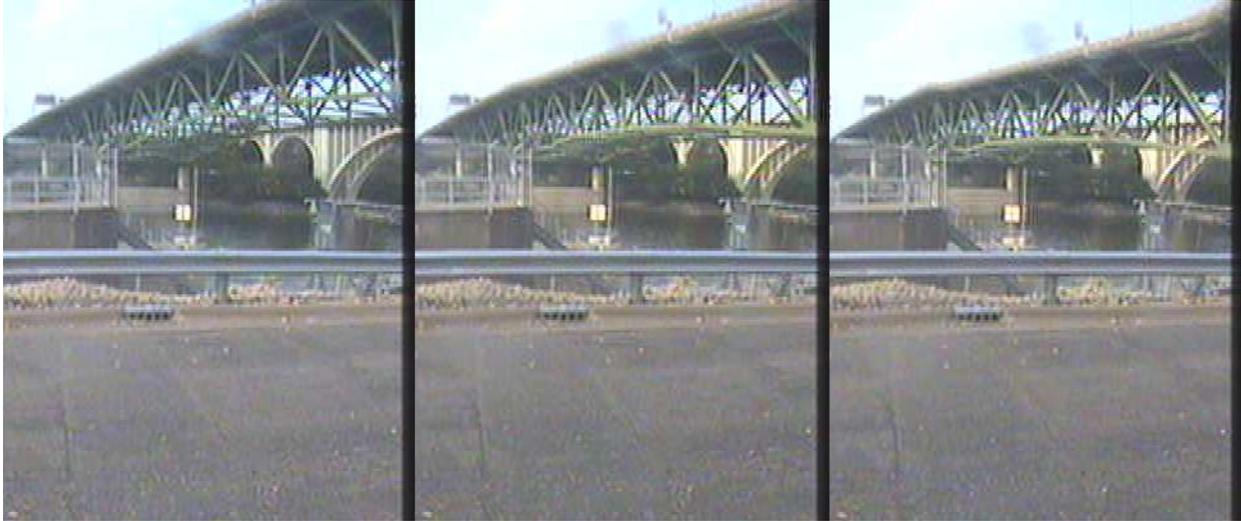
*Figure 3.4-1: First three frames captured by the security camera during the collapse*

The weather records from the University of Minnesota show that the temperature at the time of collapse was  $92.1 ^\circ\text{F}$  (WJE, 2008). The time of loading ( $t$ ) refers to the uniaxial tension test from the start of loading to the maximum load (Wright, 2012). The first three frames of the video footage were used to determine the time of loading since the frame rate of the video is 1 second. The deflection of the U10 node was scaled based on the length of the U10-L10 vertical member, resulting in an approximate  $38 \text{ in}/\text{sec}$  node velocity of (see Figure 3.4-1). In a separate two-dimensional model, the stiffness of the L9-U10 diagonal was removed shortly after the end of load Stage 3 to simulate the buckling of the gusset plates. The structural analysis results give the stress change in the cross sections related to the deflection of node U10. These two results were used to calculate the strain rate and extrapolate to get the time of loading. This approach ignores

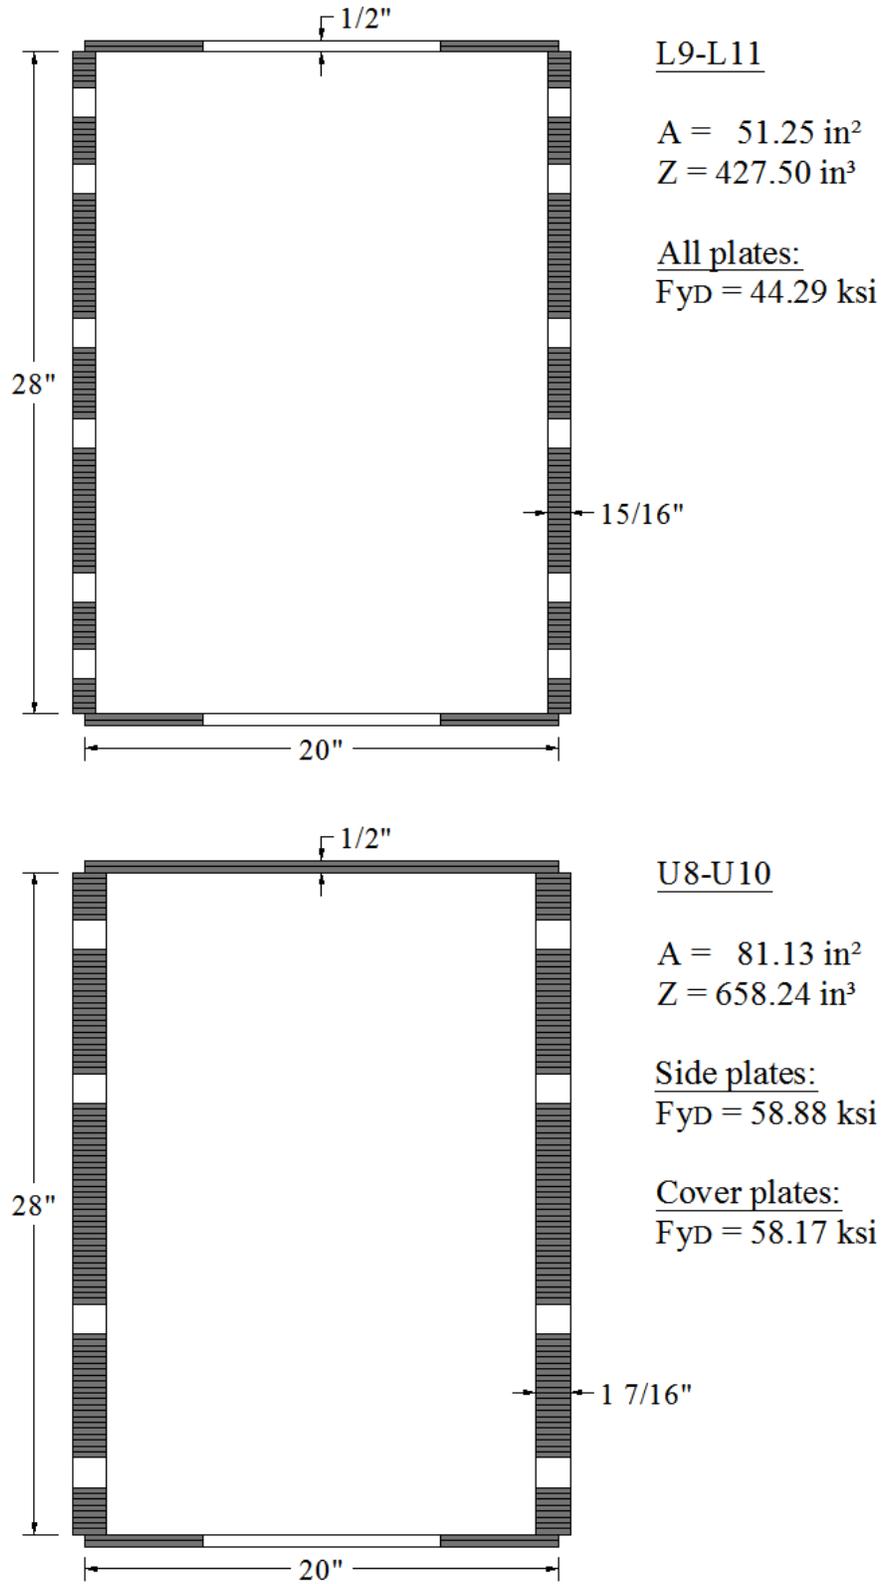
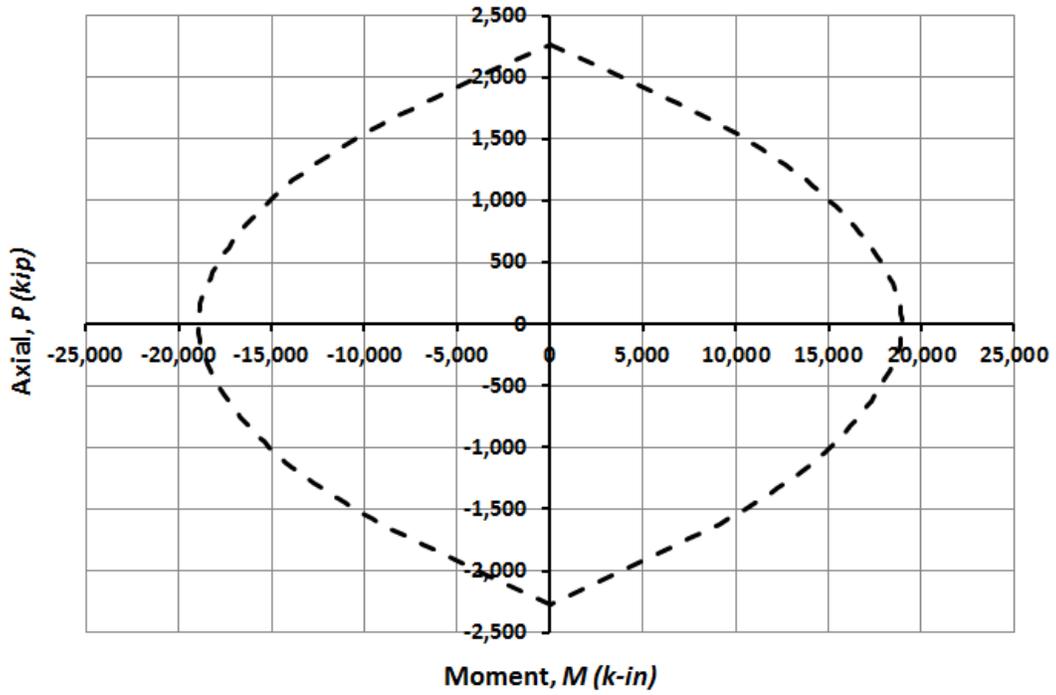
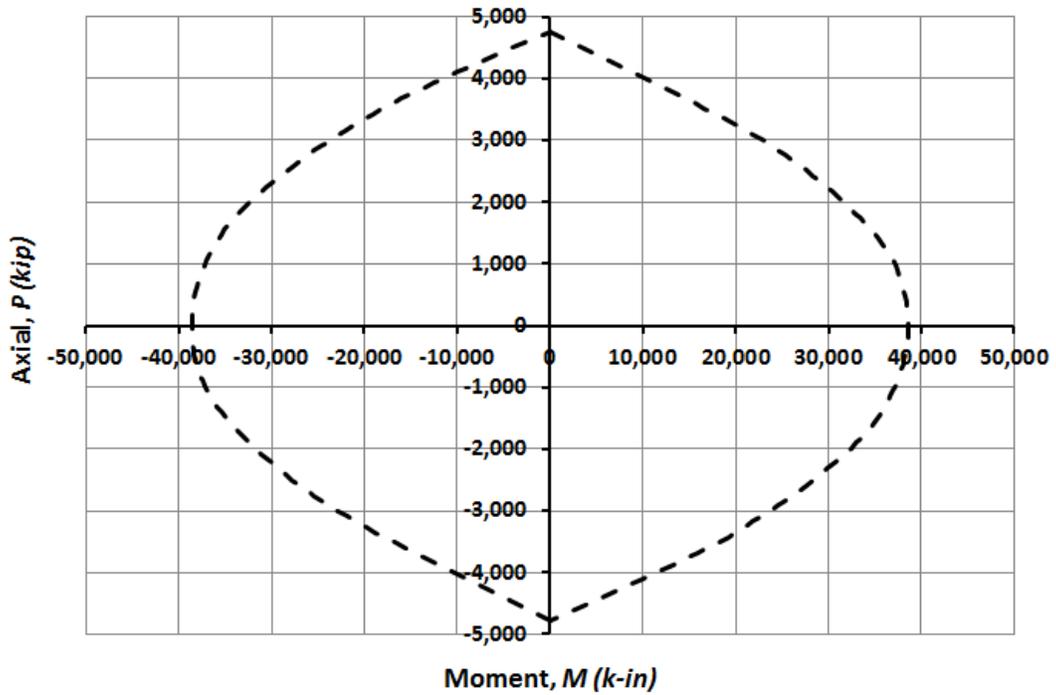
Figure 3.4-2: Discretized cross-sections for fiber analysis and their section properties

Figure 3.4-3: Axial-flexure interaction diagram for net section of L9-L11 members

Figure 3.4-4: Axial-flexure interaction diagram for net section of U8-U10 members

The net section was used to define the interaction diagrams for the members. It was assumed that the inner row of rivet holes in the side plates coincides with the same cross section containing the access holes in the cover plates. The idealized cross-sections of the L9-L11 and U8-U10 members that were used for the fiber analysis are shown in Figure 3.4-1 and their respective axial-flexure interactions diagrams in Figures 3.4-2 and 3.

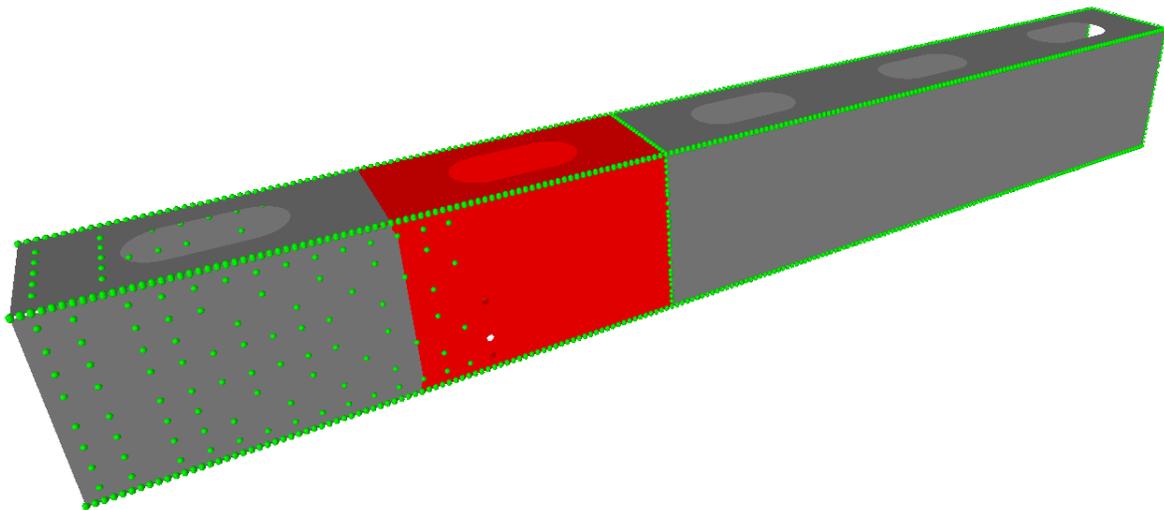
*Figure 3.5-1: Detailed segment of the L9-L11 bottom chord member  
Linear shells (gray), nonlinear shells (red) and restrained or constrained joints (green)*

The axial forces, shear forces, and bending moments were input at the free end of the segment to represent the pre and post buckling behavior of the gusset plates that was determined by the preliminary analysis. The nonlinear material behavior was included only in the shell elements contained within the 42 inches tributary length of the access hole where the rivet holes were modeled, as shown in Figure 3.5-1.

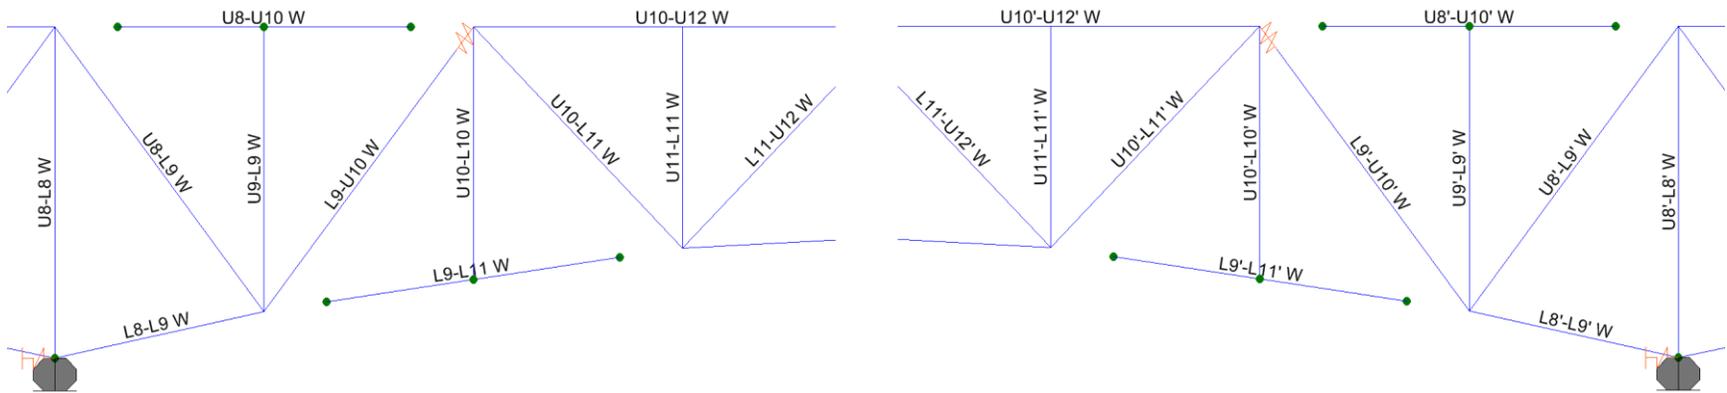
Figure 3.6-2: Center span ends of the nonlinear 2D model, elevation looking west  
 Frame Hinges (green), Springs and Nonlinear Links (orange)
