# **STUDY OF THE I-35W HIGHWAY BRIDGE COLLAPSE MECHANISM**

Thesis submitted to the Faculty of the  
Virginia Polytechnic Institute and State University  
In partial fulfillment of the requirements for the degree of

Keywords: I-35W Bridge Collapse, Collapse Mechanism, Gusset Plate Buckling,  
Plastic Hinges, Plastic deformations

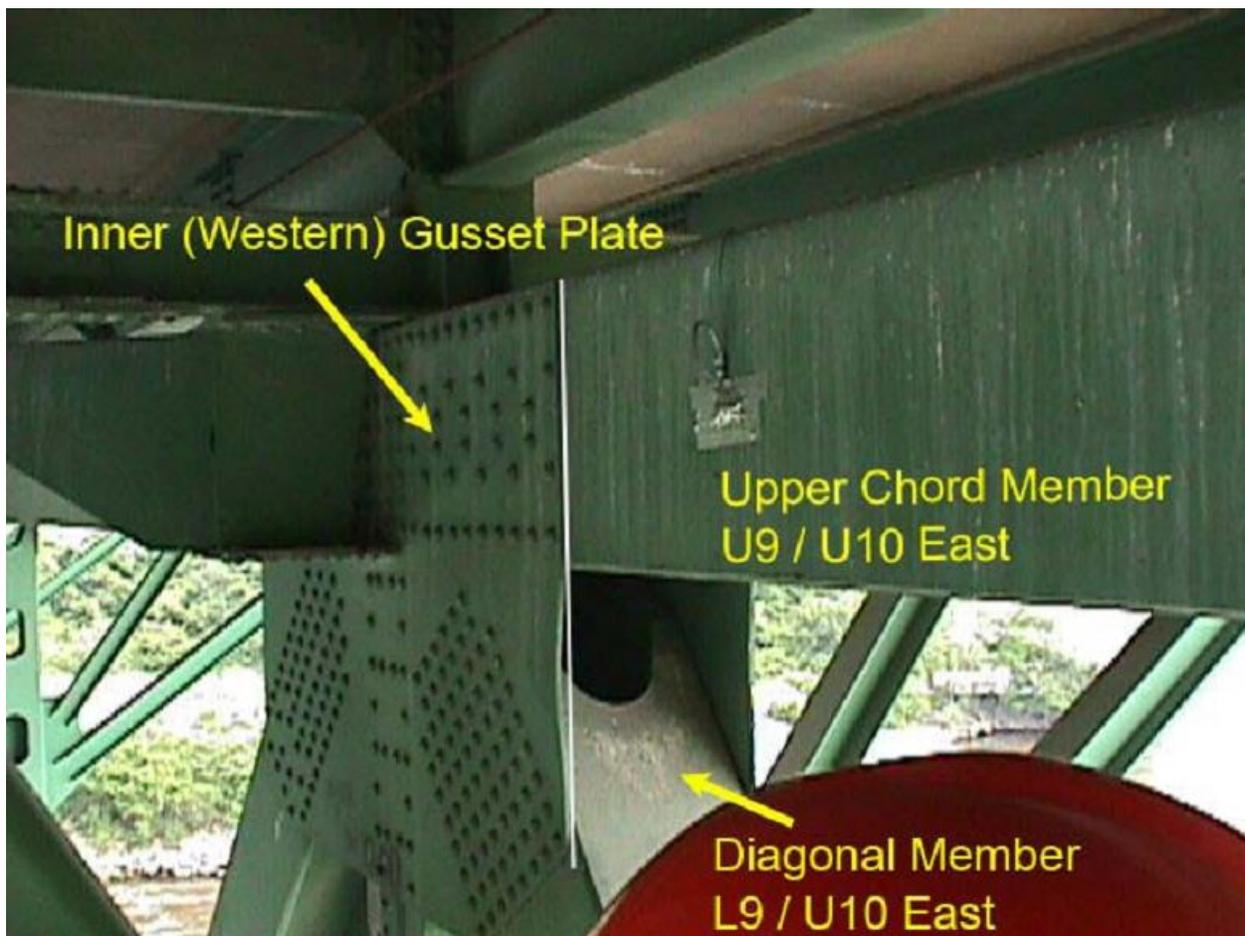
*Figure 4.1-1: Bowed U10 East Gusset Plates, looking northeast from inside the structure  
Retrieved from the NTSB HWY07MH024 – Photograph Study Report (Brazy, 2008)*

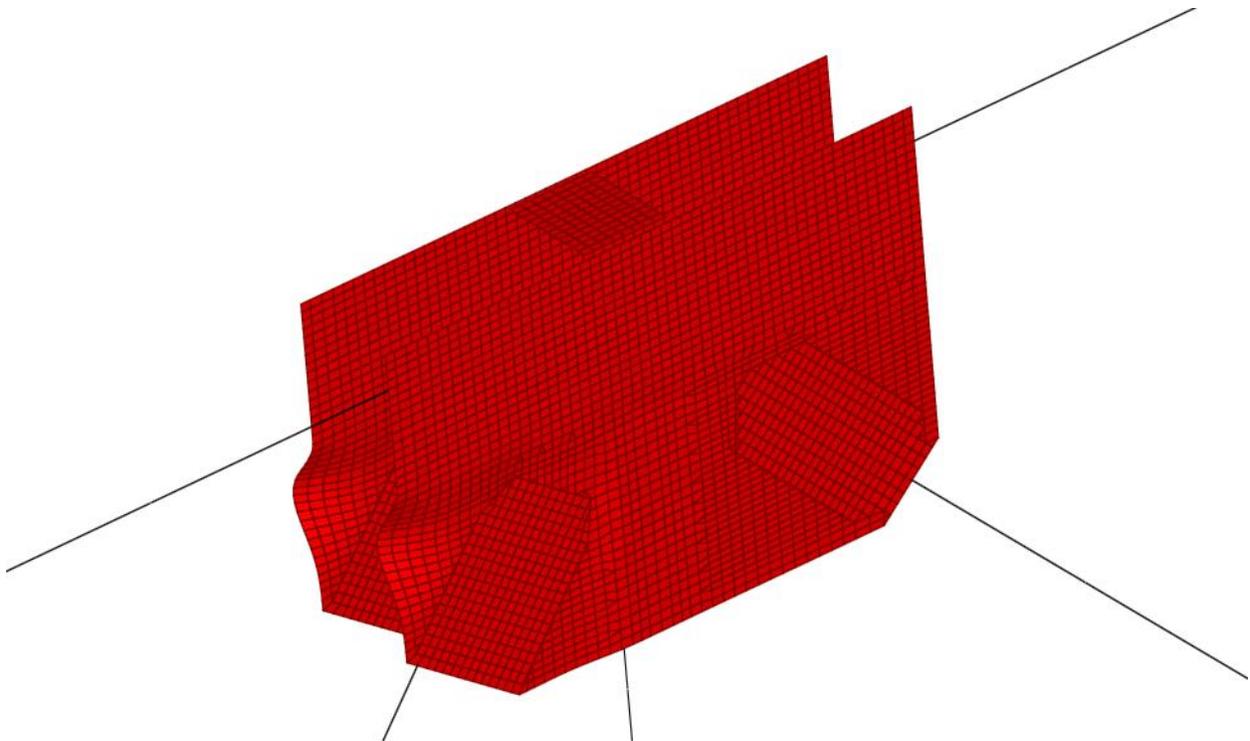
*Figure 4.1-2: Critical linear buckling mode shape of the U10 gusset plates  
(Stiffness at end of Stage 4)*

The buckling analysis of the structure was performed on the 2D model with the detailed U10 connection described in Section 3.3. The Linear Buckling analysis was performed in the structural model to compare the critical buckling mode shape to the actual out of plane distortions of the gusset planes as captured in the photographs. The resulting critical load is probably overestimated by this analysis. Figure 4.1-2 shows the buckled shape for mode 1, which is the critical mode. The out-of-plane displacements at the free vertical edge on the side where the L9-U10 compression diagonal was connected are similar to the ones shown in the photographs. This indicates that that the bowing observed in the gusset plates could have been caused by a developing buckling mode.

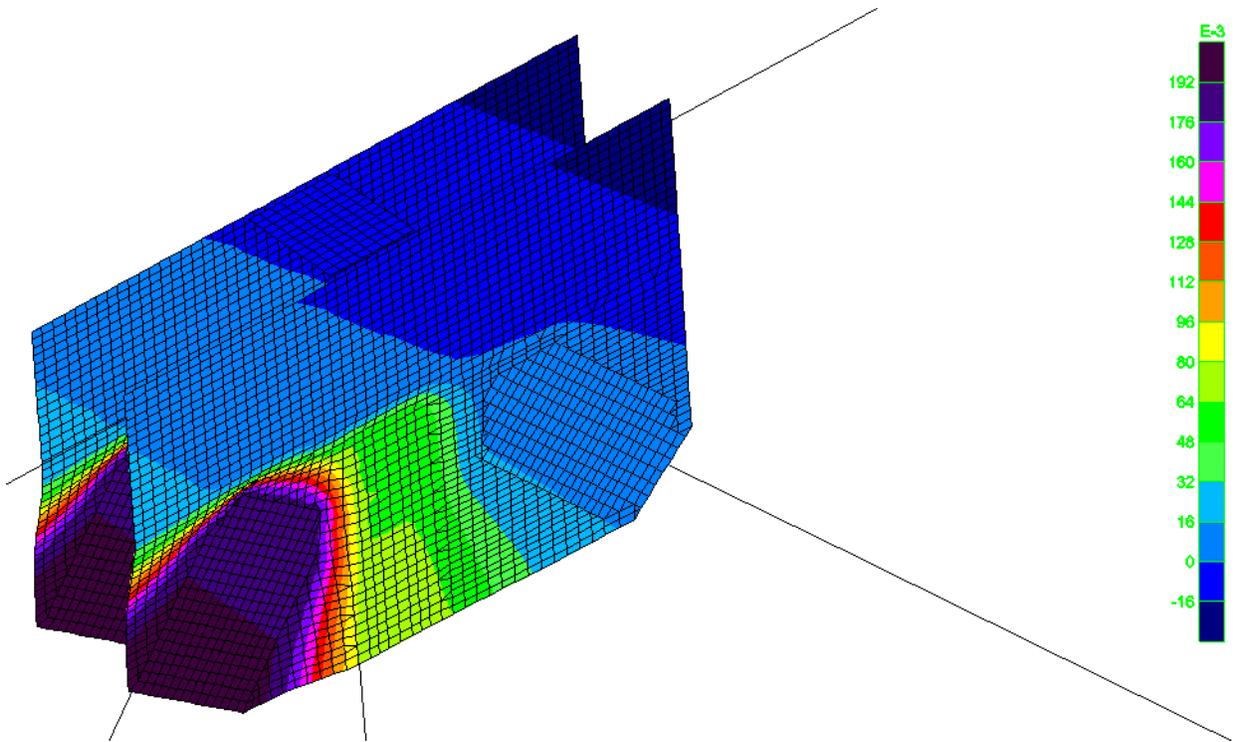
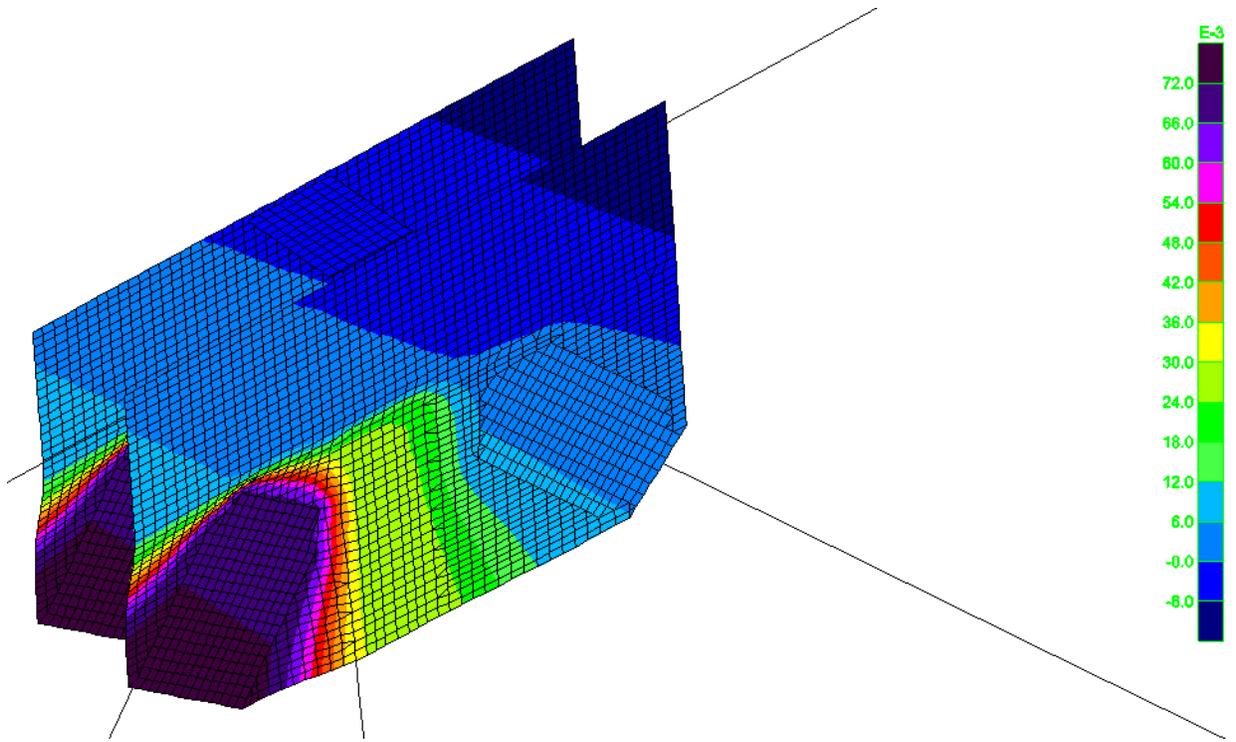
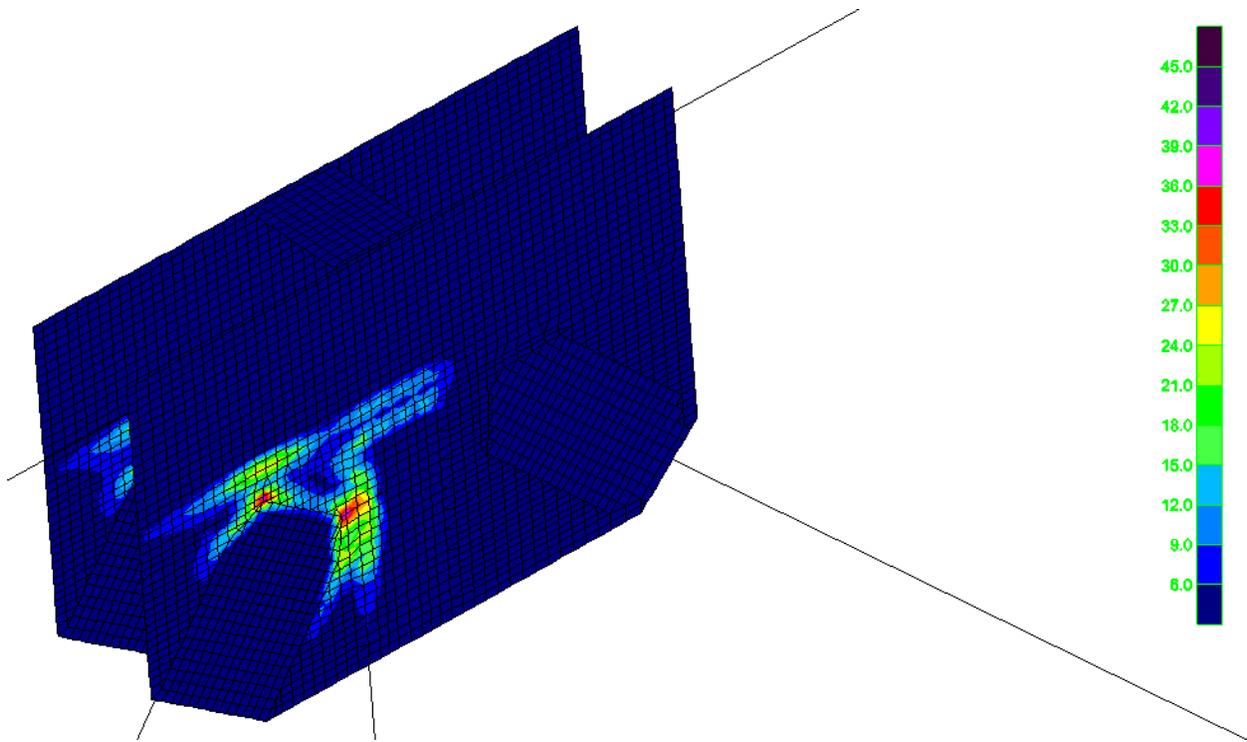
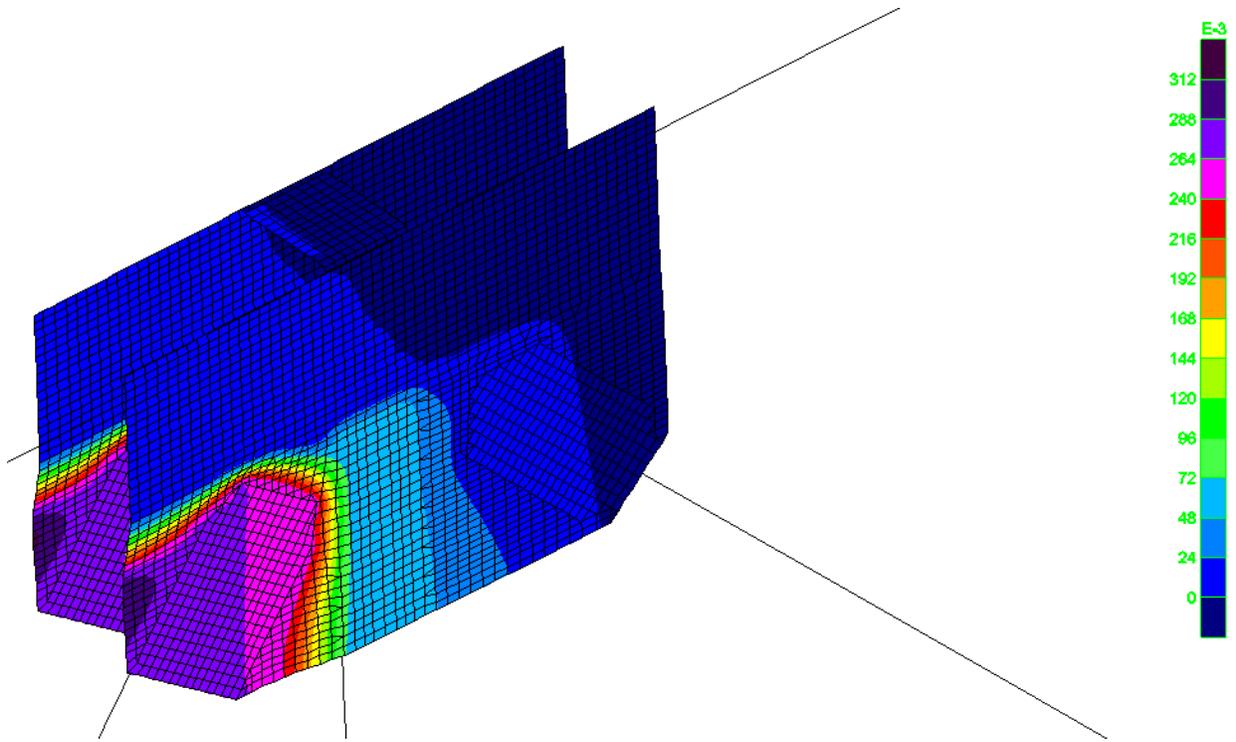
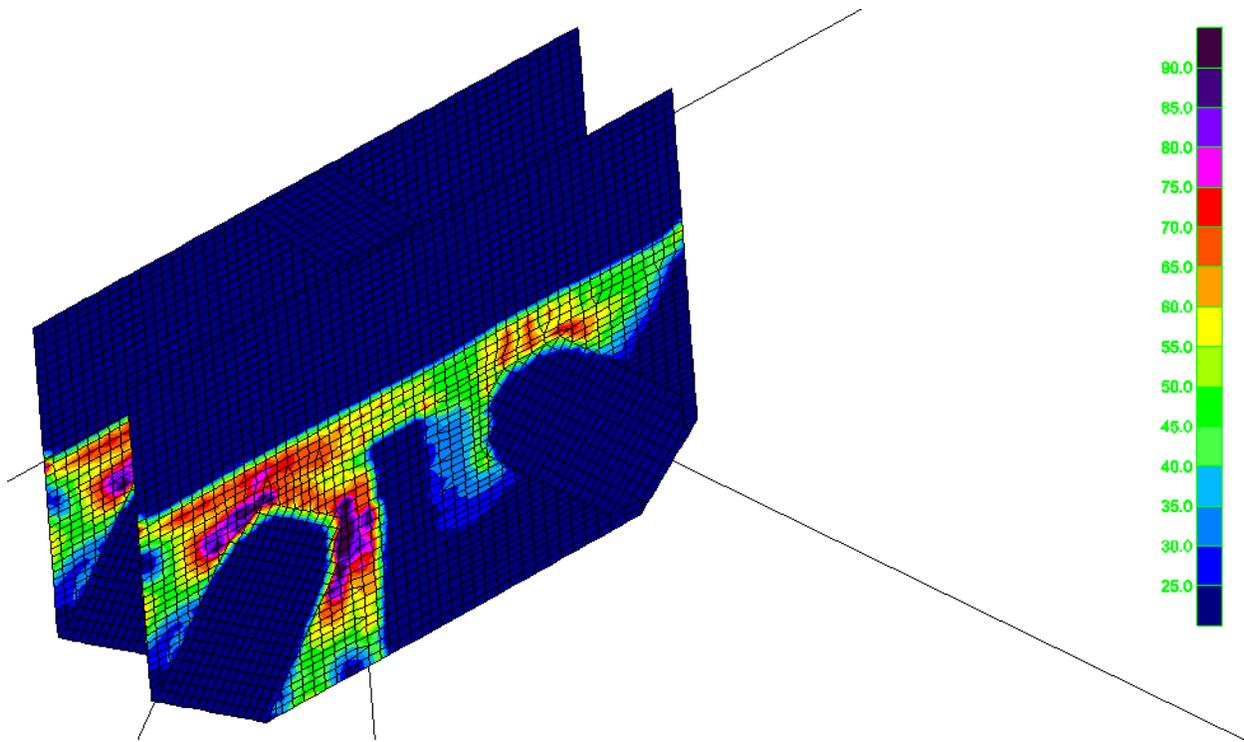
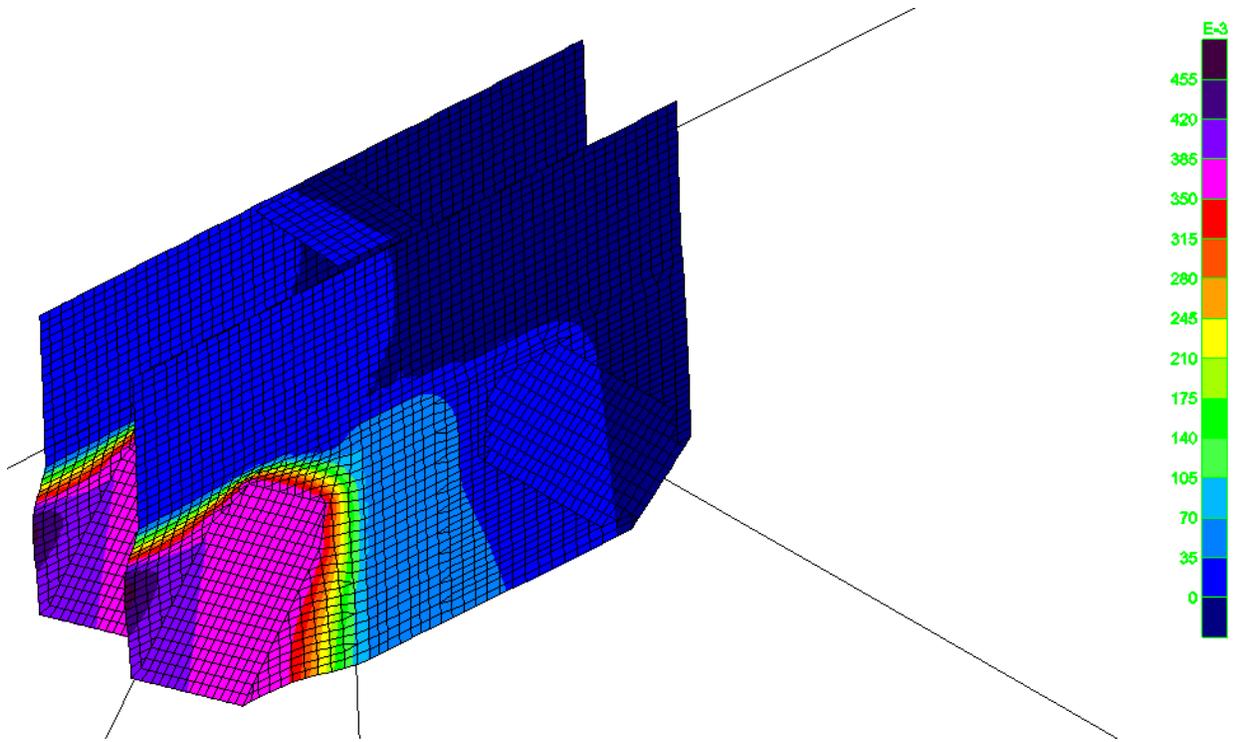
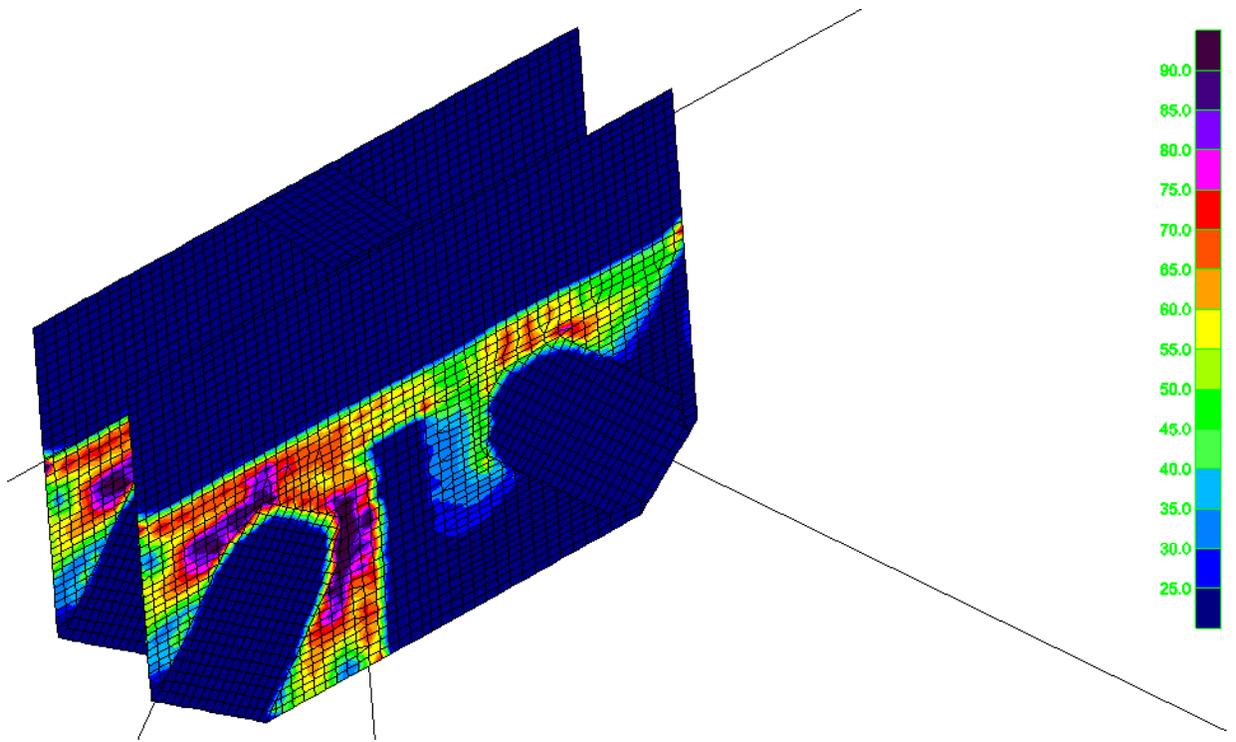
*Figure 4.1-3: Initial out-of-plane imperfections (inches) at U10 gusset plates*

Figure 4.1-4: Built-in out-of-plane imperfections (inches) at U10 gusset plates

Figure 4.1-5: Built-in Von Mises stresses (ksi) at U10 gusset plates

Figure 4.1-6: Service load out-of-plane displacements (inches) at U10 gusset plates

Figure 4.1-7: Service load Von Mises stresses (ksi) at U10 gusset plates

Figure 4.1-8: Maximum load out-of-plane displacements (inches) at U10 gusset plates

Figure 4.1-9: Maximum load Von Mises stresses (ksi) at U10 gusset plates

The built-in imperfections were modeled using a small destabilizing load at the reference point. A trial and error displacement-controlled analysis was performed initially at 0.05 in. displacement increments until the target displacement between 0.45 in. and 0.75 in. was achieved for an axial force of 2,258 *kip* in the compression diagonal. The best match was obtained with a built-in deformation of 0.075 inches resulting in a total displacement of 0.475 inches at the reference point. This required a 0.484 *kip* destabilizing load (see Figure 4.1-4). The resulting built-in Von Mises stresses in the gusset plates are about 20 *ksi* in average with peaks of about 40 *ksi* around the corners at the end of the L9-U10 diagonal, as shown in Figure 4.1-5.

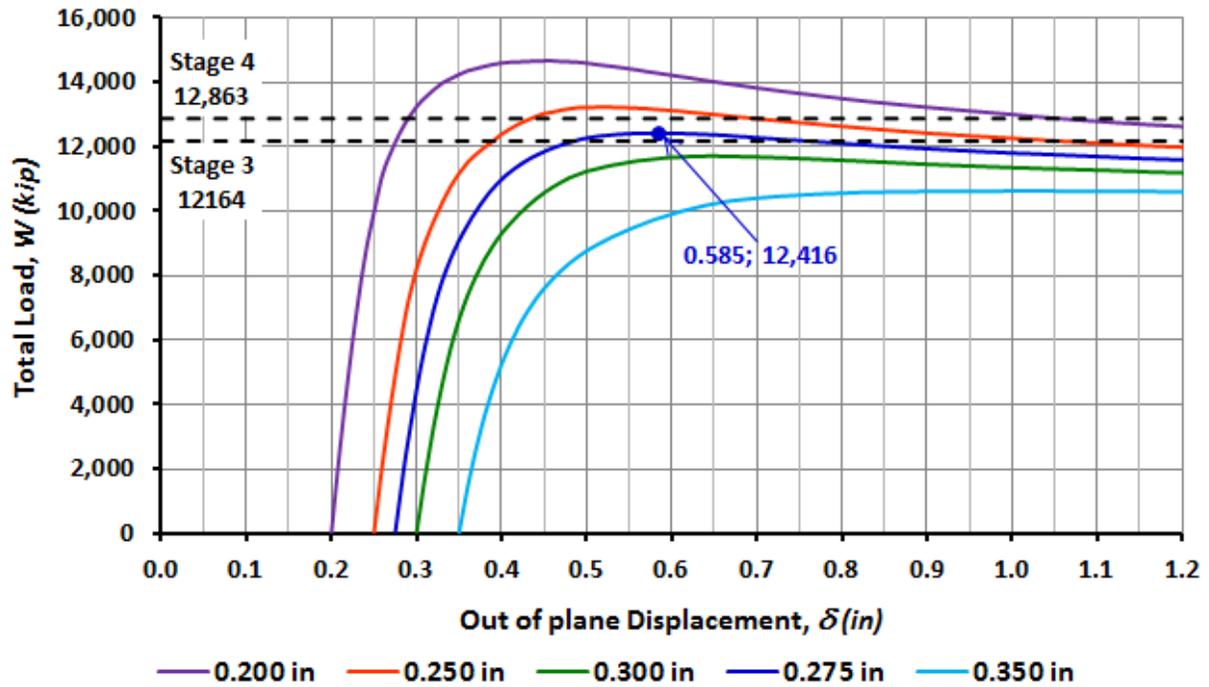
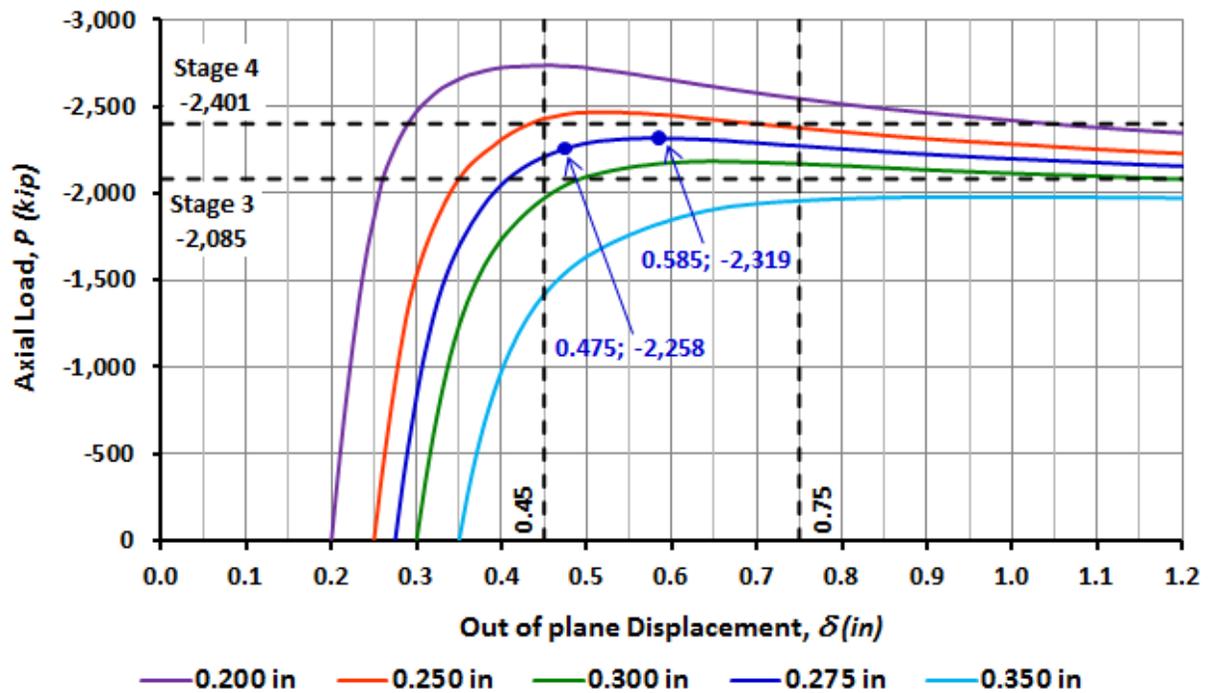
Figure 4.1-10: Total load vs out-of-plane displacement at U10 end of L9-U10 diagonal

Figure 4.1-11: Axial force vs out-of-plane displacement at U10 end of L9-U10 diagonal

The total load versus displacement and axial force versus displacement plots for the different built-in deformations are shown in Figures 4.1-10 and 11 respectively. The total load refers to the applied load in the model, which totaled 12,863 *kip* at the end of load Stage 4. The axial force is taken at the upper end of the L9-U10 compression diagonal, which reaches a maximum of 2,401 *kip* at the end of Stage 4. The displacement is the total out of plane deformations of the gusset plate at reference point including the initial imperfection, the built-in deformation and the additional deformation due to loading on the bridge. Five curves are plotted in each figure, four with increasing initial imperfections (0.2, 0.25, 0.3, and 0.35 in.) and one curve with the best estimate of the buckling capacity that starts at 0.275 in. The total load and axial forces at the end of Stages 3 and 4 and the displacement range of the photographs are shown in the figures for comparison.

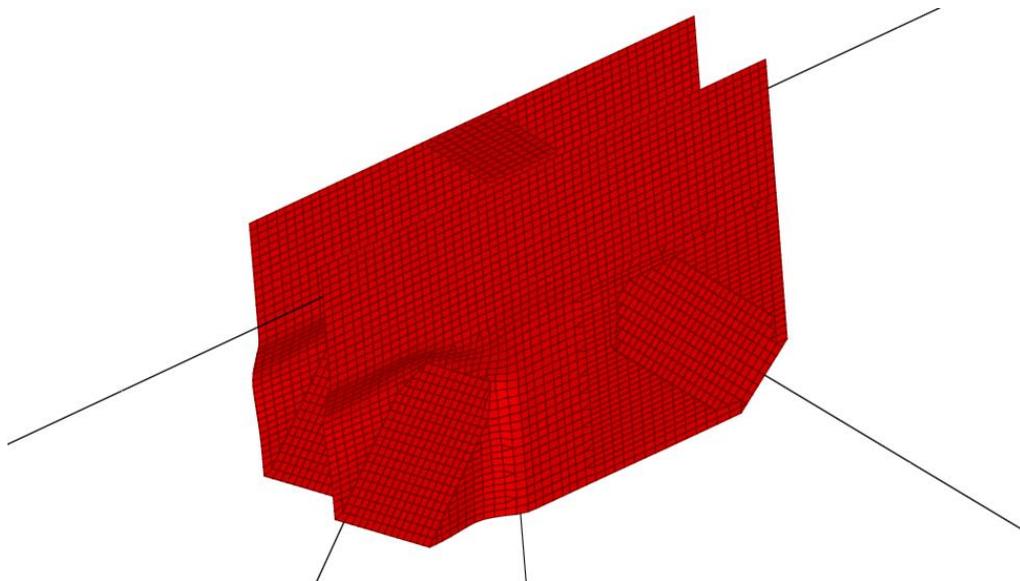
*Figure 4.1-13: Deformed shape of the U10 gusset plates at end of analysis  
(Scale factor of 1.0)*

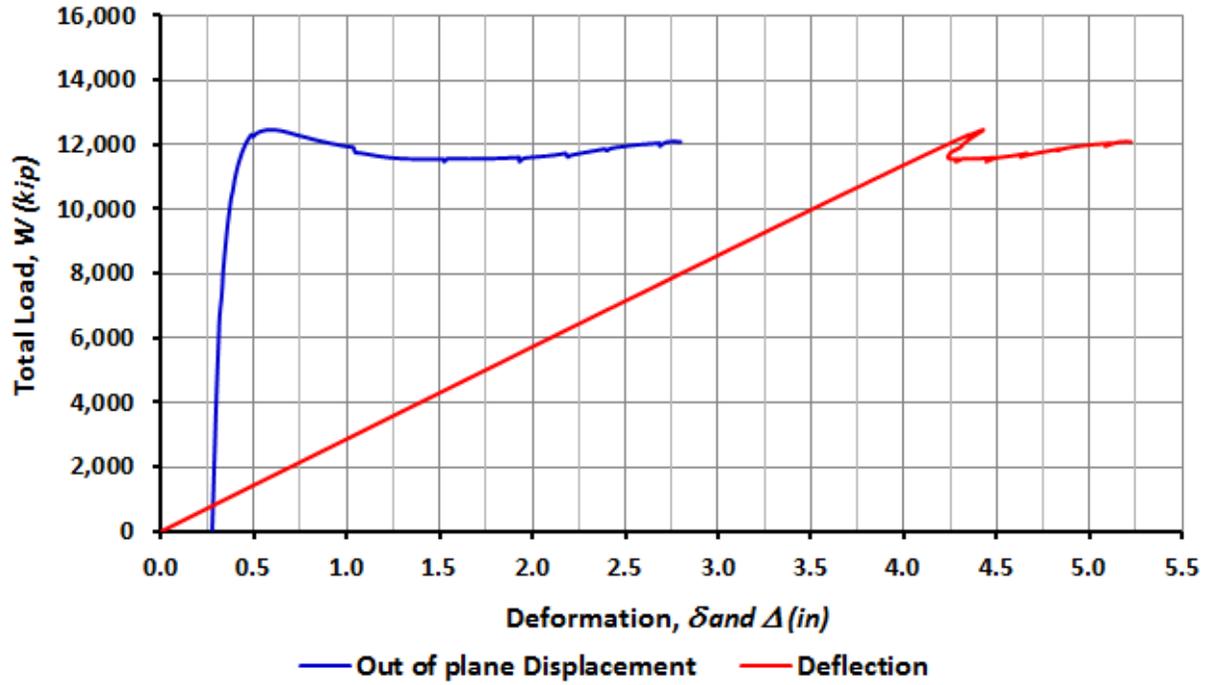
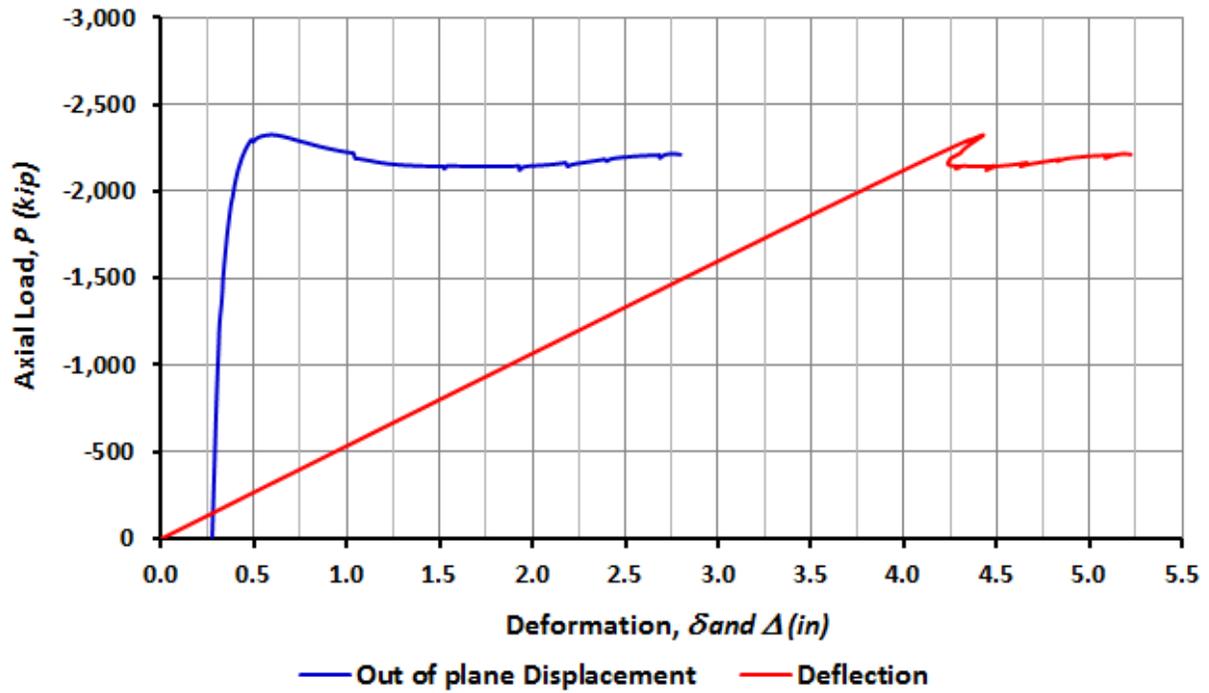
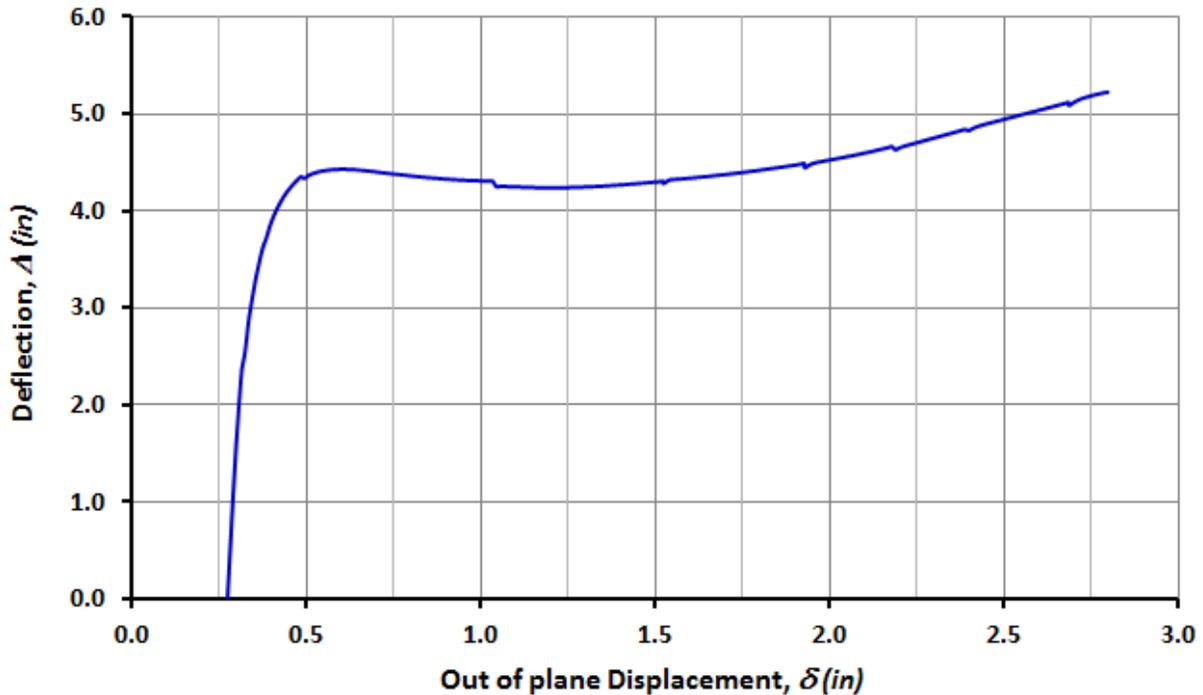
Figure 4.1-14: Total load vs deformations at node U10

Figure 4.1-15: Axial force of L9-U10 diagonal vs deformations at node U10

Figure 4.1-16: Deflection vs out-of-plane displacement of U10 gusset plate

The deflection of node U10 versus the out-of-plane displacement of the reference point is shown in Figure 4.1-16. The curve starts at 0.275 in. displacement from the 0.2 in. initial imperfection and the 0.075 in. built-in deformation. The onset of buckling is clearly noted when the displacements start increasing rapidly at 0.605 in. displacement and 4.43 in. deflection. The slight drop in deflection to 4.24 in. at 1.21 in. displacement occurs at the snap-back immediately after the buckling load shown in Figure 4.1-14 and 15. When the analysis stopped, at 2.80 in. displacement and 5.22 in. deflection, the slope of the curve was about 100 percent meaning that the displacement was increasing about 1 inch per inch of vertical deflection.

This approximation ignores the peak at the buckling load because SAP2000 nonlinear capabilities cannot capture the snap-back shown in Figures 4.1-14 and 15 in the 2D model. The monitored displacement in the detailed U10 connection model is the out-of-plane displacement of the reference point, but this is not allowed in the 2D model. In addition, fracture is likely to occur in the gusset plate shortly after where the analysis stopped. This would represent an additional drop in loading. Since evidence from the wreckage shows that the U8-U10 upper chord member came to bear against the L9-U10 diagonal member at some point during the collapse and the final goal of this research is to get the overall picture of the collapse mechanism, the fifth line keeps the final axial force constant with an unlimited deformation capacity.

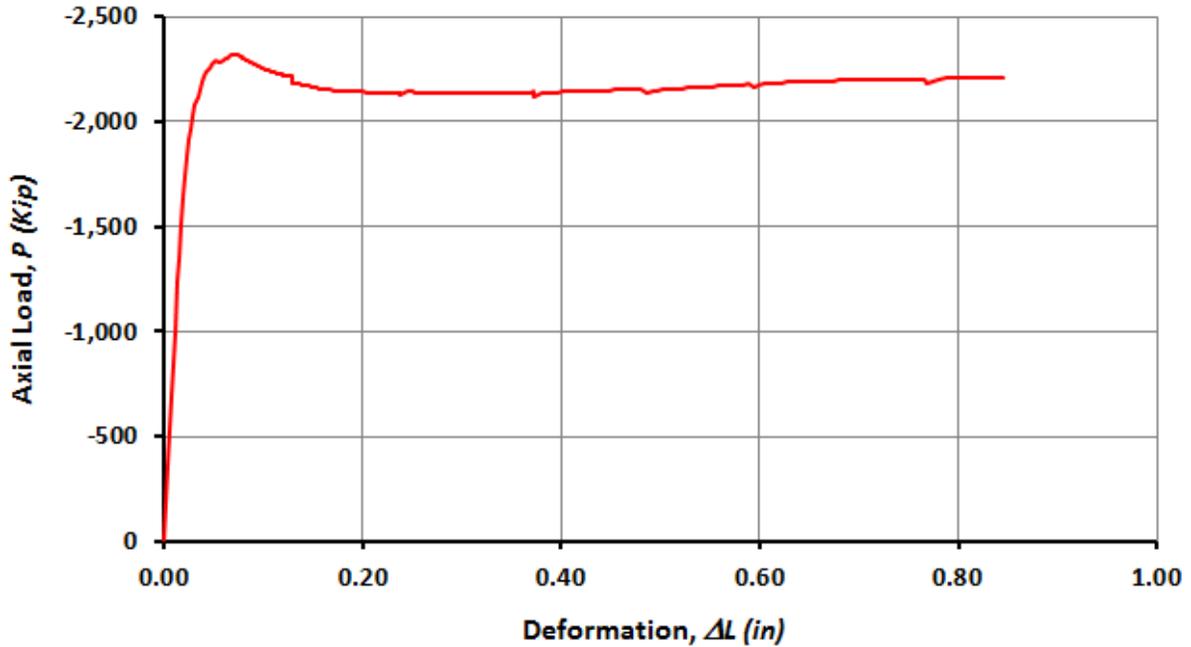
Figure 4.1-17: Force vs deformation of U10 gusset plate, L9-U10 segment

The axial force in the L9-U10 member was kept constant at 2,205 *kip* after buckling of the U10 gusset plates, as shown in Figure 4.1-17. In reality, this load may drop at some point when the gusset plates fracture and the diagonal breaks free from node U10. Predicting this effect is complicated since the diagonal is known to have post-fracture bearing contact with the upper chord. The Frame Hinges assigned to the members L9-L11 and U8-U10 were defined with elastic-perfectly plastic constitutive models and infinite rotation capacity. In reality, the load may drop further due to fracture or local buckling at the critical cross sections.

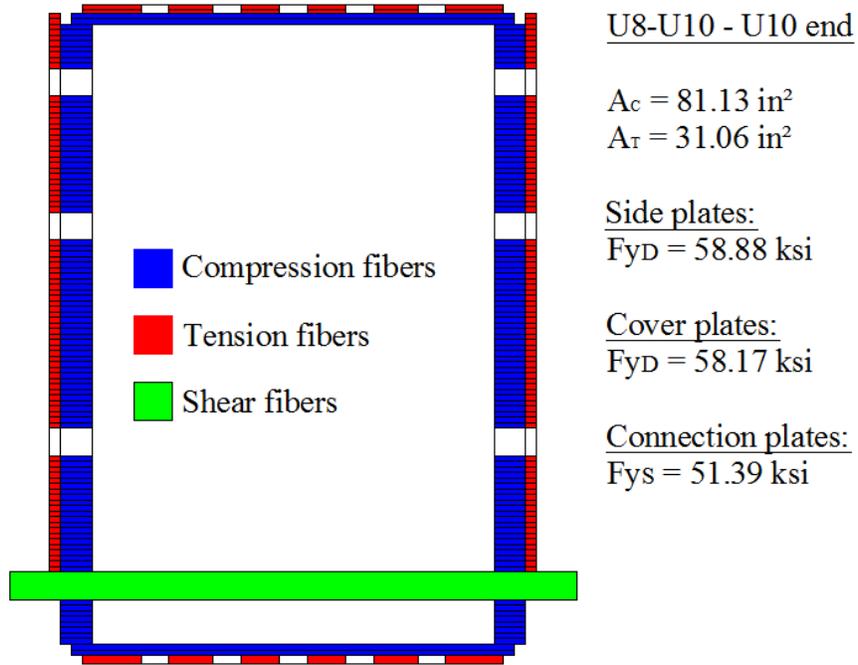
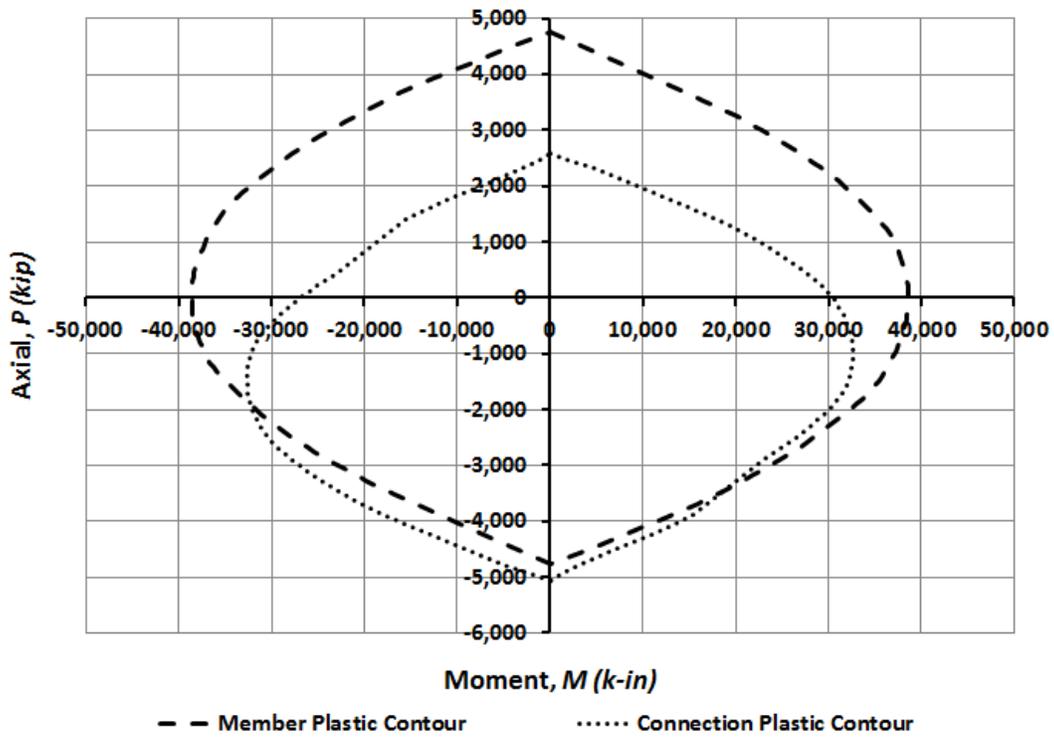
Figure 4.2-1: Discretized cross-section for fiber analysis of U8-U10 member at U10

Figure 4.2-2: Axial-flexure interaction diagram for critical sections of U8-U10 members

Comparing the relative thicknesses of the U10 connection plates to the side and cover plates of the U8-U10 member, and considering the buckled condition of the gusset plates, makes it obvious that this connection was not strong enough for the member to develop a plastic hinge at that end. Evidence from the wreckage supports this idea. In order to get a more realistic plastic contour for the U10 end of the U8-U10 member, an idealized cross section was conservatively used assuming that the buckled gusset plates only retain shear stiffness along the bottom row of rivets to restrain the upper chord member. The net shear area was defined as a rectangle with its centroid located along the bottom row of rivet holes and the shear yield strength was assumed as 60 percent of the tension yield strength. The idealized cross section is shown in Figure 4.2-1.

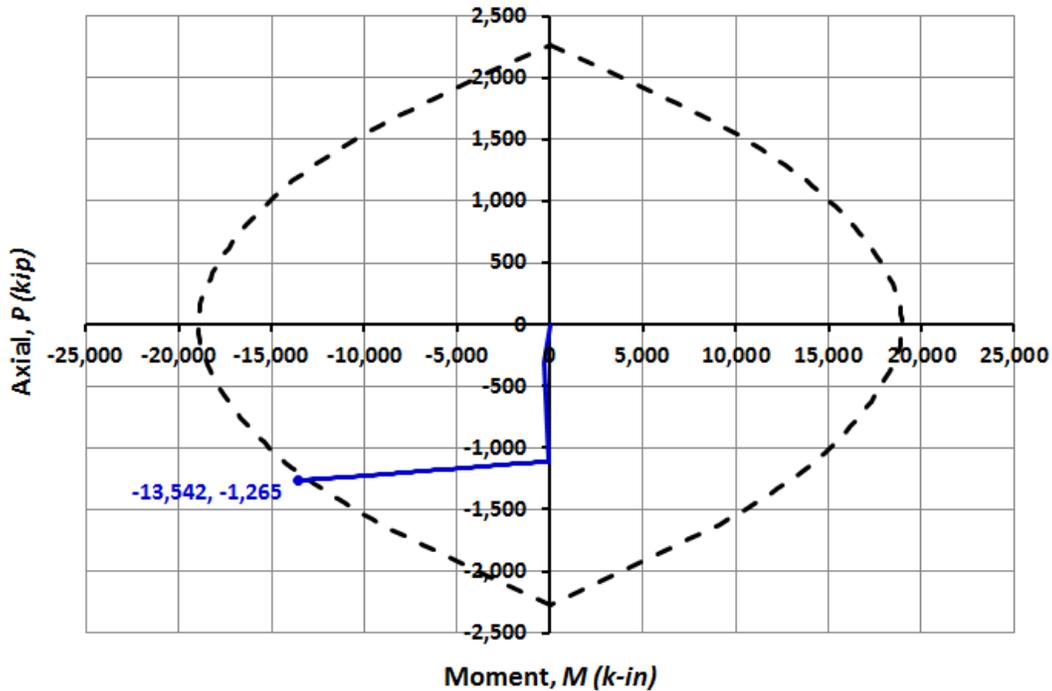
Figure 4.2-8: Applied force path and un-scaled interaction diagram of L9-L11 members

The axial force increases with very little eccentricity up to 1,109 kip in compression before the collapse initiated. After collapse begins, the eccentricity increased to a very high eccentricity of 86.65 inches. The resultant internal force in the net section at the end of the analysis slightly exceeded the plastic capacity that was previously determined; therefore, the actual strength is a little higher. This is probably caused by the low stresses at the center of the cover plates that were ignored in the fiber analysis.

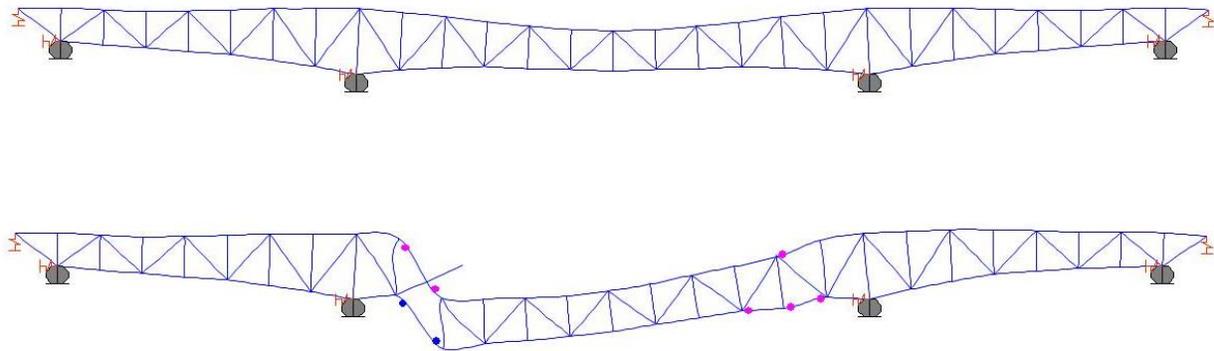
*Figure 4.3-4: Deflected shape of west main truss at collapse  
At end of Stage 3 (top) and end of Stage 4 (bottom). Scale factor of 25*

Figure 4.3-4 shows the deflected shapes at the end of load Stage 3 and at the collapse load. Between the stage of full load application and the collapse load, seven additional plastic hinges develop and there is a large deflection increase. The 10-event failure sequence determined by this analysis goes as follows: buckling of gusset plates at nodes U10 (#1) and U10' (#2); plastic hinges develop at nodes L9 (#3); L10 (#4); U10 (#5); L9' (#6); L10' (#7); U10' (#8); L11' (#9); and U9 (#10).

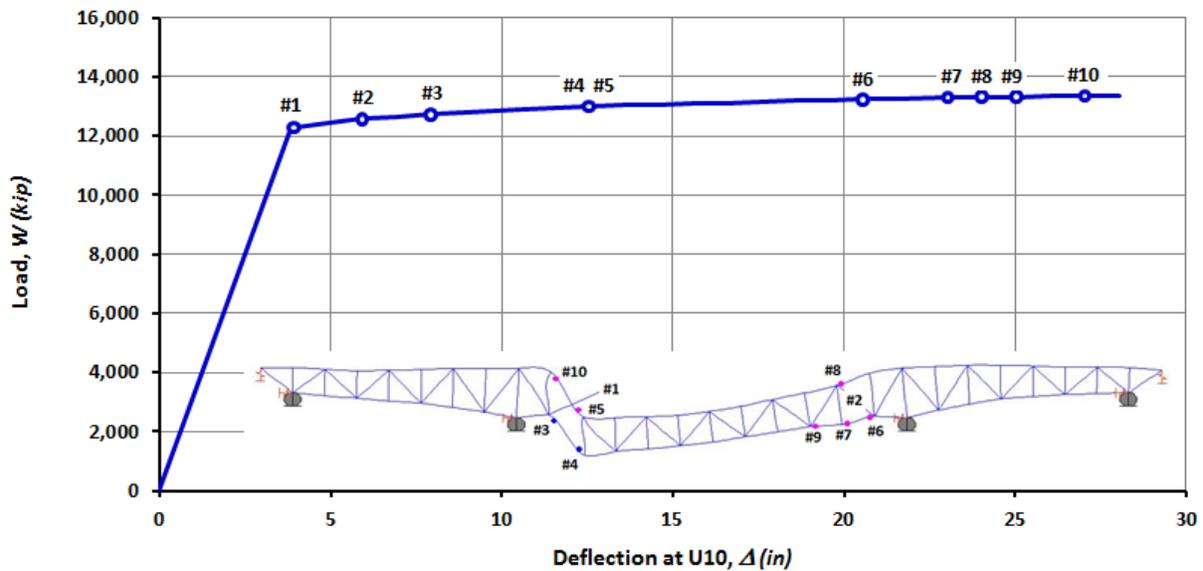
Figure 4.3-10: Collapse sequence of the bridge up to the first mechanism

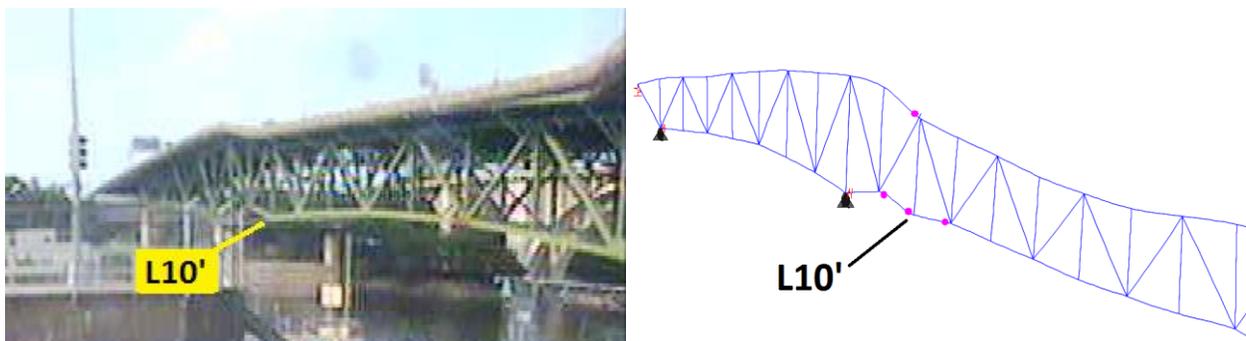
*Figure 4.4-1: Deflected shapes of the bridge during collapse, looking northeast  
Fourth frame captured by the security camera (left) and deflected shape at the end of analysis  
with a scale factor of 25 (right)*

A motion-activated surveillance video camera recorded the collapse of a major part of the structure. The fourth frame of the video footage is shown in Figure 4.4-1 compared to the deflected shape at the end of the analysis. Both the bridge and the model are viewed from approximately the same northeast vantage point. It can be seen that the U10'-L10' vertical member pushes down at the mid-point of the L9'-L11' bottom chord and pulls down at the end of the U8'-U10' upper chord. This drop causes large rotations at nodes 9' and 10' of both chords. The deflected shape shown on the right indicates very pronounced deflections of the L9'-L11' and U8'-U10' members in a very similar mode to that captured by the video camera. This comparison validates that the nonlinear behavior at the north end of the center span that was captured by the structural model.

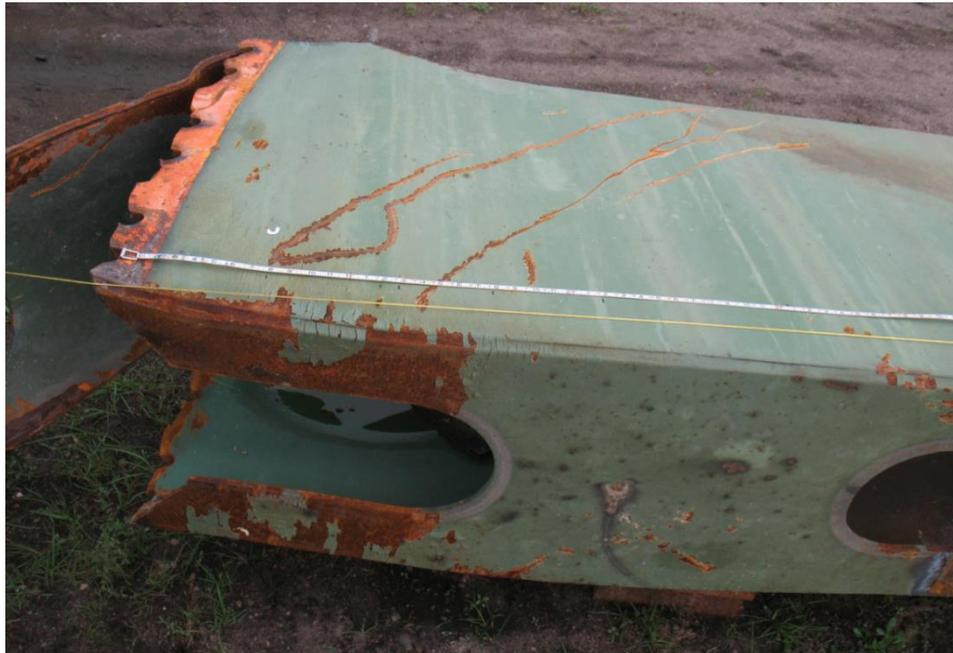
*Figure 4.4-2: L9 end of the bottom chord segment L9-L10 recovered from the wreckage*

The measured deformations on the L9-U10 member start at the innermost row of rivets at the L9 end, named as the reference location, where it completely fractured from the node during the collapse as shown in Figure 4.4-2. Measurements include out of straightness along the segment and the rotation angle at the L10 node. These deflections started 53 inches from the end of the member, projected to a straight line that connected the L9 and L11 nodes at the undeformed condition and then rotated 7.7 degrees to get the global locations and deflections. The results are shown in Table 4.4-1.

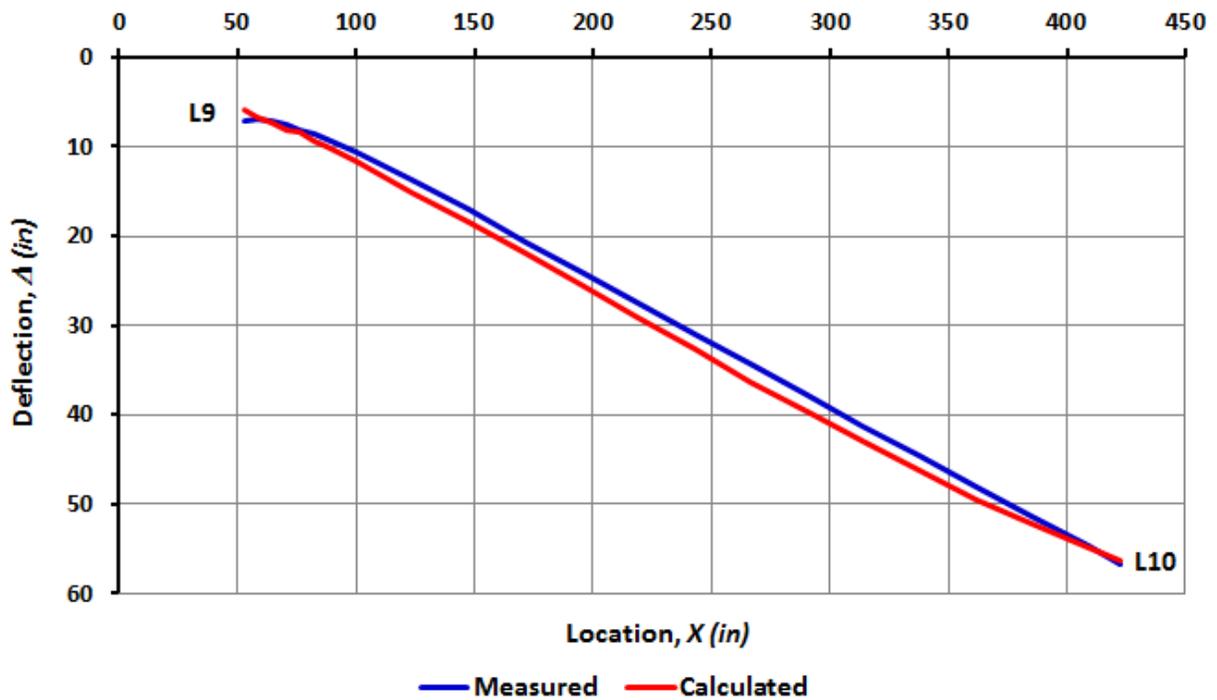
Figure 4.4-3: Measured and calculated deflections of the bottom chord segment L9-L10

As discussed previously, the collapse analysis stopped when the mechanism developed and no further information is available. Since two hinges had already developed in the segment at the end of the analysis, additional deflections in the structural model result from rigid body rotation up to the point of fracture. To compare the measured with the calculated deflections, the plastic deflections were scaled to the ultimate rotation capacity of the L9 plastic hinge, which has an approximate length of 20 inches based on evidence of cracks in the paint in the access-hole region as shown in Figure 4.4-2. The resultant scale factor of 6.595 is applied to the plastic deflections to get the scaled deflections presented in Table 4.4-2, which also show the differences with the measured deflections for comparison.
