Analysis of Anchors and Bracing Configurations with Personal Fall Arrest Systems in Residential Construction

Justin Collins Morris

Thesis submitted to the faculty of the
Virginia Polytechnic Institute and State University
in partial fulfillment of the requirements for the degree of

May 6, 2013

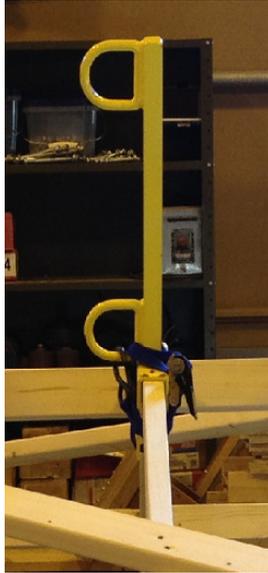
Figure 1-6: Anchor attached to a single truss

Roofing anchors are a highly critical area of research because of the work at height creating a higher risk of falling while performing a roofing task. Roofing anchors are often designed to be attached to the truss system either directly, or through layers of roofing materials such as shingles, tarpaper, and sheathing. Figure 1-6 shows an anchor attached to a single wooden truss.

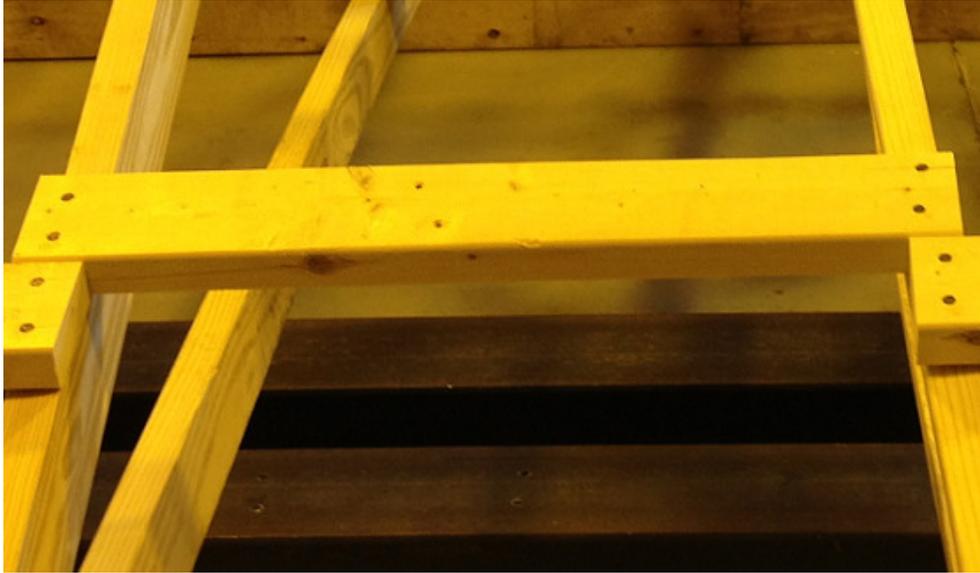
Figure 2-2: Wood bracing installed on-top of trusses

The second method was to fasten wood bracing to the top of the top chords of the trusses (Figure 2-2). The wooden braces were all cut to an approximate length of 25 1/2 inches and nailed into the two trusses with 2 16d sinker nails at each truss. The length of the brace allowed for it to span to the outer edge of both trusses providing an overlap with the adjacent brace. The next brace was lapped above or below depending on placement. Braces were placed approximately 2 feet up from the eave of the trusses as well as 2 feet down from the peaks. Bracing placed at the peaks of the trusses was placed on the side opposite of the anchor.

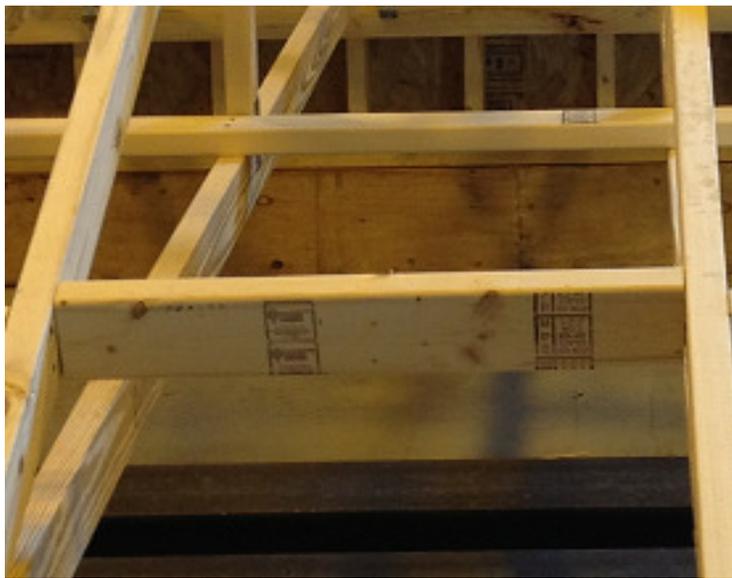
Figure 2-3: Wood bracing installed in-between trusses

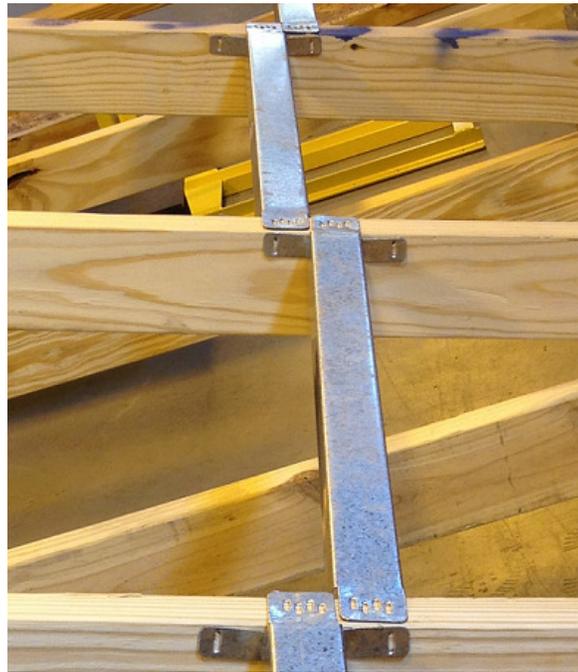
Figure 2-4: Engineered steel bracing installed in-between the trusses

particular bracing method is advertised to locate the trusses at the correct spacing while providing temporary and permanent bracing. The MiTek STABILIZER[®] is designed without nails to make the bracing process easier and eliminate problems that can occur from hand nailing or gun nailing. The metal prongs are approximately ¼ inch long and are hammered into both top and side of the truss top chords. Installation is much faster due to this simplified connection. This metal restraint was chosen as a comparison to temporary wood bracing.

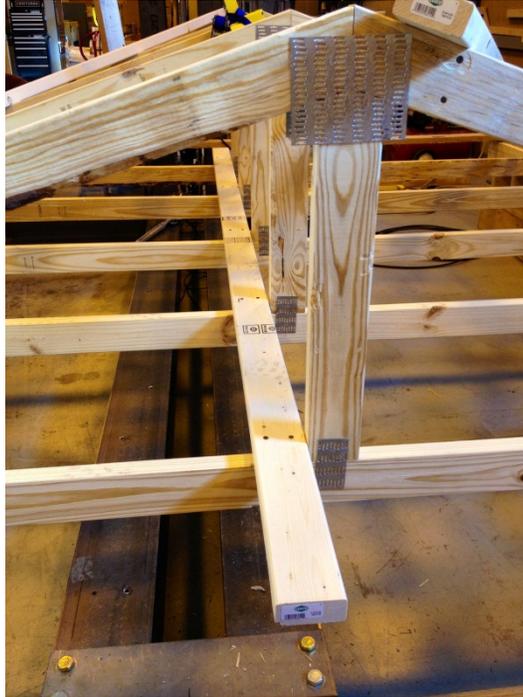
Figure 2-6: Bottom chord bracing configuration

Following the application of diagonal bracing, it is suggested by the SBCA to install lateral restraints on the bottom chord of the trusses. Lateral bracing was also attached the bottom of the trusses much like the lateral restraint on the top chords (Figure 2-6). The lateral bracing of the bottom chord was a 10 foot long 2x4 attached with 2 16D sinker nails at each truss in the assembly (Figure 2-6)

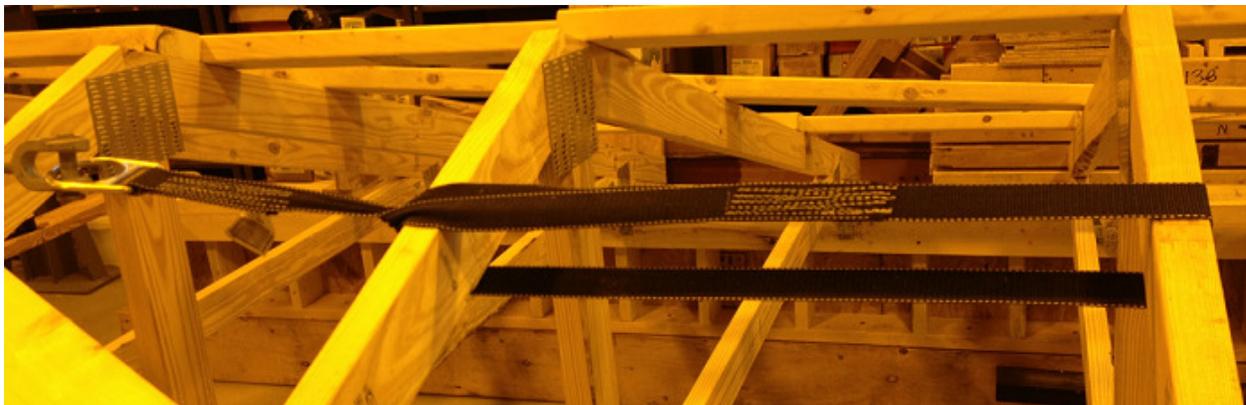
Figure 2-8: Cross-arm strap

Figure 2-8 is a photograph of a cross arm strap used for this study. This strap is a typical, heavy duty strap that meets all OSHA requirements and is used throughout every phase of construction. Straps are commonly used as anchors due to high strength, low cost, versatility, and ease of use. Straps are often preferred over other anchors which can be cumbersome and difficult to use considering the fast turnover rate of typical construction tasks. The strap, model number 8185K/6FTBK, was manufactured by Miller Fall Protection for use when tying off to structural members. The strap was 6 ft. long, 2 in. wide and made of Kevlar webbing with a D-ring at one end and a choke off loop at the other end. The strap is rated to carry 5,000 lbs. and should be attached to overhead beams and structural members (Miller, 2013).

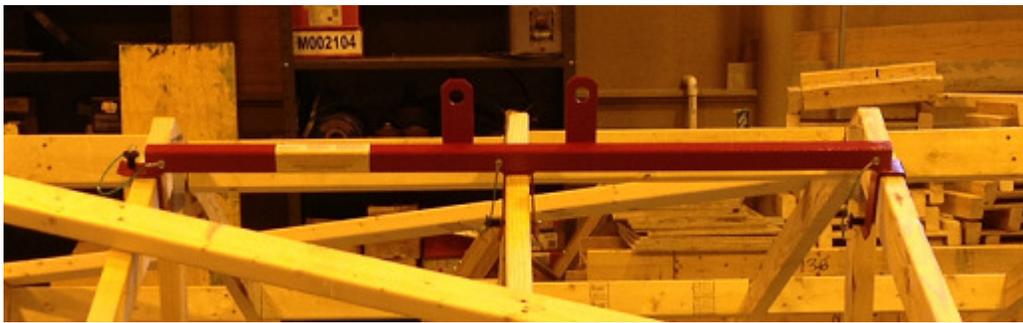
Figure 2-9: Spreader bar anchor

The spreader bar, model number SAS-1010, is manufactured by Big Rock Supply. A cold rolled steel section of 48” spans over three trusses or rafters spaced at 24” on center. This spreader bar applied load over a larger area if a fall were to occur. Detent ball lock pins 3/8” diameter are used to attach the legs of the spreader bar to the top chords of the 2x4 trusses.

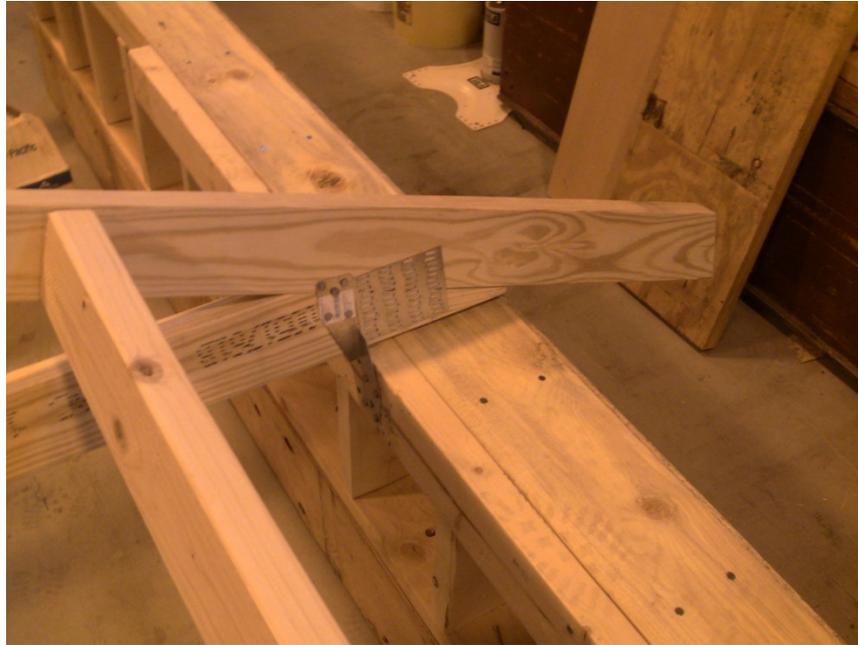
Figure 2-11: Hurricane strap application for testing

used for a truss-to-plate connection. Figure 2-11 is a photograph of the strap in use for the experiment.

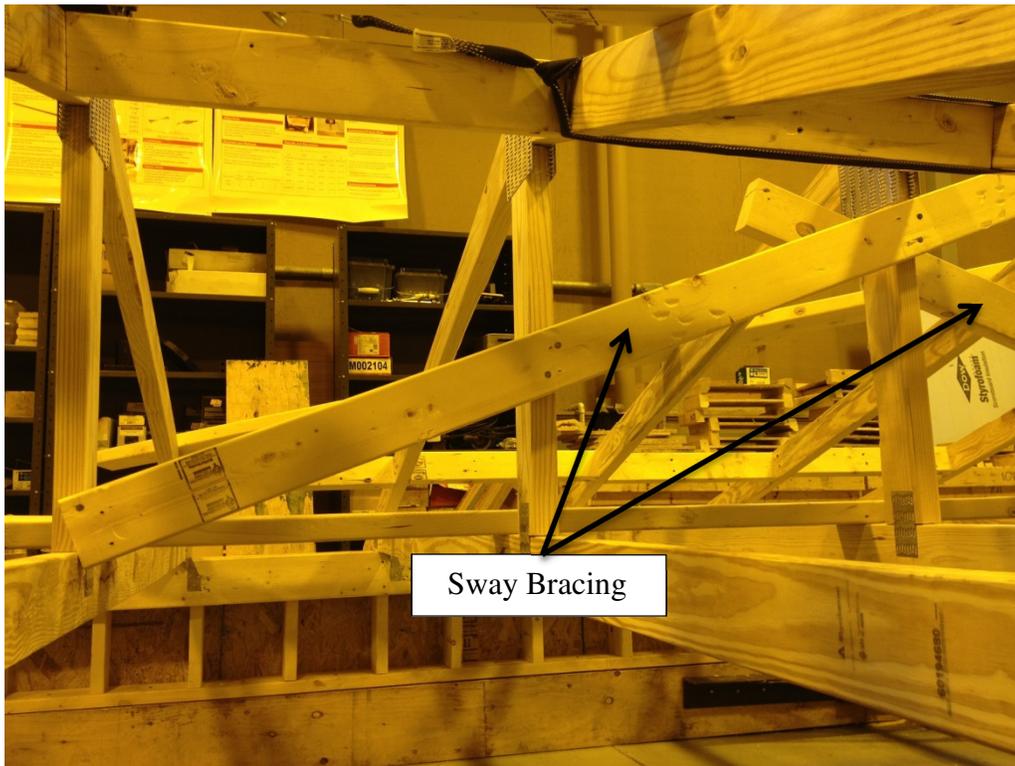
Figure 2-12: Sway bracing attached to king posts of a truss system

In addition to the nine tests shown in Table 2-1, two identical tests were performed once all other testing was completed. The purpose of the additional testing was to improve the max load of the best anchor and bracing combination tested in Table 2-1. Additional bracing, often referred to as “sway bracing” was added as an additional form of temporary bracing. Sway bracing can be utilized to form a triangle perpendicular to the plane of the trusses to prevent trusses from folding over (SBCA, 2012). The sway bracing consisted of a 2x4 attached to the king posts of each truss with 2 16D sinker nails. Figure 2-12 below shows sway bracing installed per SBCA instructions.

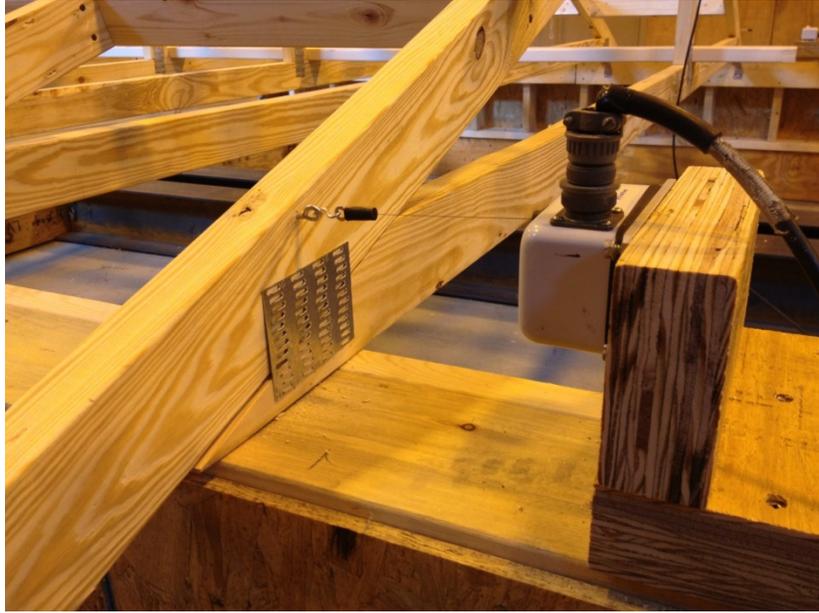
Figure 2-14: String potentiometer at truss-wall connection

Displacement was measured using a string potentiometer attached in the midspan of the top chord of the truss located closest to the HALT (Figure 2-14), as well as a string potentiometer at each wall of the same truss (Figure 2-15). The displacement measured at the top chord was used to determine the amount of deflection at both truss-plate anchors as well as the peak of the trusses.

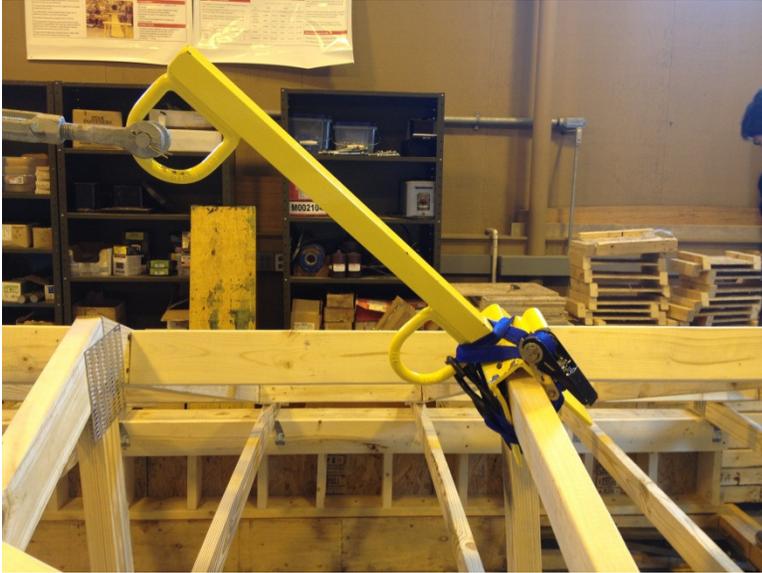
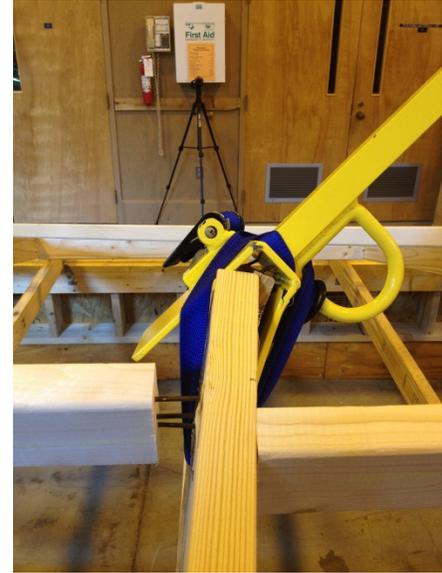
Figure 3-2: Failure in the PFA (front)

Figure 3-3: Failure in the PFA (back)

The in-between wood bracing performed well with the RFAS anchor compared to other bracing methods and reached an ultimate load of 726 lbs. A moment was placed on the anchor by the height of the PFA. Figures 3-2 and 3-3 are photographs of the PFA.

The brackets of the PFA over the truss failed, which then transferred the load to the strap wrapped around both the anchor and the truss. If the strap was not used in the connection, the anchor would have failed and disconnected from the truss. As well as failure in the anchor, failure in the bracing was observed where the nails withdrew from the end grain of the blocking (Figure 3-3). Nailing into the end grain of the wood bracing is a generally weak connection and should be avoided whenever possible. However, withdrawal nailing is recommended for this type of bracing (SBCA, 2012). Although the nails withdrew from the bracing, the deflection of the truss resulted in a “pinching” of the in-between bracing, where the corner of the bracing embedded into the truss chord (Figure 3-4). The in-between blocking continued to carry load as the truss deflected due to this “pinching” performance. Though the bracing system performed well, the ultimate failure was in the anchor itself. As the brackets failed, the load was concentrated solely in the strap. Ultimately, the PFA anchor itself failed due to excessive rotation.

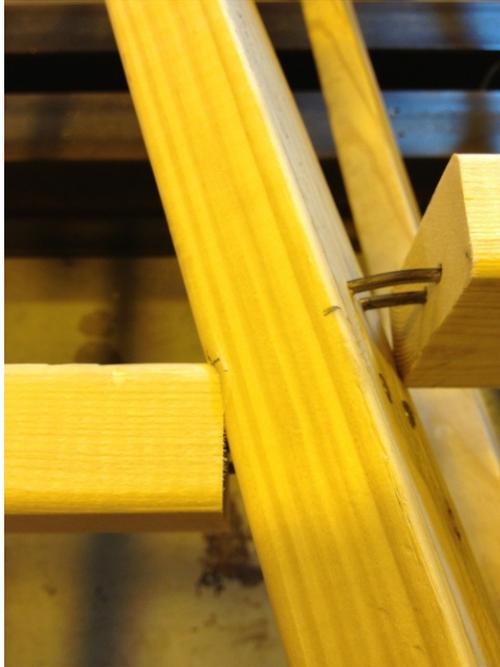
Figure 3-4: “Pinching” action of the in-between bracing

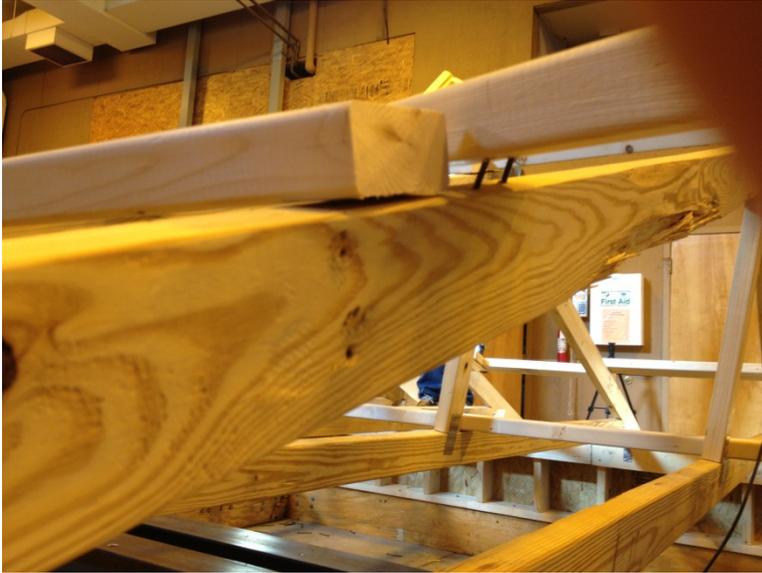
Figure 3-6: Withdrawal of the bracing with PFA

The on-top wood bracing performed well with the PFA and reached an ultimate load of 752 lbs. This was the highest ultimate load associated with the PFA. The nails placed in the top of the wood bracing generated shear forces, as opposed to the withdrawal forces at the end-grain in the in-between bracing. The PFA was not damaged due to transfer of load through the truss system. The nails connecting the bracing to the trusses withdrew from the top of the truss while splitting it parallel to the grain. The splitting was a direct result of the shear forces generated at the nail connection. Figure 3-6 is a photograph of the withdrawal of the nails from the top chord of the truss. Figure 3-7 is a photograph of the truss splitting parallel to grain at the connection point.

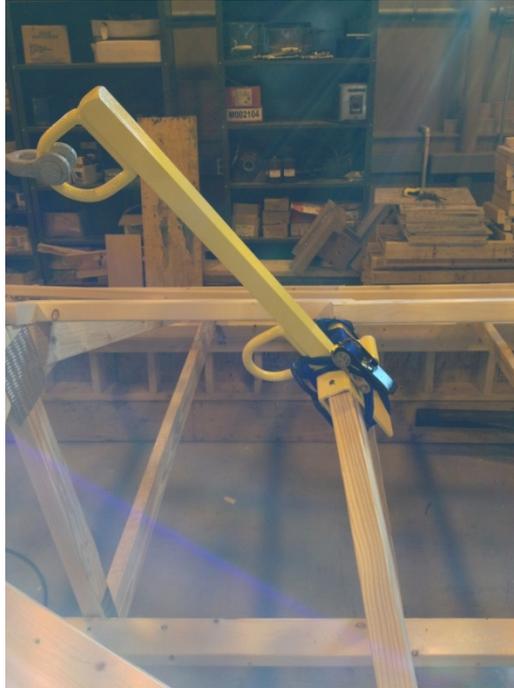
Figure 3-8: PFA after testing with on top bracing

The PFA did not fail due to the failure in the bracing system and trusses surrounding it. Therefore the post frame anchor was unharmed and remained intact and connected to the truss. Though the anchor performed well, the bracing and trusses failed abruptly resulting in a low maximum load when compared to other tests. Figure 3-8 is a photograph of the PFA after the testing was complete.

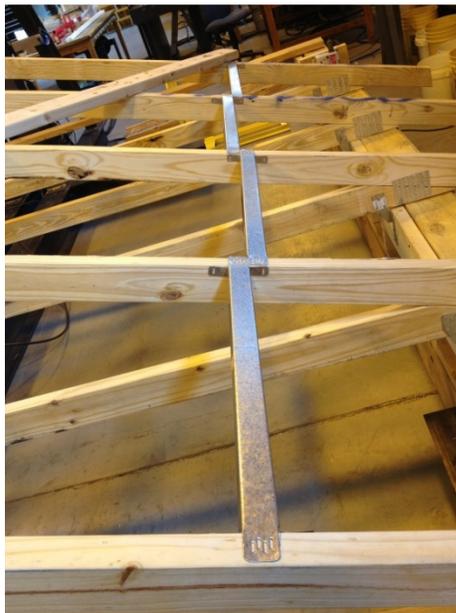
Figure 3-10: Engineered steel bracing installation

The engineered steel bracing did not perform as well as the wood bracing in this test with an ultimate load of 571 lbs., which was the lowest ultimate load of all of the PFA testing. The bracing was placed on the trusses similar to the on-top wood bracing (Figure 3-10). This allowed for easy installation however the penetration into the trusses is very small.

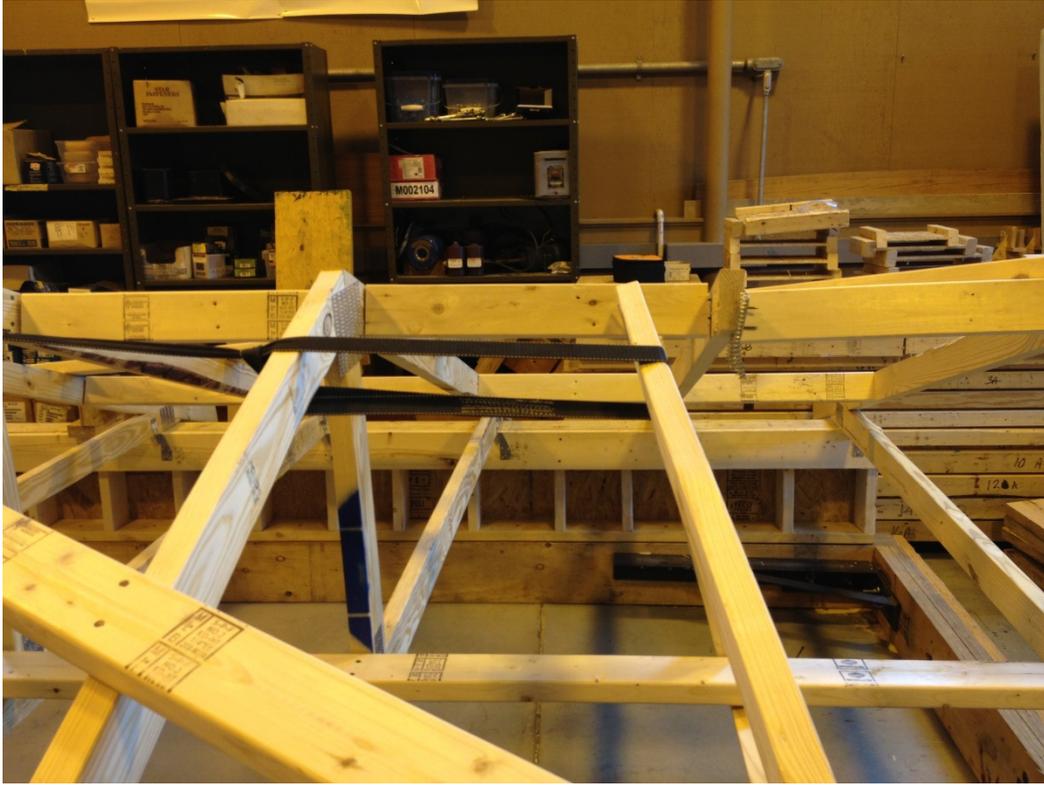
Figure 3-16: Cross-arm strap and in-between wood bracing

The in-between wood bracing performed well with the cross arm strap reaching an ultimate load of 1,412 lbs. As with the PFA, the in-between bracing was “pinched” between the trusses as the deflection increased. Though the nails withdrew from the end grain of the bracing, the bracing continued to carry load placed on the truss system. Due to the performance of the bracing, the load was concentrated on the truss furthest from the D-ring. This single truss failed at the peak truss plate and was the only source of ultimate failure in the system. This failure mode is due to the inability for the system to engage multiple trusses. Figure 3-16 shows the system after the testing was complete. Figure 3-17 shows the failure in the peak truss plate.

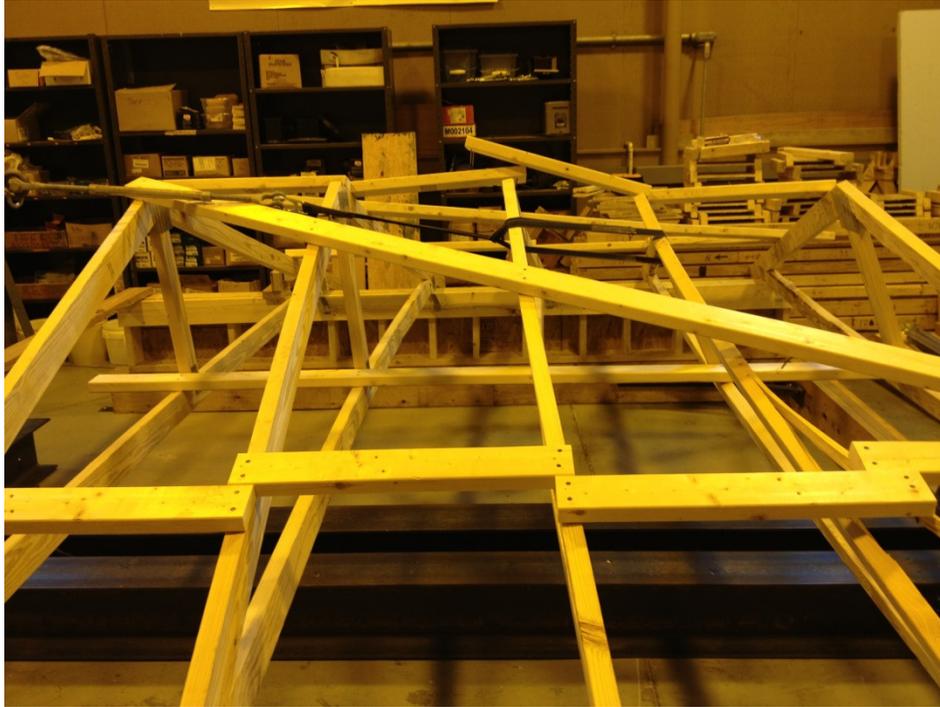
Figure 3-19: Failure in the on-top wood bracing & diagonal bracing

The on-top bracing withdrew from the trusses (Figure 3-20) and in some cases split the truss parallel to the grain (Figure 3-21). As the system deflected, the diagonal bracing began to withdraw from the truss as well. The greatest amount of failure in the bracing was located near the anchor point.

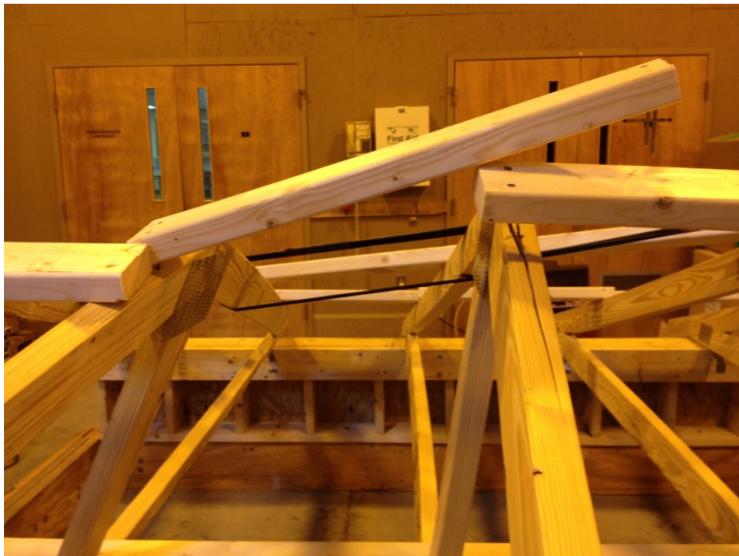
Figure 3-20: Withdrawal from the trusses

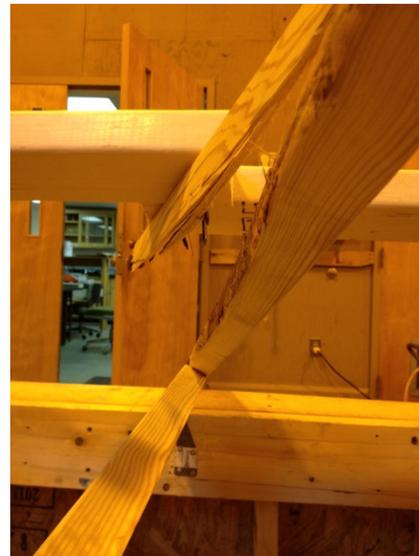
Figure 3-21: Splitting of the trusses

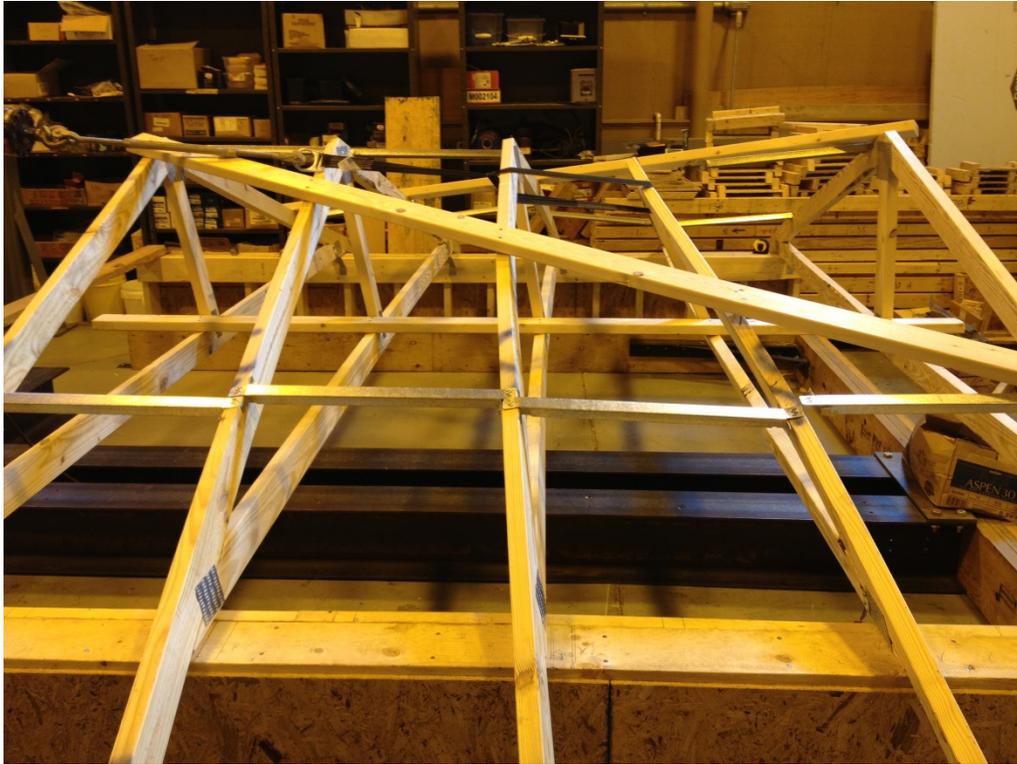
Figure 3-23: Cross-arm strap with engineered steel bracing

trusses, mainly the braces located on the same trusses as the strap. As these braces failed, the single truss carrying the load began to deflect significantly (Figure 3-23).

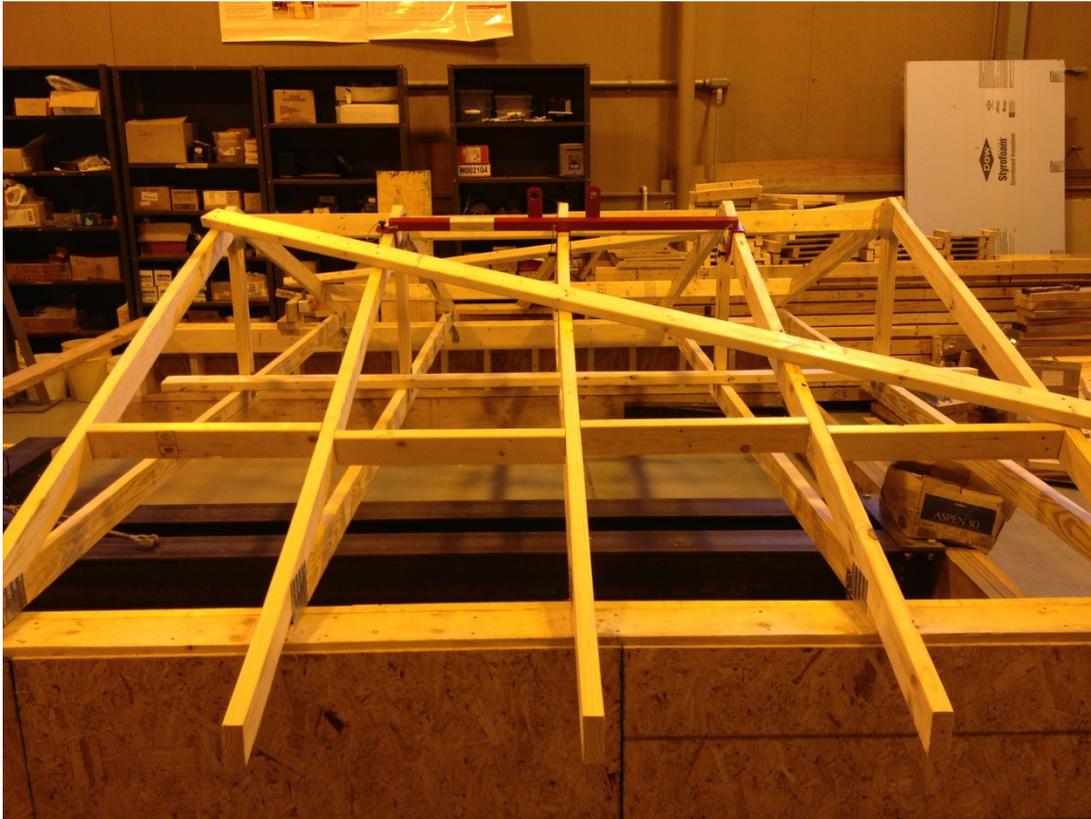
Figure 3-26: Spreader bar anchor test setup

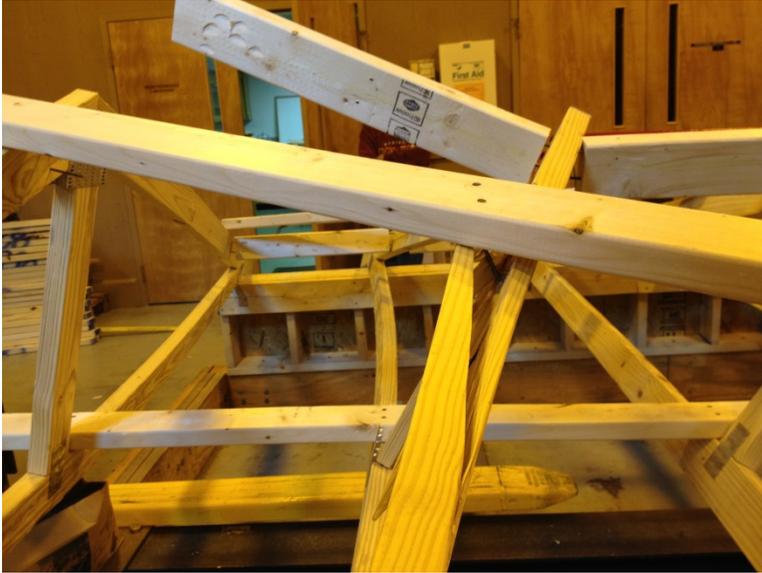
Figure 3-28: Failure in bracing and trusses

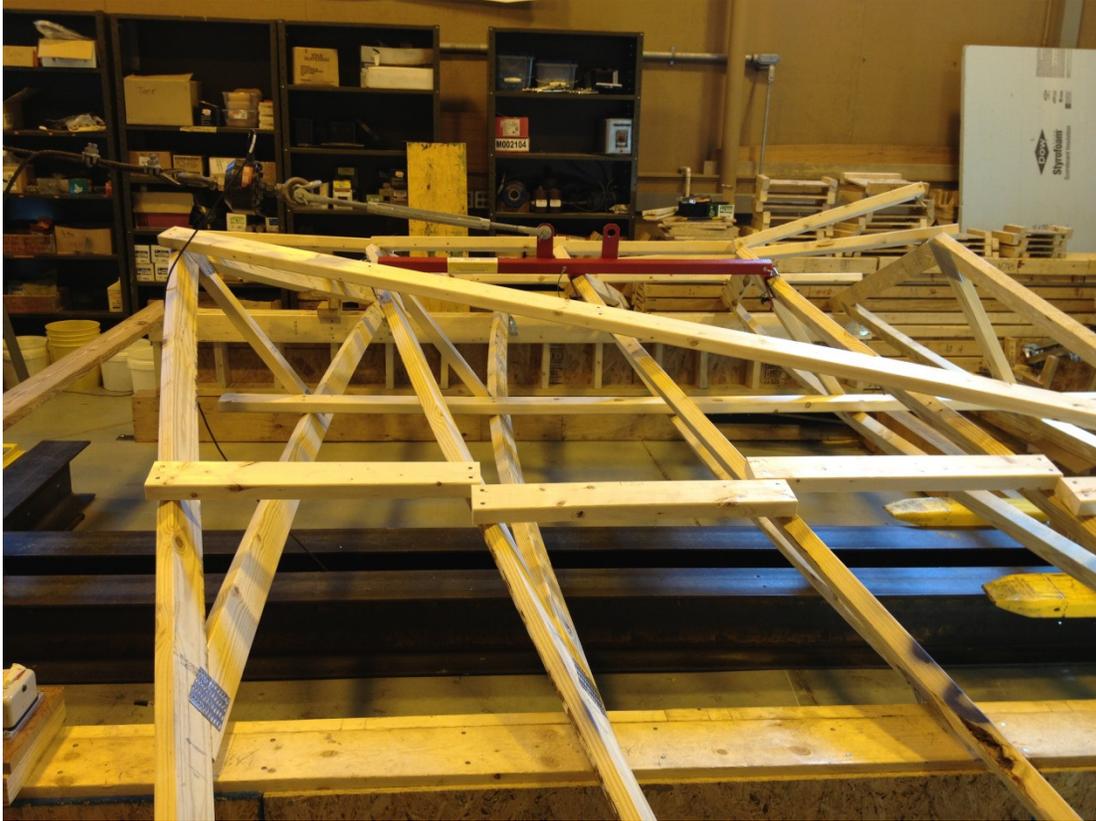
Figure 3-31: Spreader bar and on-top bracing failure

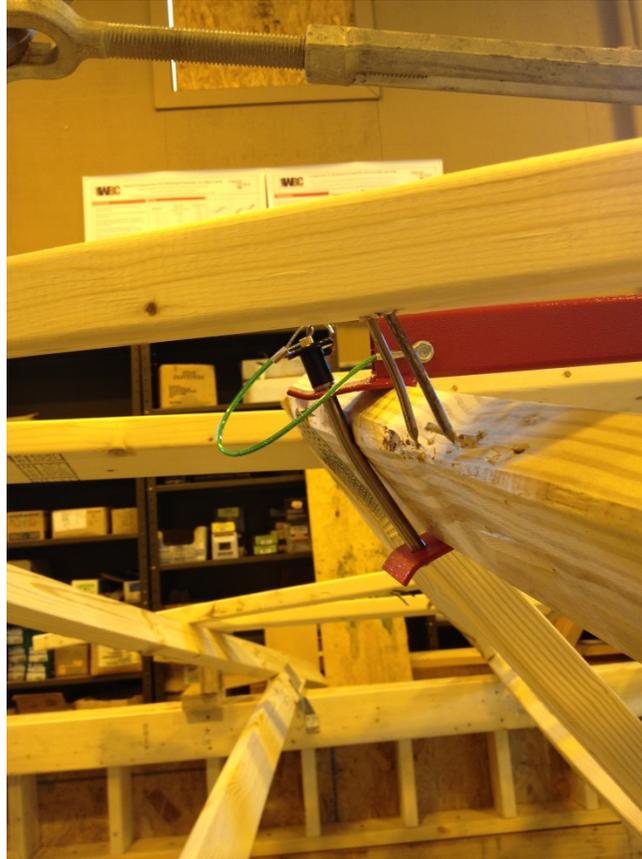
Figure 3-32: Failure in the diagonal bracing and anchor

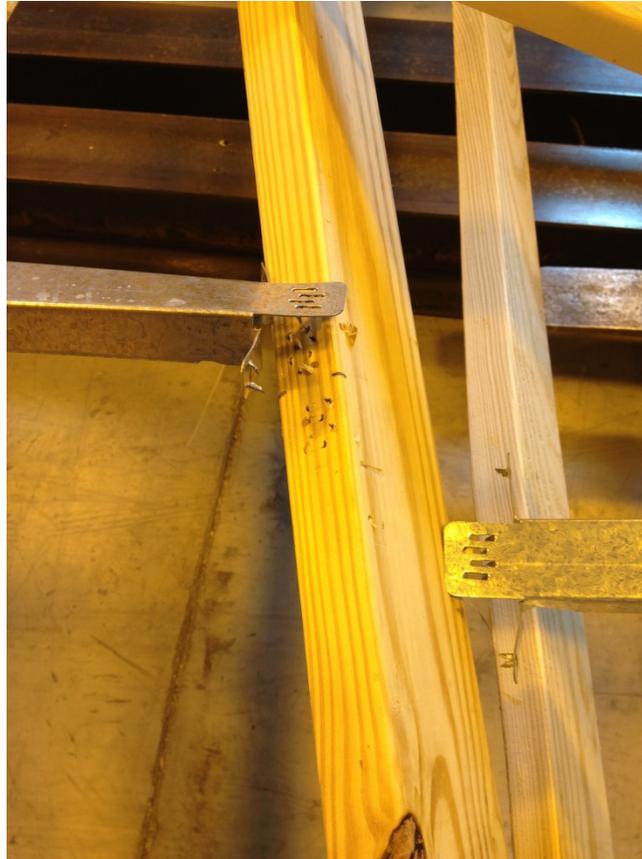
Figure 3-35: Failure in the engineered steel bracing

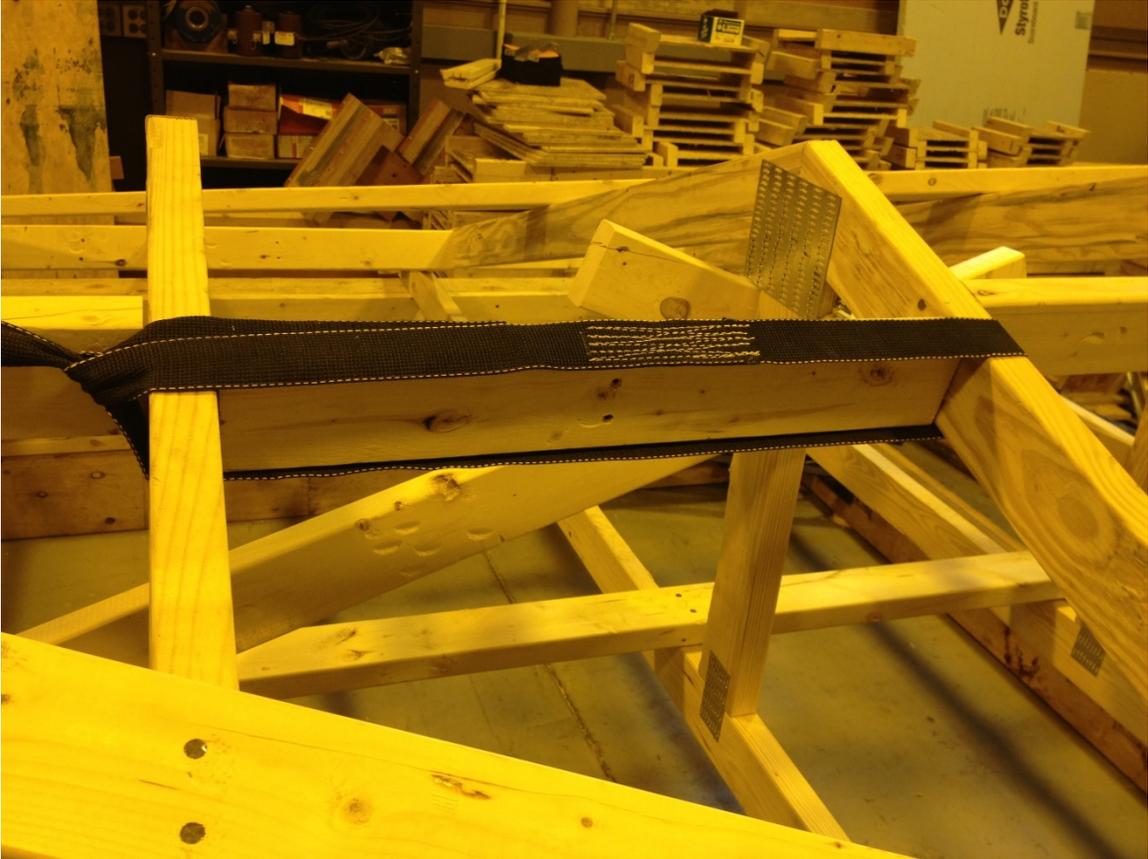
Figure 3-38: In-between bracing placed on the same side as the anchor

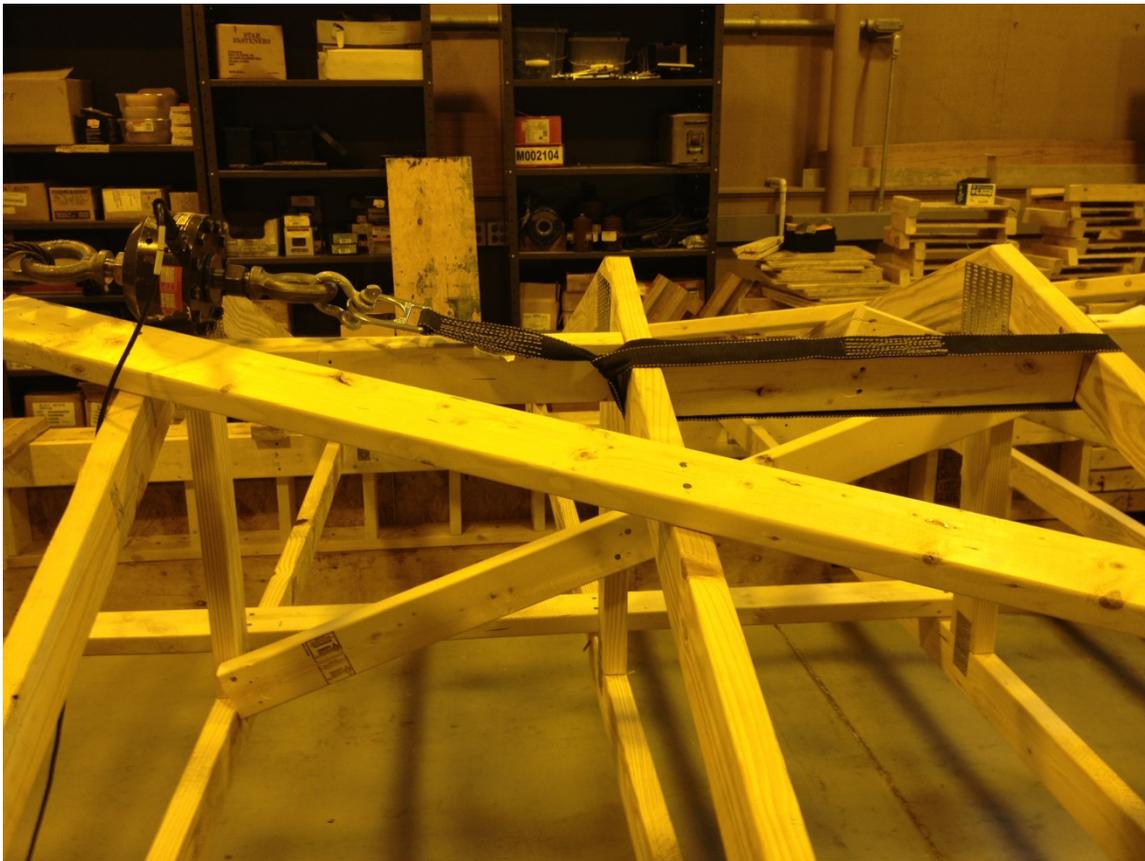
Figure 3-39: Test setup for additional testing

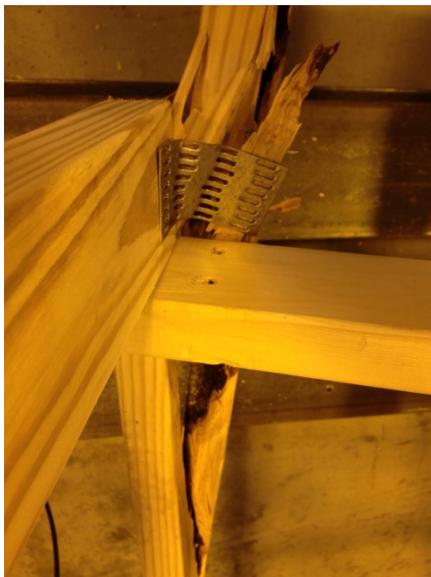
Figure 3-40: Failure in the truss

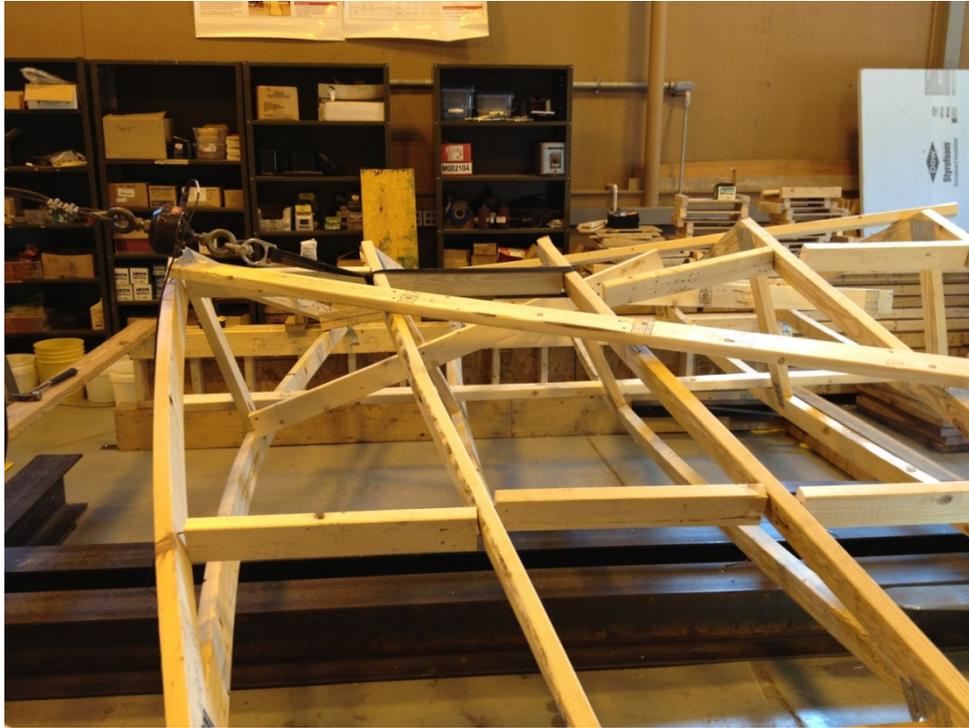
Figure 3-43: Additional test #2 failure

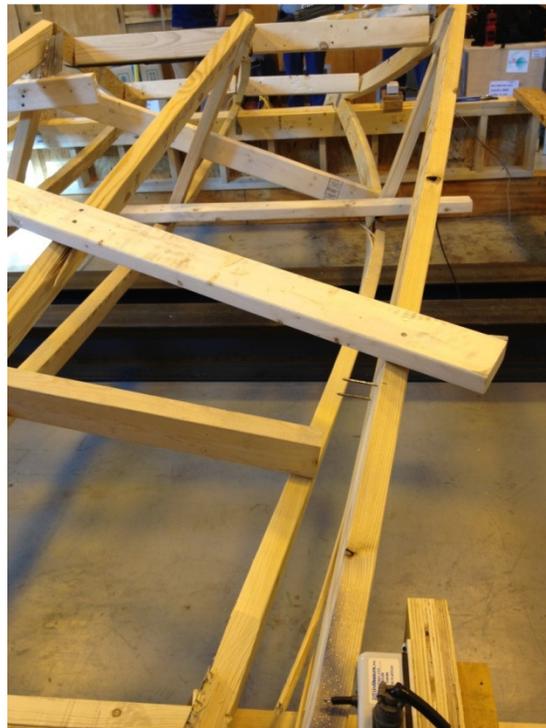
Figure 3-44: Failure in the bottom chord of the truss
