Investigation of parameters governing the corrosion protection efficacy of fusion bonded epoxy coatings

Dissertation submitted to the faculty of the
Department of Civil and Environmental Engineering
Virginia Polytechnic Institute and State University
in partial fulfillment of the requirements for the degree of

Keywords: corrosion; ECR; concrete durability; epoxy coating; FBE

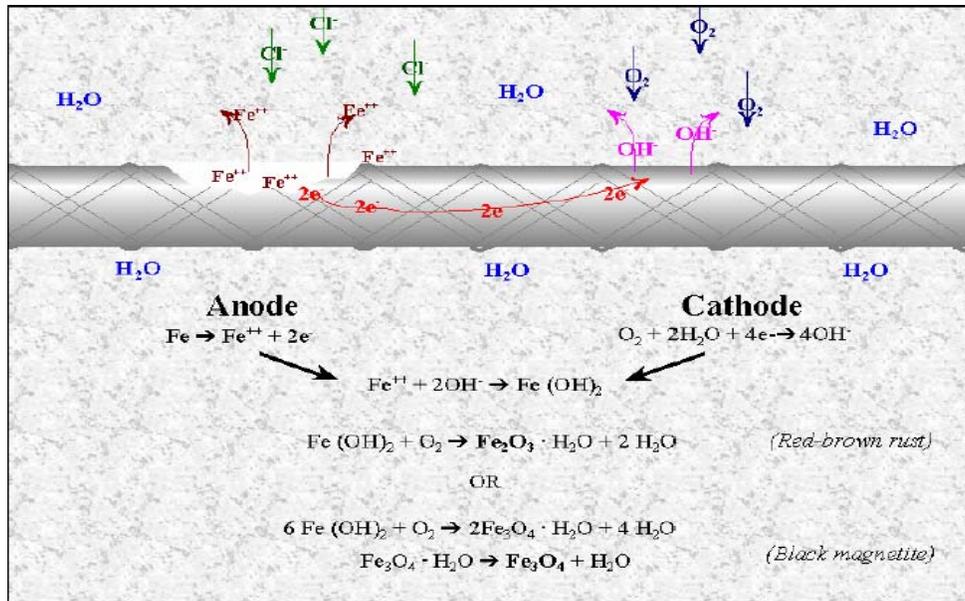
Figure 4.1 Corrosion Process Diagram (Brown, MC 2003)

The process is illustrated in Figure 4.1 (Brown, M.C. 2002).

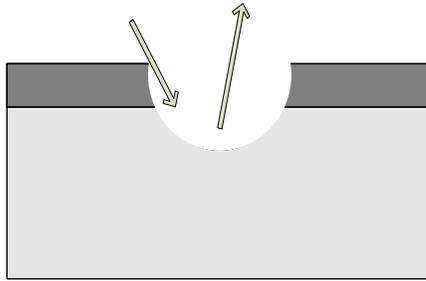
Figure 4.2 The Dissolution of the Passive Layer

The iron in the soluble complex then reacts with the hydroxyls present in the pore water solution freeing the chlorides, which are now available to repeat the reaction leading to the complete dissolution of the passive layer. Additionally, in the absence of the passive layer, the reinforcing bar is now free to continue the oxidation process unimpeded. The concentration of chlorides required to initiate and maintain corrosion is dependent upon the alkalinity of the concrete pore solution. It has been shown that there is an almost linear relationship between hydroxyl ion concentration and the respective threshold level of chloride (Lambert P., 1998). The generally accepted critical chloride threshold level in concrete at the reinforcing steel depth, at which corrosion initiates, is approximately 0.71 kg/m^3 of concrete. This value translates to a Cl^-/OH^- ratio of approximately 0.6 (Broomfield, J. P. 1997).

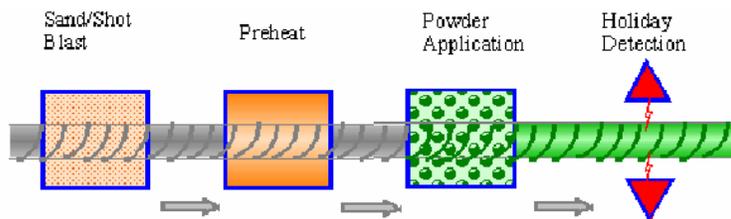
Figure 4.5. Bar Coating Process

The epoxy powder is placed on a “fluidization bed”. In a fluidization bed, the powder particles are suspended in a stream of air, in which the powder will “behave” like a fluid. Once the air supply is turned off, the powder will remain in its original form. The fluidized powder is sprayed onto the hot substrate using suitable spray guns. An electrostatic spray gun incorporates an ionizer electrode on it, which gives the powder particles a positive electric charge. The charged powder particles uniform wraps around the substrate, and melts into a liquid form. The specified coating thickness range of stand-alone epoxy coatings is between 175 to 300 μm . The molten powder ‘flows’ into the profile and bonds with the steel. Time to quench varies depending on the substrate temperature from 21 seconds (at 450°F) to 60 seconds (at 350°F). Figure 4.5 illustrates the production process (Brown, M.C. 2003) while Figure 4.6 shows freshly coated bars undergoing quenching under a spray of water.

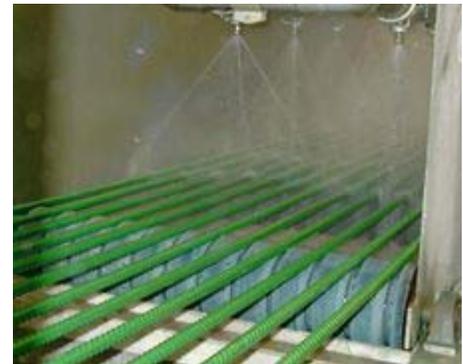
Figure 4.6. Quenching Process

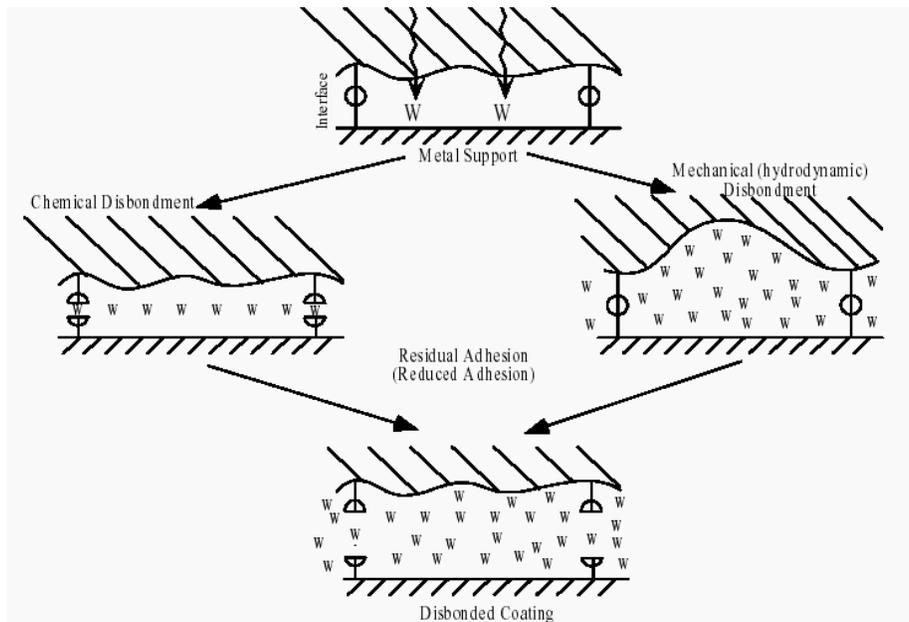
Figure 4.7 Coating Disbonding Mechanism

A common conclusion of both laboratory and field investigations of ECR was the loss of adhesion experienced by even undamaged coatings in wet environments. To address this issue, several disbondment mechanisms have been proposed. Often quoted are Leidheiser and Funke who describe the coating disbondment mechanism as follows (Leidheiser, H. and W., Funke, 1987): 1) Water and ions diffuse through the coating. 2a) Chemical disbondment – the coating-oxide bonds are replaced by water-oxide and possibly coating-water bonds. 2b) Mechanical disbondment – caused by osmotic pressures due to ion concentration gradients. The process is illustrated in Figure 4.7. In addition, further research has shown that coating disbondment is assured in moist environments. The secondary bond energy between the coating and the oxide layer approximately 10 to 26 kJ/mole is exceeded by the activation energy of 32 kJ/mole associated with the disbondment of the epoxy by water (Pyc, W.1998 and Brown, M.C. 2003). The work done by Pyc supports previous research by Gledhill and Kinlock, which showed that the measured work of adhesion of the ferric-oxide changes from 291 mJ/m² to -255 mJ/m² between dry and wet environments, respectively (Gledhill and Kinlock, 1974).

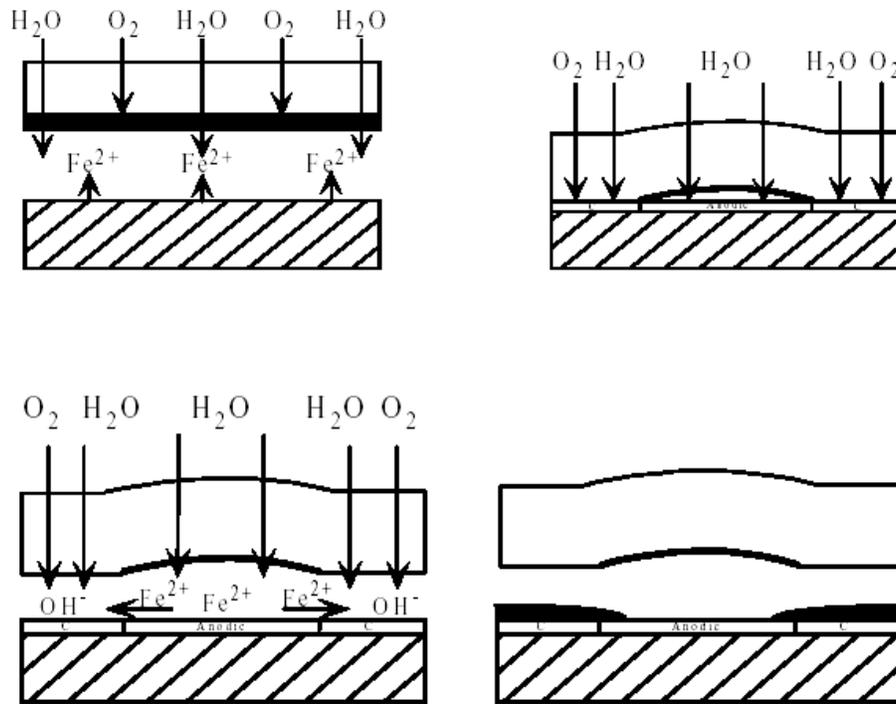
Figure 4.8 Cathodic Disbondment

Other possible disbonding mechanisms are anodic and cathodic adhesion loss. These mechanisms, which may or may not be simultaneously present, are a direct result of the corrosion process and can occur in damaged as well as undamaged films. As sufficient water diffuses to the steel-coating interface, the corrosion process is initiated. The area immediately under the blister will become anodic while the edges of the blister cathodic. One of the products of the reactions at the cathode is hydrogen. The evolution of protons causes the pH to decrease leading to further delaminations and blister growth. The difference for damaged coatings is the lack of blister formation. This process is illustrated in Figure 4.8.

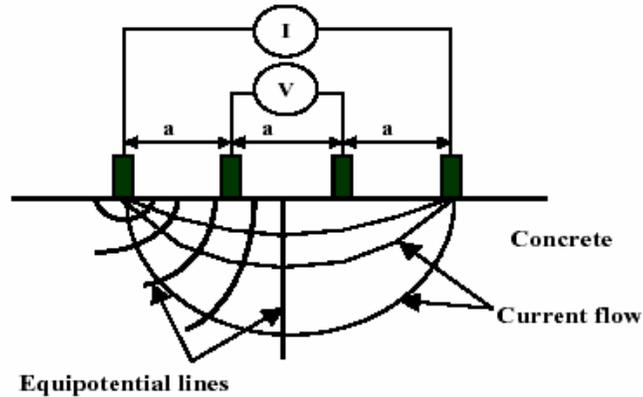
Figure 4.9 4 – point Wenner Resistivity Apparatus

A non-destructive testing procedure that is becoming increasingly popular due to its low cost and ease of implementation, is measuring the concrete resistivity by the Wenner method, as shown in Figure 4.9.

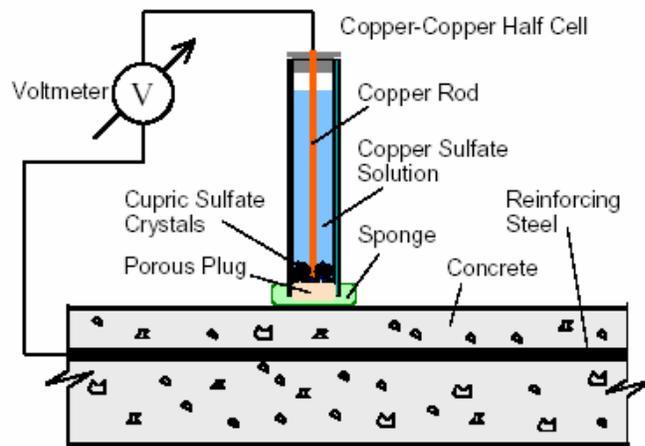
Figure 4.10 Half-Cell Potential Apparatus

Unlike resistivity, half-cell potentials can in fact indicate the potential of corrosion taking place on the reinforcing steel embedded in concrete. The basic process for the corrosion of steel in concrete is the development of micro and macro cells. That is the coexistence of passive and corroding areas on the same bar or separate bars, respectively. A short-circuited galvanic element with the corroding area as anode and the passive area as cathode is formed (Elsener, B. et al, 1994). The direct measurement is the potential difference created between the metal in the half-cell and the steel in concrete (Broomfield, J. P.1997). Therefore, places on the reinforced structure with higher concentrations of iron in solution – in this case the concrete pore solution – will exhibit higher, or more negative, potential differences. The measurements are obtained using a high impedance voltmeter. The illustration below shows the typical apparatus as described in ASTM 876-91.

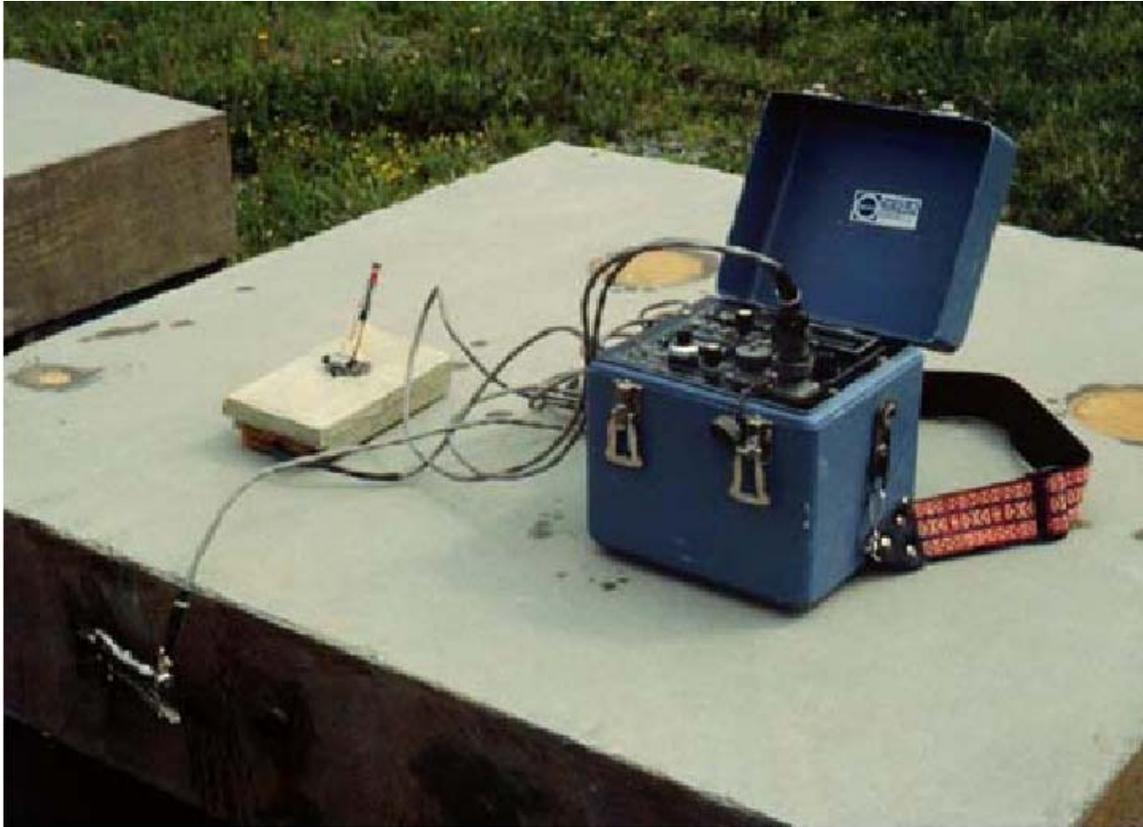
Figure 4.11 3LP Test Apparatus

A more sophisticated inspection method is the three electrode linear polarization (3LP). The 3LP device appears to be a convenient tool for measuring corrosion current densities. It yields reinforcing steel corrosion current densities that correlate reasonably well with metal losses observed in reinforcing steel specimens extracted from the decks (Clemeña, G.G. 1992). A typical unguarded linear polarization instrument and set-up are illustrated in Figure 4.11, below.

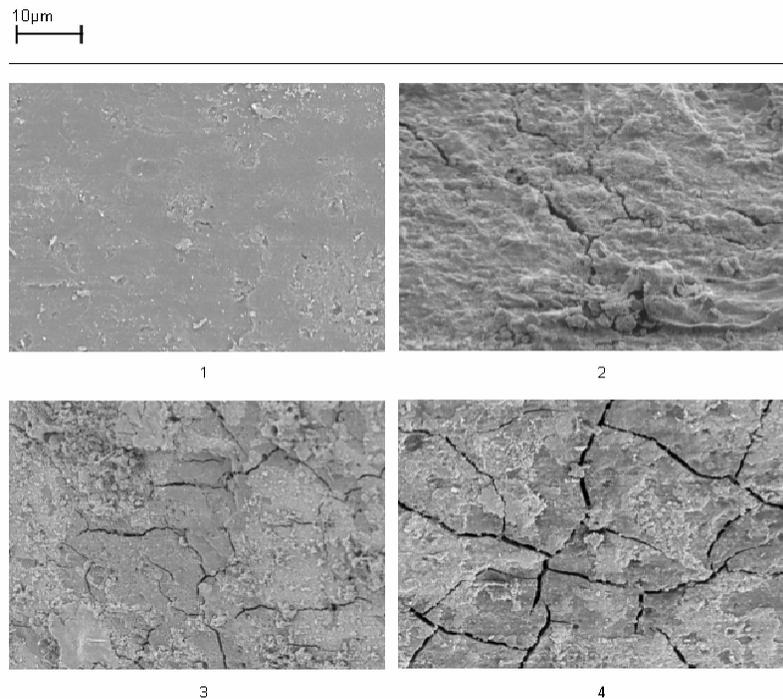
Figure 5.2 SEM Micrographs at 2k magnification

The coating damage was assessed using three different techniques: 1) by counting the number of defects visible to the unaided eye. 2) By assigning a subjective coating cracking from 1 through 4 based on the scanning electron microscope (SEM) micrograph guidelines illustrated in Figure 5.2.

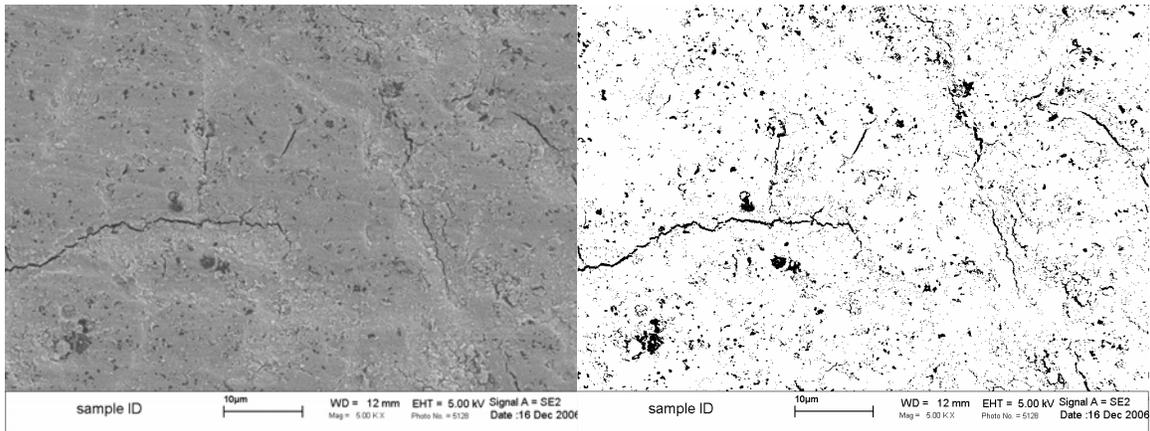
Figure 5.3 Structure 1019-8 C-4 5Kx SEM Micrograph and Binary

3) Finally, by using the image analysis program ImageJ on images collected during the SEM investigation. ImageJ is a shareware image analysis program developed by the National Institutes of Health (NIH). A 5k magnification SEM micrograph is converted to a binary image, which is then used to quantify the surface coating damage. The damage is recorded as a percentage of the surface area. Unlike technique 2, which takes into account only cracks, all damage types (cracks, pores, gouges) are included, using this method. Figure 5.3 illustrates a typical SEM 5k micrograph and its accompanying binary image.

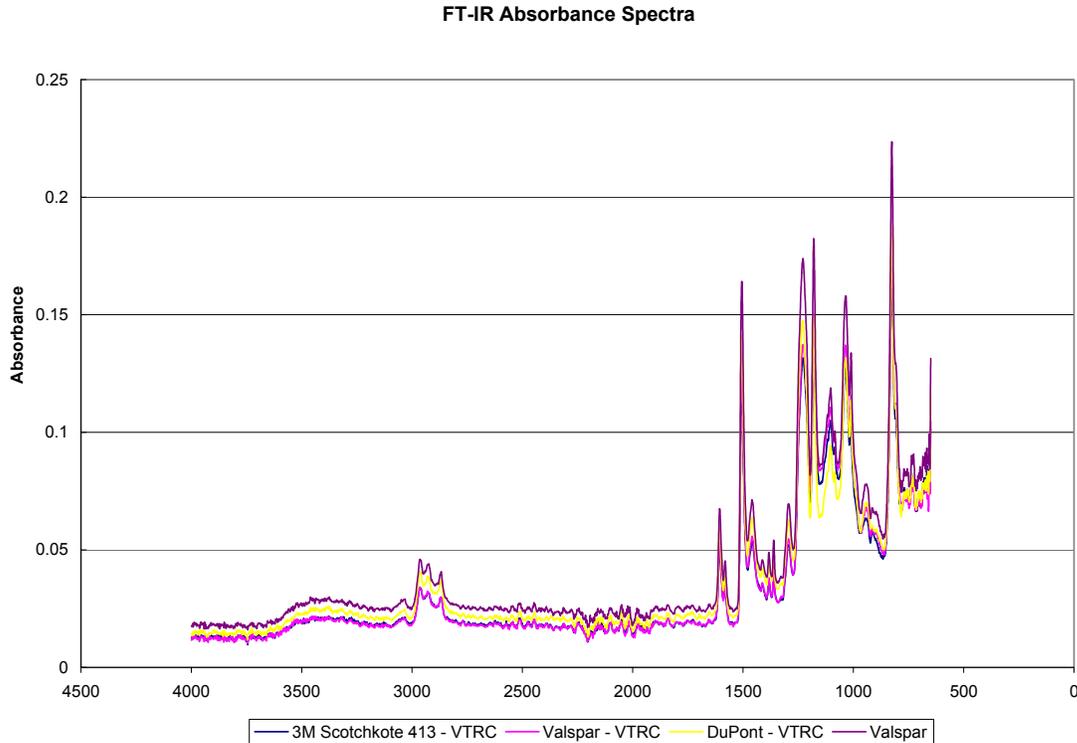
Figure 6.1 Fusion bonded epoxy powder FT-IR spectra

Infrared spectra were obtained from the four powder samples. The superimposed results are presented in Figure 6.1. From the plot, it is clear that there are no discernible differences in the general structures of the different products.

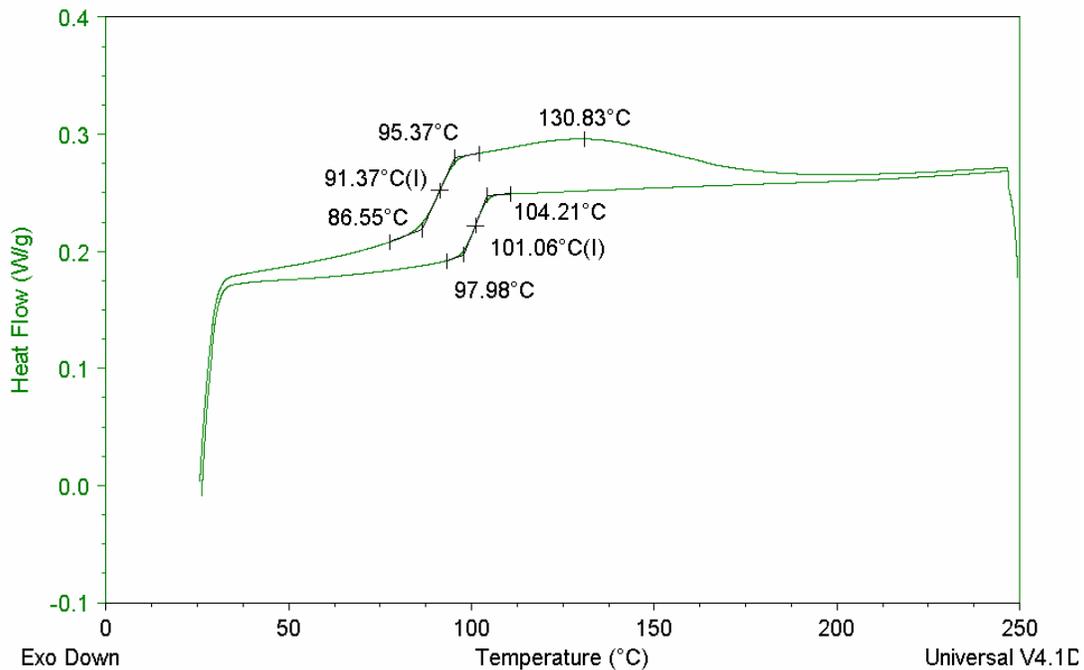
Figure 6.2 Sample LNE S2 DSC plot

Figure 6.2 illustrates a typical DSC plot showing the difference in T_g due to additional curing. The initial T_g of sample LNE – S2 was 91.4°C as shown by the upper plot in the figure, with maximum additional curing occurring at 130.8°C. The fully cured T_g of this sample was 101.1°C, with the sample showing no additional curing as evidenced by the constant slope of the lower plot at 130.8°C.

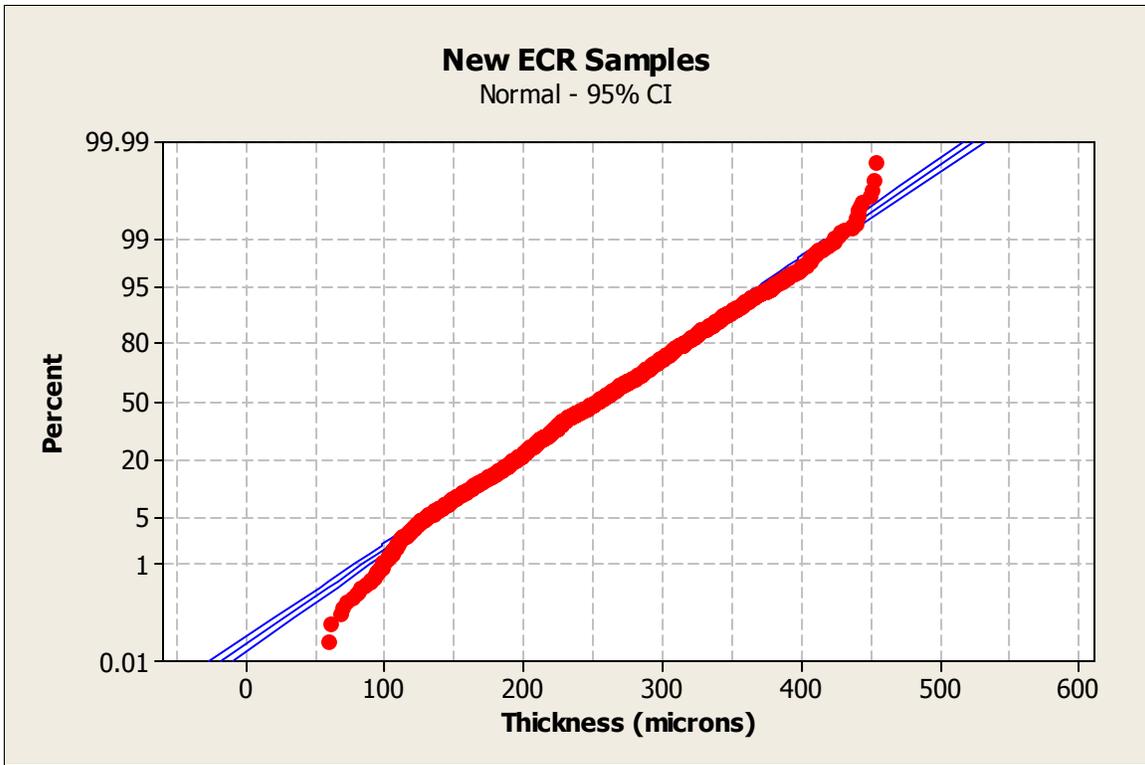
Figure 6.3 ECR Epoxy Coat Thickness Measurements Distribution

The thickness measurements were performed at 20 random locations along the bars. Three measurements were taken at each of the 20 locations and the results averaged. As illustrated in Figure 6.3, the thickness measurements were normally distributed. This conclusion is supported by the P-value 0.01 that is greater than 0.05.

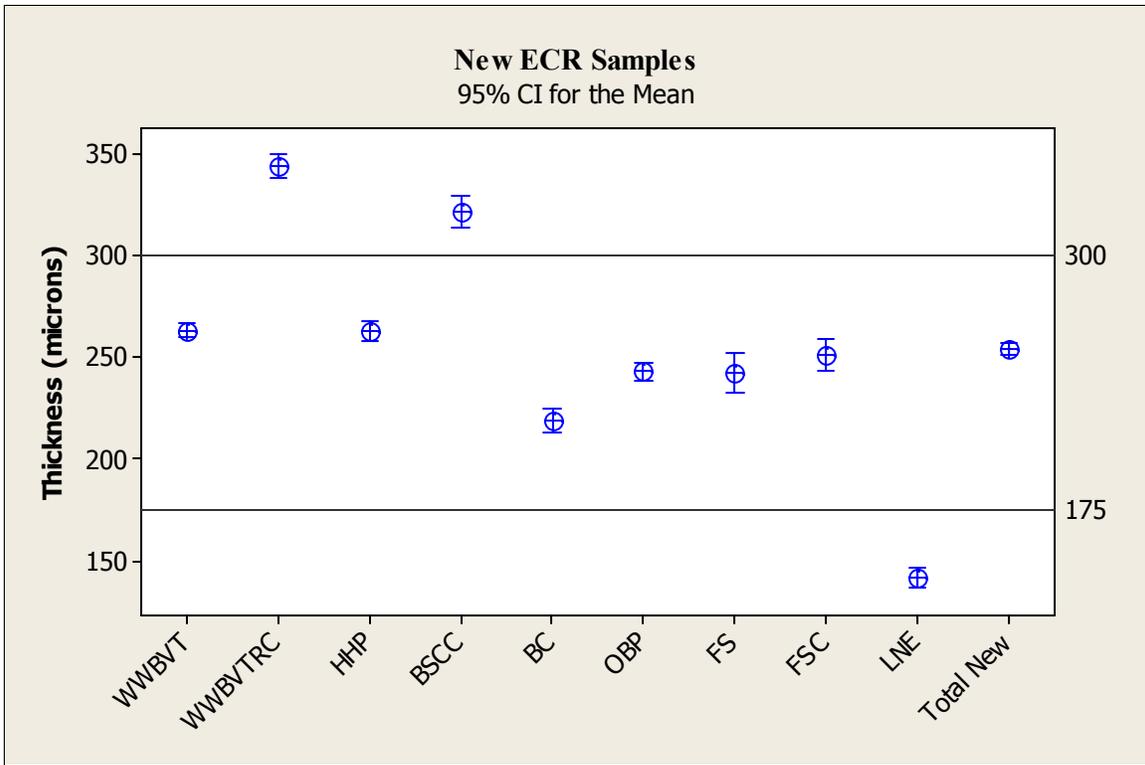
Figure 6.4 New ECR Coating Thickness

The average thickness measurements and the 95% confidence intervals are presented in Figure 6.4 for the individual samples with the minimum and maximum specified thickness represented by the two horizontal lines at 175 μm and 300 μm . Three sample sets, WWBVTRC, BSCC, and LNE failed to meet the current coating thickness specifications. The average thickness of WWBVTRC is 344 μm with a standard deviation of 46 μm , and the average thickness of BSCC is 321 μm with a standard deviation of 60 μm . The average thickness of both sample sets is above the maximum current specification. Inversely, the average thickness of LNE is below the current specified minimum of 175 μm at 141 μm with a standard deviation of 34 μm .

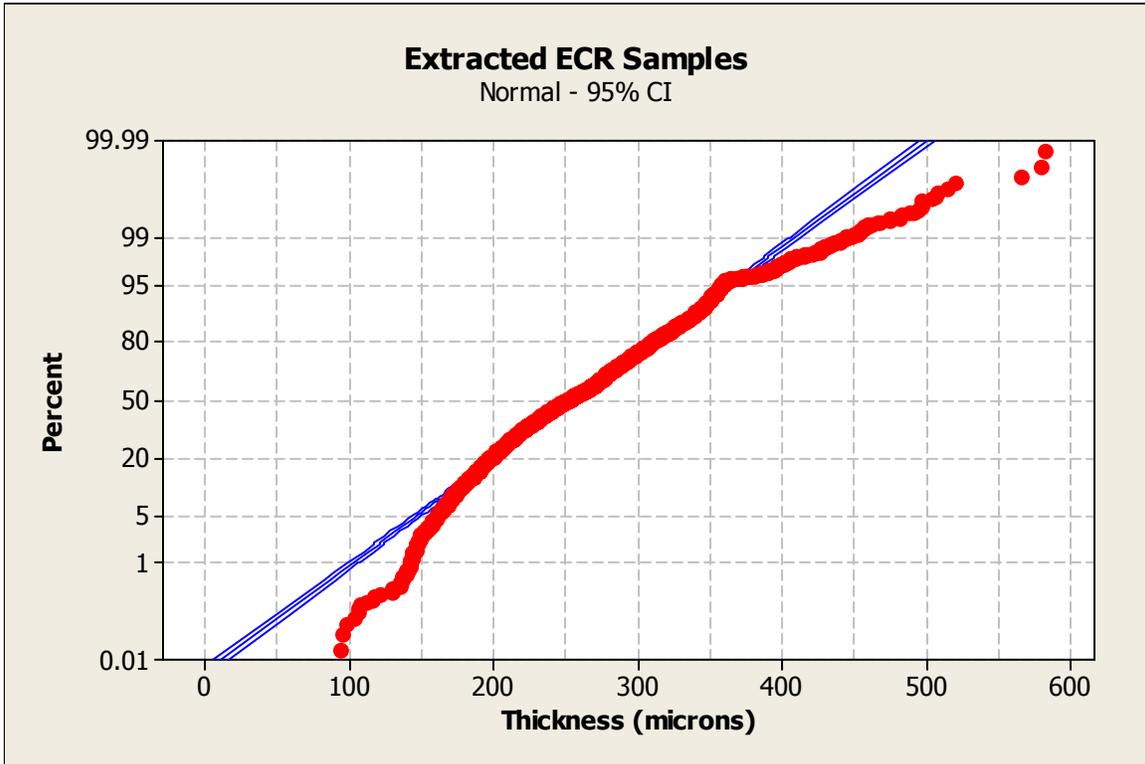
Figure 6.7 EECR Epoxy Coat Thickness Measurements Distribution

The thickness measurements were performed at six random locations along the bar sample. Three measurements were taken at each of the six locations and the results averaged. As illustrated in Figure 6.7, the thickness measurements were normally distributed

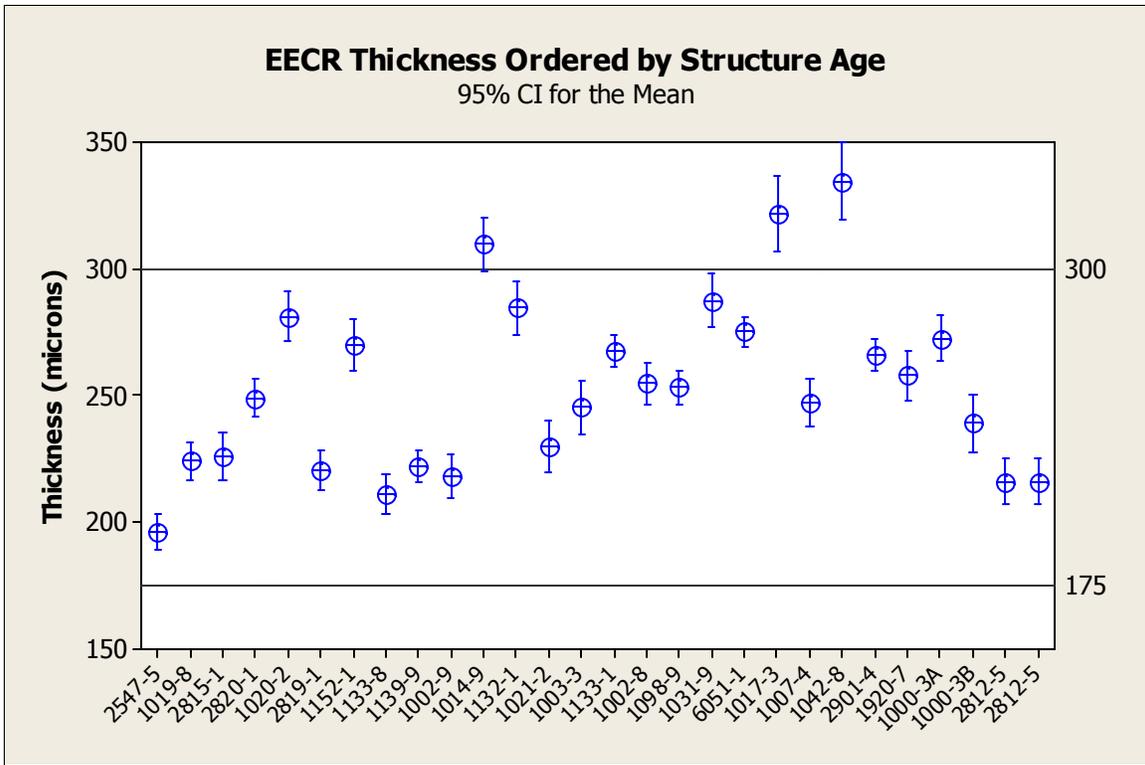
Figure 6.8 EECR Coating Thickness

The average thickness measurements and the 95% confidence intervals are presented in Figure 6.8 with the minimum and maximum specified thickness represented by the two horizontal lines at 175 μm and 300 μm . Three sample sets, 1014-9, 1017-3, and 1042-8 failed to meet the current coating thickness specifications. The average thickness of 1014-9 is 310 μm with a standard deviation of 67.1 μm , the average thickness of 1017-3 is 322 μm with a standard deviation of 78.5 μm , and finally, the average thickness of 1042-8 is 335 μm with a standard deviation of 79.1 μm . The average thickness of both sample sets is above the maximum current specification. There were no samples failing the minimum specified thickness.

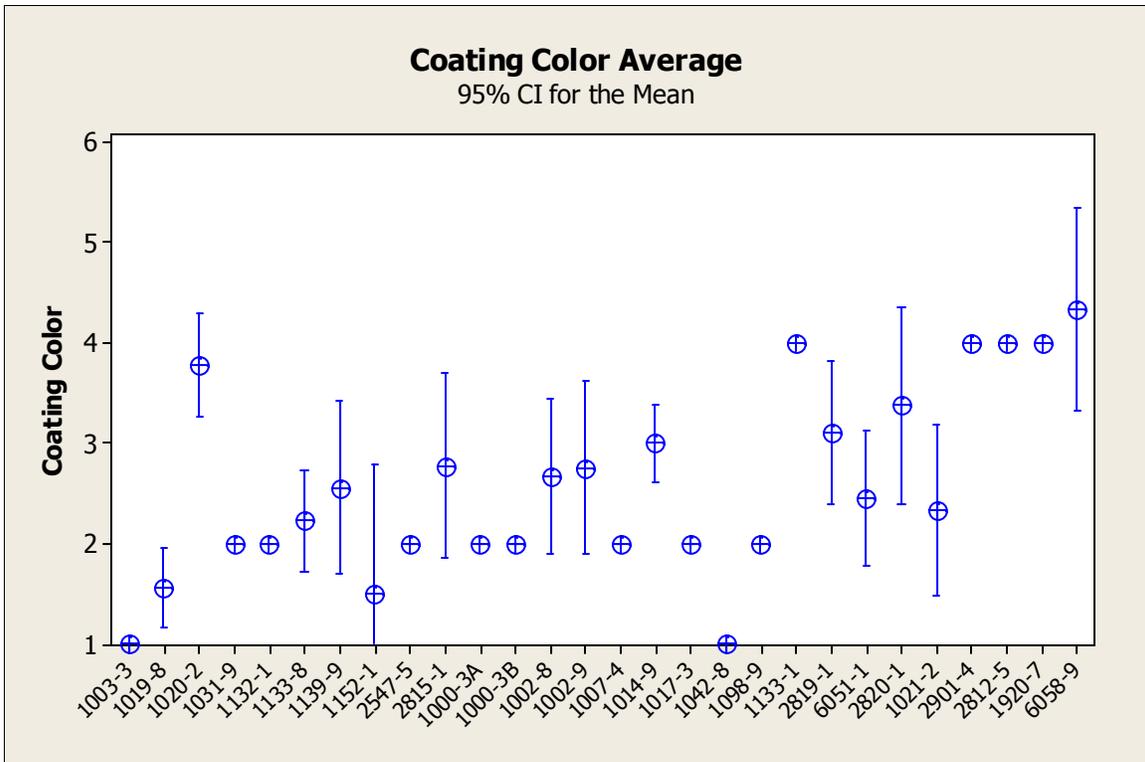
Figure 6.10 EECR Coating Color

Since a change in color from the original glossy green can be an indicator of coat degradation, this color change was recorded on a scale from 1 through 5, and the interpretation scale is presented in Chapter 5. From the sample population, the coating color of two structures showed no apparent change from new. The structures were 1003-3 and 1042-8. The remaining structures all presented some degree of coating color degradation with most experiencing loss of gloss rather than pigmentation. The distribution of color values is presented in Figure 6.9, while the mean and the standard deviation of each structure are presented in Figure 6.10.

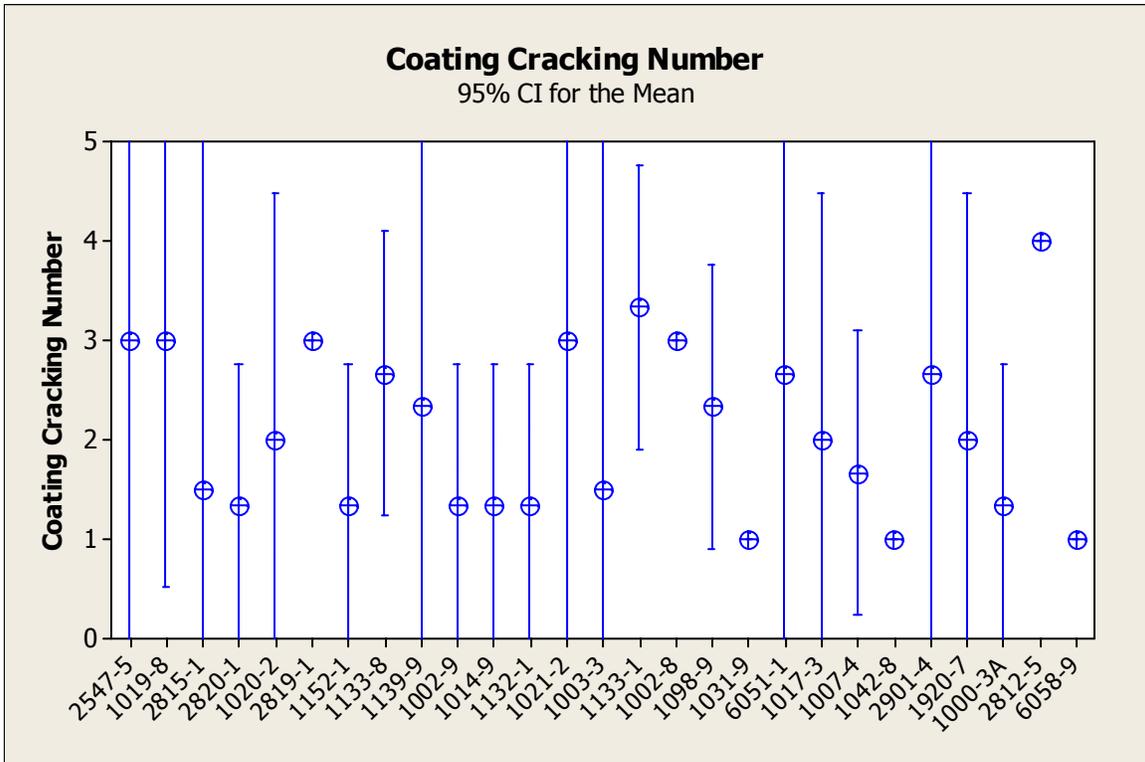
Figure 6.19 EECR Coating Cracking

A coating cracking value was assigned to each examined specimens using a 2000x magnification scanning electron micrograph. Figure 6.19 illustrates the average and 95% confidence interval for each structure. The coating samples of only three structures showed no cracking. Those structures were: 1031-9, 1042-8 and 6058-9. The remaining structures presented a mean of 2 with a standard deviation of 1.

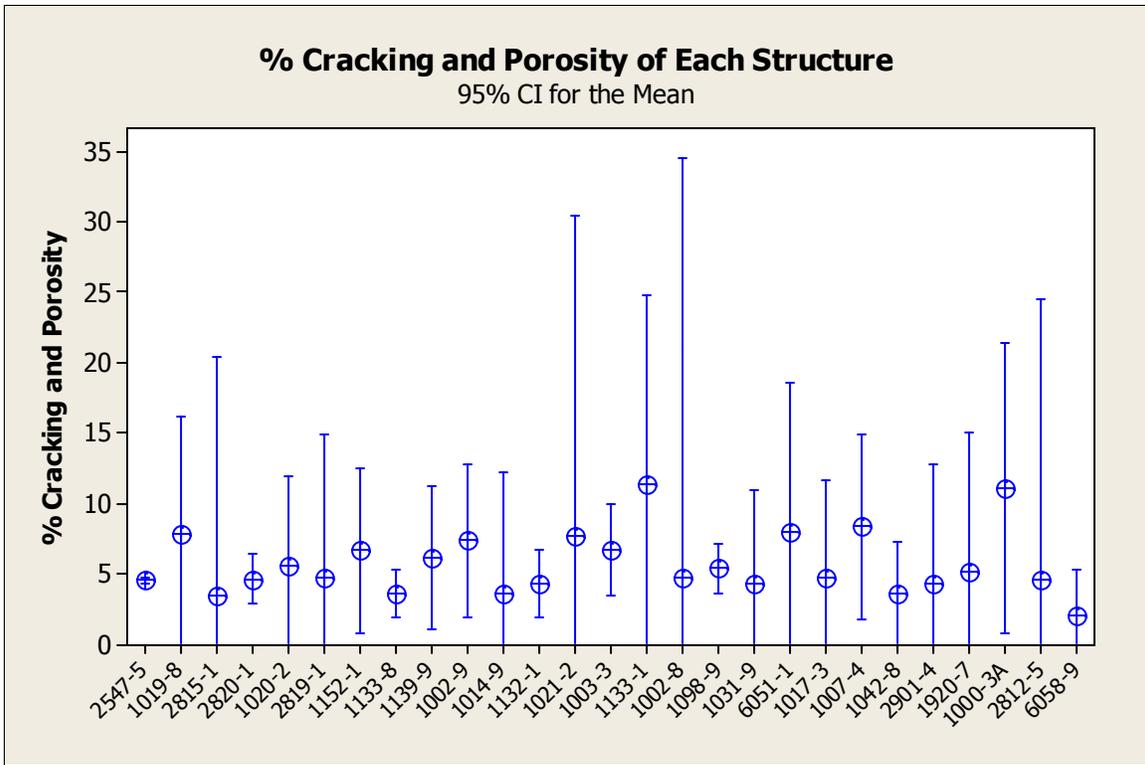
Figure 6.20 EECR Percent Cracking and Porosity

The average percent cracking and porosity for each structure are presented in Figure 6.20. Structure 6058-9 had the lowest percent cracking and porosity with an average 2.017 and a standard deviation of 0.37. Structure 1133-1 had the highest percent cracking and porosity with an average of 11.36 and a standard deviation of 5.39. Out of the individual samples examined, sample 1014-9 C6 had the lowest percent cracking and porosity with 0.71, while sample 1133-1 C1 had the highest percent cracking and porosity with 17.29. The total average and standard deviation for the entire sample population were determined to be 5.77 and 3.16, respectively. Unlike holidays and the number of damaged areas, the percent cracking and porosity were normally distributed as illustrated in Figure 6.21.

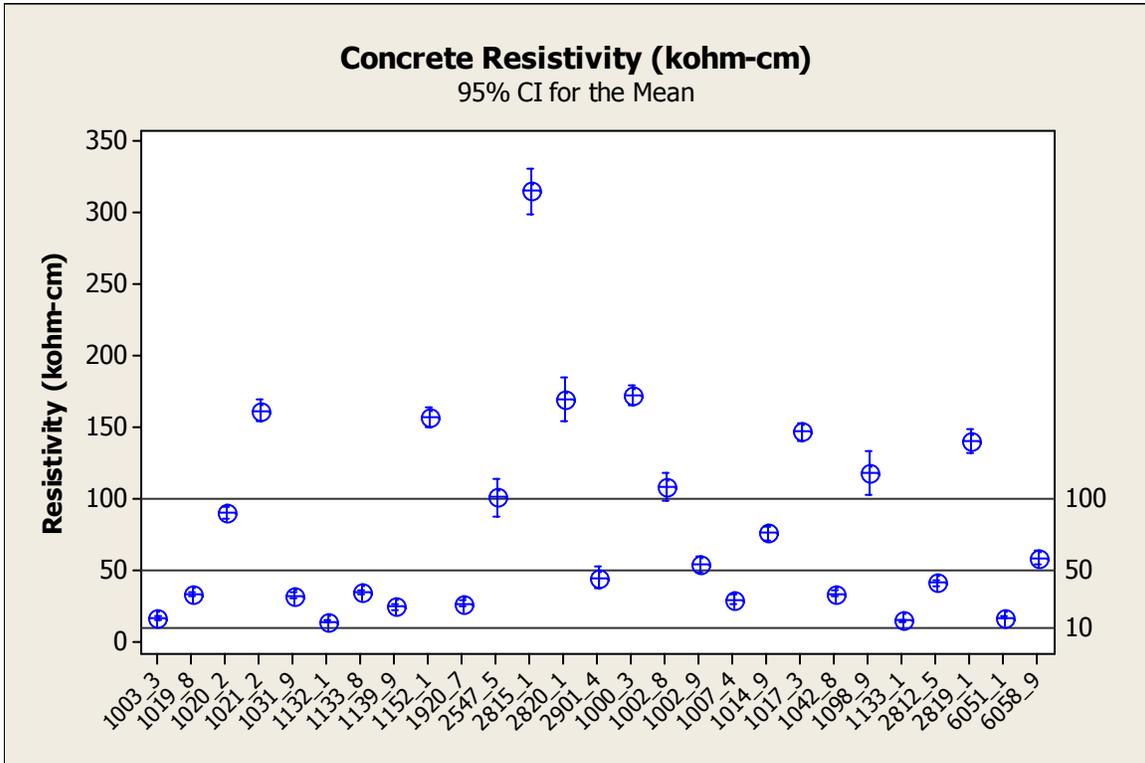
Figure 6.22 EECR Structures Concrete Resistivity

corrosion rate region of Figure 6.22. The remaining 9 structures theoretically will have low corrosion rates or the concrete was too dry when tested.

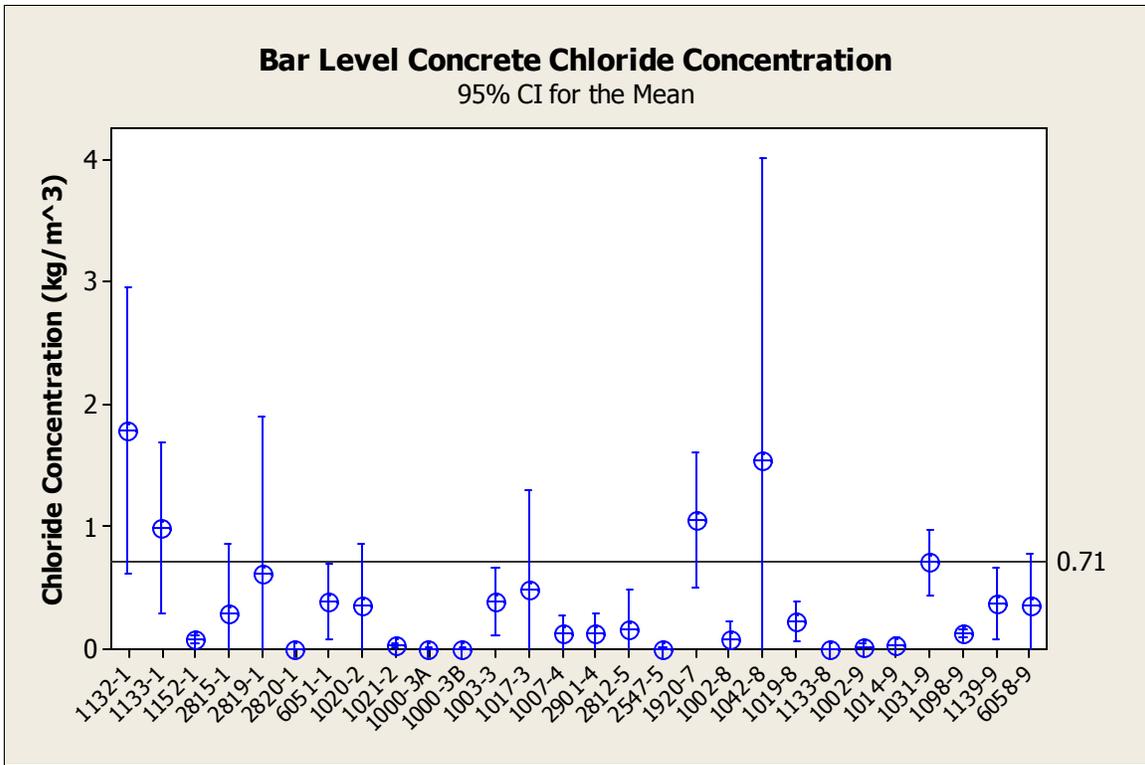
Figure 6.25 Concrete Chloride Concentration at Bar Level

Figure 6.25 illustrates the average chloride concentration at bar level, while the reference line at 0.71 kg/m³ of concrete represents a corrosion initiation level. With the exception of five structures, the chloride concentration at bar level was below the commonly used corrosion initiation threshold of 0.71 kg/m³ of concrete. The five structures that exhibited higher chloride concentrations were: 1132-1, 1133-1, 1920-7, 1042-8 and 1031-9. The average chloride concentration of these structures was 1.78, 0.99, 1.06, 1.54 and 0.71 kg/m³ of concrete, respectively.

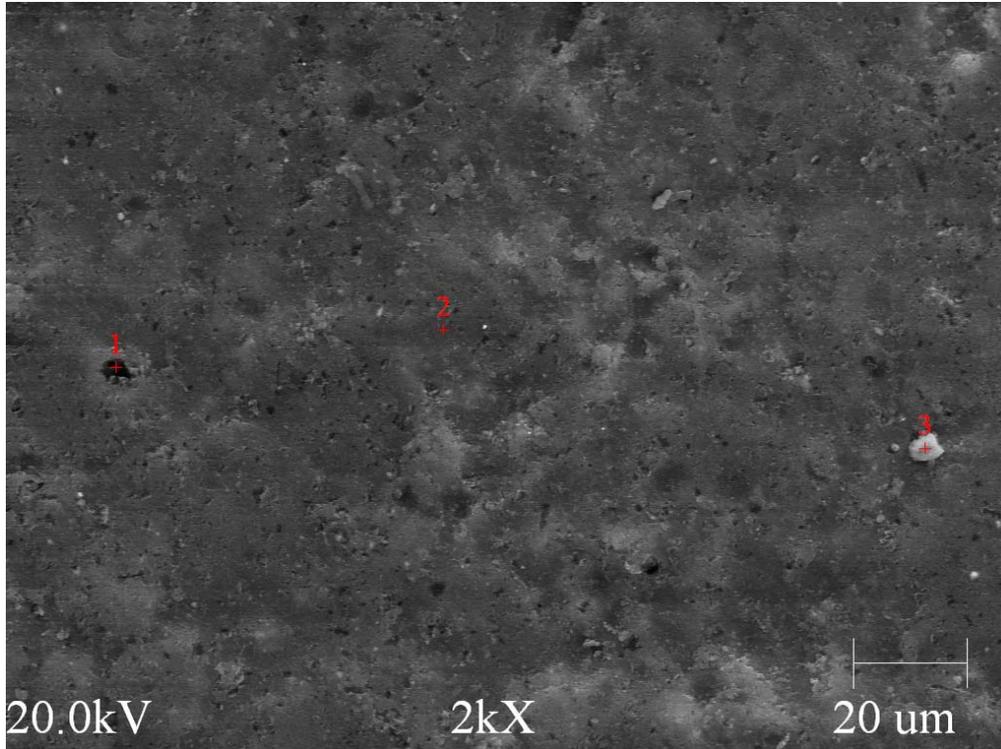
Figure 6.26 Structure 1020-2 C6 SEM Micrograph

Finally, SEM and EDS analyses were performed. Figure 6.26 illustrates an electron scanning micrograph of structure 1020-2 C6. The EDS spectra were collected at the numbered locations and are presented in Figures 6.27, 6.28 and 6.29.

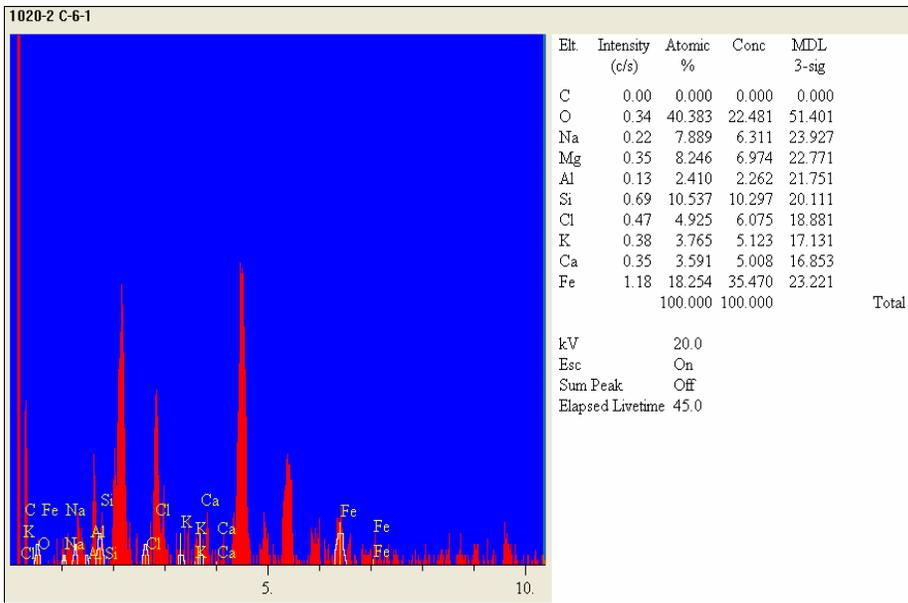
Figure 6.27 EDS Spectra 1020-2 C-6-1

The spectrum at location 1 (Figure 6.27) would indicate that the pore in the coating is continuous to the steel substrate. Although the signals are weak due to interference from the pore walls, iron still presents the strongest peak, followed by silica, chlorides, potassium and calcium, which may all be found in the concrete pore solution. Location 2 (Figure 6.28) spectra is dominated by the carbon signature as expected from an organic coating. There are traces of other elements that are commonly found in concrete or the concrete pore solution. This is due to adsorption of the pore solution on the coating surface. Finally, the third spectrum (Figure 6.29) illustrates the typical signature of cement. There is no carbon present, as expected from an organic coating, but the calcium and the silica signatures dominate.

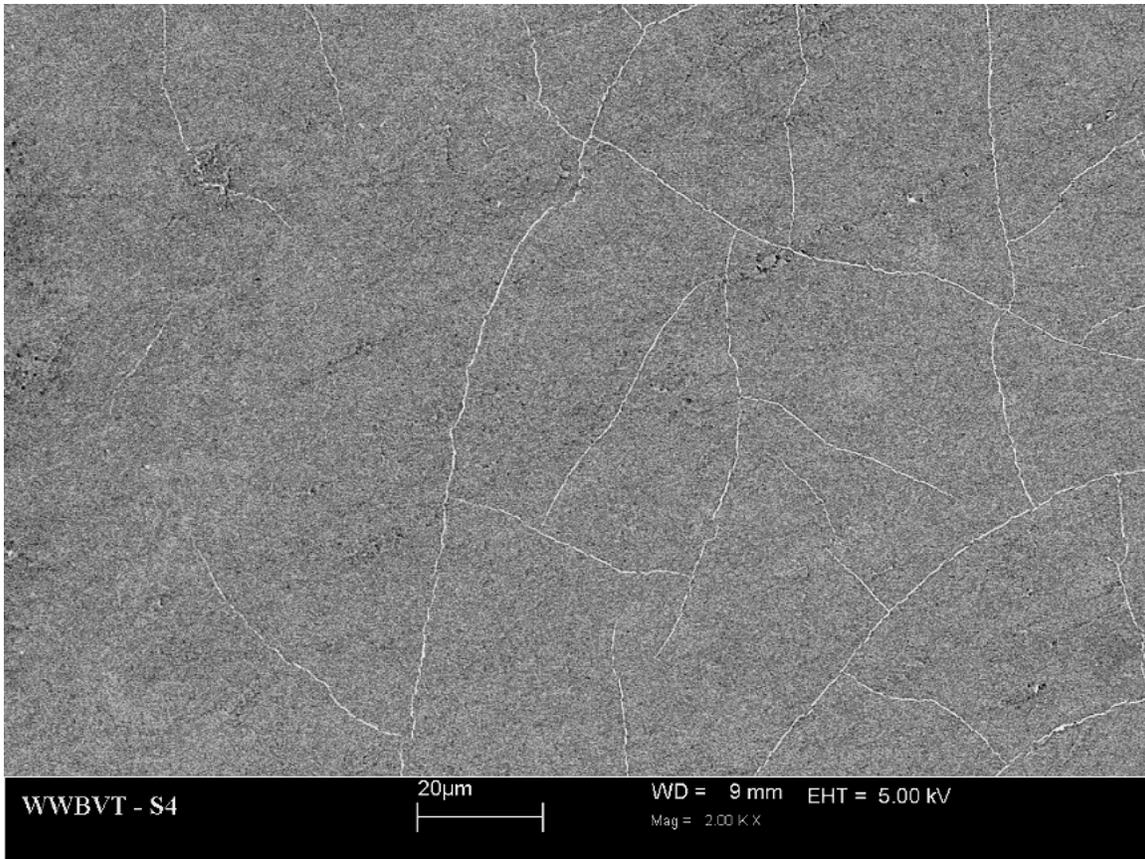
Figure 7.1 WWBVT – S4 Cracking (SEM Micrograph)

With the exception of only one new specimen (WWBVT-S4), which is presented in Figure 7.1, no map-like cracking was noted in the remaining new ECR samples. Based on the interpretation guide, WWBVT-S4 was assigned a cracking value of 3. The colors in Figure 7.1 were inverted for better contrast. Unlike the new ECR samples, the majority of the extracted ECR samples showed surface coating cracking spanning the severity scale with a total average cracking value of 2. This significant difference between the new and the extracted ECR samples indicates that while it is possible that there are factors that may contribute to coating cracking prior to concrete embedment, the majority of the cracking occurs in concrete.

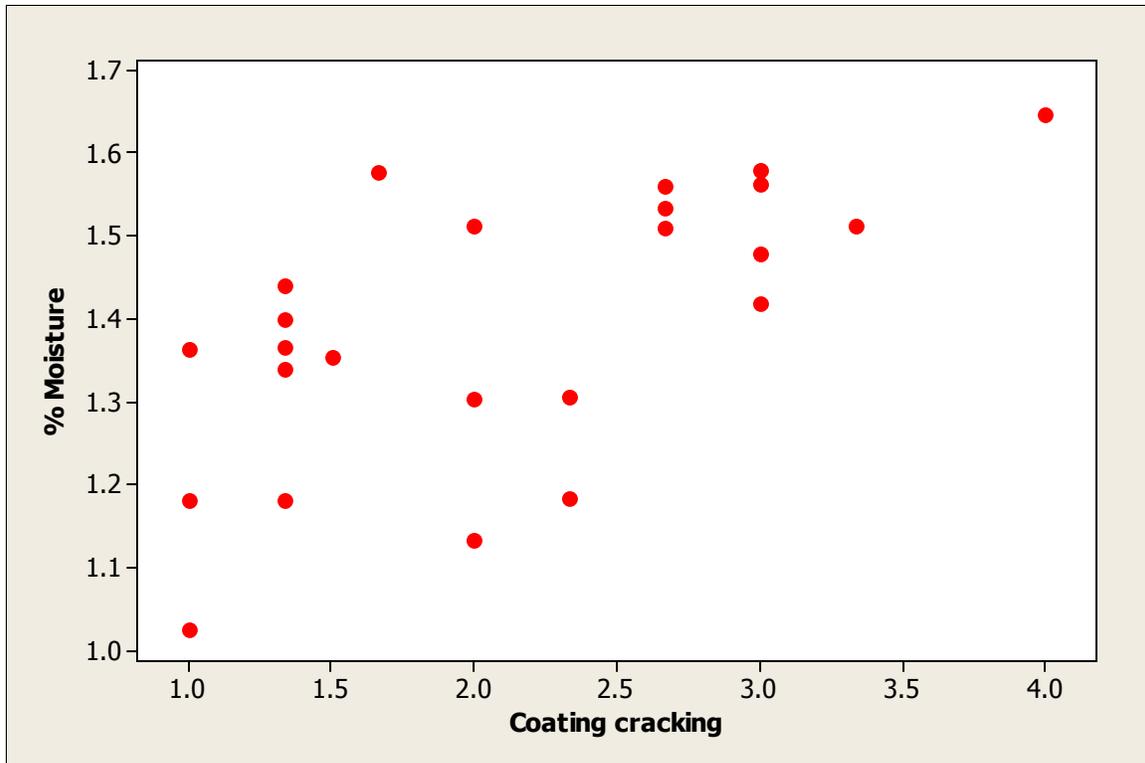
Figure 7.2 Scatter Plot of %Moisture vs. Coating cracking

Using a confidence level of 80% allows for the inclusion of chlorides at bar level, adhesion, color of corrosion products and % moisture as cracking prediction parameters. The P-values were 0.171, 0.115, 0.118 and 0.186, respectively. Further regression performed using only the parameters with P-values ≤ 0.20 ultimately yielded only the coating color as the strongest predictor of coating cracking. At the 95% confidence level, the coating color P-value was 0.003. Based on individual correlations, excluding combined effects, the cracking value correlated with the % moisture, with a Pearson correlation value of 0.637 and a P-value of 0.001 (Figure 7.2).

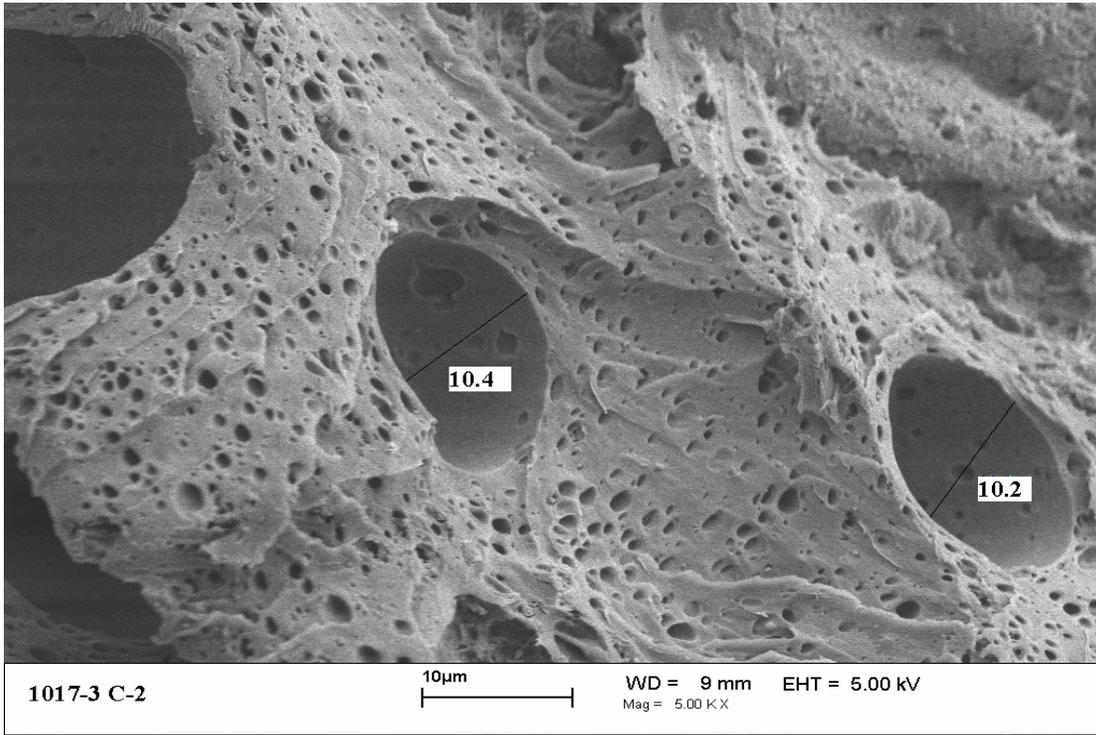
Figure 7.4 1017-3 C-2 5x SEM Coating Micrograph

The porous structure of coating samples collected from structures 1017-3 C-2 and 2820-1 C-4 is illustrated in Figures 7.4 and 7.5. The ΔT_g of sample 1017-3 C-2 is 26.42 °C while the ΔT_g of sample 2820-1 C-4 is 9.63 °C. Both coating samples present capillary-sized pores throughout the bulk of the coating. The size of the pores was 10.4 and 10.2 μm for the 1017-3 C-2 sample and 18.9 and 37.6 μm for the 2820-1 C-4 sample in addition to the multitude of pores 1 μm or less occupying the bulk of the coating. Since the examples of the porous structure presented were obtained from three structures only, we cannot conclusively state that this is a common condition. It is the opinion of the author, however, based on the random nature of the investigated samples, that this may in fact be the prevailing coating condition. Using the 1% moisture to 8°C conversion leads to ΔT_g due to insufficient curing of 16.50°C and -5.49°C, respectively. The -5.49°C in this case may be explained by the fact that some of the moisture is in fact free or bulk water, which has no plasticizing effect.
