Investigation of parameters governing the corrosion protection efficacy of fusion bonded epoxy coatings

Dissertation submitted to the faculty of the
Department of Civil and Environmental Engineering
Virginia Polytechnic Institute and State University
in partial fulfillment of the requirements for the degree of

Keywords: corrosion; ECR; concrete durability; epoxy coating; FBE

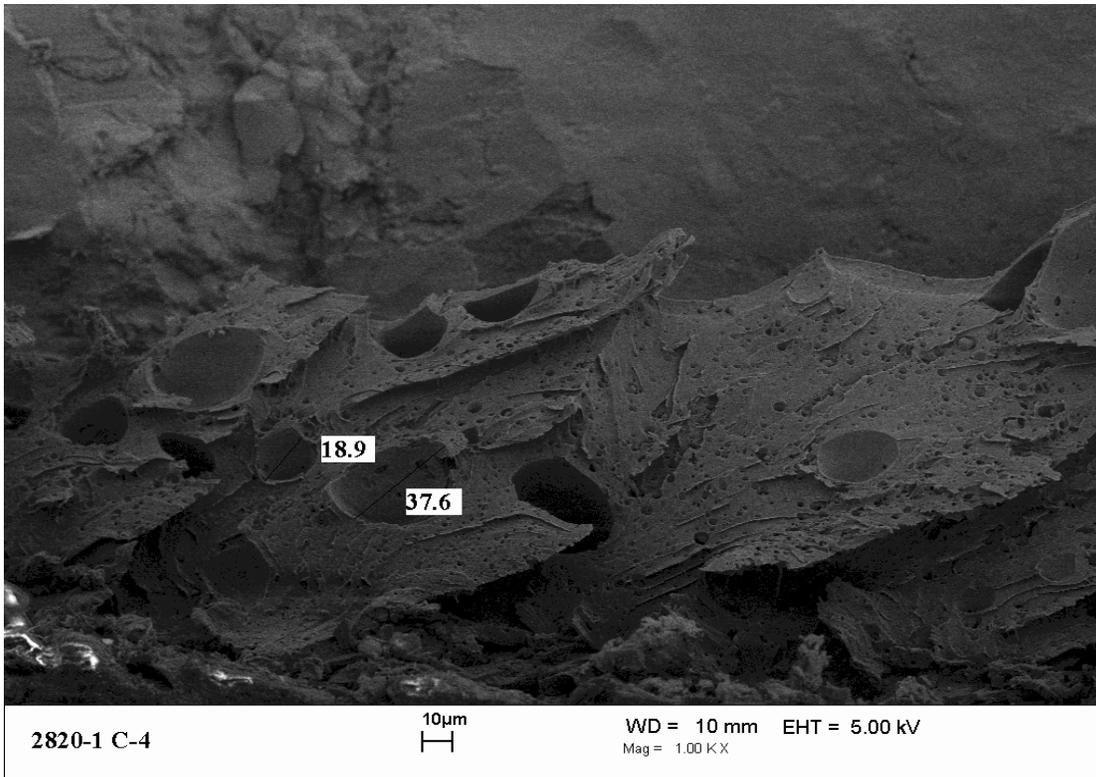
Figure 7.5 2820-1 C-4 1x SEM Coating Micrograph

The porous structure of coating samples collected from structures 1017-3 C-2 and 2820-1 C-4 is illustrated in Figures 7.4 and 7.5. The ΔT_g of sample 1017-3 C-2 is 26.42 °C while the ΔT_g of sample 2820-1 C-4 is 9.63 °C. Both coating samples present capillary-sized pores throughout the bulk of the coating. The size of the pores was 10.4 and 10.2 μm for the 1017-3 C-2 sample and 18.9 and 37.6 μm for the 2820-1 C-4 sample in addition to the multitude of pores 1 μm or less occupying the bulk of the coating. Since the examples of the porous structure presented were obtained from three structures only, we cannot conclusively state that this is a common condition. It is the opinion of the author, however, based on the random nature of the investigated samples, that this may in fact be the prevailing coating condition. Using the 1% moisture to 8°C conversion leads to ΔT_g due to insufficient curing of 16.50°C and -5.49°C, respectively. The -5.49°C in this case may be explained by the fact that some of the moisture is in fact free or bulk water, which has no plasticizing effect.

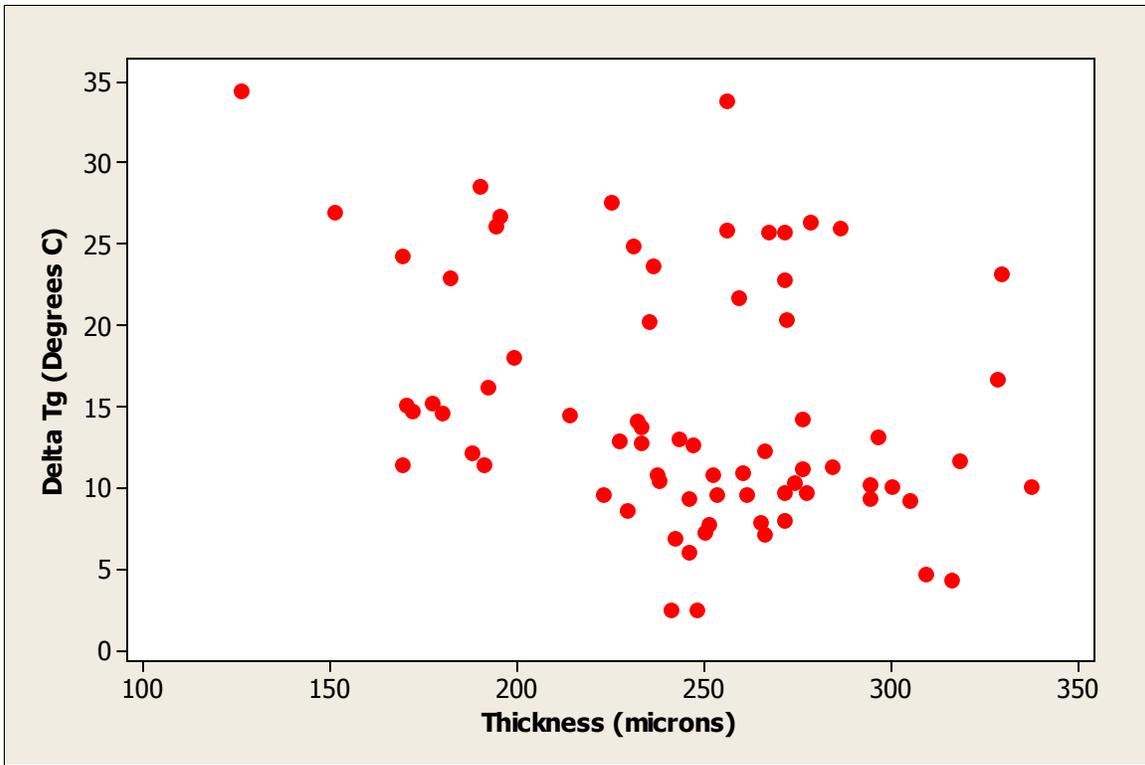
Figure 7.6 ΔT_g vs. Thickness (μm)

Since the degree of curing is independent of the material thickness, the relationship can be explained as follows: greater manufacturing speeds produce low and uneven heating of the bar element. Following the heating of the bar element, the greater speed not only impedes the adhesion of sufficient epoxy powder to the bar, but it also limits the time available for the fusion bonded epoxy to cure leading to a more porous and therefore more permeable coating structure. The LNE data deviates from this conclusion with a ΔT_g of zero indicating a fully cured coating, yet exhibiting the thinnest coating and continuous holiday detection. In this case, the bar may have in fact been overheated, flash-curing the powder coating without allowing sufficient time for the fluid to flow and fully coat the bar.
