INSIGHTS INTO NON-UNIFORM COPPER AND BRASS CORROSION IN POTABLE WATER SYSTEMS

Dissertation submitted to the faculty of the Virginia Polytechnic Institute and State University in
partial fulfillment of the requirements for the degree of

Doctor of Philosophy
In
Civil and Environmental Engineering

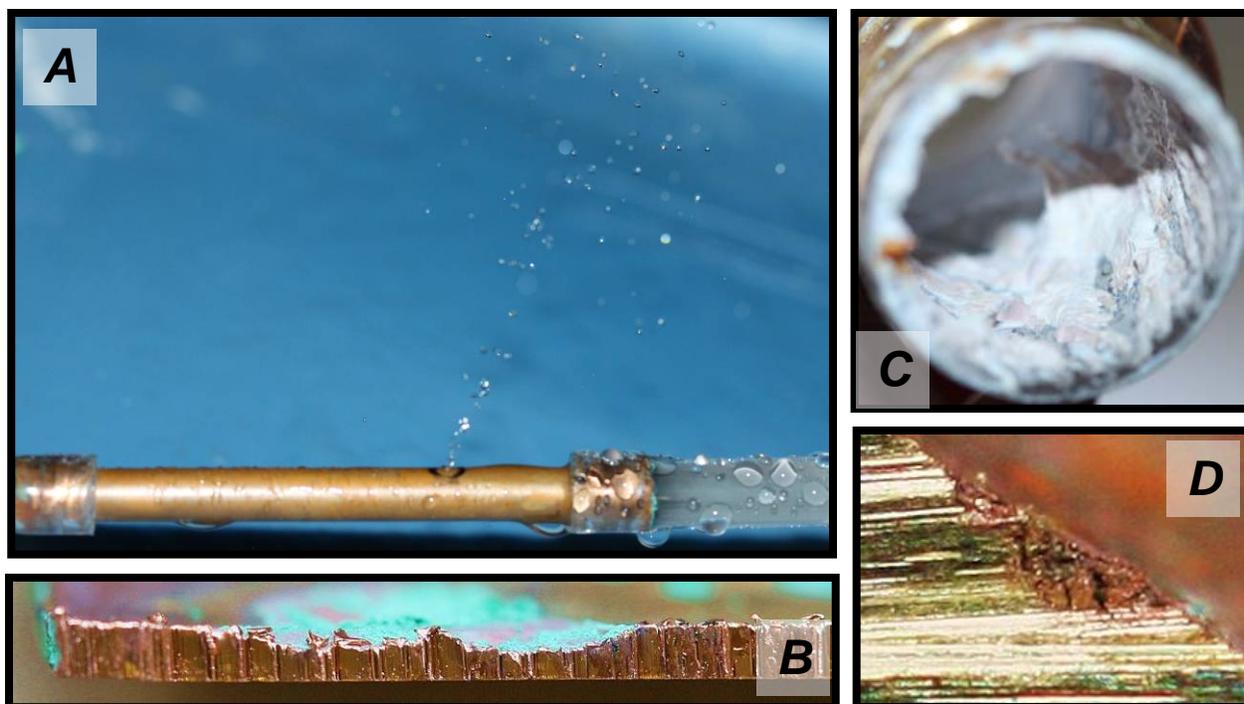
Figure P.1: Replication of copper pitting and brass dezincification phenomena in laboratory pipe-loop studies. *A* shows a fully-penetrating copper pinhole leak, *B* shows deep pits into copper tubing, *C* shows build-up of “meringue” dezincification corrosion deposits inside a brass component, and *D* shows plug-type dezincification penetrating into a brass fitting.

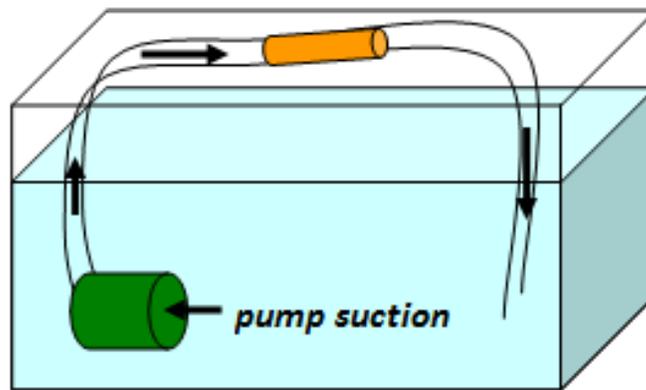
Figure 1.1: Experimental apparatus for small-scale triplicate testing; the flow velocity was about 5.0 ft/s (1.5 m/s) and direction is indicated by arrows.

Small-scale testing was conducted in 30 L pipe-loops (Figure 1.1). Each contained one 3” (7.6 cm) length of ¼” (0.63 cm) diameter, thin-walled (0.014” in or 0.036 cm) copper tubing. Clear vinyl tubing was used to connect copper pipe sections to submersible, magnet-drive centrifugal pumps (polypropylene and stainless steel construction), which re-circulated water at a constant velocity of approximately 5.0 ft/s (1.5 m/s).

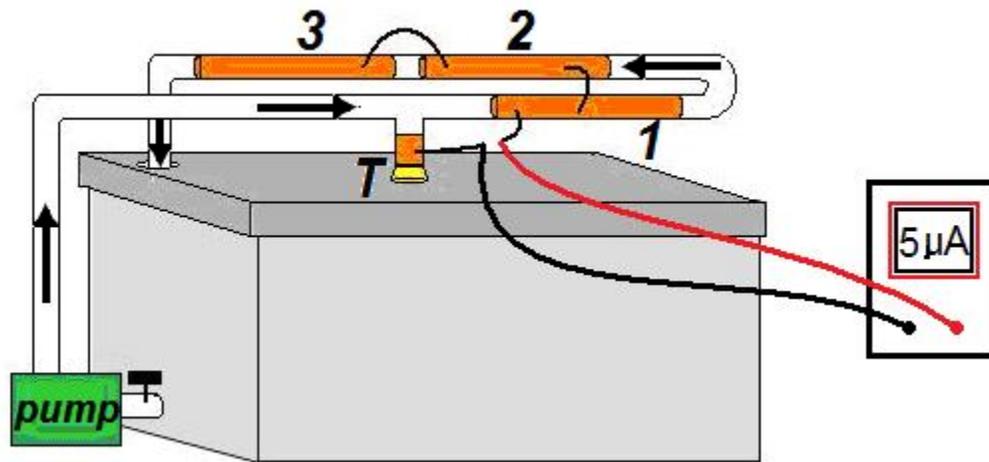
Figure 1.2: Experimental apparatus for large-scale duplicate testing; the flow velocity was about 4.5 ft/s (1.3 m/s) and direction is indicated by arrows.

Large-scale testing was conducted in 94 L pipe-loops (Figure 1.2), which were designed to more realistically represent a premise plumbing system and used off-the-shelf copper tube. All four copper sections (designated *T*, *1*, *2* and *3* in Figure 1.2) were physically separated with vinyl tubing, but were electrically connected via external copper wires. This allowed for electrochemical measurements by temporarily replacing the wires with a multi-meter. Vinyl tubing was used to connect copper to magnet-drive centrifugal recirculation pumps (polypropylene construction), which re-circulated water at a constant velocity of approximately 4.5 ft/s (1.3 m/s). Each pipe-loop included three 1’ (30.5 cm) lengths of ¾” (1.9 cm) diameter, Type M copper, which were oriented in-flow; and one 2” (5.1 cm) length of the same tubing located out-of-flow (i.e., dead-end “*T*” in Figure 1.2). This “differential flow” configuration practically represents a

plumbing system wherein one copper tube is removed from flow, while another experiences constant or frequent flow. Differential flow was expected to heighten corrosion activity in these tests via development of a concentration cell (i.e., lowered pH and chlorine levels, and build-up of high salt content in the stagnant *T* water as compared to the flowing bulk water).

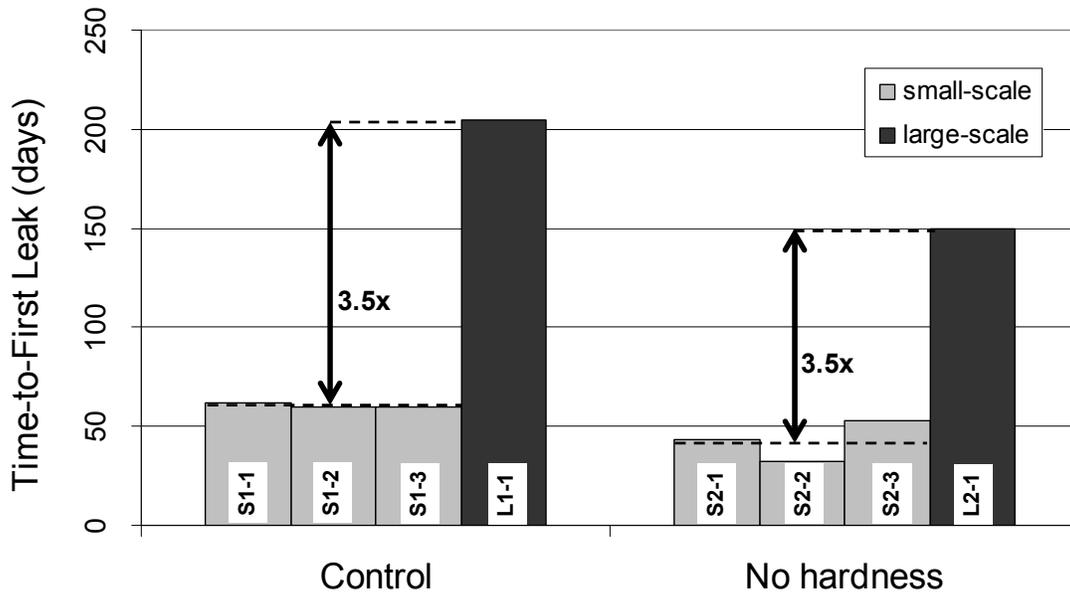
Figure 1.3: Time-to-first leak for control and no hardness conditions; in both conditions, small-scale tests leaked about 3.5 times faster on average than large-scale tests. Copper in large-scale tests had a wall thickness about 2.5 greater than that in small-scale tests.

time-to-first leak between small- and large-scale tests, small-scale tests leaked about 3.5 times faster than large-scale in both cases (Figure 1.3), indicating that scale-up from fairly simple to more complex systems was relatively reproducible after accounting for differences in tube wall thickness. Other parameters that might account for the slight differences include flow conditions (e.g., velocity, uniformity) and tube lengths.

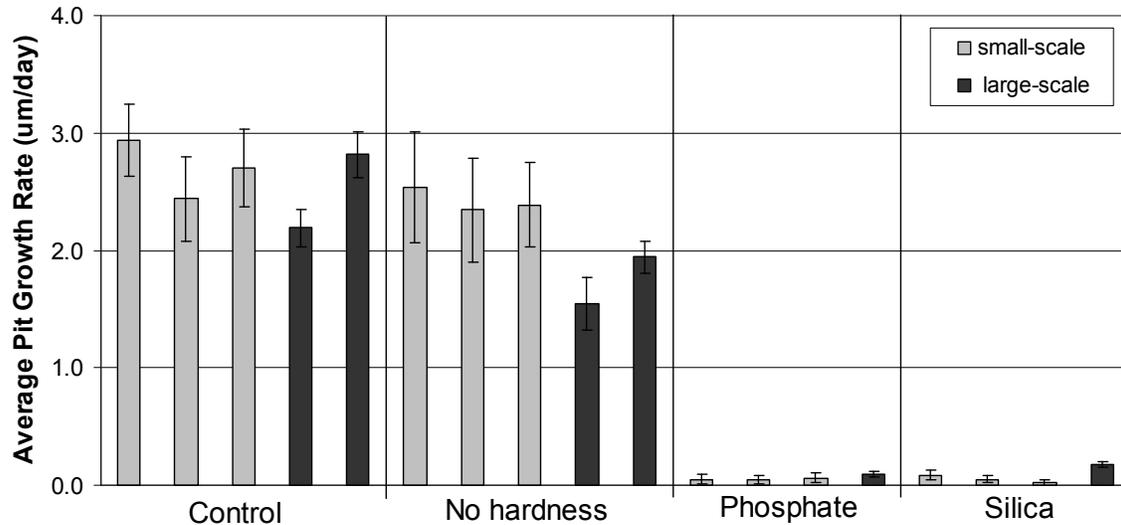
Figure 1.4: Average pit growth rates; error bars represent 95% confidence intervals.

For large-scale duplicate control and no hardness tests (L1-2 and L2-2) run at a different time of year than originals, severe pitting was observed but pinholes did not form. This may be due to several factors, including the power outage that resulted in test L2-1 running for a shorter time than was required to produce a leak in L1-1 (i.e., 161 vs. 205 days). Changes to uncontrolled parameters such as temperature may have also played a role. Despite discrepancies in maximum pit growth rates, average pit growth rates were in excellent agreement (Figure 1.4).

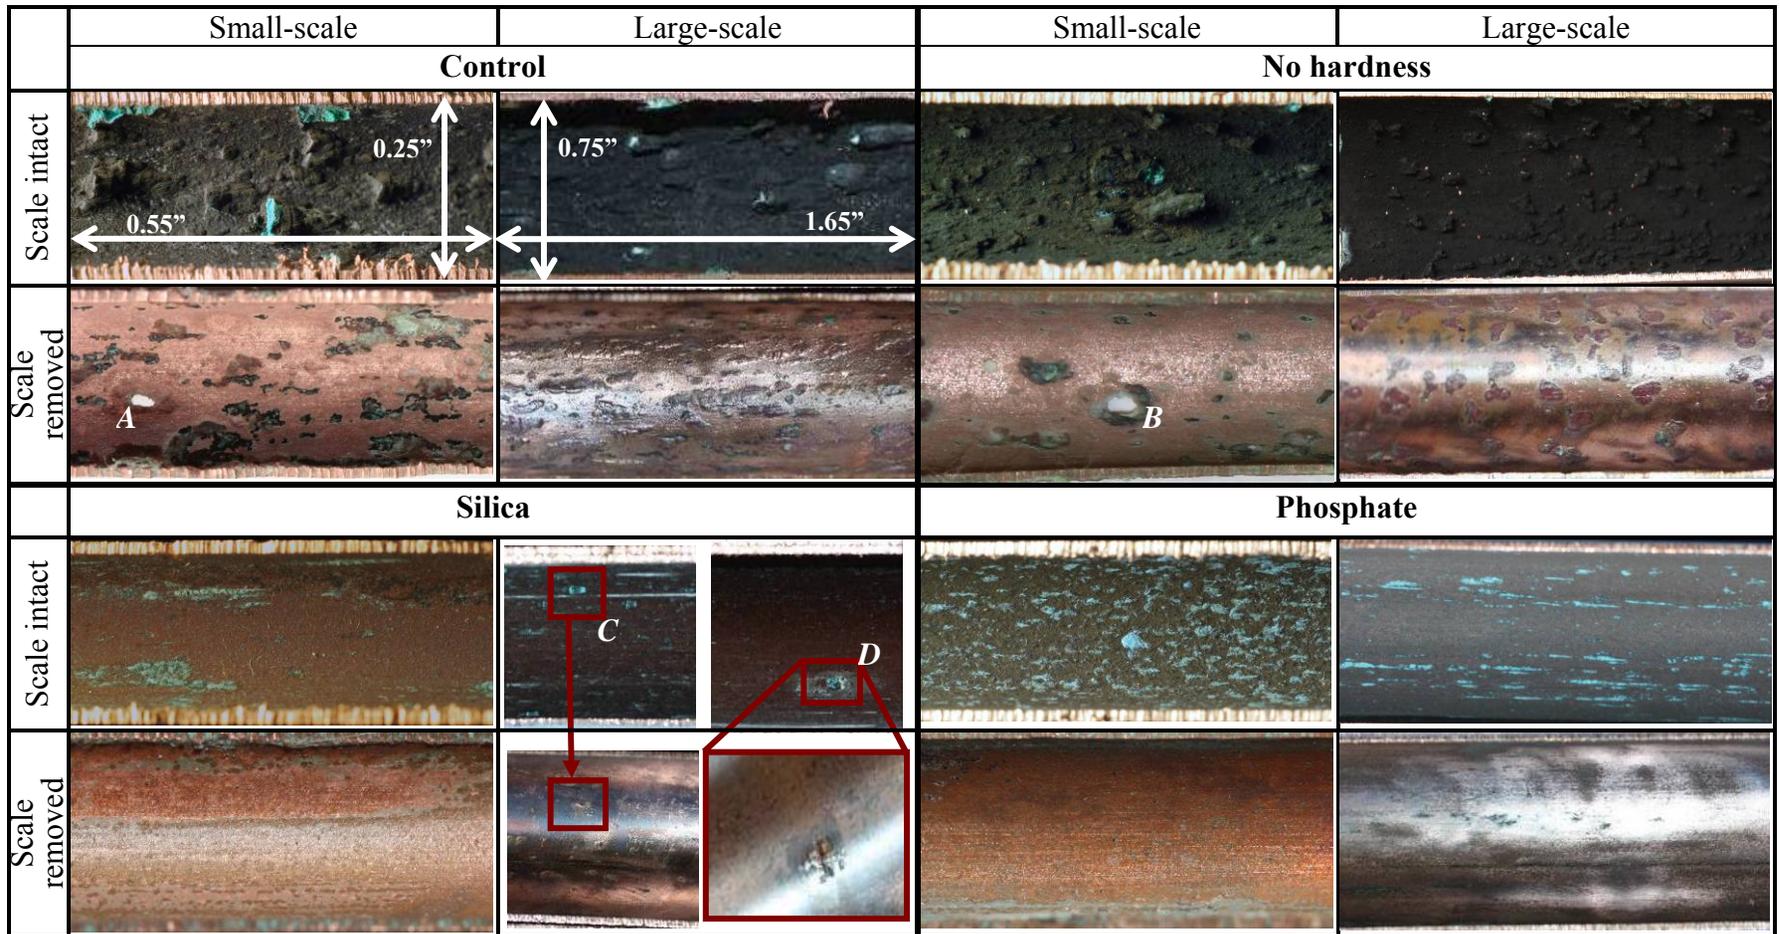
Figure 1.5: Representative photographs of copper tube interiors following testing; relative tube dimensions shown for each apparatus. A and B indicate pinholes that formed during testing, and C and D indicate pits that formed in the high silica condition.

Cross-sectioned tubes from the control and no hardness tests (Figure 1.5) revealed that a thick black scale formed with many tubercles, which were blue/green and porous, and had deep pits or pinholes underneath. Pit density appeared higher in the control and pits tended to overlap, whereas they were more isolated in the no hardness condition.

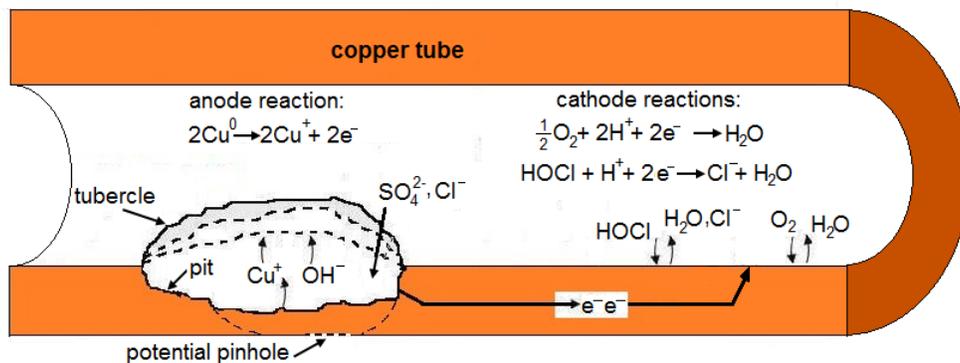
Figure 2.1: Simplified depiction of pitting corrosion of a copper tube. Electrons produced at the anode are consumed at the remote cathode.

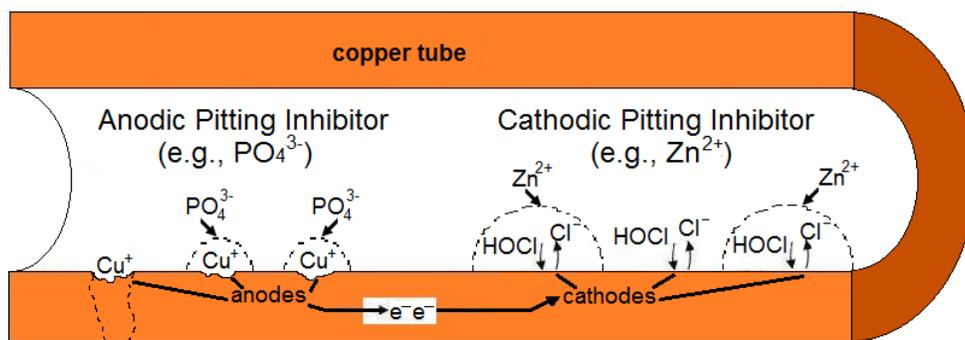
Figure 2.2: Simplified, speculative depiction of pit inhibition by anodic and cathodic inhibitors.

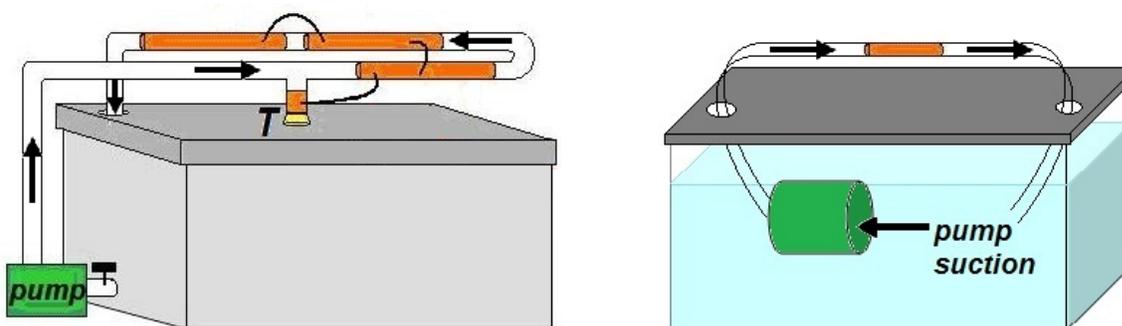
Figure 2.3: Large and small pipe-loop apparatuses; flow direction is indicated by arrows.

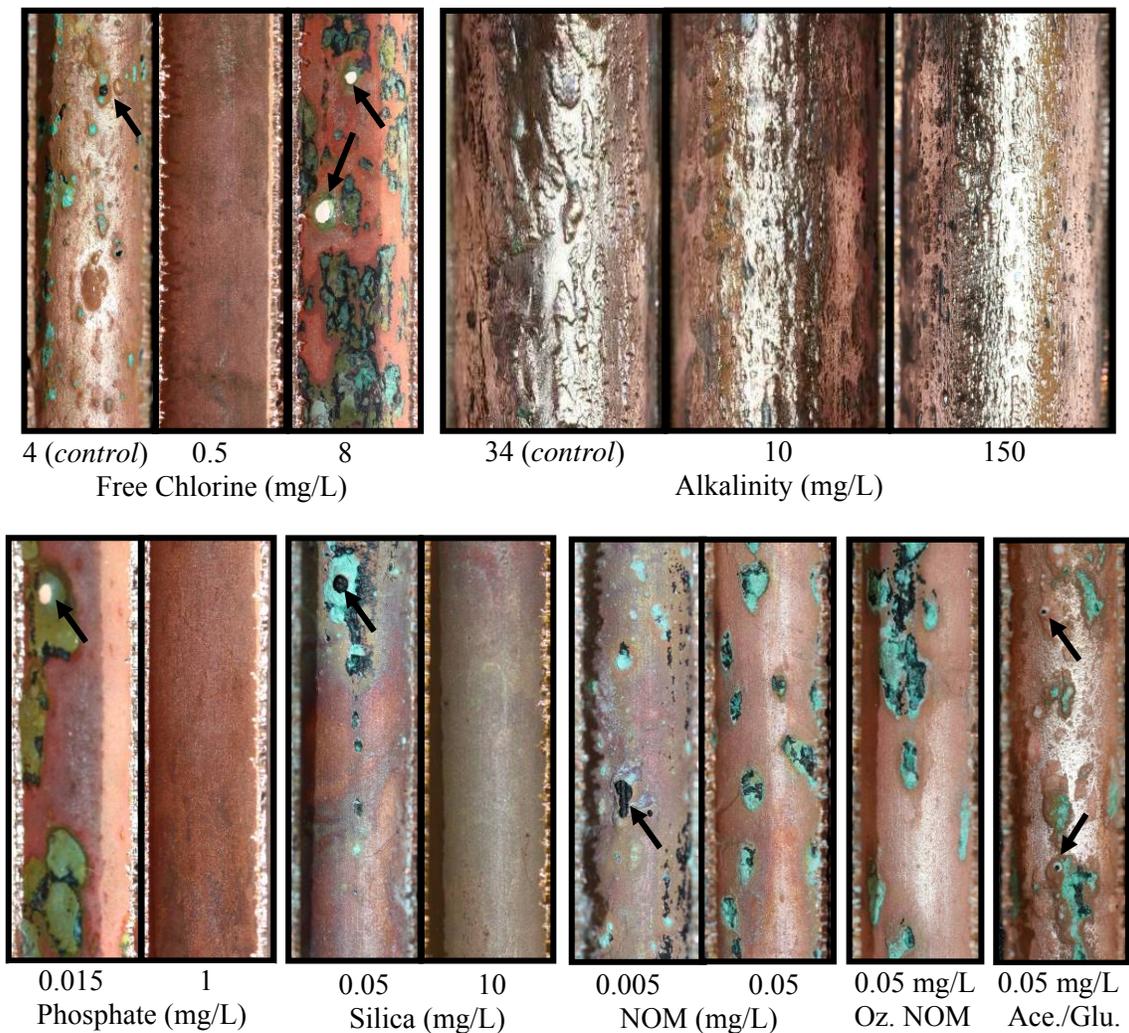
Figure 2.4: Representative photographs of copper from selected tests following scale removal. Photos are grouped by respective adjustments to control water quality, and arrows indicate some of the pinhole leaks that formed during testing. All photos show copper from small-scale tests, except for those in the variable alkalinity group.

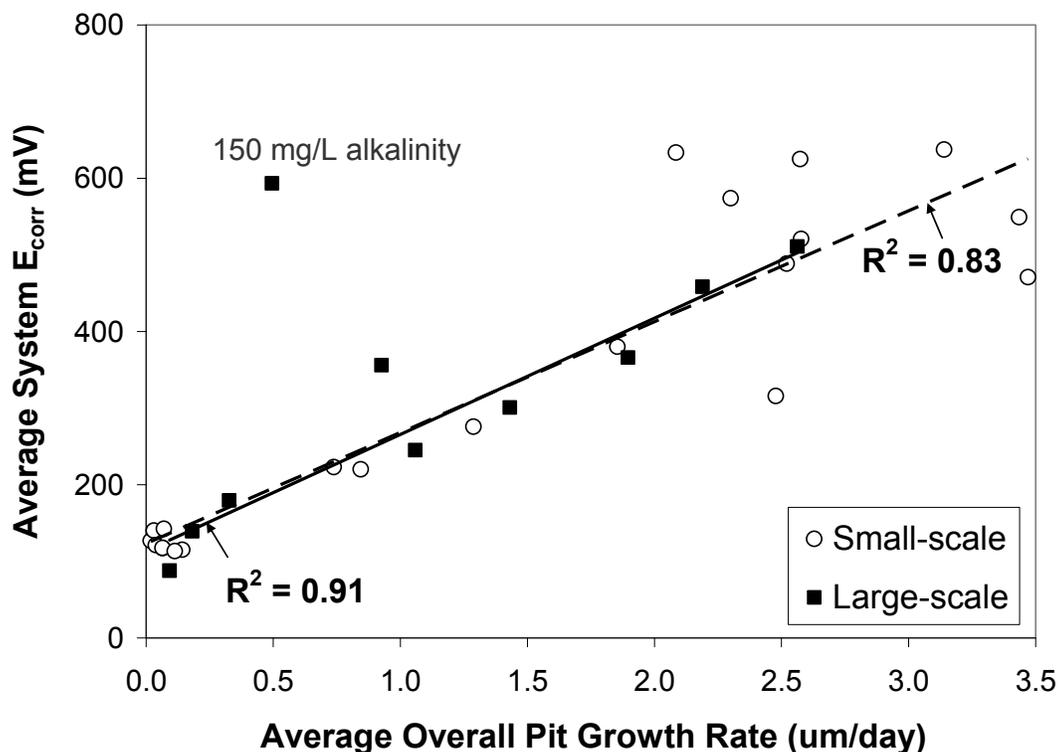
Figure 2.6: Average system E_{corr} vs. overall pit growth rate for all tests. The 150 mg/L alkalinity condition did not follow the same trend as other data, and is not included in the computed R^2 value for the large-scale tests.

Generally speaking, the overall pit growth rates correlated well with average system E_{corr} (i.e., rest potential of all copper surfaces exposed to test water vs. Ag-AgCl reference) (Figure 2.6) and chlorine demand (Table 2.2), except for a few isolated cases. For example, the high alkalinity condition consistently had high E_{corr} but produced relatively shallow pits within the test duration, albeit at a very high density (see Figure 2.4). This can be attributed to the fact that, although many pits were being initiated (as suggested by the high E_{corr} and confirmed by later visual observation), pits did not propagate rapidly. We speculate that this might be due to

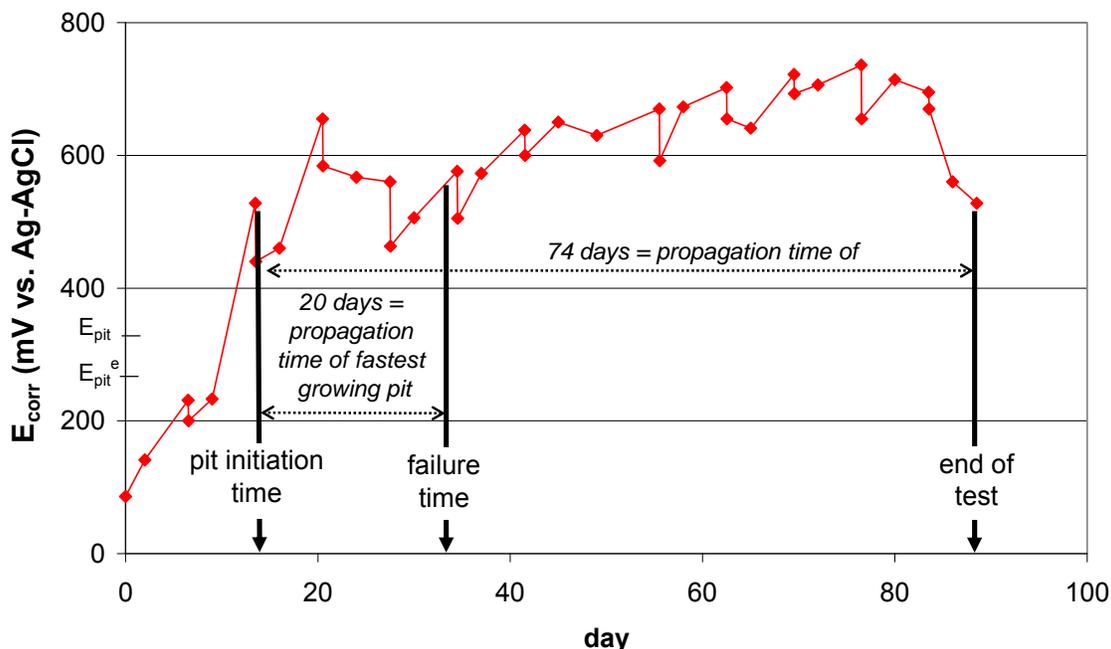
Figure 2.7: E_{corr} vs. time for small-scale test with free chlorine residual adjusted to 8 mg/L. Using $E_{pit} = 325$ mV (vs. Ag-AgCl), the pit initiation time (14 days) and the relative times available for maximum (20 days) and average (74 days) pit propagation were estimated.

In the preceding sections, trends were based on overall results, and no attempt was made to distinguish between pit initiation and propagation phases. However, it is possible, even likely, that the rates of pit initiation and propagation did indeed vary as a function of water chemistry. Assuming the conventional electrochemical interpretation is correct – that a critical potential does indicate the onset of copper pitting in aggressive waters like those tested in this work – the time-to-pit initiation and the duration of pit propagation during each experiment can be estimated from simple plots of E_{corr} versus time for each test (e.g., Figure 2.7).

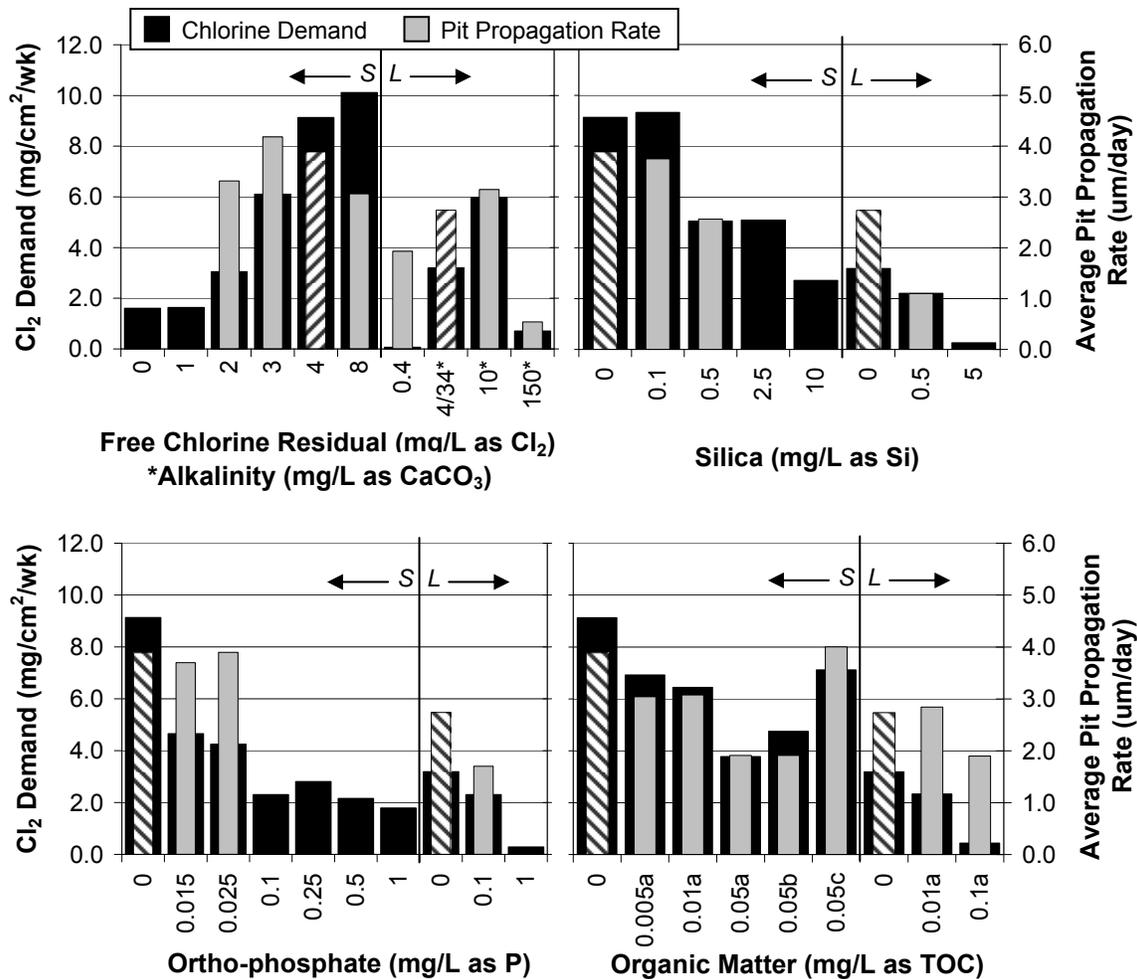
Figure 2.8: Chlorine demand (dark shading) and computed average pit propagation rates (light shading) based on $E_{pit} = 325$ mV (vs. Ag-AgCl). No propagation rate is shown for tests in which E_{pit} was not observed. Conditions are grouped by respective changes to the control water quality, and the control tests are shown with hash marks in each grouping. S and L indicate small- and large-scale tests, respectively.

Pit propagation rates and chlorine demand were also a strong function of water chemistry (Figure 2.8). For tests with variable alkalinity or with added phosphate, silica or organic matter, average chlorine demand was well correlated with computed average pit propagation rates (i.e., the penetration rate of the average pit). However, this was not the case for tests with variable free chlorine residuals, probably due to auto-decomposition kinetics of chlorine (i.e., the reaction is non-zero order, so the rate of chlorine decay is dependent on chlorine concentration).

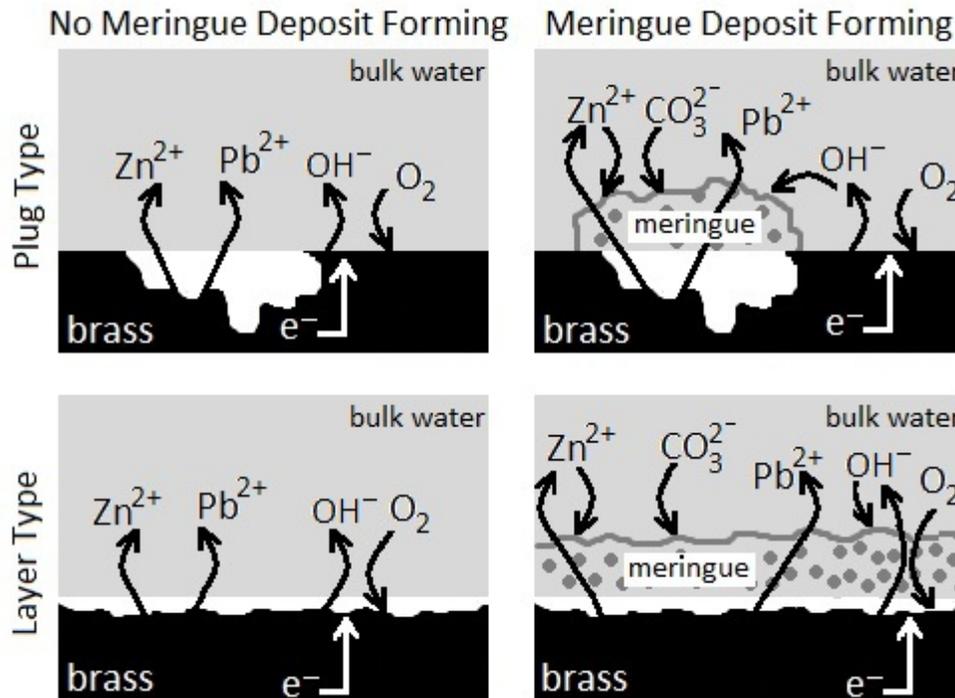
Figure 3.1: Dezincification can occur as either the plug (upper left) or layer (lower left) type, either of which may or may not lead to meringue deposition (right). Plug dezincification affects isolated areas of the brass and penetrates into the brass surface, whereas layer dezincification attacks the surface fairly uniformly.

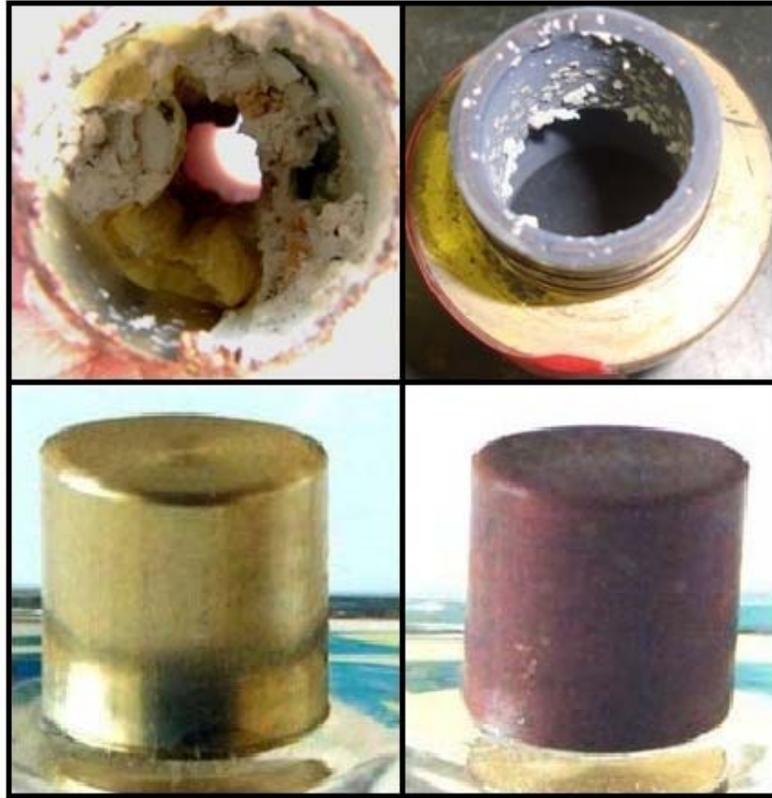
Figure 3.2: Meringue build-up inside a brass fitting can effectively block flow (upper left). After several months of plug dezincification, meringue build-up is evident on a brass fitting (upper right). As brass undergoes layer dezincification, its characteristic yellow surface (lower left) turns to a reddish color due to copper enrichment (lower right).

The most commonly cited problem associated with dezincification is the formation of “meringue” deposits on brass components, which can physically block water flow (Figure 3.2). Meringue is a characteristic white, voluminous and tenacious deposit that is visually reminiscent of a meringue dessert topping. It tends to form when pH is relatively high (above about pH 8.3) and zinc solubility is low, and is typically a basic zinc carbonate/6/ but may incorporate dissolved constituents of the brass itself or constituents of the system water. Meringue deposition can occur as part of either plug or layer dezincification, and in extreme situations the deposit can completely stop water flow through the brass device and associated plumbing line.

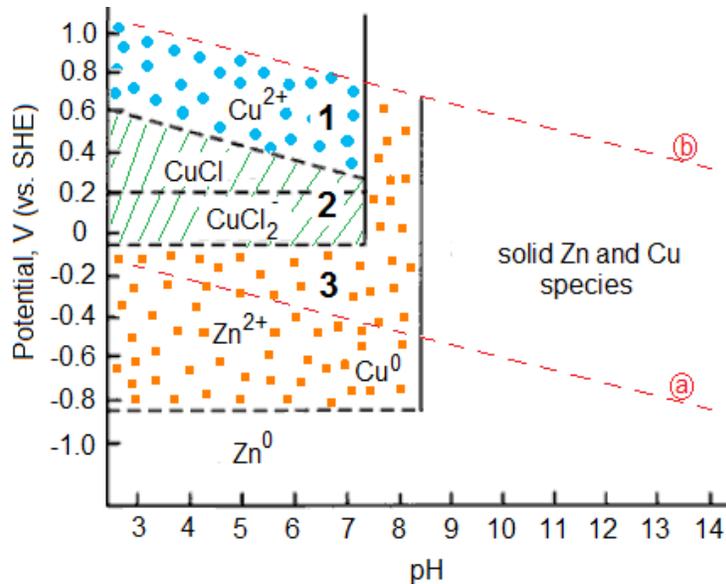
Figure 3.3: Illustrative potential-pH diagram for 70-30 brass in 0.1M chloride solution (adapted from Heidersbach & Verink 1972/18/). Region 1 represents uniform brass corrosion via copper and zinc dissolution with no copper re-deposition; 2 represents dezincification via copper and zinc dissolution with copper re-deposition; and 3 represents dezincification via selective zinc leaching alone. 2 is particularly relevant to localized environments where chloride concentrations are elevated and pH is reduced. Between lines a and b water is stable. Depending on water chemistry (e.g., chloride concentration) and brass composition, regions will shift.

The corrosion mechanism is controlled by both the oxidation-reduction potential (ORP) and the water chemistry at the dezincifying surface. Thus, it is useful to consider the potential-pH conditions under which each mechanism is thermodynamically predicted to occur (Figure 3.3).

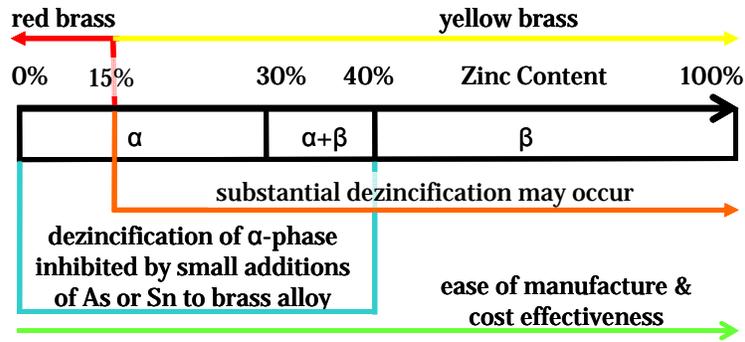
Figure 3.4: General trends for brass alloys as zinc content is varied.

Zinc content is also a key factor in determining the susceptibility of brass to dezincification (Figure 3.4). Brasses with zinc content below about 15% are generally considered resistant to dezincification/15, 16, 17/; this threshold is based mostly on field experience, but it is rare that brass with less zinc exhibits serious dezincification problems. Brasses with higher zinc contents, including alpha brass with 15-30% zinc and duplex brass (> 30% Zn), can be susceptible to dezincification attack under some circumstances./16/

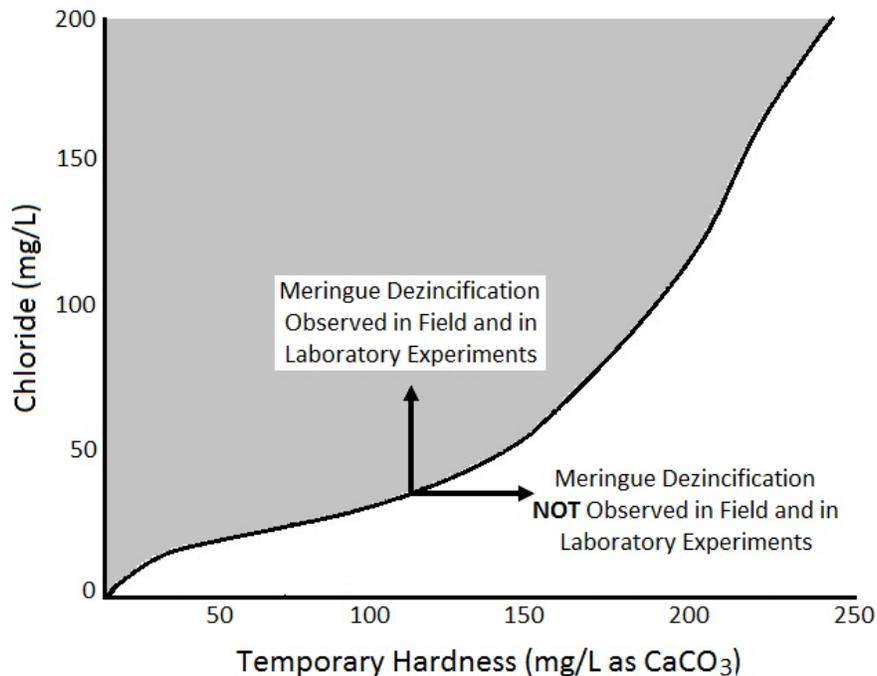
Figure 3.5: Simplified version of Turner's diagram for predicting meringue dezincification based on chloride and temporary hardness concentrations (adapted from Turner, 1961/20/). Waters in the shaded area are considered likely to produce meringue dezincification at pH 8.3 or above.

To provide a rule of thumb, the ratio of chloride to temporary hardness is widely cited as a key determinant in a given water's ability to support dezincification.^{/15/} "Temporary hardness" is an archaic measure of water chemistry, in which the amount of hardness (e.g., Ca^{+2} , Mg^{+2}) lost via precipitation upon heating is quantified. Dependent on circumstance, temporary hardness is sometimes well correlated to modern chemical measures that include alkalinity or total hardness of a water supply. The chloride to temporary hardness ratio was first suggested as a primary criterion for dezincification by Turner, who observed that waters with relatively high chloride and low temporary hardness (Table 3.3), and having a pH of about 8.3 or greater, were prone to causing meringue build-up.^{/20/} Using both laboratory and practical data, Turner empirically developed a diagram (simplified version shown in Figure 3.5) to indicate water quality regimes in which dezincification problems will likely occur based solely on chloride and temporary hardness concentrations.^{/20/} Turner's diagram has been adopted as a standard in predicting dezincification propensity based on water chemistry.

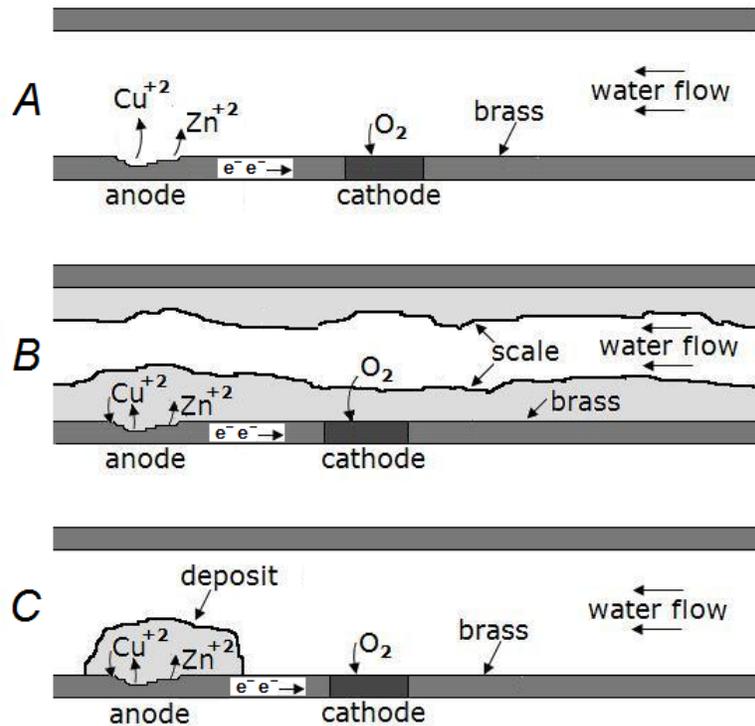
Figure 3.6: Potential manifestations of dezincification for a single piece of brass in potable water. On clean brass with or without flow, the anode and cathodes are located very near each other and corrosion proceeds uniformly (A). With time, deposits may grow and completely coat the brass surfaces (B), reducing diffusion of oxidant to the cathode and slowing dezincification. But if deposits form selectively at parts of the surface, then dezincification can be accelerated due to the low pH and high chloride near the anode (C). The lack of scale at the cathode can then allow for very high cathodic reaction rates.

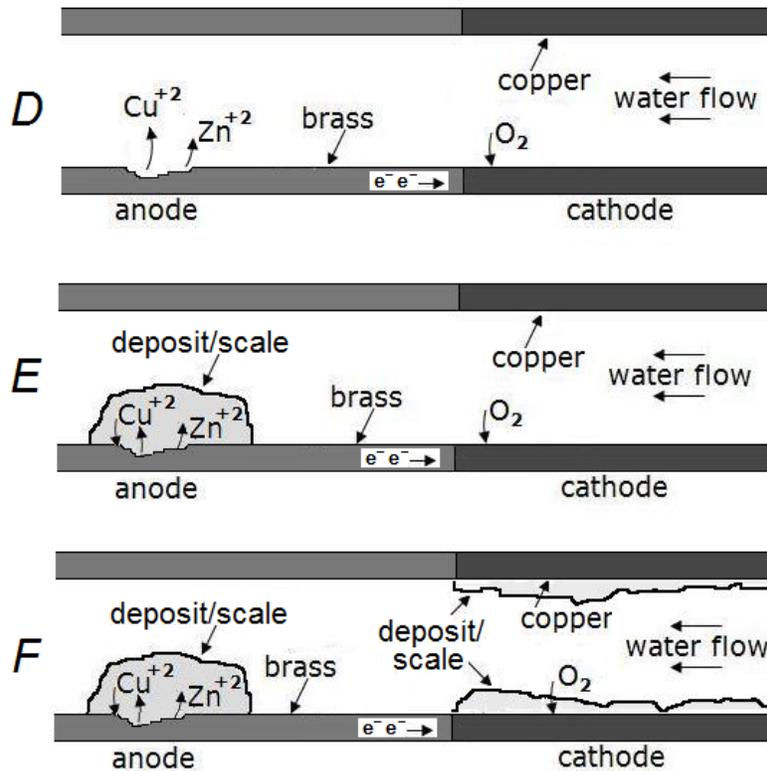
Figure 3.7: Potential manifestations of dezincification for a galvanic couple between brass and copper in potable water. D represents slow dezincification; E represents severe dezincification whereby a localized environment develops at the anode while the copper cathode is supplied with oxidant; and F represents dezincification as in E, only it is somewhat slowed by the loss of active surface area on the cathode.

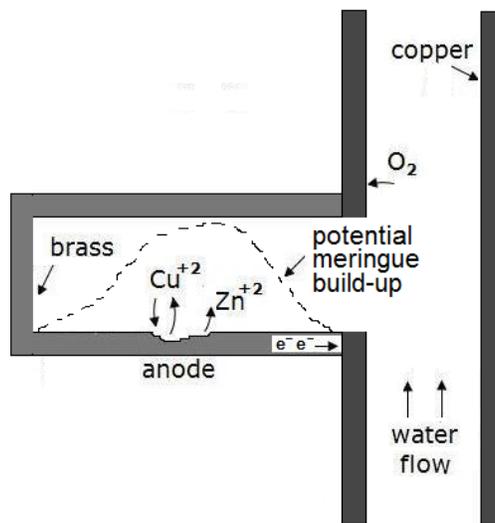
Figure 3.8: Hypothesized worst-case scenario for dezincification in the case of a galvanic couple between brass and copper in potable water. Due to its position in the system, the brass is removed from flow and a localized environment may quickly develop to promote dezincification and eventual meringue build-up.

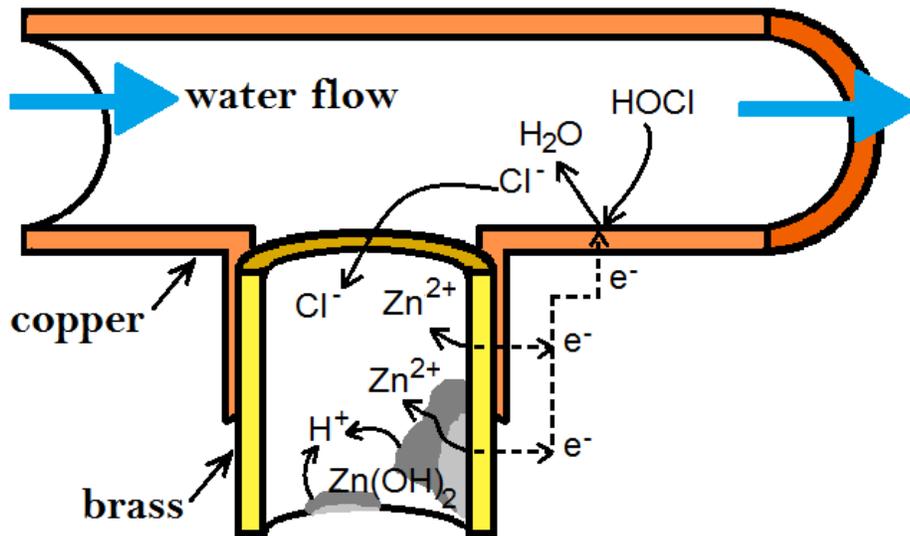
Figure 4.1: Hypothesized effects of differential flow and galvanic connection (with copper) on brass dezincification. Water flows through the copper tube, but is relatively stagnant inside the brass. The electrons liberated at the brass surface as zinc (or other alloy constituents) is oxidized are accepted at the copper surface where an oxidant (e.g., free chlorine as HOCl) is reduced. pH drops in the stagnant water due to Lewis acidity of zinc cations (Zn^{2+}), and salt content increases as chloride (Cl^-) and other anions are drawn in. In some cases, corrosion deposits (i.e., meringue) can build-up on brass surface. If flow velocity is increased or oxidant concentration is increased in the flowing water, corrosion (e.g., dezincification) on the brass surface is expected to accelerate, and vice versa.

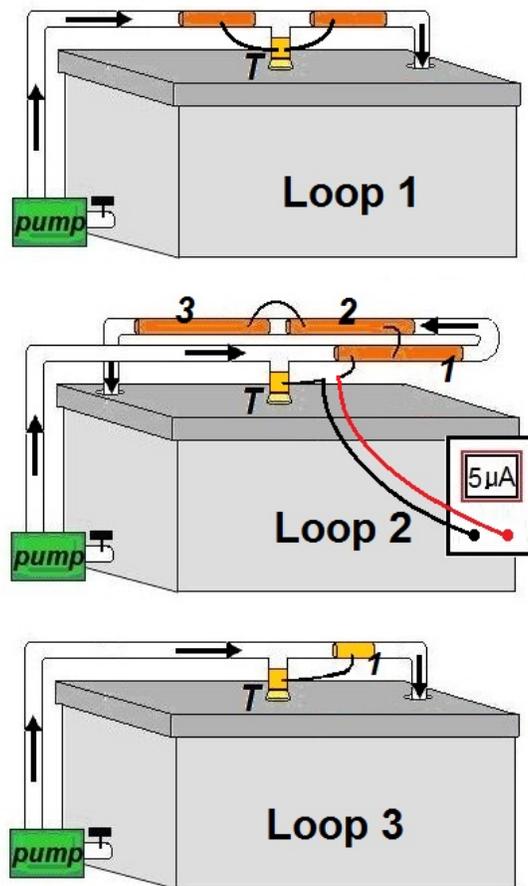
Figure 4.2: Pipe-loops for three experiments. Flow direction is indicated by arrows. The metal labeled T was brass in all loops. In Loop 1, in-flow tubes were copper in tests A and B; but in test C, the T section was completely removed and a brass tube was instead positioned in-flow. In Loop 2, the in-flow tubes were copper in tests D and E, and PVC in F. In Loop 3, the in-flow tube was brass in tests G-J, and copper in K.

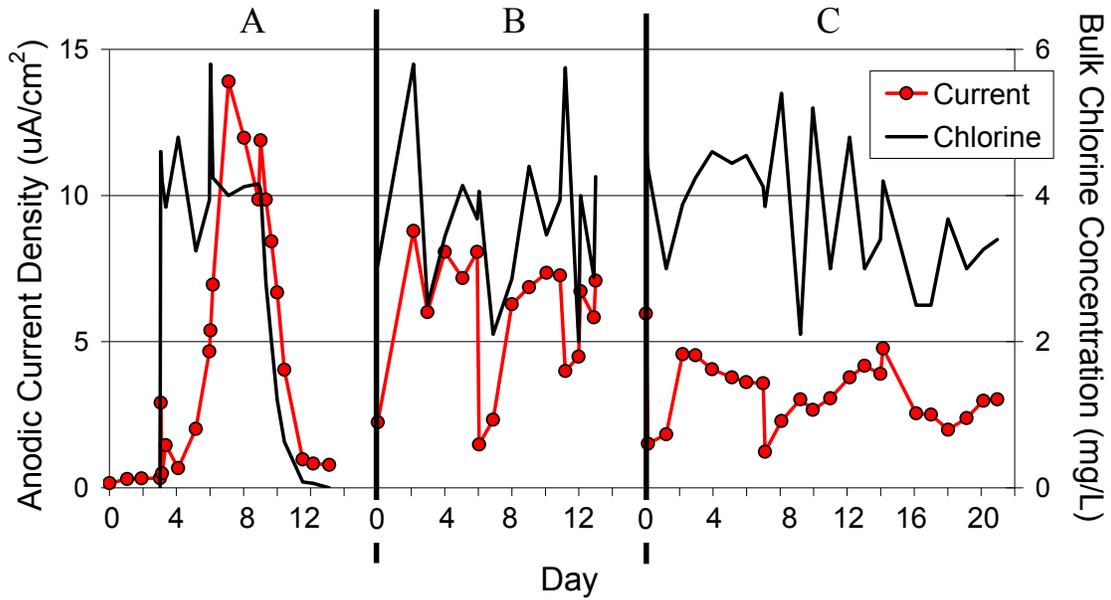
Figure 4.3: Brass current density (vs. in-flow copper) and bulk chlorine residual over time for tests A, B and C.

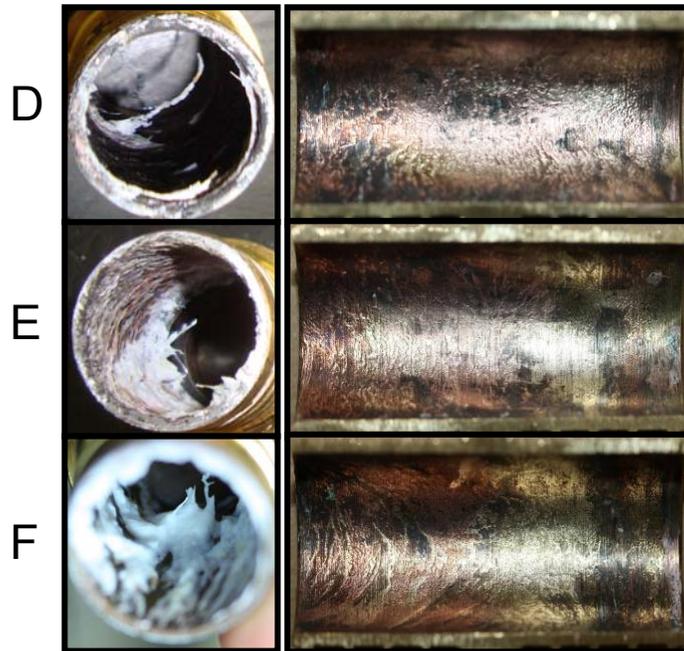
Figure 4.4: Meringue scale build-up (left) and non-uniform layer dezincification (right) revealed after scale removal on brass *T*'s from tests D (top), E (middle) and F (bottom).

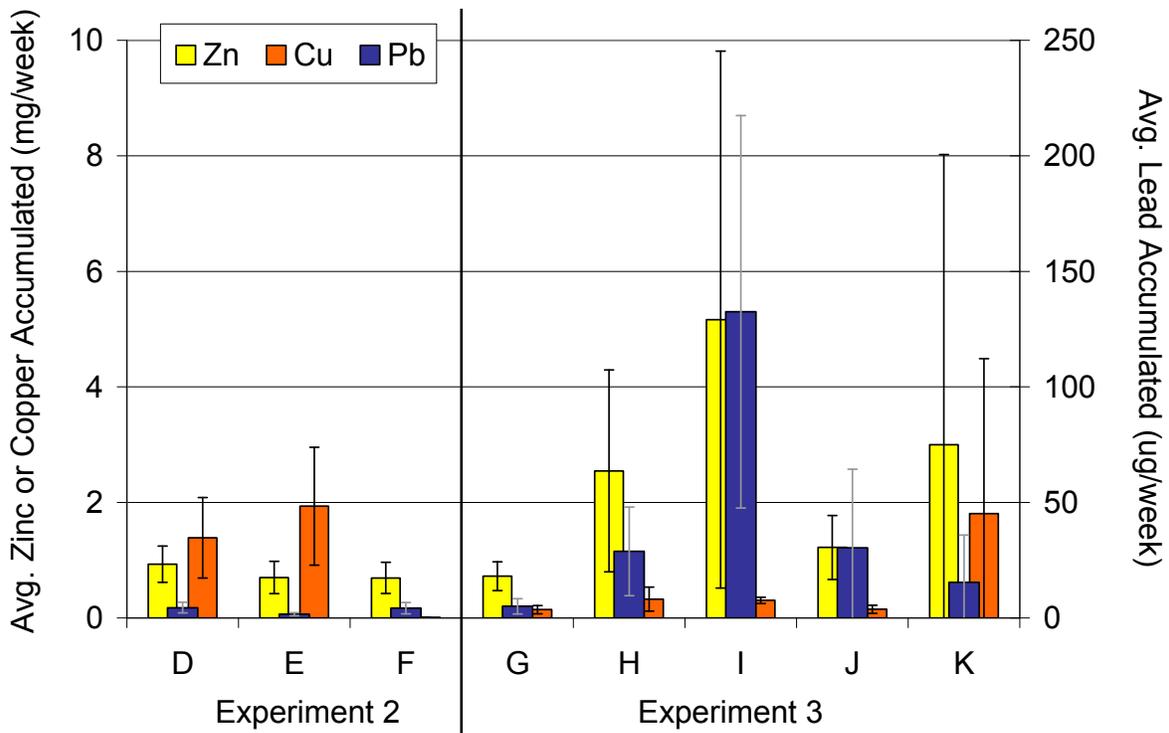
Figure 4.5: Average zinc, copper and lead accumulated (either due to leaching or settling from bulk water) in stagnant *T* waters in experiments 2 and 3. Data are normalized based on *T* water volume and sampling frequency; error bars show 95% confidence intervals.

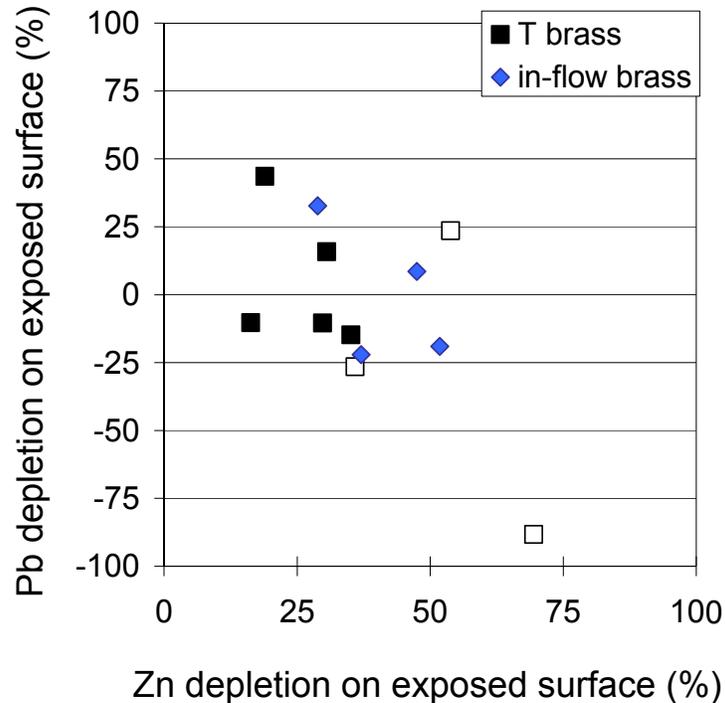
Figure 4.6: Zinc vs. lead depletion on exposed brass surfaces from experiments 2 (un-filled points) and 3 (filled points). Negative lead depletion values indicate lead enrichment.

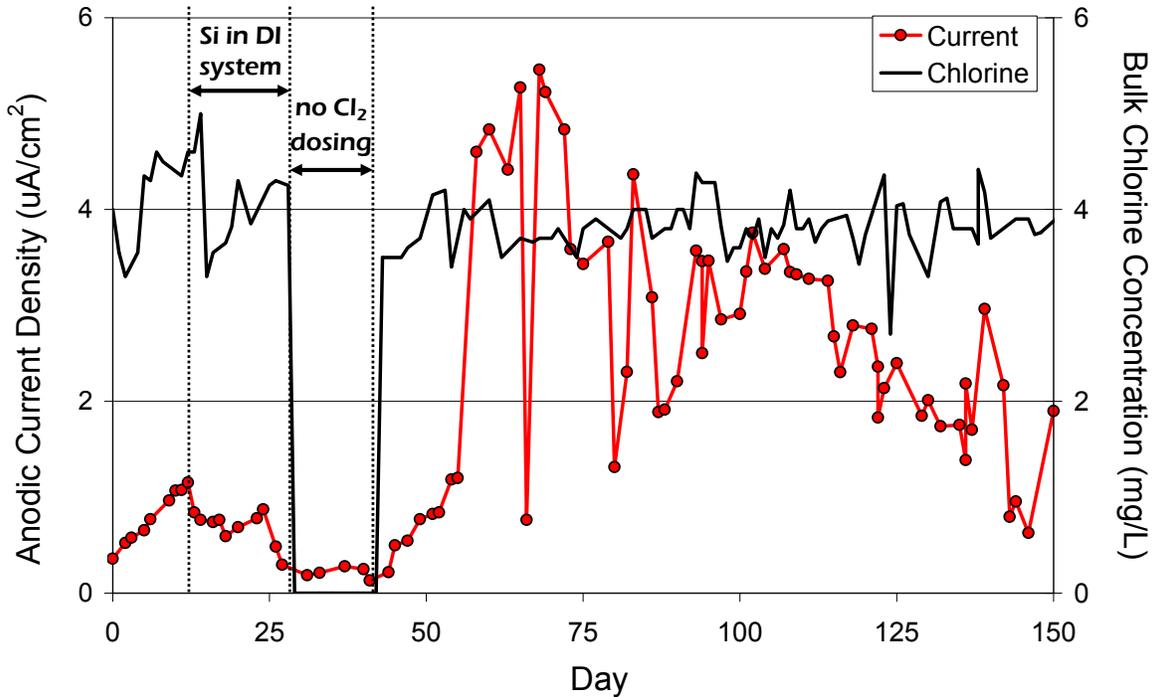
Figure 4.7: Brass current density (vs. in-flow copper) and bulk chlorine residual over time for test K. Periods of silica contamination and chlorine dosing interruption are indicated.
