INSIGHTS INTO NON-UNIFORM COPPER AND BRASS CORROSION IN POTABLE WATER SYSTEMS

Dissertation submitted to the faculty of the Virginia Polytechnic Institute and State University in
partial fulfillment of the requirements for the degree of

Doctor of Philosophy
In
Civil and Environmental Engineering

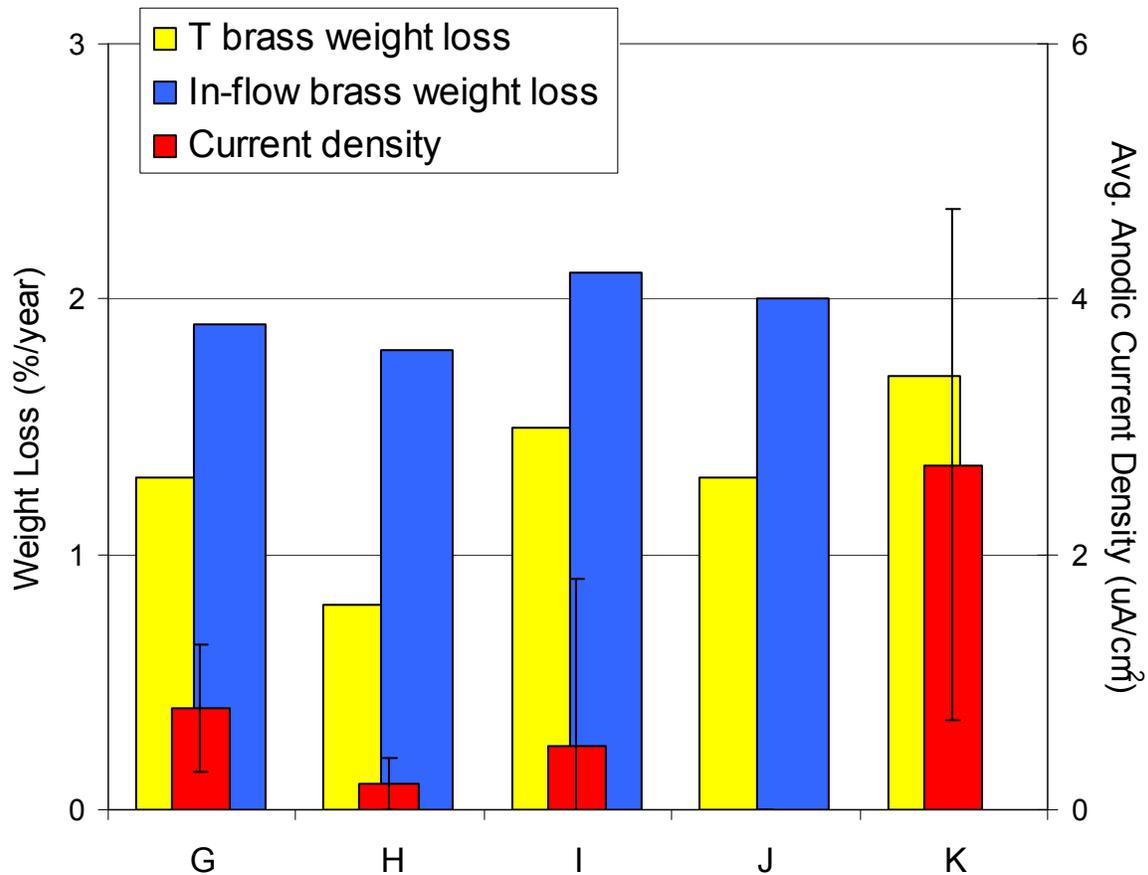
Figure 4.8: *T* and in-flow brass weight loss rates, and average current densities for tests in experiment 3. Current densities represent data from day 42 (i.e., after chlorine dosing was resumed) through the end of tests; error bars show 95% confidence intervals.

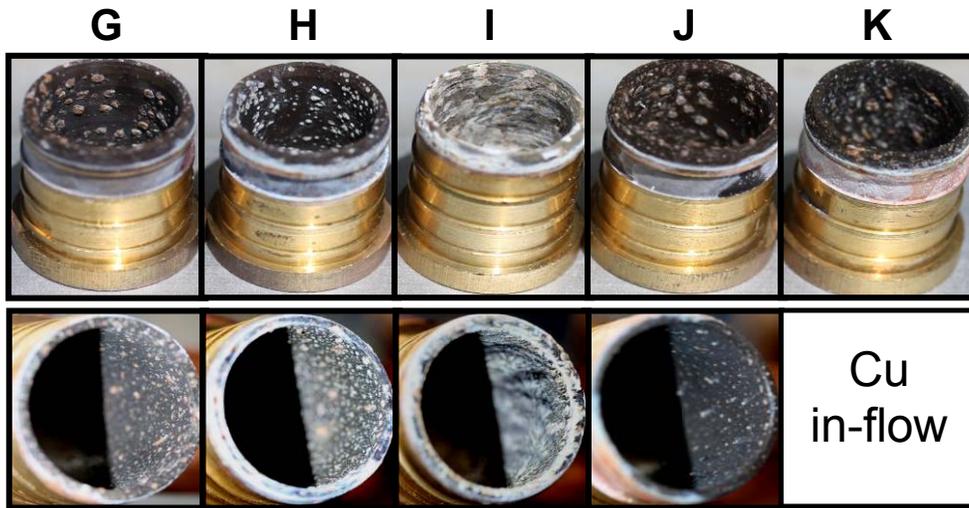
Figure 4.9: *T* (top) and in-flow (bottom) brass from all tests in experiment 3 (prior to scale removal).

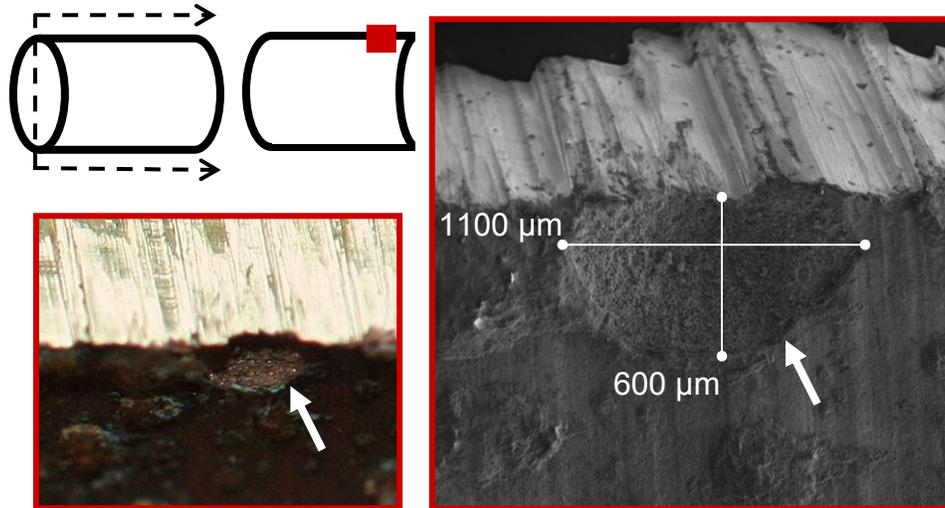
Figure 4.10: Photograph (lower left) and ESEM image (right) of pitting on in-flow brass from test H. Direction of sample cross-section (upper left) is shown and red box indicates location of imaging; white arrows indicate pit and dimensions are specified. This particular pit penetrated about 220 μm (i.e., roughly 15%) of the brass tube wall.

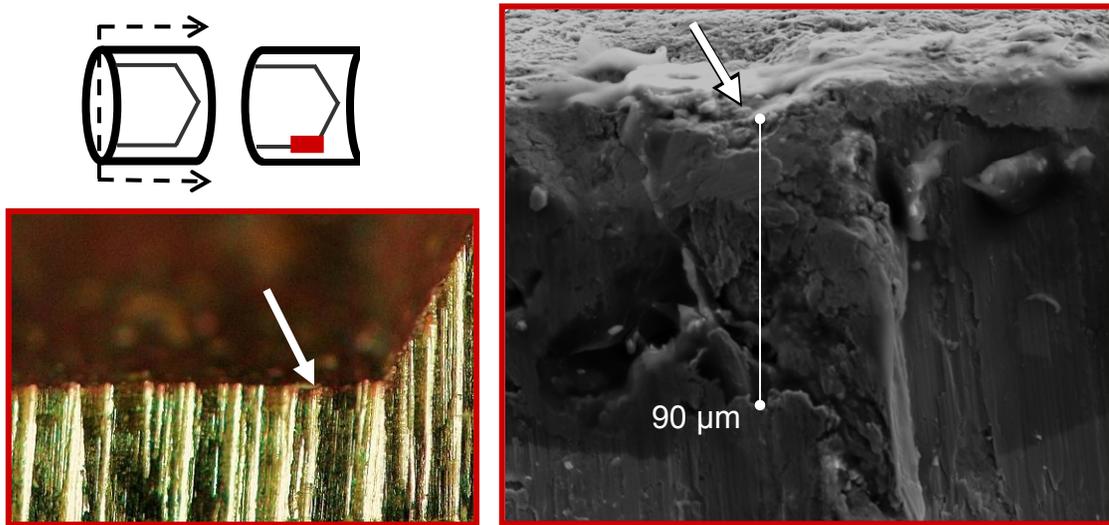
Figure 4.11: Photograph (lower left) and ESEM image (right) of deep layer dezincification on *T* brass from test K. Direction of sample cross-section (upper left) is shown and red box indicates location of imaging; white arrows indicate dezincification layer and depth at imaged point is specified.

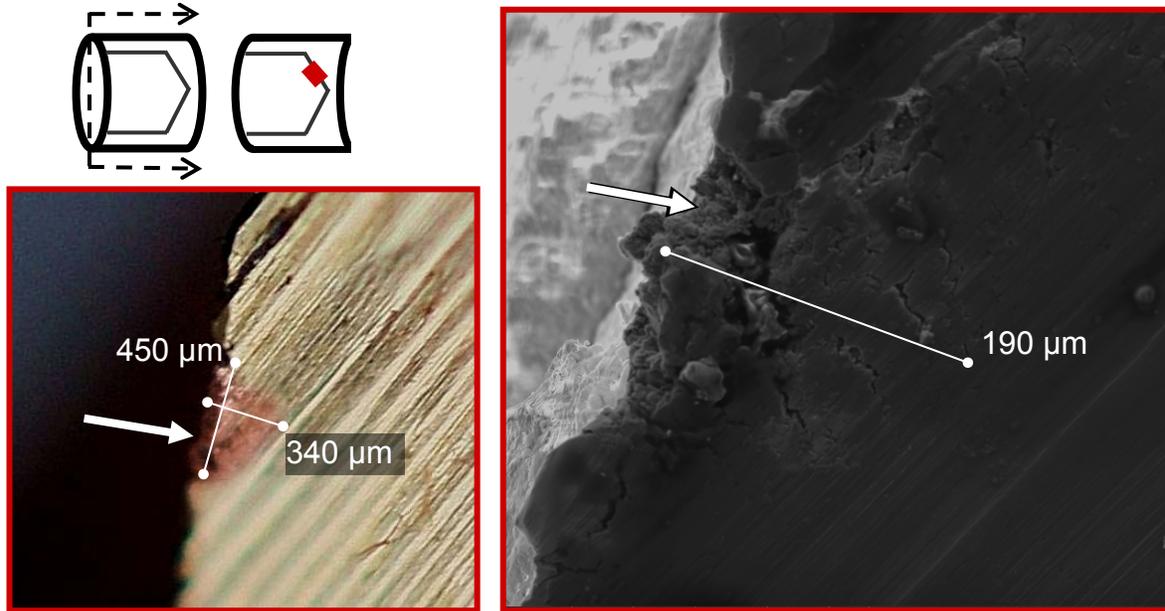
Figure 4.12: Photograph (lower left) and ESEM image (right) of plug dezincification on *T* brass from test J. Direction of sample cross-section (upper left) is shown and red box indicates location of imaging; white arrows indicate plug and dimensions are specified. Only a portion of the plug in the photograph is shown in the SEM image.

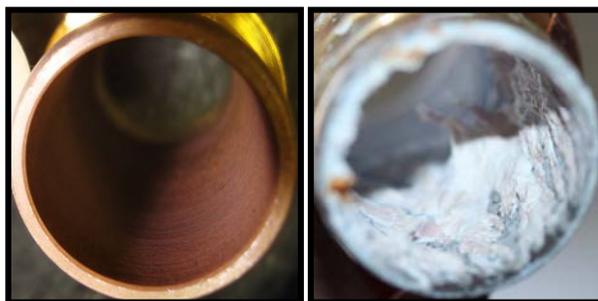
Figure 5.1: Dezincified interior (left) and meringue build-up (right) within brass plumbing components.

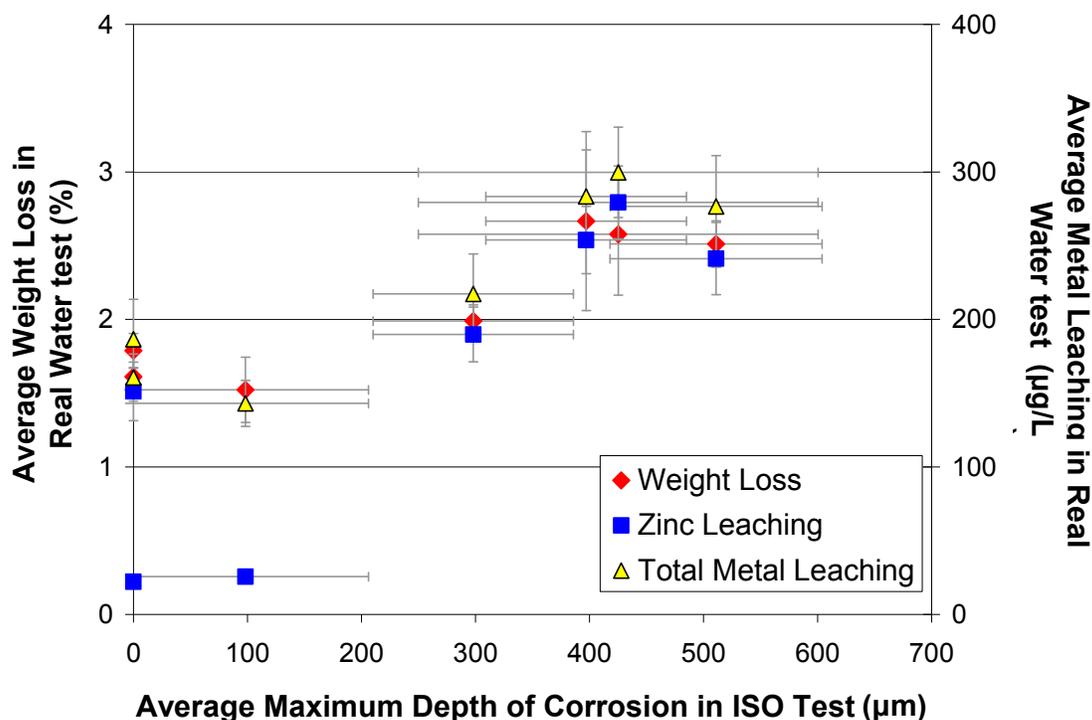
Figure 5.3: Weight loss and metal leaching in the real water exposure test vs. maximum depth of corrosion in the ISO 6509 test. Average values were computed from triplicate samples and error bars represent 95% confidence intervals.

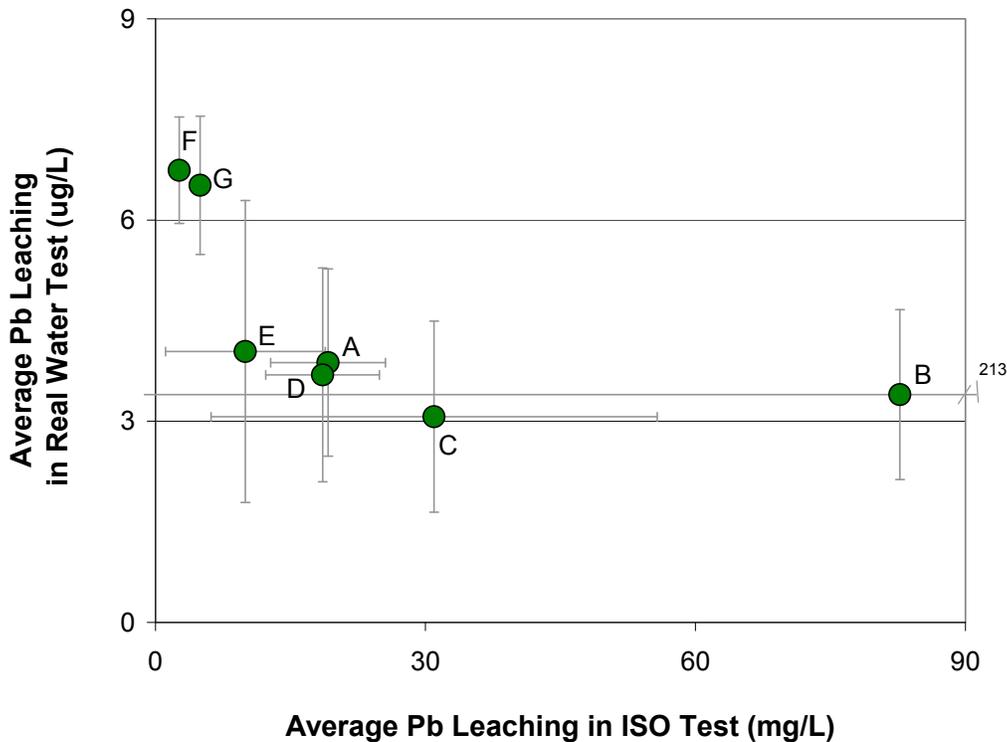
Figure 5.4: Lead leaching in real water exposure test vs. that in ISO 6509. Average values were computed from triplicate samples and error bars represent 95% confidence intervals.

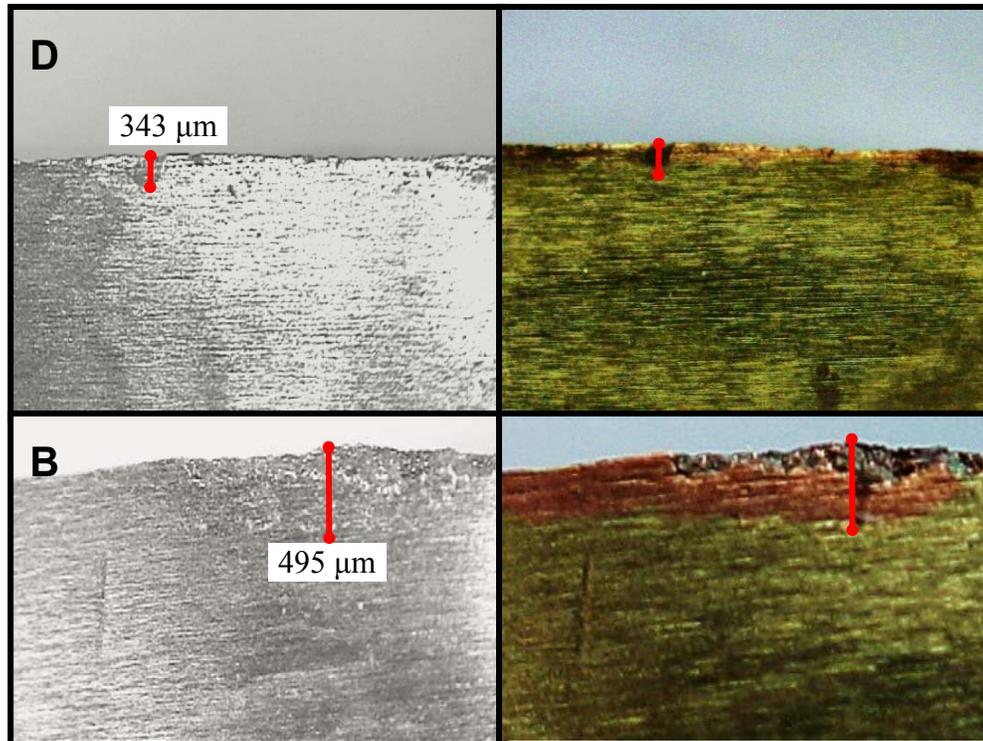
Figure 5.5: Stereomicroscope images (left) and photographs (right) of layer (top) and plug (bottom) dezincification on brasses D and B, respectively.
