Modeling the Time to Corrosion Initiation
for Concretes with Mineral Admixtures and/or Corrosion Inhibitors
in Chloride-Laden Environments

Dissertation submitted to the Faculty of the
Virginia Polytechnic Institute and State University
in partial fulfillment of the requirements for the degree of

Doctor of Philosophy
in
Civil Engineering

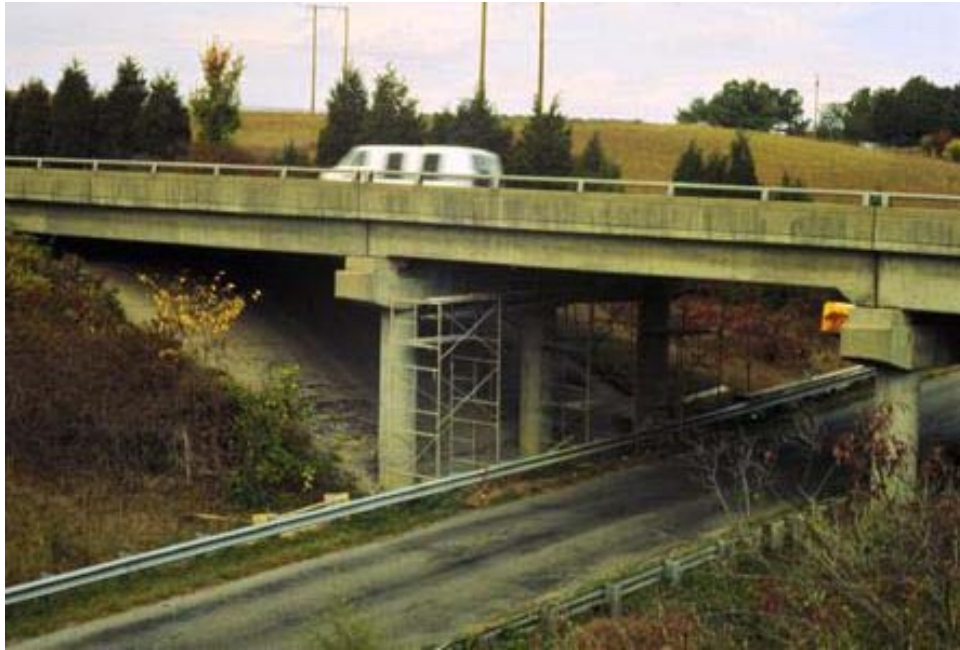
FIGURE 1. Typical Bridge, I-81 Interstate, Virginia – Pier Cap Deterioration

During the 1960s, states with winter climates introduced a “bare road policy” which resulted in a significant increase in deicer salt applications [4]. The amount of salt applied on highways in 1970 was approximately four times more than in 1960. After 1970, about 10 million tons of salts were being applied annually [5]. Because of the winter maintenance activities, a large number of concrete bridge decks is contaminated with chlorides which initiate the corrosion of the reinforcing steel. Poor preventative maintenance may also lead to a faster rate of deterioration, which in turn may decrease the time to rehabilitation. Deterioration caused by the corrosion of reinforcing steel is not limited to concrete bridge decks only. It can also affect other concrete bridge members such as piles, walls, diaphragms, girders, abutments, piers, and pier caps [6]. One of the I-81 Interstate bridges serves as an example of pier cap deterioration due to corrosion of the reinforcing steel, see Figures 1 and 2.

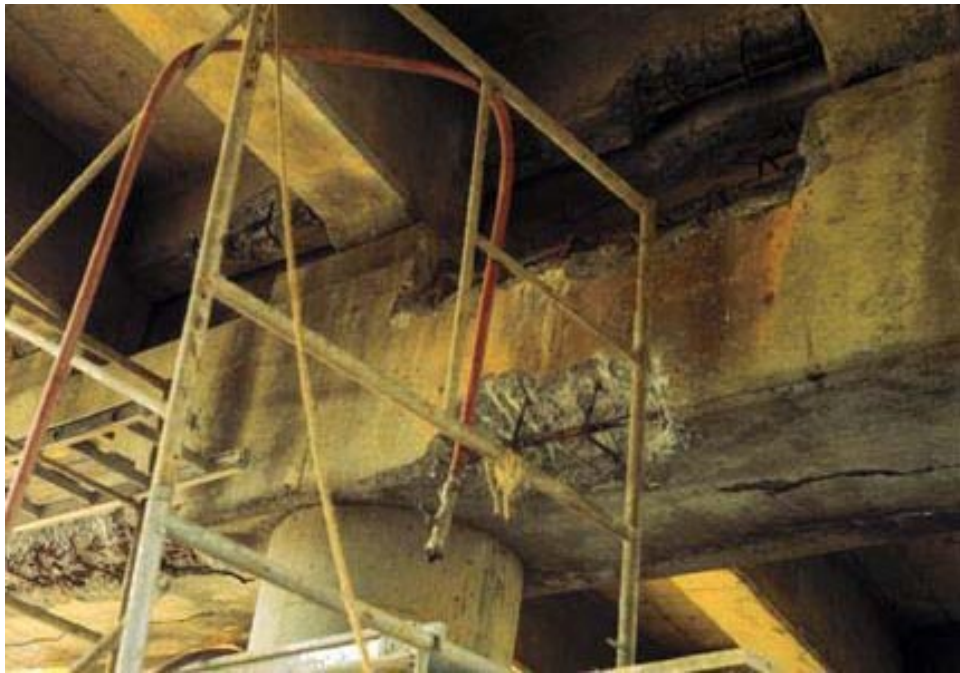
FIGURE 2. Typical Bridge, I-81 Interstate, Virginia – Close-up of Pier Cap Deterioration.

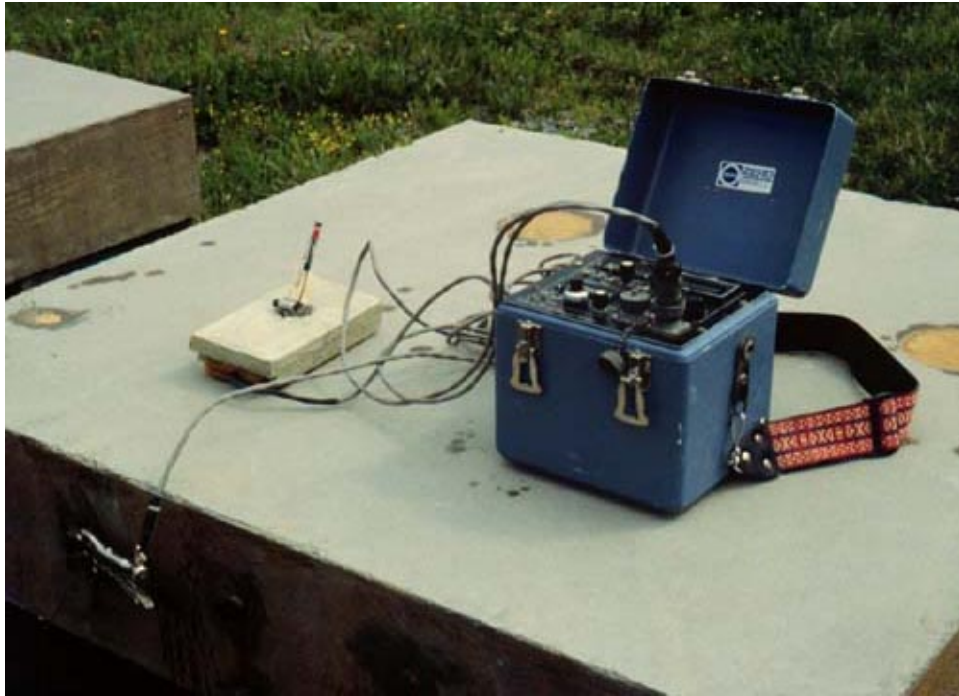
FIGURE 5. 3LP Device.

The linear polarization technique is a non-destructive method for assessing the instantaneous corrosion current density. It has been widely used in monitoring corrosion of laboratory specimens, as well as field structures [50-53]. The name refers to the linear regions of the current vs. potential curve (polarization curve). Stern and Geary showed that for a few millivolts above and below the corrosion potential, the polarization curve may be considered linear [54]. Corrosion current density is directly proportional to the instantaneous rate of metal loss. Often the corrosion current density is referred to as the corrosion rate. Several devices, based on the linear polarization method, presently exist to determine the corrosion current density of steel in concrete. One of the most common is the 3LP device, see Figure 5 [55].

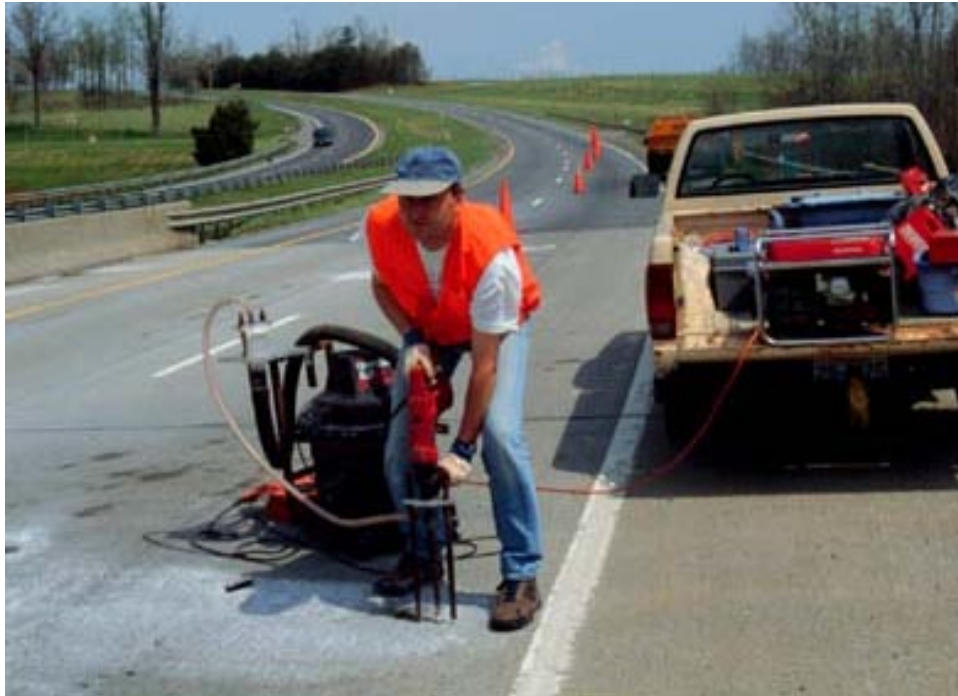
FIGURE 6. Sampling for Chloride Concentrations – Collection Apparatus: Impact Drill with Hollow Drill Bit, Powder Concrete Collection Unit, and Vacuum.

Samples for chloride concentration are collected as pulverized concrete at several average depths. The collection apparatus uses an impact drill with 29 mm (1-1/8 in) hollow diameter bit, 2.3 times the maximum aggregate size, connected to a vacuum collection unit [58]. Figure 6 shows such a setup with a portable power generator necessary for the vacuum and the drill operation.

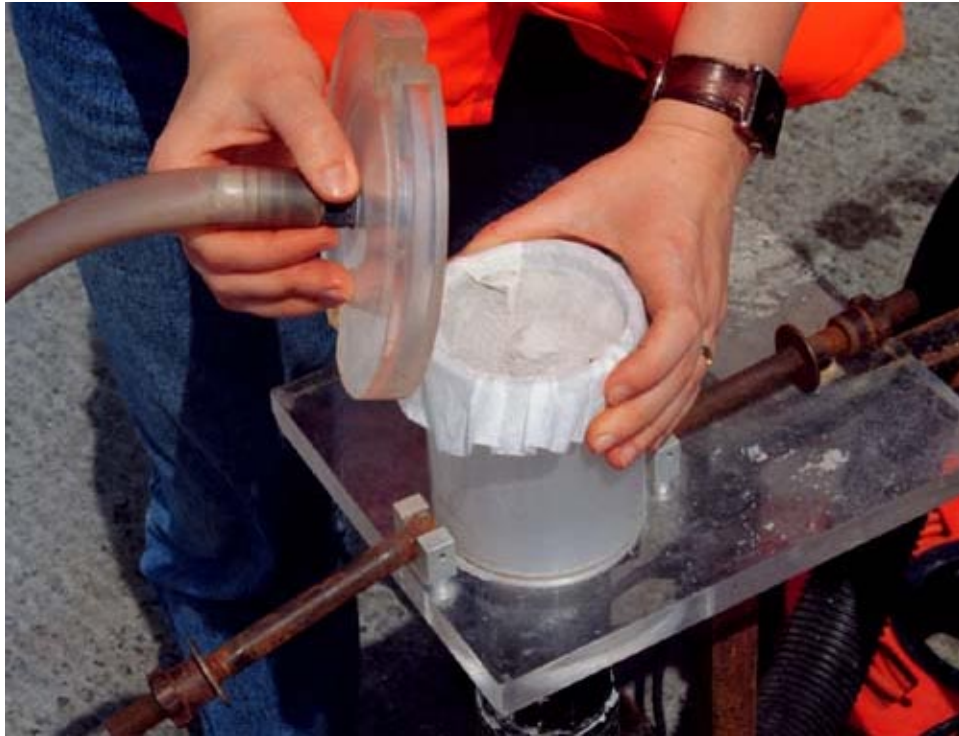
FIGURE 7. Powder Concrete Collection Unit.

The concrete powder is collected in the coffee filter, see Figure 7, which is then stored in a plastic container until chemical analysis. ASTM C 114 provides guidelines for determining chloride ion concentration in mortar and concrete [59]. A titration method is used to determine the quantity of acid soluble chlorides in the concrete digestion solution. A simple formula transfers the amount of milliliters of titration solution into chloride ion concentration expressed in kg/m^3 of concrete.

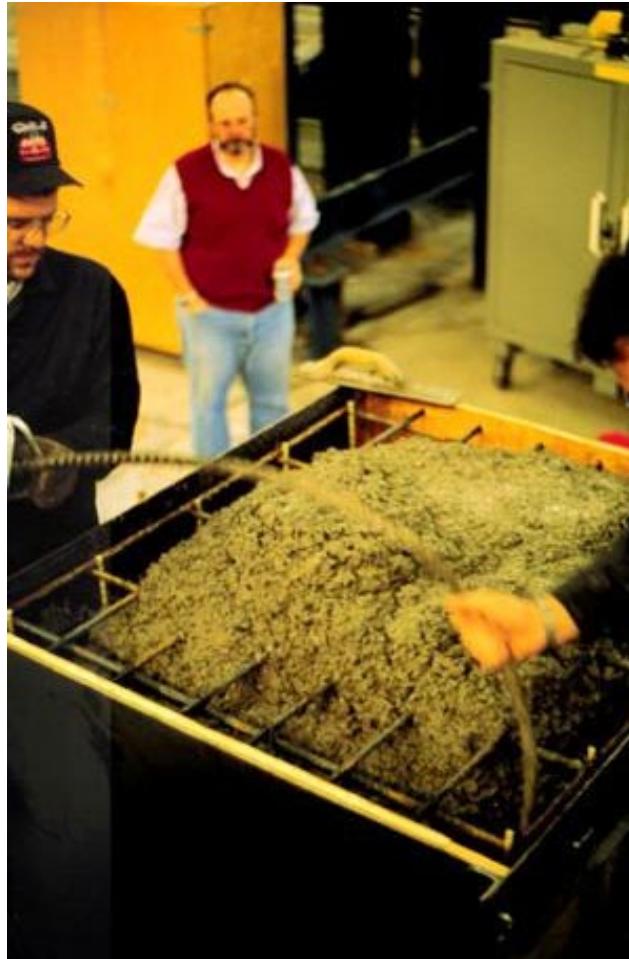
FIGURE 11. Concrete Placement and Vibration – Typical Specimen.

Specimens were cast in steel forms, which were carefully cleaned and oiled with a form release agent before each concrete placement. While placing concrete, a concrete vibrator was used to achieve good consolidation especially in the specimens' legs. Placing and vibrating concrete is presented in Figure 11.

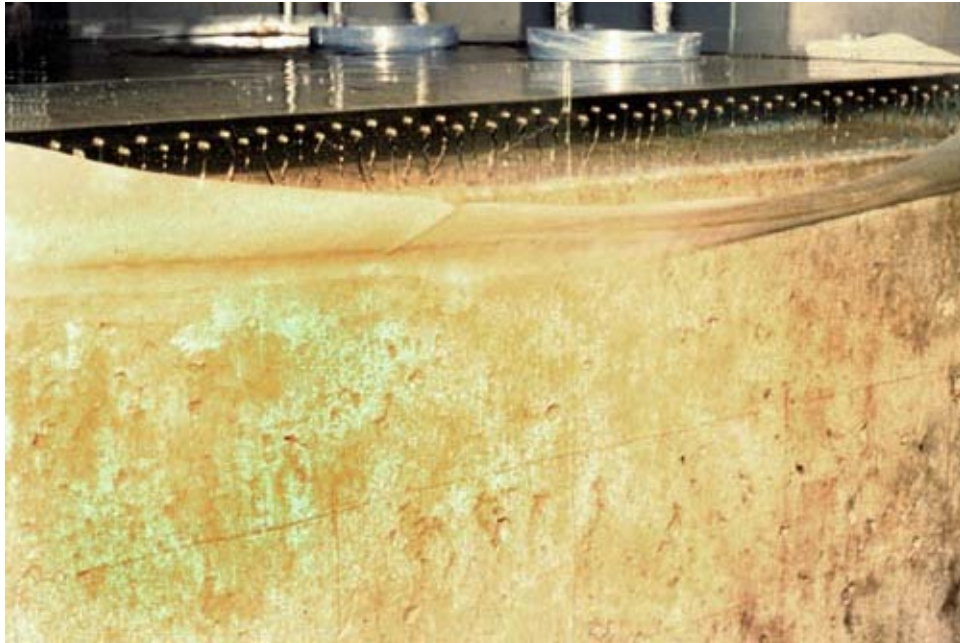
FIGURE 13. Plexiglass Dike: Horizontal / Vertical Exposure Zones.

Specimens were kept indoors and were exposed to wet-dry ponding cycles. Each cycle was one week in duration and was divided into two stages. In the first stage the wetting solution was at high tide level (610 mm from the bottom of a specimen), thus the tidal zone and the immersed zone areas were covered with NaCl solution, and the horizontal and vertical zones of the specimen were allowed to air dry. In the second stage the wetting solution, while at low tide level (water level at 305 mm from the bottom of a specimen), was pumped to the top of a specimen, thus wetting specimen surfaces in the horizontal and vertical zones. At the same time surfaces in the tidal zone were allowed to air dry. Horizontal, vertical, and tidal zones were subjected to wetting for an average of 3.5 days a week and to air drying also for an average of 3.5 days a week. The immersed zone was constantly submersed in the NaCl solution. The wetting solution used in the study was 6% sodium chloride by weight. Photographs showing specimens exposed to wet-dry cycles and a close-up of plexiglass dike in the horizontal zone are presented in Figures 13 and 14, respectively.

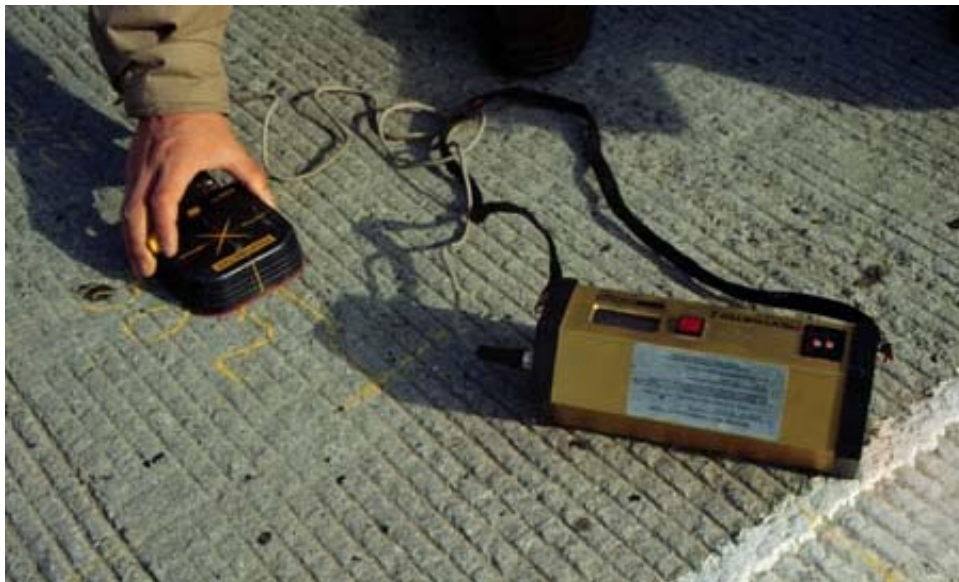
FIGURE 16. Cover Depth Measurement – Profometer III Device.

Concrete cover depths were measured in the field structures with a rebar locator device, see Figure 16. The device used in the study was Profometer III.

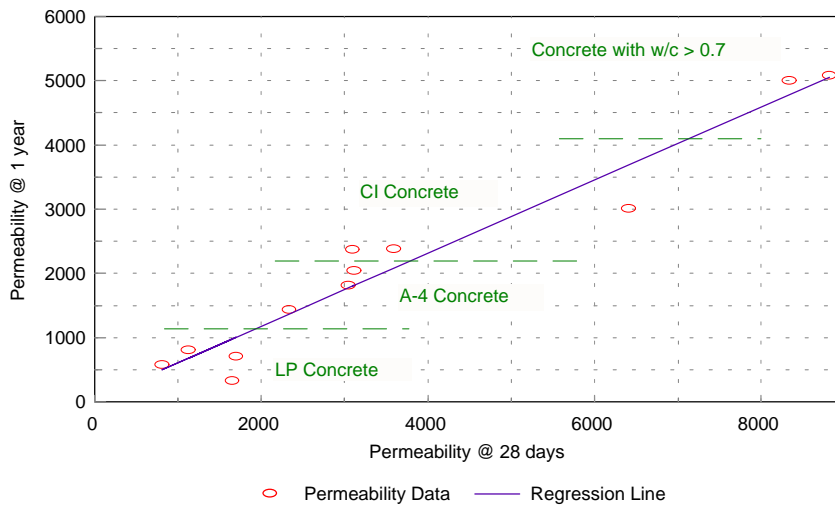
FIGURE 17. Relationship between Rapid Permeability Results at 28 Days and One Year.

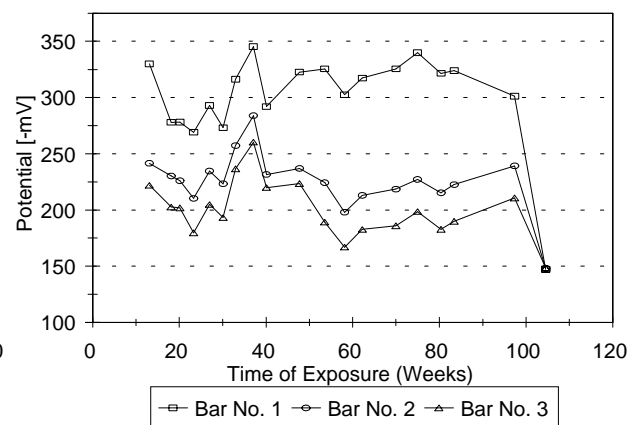
FIGURE 19 a-f. Corrosion Potentials in the Vertical Exposure Zone.

FIGURE 19 g-l. Corrosion Potentials in the Vertical Exposure Zone.

FIGURE 19 m-r. Corrosion Potentials in the Vertical Exposure Zone.

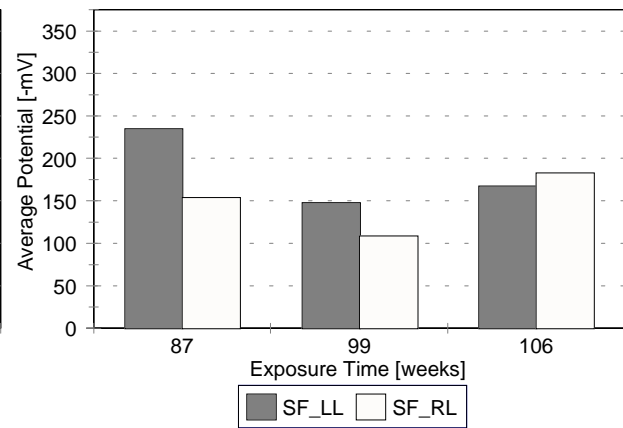
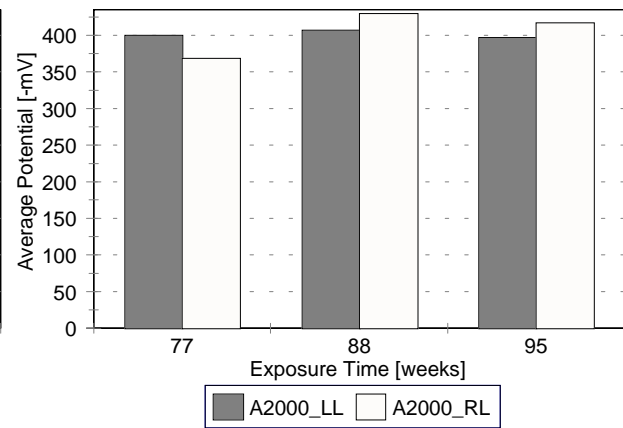
FIGURE 21 a-d. Corrosion Potentials in the Immersed Exposure Zone.
(LL = Left Leg, RL = Right Leg).

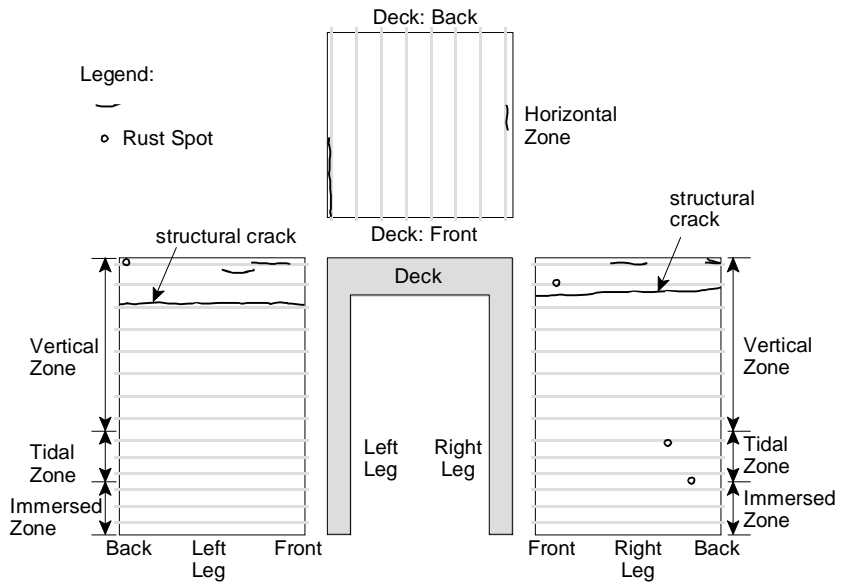
FIGURE 33 a-b. Visual Observations: Cracking and Rust Spots. October 1996.

FIGURE 33 c-d. Visual Observations: Cracking and Rust Spots. October 1996.

FIGURE 33 e-f. Visual Observations: Cracking and Rust Spots. October 1996.

The cracking, other than structural, appeared to be related to the reinforcing steel corrosion. The bars No. 1a and No. 4a in the horizontal zone were expected to corrode first since they were exposed to more severe conditions than any other bar. The chlorides diffused from the top, 25 mm of the cover depth in the horizontal zone, and from the side, 25 mm cover depth in the leg. This behavior was especially observed in the control specimens, CTL1 and CTL2. The largest number of cracks and the highest severity were observed in the control specimens and the FA, R222, and A2000 specimens. It is believed that the crack over bar No. 4, at the back side of the FA specimen, was caused by the corrosion of the hook used for lifting the specimen. Nevertheless, the cracks in the vertical zone are clearly related to the corrosion of the underlying bars. The R222 and A2000 specimens, when compared with the controls, had a similar degree of visual damage; however, more cracks were found in the horizontal zone of these specimens than in the controls. It appears that these corrosion inhibitors were not slowing the development of corrosion, but rather
