Floor Plans

## 1<sup>st</sup> Floor Elements

## 2<sup>nd</sup> Floor Elements

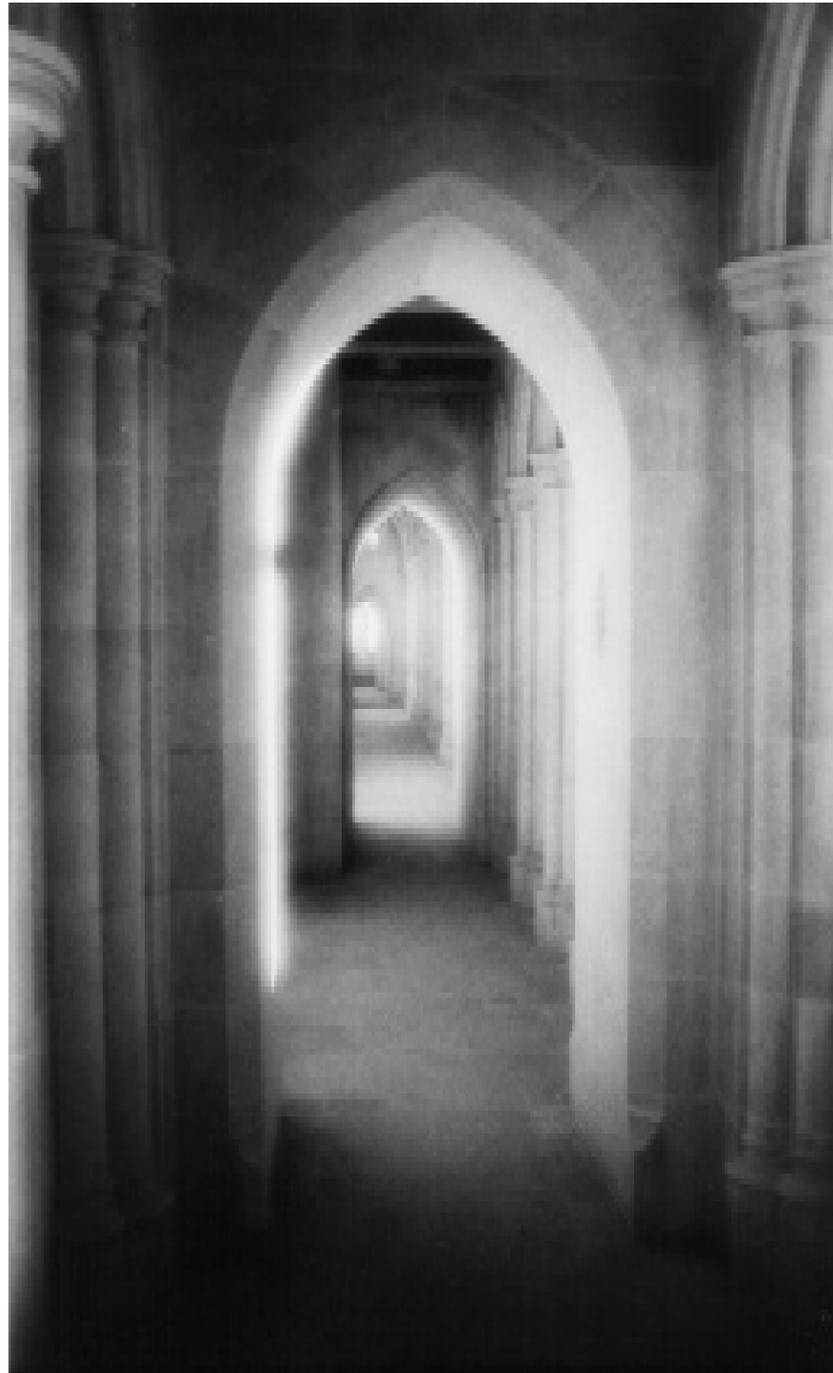
Figure 78, National Cathedral Corridor

The light and shadow patterns in the corridors would be similar to those shown in the photograph of the National Cathedral.

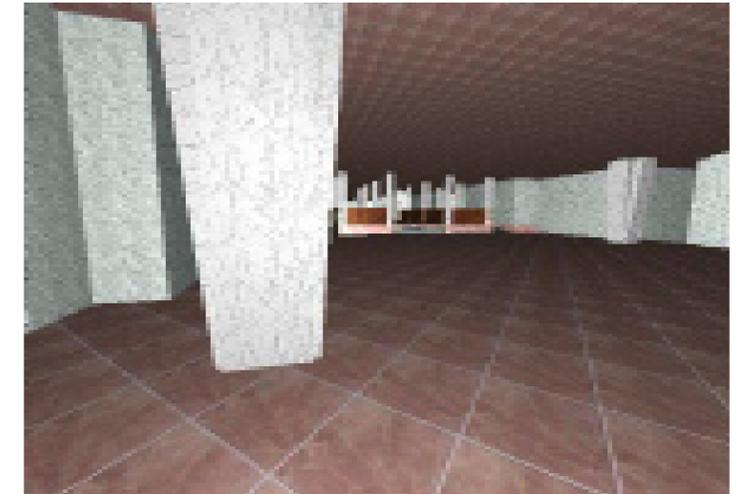
Figure 79, Open Floor Area

The church was designed to be handicap accessible. There are two ramps behind the seating area and a ramp between the study rooms on either side of the open floor area.

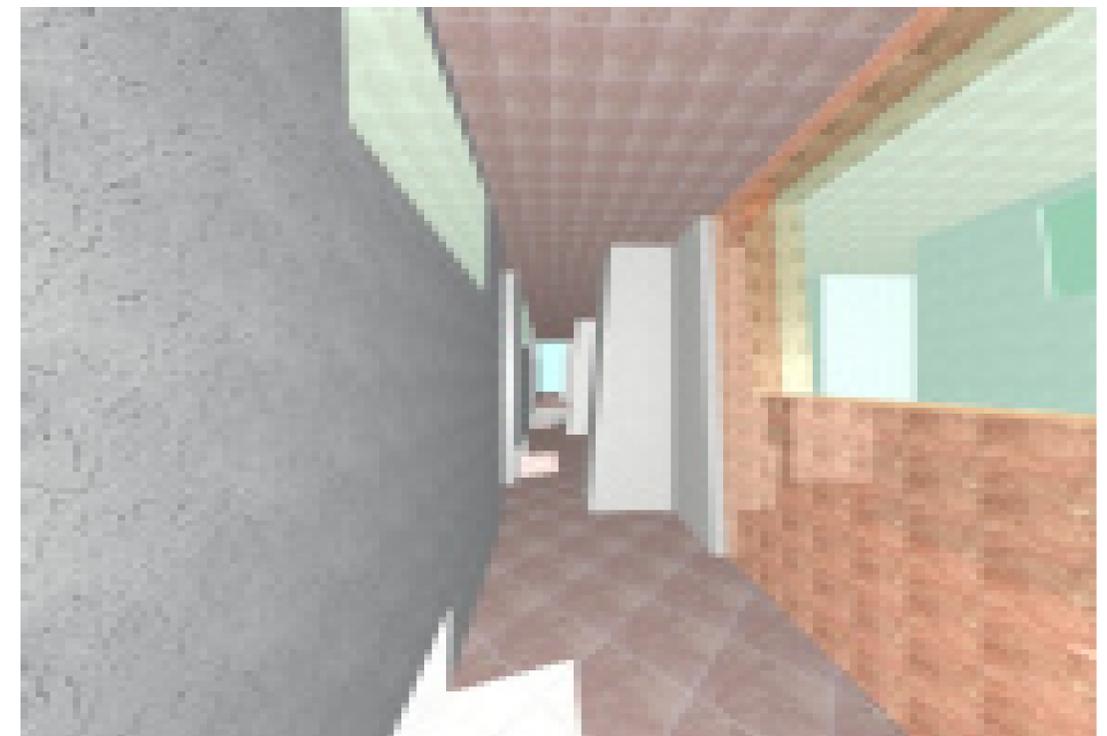
Figure 80, Corridor Light & Shadow

The exterior wall openings found at the first floor allows natural light to enter the building through the large windows that will illuminate the corridors, lobby, and study rooms. The windows at each study room are located high on the wall to prevent distractions from the occasional foot traffic outside of the rooms.

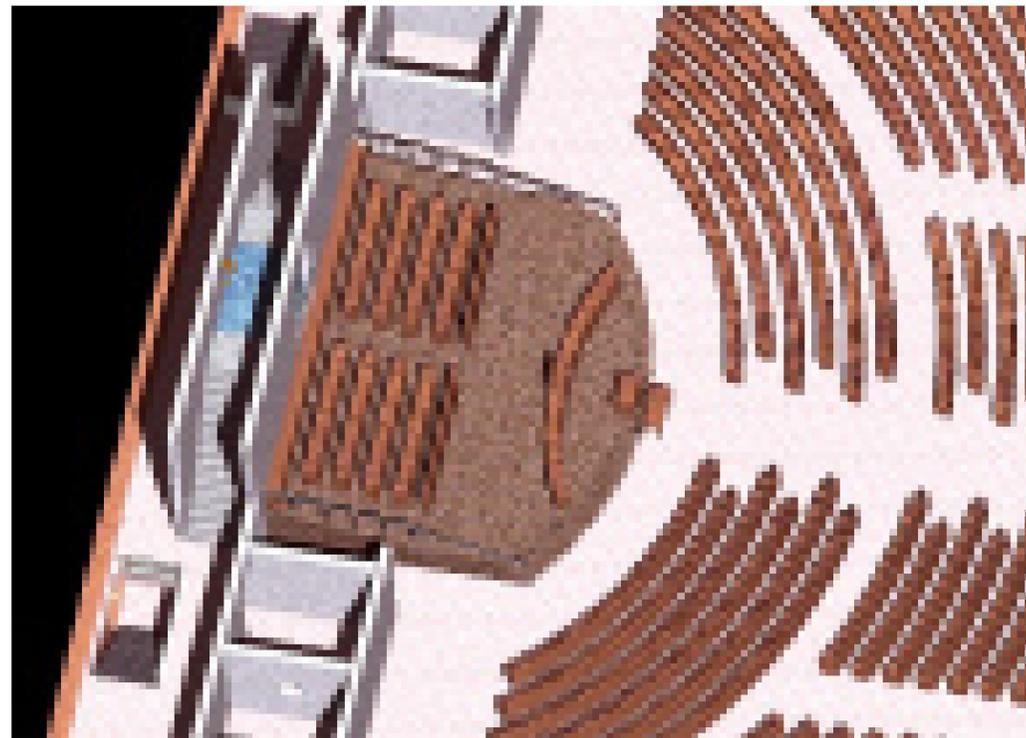
Figure 85, Altar, Choir Seating & Baptismal Pool, & Pews

The baptismal pool is elevated above the choir area and screened by a tapered wall. An opening in the wall filled with Plexiglas allows everyone in the sanctuary to view the baptismal pool. A member waiting to be baptized would be escorted up the steps behind the wall, into to the pool, and back down the steps to a changing room.

The wall which separates the choir from the baptismal pool tapers in response to the geometry of the columns. The wall serves several functions. 1. The intensity of the morning sun on the congregation is limited due the location of the wall.

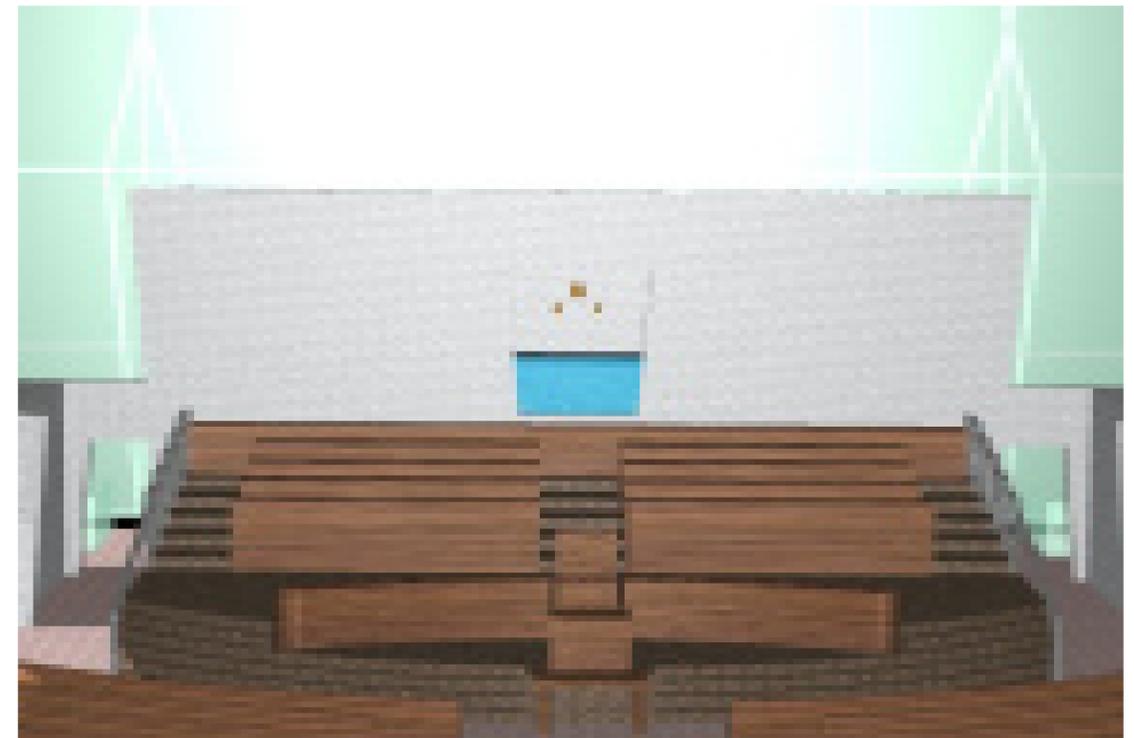
Figure 86, View of Altar

The rear stairs permit the pastor access to the altar directly from his office. Consequently, his office is only accessible after passing through the church secretary's office. This is an intentional effort to limit the number of random walk-ins and to encourage appointments. The choir would also enter the sanctuary from the lower level, but on the opposite side of the stairs. The lower level is large enough to accommodate the entire choir at one time without confining them to the narthex while competing for space with members arriving for church service. On special occasions, the choir may enter from the rear of the church while immersed in song as they walk down the nave in route to their seats. It is also not uncommon for the choir to walk along the nave while immersed in song during the offerings.
