# **Implementation of Infrared Nondestructive Evaluation in Fiber-Reinforced Polymer Double-Web I-beams**

Thesis submitted to the Faculty of the Virginia Polytechnic Institute and State University in partial fulfillment of the requirements for the degree of

Master of Science  
In  
Engineering Mechanics

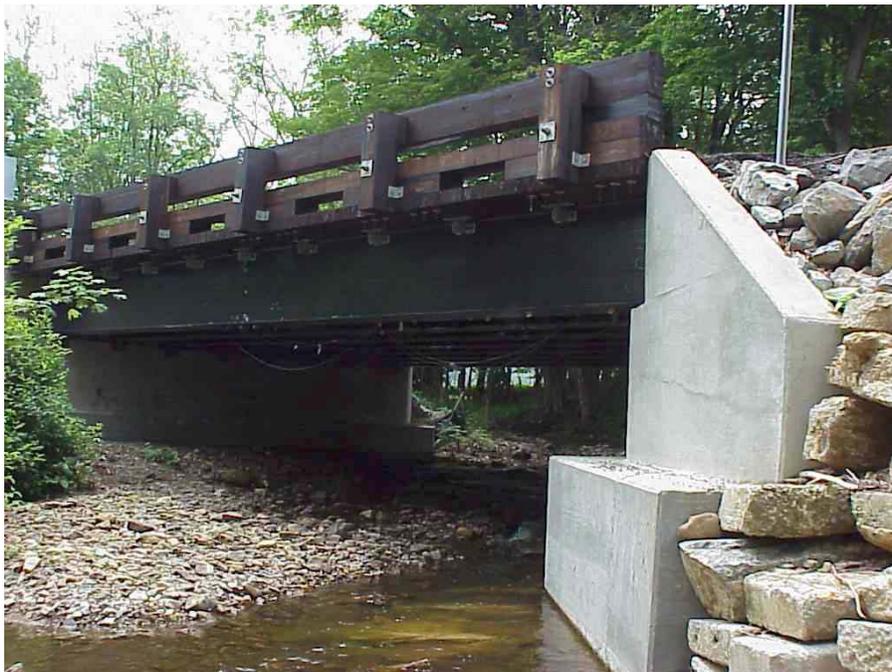
*Figure 1.1 Bridge Picture*

In the summer of 2001, a bridge in Southwestern Virginia was built with a dark-colored 36" I-beam. To the general observer, nothing would appear different other than the color of the beams that were then covered by a wood deck and a layer of asphalt (see Figure 1.1). However, the structural members of this bridge would be different than any other built in Virginia [Lesko].

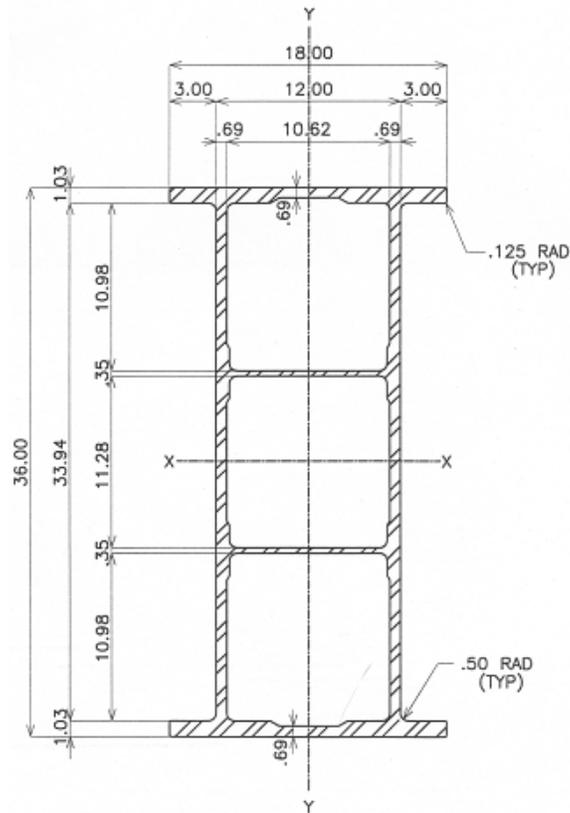
Figure 1.3: Beam with Dimensions

conventional steel beams. Individual materials of the composite beam can be positioned or oriented with respect to where they would be most useful over a constant cross section. The pultrusion process allows for continuous fiber architecture and for strategic location of reinforcing materials. In these two instances, the beams are composed of a hybrid carbon and glass fiber arrangement with a vinyl ester matrix. In order to optimize the configuration, the carbon fibers are placed near the outside surfaces of the top and bottom flanges. This architecture takes the more expensive, but lighter and stronger, carbon material and places it where it would be most effective in the smallest quantities while the remainder of the beam is made of fiberglass.

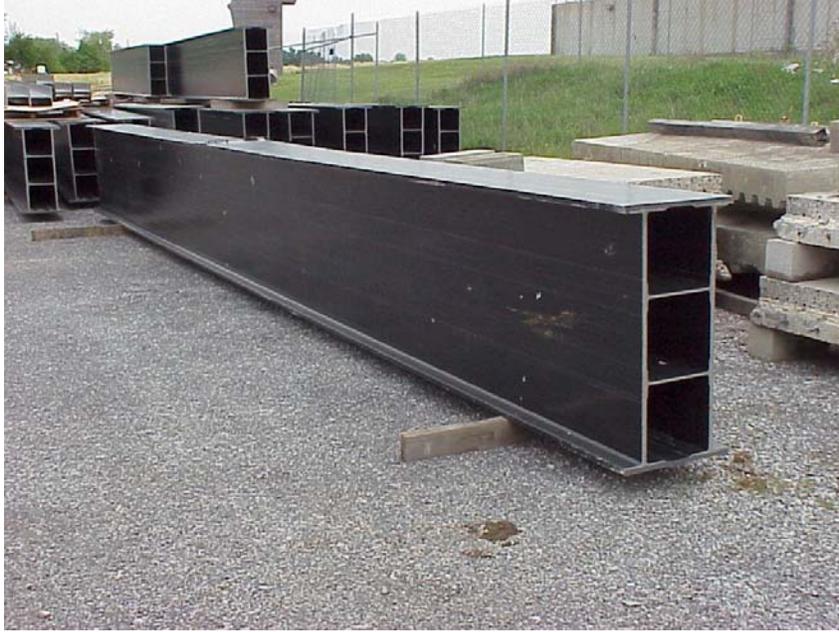
*Figure 1.4: Full Length of a Failed Beam*

At the same time this project was starting, another group at Virginia Tech was mechanically proof-testing the beams to different load levels as well as also loading several beams to failure [Schniepp, 2002]. A direct result of this study was an indication of where beam failures would initiate. In a standard four-point bending test, these areas are the material transition areas of the flange on the compression side of the beam in bending [Armstrong, 1998] (Figures 1.4 and 1.5).

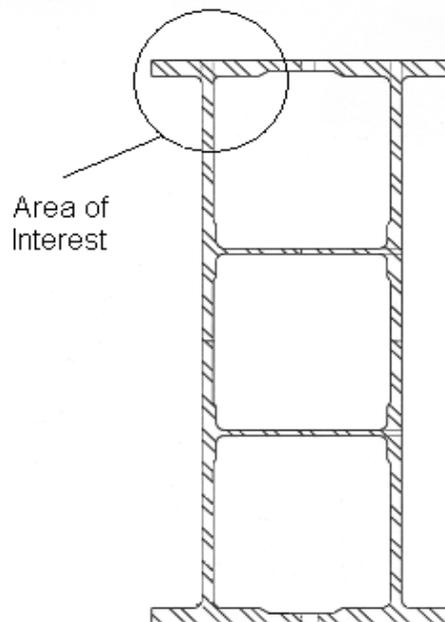
*Figure 1.6: Area of Interest on the Beam*

Further defining the sections of the 36" DWIB, an area of interest on the flange with respect to the whole beam is shown in Figure 1.6. This area of the flange holds the boundary region where the failed beams were cracking. This region, the flange, and web are both labeled in Figure 1.7.

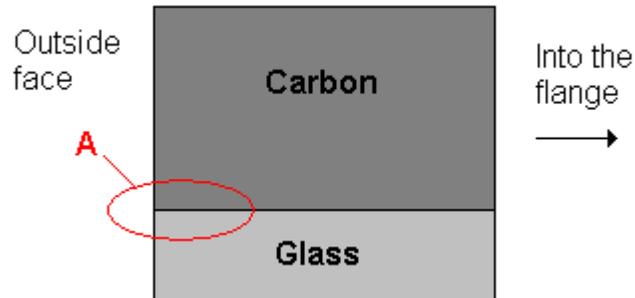
*Figure 1.10: Flange Regions with Site “A”*

Taking a cross-section of the outside edge of the flange and, once again, denoting the carbon and glass regions, Figure 1.10 shows a close-up of location “A.”

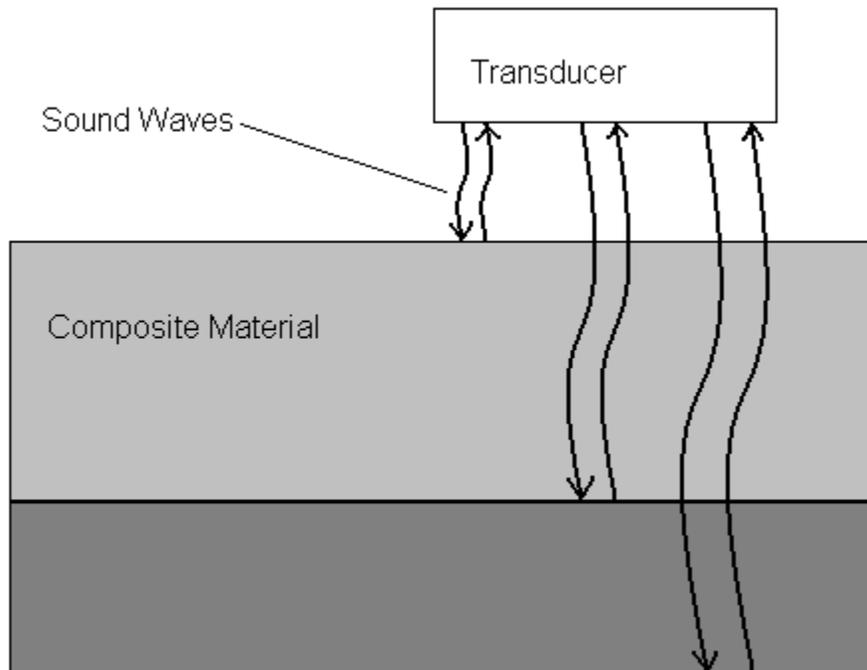
*Figure 1.11: Sample Pulse-Echo UT Setup for Analyzing a Composite Material*

Initially and conceptually, the ultrasonic method appeared to have the most potential. Using a “composite” material of two bulk materials layered on top of each other directing a UT beam into the piece of “composite” submerged in water as shown in Figure 1.11, there would be a reflection peak in the returned signal for the top surface and back surface. For this example, and the beam application, this is true. There will also be a smaller reflection peak for the boundary between the two materials and an even larger peak at that point if there was a delamination along the boundary. If these boundaries were both smooth and oriented perpendicular to the UT beam, they should produce a detectable reflection. However, this was not the case when using samples of the beam flange. Taking separated sections of the carbon and glass regions and the known speed of sound in water, thicknesses of the sections, and the relative speeds of sound in the carbon and glass regions could be determined by a through-thickness pitch-catch UT procedure as depicted in Figure 1.12. This, then applied to the pulse-echo method, could be used to determine the approximate times that the reflections should appear in the echo pattern and generate data similar to Figure 1.13 [Bray, 1997]. The typical results that were acquired in testing are shown in Figure 1.14. Figures 1.13 and 1.14 are both of the same scale pattern with voltage on the y-axis and time on the x-axis. If Figure 1.13 was superimposed on top of Figure 1.14, the initial spikes would match up but the actual laboratory data did not exhibit either the boundary or back surface reflections.

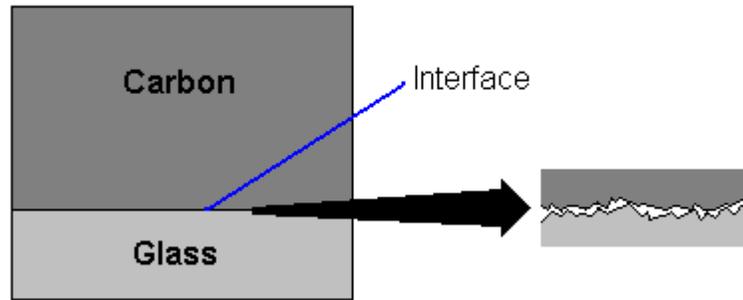
*Figure 2.2: Material Interface with Imperfection*

Conductivity across a delamination will depend on the nature of contact between the two opposing surfaces of the delamination. If the two material regions have separated and are not in full contact, as in Figure 2.2, the resistance to heat transfer across the boundary will be higher and restrict the heat energy flow in that direction [Suryanarayana, 1995]. In all actuality, the two surfaces may be in contact with each other but not perfectly with the areas of non-contact acting as the resistance [Winfrey, 2003]. How well the two surfaces are in contact cannot always be determined and in the qualitative approach to uncovering imperfections along the boundary that will be used in this study, any type of abnormality with what will be determined “good” data will be considered imperfect.

The effect of a delamination at the boundary between material regions will change the way heat energy will travel through the boundary. As a general rule, the heat energy will still move in all directions, but conduction, being a gradient driven process as well as dependant on the conductivity of the material, may have the higher gradient across the boundary but also the lower conduction. If the resultant of the gradient and the conductivity along the boundary is greater than across, the heat energy will be more likely to flow along the boundary instead of crossing it. Either way, the observed results should be different than those of a material with a mechanically connected boundary and be detectable with thermal imaging.

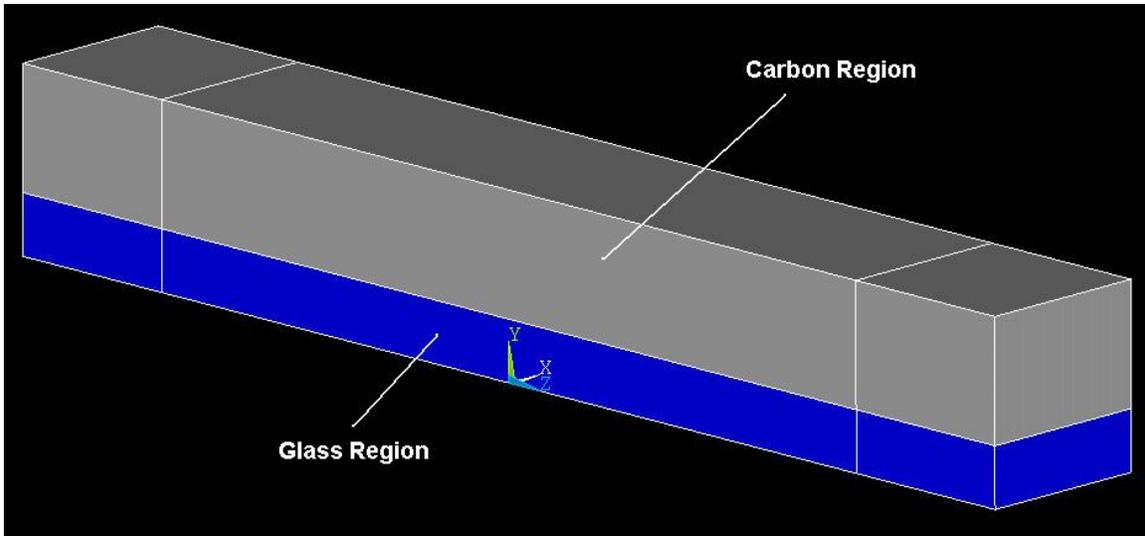
*Figure 3.1: ANSYS Model of Beam Flange Volumes – “Intact” Model – Isometric View*

Modeling of the entire flange of the DWIB would necessitate a large model and since the applied thermal loading was localized, a smaller representative section of the flange could be used and allow for a much smaller model. Creating a model, mesh, and developing similar loading conditions to the laboratory experimentation showed that the heat energy was not penetrating further than a half inch into the flange in the z-direction. The resulting flange geometry for the simplified model was selected as 1 x 8 x 1 inch (depth into the flange by distance along the length of the beam by thickness of the flange). The ensuing collection of volumes consisted of six volumes, three of each material, and is shown in Figure 3.1 with the carbon region being gray and the glass, blue. The reasoning behind the divisions along the z-axis was to create a surface on the y-z face to apply the initial conditions. This was a requirement to create a smaller face on the entire surface that would allow only part of the entire face to be heated. Without doing this, the initial loading would have had to cover the entire face and not allowed for conduction in the z-direction at the edges of the heated region into the unheated regions.

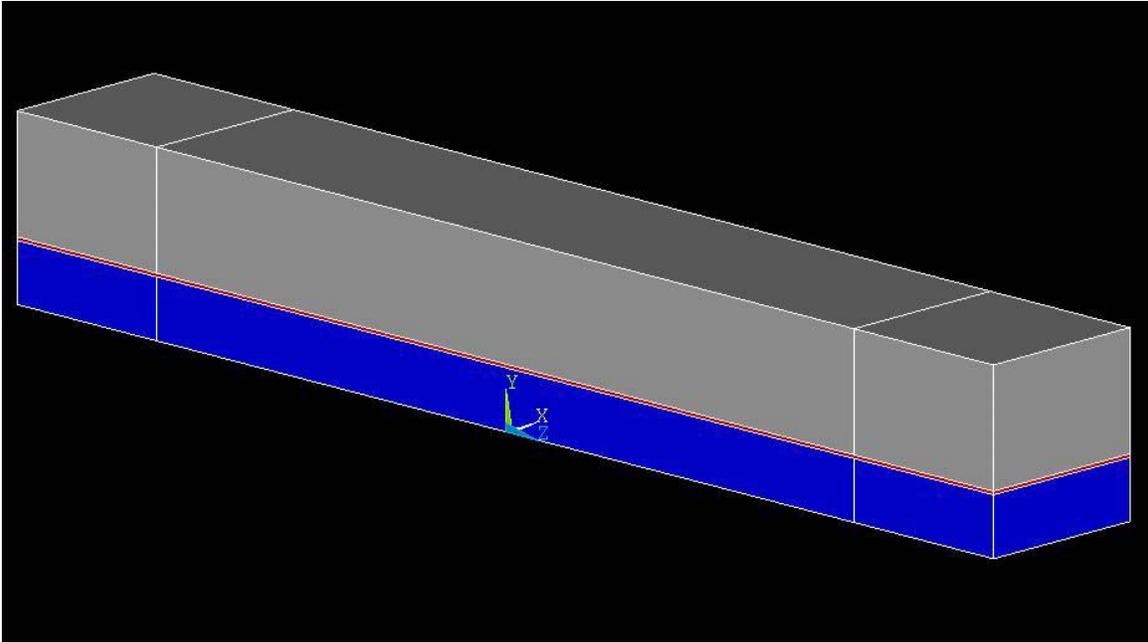
*Figure 3.2: "Delaminated" Model – Isometric View*

The second of the models included the “delamination.” Since ANSYS would not allow a gap of “nothing” to be a delamination, a thin slab of a third material was introduced between the carbon and glass regions. The development of this material will be discussed in section 3.5 while the model volumes are depicted in Figure 3.2. The red section between the grey and blue carbon and glass regions is the delamination material.

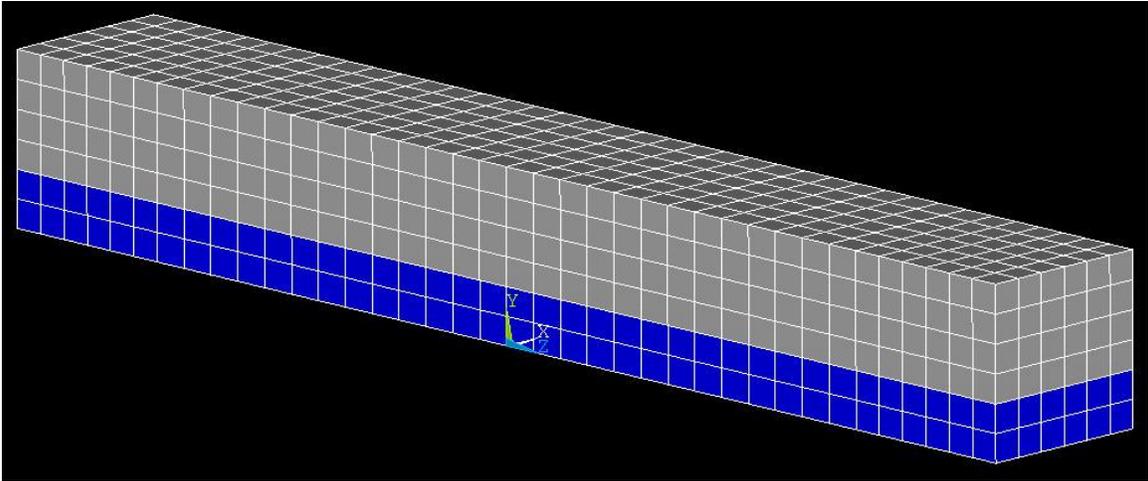
*Figure 3.4: Meshed “Intact” Model – Isometric View*

With respect to determining the appropriate size of the mesh of the bulk regions, the best way to handle this was to compare the results of progressively smaller meshes. A 5 mm mesh allowed for two divisions in the glass region and four in the carbon region and was the starting point. It is shown in Figure 3.4. Two other meshes were also created, a 2.5 mm and a 1.25 mm, which doubled and quadrupled the divisions, respectively. Under the same loading conditions, vertical line profiles at the center of the flange section were extracted from ANSYS for the three meshes and are shown in Figure 3.5. The results were sampled at the 1st second time interval and will be the same for all results shown in this chapter. The temperature difference at the boundary node between the carbon and glass regions node was less than of a hundredth of a degree C between the 5 mm and 1.25 mm meshes. Since the degree of precision to a hundredth of a degree was not necessary in this study, the only benefit of using

the smaller mesh would be to have smaller divisions along the surface to generate the temperature profile. But, with respect to the reduced computational time and the use of “bulk” materials, the larger mesh was determined to be sufficient in modeling the appropriate trends and will be used for the remainder of this discussion.

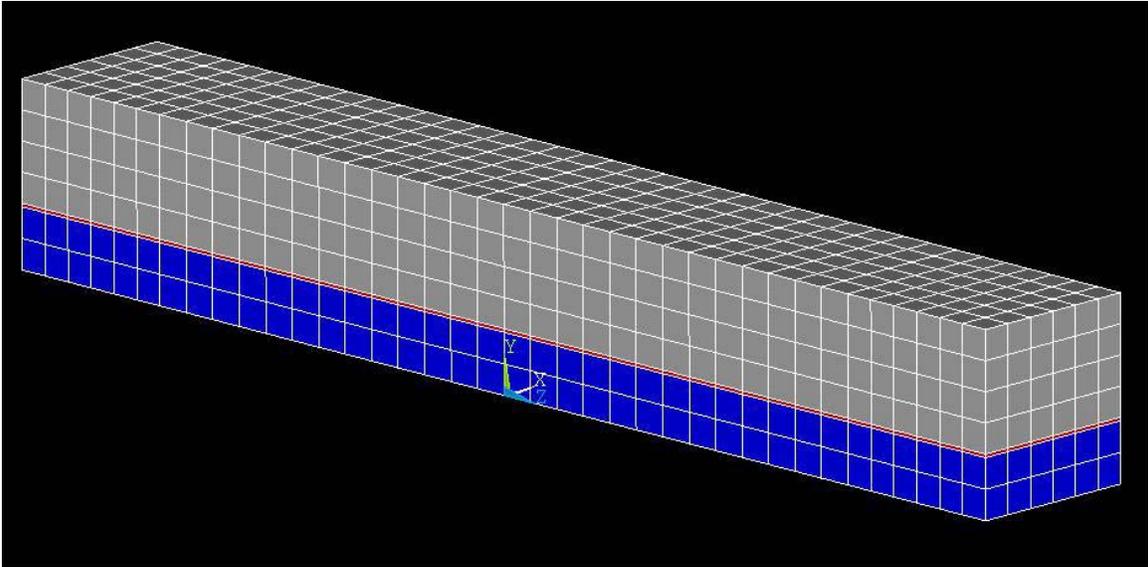
Figure 3.6: Meshed “Delaminated” Model

Figure 3.6 shows the “delaminated” model with its mesh. In order to determine if the mesh size would affect the material values in the delamination region, the values for the carbon region were entered into the delamination material. The desired result would be similar output from the models with and without a delamination. Running the two models under the same conditions, the results showed that the difference in the mesh size did not affect the results significantly and are displayed in Figure 3.7.

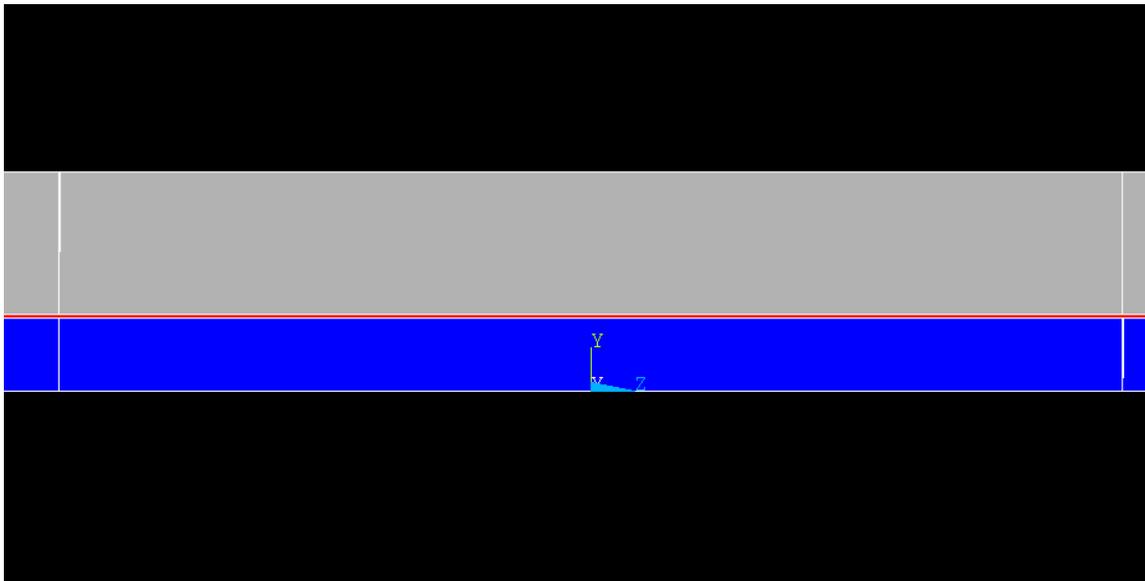
*Figure 3.8: “Delamination” Face Close-up*

In order to create a delamination in ANSYS, “something” had to occupy the space between the two material regions. By leaving a gap in which the two materials are not touching, FEA has no way of generating results such that convection and radiation across the gap could take place as in real life. The result would be the free run of the two material regions with no interaction between them with exactly similar results as if they were two different models. So, a thin material had to be inserted in between the carbon and glass regions with the material values selected to represent the effects of the delamination. Figure 3.8 shows the y-z face of the flange with the delamination material in red.

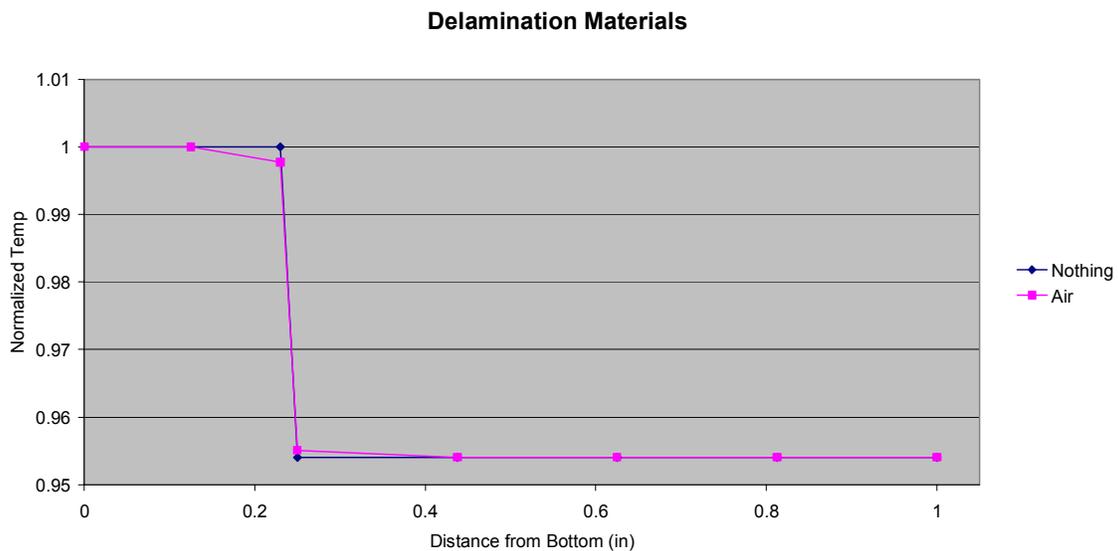
Figure 3.9: Comparison of Air and “Nothing”

model with “nothing” or null values was created along with a case where the material properties of air were used in the delamination material. The results showed the differences between the two situations and are displayed in Figure 3.9. The results were similar in that “nothing” did not allow any conduction between the regions while air showed very little. This confirms that air is a thermal insulator and that a “material” would need to be created for a more accurate representation of a delamination. The delamination gap is at .25 inches from the bottom in all the FEA results.

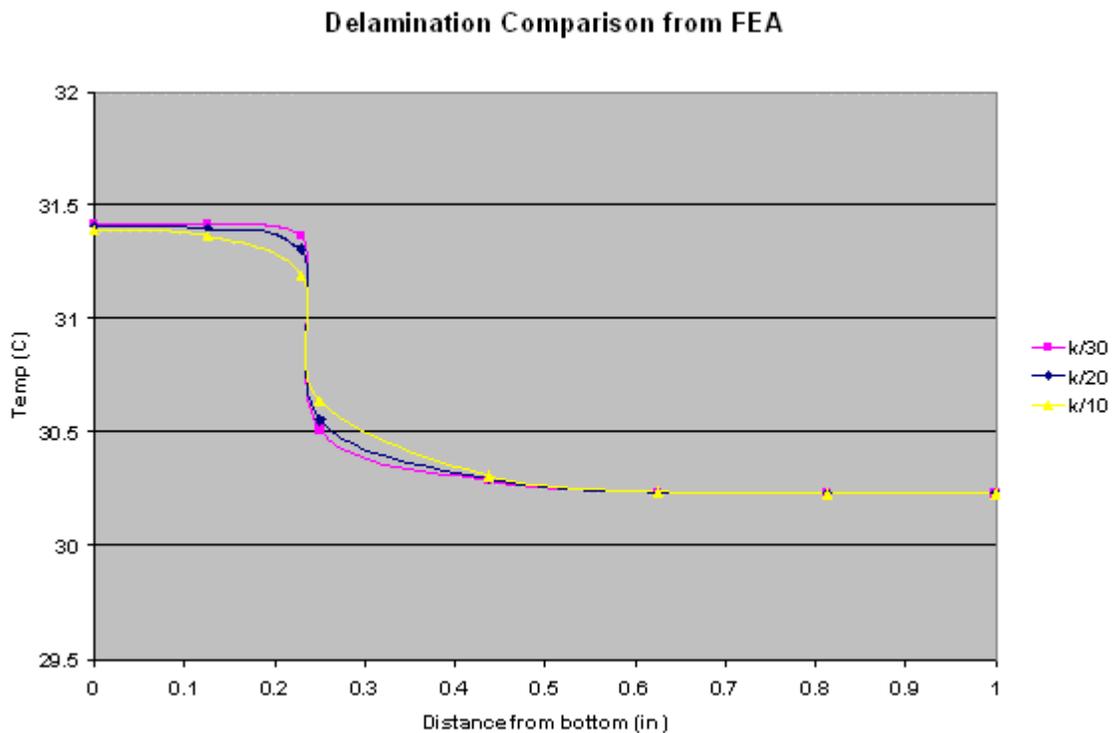
Figure 3.10: Temperature Profiles from a .5 mm Gap

happen if the materials were still in contact with each other, but with a reduced contact area. Reducing the conductivity values was considered to be the simplest way to model a reduced contact area in the delamination material between the carbon and glass material regions. The two thicknesses for the gaps were .25 and .5 mm with the conductivities being reduced by factors of 10, 20 and 30 of the carbon region values. Figures 3.10 and 3.11 illustrate the results and show that the larger delamination thickness as well as lowering the conductivity of the region would yield a higher resistance to conduction across the boundary. Taking the  $k/30$  plots for each thickness, Figure 3.12 was developed. Based on the laboratory results, the larger delamination thickness with the lowest of the three conductivities was selected as the most appropriate.

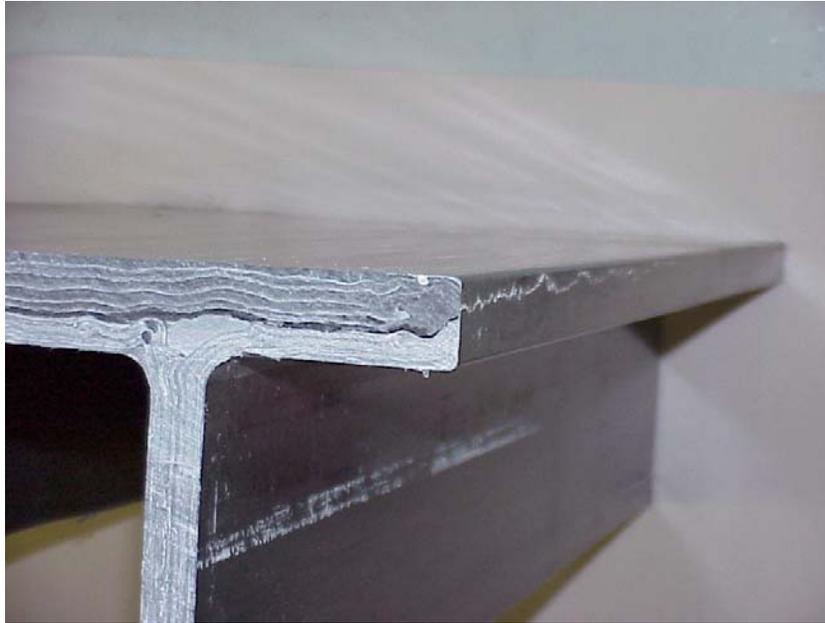
*Figure 4.1: Beam Section with Crack*

The major difference between the two sections of beam was how much they had been delaminated. When the full beam had been loaded to failure, the central area of the beam, more or less, exploded, splintering a majority of the flange (reference Figures 1.4 and 1.5 for images). However, as one would move away from the splintered center section towards the ends, the breakage would diminish. A transition region existed neighboring what would appear to be a perfectly intact remainder of the beam length. The two sections were removed from the transition and intact regions. The one closest to the failure region was fully delaminated, meaning the web had totally separated from the flange at the carbon/glass interface. The second section continued with being fully delaminated and over its length traversed the intermediate region to fully intact at the opposite end. This section would be very important in testing in that it contained fully intact, fully delaminated and partially attached regions depending on where the evaluation was performed on the section. Figure 4.1 shows this section of beam in which the edge of the delamination can be seen along the outside edge of the flange.

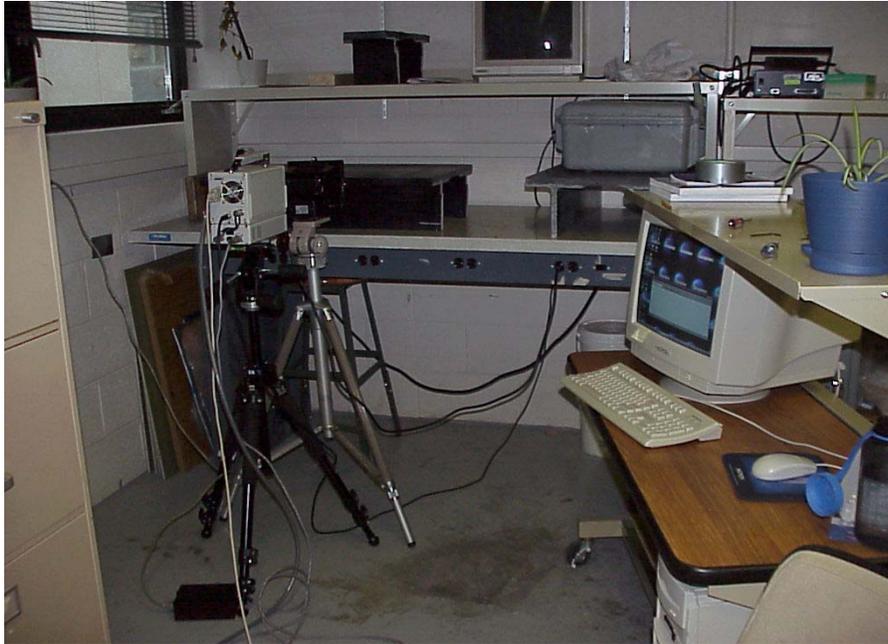
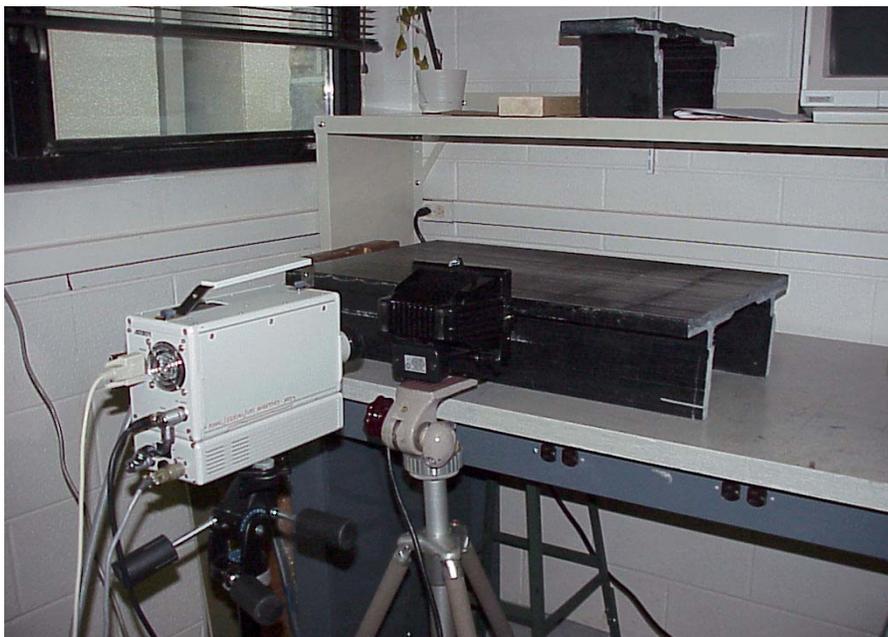
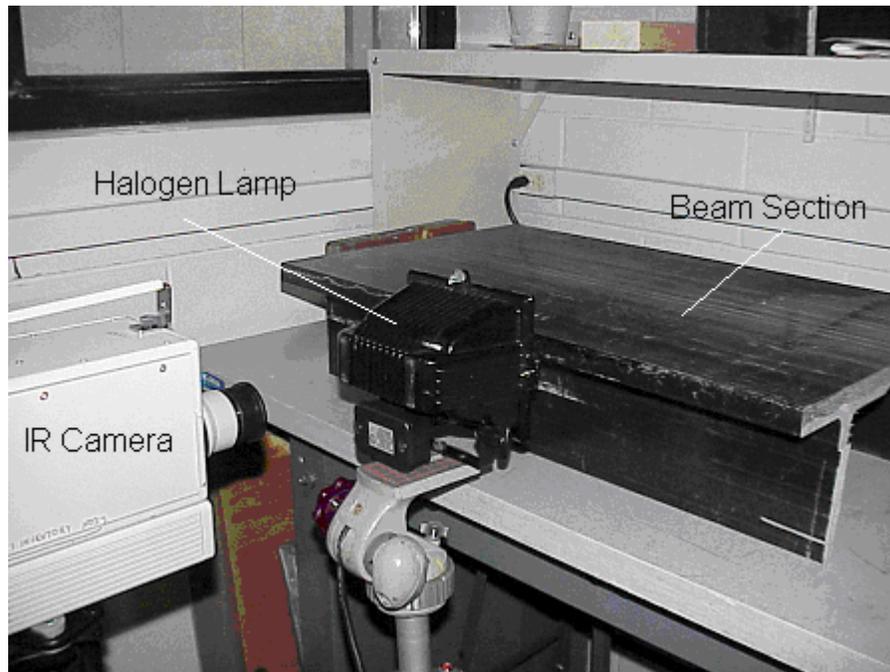
*Figure 4.2: Laboratory Setup*

After an initial period of trial and error, the experimental procedure established itself as the following: Heat with the lamp center 1" away from the flange and remove from the camera field of view which was placed 16" away from the flange behind the lamp. It was also necessary to manipulate the raw data from the images into a usable form and analyze the results. Figures 4.2 to 4.4 show the laboratory setup as it was used.

The positioning of the heat lamp and the camera were related in that the lamp had to remain close to the beam in order to produce the most even heating of the surface. Positions closer than one inch had a tendency to damage the surface and those further away yielded irregular surface temperatures. Using the 50mm lens with the IR camera, the 4 to 5” area that the lamp was able to heat would fill most of the acquisition area of the camera when placed 16” away.

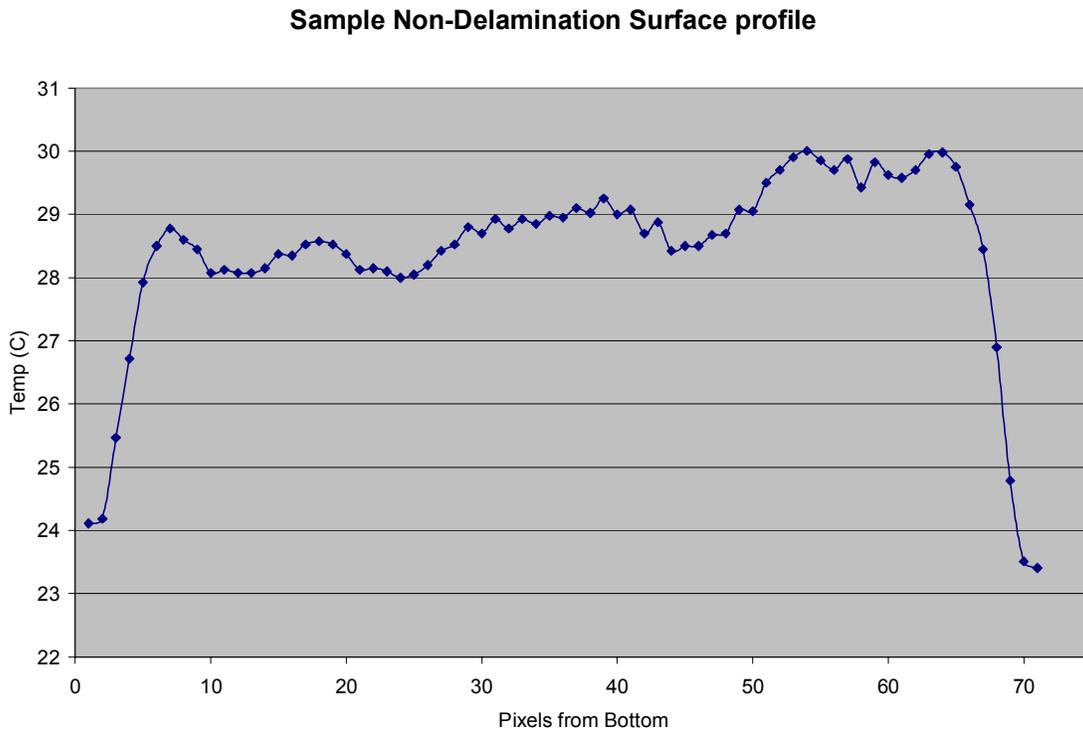
*Figure 5.2: AOI Line Profile Displaying Flange Surface Temperature*

To simplify the entire surface image into a more usable form, a specific area of interest (AOI) in the form of a vertical line was selected. Now, instead of comparing an entire surface, the results from a single column of pixel data were compared. This line AOI will generate the thermal response in the following form:

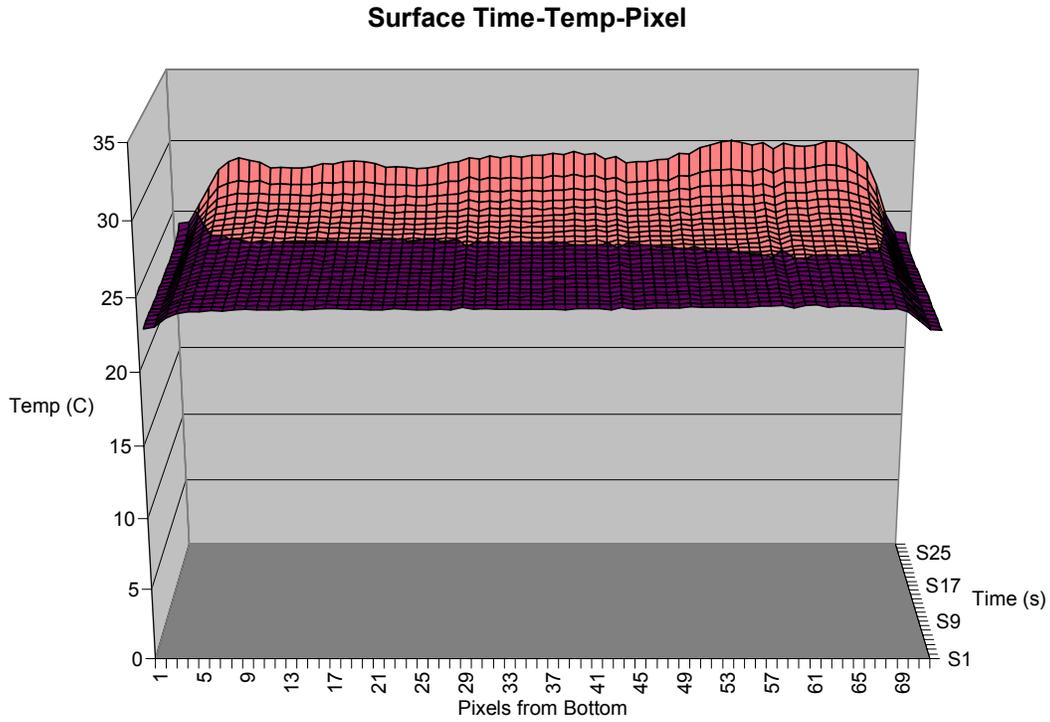
Figure 5.3: Surface Decay Profile

Since a single line profile only shows the results of one second's worth of data, each successive set of data may be plotted to show the surface temperature decay by generating a time-temperature-pixel surface as in Figure

5.3. Figure 5.4 shows the temperature-time decay profile from a single pixel, 57 in this instance. In order to compare the experimental and FEA data in a quantitative manner, it is convenient to use individual points of the surface for correlations rather than the entire surface. Note that the most transient part of the data was observed to occur within the first ten seconds of decay.

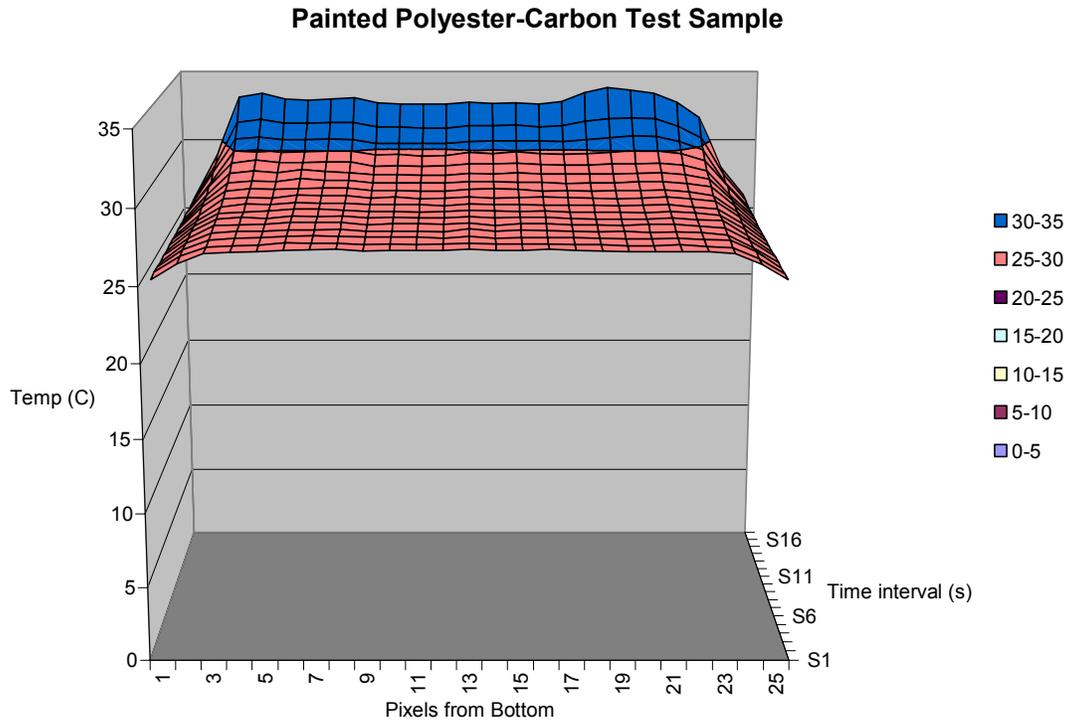
*Figure 5.6: Surface Decay Profile of the Painted Polyester-Carbon Test Sample*

unidirectional carbon fiber and biaxial fiberglass with polyester and epoxy matrices and the general dimensions of the beam flange. This process allowed some minor inconsistencies in the materials to be present. For the most part, these were insignificant, but when applying thermal imaging, they caused slight thermal variations across the surface in the form of undulations as shown in the surface decay profile in Figure 5.5. Since many of these undulations were local with respect to position along the length of the sample, more regular areas were considered. Ultimately, the entire surface was painted flat black which resulted in the most consistent surface profile shown in Figure 5.6.

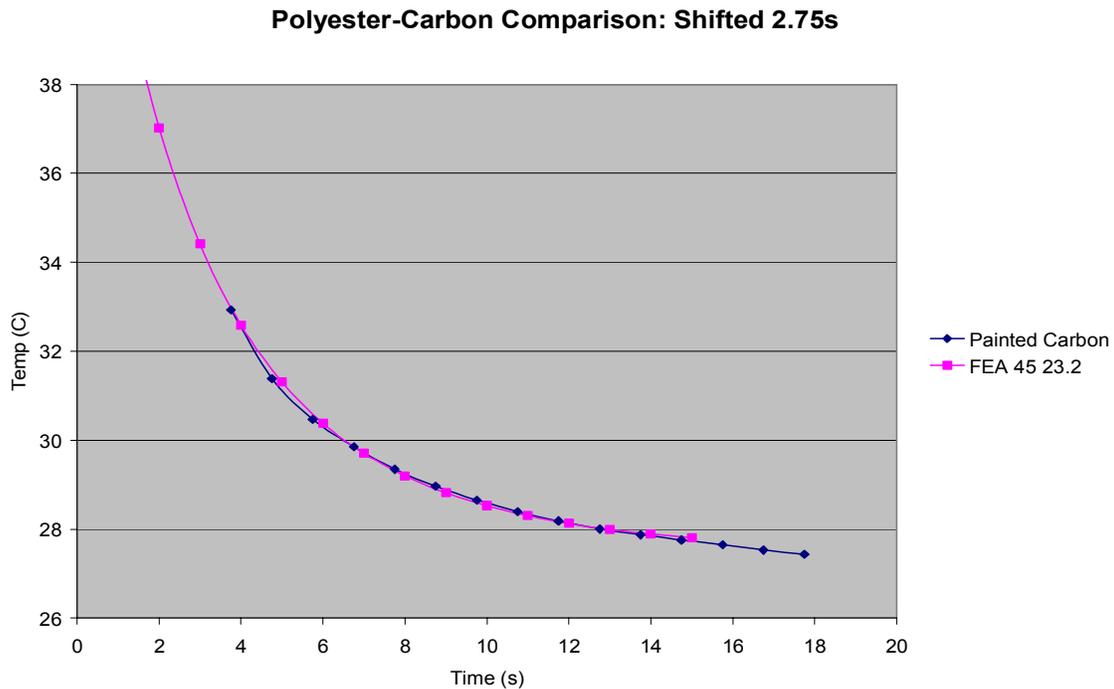
Figure 5.9: Polyester-Carbon Experimental and FEA Comparison with Time Shift

A typical data comparison then resembles the previous figure in which the two temperature-time profiles do not match up. However, if the experimental data were to be shifted ahead in time, the two profiles as seen before actually match up quite well. Figure 5.9 shows the results of a 2.75 second forward shift in the experimental results.

The results of the polyester-carbon comparison were shown in Figure 5.9. Following, in Figures 5.11 through 5.13 are the results of the other combinations of materials.

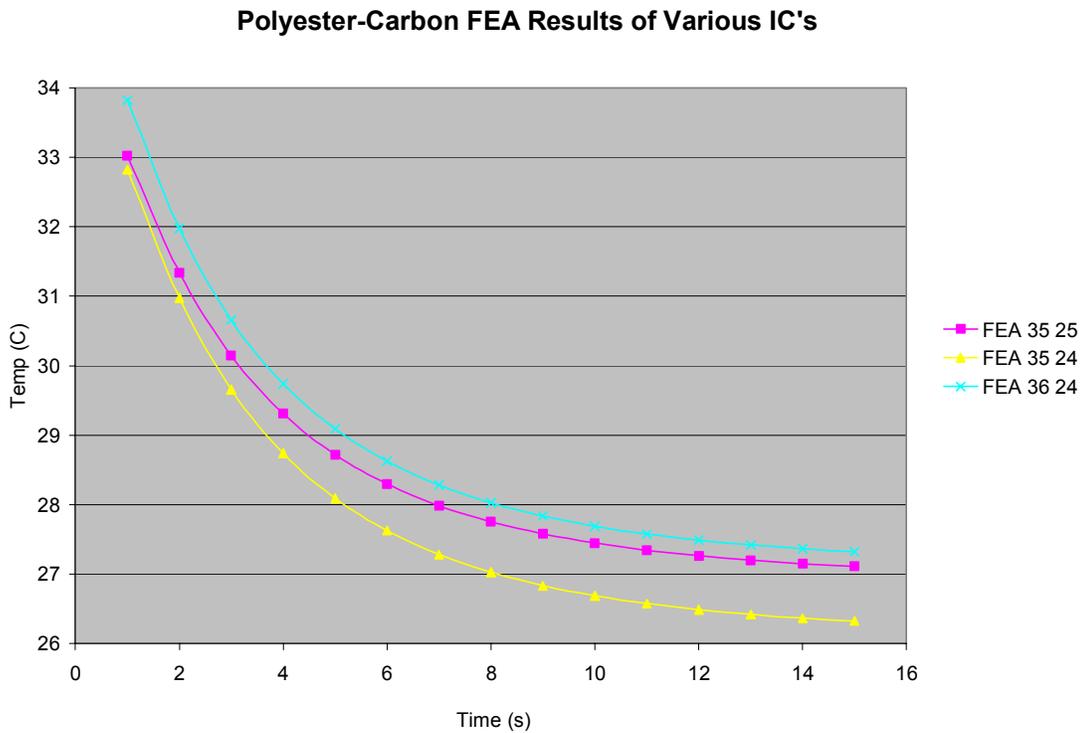
Figure 5.10: FEA Results from Various Initial Conditions

Another drawback of the unsynchronized lamp and camera was the inability to exactly replicate an experiment. That said, great effort was taken to keep the experiments as uniform as possible but two trials of the same material would be slightly different due to variations in lamp setup and heating time. Also, a few degrees variation in room temperature would affect the ambient conditions that would be needed to have the FEA results match the lab results. Since the ANSYS results could be refined after the experimental data was collected, the initial conditions used in the FEA could be adjusted to achieve a better fit. Figure 5.10 shows the variations in the decay profile of the polyester-carbon FEA results when the initial condition temperatures are varied.

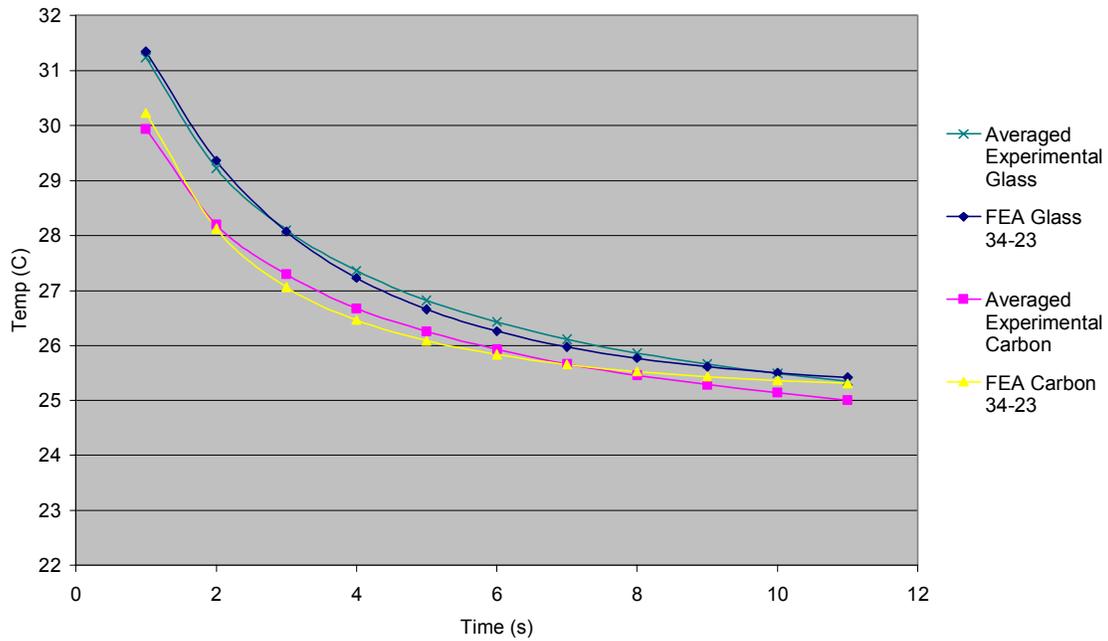
*Figure 6.1: Averaged Material Decay Comparison of an Intact Sample*

Matching the time decay for the averaged material values of an intact beam flange sample and FEA results by only adjusting the IC's without any time shifts produces the following results:

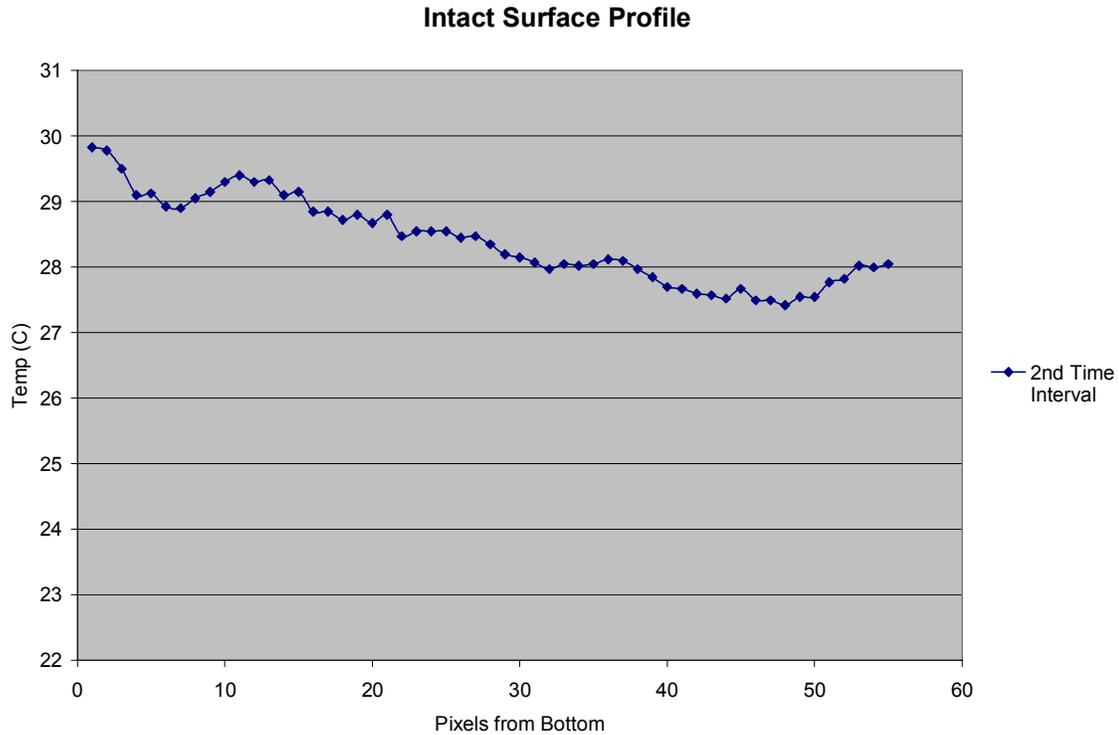
Figure 6.2: Experimental Surface Profile of an Intact Sample

The data at the second time interval matches the closest between the FEA and experimental results for both material regions. At the second time interval, the vertical surface profile of the experimental results is shown in Figure 6.2.

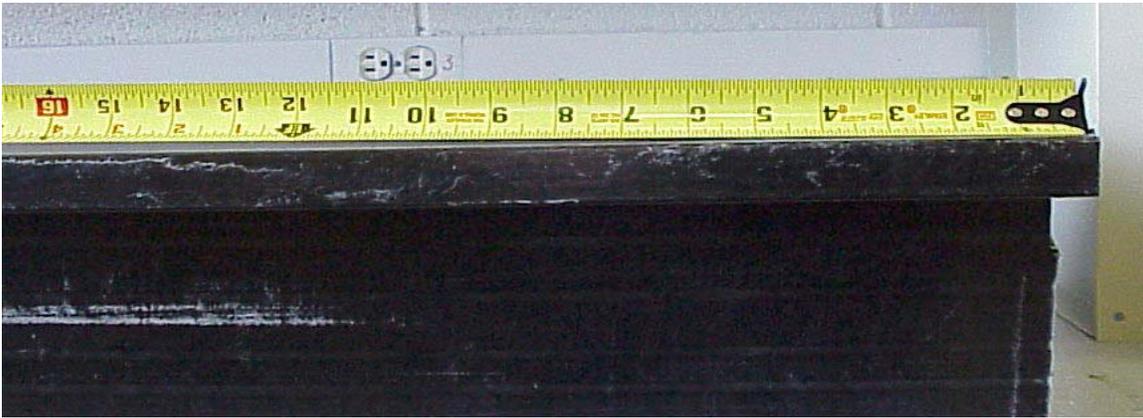
*Figure 6.3: Picture of Tested Flange with Ruler*

plot was taken from a region near the right of this flange section. The visible crack ends near the 12 inch mark on the ruler and does not extend to the end of the beam. Figure 6.3 shows the flange surface from which the results were taken. The intact region was towards the right, far away from where the visible crack ends near the 12 inch mark. The crack does not extend to the end of the beam.

From the same flange section pictured in Figure 6.3, another test was conducted near where the visible crack ends with a close-up of the region as follows in Figure 6.6. This region was deemed “intermediate” in that the visible surface crack ended at the 12 inch mark on the ruler. However, it was believed that the crack extended into the flange at an angle in a way that the crack would be present behind the surface for some unknown distance past where a visual surface indication would be present. For that matter, the experimental IR results would show some manner of delamination or difference from the intact experimental results. Tests in this region were conducted near the 9 inch mark. The material decay profiles for this test area are found in Figure 6.7.

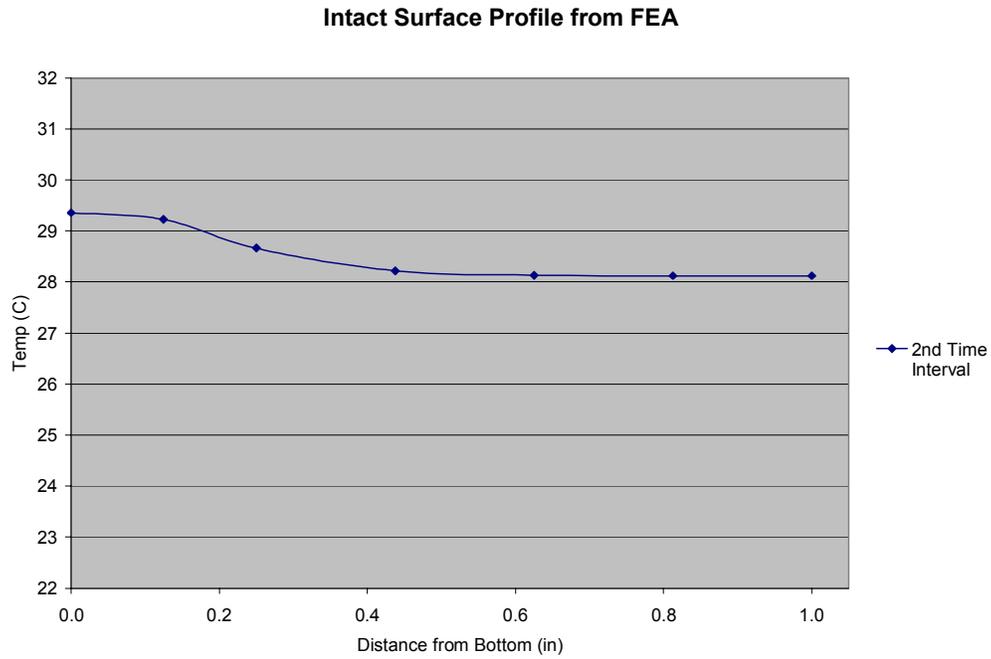
Figure 6.4: FEA Surface Profile of an Intact Sample

The corresponding FEA results for the second time interval would appear as in Figure 6.4. In order to plot the two surface profiles together, the pixel axis (x-axis) of the experimental lab data was normalized and then displayed in Figure 6.5.

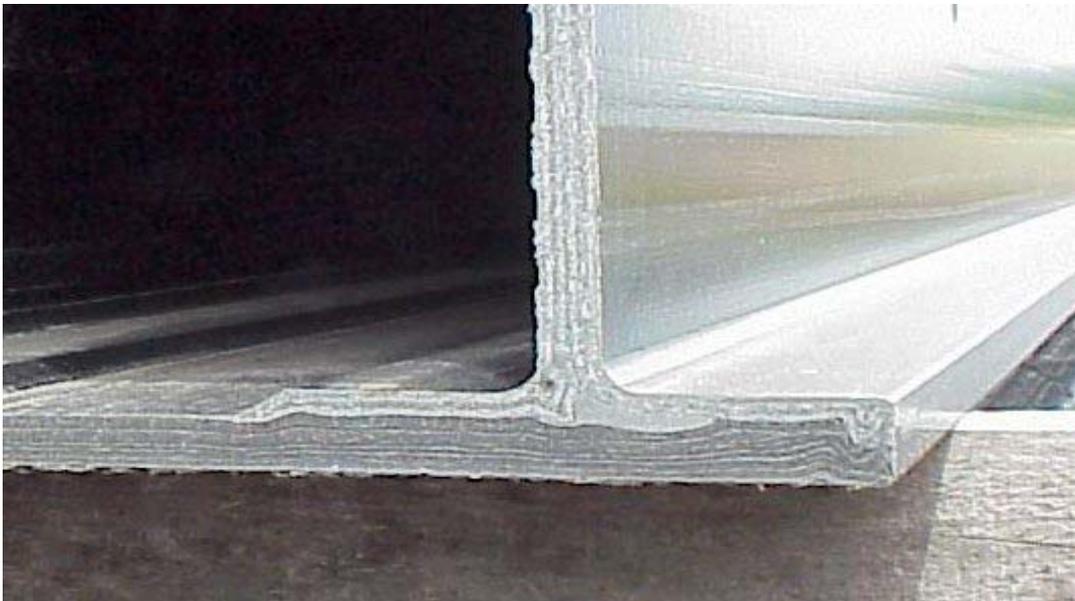
*Figure 7.1: Reduced Waviness of the Second Generation Beams*

an issue in itself and hindered the application of UT and the determination of where the carbon-glass boundary was located, something that was not previously addressed was that there were two different generations of beams. The initial proof testing and construction of the bridge were done with what was later dubbed the first generation beam and, for the most part, was the version of the beam that the analysis in this report was focused on due to the interest in an application for the bridge inspection. The second generation beam, externally, did not appear different but as an added aid in trying to keep the layers more planar and thus avoiding some of the waviness that caused the analysis problems, it had a fine fabric woven into the individual layers to hold them in place. This helped, but did not fully eliminate the issue of the waviness (see Figure 7.1 for a comparison with Figure 1.7). Since the bridge was not built of this version of the beam and structural differences had not yet been determined, the aspect of evaluating the second generation beam for the analysis was not pursued further.
