# **Implementation of Infrared Nondestructive Evaluation in Fiber-Reinforced Polymer Double-Web I-beams**

Thesis submitted to the Faculty of the Virginia Polytechnic Institute and State University in partial fulfillment of the requirements for the degree of

Master of Science  
In  
Engineering Mechanics

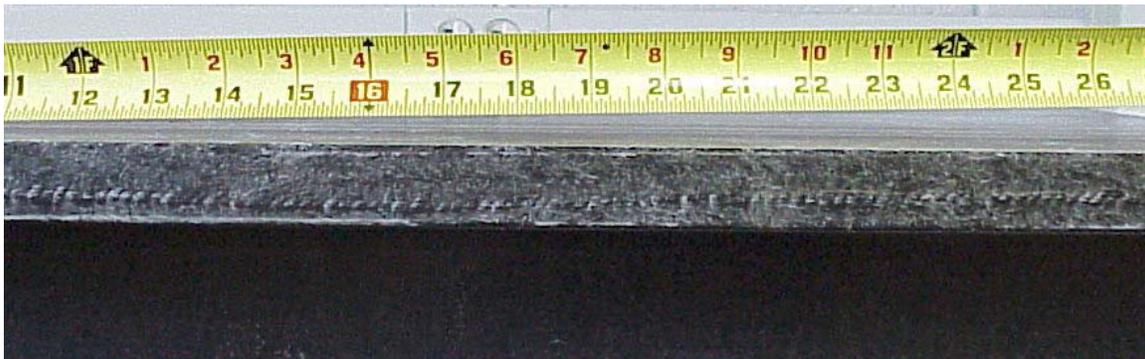
*Figure 7.5: Flange Surface Irregularities*

Another issue of consideration for change on the beam was some of the surface irregularities. While not an issue when selecting flange areas of the laboratory samples for testing, it would be an issue for other areas of the beam surface. Beyond what was needed in this study, a brief amount of time was spent scanning the larger surfaces of the beam. Since the web of the beam was not noted as being an area of interest for the life expectancy of the beam, the large surface of the top of the flange was scanned for irregularities. In several areas, some of the internal waviness resulted in bunching of strands on the surface of the beam. This either showed up as longitudinal streaks as in the lower edge of Figure 7.4 or, for lack of a technical term, globs of random fiber as in the upper part of the figure. Also seen in this figure as well as Figure 7.5 are how some of the rovings in the material cover the edge of the flange. While these areas could

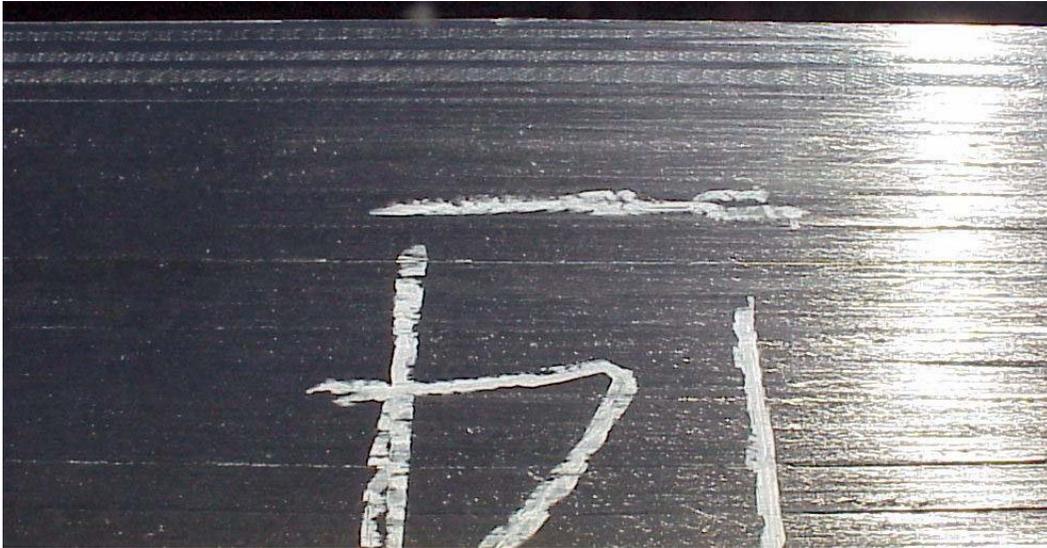
*Figure 7.6: Surface Irregularities*

Some of these longitudinal streaks are also seen in Figure 7.6 and turn up in the IR images of the same region. Also present are chalked markings (upside-down “14”) that designated the beam for testing purposes and are also seen on the bridge beams. Cleanliness of the inspection surfaces will affect the thermal imaging as the emissivities will be changed.

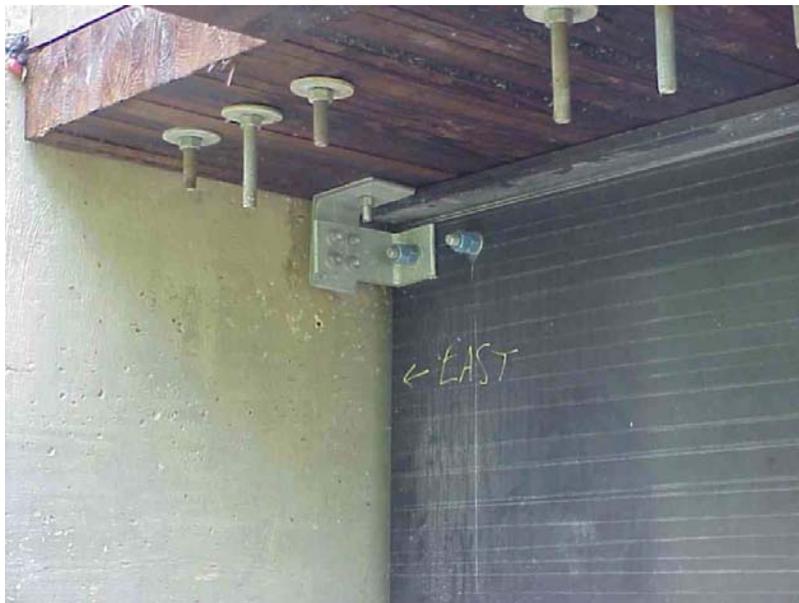
*Figure 7.8: End Constraints*

As shown in Figure 7.8, the ends of the beam are almost butted up to the face of the concrete abutments. Although the area of interest for the research was at the outside of the flange edge, having access to the inside of the beam would have increased the options for evaluating the web, heating, or viewing the beam from the inside, such as location “B” from Figure 1.8. To accomplish this, the bridge design would need access points to the interior boxes of the beam. The nature of access would depend entirely on what would be placed inside the

beam. If it were the camera, the gap between the end of the beam and the concrete embankment would have to be at least six inches. If it were the heat lamp, then the gap could be just slightly less. Also, depending on how an alternative inspection technique might be developed and applied, a device might be needed to guide the camera or lamp along the beam and would also need to fit through the gap. Since the structural analysis of the Dickey Creek Bridge was not something that this study considered, the small gap at the end of the beam may have been something that was changeable.
