**Post Harvest Evaluation of Best Management Practices for the
Prevention of Soil Erosion in Virginia**

Thesis submitted to the faculty of Virginia Polytechnic Institute and State University in
partial fulfillment of the requirements for the degree of

Key Words: Forestry BMPs, Erosion, Harvesting Effects, USLE, Forest Access Roads

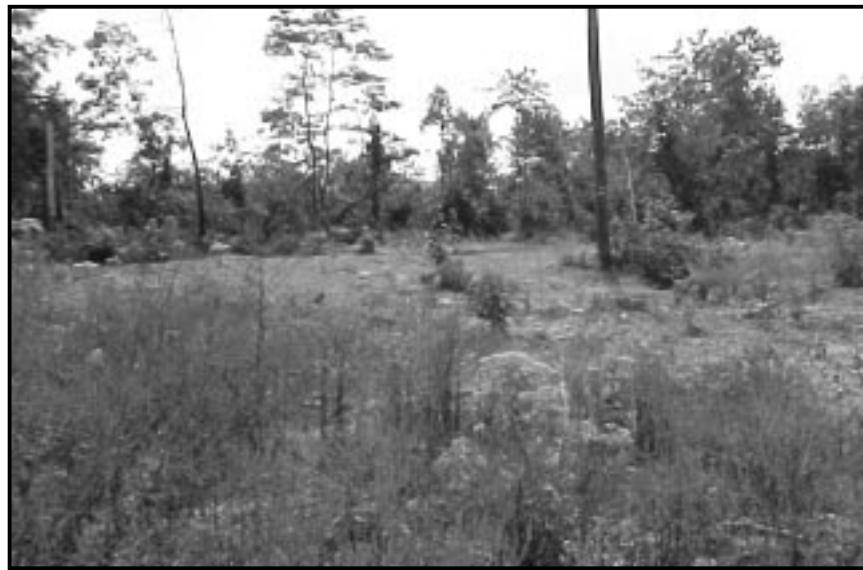
Figure 4. A log deck in Botetourt County, with approximately 505 of the log deck successfully seeded with grass.

In the instance, as depicted in Figure 4, where one sample had fine roots and the other sample did not the fine root subfactor value was divided by two to suggest that 50 percent of the site had a fine root mat of invading vegetation. For those disturbance categories that were not easily divided received either 100 percent in fine root mats or 0 percent in fine root mats.

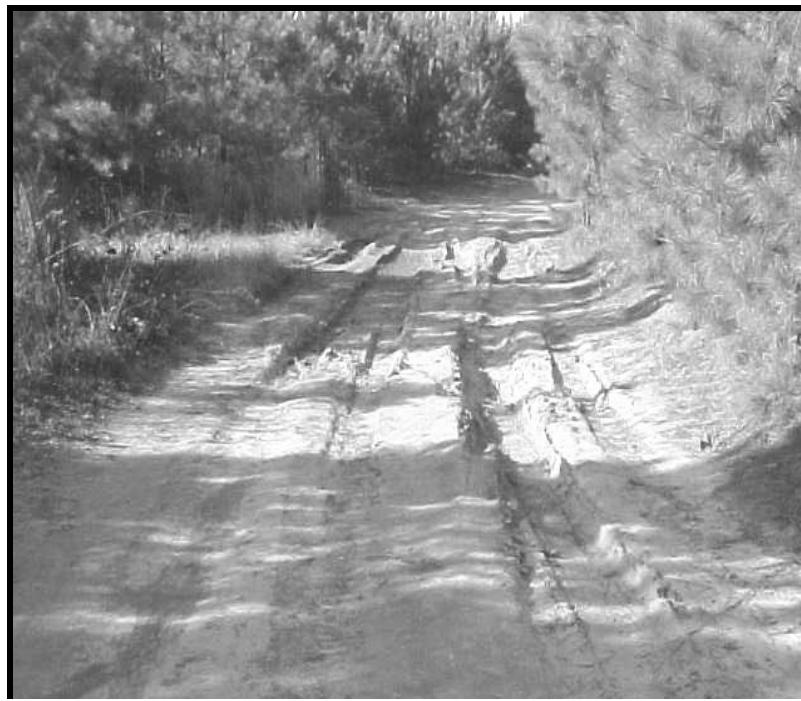
Figure 5. Heavy off road vehicle usage in Buckingham County is often detrimental to established BMPs.

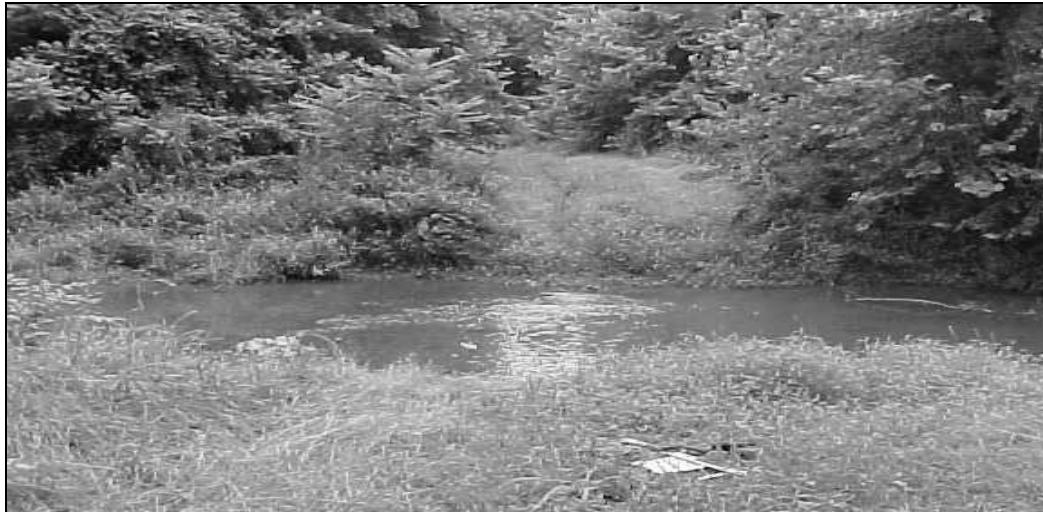
Figure 6. Stream crossing sample sites, such as this one in Faquier County, were always measured and visually inspected for active erosion.

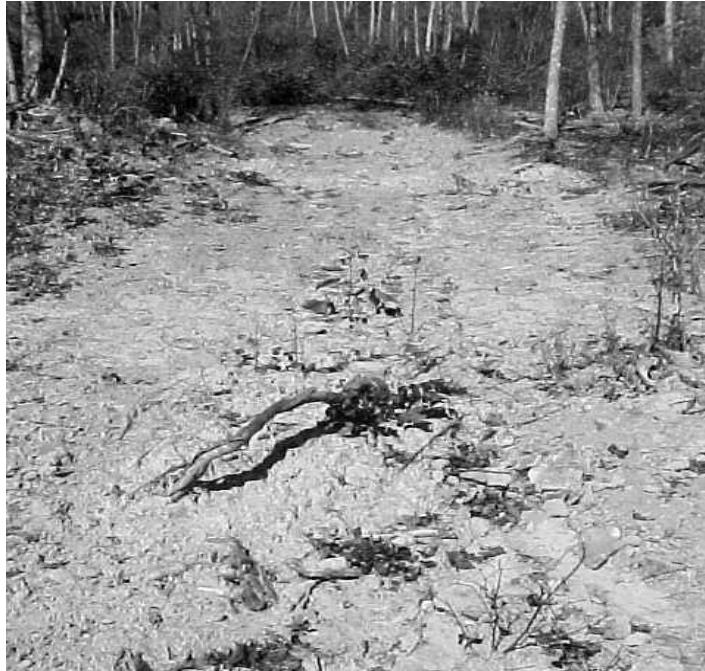
Figure 7. An example of a poorly constructed skid trail from a 1999 harvest in Grayson County, VA.

Disturbance categories within the tract was established in representative areas in addition to the representative disturbance category samples, erosion measurements were also taken at locations that were obviously eroding at a higher rate than the remaining site. These disturbance categories were classified as high-erosion samples and their erosion rate was averaged with a more representative sample within the tract. An example of a high-erosion disturbance category was typically where BMPs were absent or not implemented properly. Figure 7 provides an example of a high-erosion classification on a skid trail disturbance category on a tract in Grayson County, Virginia.

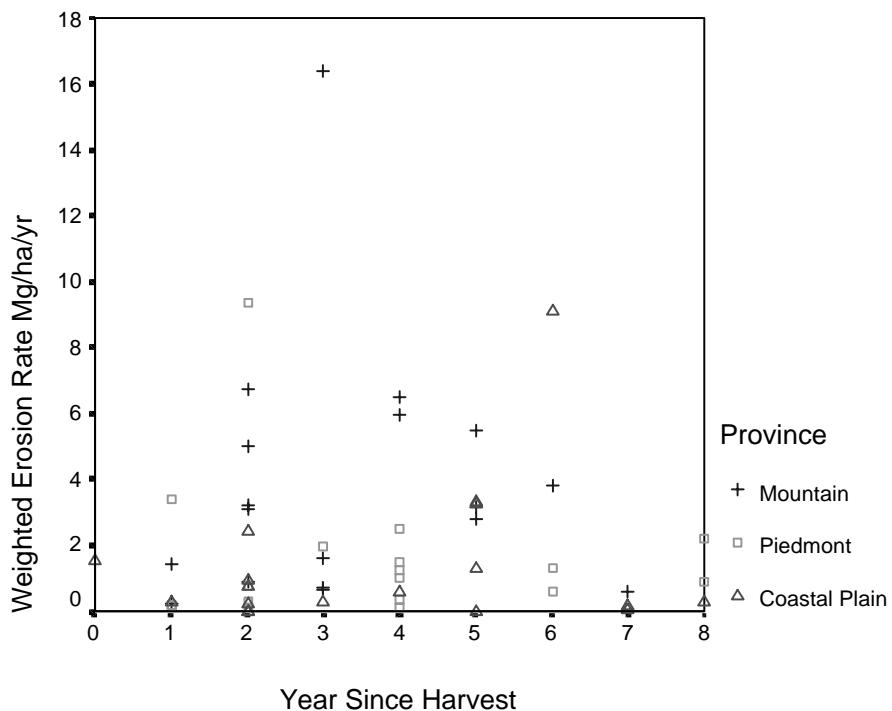
Figure 8. Weighted Erosion Rate Distribution by Physiographic Province.

Soil erosion rates were estimated using the Dissmeyer and Foster method for each of the representative disturbance categories (log deck, skid trail, access road, stream crossing, harvest, and control) within each harvested tract. Results from the calculated weighted erosion rates indicated that there were large variations in soil loss between and within provinces (Figure 8).

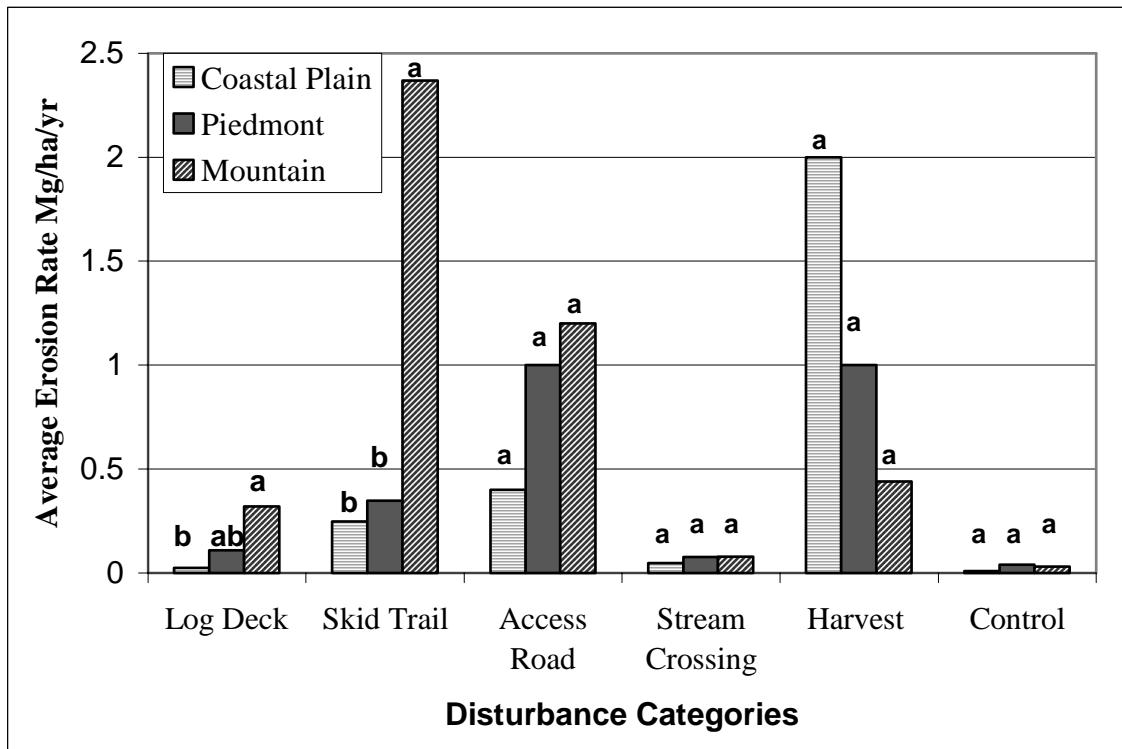
Figure 9. Average erosion rates from each disturbance category by physiographic province when extrapolated to the ratio of land that each disturbance category occupies.

The previous estimated soil loss values presented annual erosion in Mg/ha/yr, but these values do not account for the ratio or percentage, which are not the same for disturbance category area or percent relative to the total tract size. The erosion amount, by disturbance category in Mg/ha/yr accounts for the area that each disturbance category occupies within a tract. This erosion rate calculation provides the average erosion rate by multiplying the USLE erosion value by each disturbance categories percent of area within the total tract by physiographic province (Figure 9).

From the results of the multiple comparisons test, the obvious interpretation is that the average estimated erosion rates from all disturbance categories were far less than that from traditional agricultural practices. Mountain skid trails, which contributed the

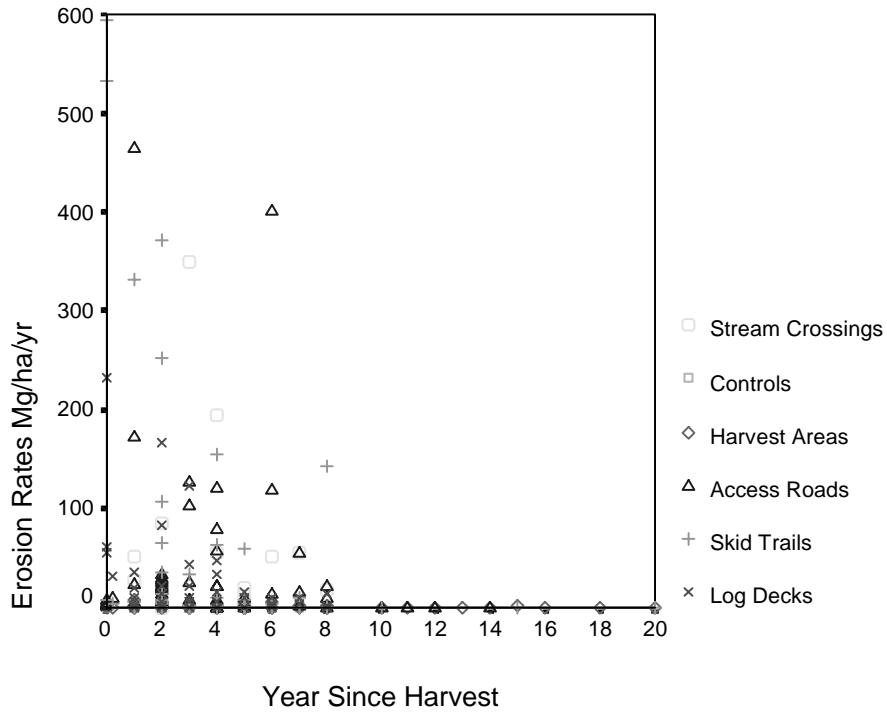
Figure 10. Disturbance category estimated erosion trends over time.

To better understand how timber harvest sites recover, a scatter plot was created to show erosion rate distributions for each disturbance category. Ongoing timber harvesting operation erosion rates as well as control tract erosion rates was included to illustrate erosion rates from of time of harvest to 20 years since harvest. Overall, erosion rate trends over time either indicated soil loss reduction or an increase (Figures 10).

Erosion trends decrease for the majority of disturbance categories over time. An erosion trend line was not produced for Figure 10 as a result of the data variability. Overall, all disturbance categories seemed to essentially recover between six and 10 years since harvest. Although there are some disturbance categories which exhibited higher values, they are still within the range of erosion rates found from other land uses.

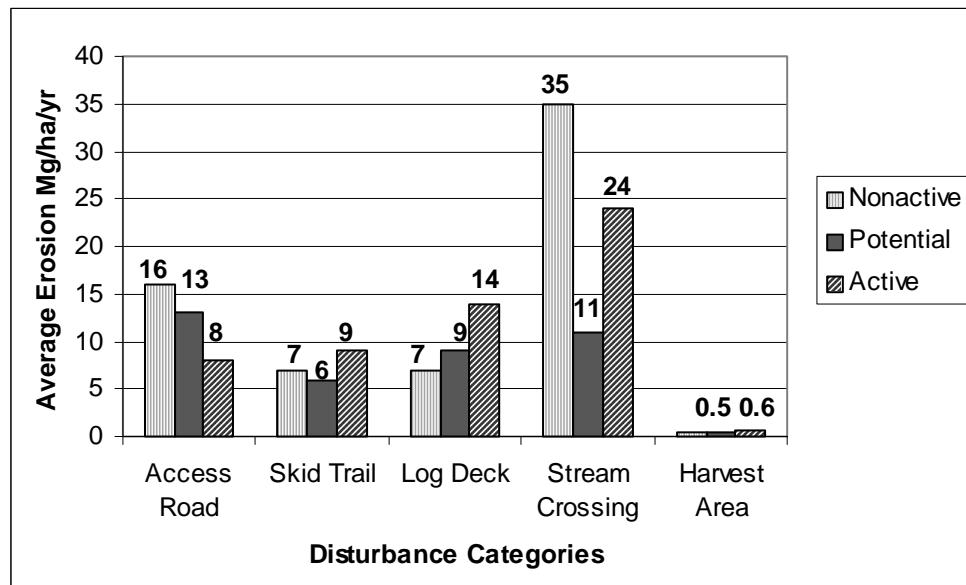
Figure 11. The average estimated erosion rates from each disturbance category by VDOF classification.

When displaying the data in graph form, the distribution of the average estimated erosion rate can clearly show which areas the VDOF are accurate in predicting water quality problems, and those areas that need further examination during the audit (Figure 11).

An expected erosion distribution would be a trend showing that nonactive tracts erode far less than potential, which erode far less than active. However, erosion rates vary regardless of VDOF classification. The erosion distribution from Figure 11 showed that VDOF audits did not correlate with the predicted erosion rates.

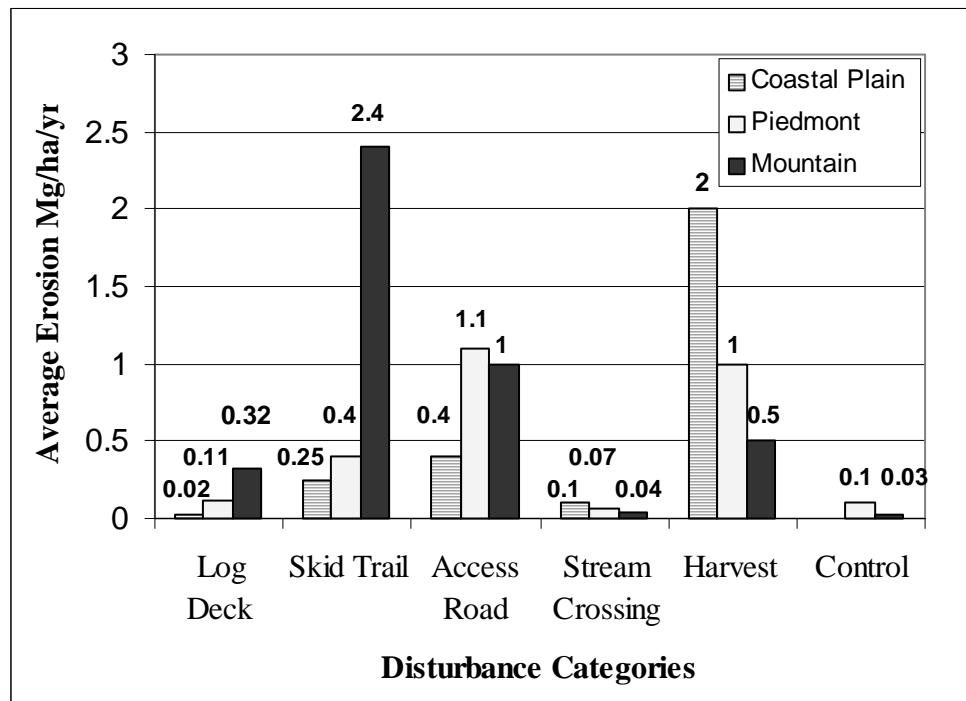
Figure 12. Average erosion rates by disturbance category and physiographic province based on VDOF classifications.

The estimated average erosion rates from the VDOF audits, based on the ratio of each disturbance category to the total tract area, were broken out by physiographic province (Figure 12).

The differences in erosion rates were assumed a result of erosion rate variability as well as the sample size for each disturbance category. For example, the harvest disturbance category is based upon 18 samples per province, while the stream crossing erosion rates were based upon five samples in the Coastal Plain and seven samples in the Piedmont as well as the Mountains.
