Chapter Four. Findings

Public house design

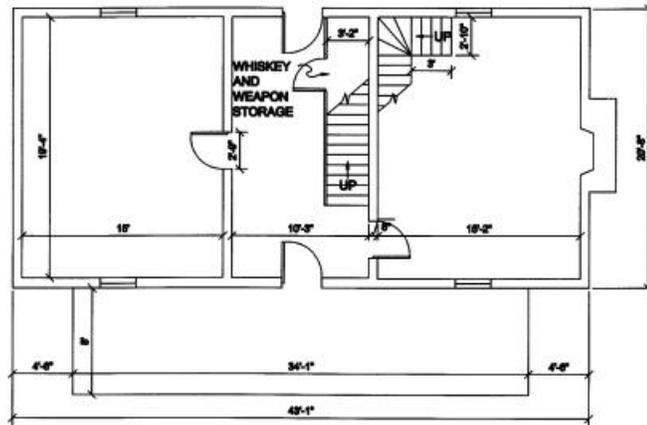
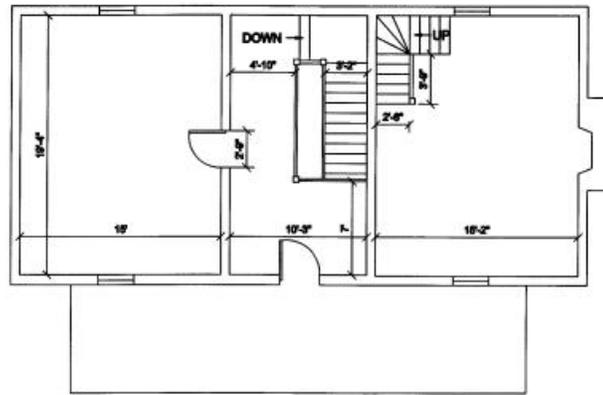
Figure 4.3. Floor plan of the original portion of Jesse Hall residence.

FIRST FLOOR PLAN

SECOND FLOOR PLAN

Upon entering the home, there is a central foyer with one room flanking either side (see Figure 4.3). Two rooms are located on each floor of the two floors, with some containing the original 8" pine floors. Originally wainscoting was located throughout the first floor. The current owner removed the wainscoting in the two rooms flanking the foyer. The 10'-0" x 19'-6" foyer retains the original wainscoting. The 32" high wainscoting is made up of two horizontal pieces of wood, 11" and 13 ¼" in width, a 6" baseboard and 1 ¾" trim. The two rooms flanking the foyer measure 15'-0" x 19'-6", with 9'-4" ceilings.

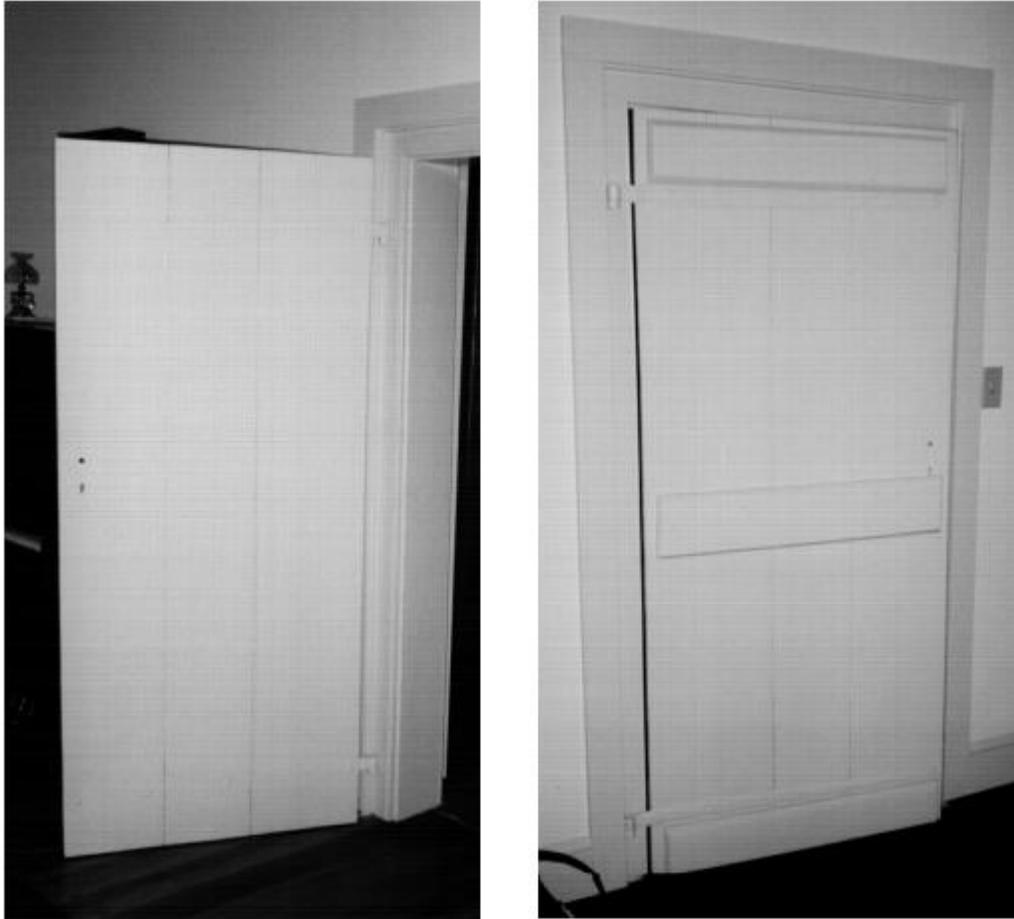
Figure 4.4. Original batten doors with full-length strap hinges.

Original batten doors are throughout the home, with reproduction full-length strap hinges made of common iron. The current owner stated that they had the hinges replaced to resemble what would have been original. The doors are typically 6'-4" tall, and 32" wide (see Figure 4.4). Six-inch baseboards and five-inch wide door casings are throughout the home.

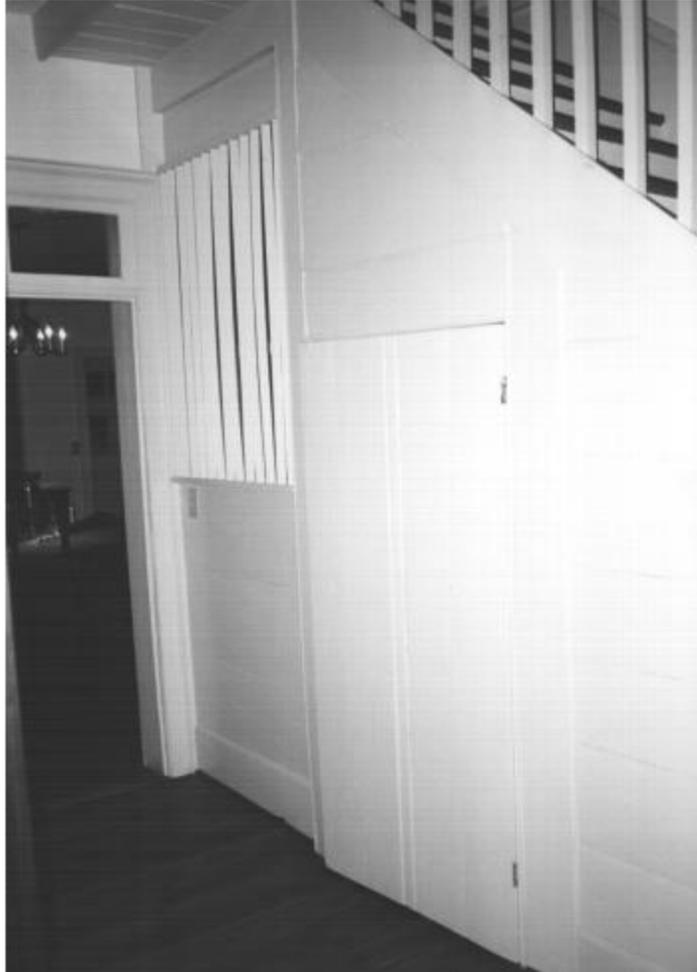
Figure 4.5. Possible storage area for whiskey and weapons located under the foyer stairway of the Jesse Hall's public house. Permission granted from homeowner.

One interesting feature is a storage area under the main stairway in the foyer (see Figure 4.5). The space below the stairs is enclosed, with a 33" by 46" ventilated opening and a

66” by 30” door. Thirteen identical vertical pickets partition off the area. Each picket is about 1 1/8” square, and positioned on a 45-degree angle. This area is similar in appearance to other storage areas described and photographed within public houses of the same period. For example, the Rising Sun tavern, located in Fredricksburg, Virginia, built in 1760, has a similar enclosed space with a picket opening (Sincock, 1992, 9). These unique storage areas have been identified as both a secure bar and a storage space for weapons.

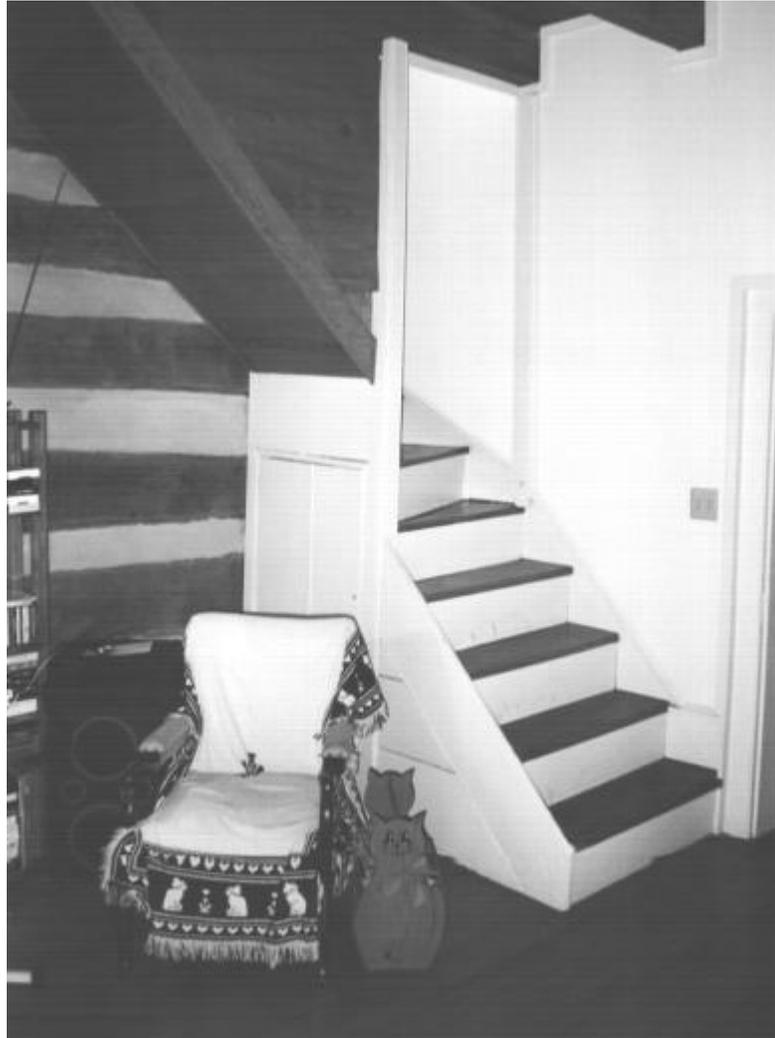
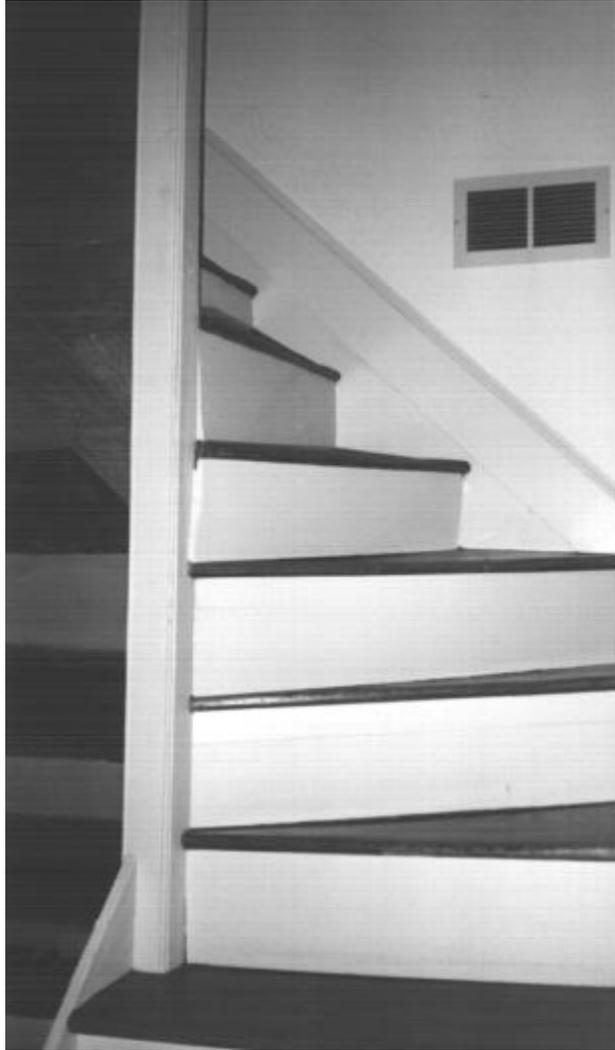
Figure 4.6. Second stairway in Jesse Hall public house.
Permission granted from homeowner.

Figure 4.7. Second stairway in Jesse Hall public house.
Permission granted from homeowner.

In addition to the stairway located in the foyer, there is a stairway in the room to the right of the front entrance (see Figures 4.6 and 4.7). The small 90-degree stairway leads to a room upstairs, and then on to the attic. Originally the only entry to the room above and the attic is by this staircase. This presents two scenarios for the purpose of the two staircases and the rooms closed to the hallway on the second floor. The family might have used this as a private stairway from their main living area to sleeping areas on the second floor and attic. With this arrangement, the family would have been secure, because they could have locked the door on the first floor, keeping patrons separate from the family.

Another possibility might have been the opposite. The family could have lived in the public space on the first floor during the day and then retired to the second floor by using the staircase in the foyer. The overnight guests would have stayed in the secure area on the second floor and would have used the attic for additional sleeping space. With the guests being in the secure area, the owner of the home could regulate their traffic and any outstanding bills.

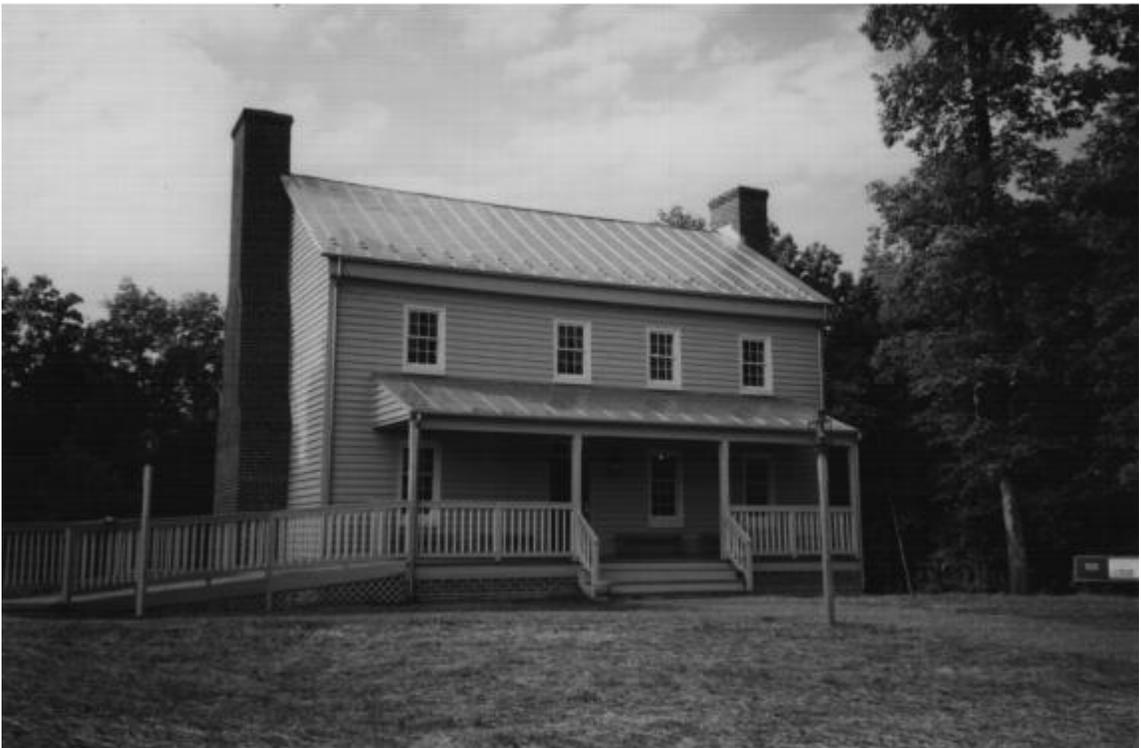
Figure 4.8. Brugh public house located in Virginia's Explore Park.
Permission granted from Mr. Scott Sarver.

The rectangular 2 ½ story log structure has a full basement, and a metal gable roof (see Figure 4.8). The rooms on both floors have over nine-foot ceilings, with walls of flat face nine-inch v-notched logs ranging from twelve to fourteen inches in width (see Figure 4.9). The two brick chimneys on either end of the house still function today. The existing mantels are not thought to be original to the house.

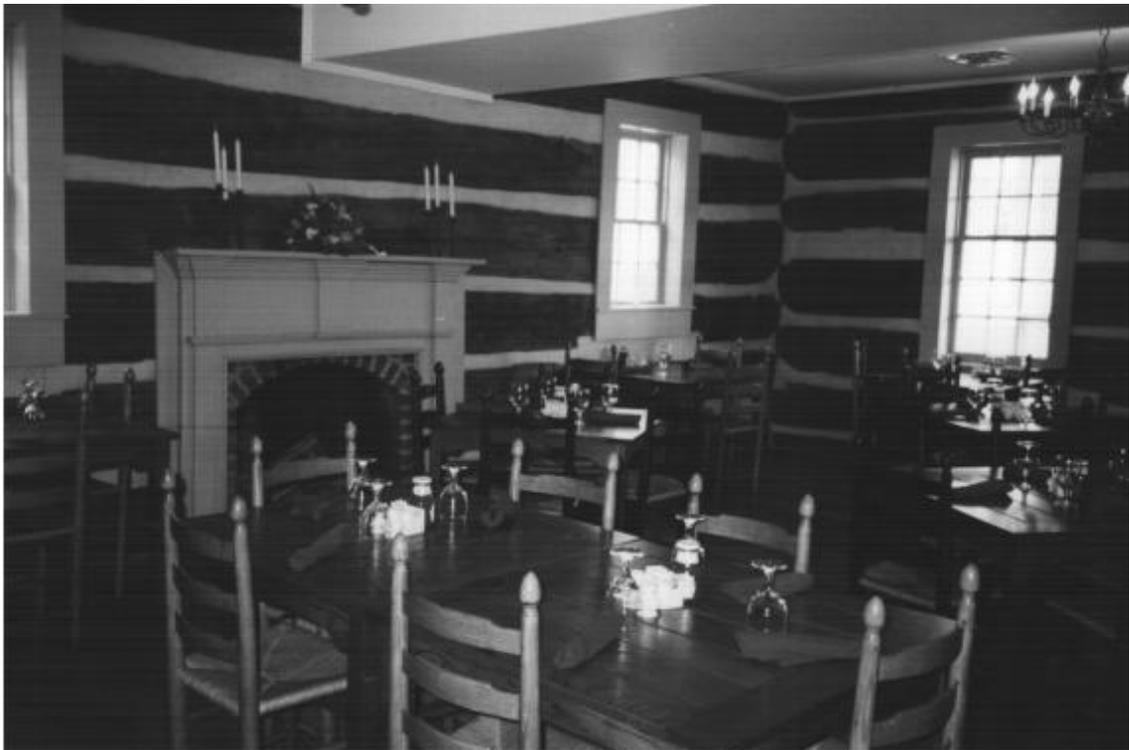
Figure 4.9. Interior of the room on the first floor, located on the right hand side of the Brugh public house. Permission granted from Mr. Scott Sarver.

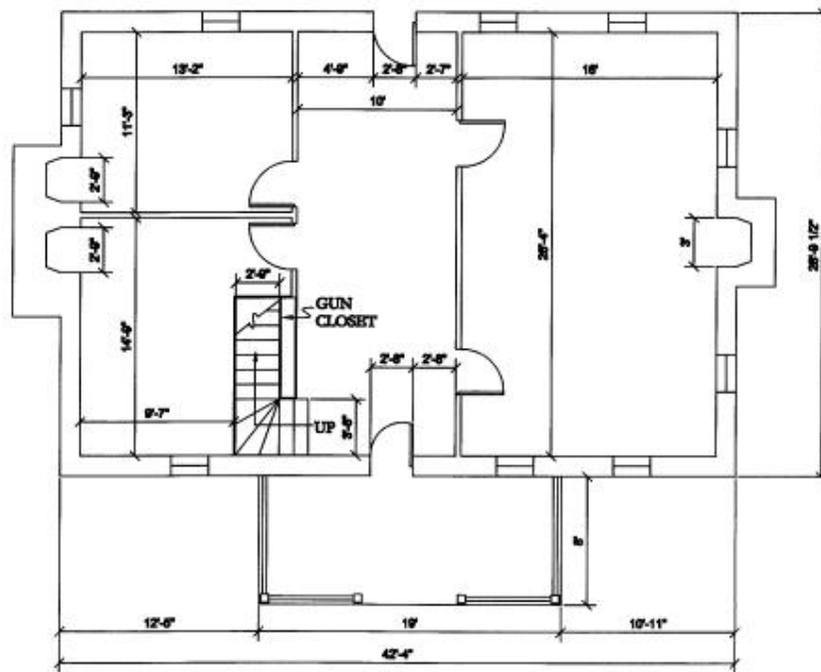
Figure 4.10. Floor plan of Brugh public house.

FIRST FLOOR PLAN

Like other houses in this study there is a central foyer with rooms flanking either side (see Figure 4.10). The foyer is 10'-0" x 26'-4", which contains a front and back door. Two rooms are located to the left of the foyer, and one to the right. Each of the three rooms have a fireplace. The chimney that flanks the left side of the house contains separate flues for each of the two smaller rooms. The spatial arrangement of the second floor duplicates the first floor.

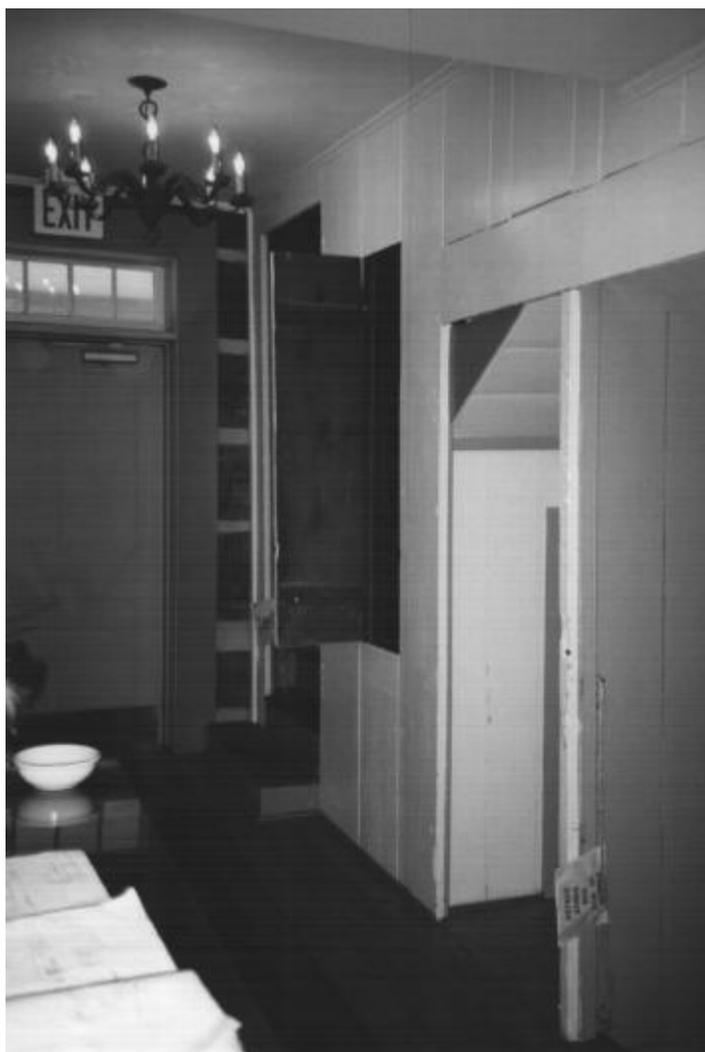
Figure 4.11. Storage area located under the stairway of the Brugh public house.
Permission granted from Mr. Scott Sarver.

The foyer of the Brugh Tavern has a boxed in stairway located at the front door similar to Jesse Hall's foyer stairs. Scott Sarver believes that this storage closet is where the guests would have stored their weapons (see Figure 4.11). The millwork in the house, including the mantels, wainscoting, baseboards, and casings, is not known to be original. Original 8" to 12" red oak floors are located on the second floor. The doors are not original, however batten doors with full-length strap hinges made of common iron have been replicated. The interior walls in the home are four inches thick, being made of boards.

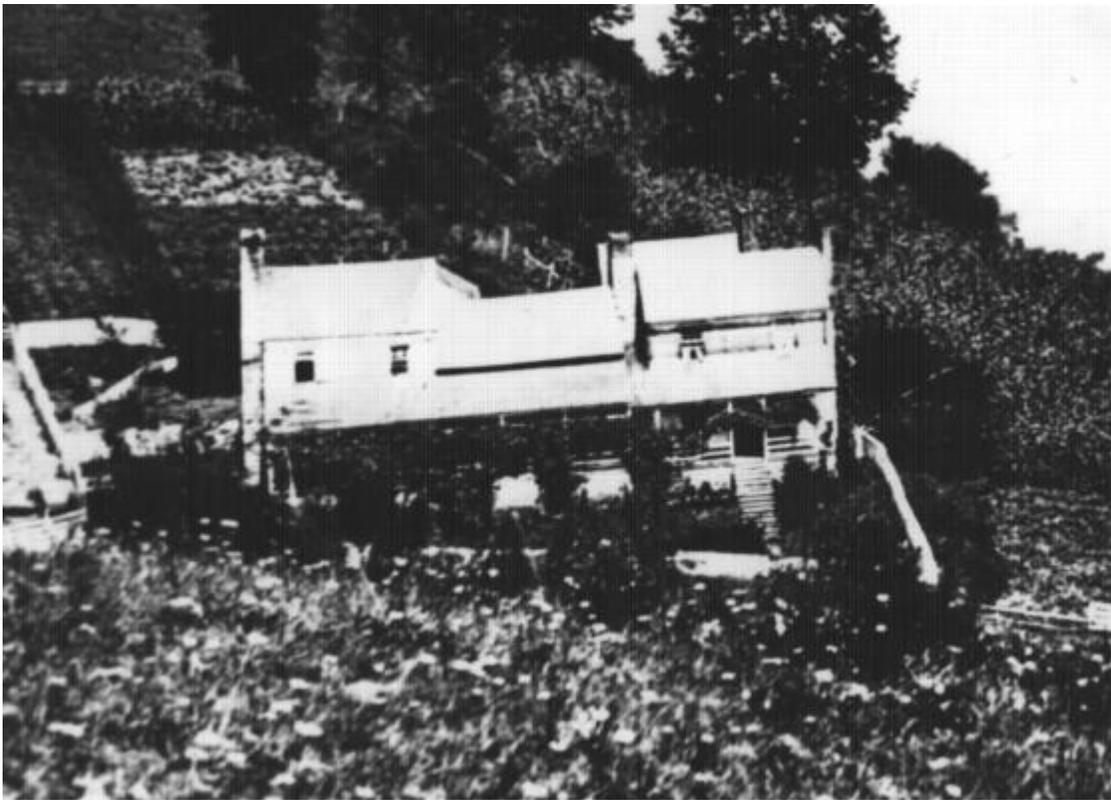
Western addition	Original structure	Eastern Addition
---------------------	-----------------------	---------------------

Figure 4.12. Original structure, with western and eastern additions of Ingles public house.

A photograph predating the demolition shows the second floor of the western addition to have two windows on the upper floor of the front façade (see Figure 4.12). Evidence of a

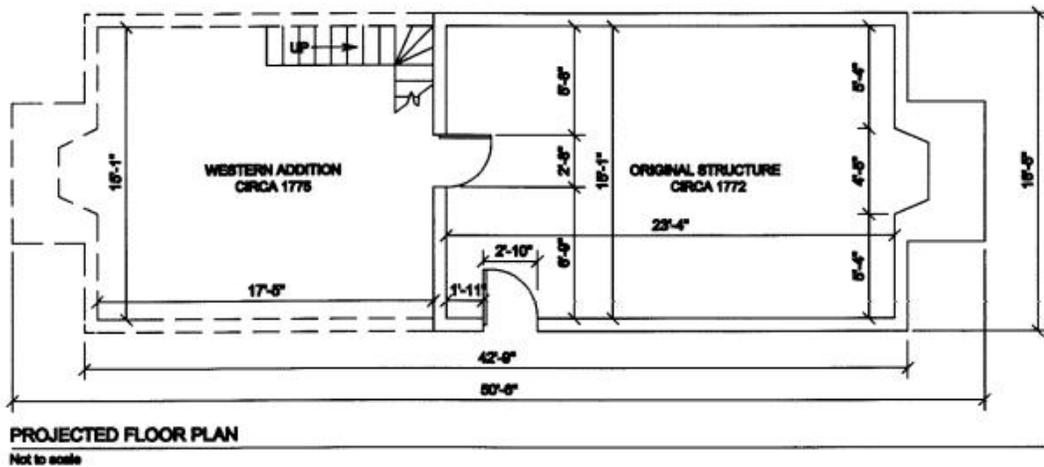
Figure 4.13. Projected floor plan of Ingles public house predating 1823.

staircase was seen on the exterior of the original section. From the ghost marks, a tread and riser height is evident, thus providing the actual size and location of the staircase (see Figure 4.19). The staircase would have led to the attic in the original section and the bedrooms in the addition (see Figure 4.13).

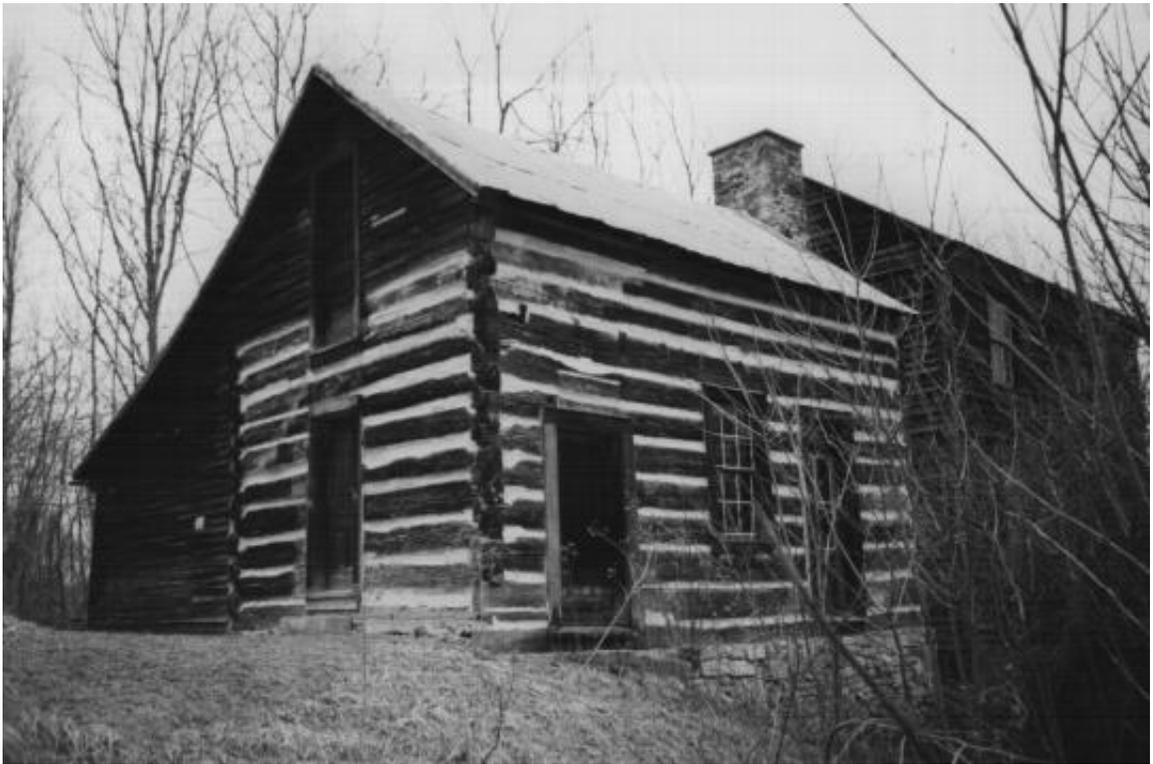
Figure 4.14. Existing Ingles public house, located in Radford, Virginia.

Visits to the site found the original 1 ½ story rectangular log section to have a metal gable roof and no cellar (see Figure 4.14). The seven-inch v-notched split face logs range from

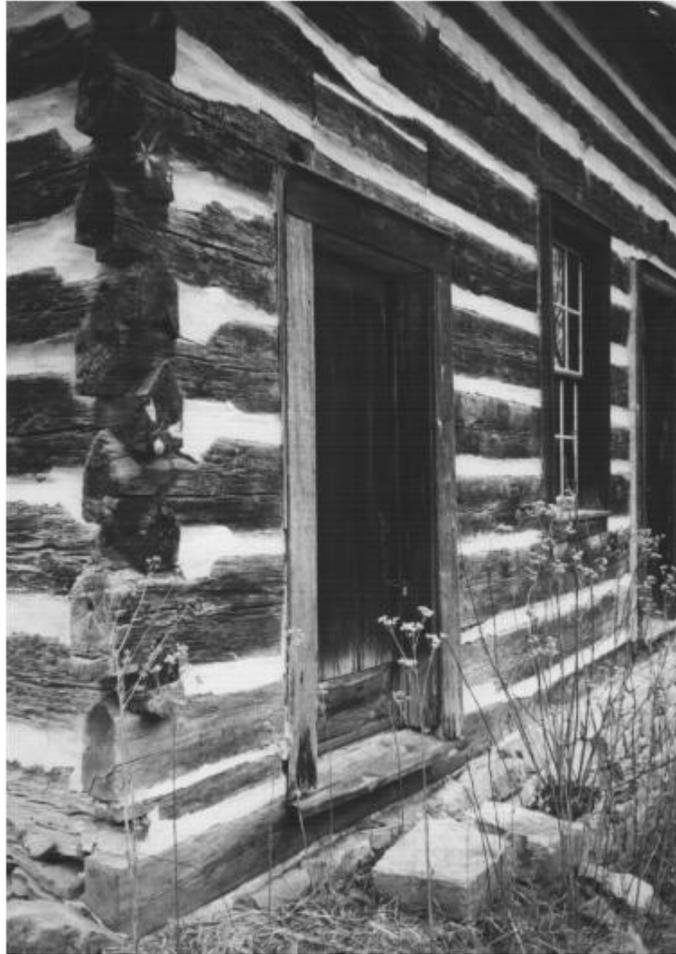
Figure 4.15. Original front entrance to the Ingles public house.
Permission granted from Mrs. Roberta Ingles Steele.

A means of access to the attic in the original section is unknown because there is no evidence of a stairway having existed. However, it is possible that the attic area was reached with the use of a ladder. The millwork, (mantels, wainscoting, baseboards, and casings) in the house is not known to be original. The floors are not original, although the batten entrance door (see Figure 4.15) is believed to be original.

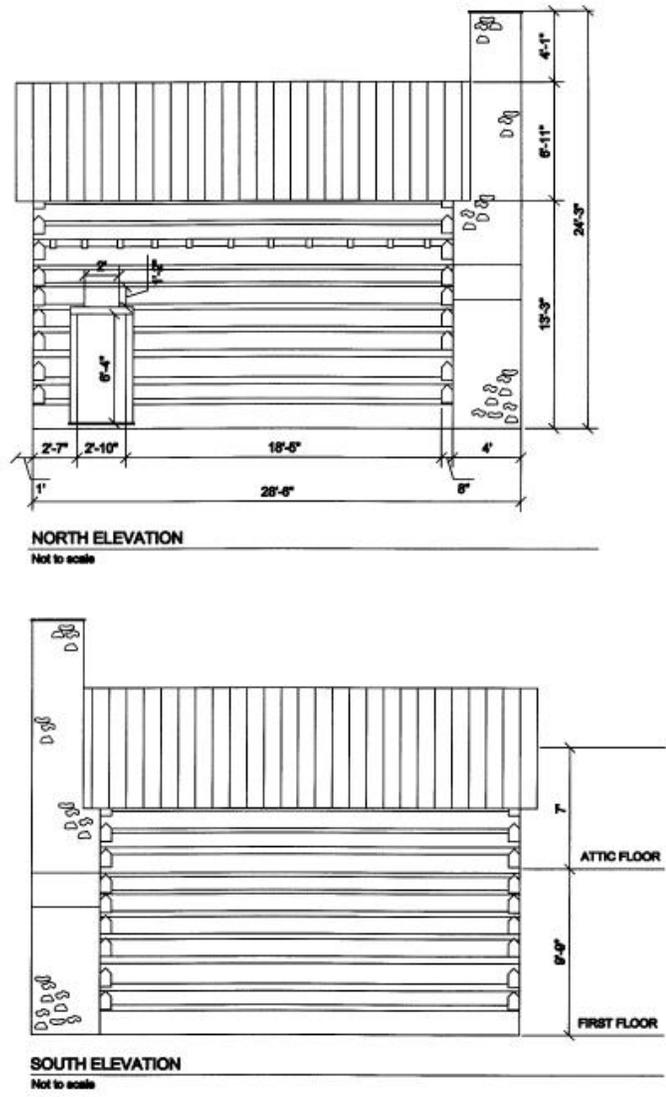
Figure 4.17. North and south elevation of Ingles public house.

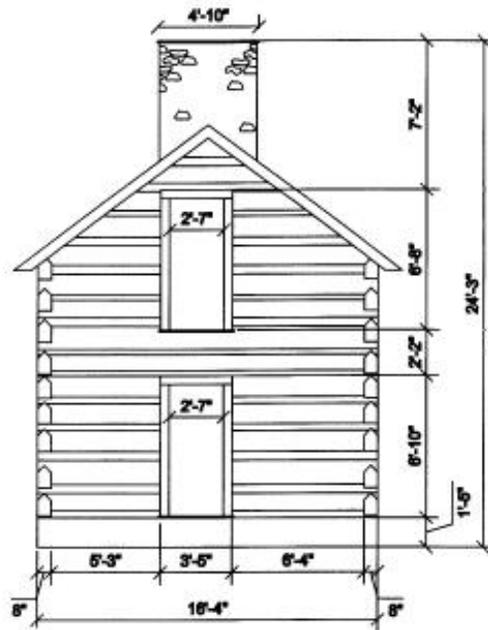
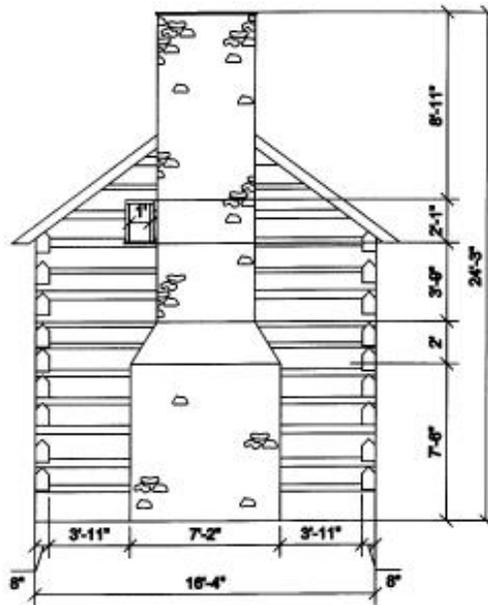
Figure 4.18. East and west elevation of Ingles public house.

WEST ELEVATION

EAST ELEVATION

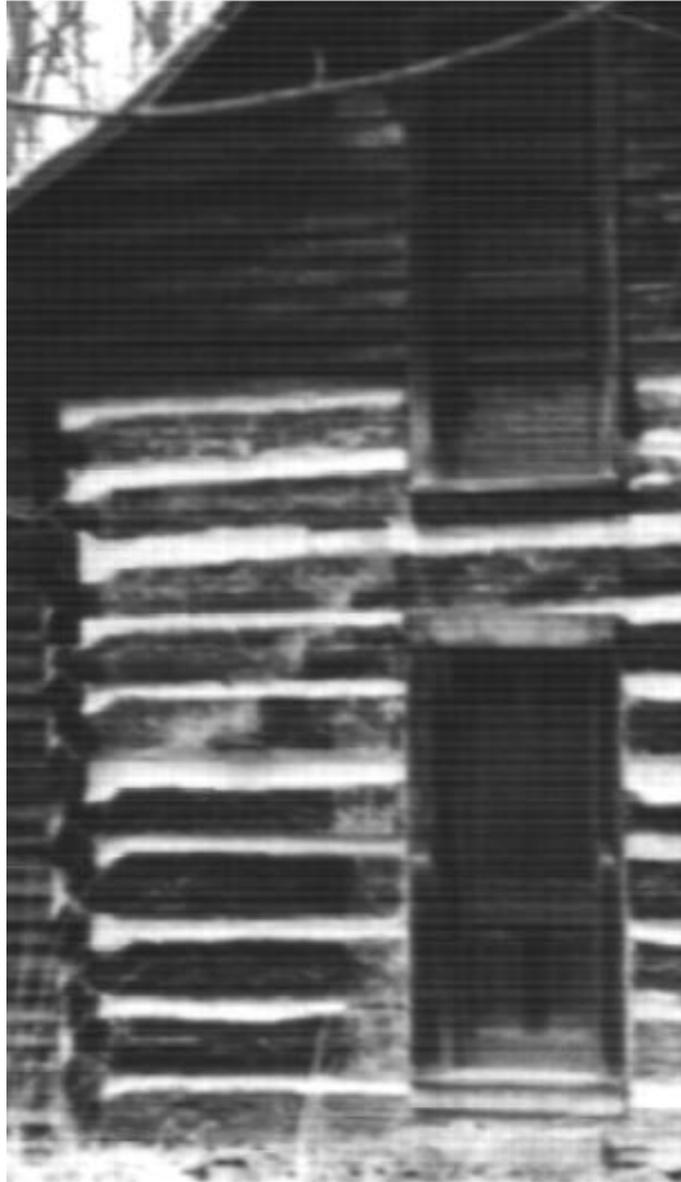
Figure 4.19. Ghost markings of previous stairway in Ingles public house, located in Radford, Virginia. Permission granted from Mrs. Roberta Ingles Steele.
