Chapter 2

Experimental Work

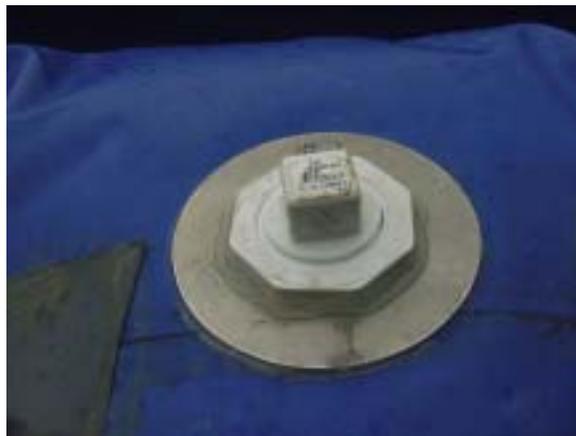
For the two new tubes, one release drain was installed 30 inches away from one end of the tube on the main seam. For this addition, a 2-inch circular hole was cut into the tube material. Aluminum washers 1/8-inch thick with a 4½-inch outer diameter and 2-inch inner diameter were then glued both on the underside and topside of the hole. The washers were attached using GOOP™ adhesive. A 2-inch to 1½-inch female pipe thread PVC drain was then placed on top of the topside washer such that the lip of the drain rested on the top of the outside washer. GOOP™ was then liberally applied to the connection areas where the drain and outside washer came in contact. A 1½-inch plug with teflon tape applied to the threads was then installed into the drain. This drain system, shown in Figure 2-1, allowed the tube to drain within ten minutes.

Figure 2-1: Release Drain Installed on Two New Tubes

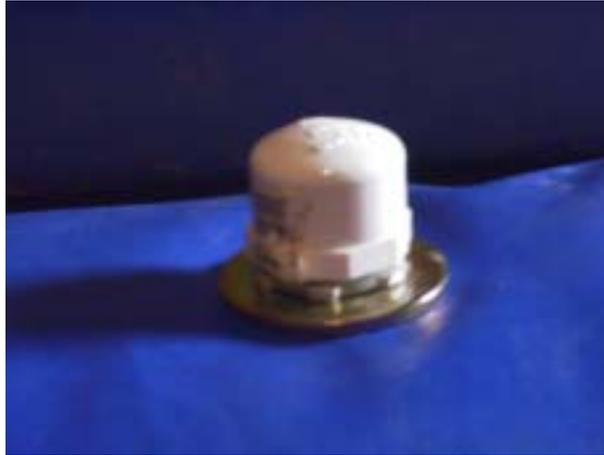
tube. Teflon tape was then applied to the threads of the reducer, and a 5/8-inch PVC cap was screwed onto the threads. This drain system was placed at both ends of the tube in order to expedite draining the tube. With this drain system, as shown in Figure 2-2, the tube could be drained within 30 minutes.

Figure 2-2: Release Drain Installed on Existing Tube

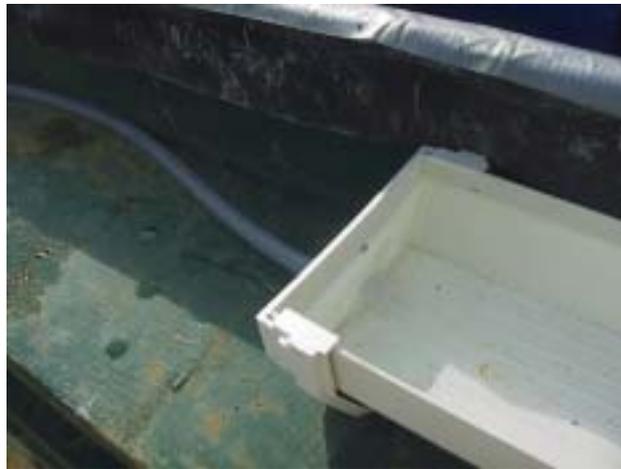
In order to connect the gutter sections, 3/8-inch inner diameter flexible tubing was extended from end cap to end cap. The end of the hose was inserted into one end cap through the hole previously drilled, then extended around the box corner to the adjacent end cap, inserted into that end cap, and snipped (see Figure 2-3). This process was continued until all gutter sections were connected with the hose material.

Figure 2-3: End Cap and Connecting Hose Used in Leveling Trough

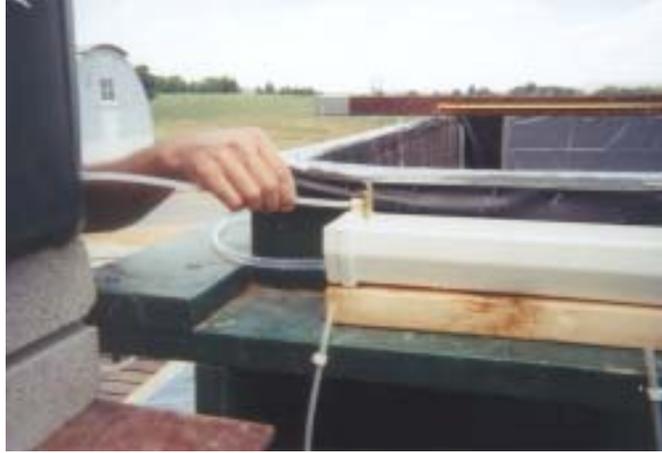
An inflow drip line and an outflow drip line were installed on the leveling trough system as well. The inflow drip line consisted of ¼-inch inner diameter polyethylene tubing extending from the reservoir system to an adjustable valve. The adjustable valve, as shown in Figure 2-4, was placed in the gutter section on the side nearest the reservoir system. During normal testing operations, the adjustable valve was opened such that the flow was approximately two drops of water per second.

Figure 2-4: Inflow Drip Line with Adjustable Valve

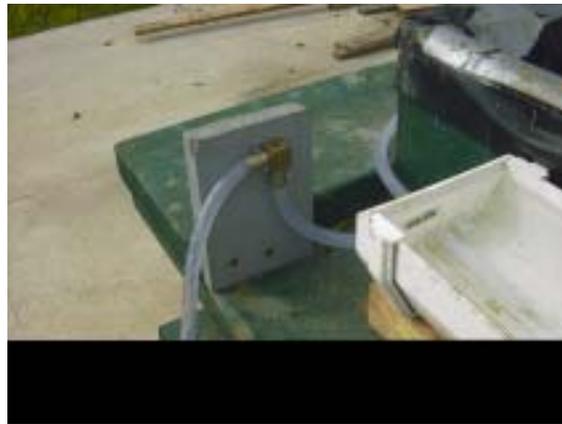
The outflow drip line consisted of 3/8-inch inner diameter flexible tubing extending from the gutter section opposite the inflow system to an elbow. The elbow was set at a constant elevation during testing operations. A piece of 3/8-inch inner diameter flexible tubing was attached to the elbow and extended away from the box area, as shown in Figure 2-5. In this manner, a constant head of water was maintained completely around the box.

Figure 2-5: Outflow Drip Line with Fixed Head Location

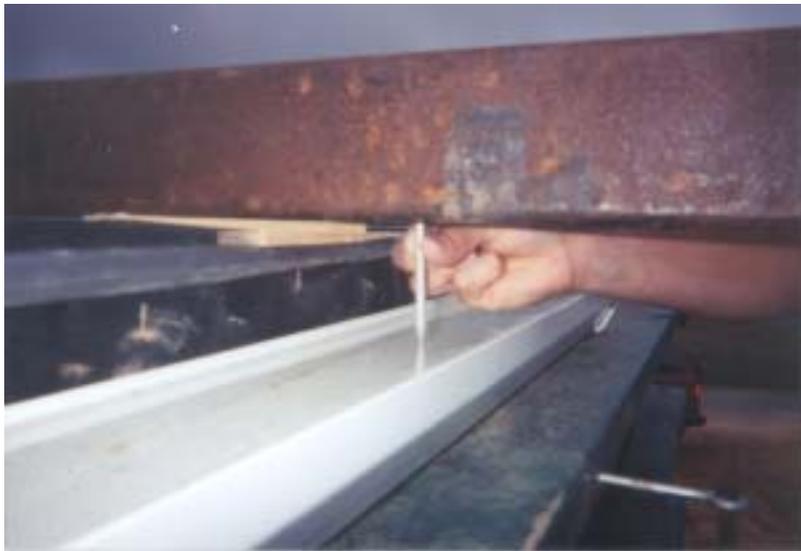
Next, the beam elevation was standardized in the vertical direction by using wooden shims and a measurement implement. The wooden shims had dimensions of 8 inches by 2 inches by $\frac{1}{2}$ inch (on the thickest end). The measurement implement consisted of an aluminum gutter spike cut down to a length of 3 inches. The shims were placed under the beam on each end where the beam touched the upper edge of the box. The gutter spike was placed perpendicular to the underside of the beam and referenced to the water level in the water trough system. If the end of the gutter spike extended into the water, then the beam was raised with the shims until the spike barely touched the surface of the water. This process was repeated on both ends of the beam, as shown in Figure 2-6. As a result, the measurement beam was aligned in the vertical direction.

Figure 2-6: Aligning of the Measurement Beam in Vertical Direction

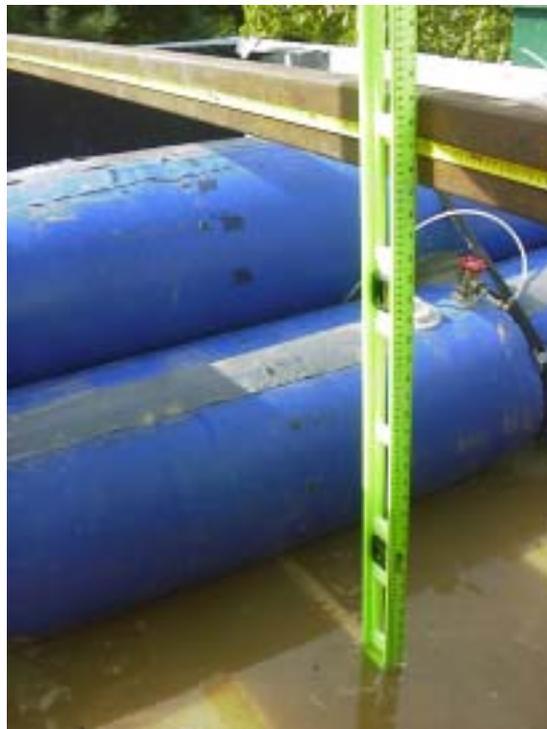
The locations at which the undersides of the tubes encounter the foundation material could not be obtained in the same fashion. For this reason, a special measurement tool was constructed in order to obtain these measurements. The tool was a 4-foot level with a yardstick glued to the end of the level. The yardstick was shortened to have dimensions of 12 inches by 1 inch. In order to obtain horizontal (X-coordinate) measurements in these critical locations, the yardstick end of the tool was inserted under the tubes to a point where the yardstick was wedged between the tube and the foundation material. The level was then plumbed in the vertical direction and the X-coordinate was noted. It was assumed that the Y-coordinate at these locations had the same value as the foundation material. Figure 2-7 depicts the measurement tool used to obtain these measurements. It should be noted that this measurement tool was not implemented into the measurement procedure until Trial 5 of the testing process.

Figure 2-7: Measurement Tool for Obtaining Measurements Under the Tubes

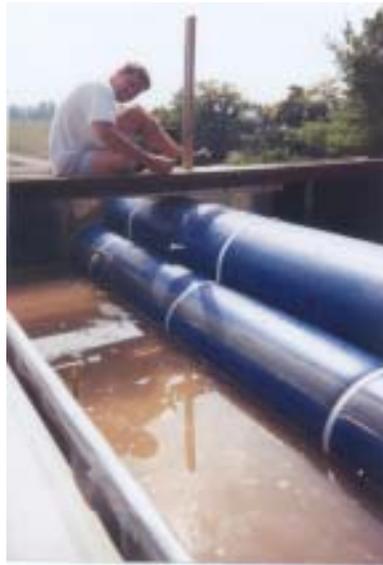
All measurements were recorded in metric values. Figure 2-8 illustrates the procedure for taking measurements.

Figure 2-8: Measurement Procedure Using Plumb Bob

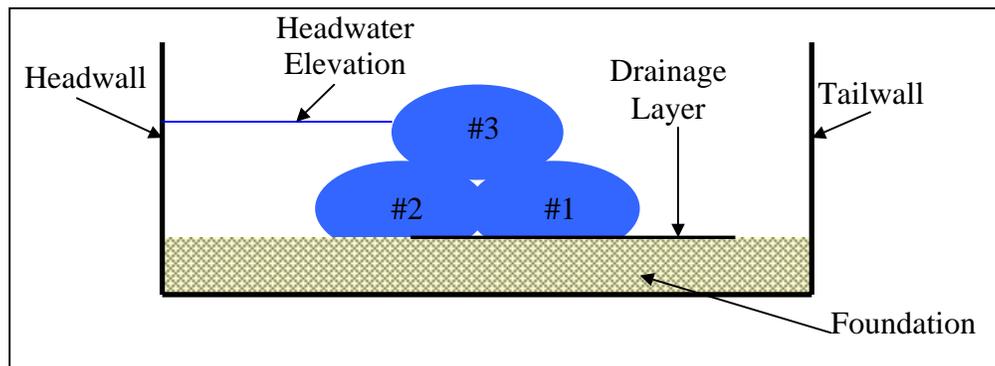
A configuration of three tubes was utilized with the goal of resisting higher headwater elevations than those achieved by a single tube. The configuration consisted of two tubes placed side by side, with a third tube placed on top and resting in the depression between the other two tubes. The important issues related to this configuration were the strapping system used to hold the tubes together, the location of the drainage layer, and end friction considerations. The stacked configuration has a typical cross section as shown below in Figure 2-9.

Figure 2-9: Typical Cross Section of Three-Tube Configuration

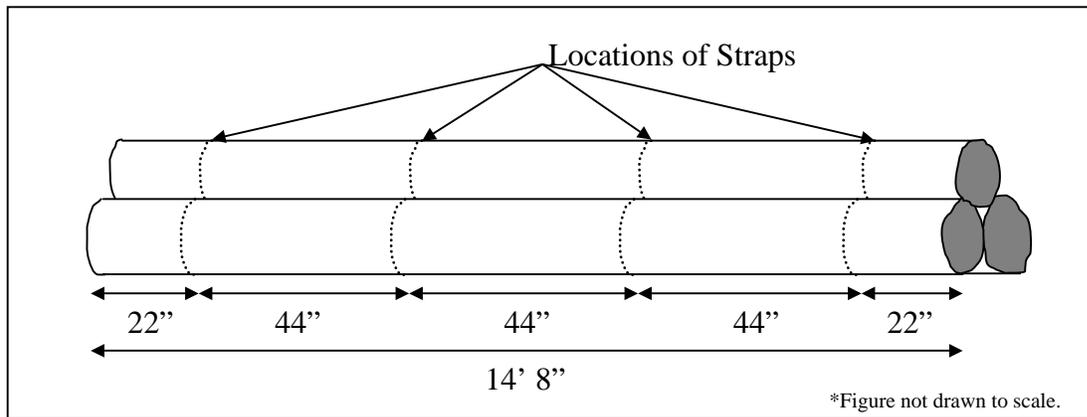
tubes. With the upper tube resting on the bottom two tubes, it was necessary to provide restraint so that the bottom two tubes did not roll away from one another. Also, the strapping system had to sufficiently grasp the tubes so that the tubes did not roll within the strapping system, thereby constituting a rolling-type failure. The strapping system consisted of four sets of straps, located at strategic locations along the longitudinal lengths of the tubes. The locations of the individual straps are depicted in Figure 2-10. Different strapping systems were utilized throughout the testing program and will be discussed in subsequent sections. It should be noted that while different strapping systems were utilized for different trials, the location of each strap along the longitudinal lengths of the tubes did not change from trial to trial.

Figure 2-10: Locations of Straps along Longitudinal Length of Tubes

The strapping system was placed in four separate locations, as previously displayed in Figure 2-10. Figure 2-12 shows the strapping system, at any one location, as it wraps around the tubes.

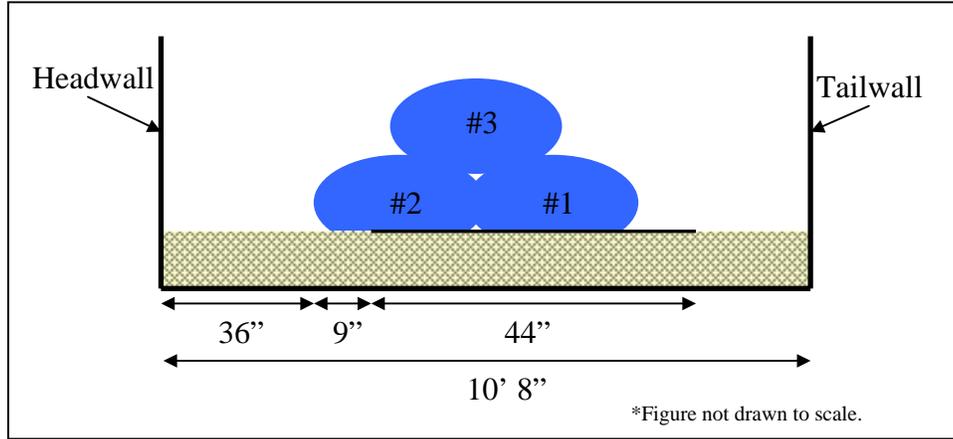
The strapping system for Trial 1 consisted of a 1-inch wide nylon strapping with a maximum tensile force capacity of 500 lbs. Approximately four separate sections of this nylon strapping

Figure 2-11: Cross Section of Trial 1 Setup

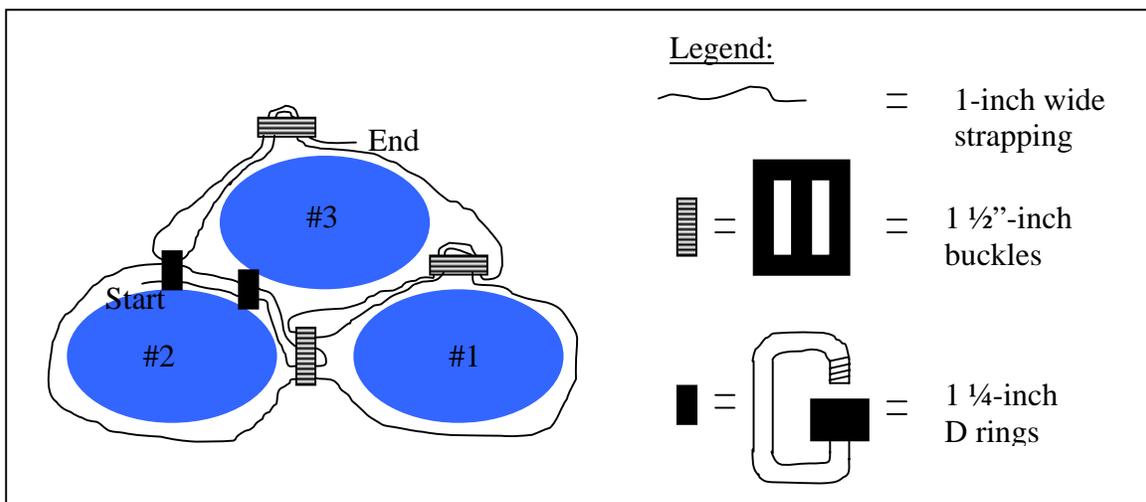
Figure 2-12: Strapping System for Trial 1

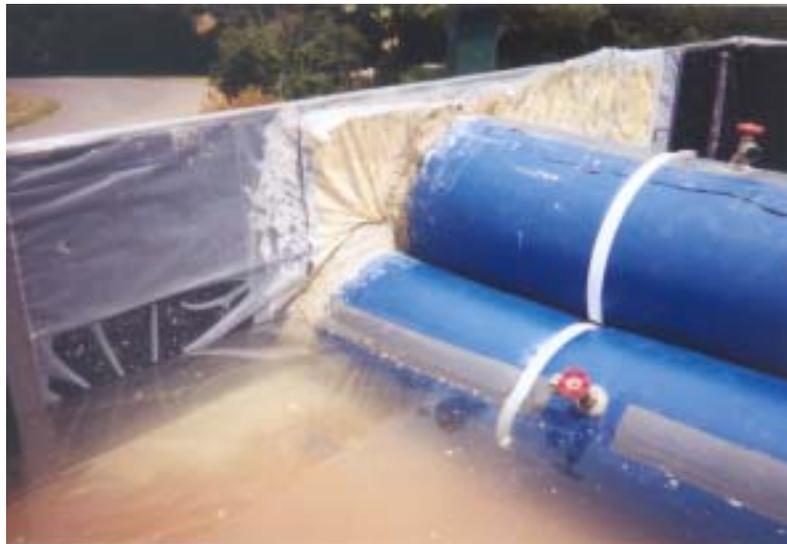
From the 0-inch to 5-inch headwater increments, the three-tube configuration moved only slightly. It was not until the 10-inch headwater elevation was achieved that movements were significant. At the 10-inch headwater elevation, tube #2 had noticeably rotated away from the rising headwater in a clockwise manner. This caused the plastic sheeting on the sidewalls to rotate as well, as depicted in Figure 2-13. It was apparent that because of this large amount of movement, the bentonite paste along the sidewalls would have to be constantly monitored to ensure that it would not separate from tube #2 and the sidewall. In addition to this, the tailwater elevation increased to an elevation of 1 inch above the sand elevation.

Figure 2-13: Tube #2 Rolling Away from Headwater at 7.5-Inch Water Height in Trial 1

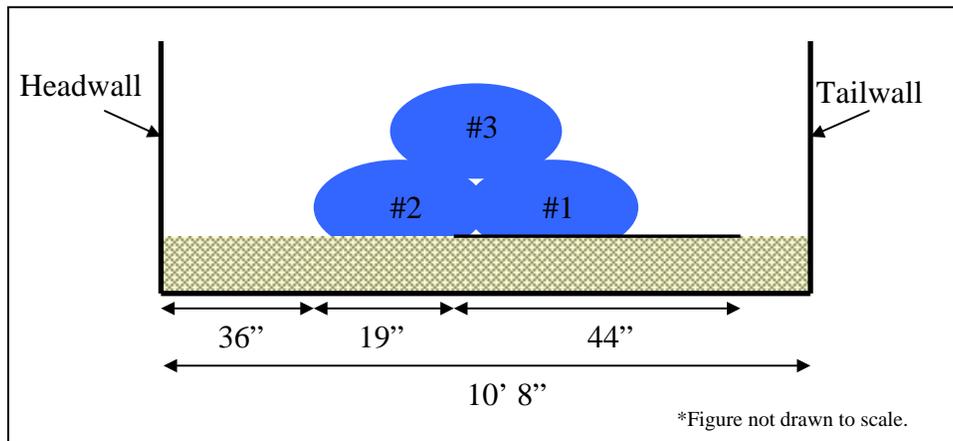
The preliminary setup locations for this trial concerning the three-tube configuration and the drainage layer are depicted in Figure 2-14. The drainage layer was placed under the bottom two tubes so that the leading edge of the drain was 19 inches from the vertical tangent of tube #2 on the headwater side. The trailing edge of the drainage layer extended 44 inches to the right of this point under tube #2 and tube #1 and into the tailwater side of the box. Tube #2 was placed such that the vertical tangent of the tube on the headwater side was 36 inches to the right of the headwater side of the box. Tube #1 was then placed to the right of this point such that tube #1 and tube #2 were in contact with one another on their vertical tangents. Next, tube #3 was placed in the depression formed by tube #1 and tube #2. The exact dimensions of the tubes relative to one another can be found by referencing Appendix A for Trial 2 for a headwater elevation of 0 inches.

Figure 2-14: Cross Section of Trial 2 Setup

For Trial 3, the preliminary setup locations concerning the three-tube configuration and the drainage layer were the same as Trial 2, depicted in Figure 2-14. The exact dimensions of the tubes relative to one another can be found by referencing Appendix A for Trial 3 for a headwater elevation of 0 inches.

For Trial 4, the preliminary setup locations concerning the three-tube configuration and the drainage layer were the same as for Trial 2, depicted in Figure 2-14. The exact dimensions of the tubes relative to one another can be found by referencing Appendix A for Trial 4 for a headwater elevation of 0 inches.

For Trial 5, the preliminary setup locations concerning the three-tube configuration and the drainage layer were the same as for Trial 2, depicted in Figure 2-14. The exact dimensions of the tubes relative to one another can be found by referencing Appendix A for Trial 5 for a headwater elevation of 0 inches. The strapping system used in this trial was identical to that for Trial 4. A diagram of the strapping configuration can be found in Figure 2-19.

For Trial 6, the preliminary setup locations concerning the three-tube configuration and the drainage layer were the same as for Trial 2, depicted in Figure 2-14. The exact dimensions of the tubes relative to one another can be found by referencing Appendix A for Trial 6 for a headwater elevation of 0 inches. The strapping system used in this trial was identical to that for Trial 4. It is diagrammed in Figure 2-19.

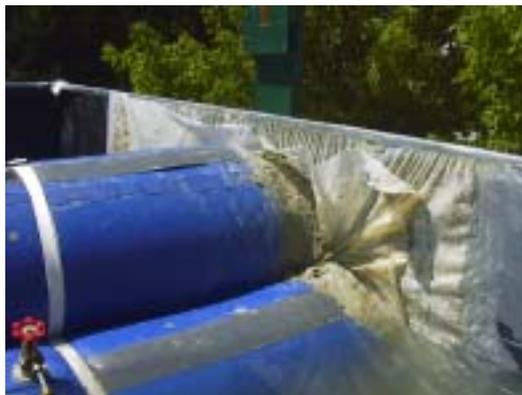
The amount of lateral movement that the three-tube configuration underwent from the 0-inch to the 7½-inch headwater elevation was approximately 2 cm. From the 7½-inch increment to the 15-inch increment, the three-tube configuration moved much more. From observations of the plastic sheeting on the sides of the box, the tubes were rolling away from the headwater. An example of the tubes rolling on the sides of the box is shown in Figure 2-15. In order to take measurements at the 15-inch headwater elevation, two hoses were required to provide flow into the headwater side of the box to maintain a constant headwater. A large amount of headwater was then moving beneath or around the tubes and making its way to the tailwater side of the box.

Figure 2-15: Rotation of Tube #2 Against Sidewall of Box at 10-Inch Water Height in Trial 2

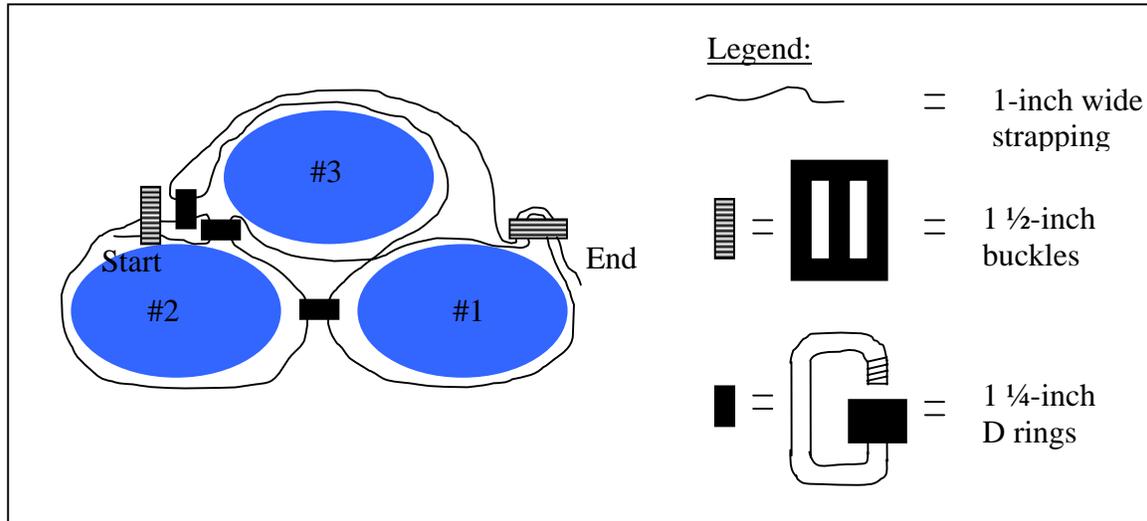
strap system the tubes might initially move, but would stop moving after the strapping system had increased the pressure within the straps. Figure 2-16 depicts the strapping system for Trial 3.

Figure 2-16: Strapping System for Trial 3

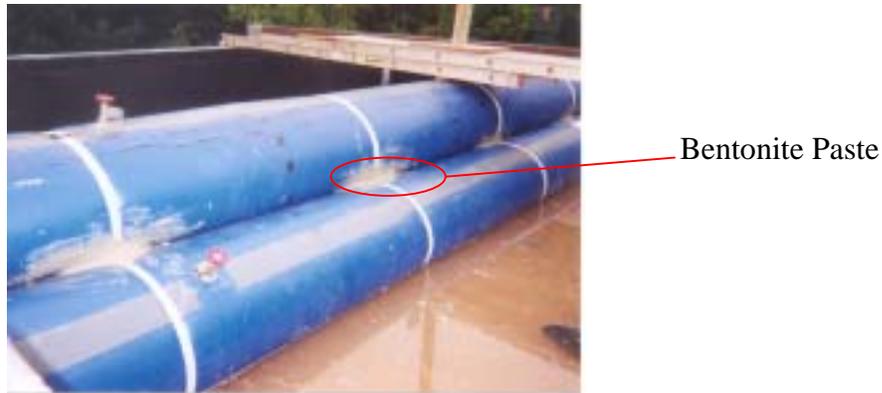
As a consequence of using this new strapping system, bentonite paste was added to the locations where the strapping system of tubes #2 and #3 encountered one another. This was done in order to prevent leakage of headwater between tube #2 and tube #3. The bentonite paste was liberally applied to the areas where the strapping system tied into tube #2 and then rose vertically over tube #3. Figure 2-17 illustrates the location and amounts of bentonite paste applied to these locations.

Figure 2-17: Bentonite Paste Applied to Tube #2 and Tube #3 in Trial 3

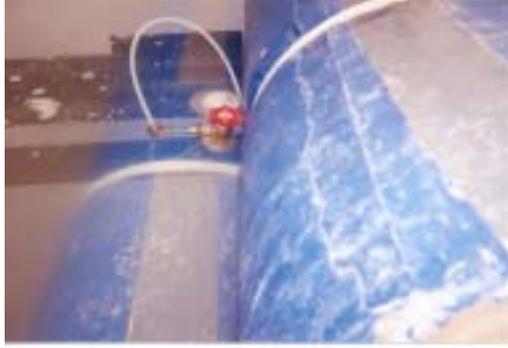
The tube deformation measurements from this trial indicate that there was minimal movement of tube #1 and tube #3 as the headwater was raised from 0 inches to 10 inches. Unfortunately, the buckles used in the strapping system still allowed tube #2 to roll within the straps away from the headwater. The 1½-inch buckles were slipping throughout the strapping system and this caused the rolling of tube #2 (see Appendix A for a complete set of figures for this trial). After taking measurements at the 10-inch headwater elevation, the headwater was increased to the 17-inch elevation. At this point, the rolling of tube #2 was so considerable that the valve connections on top of tube #2 were at risk of being sheared off by tube #3, as shown in Figure 2-18. For this reason, Trial 3 was stopped at the 17-inch headwater elevation.

Figure 2-18: Valve on Tube #2 Nearly Sheared Off by Tube #3 in Trial 3

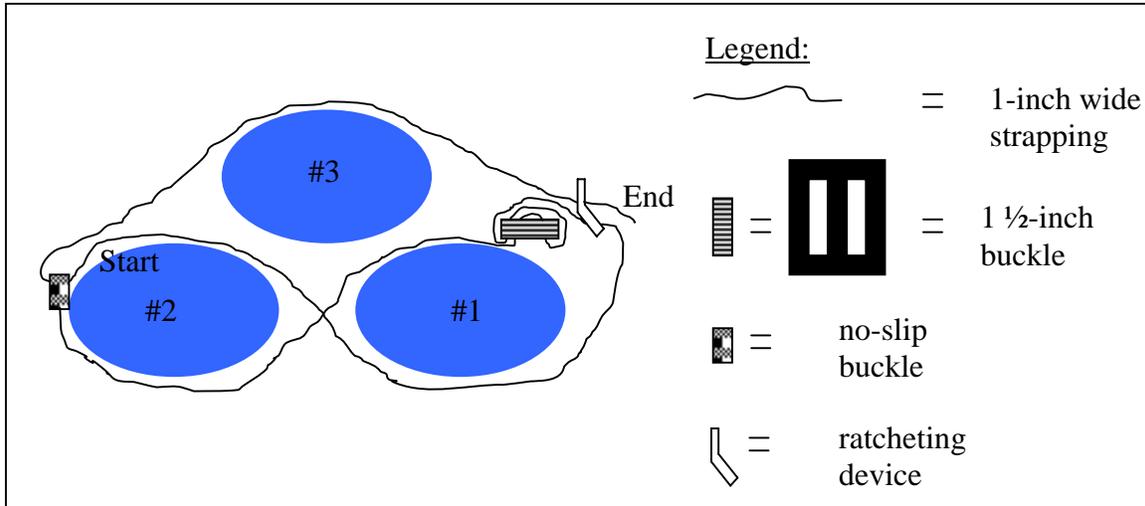
With this strapping system, it was once again necessary to apply bentonite paste to the contact areas of tube #2 and tube #3 at the strapping system locations. This was needed in order to prevent the headwater from escaping through the indentation provided by the strapping system. Figure 2-22 illustrates the bentonite paste after it has been applied to the areas between tube #2 and tube #3. The process of applying the bentonite paste to the strap locations was continued for each of the subsequent trials.

Figure 2-19: Strapping System for Trial 4

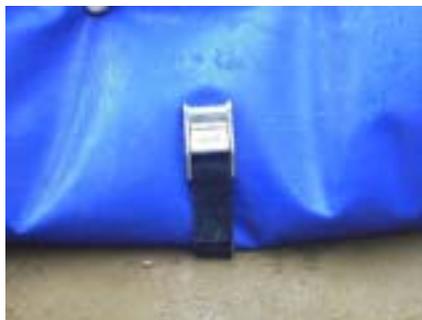
Figure 2-20: No-Slip Buckle

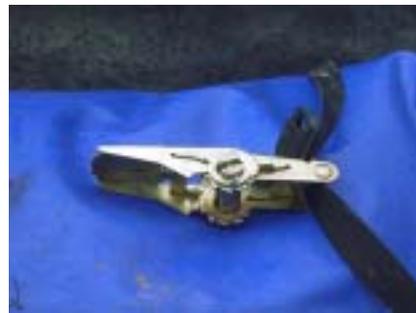
Figure 2-21: Ratcheting Device

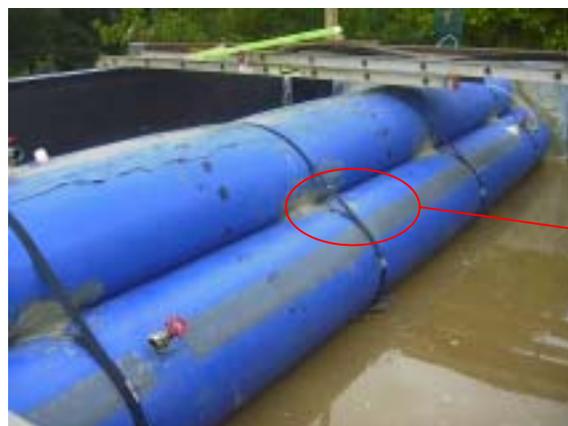
Figure 2-22: Bentonite Paste Applied to Strap Locations on Tube #2 and Tube #3 in Trial 4

Bentonite Paste

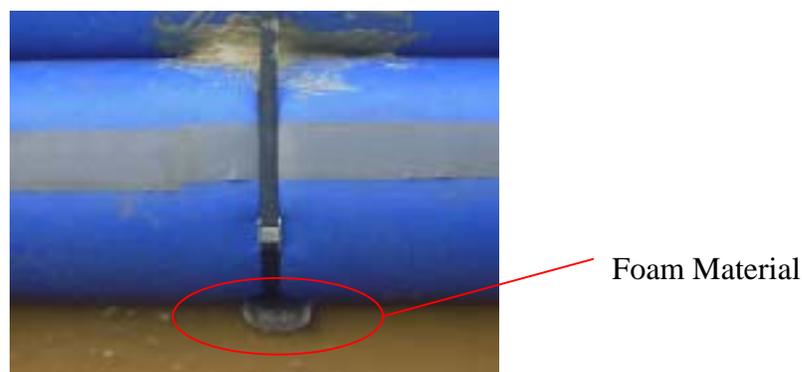
In order to overcome the piping failure present in Trial 4, foam material used in plumbing applications to insulate copper pipes was introduced. The foam material was placed on top of the sand foundation in the areas where the strapping system wrapped under tube #2. The foam extended under the tubes at the strap locations and up onto the drainage layer. Dimensions of the foam were approximately 4 inches wide, ½-inch thick, and 18 inches in length. To ensure a smooth transition from the foundation material to the foam material, the foam was tapered along both sides of its 18-inch length. Somewhat compressible, this foam material was expected to prevent piping. Figure 2-23 depicts the foam material under tube #2 at a strapping location.

Figure 2-23: Foam Material under Strapping System in Trial 5

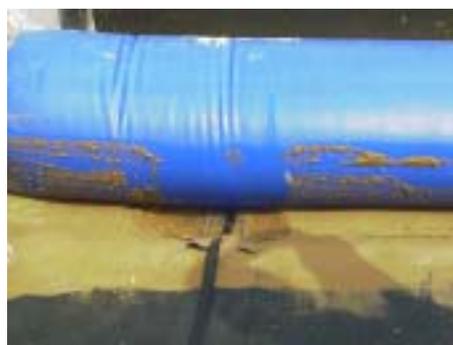
As in all trials, initial measurements were taken at the 0-inch headwater elevation. The headwater elevation was then increased, but only to the 4-inch headwater elevation before failure occurred. Once again, piping was evident at all four strapping locations. At a mere 4 inches of headwater, piping had inflicted a destructive effect on the foundation. The trenches created by the piping left depressions in the soil approximately 2 inches deep, 6 inches wide, and 20 inches in length. Apparently the cushion material was not adequate to keep the sand foundation particles from being piped away. Figure 2-24 depicts the effects of the piping failure on the sand foundation material.

Figure 2-24: Piping Failure at Strap Locations in Trial 5

It was determined that there were two issues from Trial 5 to overcome in future tests. First, the foam material must be more compressible. It was believed that the weight of the tube did not compress the material enough to provide a smooth transition from the foam to the soil foundation. However, a more compressible material may not provide adequate pressure on the sand to contain the sand particles and prevent piping. Second, it was conceivable that due to repeated testing and piping failures, the top 2 inches of foundation material had become weak and unstable. Prior to Trial 6, the top 2 inches of the sand foundation would need to be recompact.

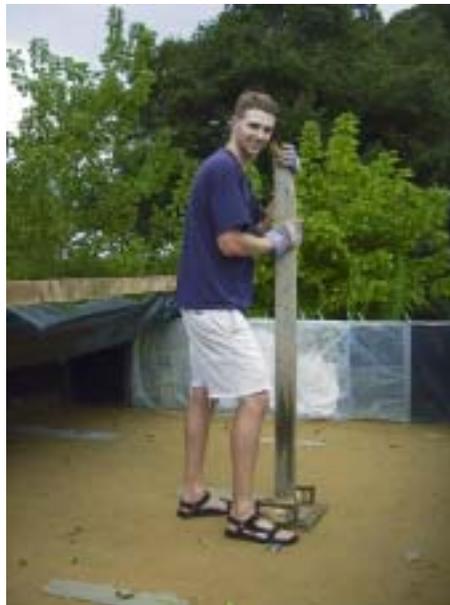
Before any additional methods were employed to prevent the piping failure of the previous trials, it was decided to recompact the top 2 inches of the sand foundation material. For this, two compaction methods were implemented. First, a vibratory plate compactor (WACKER™ BPU244A) was used to initially compact the sand with a total of three passes in the longitudinal direction. Next, a flat plate hand compactor compacted the sand along the edges of the box. The square flat plate had side dimensions of 15 inches and a weight of 25 pounds. Figure 2-25 illustrates the flat plate hand compactor in operation.

Figure 2-25: Flat Plate Hand Compactor in Operation

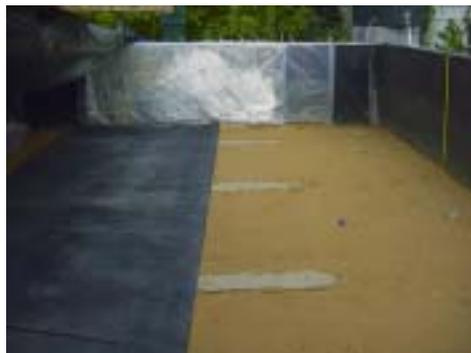
bentonite cutoff trench located beneath each strap location would prevent piping. This would be similar to the treatment of the tube ends along the sides of the box. Therefore, four of these trenches were installed in the box at the locations where the strapping system would encounter the sand foundation material. The trenches had dimensions of 4 inches wide by 1 inch deep by 20 inches long. Figure 2-26 depicts the trenches before tube #2 was placed on top of them. Figure 2-27 depicts one of the trenches after tube #2 was placed on top of it.

Figure 2-26: Bentonite Cutoff Trenches to Prevent Piping under Strap Locations in Trial 6

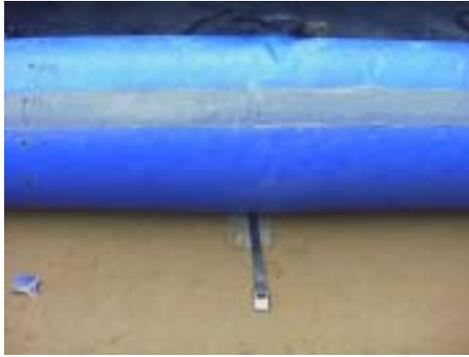
Figure 2-27: Bentonite Cutoff Trench after Tube #2 Installed

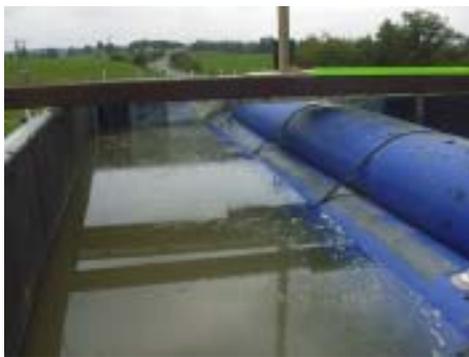
Initial measurements were taken at the 0-inch headwater elevation. The headwater elevation was then increased to the 12½-inch headwater elevation and measurements were again taken. From these measurements, it was evident that tube #1 had slid back approximately 2 cm. Tube #2 moved in a rolling fashion away from the rising headwater approximately 2 cm. Tube #3 also moved, but it was due to the movement of the bottom two tubes. This movement was in a horizontal direction away from the rising headwater. Figure 2-28 depicts the three-tube configuration at the headwater elevation of 12½ inches. Appendix A contains a complete set of figures for this trial.

Figure 2-28: Trial 6 at Headwater Elevation of 12 1/2-inches

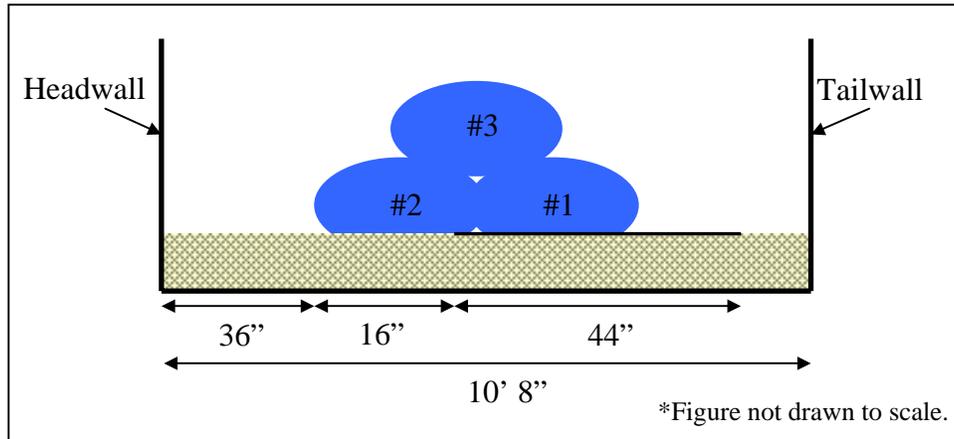
Figure 2-29: Cross Section of Trial 7 Setup

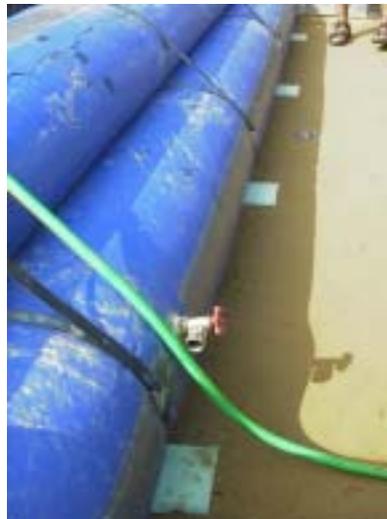
For this trial, foam padding was again utilized on top of the sand foundation in the areas where the strapping system wrapped under the tubes. The foam extended under the tubes at the strap locations and up onto the drainage layer. Dimensions of the foam were approximately 6 inches wide, 1/2-inch thick, and 36 inches in length. To ensure a smooth transition from the foundation

material to the foam material, the foam was tapered along both sides of its 36-inch length. Much more compressible than the foam used in Trial 5, this foam material was expected to prevent piping. Figure 2-30 depicts the foam material under tube #2 at the strapping locations.

Figure 2-30: Foam Material Placed under Strap Locations for Trial 7

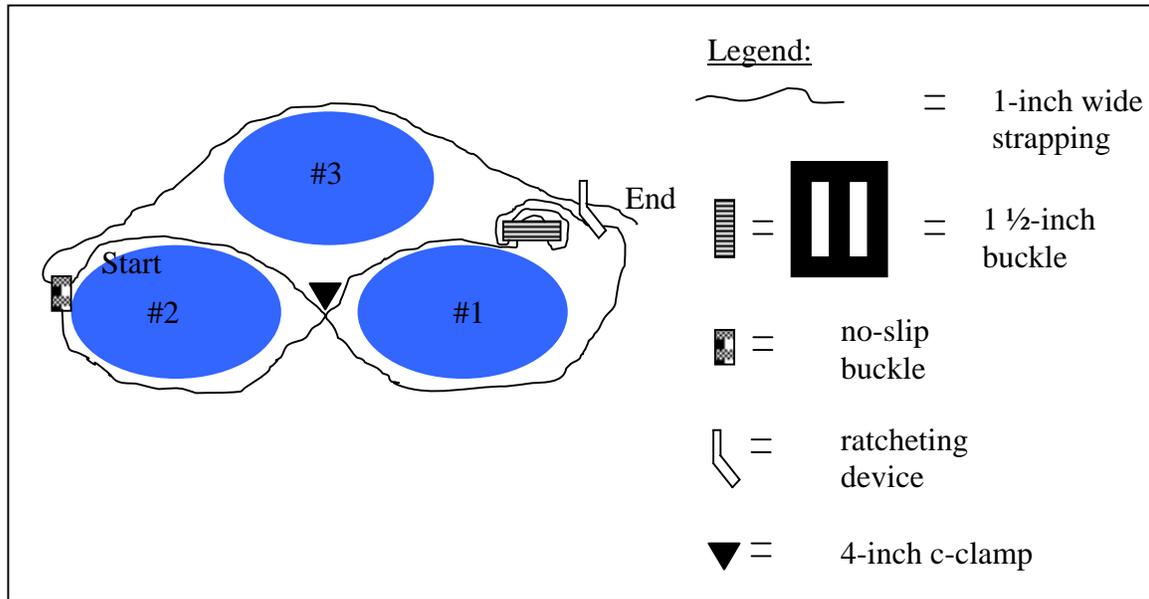
Figure 2-31: Strapping System for Trial 8

The strapping system for this trial was identical to the strapping system used in Trial 8 and illustrated in Figure 2-31.

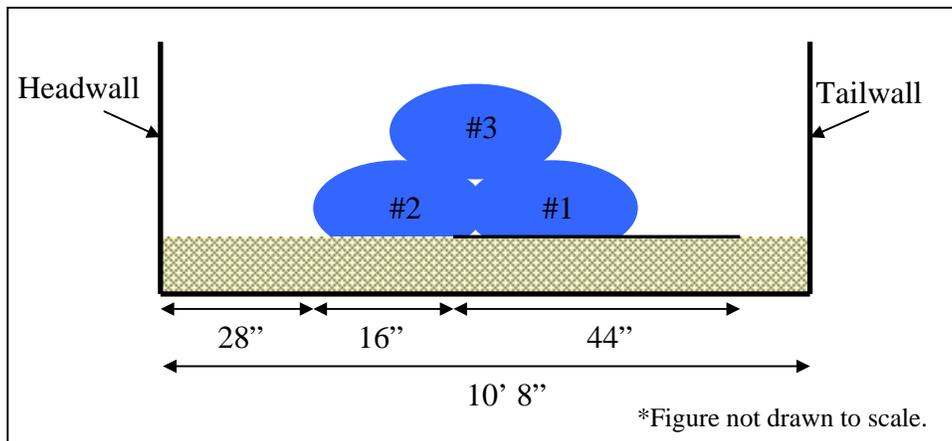
that the vertical tangent of the tube on the headwater side was 28 inches to the right of the headwater side of the box. Tube #1 was then placed to the right of this point such that tube #1 and tube #2 were in contact with one another on their vertical tangents. Next, tube #3 was placed in the depression formed by tube #1 and tube #2. The exact dimensions of the tubes relative to one another can be found by referencing Appendix A for Trial 9 for a headwater elevation of 0 inches.

Figure 2-32: Cross Section of Trial 9 Setup

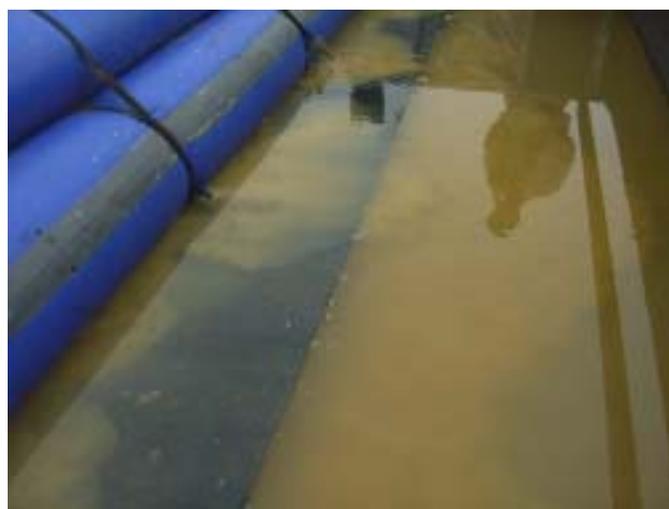
Figure 2-33: Beginning of Piping Failure on Tailwater Side of Tubes in Trial 9

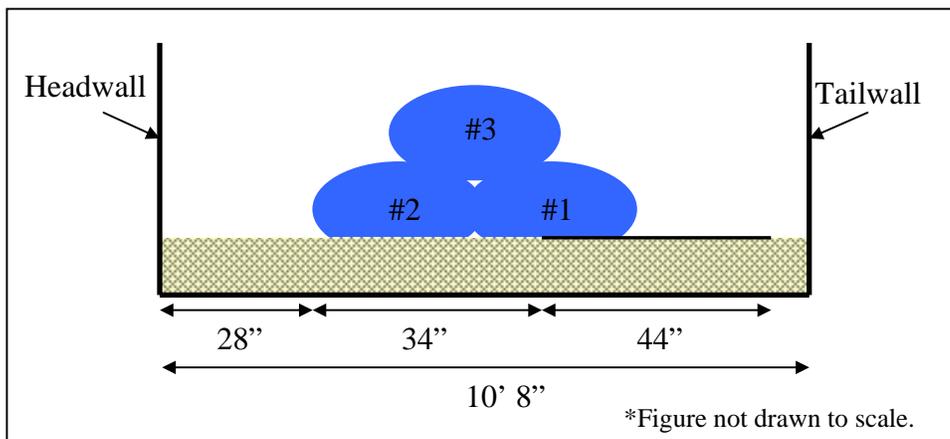
Once again, bentonite paste was applied to the contact areas of tube #2 and tube #3 at the strapping system locations on the headwater side of the tubes. In addition, bentonite paste was also added to the contact areas of tube #1 and tube #3 at the strapping locations on the tailwater side of the tubes. This was needed in order to prevent the headwater from escaping through the indentation produced by the strapping system on both the headwater side and the tailwater side of the tubes.

Figure 2-34: Cross Section of Trial 10 Setup

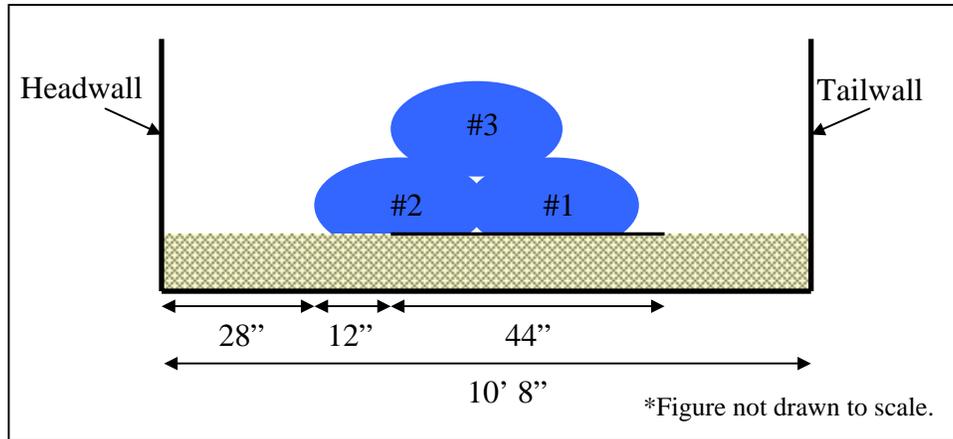
Figure 2-35: Cross Section of Trial 11 Setup

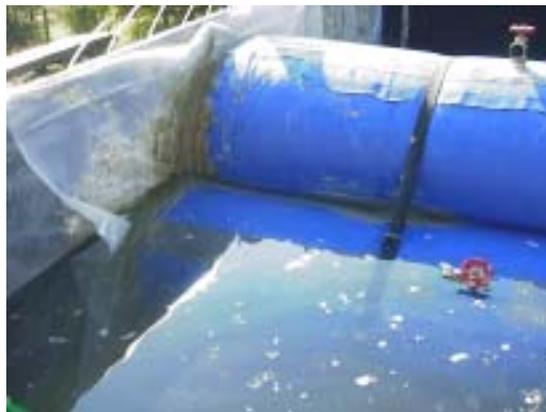
Measurement locations for this trial included the 0-inch, 12½-inch, and 16-inch headwater elevations. Deformations of the tubes were minimal as the headwater was increased from the 0-inch to 12½-inch headwater elevation. Overall, the three-tube configuration moved away from the headwater elevation an average of 1¼ inches. The headwater elevation was then raised to the 16-inch elevation, where deformations increased as well. Tube #2 deformed laterally an additional 1½ inches away from the headwater, while tube #1 and tube #3 deformed an additional 1¼ inches. Figure 2-36 depicts Trial 11 at a headwater elevation of 16 inches. Appendix A contains a complete set of figures for this trial.

Figure 2-36: Trial 11 at a Headwater Elevation of 16-Inches

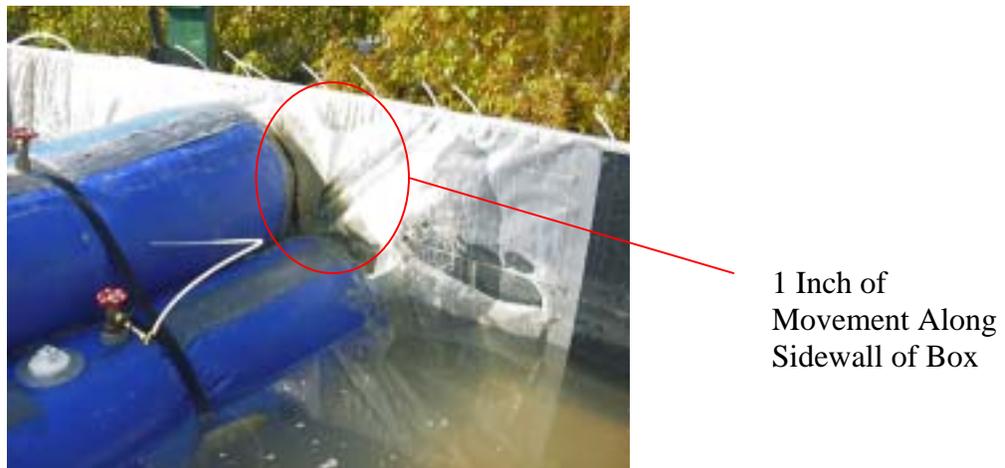
At a headwater elevation of 18 inches, a sliding failure occurred. The entire three-tube configuration moved approximately 1 inch in a time span of about 15 seconds. At this point, piping began to occur along the entire longitudinal length of the tubes. This piping was believed to have occurred as a direct result of the sliding failure that was present. Figure 2-37 depicts the three-tube configuration just after the sliding failure. At this point, the trial was terminated.

Figure 2-37: Trial 11 Just After Sliding Failure

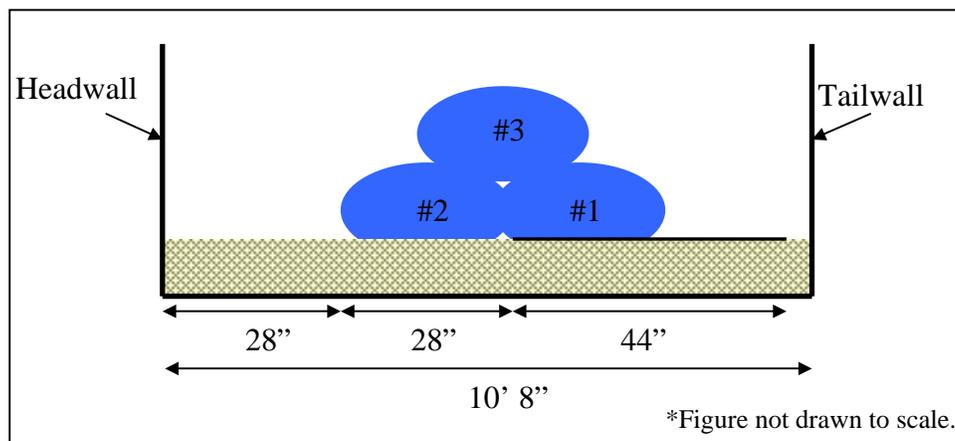
Figure 2-38: Cross Section of Trial 12 Setup

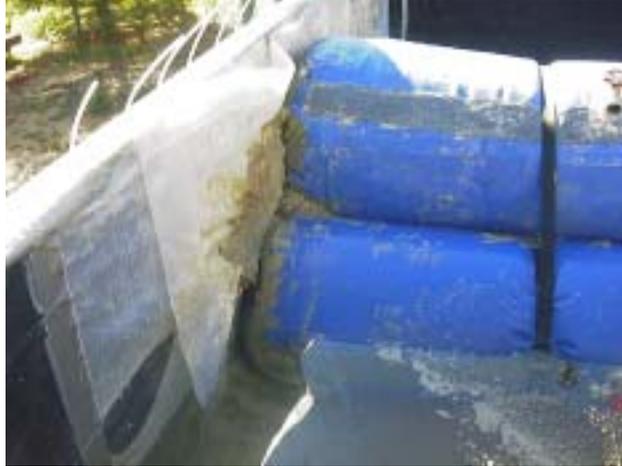
At a headwater elevation of 16½ inches, a sliding failure occurred. The entire three-tube configuration moved approximately 2 inches in a time span of about 20 seconds. At this point, the trial was terminated. Figure 2-39 depicts the three-tube configuration just after the sliding failure occurred.

Figure 2-39: Trial 12 Just After Sliding Failure

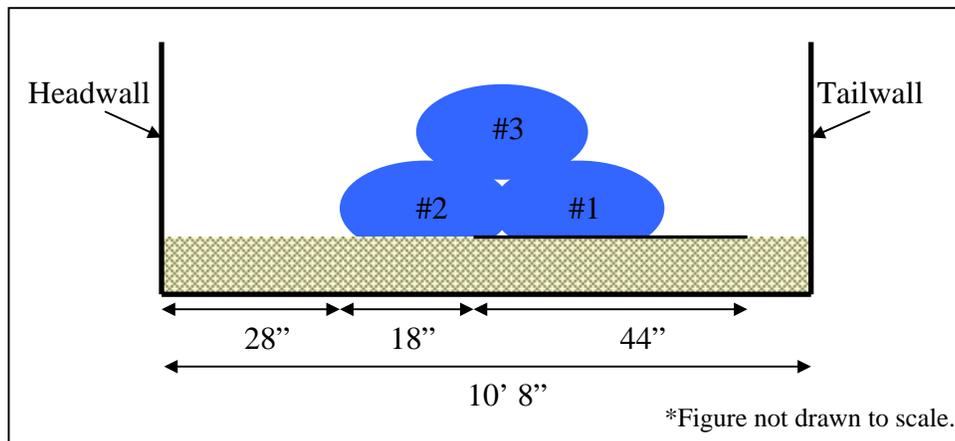
Figure 2-40: Cross Section of Trial 13 Setup

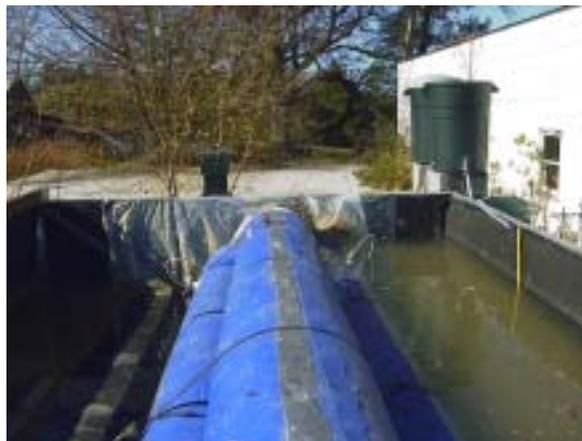
Figure 2-41: Trial 13 at Headwater Elevation of 15-Inches

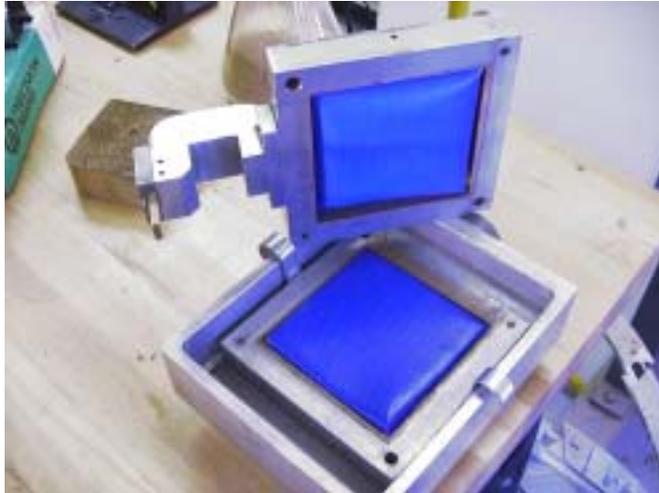
In order to distribute a normal stress to the PVC material evenly over its cross section, a sand filler material was used. First, a piece of plastic wrap with approximate dimensions of 12 inches square was placed on top of the upper ring and allowed to drape over the testing rings. The sand filler material was then placed into the upper ring and compacted using a 1-inch steel tamper until the filler material was 1/8-inch below the top of the upper ring. The top platen was then placed on top of the filler material within the upper ring.

Figure 2-42: Shear Box with Upper and Lower Ring Prepared for Testing

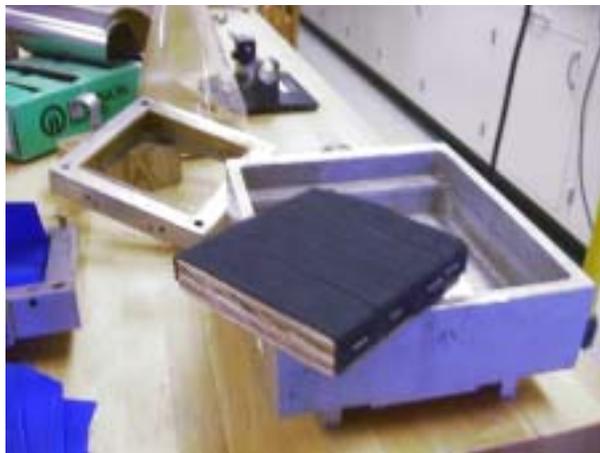
Figure 2-43: Strapping Material Attached to the Wooden Block

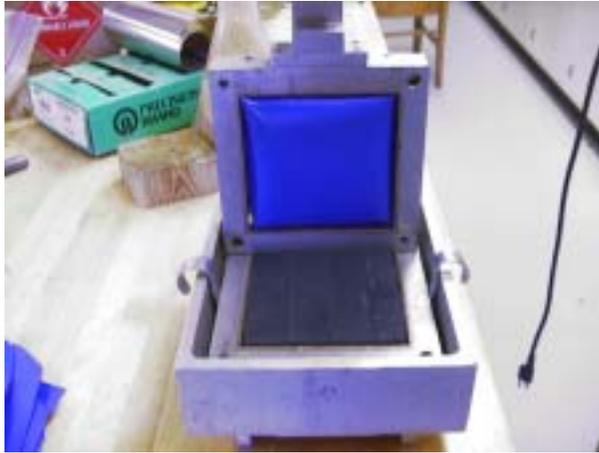
The rest of the setup process was identical to the previous process used for the reinforced PVC against reinforced PVC. Figure 2-44 depicts the shear box prior to testing of the strapping material against the reinforced PVC material.

Figure 2-44: Setup of the Shear Box Prior to Testing

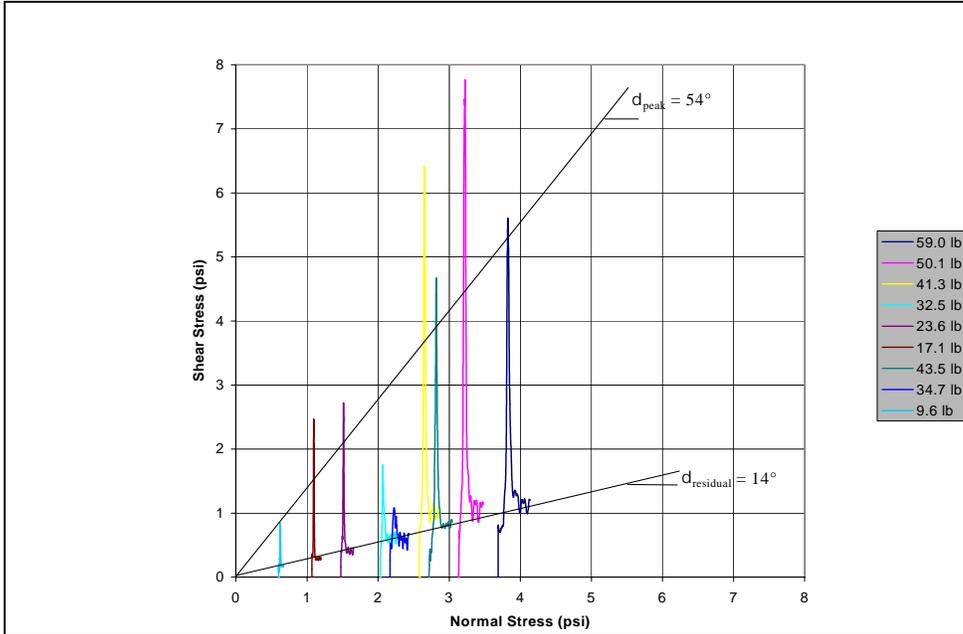
Figure 2-45: Plot of Shear Stress vs. Normal Stress for Reinforced PVC against Reinforced PVC

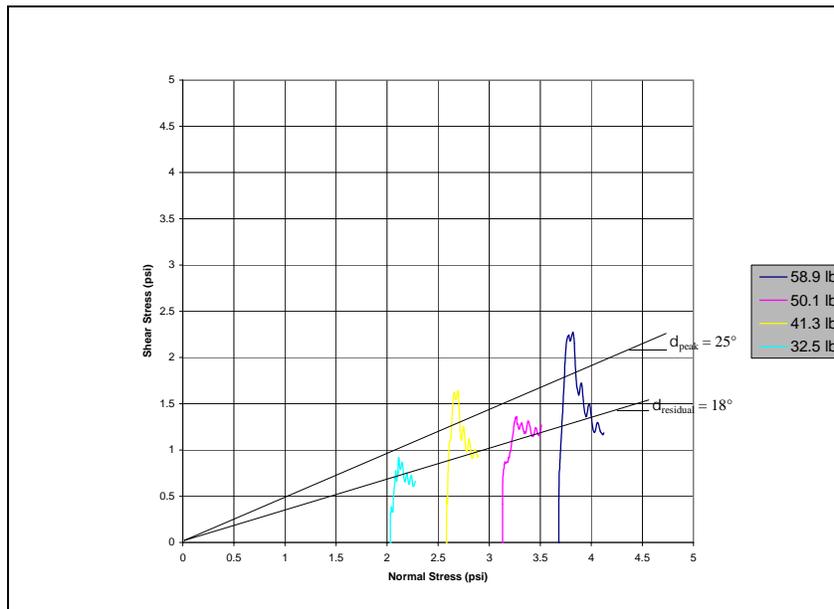
Figure 2-46: Plot of Shear Stress vs. Normal Stress for Reinforced PVC against Strapping Material
