**DISTINCT ELEMENT SIMULATION OF THE FEBRUARY 17TH, 2006, LEYTE,
PHILIPPINES ROCKSLIDE**

THESIS SUBMITTED TO THE FACULTY OF THE VIRGINIA POLYTECHNIC INSTITUTE AND
STATE UNIVERSITY IN PARTIAL FULFILLMENT OF THE REQUIREMENTS FOR THE DEGREE
OF

MASTER OF SCIENCE
IN
GEOTECHNICAL ENGINEERING

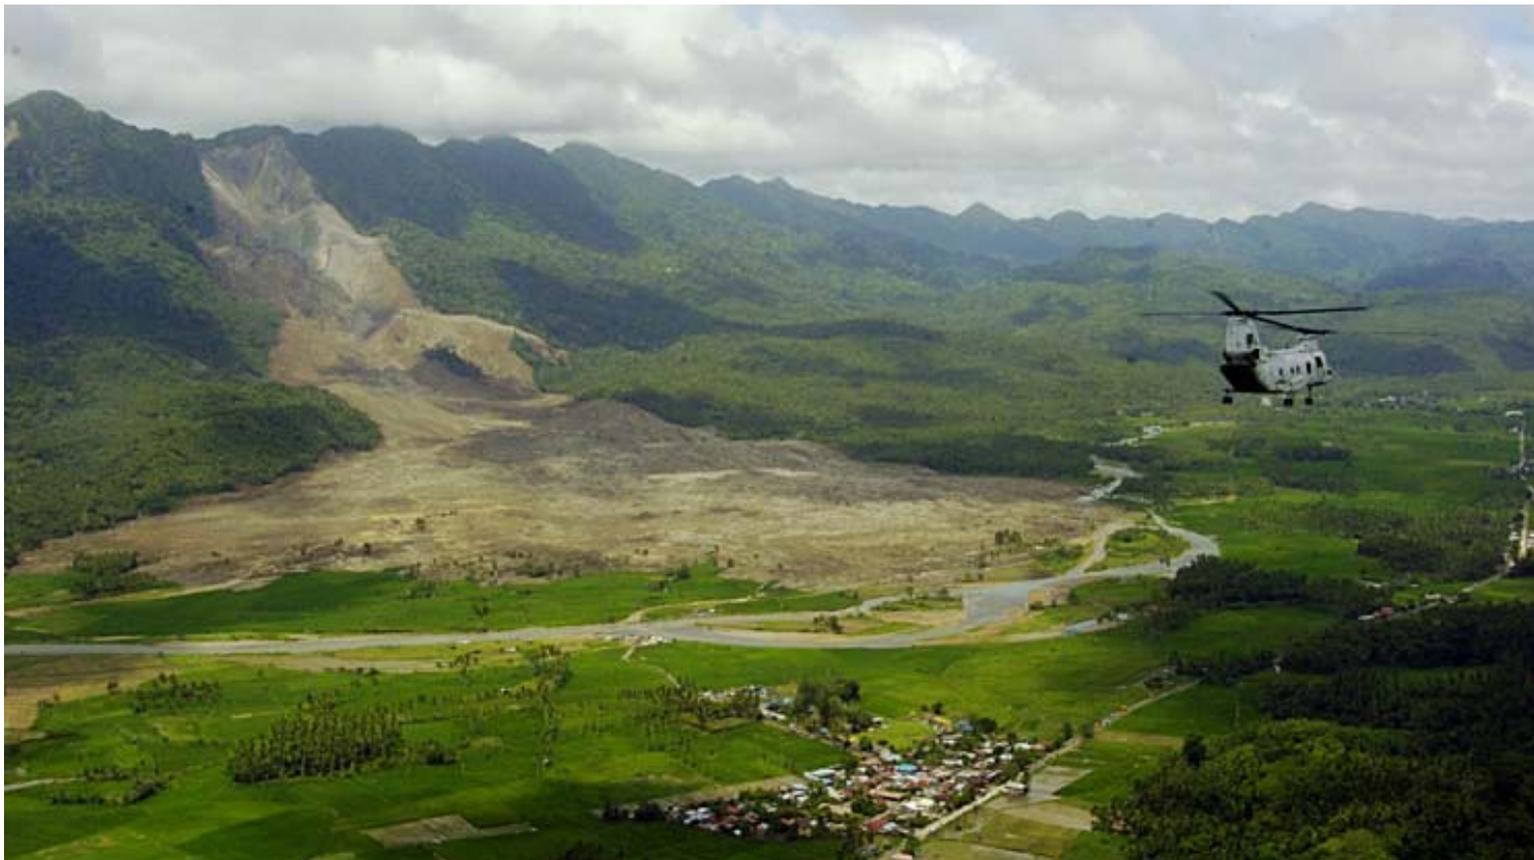
Fig.1.1 - Scarp on Mt. Cabac and debris extent from the February 17th, 2006, Leyte, Philippines rockslide (USDOD)

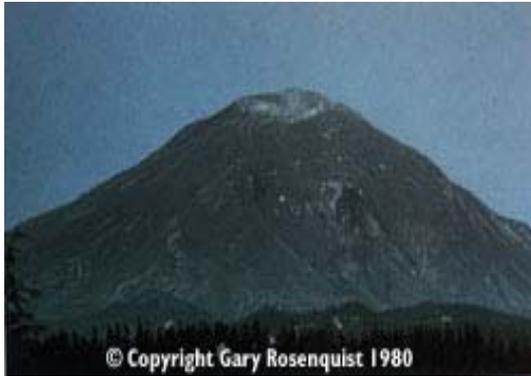
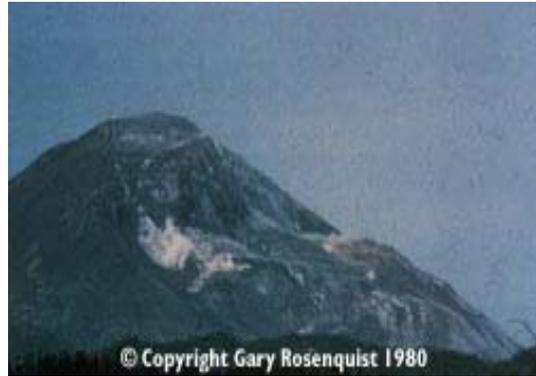
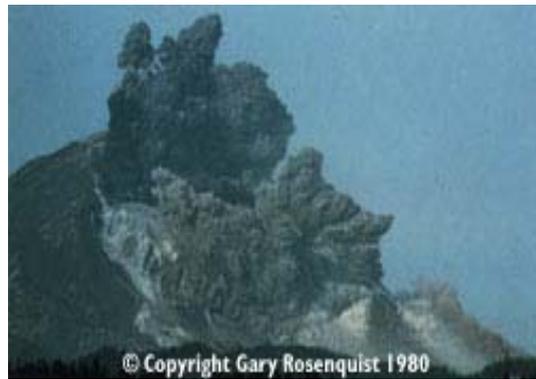
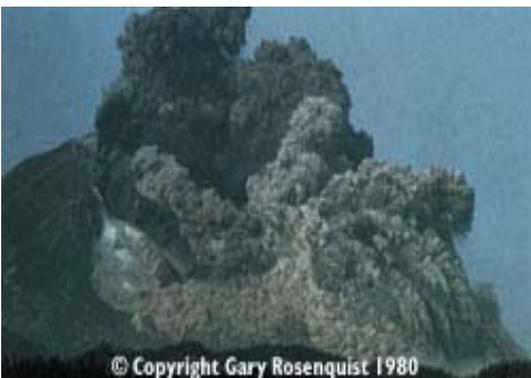
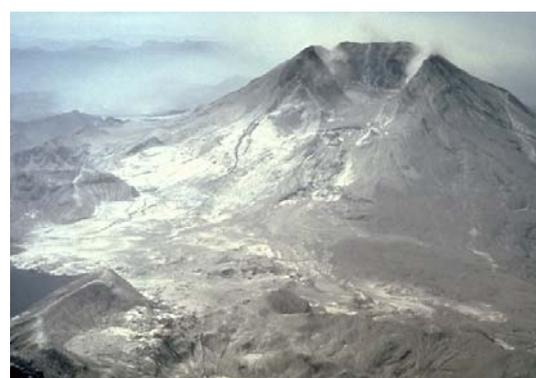
Fig. 1.3 - May, 1980: Progression of landslide on Mt. St. Helens which triggered volcano eruption, Washington, USA (USGS, 2002)

The largest landslide in the world in terms of volume of debris involved occurred only a couple of decades ago during the 1980 Mt. St. Helens volcano eruption in Washington state, USA. A moderate earthquake caused a huge landslide on the surface of Mt. St. Helens, which completely removed the side, the summit, and the inner core of the volcano, and triggered a series of massive explosions. The scarp that was created was 23 km long and generated 2.8 km³ of debris that traveled for approximately 100 km away from the scarp (Fig. 1.3).

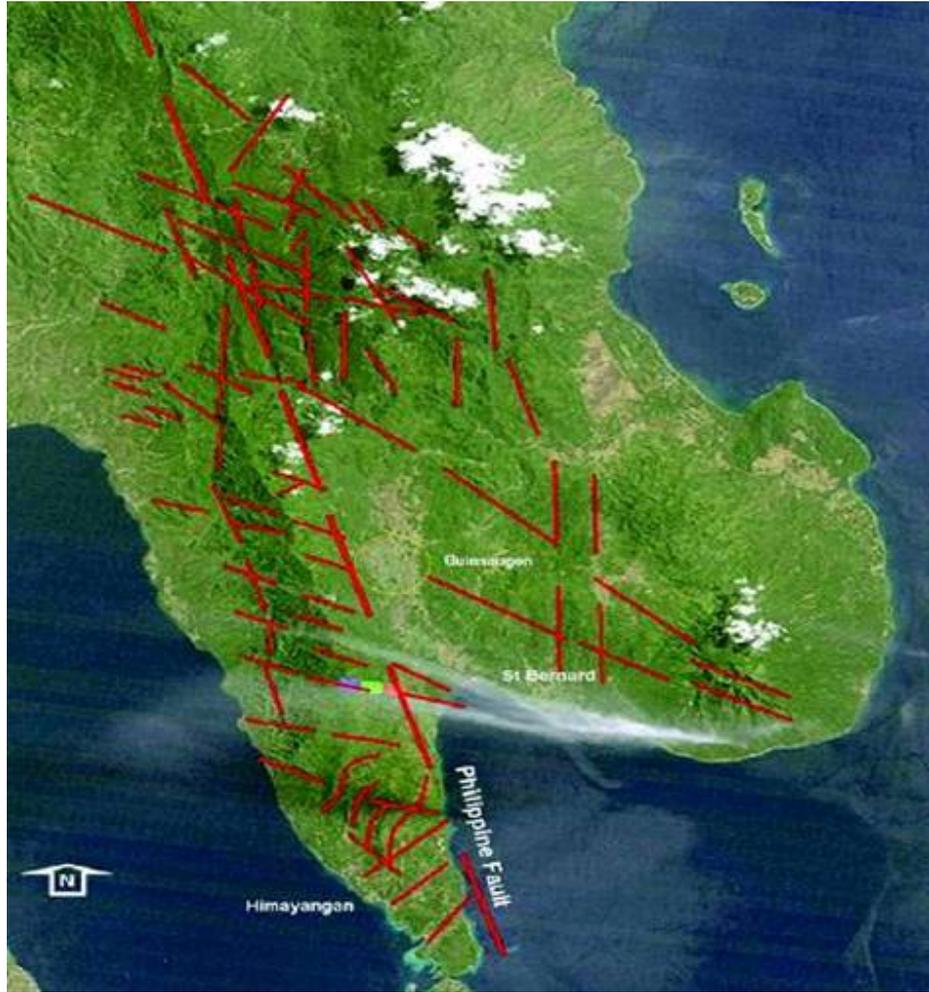
Fig. 2.5 - Lineaments of the fault system in Southern Leyte (Gutierrez et al., 2006)

One reason for the high activity of the Guinsaugon area along the PFZ, in relation to the constant and steady lateral movement of the fault system, is the presence of a series of minor faults, which criss-cross over the area of the town of St. Bernard. Conjugated Reidel-type faults, which are identified by surface lineaments as shown in

Figure 2.5, cross over the main fault in a general northwestern direction (Gutierrez et al., 2006). Additionally, other minor faults that run parallel to the main fault were also identified. Unfortunately, due to the dense vegetation in the area, some of the surface lineaments were not visible and therefore could not be easily identified such that possible fault-related landslide risks could be evaluated. Reconnaissance studies showed that one of the mentioned faults that run along the main PFZ direction was one of the major failure surfaces of the sliding mass responsible for the massive rockslide of February 17, 2006

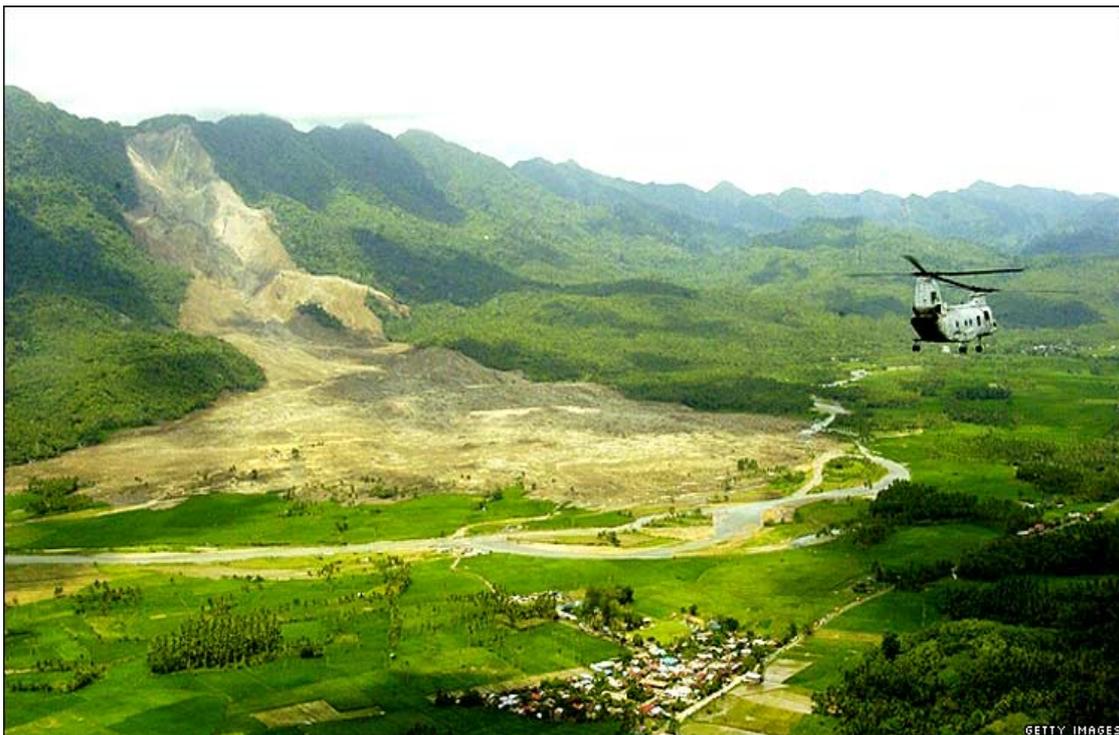
Fig. 2.6 - Scarp on Mt. Cabac and debris from the Leyte rockslide (USDOD, 2006)

Mt. Cabac is an 800 m high mountain range with very steep slopes passing through Southern Leyte province (Figs. 2.2 and 2.6). Guinsaugon village is located at the foot of Mt. Cabac on the eastern side of the mountain range. The massive slide that occurred between 10:30 am and 10:45 am on February 17th 2006 involved failure of an overhanging rock formation on the eastern slope of Mt. Cabac, above the village of Guinsaugon. Rock overhangs are a general characteristic of the Mt. Cabac formation (Figs. 2.2 and 2.6) and small-scale failures of such blocks are common in the area. However, a large-scale failure of such an overhanging rock formation was not of great concern to the residents of Guinsaugon. They strongly believed that the two small hills at the foot of the mountain would protect the village by preventing potential slide materials from moving further down the slope and becoming a threat to the village and its population.

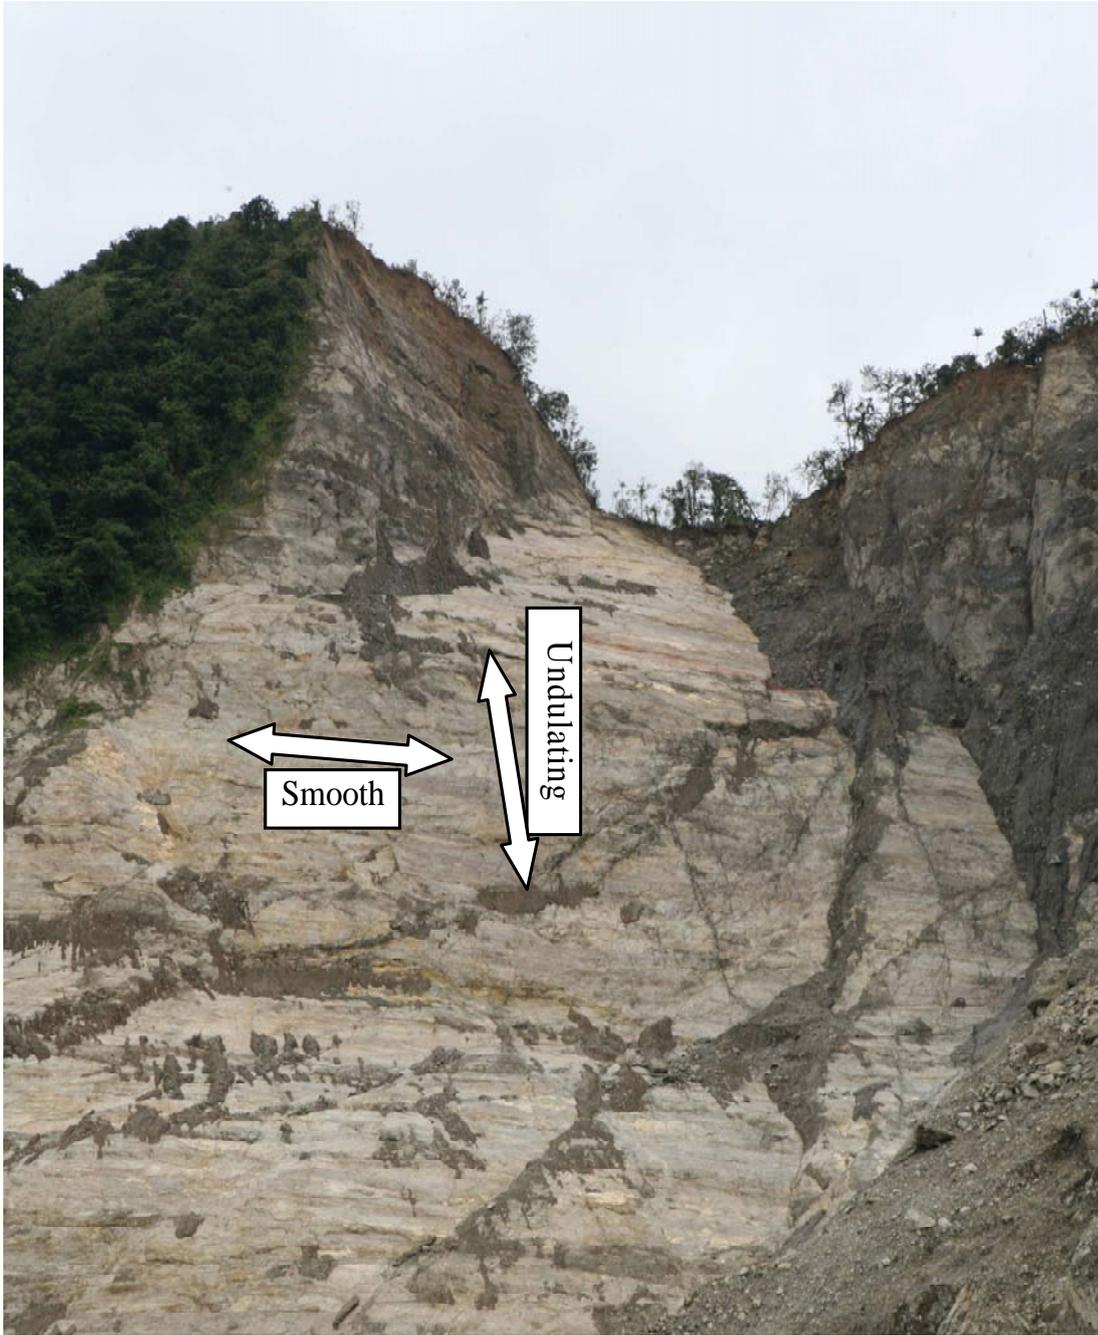
Fig. 2.7 - Photograph of the surface of the fault forming part of the scarp.
(Gutierrez et al., 2006)

The scarp consists of three major failure surfaces, forming a complicated sliding wedge. The main failure surface appeared to be very smooth and reflective (Fig. 2.7). It was initially assumed that the slickensided surface was created during the event of the rockslide, and this assumption was supported by the presence of vertical streaks along the failure surface. After extensive investigation of the main failure surface, it was determined that the initially observed vertical streaks were a result of fine materials sliding along the failure surface rather than due to the slide itself (Gutierrez et al., 2006). Careful examination of the main failure surface and its morphology demonstrated that the main failure is a strike slip fault and that the surface is actually smoother along the horizontal direction and undulated along the vertical direction (Fig. 2.7). This observation lead to the identification of the main failure surface as part of an active fault system, in this case part of the Philippine Fault Zone. The lateral movement along the fault is identified as the cause for the undulations in the vertical direction as well as the smoothness of the surface. The ability of the surface to reflect light was attributed to the fact that rock contained quartzite minerals and thus was very hard as proven by Schmidt hammer rebound tests (Gutierrez et al., 2006).

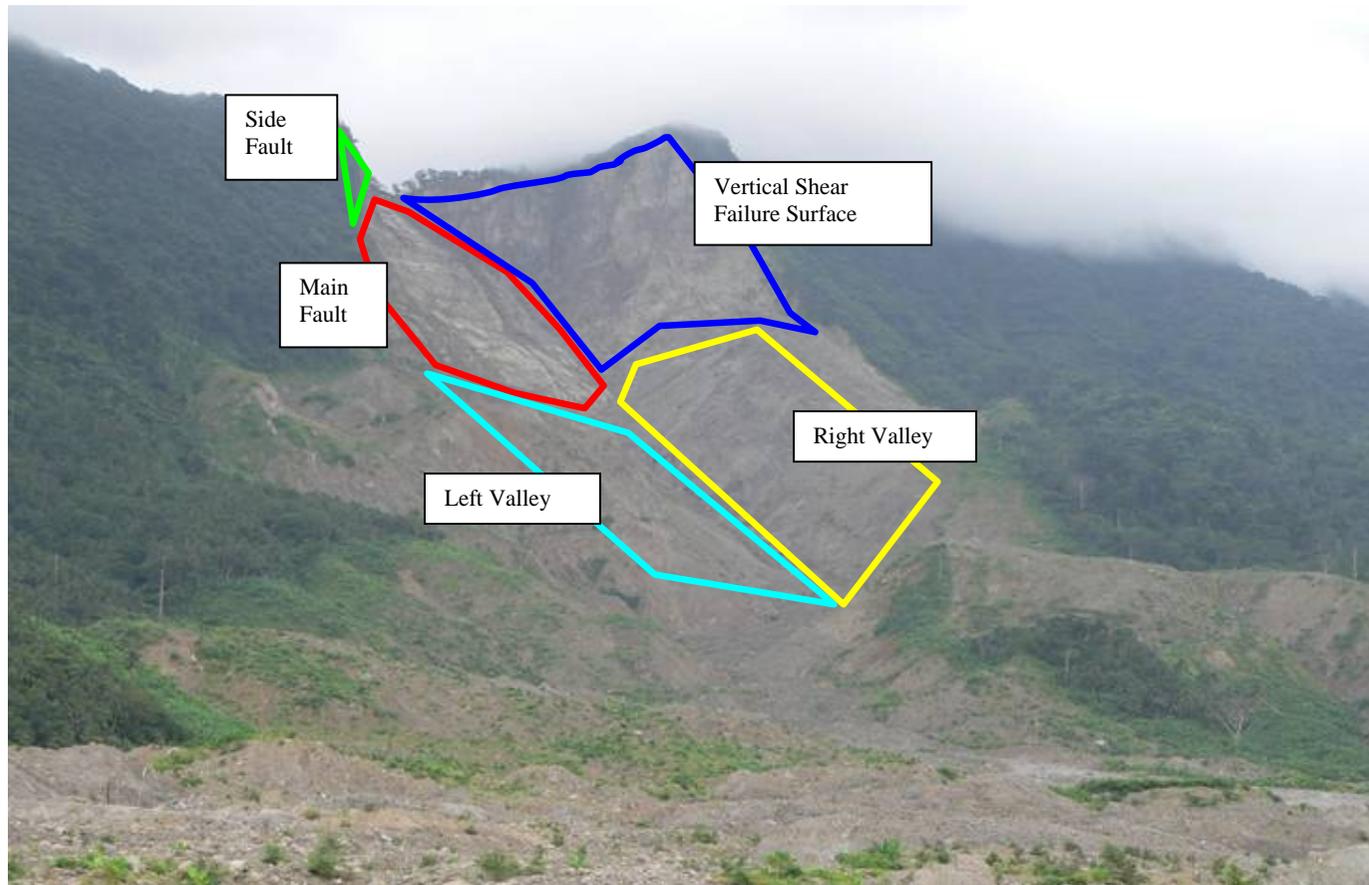
Fig. 2.8 - Escarpment and interpreted failure planes

Once the main failure surface was identified as an active fault part and splay of the PFZ, the assumption that the slide was initiated along the fault was made. Thus, the failure mode responsible for the slide was to be determined. The two possible failure modes in this case were: (a) overturning or toppling, and (b) sliding failures. After investigation of the geological characteristics of the slide, as well as careful consideration of witness accounts of the event, it was concluded that sliding was the most probable mode of failure of the overhanging rock mass. Observation of the geometry and geomorphology of the scarp demonstrated that the rock mass, once triggered, slid along the existing fault and failed by shear on the vertical surface on the north side of the scarp (Fig. 2.8).

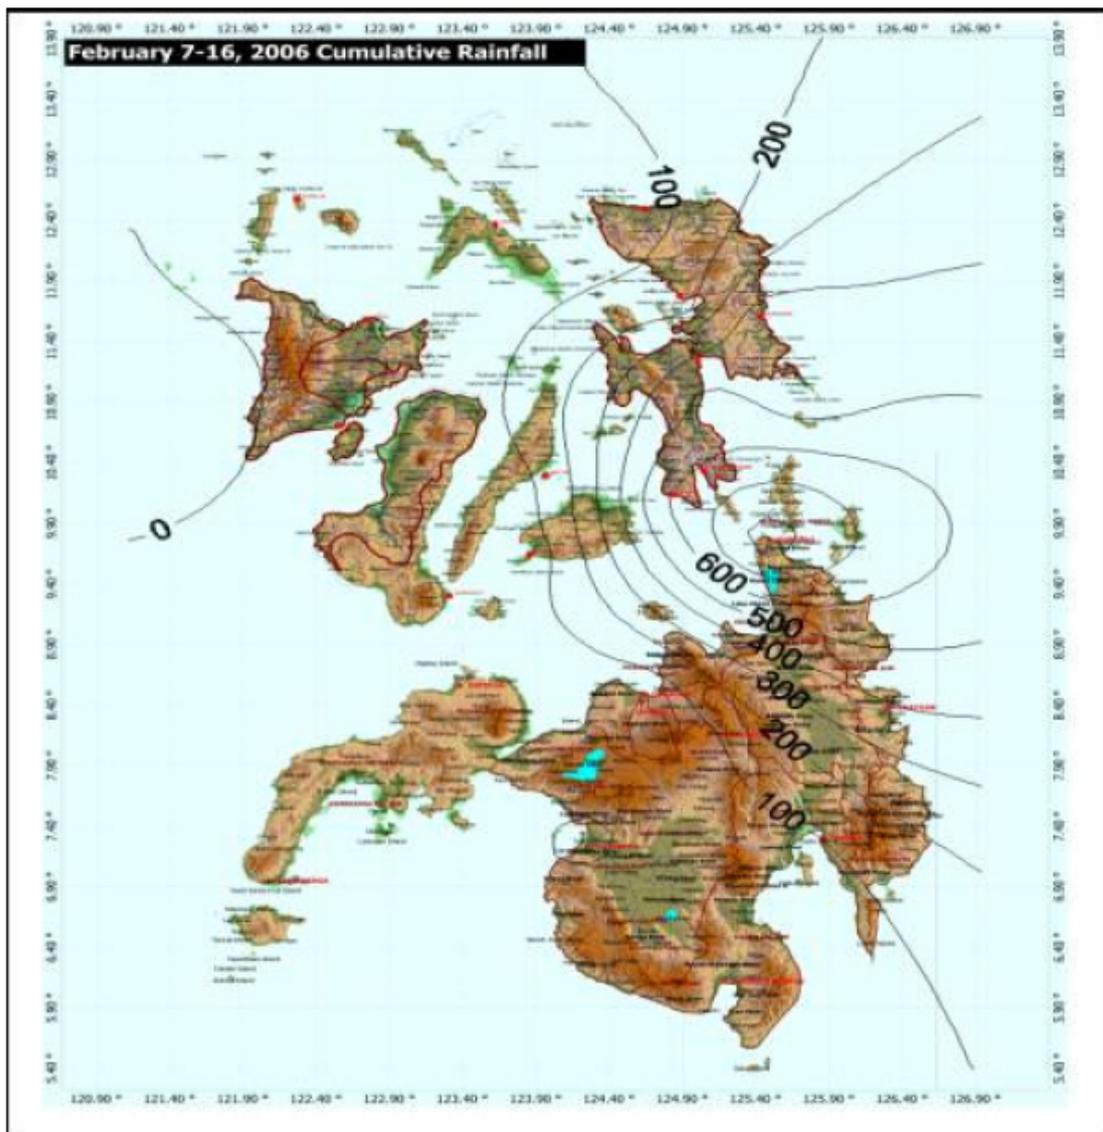
Fig. 2.11 - Isohyetal analysis from February 7-16, 2006. The contour lines indicate locations that received approximately equal amounts of rainfall (DOST - PAGASA, 2004).

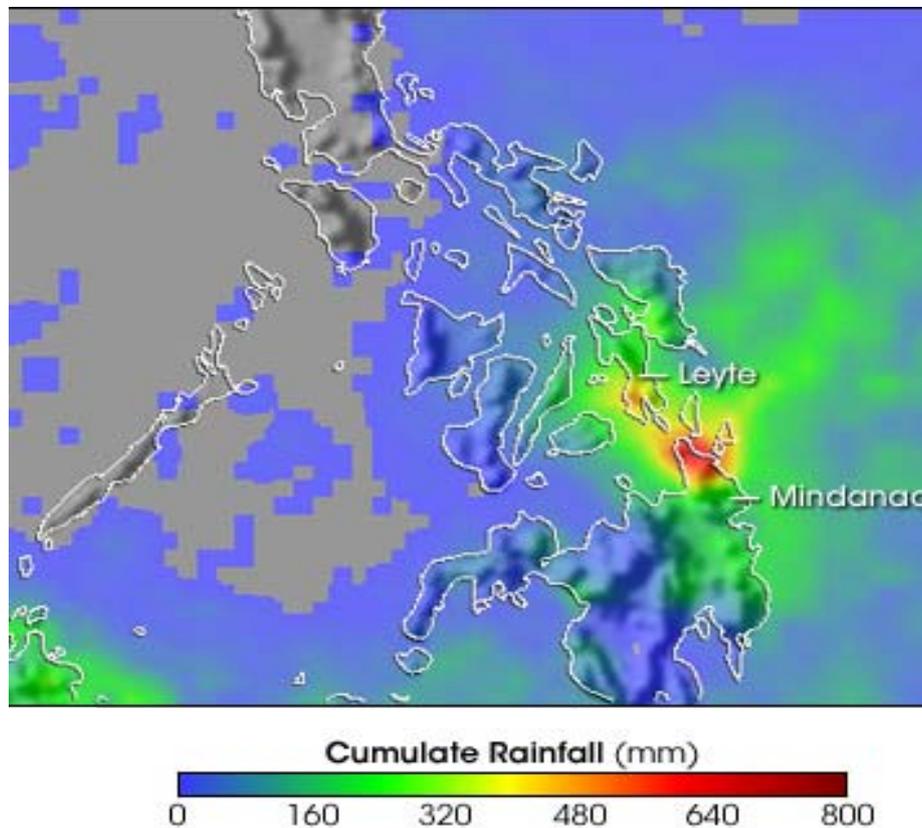
Figure 2.12 - Cumulative rainfall in southern Philippines, for February 4-17, 2006 (NASA, 2005).

Data collected by the NASA's Tropical Rainfall Measuring Mission (TRMM) Satellite proves that the top of Mt. Cabac, in southern Leyte near the town of St. Bernard, is continuously covered by rain clouds as shown in Figure 2.12 (NASA, 2005).

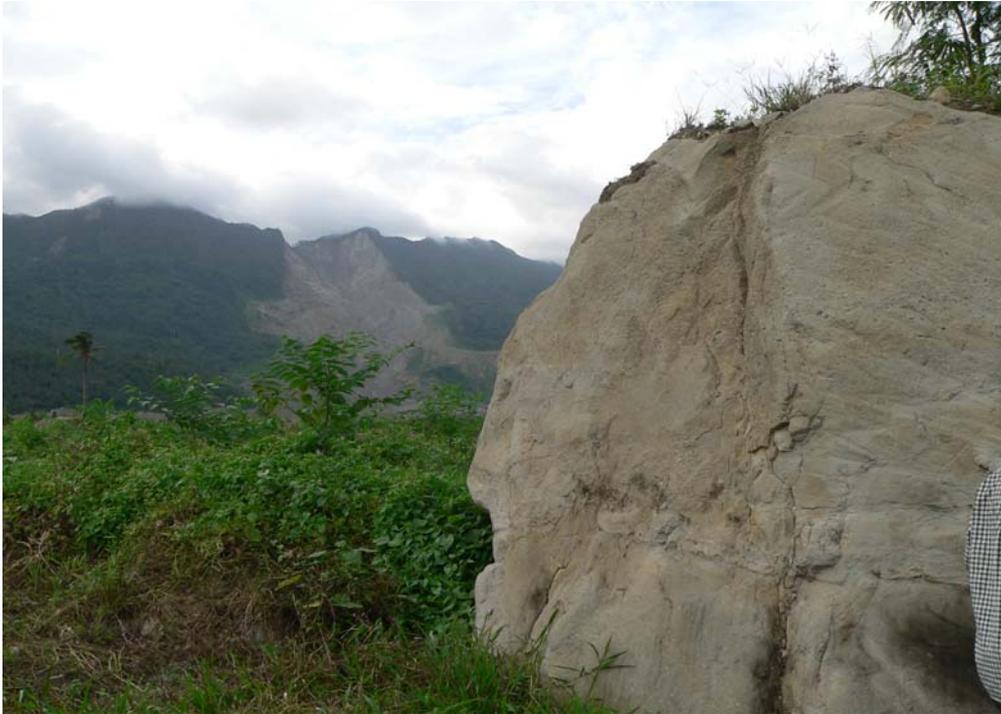
Fig. 2.14 - Large boulder found among the debris materials (Gutierrez, 2006)

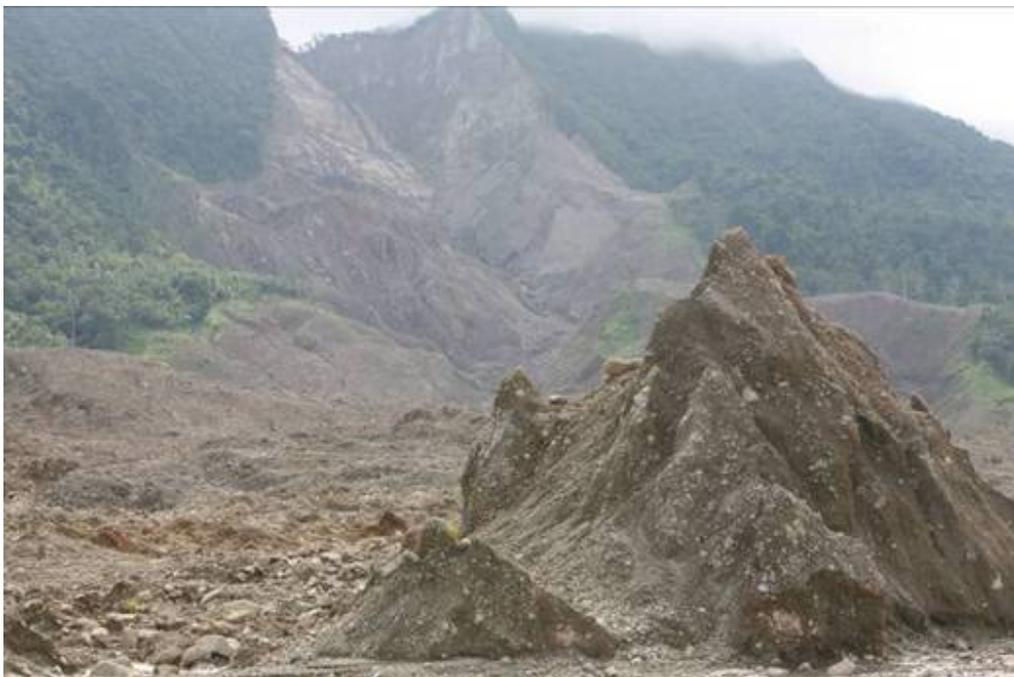
Fig. 2.15 - Mounds of debris materials possibly created from impact of deposited conglomerate with the ground (Gutierrez, 2006)

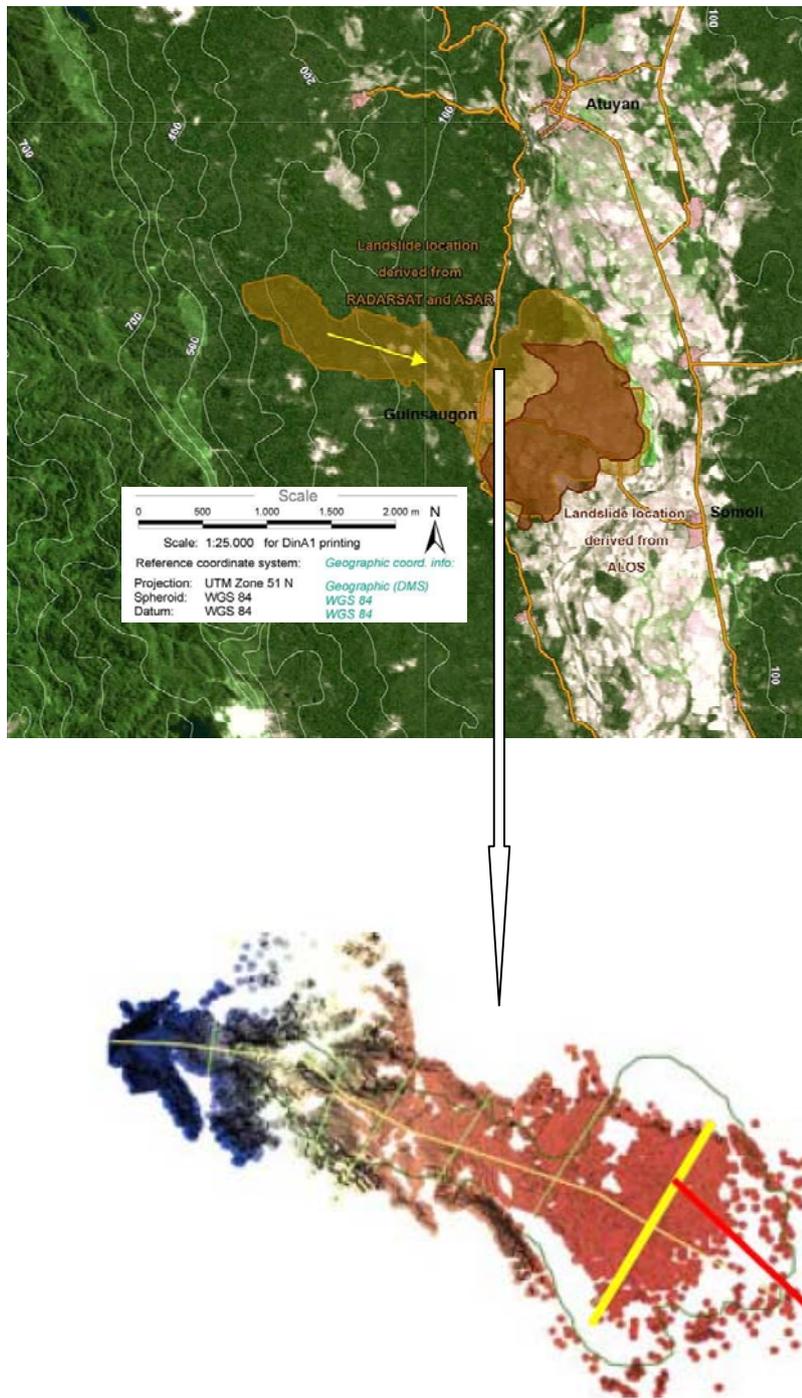
Fig. 2.16 - Extent of the combined scarp and debris area from Satellite imaging (top) (UNOSAT, 2006), and LIDAR survey (bottom) (DPRI, 2006).

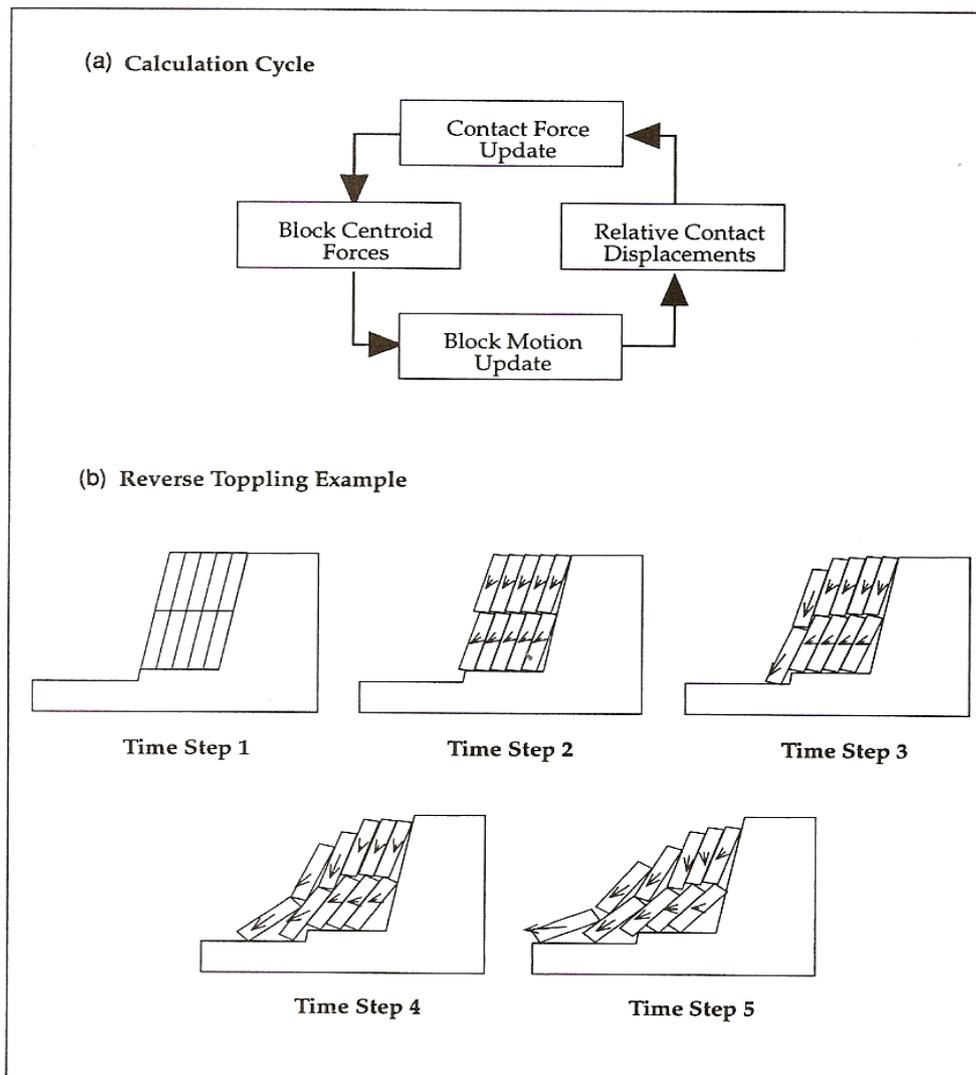
Fig. 3.1 - Distinct element modeling (Lorig et al., 1991)

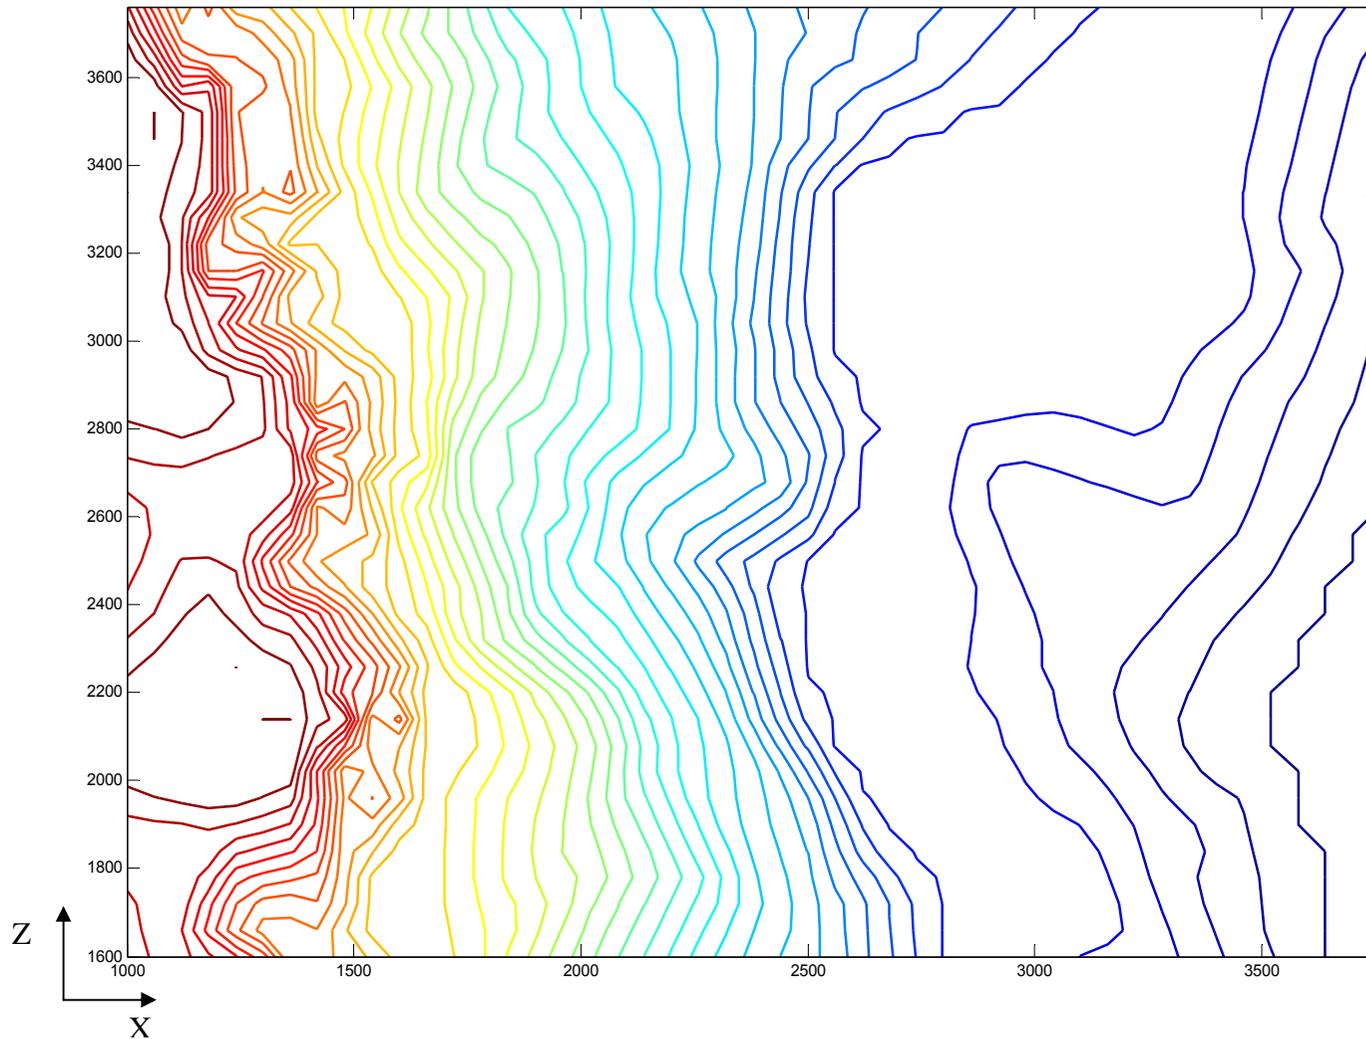
Fig. 4.3 - Elevation contours prior to the February 17th, 2006 slide. Elevation points used to produce these contours were also used to create the 3DEC elevation model.

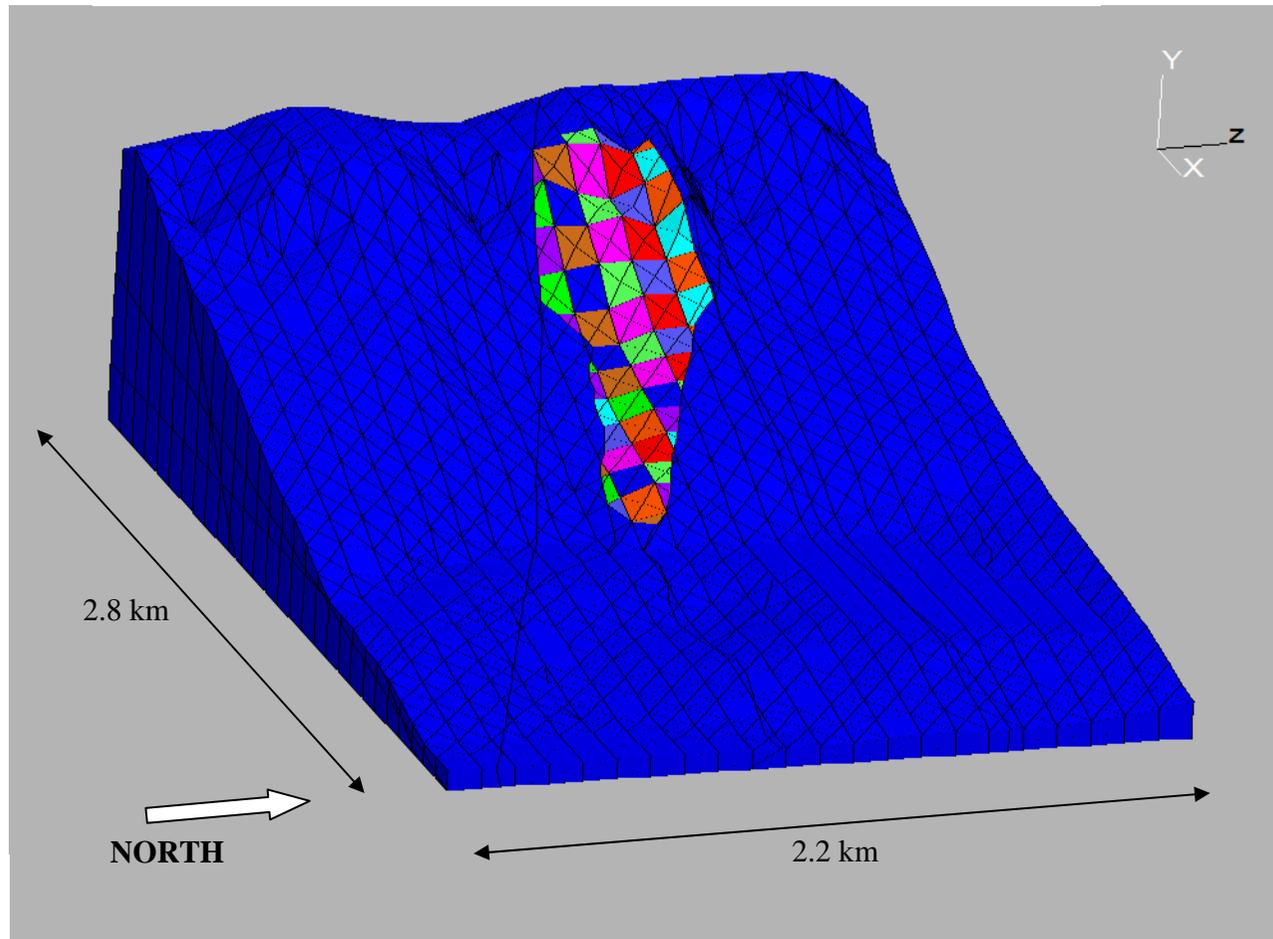
Fig. 4.4 - Digital Elevation Model of the slide area in 3DEC on a 100 m by 100 m grid.

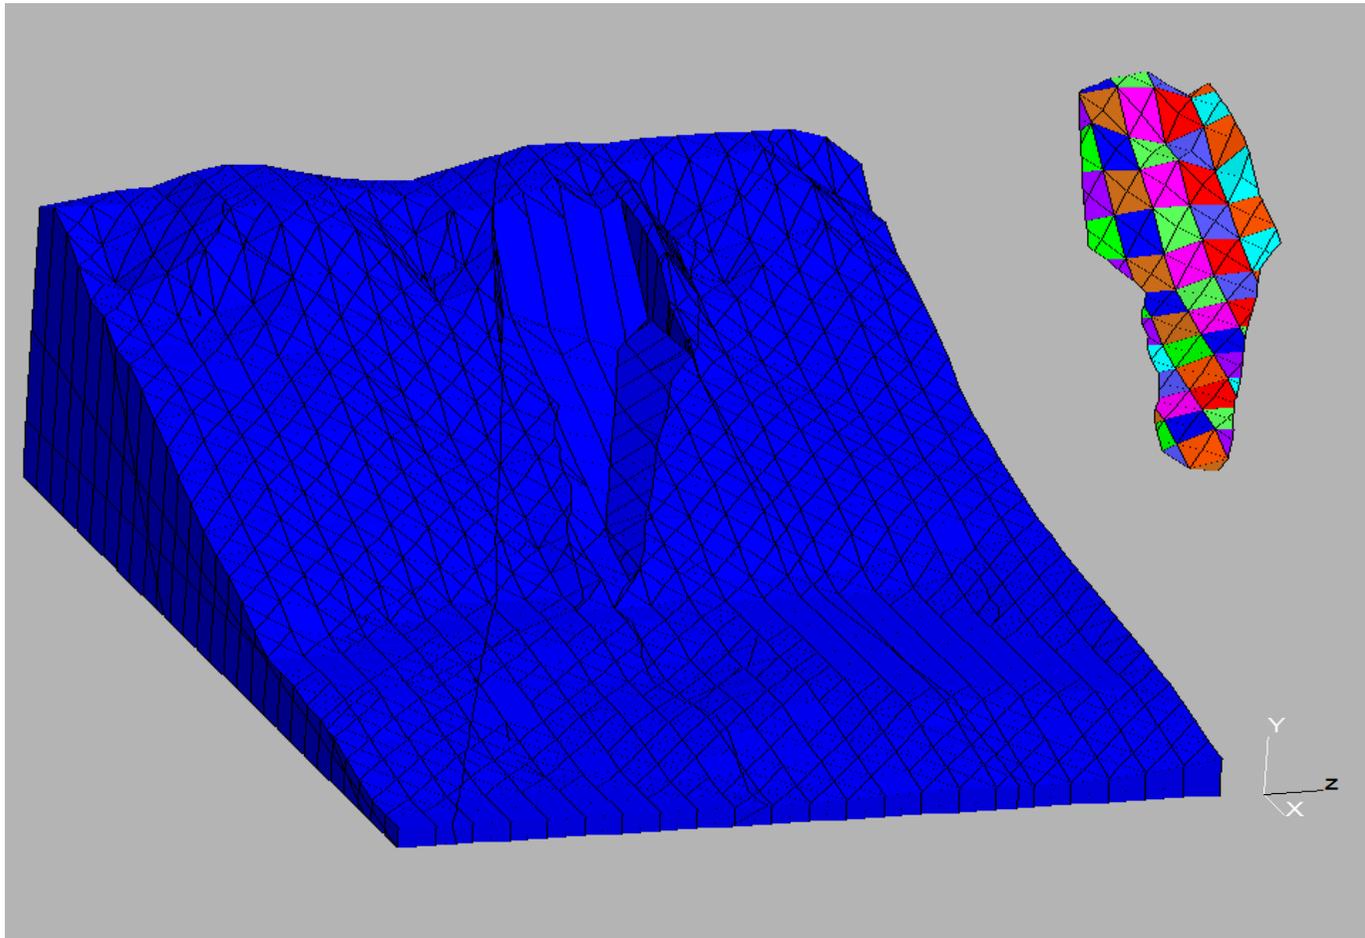
Fig. 4.5 - Digital Elevation Model in 3DEC showing detached block and exposed failure surface.

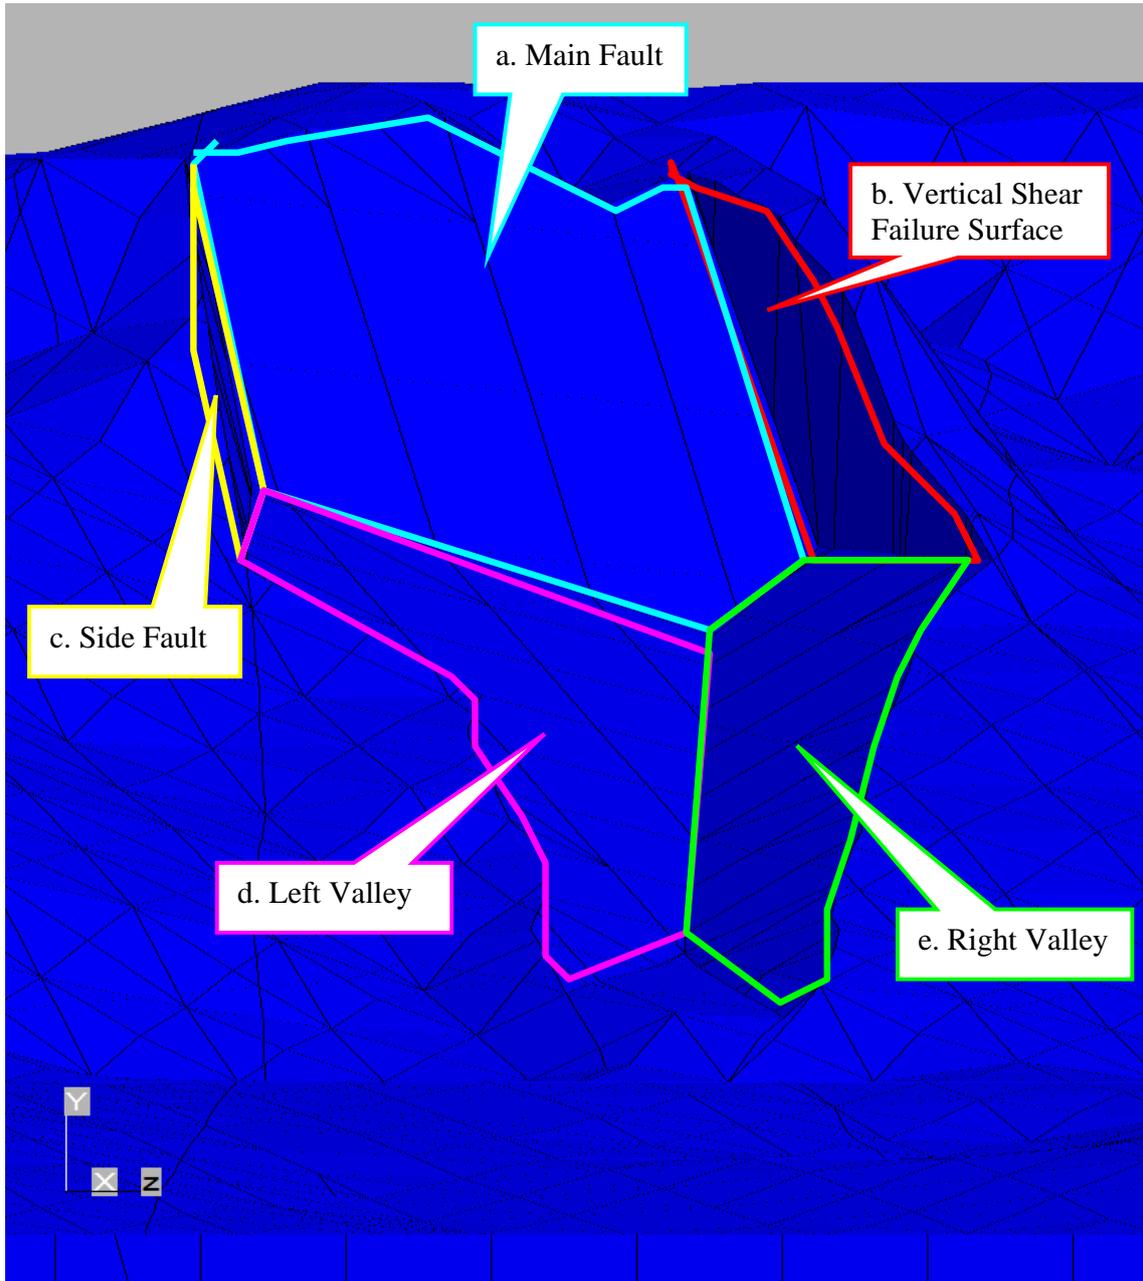
Fig. 4.6 - Scarp and five identified failure surfaces.

- Main Fault: Dip = 48° Dip Direction = 85°
- Vertical Shear Failure Surface: Dip = 88° Dip Direction = 175°
- Side Fault: Dip = 75° Dip Direction = 25°
- Left Valley: Dip = 25° Dip Direction = 57°
- Right Valley: Dip = 29° Dip Direction = 172°

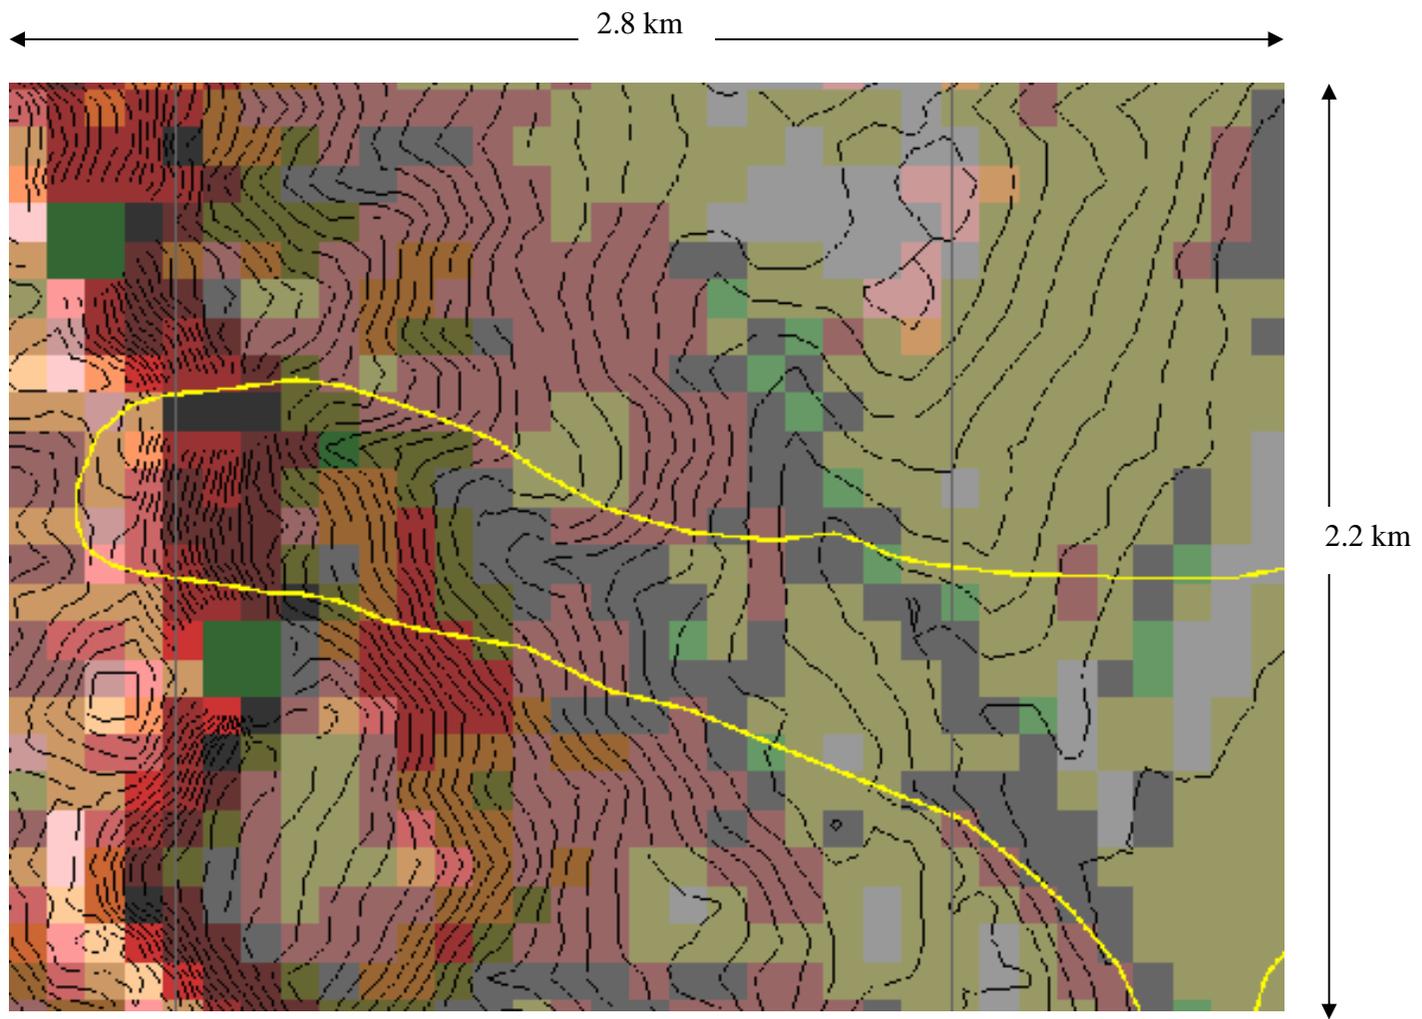
Fig. 4.7 - Post-Slide topographic map of the area including surveyed outline of the extent of the Guinsaugon slide.

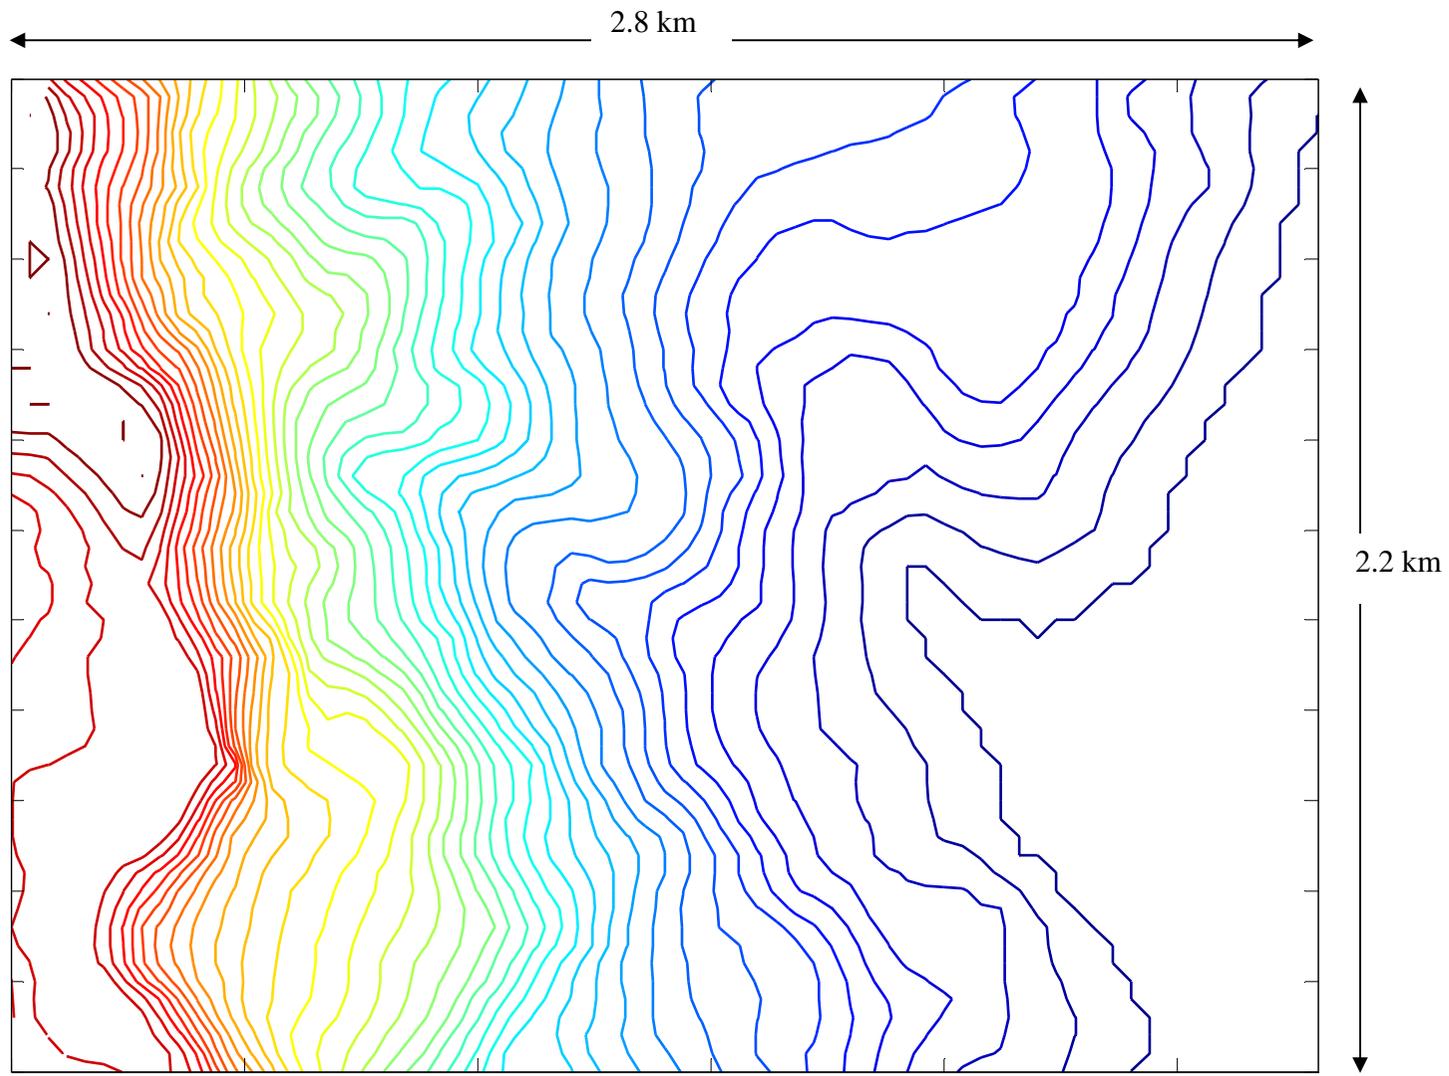
Fig. 4.8 - Matlab generated contours based on digitization of the original contour map of the area. This digitized version of the topographic map is considered less accurate due to additional human error from digitization process.
