**DISTINCT ELEMENT SIMULATION OF THE FEBRUARY 17TH, 2006, LEYTE,
PHILIPPINES ROCKSLIDE**

THESIS SUBMITTED TO THE FACULTY OF THE VIRGINIA POLYTECHNIC INSTITUTE AND
STATE UNIVERSITY IN PARTIAL FULFILLMENT OF THE REQUIREMENTS FOR THE DEGREE
OF

MASTER OF SCIENCE
IN
GEOTECHNICAL ENGINEERING

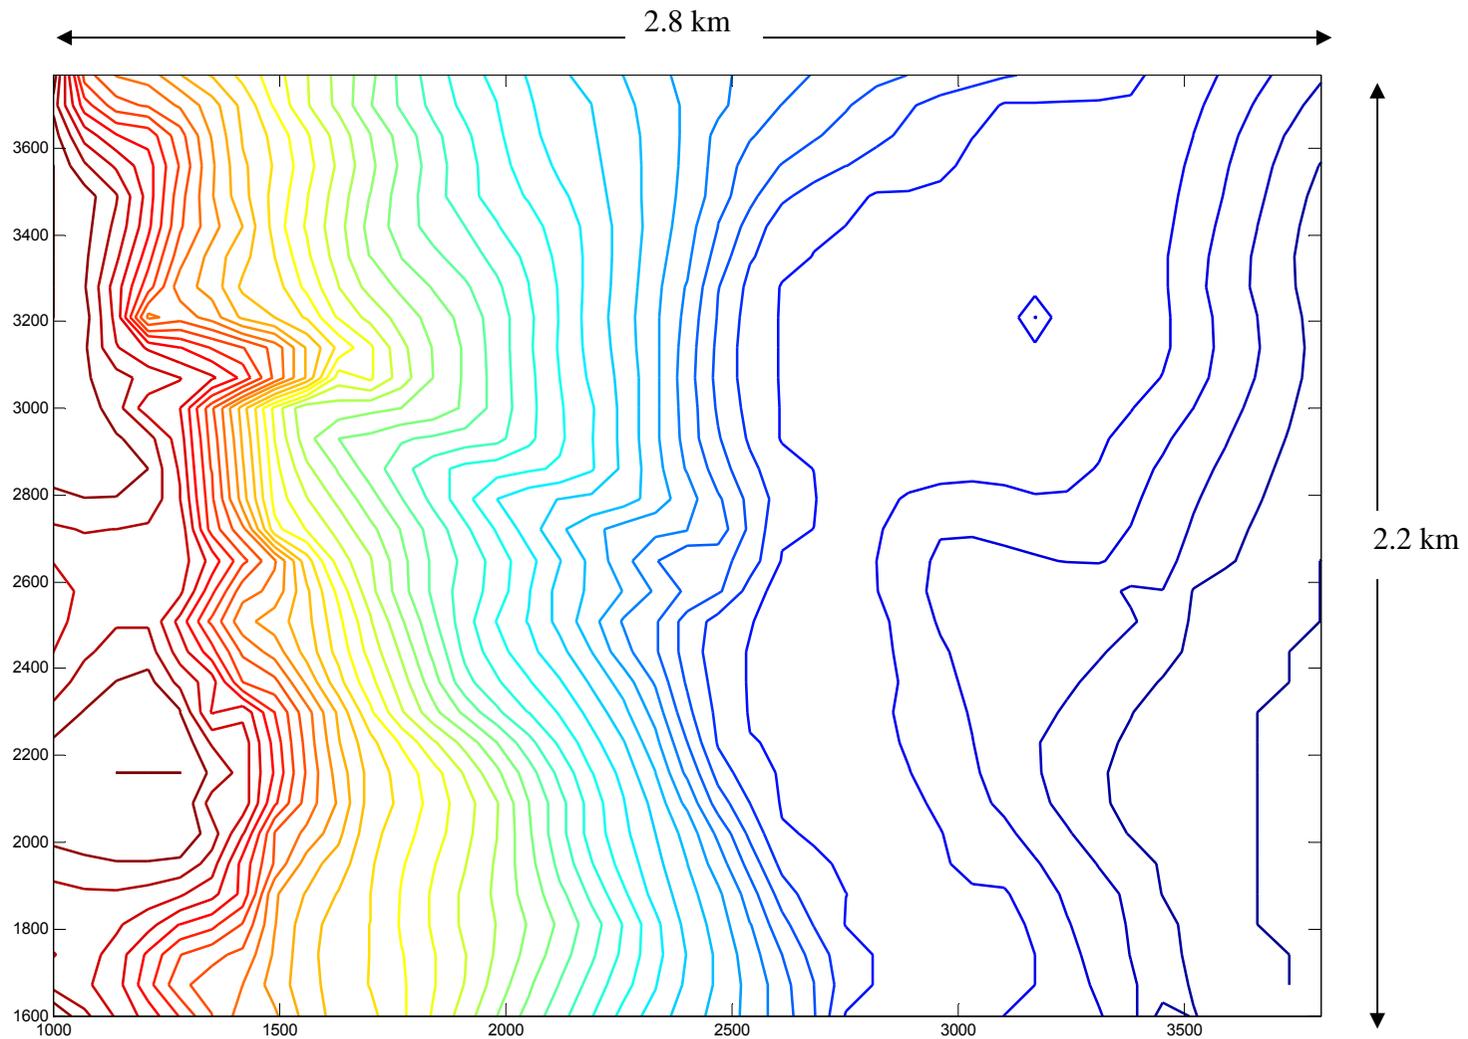
Fig. 4.11 - Matlab post-slide contour plot based on the final 3DEC model. These contours are to be compared to the actual post-slide contours on the topographic map of the area.

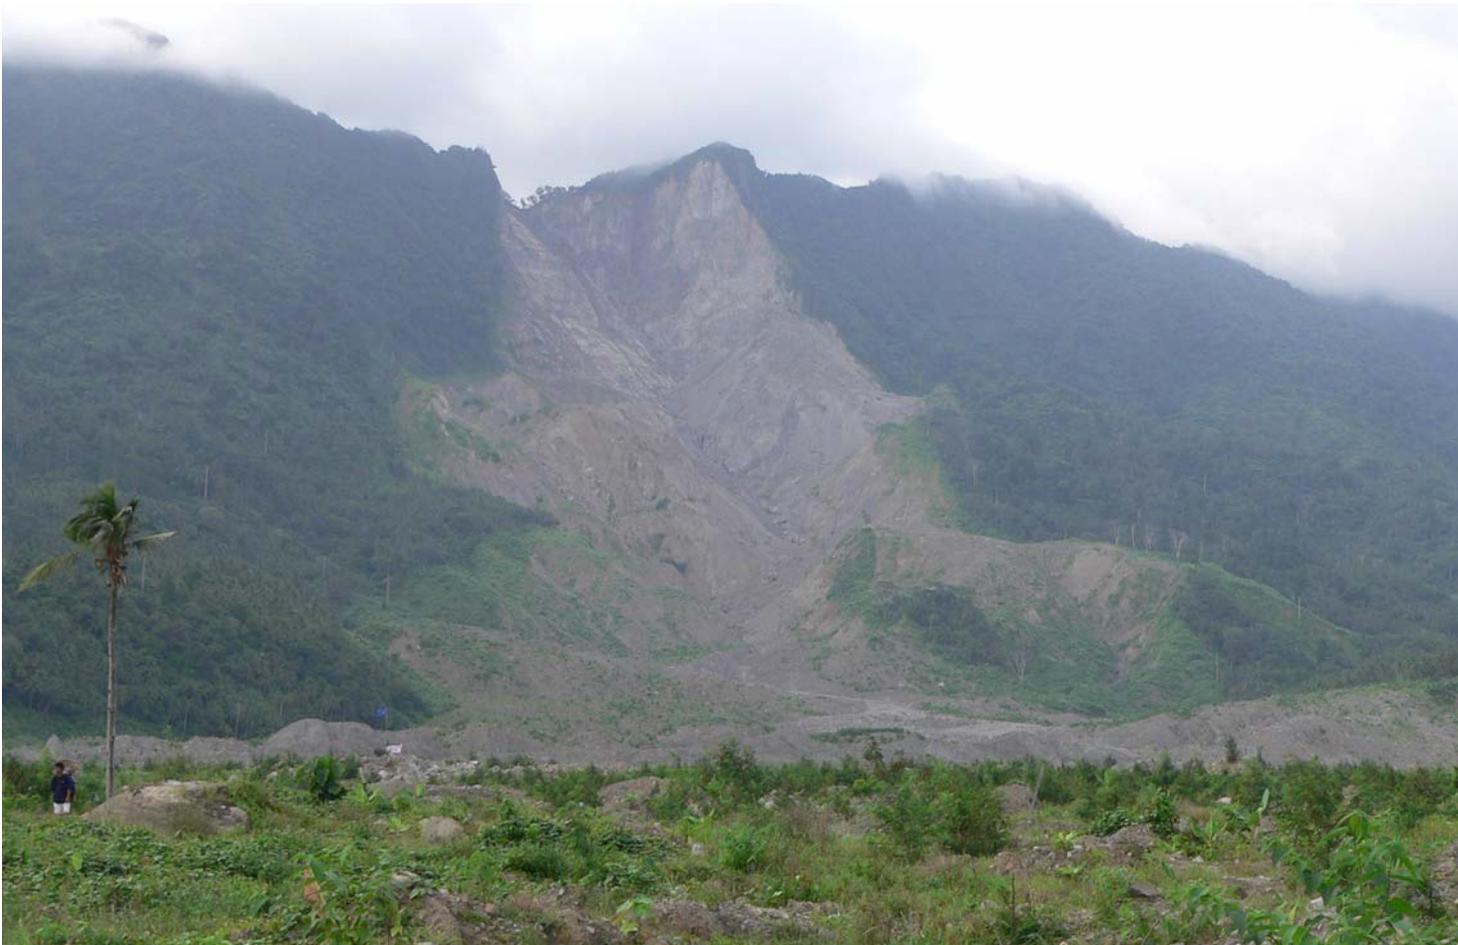
Fig. 4.12 - North-west view of the scarp (Gutierrez, 2006)

In addition to the contour comparison of the post-slide topographic map to the Matlab generated contours of the 3DEC block-removed model, the 3DEC model was also visually compared to an actual picture of the scarp taken during the reconnaissance team's visit to the site (Fig. 4.12). Although this is not considered an accurate comparison and cannot be reliable on its own, it still believed as an important step in achieving a model that is as close to real as possible. Appendix A includes several photographs of the scarp and debris material, obtained by the U.S. Reconnaissance Team during their site visit.

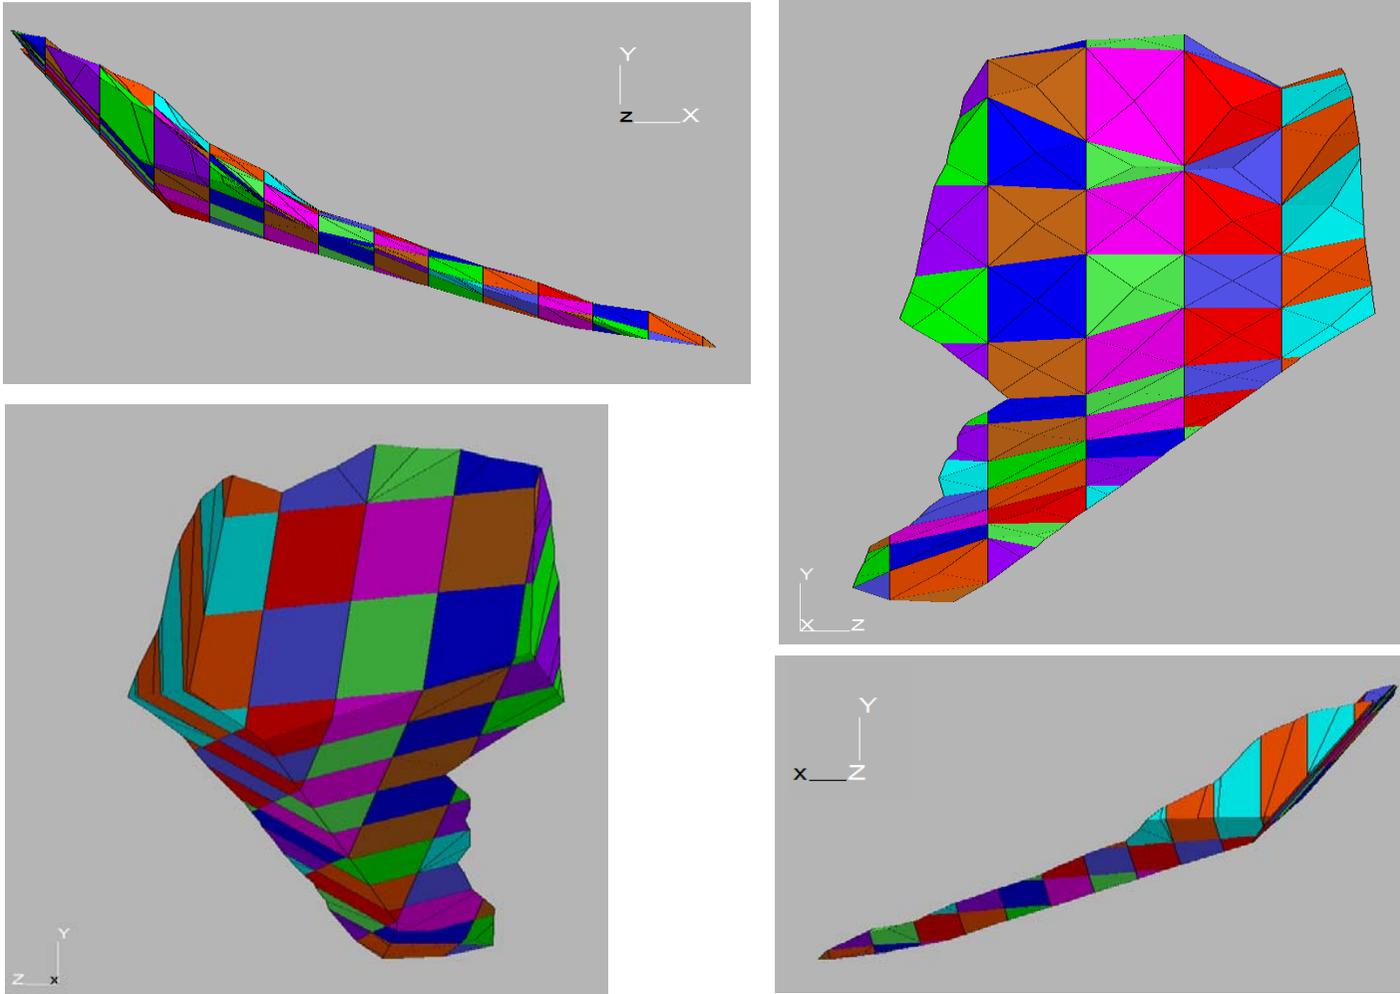
Fig. 4.14 - Various views of the overhanging rock mass modeled as a rigid and intact block

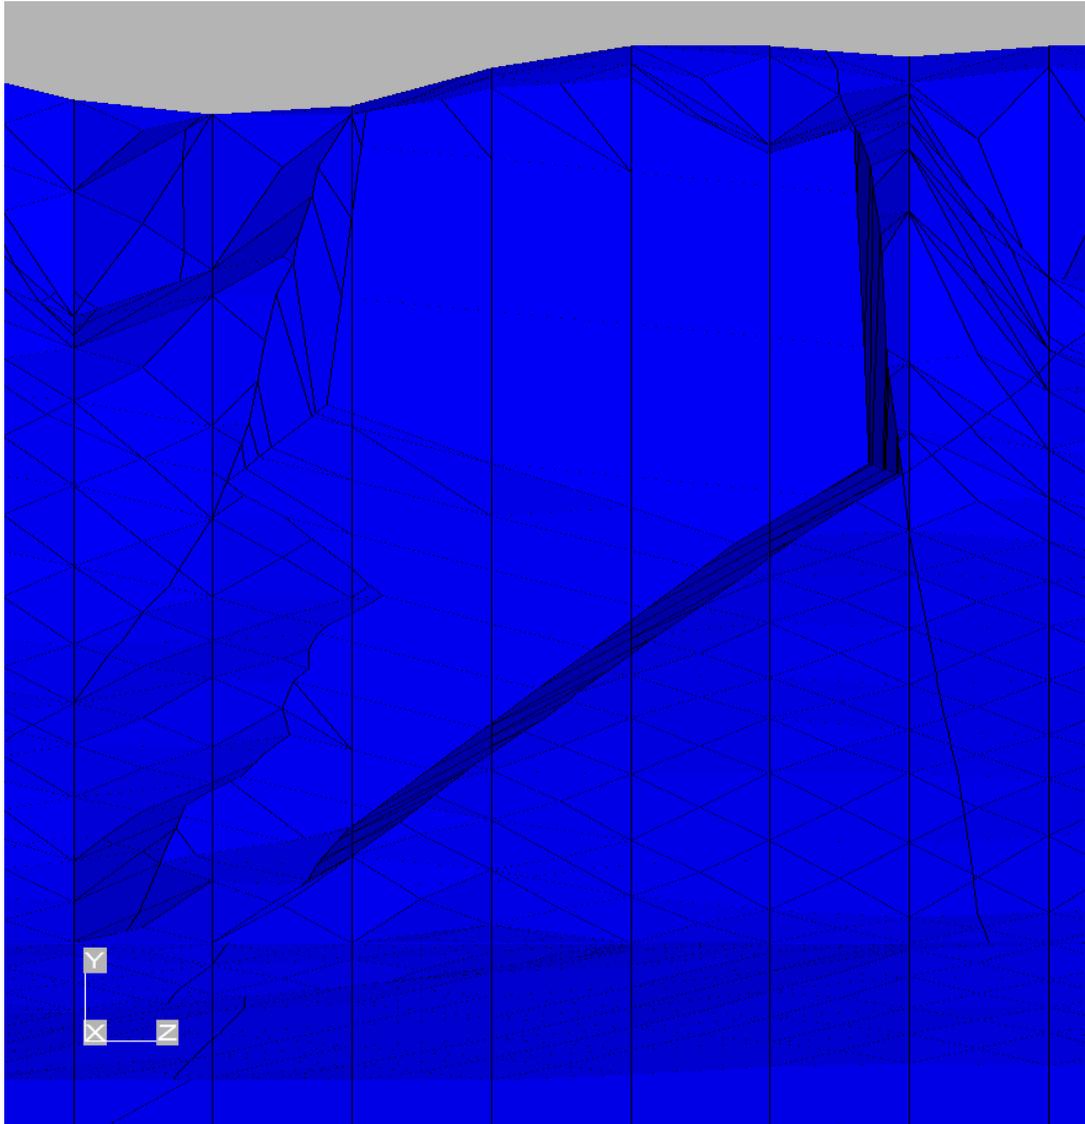
Fig. 4.15a - Scarp created by removal of the sliding block, showing all five failure surfaces involved.

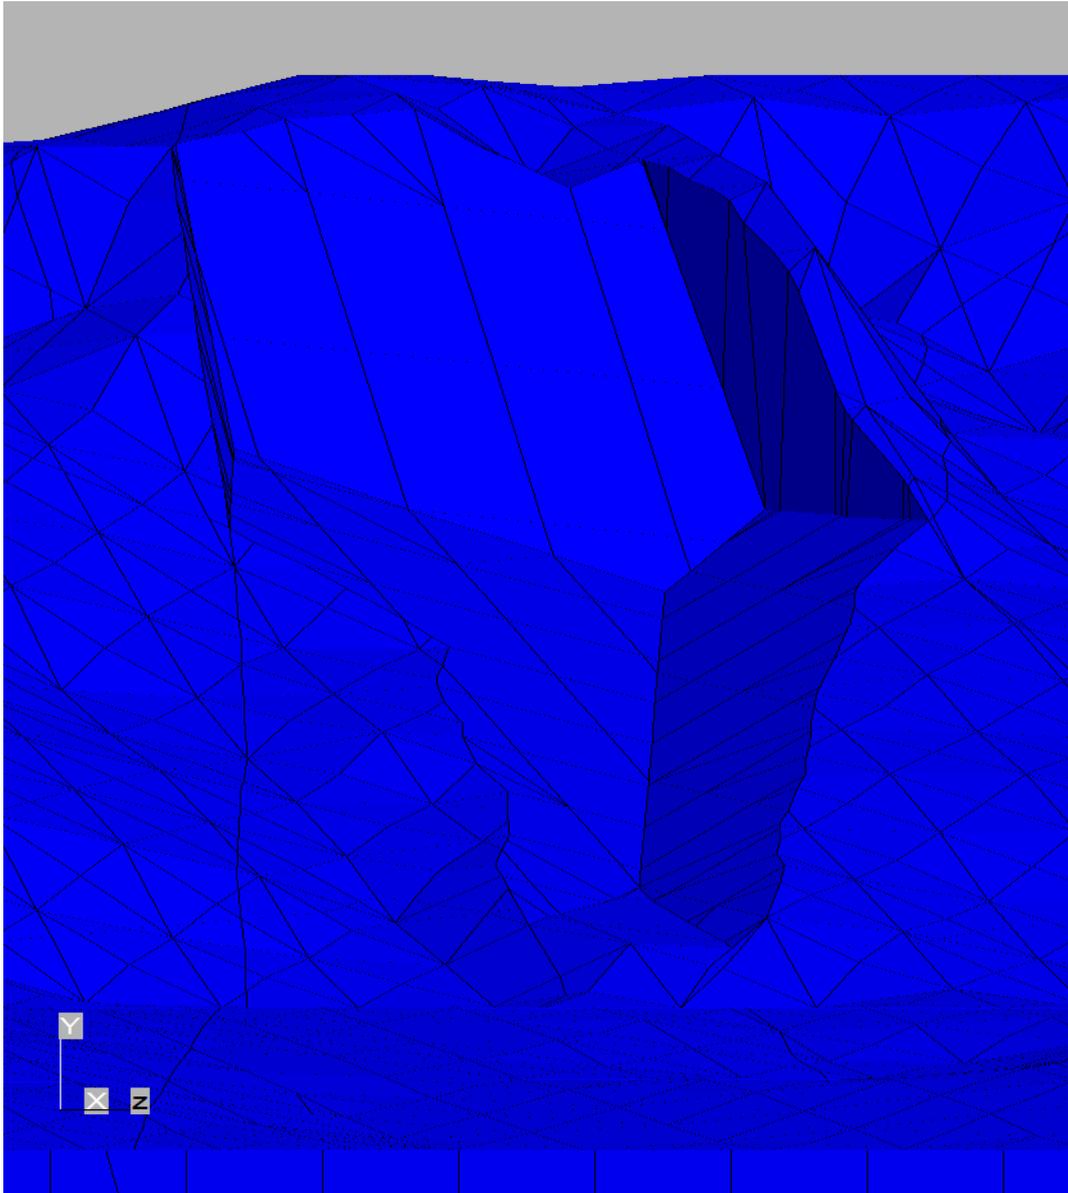
Figure 4.15b - Scarp created by removal of the sliding block, showing all five failure surfaces involved.

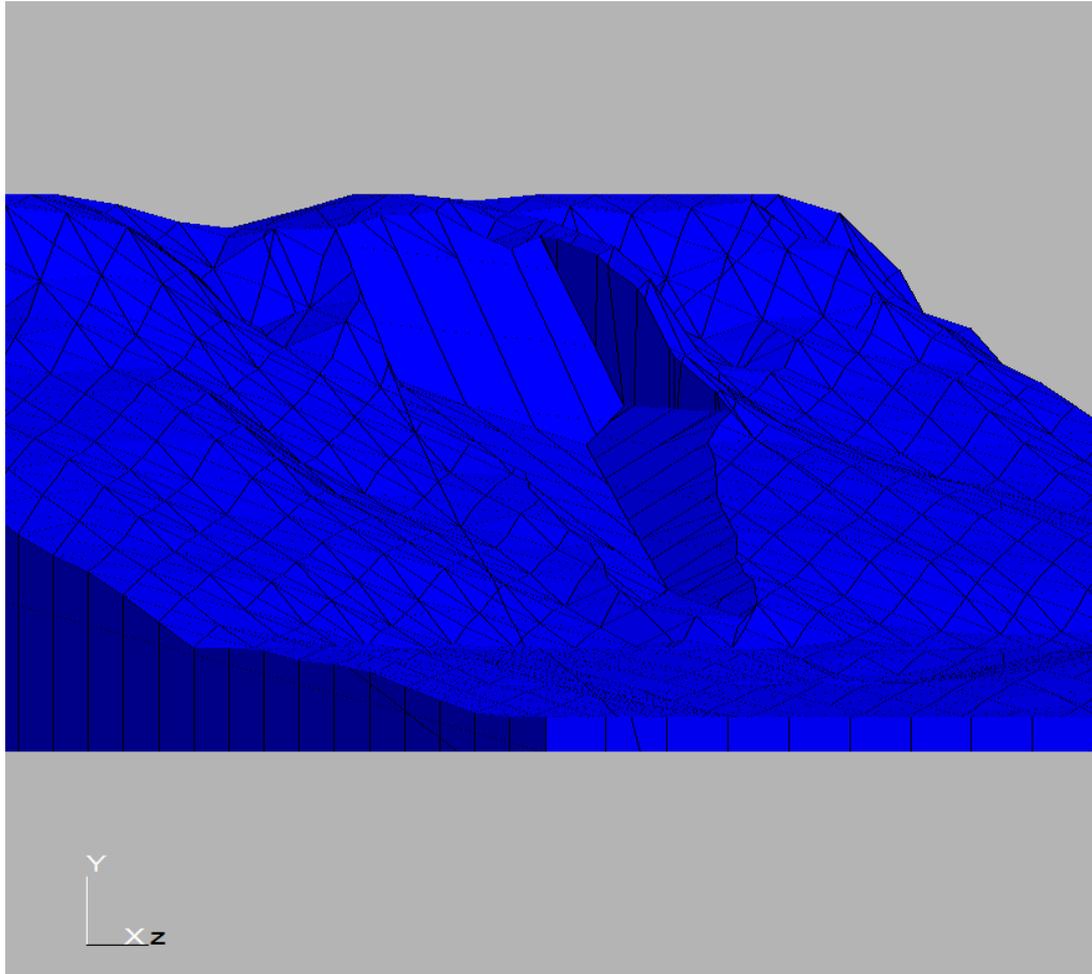
Figure 4.15c - Scarp created by removal of the sliding block, showing all five failure surfaces involved.

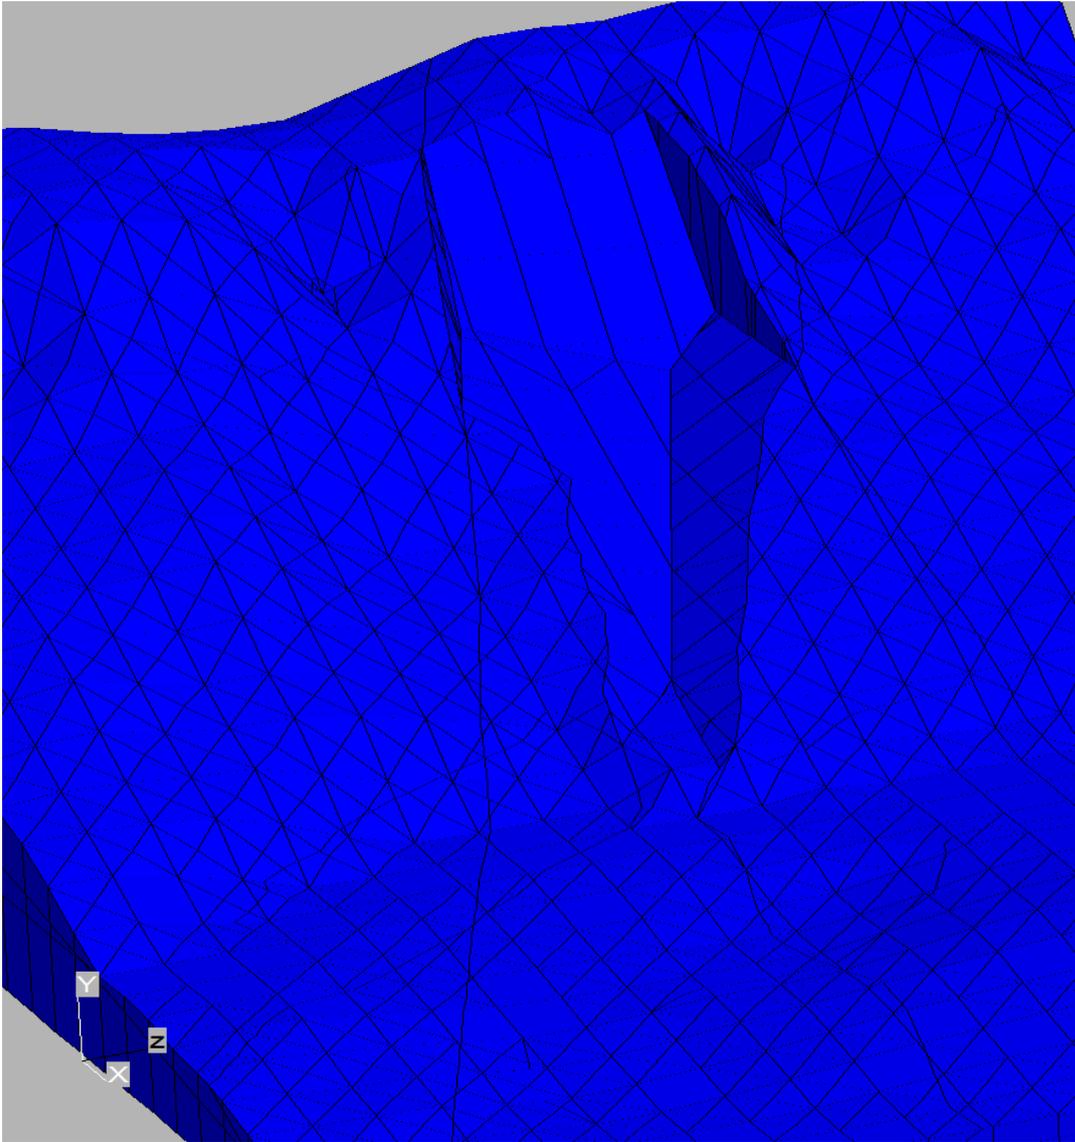
Figure 4.15d - Scarp created by removal of the sliding block, showing all five failure surfaces involved.

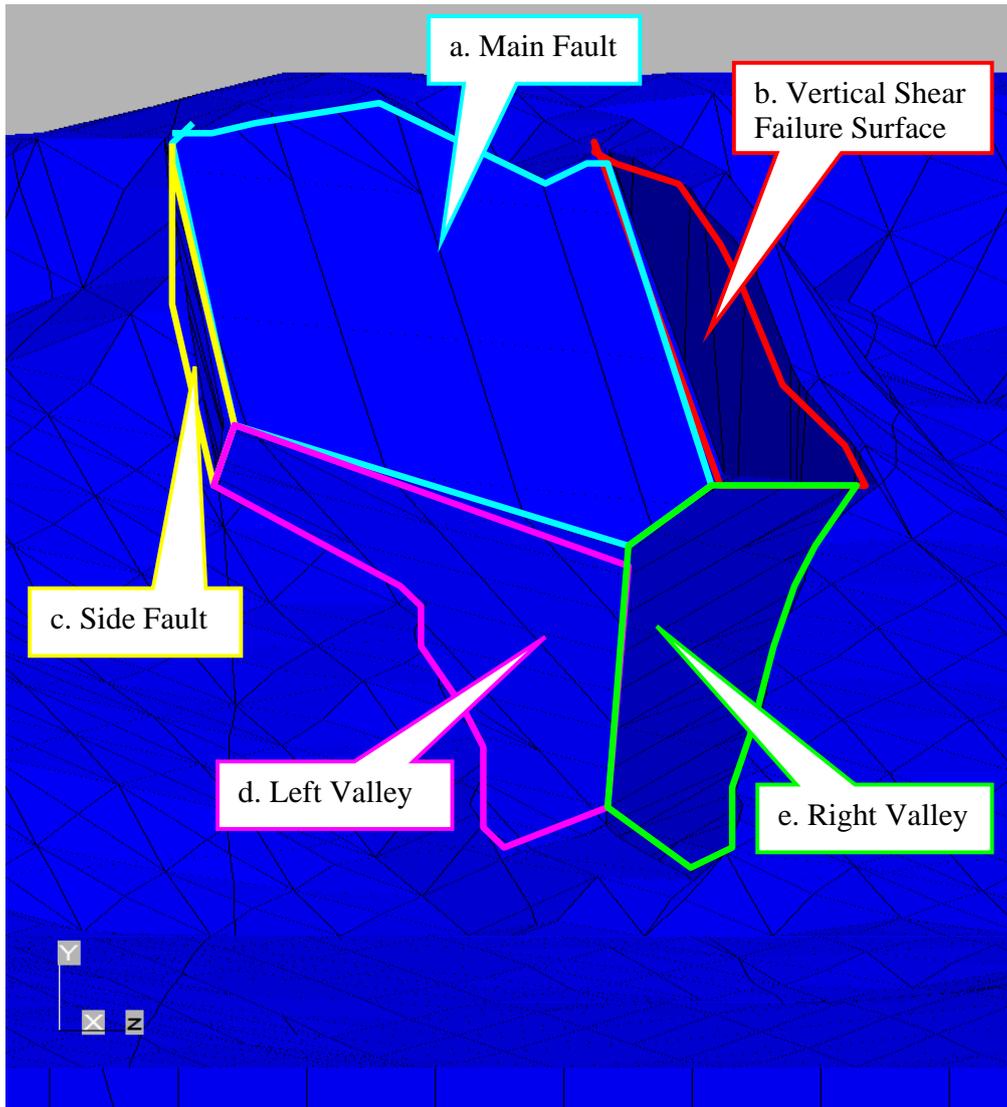
Fig. 5.1 - Scarp and five identified failure surfaces.

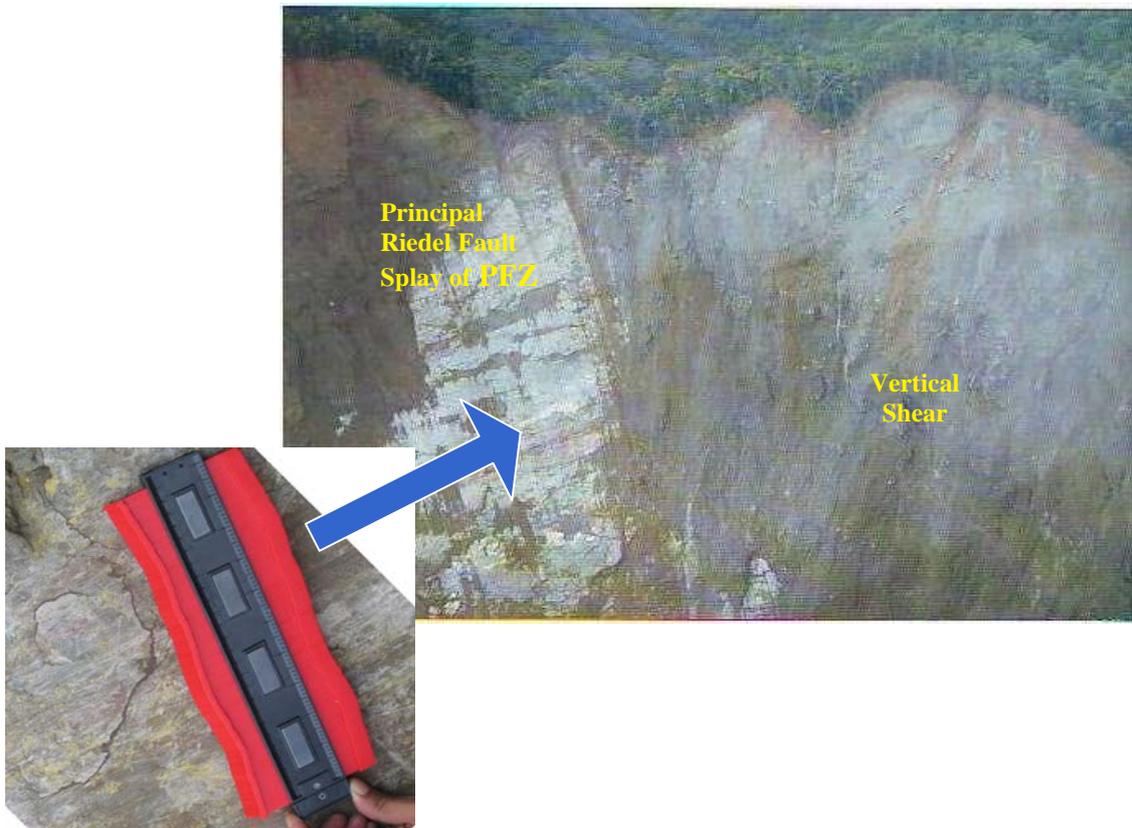
Fig. 5.2 - Typical 20 cm fracture profile of the main the fault.

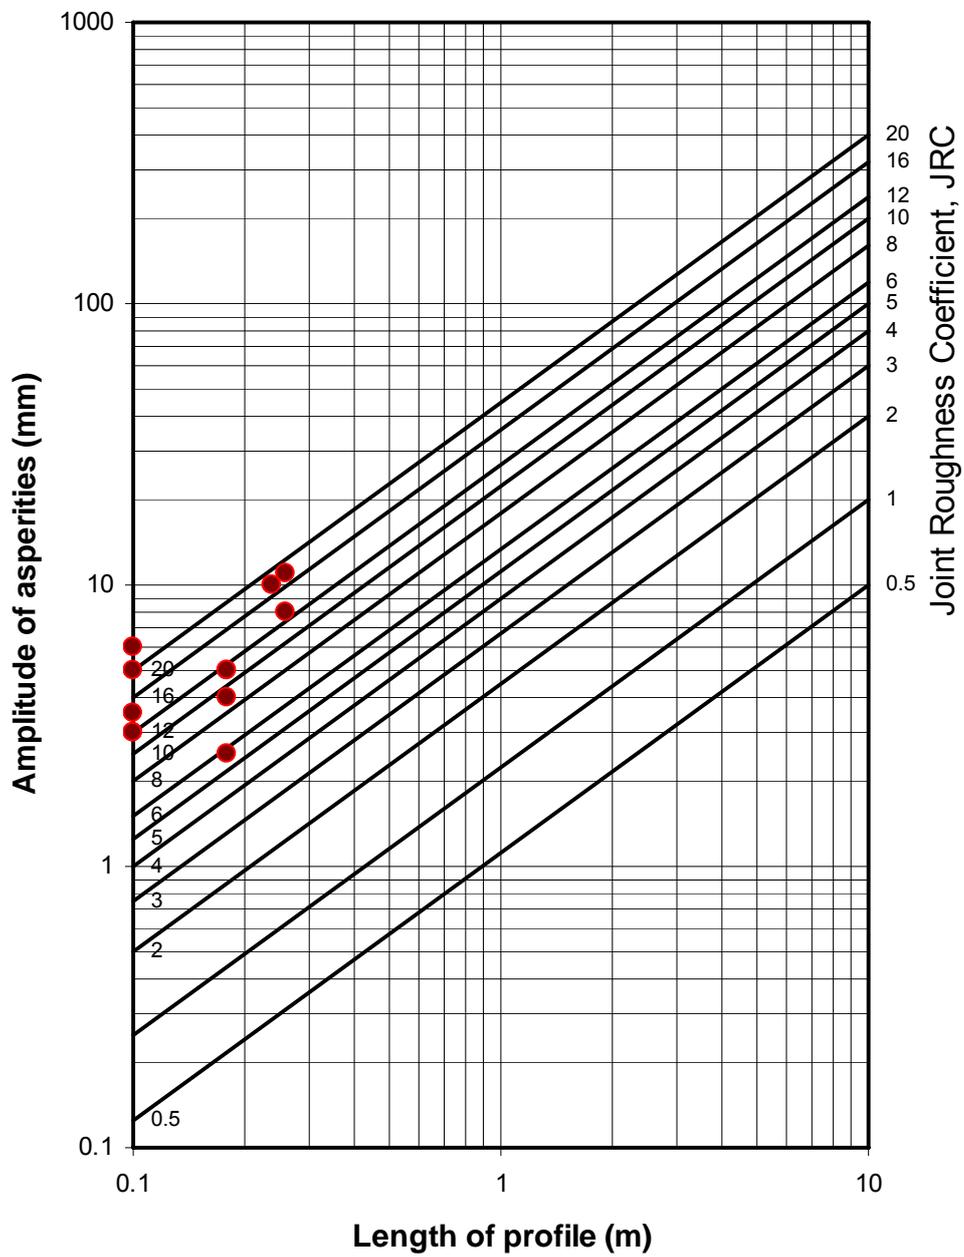
Fig. 5.3 - Determination of the Joint Roughness Coefficient (JRC_o) of the main the fault from profilometry (Barton and Choubey, 1977).

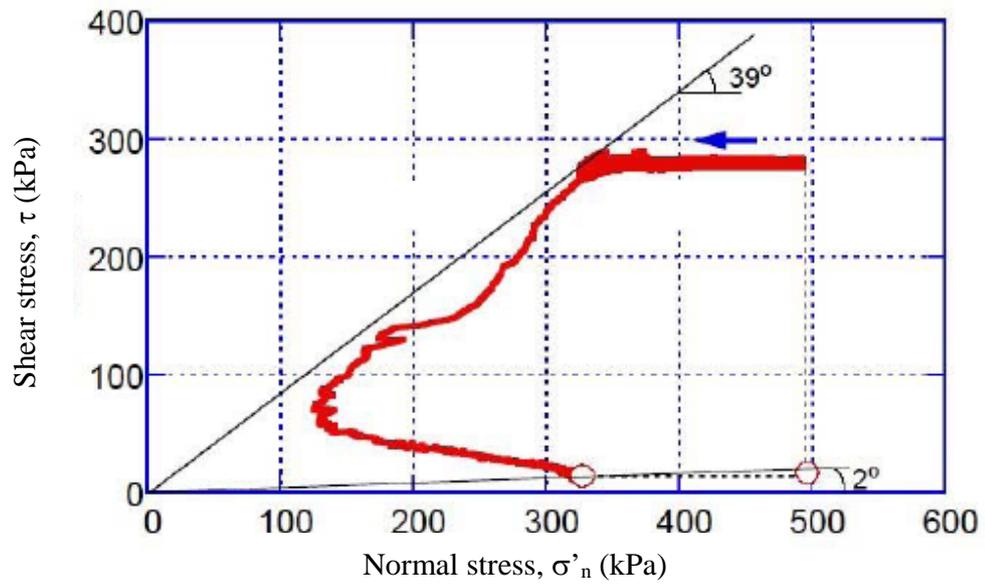
Fig. 5.4 - Results of a direct shear test on volcanic soils from the Guinsaigon slide (Tamaoki, 2006).

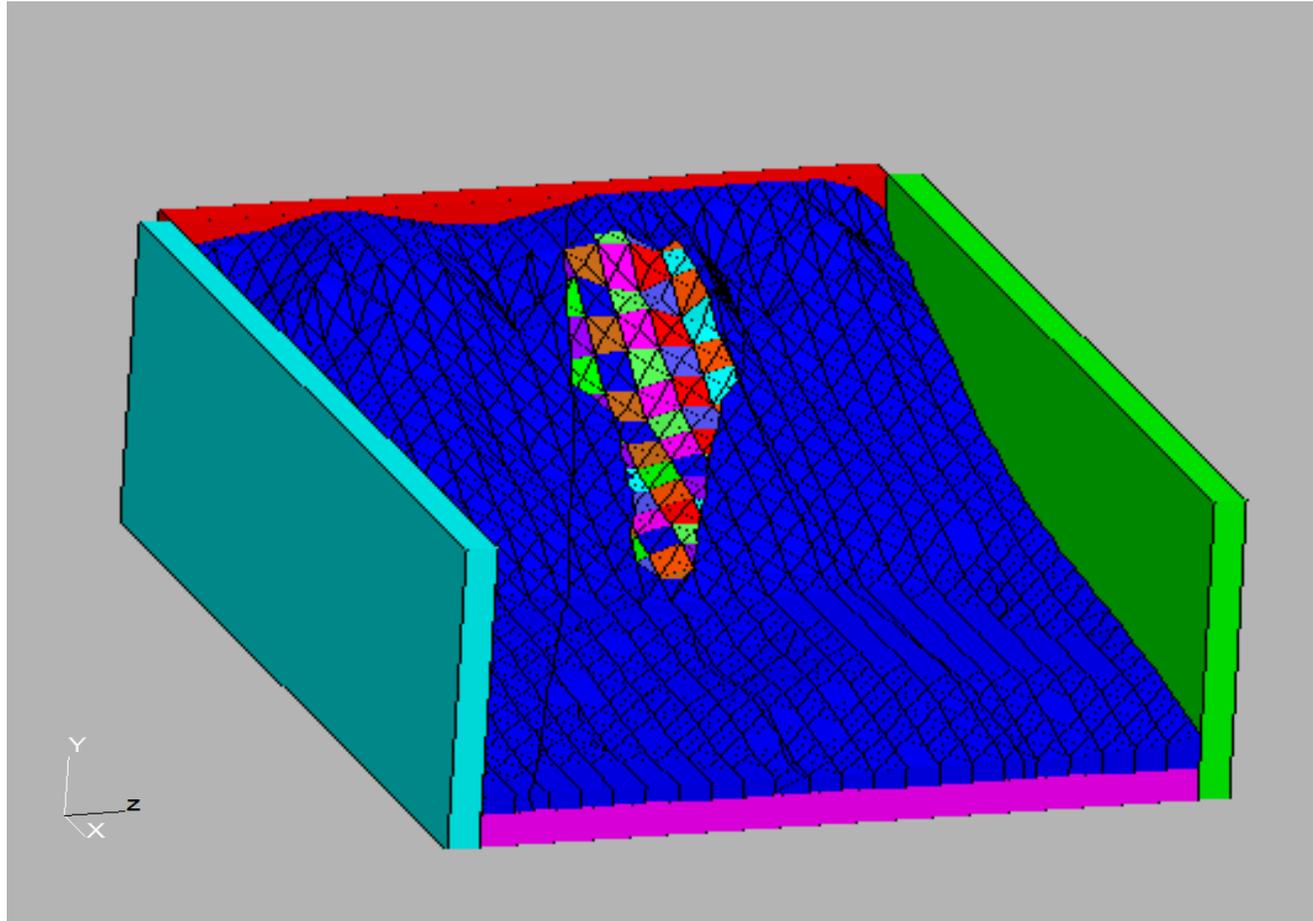
Fig. 6.3: Final 3DEC model showing boundary restraints.

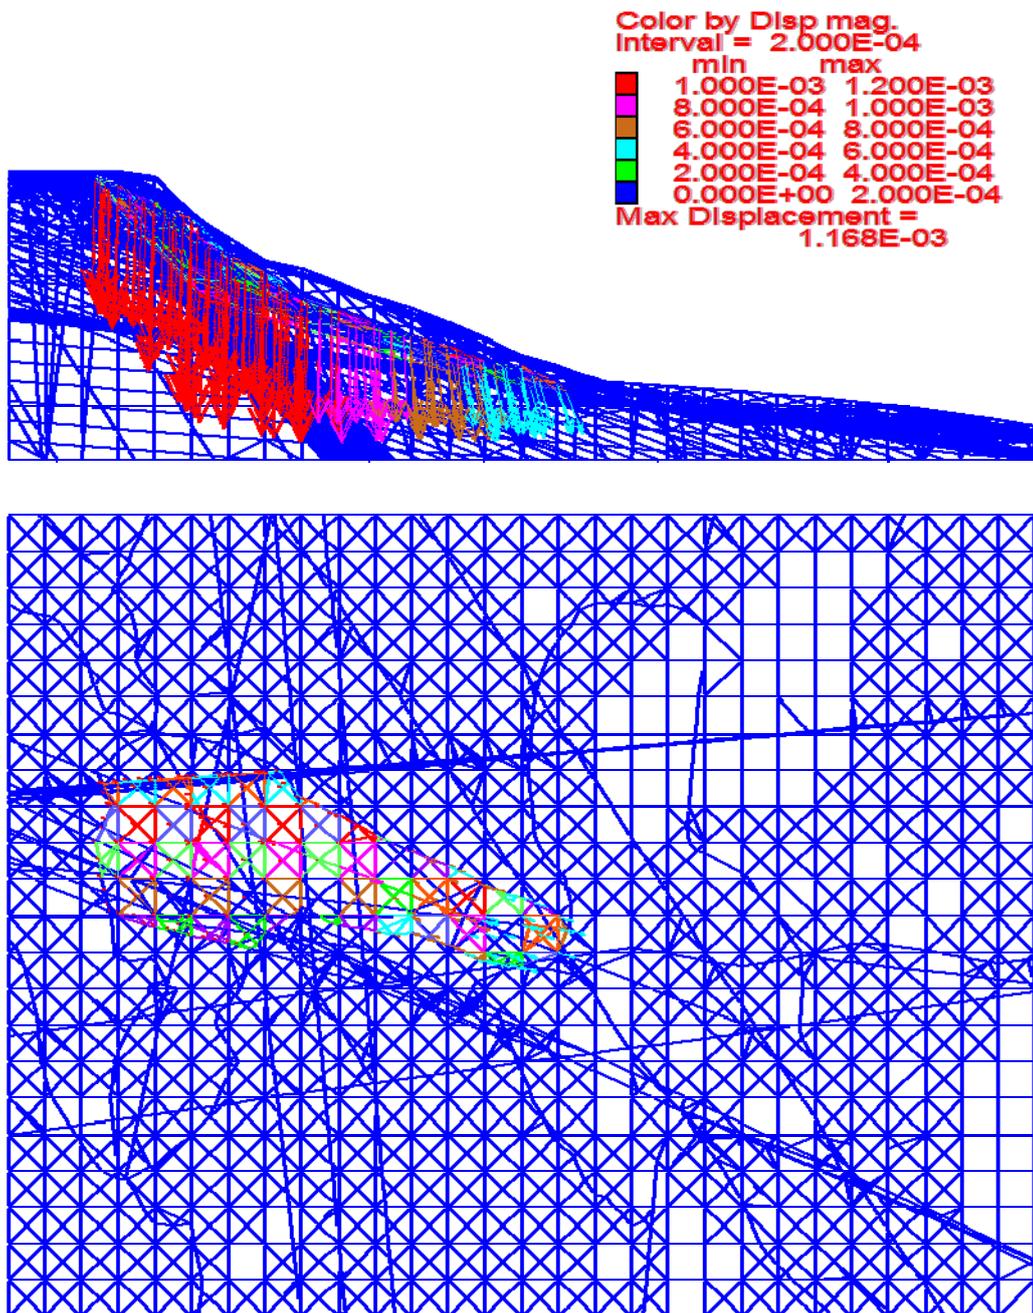
Fig. 6.4: Profile and plan view of 3DEC model showing displacement vectors of overhanging block – Stage A

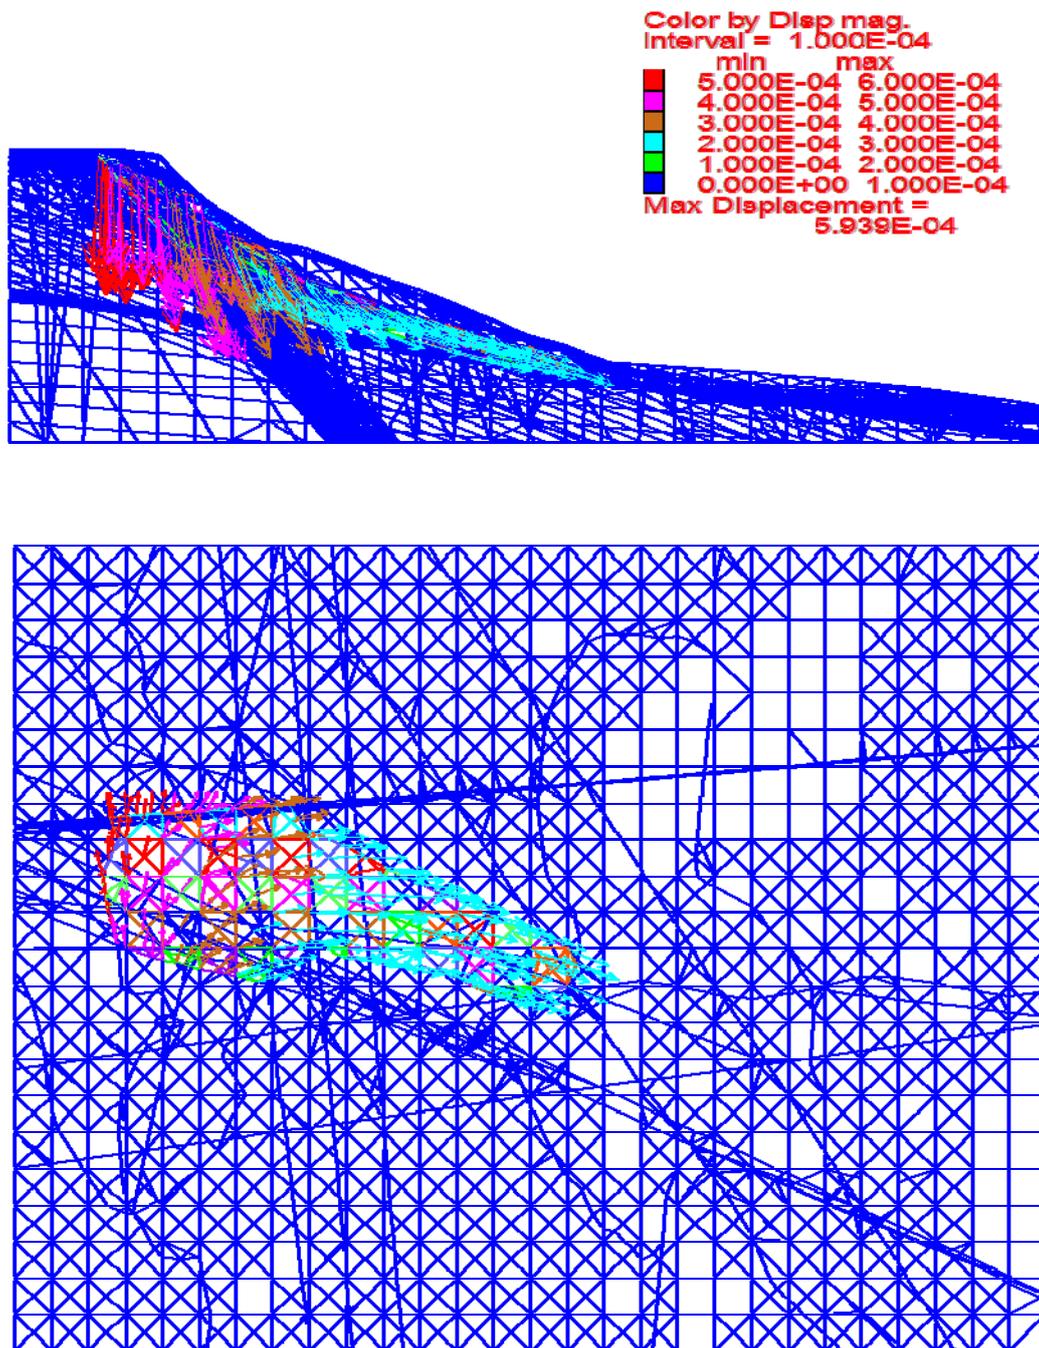
Fig. 6.6: Profile and plan view of 3DEC model showing displacement vectors of overhanging block – Stage B

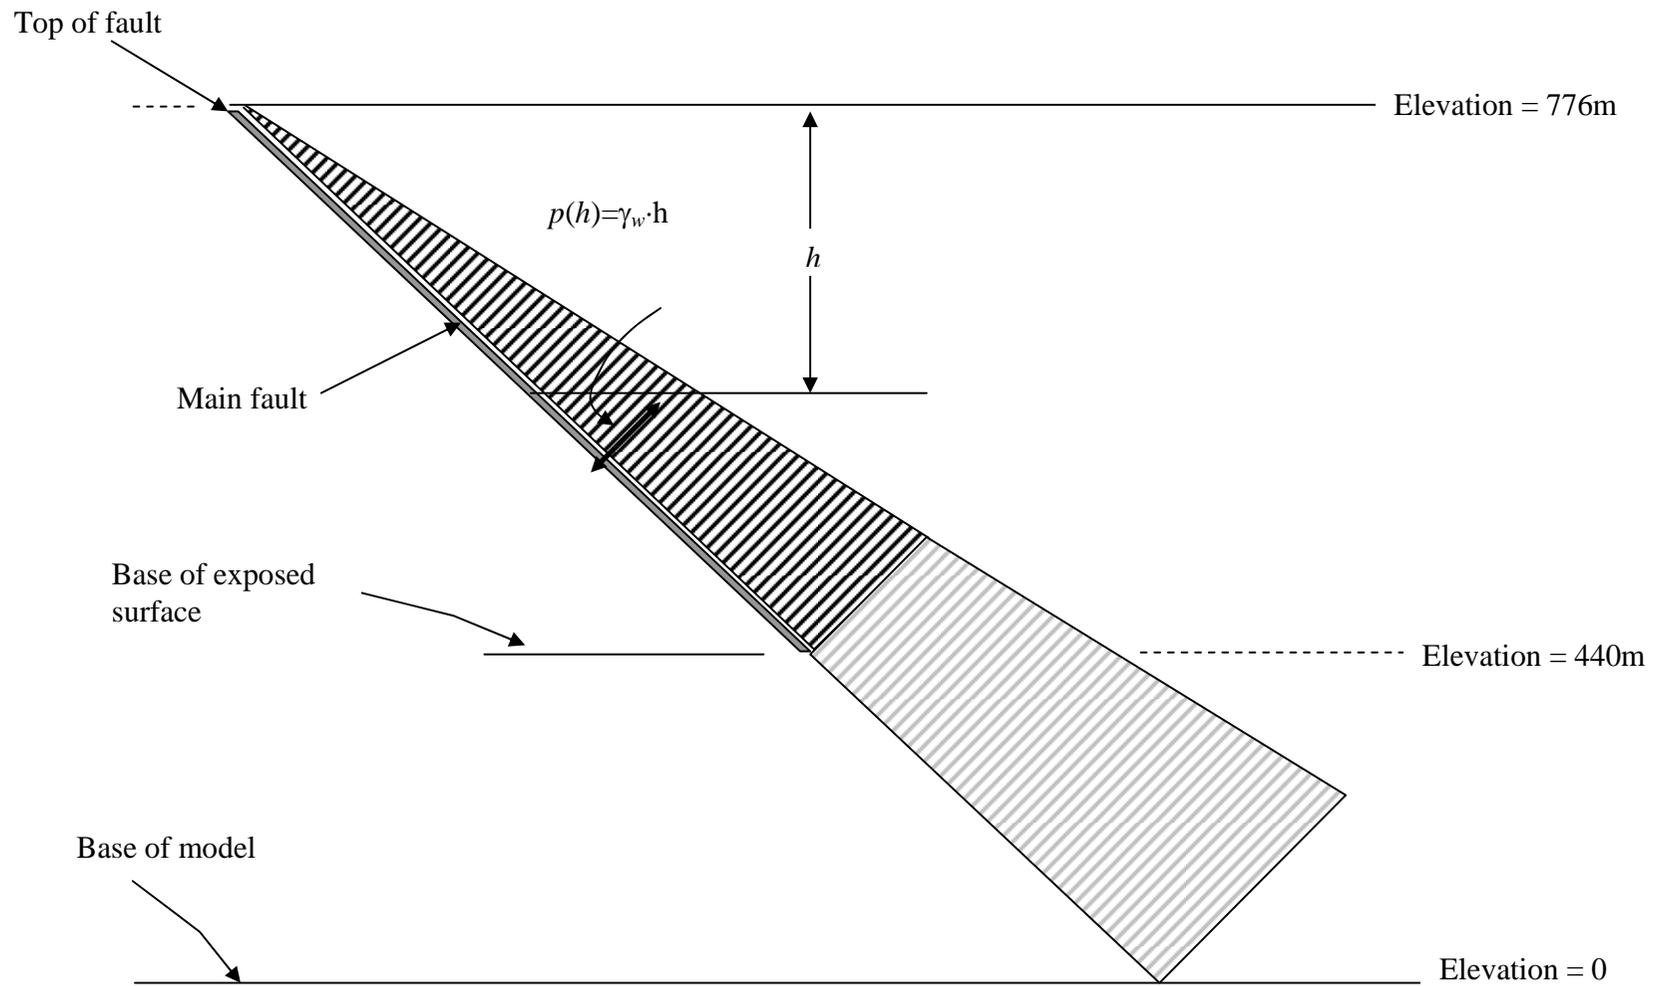
Figure 6.8: Main Fault subject to linearly varying pore pressure in the fault.

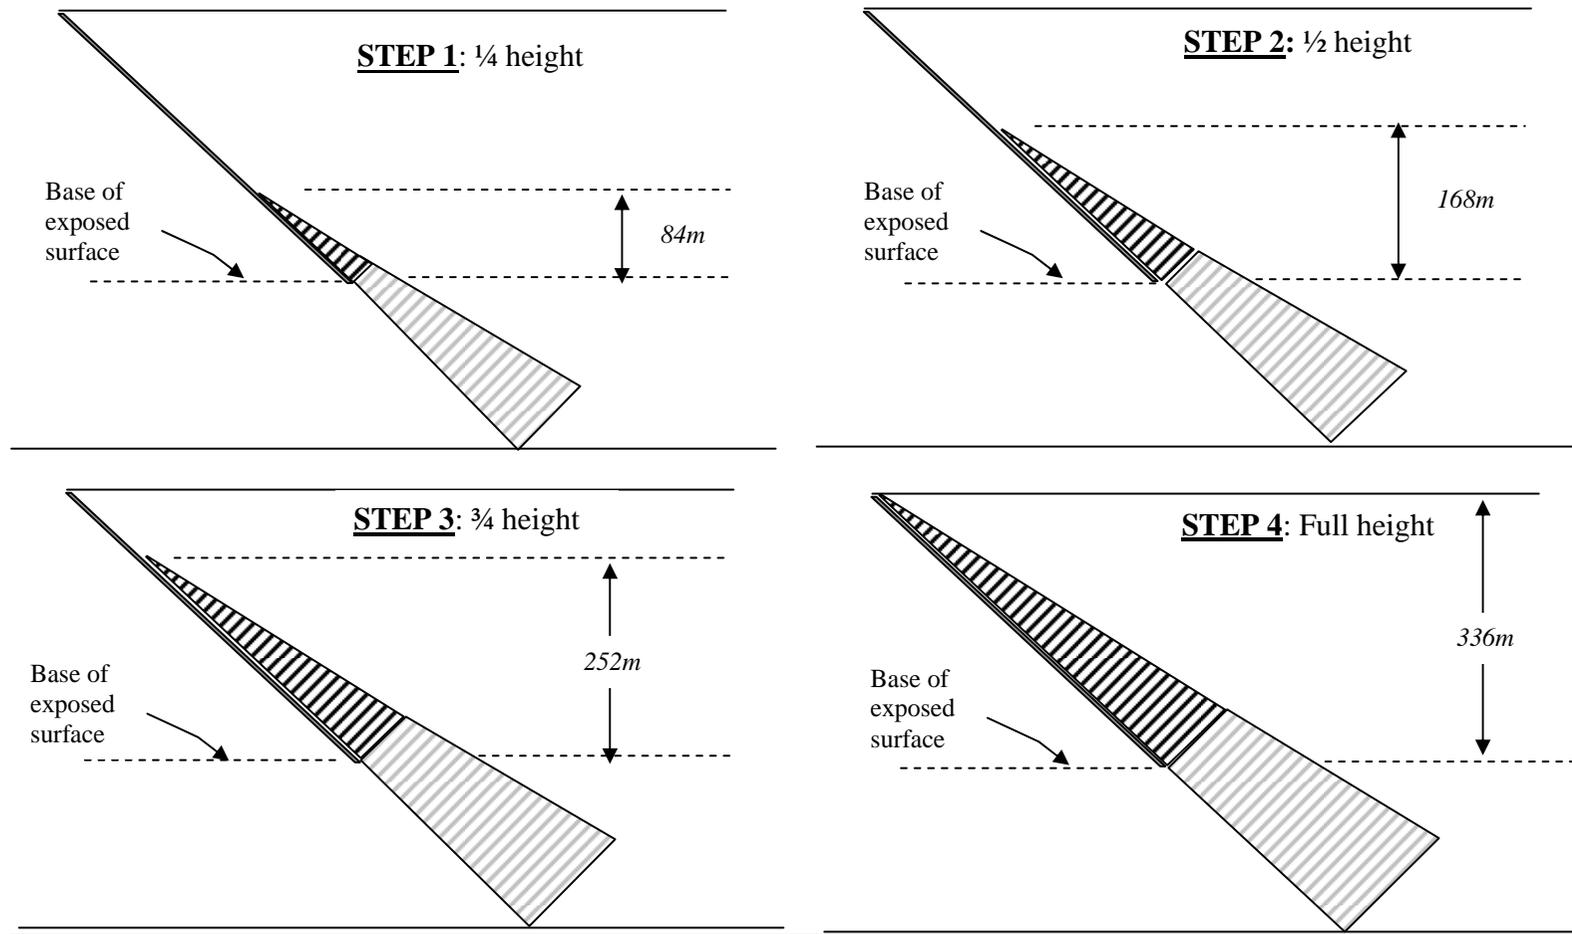
Figure 6.9: Graphical representation of gradual application of pore pressure in the main fault.

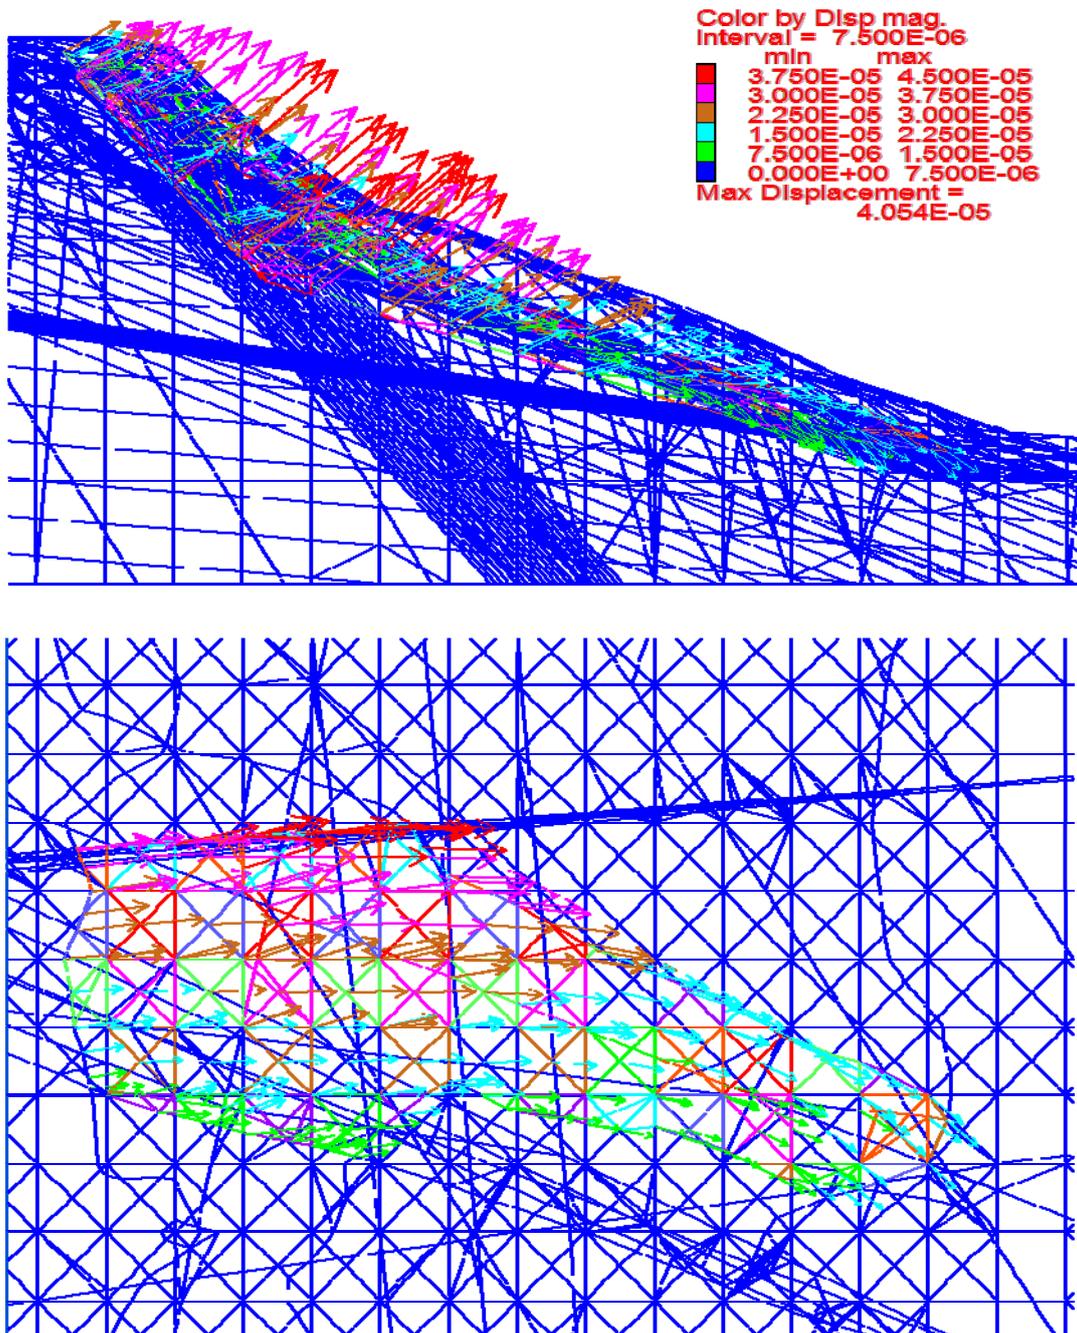
Fig. 6.11: Profile and plan view of 3DEC model showing displacement vectors of overhanging block – Scenario C1
