**DISTINCT ELEMENT SIMULATION OF THE FEBRUARY 17TH, 2006, LEYTE,
PHILIPPINES ROCKSLIDE**

THESIS SUBMITTED TO THE FACULTY OF THE VIRGINIA POLYTECHNIC INSTITUTE AND
STATE UNIVERSITY IN PARTIAL FULFILLMENT OF THE REQUIREMENTS FOR THE DEGREE
OF

MASTER OF SCIENCE
IN
GEOTECHNICAL ENGINEERING

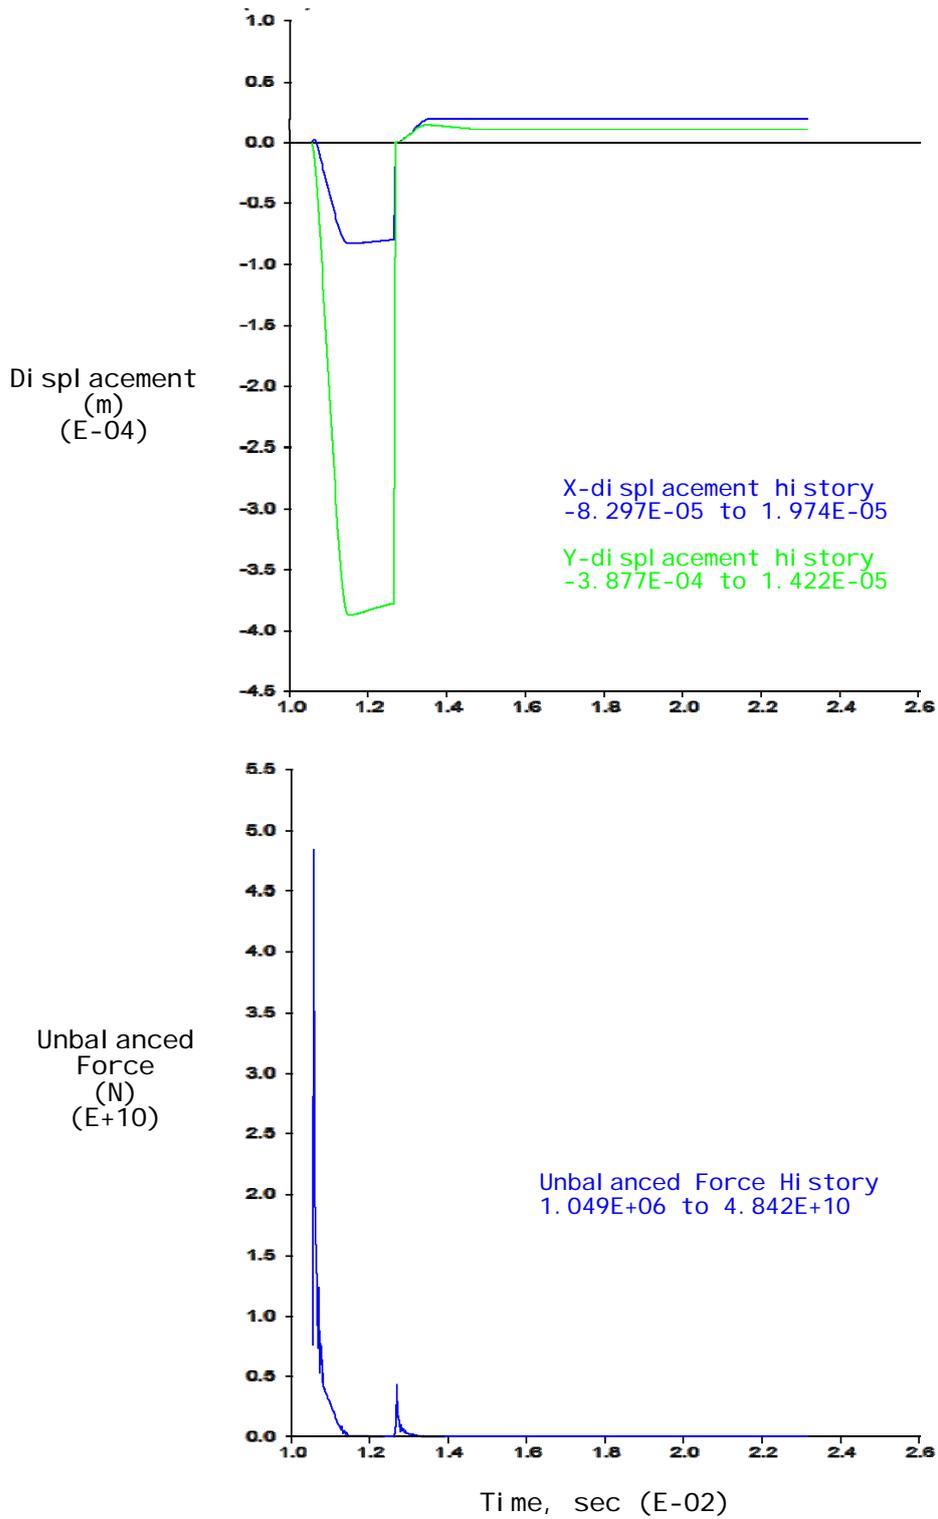
Fig. 6.12: Top: Displacement history plot of point A on sliding block vs. Time
 Bottom: Unbalanced Force History plot of model vs. Time (Scenario C1)

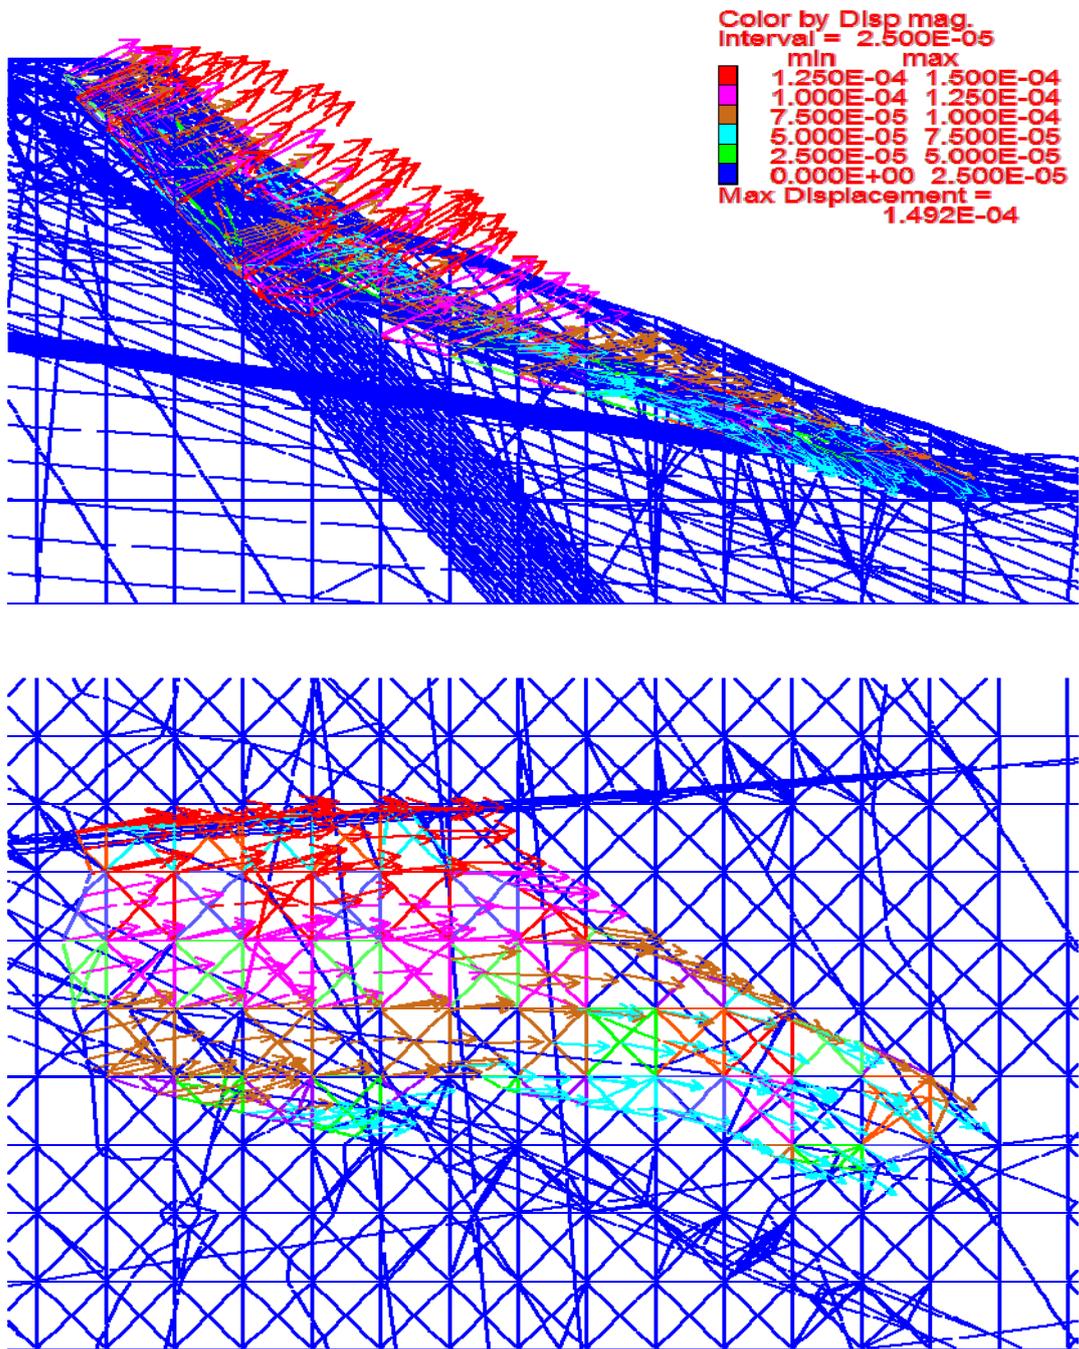
Fig. 6.14: Profile and plan view of 3DEC model showing displacement vectors of overhanging block – Scenario C2

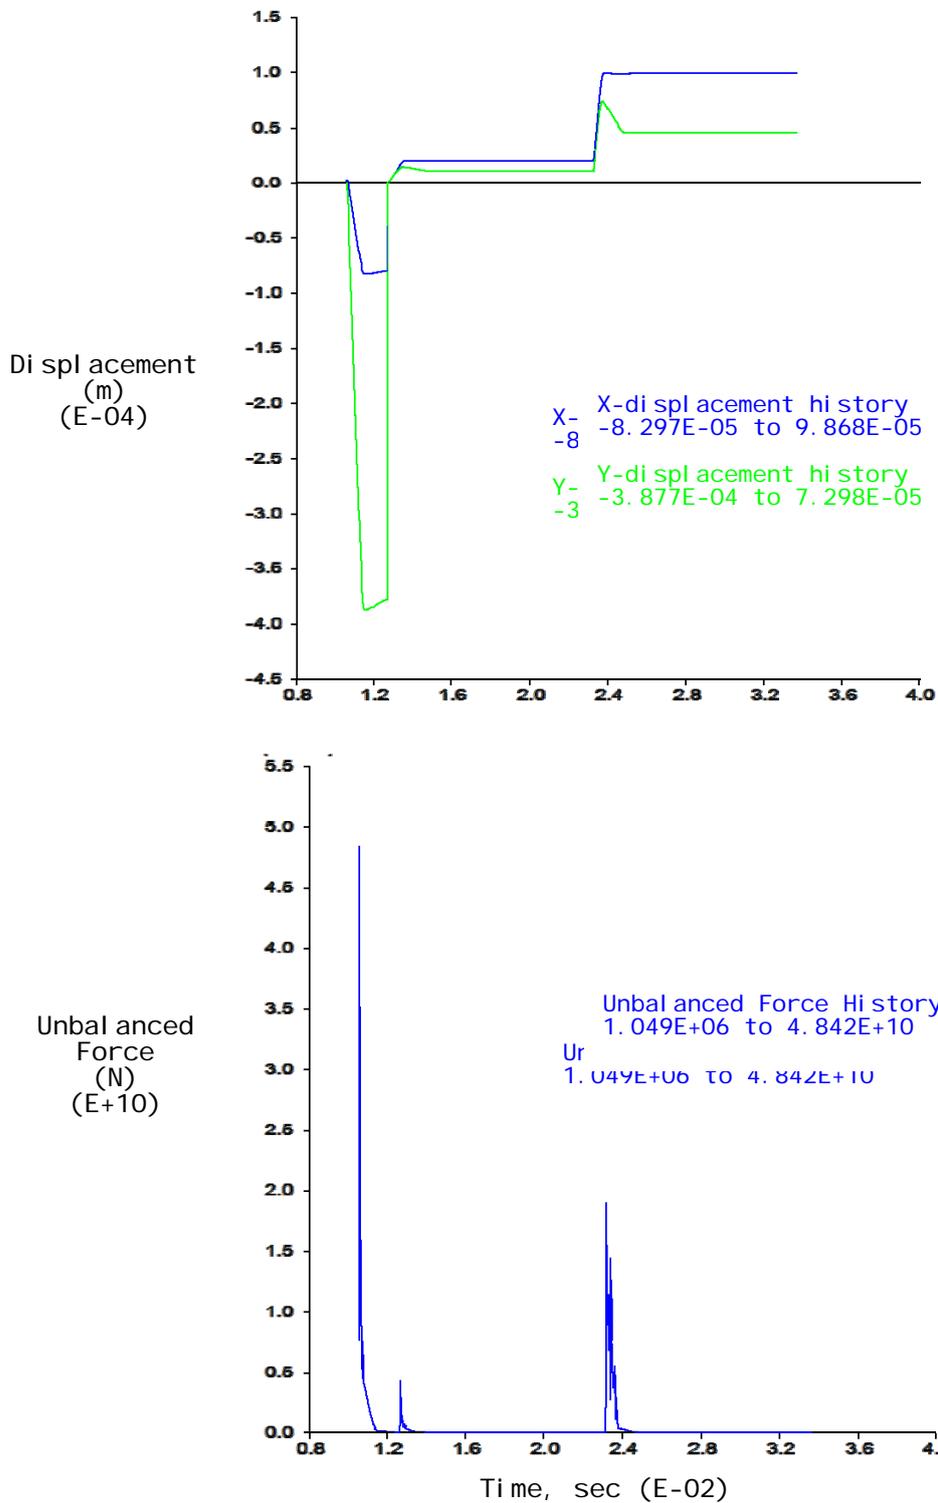
Fig. 6.15: Top: Displacement history plot of point A on sliding block vs. Time
 Bottom: Unbalanced Force History plot of model vs. Time (Scenario C2)

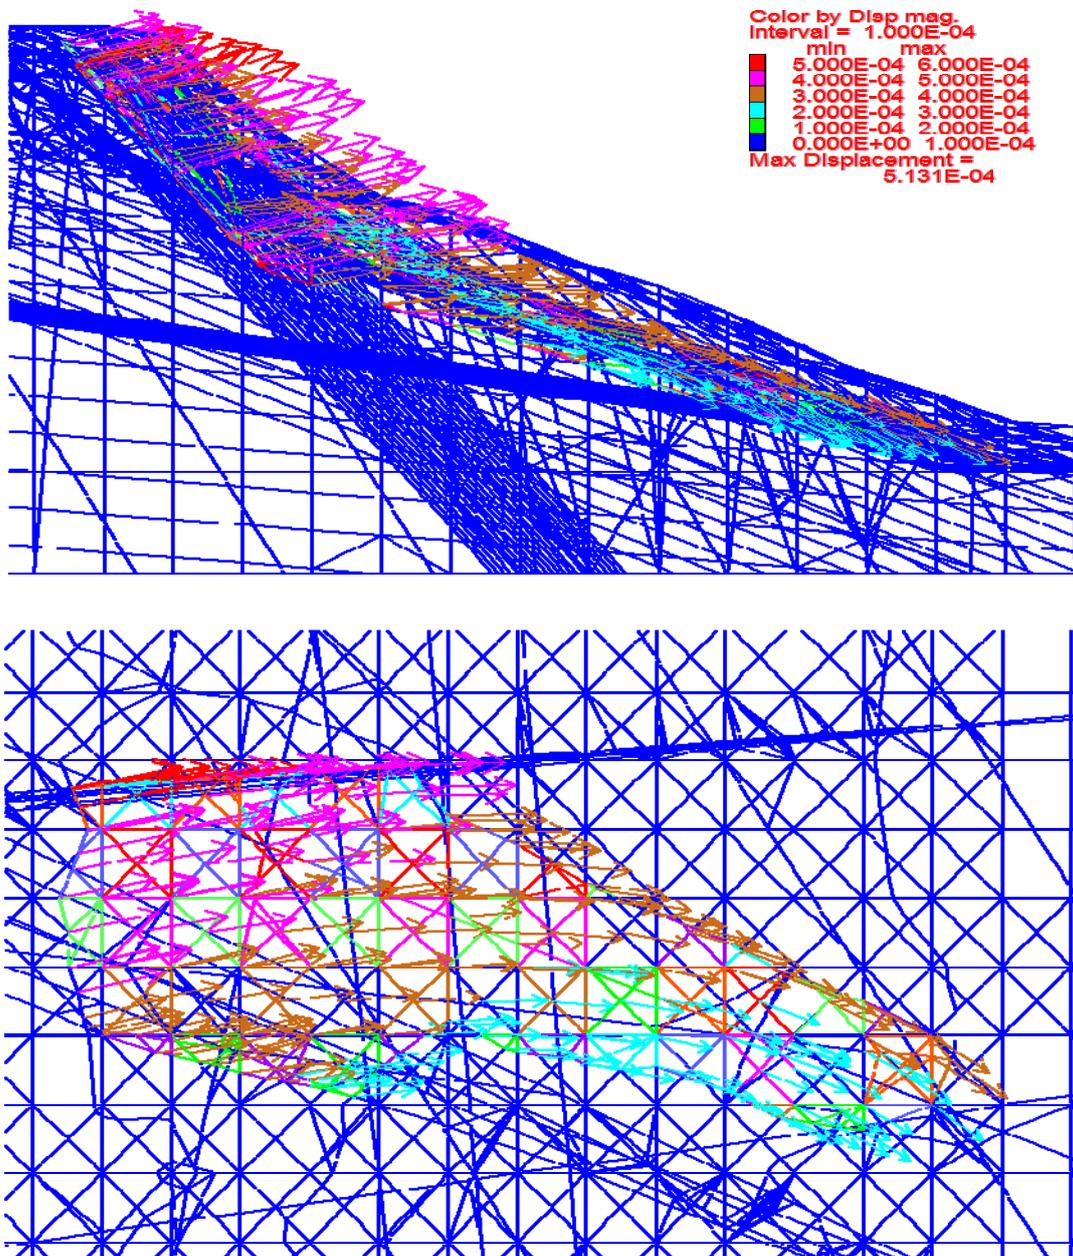
Fig. 6.17: Profile and plan view of 3DEC model showing displacement vectors of overhanging block – Scenario C3

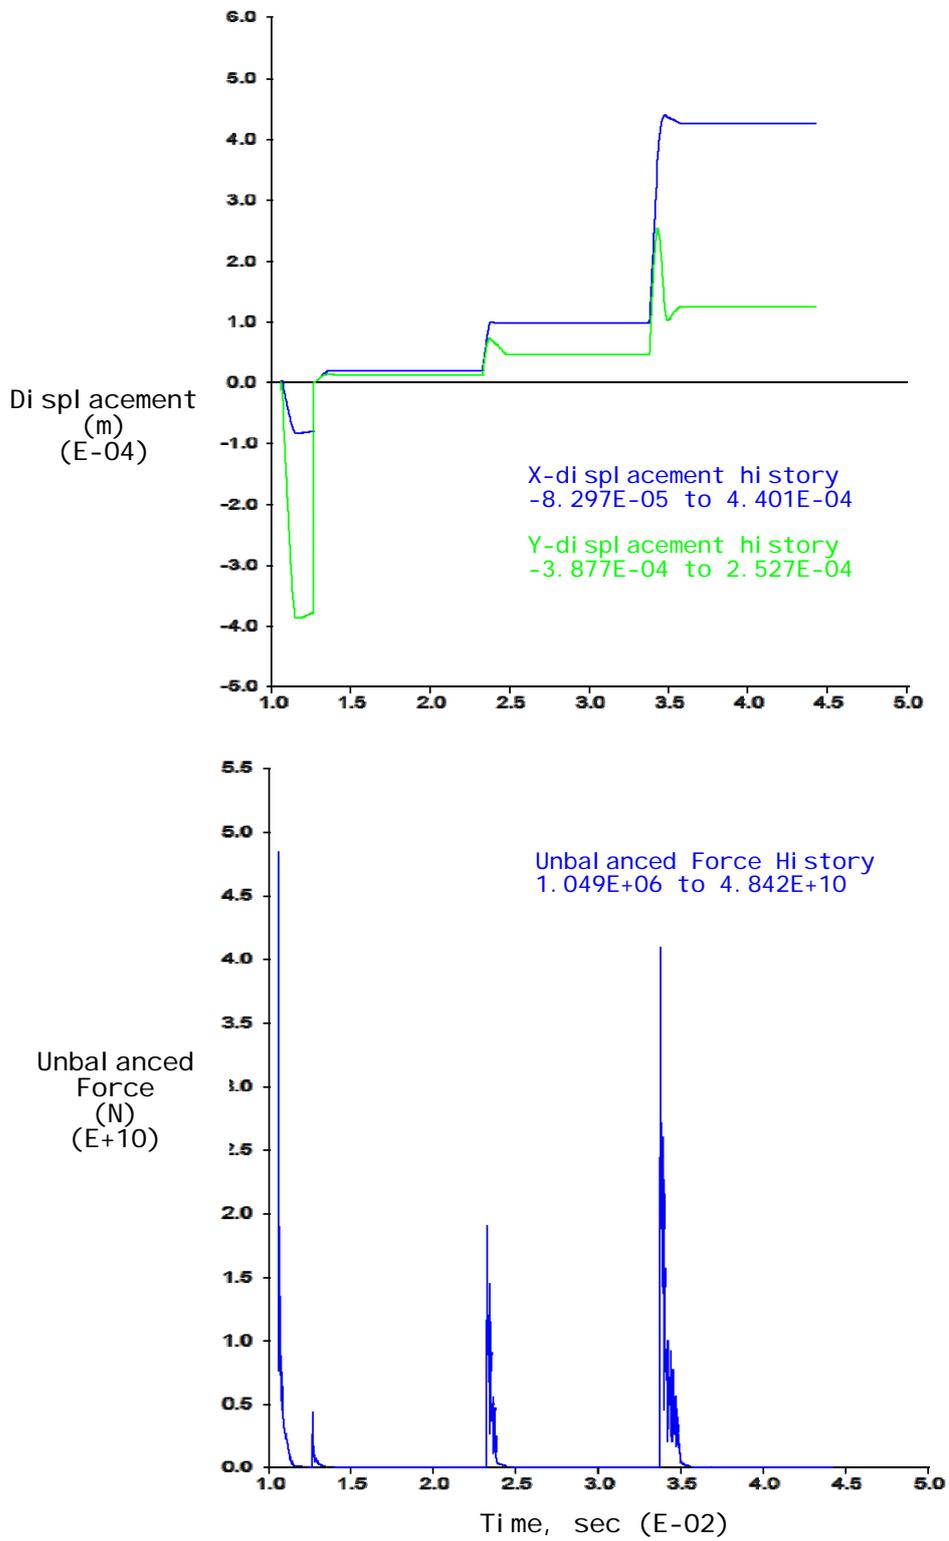
Fig. 6.18: Top: Displacement history plot of point A on sliding block vs. Time
 Bottom: Unbalanced Force History plot of model vs. Time (Scenario C3)

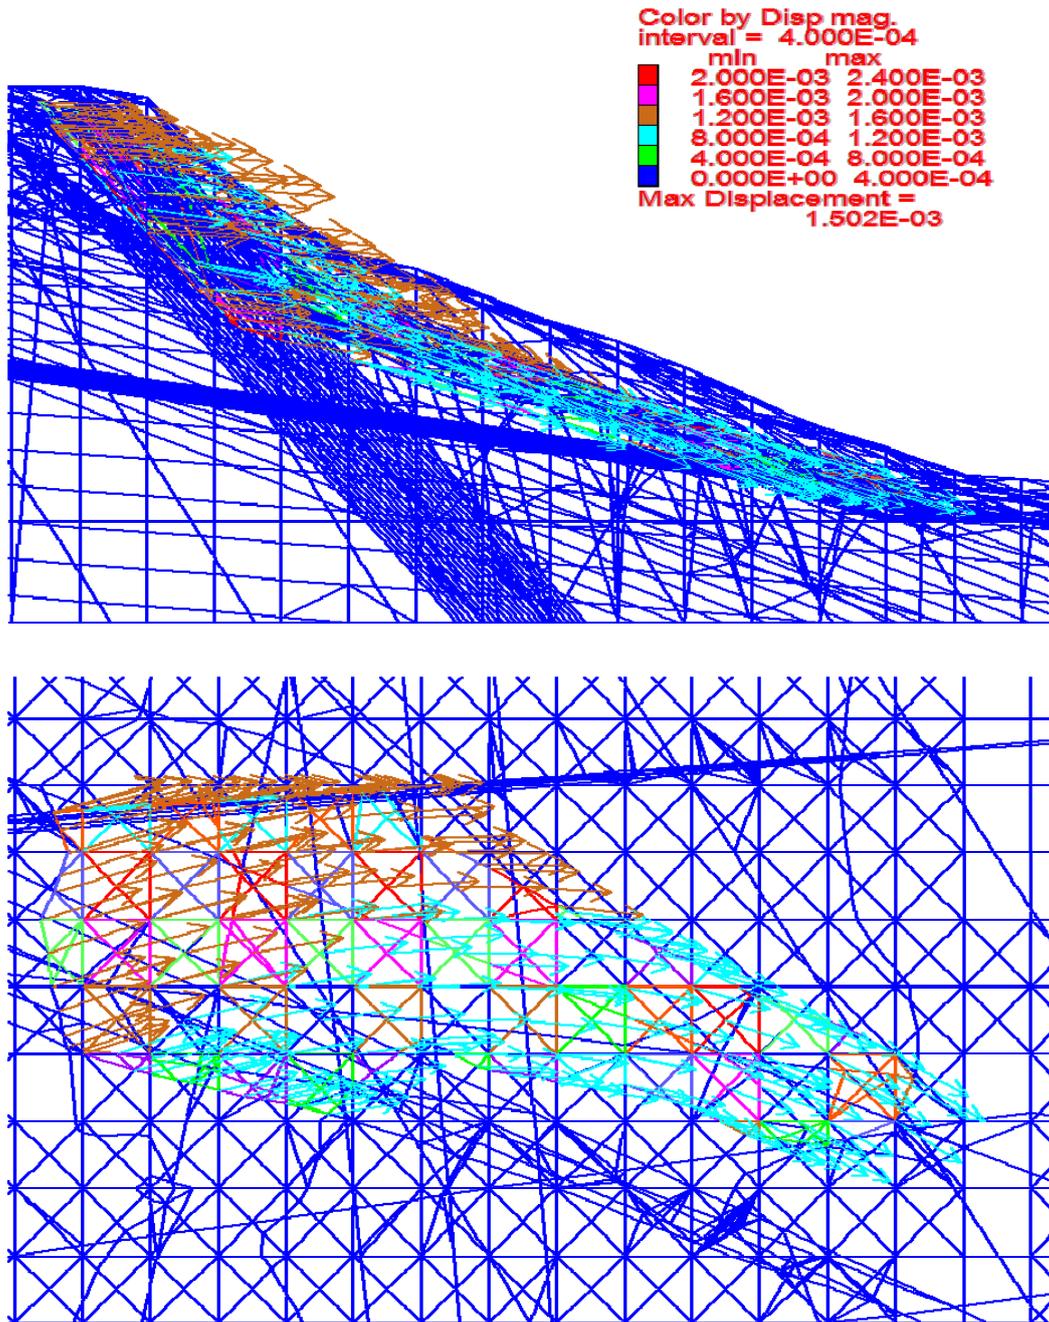
Fig. 6.20: Profile and plan view of 3DEC model showing displacement vectors of overhanging block – Scenario C4

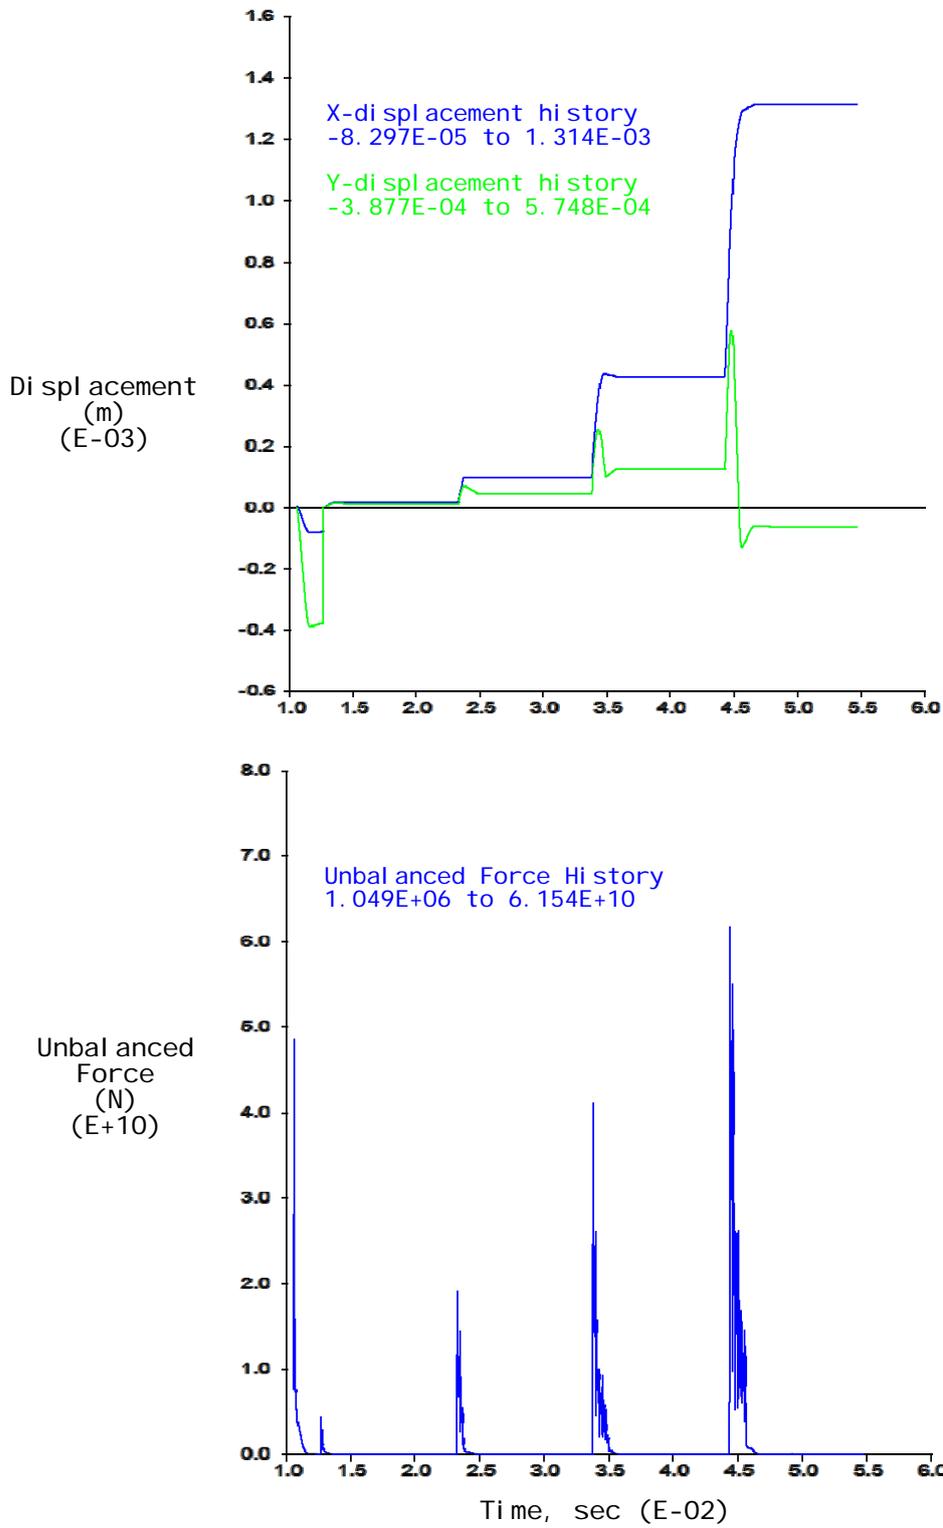
Fig. 6.21: Top: Displacement history plot of point A on sliding block vs. Time
 Bottom: Unbalanced Force History plot of model vs. Time (Scenario C4)

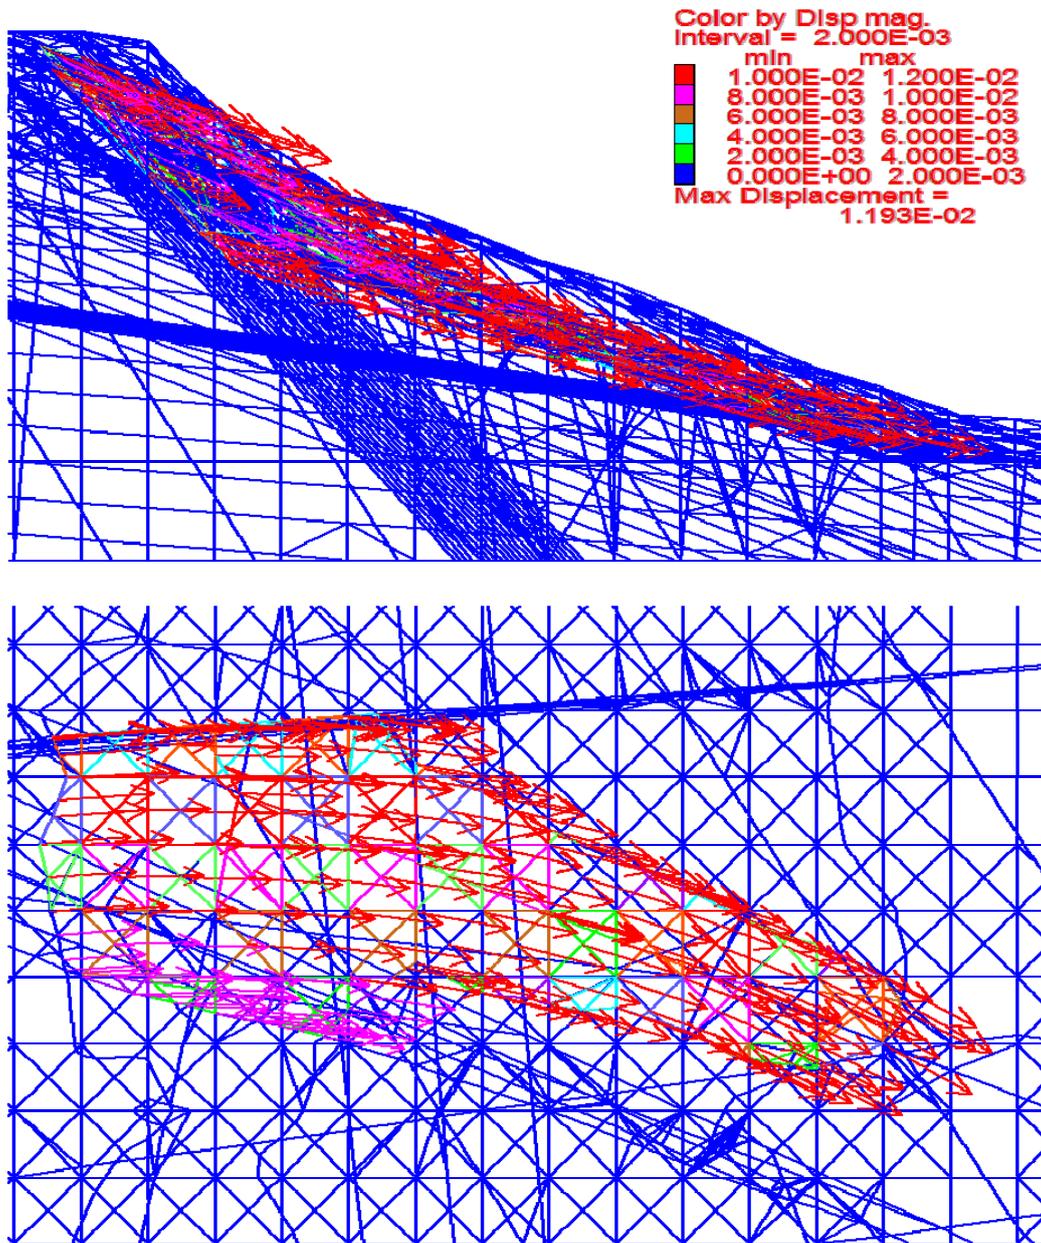
Fig. 6.25: Profile and plan view of 3DEC model showing displacement vectors of overhanging block (Scenario D2)

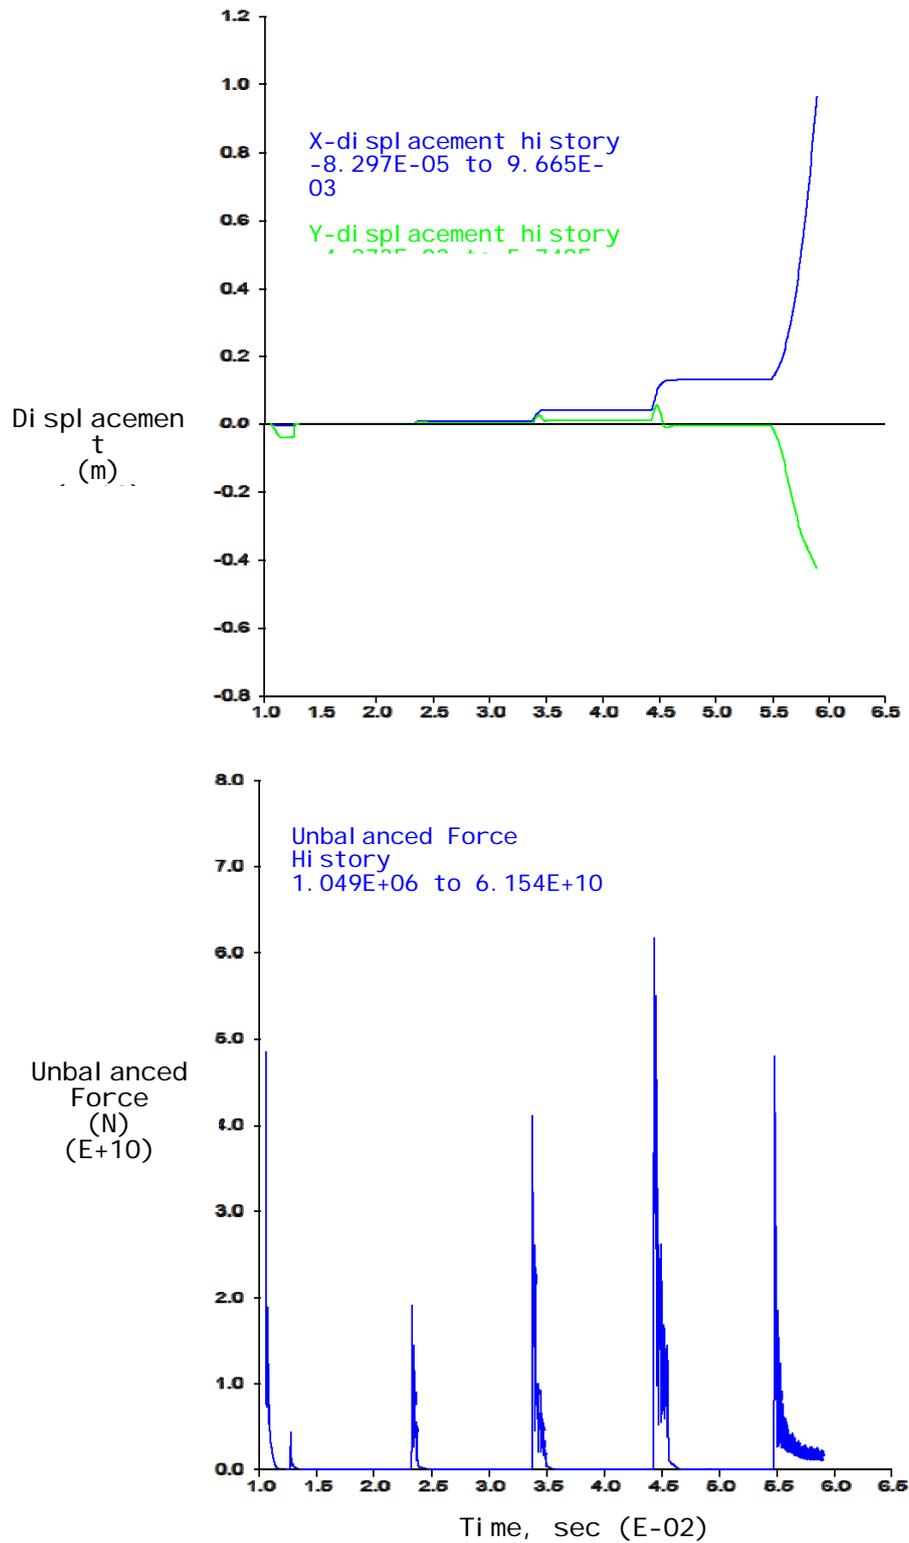
Fig. 6.26: Top: Displacement history plot of point A on sliding block vs. Time
 Bottom: Unbalanced Force History plot of model vs. Time (Scenario D2)

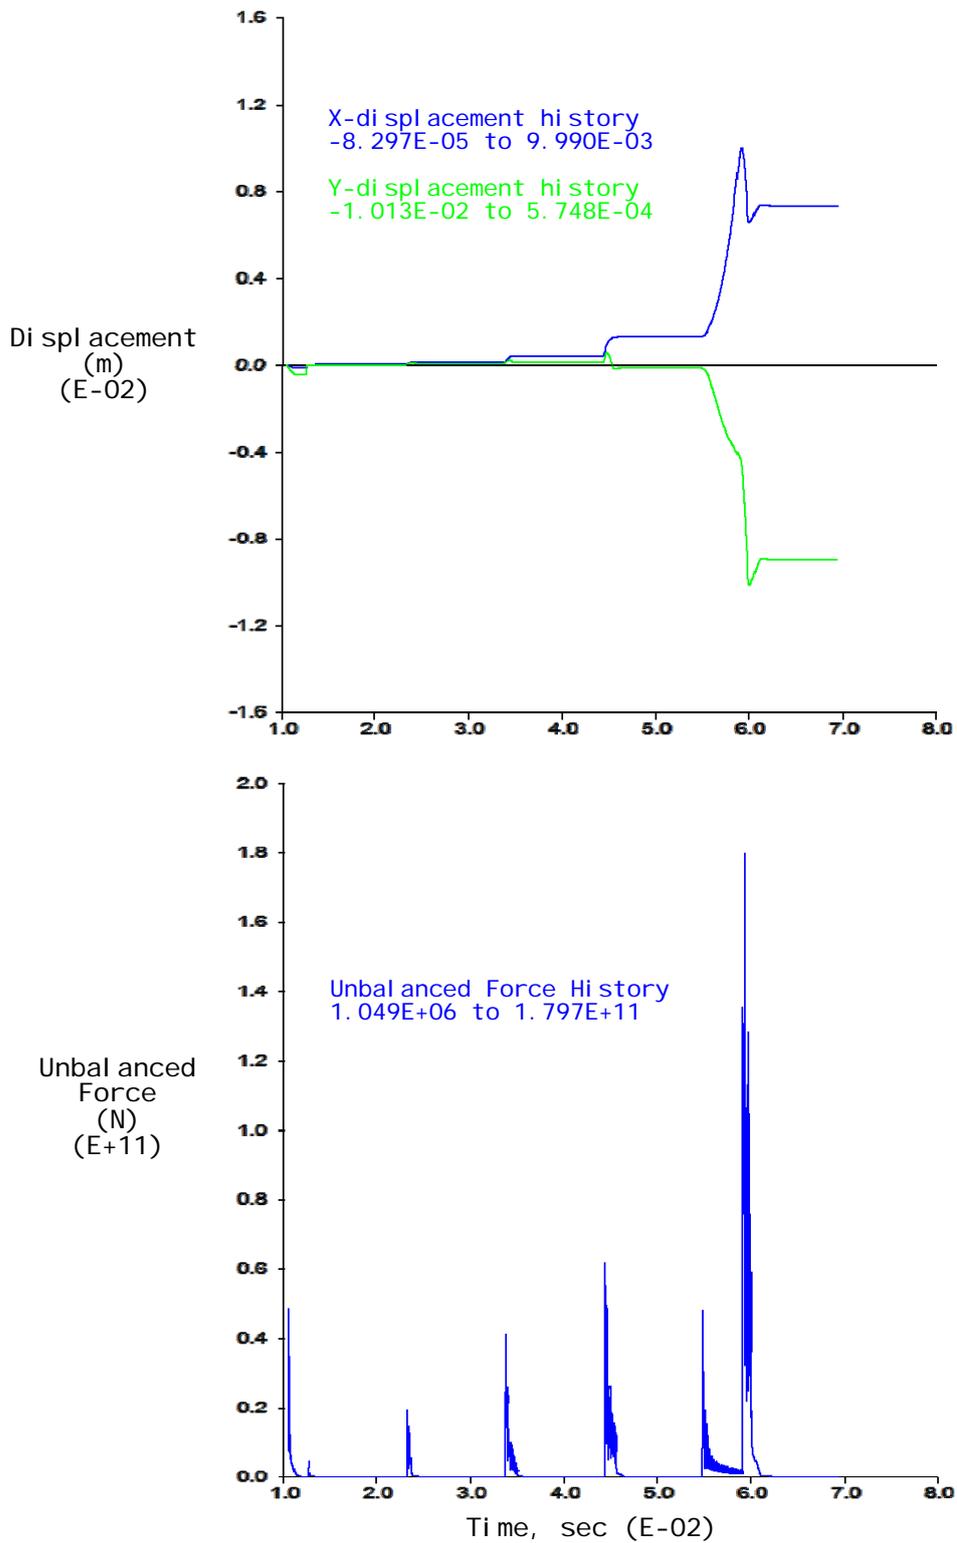
Fig. 6.28: Top: Displacement history plot of point A on sliding block vs. Time
 Bottom: Unbalanced Force History plot of model vs. Time (Scenario D2-b)

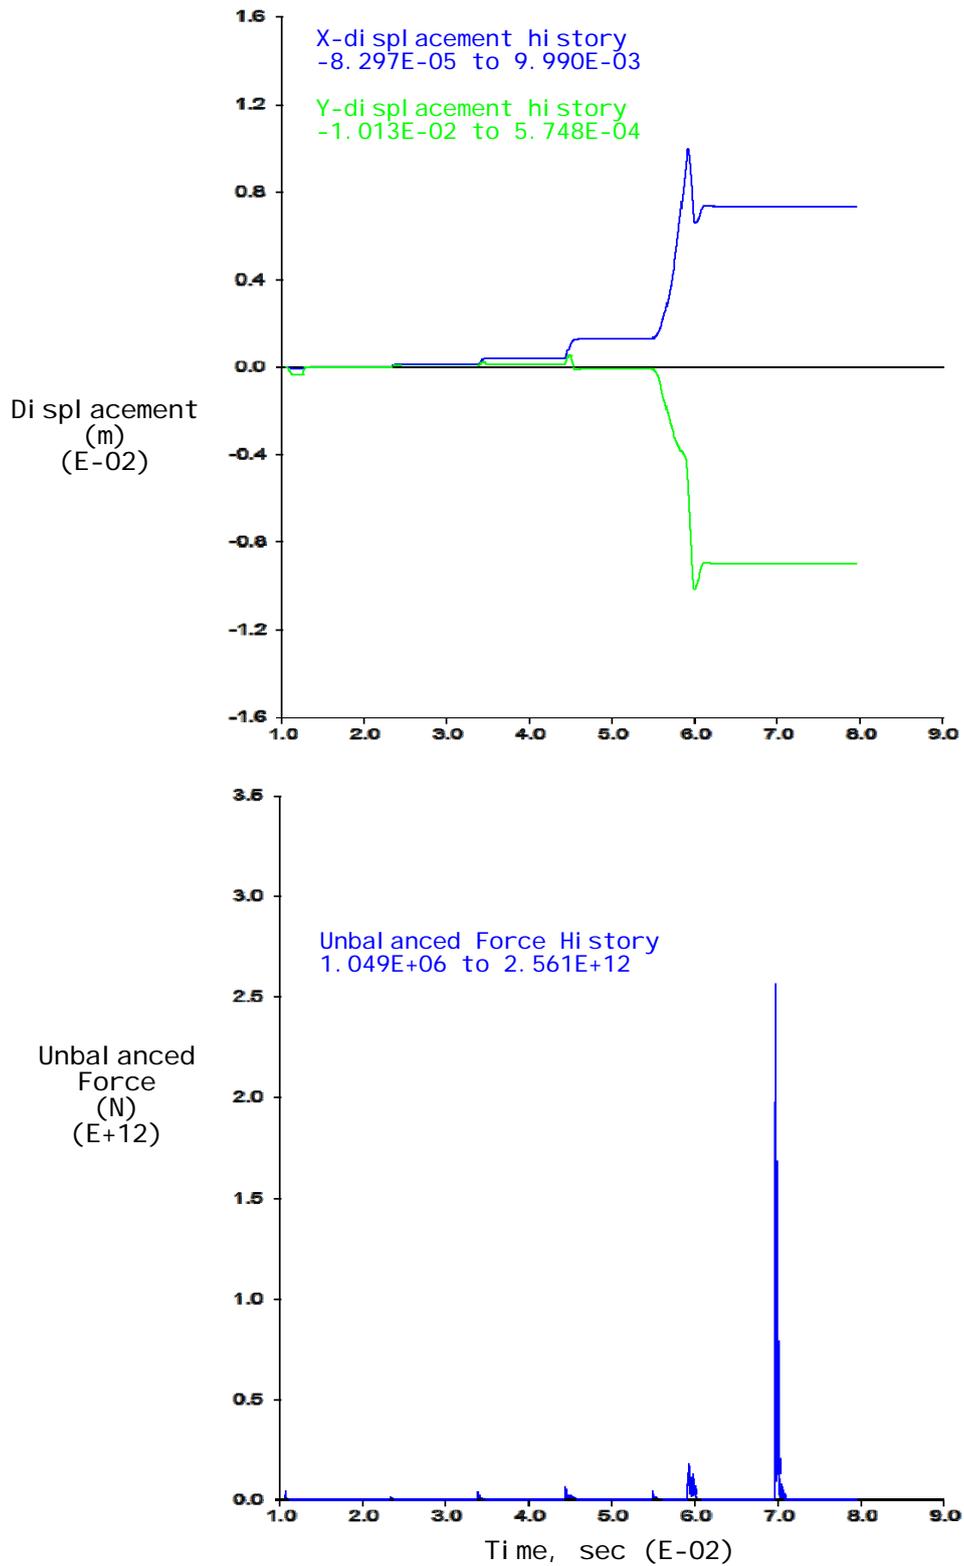
Fig. 6.31: Top: Displacement history plot of point A on sliding block vs. Time
 Bottom: Unbalanced Force History plot of model vs. Time (EQ1)

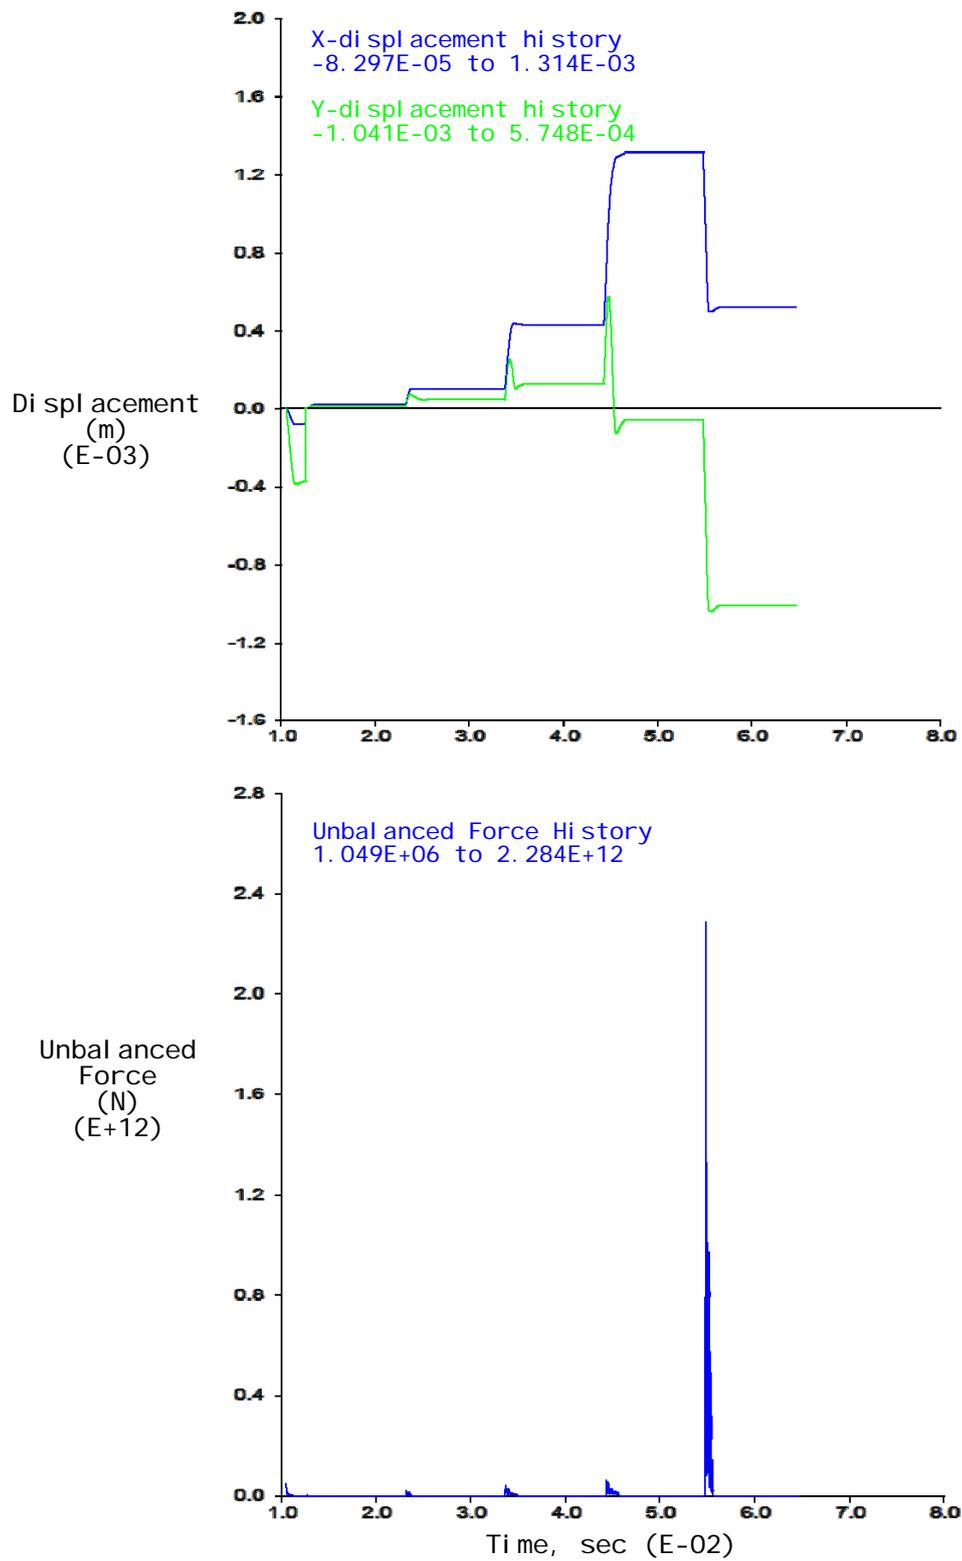
Fig. 6.33: Top: Displacement history plot of point A on sliding block vs. Time
 Bottom: Unbalanced Force History plot of model vs. Time (EQ2)

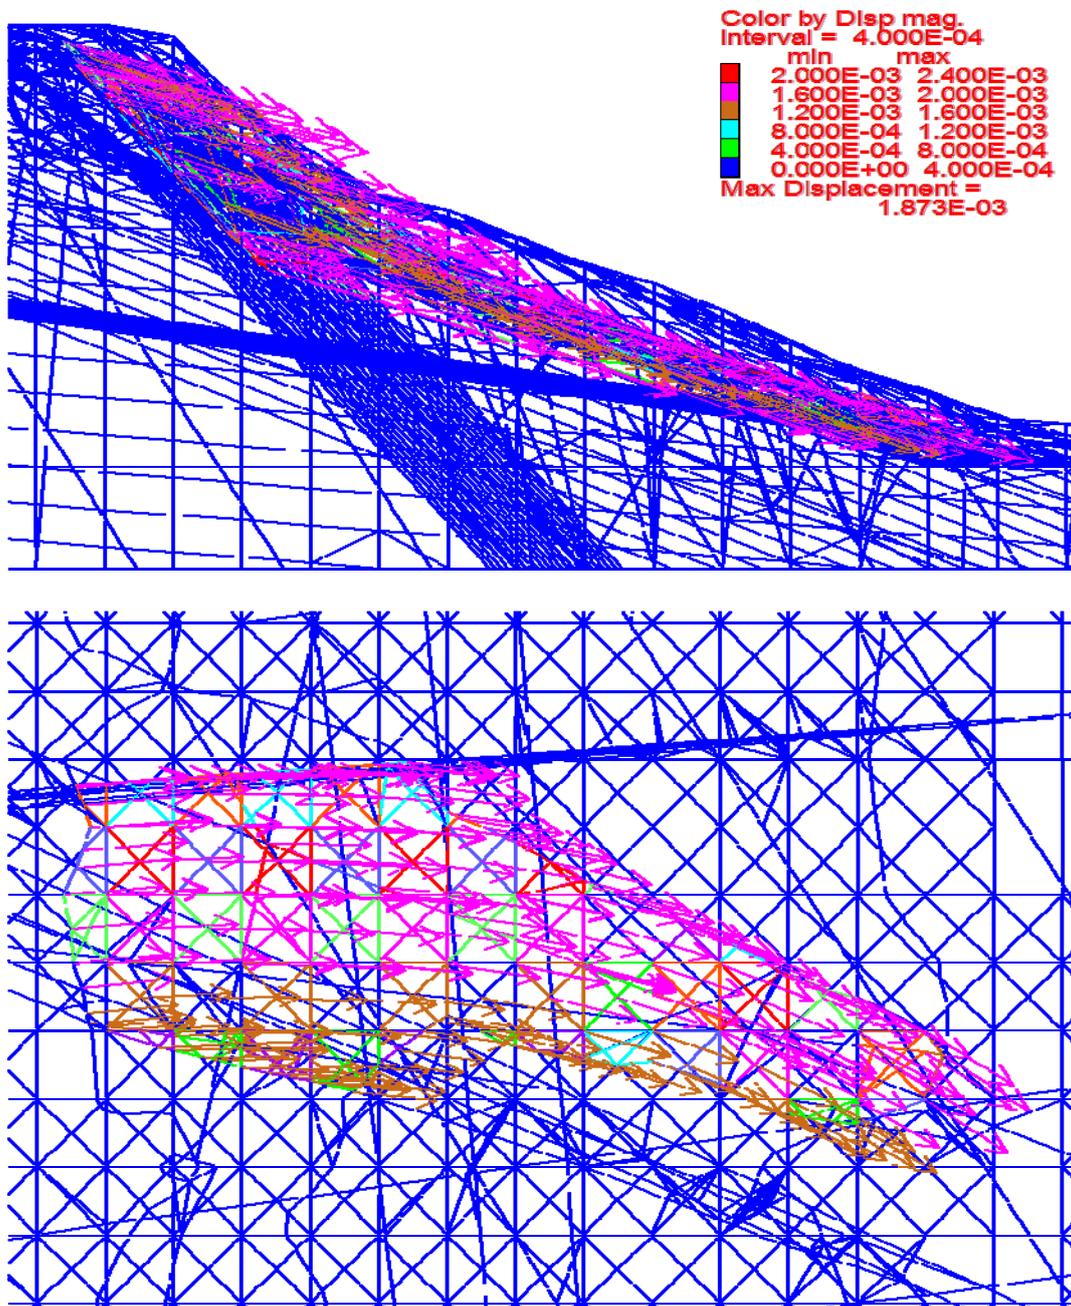
Fig. 6.34: Profile and plan view of 3DEC model showing displacement vectors of overhanging block – Scenario EQ3

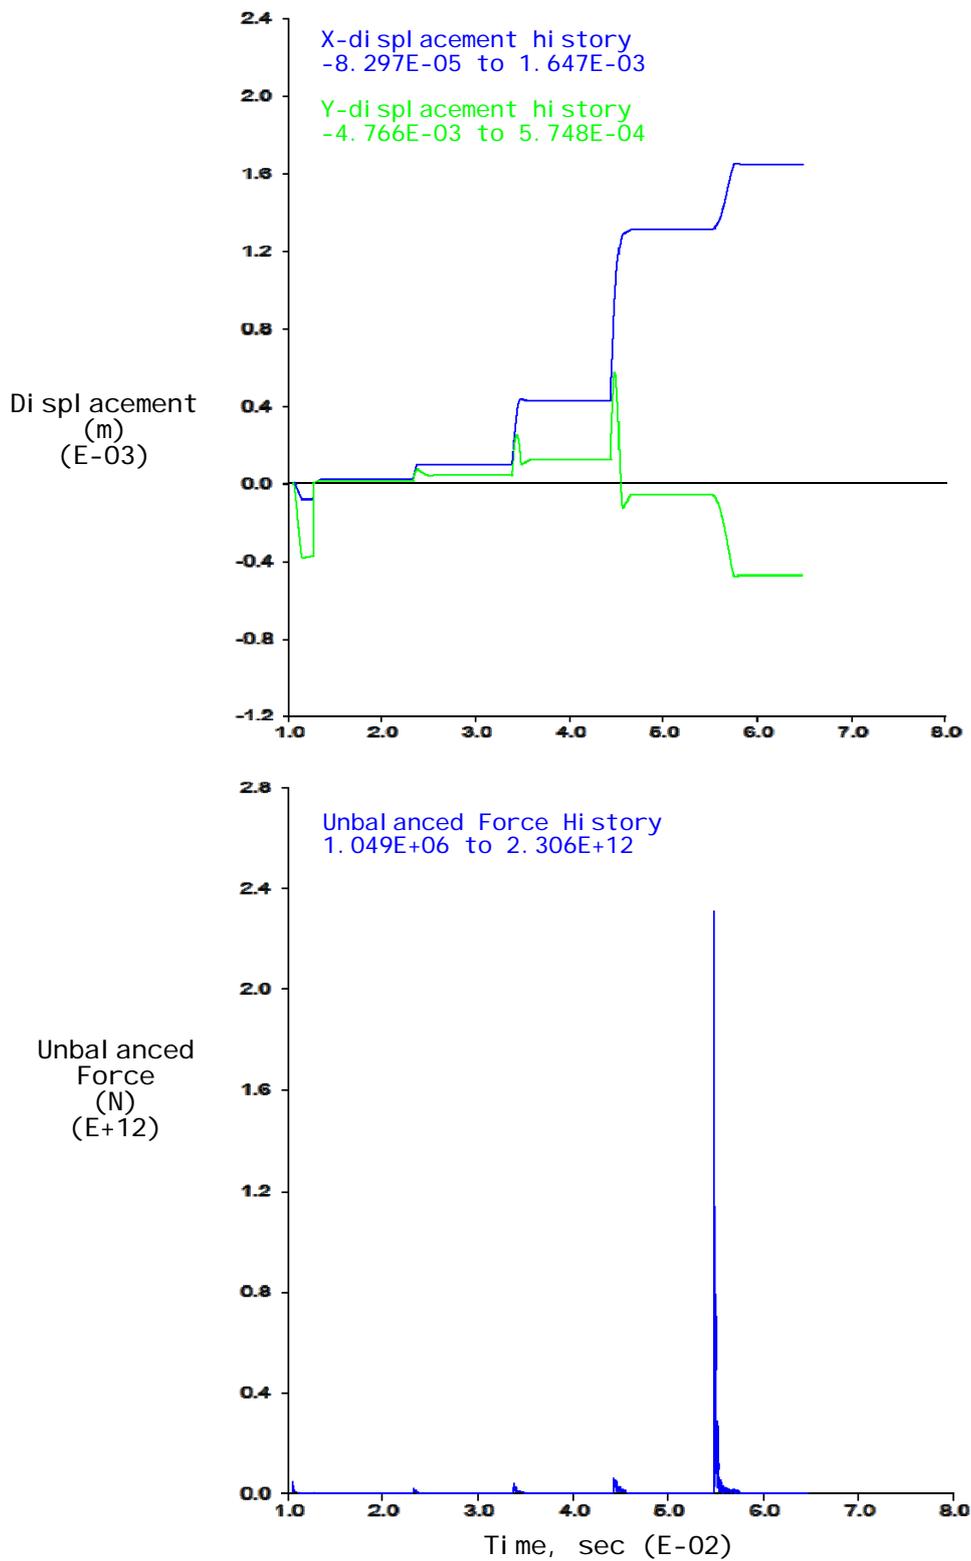
Fig. 6.35: Top: Displacement history plot of point A on sliding block vs. Time
 Bottom: Unbalanced Force History plot of model vs. Time (EQ3)

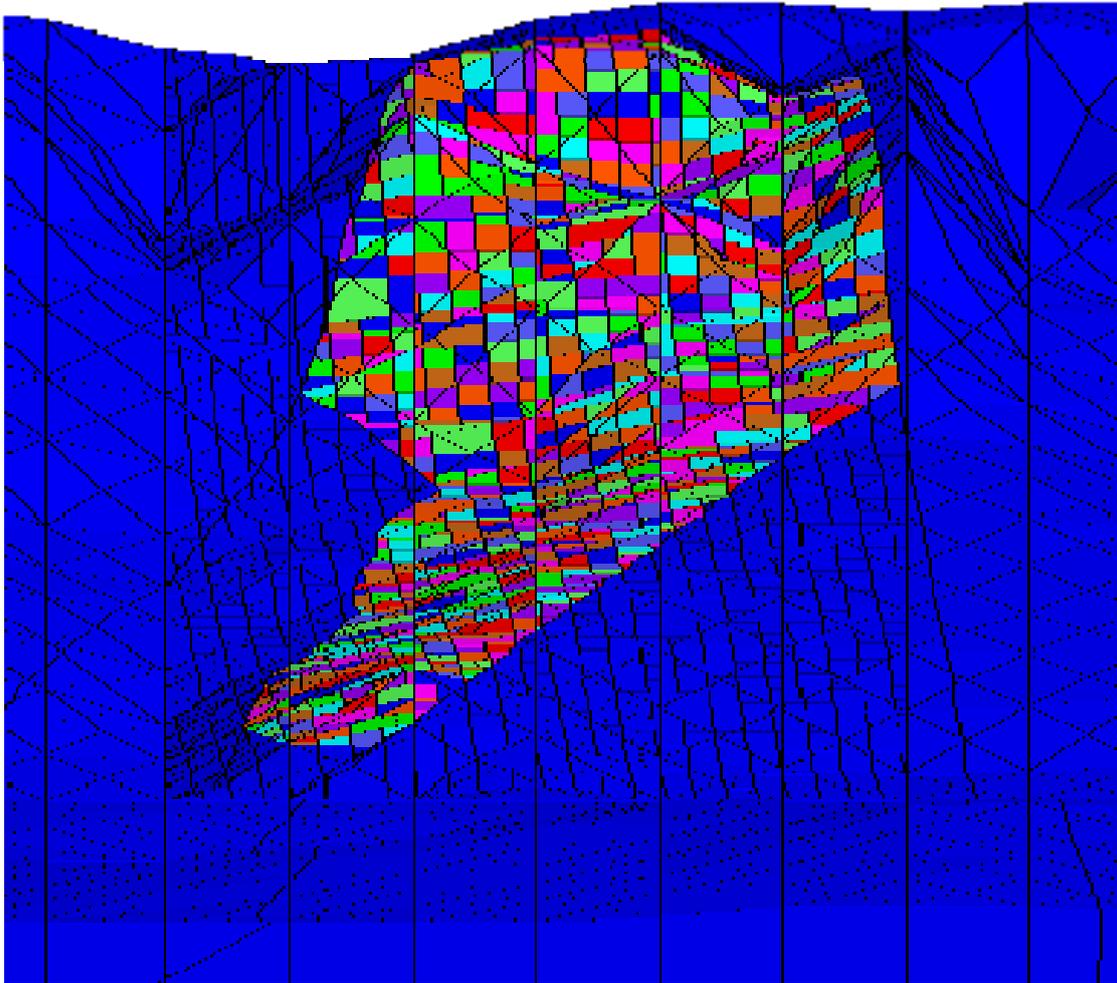
Fig. 7.1 - Front view of the fractured falling block showing the three joint sets.

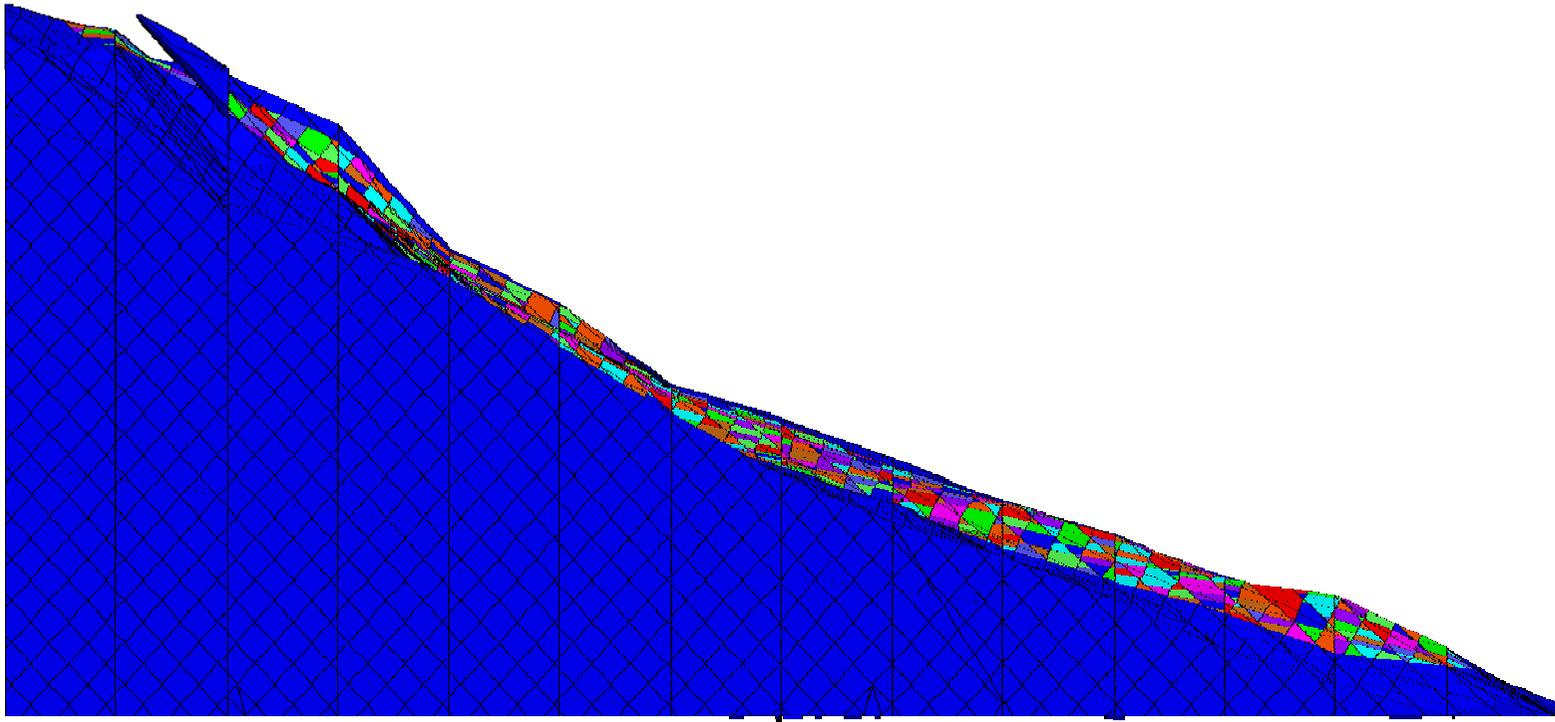
Fig. 7.2 - Side view of the fractured section of the model showing orientation of the joint sets parallel and perpendicular to the main fault surface
