**DISTINCT ELEMENT SIMULATION OF THE FEBRUARY 17TH, 2006, LEYTE,
PHILIPPINES ROCKSLIDE**

THESIS SUBMITTED TO THE FACULTY OF THE VIRGINIA POLYTECHNIC INSTITUTE AND
STATE UNIVERSITY IN PARTIAL FULFILLMENT OF THE REQUIREMENTS FOR THE DEGREE
OF

MASTER OF SCIENCE
IN
GEOTECHNICAL ENGINEERING

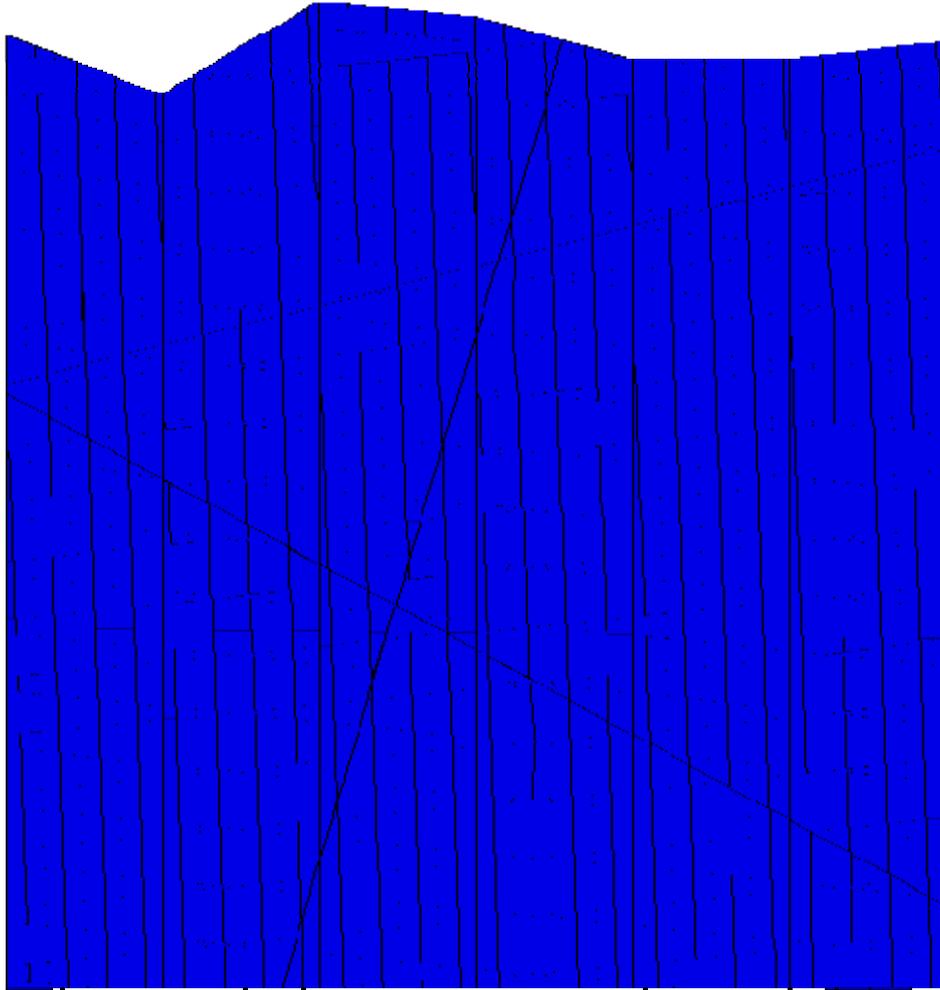
Fig. 7.3 - View from the back side of the fractured section of the model showing the joint set parallel to the vertical shear failure surface.

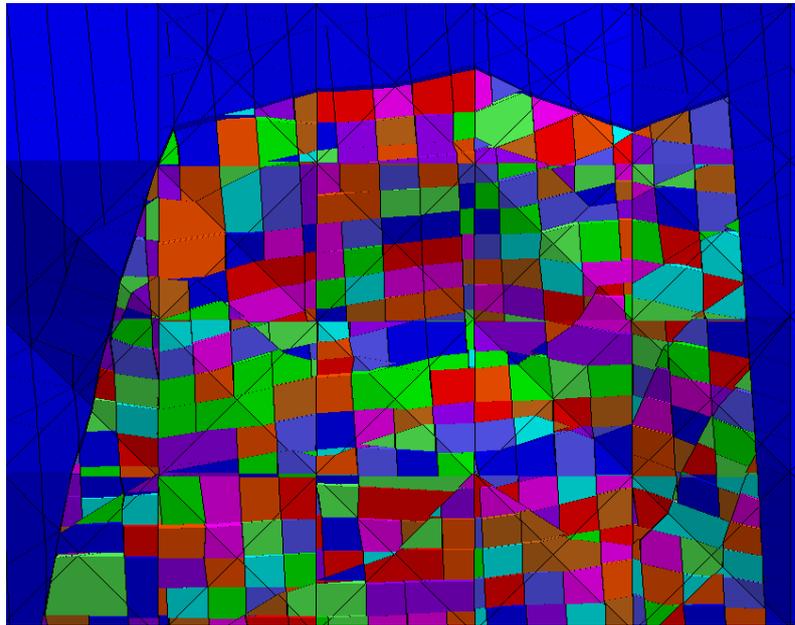
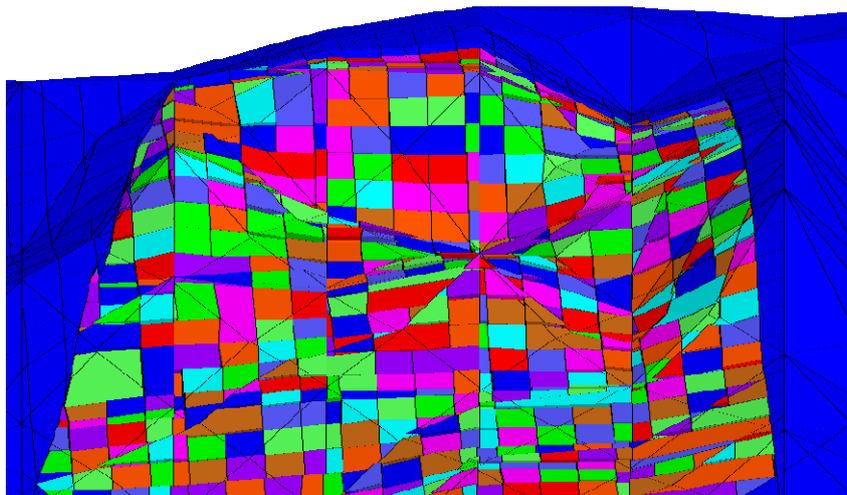
Fig. 7.4 - Plan and front view of top section of failing block showing the initial stages of disintegration of the block at the top part of the rock mass, mainly along the horizontal fracture sets.

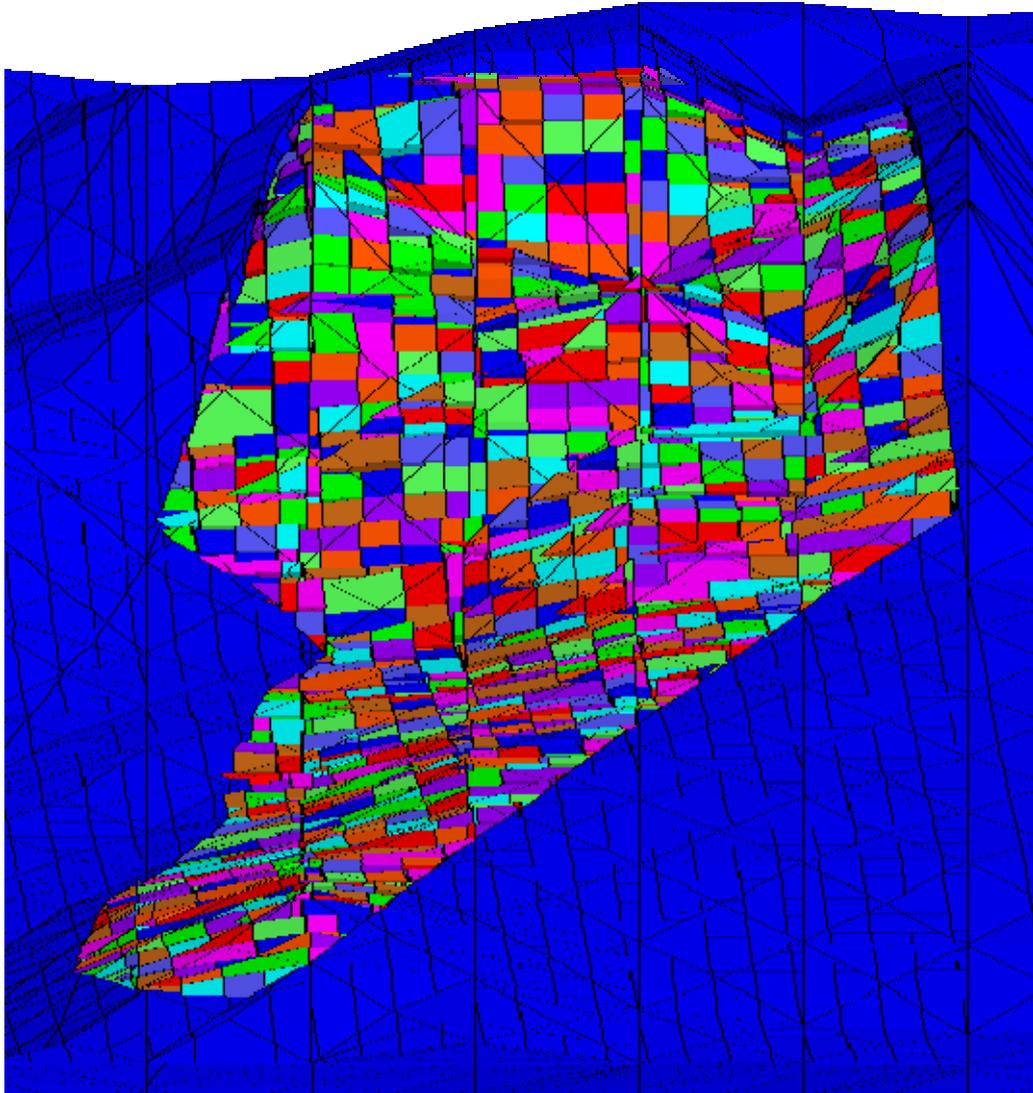
Fig. 7.5 - Initial stages of disintegration showing most disintegration at the top and initiation of sliding along the main fault dip direction.
