Impedance-Based Structural Health Monitoring to Detect Corrosion

Thesis Submitted to the Faculty of the
Virginia Polytechnic Institute and State University
in partial fulfillment of the requirements for the degree of
Master of Science

Mechanical Engineering

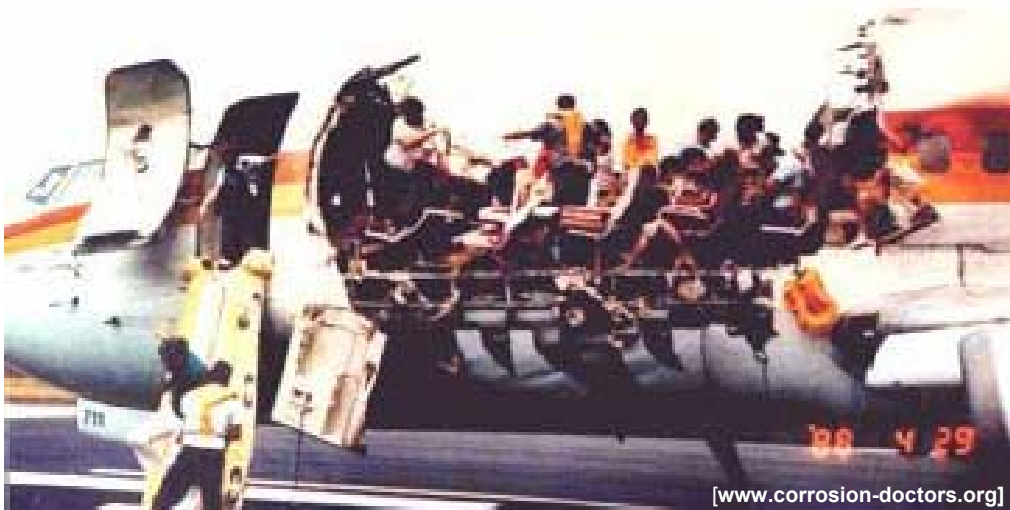
Figure 1.1.2: Corrosion induced in-flight failure in an Aloha Airlines 737 [1].

However, in the time it takes for aircraft corrosion to become visually observable to an untrained eye, the real structural damage is done and maybe irreversible. Even under careful examination by well-trained maintenance personnel, corrosion can lead to structural deficiencies which go unnoticed until mechanical failure is reached. Figure 1.1.2 shows an Aloha Airlines 737 after corrosion accelerated fatigue failure caused the aircraft to lose the upper half of the fuselage during flight at 24000 ft [1]. According to a National Transportation Safety Board report, the operator’s maintenance program failed to detect the corrosion damage that led to the failure [1]. The Aloha Airlines flight is an extreme but by no means isolated case of corrosion induced

in-flight failure that graphically conveys the fact that the structural effects of corrosion are significant and must be detectable and understandable. Even after the post-Aloha incident inspection and maintenance reforms and the development of nondestructive inspection (NDI) tools, aircraft corrosion detection still relies heavily on “find and fix” maintenance approaches [20]. To improve safety it is imperative to further improve existing NDI techniques and develop new NDI techniques to detect smaller hidden corrosion defects earlier and more economically [20].

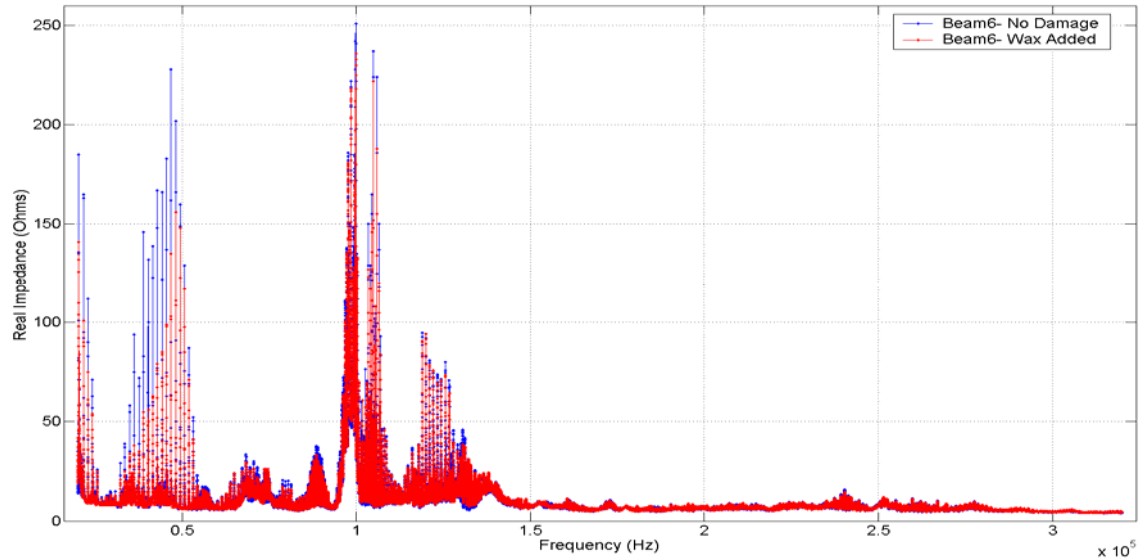
Figure 2.2.1: Sensitivity tests aid frequency selection by showing areas responsive to damage.

better approach to sensitivity testing will be discussed, and the approach will be modified to account for damage sensitivity and ambient variations.

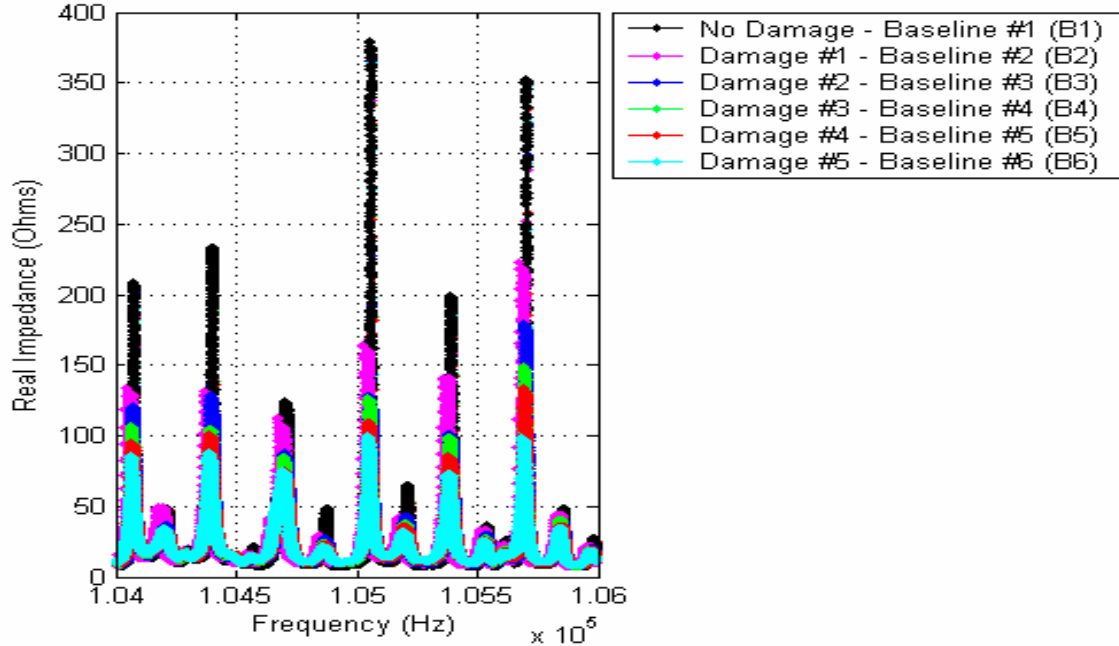
Figure 2.2.5: The baseline measurements show changes in the impedance signatures due to damage in beams.

A baseline measurement consists of 30 or more repeated impedance signatures. Before corrosion occurs to the structure, a baseline measurement is made to characterize the impedance signatures for a healthy structure. Therefore the response of the healthy structure to a known input is quantified, and the only difference between each signature is due to random experimental error. After corrosion damage occurs on the structure, a new baseline measurement of 30 or more repeated impedance signatures is made. This characterizes the response of the damaged structure to a known input. Each impedance signatures within the new “damaged” baseline measurement will be similar to other measurements within the same baseline with only slight difference due to random error. However, when the damaged baseline is compared to the healthy baseline the differences will be significant because the healthy and damaged systems respond differently. This happens because the corrosion damage changes the mass, stiffness, and/or damping properties of the structure which in turn causes the shape of the impedance signature to change. Figure 4 represents a visual example of this how the impedance signatures change/shift as the condition of the structure changes. In Figure 4, each shift was caused by the addition of 0.05g of wax to the aluminum beam. Visual observation of the impedance signature shifts between baselines is not sufficient to quantify or characterize damage detection.

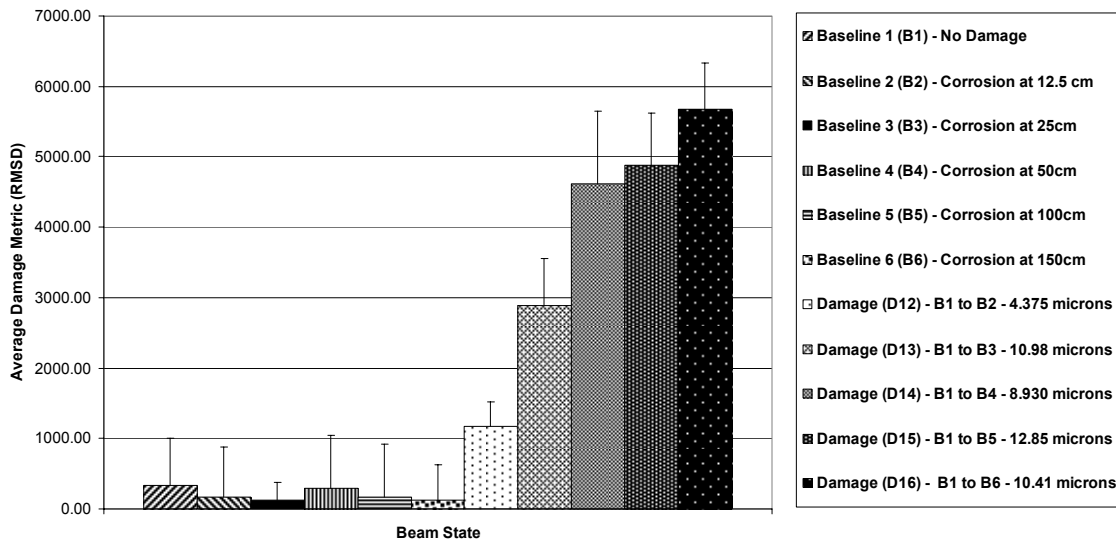
Figure 2.3.1: Beam corrosion detection results for the beam for all tested frequencies measured relative to the baseline #1.

Recall that the damage metrics were calculated in two ways. The first method yields a single damage metric for all six frequencies tested for each baseline comparison. A plot of the corrosion detection results for the beam may be seen in Figure 2.3.1. The first six bars B1-B6 represent the sample means of the individual baselines. The magnitudes of bars B1-B6 are small because the damage metrics were calculated from impedance sweeps from the same baseline. The confidence intervals represent the range the population mean should fall within. Since the metrics are calculated relative to the healthy baseline, the plot actually depicts damage accumulation in the structure (MSD). Based on the sample means, the impedance method can detect the light, MSD, pre-crack surface corrosion, so damage is being detected and monitored before crack formation begins.

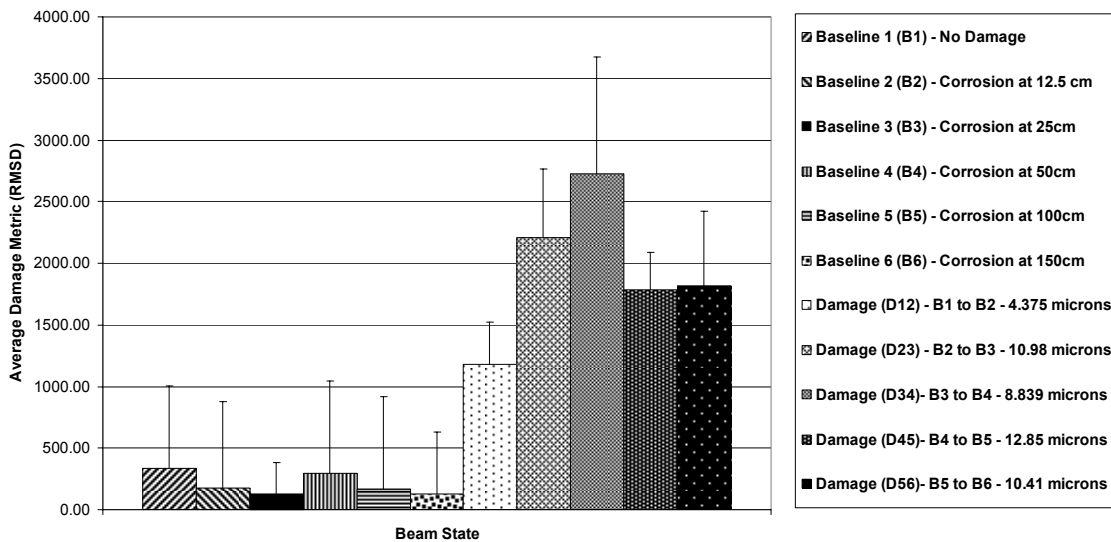
Figure 2.3.2: Beam corrosion results measured relative to previous instances of damage.

In an effort to improve upon the previous method, the damage metrics were calculated relative to previous baselines instead of baseline #1. Viewing the damage in this way eliminates the ability to see damage accumulation in the system because the damage is not quantified from the initial baseline. However, it removes the requirement for the confidence intervals of the damage cases to not overlap to be considered distinguishable damage. From Figure 2.2.2, all of the damaged sample means are larger than the first six baselines, so all five instances of damage are detectable. Once again, bar D12 is not distinguishable from B1 & B2 because of confidence interval overlap. The other four damage cases D23, D34, D45, and D56 are all distinguishable from their associated baselines based on no confidence interval overlap. All five light, pre-crack, 1.4% surface coverage corrosion damages are detectable, and 4 of the 5 are distinguishable using the impedance method. Therefore, trading the ability to detect MSD aids the ability to distinguish damage using single site damage (SSD) methods.

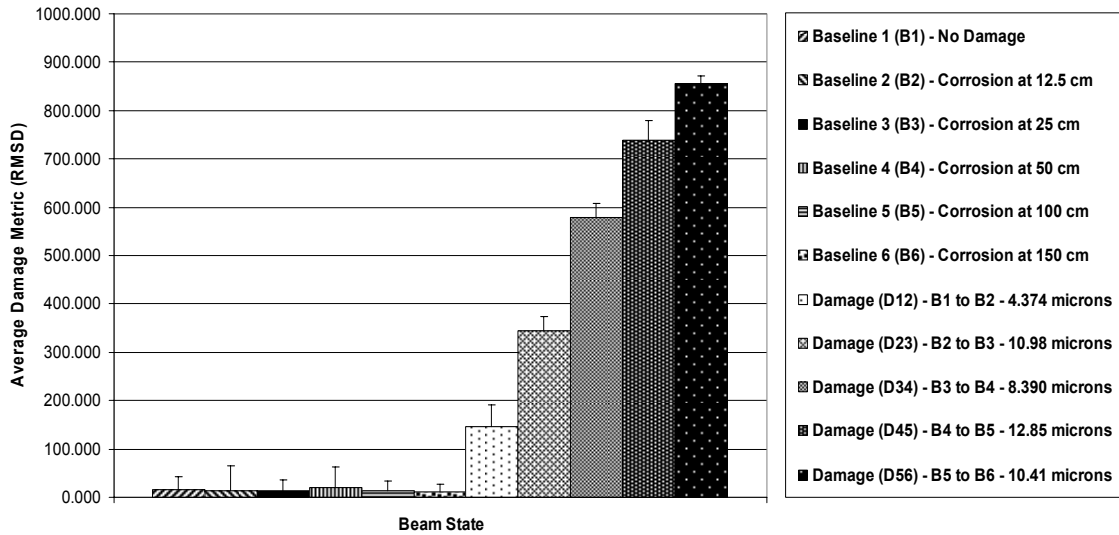
Figure 2.4.1: Beam corrosion damage detection for impedances sweeps from 20-22 kHz.

The second method calculates one damage metric for each level of damage within the six frequency ranges. This method greatly aids corrosion detection because frequencies with large confidence intervals may be ignored, and detection can be based on frequency ranges with favorable confidence intervals. An example of this may be seen in Figure 2.4.1. From 20-22 kHz the damage can be detected and distinguished at every level out to 150 cm on the beam. Since the 95% confidence intervals do not overlap, there is a 95% certainty that the population means will not overlap. That implies each instance of corrosion is detectable and distinguishable using the impedance method in the beam tested. This is a very important result because the estimated mass loss for each instance of corrosion is approximately 0.05g, and the impedance method can detect and distinguish that damage. Since all five levels of damage are distinguishable it can be said that light, pre-crack, 1.4% surface coverage, multiple site damage (MSD) corrosion is detectable out to 150 cm using the impedance method. So long as the damage does not occur simultaneously, MSD corrosion detection is possible using the impedance method.

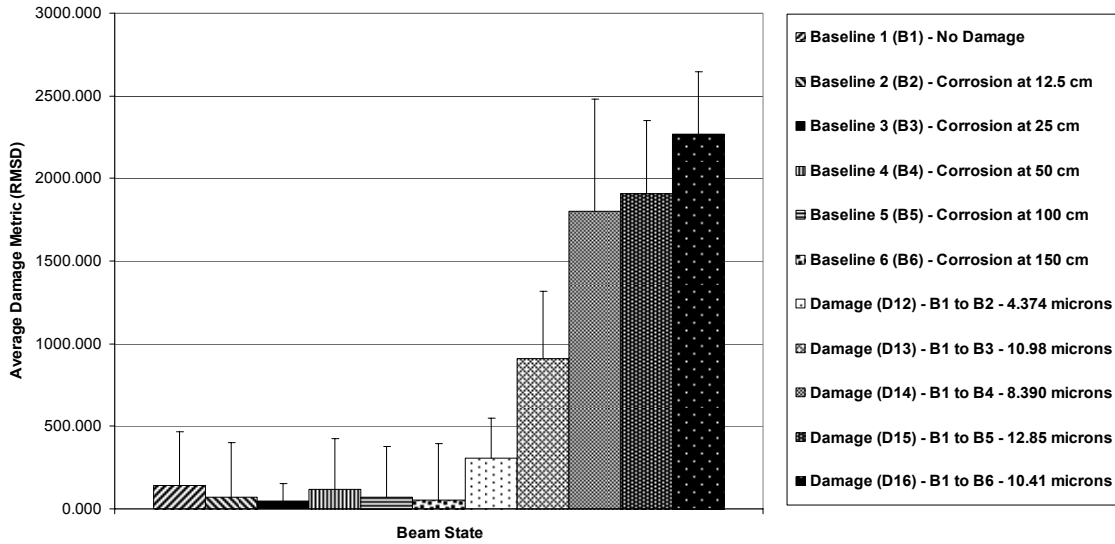
Figure 2.4.2: Corrosion detection results for beam impedance testing between 103-105 kHz.

All testing frequencies do not perform equally well detecting corrosion using the impedance method. Figure 2.4.2 is the best result of the six frequencies, and Figure 2.4.3 shows the worst corrosion detection results for an individual frequency range. At 103-105 kHz, the confidence intervals are large relative to the change in the sample mean of the damage metric, so the population mean of the damage levels are indistinguishable. At 71-73 kHz the damage confidence intervals are small, but the accumulation trend is not correct. Of the six frequencies tested, the lower frequencies 20-22 kHz (5 of 5 distinguishable) and 54-56 kHz (4 of 5 distinguishable) provide the best results. The 71-73 kHz range can distinguish 3 of 5 damages, and 126-128 kHz can distinguish 1 of 5 damages. The 95.5-97.5 kHz and 103-105 kHz frequencies cannot distinguish any of the damages due to confidence interval overlap. It should be noted that the damage trends are correct, and if less confidence is required, or more damage tolerance is acceptable, these frequencies could be used for damage detection. Also, no outlier detection has been performed on the data, so eliminating outliers would reduce variability and increase damage detection [28].

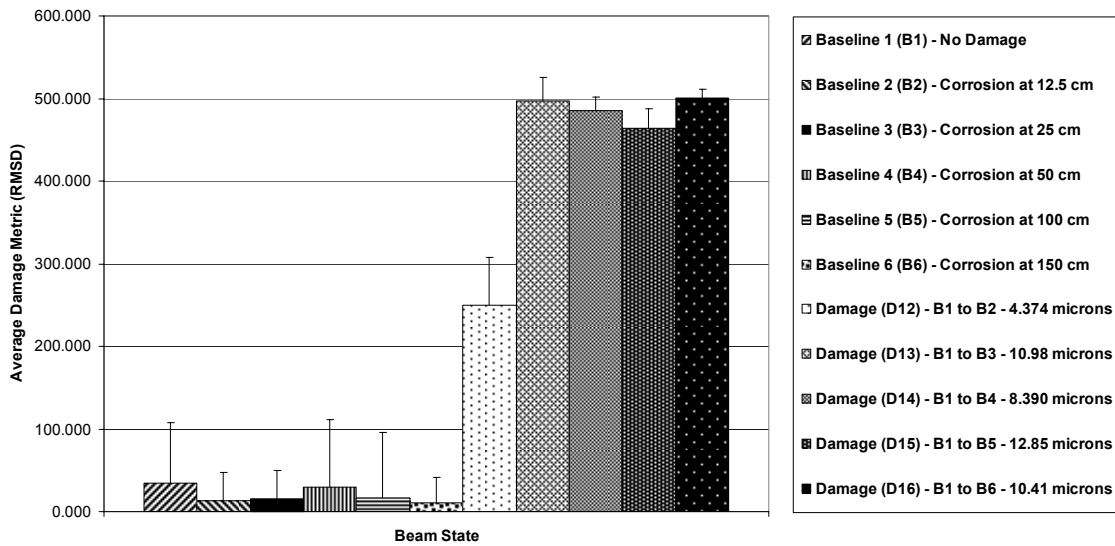
Figure 2.4.3: Corrosion detection results for beam impedance testing between 71-73 kHz.

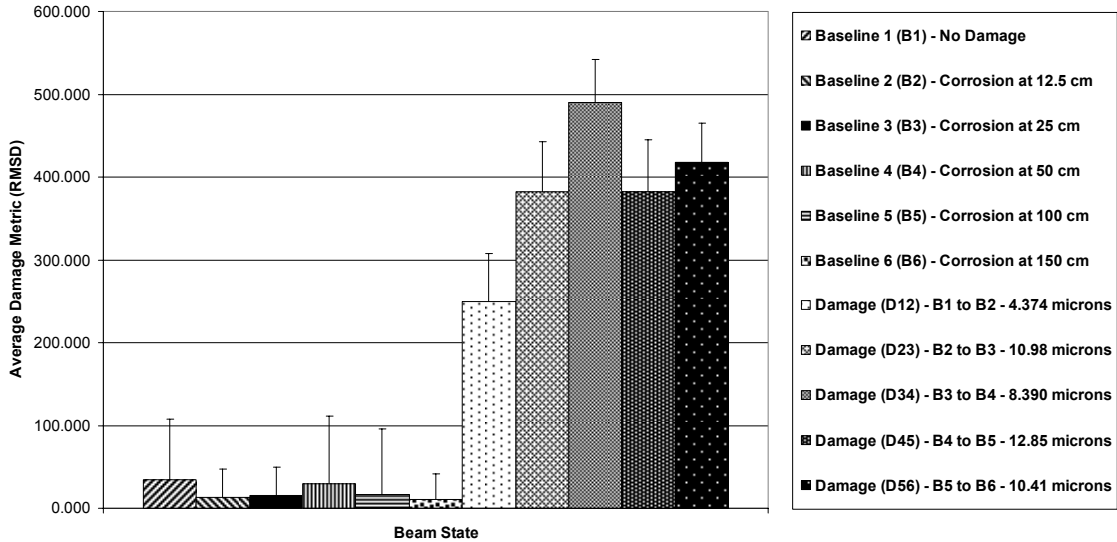
Figure 2.4.4: All five levels of corrosion damage are distinguishable for 71-73 kHz.

method. Now, all five levels of damage are distinguishable from their associated baselines, so all five damages are distinguishable. The frequencies of 20-22, 54-56, and 71-73 kHz distinguish 5 of 5 damages. At 95.5-97.5 kHz, three of the five damages are distinguishable. The frequencies of 103-105 kHz and 126-128 kHz cannot distinguish any of the 5 damages. Table 2.4.1 summarizes all of the beam detection results. Appendix A contains all the impedance signature, average damage metric plots, MSD, and SSD plots.

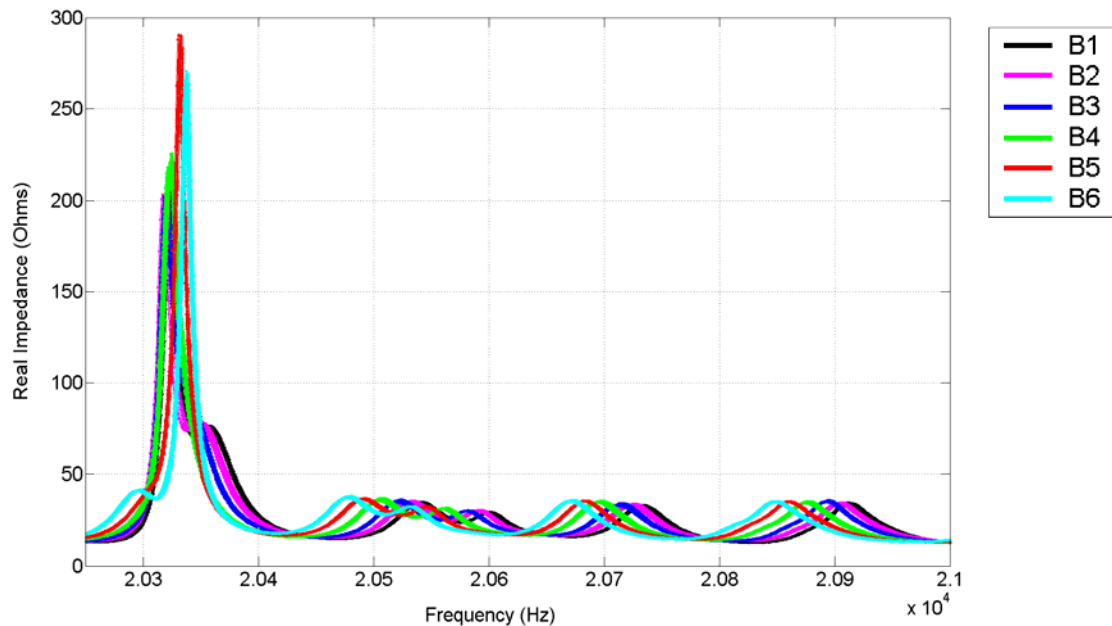
Figure 2.5.1: Impedance signatures from 20.25-21.00 kHz.

The impedance method can clearly identify corrosion in beams, but the ability to detect the damage depends on the damage surface coverage, location, pit depth, and test conditions. Structural health monitoring relies heavily upon pattern identification, so it is useful to identify patterns in the impedance signatures that are conducive to corrosion detection. For remote structural health monitoring devices, this information may not be available to the end user, but all of these calculations will be made onboard the device and could be used to identify damage. The 20-22 kHz frequency range proved to be good for distinguishing corrosion damage because the frequency was sensitive to damage without producing too much error. The impedance baselines for 20.25-21 kHz are plotted in Figure 2.5.1, and each colored line is actually 30 or more individual impedance signatures. The three groups of smaller peaks in Figure 2.5.1 show the same pattern, but the larger peak does not.

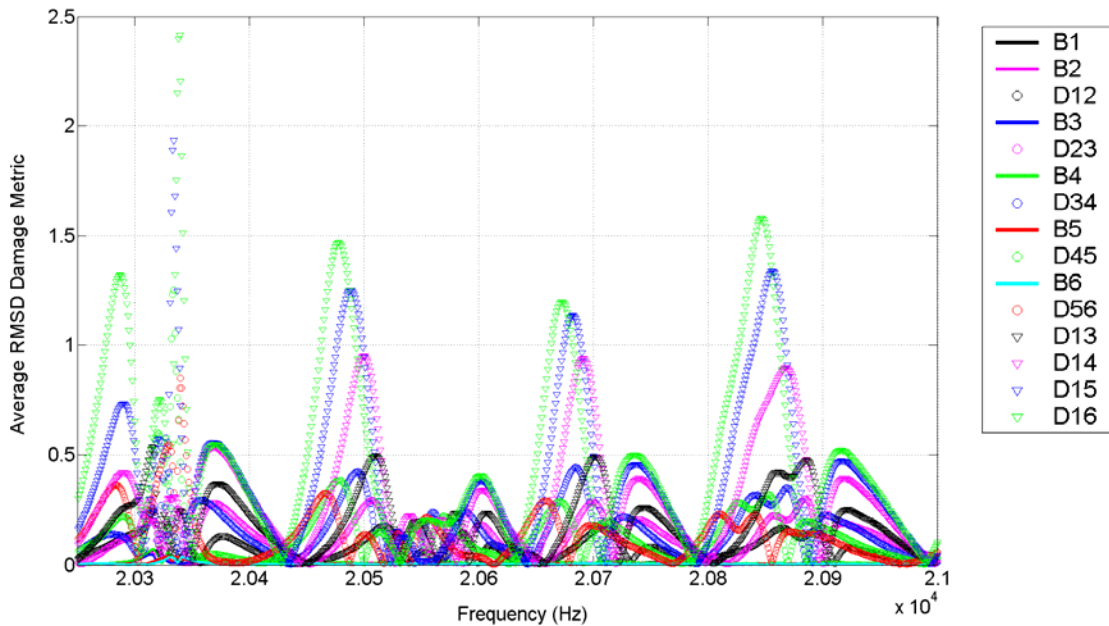
Figure 2.5.2: Average damage metrics versus frequency plot identifies which individual impedance peaks are sensitive to damage.

D15 < D16 in the presence of impedance peaks. The smaller peaks follow the pattern, but the largest peak does not, so it will contribute to error that makes the damage more difficult to distinguish. For the best corrosion damage detection, it is necessary to choose frequencies sensitive to damage that do not produce too much variation. During sensitivity testing it should be possible to focus the detection on frequencies most conducive to detecting damage. Ultimately new damage metrics should be developed and better statistical and digital processing tools should be developed and introduced to impedance based damage detection.

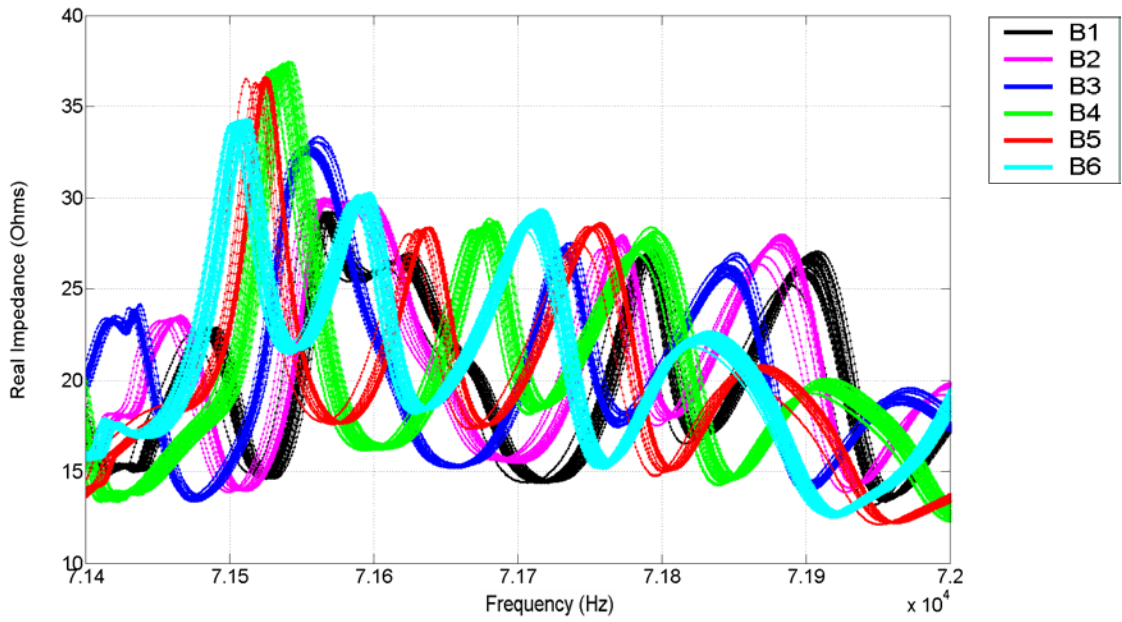
Figure 2.5.3: Impedance signatures from 71.4-72 kHz.

The 71-73 kHz frequency range did not fare as well during corrosion detection as the two lower frequencies did. In fact, careful analysis of the impedance signatures shows that it is too sensitive for the peak density at that frequency. The impedance signature plot in Figure 2.5.3 shows that the corrosion damage shifts the peaks so much that they move under previous peaks. This actually caused the damage metric to correlated better when the damage is actually getting worse. Thus, the damage metric (a correlation) does not consistently get larger because the shifts align peaks with other peaks as the damage occurs. The average damage metrics in Figure 2.5.4 shows that the peaks do not follow a pattern that is conducive to damage identification. In this case, the detection fails, but the metric is sensitive to damage.

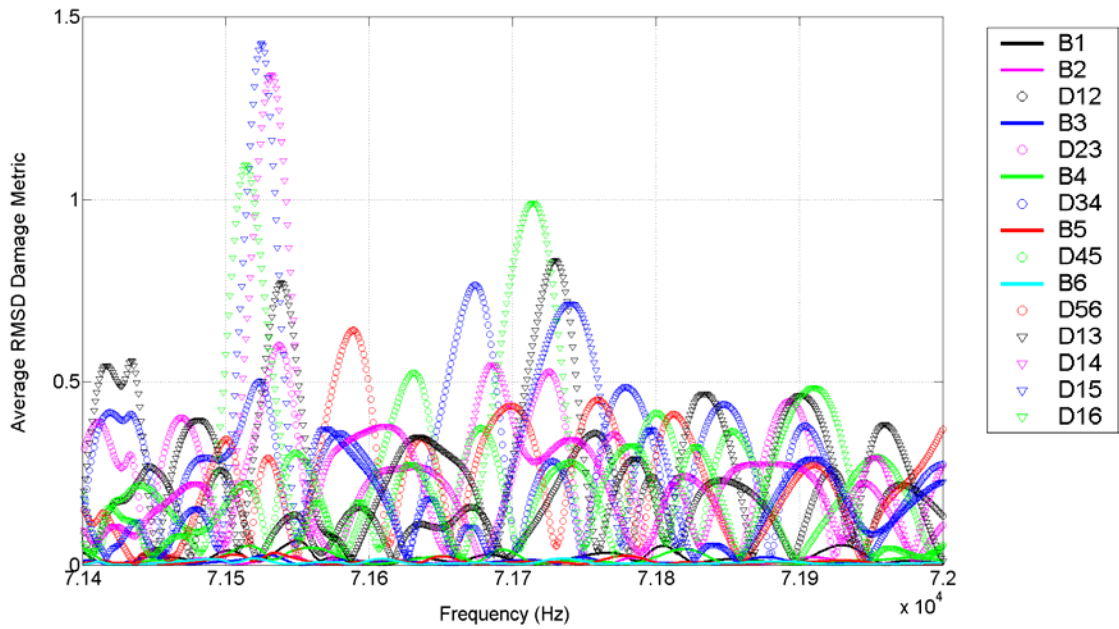
Figure 2.5.4: Average damage metrics versus frequency plot identifies which individual impedance peaks are sensitive to damage but can't distinguish damage.

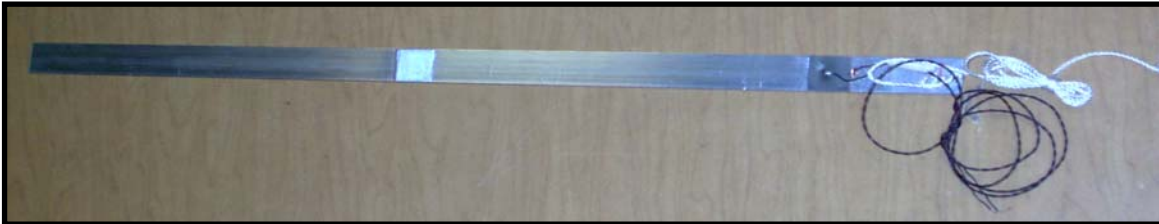
Figure 3.2.1: The beam used for pit depth detection after 5 levels of corrosion damage.

For the pit depth detection test a smaller beam was chosen, so that the mass loss could be accurately recorded with a balance. A PZT 5H4 patch 2.54 x 2.28 x 0.0254 cm patch was bonded to a 62.9 x 2.54 x 0.159 cm 6063 T5 alloy aluminum beam which was hung vertically to simulate free-free boundary conditions. The centerline of the PZT was 7.62 cm from the edge of the beam, and all of the damage was added in a 2.54 cm² area 25 cm from the PZT patch. The beam was baselined for 5 days before damage was added. The impedance measurements were made 20-22 kHz, 44-46 kHz, 54-56 kHz, 72-74 kHz, 97-99 kHz, and 104-106 kHz. To damage the beam, hydrochloric acid was placed on the beam for predetermined time intervals. The surface roughness and mass of the beam were measured before and after each addition of damage. The goal of the experiment was to determine if the damage metric could be correlated to a change in pit depth or material mass loss. This correlation could prove very useful for fatigue life adjustments based on known amounts of corrosion found during routine inspections. The results show the impedance method and damage metric can be correlated to material loss. Figure 3.2.1 shows the beam after five levels of corrosion.

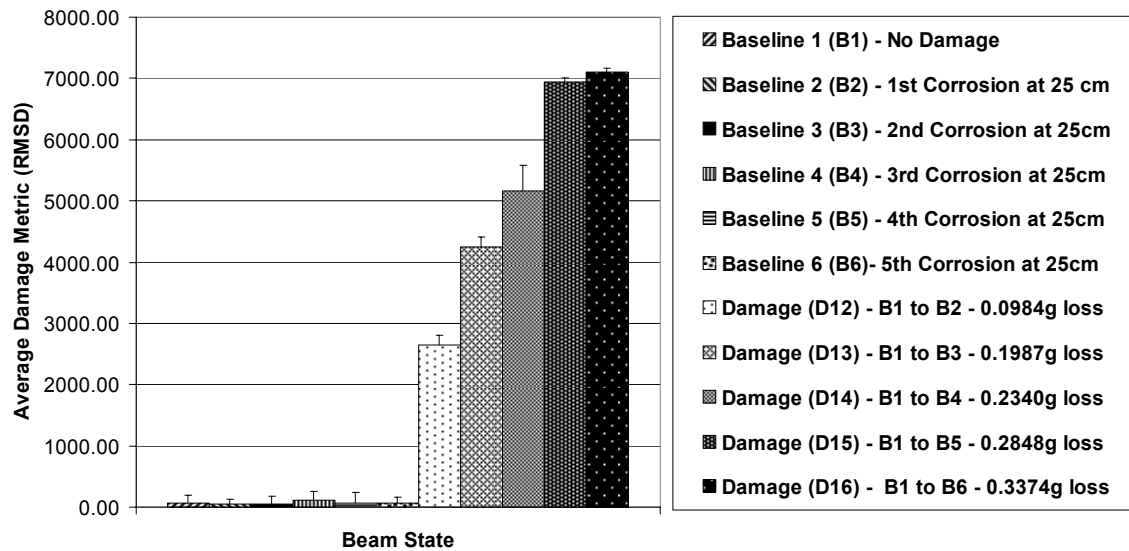
Figure 3.3.1: For 22-106 kHz, corrosion pit depth changes are detectable and distinguishable.

reduced to just 11 numbers. The individual frequency analysis requires six times that many numbers to characterize the system.

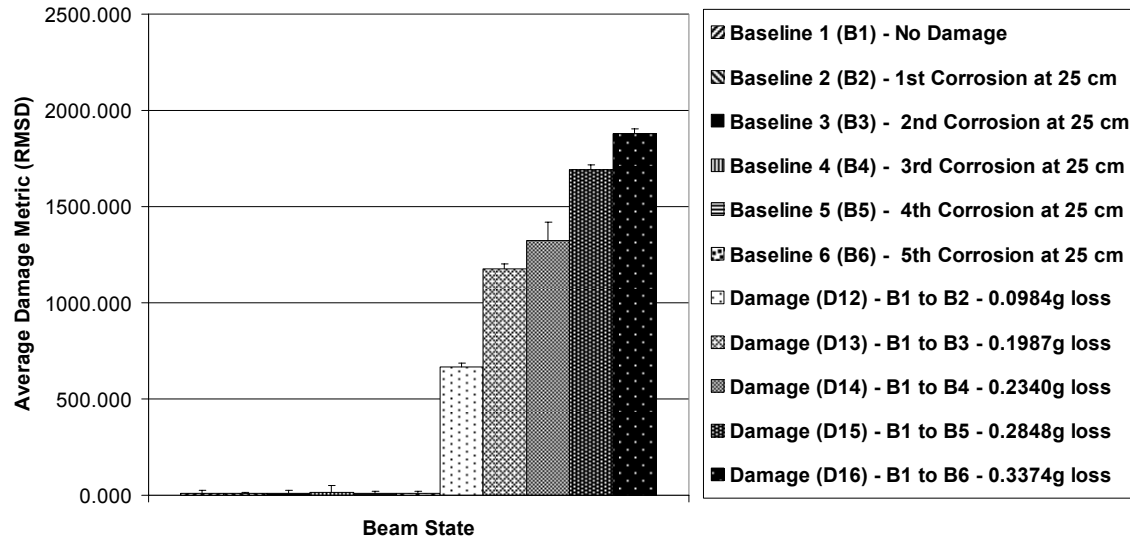
Figure 3.3.2: For 20-22 kHz, corrosion pit depth changes are detectable and distinguishable.

When the corrosion pit depth changes are analyzed using RMSD metrics calculated for each of the six frequencies the structural changes are distinguishable for all five levels of damage in 1 of the 6 frequencies ranges tested. Four of the six frequencies can distinguish 4 levels of damage, and one frequency range can only distinguish 3 levels of damage. The results for 20-22 kHz range can be seen in Figure 3.3.2. Once again, multiple site damage of light pre-crack surface corrosion is distinguishable. All damage metric plots can be seen in Figures B.1-B.60 shown in Appendix B.

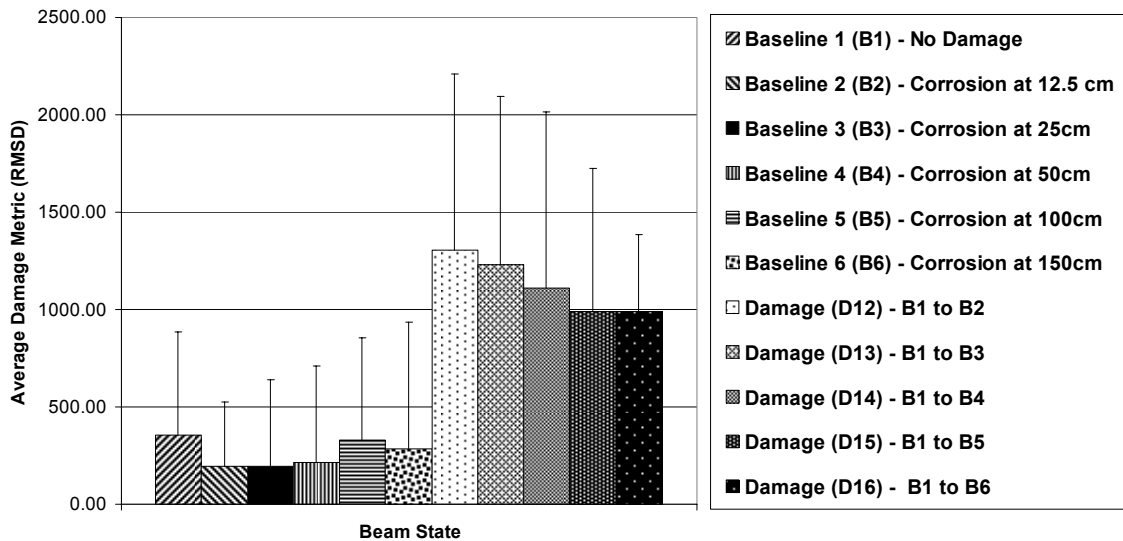
Figure 3.3.5: For damage metrics calculated across all six frequencies the damage is detectable.

beam as seen in Figure 3.3.5. The large error bars and small magnitude changes in the damage metrics indicate the impedance method is not as sensitive to changes in the simulated corrosion location. Narrowing the test frequency range and measuring relative to previous baselines does not make the damage distinguishable in all cases. Even for the best result seen in Figure 3.3.6, only three of the five instances of damage are distinguishable. All damage metric plots can be seen in Figures B.1-B.60 of Appendix B.

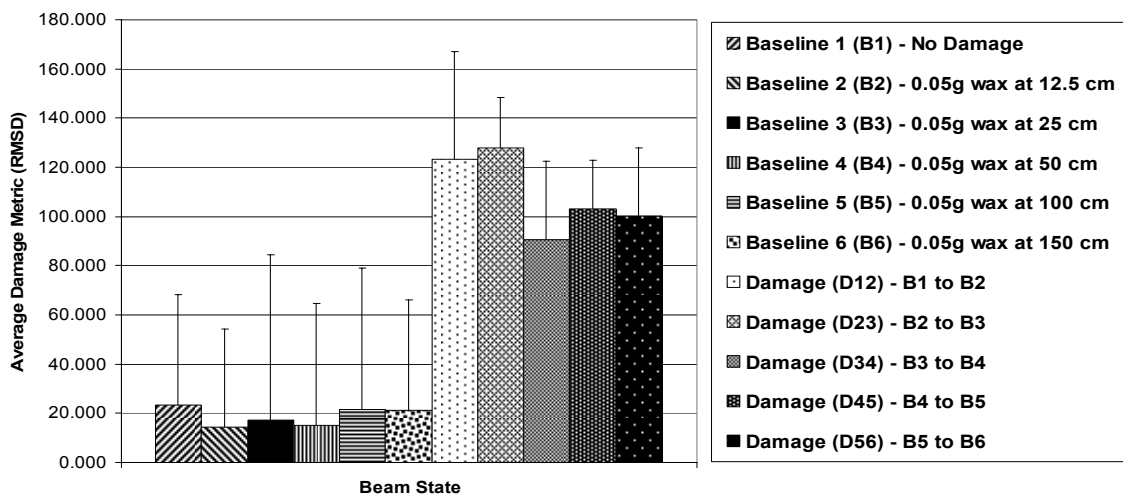
Figure 3.3.6: From 20-22 kHz, three levels of damage are distinguishable.

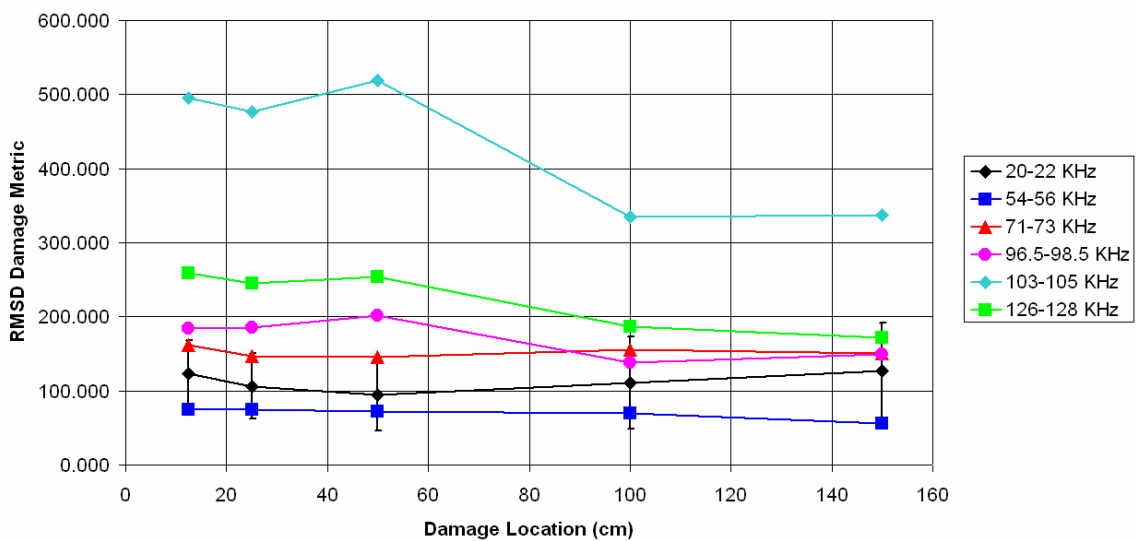
Figure 3.3.7: Damage metric values versus corrosion damage location in beams.

The main purpose of the location testing was to see if there is a relationship between the damage metrics and corrosion location. From the testing this relationship was established for each of the test frequencies, and Figure 3.3.7 shows the results. The plot shows that the damage metric seems to decrease as the corrosion location moves away from the sensor; however, the error in each measurement makes this assumption somewhat inconclusive. There is clearly a pattern, but the experimental error reduces. For simulated 1.4% coverage of light 6.32 micron corrosion, impedance-based corrosion location detection may not be the optimal technique. If the tolerance for damage was greater, the test frequencies were raised, or a more damage sensitive structure were utilized the method may be better able to establish a pattern that could be used in a predictive manner. The impedance method and damage metric could be used to locate damage on a structure; however, the impedance method may be better suited to other quantification tasks.

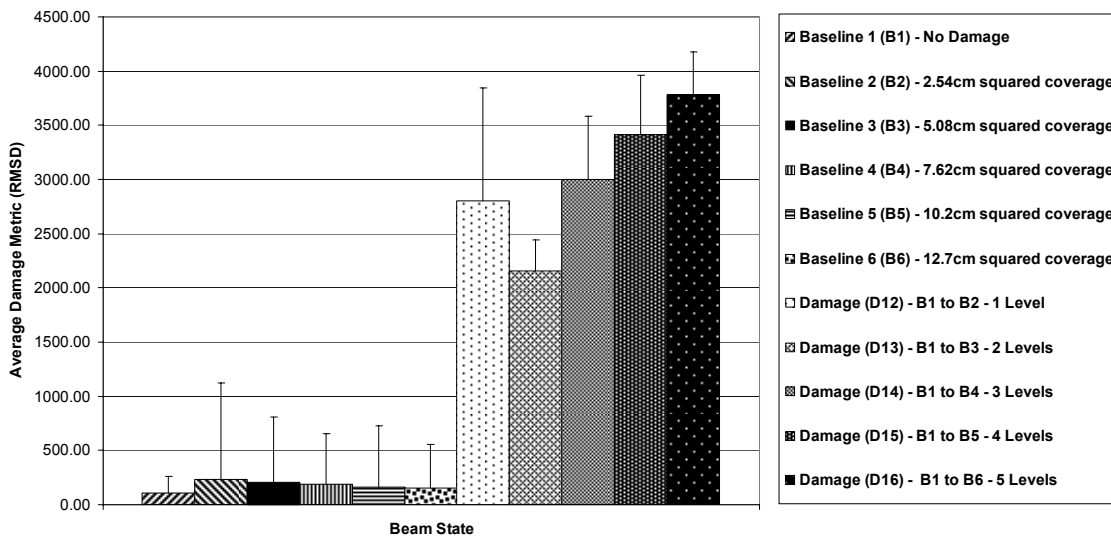
Figure 3.3.8: The results of the surface coverage test for all of the test frequencies combined.

Figure 3.3.8 shows the findings of the corrosion coverage results for a single damage metric calculated for all six test frequencies measured relative to the initial baseline. For each change in corrosion surface coverage (simulated by a 0.0500g mass change) the damage should increase as the level of damage on the structure increases. For this global test, only the first instance of damage (D12) does not follow the expected detection trend. The other four surface coverage changes increase the damage in a detectable manner that follows the expected trend. Only the first instance of damage is distinguishable based on the 95% confidence interval. As the simulated surface coverage increases the last four levels of damage are not distinguishable because of the large relative error caused by ambient changes.

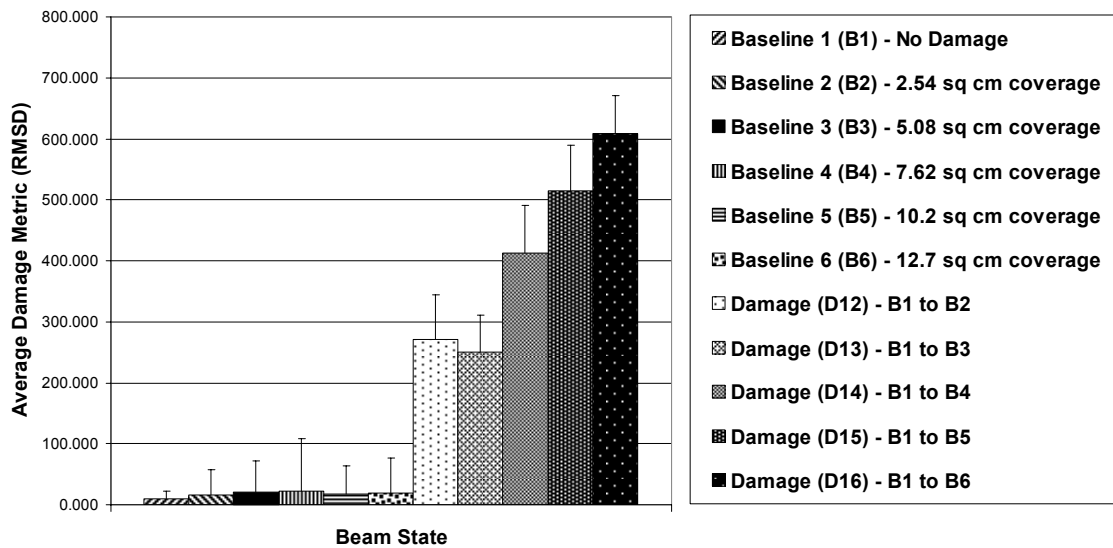
Figure 3.3.9: The results of the surface coverage for all for 20-22 kHz shows all are detectable.

Surface coverage tracking can be improved by narrowing the test frequencies to ranges sensitive to the damage but insensitive to ambient changes. In four of the six frequencies tested, only two of the levels of damage are distinguishable, and the other two frequencies cannot distinguish any levels of damage. An example of the individual testing results may be found in the Figure 3.3.9. Thus, the surface coverage tracking results are not conclusive for distinguishing changes in surface corrosion coverage. The cause of the over prediction of the first instance of damage is unknown, but it occurs for 5 of the 6 frequency ranges tested. All of the surface coverage damage metric plots and related impedance signature plots can be found in Figures B.1-B.60 in Appendix B.

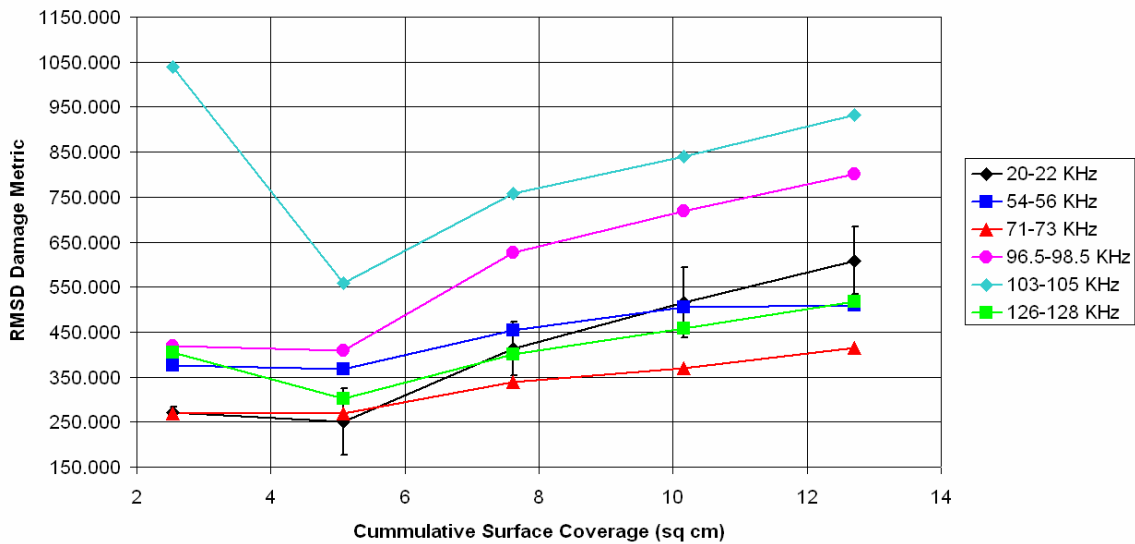
Figure 3.3.10: Plots of the damage metric versus surface coverage correlation for each frequency.

relationship between the two exists then the data could be fused with maintenance records to track and even predict the spread of surface corrosion with respect to time. Figure 3.3.10 shows a plot of the RMSD damage metric versus the cumulative change in the corrosion surface coverage for each of the six test frequencies. To prevent visual obstruction of the plot, the error bars are only displayed for 20-22 kHz because they are representative of the error for other frequencies. At all of the frequencies there is an increase in the damage metric as a function of surface coverage, but it is debatable whether or not the relationship is linear. However, since there is a relationship between the two it could be possible (when used in conjunction with other maintenance data) to define the relationship in order to use it in a tracking or predictive fashion.

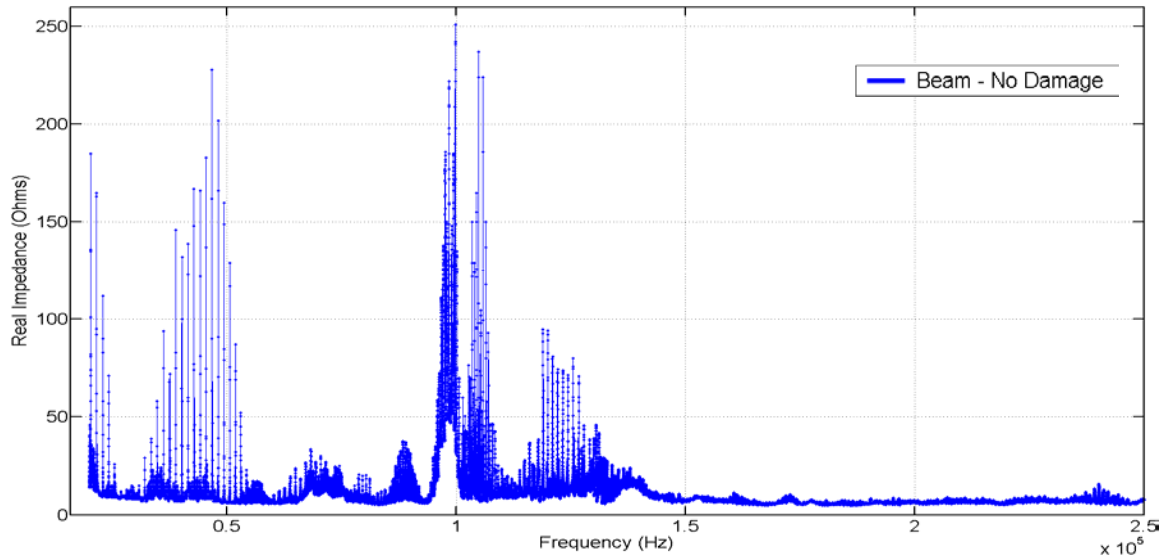
Figure 4.2.1: The peak density for beam-like structures is low relative to plate-like structures.

extend from 20-250 kHz, the test range considered for most structures. In general, the impedance peak density for a beam is much lower than the impedance peak density in plates. Also, the real impedance magnitude in beams varies much more than those in a plate. Remember from chapter 2 it was noted that some of the best corrosion detection occurred for well-spaced impedance peaks with small magnitudes in beams. In plates, the impedance peak density is so high, finding well-spaced peaks is difficult especially for peak with small magnitudes. These general observations play a role in the amount of error incurred when calculating damage metrics.

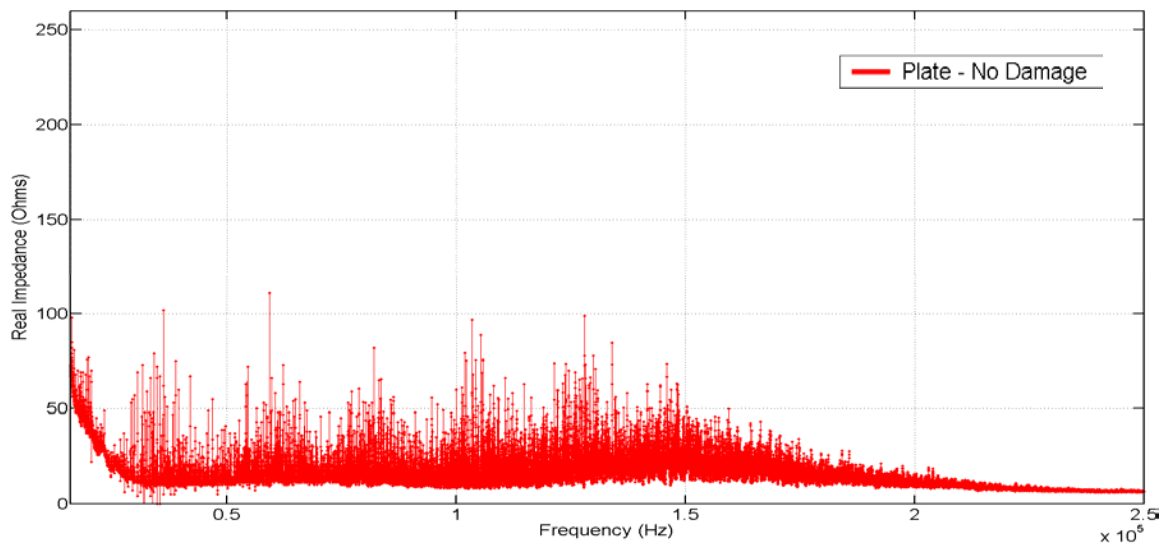
Figure 4.2.2: The peak density and real magnitudes for plate-like structures is large.

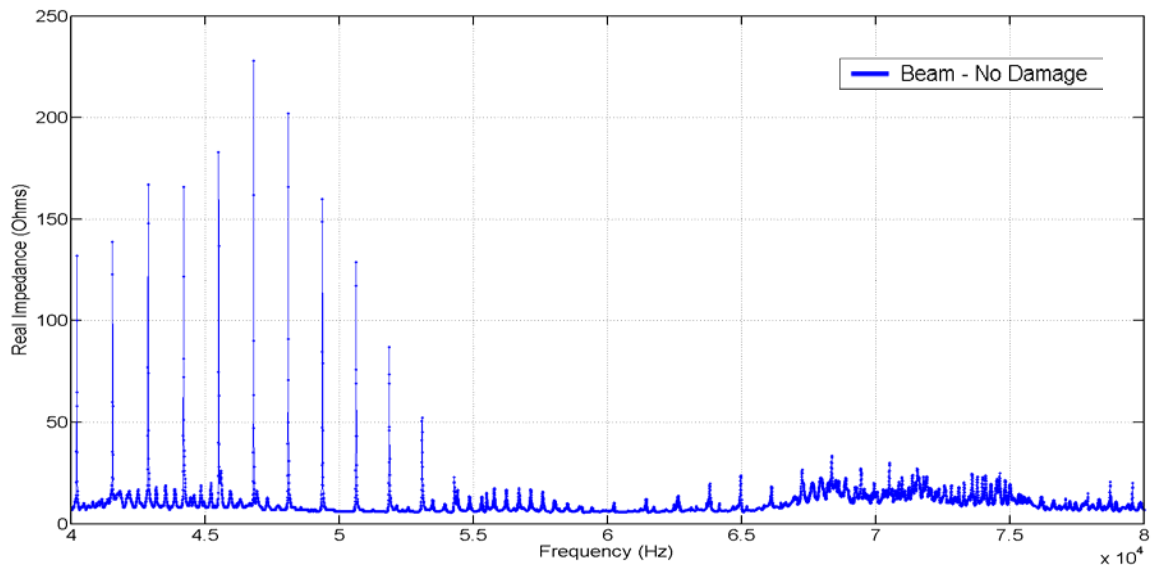
Figure 4.2.3: The peak magnitudes are lower and appear to be more damped in beams.

A closer look at the impedance responses over a smaller frequency range yields more valuable observations. Figures 4.2.3 and 4.3.4 show the impedance signatures for beams and plates from 40-80 kHz. It should be noted that this data was recorded for sensitivity testing at a frequency resolution of 1 point per 5 Hz, which causes the peaks to appear jagged. For the actual impedance testing, the frequency resolution was always set to 1 point per 1 Hz, which tends to smooth out all but the steepest and narrowest peaks. In the beam plot, many of the smaller peaks (less than 50 Ohms) appear to be short and fat like a well damped peak in a traditional FRF. For the plate plot, most of the peaks appear tall and narrow relative to most beam peaks. The tall narrow peaks cause variations in the damage metrics to increase in the presence of ambient noise like temperature induced variation. Think of the damage metric as the inverse of the correlation between the same impedance peak recorded at different times. For tall narrow impedance peaks in the healthy impedance sweep, ambient lateral shifts (may be temperature induced) for the corresponding impedance peak in the damaged impedance sweep causes the RMSD damage metric to rapidly increase (the correlation rapidly decreases). Thus, tall narrow peaks in plates are more sensitive to impedance changes than short wide peaks in beams. For damaged induced impedance shifts the added sensitivity is advantageous, but the drawback is that ambient induced impedance shifts are greater. The two tend to offset one another, and make distinguishing damage induced changes from ambient induced changes more difficult in plates than beams. It may seem subtle, but this fact makes detecting and distinguishing corrosion in plates more challenging than for beams.

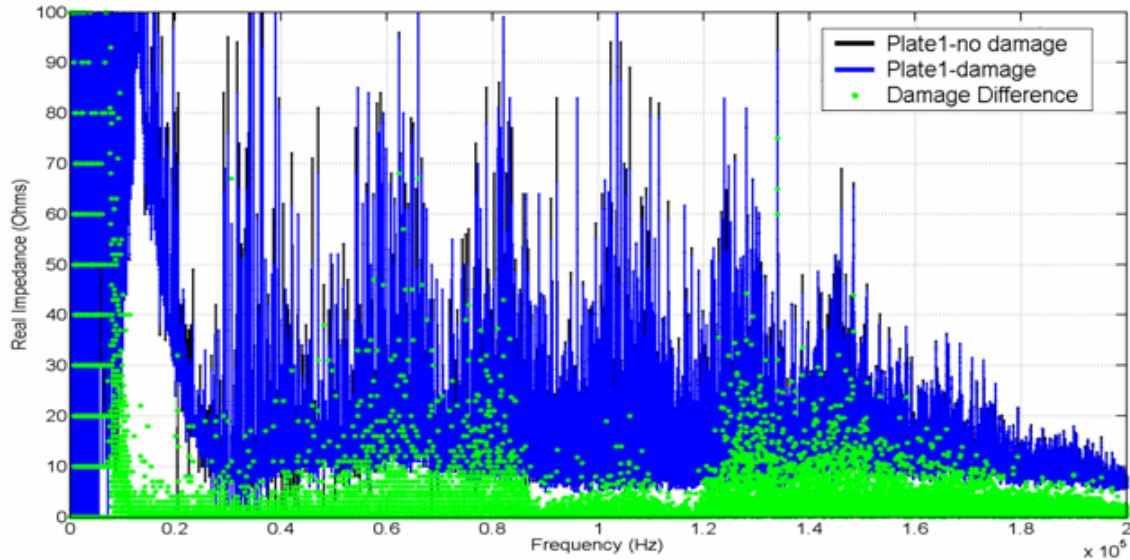
Figure 4.2.5: A sensitivity test on a plate with the damage metric difference overlaid.

Since it is more difficult to detect and distinguish plate corrosion, sensitivity testing and frequency selection become more important. For beams the test frequencies were selected by measuring a healthy impedance signature then measuring a damaged signature simulated by adding a small amount of wax to the structure. The two baselines were plotted, and based on the visual differences between the signatures test frequencies were selected. For plates, the same process was repeated with one additional step. For each frequency, the difference between the two impedance signatures was computed and then overlaid on the two impedance signatures to visually depict frequencies sensitive to damage. Figure 4.2.5 shows an example of the sensitivity test for one of the plate sensors.
