Impedance-Based Structural Health Monitoring to Detect Corrosion

Thesis Submitted to the Faculty of the
Virginia Polytechnic Institute and State University
in partial fulfillment of the requirements for the degree of
Master of Science

Mechanical Engineering

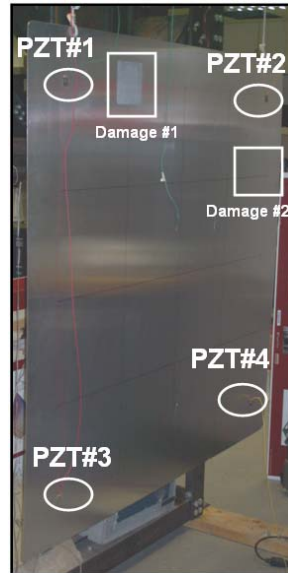
Figure 4.2.6: Ovals mark the PZT locations and squares mark the corrosion damage locations.

For the plate testing, a 122 x 122 x 0.098 cm sheet of aluminum 3105-H12 was cut from sheet stock. A 1 x 1 m square grid was laid out in the center of the aluminum sheet and 4 pieces of 1.905 x 1.905 x 0.0267 cm PZT 5A material were bonded to the four corners of the grid. The 1 m² area was subdivided into sixteen 25 x 25 cm squares with the intersections of the grid serving as possible corrosion damage locations. A picture of the plate may be seen in Figure 4.2.6. Leads were attached to the piezoelectrics, and then entire plate was hung vertically from two ropes to simulate free-free boundary conditions. The leads from the piezoelectrics were attached to an HP 4194A impedance analyzer which was controlled with LabView GPIB interface. Initially, sensitivity tests were conducted from 0.100-500.1 kHz to determine useful

While the plate was in pristine condition, at least 30 samples of impedance data (baseline) were collected from each piezoelectric for the frequency range. The baseline measurement was made over a 7 day period to capture the ambient variability of the system. Once the initial baseline measurement was complete, the plate was corroded with hydrochloric acid. To reduce boundary condition changes, damage to sensors, and non-corrosion damage to the plate, all corrosion damage was added to the plate while it was hanging. The damage was “slight to moderate” corrosion with a 1% (depth 58.7 microns) and 0.25% (depth 66.0 microns) surface coverage. Slight to moderate corrosion damage was chosen for testing because that type of damage is of the magnitude found in aircraft entering the aging maturity phase [22]. A new baseline impedance measurement was made, and the process was repeated for each damage case. Damage locations were chosen such that the distance from each sensor ranges from 25, 75, 103, and 125 cm. This is important because with the plate and piezoelectric configuration used in this study, the greatest distance damage can occur from a sensor is 70.7 cm. Thus, the setup allows for the 3 sensors to detect the damage at distances greater than 70.7 cm.

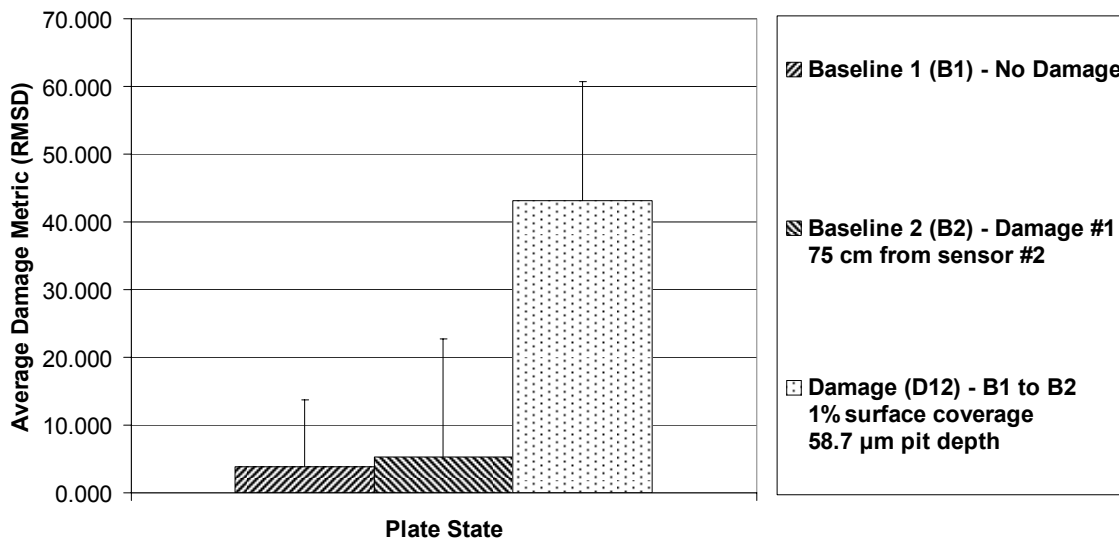
Figure 4.3.2: Corrosion detection results from PZT #2 at 230-231.2 kHz.

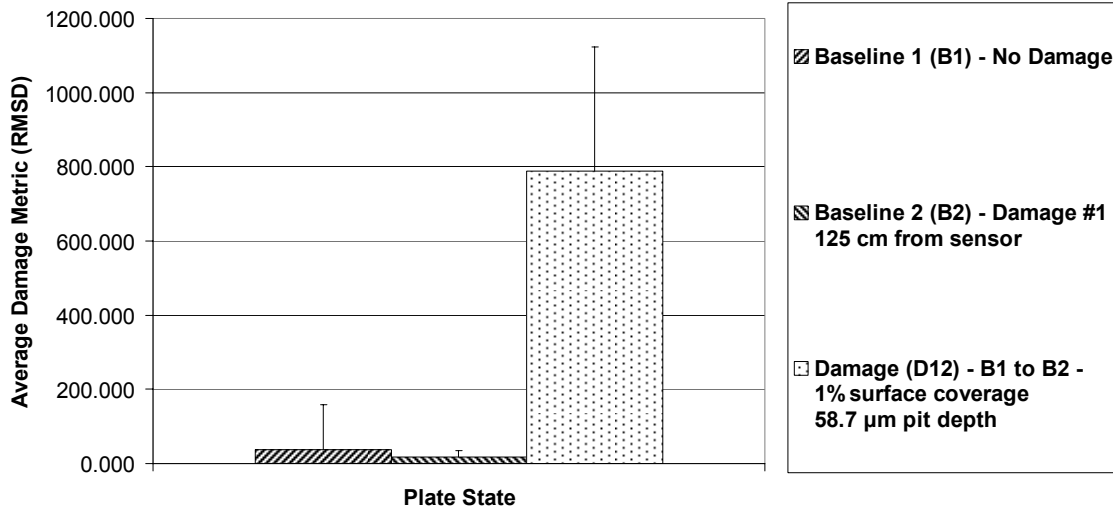
Figure 4.3.3: Corrosion detection results from PZT #4 at 7.5-8.7 kHz.

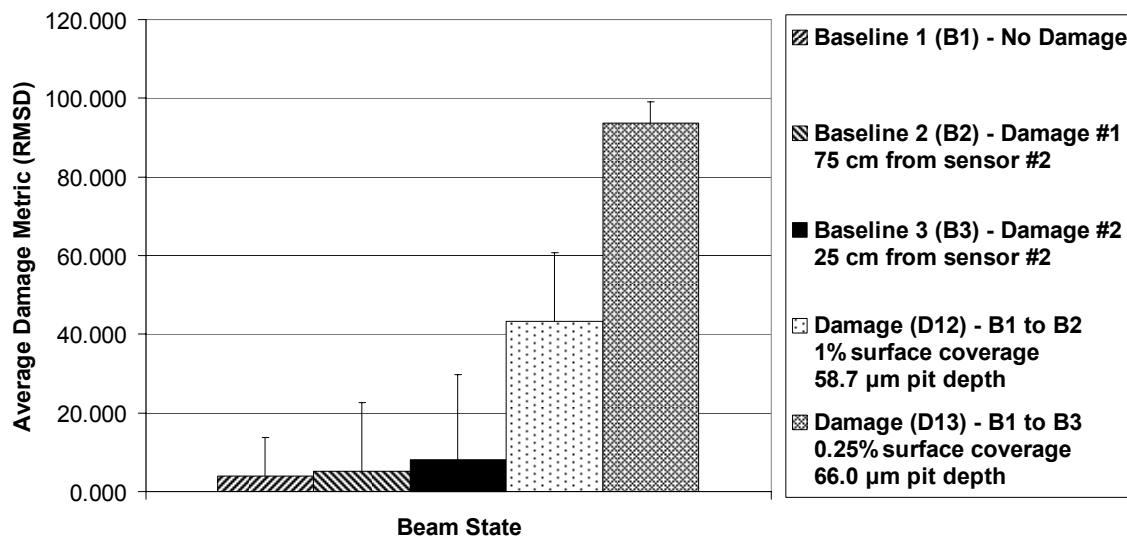
Figure 4.3.4: At 230-231.2 kHz the corrosion damage #2 is distinguishable from PZT#2.

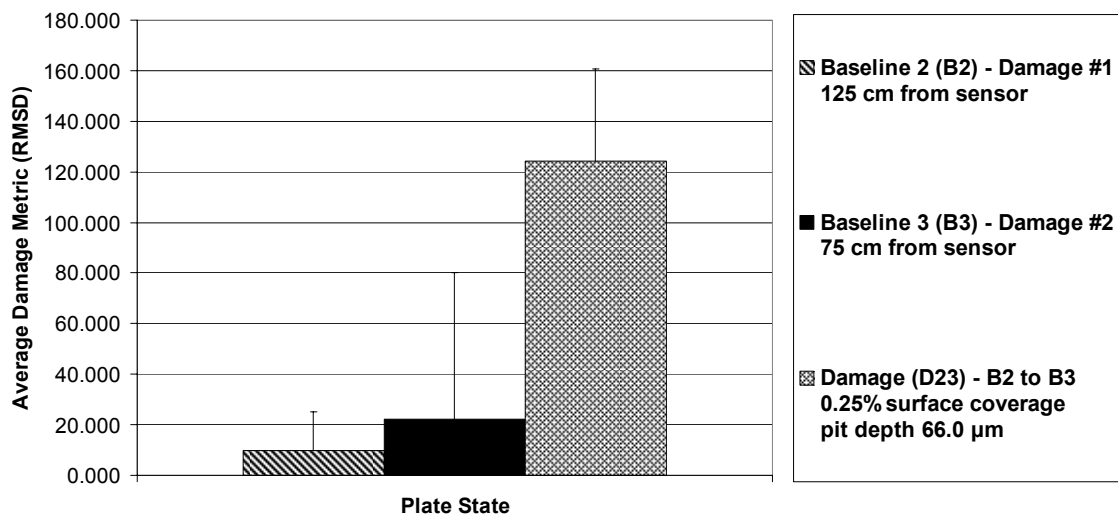
Figure 4.3.5: Damage #2 is distinguishable from PZT #4 at 52-53.1 kHz.

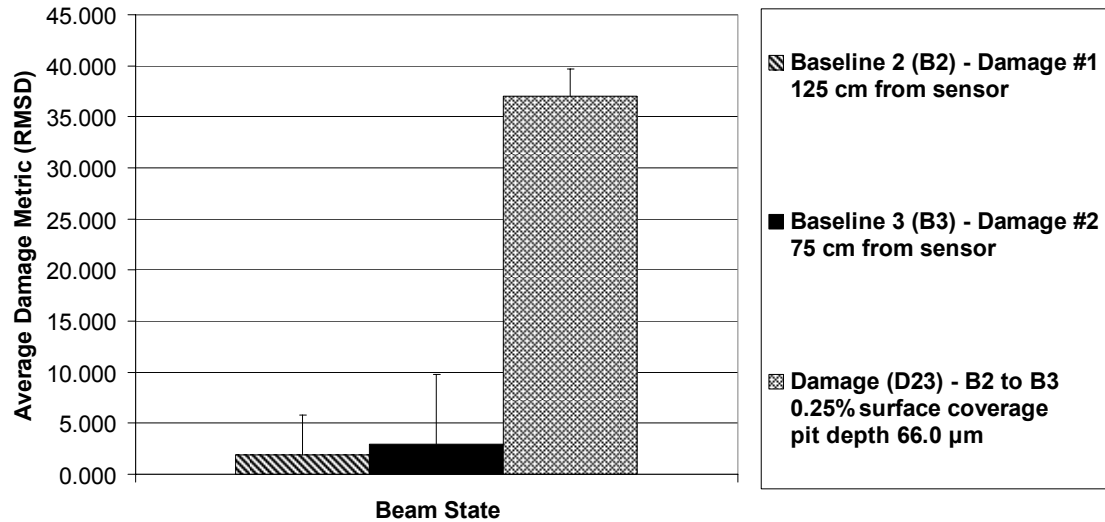
Figure 4.3.6: Damage #2 is distinguishable from PZT #4 at 230-231.2 kHz.

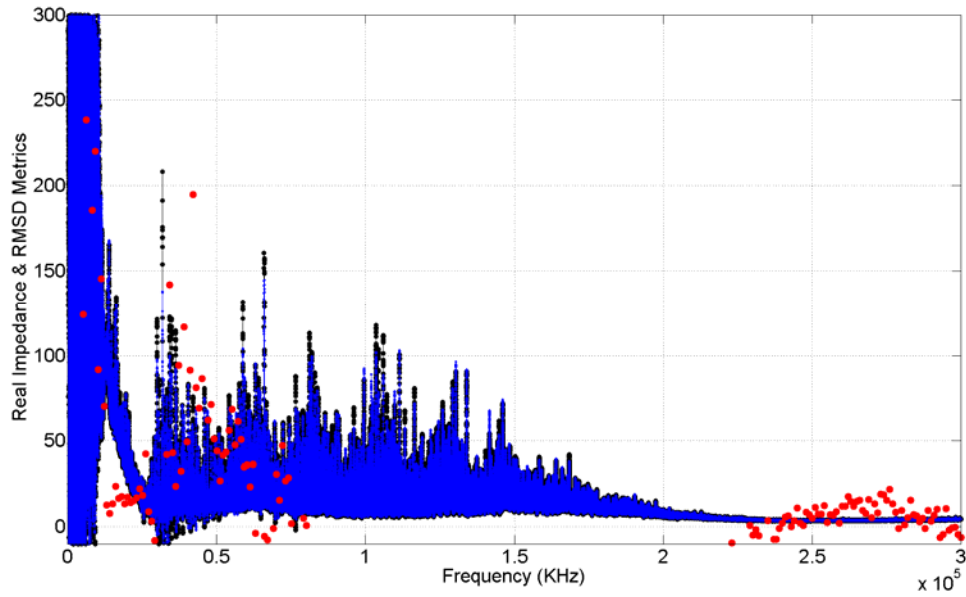
Figure 4.2.7: Impedance signatures with distinguishable damage overlaid for PZT #3.

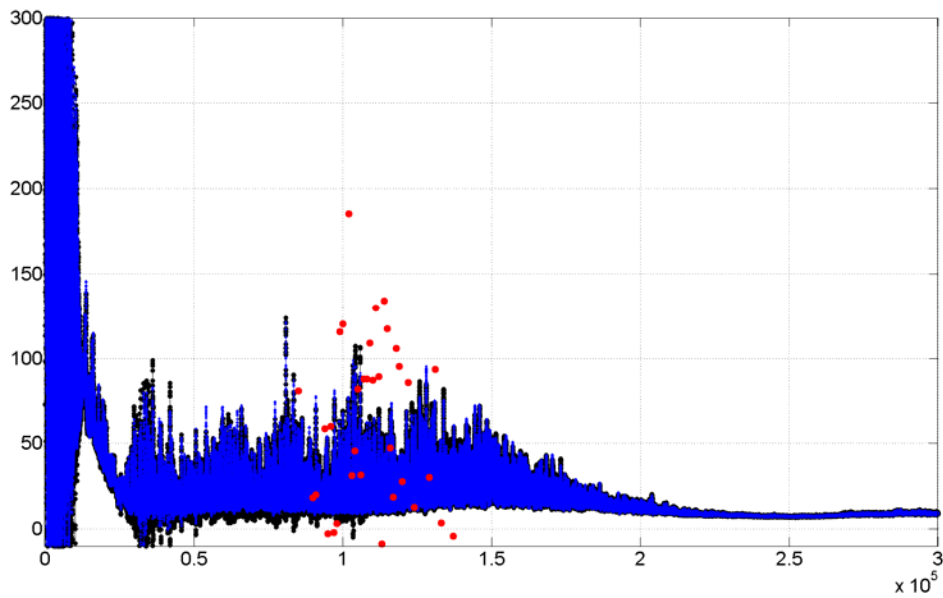
Figure 4.2.8: Impedance signatures with distinguishable damage overlaid for PZT #2.

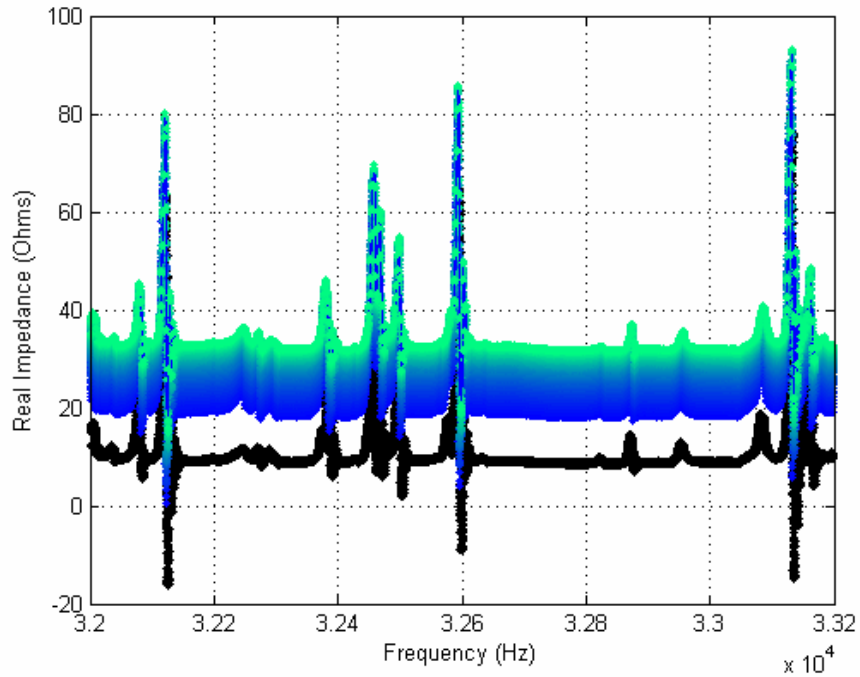
Figure 5.2.1: The impedance change in PZT #1, where black is 43 undamaged signatures and the blue to green colormap is the 33 signatures for damage #1 measured with a corrosion damaged sensor.

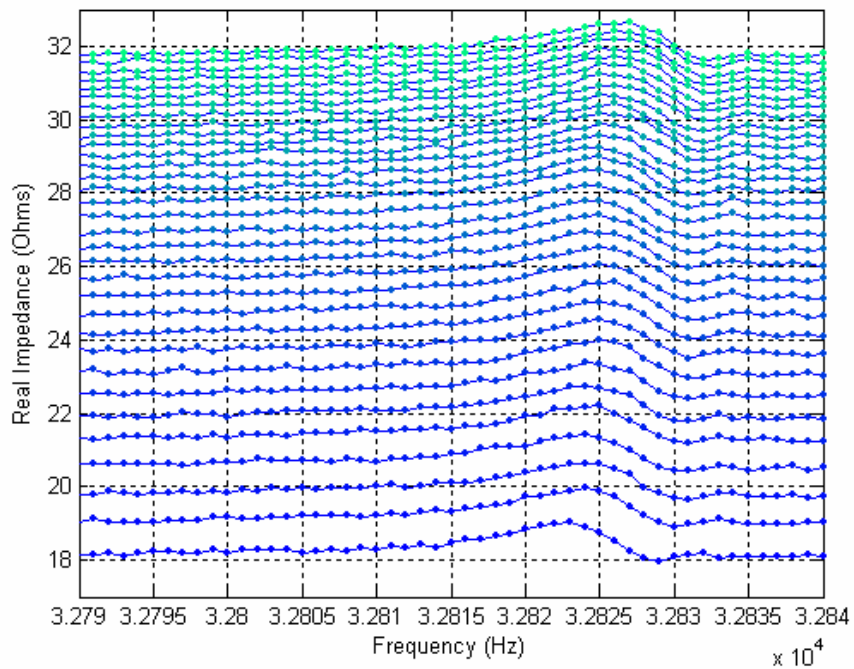
Figure 5.2.2: Over a narrow frequency band, it is easy to see the time dependant shift in the impedance signature caused by the corrosion damaged sensor.

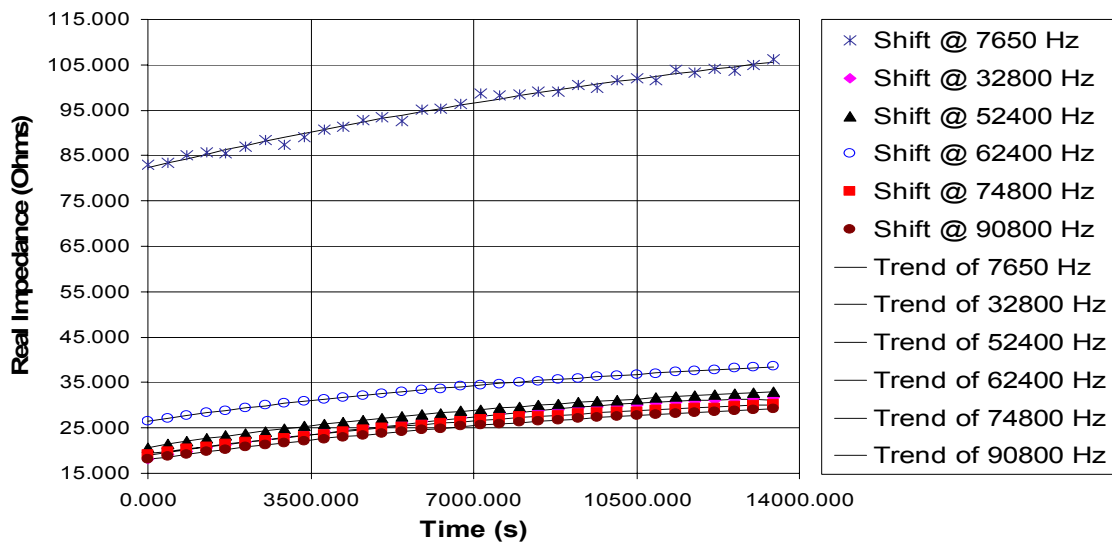
Figure 5.2.3: Impedance versus time plot for a damage PZT sensor show definite trends.

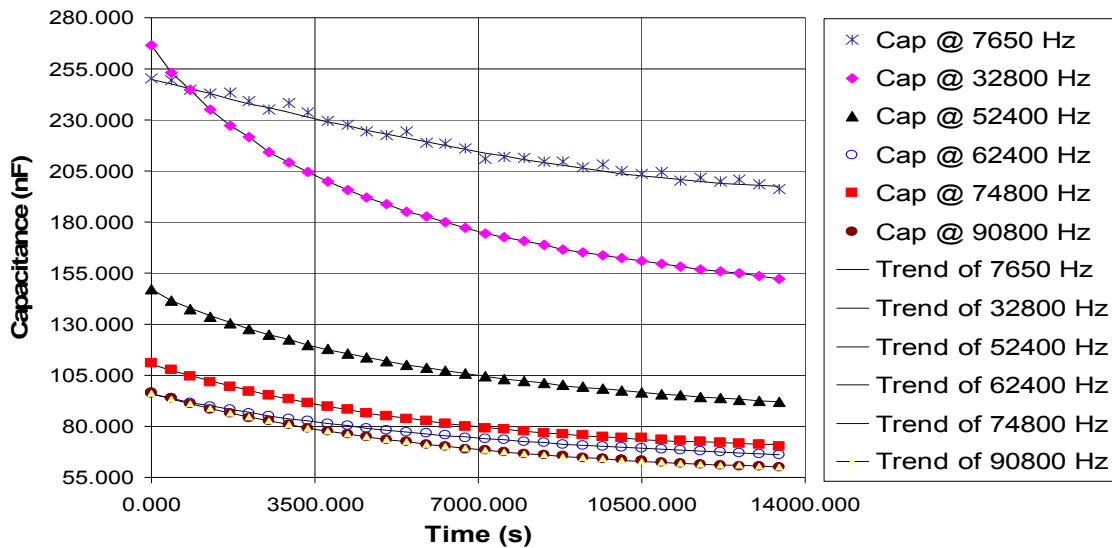
Figure 5.2.4: Capacitance versus time plot for a damage PZT sensor show definite trends.

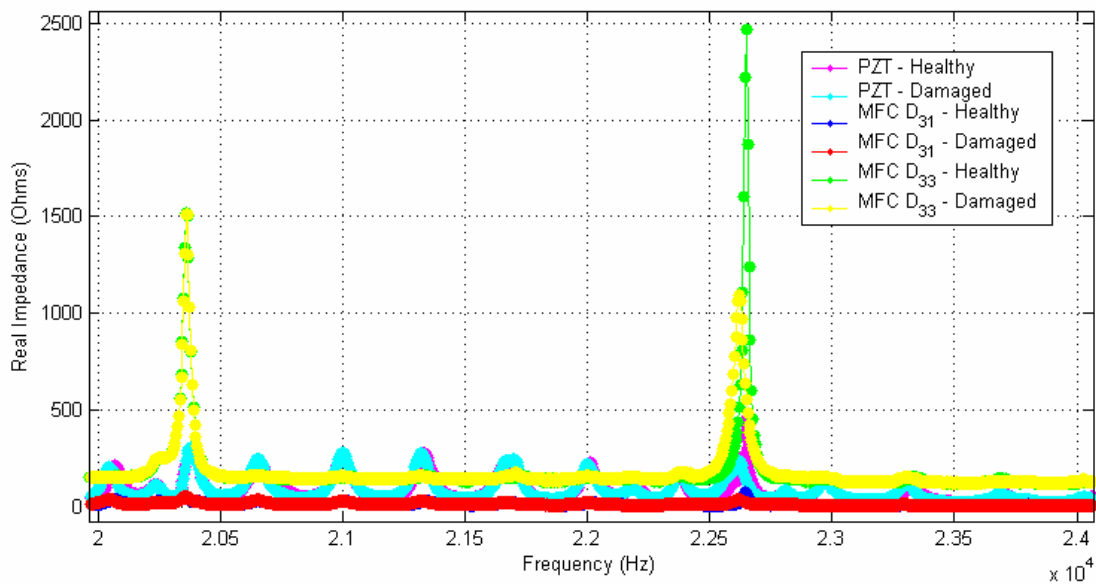
Figure 5.3.2: Sensitivity test results show the impedance response differences between PZT, MFC D₃₁, and MFC D₃₃.
