FLOW INDUCED FAILURES OF COPPER DRINKING WATER TUBE

Thesis submitted to the Faculty
of the Virginia Polytechnic Institute and State University
in Partial Fulfillment of the requirements for the degree of

Masters of Science
in
Environmental Engineering

May 5, 2009
Blacksburg, VA

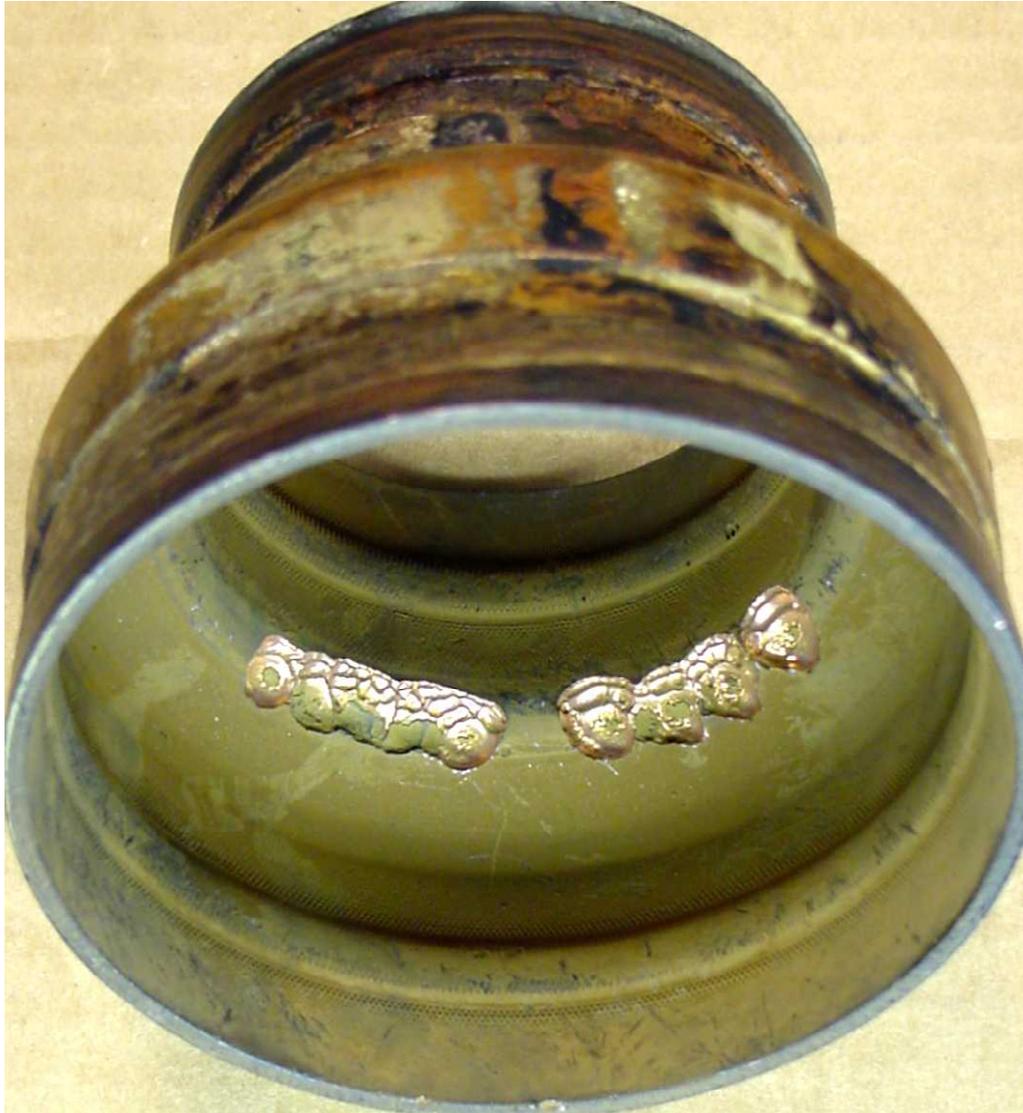
Figure 1-2: Pipe from a Real Premise Plumbing System Exhibiting Possible Cavitation Bubble Implosion Damage

evaluations of copper pipe sections revealed a damage pattern consistent with that believed to be cavitation implosion (Figure 1-2).

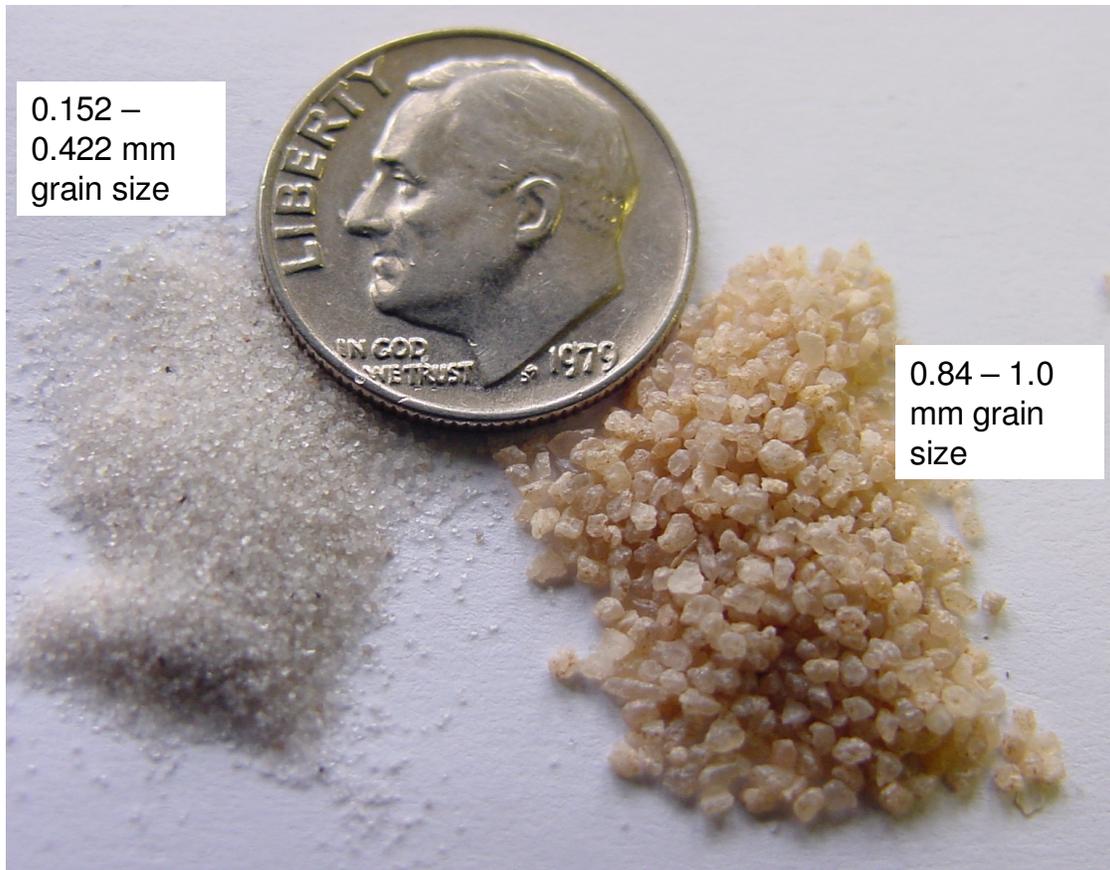
Figure 3-6: Grain Size Comparison

(0.017”), and particles between 0.84 mm (0.033”) and 1.0 mm (0.04”) were used in the final trial (Figure 3-6). Copper pipe components were weighed and inspected before and after testing.
