# **Fatigue Assessment for Failed Bridge Deck Closure Pour**

Thesis submitted to the faculty of the Virginia Polytechnic Institute and State University  
in partial fulfillment of the requirements for the degree of

Keywords: Fatigue, Bridge Deck, Closure Pour, Reinforcing Steel, Construction Joint

After 17 years in service, a 3 ft by 3 ft closure pour section of an Interstate 81 (I-81) bridge deck failed by punching through near Marion, Virginia. Visual inspection noted that there was considerable corrosion on some of the reinforcing bars in the vicinity of the construction joint, while other failure bars had little or no corrosion. Sections of the bridge deck were cut and delivered to Virginia Tech for further investigation.

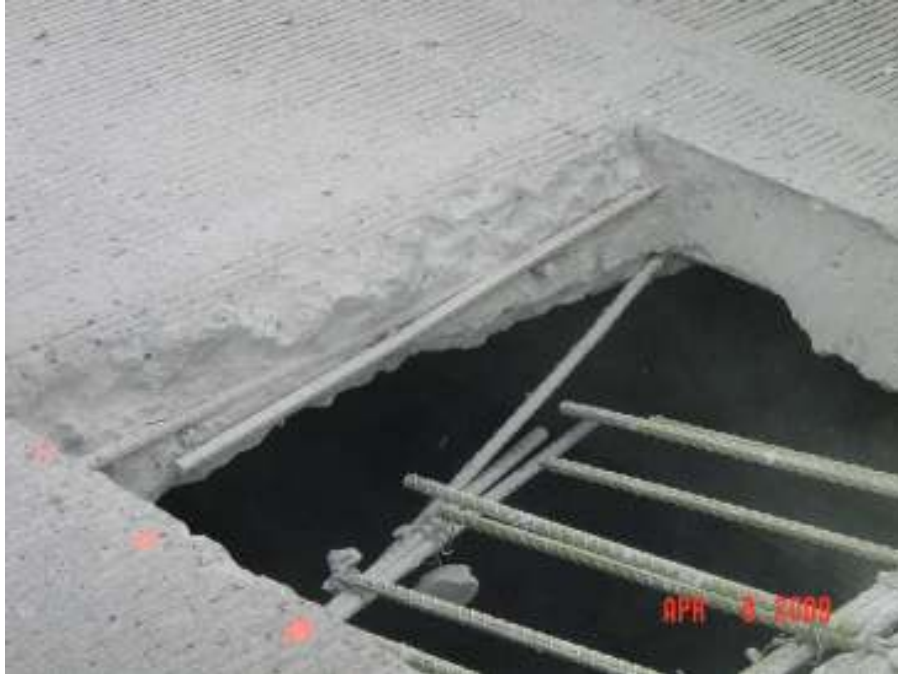
Seventeen years after the deck replacement, on April 2, 2009, a 3 ft x 3 ft section of the closure pour failed by punching through on the southbound bridge at mile marker 43. Since the failed section was located at the end of the deck, it fell onto the bridge's end diaphragm directly below it. When the failed section was being repaired, it became apparent the entire closure pour strip was in poor condition requiring immediate replacement (Sprinkel, et al., 2010). The failed closure pour section is shown in Figure 1-1. This photograph was taken after the concrete had been removed to reveal the reinforcing bars.

**Figure 1-1. Failed Closure Pour Section (Sprinkel, et al., 2010)**

The failed section was repaired by cutting out an 8-ft section of the deck along the entire bridge that spanned between the two adjacent steel girders which enclosed the closure pour. Expansive concrete with Type K cement and MMFX2 (corrosion resistant) reinforcement was used in replacing the 8-ft section (Sprinkel, et al., 2010). This repair widened the closure pour section and moved the construction joints to the center of the bridge girders to provide direct support for the joints. This contrasts with the original 3 ft closure pour where the joints had no vertical support.

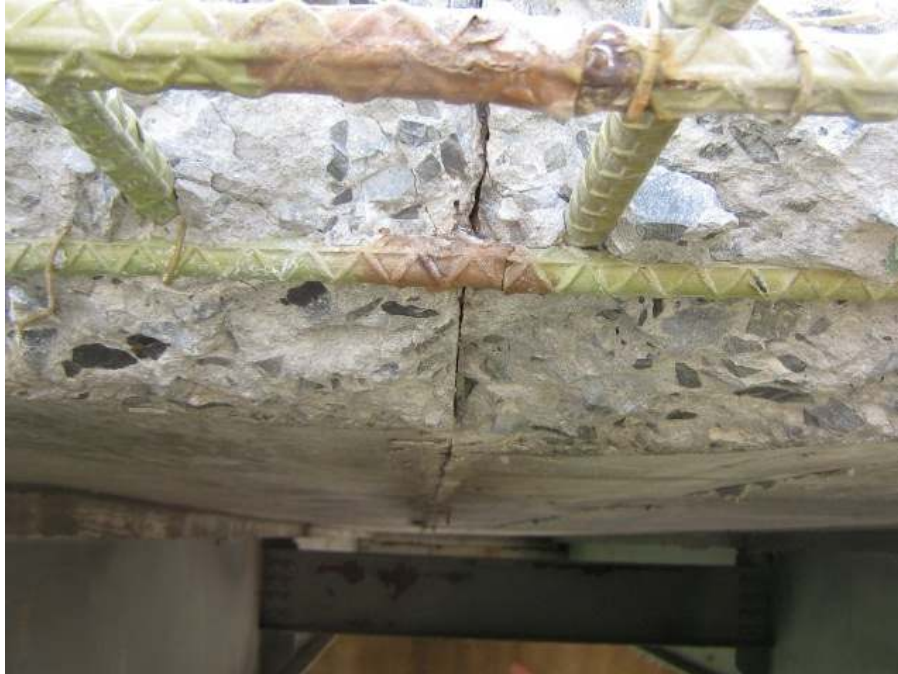
Three weeks prior to the failure, a 1/8 in. transverse crack across the closure pour was noticed during a routine inspection. This crack formed one of the boundaries of the failed section as shown across the top of Figure 1-1. The post-failure examination showed that a total of eighteen No. 5 reinforcing bars had been sheared along the boundaries of the failed section. Ten were in the transverse direction across the closure pour construction joints, while eight were in the longitudinal direction. The examination also revealed that the ECR had sustained section loss due to corrosion at the location of the construction joints. Figure 1-2 shows two transverse bars that have cracked along the closure pour joint after concrete was removed. The brown coloration of the epoxy coating indicates that corrosion is occurring on the surface of the bars at the failure location. The bars have transverse fractures and are completely severed in planes that are offset from the plane of the construction joint.

**Figure 1-2. Sheared Bars at Closure Pour with Corrosion Damage (Sprinkel, et al., 2010)**

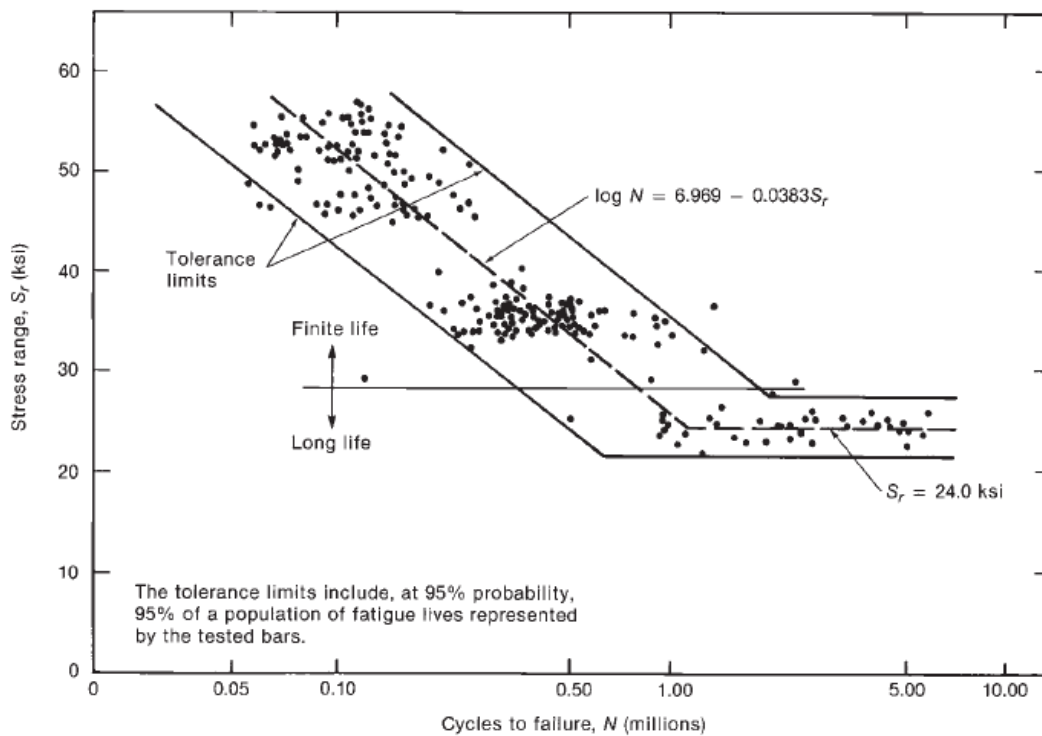
as reinforcing steel, the S-N plot shows that number of cycles to failure decreases as the stress range increases. However, there is a stress range level where failure rarely occurs and the fatigue life is said to be virtually infinite. This lower bound stress range level is called the endurance limit or fatigue threshold. The number of cycles to failure is usually plotted on logarithmic scale since it changes rapidly with stress range level and could span over several orders of magnitude. Figure 2-1 shows the S-N plot of concrete reinforcing steel from a single manufacturer. Wight and MacGregor present this plot based on an investigation on the fatigue of reinforcing bars (Helgason and Hanson, 1974). The statistically-determined tolerance limits for the data are shown on plot, with the lower limit being critical for design.

**Figure 2-1. S-N Plot of Tests Conducted on Steel Reinforcing Bars (Wight and MacGregor, 2009)**

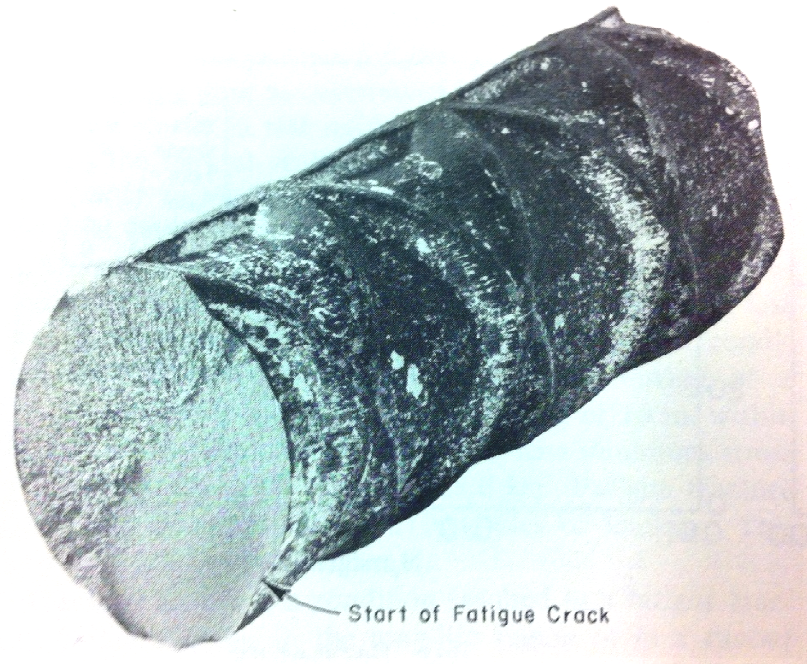
same way when embedded in the beam for testing. The described fracture face texture is clear and the focal point is at the location of a transverse lug.

**Figure 2-3. Fracture Face of Fatigue-Failed Test Bar (Helgason, et al., 1976)**

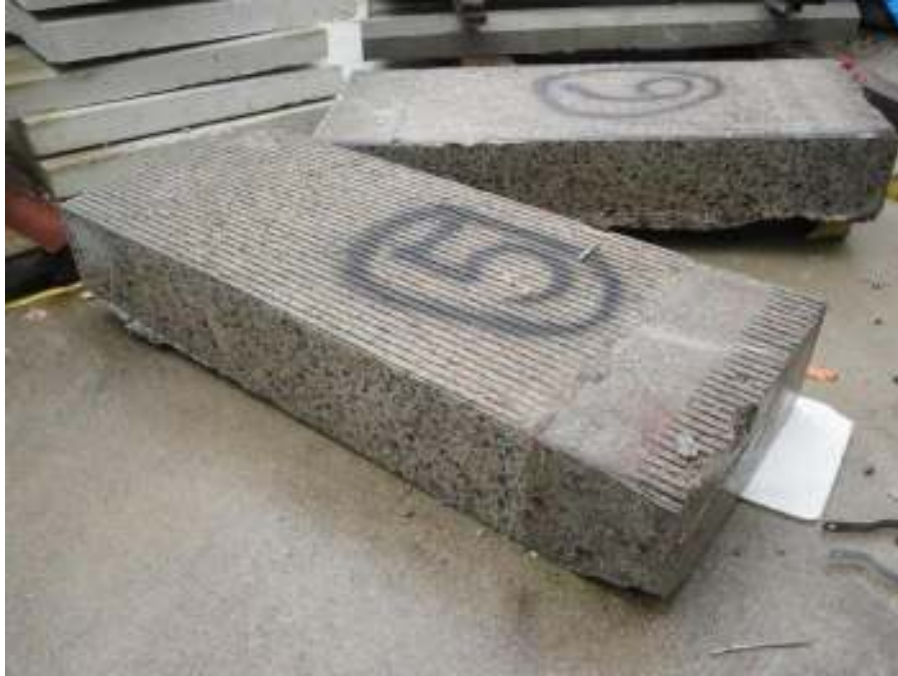
When the closure pour was being repaired, four large sections of the deck (including the 3-ft closure pour) were saw cut out of the bridge and sent to the Thomas M. Murray Structures and Materials Research Laboratory at Virginia Tech for assessment and testing. The condition of the slabs was assessed both visually and using a variety of non-destructive evaluation techniques to detect internal corrosion of the reinforcing steel. After the initial investigation, the slabs were cut into smaller strips for the structural fatigue and strength tests. A total of eight test specimens were cut from the four large slab sections that were removed from the I-81 southbound deck. The resulting specimens were about 22 in. wide and 54 in. long with the depth equal to the full 9 in. bridge deck thickness. Each specimen has two closure pour joints transversely located along the length about 9 in. from each end. There were slight dimensional differences due to construction tolerances and cutting precision. Figure 3-1 shows the 3-ft closure pour section located in the center with about 9 in. of adjacent slab on each side. The figures in Appendix B indicate the exact location of the eight specimens in the four original slabs.

**Figure 3-1. Typical Specimens Cut From the I-81 Bridge Deck**

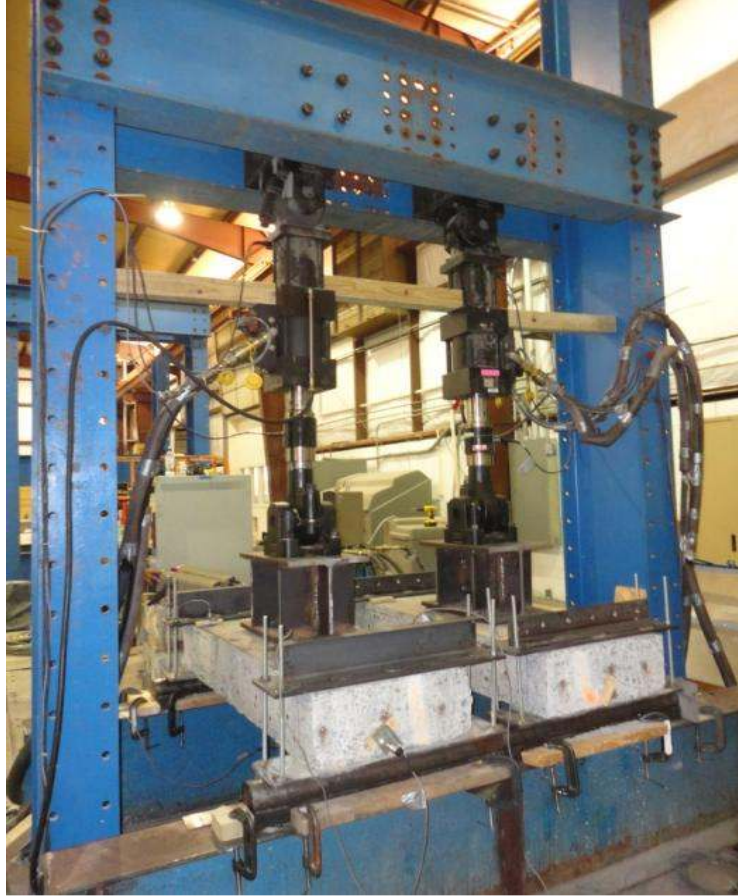
The major difference between the actual setup shown in Figure 3-9 and the original idealized setup from Figure 3-8 is that a stiffened steel I-section was used to spread the jack load over the wheel patch area. This I-section was bolted in series to the MTS actuator and used as an extension since the actuator could not extend down to the top surface of the specimens. During loading, it was in direct contact with the elastomeric pad.

**Figure 3-9. Complete Setup for Fatigue Loading**

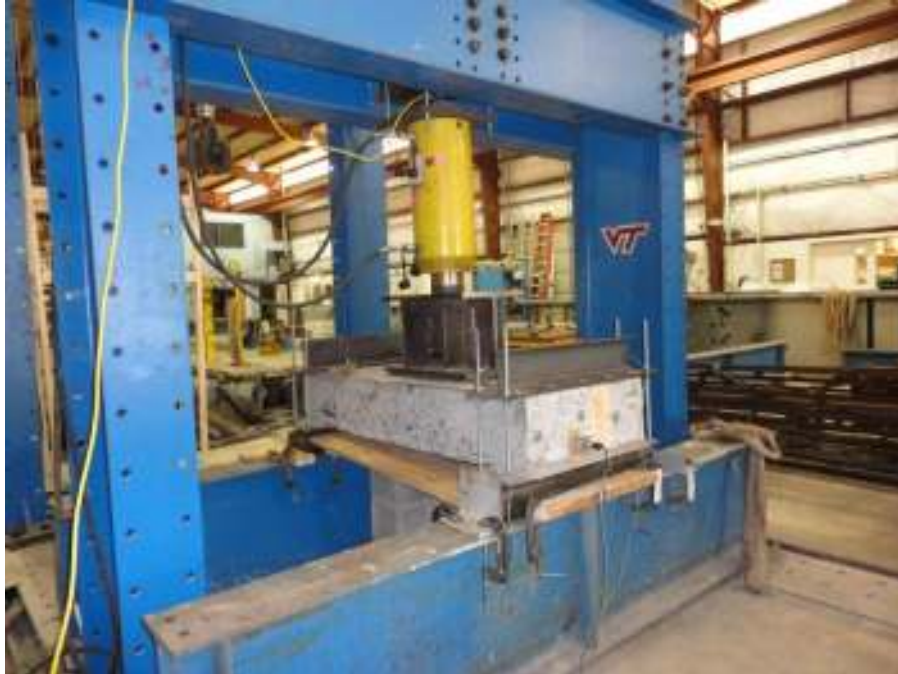
The strength tests could not be performed at the same location as the fatigue tests since the required loads exceed the MTS actuator capacity. Therefore, a slightly different setup was used for the strength tests. The setup was essentially the same as the fatigue tests with a different loading actuator. Figure 3-10 shows the strength test setup. Since strength tests are relatively short in duration compared to fatigue tests, there was no need to assemble two simultaneous testing setups. The same roller supports were used as well as the same type of frame assembly and I-section pedestals.

**Figure 3-10. Complete Setup for Strength Tests**

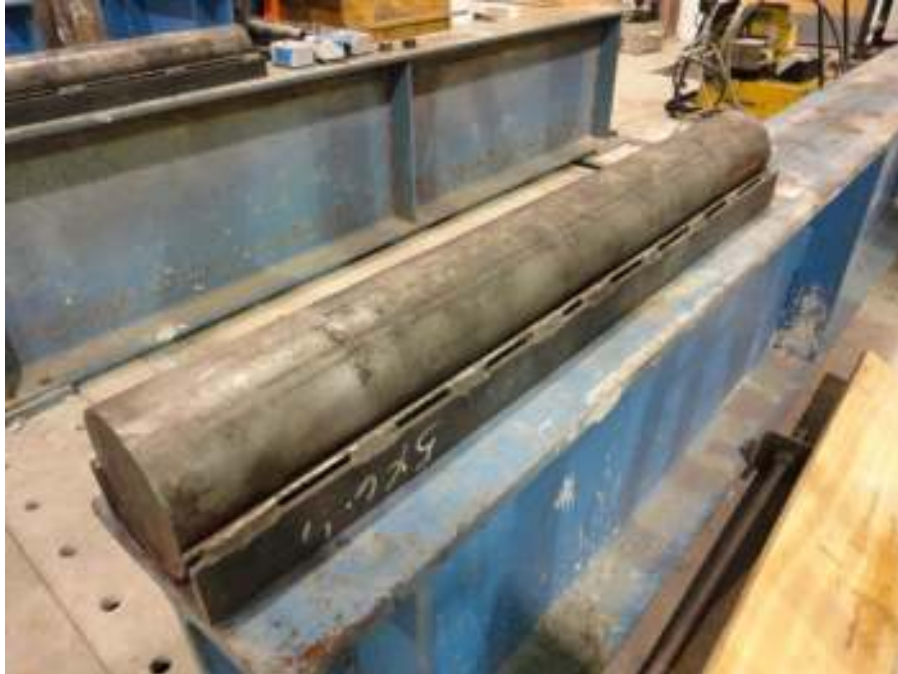
The supports used in all the tests were of the roller type, shown in Figure 3-11. These had been previously assembled in the laboratory for general lab use. A 4-in. diameter steel bar (32-in. length) sits on a semicircular steel cradle welded to a 5-in. channel-section base. The steel bar and semicircular plates were greased to reduce friction.

**Figure 3-11. Roller-Type Support Used for all Tests**

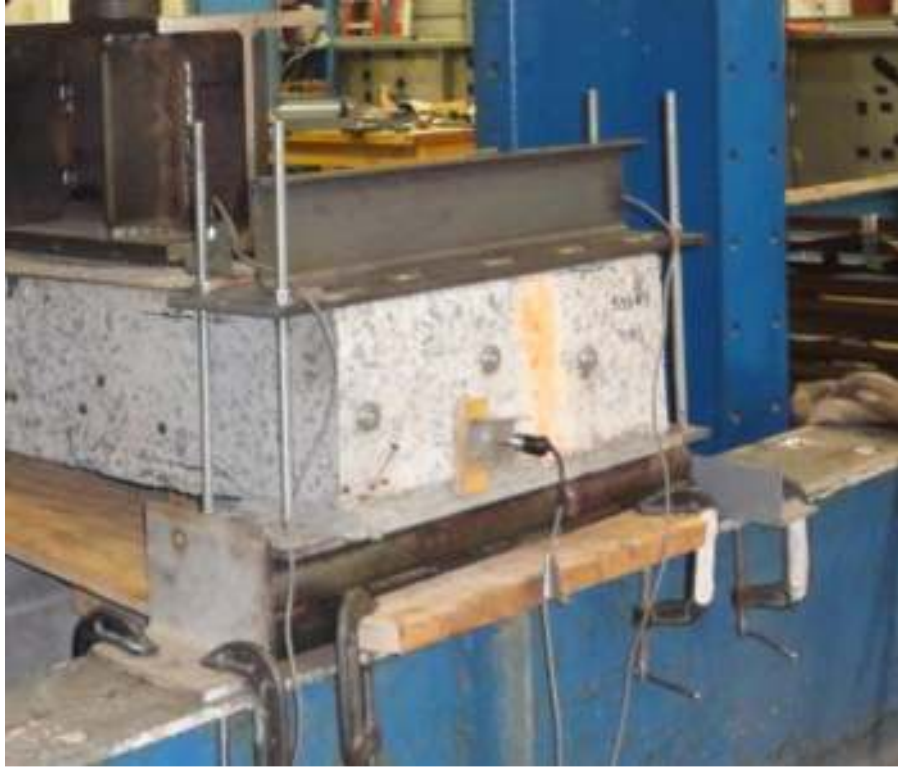
As previously mentioned, the slab specimens were not in direct contact with the roller supports. The concrete end blocks were sandwiched between two steel plates and clamped with four steel rods at the corners. This was done for two reasons: 1) to provide a bearing plate to prevent concrete crushing under direct contact with the roller; and 2) to add some additional constraint to the end block to help prevent cracking that might affect development length. The plates used were 7 in. by 30 in. by  $\frac{1}{2}$  in. and four  $\frac{1}{2}$ -in. rods were used to align the plates and hold them together. Figure 3-12 shows the entire assembly in place with the grout layer between the specimen and the bottom plate. The rods were welded to the bottom plate and fastened to the top plate with nuts and washers. To stiffen the top plate and prevent bending from tightening the nuts, a channel section was welded to the top plate. There were a total of four plate assemblies constructed. Two used channel sections for plate stiffness and two used angle sections.

**Figure 3-12. Steel Plate Assembly at Support Locations with Grout Layer**

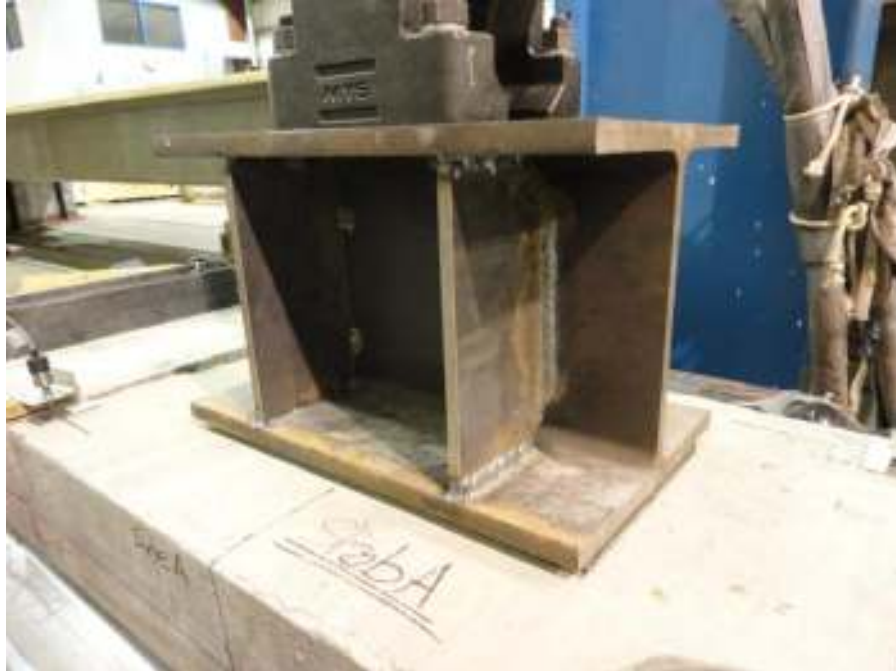
Since the stroke extension of both actuators (MTS and Enerpac) was not sufficient to make direct contact with the specimens, a 20-in. long W12x87 steel section was used as an extension for all tests. Once centered on top of the elastomeric pad, the actuator applied the load directly to the top of the section. Its weight was accounted for in the data analysis. Figure 3-13 shows the section with four ½-in. plates (two shown) that were welded to the web and flanges for stiffness purposes.

**Figure 3-13. Stiffened W12x87 Section Used as Loading Extension**

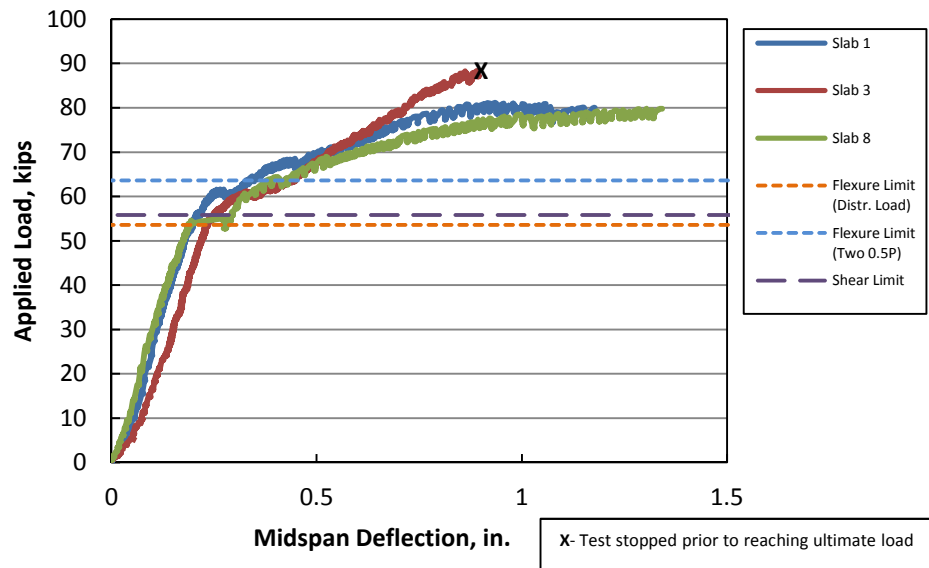
bridge deck, the locations of the bars were not exactly the same in all specimens. The contribution of the construction joints is also uncertain. In addition, the actual yield and ultimate stress values are higher than the specified values. This, and with the calculations showing that the steel is in strain hardening at ultimate conditions, could also be reasons for the higher capacity of the specimens.

**Figure 5-3. I-81 Specimens Load-Displacement Curves with Flexural and Shear Limits**

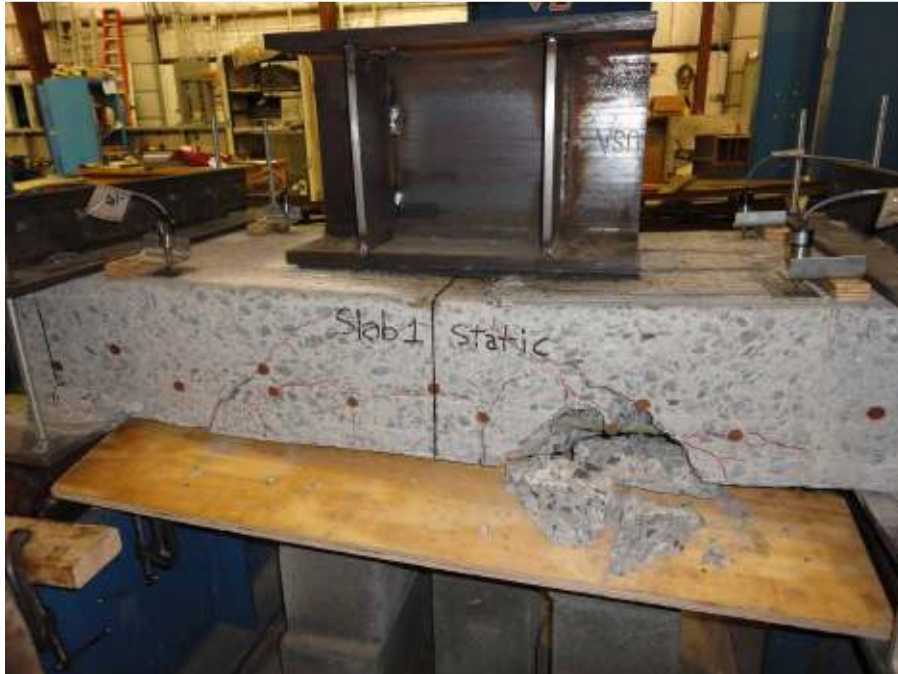
the load-displacement curves. After these cracks formed, smaller cracks began to branch out from them and other small ones formed in between them. There were sections of concrete that spalled off on the bottom face of the specimens, revealing the reinforcing bars.

**Figure 5-4. Failed I-81 Specimen with Test-Induced Cracks (Marked in Red)**

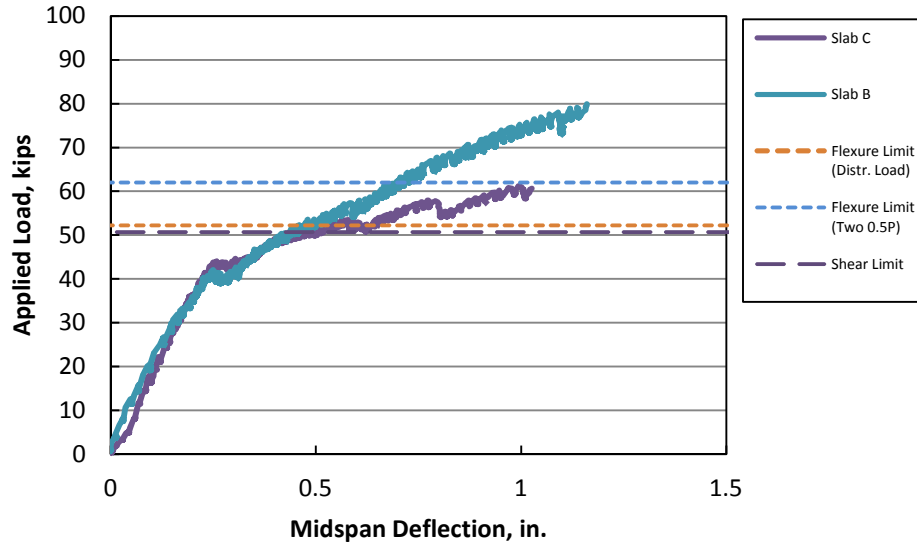
under the basic setup (no jacking), failed closer to the two-point load case flexural limit than the other limits. The curve for Specimen B, tested with the jacking setup (opened joints), behaved almost the same as that of Specimen C until 50 kips. After this point, it continued to deflect and take more load until it failed close to 80 kips.

**Figure 5-5. Cast Specimens Load-Displacement Curves with Flexural and Shear Limits**

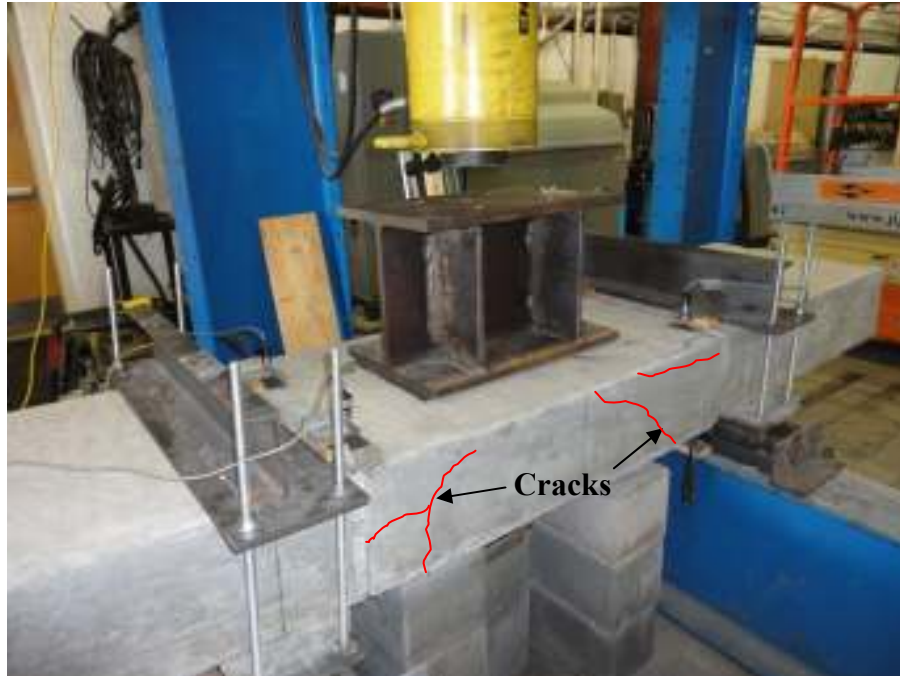
The main differences observed between Specimen C and the I-81 specimens are: 1) the ultimate load of Specimen C was significantly lower; 2) there was significant spalling of the concrete on the top face of Specimen C; and 3) there were fewer cracks compared to the I-81 specimens.

**Figure 5-6. Failed Specimen C with Main Cracks Indicated**

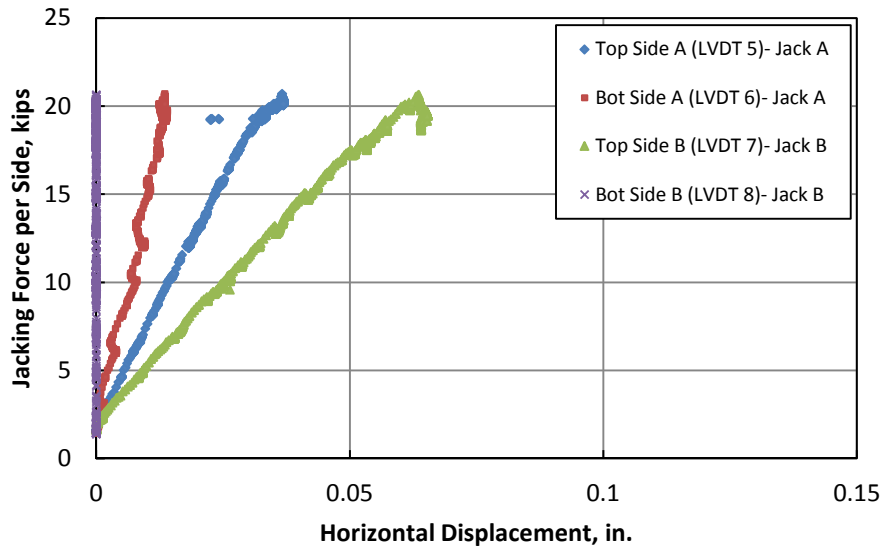
**Figure 5-8. Joint Opening LVDT Readings at Joint 1 during Jacking**

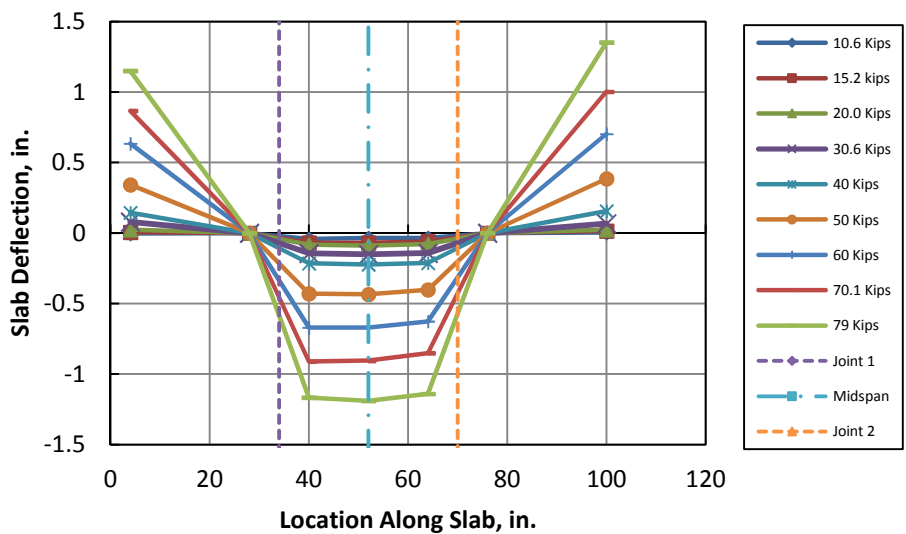
The vertical deflected shape of Specimen B from the beginning of the test till failure is shown in Figure 5-11, while the zoomed-in deflected shape up until 20 kips of applied load is shown in Figure 5-12. The three middle deflection measurements were relatively constant at all load steps. Based on bending theory the midspan deflection would be expected to be higher compared to the other two locations. This indicates that the center region of the specimen is deflecting somewhat as a rigid body and shear deformation at the joints and crack locations are affecting the deflection response.

**Figure 5-11. Deflected Shape of Specimen B Throughout Testing**

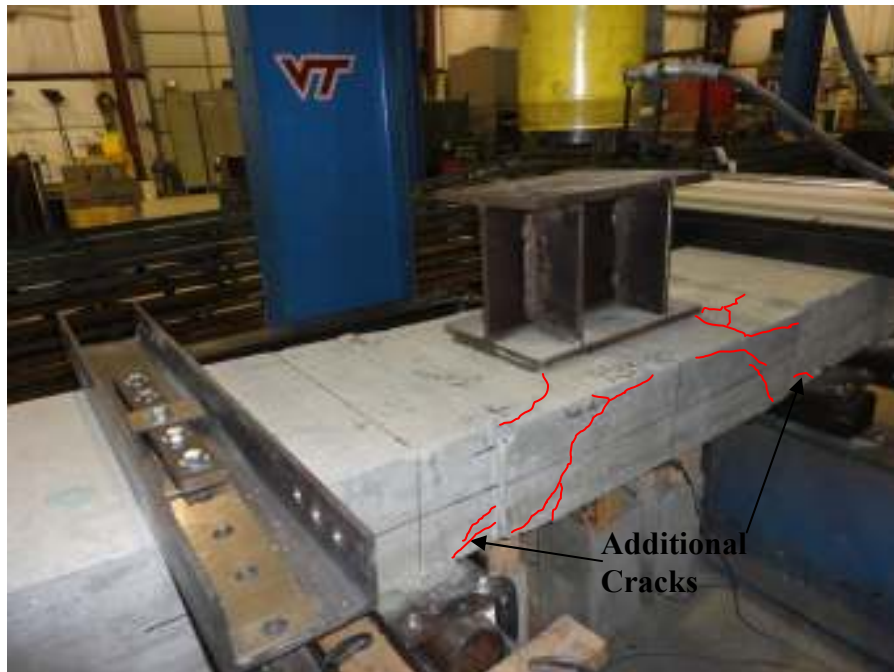
Figure 5-13 is a photograph of the failed Specimen B once the instrumentation and jacks were removed. The test-induced cracks are marked in red. The two main cracks described in the other specimens, also appeared in Specimen B, but there were also additional cracks that formed on the sides of the specimen. These were located between the roller supports and the construction joints and are indicated in the picture. Refer to Appendix D for more photographs of failed Specimen B and the other strength test specimens.

**Figure 5-13. Failed Specimen B with Test-induced Cracks Marked**

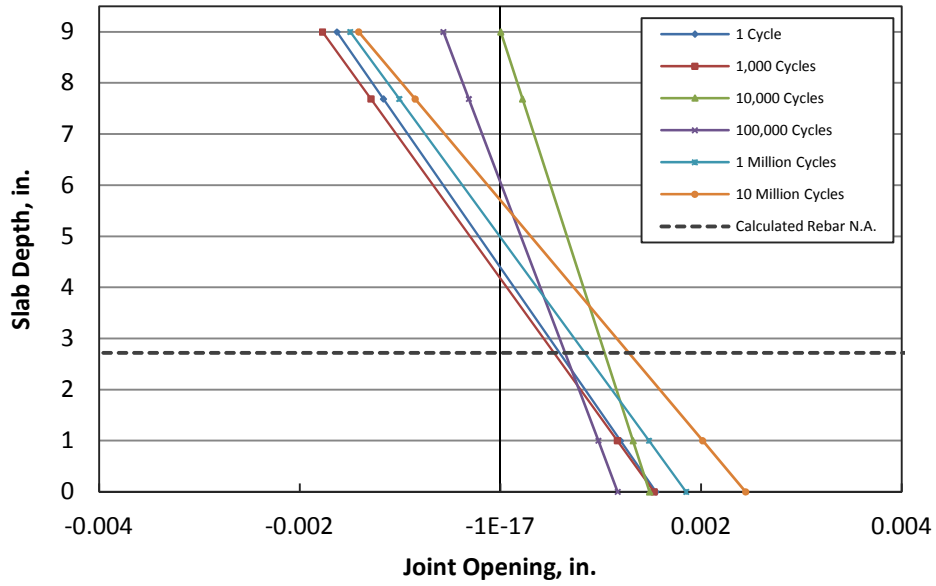
Figure 5-18. Opening of Joint 1 (Specimen 7, Side A)

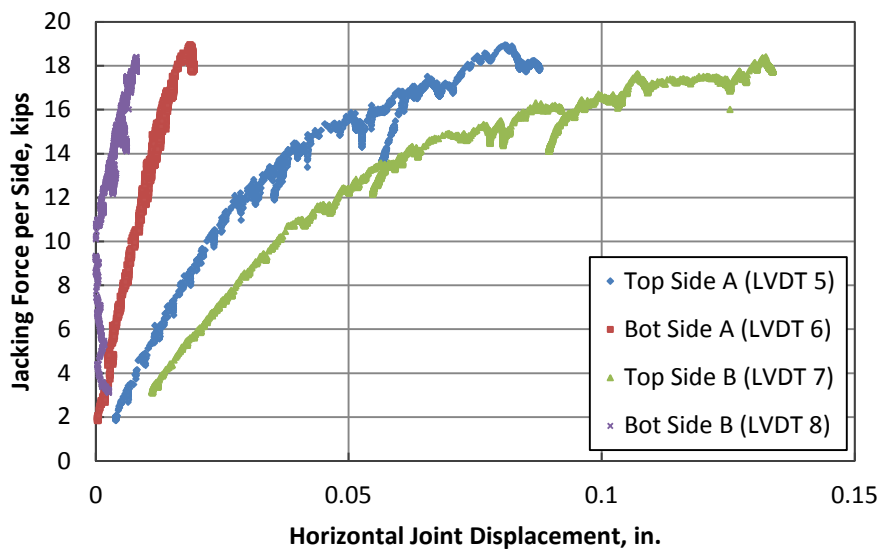
Figure 5-24. Joint Opening LVDT Readings at Joint 1 during Jacking

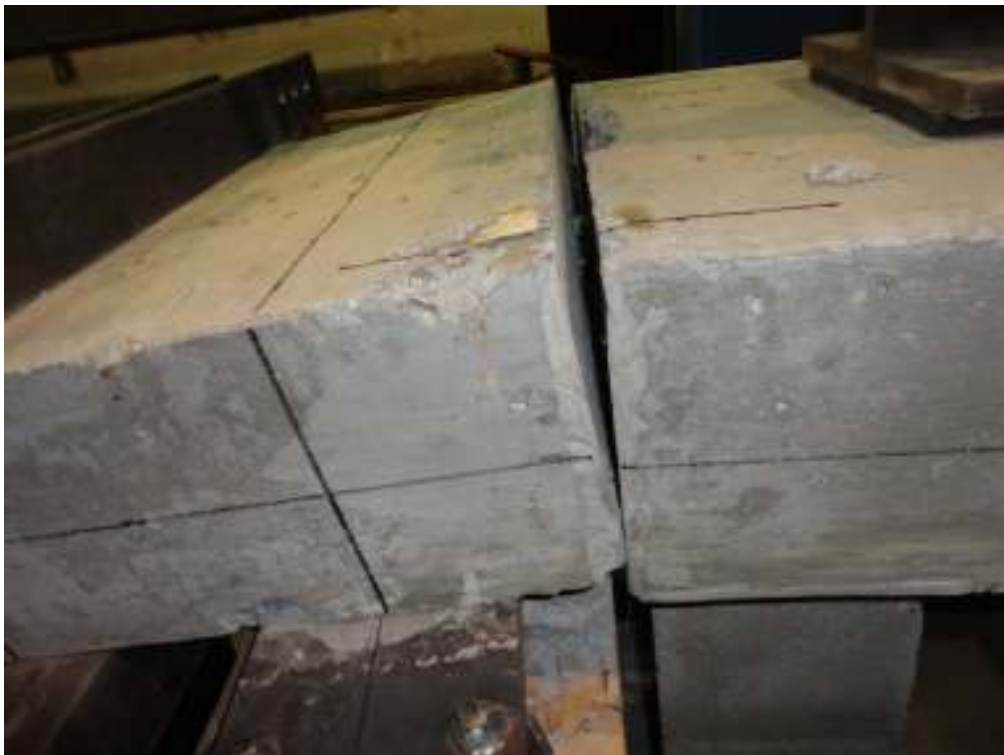
**Figure 5-29. Opened Joint after Fatigue Failure, Closure Pour Section on Right Side**

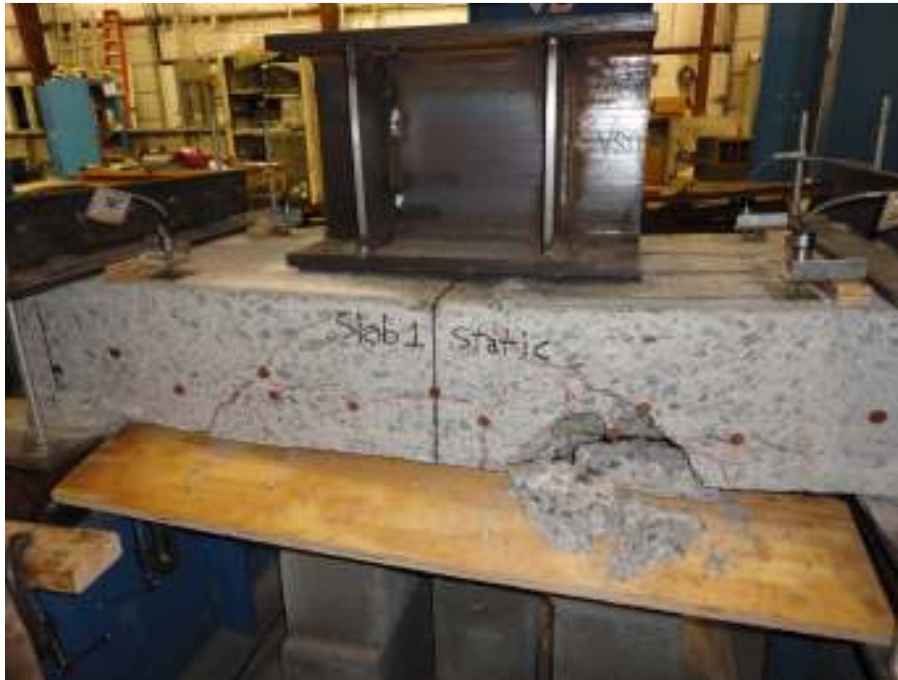
Figure D-1. Side A View of Failed Specimen 1

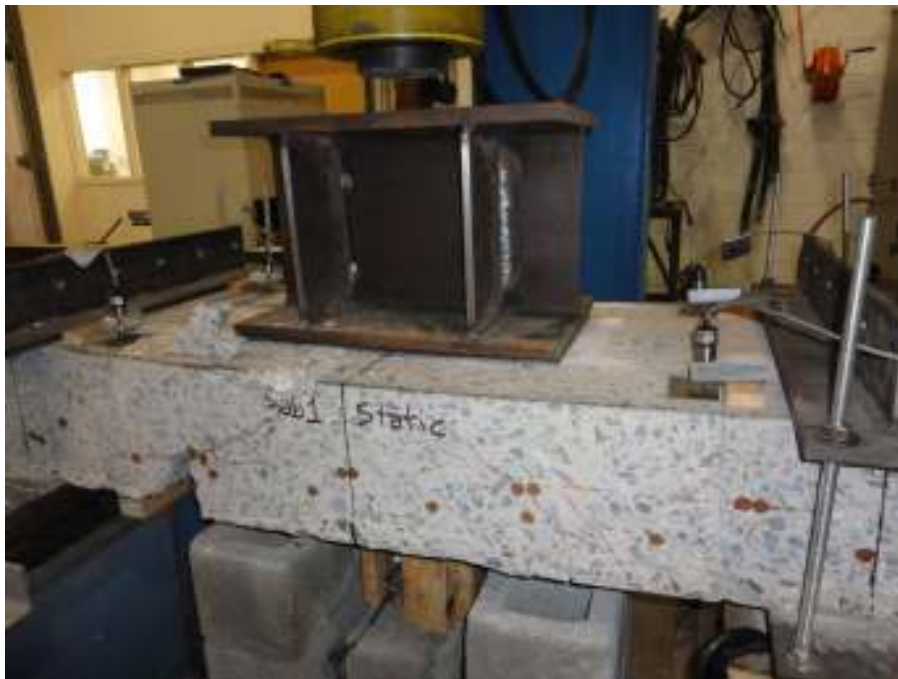
Figure D-2. Side B View of Failed Specimen 1

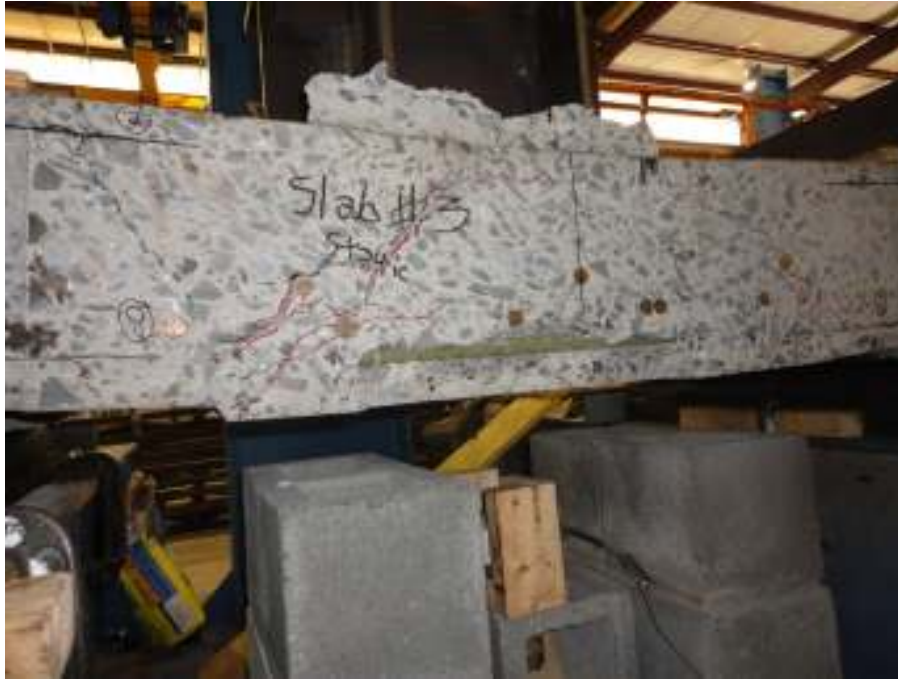
**Figure D-3. Side A View of Failed Specimen 3**

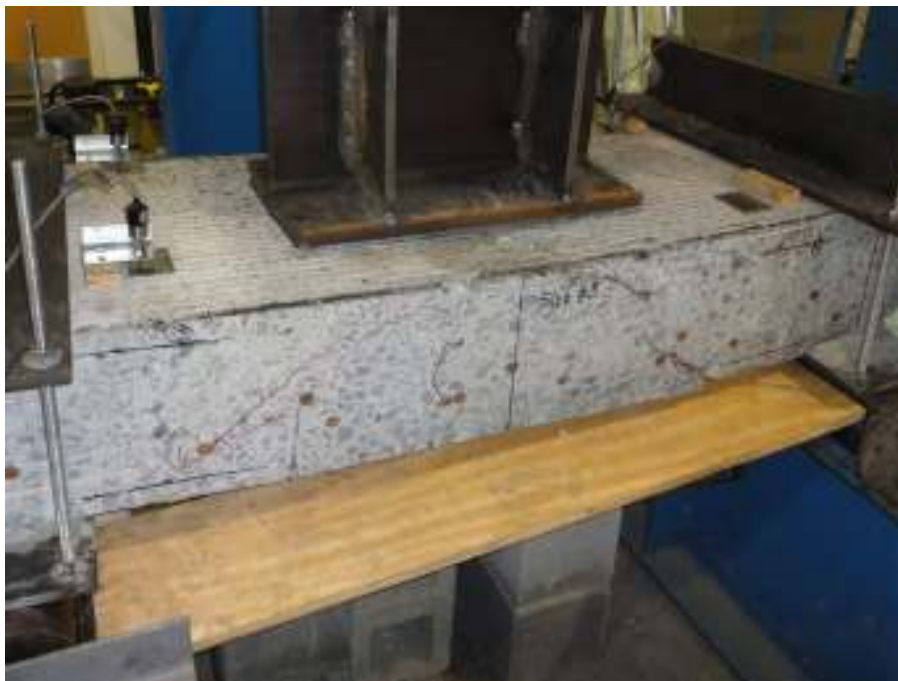
**Figure D-4. Side B View of Failed Specimen 3**

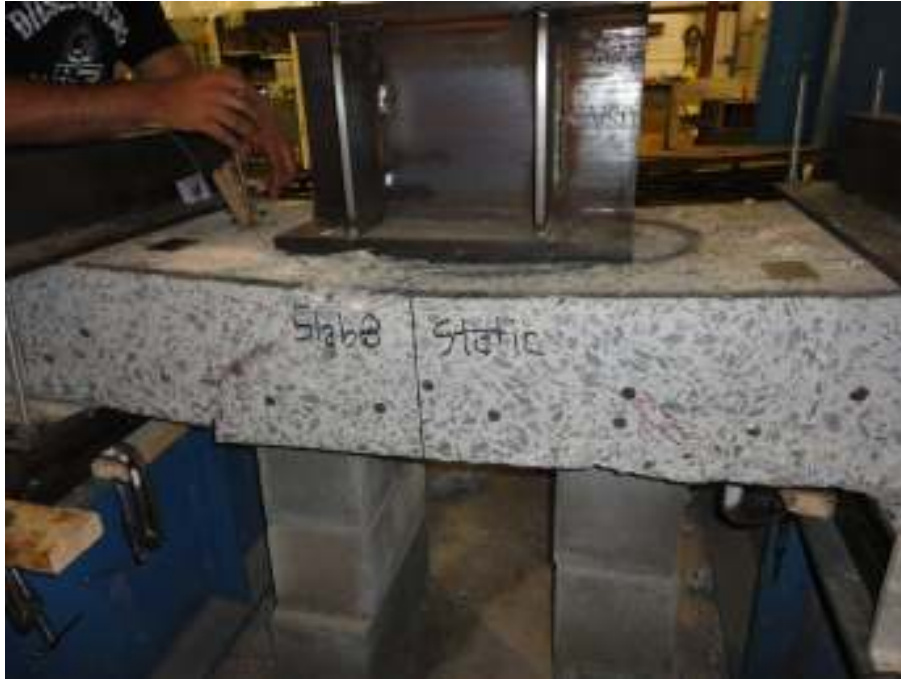
**Figure D-5. Side A View of Failed Specimen 8**

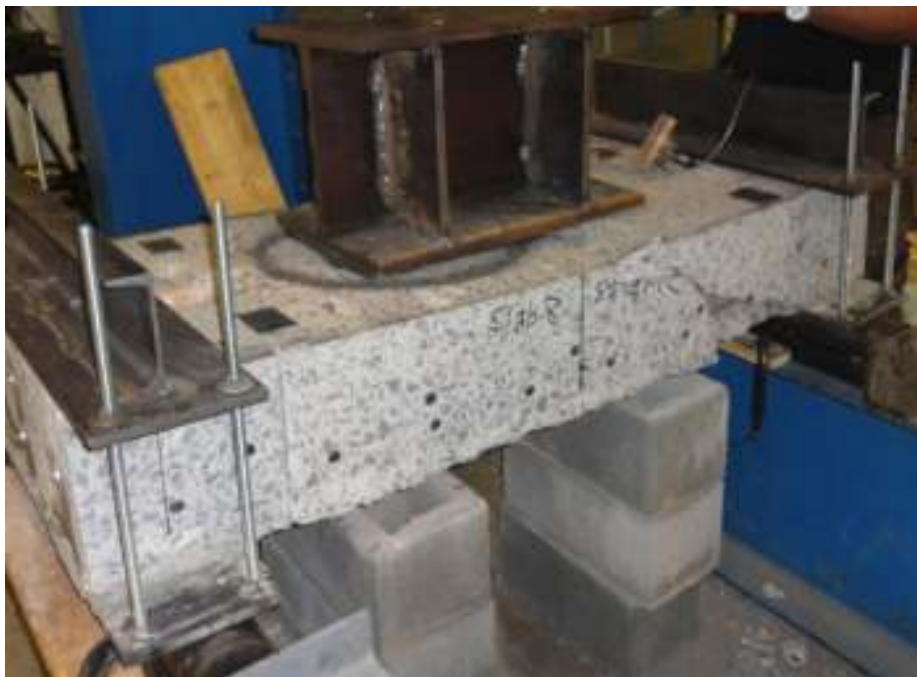
**Figure D-6. Side B View of Failed Specimen 8**

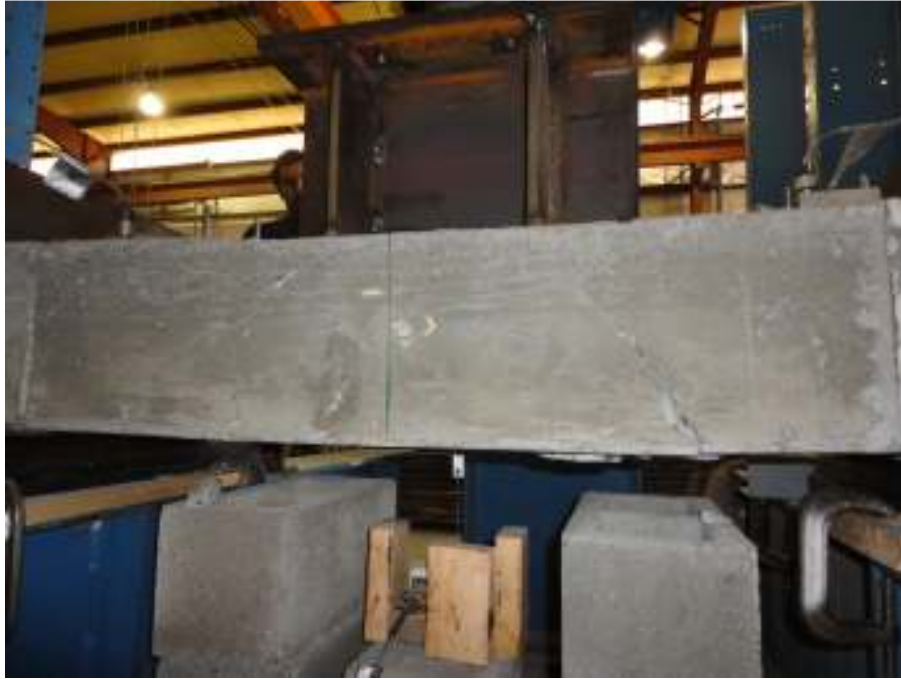
**Figure D-7. Side A View of Failed Specimen C**

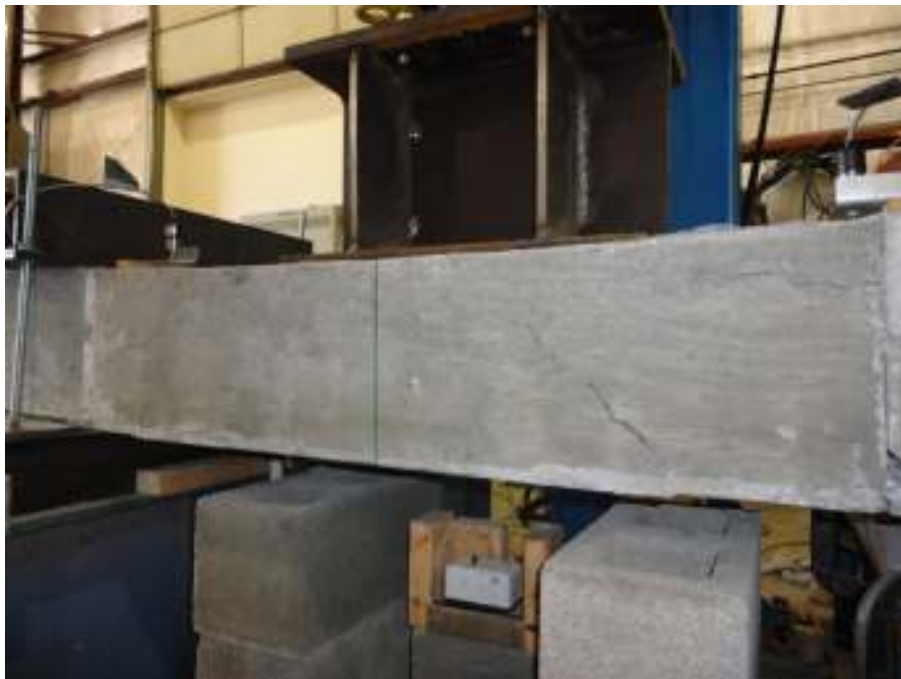
**Figure D-8. Side B View of Failed Specimen C**

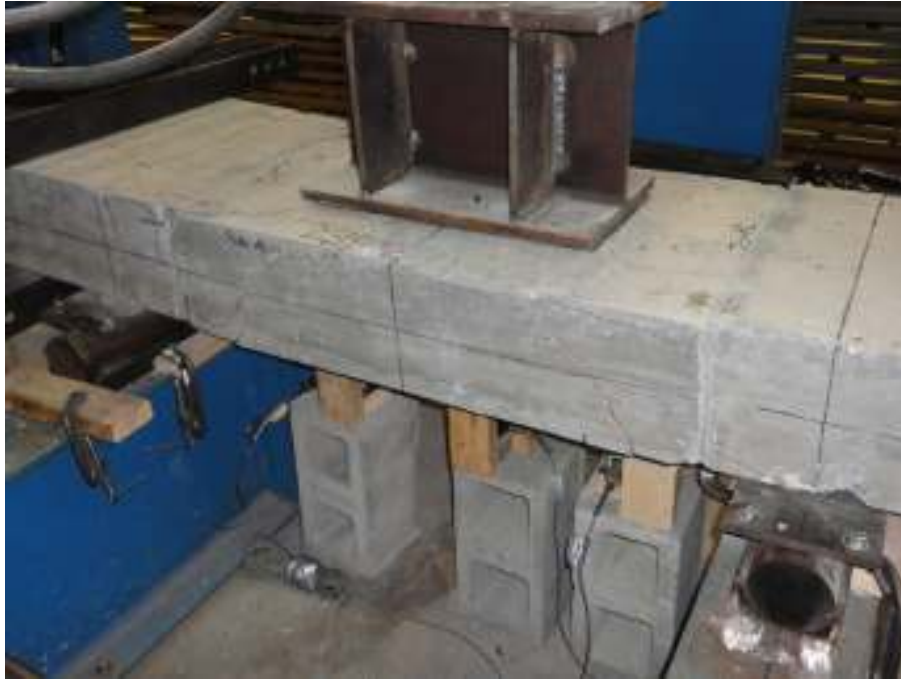
**Figure D-9. Side A View of Failed Specimen B**

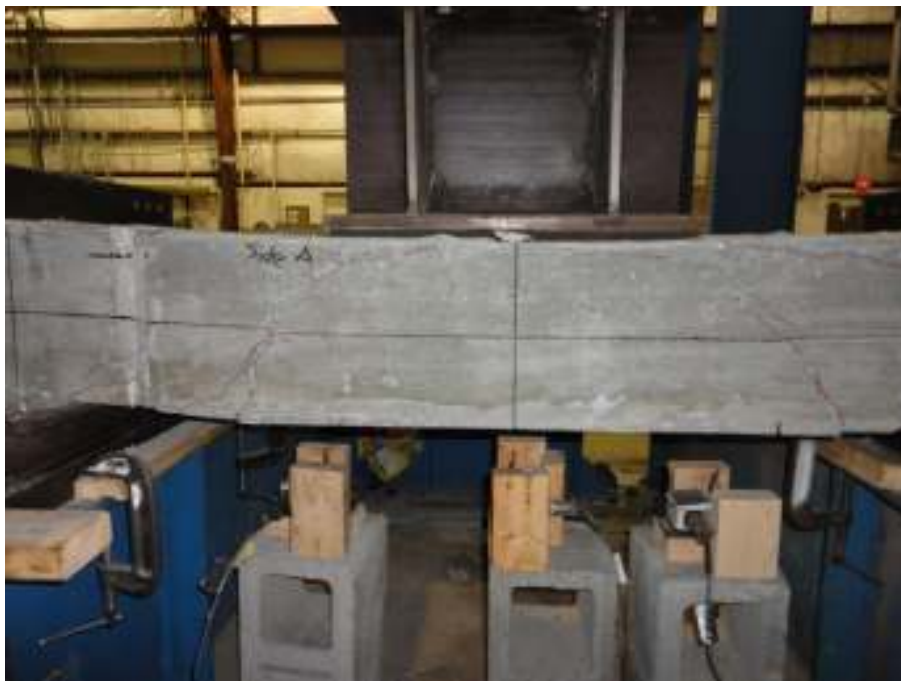
**Figure D-10. Side A View of Failed Specimen B with Focus on Joint 2 and Main Cracks**

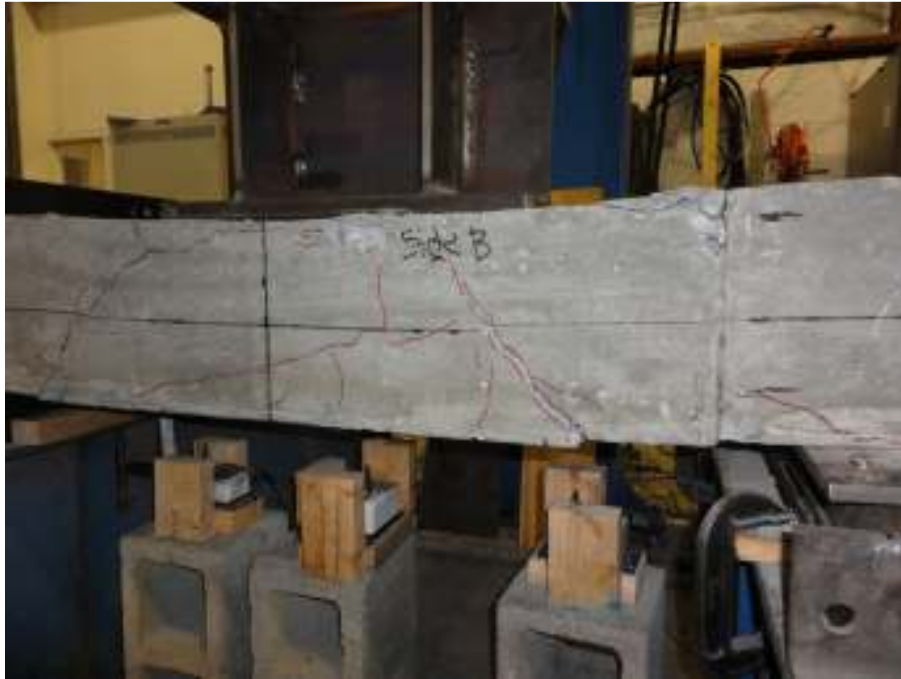
**Figure D-11. Side B View of Failed Specimen B with Focus on Joint 2**

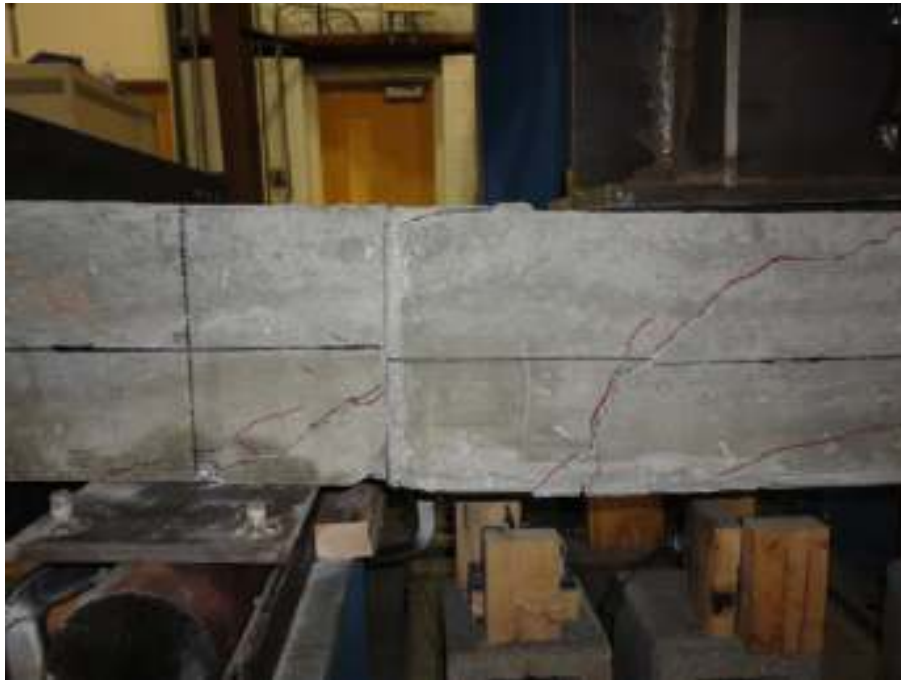
**Figure D-12. Side B View of Failed Specimen B with Focus on Joint 1**
