# **Fatigue Assessment for Failed Bridge Deck Closure Pour**

Thesis submitted to the faculty of the Virginia Polytechnic Institute and State University  
in partial fulfillment of the requirements for the degree of

Keywords: Fatigue, Bridge Deck, Closure Pour, Reinforcing Steel, Construction Joint

After 17 years in service, a 3 ft by 3 ft closure pour section of an Interstate 81 (I-81) bridge deck failed by punching through near Marion, Virginia. Visual inspection noted that there was considerable corrosion on some of the reinforcing bars in the vicinity of the construction joint, while other failure bars had little or no corrosion. Sections of the bridge deck were cut and delivered to Virginia Tech for further investigation.

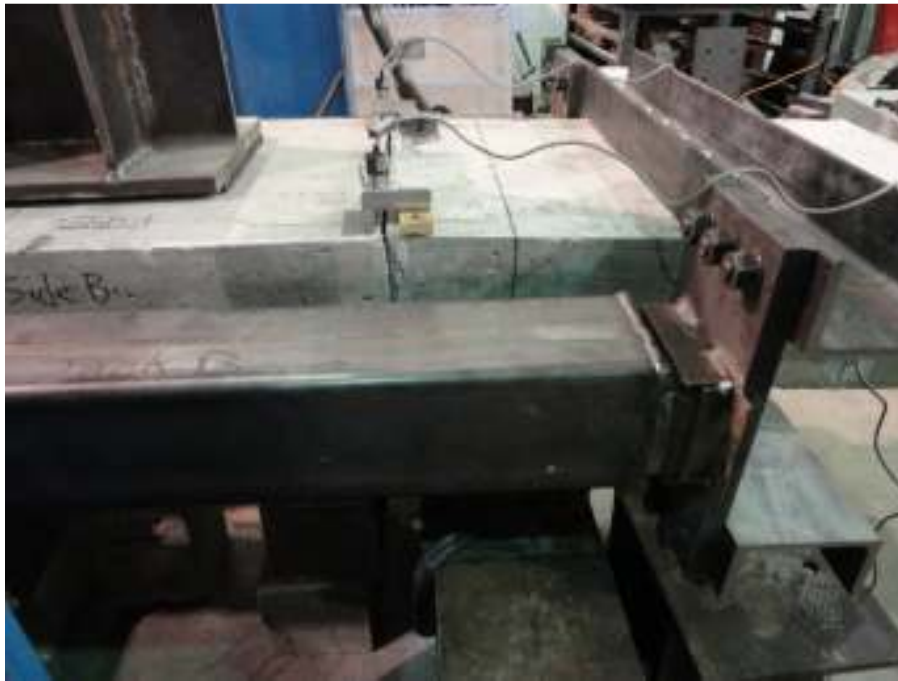
Figure D-13. Joint 2 after Top Rebar Failed in Fatigue (Jacking Setup in Place)

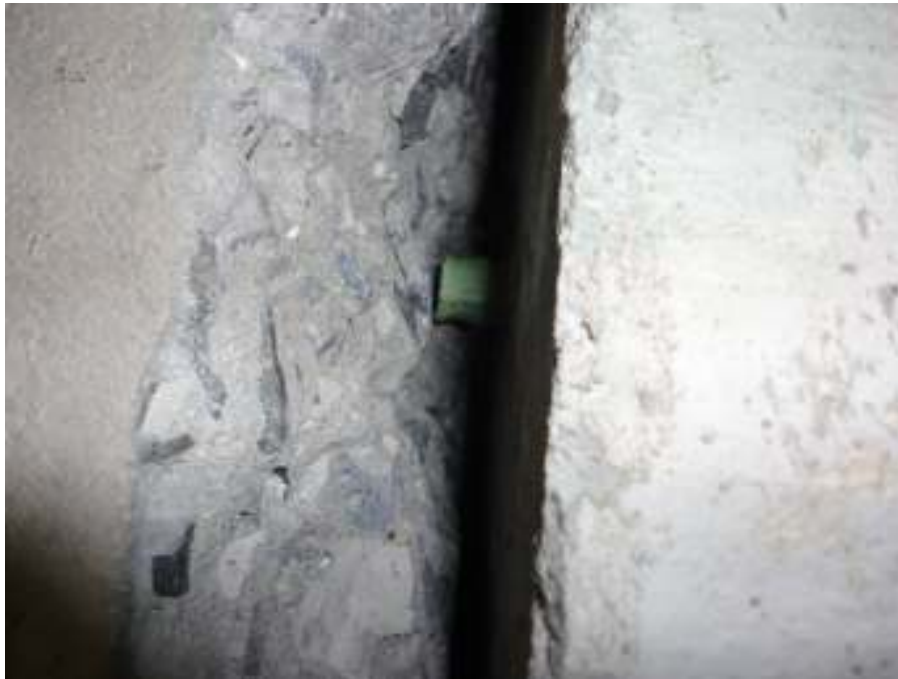
Figure D-14. Top View of Failed Rebar at Joint 2 (Spalled Concrete Removed)

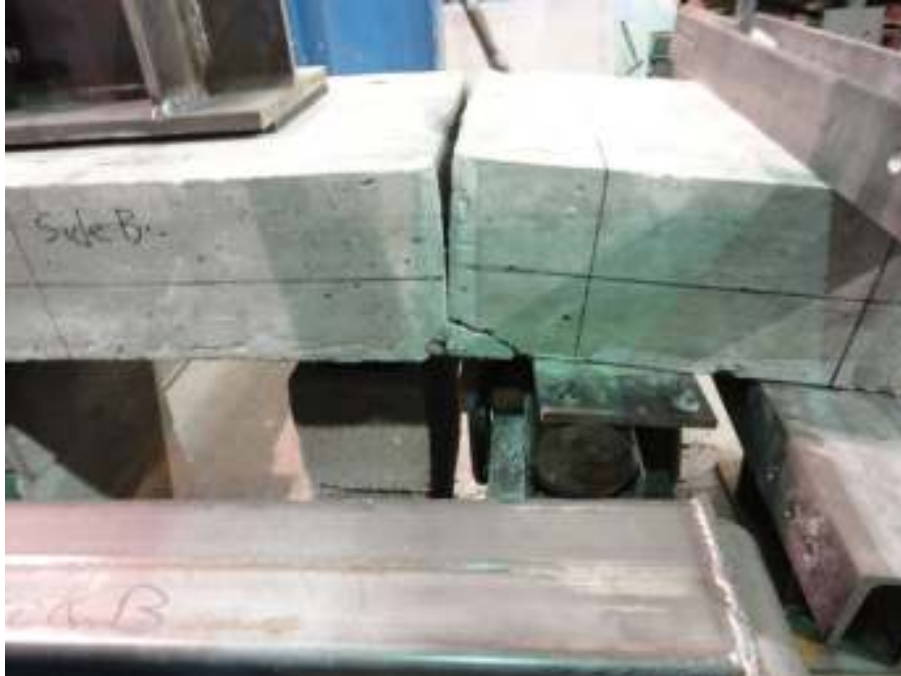
**Figure D-15. Joint 2 with Jacking Struts and Connections Removed**

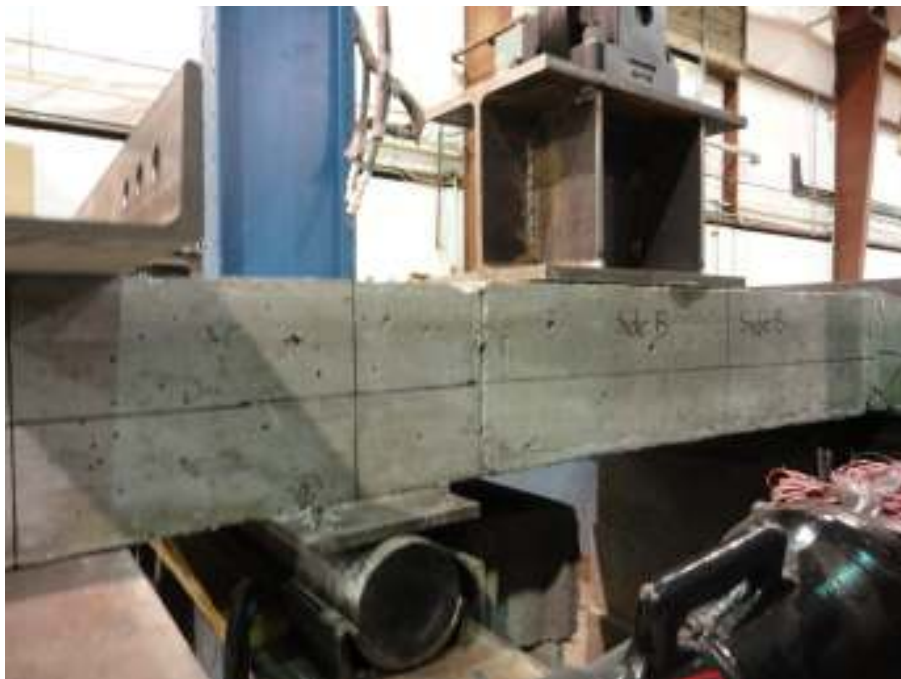
**Figure D-16. Joint 1 with Jacking Struts and Connections Removed (No Failed Fatigue Rebars)**

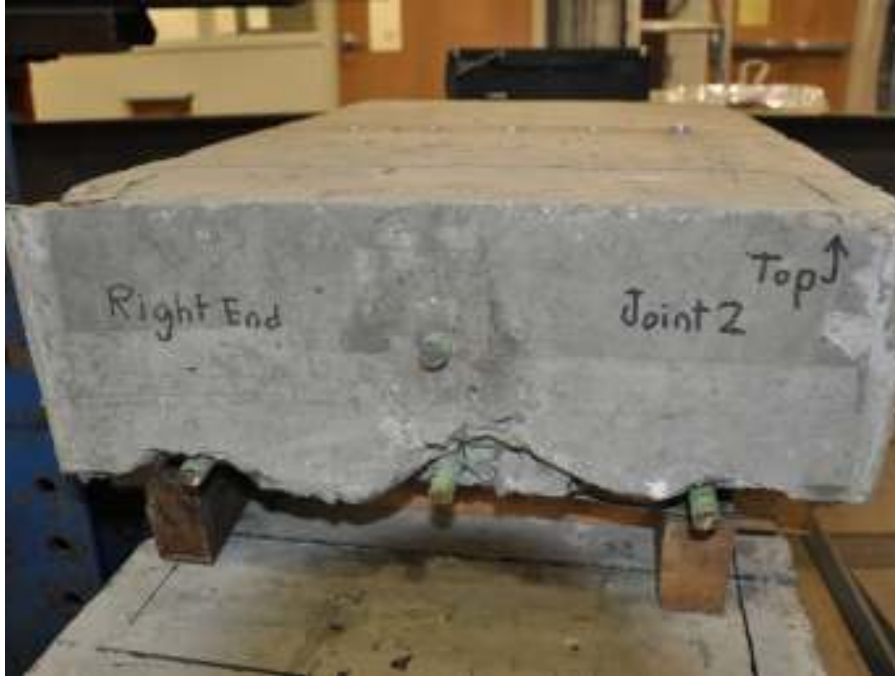
Figure D-17. End Face of Joint 2 with Failed Top Rebar (Bottom Bars Were Cut)

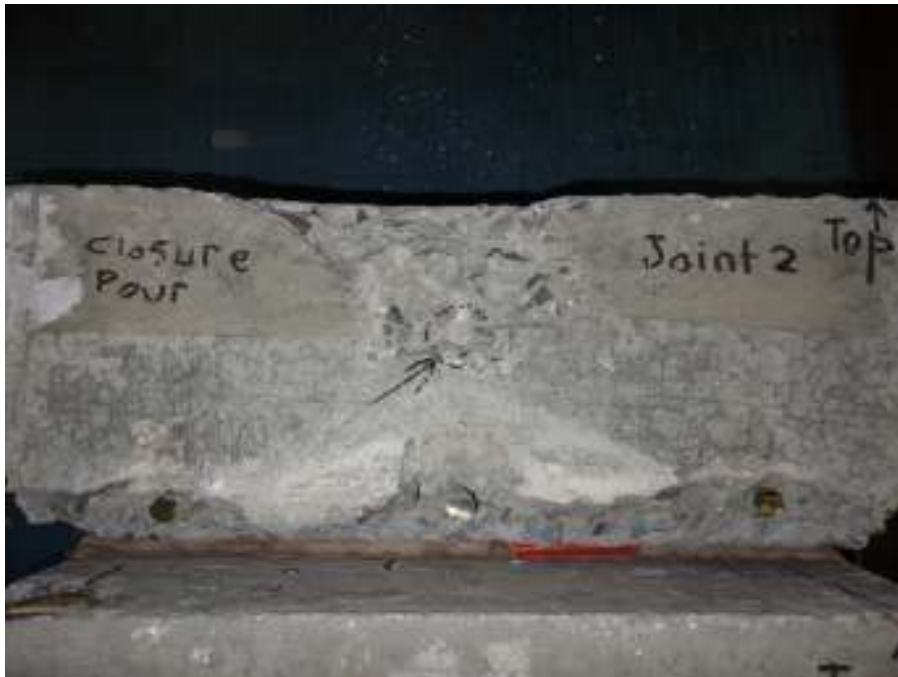
Figure D-18. Closure Pour Face of Joint 2 with Failed Top Rebar
