**The Log Outbuilding at Solitude:
An Architectural and Archaeological Investigation
of Virginia Tech's Second Oldest Building**

Thesis submitted to the Faculty of Virginia Polytechnic Institute and State University

Architecture

**May 1, 2000
Blacksburg, Virginia**

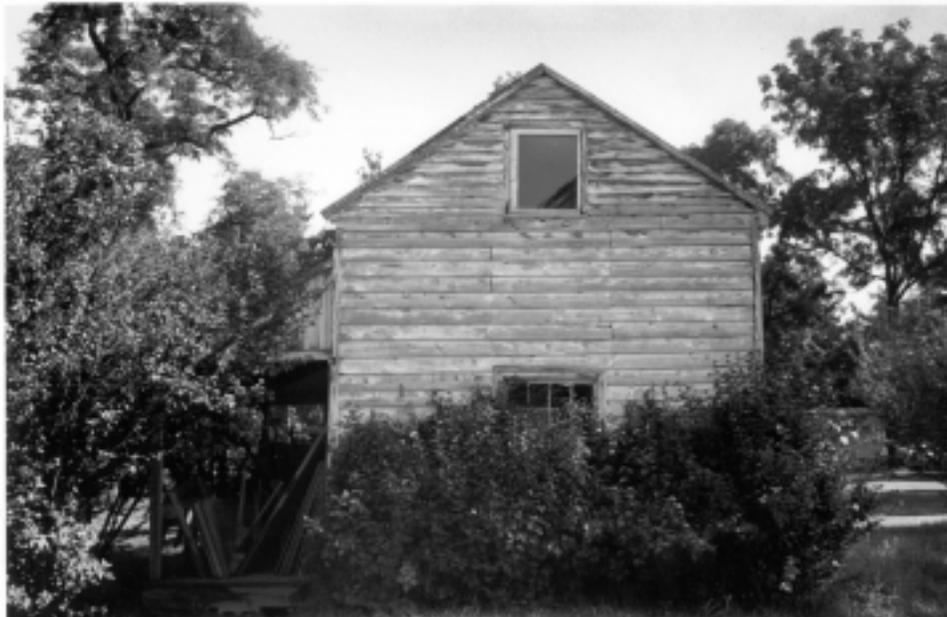
Fig. 1 View of the outbuilding from the south, photo taken in the late 1970s or early 1980s.

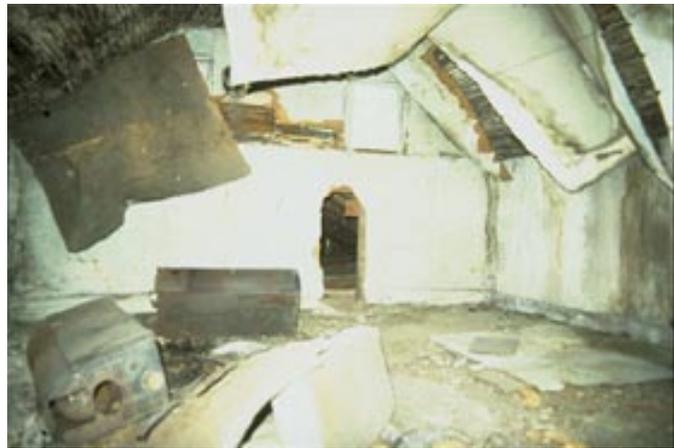
Fig. 2 1989 photograph of loft in the original log section of Solitude outbuilding.

For documentation purposes, the author inspected most of the building's wood during the summer of 1999, in order to provide for a general statement concerning the building's overall condition. In doing so, a moisture meter was employed to find where conditions were conducive to further deterioration. It was found that on a dry summer day moisture readings were still dangerously high, in spite of the extravagant temporary roof that had been assembled over the building a few months earlier. Logs within one foot of the ground surface had a moisture content of eighteen to thirty percent, inviting wood boring insects and decay fungi. The extent of the deterioration caused by these organisms over the last decade was extensive, due to high moisture levels caused principally by poor site drainage and a failed roof, and further exacerbated by deferred maintenance of the building (see figs. 2, 3, 4, 15, 16, 20, 21, 23, 26).

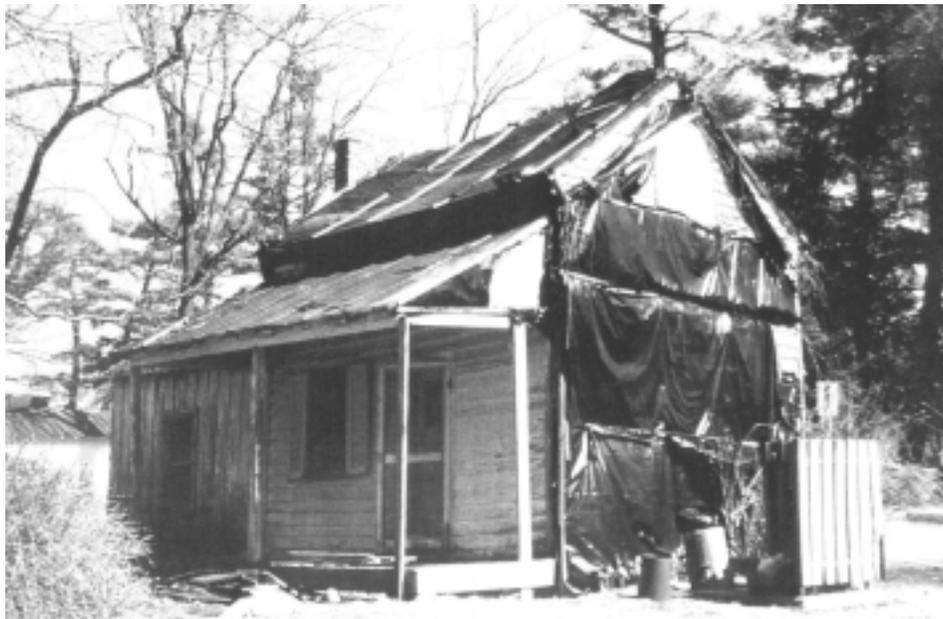
Fig 3 1990 photograph of outbuilding prior to its dismantling in piecemeal fashion.

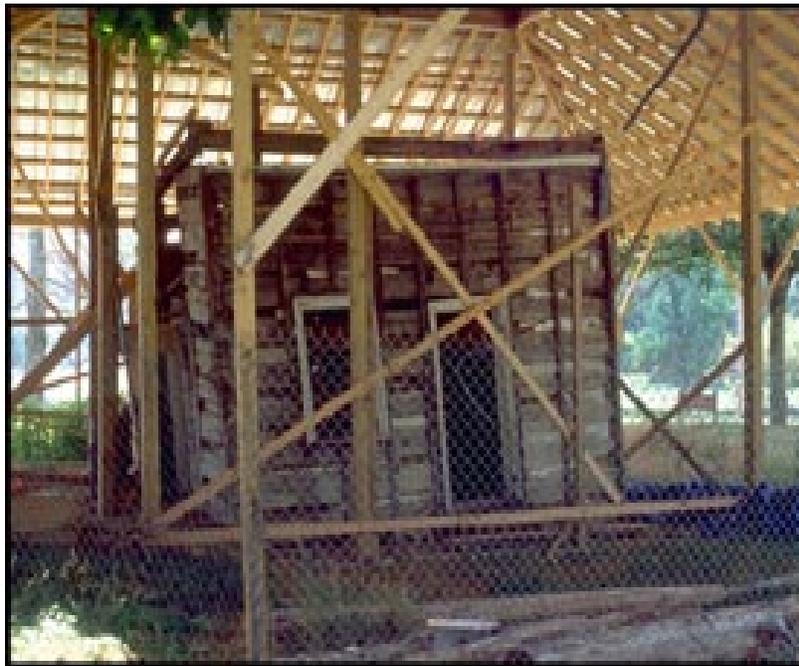
Fig. 4 September 1999 photograph of outbuilding under its extravagant new shelter. Note the substantial bracing (left, background) now required to prevent further slumping.

The unfortunate effects of these moisture related problems have been well documented at Solitude (figs. 23, 26, 29-31). The stately main house has suffered tremendously, while the outbuilding was reduced to ruins in only a few short years. During the ongoing rehabilitation, many of the original oak logs from both buildings have had to be removed and discarded. In some cases, i.e. the outbuilding's lowest course of logs, there was little or nothing left to remove. Furthermore, the attenuated strength of the remaining logs has necessitated substantial additional support in order to stabilize the structure (fig. 4).

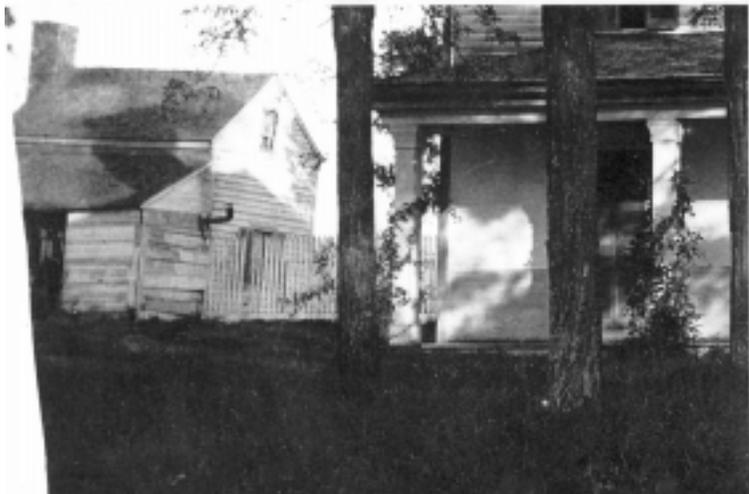
Fig. 10 Close-up of outbuilding that probably served as a servant’s cabin. From a photograph hand-labeled “professor’s house, ‘Solitude’ 189-,” in reference to the main house. Newman Library Special Collections

The roof structure consisted of a rafter and ridgeboard system with cross-ties or *collar beams*, all of which was comprised of hewn oak members. The rafters were nailed to the ridgeboard, but the cross-ties were lapped and pegged into each pair of rafters.⁵² The roof was covered with American chestnut (*Castaneda dentata*) shingles, two of which were recovered during the recent rehabilitation of the building. The shingled roof is visible in an early photograph (fig. 10).

Late nineteenth century maps and photographs suggest that the board-and-batten clad frame addition on the north side of the log pen, removed in the early 1990s, was not constructed until the 1890s (figs. 8, 10). It appears that the original brick chimney was demolished when the addition was built, and replaced with a smaller brick chimney containing a flue for a coal furnace. The addition had a door at the rear and a window centered on the front side (fig. 22).

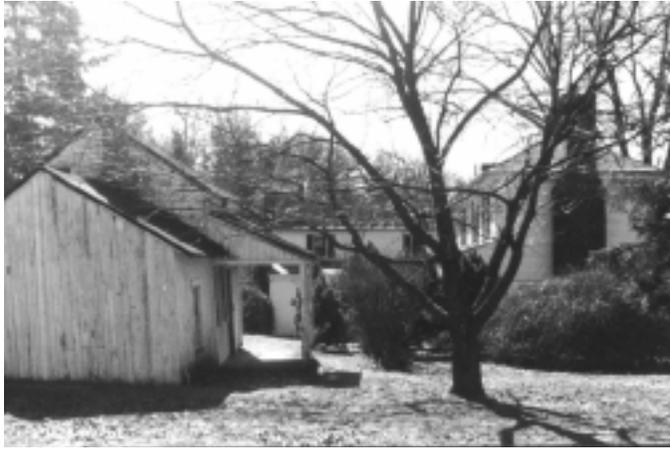
Fig. 11 1989 photo of outbuilding and main house from the north side.

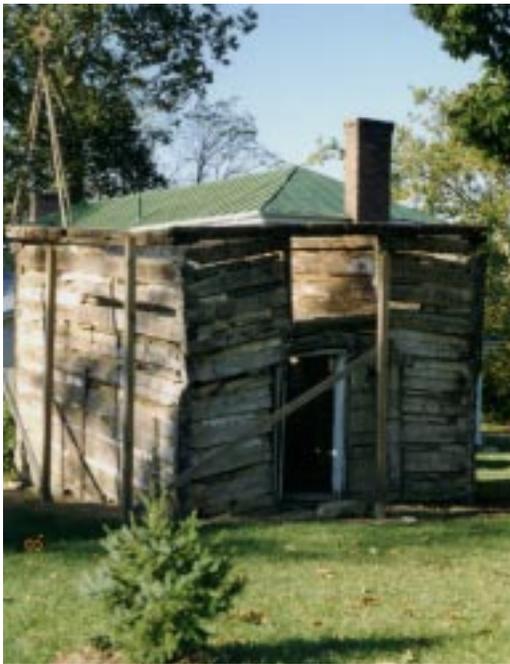
Fig. 13 1998 photograph of slumping outbuilding (servant's cabin) remains.

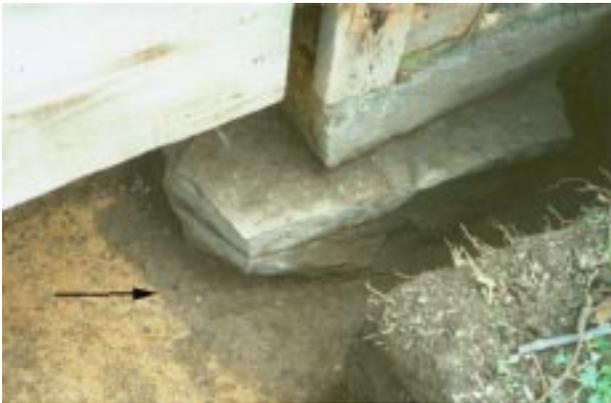
Fig. 17 Edge of hole dug for footer placement is clearly defined by difference in soil color.

The cabin was built with oak logs, set on cut stone piers placed below the corners and door. A hole dug deep into the subsoil was prepared for footers below each pier. Dark soil marking the exact edge of each hole was uncovered during archeological excavations (fig.17). The stones do not appear to have subsided. Instead, the ground surface around the building has gradually built up. However, it is doubtful that the first course of logs were ever more than one foot above the ground surface. Had the piers been built to two feet above the ground surface, the lower logs and floor joists would have stayed drier, and thus would have suffered far less deterioration.

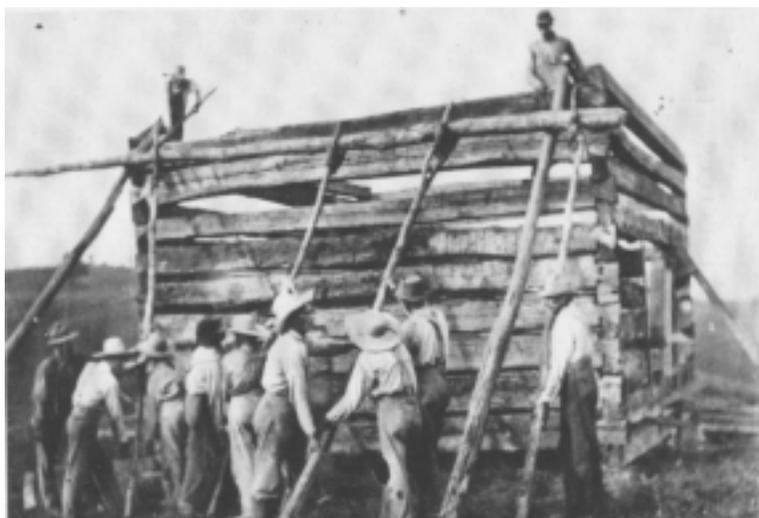
Fig. 18 Late 19th century photograph showing how log pens similar to the one at Solitude were typically constructed. Each log was pushed up on skids, using long poles. Notice that a window has already been cut so the builders could enter the pen's interior. Notice also the large gaps caused by bowed logs. Hutslar, Donald A. *Log Construction in the Ohio Country, 1750-1850*. (Athens: University of Ohio Press, 1992), frontispiece.

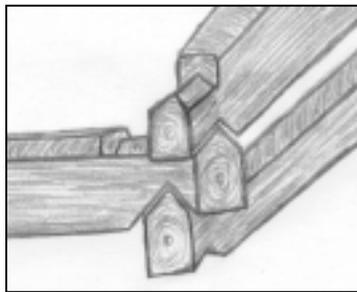
Fig. 19a Indented V-notch

Tool marks reveal how the logs were worked and which tools were employed. Many of the logs, especially the smaller ones, appear to have been worked with only a felling axe and a hatchet. The felling axe was suitable for hewing the smaller logs because only a small amount of stock had to be removed to reach the desired thickness, with straight sides. The hatchet was used mainly for cutting and retouching the corner notches for a secure fit. The larger logs required more work. Because all the logs were hewn to about the same thickness, (5½ -7 inches), a considerable amount of stock had to be removed. In this case, the builders used a felling axe to cut deep notches perpendicular to the grain, at 1-2 foot intervals. Indistinct markings indicate they may have used a broadaxe to cleanly and easily remove the bulk of the stock between notches.⁴⁷ The log surfaces were smoothed with a foot adz. Adz marks, although quite subtle, can clearly be seen on many of the logs. Again it is mainly the larger logs that bear the adz marks; because they had been reduced more, they needed additional work for smooth, flat surfaces. It was important that the logs were square and flush when it came to applying the weatherboards on the exterior and lath on the interior. The well-hewn logs and tightly fitted notches are evidence that the builders were indeed skilled in log construction.

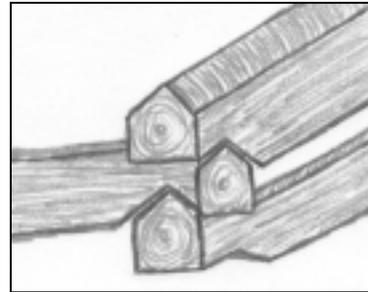
Fig. 19b Regular V-notch

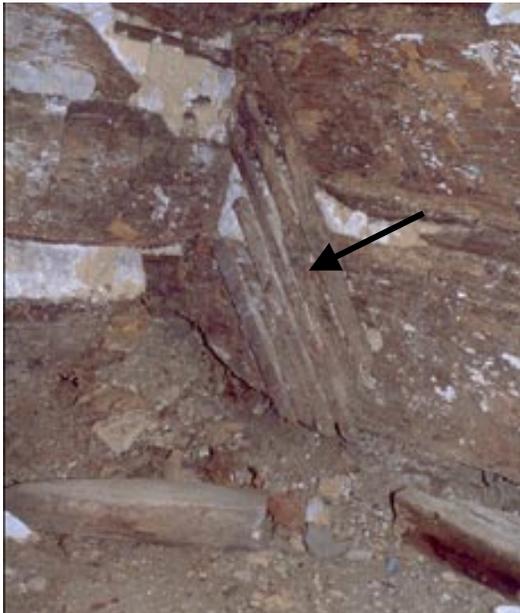
Fig. 20 1999 photograph showing some of the surviving original lath, nailed directly into the wall logs (NE corner of log pen). Some whitewash can be seen on the logs also.

All that remained of the interior treatment at the time of this study was some lath and small areas of intact plaster. The lath was split or *riven* with a fro and then shaved with a drawknife into markedly uniform pieces. Each piece was nailed with tiny, specialized, machine-cut lath nails, directly into the logs without the use of vertical nailers (fig. 20).⁵³ The fact that this method left little space for adequate *keying* behind the lath may have contributed to the plaster's lack of adhesion, hence the dramatic loss of plaster as the building aged (fig. 21).⁵⁴ The plaster was applied in three coats with varying proportions of ingredients.⁵⁵ The base coat or scratch coat, varying between 1/4" and 3/8", formed a mechanical bond with the lath as it was pushed through the gaps between pieces of lath, forming curls or *keys* that held the plaster to the lath.

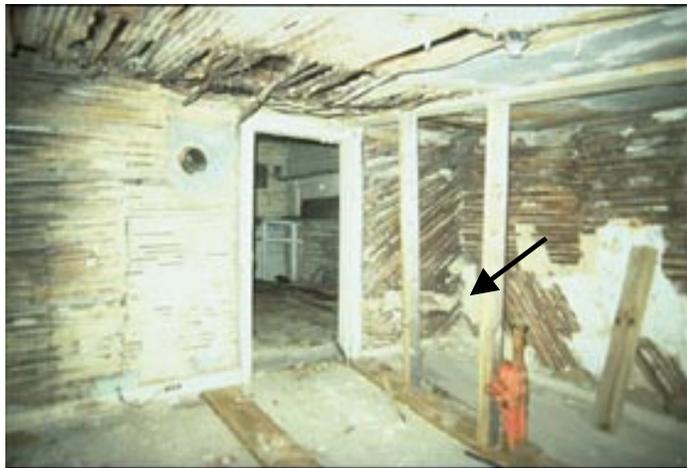
Fig. 21 1989 photo of lower floor of original log section, looking into the frame addition through the doorway. Note the severe loss of plaster. Arrow points to the same corner as the arrow in Figure 20.

⁵⁴ Settling of the building and moisture infiltration certainly expedited the plaster loss. Shrinking and swelling of wooden lath due to excessive changes in moisture are a common factor in the loss of plaster in historic buildings.

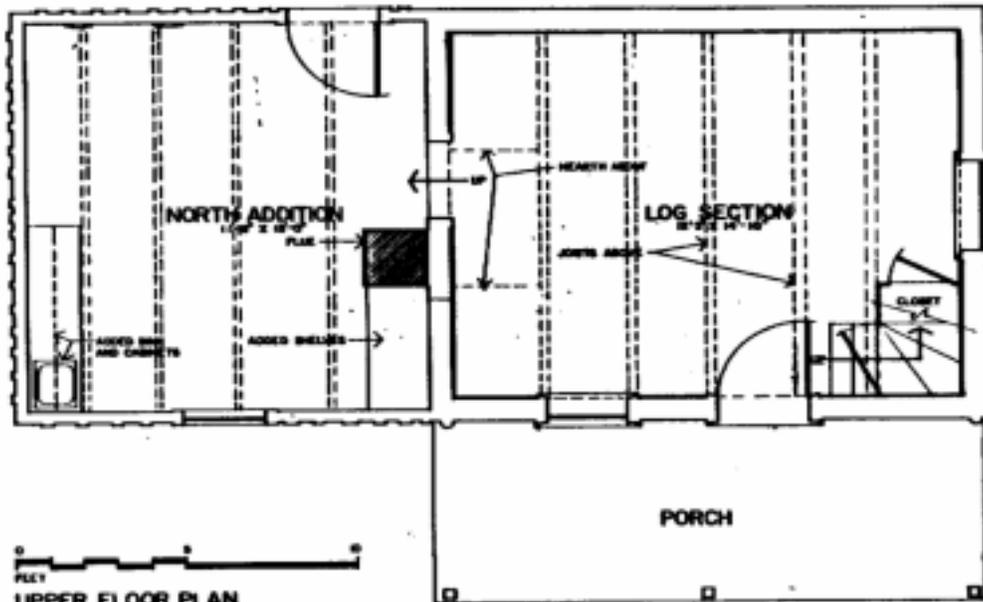
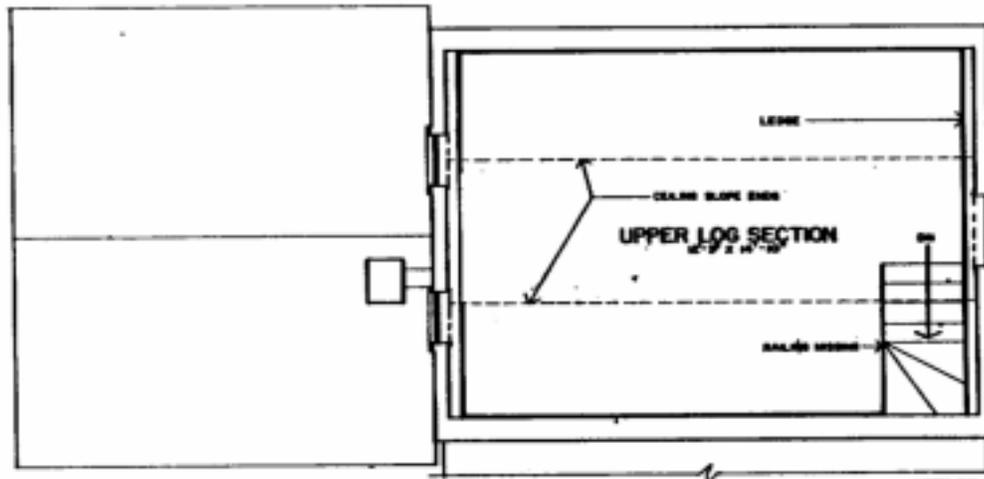
FIRST FLOOR PLAN

Fig. 22 Plans of Solitude outbuilding by Gibson Worsham, from *Historic Structure Report*, 1989.

A boxed-in stairway in the southwest corner led to the loft (fig. 22). The small space below the stairs was used for storage, and was equipped with a door. The lack of whitewash on the logs in the space under the stairs indicates that the stairs were installed immediately after the log pen was constructed. The loft had pine tongue-and-groove flooring supported by joists that were

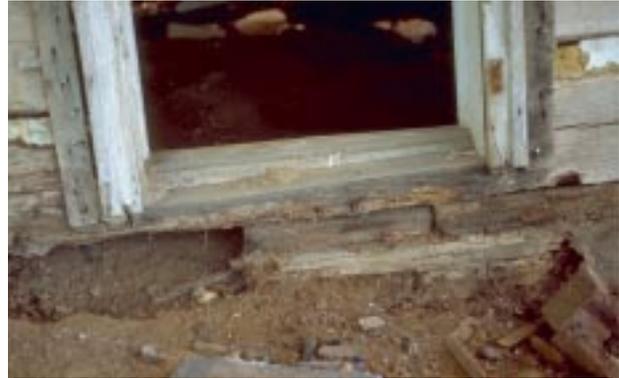
Fig. 23 Remains of log below door

Logs within one foot of the ground surface had a moisture content of eighteen to thirty percent, inviting wood boring insects and decay fungi. The extent of the deterioration caused by these organisms over the last decade was extensive, due to high moisture levels caused principally by poor site drainage and a failed roof, and further exacerbated by deferred maintenance of the building (see figs. 2, 3, 4, 15, 16, 20, 21, 23, 26).

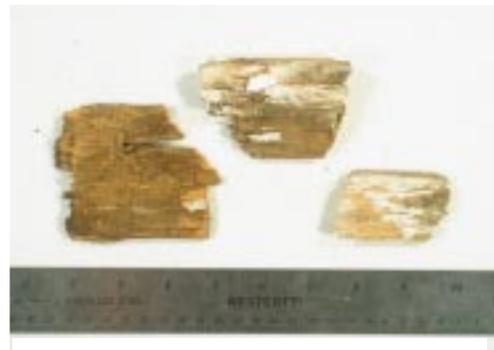
Fig. 25 Sample no. 4 Oak chinking chips

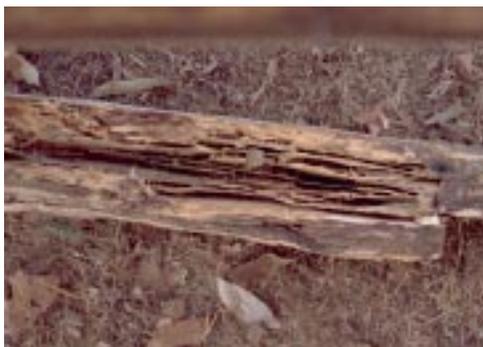
Fig. 26 Termite damaged log floor joist

Investigations have shown the eastern subterranean termite (*Reticulitermes flavipes*) and powder post beetles (*Lyctur brunneus*) to have been the most active insects (Fig. 24). Of the two, the termites were by far the most destructive, in some cases almost completely devouring the log. Decay fungi have also been found throughout the building, with brown rot fungi overwhelmingly the most prevalent, and thus causing the most damage. White rot fungi were also notably present however. The extent of fungal growth suggests that in the recent past, the moisture content of the wood elements exceeded the fiber

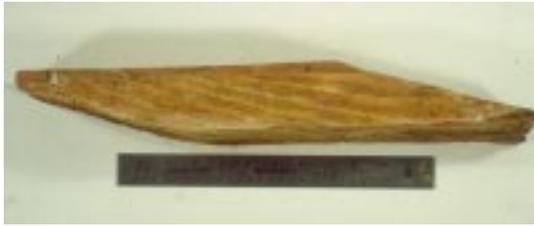
Fig.28 Sample no. 3 Large chestnut chinker

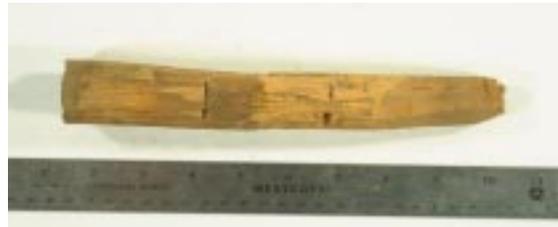
Fig. 27 Sample no. 8 Oak treenail

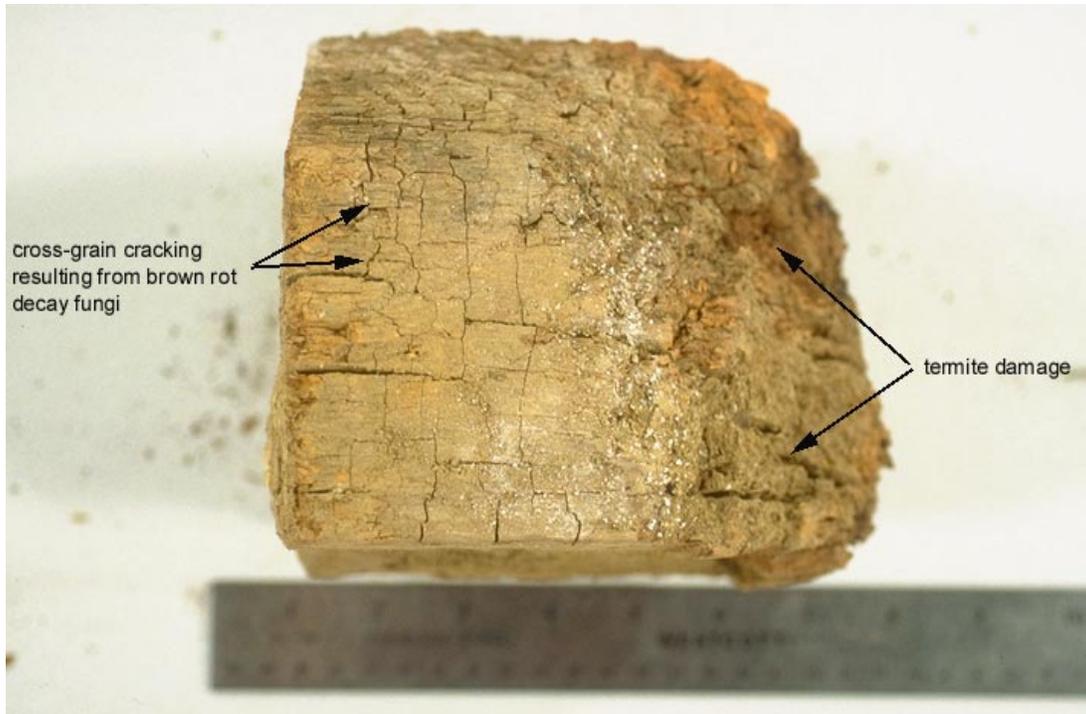
Fig. 29 Severely deteriorated lower floor joist. Listed as Sample 11 in Table 1.

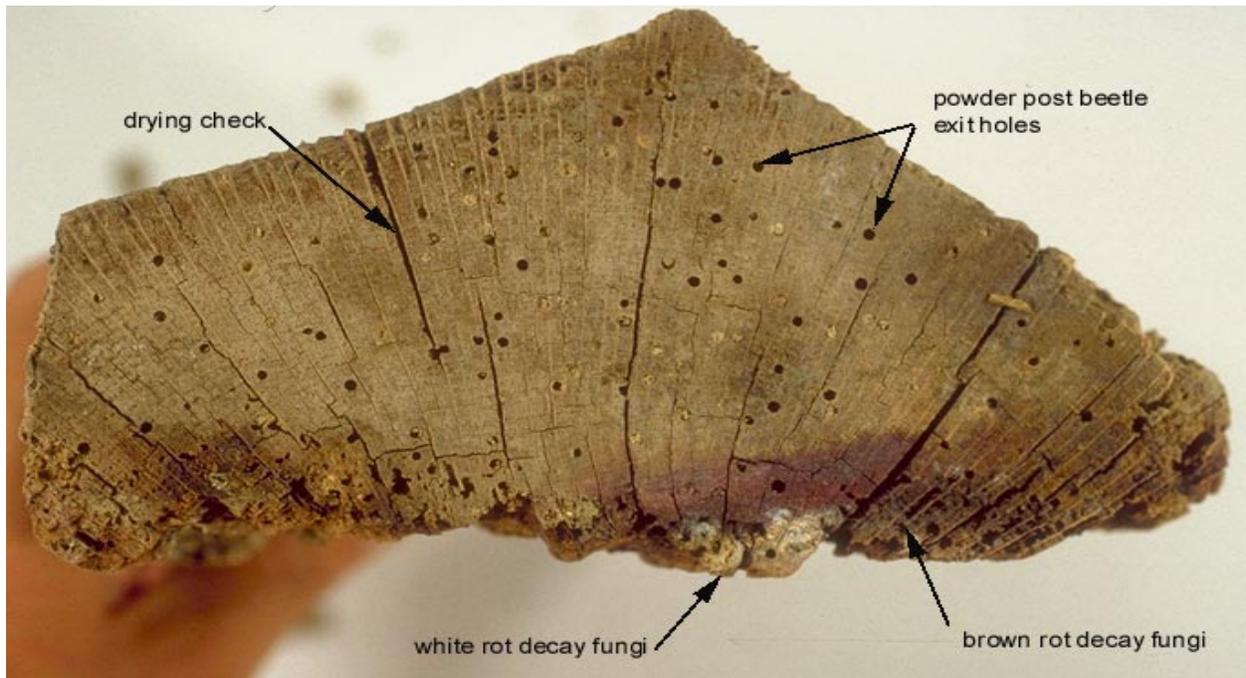
Fig. 30 Severely decayed lower course wall log. Listed as Sample 10 in Table 1.

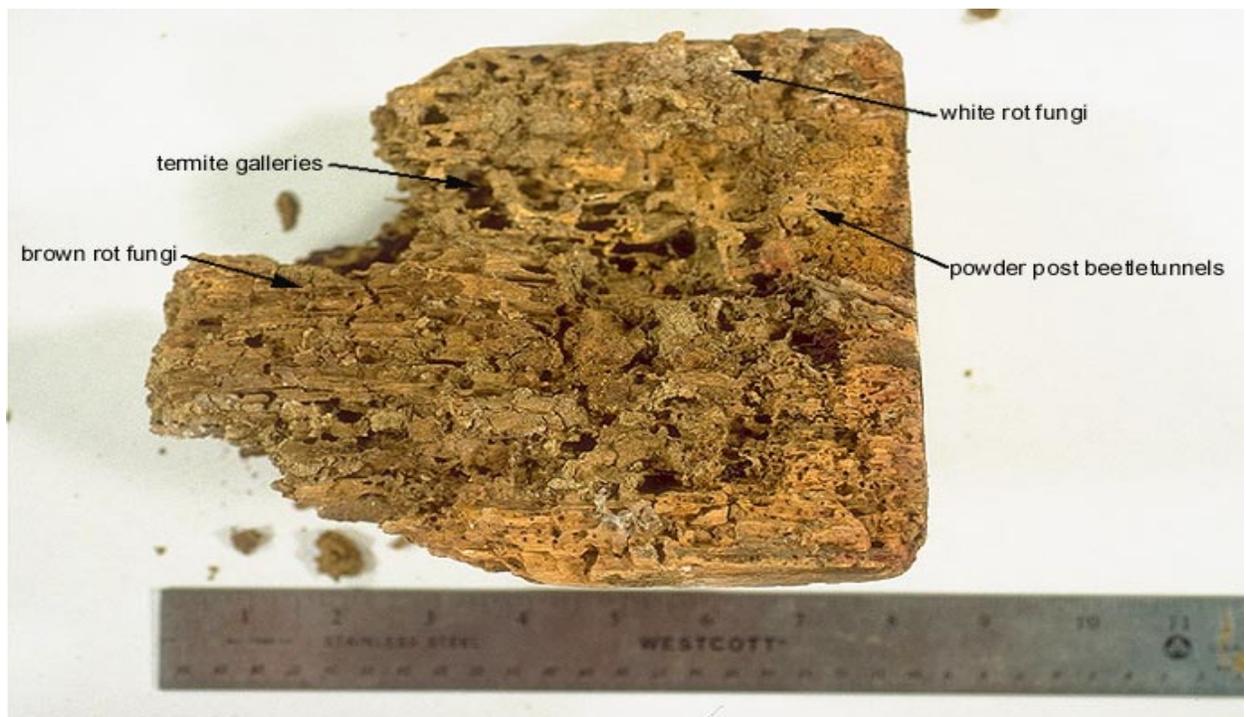
Fig. 31 Severely deteriorated lower course wall log (not included in Table 1).

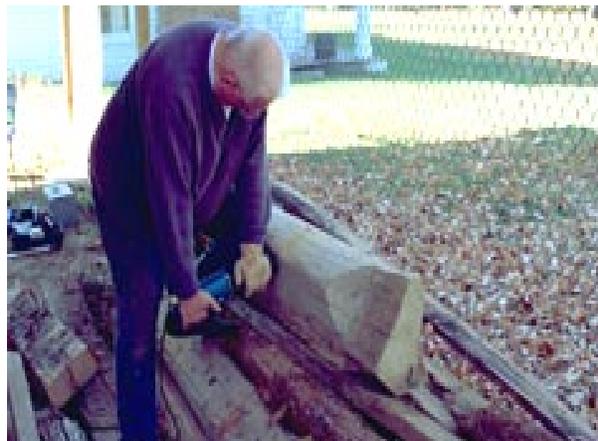
Fig. 32 Dr. Heikkenen saws a sample from log sill. The sill had already been replaced due to its badly deteriorated condition.

The method employed in the study involves the precise measuring of the intervals between growth rings, visible in the cross section of a log, and comparing the intervals with those from other logs for which a felling date has been established. The *key-year* alignment technique is Heikkenen's patented dendrochronological method for studying annual growing seasons according to tree species over a lengthy time period. This method works particularly well for accurately determining the year of construction of historic buildings or the authenticity of logs within buildings.⁶³

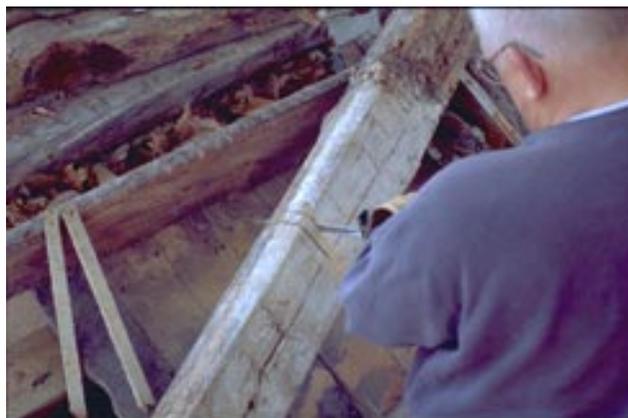
Fig. 33 Photograph showing thickness of sample taken from a floor joist.

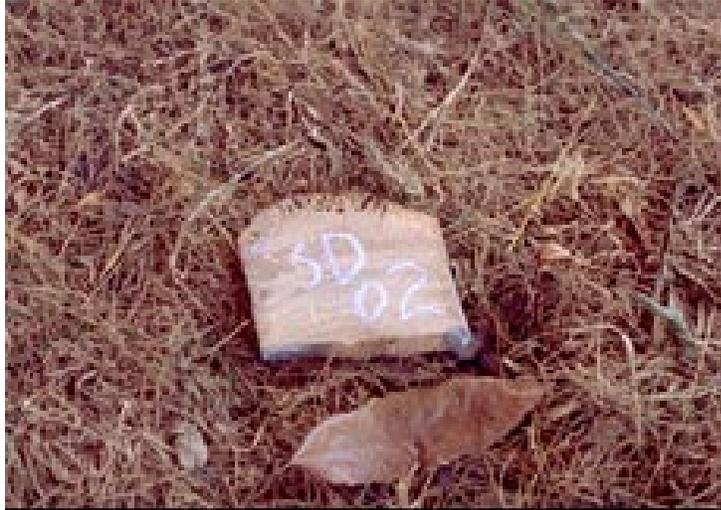
Fig. 34 Photograph showing dendrochronology sample taken from a discarded wall log.

trees were felled. He found that the year of best fit was 1843, having highly significant statistical values.⁶⁴

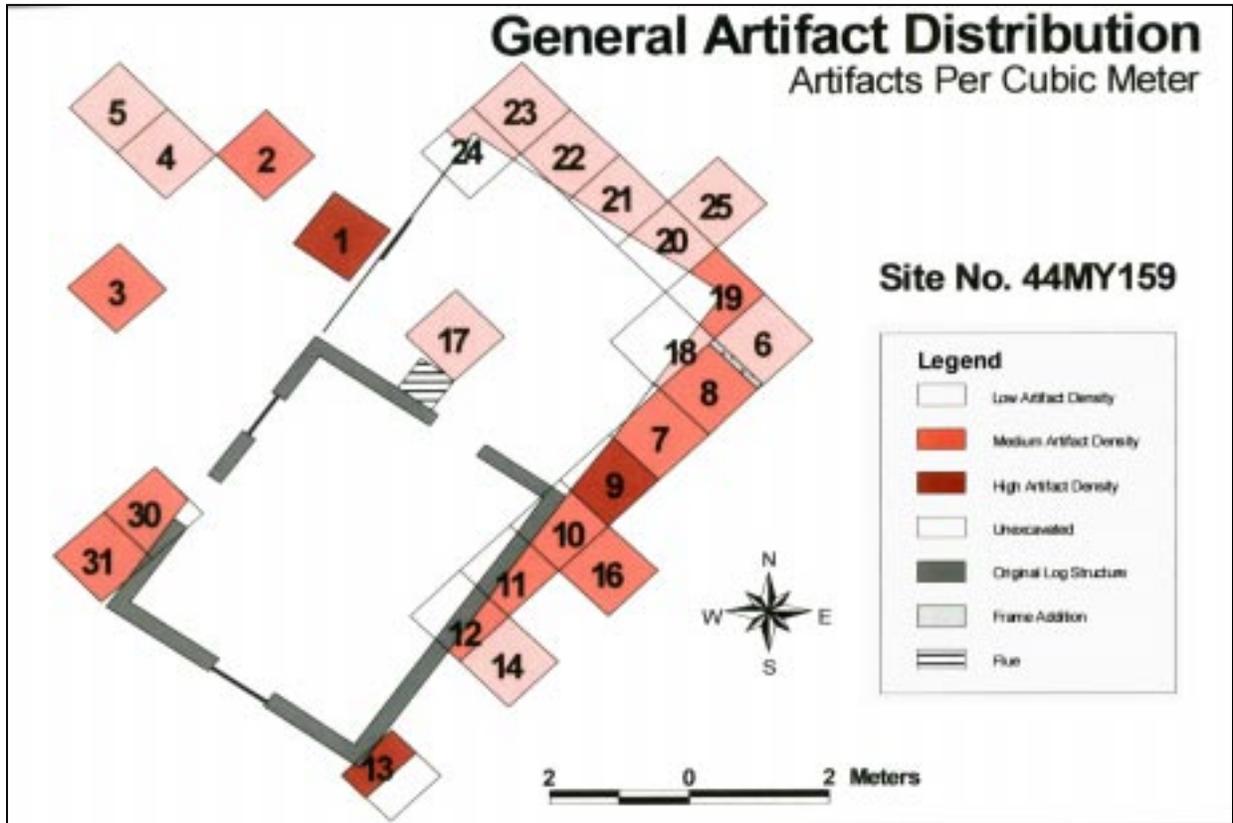
Fig. 36 Shows general artifact density by unit. Densities have been adjusted for variations in the volume of earth removed from each unit.

Based on a grid system, thirty-one 1-meter square excavation units were laid in strategically around the outbuilding (figs. 36, 37), working under the assumption that artifacts associated with the outbuilding should be found in close proximity to it, and that the probability of contamination with artifacts associated with other nearby buildings or yard activities increases with distance from the building. In addition, trenches, or in this case holes dug to accommodate footers supporting the building, are often found to have been receptacles of debris associated with building construction. Unit coordinates were shot in with a transit, and tied in with an established Virginia Tech benchmark.

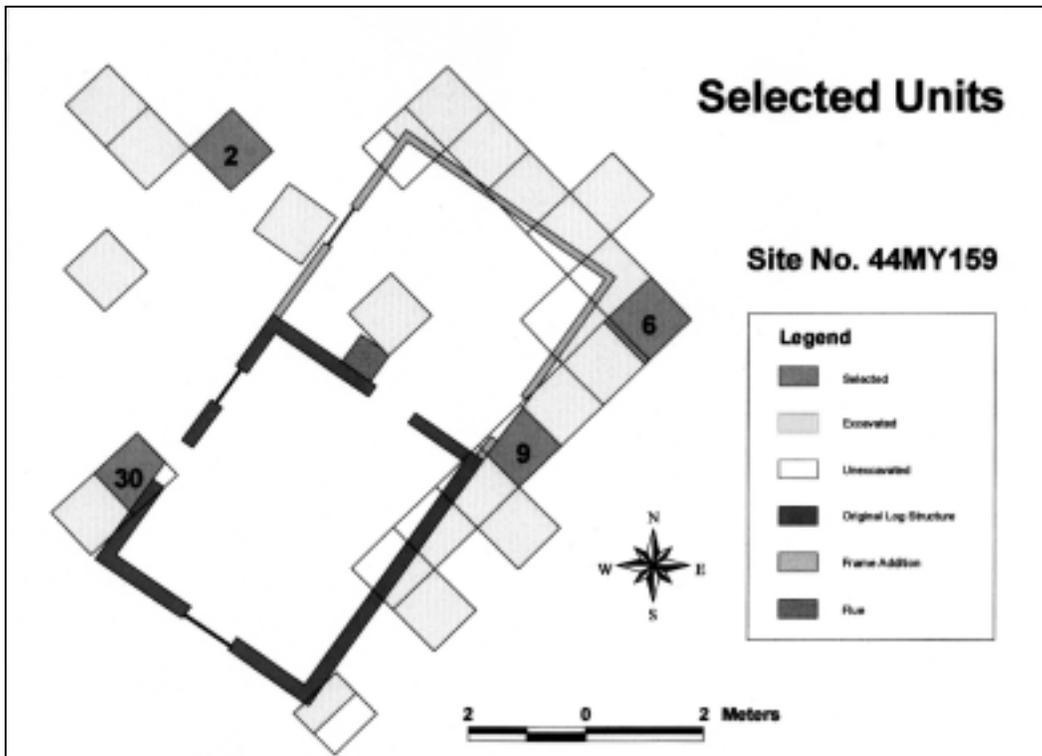
Fig. 37 Schematic highlighting the four units that were selected for nail and window glass analysis. Selection was based on location and artifact content.

Analysis of the nails recovered from the selected excavation units (see fig. 37 for unit locations) was not as successful as was hoped for, due to very poor preservation. High soil moisture content around the cabin had caused metal objects to oxidize rapidly, in many cases beyond recognition. Because time, personnel, and funding did not permit adequate cleaning and conservation when the artifacts were first recovered, further oxidation has occurred while the artifacts were in storage. Unfortunately, few characteristics of the nails could be discerned during a recent examination. In any event, it is unlikely that further information could have been obtained from the analysis of nails found in the subsurface context, given their already poor condition. Table 5, above, lists the numbers and percentages of cut and wire nails that could be identified, as well as for those that could not be identified.

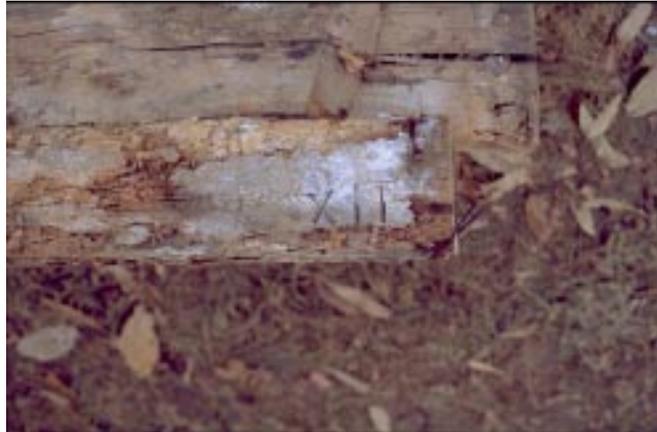
Fig. 38 Log floor joist bearing carpenter's mark.

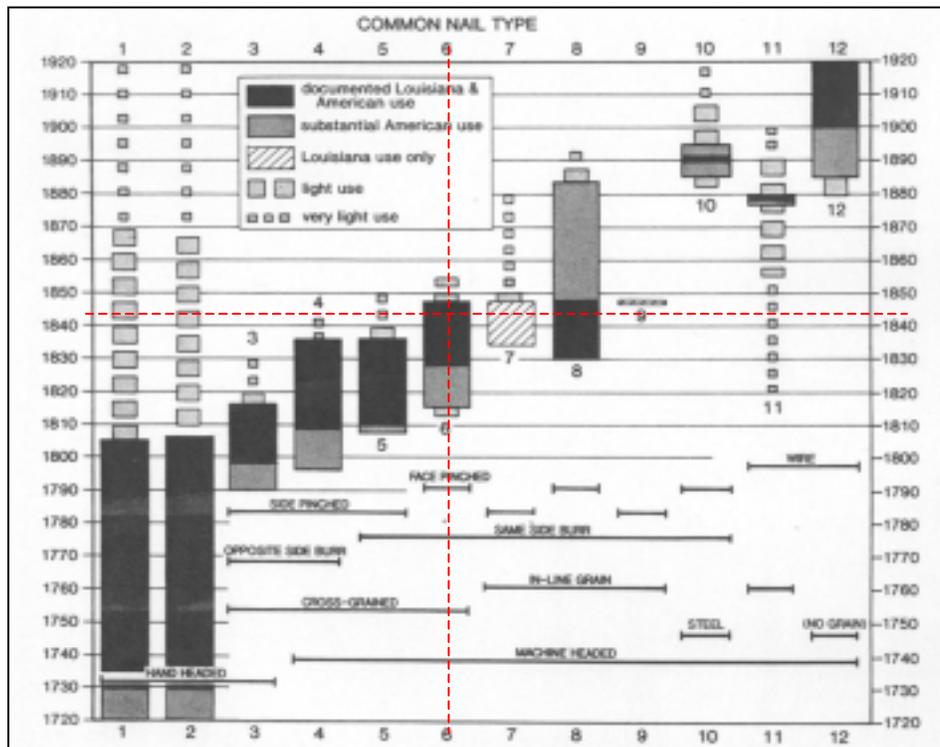
Fig. 40 Time Line Chart. A Summary of the Evolution of 12 nail types. The flooring brad and sprigs recovered from Solitude outbuilding correspond to type 6. Reprinted from Edwards, Jay D. and Wells, Tom, *Historic Louisiana Nails*, 1993, p.63.

The two sprigs and the brad are each made of iron, and are L-shaped, machine-cut, and machine-headed. They exhibit curved transitions from the head to the shaft, rounded points, and uniform, rectangular shaft sections. They were “face pinched” rather than “side pinched” by the header clamp during manufacture, and have both burrs on the same side of the nail. Above all, the most telling detail is the orientation of the iron grains that make up the nail shaft. That is, in these three examples the grain is perpendicular to the length of the nail, or “cross-grained,” rather than parallel, or “in-line.” Because of changes in nail manufacture during the early to mid-nineteenth centuries, it is possible to date cross-grained nails, sprigs and brads to before 1850 (fig. 39). The improved, in-line grained nails were introduced during the 1840s, and quickly replaced the cross-grained nail which had inferior bending properties.⁶⁹ Until in-line grained nails became available, carpenters continued to use old-fashioned hand-wrought nails for clenching, because cross-grained nails would fracture easily if bent to a sharp angle. Cross-grained nails would tolerate a certain amount of bending however, as the sprigs in this sample illustrate.

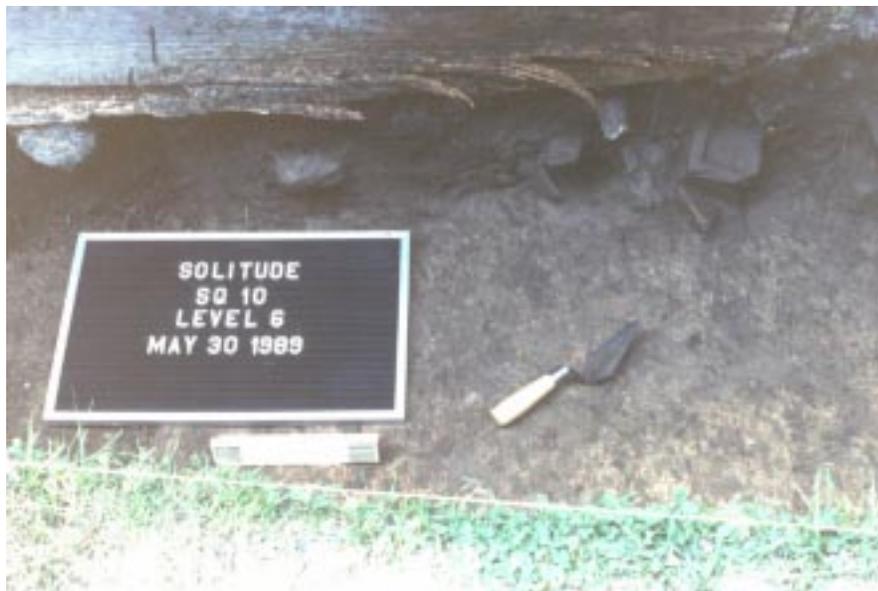
Fig. 41 Base of excavation plan view. Bottom course wall log is visible at top of photograph.

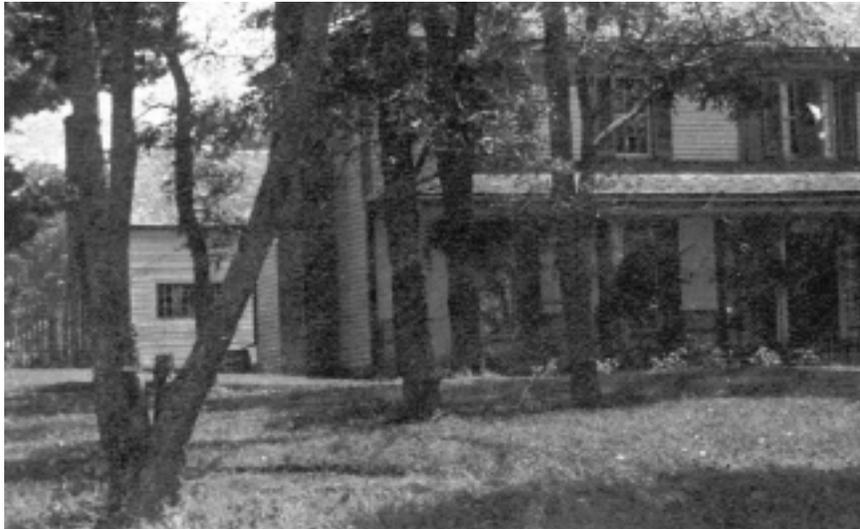
Fig. 47 Enlarged photograph from 1901 provides a slightly better view of outbuilding no. 2. Outline of chimney is just visible behind far left tree. Newman Library Special Collections.

First, a nineteenth century map shows a slightly smaller outbuilding (here denoted as outbuilding no. 2) that stood even closer to the main house, in a more logical placement for a detached kitchen (fig. 48). In fact, two early photographs of outbuilding no. 2, dated 1901 and 1904, also exist. (fig. 46, 47). Although the pictures are quite grainy, it appears that outbuilding no. 2 had a larger chimney than its surviving neighbor did. This chimney, located on the north gable end, was sized for a very large hearth suitable for cooking for a well-to-do family and guests. Although outbuilding no. 1 had a sizable chimney, it is known that it contained two flues, since the loft had its own hearth. This, of course, indicates that the loft was intended for use as a bedroom. The entrance to outbuilding no. 2 was either on the east wall or the south gable end, closest to the rear door of the main house. A picket fence ran from the southwest corner of outbuilding no. 1 to the northwest corner of outbuilding no. 2. This may suggest that both buildings were in the domain of the house servant(s) who lived in outbuilding 1. The Prestons themselves would have little reason to enter this domain, where the mundane chores such as cooking and washing were undertaken. The type and placement of the windows, lack of curtains

in the photograph, and lack of a porch all suggest a utilitarian function for outbuilding no.1, such as a kitchen or washhouse, rather than a dwelling. They appear to possibly be casement windows, which when opened, would allow for more heat to escape than would sash windows.

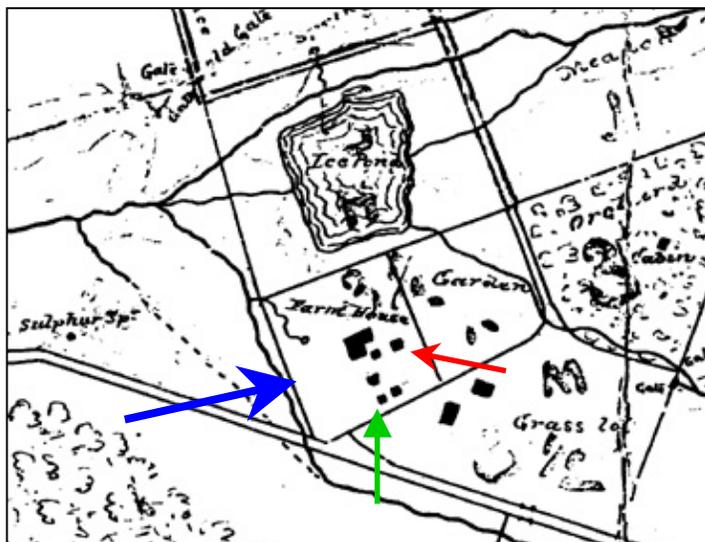
Fig. 48 The Virginia Agricultural and Mechanical College Farm and Grounds, by Col. Wm W. Blackford, 1882. Newman Library Special Collections. Blue arrow denotes Solitude site. Red arrow denotes extant Solitude outbuilding. Green arrow denotes possible slave quarter.

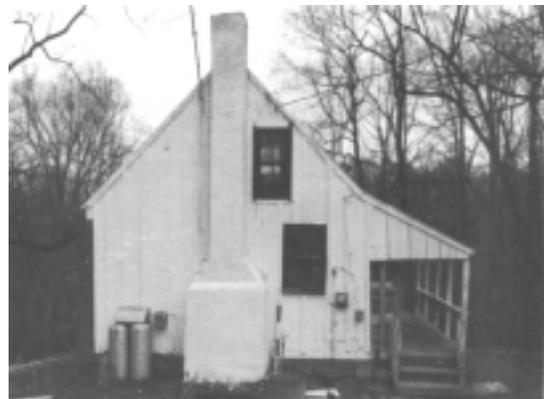
Fig. 49 Home of slave house servants, Anne Arundel Co. Maryland. Located approximately 100 yds. behind the main house. McDaniel, *Hearth and Home*, 93.

corner notching, the V-notch, appears to have been standard, at least in the southern states.⁸⁴ This type of structure was erected quickly and easily, at virtually no cost, and could be disassembled and moved if necessary. Figures 49-52 provide examples of known slave dwellings that were similar in dimensions, form and/or construction. The slave house at Bremono Plantation (fig. 52), was practically identical, complete with a hearth upstairs in the loft. Considering the location and date of the building, two windows, a brick chimney, a wood shingled roof, plank floors and a porch across the front all fit well within the norm. Like the Solitude quarters, the house servant's house in figure 49 is known to have been lathed and plastered on the interior during slave occupation. In many cases, the dwellings were built by slave carpenters, with the design and materials dictated by their master.

George McDaniel, in his book *Hearth and Home*, provided a good look at house servant's quarters on antebellum Maryland plantations (fig 49, 50). He duly noted that house servant's quarters were typically in

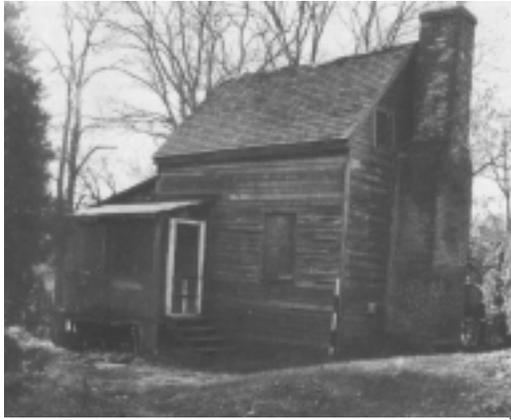
Fig. 50 Slave or servant house built ca.1860.
Anne Arundel Co. MD. McDaniel,
Hearth and Home, 92.

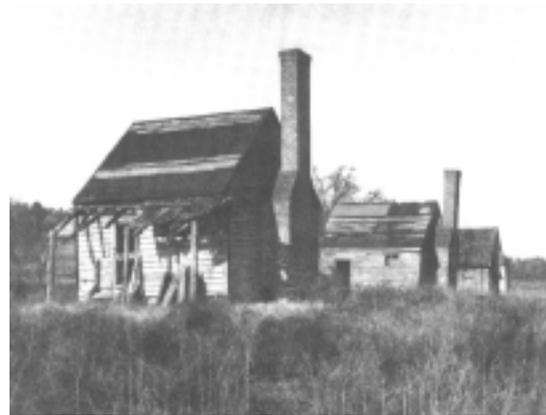
Fig. 51 Row of single-pen slave houses, built ca. 1850.
Roseberry Plantation, Dinwiddie Co. Virginia.
Vlach, "Snug Li'l House" in *Gender, Class and Shelter*, 119.

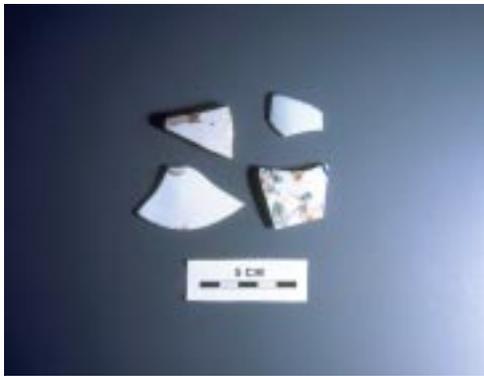
Fig. 54 Transfer-printed and plain whiteware, and two porcelain sherds from the Solitude outbuilding excavations, 1989.

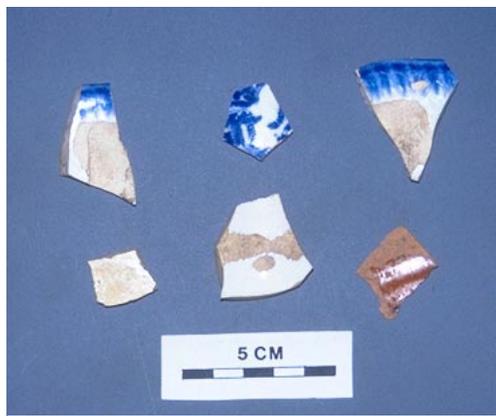
Fig. 55 Assorted whitewares and brown-glazed redware.
