THE VIABILITY OF STEEL-CONCRETE COMPOSITE GIRDER BRIDGES WITH
CONTINUOUS PROFILED STEEL DECK

Thesis submitted to the Faculty of the Virginia Polytechnic Institute and State University in
partial fulfillment of the requirements for the degree of

VIABILITY OF STEEL-CONCRETE COMPOSITE GIRDER BRIDGES WITH CONTINUOUS PERMANENT STEEL DECK FORM

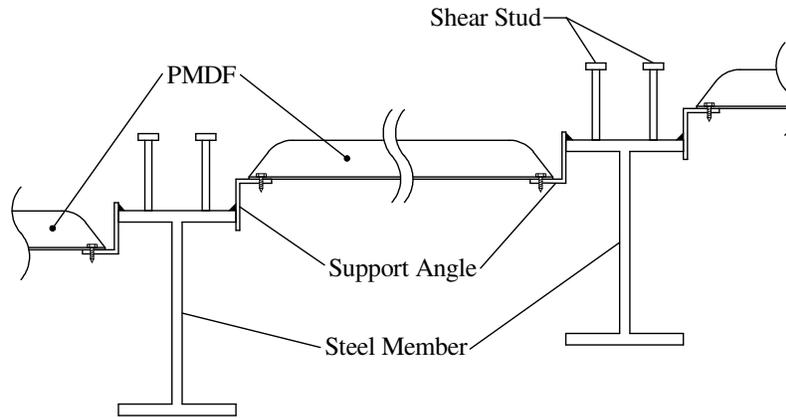
Figure 1.1: Current practice cross-section

In current bridge construction practice, stay-in-place steel deck forms, also known as permanent metal deck forms (PMDF), are often used to support fresh concrete during deck placement for both plate girders and rolled shapes. The PMDFs are placed between the girders and are attached to the top flange using support angles, resulting in a simple span for the deck sheets as illustrated in Fig. 1.1. The advantage of this system is that it allows the contractor to adjust the height of the form to account for variations in girder camber and flange thickness along the length of the girder, thus leading to a uniform deck thickness. A degree of lateral restraint is also provided by the PMDF to the top flange of the girder, however this restraint is reduced by eccentricities resulting from the support angle system and therefore is ignored in current AASHTO LRFD (2007) specifications (Egilmez et al. 2007).

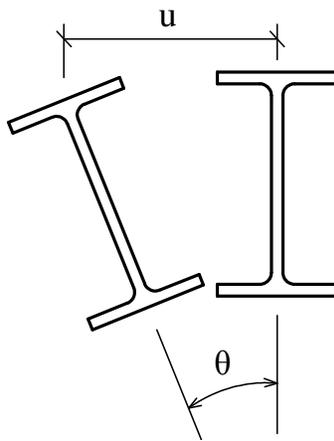
Figure 2.1: Lateral-torsional buckling

Lateral stability is very important to consider during the design of steel bridge girders. This becomes an issue mainly during the construction phase of a steel girder bridge when the concrete is still fresh, creating a large uniform dead load on the girders while providing no lateral restraint for the compression flange of the girders. The failure mechanism that results is known as Lateral-Torsional Buckling. Lateral-torsional buckling (LTB) is a failure mode that involves both a twist and lateral displacement of the section, as illustrated in Fig. 2.1. It is possible to prevent such failure by restraining either torsional or lateral deformations (Yura 2001).

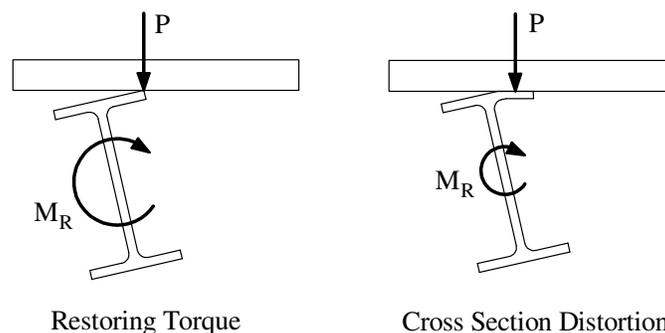
Figure 2.3: Tipping effect in unattached deck (adapted from Yura 2001)

created by load eccentricity. Yura (2001) states that the brace should be placed where it will offset the twist to the greatest degree, therefore bracing applied at the top flange in simple span beams subject to top flange loading causing positive moment will be more effective than bracing placed at the centroid of the section. Top flange loading causes the center of twist to move towards the centroid, which renders a lateral brace placed at the centroid ineffective because there will be no appreciable lateral movement at the brace location. If the loading travels to the girder through a deck that is not attached to the girder, a beneficial tipping effect may also be present. As the section begins to twist, the point of load transfer between the deck and girder shifts from the mid-flange of the girder to the tip of the flange, as shown in Fig. 2.3. This results in a force that resists further twisting of the section. However, this effect is reduced by cross section distortion, which results in more of the section coming into contact with the deck causing the centroid of the restoring force to move towards the center of twist, shown in Fig. 2.3. Section distortion can be prevented by adding transverse stiffeners, however due to the moving concentrated loads in bridge applications, placing transverse stiffeners becomes impractical (Yura et al. 1992). Section distortion, along with the sensitivity of cross section shape and initial load location on the resisting force, lead to the conclusion that the tipping effect should be neglected in design (Yura 2001). The moment gradient also has an effect on the buckling strength of beams. A beam with non-uniform moment, such as that induced by a point load at mid-span, will have a higher buckling strength than a beam subjected to constant moment. This effect was shown to be adequately accounted for through the use of a C_b factor used to describe moment gradient (Yura 2001). One final factor shown to affect the bracing requirements of continuous (and lean-on) systems is the elastic or inelastic stiffness of the member being braced, which affects the contribution of the member being braced to the system as a whole (Yura 1995).

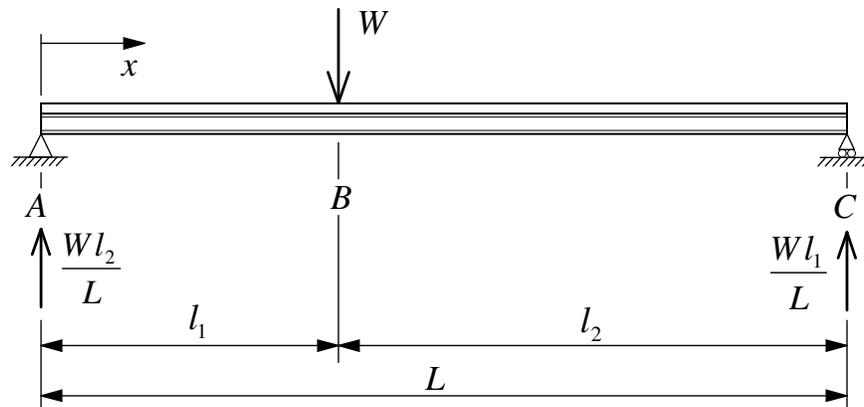
Figure 2.4: Analysis simply-supported beam with point load (adapted from Johnson 1981)

In a linear partial-interaction analysis, a governing differential equation is created based on equilibrium, compatibility, and elasticity that is dependent on the loading condition and solved using the boundary conditions (Johnson 1995). This review will be limited to the case of a simply-supported beam with a point loading at a variable location as this is the setup being investigated in this project's tests. This review presents an analysis method introduced by Johnson (1981) for the beam being considered in Fig. 2.4. In this analysis, it is assumed that the concrete is uncracked and unreinforced, that there is equal curvature in both the concrete slab and steel member, that shear connectors of the same linear stiffness are placed evenly across the whole length of the beam, and that loading is low enough to cause a linear load-slip relation (which should be valid at service loads). Definitions of cross section properties are given in Fig.2.5a while definitions of internal forces are given in Fig. 2.5b.

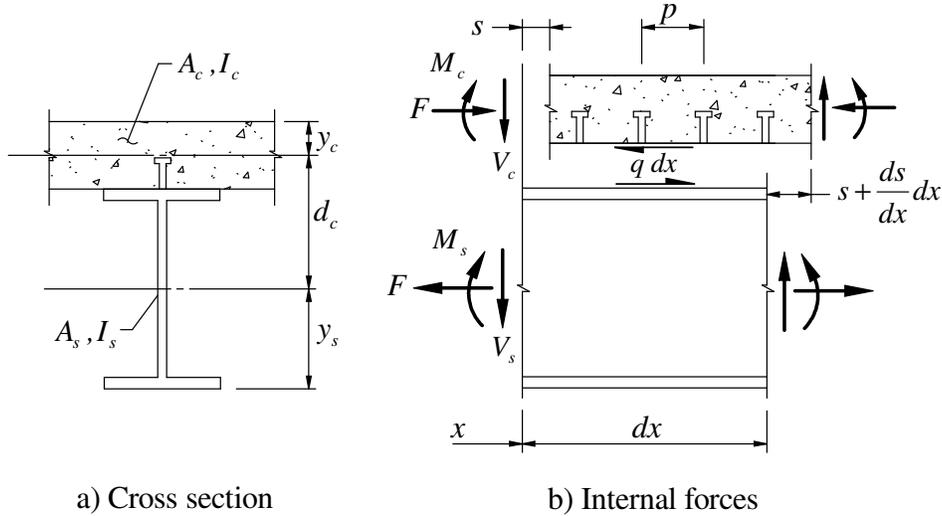
Figure 2.5: Variables used for linear partial-interaction analysis (adapted from Johnson 1981)

At this point the load and boundary conditions specific to the problem at hand are applied to solve for the two constants of integration. For the setup involving the point load as shown in Fig.

2.5 the boundary conditions are $\frac{ds}{dx} = 0$ at $x = 0$ and $x = L$. Due to the discontinuity in the

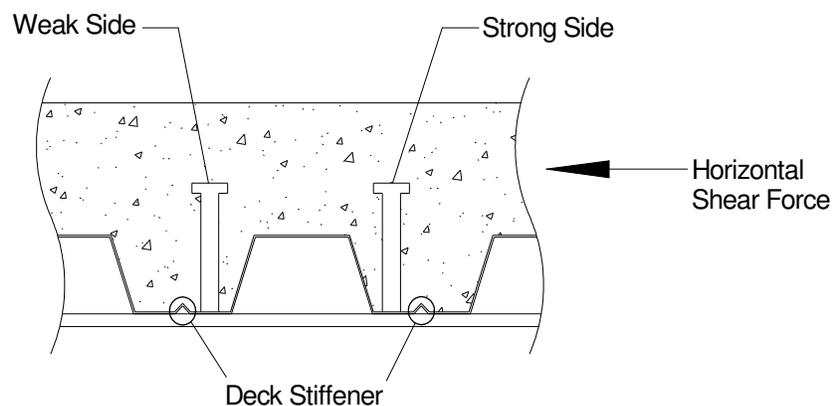
Figure 2.6: Strong Side versus Weak Side shear stud placement
(adapted from Easterling et al.1993)

side of the deck stiffener closest to the end of the span as opposed to a shear stud in the “strong” position which is placed on the side of the deck stiffener closest to the point of maximum moment, as shown in Fig. 2.6. Differences in strength had been noted between the strength of the shear studs in either position, a fact which is partially explained by the amount of concrete between the shear stud and the deck web (Easterling et al. 1993). From the results of four composite beam tests and eight push-out tests, Easterling et al. showed that existing design methods for calculating the static strength of shear studs were unconservative, with shear studs placed in the weak position having a lower static strength than those placed in the strong position. In the beam tests, shear studs in the strong position tests failed by either shearing of the stud shank or by the formation of a concrete shear cone. In the push-out tests, studs failed by the formation of a failure surface in the concrete. Therefore, it was determined that stud strength as a function of the concrete strength. Weak side studs failed by punching through the web of the steel deck without developing the full strength of the concrete or stud shank, therefore the shear stud strength was taken as a function of the steel deck strength. Easterling et al. made no recommendations for changes to existing standards in this study.

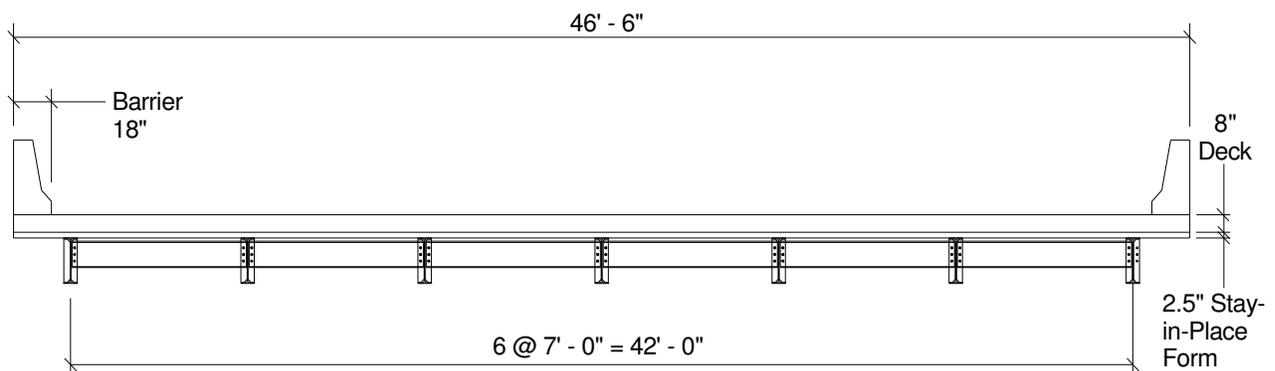
Figure 3.1: Full design bridge cross-section

The girders used in this project have been designed as typical interior girders of the fictitious design bridge shown in Fig. 3.1. The bridge was designed as simply supported with a span of 30 ft. This span was chosen because it represents a typical span length for bridges in which this design system is intended in the field as well as being a length which can easily be accommodated in the lab. The design of the bridge superstructure was conducted following the 2007 AASHTO LRFD Bridge Design Specifications with the only departures occurring in the areas covered by the scope of this project, as will be described in later sections of this chapter.

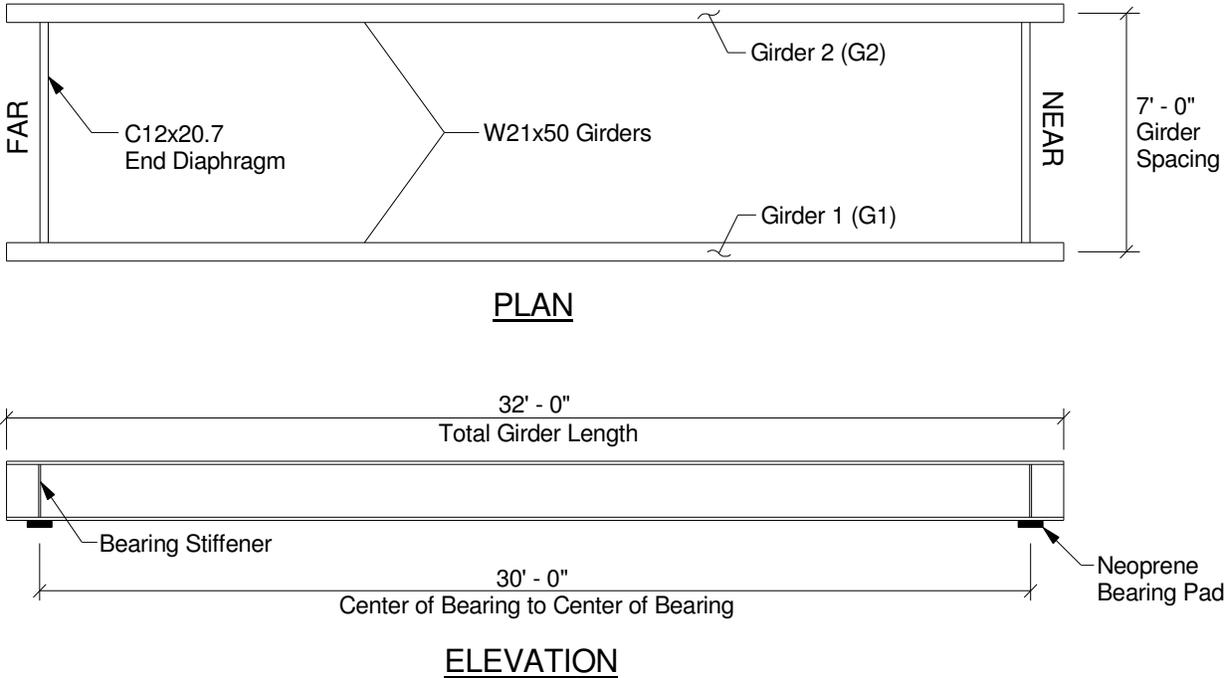
Figure 3.4: Final steel frame system

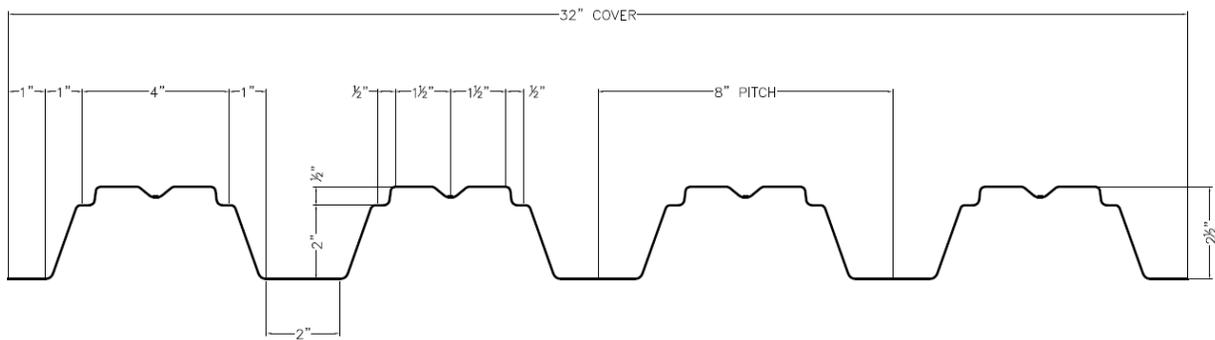
Figure 3.7: Steel deck dimensions

Depth (in)	2.5
Pitch (in)	8
Panel Width (in)	32
Thickness (in)	0.0359
Section Modulus (in ³)	0.457
Moment of Inertia (in ⁴)	0.623
Weight (psf)	2.250

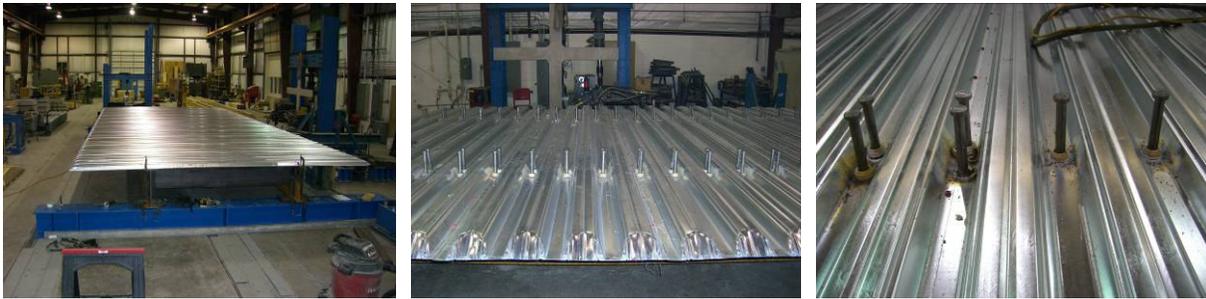
Figure 3.8: Steel deck construction details (a) at form placement (b) swedging of steel deck (c) welded shear studs

was used to trim off the excess at the girder end. Also, the steel deck ends were swedged down to allow for proper connection to pour stops at the edges of the deck, as shown in Fig. 3.8(b).

At this point, the shear stud locations were marked and shear studs were welded in place as illustrated in Fig. 3.8(c). Shear studs and ferrules for this project were manufactured and supplied by Nelson Stud Welding. All shear studs were sound tested to check for weld quality and any studs not passing this test were subjected to the 15° bend test. Any shear stud failing this test was removed and a new stud was welded in its place. The ferrules were then broken off and the bridge was cleared of all debris prior to placing concrete.

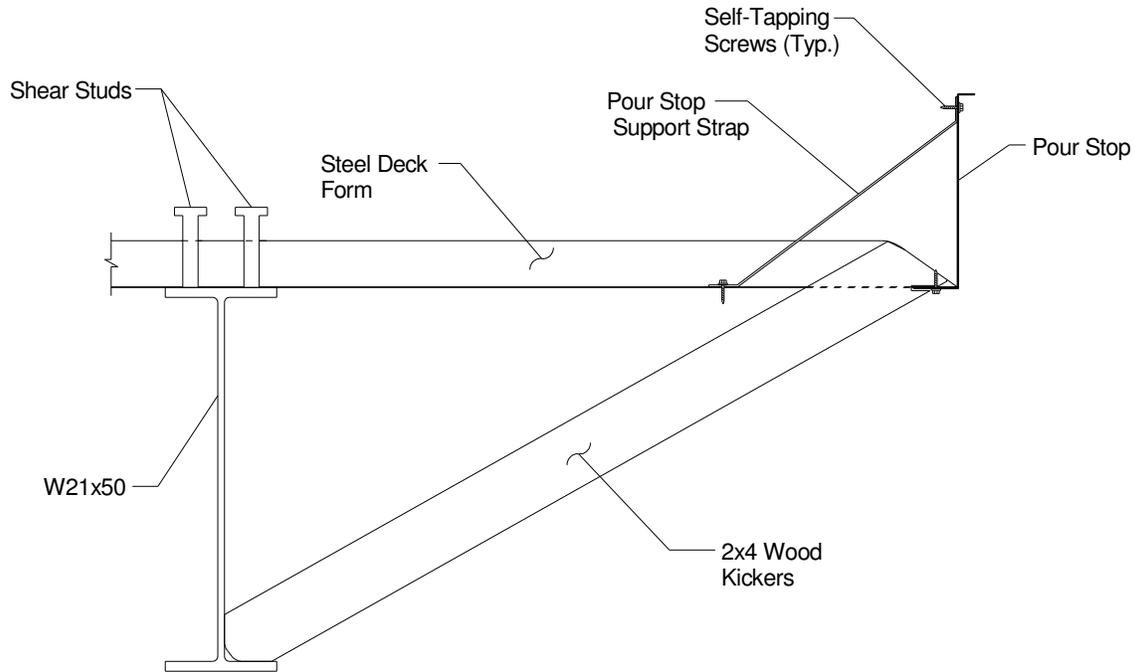
Figure 3.9: Bridge concrete deck formwork

Formwork for the concrete deck was constructed as shown in Fig. 3.9. The 10.5 in. tall steel pour stops were installed first by placing them against the bottom of the steel deck forms and drilling a self-tapping screw up through both the pour stop and the bottom of the ribs at a spacing of every other rib. A 2 ft overlap was provided at each pour stop joint to provide adequate strength to support the fresh concrete. Corners were secured with 6 in. angles cut out of excess pour stop material and then screwing both edges of the pour stop into this angle (see Fig. 3.10(a)). To prevent the tops of the pour stops from bowing out due to excessive concrete pressure during deck placement, 1 in. wide steel straps were installed every 3 ft to connect the tops of the pour stops down to the steel deck, as shown in Fig. 3.10(b). These support straps were placed on the inside of the pour stops and attached by inserting screws from the outside of the form for ease of pour stop removal. Pour stops and steel support straps were both provided along with the steel deck by Wheeling Corrugating, Co.

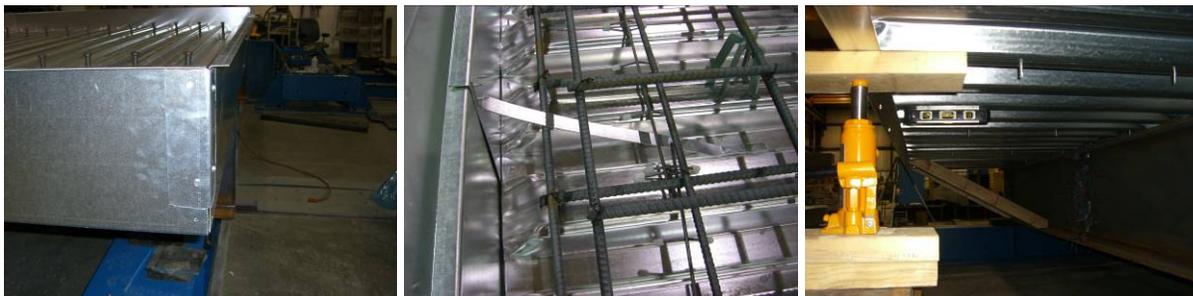
Figure 3.10: Concrete deck formwork details (a) pour stop corner (b) pour stop support straps (c) timber kickers

To support the 3.5 ft deck overhangs before curing of the concrete, 2 in. by 4 in. timber kickers were secured between the girder and the pour stop, as shown in Fig. 3.10(c). This design was chosen because it was desired to have the girder support the formwork during deck placement so that an unshored condition was created. The timber kickers were installed every 2 ft (every third swedge location) by first lifting the edges of the steel deck up so that the overhangs were level using hydraulic bottle jacks, as seen in Fig. 3.10(c). This was done because the deck had a slight camber to it, causing a “rainbow” effect of the formwork. Once level, the timber kickers were installed by placing the proper end in the cavity formed between

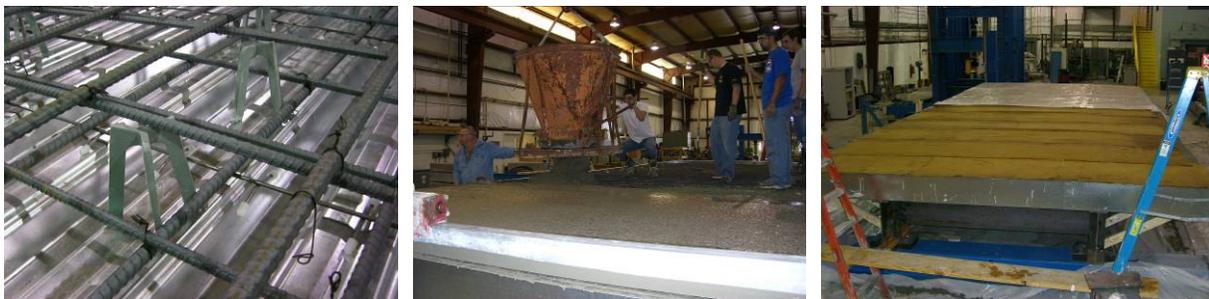
Figure 3.11: Concrete deck pour details (a) Rebar placement (b) deck pour (c) deck moist curing

The two layers of reinforcing steel were added following the installation of the pour stops. For the bottom layer, 5/16 in. rebar chairs were distributed across the top of the steel deck at a spacing of 3 ft (see Fig. 3.11(a)) after which the transverse rebar (No. 5 bars) then longitudinal rebar (No. 4 bars) were laid out on top of these at their respective spacing. The two directions of reinforcing steel were secured together at every other joint using rebar ties. The top rebar layer was constructed in much the same way, using individual 4.5 in. rebar chairs that were set on the top of the ribs. The rebar chairs were placed in a 2 ft by 2 ft grid pattern and the longitudinal rebar was placed directly on top followed by the transverse rebar. The joints were again secured using rebar ties; however, the rebar chairs were tied to the steel bars whenever possible to prevent chair movement during the deck pour.

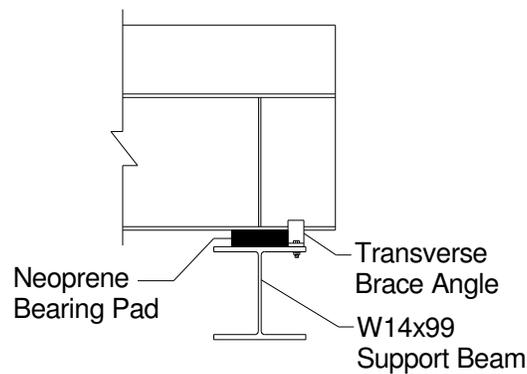
Figure 3.13: Girder bearing details

bearing pads that have been centered on the girder bearing stiffeners to achieve the simply supported, 30 ft span required. The bearing pads then rest on W14x99 support beams on the span ends that are bolted to the reaction floor in the laboratory to prevent movement. This support setup was chosen because it accurately recreates bearing and support conditions used in the field and also because the lab already owned reinforced neoprene bearing pads that could be used for this purpose.

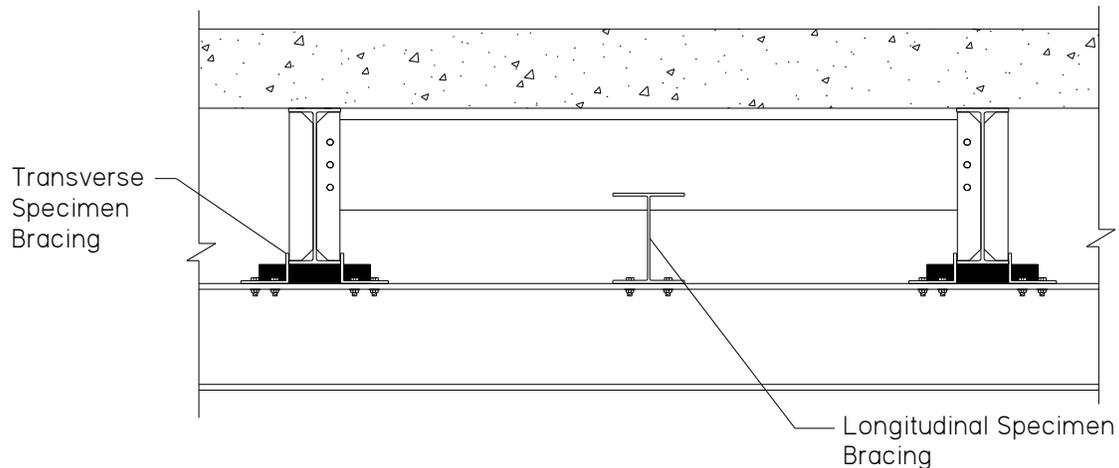
Figure 3.14: Test specimen bracing types

Two types of bracing were installed to prevent movement of the test specimen during the cyclic loading of the fatigue tests. To restrain transverse movement, a series of 2.5 in. wide steel angles (L6x4x3/8) were bolted to the support beam outside of the bearing pads on either side of the specimen girder bottom flanges, as shown in Fig. 3.13 and 3.14. Two of these angles were attached at each bearing location and were placed so that the vertical leg bore directly against the bottom flange, completely restraining all movement. Longitudinal movement was prevented by bolting a 6 in. long wide flange member to the support beam at the center of the end diaphragm, as shown in Fig. 3.14. To allow for rotation of the end diaphragm during loading, the longitudinal bracing was installed so that there was a 0.25 in. clear space between itself and the specimen end diaphragms.

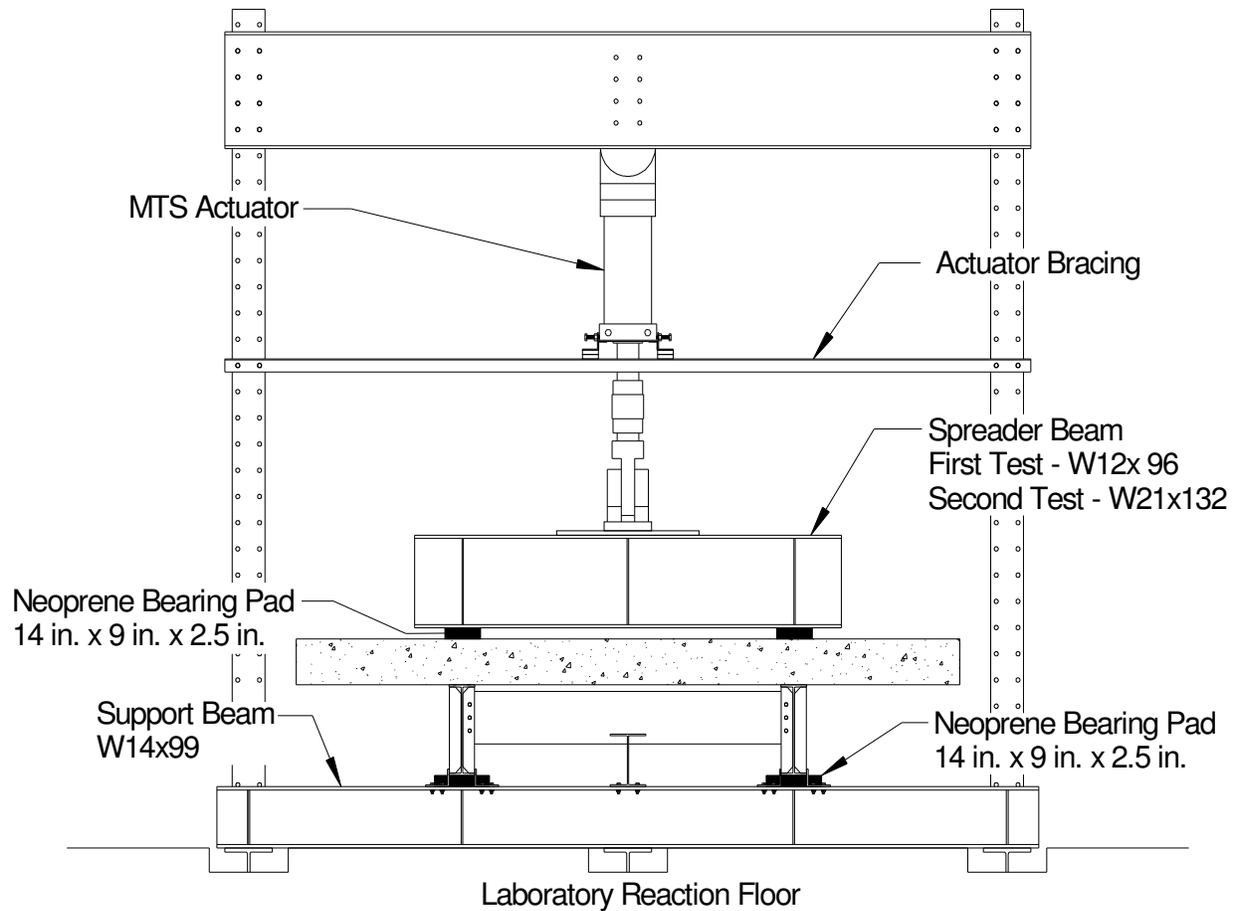
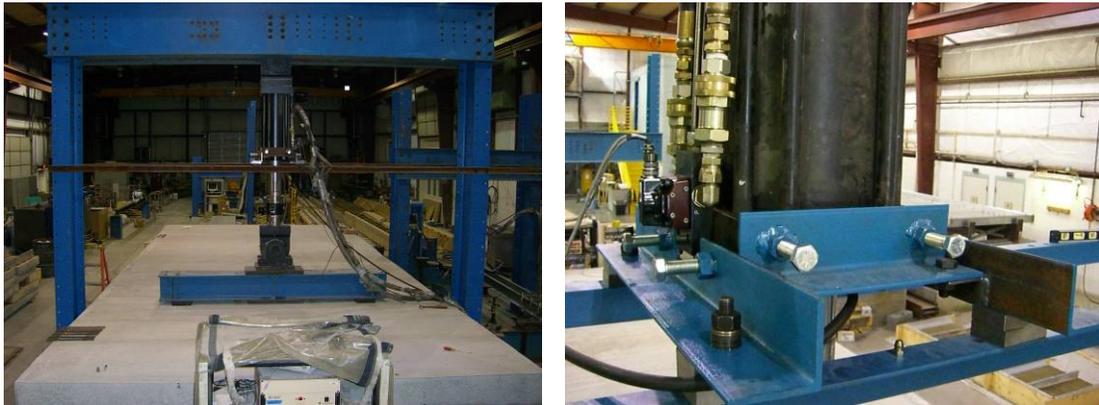
Figure 3.20: Fatigue testing setup

For both tests, a 225 kip hydraulic actuator with a 20 in. stroke length connected to a 30 gpm hydraulic power supply was used to apply the cyclic loading during the fatigue tests. The actuator was mounted in the center of a steel load frame consisting of two vertical columns and two cross members that were bolted down to the reaction floor to ensure that a closed loading system was created, seen in Fig. 3.20. To prevent any lateral or longitudinal movement of the actuator during testing, steel angle bracing was installed that connected the body of the actuator to the columns of the load frame, also shown in Fig. 3.20. The bracing had a clear distance of 0.75 in. from the actuator body on all four sides with bolts placed through nuts welded to the angles that bore against the actuator body which made it possible to adjust the actuator location. Once the actuator was plumb, the bolts were tightened which locked the actuator in place. To properly distribute the load applied by the actuator to the two specimen girders, the actuator head was bolted to the center of a 9 ft long, wide flange spreader beam that bore on two 14 in. by 9 in. by 2.5 in. thick neoprene bearing pads placed on the specimen deck. The neoprene bearing pads were placed at a 7 ft transverse spacing (3.5 ft from the longitudinal centerline of the bridge) on the test specimen at the loading point. This was done to ensure that exactly half the load was transferred directly to each girder while also providing a 2.5 in. clear distance between the deck and the spreader beam that accounted for deflections in the spreader beam under loading.

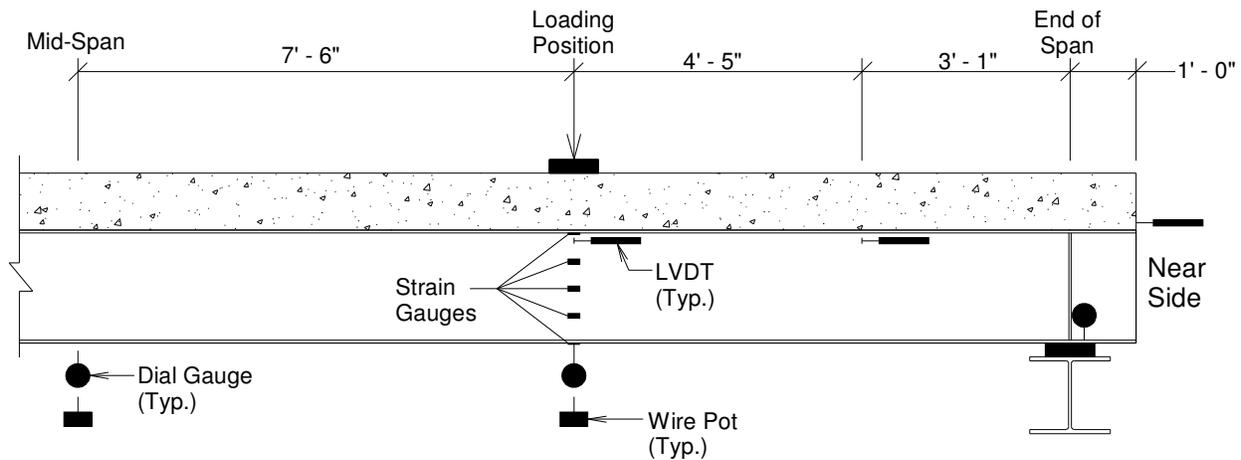
Figure 3.21: Fatigue Test 1 details

horizontal shear and therefore were the most susceptible to fatigue damage. A 50 kip cyclic load range was calculated for this test based on the AASHTO LRFD (2007) design specification equation for the spacing of shear connectors under fatigue loading utilizing a 1,000,000 cycle test length, a shear stud pitch of 8 in. (the rib spacing), a one stud per group layout, and section properties which had been determined from static tests of the specimen. Details of the calculations used to determine the load range are given in Appendix B. The test specimen was loaded cyclically between 5 kips and 55 kips to achieve this range. The cycle rate for the fatigue loading of 1 Hz was based on the limitations of the hydraulic power supply unit. For the static tests, the load was ramped from 1 kip to 51 kips in compression at a constant rate of 250 pounds per second to get the required data. Originally, the first fatigue test was designed to run for 1,000,000 cycles. However, it was later decided to increase the number of cycles to 1,200,000 for two reasons: to determine if trends in the static testing data would continue at the same rate as was being observed and also to observe specimen behavior beyond the design number of cycles.

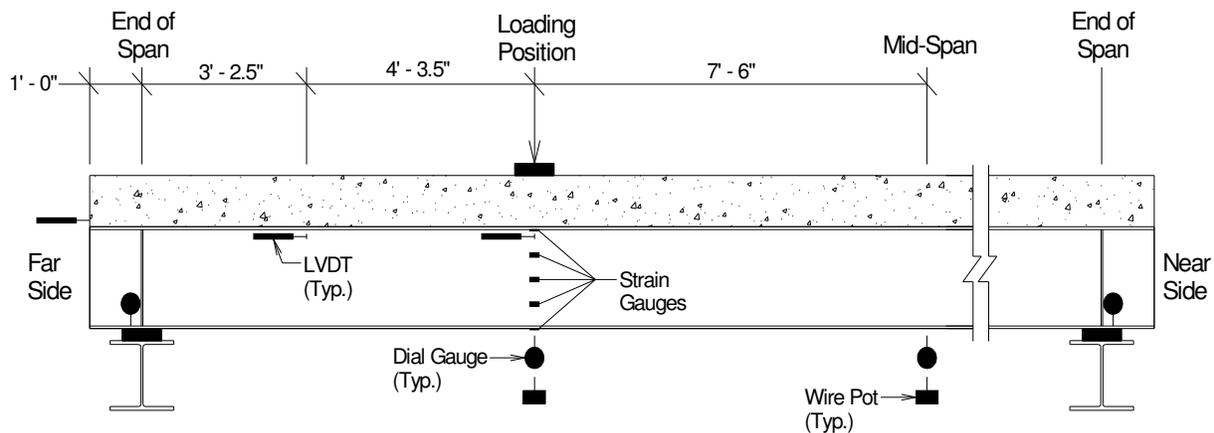
Figure 3.22: Fatigue Test 2 details

Figure 3.22 shows the type and locations of the sensors used to acquire the data during static tests performed at stopping points. The sensor layout was exactly the same for both specimen girders. To more accurately account for the compression of the bearing pads at the girder supports, one additional dial gauge per girder (two total) was added at the near side support to measure the deflection of the girder bottom flange at the supports farthest from the point of loading. All other sensors were located as shown and placed in the same way as in the first fatigue test, described above. All wire pots and dial gauges were again unhooked from the girder bottom flange during cycling, as in the first test, to prevent causing unnecessary damage to the sensors.

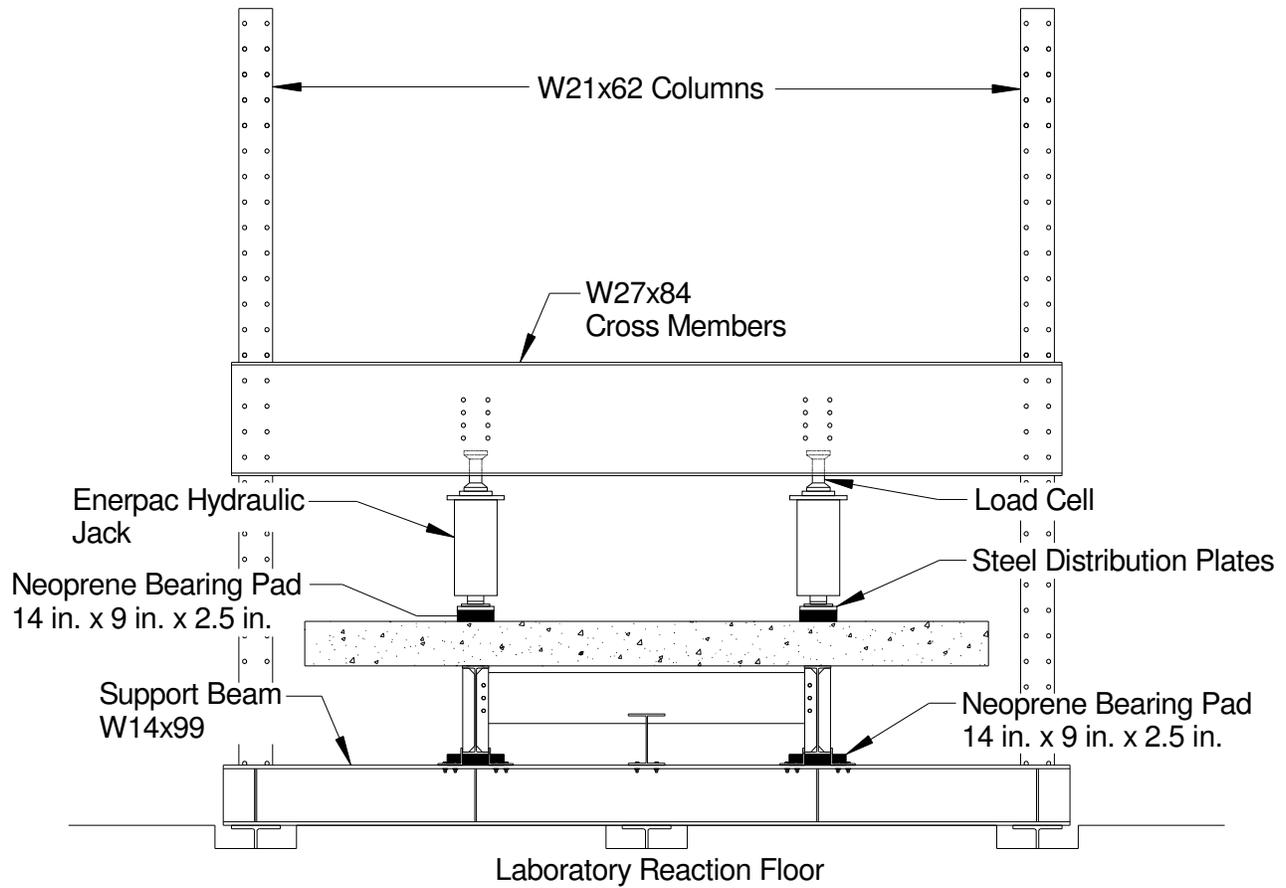
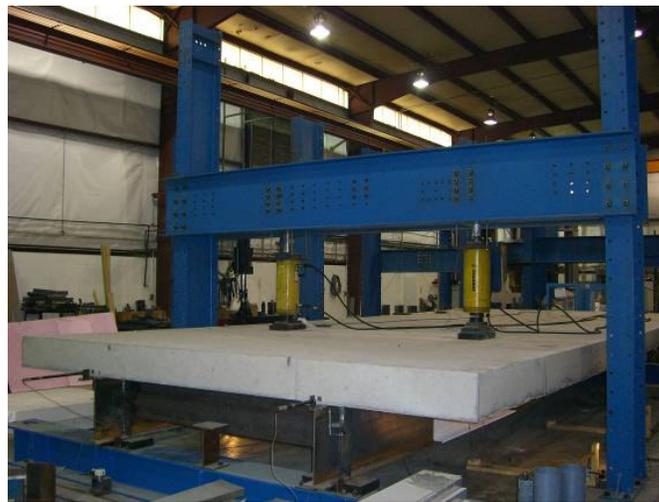
Figure 3.23: Static testing setup

Upon completion of the second fatigue test, static tests were conducted at the quarter points of each half of the test specimen to determine the residual capacity (or plastic moment capacity) of each type of stud layout to observe how these compare to calculated values. The static test support conditions were kept the same as in the fatigue testing, with the bridge resting on 9 in. by 14 in. neoprene bearing pads to create a simply supported condition. Longitudinal and transverse bracing was also kept in place to ensure that no movement of the test specimen occurred. The overall test setup is shown in Fig. 3.23.

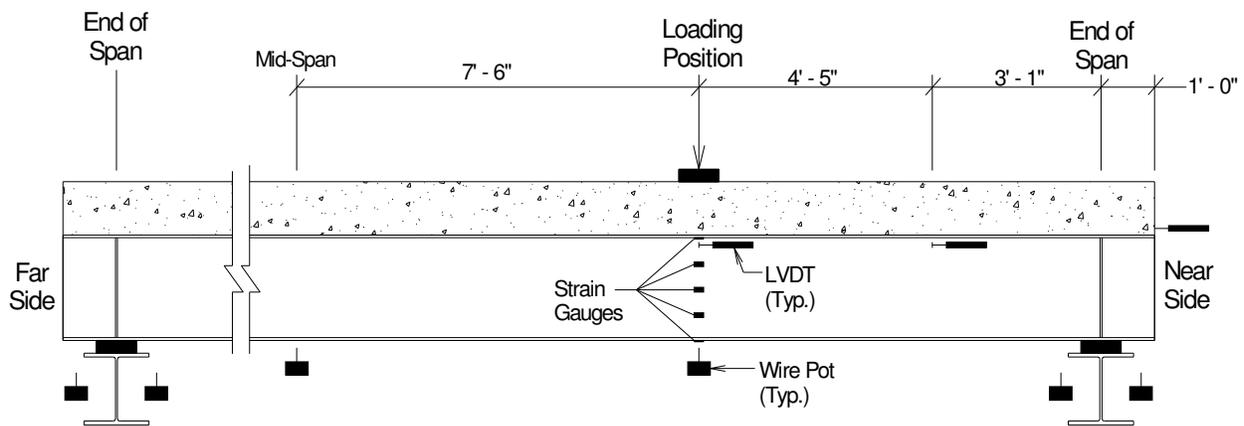
Figure 3.24: Near side static testing details

The first static test was conducted at the quarter point of the test specimen located in the near half, where there was a one stud-per-rib layout. Loading and instrumentation details of the first static test are given in Fig. 3.24. The purpose of this test was to determine the elastic response of the test specimen with the one stud-per-rib layout. An initial load of 20.0 kips, approximately 12% of each girder's near-half calculated plastic capacity of 170.6 kips for each composite girder, was applied to each girder and then removed to seat the specimen before the static test began. Details of the calculation of plastic moment capacity are given in Appendix G. All instruments were zeroed following the seating of the specimen. For the actual test, load was applied in 5 kip increments until up 65 kips was reached on each girder. At this point, the test was stopped while the specimen was still in the elastic response region and the specimen unloaded to prevent causing any significant damage that could negatively affect the results of the second test. The results of the second test were deemed to be of greater value due to the more reasonable level of composite action utilized in the two stud-per-rib geometry. The specimen was unloaded and the load frame moved to the far side quarter point to run the second static test.

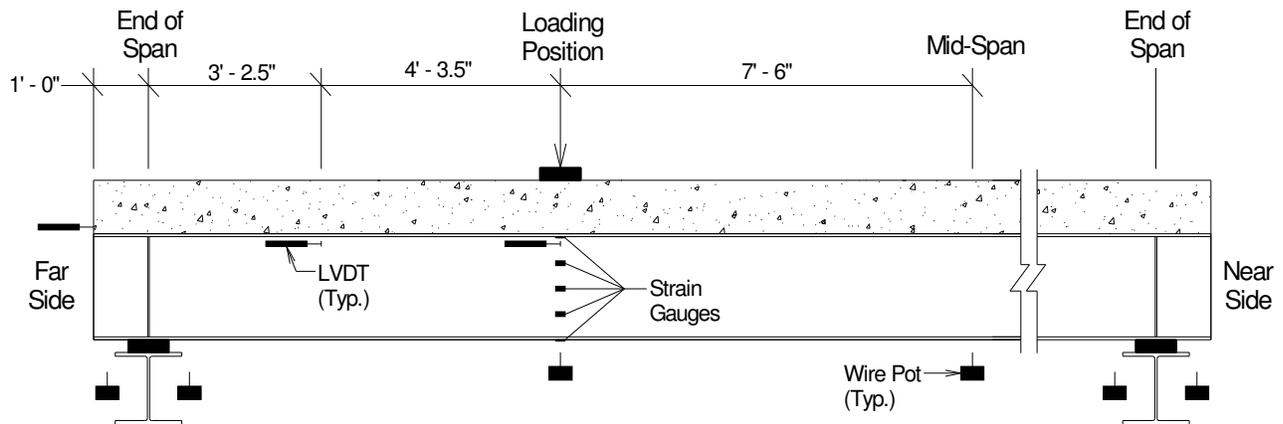
Figure 3.25: Far side static testing details

The second static test was conducted at the quarter point of the test specimen located in the far half, where there was a two stud-per-rib layout. Loading and instrumentation details of the first static test are given in Fig. 3.25. A load of 26 kips, approximately 15% of the calculated plastic capacity of 204.2 kips for the far half test specimen, was initially applied and removed to seat the specimen for the test and then all instruments were zeroed. Details of the calculation of plastic moment capacity are given in Appendix G. Load was then applied in 5 kip increments while a plot of the load versus vertical deflection at the point of loading was created. At the point when the graph began to indicate a non-linear behavioral response of the specimen, the method of loading was changed from increments of load to increments of deflection. Loading was continued until a total vertical deflection of 2.75 in. at the point of loading was reached, where it was determined that the plastic moment had been attained. The specimen was then unloaded and the load frame and all sensors were moved back into position to load the near half quarter point.

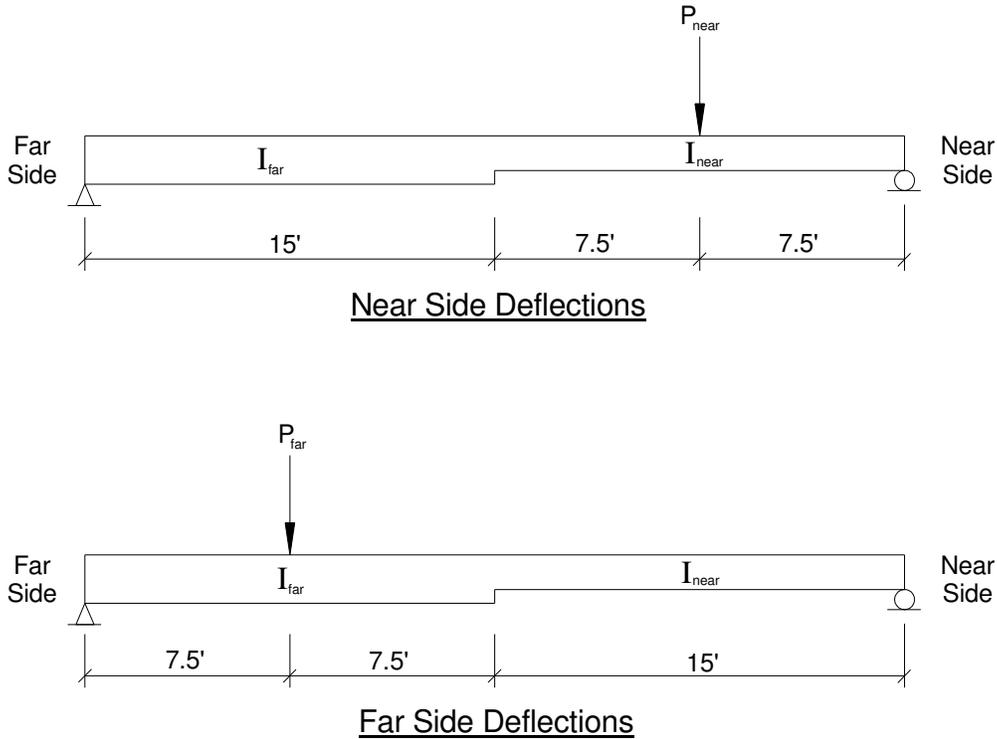
Figure 4.1: Calculation of non-prismatic beam deflections

deflections at the point of loading for both girders. As was assumed, the results indicate that when a non-prismatic section is used, the near half deflections decrease while the far half deflections increase, illustrating that the change in stiffness of one side affects the stiffness of the other.

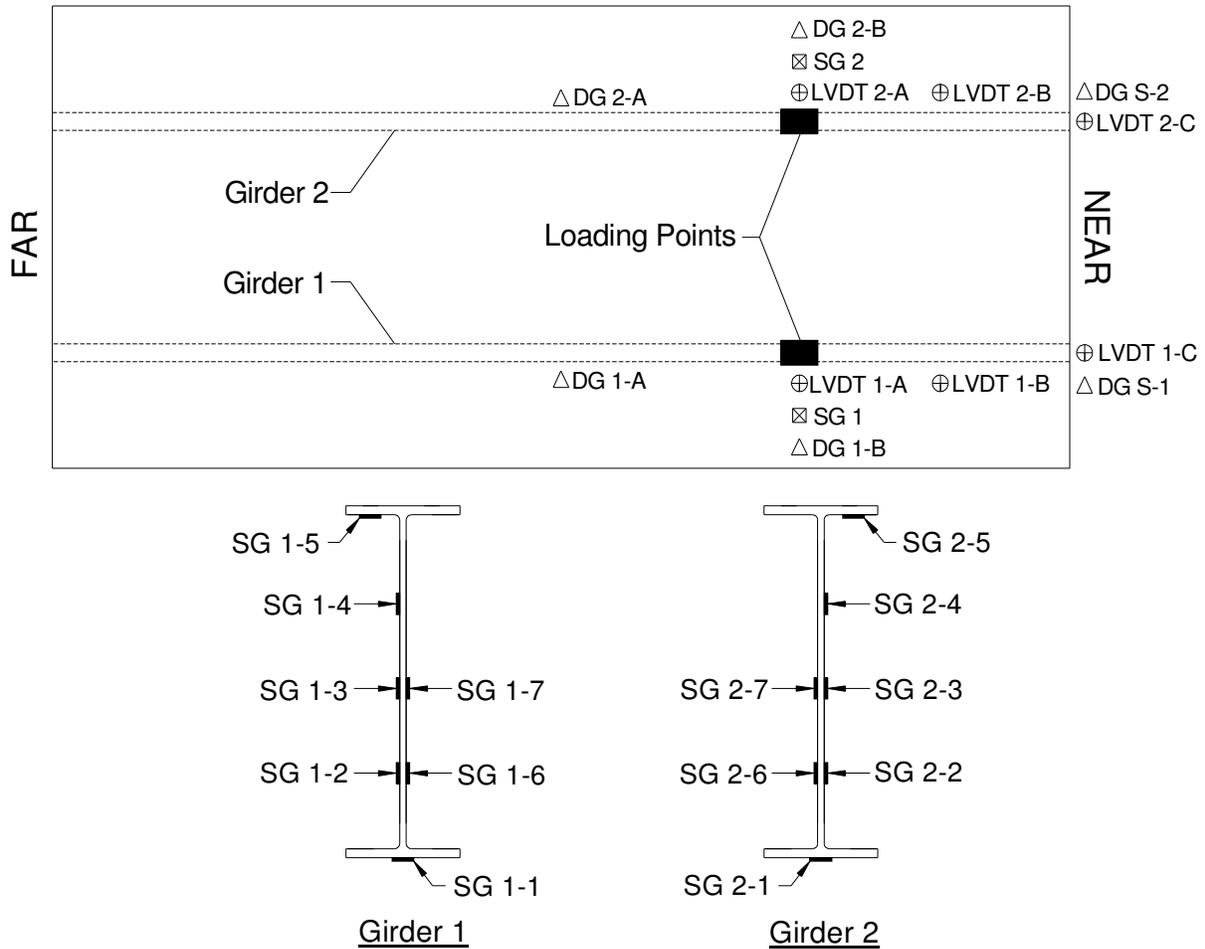
Figure 5.1: Fatigue Test 1 sensor locations and labels

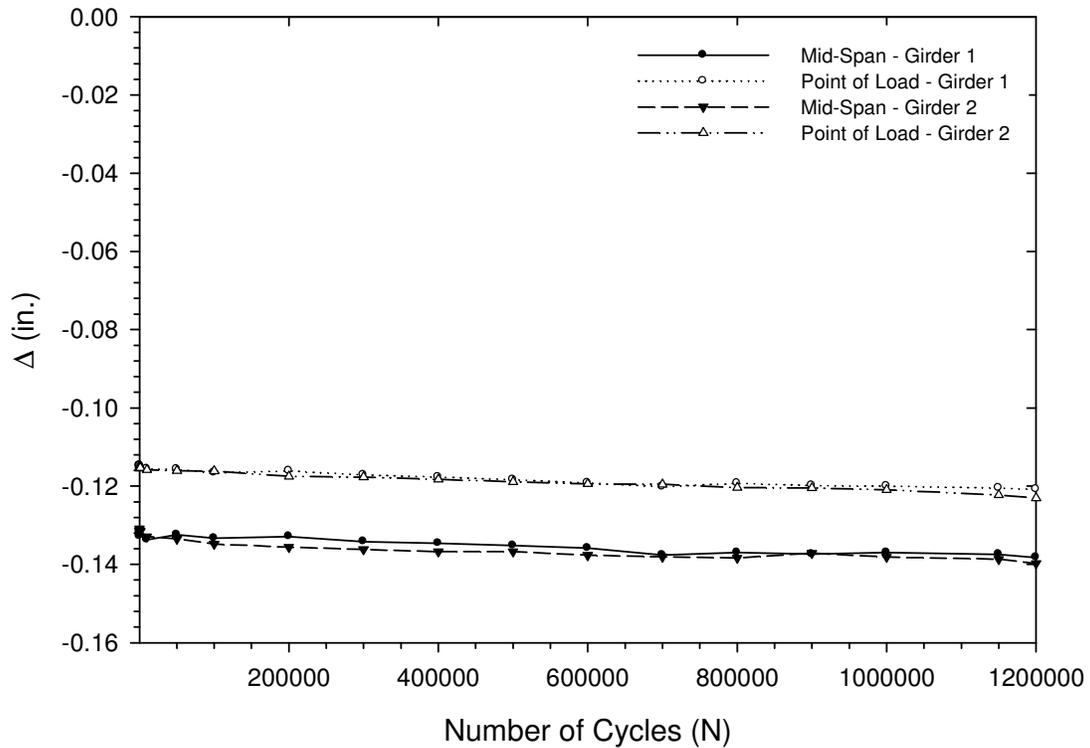
Figure 5.2: Vertical deflection results for 50 kip loading in Fatigue Test 1

Figure 5.2 provides a plot of the adjusted vertical deflections at each sensor location (corrected for support effects) under the 50 kip loading versus the number of cycles for both the mid-span (A) and the point of loading (B) locations. The group of two lines with the lower values represents the vertical deflection at the point of loading locations, 1-B and 2-B, while the group with the higher values represents the vertical deflection at the mid-span locations, 1-A and 2-A. As can be seen, from 1 to 50,000 cycles, the deflections in both girders increase at a rate faster than any other time during the test, which seems to indicate that some settling of the test specimen occurred during this time period. It is assumed that pockets were formed in the concrete adjacent to the shear stud shanks during this settling period which lead to large slips in the composite system causing the loss of stiffness and increased deflections until the concrete compacted and stabilized around the studs and slips stopped increasing. This assumption is supported by the slip results (presented in later sections) which show large increases in slip until 100,000 cycles were reached when the slip values at all three locations began to level off or even decrease. After the 50,000 cycle mark, both girders behaved similarly over the course of testing, and appear to lose stiffness at about the same rate with the increase in deflection per number of cycles appearing to be almost linear for all locations on both girders. Figure 5.2 also shows that at the design number of cycles, there was no significant jump in the rate of the increase in vertical deflection in Girder 1 while there was only a slight increase in Girder 2, which will be addressed in the elastic neutral axis results.

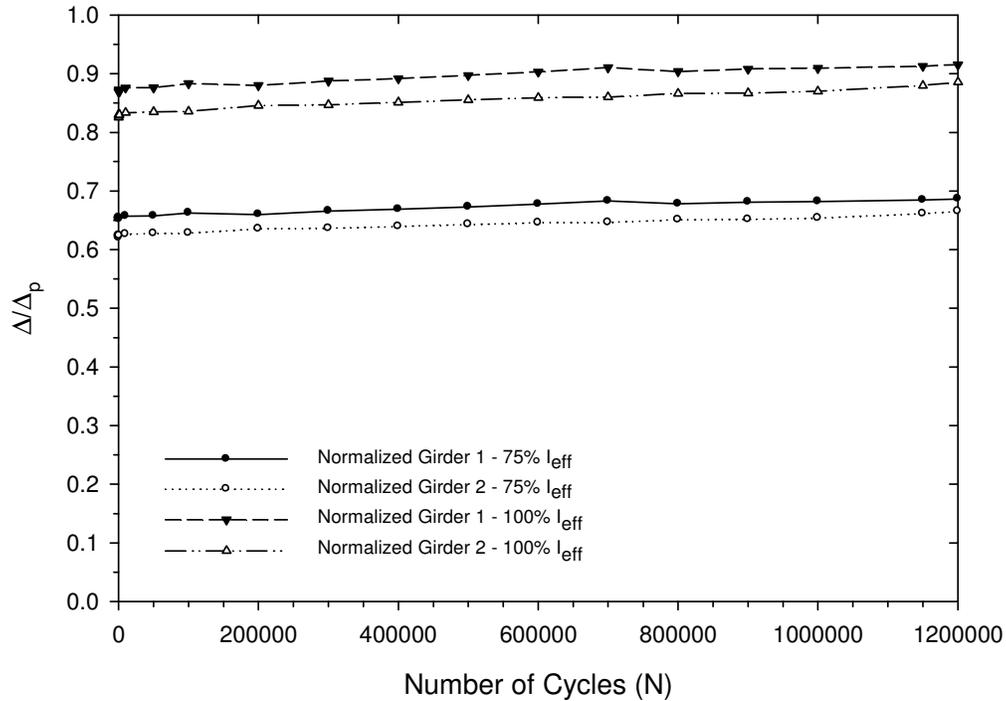
Figure 5.3: Point of loading deflections normalized to predicted values in Fatigue Test 1

It is important to note that the initial deflections for both girders at all locations were lower than was predicted for the given level of composite action. Figure 5.3 provides a plot of the measured deflection values at the point of loading normalized to the calculated values of deflection at this point using both 75% and 100% of the effective moment of inertia as provided by the AISC commentary provisions (2005) for both girders in Fatigue Test 1. As can be seen, the measured deflections are less than the calculated deflections for both values of the effective moment of inertia over the entirety of the test. These results indicate that the predicted moments of inertia were conservative for the level of composite action present in the system (at 32% composite) even at the end of testing. The unreduced effective moment of inertia provides a more accurate prediction of the deflections while still remaining slightly on the conservative side.

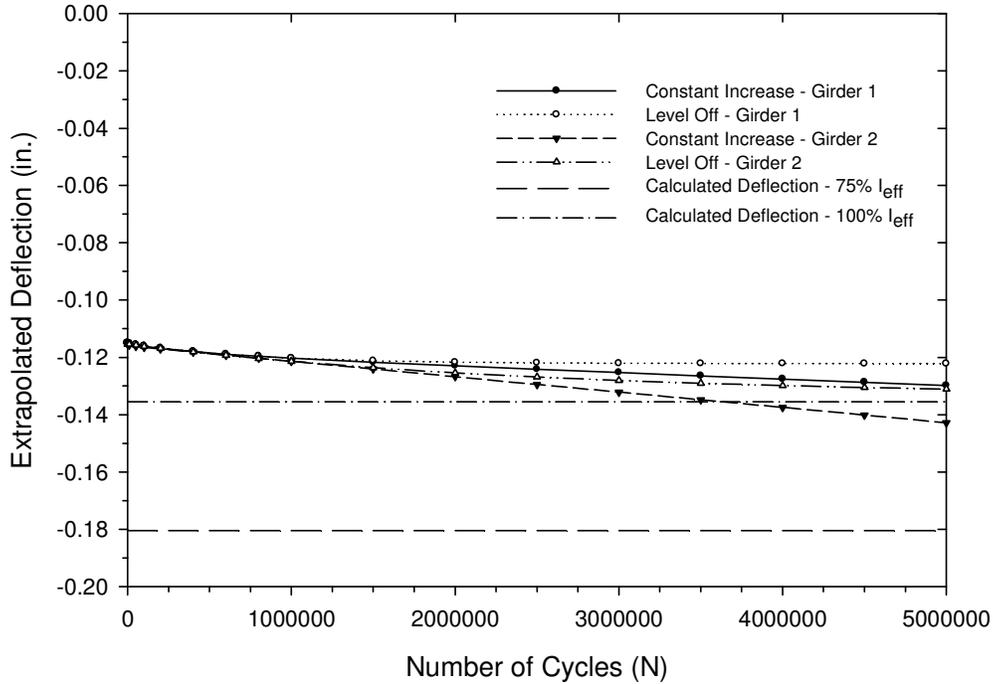
Figure 5.4: Vertical deflections extrapolated to 5 million cycles in Fatigue Test 1

reflected in the testing. These results indicate that there is still a significant amount of residual strength and stiffness at five times the design number of cycles.
